Annual Stormwater Management Report

VSMP Permit No. 0088595 – FY 2016

Submitted by:
Prince William County
Department of Public Works

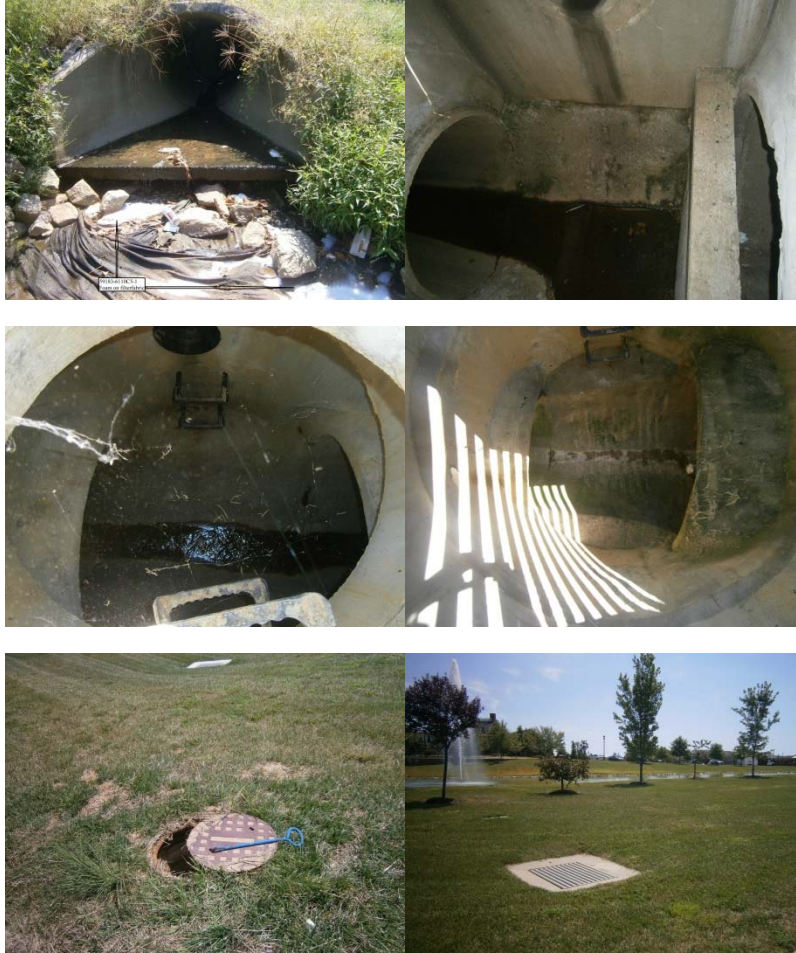
Foam found to be developed on filter fabric laid after outfall in detention basin. After tracking discharge it had been concluded that the significant amount of discharge generated by ground seepage thru leaky joints along storm sewer. The inclusive investigation will need to inspect storm sewer, laid in- between houses and parking garage of house no 2739 to 2731 Celestial Drive, in which access was not available at this inspection. Observed foam gassed to be produced by singular events of washing and cleaning with soap, detergent or chemicals in storm sewer commanding areas because there was no permanent stain on structural surfaces and the result of water quality parameter found within the standard limits. The violator could not identify so the case has been closed. However, Periodic inspections need to be done for inclusive investigation since it had been kept in suspected outfall in future.

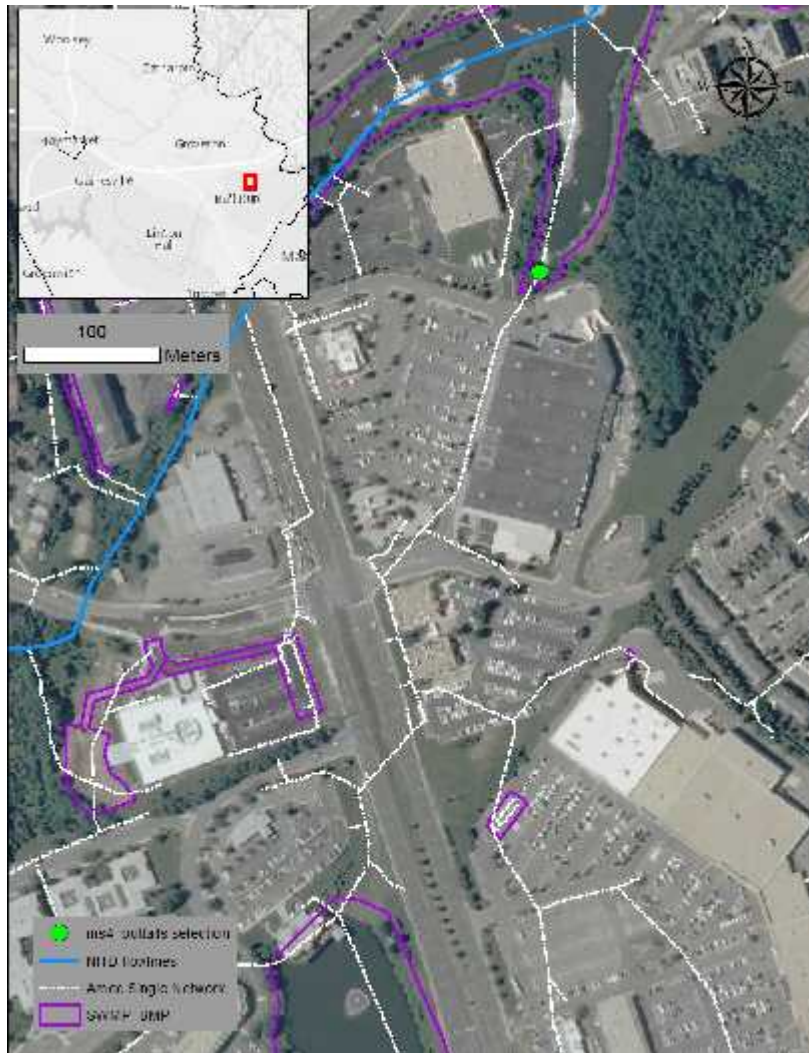
#684: Bull Run, Lowes Parking Lot

- 84" x 54" box culvert
- Contribution from upstream BMP
- ~1" flow during storm (7/18)
- Low visibility, steep slopes

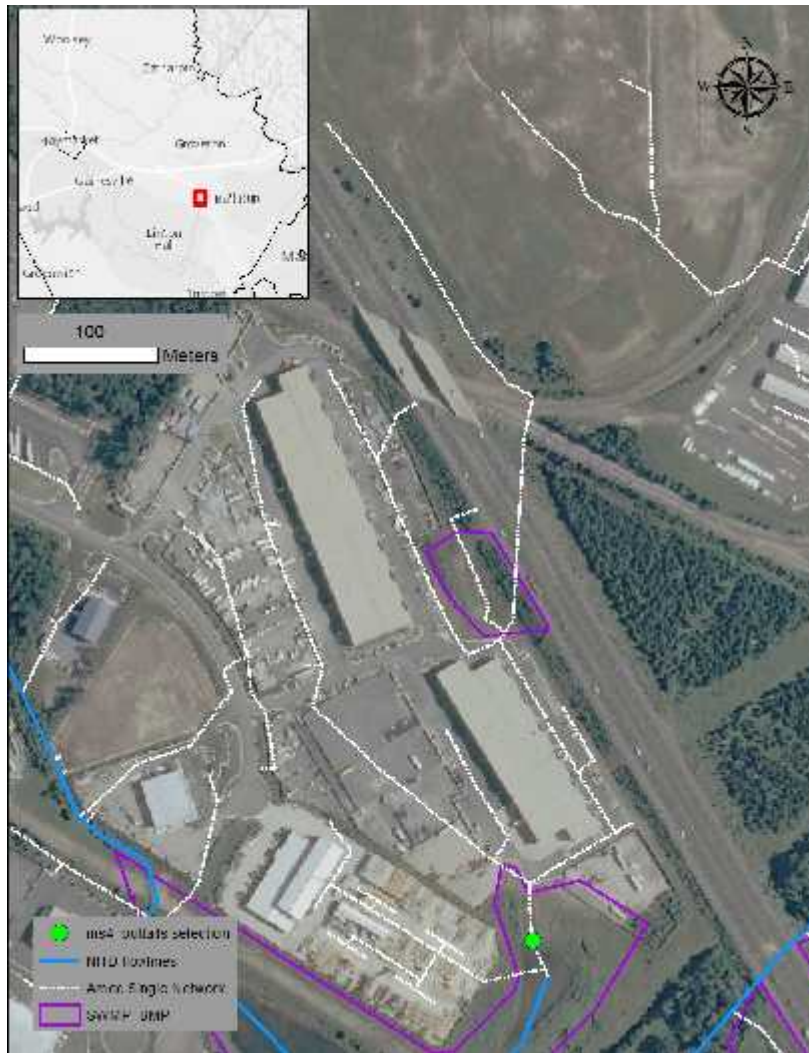
#941: Bull Run, Prince Wm. Parkway

- **54" concrete pipe**
- **Signs of recent repair**
- **1/4" water, level with spillway**
- **Debris in spillway**
