Appendix F Index

Stream Assessment Photographs

Appendix F
Stream Assessment Photographs
Occoquan Watershed – Study of Four Subsheds
WSSI #25156.01

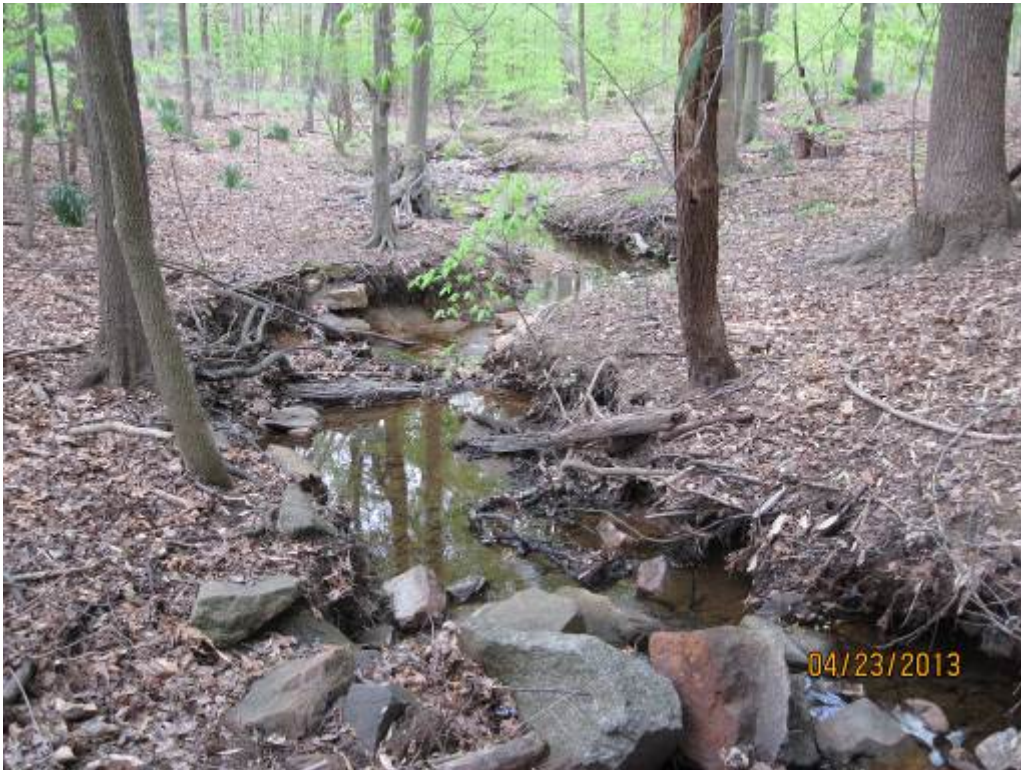
1. Looking downstream at Stream Reach 2. This is a typical view of Stream Reach 2, showing some incision and bank instability throughout the reach.

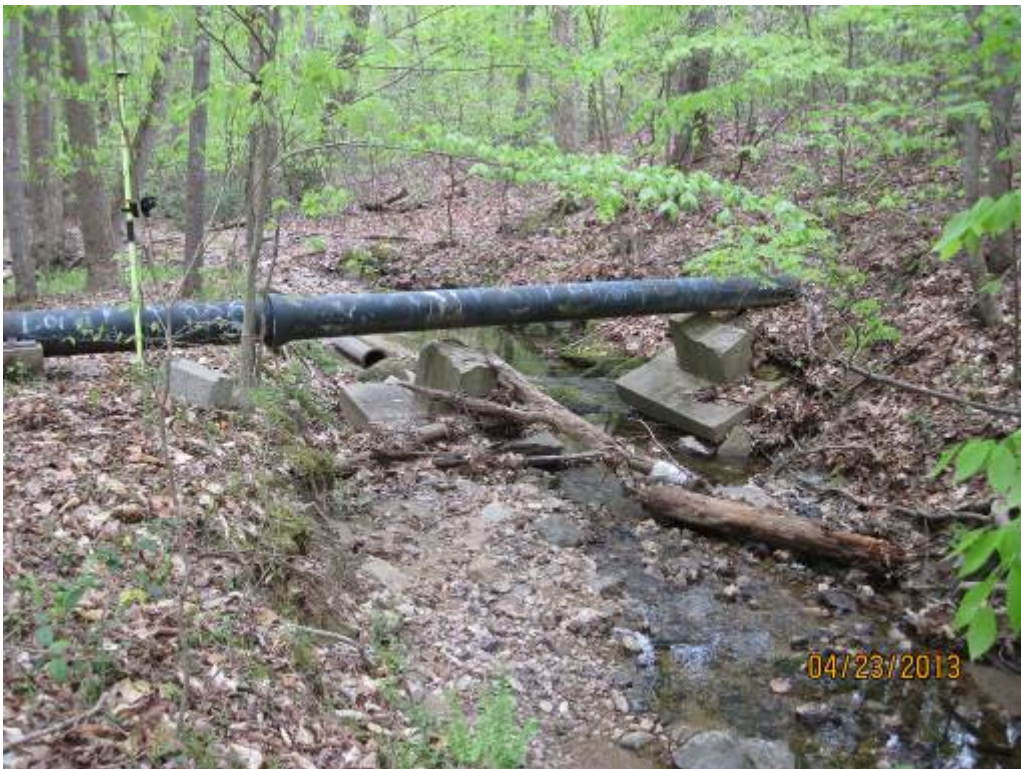
2. Looking downstream at failing piers of an elevated utility that crosses Stream Reach 2, a result of the active incision and widening of this reach.

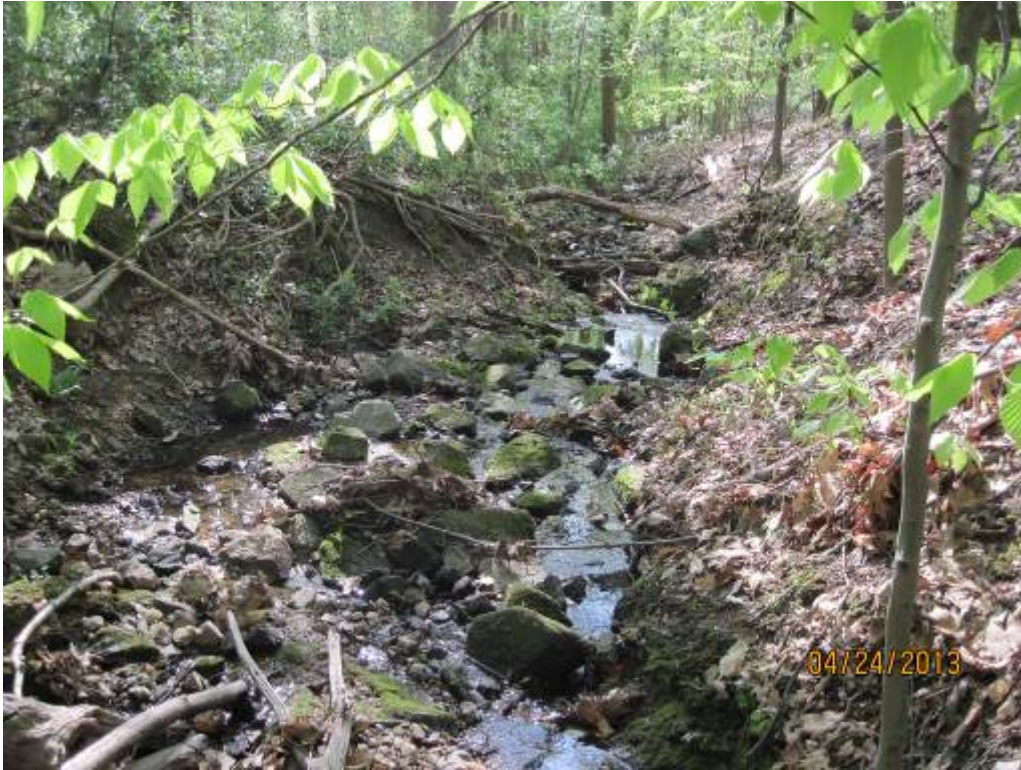
3. Looking downstream at Stream Reach 3. This is a typical view of Stream Reach 3, showing incision and bank instability throughout the reach.

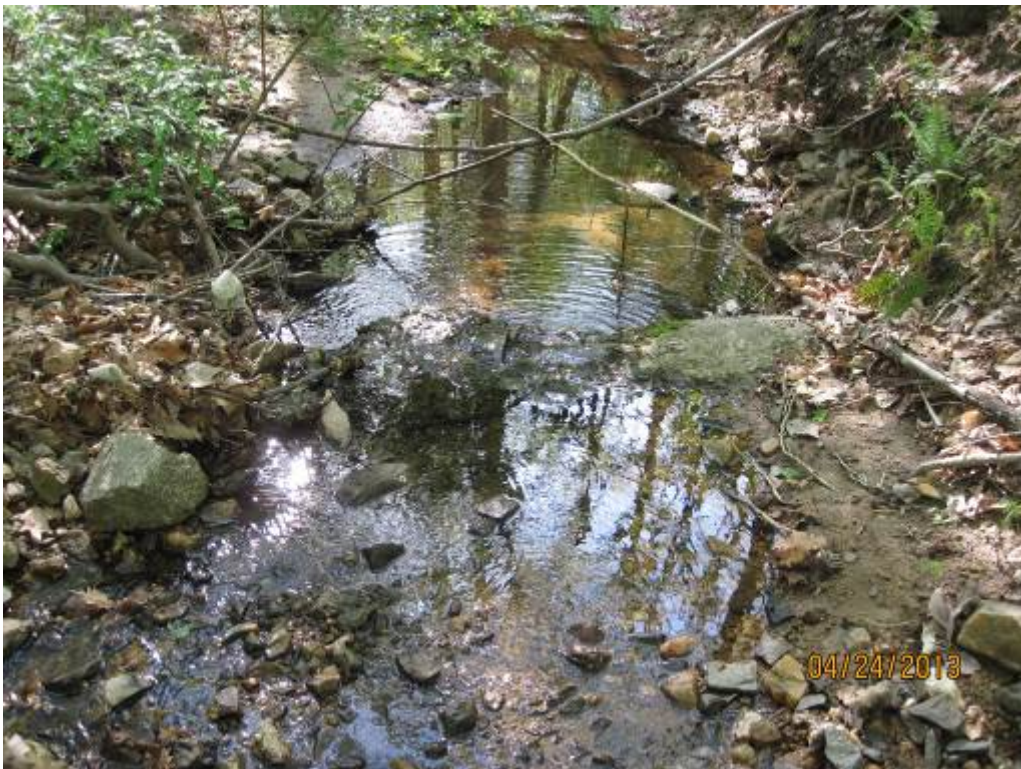
4. Looking downstream at an exposed utility within Stream Reach 3.

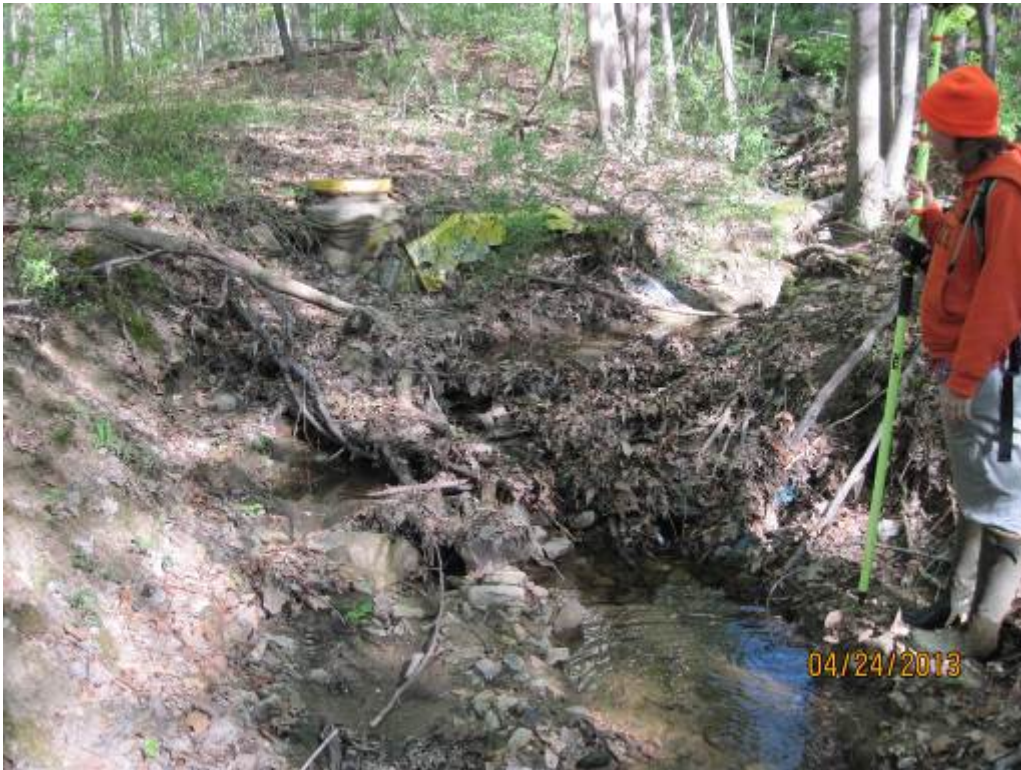
5. Looking upstream at an exposed sanitary sewer manhole along Stream Reach 3. The stream is migrating toward the manhole, exposing it.

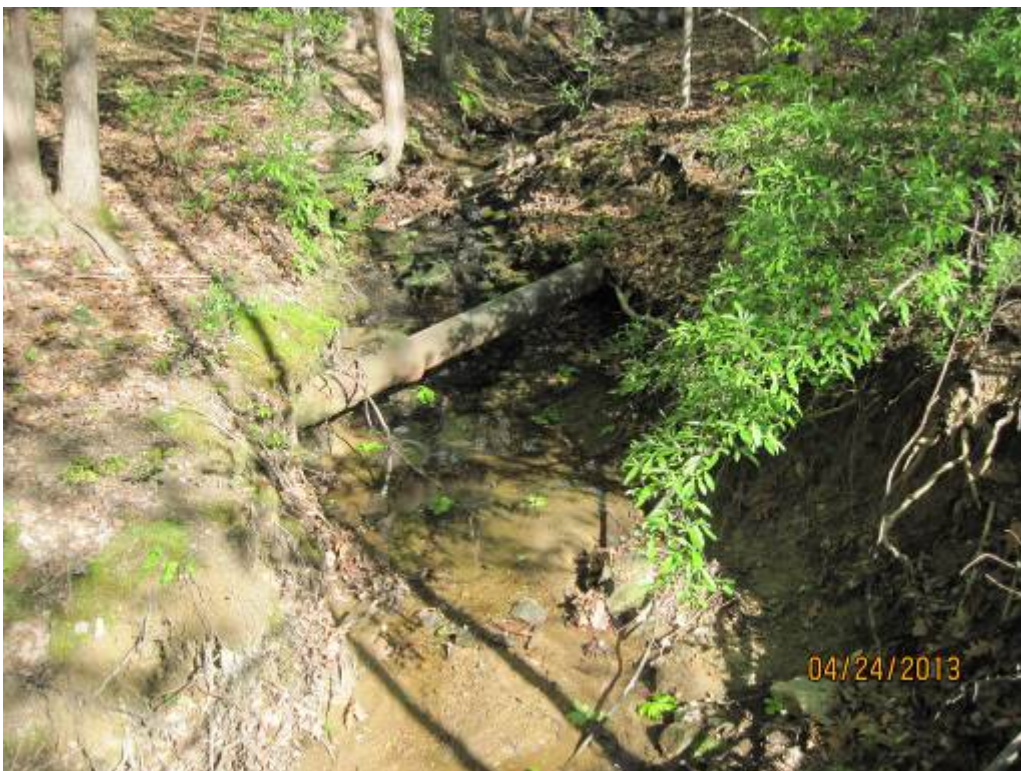
6. Looking downstream at a completely exposed and undercut utility in Stream Reach 3. This utility is at risk of failing if the erosion and incision continues.

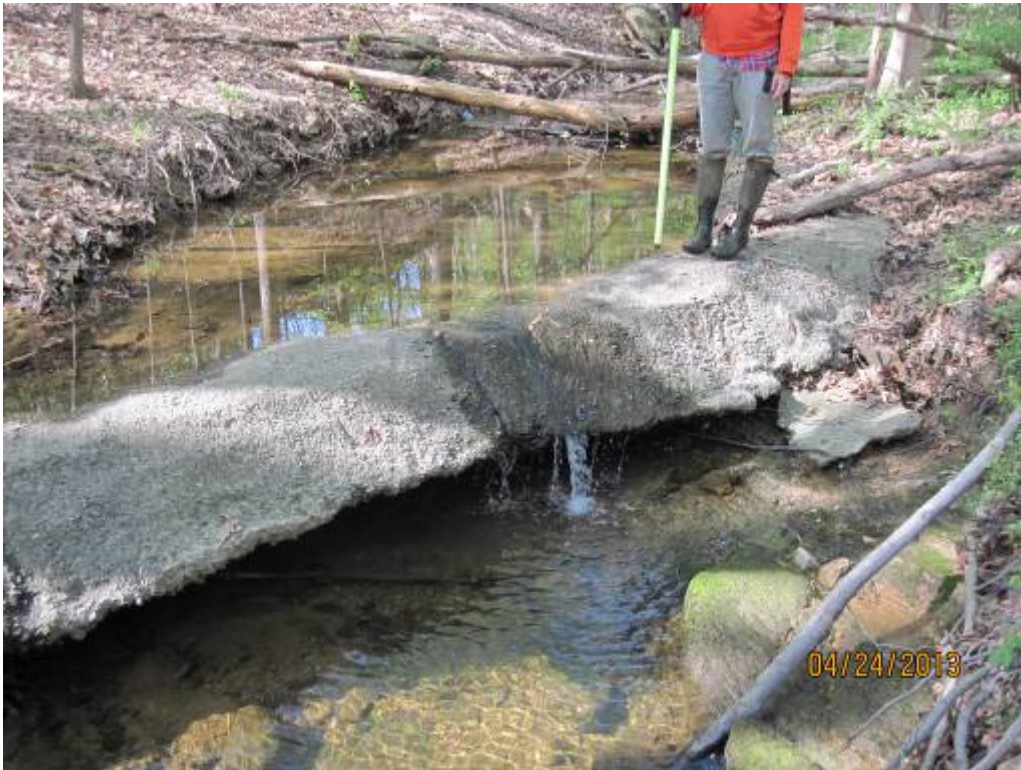
7. Looking upstream at an exposed concrete-capped utility in Stream Reach 3. This utility is being actively undercut.

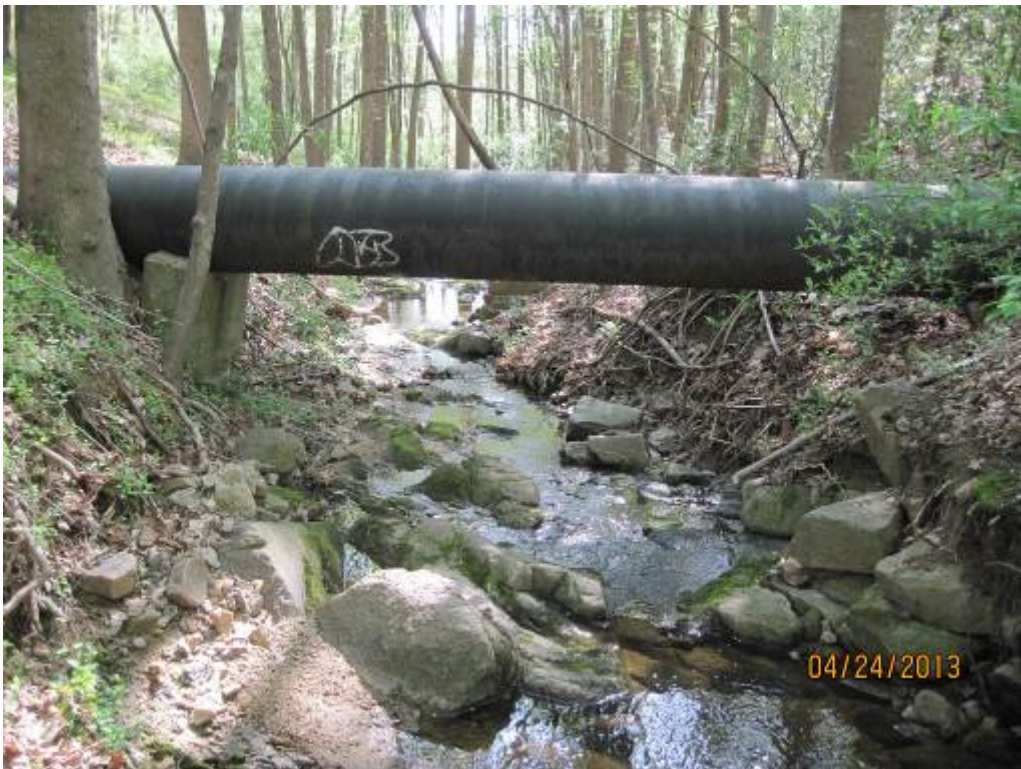
8. Looking downstream at a failing pier of an elevated utility that crosses Stream Reach 3, a result of the active incision and widening of this reach.

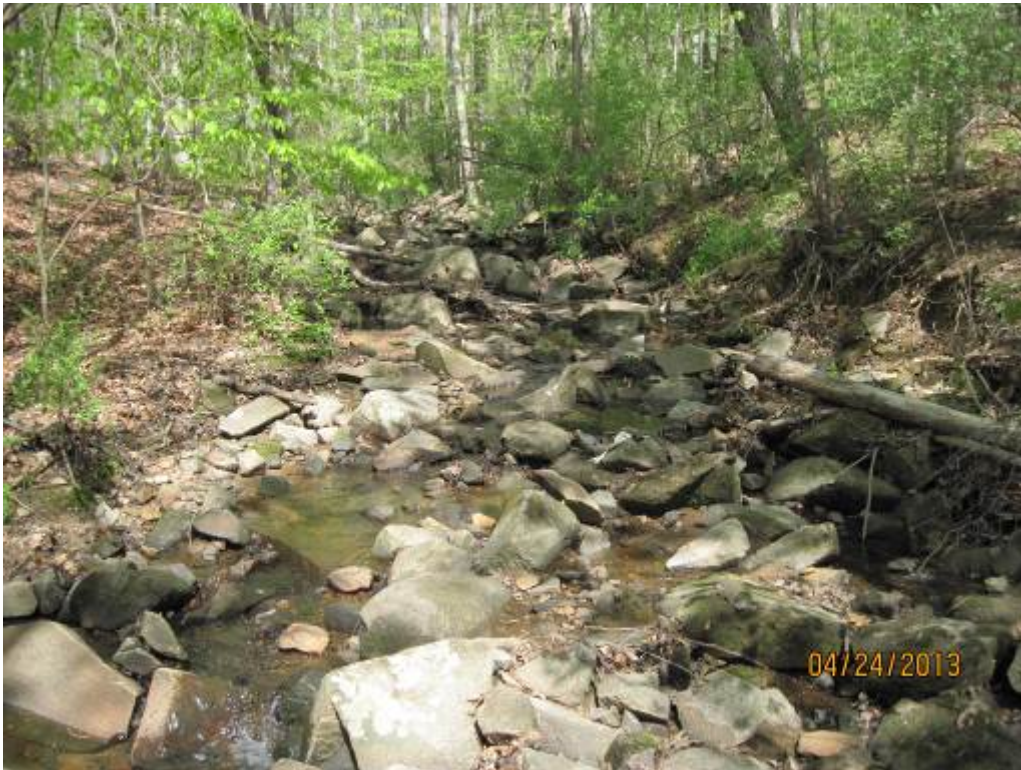
9. Looking upstream at a typical view of Stream Reach 4. This stream has only a few areas of active erosion, and a relatively stable streambed.

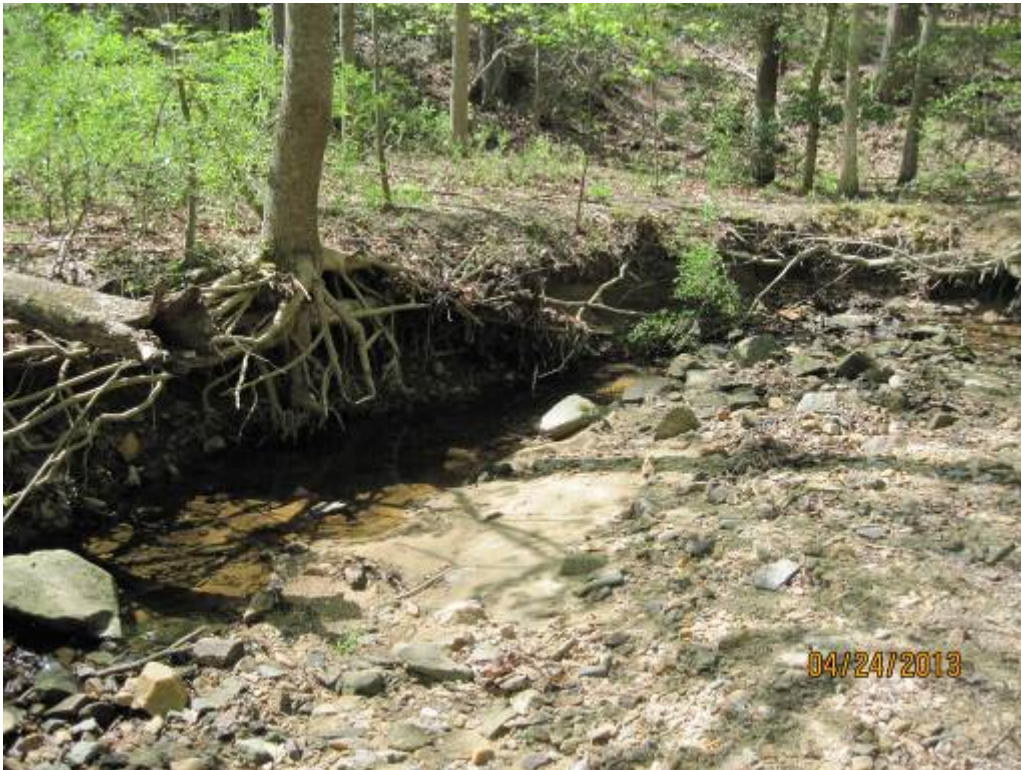
11. Looking upstream at a streambend showing some significant erosion in Stream Reach 4.

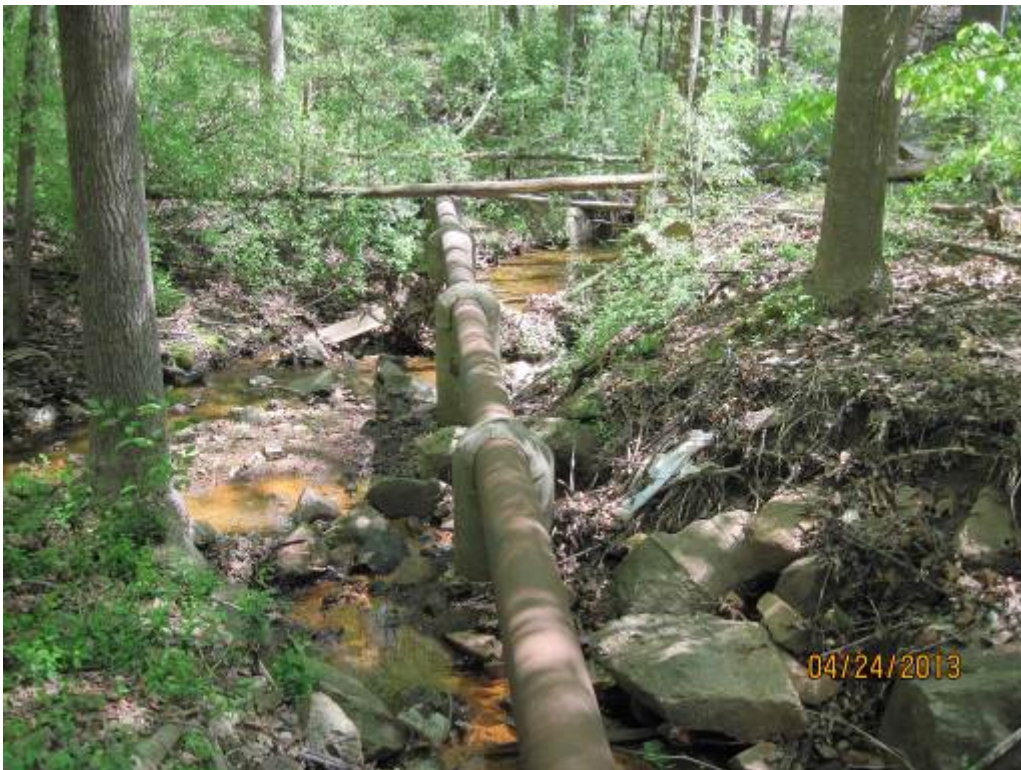
12. Looking downstream at an elevated utility crossing over Stream Reach 5. Some erosion is present around these piers.

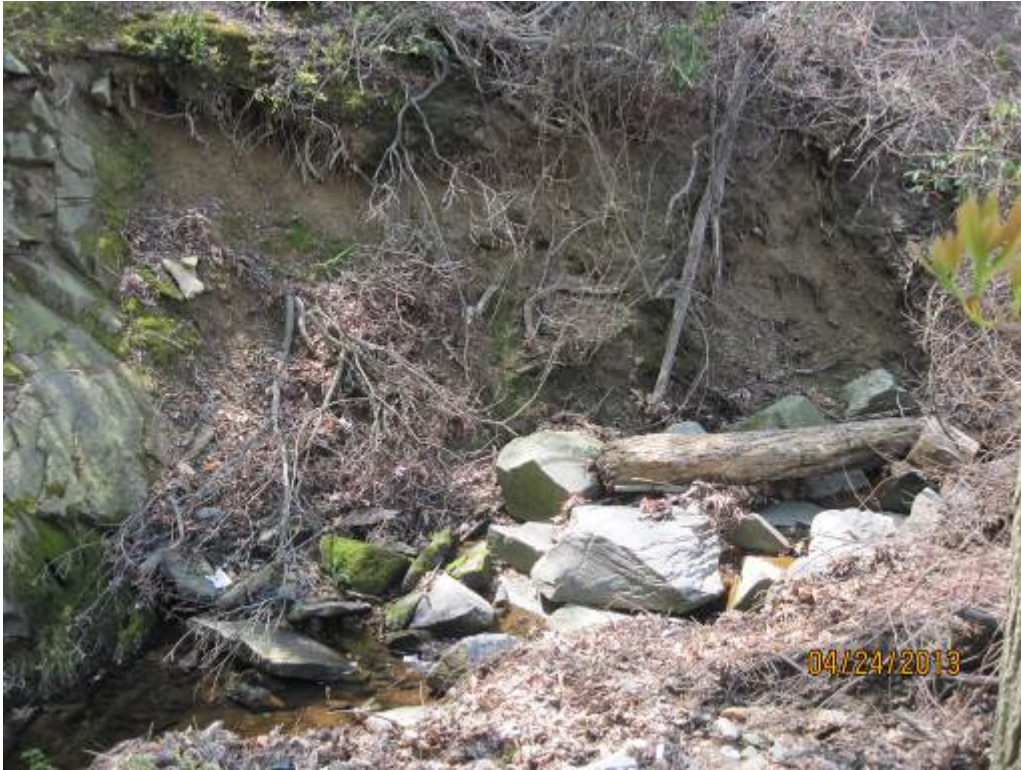
13. Looking upstream at a severely eroding bank downslope of a stormwater pond outfall located on-line with Stream Reach 5.

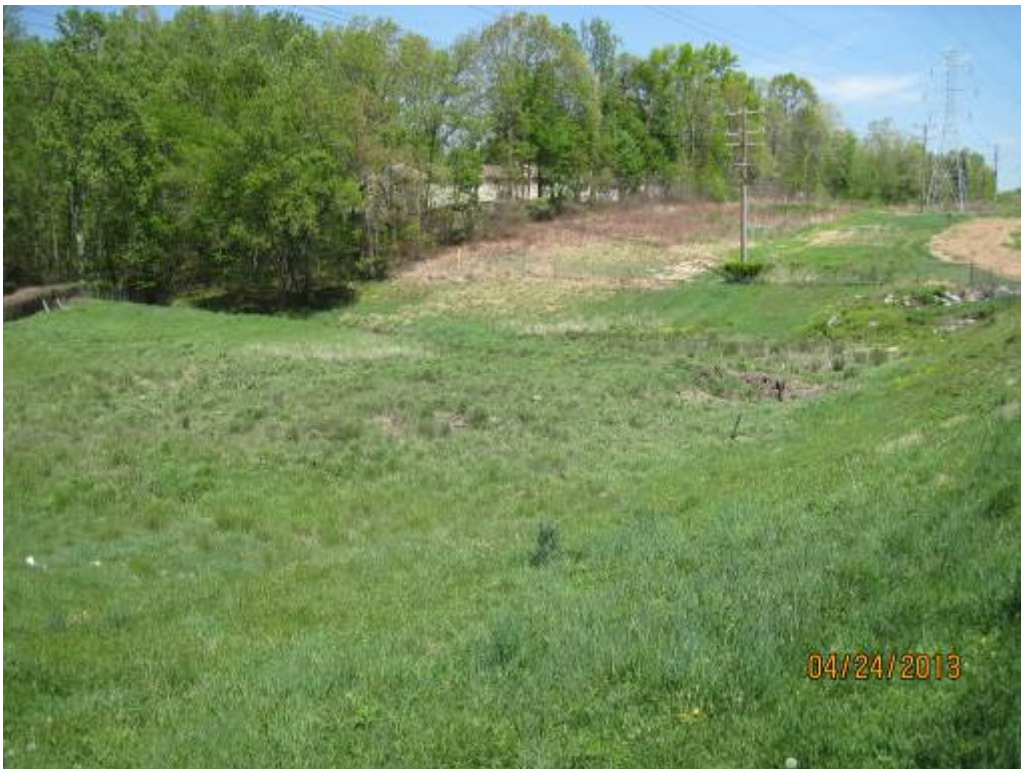
14. Looking across the stormwater management pond located on-line with Stream Reach 5.

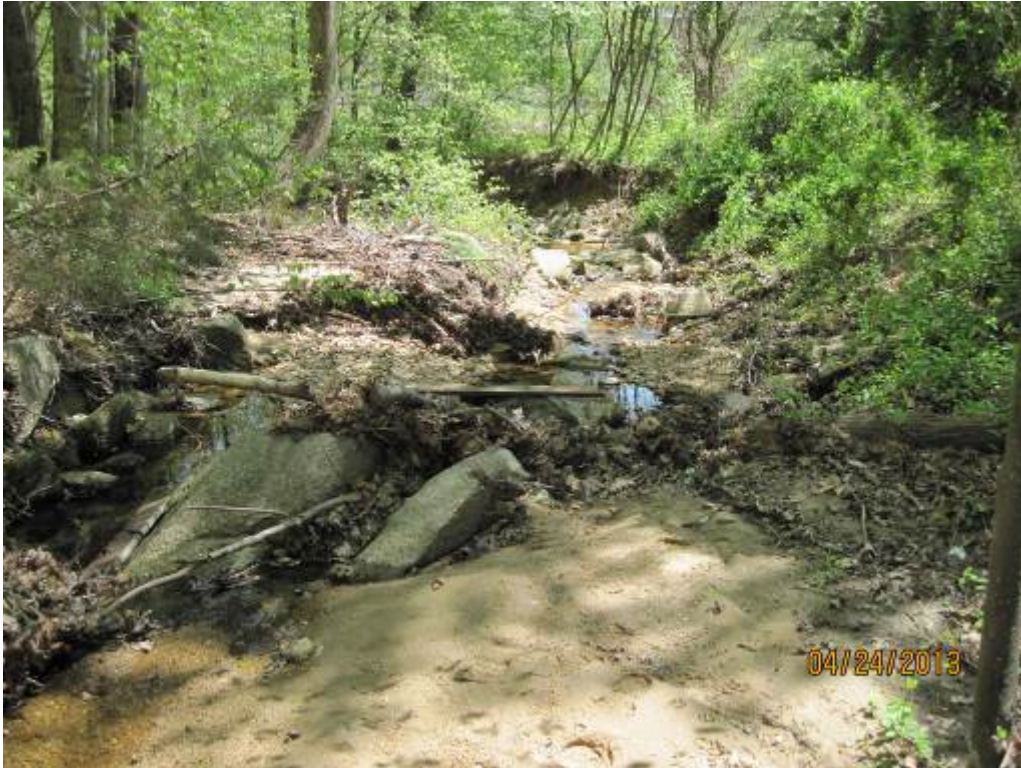
15. Looking upstream at a typical section of Stream Reach 5. This stream exhibits significant erosion and incision, with large amounts of deposition in the streambed.

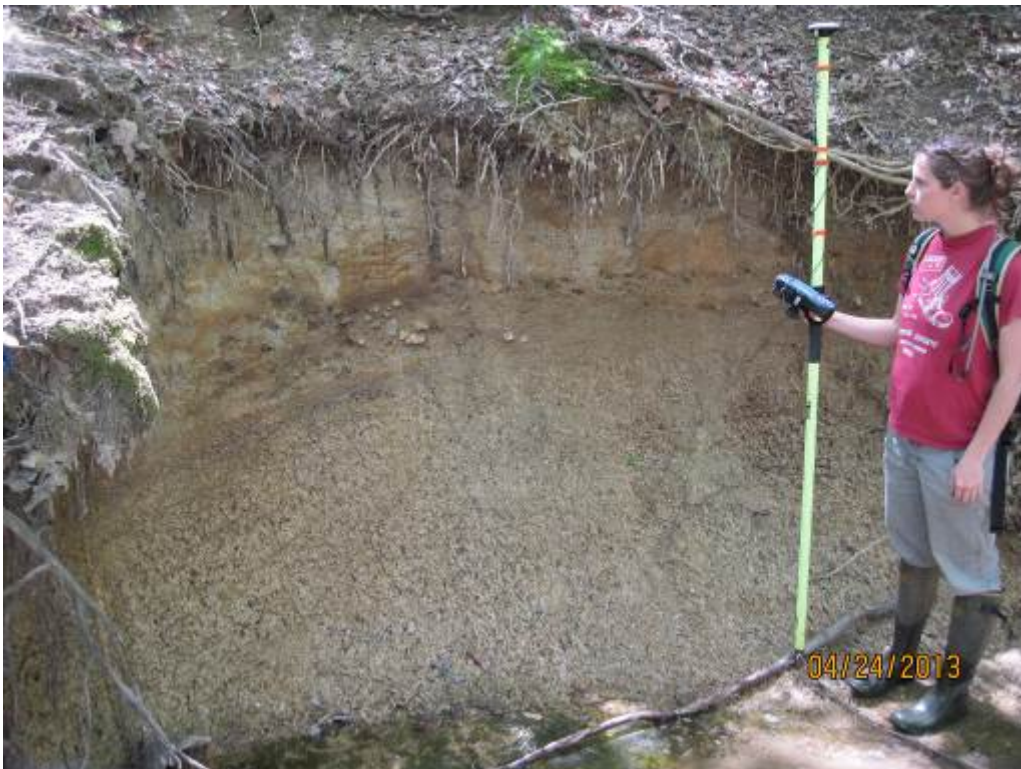
16. Looking upstream at a severely eroding streambank in Stream Reach 5.

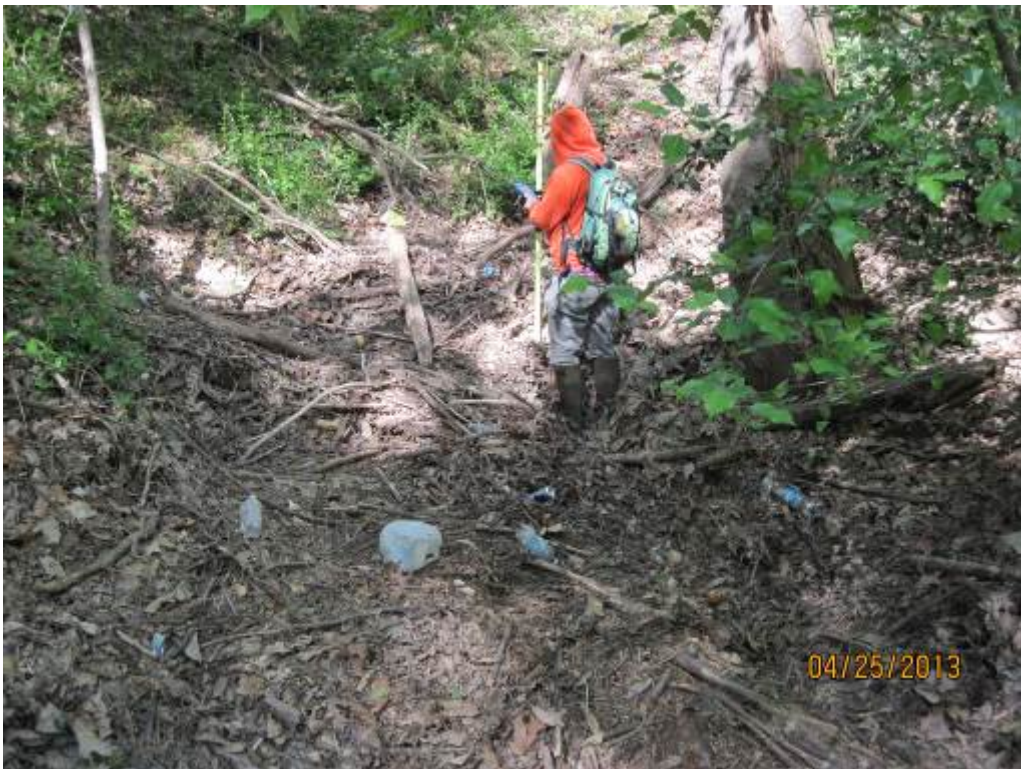
18. Looking downstream at the blocked culvert of Stream Reach 6A, under Colby Dr. This blockage has contributed to the aggrading of this portion of the stream.

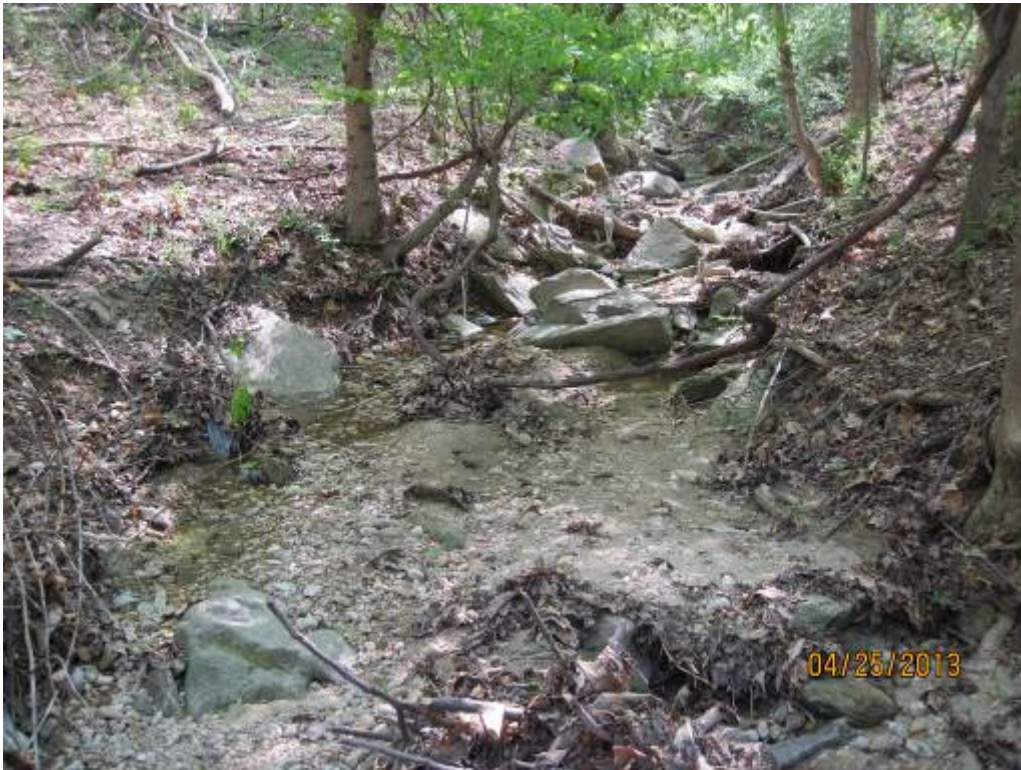
19. Looking upstream at a typical view of Stream Reach 6A. This portion of the stream is incised, and is aggrading at the downstream end.

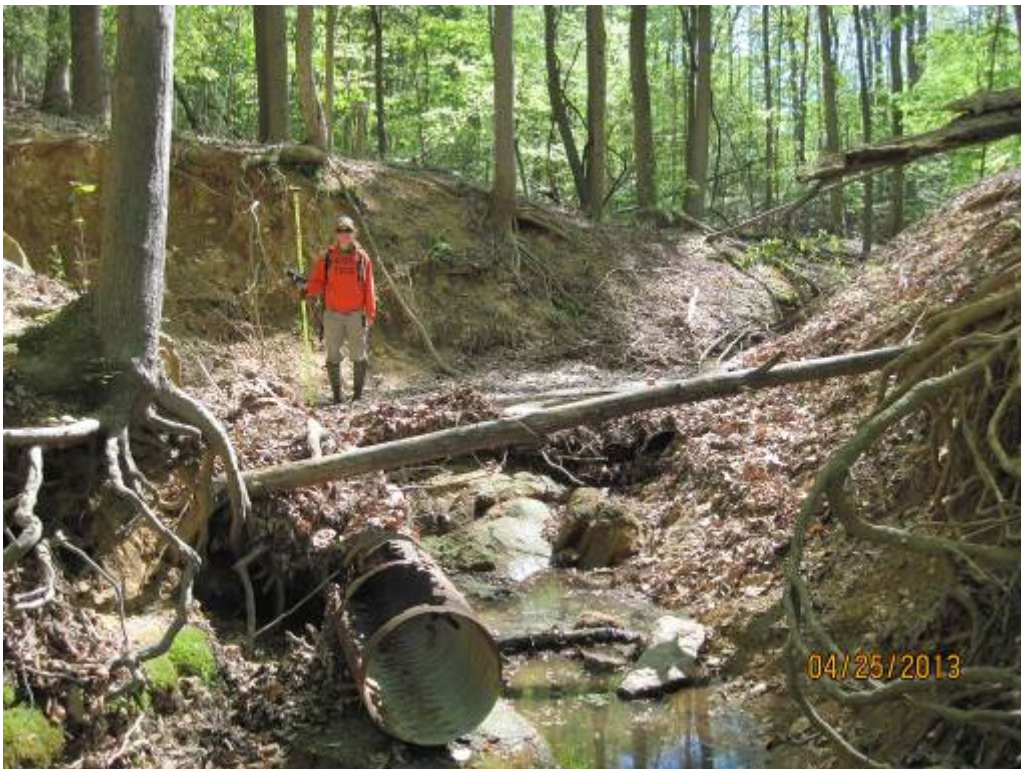
20. Looking upstream at an area of significant erosion in Stream Reach 6A. Several pipes were in this area in the past, but have since washed out of their location, leaving a very unstable bank.

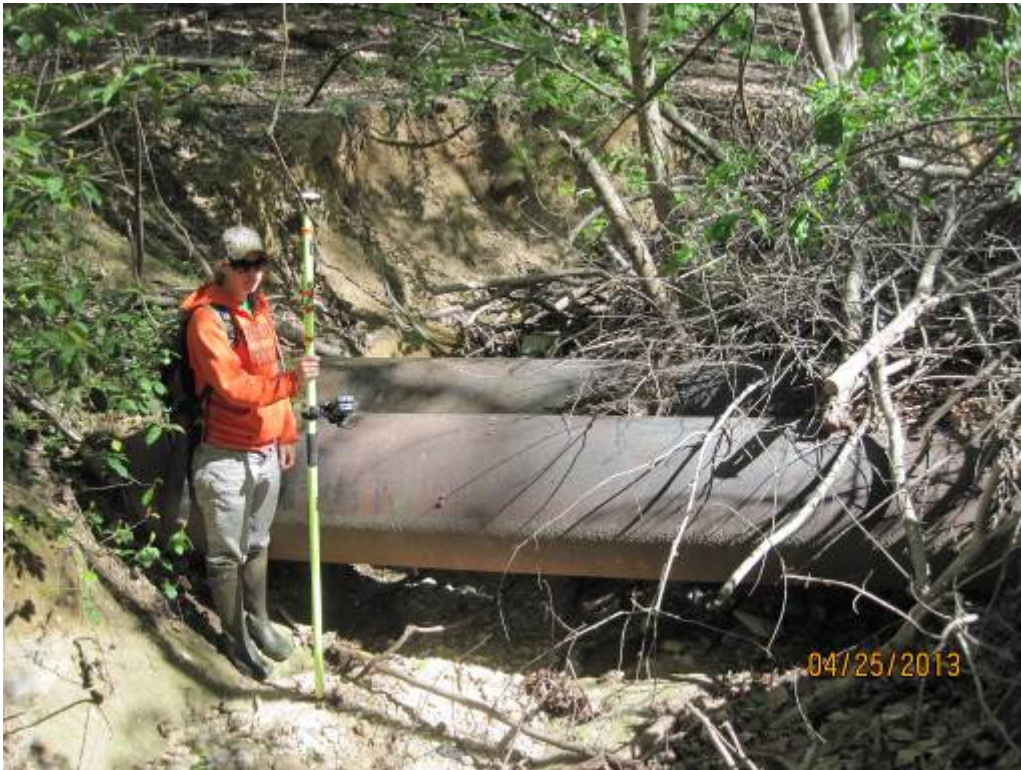
21. Looking upstream at an exposed and undercut utility crossing a tributary to Stream Reach 6A. This has the potential for failure, if left unmitigated.

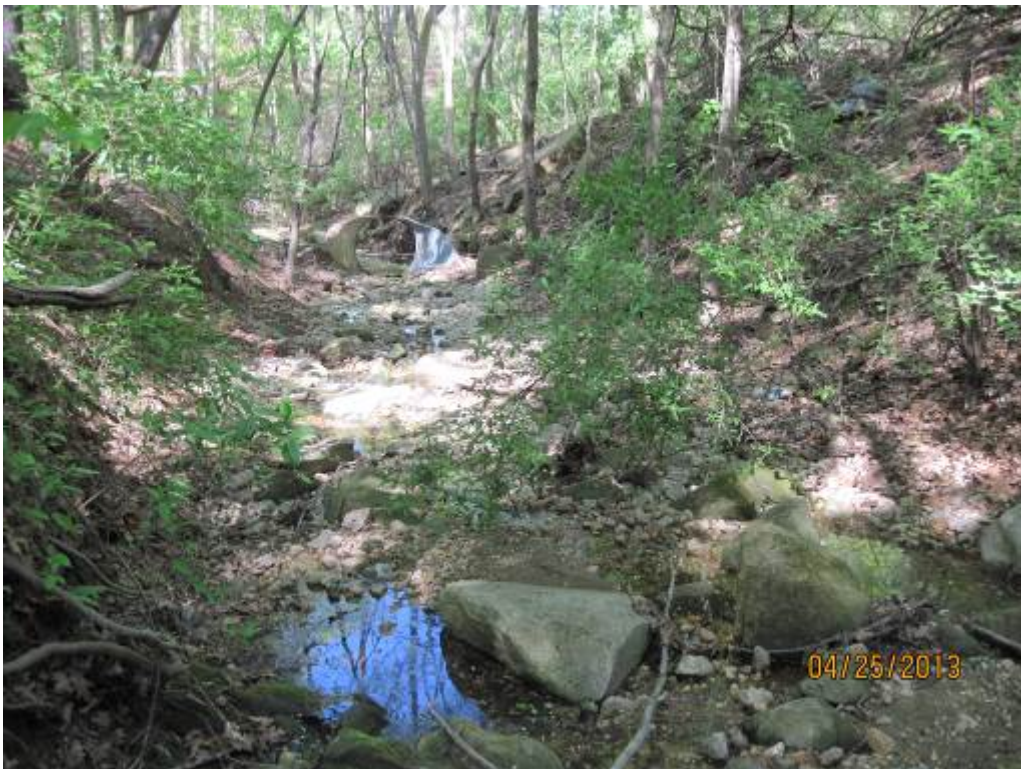
22. Looking downstream at a typical section of Stream Reach 6B. This stream has incised some, but has also been aggrading due to the large amounts of erosion present in Stream Reach 6A.

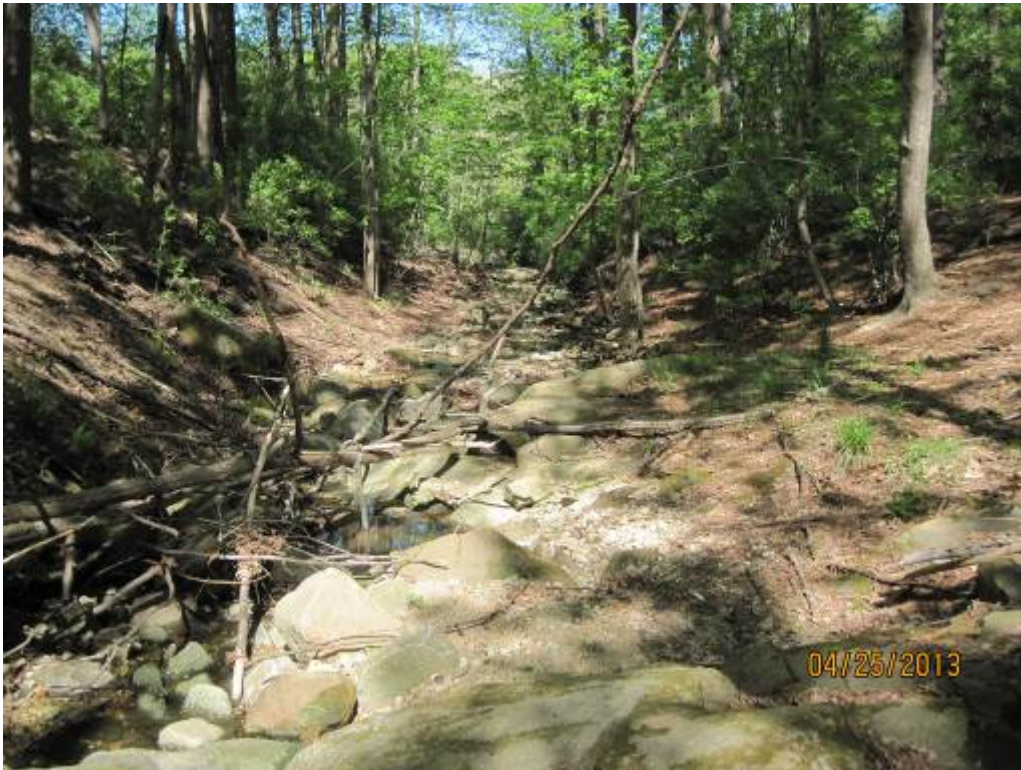
23. Looking downstream at another typical view of Stream Reach 6B.

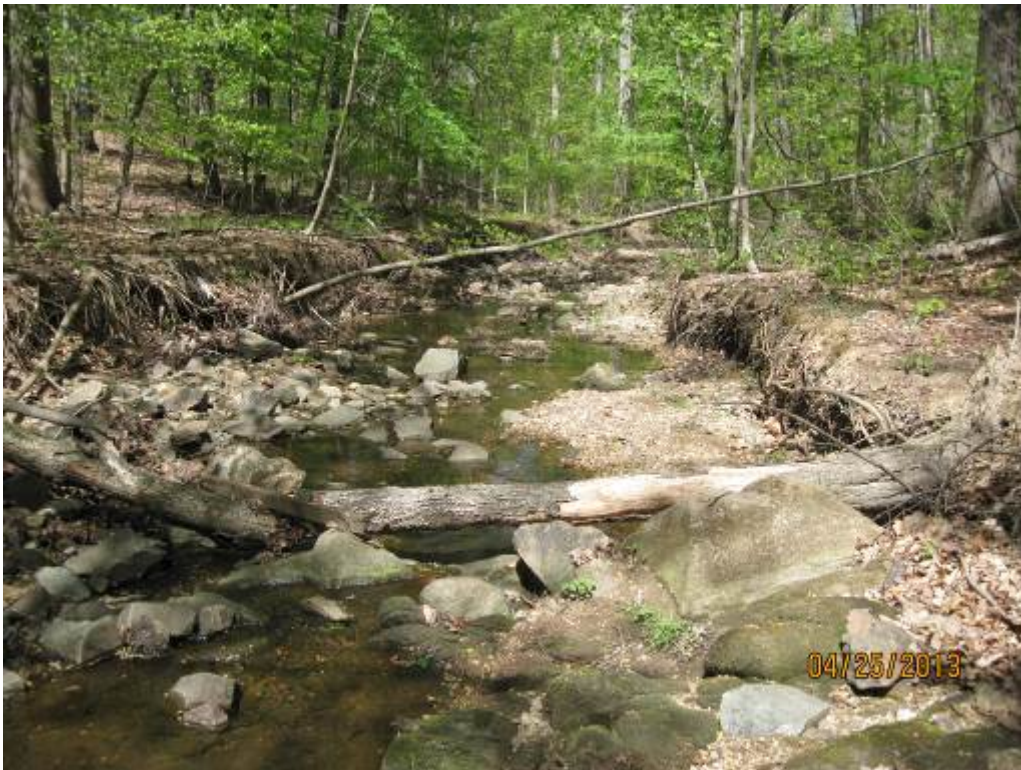
24. Looking downstream at typical section of Stream Reach 7. This stream shows instability along the majority of both banks.

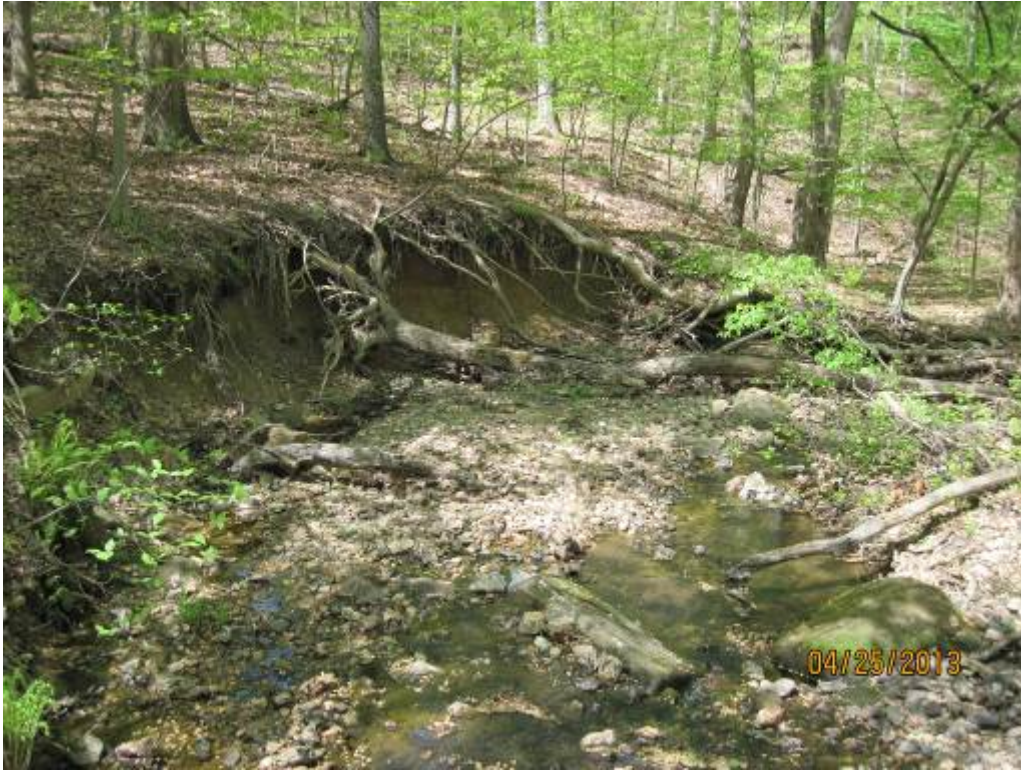
25. Looking downstream at a section of severely eroding bank at a stream bend in Stream Reach 7.

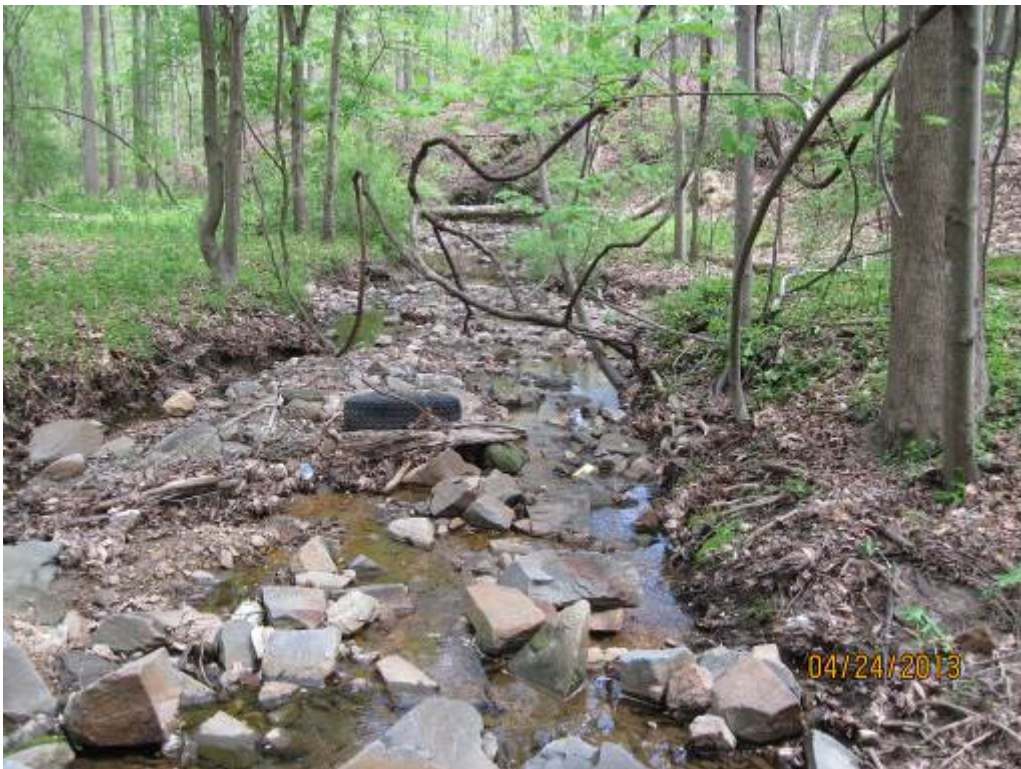
26. Looking downstream at a typical section of Stream Reach 8A. This stream is incised with erosion present along both banks.

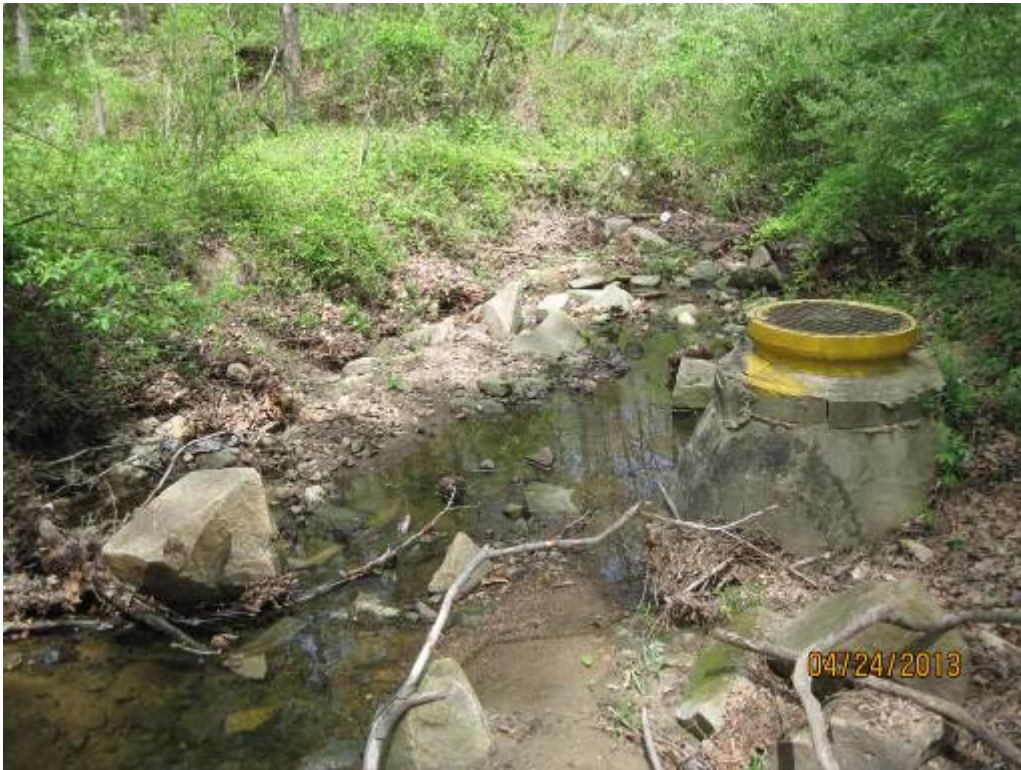
27. Looking downstream at a sanitary sewer line crossing of Stream Reach 8A. This crossing is stable now, but could be compromised in the future, depending on the erosion rate of the stream.

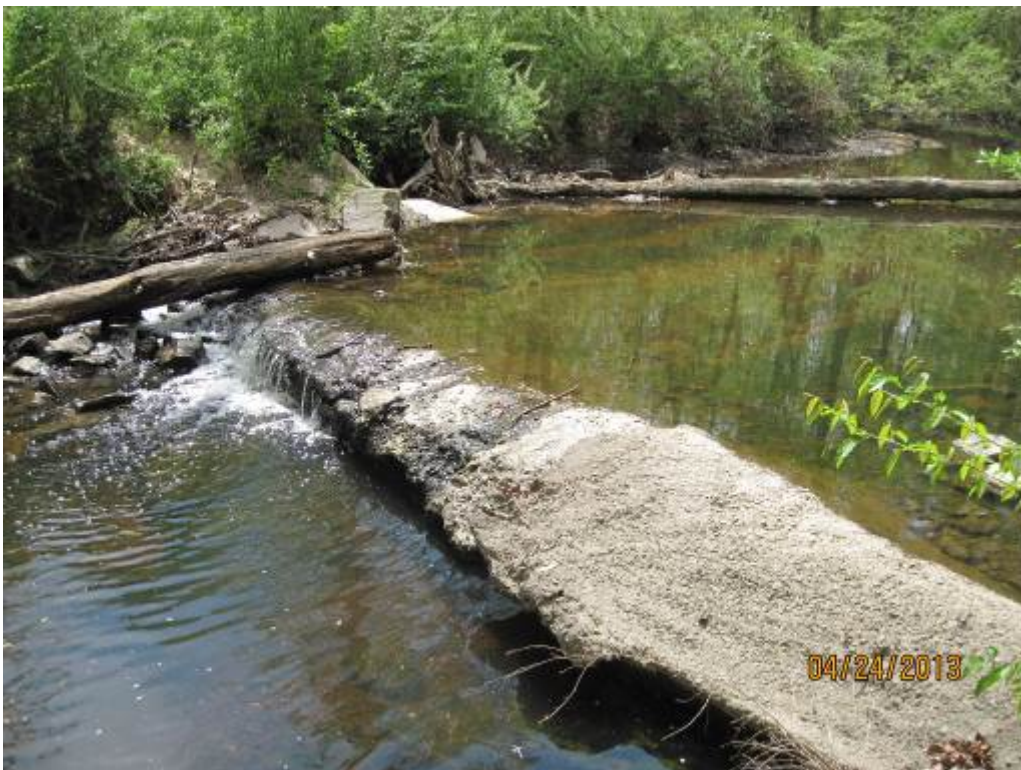
28. Looking upstream at an exposed utility line crossing on Hoes Run, immediately adjacent to its confluence with Stream 8A. This crossing is undercut and could become compromised in the near future.

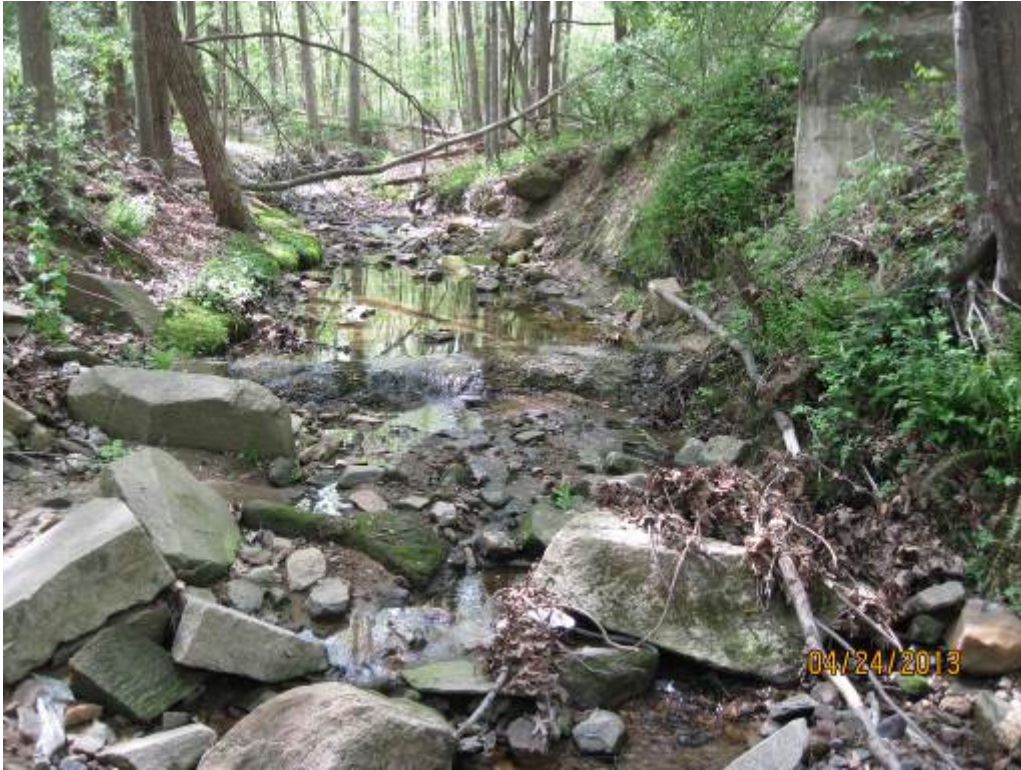
29. Looking upstream at a typical section of Stream Reach 8B. An exposed sanitary sewer line is present in this location, due to the increased incision and erosion occurring along this stream.

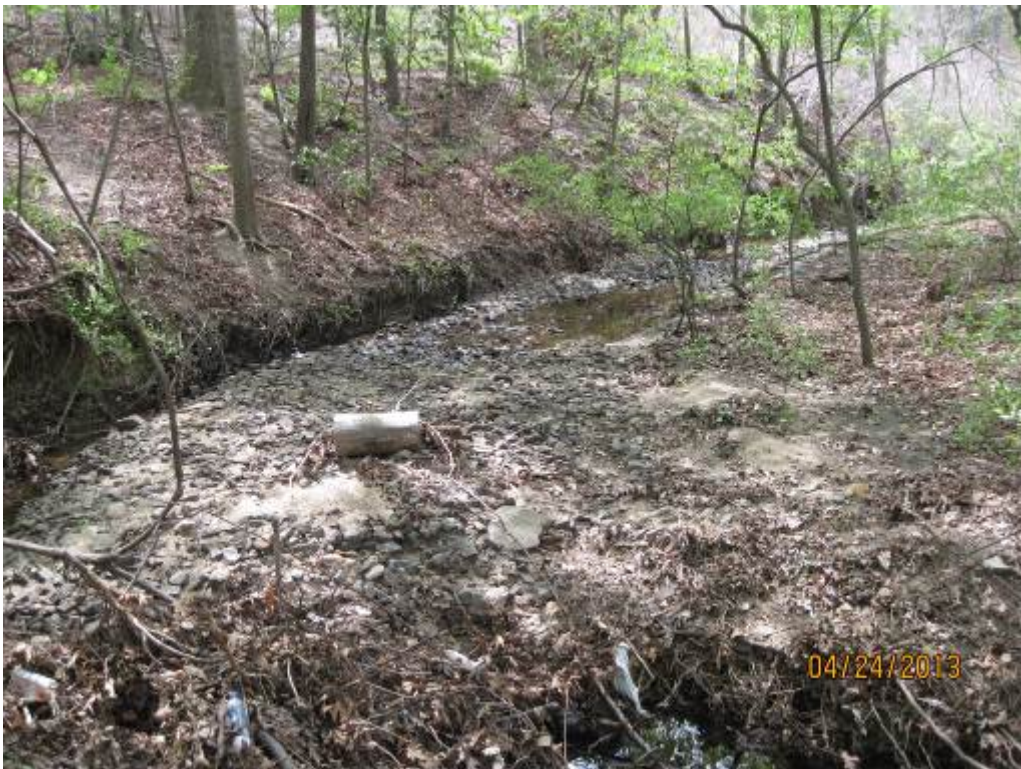
30. Looking upstream at a typical section of Stream Reach 8B.
