Appendix F Index

Stream Assessment Photographs

Appendix F
Stream Assessment Photographs
Occoquan Watershed – Study of Four Subsheds
WSSI #25156.01

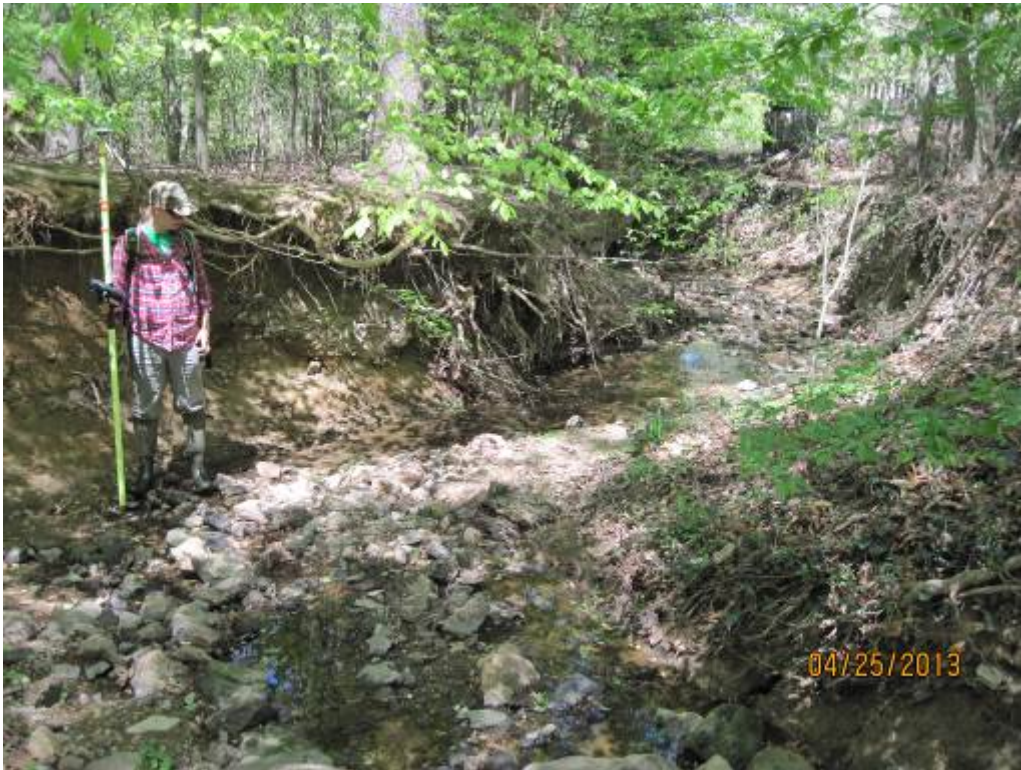
31. Looking downstream at a typical section of Stream Reach 9. There is significant erosion along this stream due to residential encroachment and stormwater outfalls along the majority of the stream.

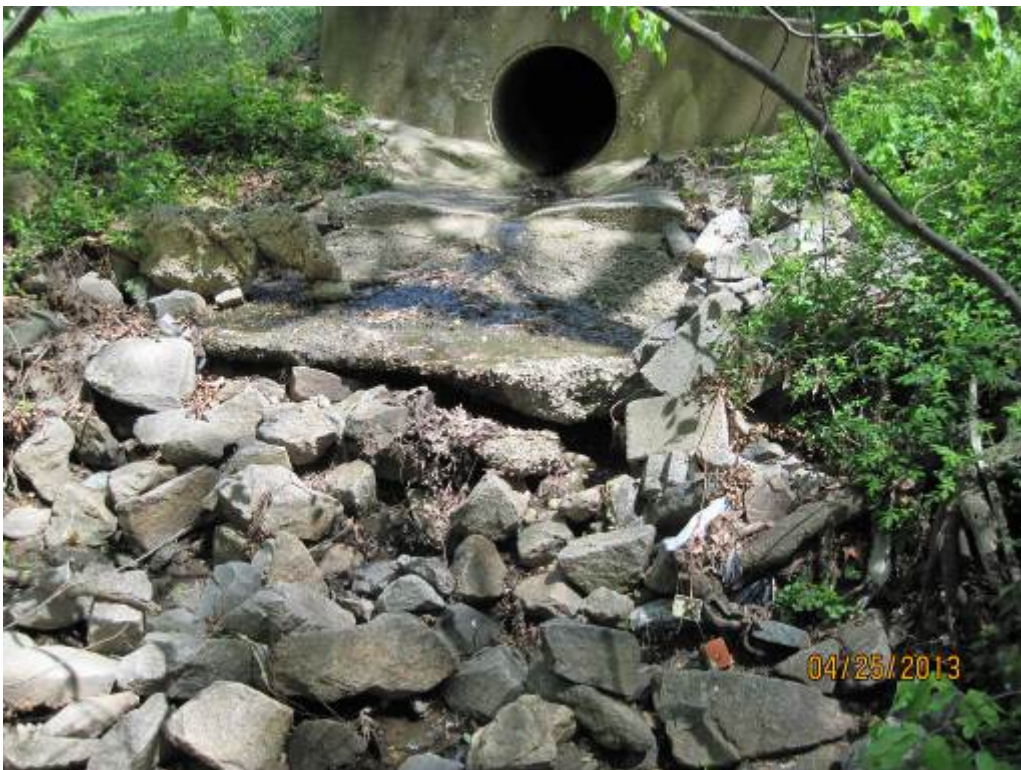
32. Looking upslope at a stormwater outfall along Stream Reach 9. Stormwater flows unchecked from the streets in the surrounding development.

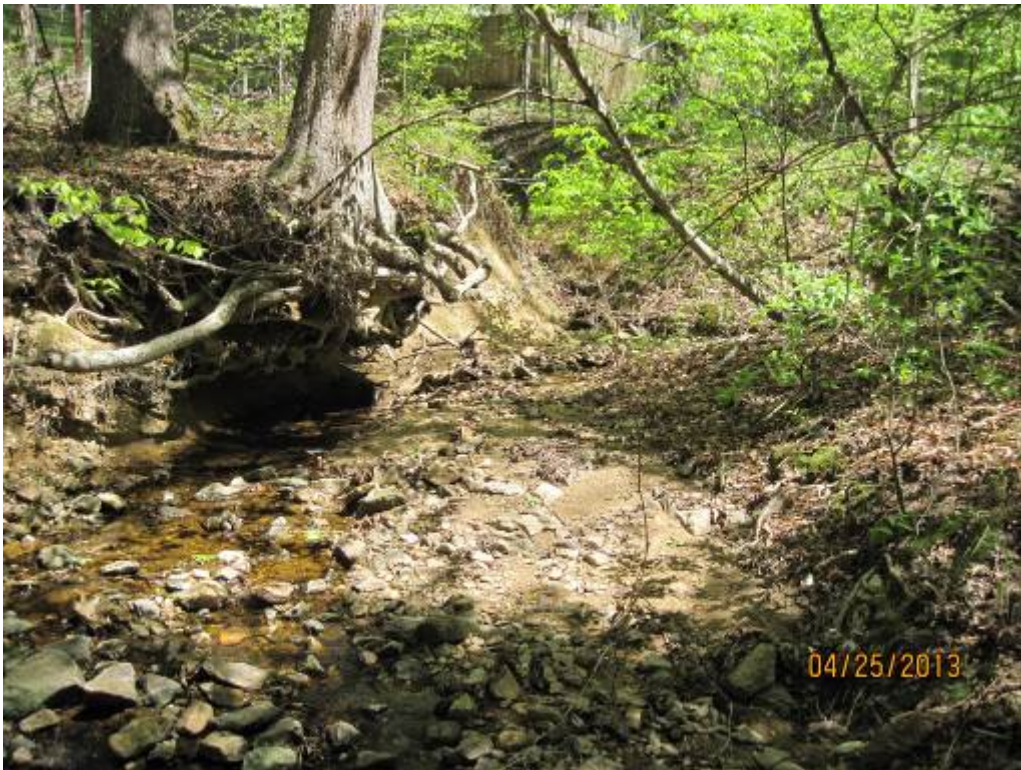
34. Looking upstream at a typical section of the downstream portion of Stream Reach 9.

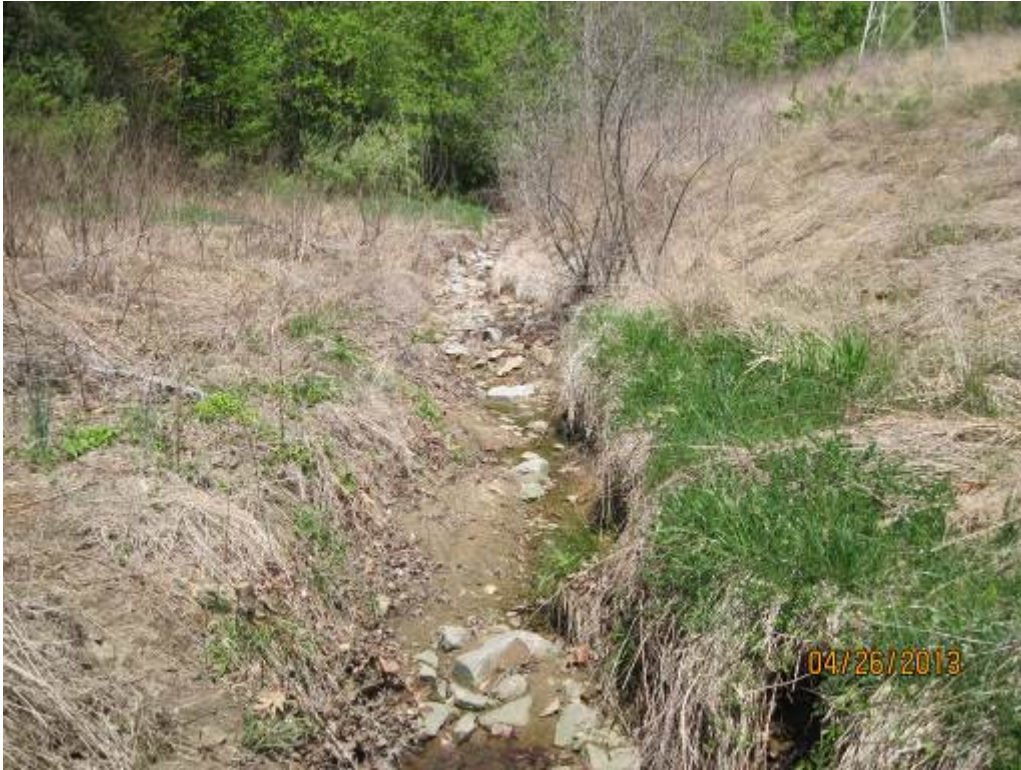
35. Looking upstream at a portion of Stream Reach 10 within a powerline easement. This section is significantly aggraded due to upstream erosion.

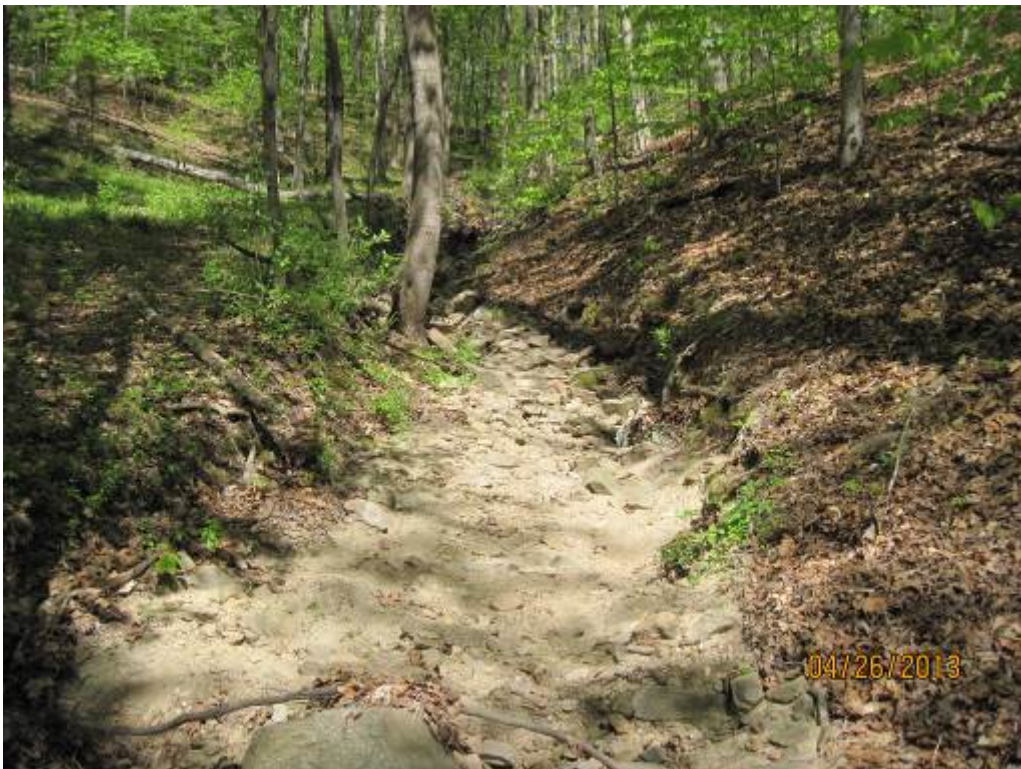
36. Looking upstream at a typical section of Stream Reach 10. High amounts of deposition are present in this stream channel.

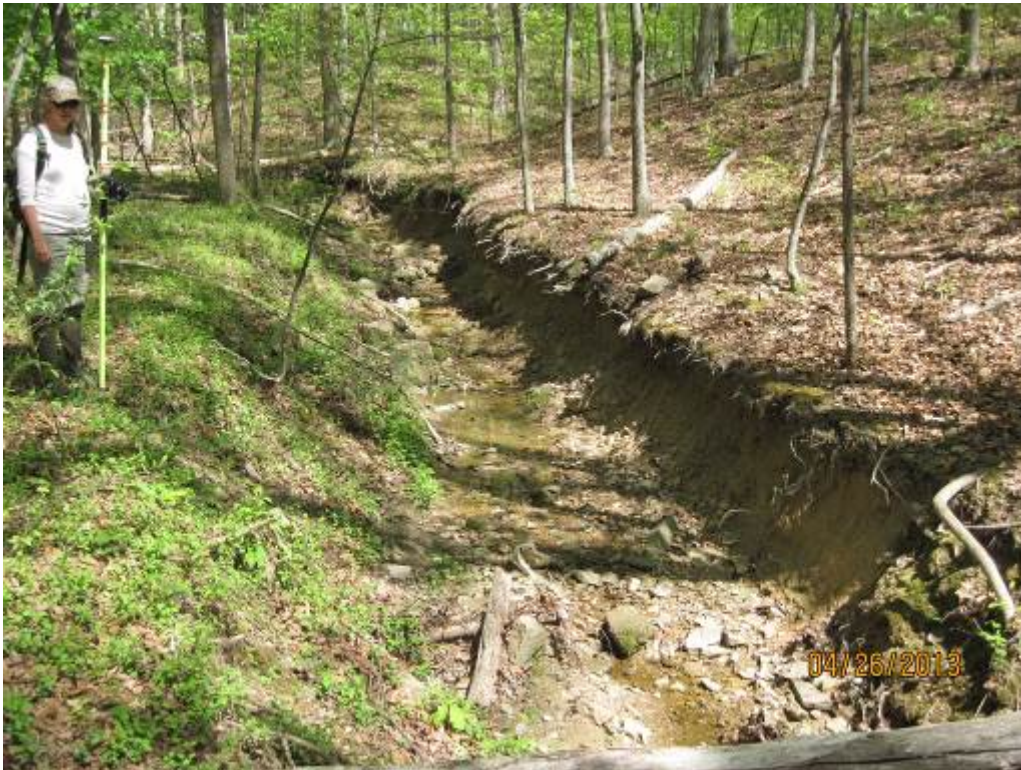
37. Looking upstream at a typical section of the upstream portion of Stream Reach 10. This section is significantly eroding and unstable.

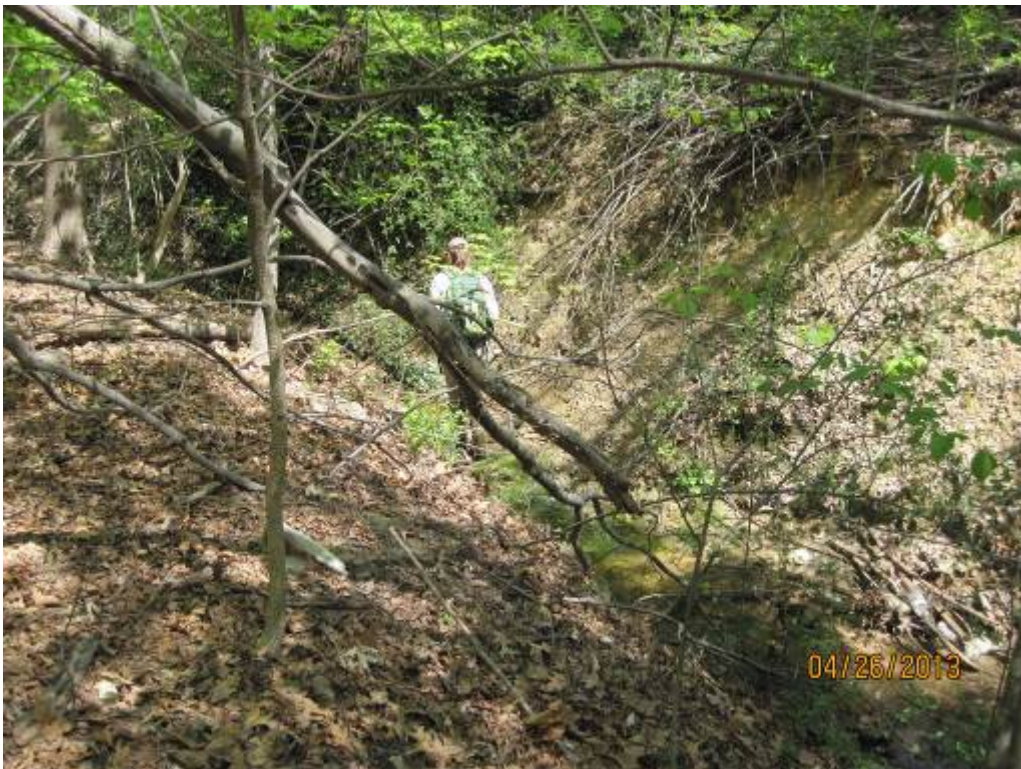
38. Looking upstream at an area of significant erosion along the upstream portion of Stream Reach 10. Some exposed utilities (cable, telephone) are also present in this area.

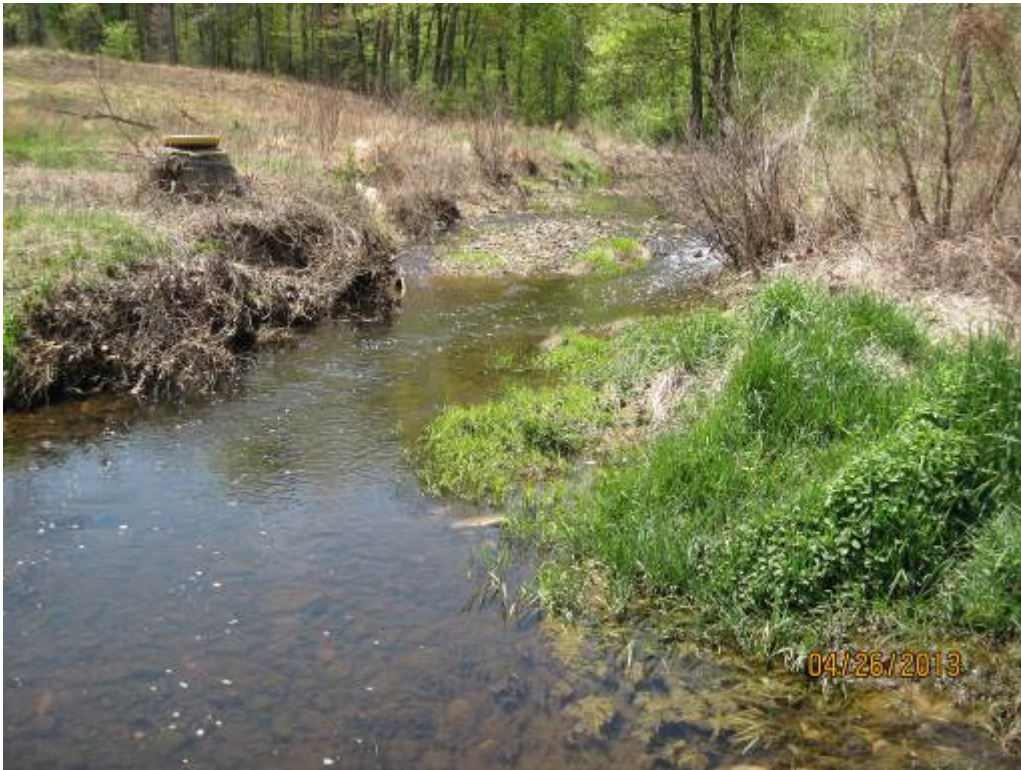
39. Looking upstream at a section of Stream Reach 11 within a powerline easement. This section is relatively stable.

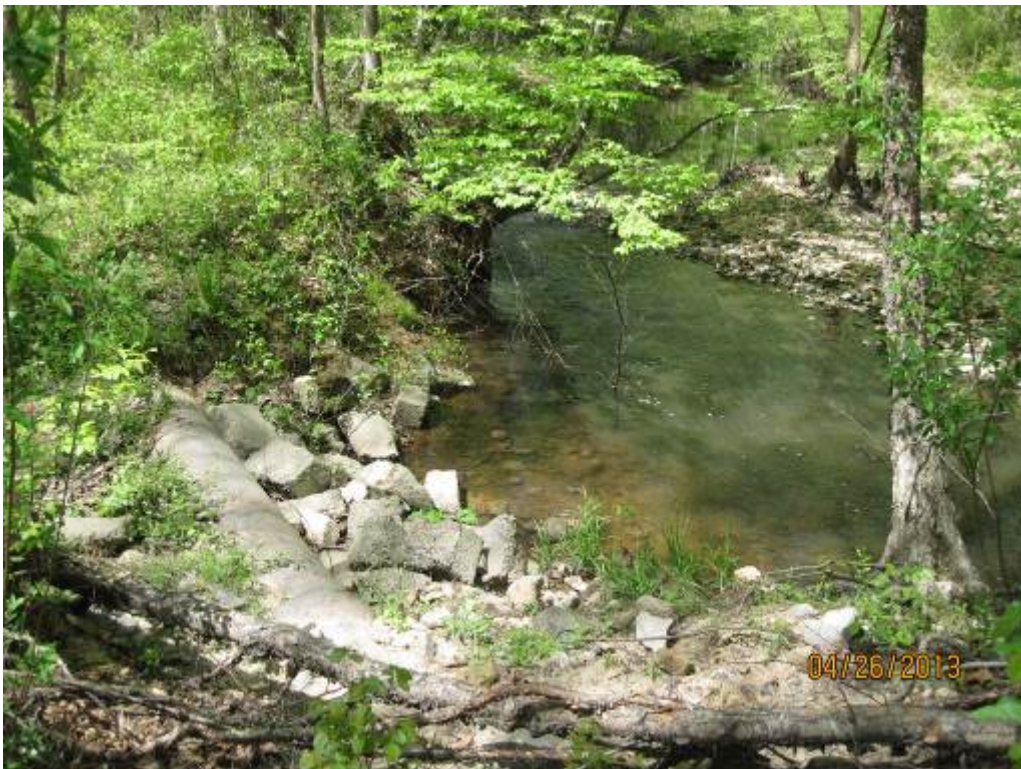
40. Looking upstream at an exposed sanitary sewer line along Stream Reach 11. It appears that some unsuccessful stabilization measures have been attempted in this area.

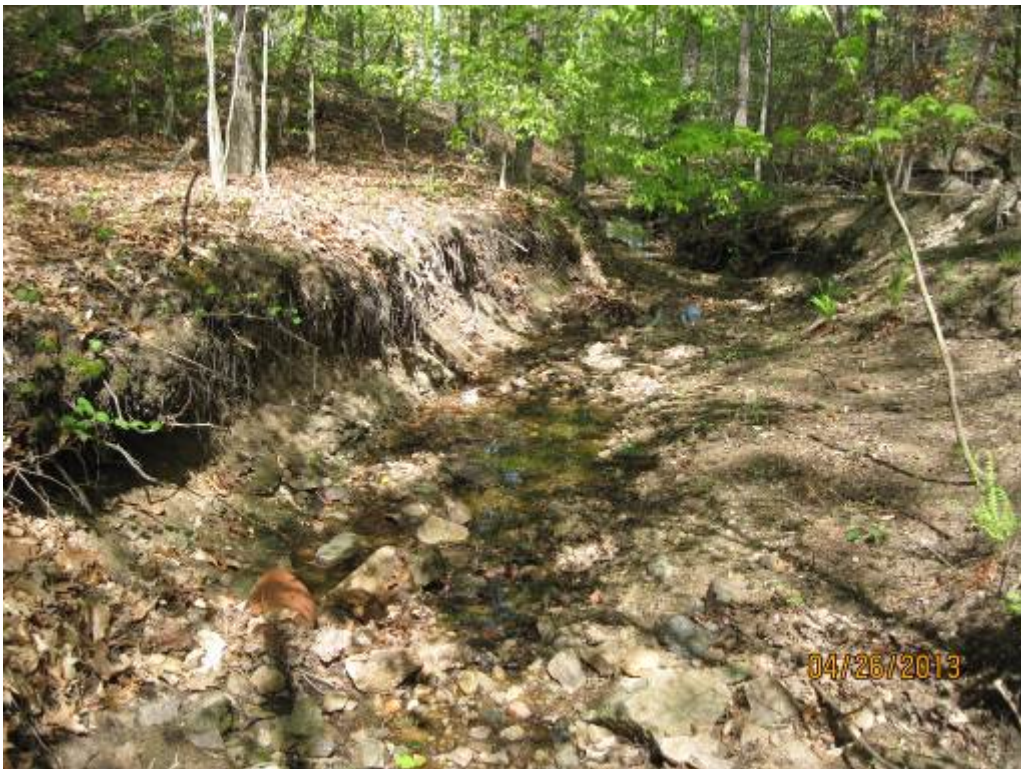
44. Looking downstream at a typical section of the downstream portion of Stream Reach 12. This portion shows significant incision. The area below this section is severely aggrading.

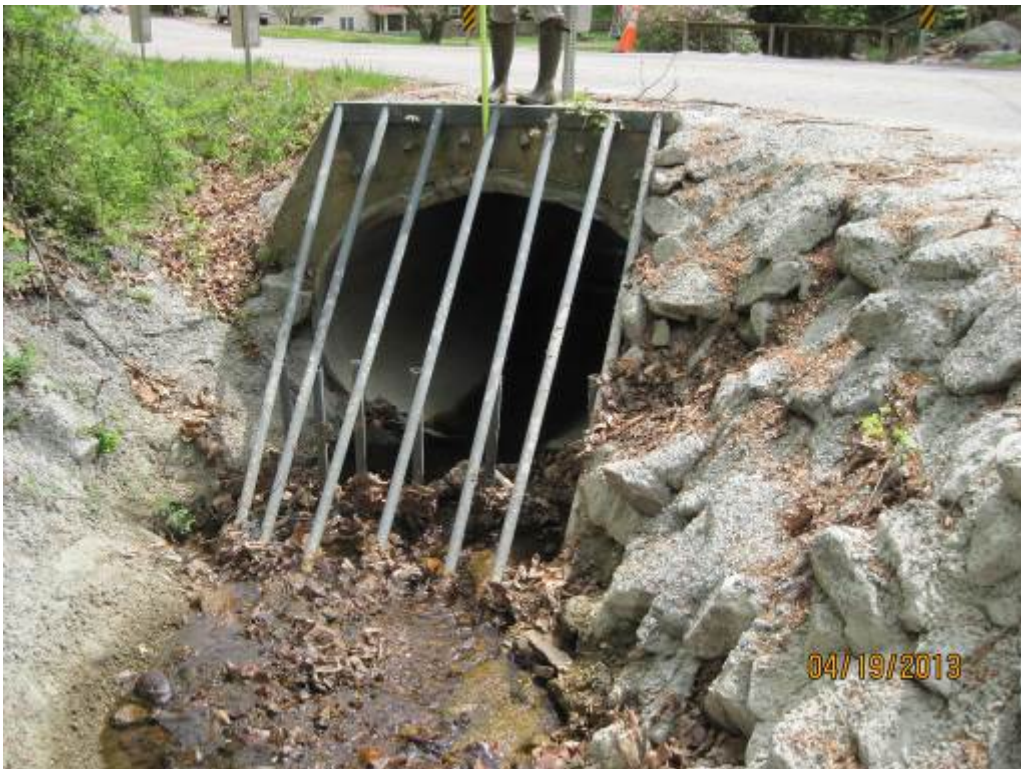
46. Looking downstream at a culvert which carries Stream Reach 15 under Tanyard Hill Road, into the Town of Occoquan. This portion of the stream is hardened and channelized.

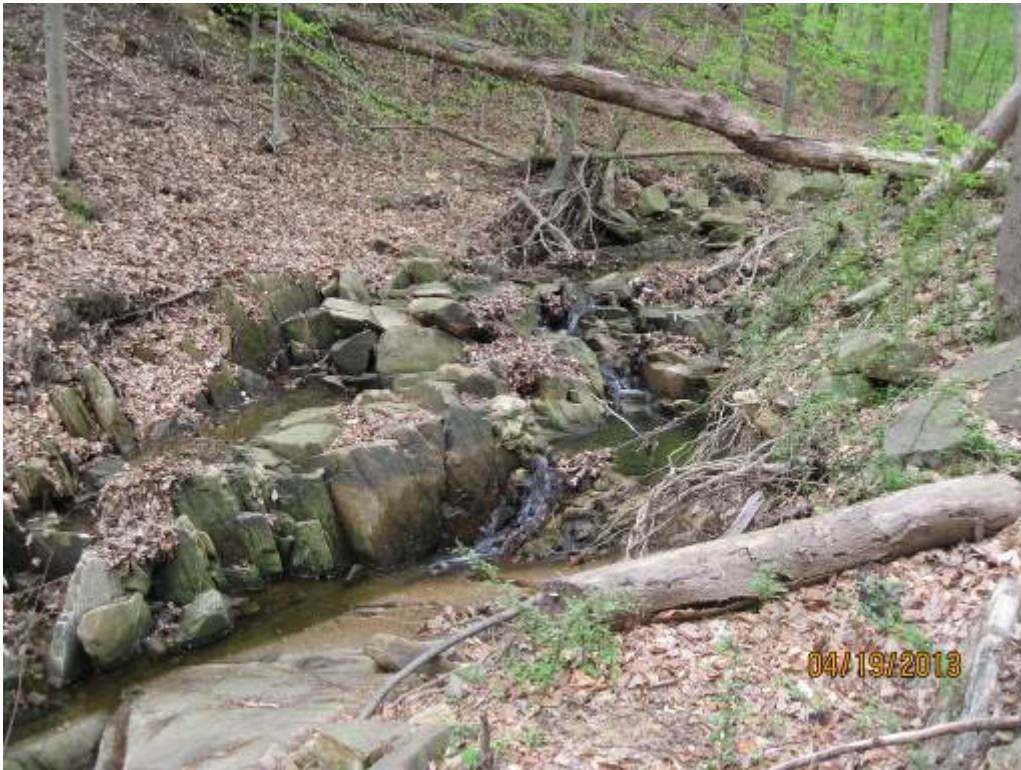
47. Looking upstream at a typical section of Stream Reach 15. Some erosion is present along this stream, but it is mostly stable, due to the presence of shallow bedrock.

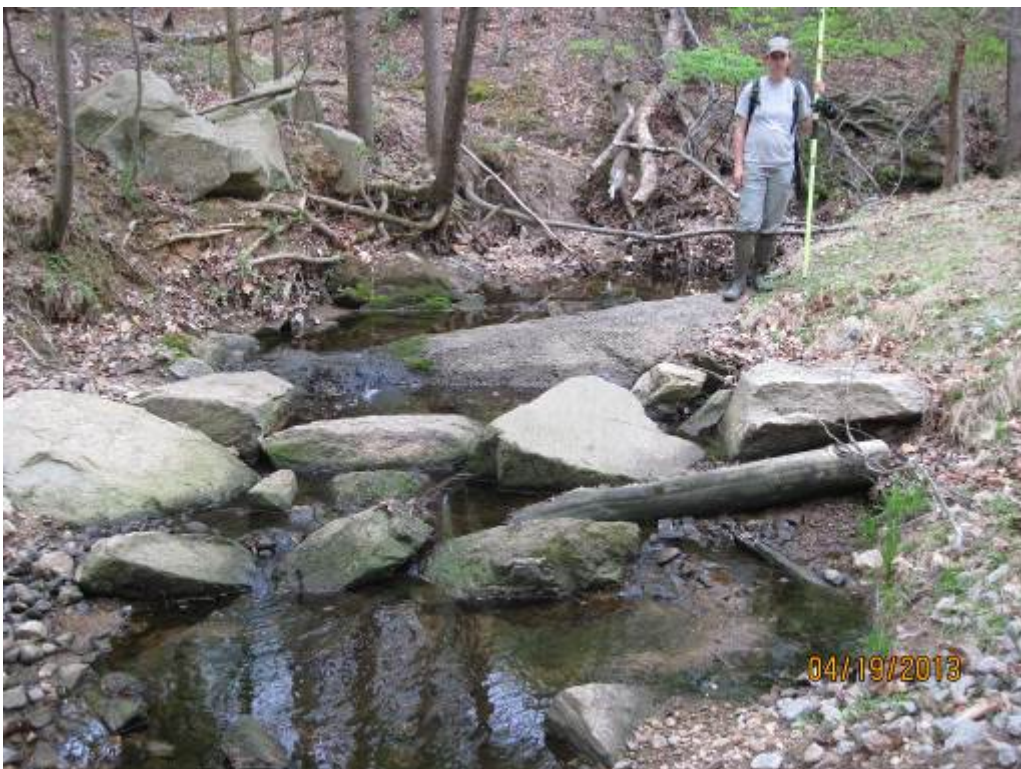
48. Looking upstream at a typical section of Stream Reach 15. A utility crossing has been exposed in this area, and is one of several such exposed lines.

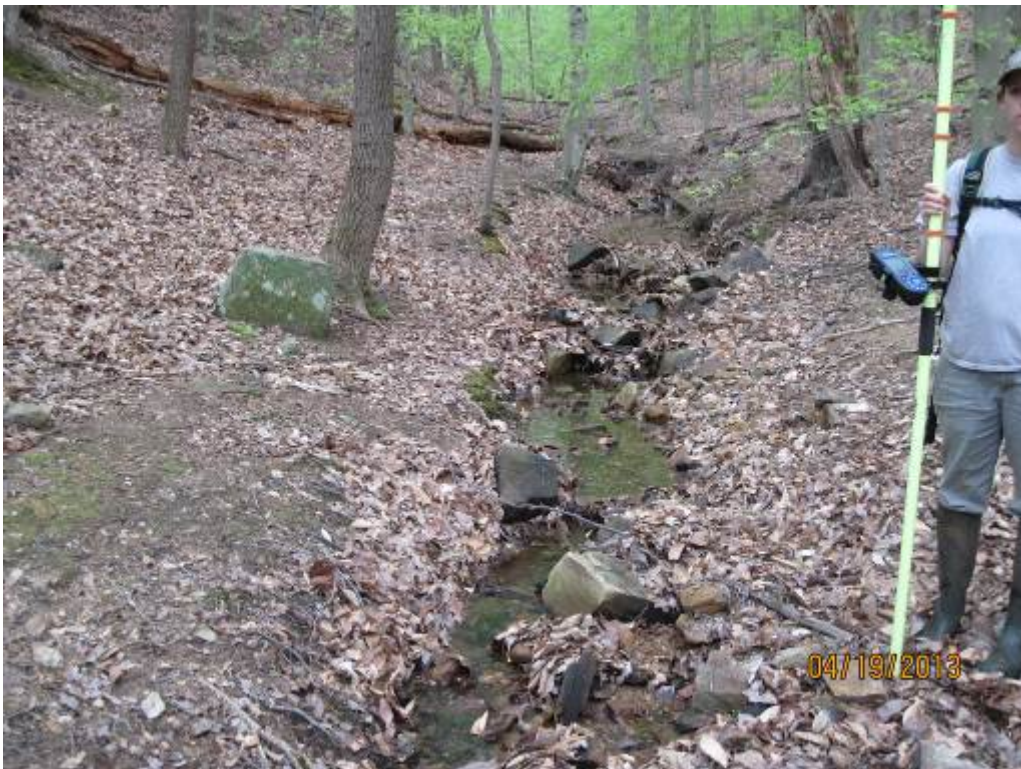
50. Looking upstream at a typical section of Stream Reach 16.

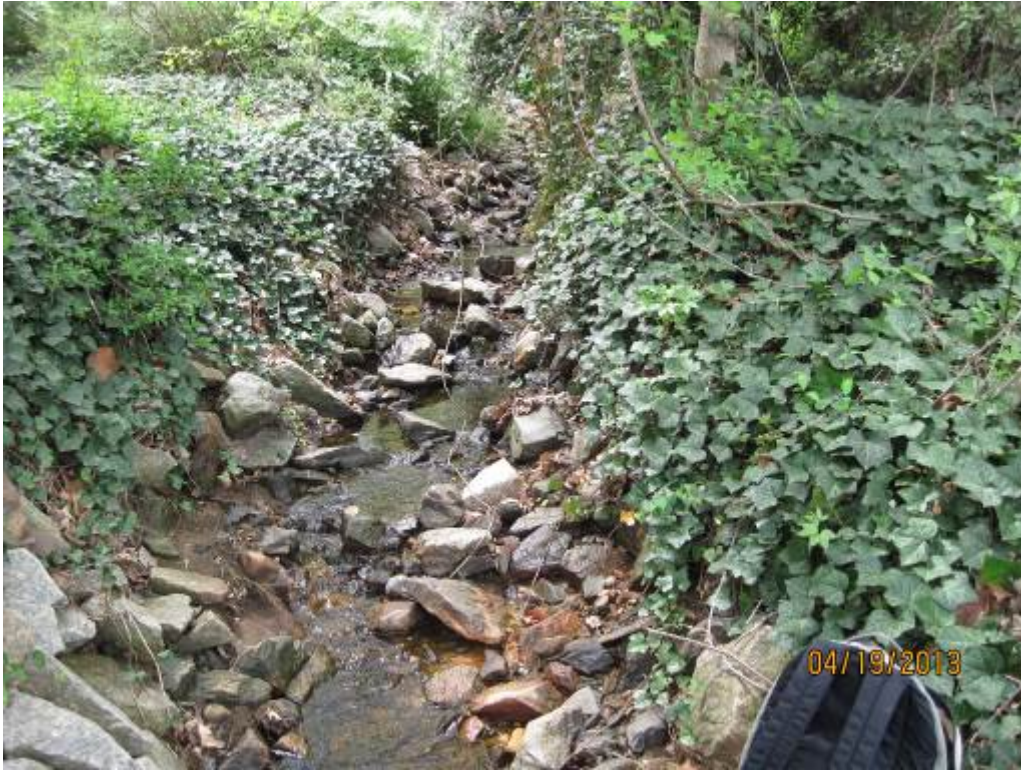
51. Looking upstream at Stream Reach 17A. This stream has been encroached upon by adjacent residential development.

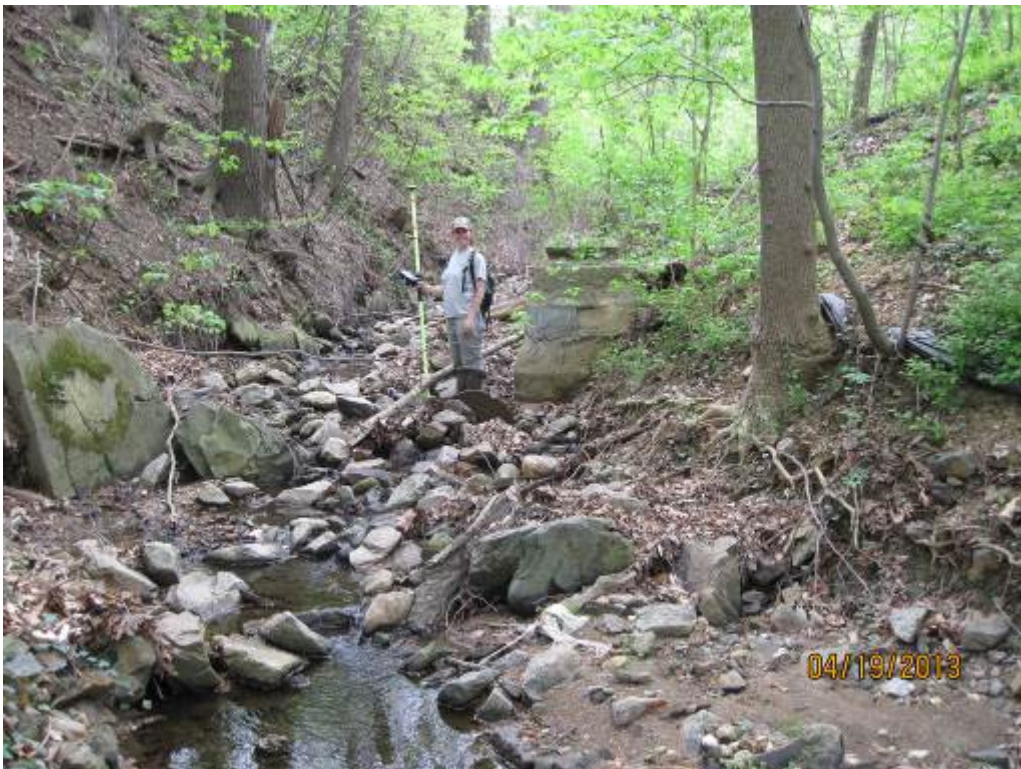
52. Looking upstream at a typical section of Stream Reach 17A. This section is somewhat incised, partially exposing at least one sanitary sewer line.

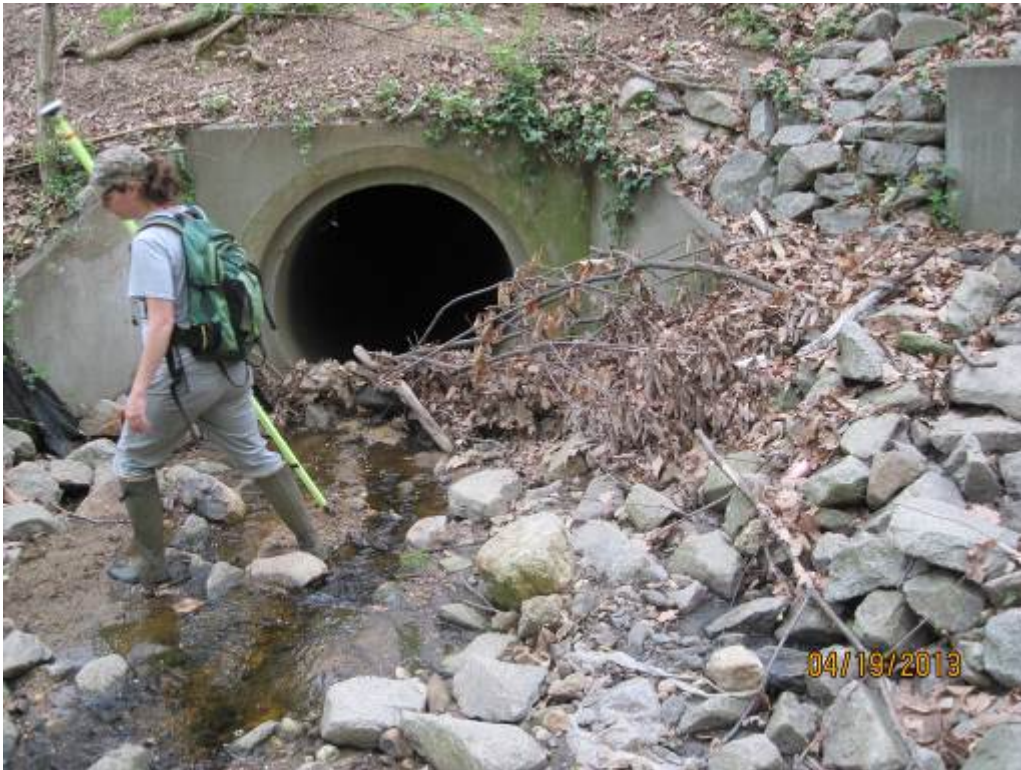
53. Looking downstream at Stream Reach 17B. The downstream portion of the channel is aggrading near this culvert.

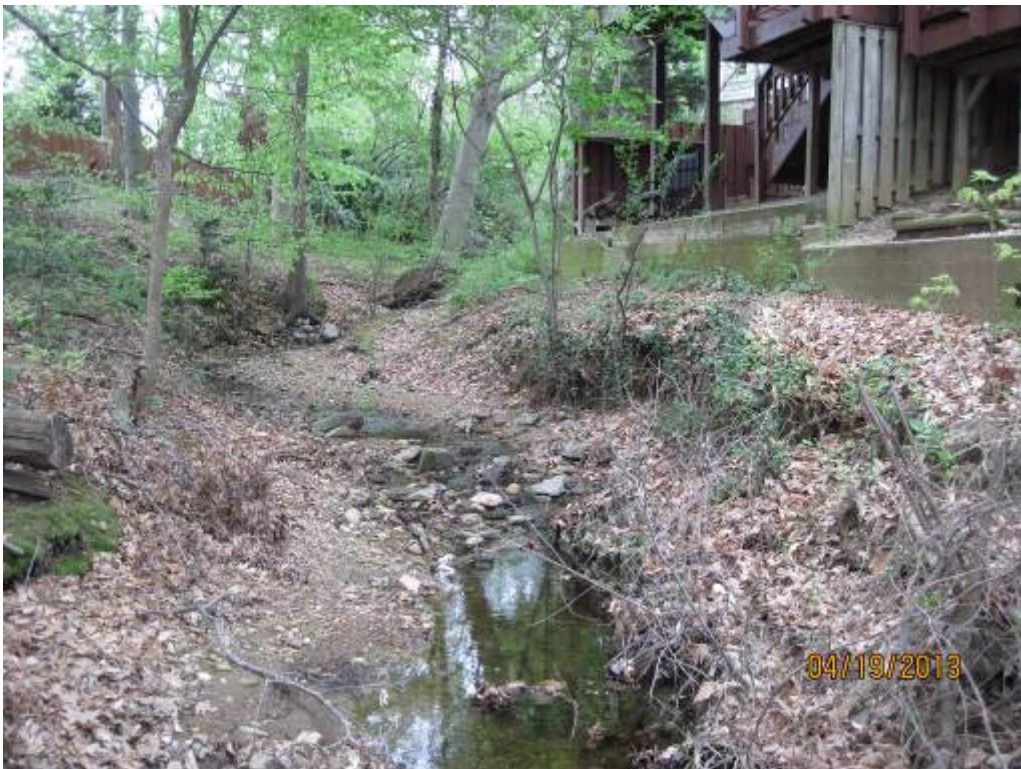
54. Looking upstream at a typical section of Stream Reach 17B. This section is eroding and unstable, and could pose a threat to the encroaching adjacent residences.

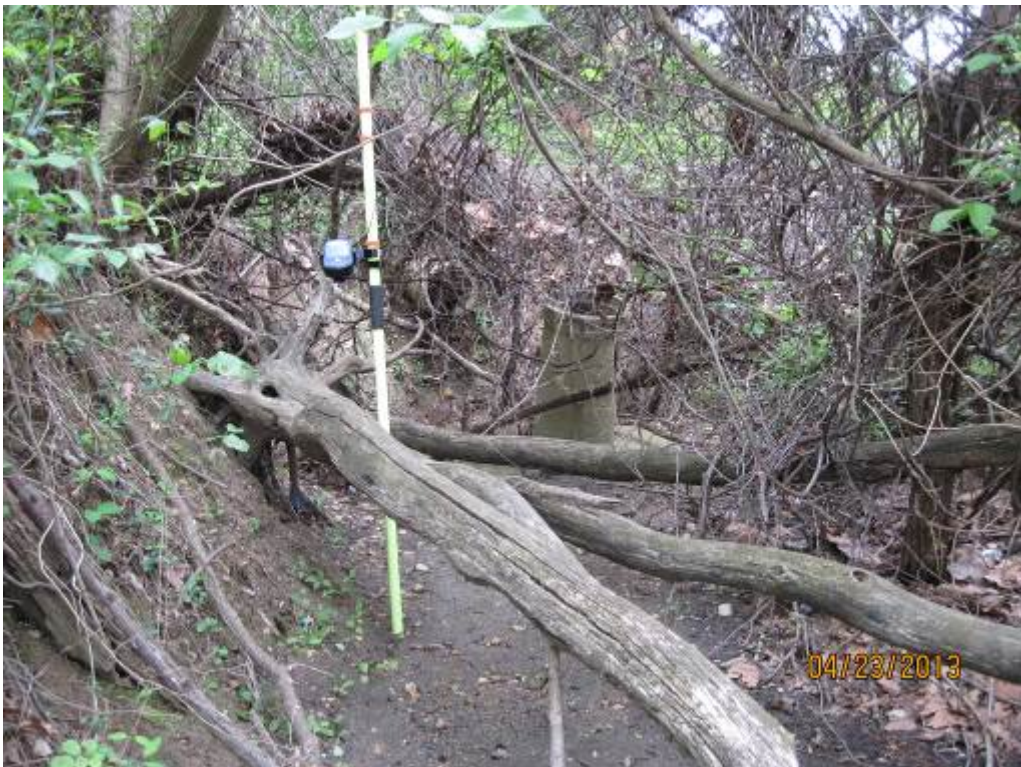
56. Looking upslope at a failing section of pipe adjacent to Stream Reach 18A. The pipe has undercut itself and the end-section has fallen off.

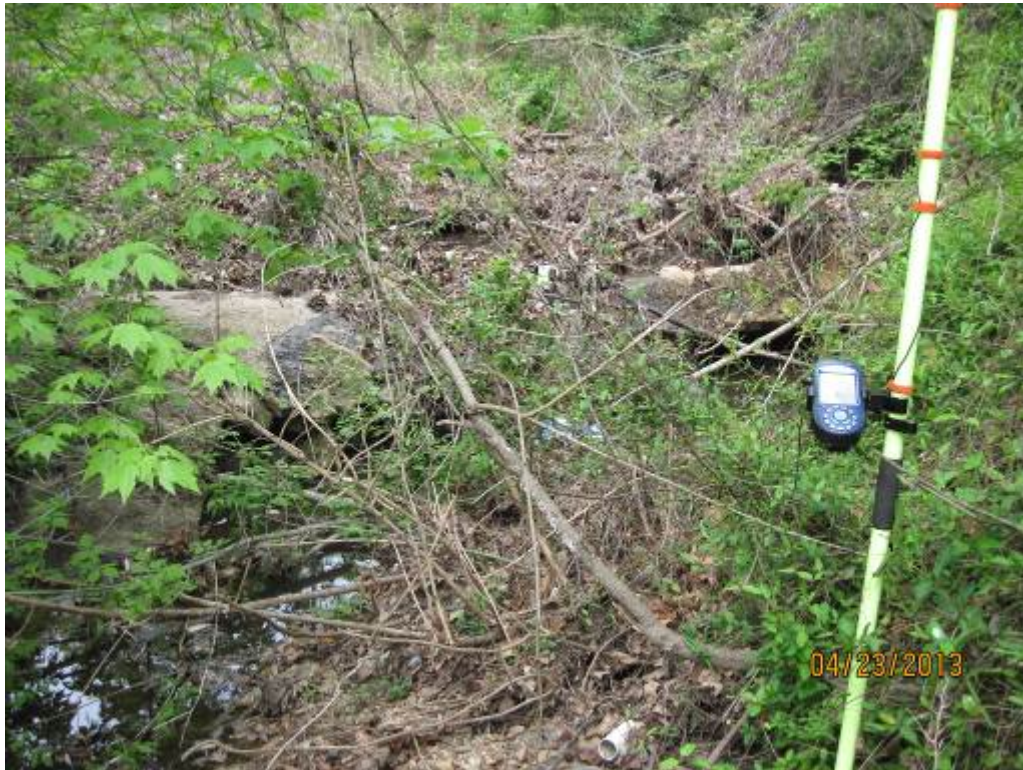
57. Looking upstream at an exposed sanitary sewer line in Stream Reach 18A. This utility is beginning to be undercut, with the possibility of future failure.

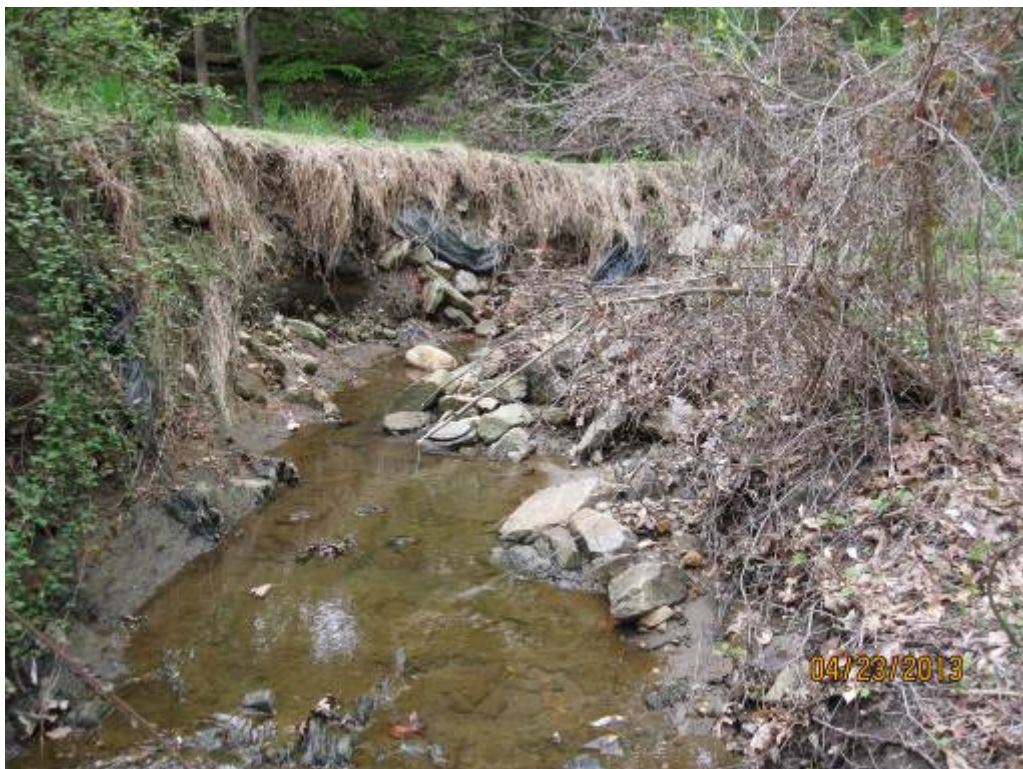
58. Looking upstream at a typical section of Stream Reach 18B. This stream is incised with areas of instability throughout.

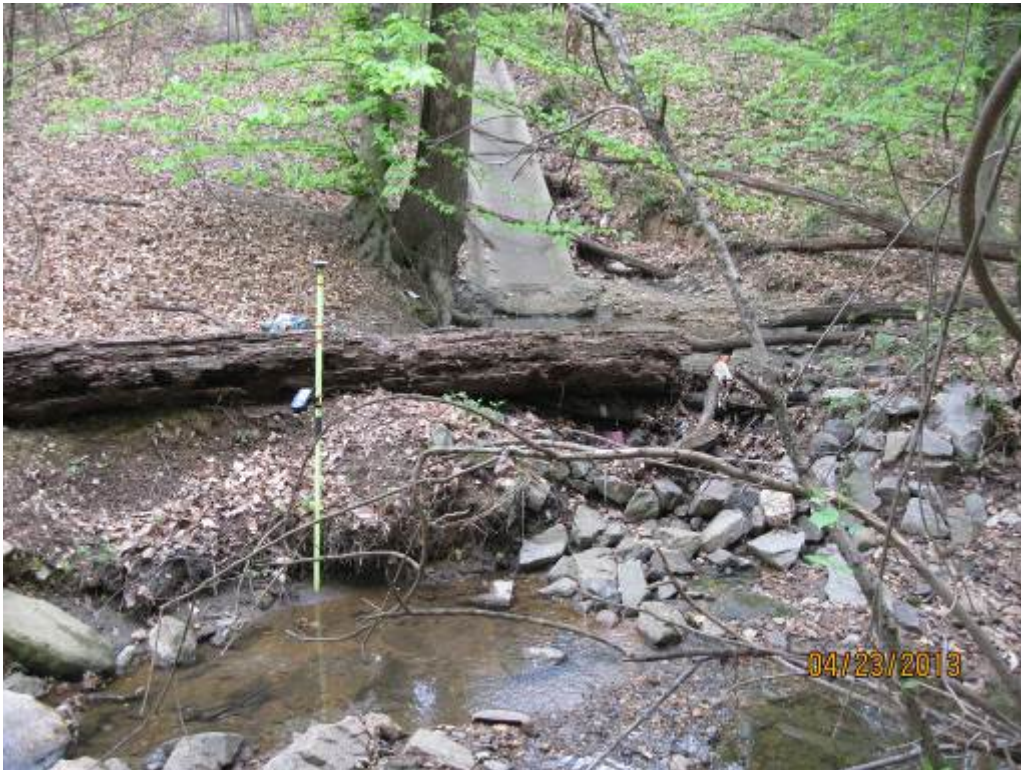
59. Looking upstream at a concrete flume that carries stormwater to Stream Reach 18B. These flumes are likely responsible for at least some of the erosion seen in this channel.

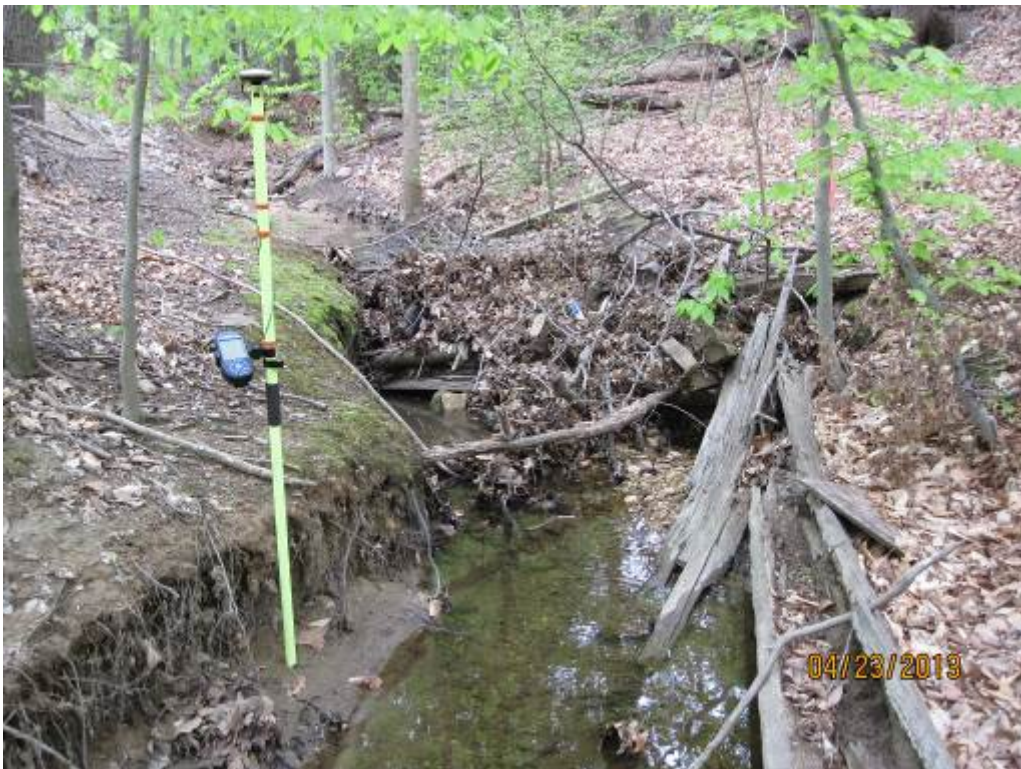
60. Looking upstream at a typical section of the upstream portion of Stream Reach 18B. This section is incised and has been affected by adjacent residential development.

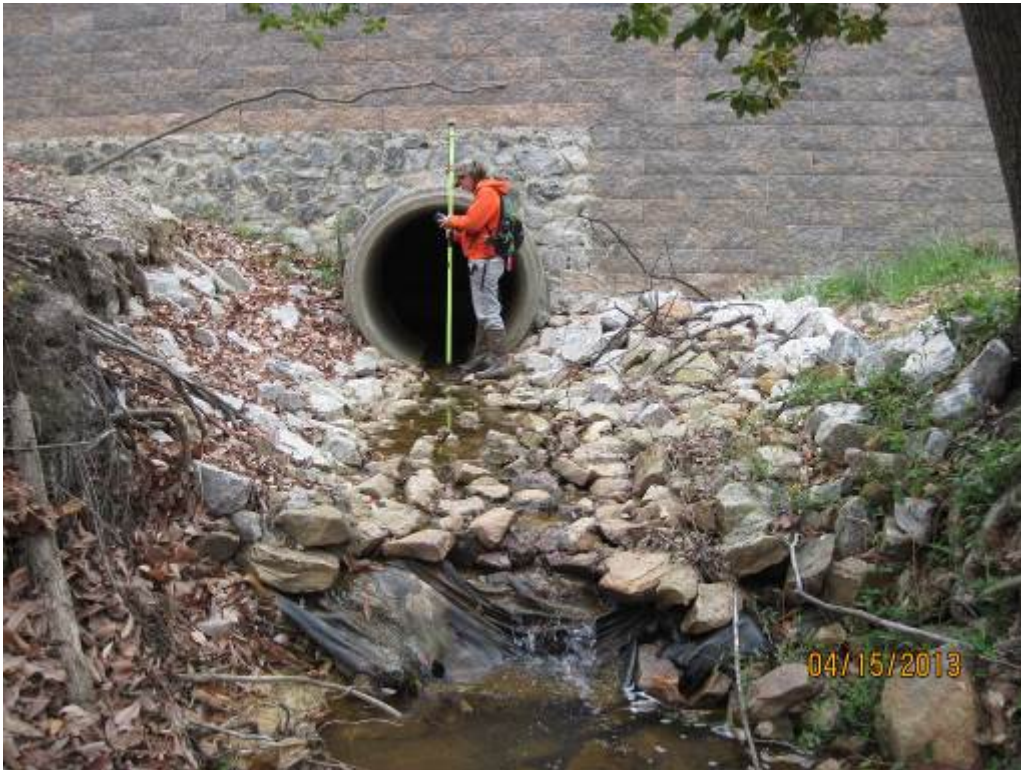
61. Looking upstream at Stream Reach 19A. The end of the rip-rap channel lacks a stable transition to the stream channel, and is starting to fail.

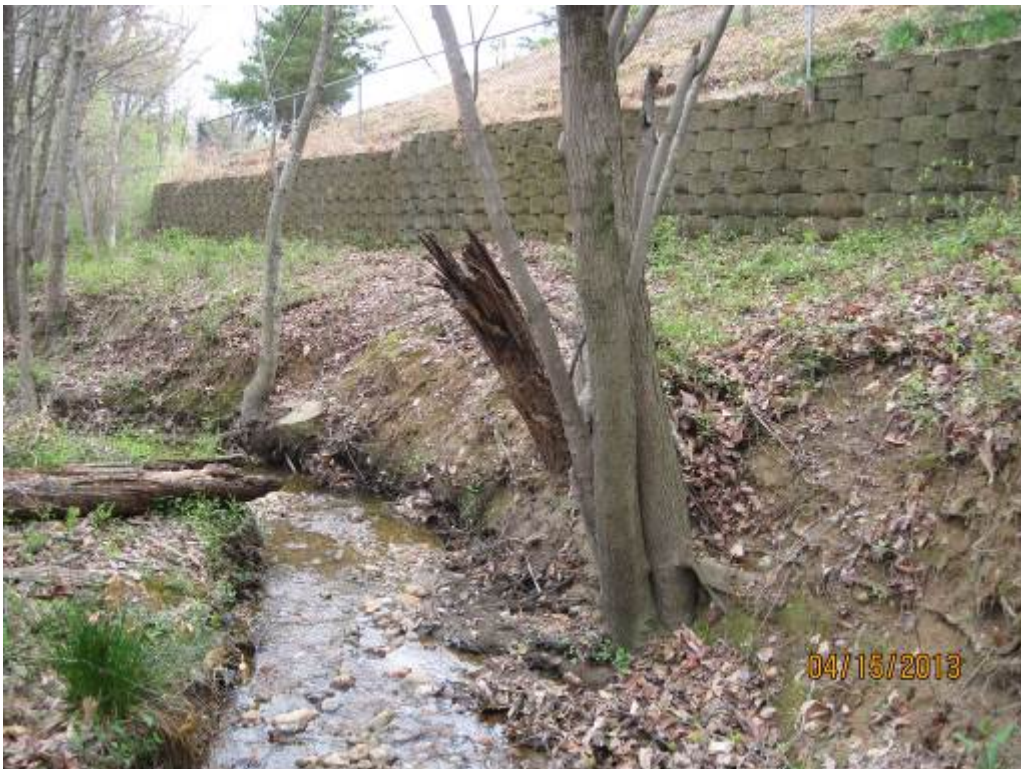
62. Looking downstream at a typical section of Stream Reach 19A. Residential encroachment along this stream has compromised the riparian zone.

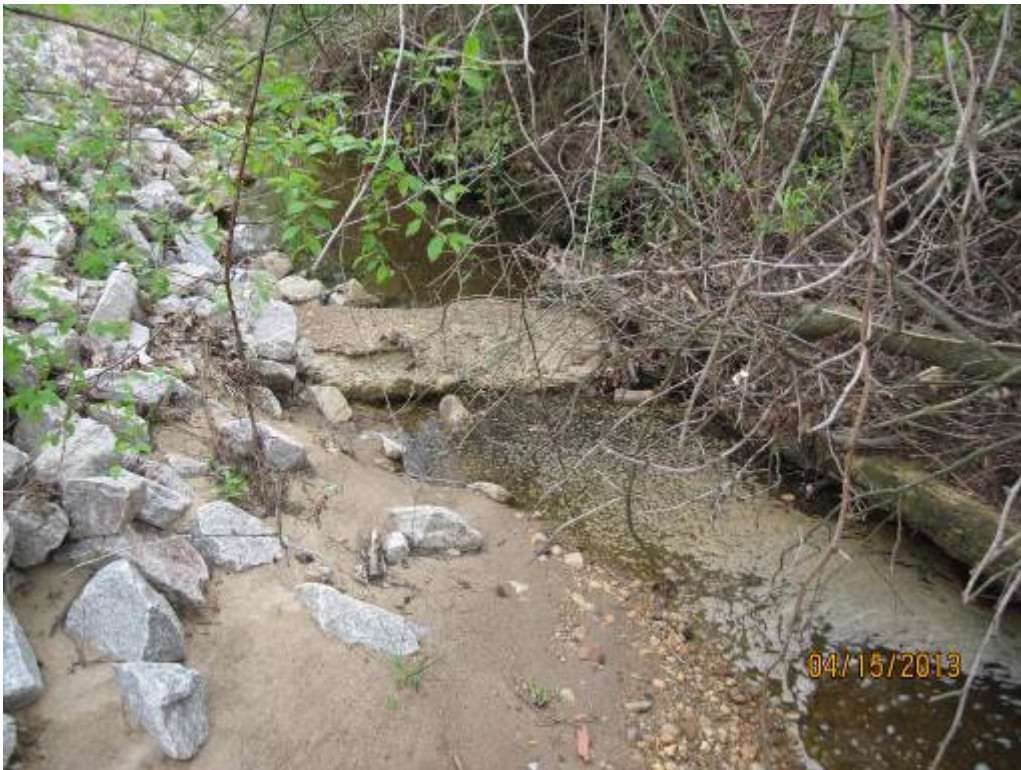
64. Looking downstream at an exposed utility within Stream Reach 19B. This stream has been significantly altered in order to stabilize the left bank, along Devils Reach Road.

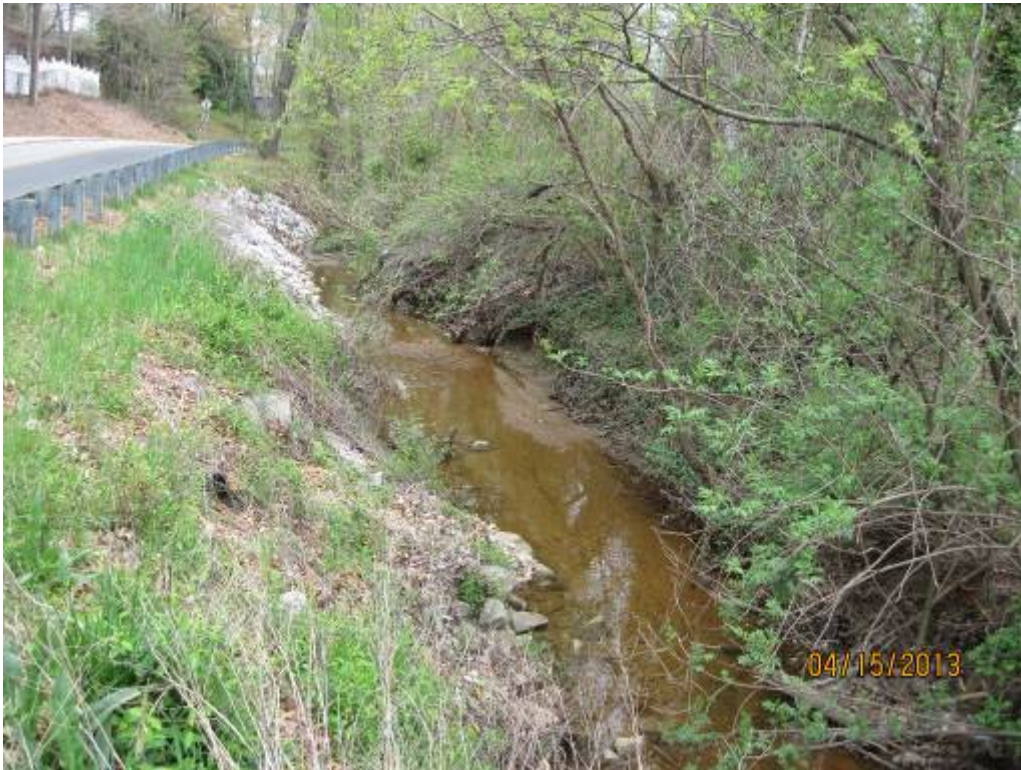
65. Looking downstream at a typical section of Stream Reach 19B.

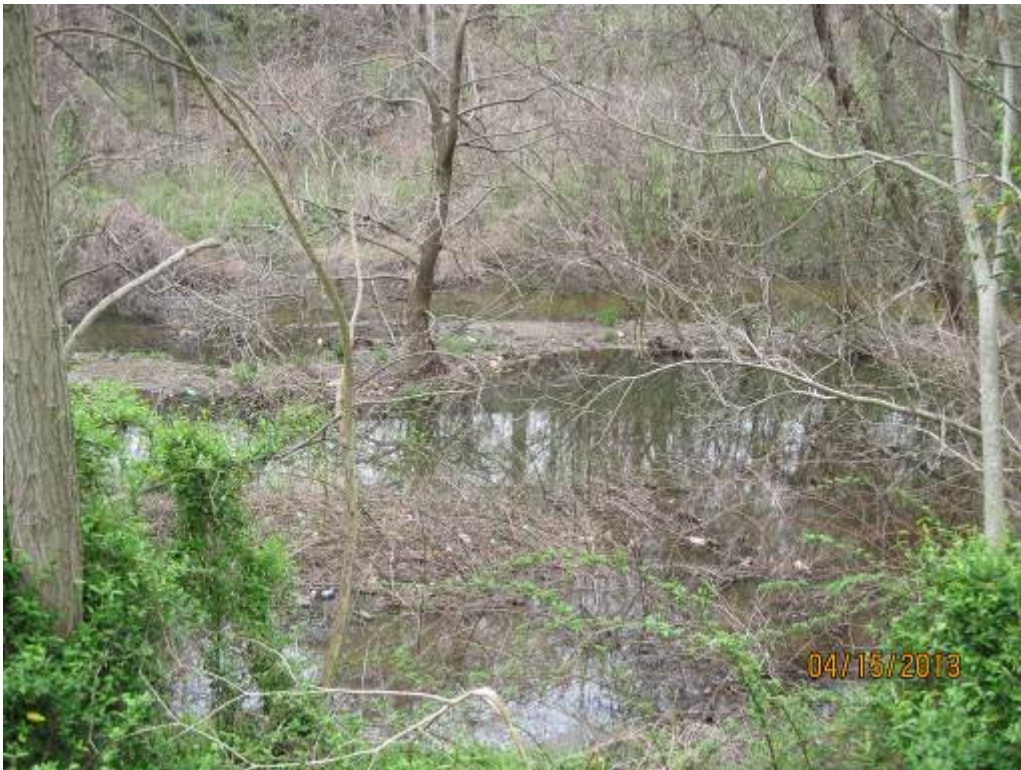
66. Looking downstream at a typical section of Stream Reach 19B, where it flows into a stormwater management basin.
