Appendix F Index

Stream Assessment Photographs

Appendix F
Stream Assessment Photographs
Occoquan Watershed – Study of Four Subsheds
WSSI #25156.01

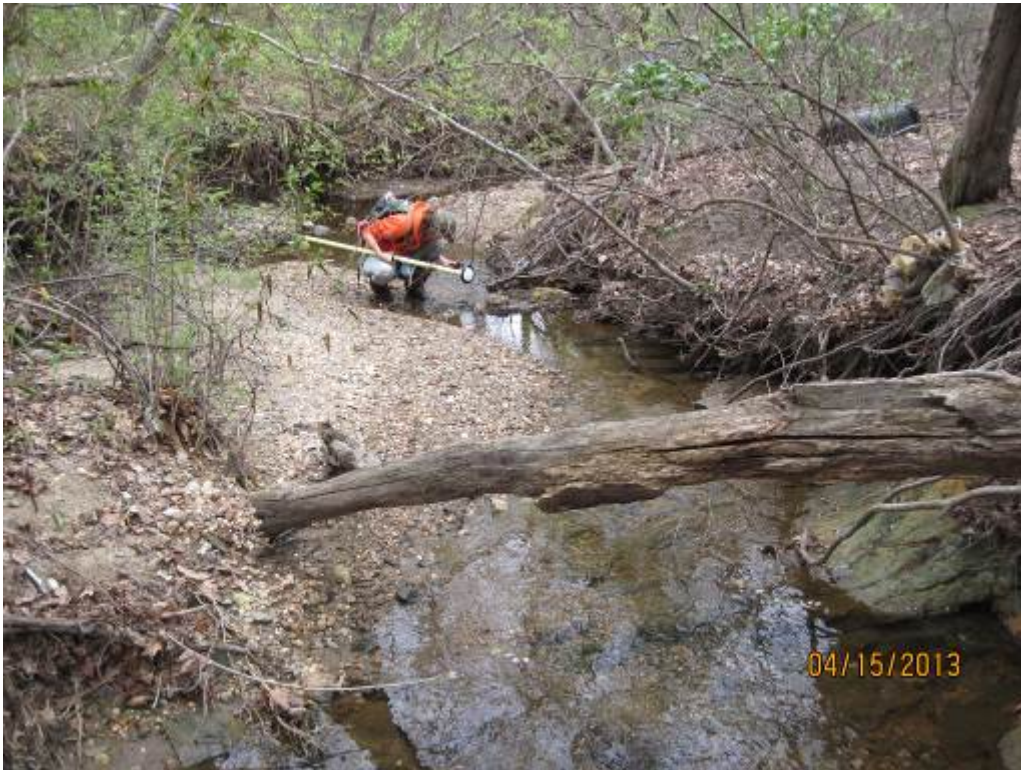
67. Looking downstream at a typical section of Stream Reach 20A. This section is somewhat incised, but has areas of exposed bed rock, which contribute to stability.

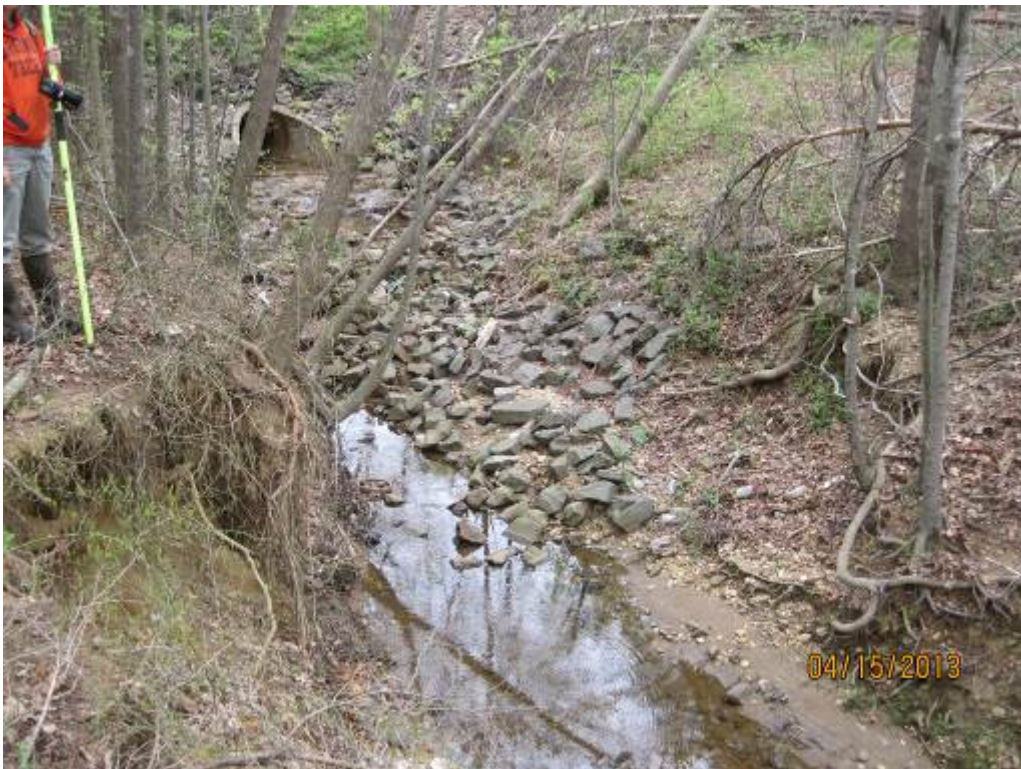
68. Looking upstream at a typical section of the upstream portion of Stream Reach 20A. This portion is incised, with areas of instability.

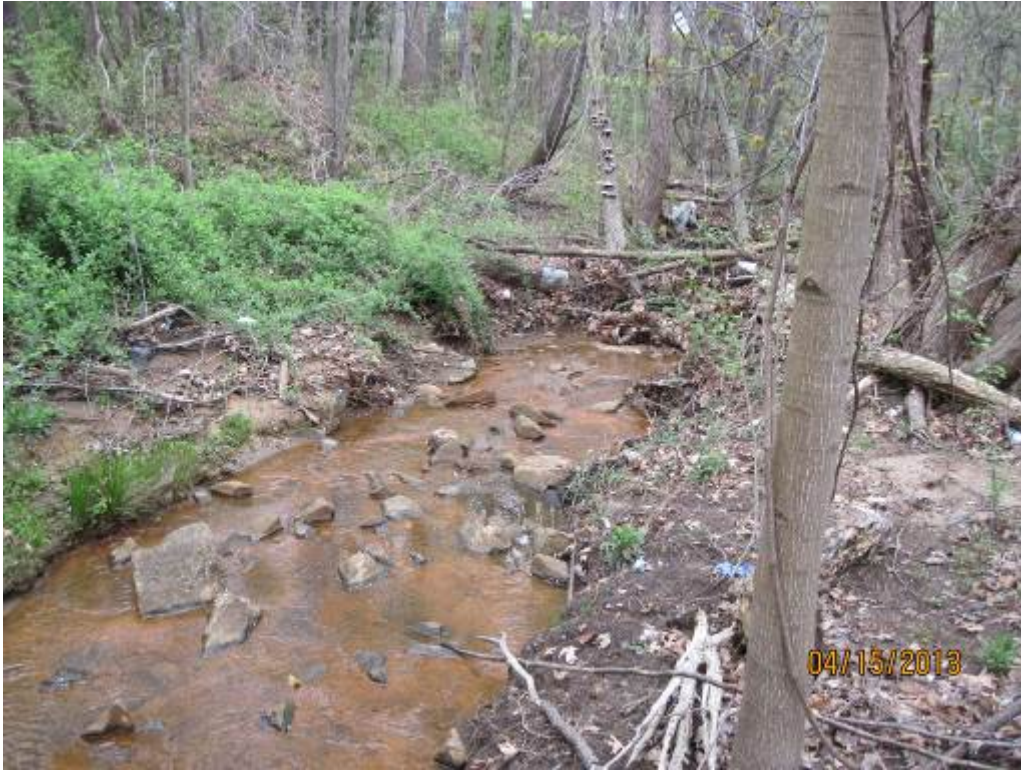
69. Looking downstream at a typical section of Stream Reach 20B. This stream is somewhat incised, with residential encroachment on all sides.

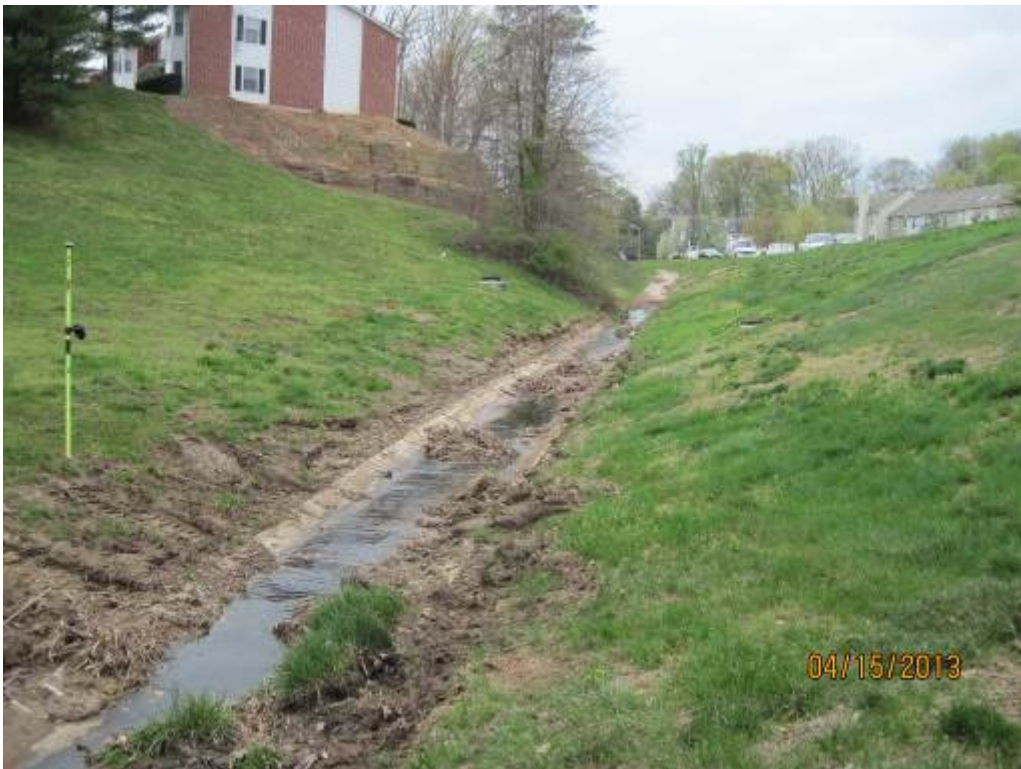
70. Looking upstream at a concrete channel that concentrates water into Stream Reach 20B.

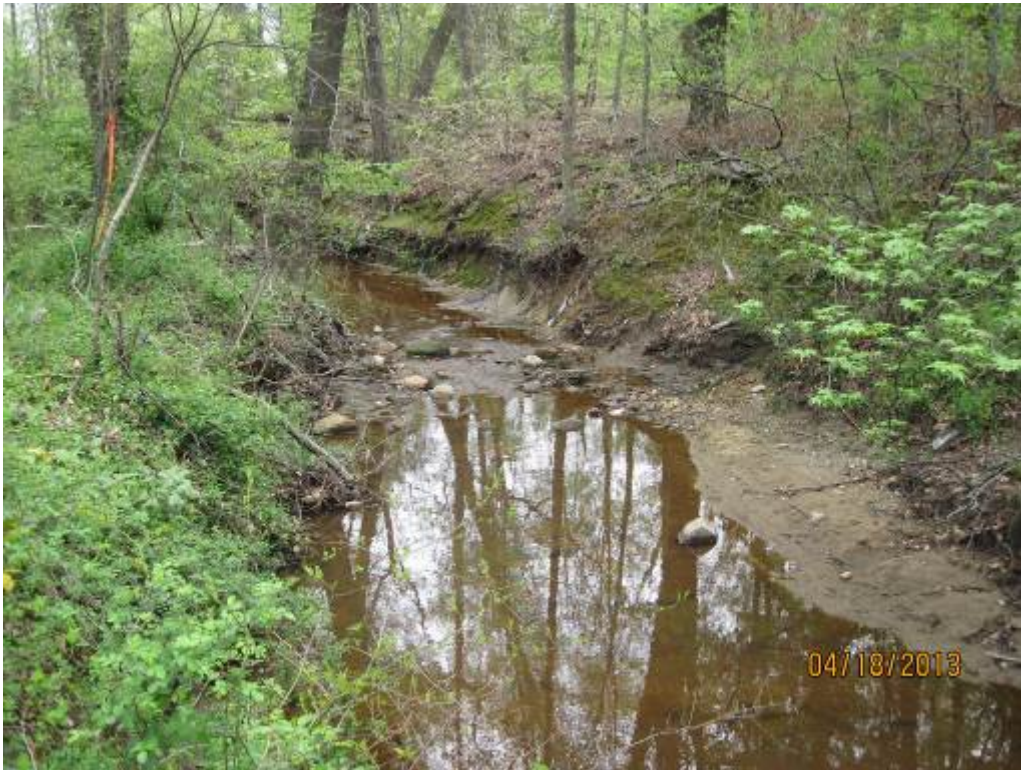
71. Looking downstream at a typical section of Stream Reach 21. This section is incised, with areas of instability.

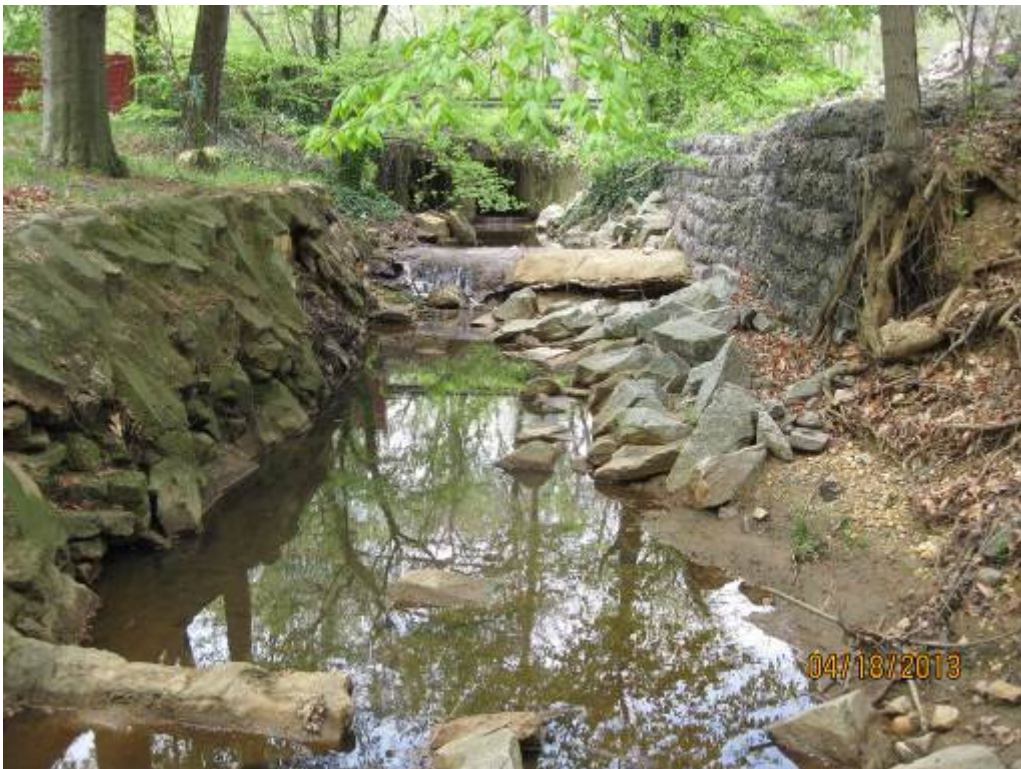
72. Looking upstream at Stream Reach 21, east of Occoquan Road. This section of the stream has been heavily armored, yet several exposed and undercutting utilities are present. Encroachment from development is present on both sides of the stream channel.

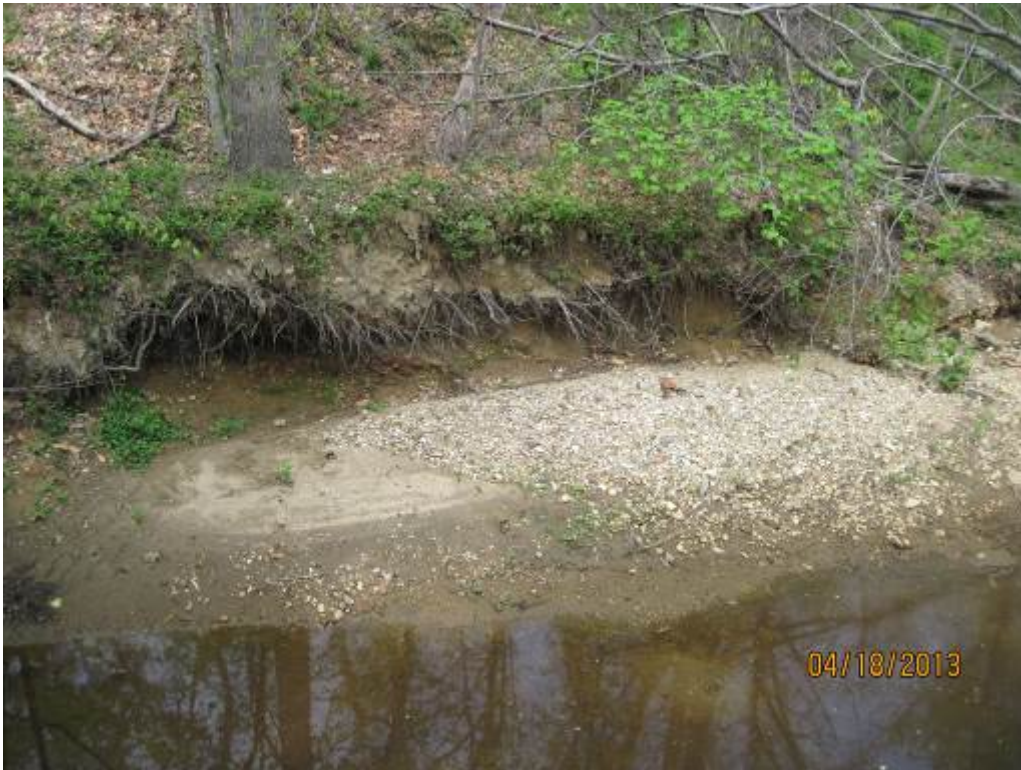
73. Looking downstream at a typical section of Stream Reach 21. This section is unstable, with incision and deposition throughout.

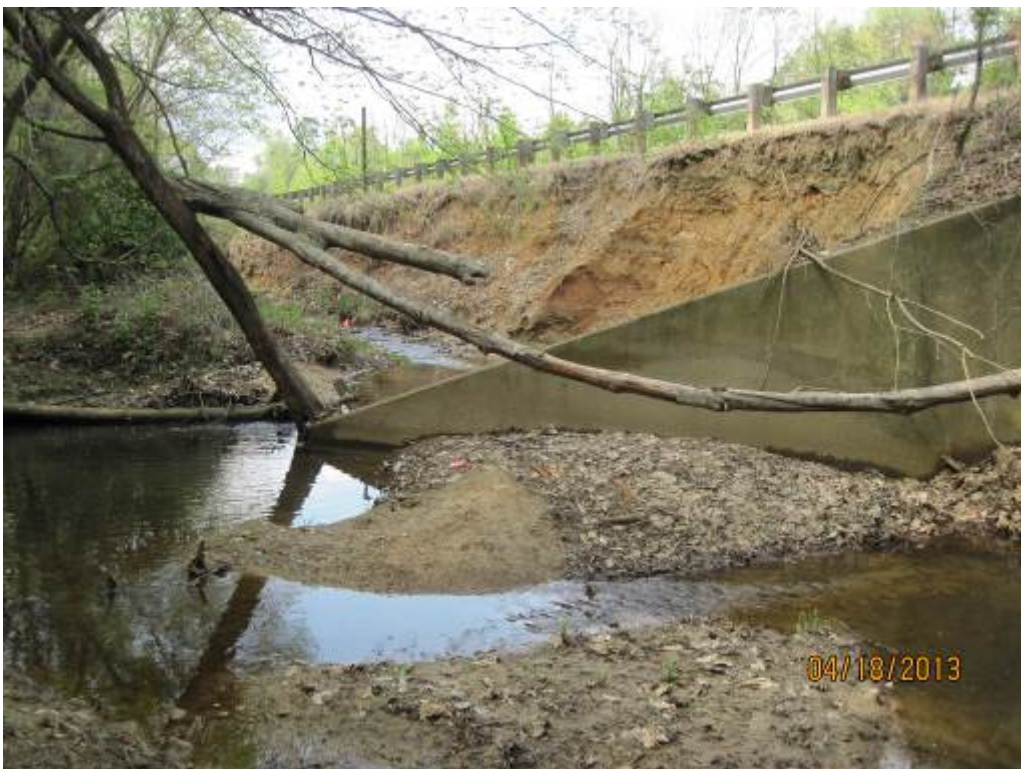
74. Looking upstream at the downstream end of Stream Reach 21. This section is severely eroding behind the wing-wall under a ramp for I-95. This stream poses a danger to the ramp itself.

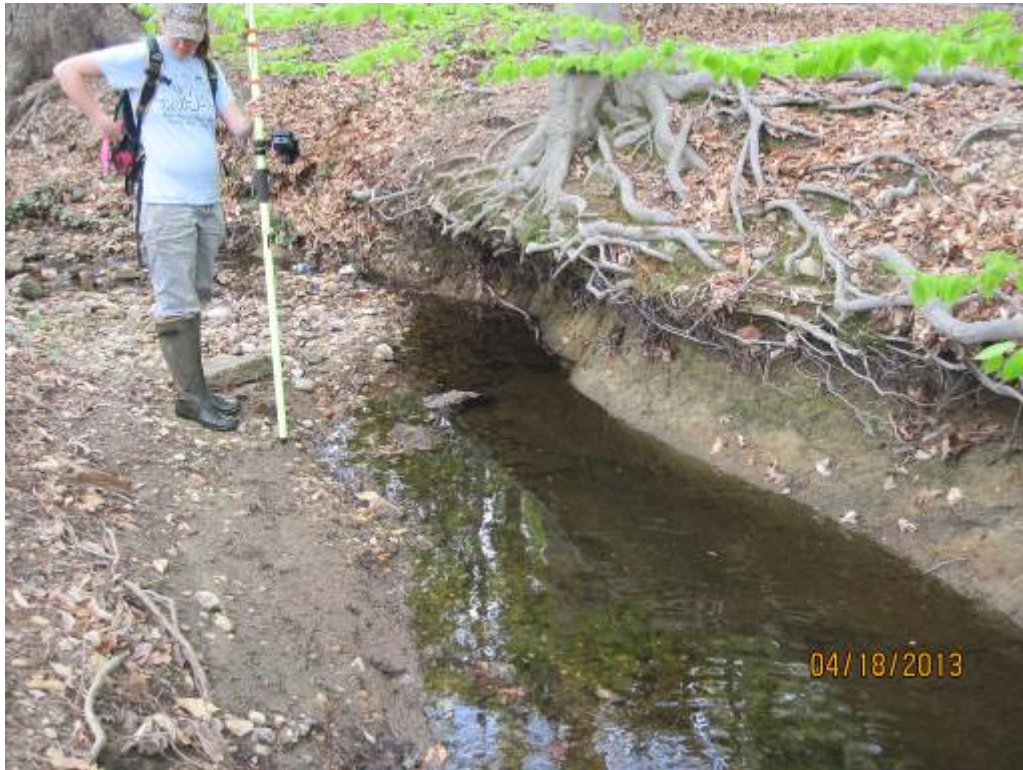
75. Looking downstream at a typical section of Stream Reach 22. This stream reach typically shows incision on one side of the channel.

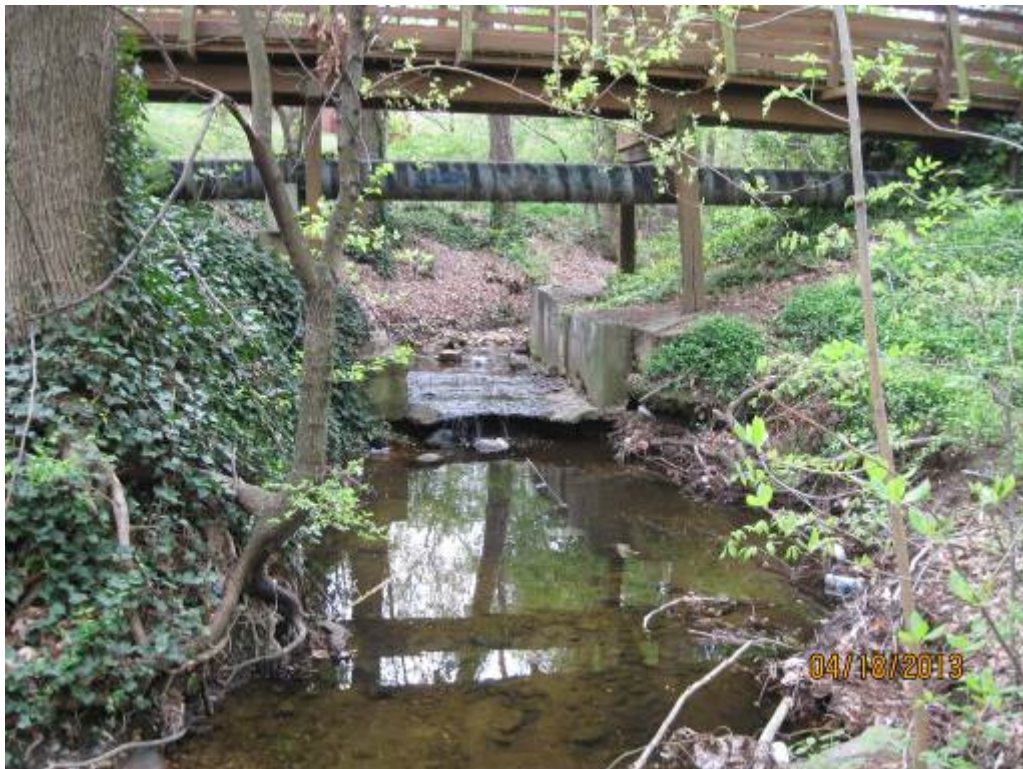
76. Looking upstream at a utility crossing over Stream Reach 22. The concrete apron is starting to undercut.

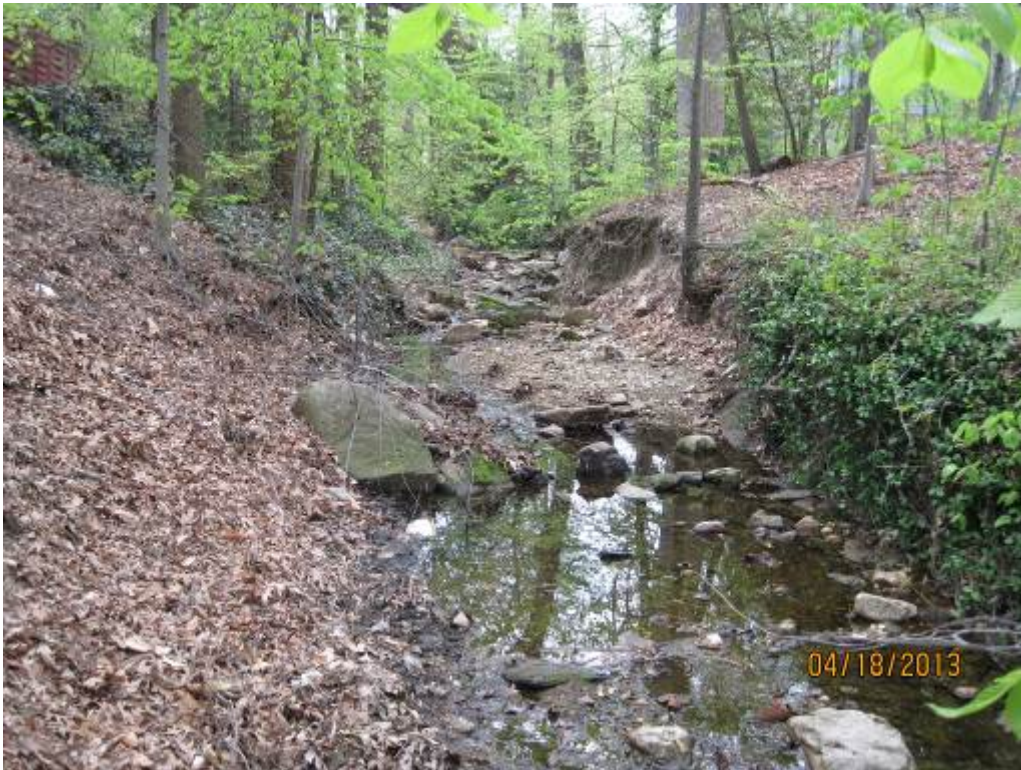
77. Looking upstream at a typical section of Stream Reach 22.

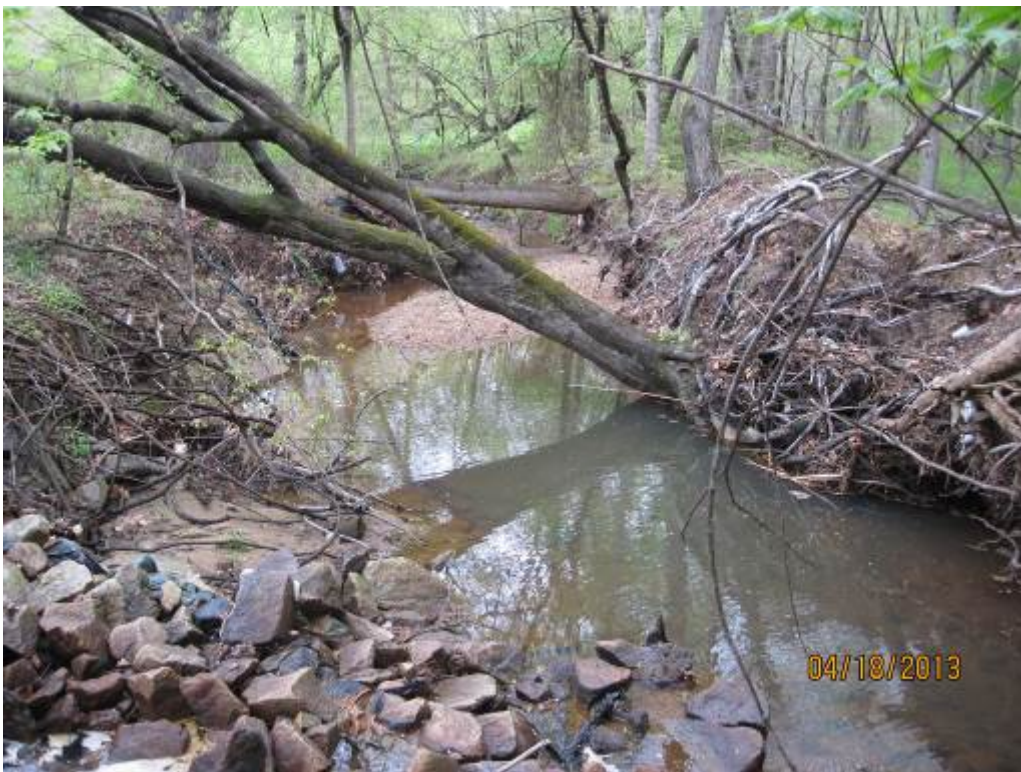
78. Looking downstream at a typical section of Stream Reach 23. This stream is unstable, with significant erosion and undercutting.

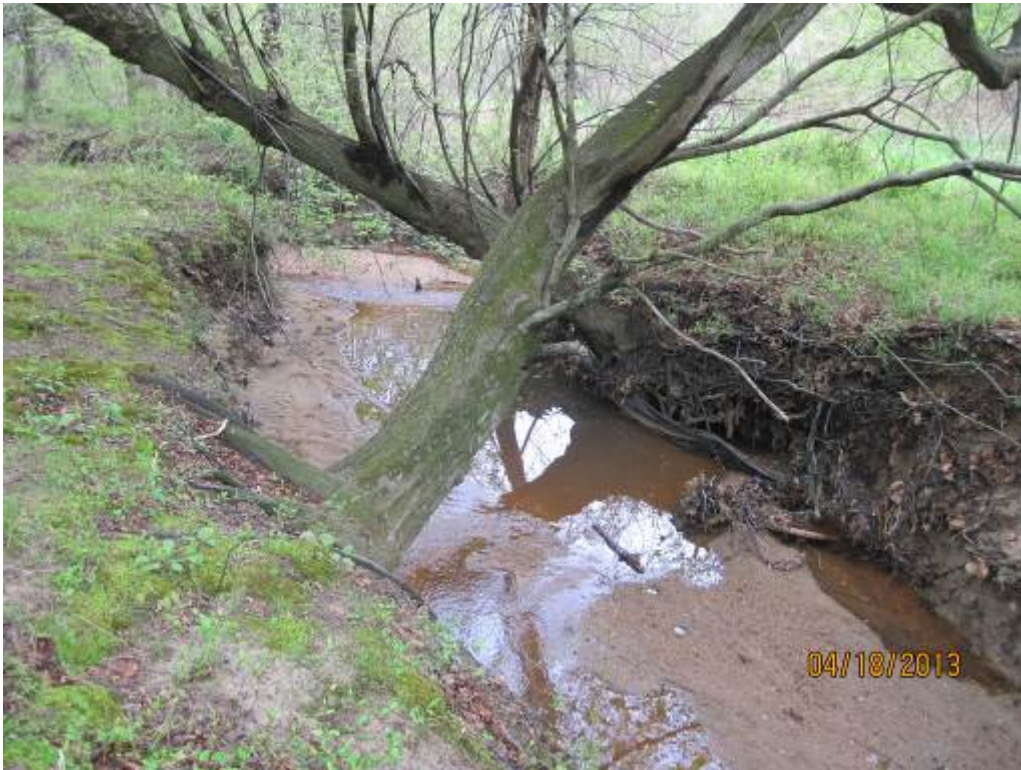
79. Looking upstream at a typical section of Stream Reach 23.

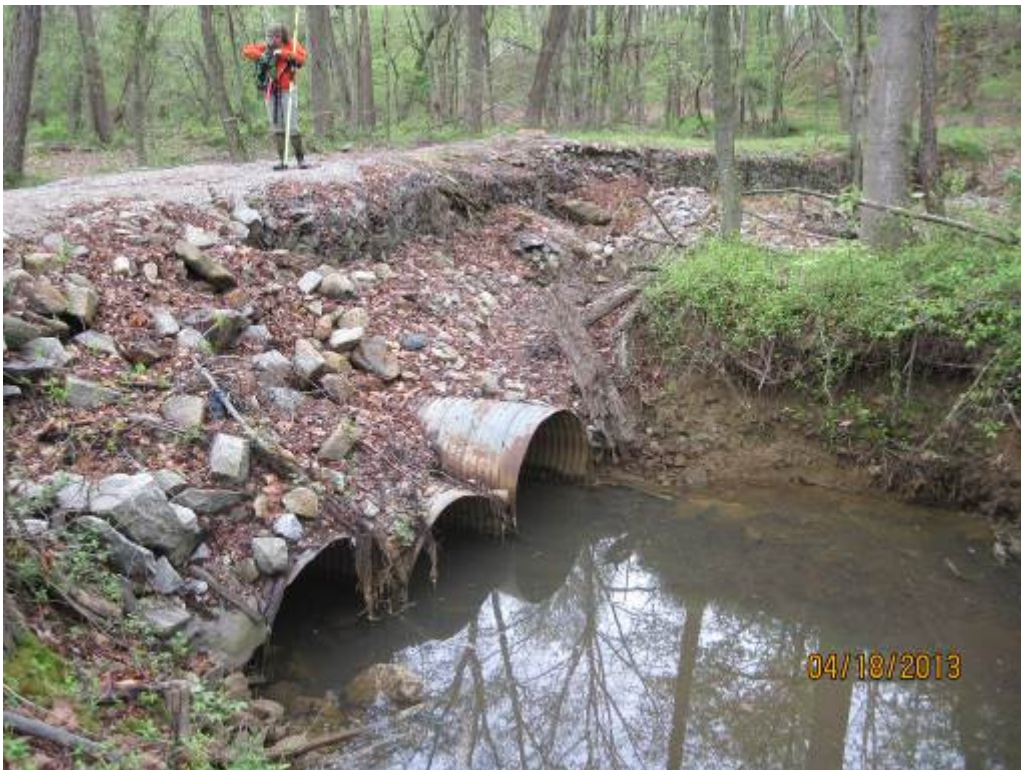
80. Looking upstream at the downstream end of Stream Reach 23, where a sanitary sewer line crosses above the stream and the corrugated metal pipes. This area has been stabilized with gabion baskets, which have shifted the areas of erosion. This area could be compromised in the future.
