**Marumsco Creek and Farm Creek
Watershed
Stormwater Management Facility
Inspections**

Stormwater Management Facility Inspection

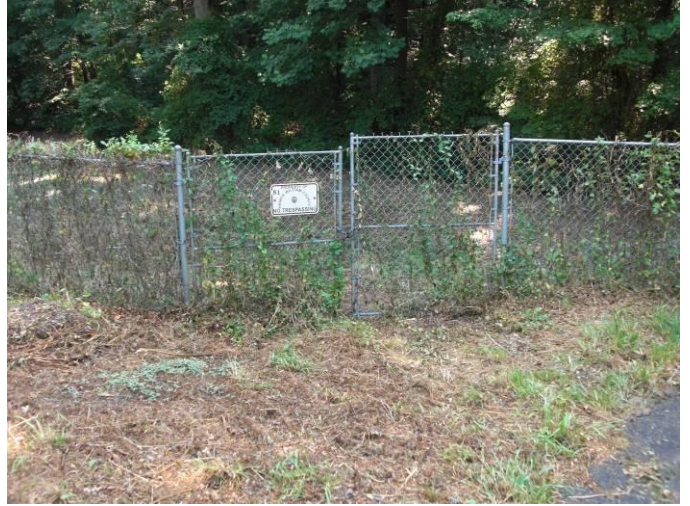
Overview of SWM facility from north

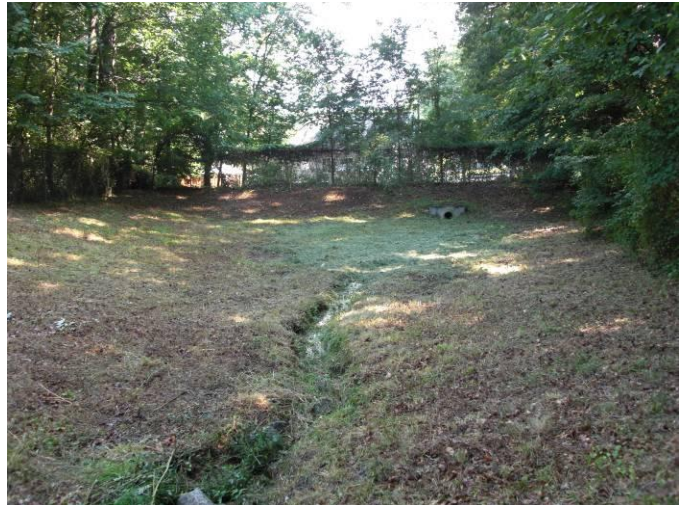
Outlet structure consists of a single reinforced concrete pipe and headwall. No riser / no low flow orifice.
Outlet Notes: Pipe outfall was not found nor inspected.

Outlet structure at the southern end of the SWM facility

The project concept for retrofit of this site involves conversion of the BMP from a quantity control structure to a quantity and quality control structure by installing a riser structure. The conversion of pond to water quality BMP will reduce the amount of pollutants transported from the I-95 corridor and the residential area into the receiving waters downstream of the BMP.

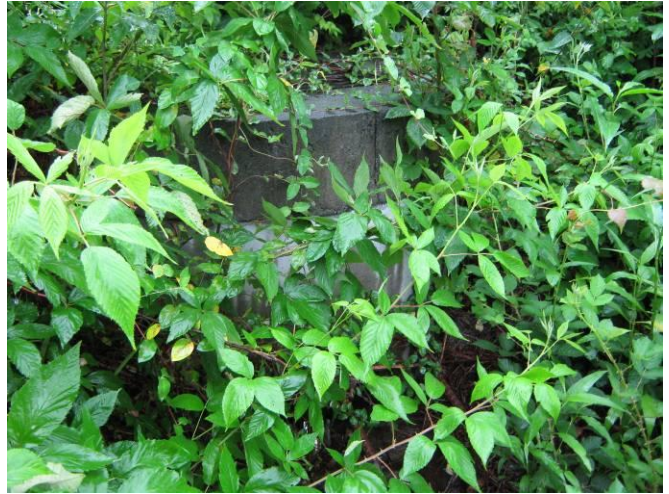
Outlet structure consists of a riser structure with a low flow orifice, trash racks, and a high flow bypass.

Overview of BMP outlet riser structure

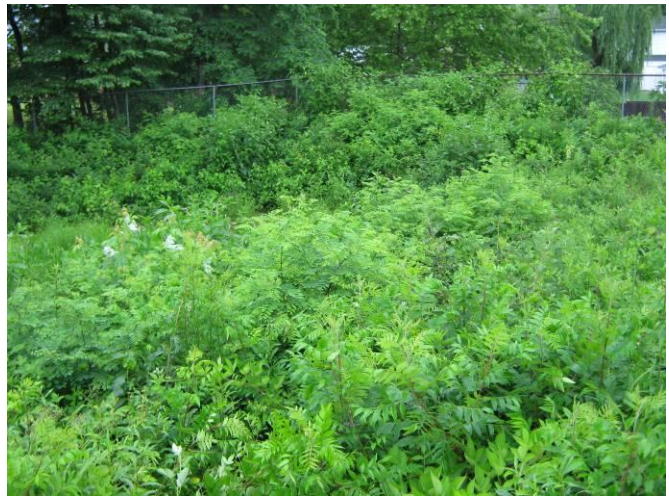
The pond serves an older low density residential area. The pond has an abundance of invasive vegetation. Maintenance access for county vehicles/equipment is slightly problematic due to an overgrown access path. Primary issue with the SWM facility appears to be trash accumulation near the riser. The riser has trash racks installed.

**SWM facility overview from access gate.
Woody vegetation inside SWM facility.**

Maintenance opportunities include removal of woody vegetation and invasive species inside the pond, on the embankment and along the access path.

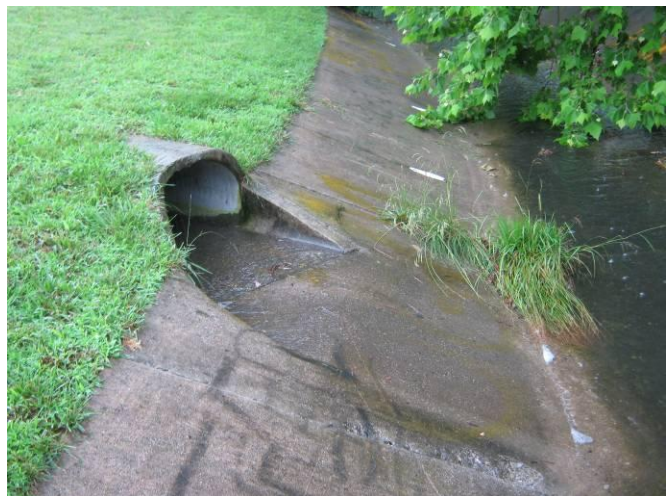
Pipe outfall was determined to be in good condition

SWM BMP Outfall

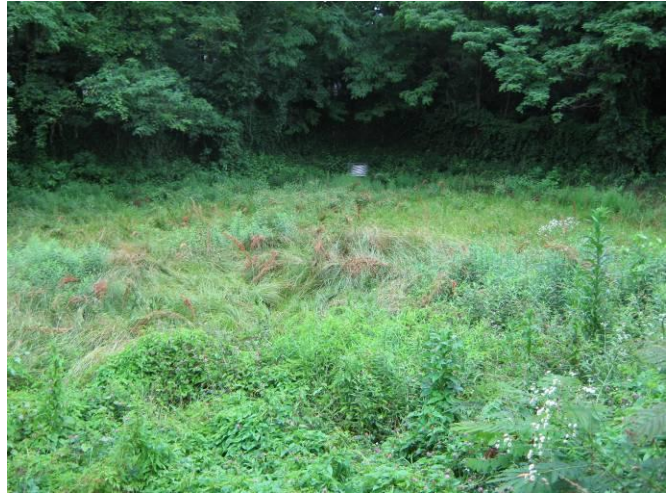
There is a lot of woody vegetation inside and outside the SWM facility.
All other attributes of the facility were determined to be in good condition.

Overview of SWM facility from access gate

Maintenance opportunities involve removal of woody vegetation and invasive species inside the pond and on the embankment

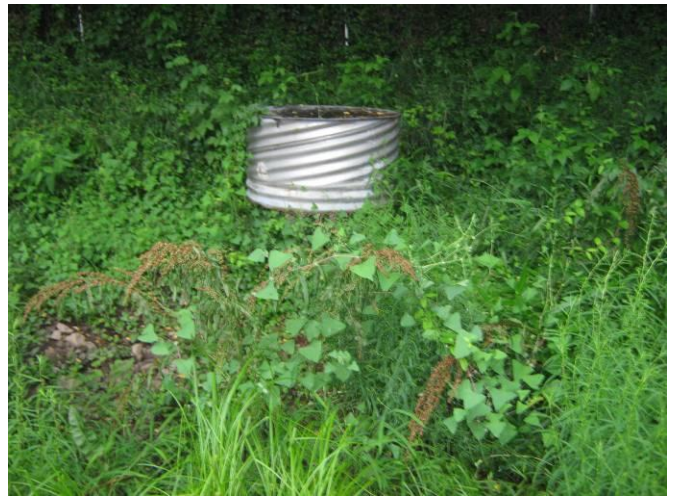
Outlet structure consists of a riser structure with a low flow orifice and a high flow bypass. The low flow orifice appears to be fitted for extended detention through use of a synthetic geotextile covering over the orifice.

Overview of the outlet riser

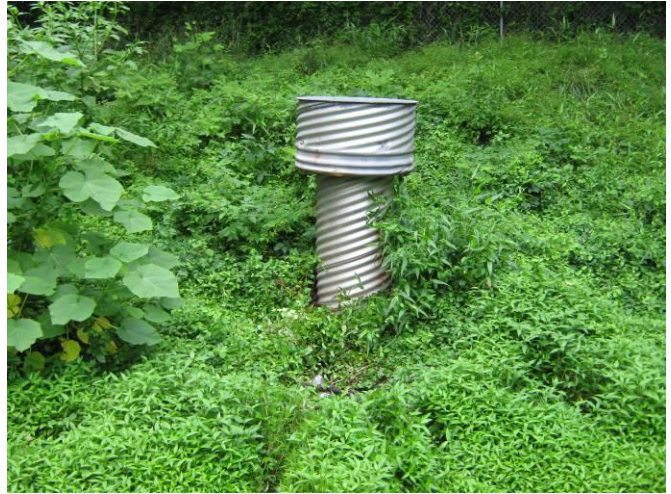
Outlet structure consists of a riser structure with a low flow orifice and a high flow bypass. The low flow orifice appears to be fitted for extended detention through use of a synthetic geotextile covering over the orifice.

Overview of the outlet riser

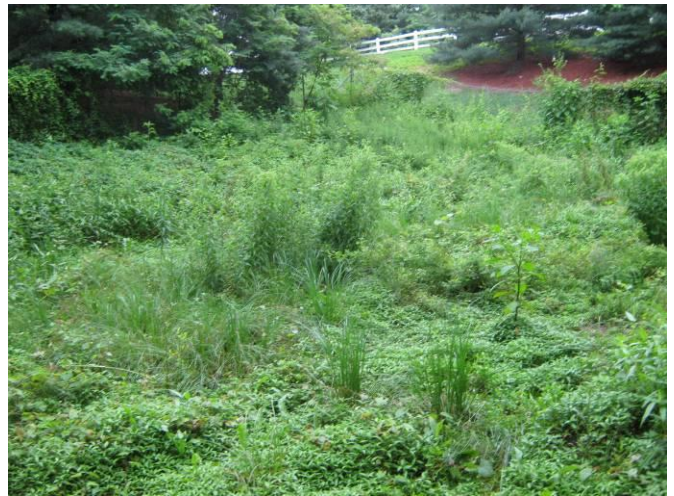
There is significant growth of woody vegetation on the embankment outside the fence.

Overview of pond from outlet riser

Maintenance opportunities involve removal of woody vegetation and invasive species on the embankment.

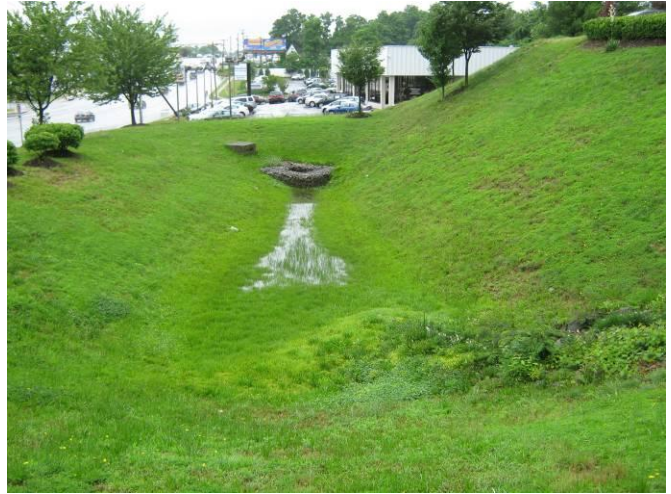
Overview of primary riser and low flow orifice structure from the driveway.

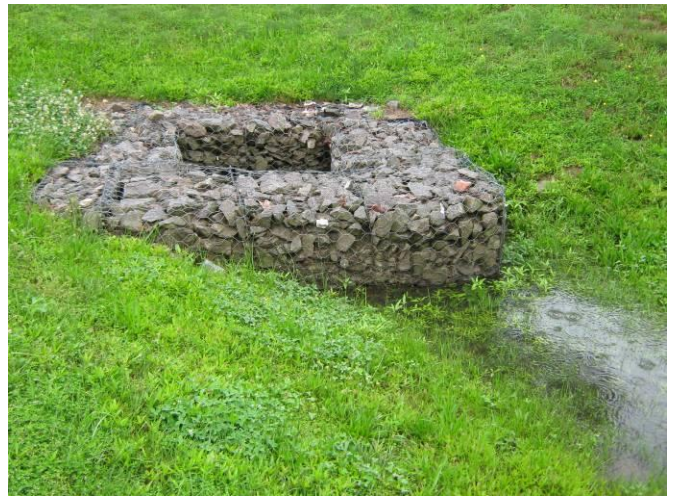
Outlet structure consists of a riser structure with a low flow orifice, trash racks, and a high flow bypass. The low flow orifice has been retrofitted for extended detention using gabion baskets.

The pond is already retrofitted for extended detention using gabion basket riser structure.

Gabion retrofit structure to low flow orifice

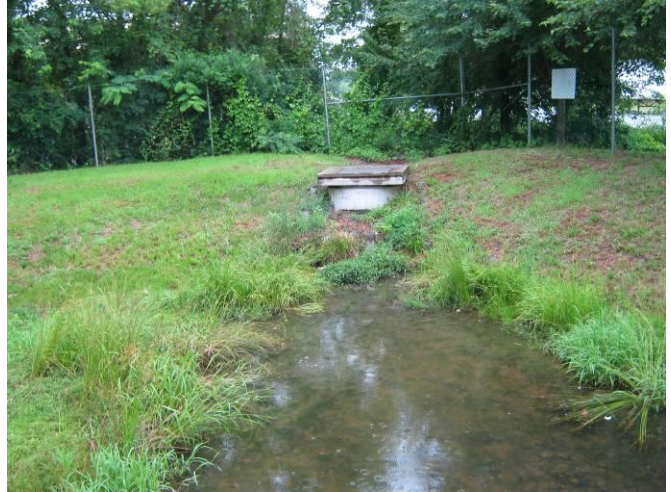
Outlet structure consists of a riser structure with a low flow orifice and a high flow bypass. Inspection was unable to determine if the low flow orifice was fitted for extended detention or if the low flow structures were protected by trash racks.

Overview of the outlet riser

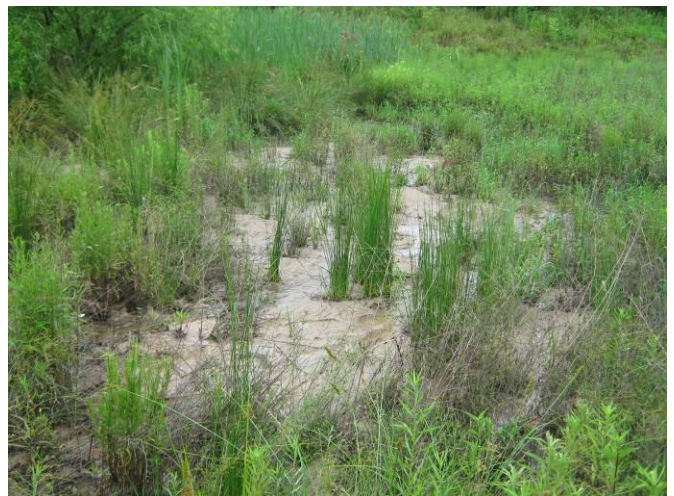
observed near the inlet channel. Periodic monitoring of sediment buildup is recommended. Minor trash is also building up in the facility.

Fine sediment deposition near inlet

Sediment Removal

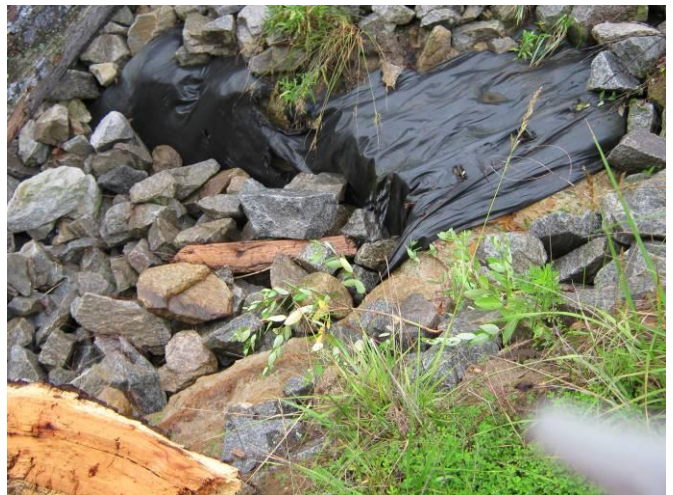
A riprap channel tributary to the pond has undermining and headcutting occurring. The riprap inlet channel also has fallen trees that can potentially harm the fence during a high storm. The riprap revetment of the inlet channel may have been an attempt to stop erosion, however, undermining and slumping appears to be a continuous problem. SWM facility embankment has minor erosion at locations with sandy soils; however, the erosion is not anticipated to be a significant problem. Minor sediment buildup was

Headcut at the riprap channel

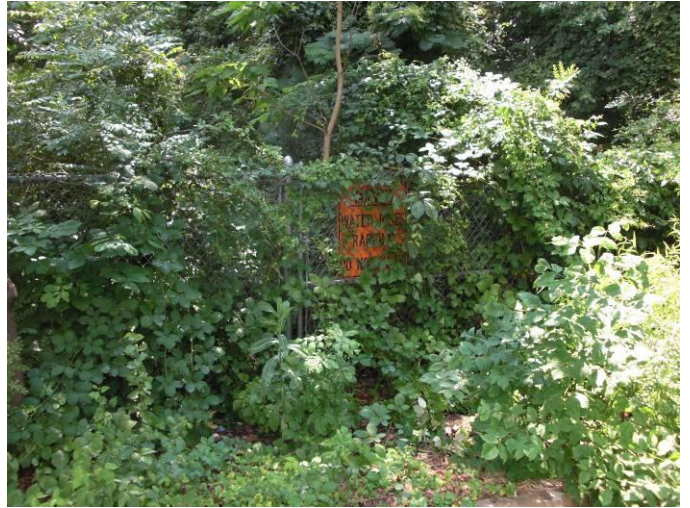
Access gate does not have a county lock.

Access gate does not have a county lock

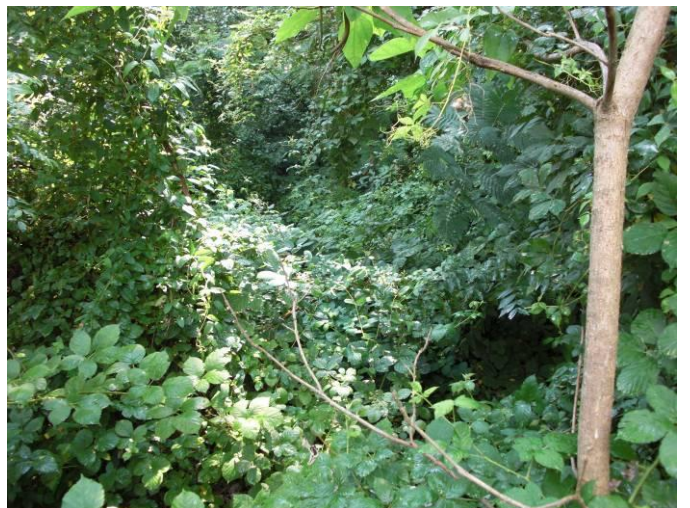
The pond appears to be older with significant amounts of woody vegetation inside the fence line and throughout the pond. Significant amounts of invasive species present.

View of SWM facility from fence line

Maintenance opportunities at the site involve removal of woody vegetation and invasive species inside the pond and on the embankment along with replanting of appropriate vegetation to supplant the growth of wetland inside the pond to achieve water quality benefits. Given the lack of access and appropriate county locks, the ownership and maintenance responsibility for the pond may need investigation.

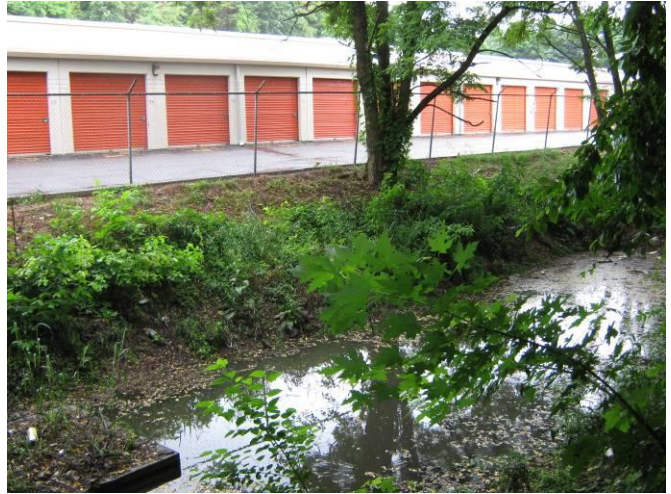
- Facility appears to be a dry pond that has ponded water in it. Inspection can not conclusively determine the reason for ponding and the design intent for the facility.
- No access to the SWM facility due to access restrictions from Public Storage facility.
- Riser opening appears to be clogged with debris.
- Some roots in the embankment are exposed.
- There is also evidence of presence of woody and invasive vegetation.
- All other attributes of the facility were determined to be in good condition.

Overview of SWM facility from fence line

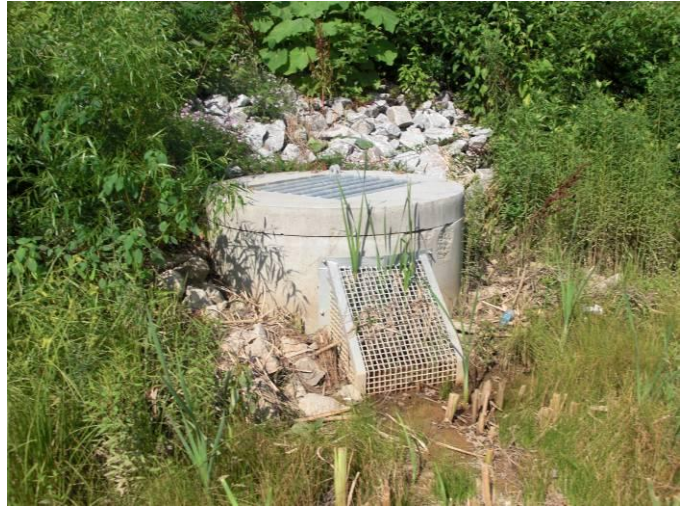
- Fine sediment accumulation was observed near the riser structure.
- All other attributes of the facility were determined to be in good condition.

Overview of the outlet riser and low flow orifice

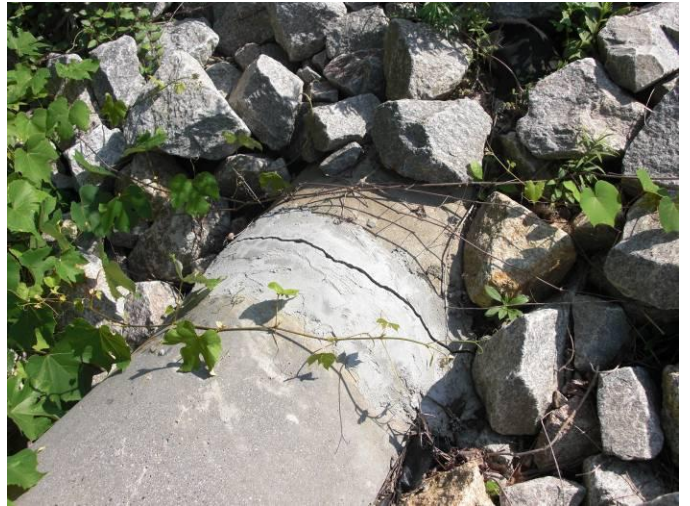
Crack in outfall pipe
