Basin 650, Middle Little Creek - Project Reach Descriptions

Basin 665, Swans Creek - Project Reach Descriptions

Basin 690, Lower Little Creek - Project Reach Descriptions

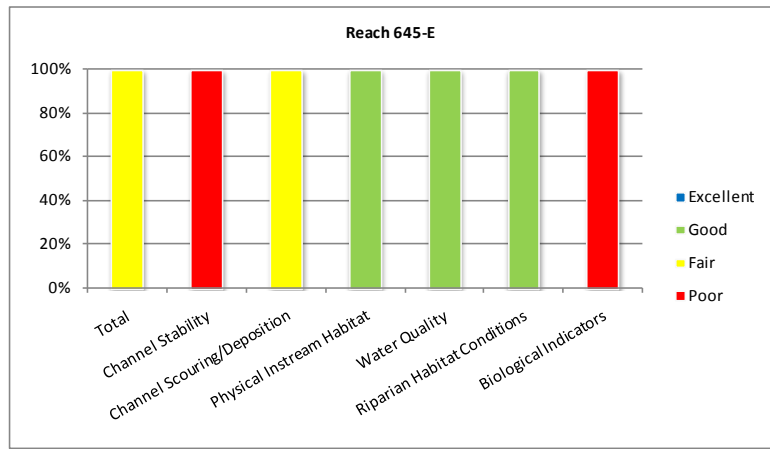
Reach Name: 645-E

Reach 645-E is a fair quality stream, with an average total RSAT score of 22. Channel incision is responsible for low channel stability scores and bed and bank erosion along nearly 50% of the reach. Channel scouring/deposition scores are fair, with an increase in deposition, increased embeddness of riffle material, and few deep pools. Physical instream habitat scores are good, with a mix of riffle, run and pool habitat, and a varied velocity and depth regime.

Riparian habitat is in good condition, with a forested buffer of at least 100ft on either side of the channel, and dense canopy cover, providing more than 60% shading. Biological indicators are absent along this reach (resulting in a score of 0), but water quality is good, with light substrate fouling, moderate TDS, and a depth of visibility of up to 3ft.

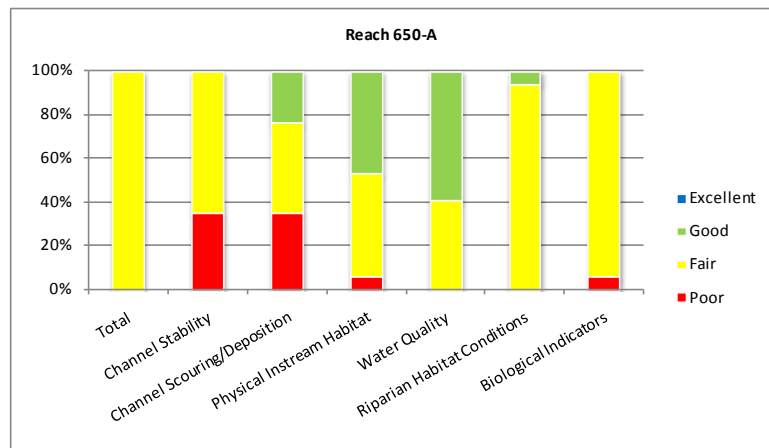
Reach Name: 650-A

Reach 650-A is a fair quality stream, with an average total score of 22. Channel stability scores along Reach 650-A are influenced significantly by systemic channel widening, with approximately 50% of the streambanks experiencing sloughing or scour. Bank erosion is particularly severe on the outside of bends, in areas where riparian vegetation is sparse, and in the lower portion of the reach where fresh sand and gravel bars are common. Channel scouring/deposition and physical instream habitat scores were fair, with an increasing number of depositional features, increased embeddness of riffle material, few deep pools and a shallow riffle and run dominated morphology. Scores for channel stability, scouring/deposition, and physical instream habitat all tended to decrease in the lower portion of the reach, in the vicinity of the golf course.

Riparian habitat is in fair condition, with only a narrow band of trees and woody vegetation through the golf course, and only 50% canopy coverage. Despite the level of channel degradation, biological indicators remain in fair condition, with a number pollution-tolerant species, including caddisflies and midgeflies. Water quality is fair, with a moderate level of substrate fouling, increased TDS, and a depth of visibility no more than 1ft.

- Channel incision and widening has resulted in widespread, systemic streambank erosion and loss of property from Old Triangle Road to Windsor Road.
 - Removal of riparian forest, encroachment on the stream corridor, and dumping of rubble and debris have exacerbated erosion problems locally.
 - Fence lines and residential outbuildings have been undermined by ongoing bank erosion. Failure appears imminent behind properties along Fuller Heights Road, between Kerill and Lionsfield Roads, and again near Belleau Wood Drive.

Restore approximately 8300ft of stream, from Old Triangle Road to Windsor Road, using fabric and plant bank treatment, rock toe, and gravel or earth wraps to stabilize eroding streambanks, and up to 22 rock riffles for permanent grade stabilization.

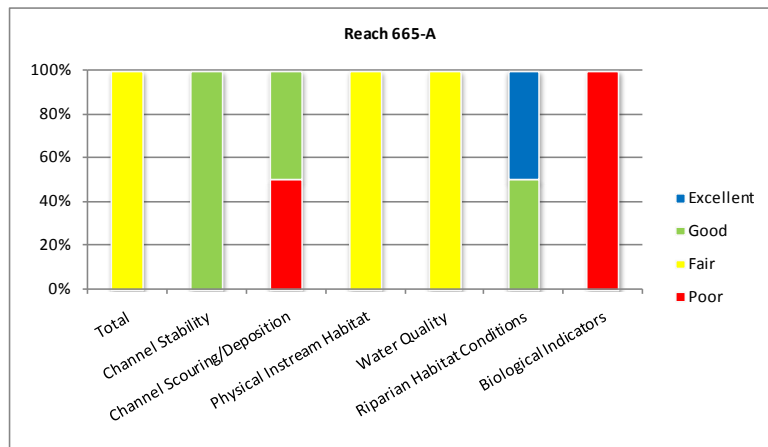
Reach Name: 665-A

Reach 665-A is a fair quality stream, with an average total score of 24. Reach 665-A has good channel stability, with relatively stable streambanks, little bank sloughing or erosion, and resistant bed and bank materials. Channel scouring/deposition and physical instream habitat scores were fair, with an increasing number of depositional features, particularly in the lower portion of the reach, where deposition of sand and sediment has increased embeddness of riffle material and filled in most pools, resulting in a slow and shallow velocity/depth regime.

Riparian habitat is in excellent condition, with a wide forested buffer in excess of 200ft on either side of the channel, and canopy cover is dense, providing approximately 80% shading. However, biological indicators are absent along this reach (resulting in a score of 0). Water quality is fair, with a moderate level of substrate fouling (21-50%), increased TDS, and reduced depth of visibility.

- Moderate channel incision has resulted in streambank erosion, between Swans Creek Lane and Crystal Downs Terrace. The extent and severity of erosion has been limited, due to influence of a wide riparian buffer.

- Enhance more than 1500ft of degraded stream, between Swans Creek Lane and Crystal Downs Terrace, using fabric and plant bank treatment and up to 5 rock weirs or wing deflectors.

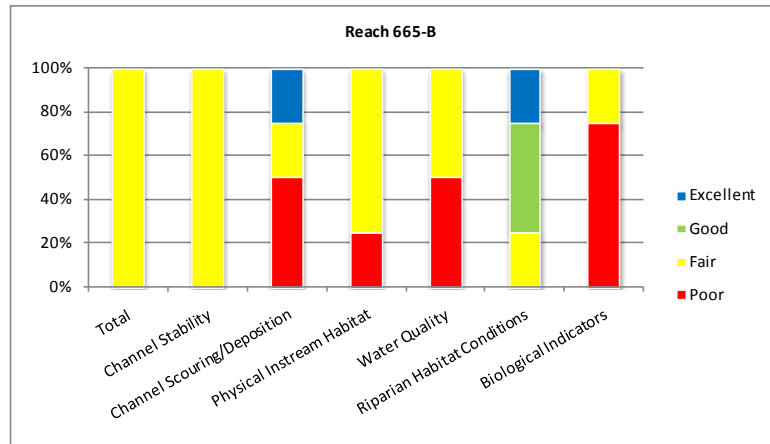
Reach Name: 665-B

Reach 665-B is a fair quality stream, with an average total RSAT score of 21. Reach 665-B has good channel stability, with relatively stable streambanks, little bank sloughing or erosion, and resistant bed and bank materials. Channel scouring/deposition and physical instream habitat scores were fair, with an increasing number of depositional features, increased embeddness of riffle material, and few deep pools.

Riparian habitat is in good condition, with a 100ft wide forested buffer providing greater than 60% canopy coverage. Biological indicators are poor, with only a handful of pollution tolerant species found throughout the reach. Water quality is fair, with a moderate level of substrate fouling, increased TDS, and a depth of visibility to approximately 1ft.

- Deposition and widening has prompted localized erosion between Desert Palm and Oyster Bay Courts.
 - Sedimentation of an inline basin, east of Oyster Bay Court, has clogged the outlet structure, resulting in a loss of sediment transport competency and capacity to downstream reaches.

- Purchase, preserve and monitor the existing riparian corridor with a permanent deed restriction or conservation easement, along more than 2400ft of stream, between Desert Palm and Oyster Bay Courts.
 - Remove and dispose of sediment, retrofit existing inline structure with multi-stage outlet, and enhance 200ft of degraded stream east of Oyster Bay Court using fabric and plant bank treatment and 2 rock weirs or wing deflectors.

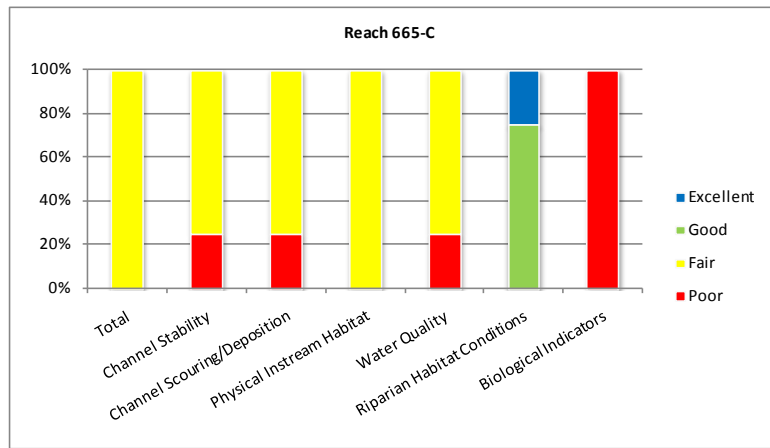
Reach Name: 665-C

Reach 665-C is a fair quality stream, with an average total RSAT score of 18. Channel incision is responsible for low channel stability scores and bed and bank erosion along nearly 50% of the reach. Channel scouring/deposition and physical instream habitat scores were fair, with an increasing number of depositional features, increased embeddness of riffle material, and few pools.

Riparian habitat is in good condition, with a forested buffer of at least 100ft on either side of the channel, and dense canopy cover, providing more than 60% shading. Biological indicators are absent along this reach (resulting in a score of 0), but water quality is fair, with a moderate level of substrate fouling, increased TDS, and a depth of visibility to approximately 1ft.

- Moderate channel incision has been slowed by woody debris jams and bank stabilization, provided by the existing riparian forest, between Medford Drive and Avenel Lane.

- Purchase, preserve and monitor the existing riparian corridor with a permanent deed restriction or conservation easement, along more than 2000ft of stream, between Medford Drive and Avenel Lane.

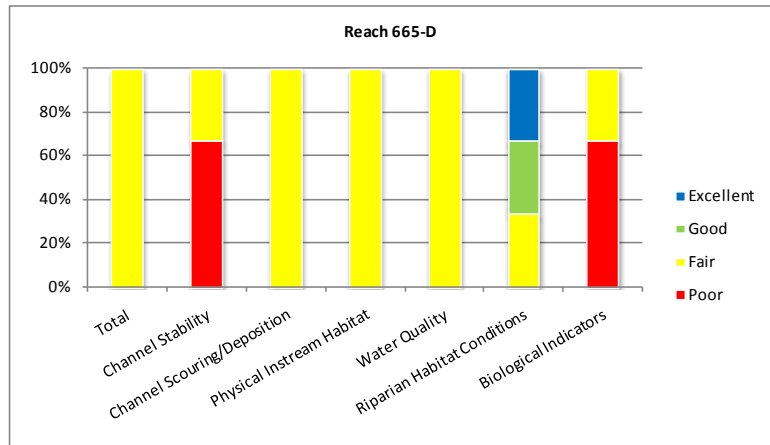
Reach Name: 665-D

Reach 665-D is a fair quality stream, with an average total RSAT score of 19. Channel incision and widening is responsible for low channel stability scores and bed and bank erosion along nearly 50% of the reach. Channel scouring/deposition and physical instream habitat scores were fair, with an increasing number of depositional features, increased embeddness of riffle material, and few pools.

Riparian habitat is in good condition, with a forested buffer of at least 100ft on either side of the channel, and dense canopy cover, providing more than 60% shading. Biological indicators are poor, with only a handful of pollution tolerant species found throughout the reach. Water quality is fair, with a moderate level of substrate fouling, increased TDS, and a depth of visibility to approximately 1ft.

- Channel incision and widening, has resulted in systemic streambank erosion, from Medford Drive to the confluence with Reach 665-B.
 - Removal of riparian forest and encroachment on the stream corridor, underneath the power lines, has exacerbated the erosion problems.
 - Channel incision has exposed a previously buried sewer line, approximately 500ft downstream from Medford Drive.

- Restore more than 1700ft of stream, from Medford Drive to the confluence with Reach 665-B, using fabric and plant bank treatment with live fascines or brush mattress to provide immediate vegetative cover, and up to 5 rock riffles for permanent grade stabilization.

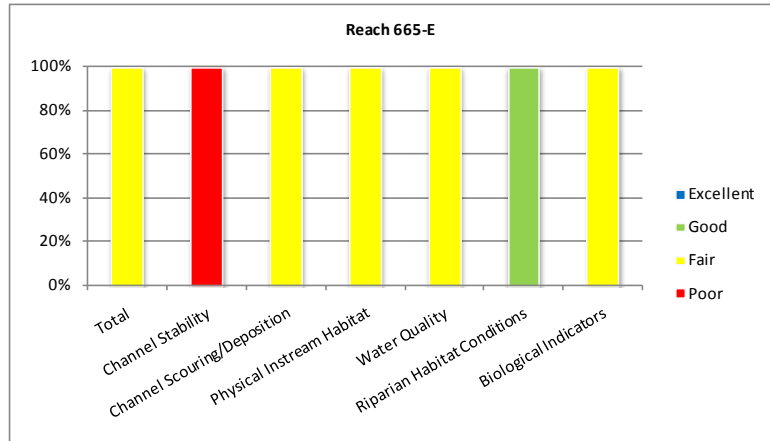
Reach Name: 665-E

Reach 665-E is a fair quality stream, with an average total RSAT score of 21. Channel incision is responsible for low channel stability scores and bed and bank erosion along nearly 50% of the reach. Channel scouring/deposition and physical instream habitat scores were fair, with an increasing number of depositional features, increased embeddness of riffle material, and few pools.

Riparian habitat is in good condition, with a forested buffer of at least 100ft on either side of the channel, and dense canopy cover, providing approximately 75% shading. Biological indicators remain in fair condition, with a number pollution-tolerant species, including caddisflies and midgeflies. Water quality is fair, with a moderate level of substrate fouling, increased TDS, and a depth of visibility no more than 1ft.

- Moderate channel incision has been slowed by woody debris jams and bank stabilization, provided by the existing riparian forest, from Myrtlewood to Medford Drive.

- Purchase, preserve and monitor the existing riparian corridor with a permanent deed restriction or conservation easement, along 1200ft of stream, from Myrtlewood to Medford Drive.

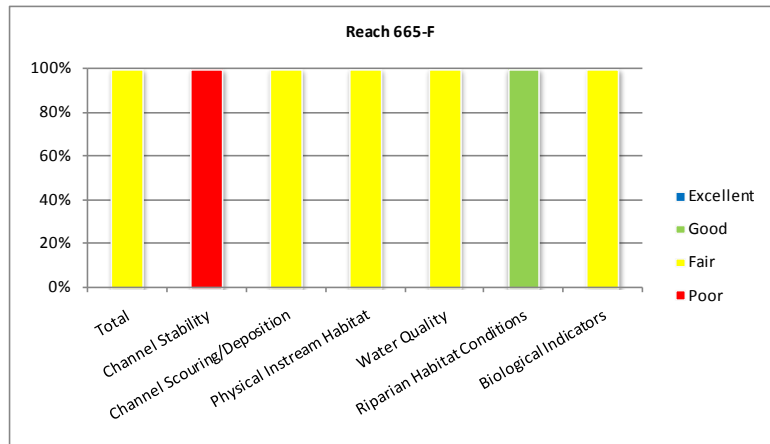
Reach Name: 665-F

Reach 665-F is a fair quality stream, with an average total RSAT score of 20. Channel incision and widening is responsible for low channel stability scores and bed and bank erosion along nearly 50% of the reach. Channel scouring/deposition and physical instream habitat scores were fair, with an increasing number of depositional features, increased embeddness of riffle material, and few pools.

Riparian habitat is in good condition, with a forested buffer of at least 100ft on either side of the channel, and dense canopy cover, providing approximately 75% shading. Biological indicators are absent along this reach (resulting in a score of 0), but water quality is fair, with a moderate level of substrate fouling, increased TDS, and a depth of visibility to approximately 1ft.

- Channel incision has resulted in systemic streambank erosion, downstream from Medford Drive to the confluence with Reach 665-D.

- Restore 800ft of stream, from Medford to the confluence with Reach 665-D, using fabric and plant bank treatment with rock toe to stabilize eroding streambanks, and 2 rock riffles for permanent grade stabilization.

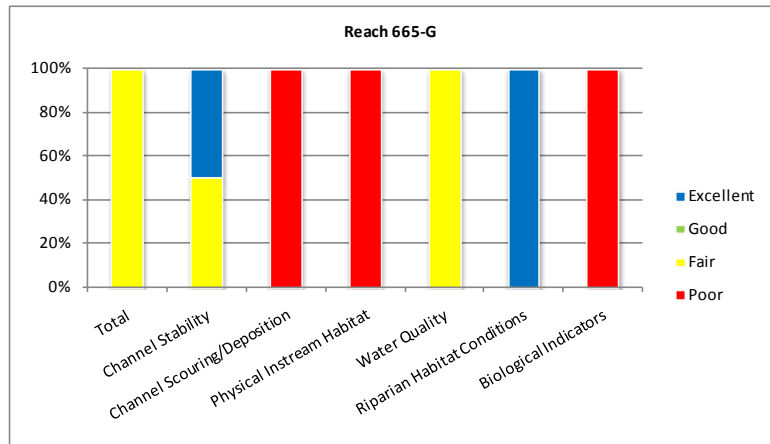
Reach Name: 665-G

Reach 665-G is a fair quality stream, with an average total RSAT score of 20. Reach 665-G has good channel stability, with relatively stable streambanks, little bank sloughing or erosion, and resistant bed and bank materials. However, channel scouring/deposition and physical instream habitat scores were poor, with a significant increase in deposition, sand and sediment bars, nearly 75% embeddness of riffle material, and a lack of pool habitat.

Riparian habitat is in good condition, with a 100ft wide forested buffer providing greater than 60% canopy coverage. However, biological indicators are absent along this reach (resulting in a score of 0). Water quality is fair, with a moderate level of substrate fouling, increased TDS, and a depth of visibility to approximately 1ft.

- Channel widening and subsequent deposition of silt and sediment has resulted in localized bank erosion and mass wasting, between Myrtlewood to Medford Drives.

- Purchase, preserve and monitor the existing riparian corridor with a permanent deed restriction or conservation easement, along more than 1230ft of stream, between Myrtlewood to Medford Drives.

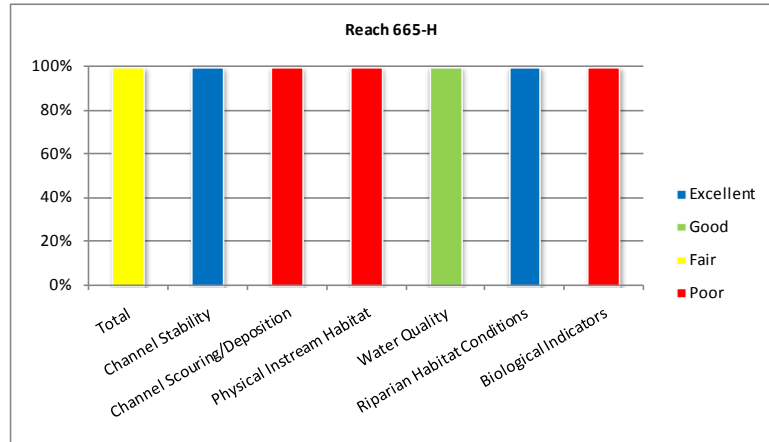
Reach Name: 665-H

Reach 665-H is a fair quality stream, with an average total RSAT score of 25. Reach 665-H has excellent channel stability, with stable streambanks, a lack of bank erosion, and resistant bed and bank materials. However, channel scouring/deposition and physical instream habitat scores were poor, with a significant increase in deposition, sand and sediment bars, nearly 75% embeddness of riffle material, and a lack of pool habitat.

Riparian habitat is in good condition, with a 100ft wide forested buffer providing approximately 75% canopy coverage. However, biological indicators are absent along this reach (resulting in a score of 0). Water quality is good, with only light substrate fouling, moderate TDS, and a depth of visibility to approximately 2ft.

- Channel widening and deposition of sediment, upstream of Myrtlewood Drive, has resulted in localized bank erosion.

- Purchase, preserve and monitor the existing riparian corridor with a permanent deed restriction or conservation easement, along 700ft of stream, upstream of Myrtlewood Drive.

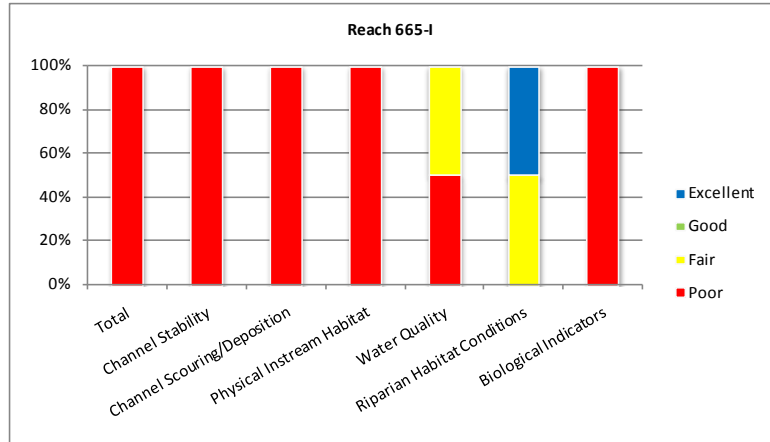
Reach Name: 665-I

Reach 665-I is a poor quality stream, with an average total RSAT score of only 9. The low score is due to systemic channel erosion, coupled with large amounts of sand and sediment deposition in the lower portion of the reach, and no available biological indicators. Channel stability along Reach 665-I had an average score of 1, with more than 75% of the streambanks experiencing sloughing or scour, undercut streambanks, and frequent tree falls. Channel scouring/deposition and physical instream habitat scores were poor, with a dramatic increase in depositional features in the lower portion of the reach, nearly 75% embeddness of riffle material, and minimal pool habitat.

Channel scouring/deposition and physical instream habitat scores were poor, with a dramatic increase in depositional features in the lower portion of the reach, nearly 75% embeddness of riffle material, and minimal pool habitat.

Riparian habitat is in good condition, with a predominantly 100ft wide wooded corridor. Biological indicators are absent along this reach (resulting in a score of 0). Water quality is poor, with a high level of substrate fouling, increased TDS, and a depth of visibility no more than 1ft.

- Severe channel incision has resulted in systemic erosion, mass wasting, and imminent loss of property along the *Swan’s Creek Reach*, downstream of Barrley Drive to the confluence with Reach 665-H. Near-vertical, eroded banks stand approximately 12ft high, posing a significant risk to public safety.

- Restore 1100ft of stream, along the *Swan’s Creek Reach*, downstream of Barrley Drive to the confluence with Reach 665-H, using fabric and plant bank treatment with rock toe to stabilize eroding streambanks, and up to 3 rock riffles for permanent grade stabilization.

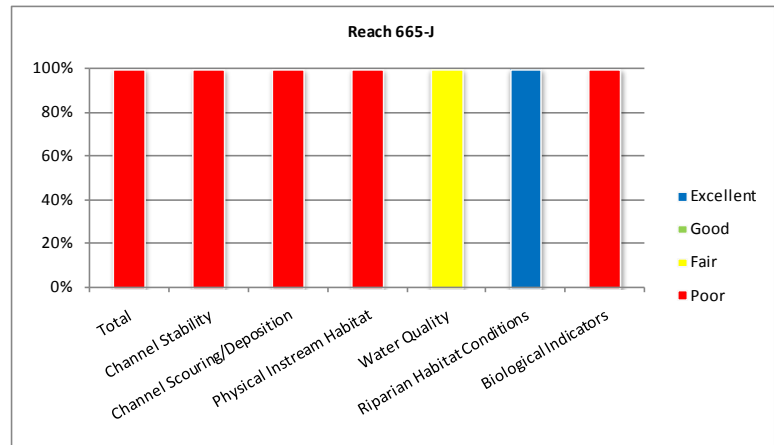
Reach Name: 665-J

Reach 665-J is a poor quality stream, nearly identical in condition to Reach 665-I, with an average total RSAT score of only 14. The low score is due to systemic channel erosion, large amounts of sand and sediment deposition in the lower portion of the reach, and no available biological indicators. Channel stability along Reach 665-J had an average score of 1, with more than 75% of the streambanks

experiencing sloughing or scour, undercut streambanks, and frequent tree falls. Bank erosion is particularly severe on the outside of bends, in areas where riparian vegetation is sparse, and alongside freshly deposited sand bars. Channel scouring/deposition and physical instream habitat scores were poor, with a dramatic increase in depositional features in the lower portion of the reach, nearly 75% embeddness of riffle material, and minimal pool habitat.

Riparian habitat is in good condition, with a predominantly 100ft wide wooded corridor. Biological indicators are absent along this reach (resulting in a score of 0). Water quality is fair, with a moderate level of substrate fouling, increased TDS, and a depth of visibility of approximately 1.5ft.

- Severe channel incision, from River Heritage Boulevard to the confluence with Reach 665-H, has resulted in systemic erosion and loss of property.

- Restore approximately 1250ft of stream, from River Heritage Boulevard to the confluence with Reach 665-H, using fabric and plant bank treatment with rock toe to stabilize eroding streambanks, and up to 3 rock riffles for permanent grade stabilization.

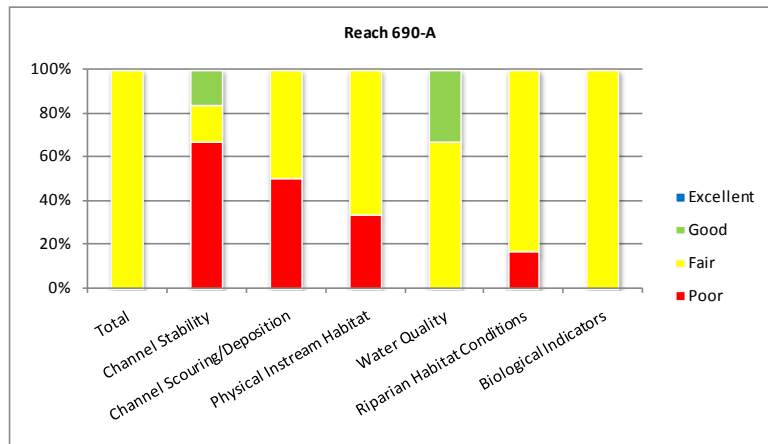
Reach Name: 690-A

Reach 690-A is a fair quality stream, with an average total score of 19. Channel stability scores along Reach 690-A are influenced significantly by systemic channel widening, with approximately 50% of the streambanks experiencing sloughing or scour. Bank erosion is particularly severe on the outside of bends, in areas where riparian vegetation is sparse, and alongside sand and gravel point bars. Channel scouring/deposition and physical instream habitat scores were fair, with an increasing number of depositional features, increased embeddness of riffle material, few deep pools and a shallow riffle and run dominated morphology.

Riparian habitat is in fair condition, with only a narrow band of trees and woody vegetation through the golf course, and only 50% canopy coverage. Despite the level of channel degradation, biological indicators remain in fair condition, with a number pollution-tolerant species, including caddisflies and midgeflies. Water quality is fair, with a moderate level of substrate fouling, increased TDS, and a depth of visibility no more than 1ft.

- Active channel widening, coupled with the loss of a riparian buffer zone and continued removal of woody vegetation (associated with golf course maintenance), has resulted in systemic streambank erosion from Windsor Road to Geiger Road.
 - A low head dam on the Medal of Honor Golf Course, near the intersection of Fuller Heights and Windsor Road, has impaired sediment transport, thereby exacerbating deposition and channel widening upstream of the dam.

- Restore approximately 4750ft of stream, from Windsor Road to Geiger Road, using fabric and plant bank treatment, rock toe, and gravel wraps to stabilize eroding streambanks, and up to 12 rock riffles for permanent grade stabilization.
 - Remove the low head dam at the Medal of Honor Golf Course, restore up to 100ft of streambank using fabric and plant bank treatment and 2 rock weirs or wing deflectors to restore sediment transport competency and to alleviate deposition and widening upstream.
