Appendix C

Outfall Stabilization Opportunity

Fact Sheet Summaries

Neabsco Creek Watershed Study Outfall Stabilization Project Opportunity

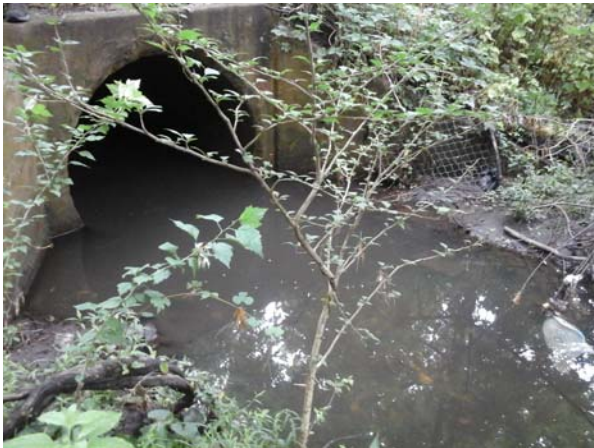
The outfall pipe is submerged and was observed with flow. The outfall channel has a headcut about 25 feet below the outfall exposing two pipes (possible utilities) and has significant erosion along the remainder of the channel to the stream. The recommended stabilization project is a regenerative stormwater conveyance as it could treat a large stormwater network and has ample room between the upper end of the channel and its confluence with the stream.

Submerged outfall pipe with flow present surrounded by shrubs and trees.

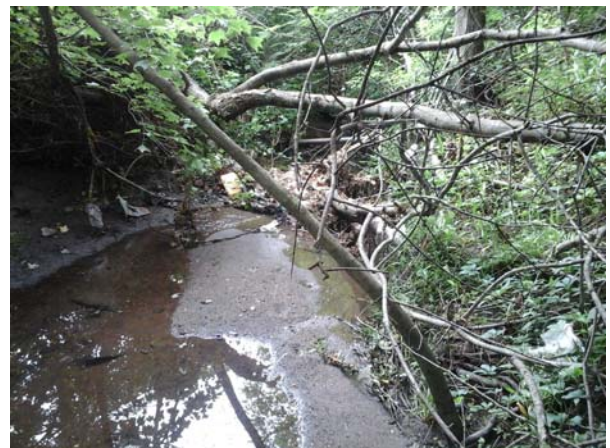
Densely wooded confluence with stream channel.

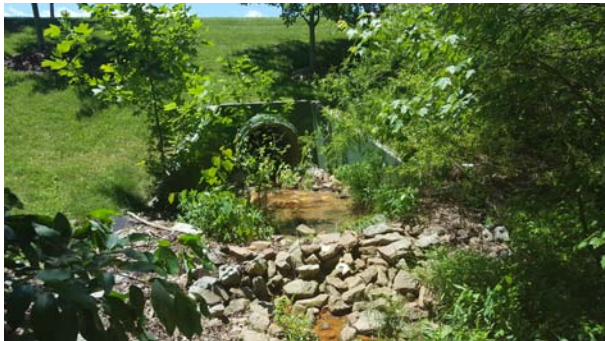
Discharge from the outfall is the headwaters of a first order stream. The channel is armored for about 75 feet, but the armor is failing in spots and geotextile visible. Below the rip rap, erosion is heavy and continues downstream. Regenerative stormwater conveyance is the recommended stabilization project to manage and treat the discharge from the outfall.

Outfall pipe and remaining rip rap/armor at the head of channel.

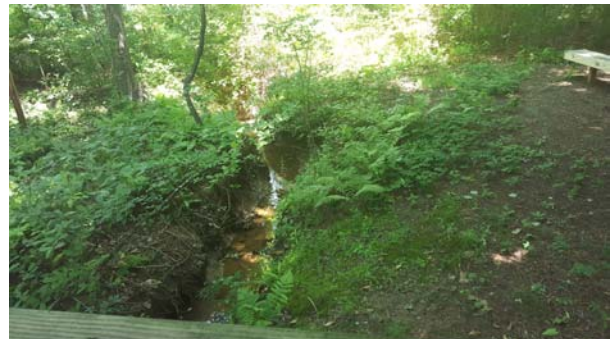
Heavily eroded channel just downstream from the outfall pipe and failing armor.

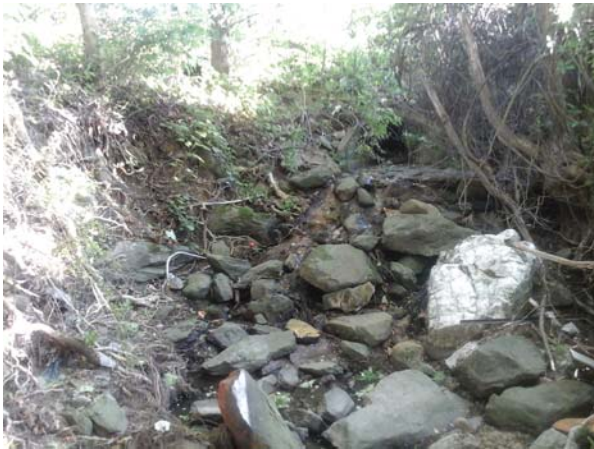
The outfall channel is severely blown out and has been eroded down to bedrock in some places. Some of the boulders from the outfall channel appear to have washed down to the confluence with the stream. The recommended outfall stabilization project is a regenerative stormwater conveyance.

Severely eroded outfall channel and dispersed boulders just downstream of the pipe.

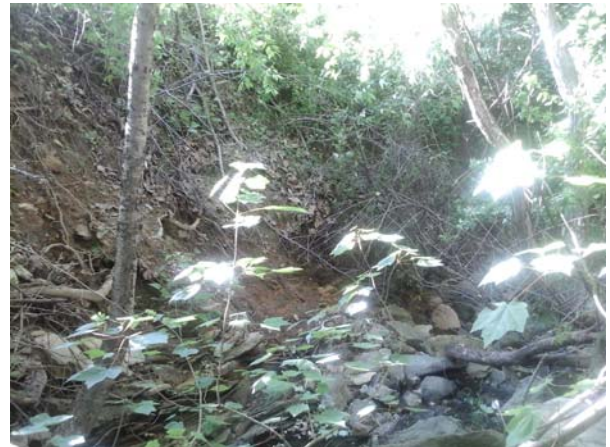
Severely erosion in the outfall channel and steeply sloped banks surrounding the channel.

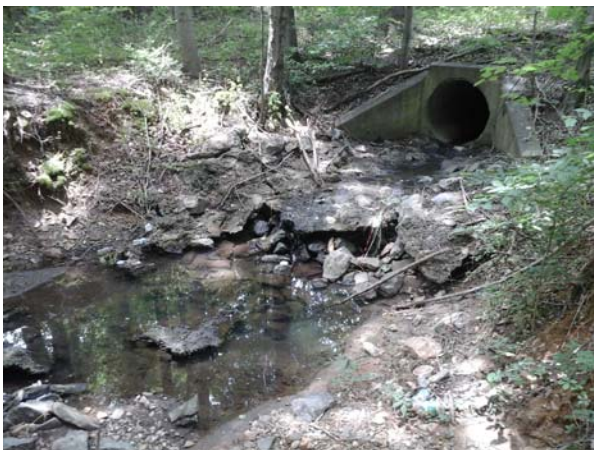
The concrete deck below the outfall pipe is breaking apart into the channel. There is severe erosion downstream from the concrete deck. It is unclear if the site needs outfall or stream restoration, but the site requires attention and the contributing drainage area needs improved stormwater control. The recommended outfall stabilization project approach is regenerative stormwater conveyance.

Outfall pipe with crumbling concrete deck, falling into the highly eroded channel.

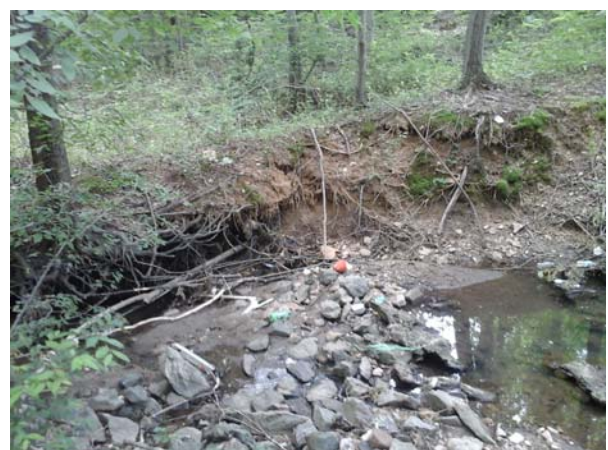
Highly eroded channel with steep banks, surrounded by tree cover.

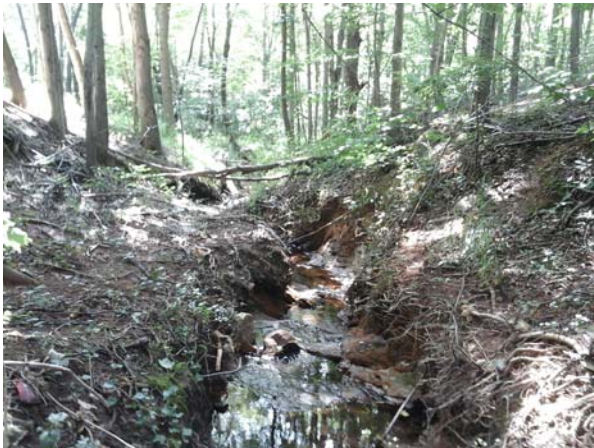
The site features a highly eroded outfall channel leading to an eroded stream channel. The outfall structure itself is in good condition, but the channel is degraded. The stream reach at the end of the outfall channel was not part of any assessment, but should be evaluated and possibly be restored. The recommended outfall stabilization project approach is regenerative stormwater conveyance.

Highly eroded outfall channel surrounded by dense tree cover.

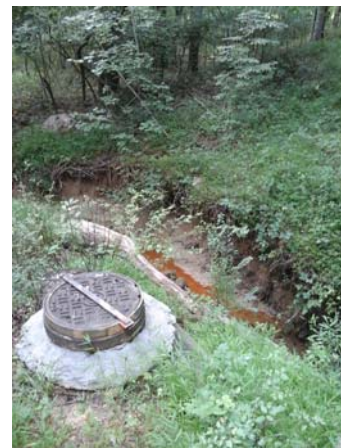
The sanitary sewer manhole lies directly next to the outfall channel and could prove to be a potential project constraint. In addition, heavy tree cover nearby could mean a potentially significant impact on the trees in the area.

Sanitary manhole directly adjacent to highly eroded outfall channel.

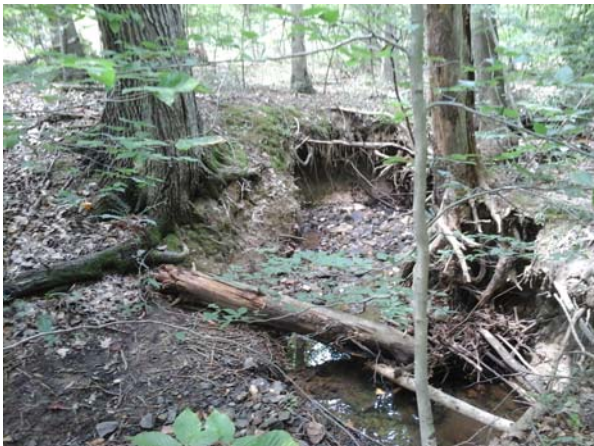
The outfall channel is eroded and is beginning to scour around the culvert underneath the transmission right of way. The channel remains eroded downstream of the culvert and joins a second eroded outfall channel to form one severely eroded channel. The recommended stabilization project is an RSC and drop structure combination. Both channels are severely eroded and need stabilization, or even stream restoration, but flow must be controlled upstream for any project to be viable.

Outfall channel just downstream of the pipe.
Severely eroded banks with large trees
surrounding the channel.

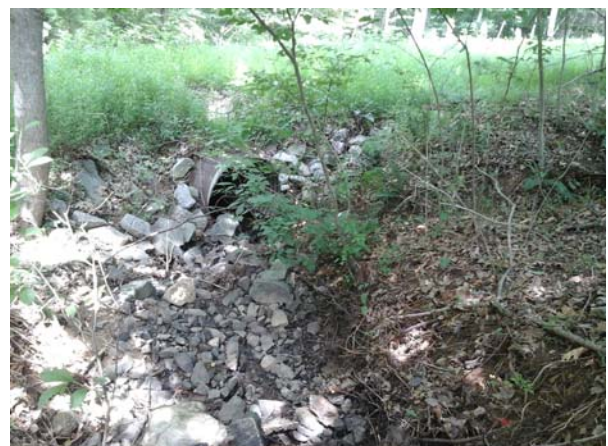
Upstream view of the outfall pipe and remnants
of rip rap and concrete deck.

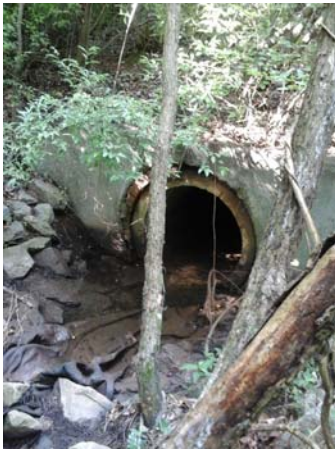
The outfall channel itself is not severely eroded, however the small stream it enters is in poor condition with serious erosion and flocculent material present. The recommended outfall stabilization project for this site is rip rap to slow the flow and control discharge into the small stream.

Stream channel downstream of outfall, flocculent heavily present and erosion visible.

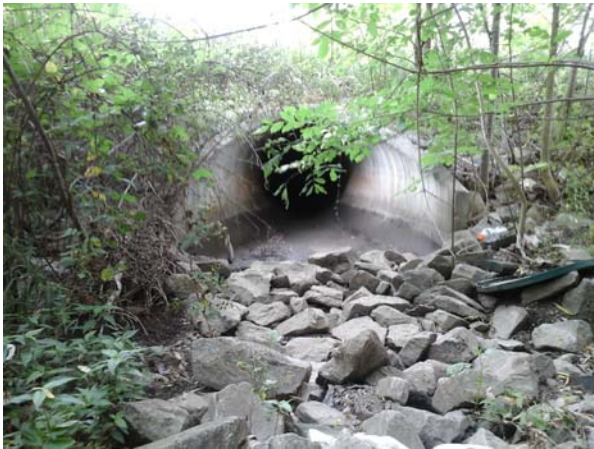
Upstream view of the outfall pipe itself, heavy vegetation and rip rap present.

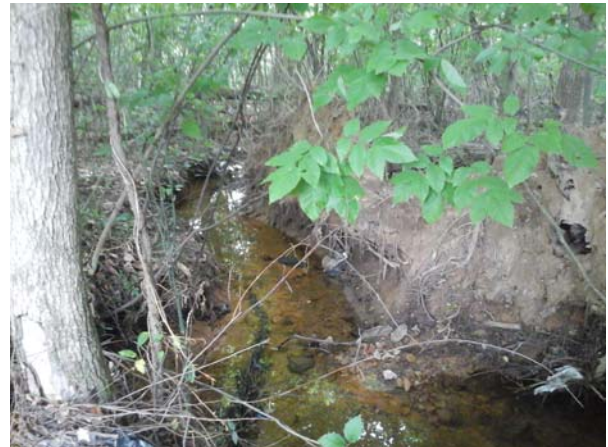
The outfall channel exhibits severe erosion just 15 feet downstream of the outfall pipe itself. The recommended outfall stabilization project is regenerative stormwater conveyance in order to control the powerful discharge from this outfall.

Severely eroded channel just downstream from the outfall pipe, with near vertical banks and trees surrounding the channel.

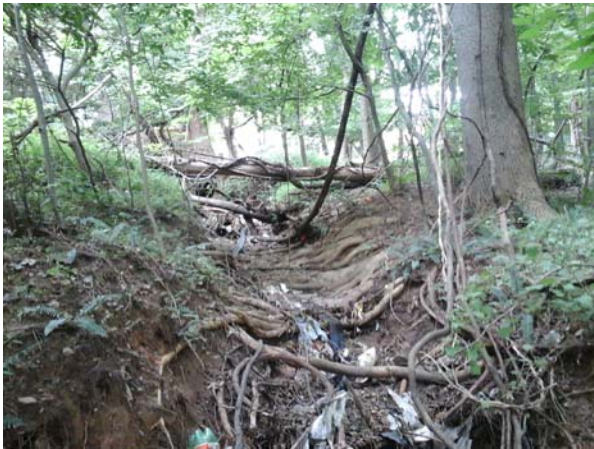
The outfall channel is eroded for a short distance, but quickly becomes more stable before meeting with a small stream. The recommended outfall stabilization project is regenerative stormwater conveyance to the confluence with the stream and maybe even along the stream since it is so small.

Upstream view of the outfall pipe and the eroded area immediately downstream of the pipe.

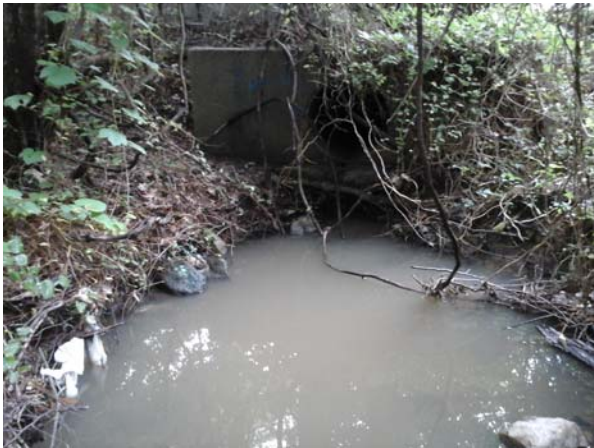
There is a clearly-defined plunge pool directly in front of the outfall pipe, followed by a pile of rip rap leading to the stream. The recommended outfall stabilization project is to add rip rap to the existing pile to increase the effectiveness.

Upstream view of the outfall pipe with plunge pool directly downstream of pipe opening.

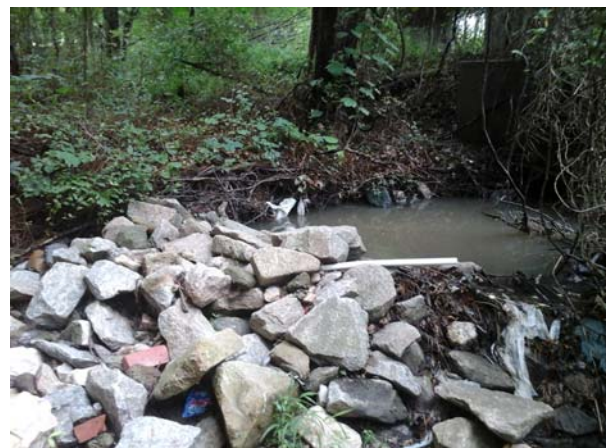
Pile of rip rap just downstream from the plunge pool and opening of outfall pipe.

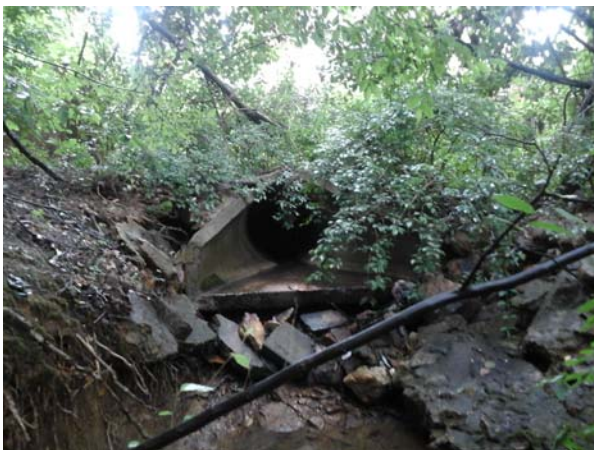
Upstream view of the outfall pipe and remaining pieces of the pipe deck. High levels of degradation are visible from the discharge

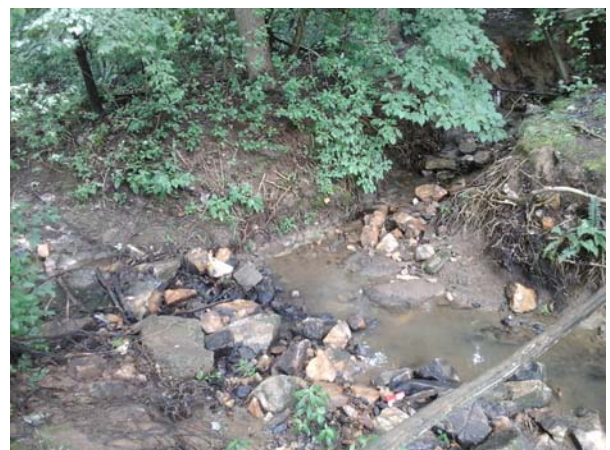
Outfall channel just downstream of the pipe opening, highly eroded banks and tree cover is visible.

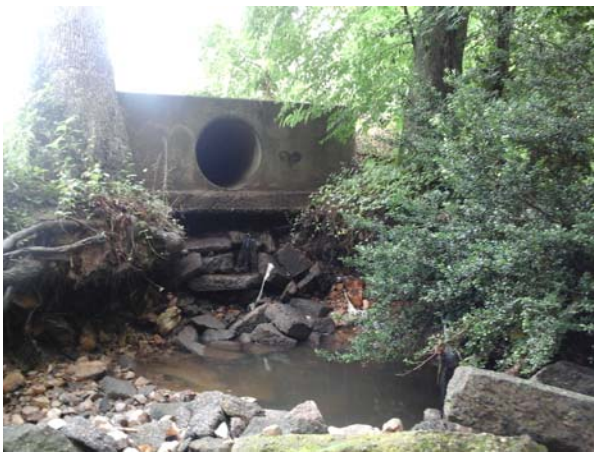
Some erosion in the stream channel occurs above and below outfall the channel but increases in severity downstream of the outfall confluence. This site is recommended for both stabilization and stream restoration. The pipe deck is completely destroyed and the discharge drops five feet directly into the channel. The recommended outfall stabilization project is a drop structure.

Upstream view of the outfall pipe, pipe deck completely gone and erosion visible in the receiving channel.

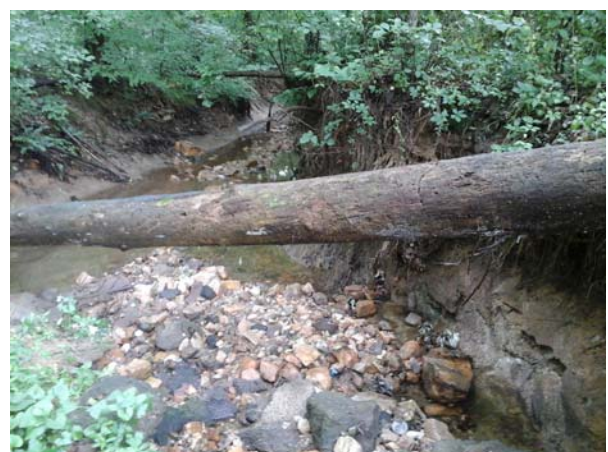
Downstream view of the outfall channel, wooded banks and severe erosion visible.

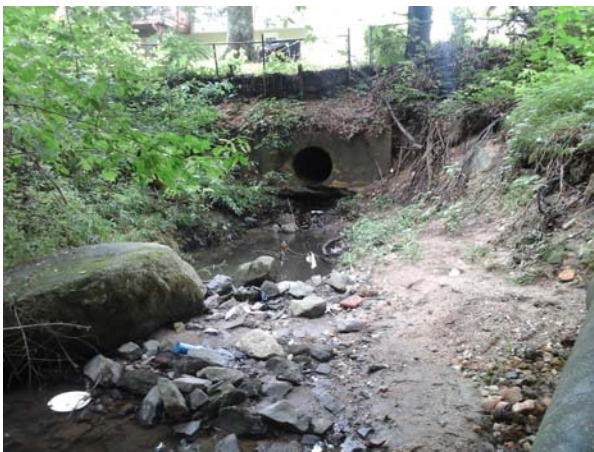
The stream channel is 2 feet below the outfall and the outfall's headwall is undercut and dangerous. Old, exposed pipes are visible in the short outfall channel. The recommended outfall stabilization project is a drop structure to control the discharge from the outfall pipe. The site is wooded, with a dangerous drop off at the edge of the property.

Upstream view of the outfall pipe, drop into channel is visible as well as the steep drop off on the property.

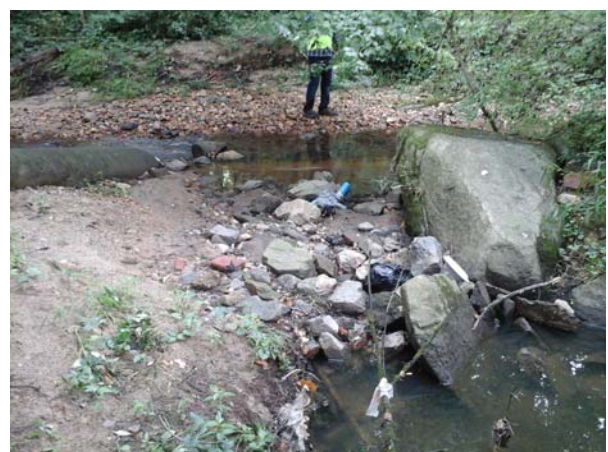
Downstream view of the short outfall channel with exposed pipes visible.

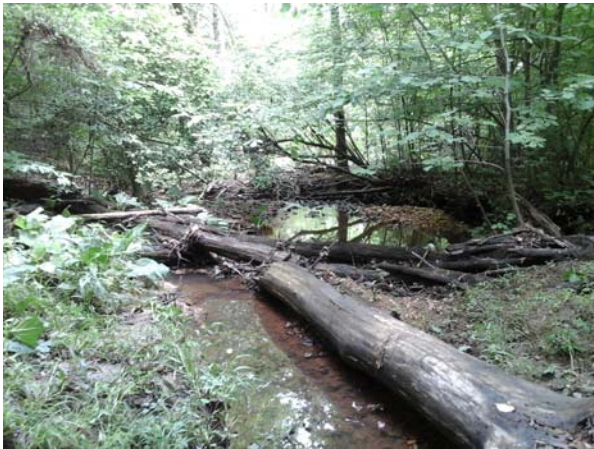
The landscape appears to be acting as a natural level spreader coming out of outfall with some skunk cabbage present. Approximately 30 feet away is a headcut with 15 feet of minor to moderate erosion in the stream. The recommended outfall stabilization process is added rip rap to the remaining pile.

Downstream view of the stream channel, heavily wooded area is visible and minor erosion present.

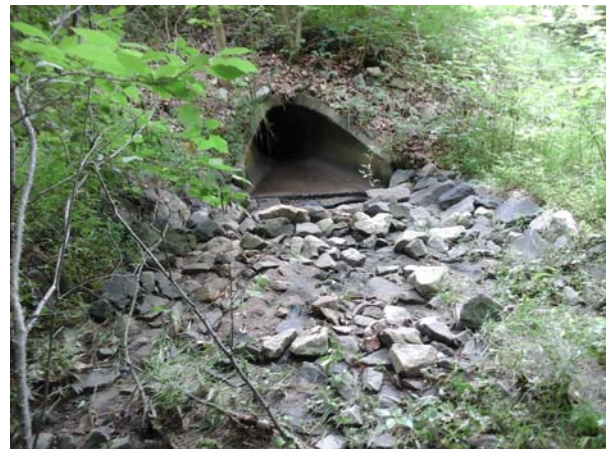
Upstream view of the outfall pipe and remaining rip rap at the opening.

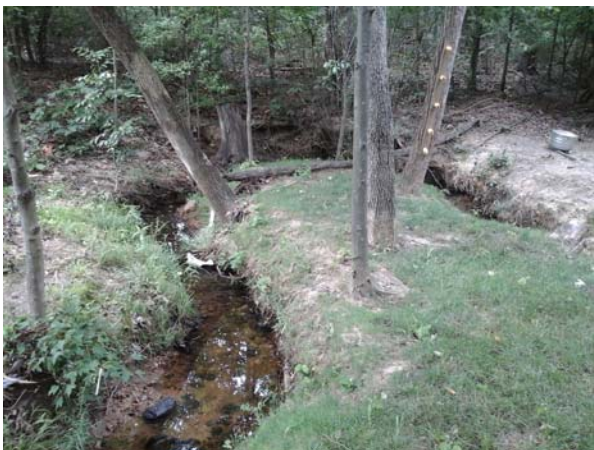
The outfall itself is in okay physical condition, but the outfall channel has a steep slope and is significantly higher than the stream. Erosion into stream appears to be attributable to the steep slope of the channel. The recommended outfall stabilization project is a drop structure to reduce the impact of the water from the steep slope.

Downstream view of the stream channel, wooded and eroded banks visible.

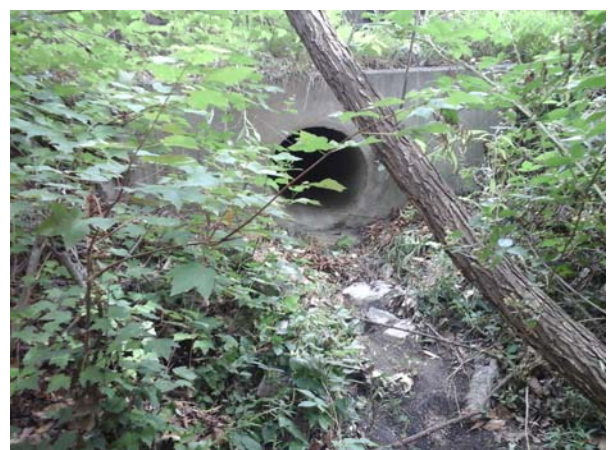
Upstream view of the outfall pipe, surrounding vegetation and beginning of the steep channel are visible.

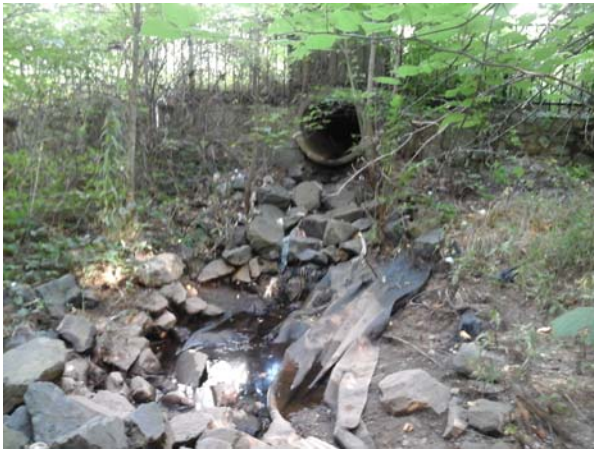
The outfall has a slight drop off into an armored channel, stream is moderately eroded at confluence with outfall channel. The outfall channel is steep and rip rap seems to be getting dispersed. The recommended outfall stabilization project is regenerative stormwater conveyance to reduce the effects of the discharge down the steep slope. The area is surrounded by private properties, wooded, and is on a steep slope.

Upstream view of the outfall pipe, steep slope and drop into the channel visible.

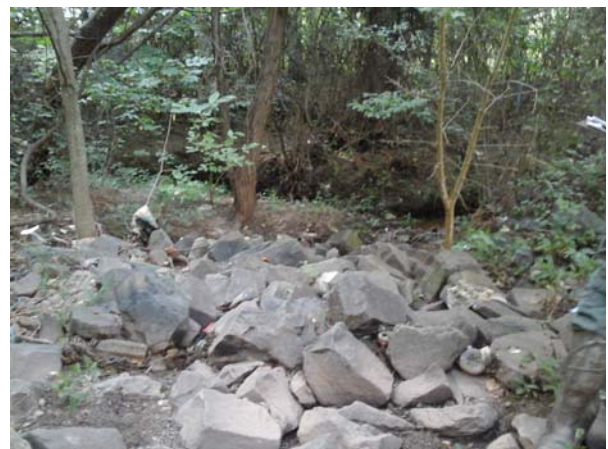
Downstream view of confluence of outfall and stream channel. Moderate erosion and steep slope visible.

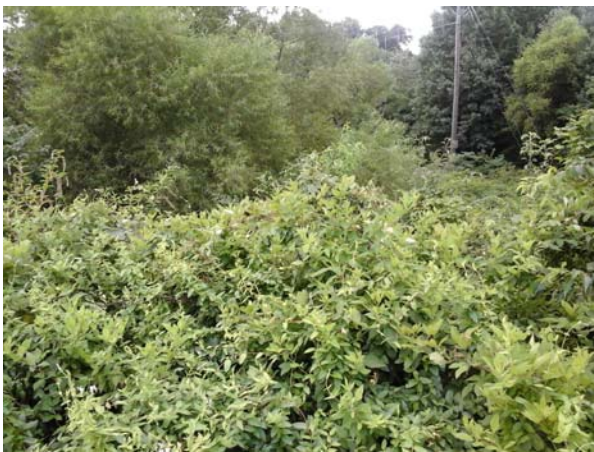
Dense vegetation surrounding the site in the transmission right-of-way.

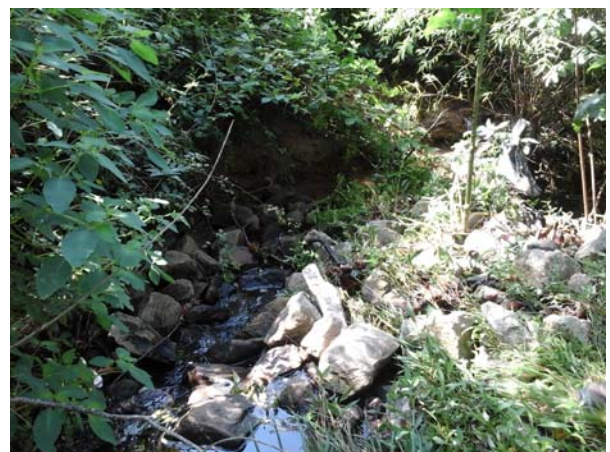
The site features a large outfall in a densely vegetated edge of a transmission right of way. The outfall is at least 3 feet higher than the channel over a 45-foot distance, and is eroding the outfall channel despite riprap present. The recommended outfall stabilization project is a drop structure to reduce the impact of the discharge through the channel.

Downstream view of the outfall channel, steep slope and remaining riprap visible.
