Appendix C

Rocky Branch (246) Subwatershed Project Conceptual Design Narratives

Project: Rocky Branch – Study of Kings Brook Home Owners Association Bioretention Facilities

Project: Rocky Branch 246-395 Repair or Water Quality Retrofit

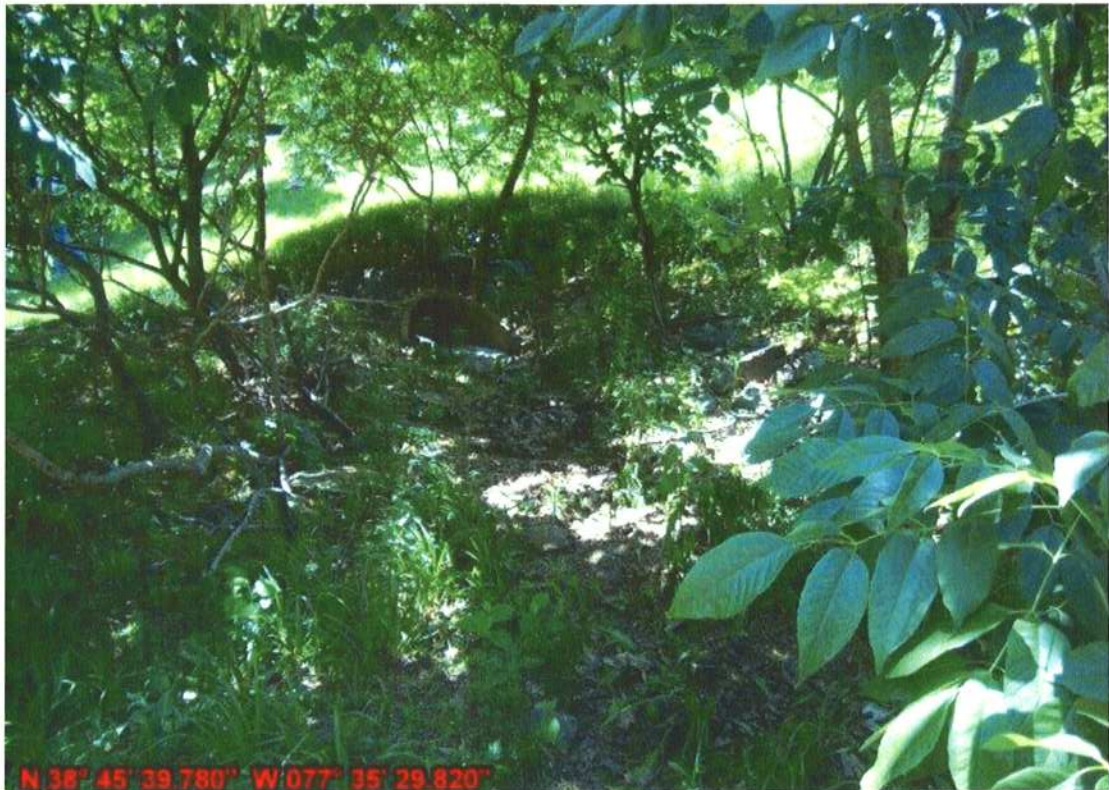
Problem Description: Four of the 17 Bioretention BMPs within this Kings Brook Home Owners Association property were inspected in the field. In two cases (243 & 244), the facility appears to be a simple outfall into a vegetated area without any features to generate retention, infiltration or other water quality or quantity treatment. In two other cases (364 & 365) the outfalls flow into landscaped areas without retention. In some cases there was a graded basin present, but the outfall did not discharge to the basin. Although all four facilities inspected were listed in the County database as bioretention facility, none of the facilities inspected conformed to current standards for bioretention. All of the BMP facilities were added to the County database between 1998 and 2002, when standards for bioretention were not well developed.

Photo 1 (244): Typical example of outfall into vegetated swale classified as “Bioretention”

Project Description: A study is recommended to assess all 17 “bioretention” BMPs within this neighborhood to determine if sufficient levels of stormwater quality protection are being performed by the existing facilities. Where possible, modifications or retrofits to the facilities should be made to improve their water quality functioning and bring them more into conformance with current standards. In particular, landscaping and property maintenance practices that may have altered or degraded the original function of the facility should be identified.

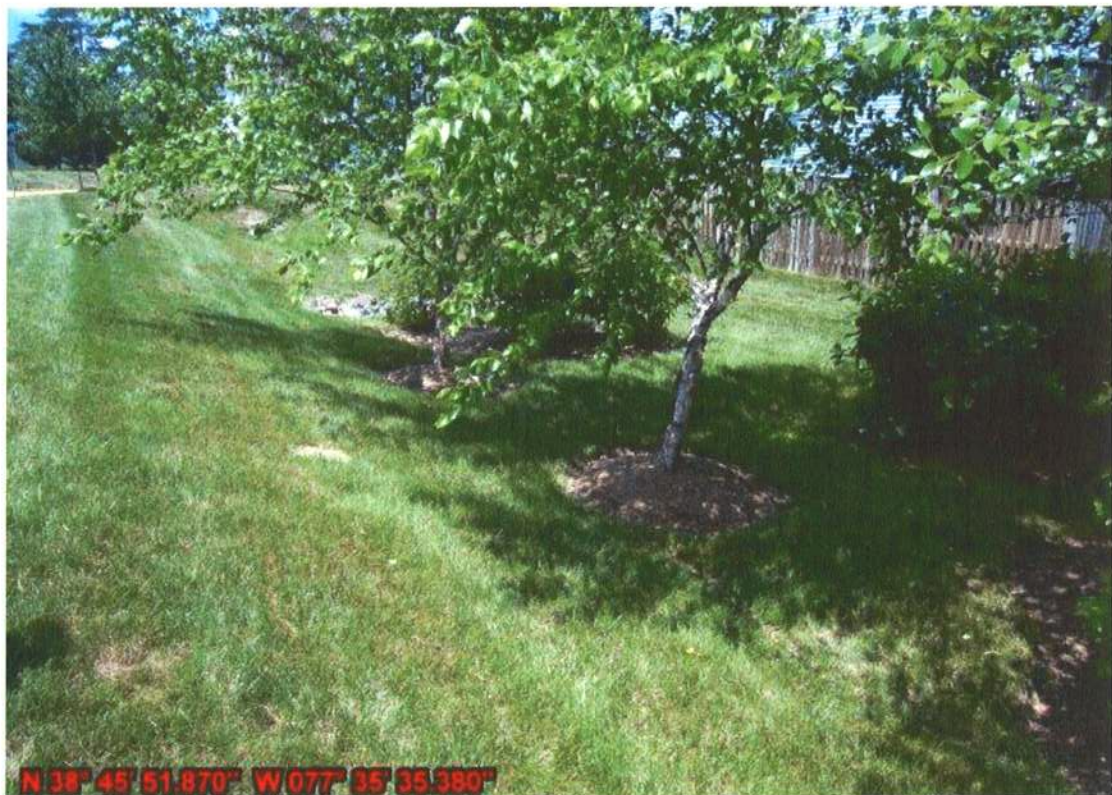
Photo 2 (364): Typical example of “Bioretention” facility lacking detention

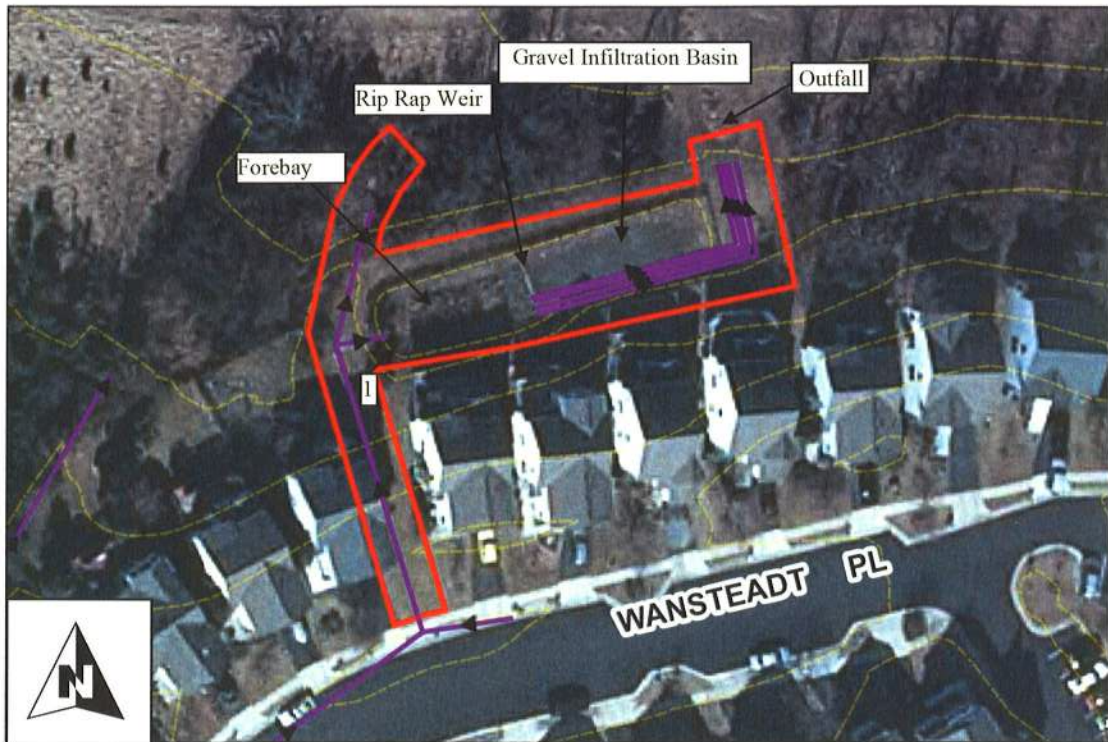
Problem Description: This BMP is listed as a wet pond in the County database with a 72 inch riser and constructed before 2002. Onsite inspection indicates it's a gravel filter with a forebay and underdrains. One inlet discharges to a forebay that is filled with sediment, litter and cattails. The forebay (1,000 sf) appears to remain ponded permanently. A riprap check dam separates the forebay from the gravel infiltration basin. The gravel filter basin (1,200 sf) has some vegetation, including one large sycamore tree. The surface of the basin appears compacted and probably clogged with fines. The four underdrains discharge to an open ditch that leads to the nearest stream channel. The whole facility is set within a basin that would allow up to several feet of ponding. There appears to be a splitter box to bypass high flows. The forebay has very little capacity left to capture or store sediment. The dense vegetation makes it hard to remove the litter that is accumulating in the site. With minimal maintenance over the past 10 years, the infiltration capacity of the basin may be greatly reduced.

Existing Condition: Facility in need of maintenance and possible retrofit

Project Description: Recommendations are to renovate the forebay by removing the sediment, vegetation and litter. To restore the gravel infiltration basin, either replace the gravel or consider conversion to a bioretention basin. However, the existing facility, exclusive of the forebay, is only 1,200 sf. Based on 6 inch ponding for bioretention, this site could only provide treatment for 0.33 acres of impervious surface, or about 0.5 acres of high density housing. With a drainage area of approximately 5 acres of high density housing, this facility is significantly undersized regardless of the type of water quality treatment.

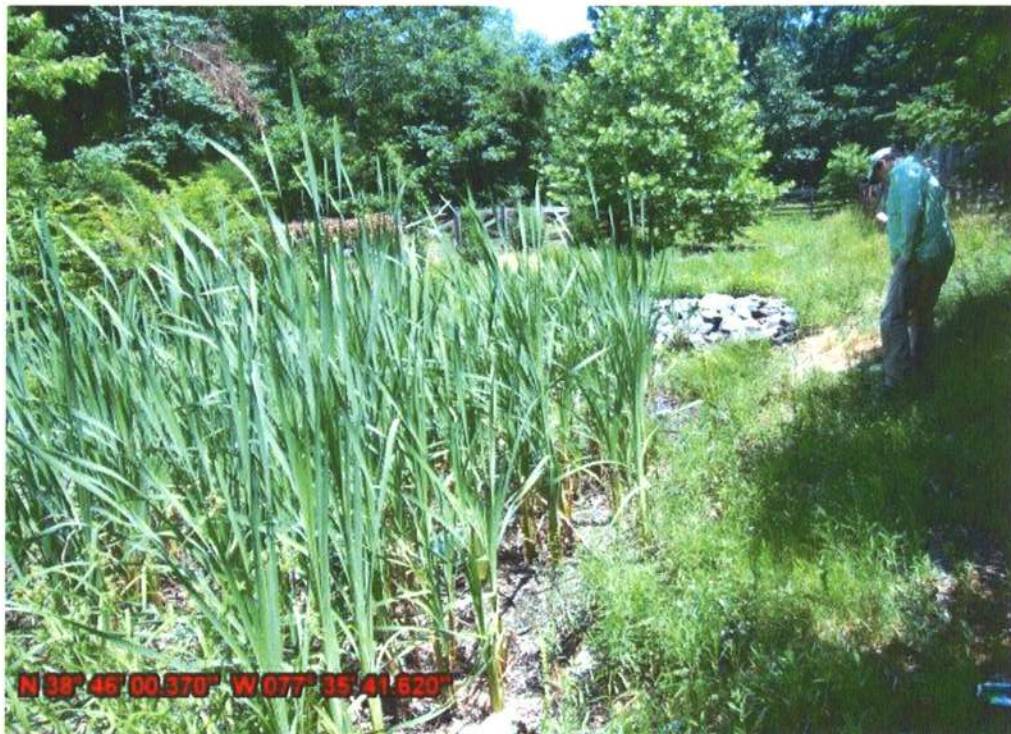
Photo 1: Forebay ponded and supporting wetland vegetation

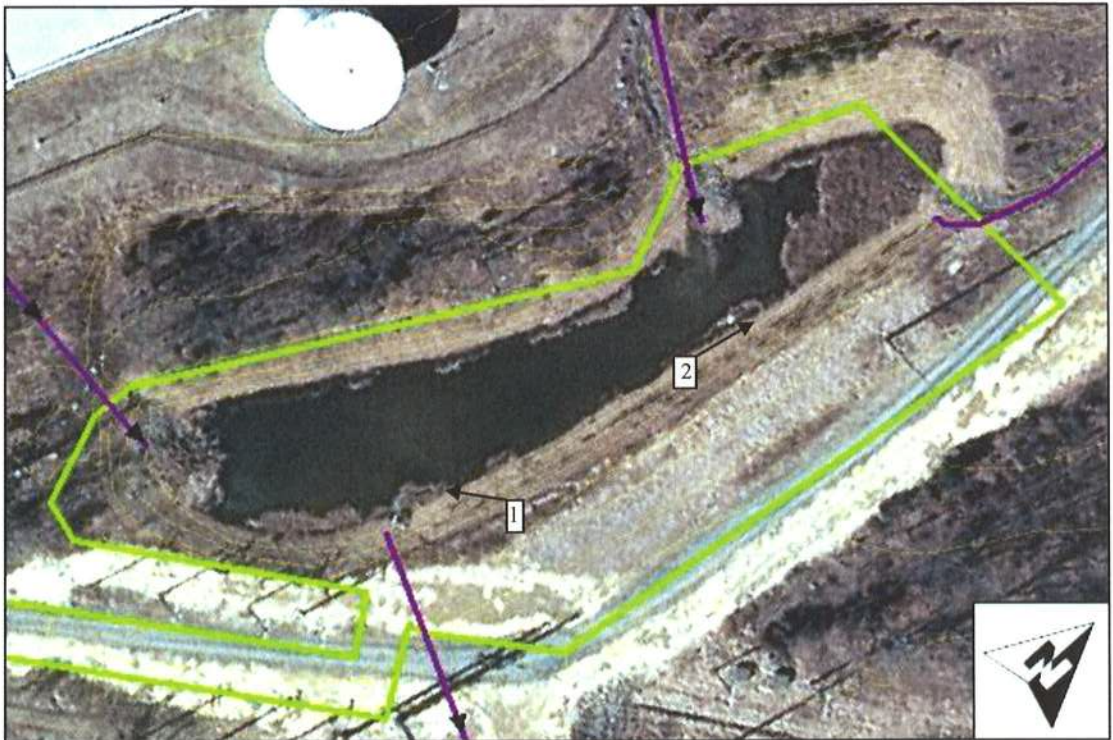
Problem Description: This facility is listed in the database as a County maintained dry basin constructed sometime before 2002. It has a 48 inch riser and drains approximately 23 acres of a large commercial building (11.4 acres impervious). The BMP is 30,900 square feet in area. The BMP is designed as a dry pond, however, under current conditions it contains approximately 12 inches of water across its entire footprint. Approximately 10-20% of the basin is supporting native wetland plants, including bulrush, indicating a permanently ponded condition. The facility does not have forebays and significant sediment accumulation can be seen at the three inlets and at the riser.

Existing Conditions: Dry basin BMP with permanent pool and wetlands

Project Description: This facility clearly shows the ability to support permanent wetland vegetation and a consistent pool elevation. Recommendations include adding sediment forebays to control sedimentation, and retrofitting the remaining basin into a constructed wetland with a larger amount of wetland vegetation, variation in water depths, and a micropool at the riser. The riser would be modified to allow for subsurface withdrawal which will minimize clogging.

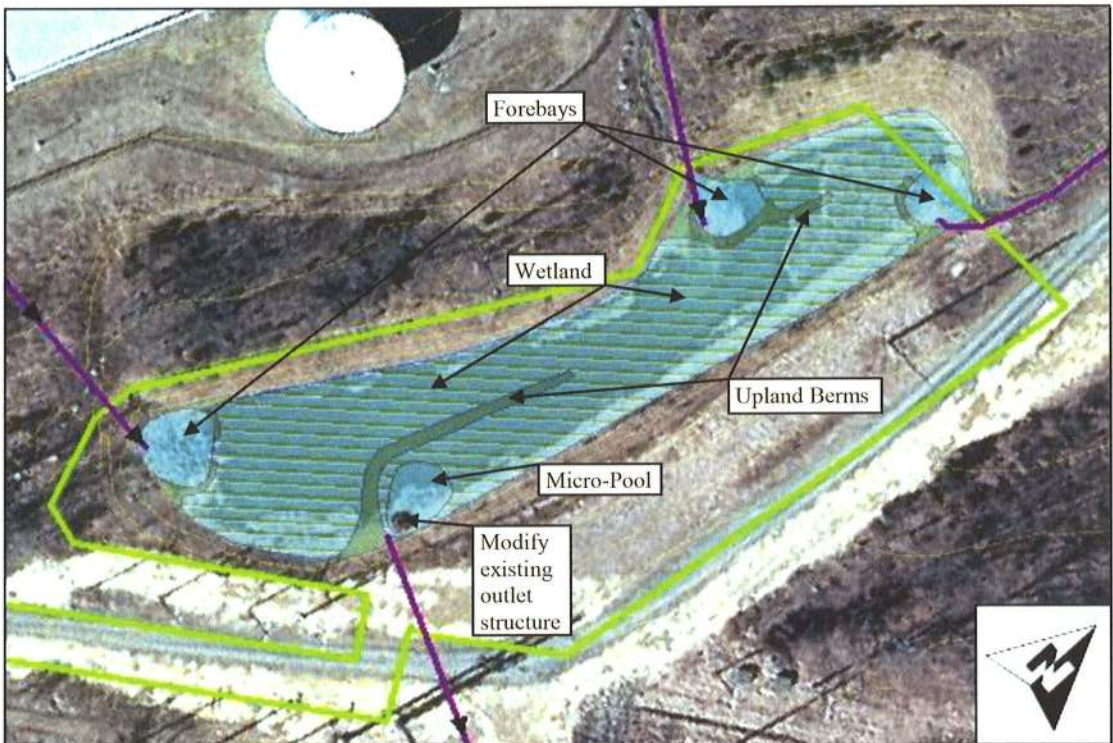
Conceptual Plan: Convert dry basin to constructed stormwater wetland facility

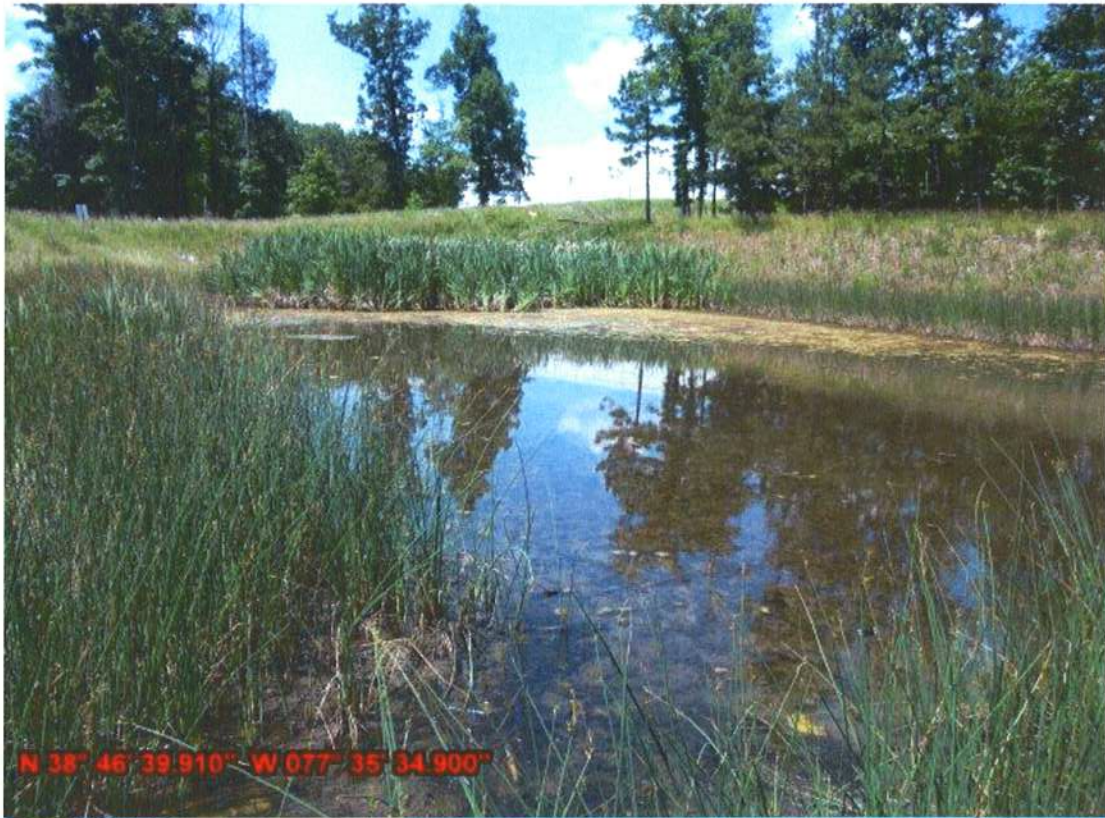
Photo 1: Wetland covers a significant portion of this dry basin with 12” of water over the entire basin

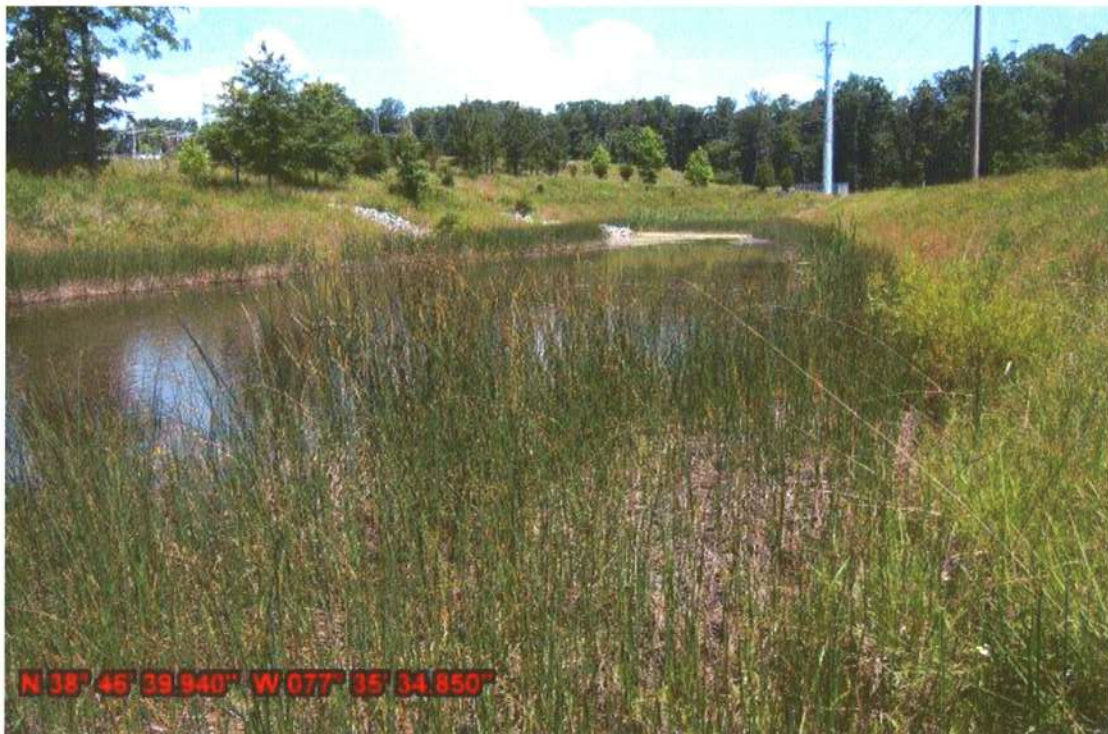
Photo 2: Sediment accumulation visible in background

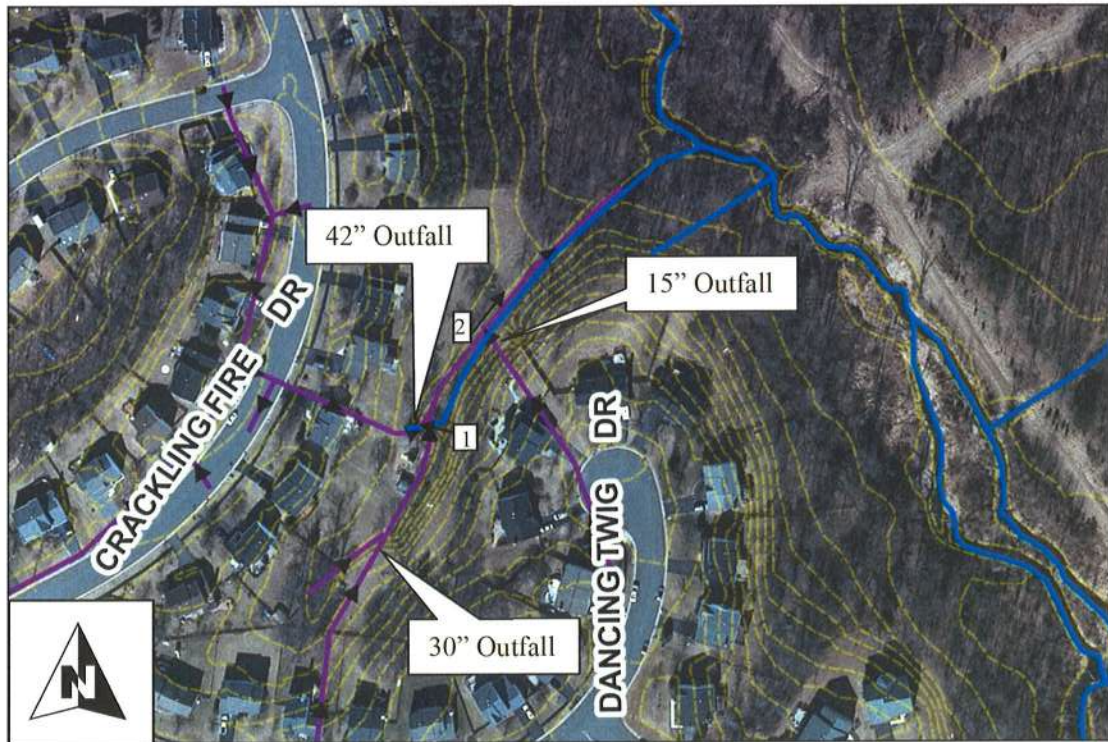
Problem Description: The 42 inch stormwater outfall provides a continuous baseflow for much of the year. There is also a 30 inch and a 15 inch outfall which only flows during storm events. Wetland plant species typical of constant hydrology are growing along the stream channel and the channel supports a fish population, probably mosquito fish. The stream channel flows through a graded high flow drainage swale with a well-manicured lawn. The two smaller outfalls drain approximately 10 acres without stormwater management. The 42 inch outfall actually drains a large area (30 acres), including two significant BMPs (#576 and #5492).

Existing Condition: Three outfalls discharge to a graded drainage swale

Project Description: Due to the large total drainage area and limited space at this site an outfall retrofit is not possible. However, the baseflow provides the opportunity to reconstruct the swale into an actual stream channel with a wetland floodplain and a woody riparian buffer. This work would convert the manicured lawn along the drainage swale into a more natural floodplain and riparian buffer, with a baseflow aquatic channel. Baseflows should be screened for illicit discharges based on the high concentration of filamentous algae in the stream channel and to determine the source of the baseflows. The baseflow channel would be limited to the lower 300 feet of the swale. The channel would be about 2 feet wide and only 0.5 feet deep, with a gravel/cobble bottom. The floodplain benches would be planted and seeded with wetland species. The side slopes of the swale would be planted with shrubs.

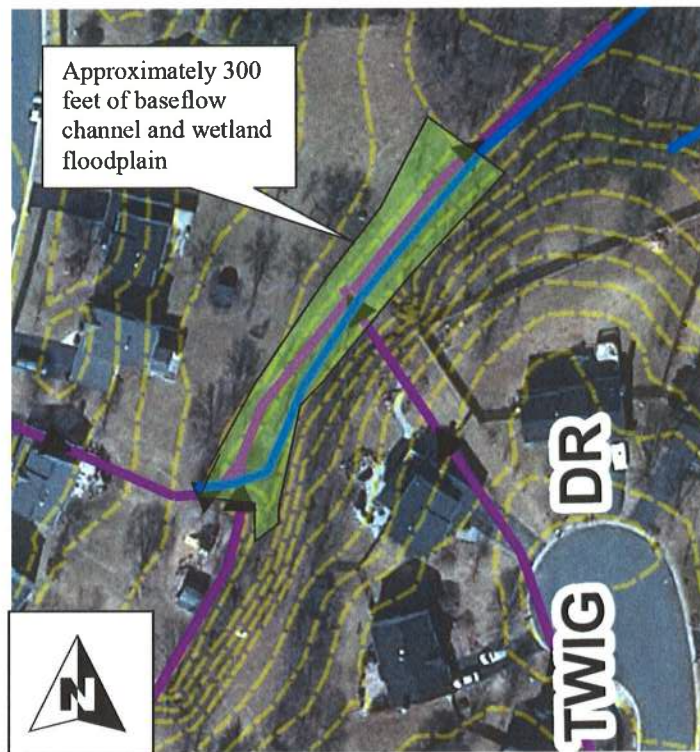
Conceptual Plan: Restore 300 linear feet of baseflow channel with wetland floodplain and riparian buffer

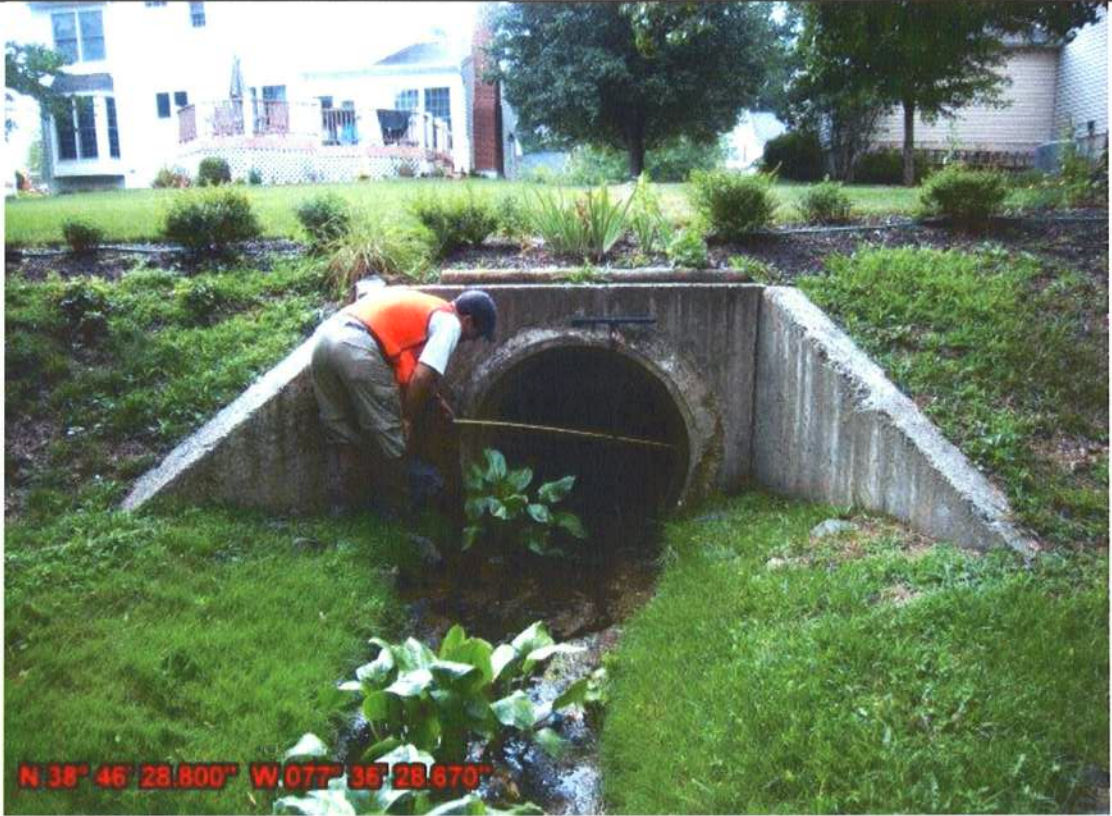
Photo 1: Continuous baseflow supports wetland plants (skunk cabbage)

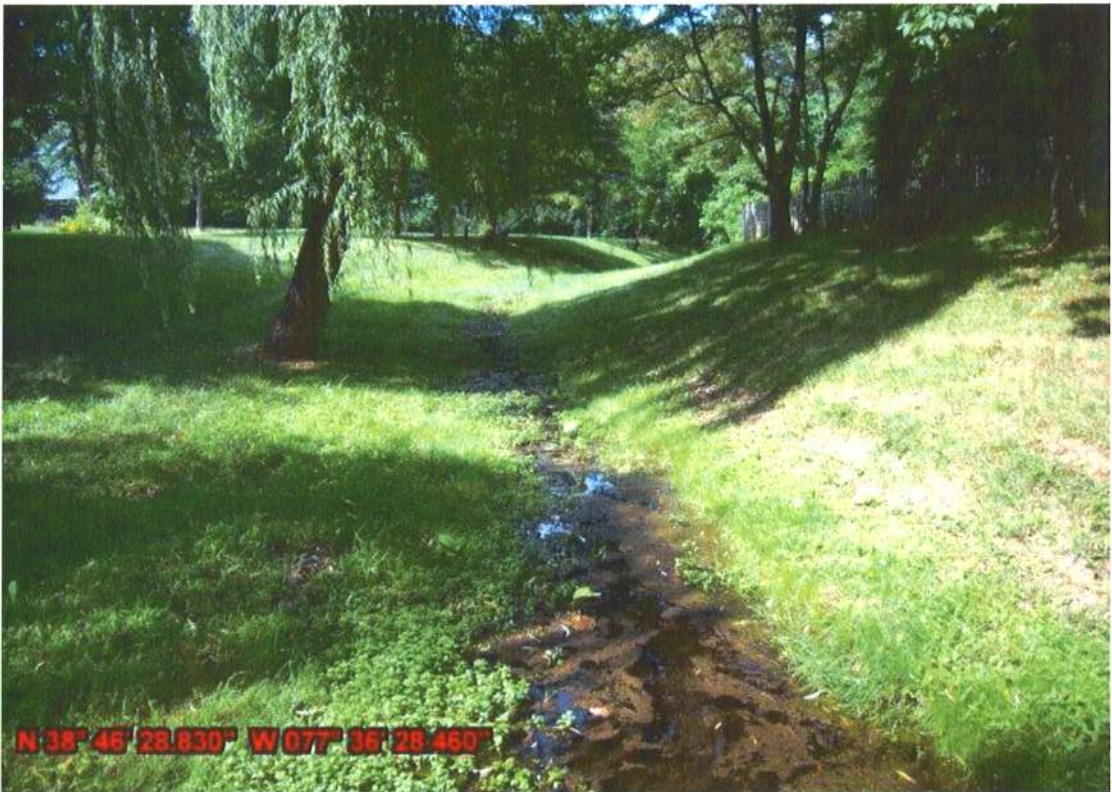
The residents consider the poor drainage, soggy soils and ponding along the swale undesirable. They often mow the swale to keep the vegetation under control, and cleanout the channel to keep it flowing. Storm flows can be very deep with the channel. The stream channel has a high concentration of filamentous algae.

Photo 2: Poorly draining grassed drainage channel is routinely mowed by adjacent landowners, note high algae load in channel
