APPENDIX B – REACH PHOTOGRAPHS

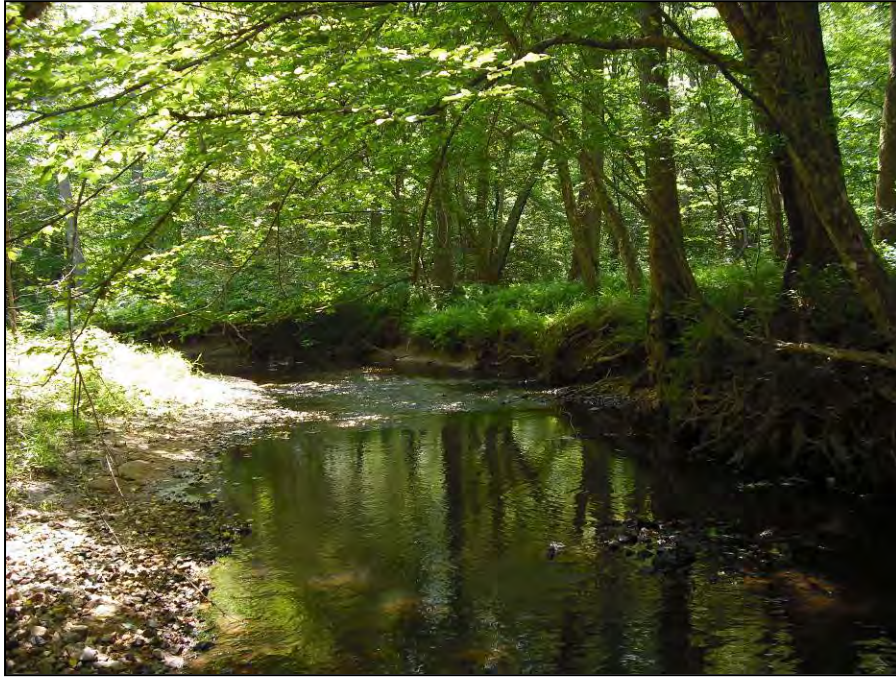
Photo 2: Uppermost portion of Reach 615-C, South Branch of Quantico Creek.

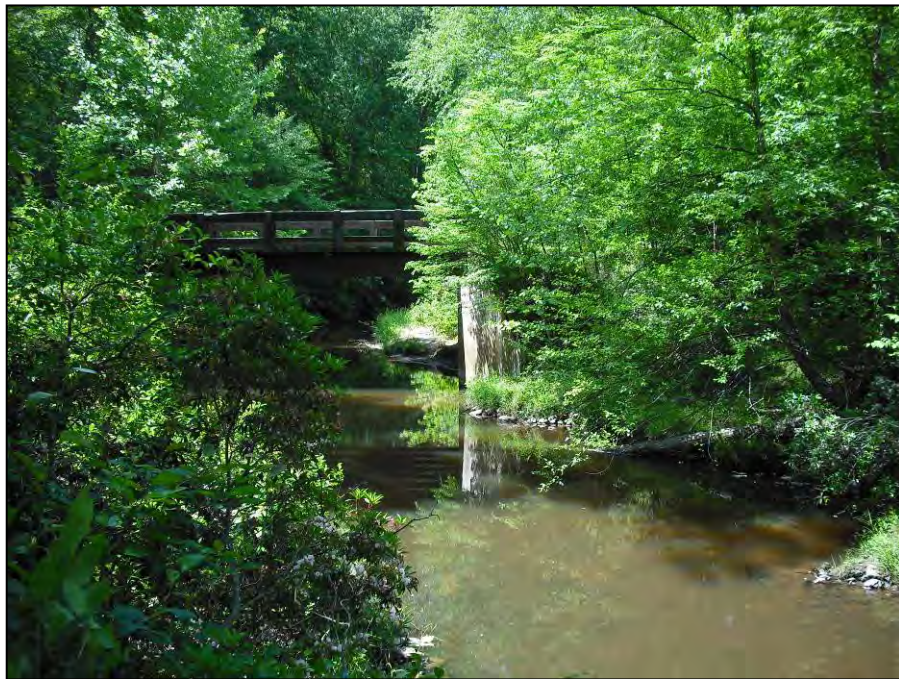
Photo 9: Access road bridge in Prince William Forest Park, Reach 615-C.

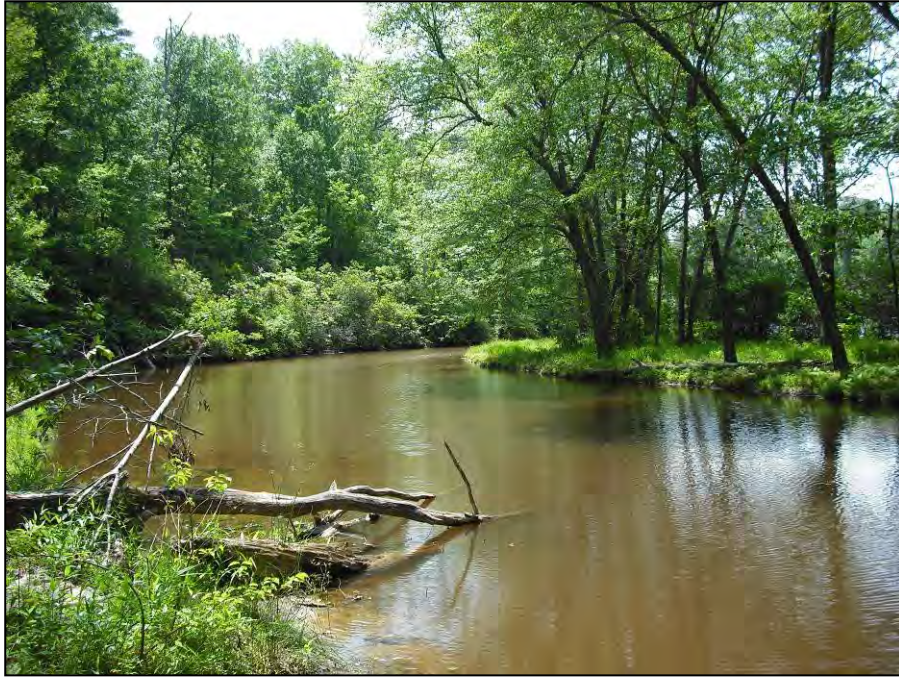
Photo 19: The lake at Prince William Forest Park, lowermost portion of Reach 615-C.

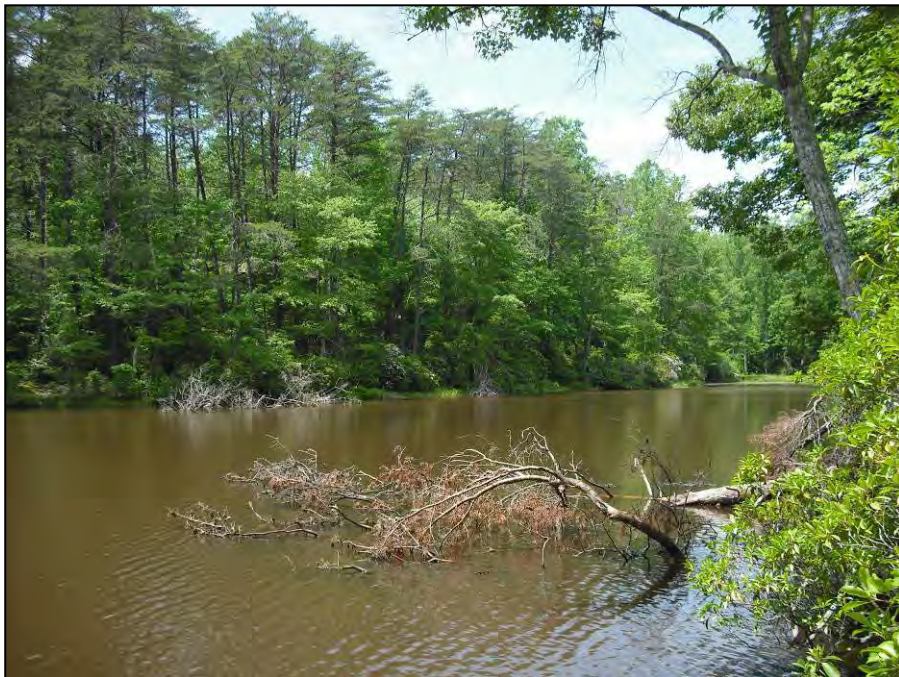
Photo 20: The lake at Prince William Forest Park, lowermost portion of Reach 615-C.

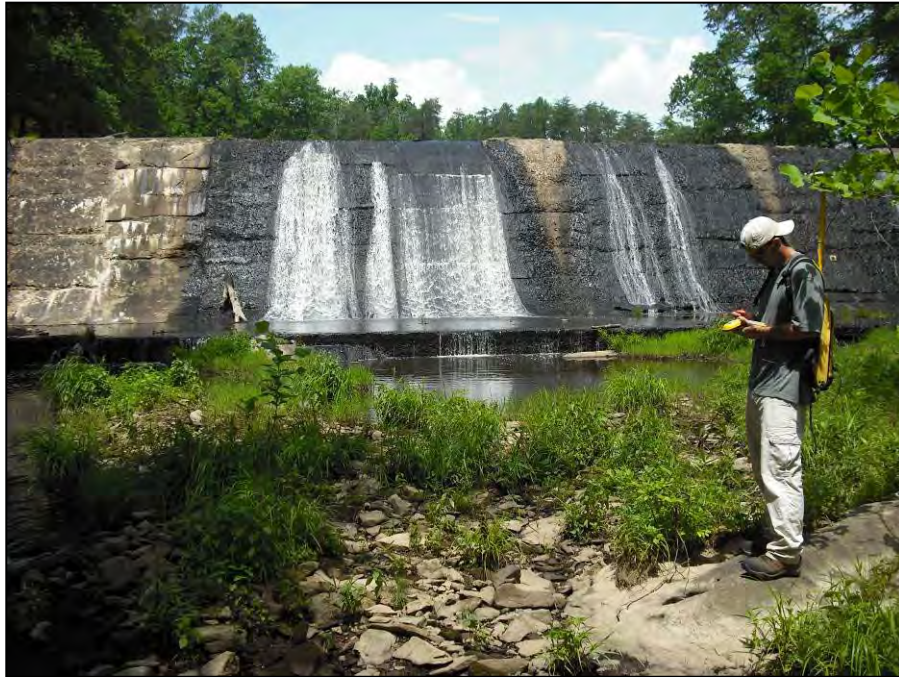
Photo 23: The dam at the lower end of the lake in Prince William Forest Park, Reach 615-B.

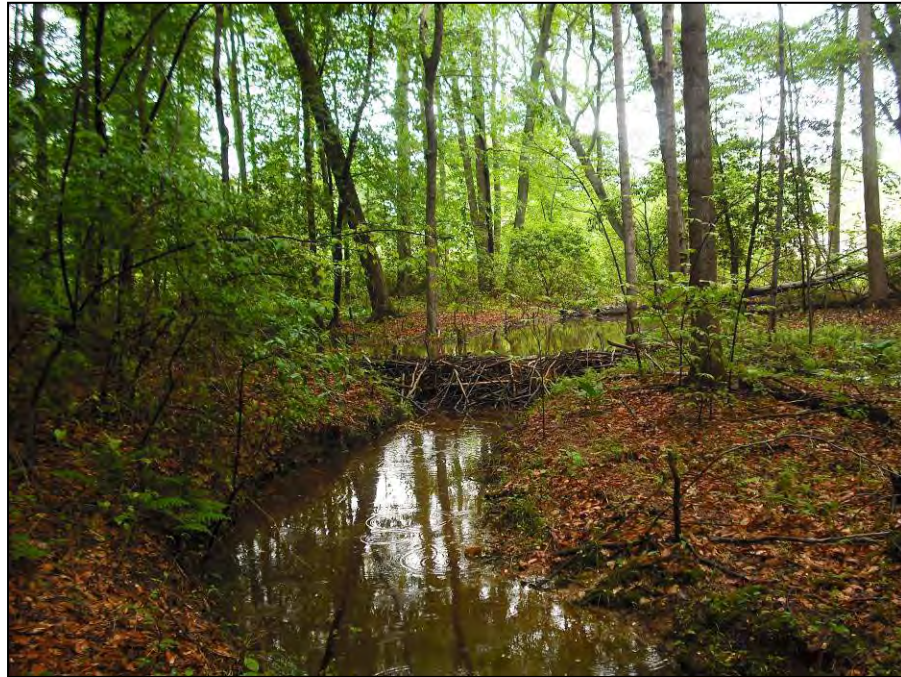
Photo 4: Uppermost portion of Reach 630-E.

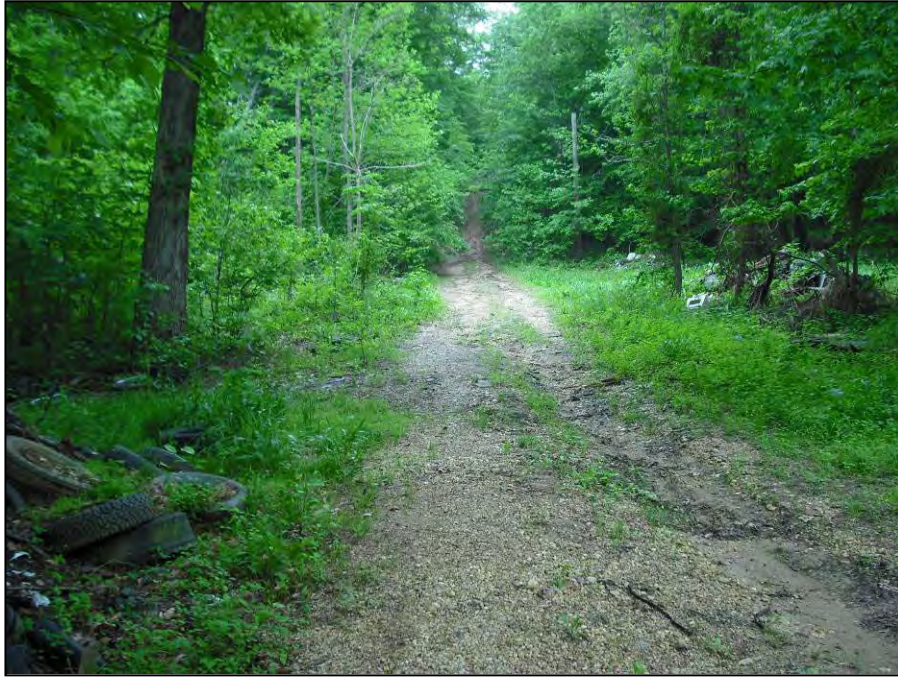
Photo 14: Tire and rubble dumping along gravel road, near upstream end of Reach 630-D.

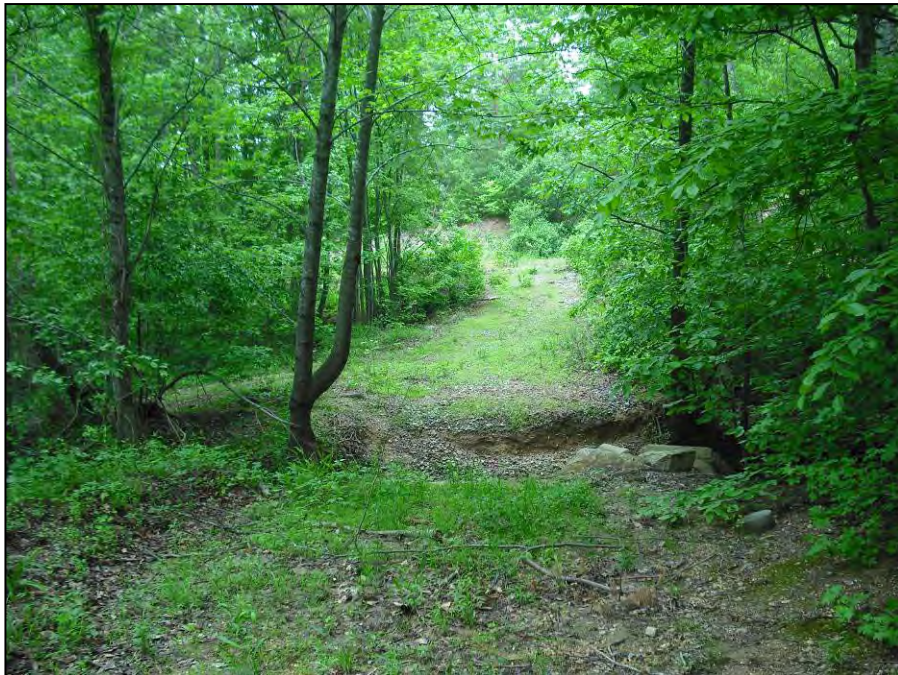
Photo 15: Gravel road channel crossing, near upstream end of Reach 630-D.

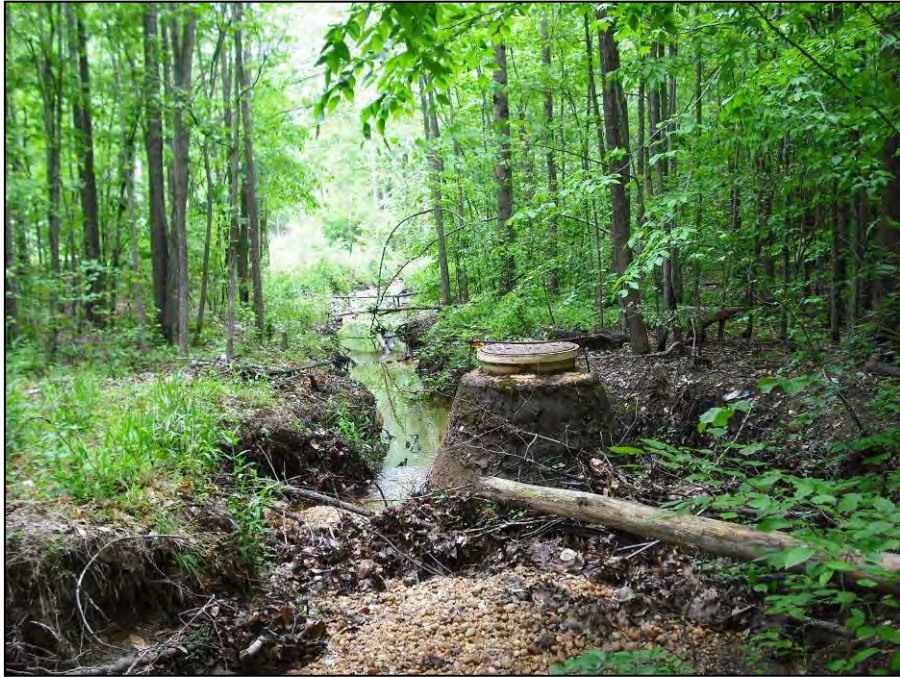
Photo 27: Channel erosion and exposed sanitary sewer along Reach 630-D.

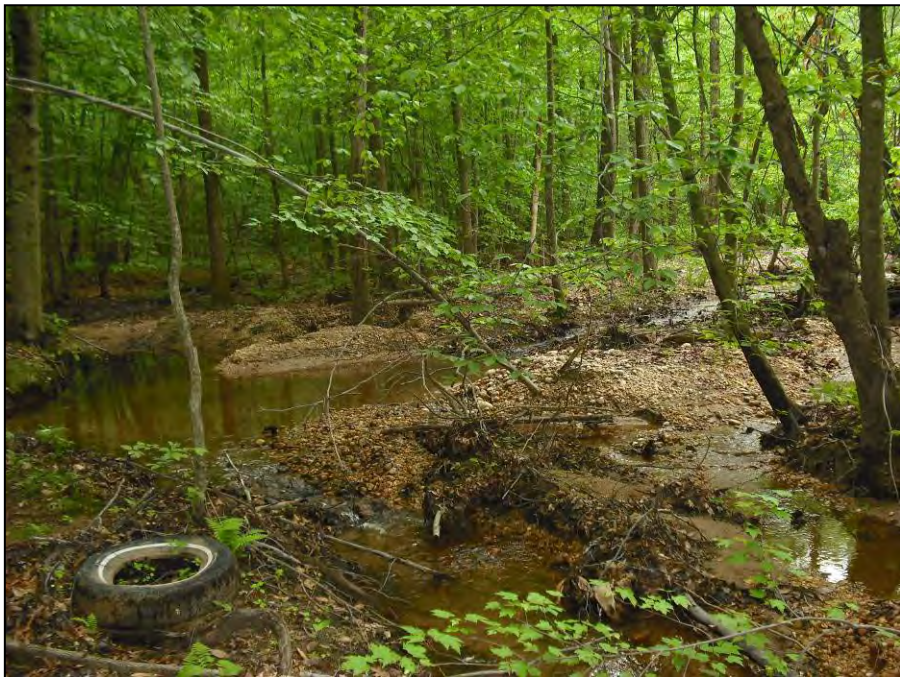
Photo 30: Channel widening along Reach 630-D.

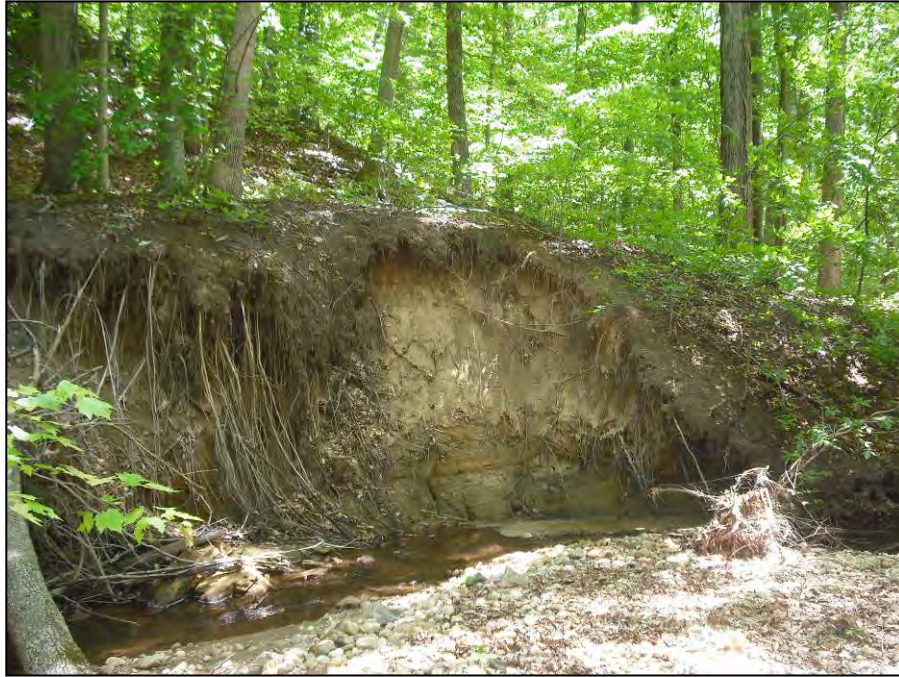
Photo 112: Localized streambank erosion on the outside of a meander on Reach 630-C.

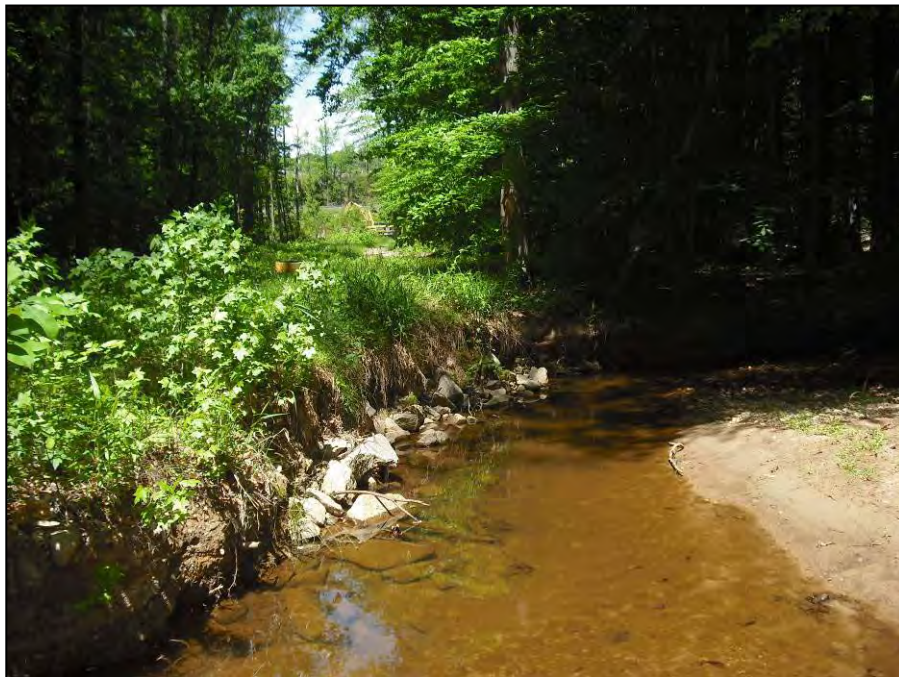
Photo 115: Deposition and channel widening along Reach 630-C.

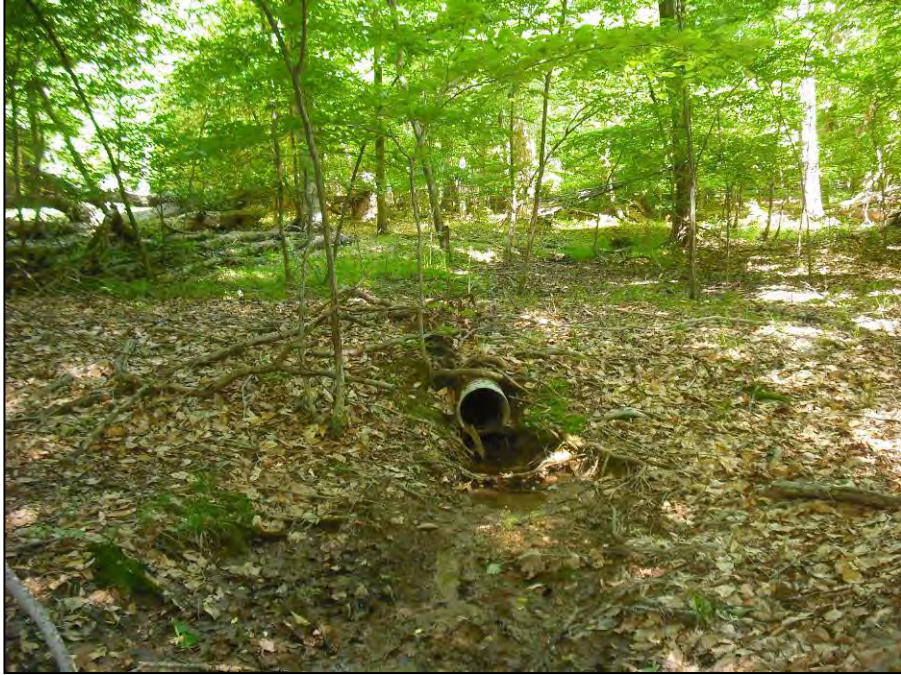
Photo 408: Pipe outfall, downstream of Park Entrance Road, on Reach 645-D.

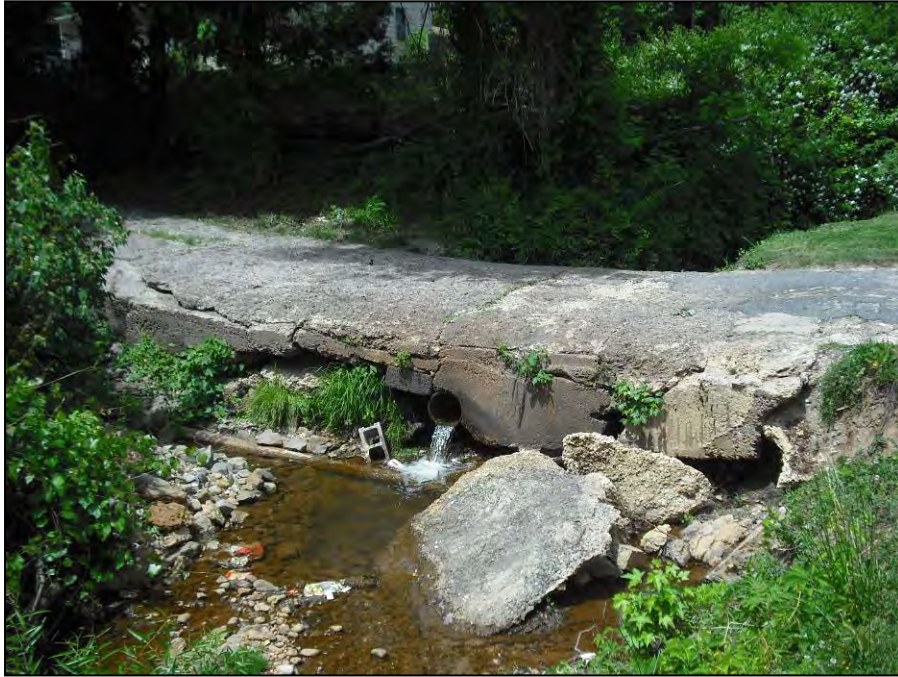
Photo 471: Paved low water crossing in poor condition, along Reach 645-A.

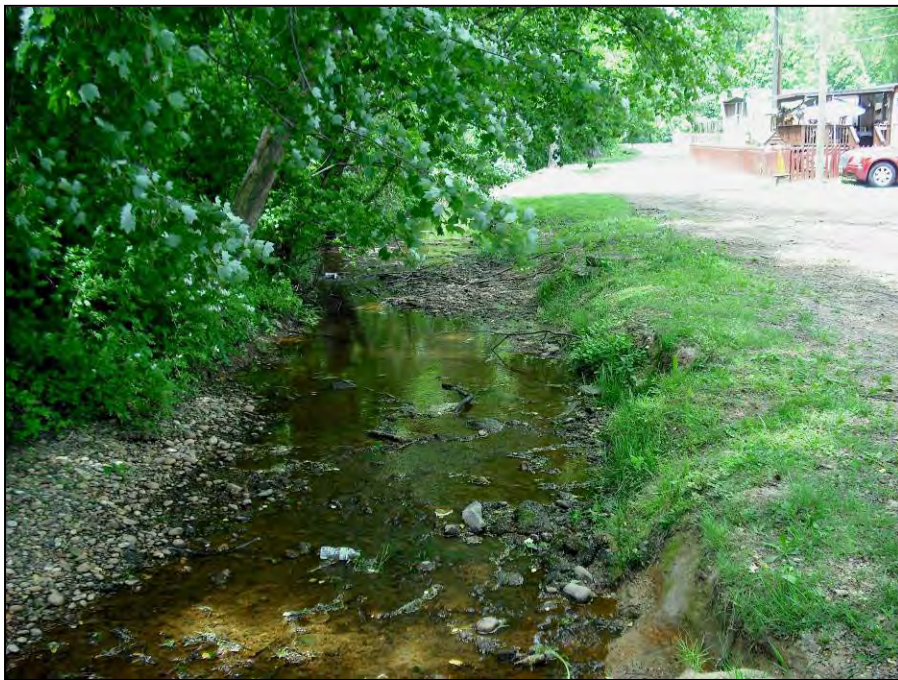
Photo 476: Loss of riparian buffer and stream corridor encroachment along Reach 645-A.

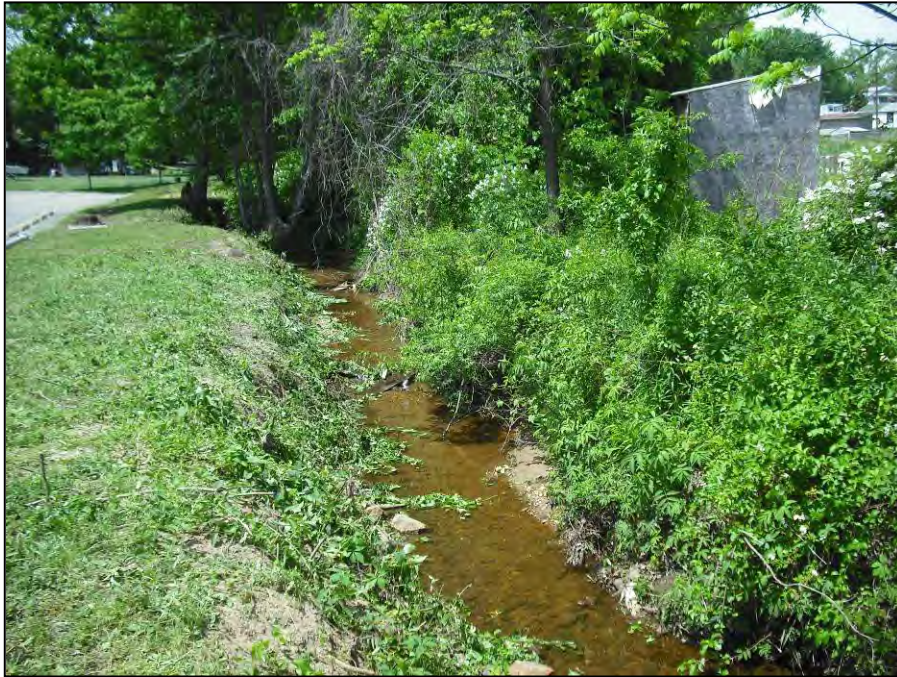
Photo 483: Loss of riparian buffer along Reach 645-A.

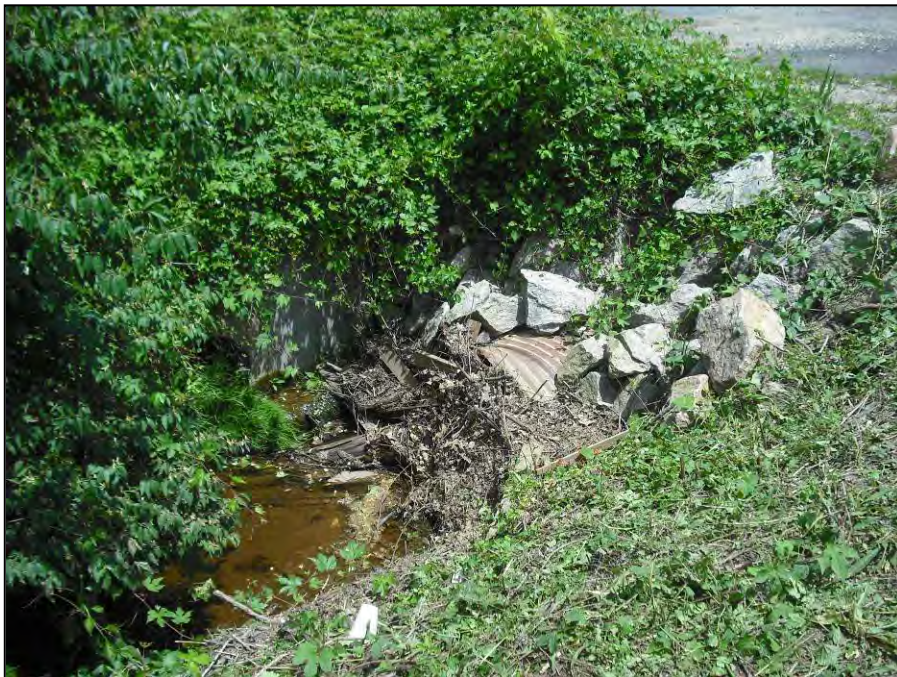
Photo 484: Debris clogging the CMP culvert at the downstream end of Reach 645-A.

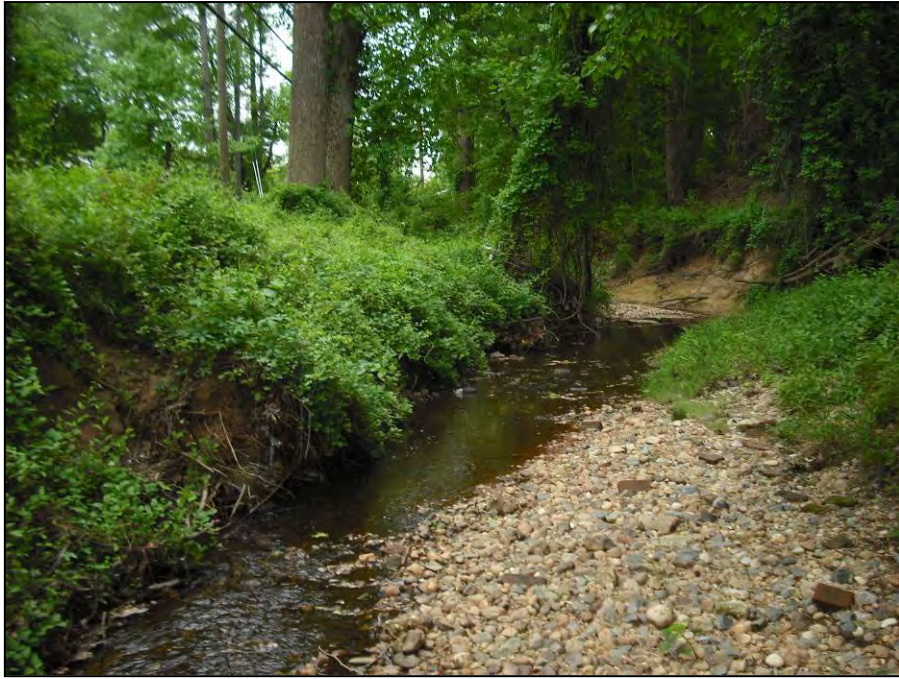
Photo 654: Streambank erosion along the upper portion of Reach 650-A.

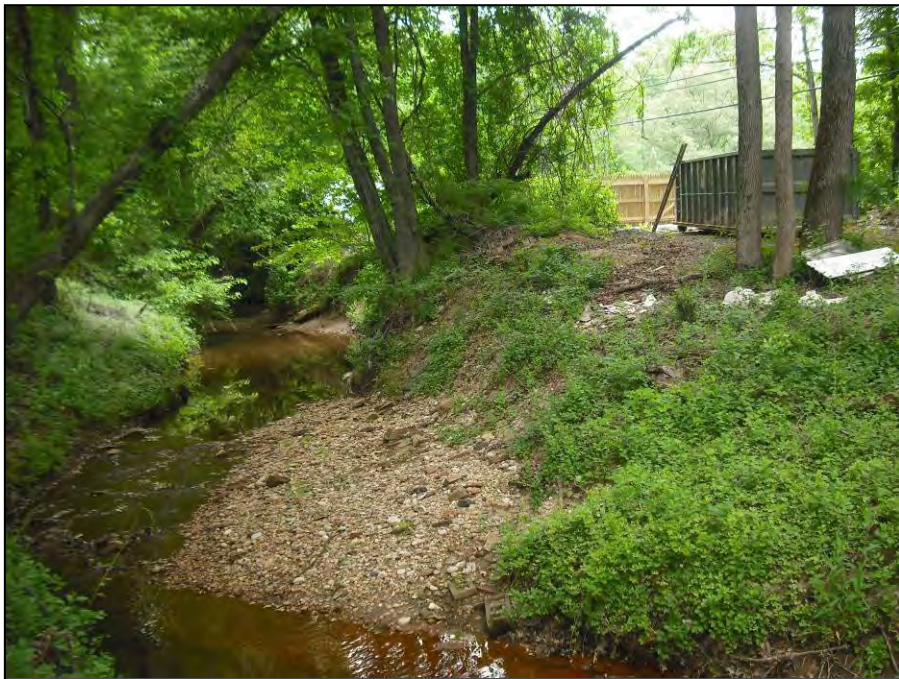
Photo 660: Garbage and debris dumping along the top of the bank of Reach 650-A.
