Broad Run Watershed

an Assessment of Stream
Corridors and Stormwater
BMPs in Five Representative
Subwatersheds

Whitman, Requardt & Associates, LLP
Engineers • Architects • Planners
9030 Stony Point Parkway, Suite 220
Richmond, Virginia 23235

September 2012

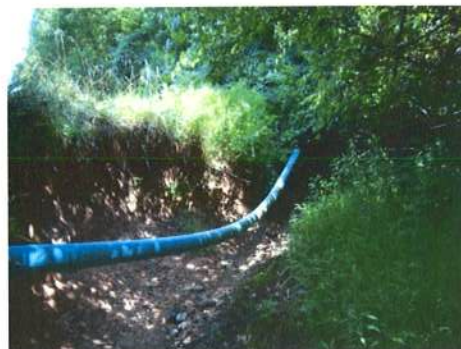
**Table 27:
Utility Summary Table**

Only ten utility stream crossings were catalogued during stream field assessments (Table 27). The majority of the utility crossings appear to be buried well below the streambed. Two utility crossings were considered moderately exposed and none were severely exposed. A majority of the exposed utilities were irrigation pipes within a County golf course.

Subwatershed Name and ID	Site ID	General Description	Severity	Recommendations
Rocky Branch (246)	246-1-U1	Sewer pipe embedded in substrate	0	None
Tributary to Broad Run (250)	250-3-U1	Exposed irrigation pipe along stream bed	3	None
	250-3-U2	Exposed irrigation pipe above stream bed	3	None
	250-3-U3	Exposed irrigation pipe above stream bed	7	Relocate irrigation pipe
	250-3-U4	Exposed irrigation pipe above stream bed	3	Relocate irrigation pipe
	250-3-U5	Exposed irrigation pipe along left bank (Aerial)	7	Relocate irrigation pipe
Dawkins Branch (262)	262-1-U1	Gas pipe buried below streambed	0	None
	262-1-U2	Sewer pipe buried below streambed	0	None
	262-2-U1	Gas pipe buried below streambed	0	None
	262-3-U1	Gas pipe buried below streambed	0	None

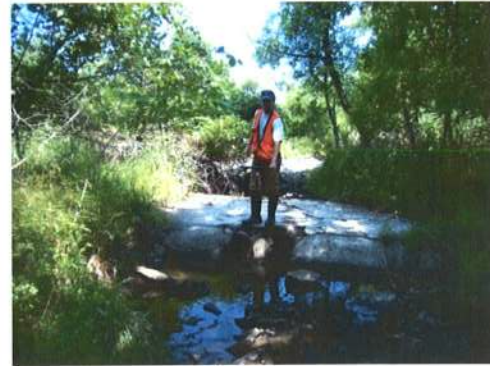
Table 29:
Obstruction / Fish Barrier / Head Cut Summary Table

Head cuts (i.e., areas of vertical bed erosion), fish barriers, or obstructions that restrict stream discharge were evaluated and assigned a score of minor, moderate, or severe (**Table 29**). A total of three headcuts were found during the evaluation. No severe headcuts were documented during our evaluation. Four obstructions were identified; most were old culvert crossings left in the stream channel. Two were creating a significant blockage of the channel.

Subwatershed Name and ID	Site ID	General Description	Severity	Recommendations
Tributary to Rocky Branch (244)	244-3-H1	Head cut	5	None
	244-3-H2	Head cut	5	None
	244-4-O1	Obstruction	10	Remove Pipe
	244-4-O2	Obstruction	5	Remove Pipe
Tributary to Broad Run (250)	250-3-O1	Obstruction	10	Potentially remove pipe
Dawkins Branch (262)	262-3-H1	Head cut	3	None
Kettle Run (272)	272-5-O1	Obstruction	3	Potentially remove pipe
