Quantico Creek Watershed Assessment April 2011

APPENDIX C – RSAT DATA SUMMARY

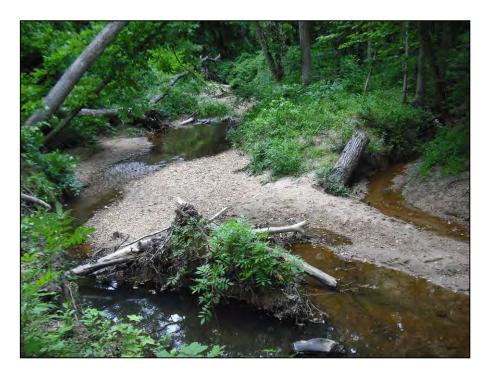
Photo 672: Channel widening and mass wasting along Reach 650-A.

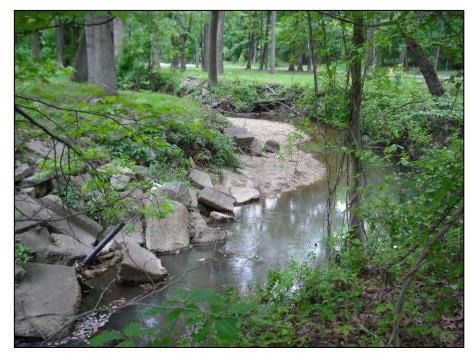
Photo 686: Concrete rubble bank armoring in response to channel erosion along Reach 650-A.

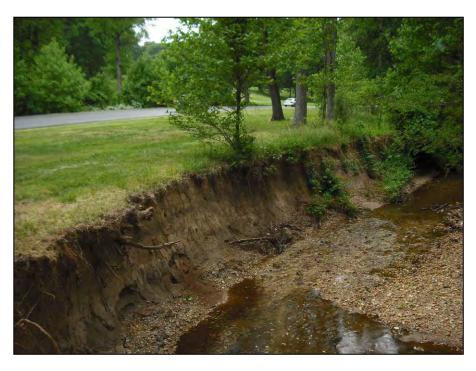
Photo 710: Bank scouring near Fuller Road, along Reach 650-A.

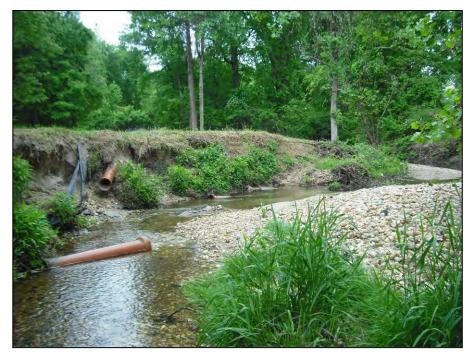
Photo 716: Collapsed pipe on the left bank of Reach 650-A.

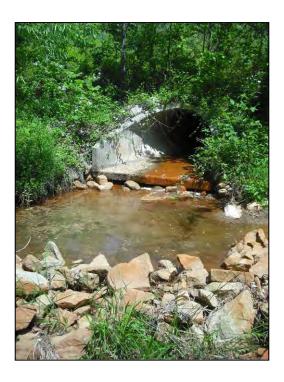
Photo 371: Concrete pipe outfall at the upstream end of Reach 665-C.

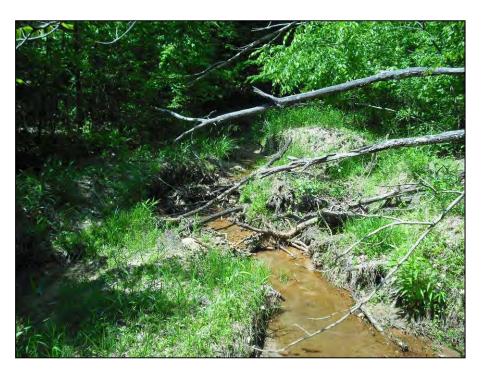
Photo 356: Water quality impairment approaching the downstream end of Reach 665-C.

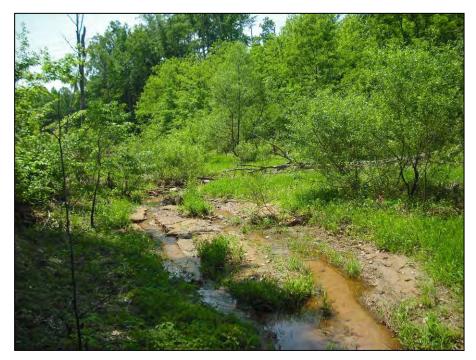
Photo 352: Deposition of sand and silt in the lower portion of Reach 665-C.

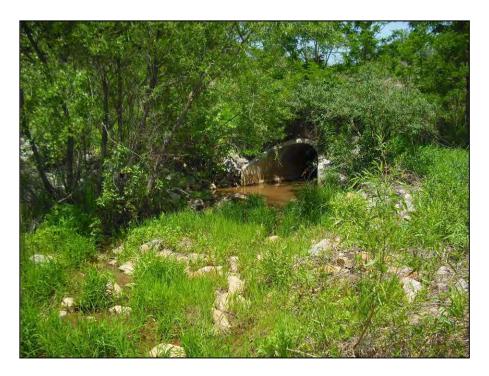
Photo 347: Concrete pipe outfall at the upstream end of Reach 665-B.

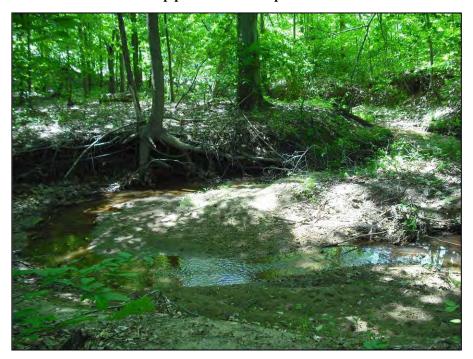
Photo 344: Deposition and streambank erosion along Reach 665-B.

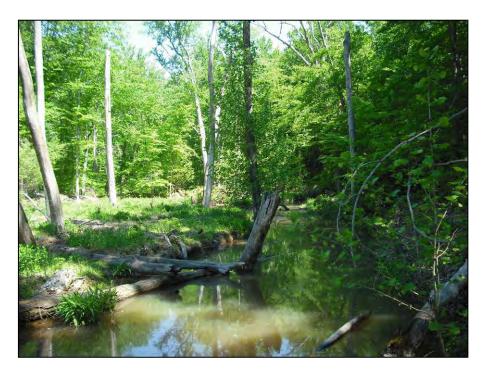
Photo 228: Backwater conditions upstream of a beaver dam on Reach 665-A.

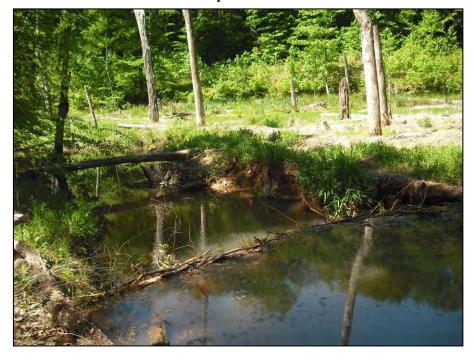
Photo 227: Large beaver dam acting as natural, de facto grade control on Reach 665-A.

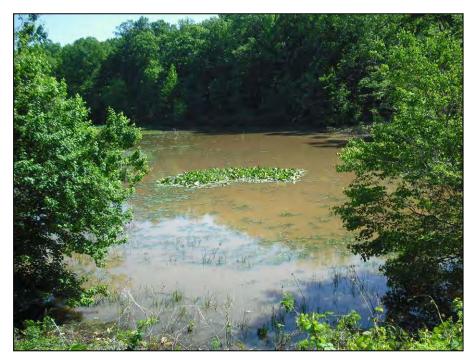
Photo 219: Quantico Bay at the downstream end of Reach 665-A.

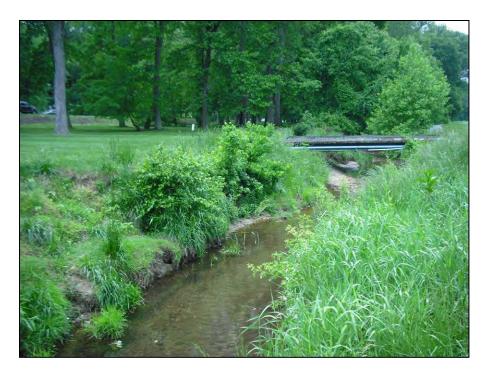
Photo 744: Loss of riparian buffer through the Medal of Honor Golf Course along Reach 690-A.

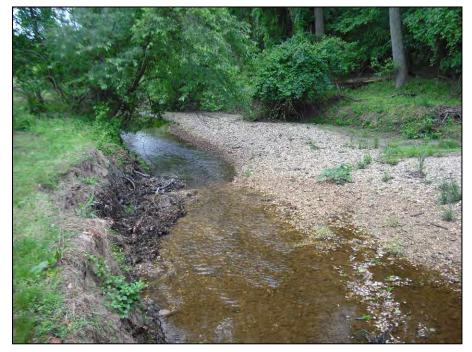
Photo 762: Channel widening along Reach 690-A.

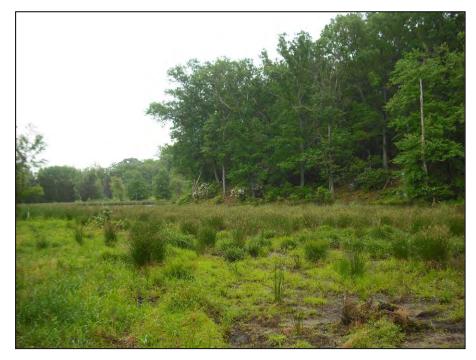
Photo 780: Large wetland near the downstream end of Reach 690-A.
