PRINCE WILLIAM COUNTY, VA
DEPARTMENT OF PUBLIC WORKS

Bull Run Watershed Study

Appendices

March 2010

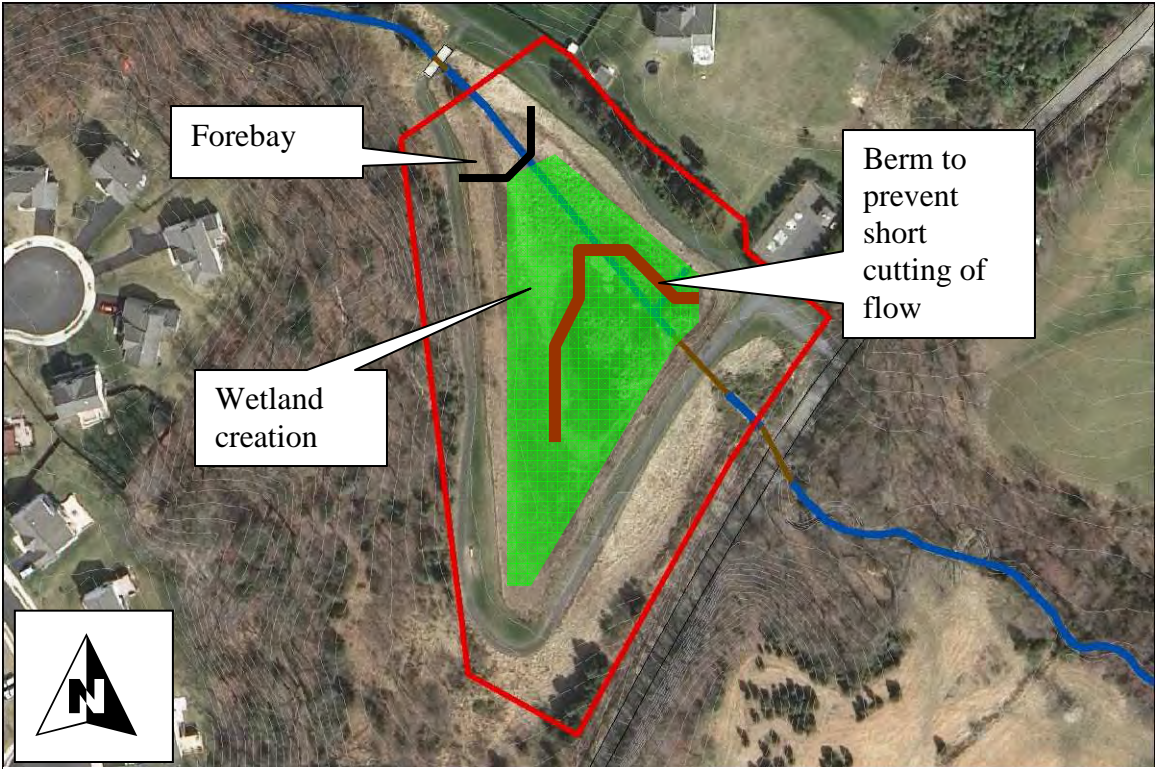
Problem Description: This dry basin was built in 2002 on a perennial stream with a drainage area of 112 acres. Due to a clogged low flow orifice it is functioning as a wetland. It lacks a forebay and sediment from the stream has accumulated in the basin. The facility has a HOA trail around it. Due to the triangular shape, the flows short circuit between the inflow and the 72 inch riser. Two severe head cuts (B6B-H2 and B6C- H2) are actively eroding the upstream channels. A head cut (B6C-H2) in reach B6C has incised four to five feet and is encroaching upon an upstream sanitary utility. Reach B6C is in fair condition and Reach B6B is in good condition. A large tree fall is generating a moderate obstruction (B6B-O1) resulting in bank erosion.

Conceptual Plan: Existing dry basin would be converted to wetland

Project Description: The large watershed size, perennial flow, and large stormwater facility size makes this site well suited for a conversion to a stormwater wetland. This project would address the stormwater facility, stream buffer, and head cuts as a single project. The stormwater facility would be graded to create marsh, berms, and micro-pools. A forebay will be installed to help manage sediment from the perennial stream. The head cuts in the streams would be stabilized with stone structures. The obstruction would be removed to prevent additional bank erosion. A management plan would be developed to help the HOA properly maintain the stream buffers, monitor stream condition, and maintain the stormwater facility.

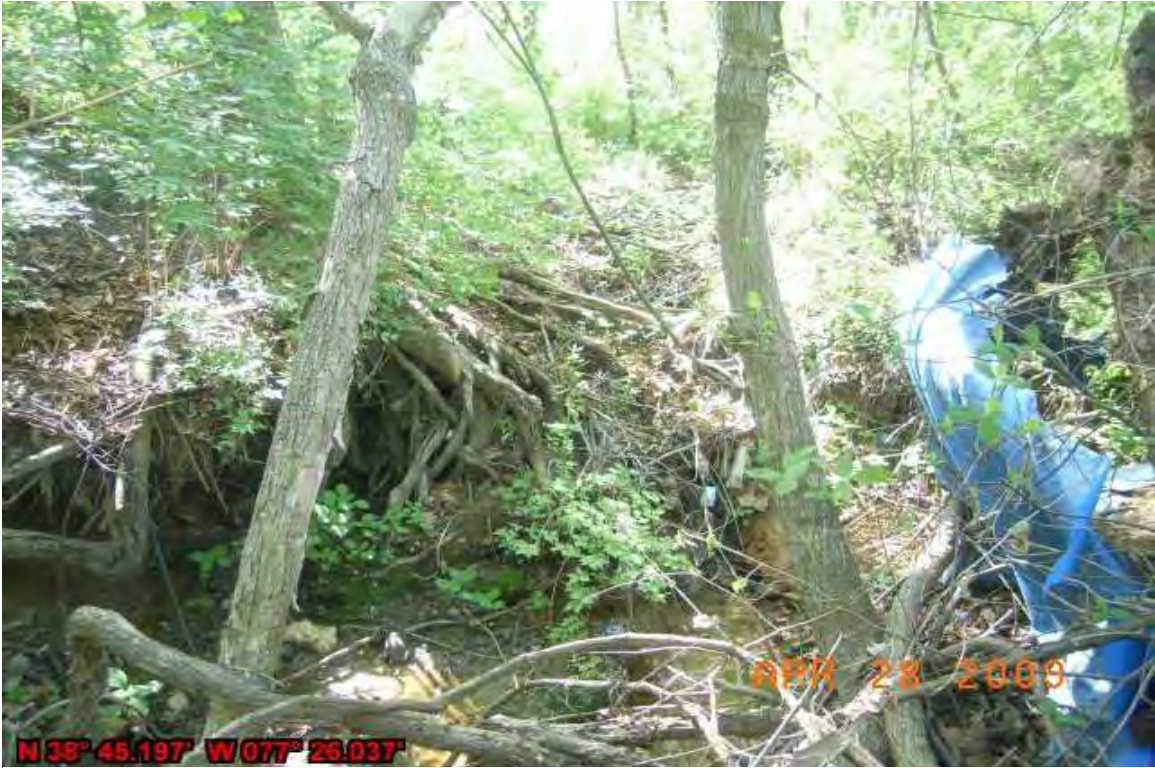
Photo 1: Headcut B6B-H2 would be stabilized

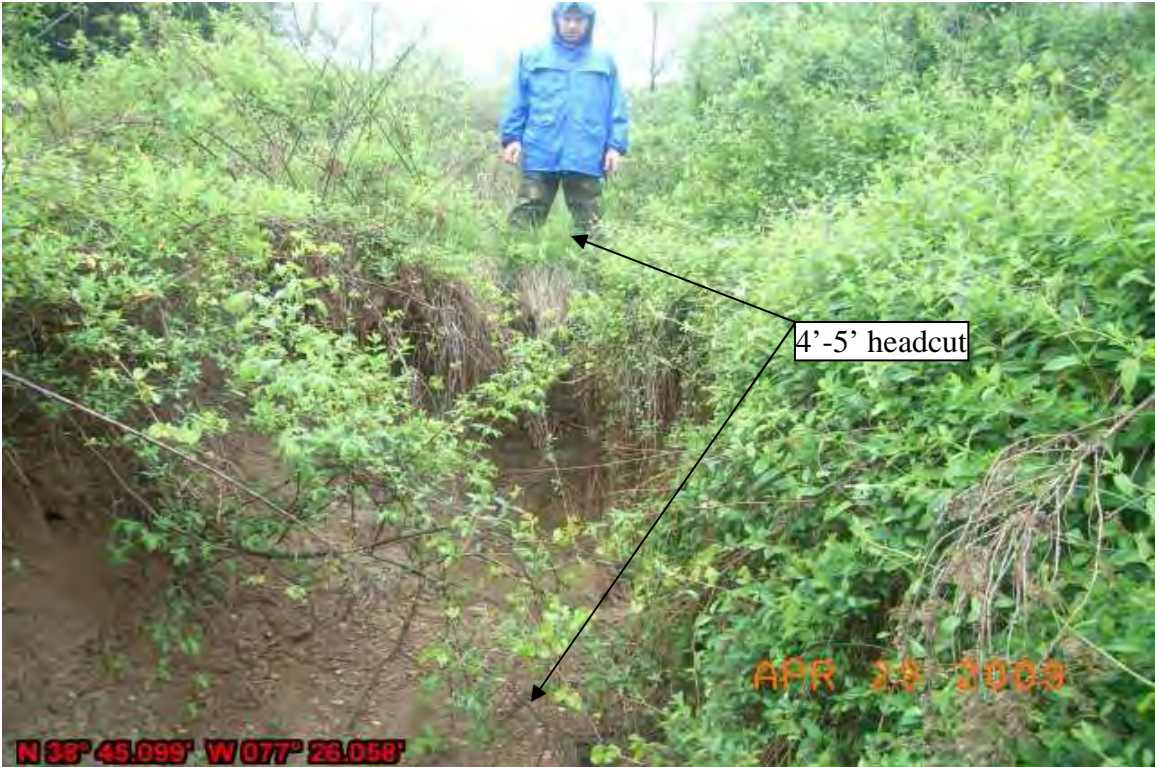
Design Considerations: Construction access to reach B6 and site 194-1 would be from a HOA recreational trail. Headcut B6C-H2 is in an open area that can be accessed through a utility easement upstream from the failing area. Clearing of mature trees in the riparian buffer is necessary to access the failing areas.

Photo 2: Headcut B6C-H2 would be stabilized

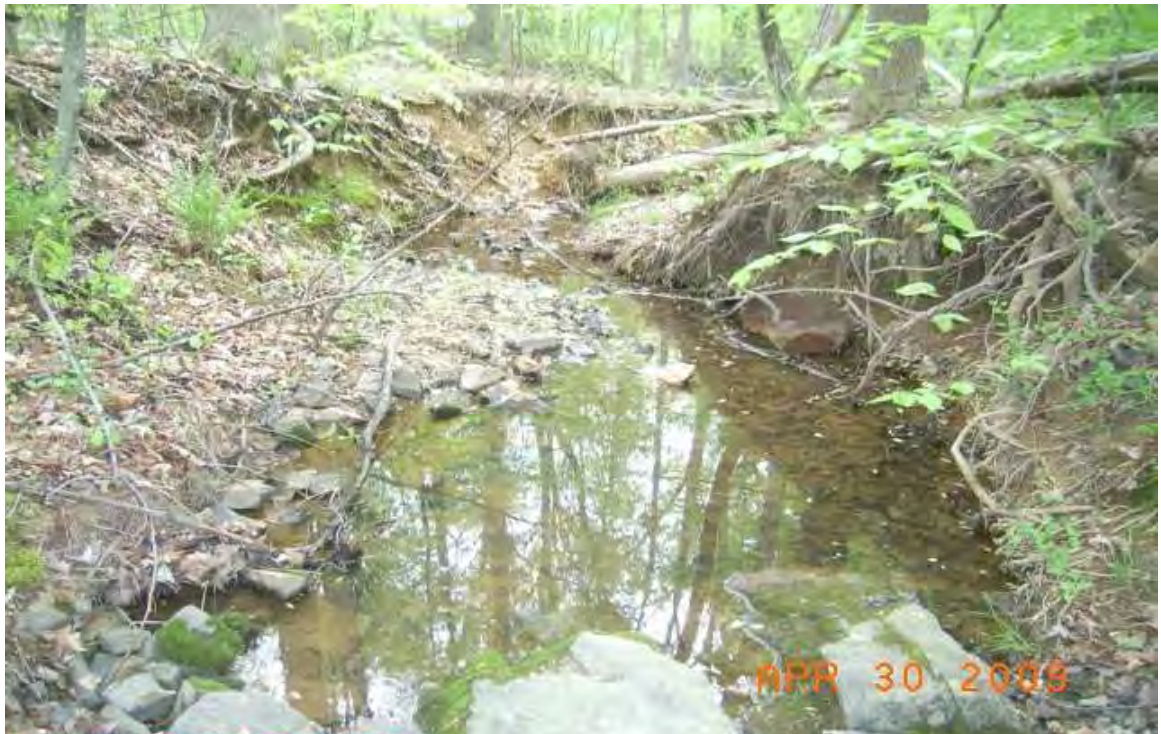
Problem Description: Approximately 50 acres of drainage discharges into the existing stormwater facility. The drainage area consists primarily of large wooded residential lots with minimal impervious area. A perennial stream is conveyed through a 30" CMP driveway culvert into the facility. There is no riser structure in the stormwater facility and the outlet is a 21" CMP pipe. The emergency spillway seems to be high and not accessed often. The facility itself appears to be in good condition. The smaller outlet pipe results in detention within the basin, but has resulted in significant erosion of the receiving channel. There appears to be minimal scour protection in the receiving stream. The County inventory indicates that this facility was constructed in 1992. This design is similar to many facilities constructed in large lot residential areas with minimal impervious surfaces. Other similar stormwater facilities may also be resulting in stream instability.

Photo 1: Scour and erosion is evident downstream of BMP outlet

Project Description: A detailed investigation of the stormwater facility is recommended, including the design of an outlet structure, the water quality volume needed to treat the impervious runoff, and the height of the emergency spillway. The riser design should provide a non-erosive draw down velocity. Stabilization of the receiving channel is also recommended. The County may consider a field evaluation of all stormwater facilities of similar design to determine if stream de-stabilization is a problem common to this older design.

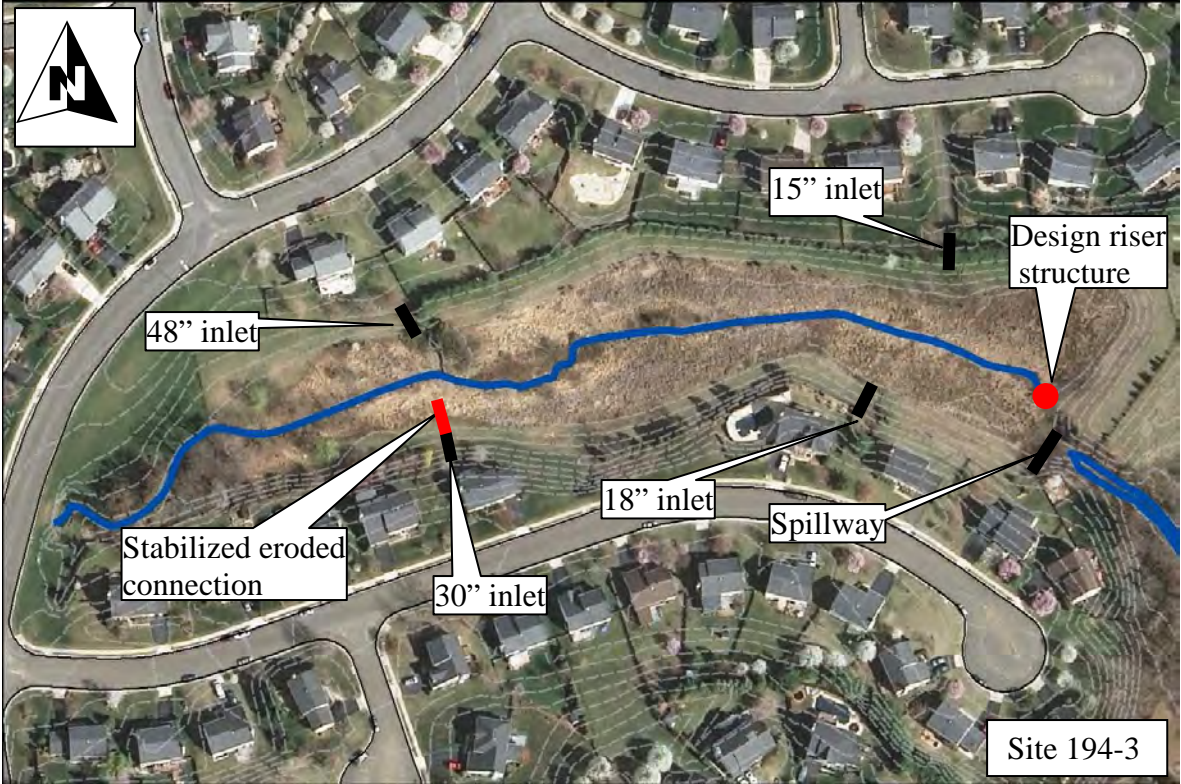
Conceptual Plan: Install riser structures and stabilize eroding inlet

Cost Estimate: The estimated total cost for this project is approximately \$70,000, which includes a new riser, removal of accumulated sediment, inlet stabilization, and hydrology study.

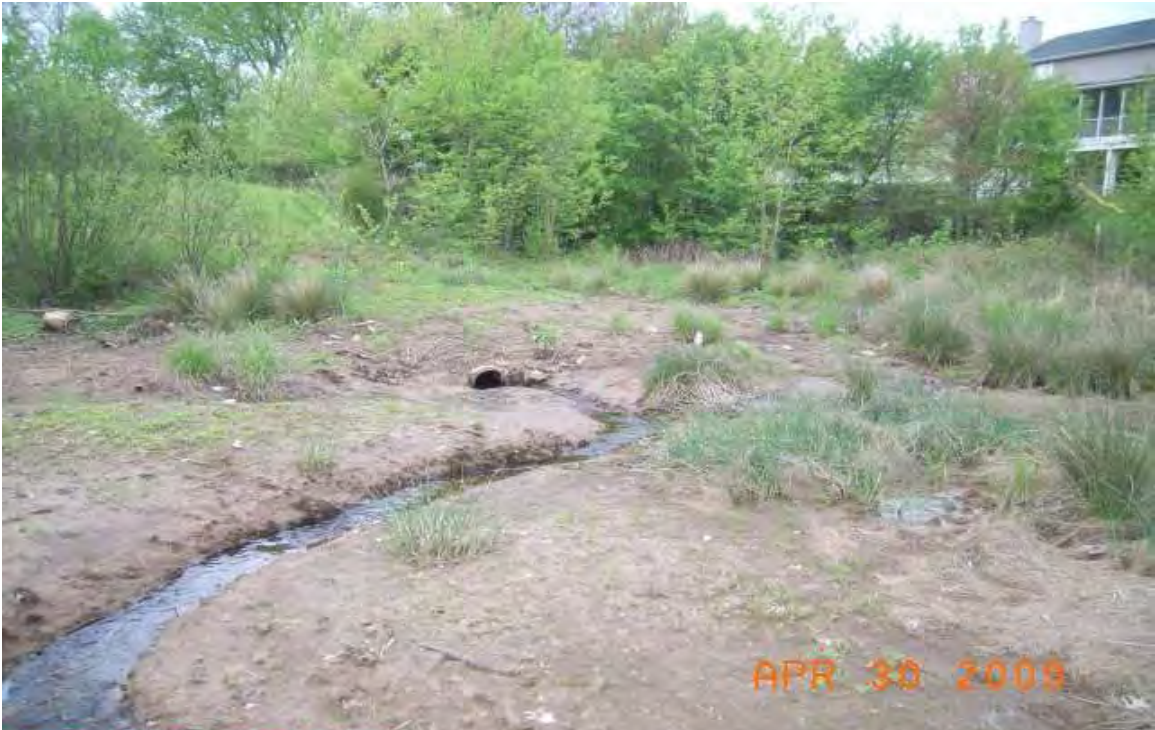
Photo 1: 15" Outlet Pipe

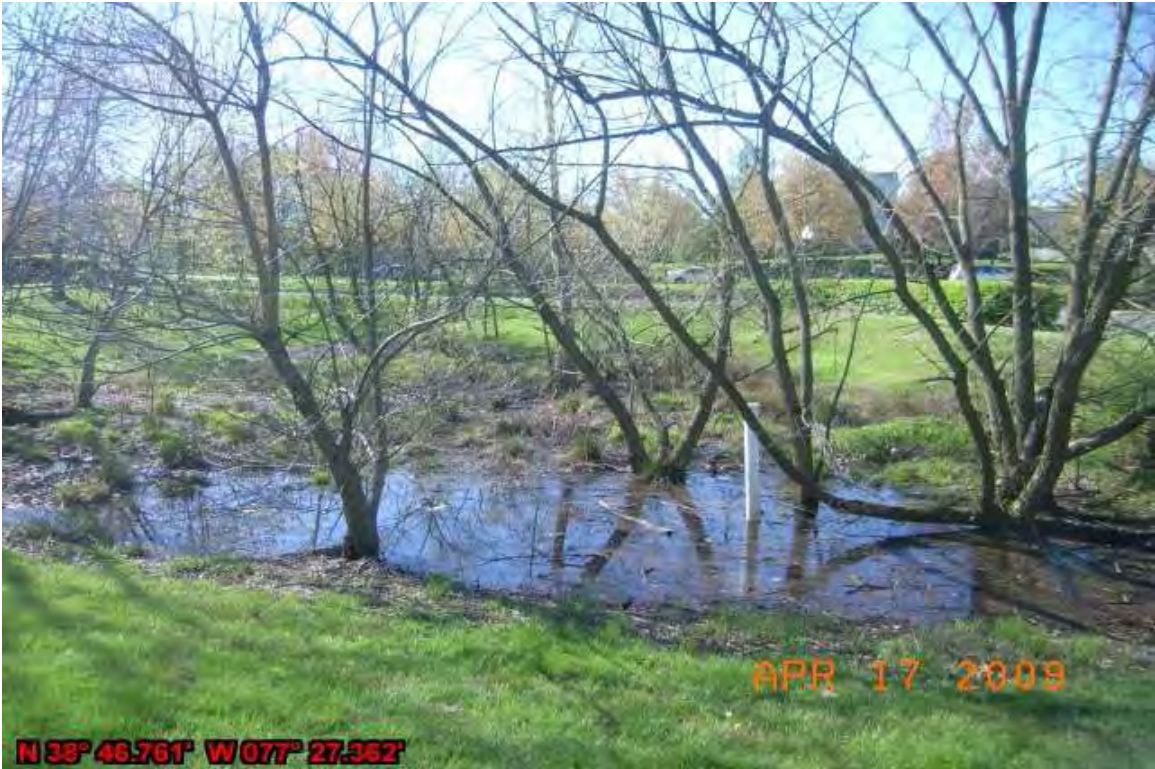
Photo 1: Dry basin is ponded, supporting a wetland community

Project Description: This site would be re-designed as a constructed wetland. In addition, a revised riser structure is recommended. The addition of a fence is recommended due to the ponding depth and the location of the stormwater facility in a residential area. To the extent possible, the water quality retrofit would preserve the existing mature wetland trees.

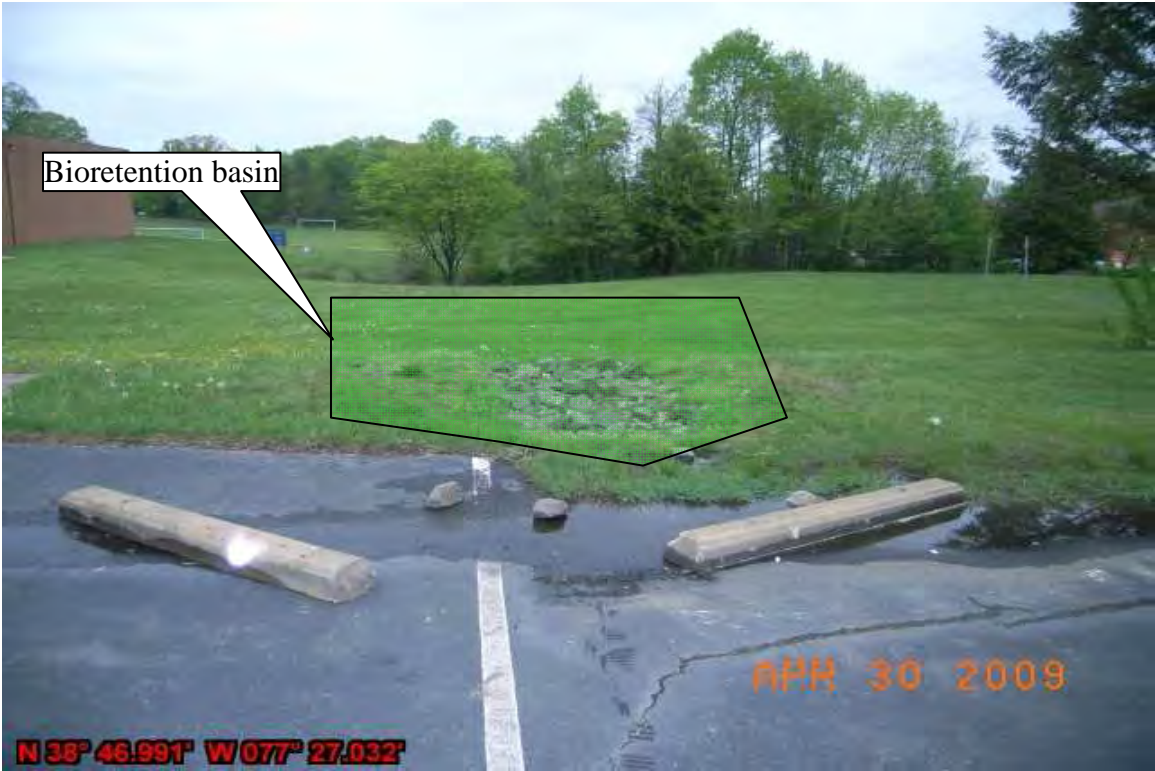
Problem Description: The runoff to the stream is currently untreated for water quality or quantity. Approximately 6 acres (about 50% impervious cover) drains through the site. There is one outlet pipe on site that discharges directly into the existing stream. The parking lot drainage sheet flows over the lawn and into the stream. Additional untreated off site runoff discharges at Y1-P1. In addition runoff from Centerville Rd. discharges into a swale that also enters into the stream. The existing stream banks and bed are unstable and eroding, resulting in a reach condition assessment of fair. Invasive species and mowing the riparian buffer are decreasing the water quality and ecology of the channel. However, groundwater supplies the stream with strong base flow which supports aquatic species including caddisflies.

Photo 1: Bioretention basin is proposed to replace current efforts to treat parking lot runoff

Project Description: A 2180 sf bioretention basin is recommended to treat the runoff from the church school parking lot. A 3180 sf enhanced extended detention basin is recommended at the intersection of the swale and the channel from the outfall pipe. There appears to be sufficient space available to accommodate these facilities. A riparian buffer management plan would be developed to assist the church school in maintaining these facilities, as well as the riparian buffer.

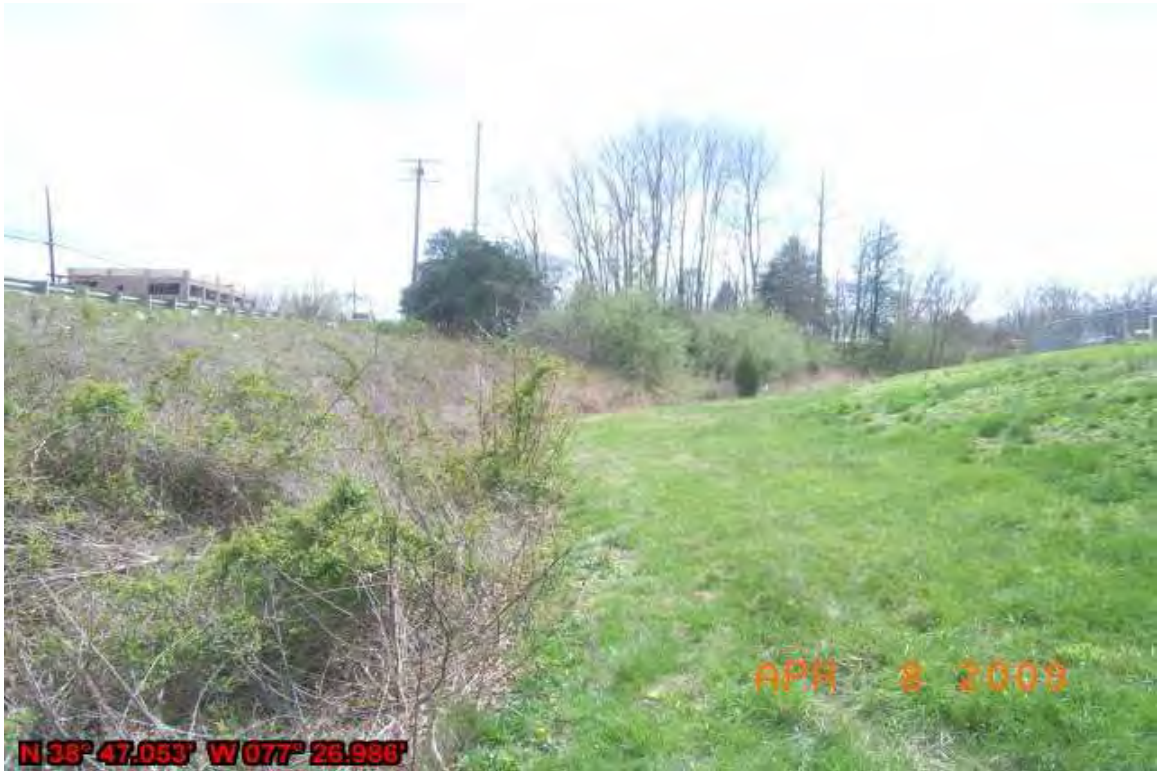
Photo 2: Buffer management plan could improve streamside maintenance practices

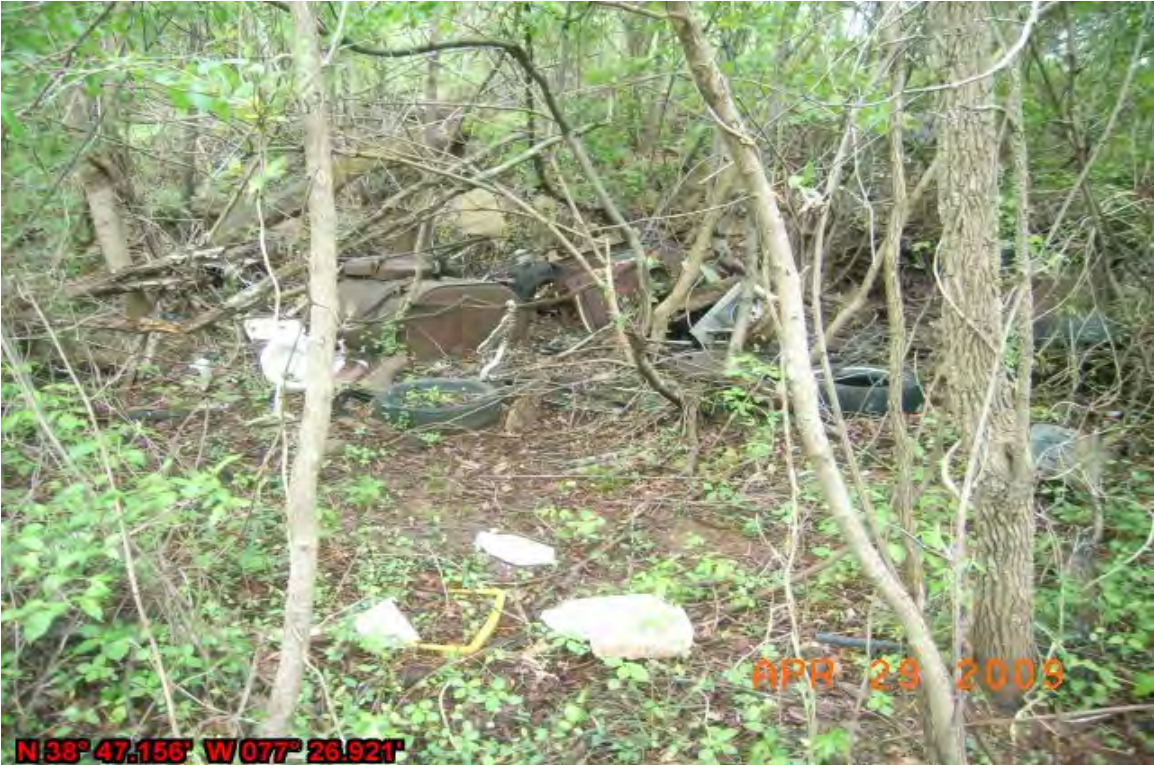
Problem Description: This reach is hidden in a steep valley between commercial properties where it is out of sight of adjacent landowners and the public, which leads to a lack of concern and maintenance. This stream reach scored as fair condition, with a particularly low channel bed stability score and aquatic habitat score. The channel has two significant head cuts (Y7-H1 & Y7-H2) with 2 or more feet of channel bed incision. This reach has one of the largest dump sites in the study (Y7-T1), composed of automotive debris, furniture, appliances, and paper/plastics. There are two outfalls (Y7-P2 & Y7-P1) which require stabilization or maintenance. There is no stormwater control upstream of this reach.

Photo 1: Remove debris from dump Y7-T1

Project Description: The proposed work along this reach would be to stabilize the channel bed, particularly at the two head cuts, addressing any outfall stabilization, and removing the debris dump. The narrow stream valley and existing riparian buffer limits the extent of restoration that could be performed. The work would focus primarily on stabilization. Given it's location between commercial properties, management of the riparian buffer and adjacent land should be addressed. This project would benefit from the recommended improvements upstream at Site 186-5 which will provide stormwater quantity and quality controls.

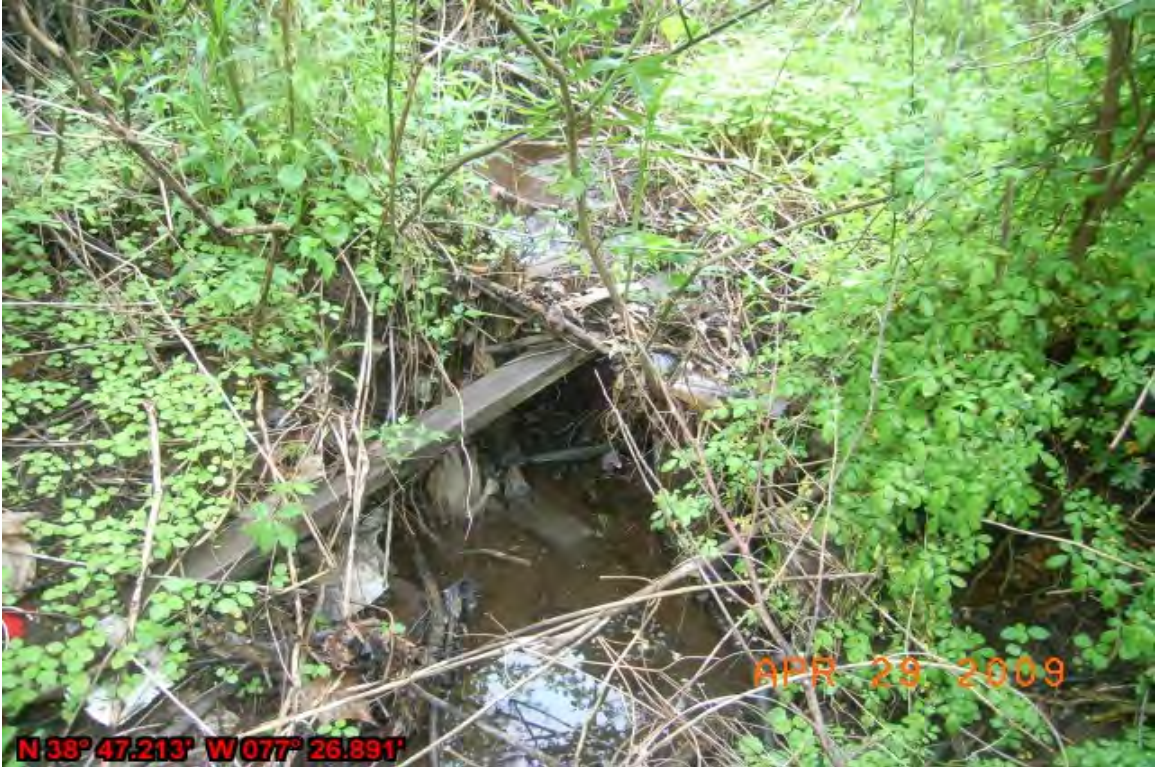
Photo 2: Stabilize headcut Y7-H1

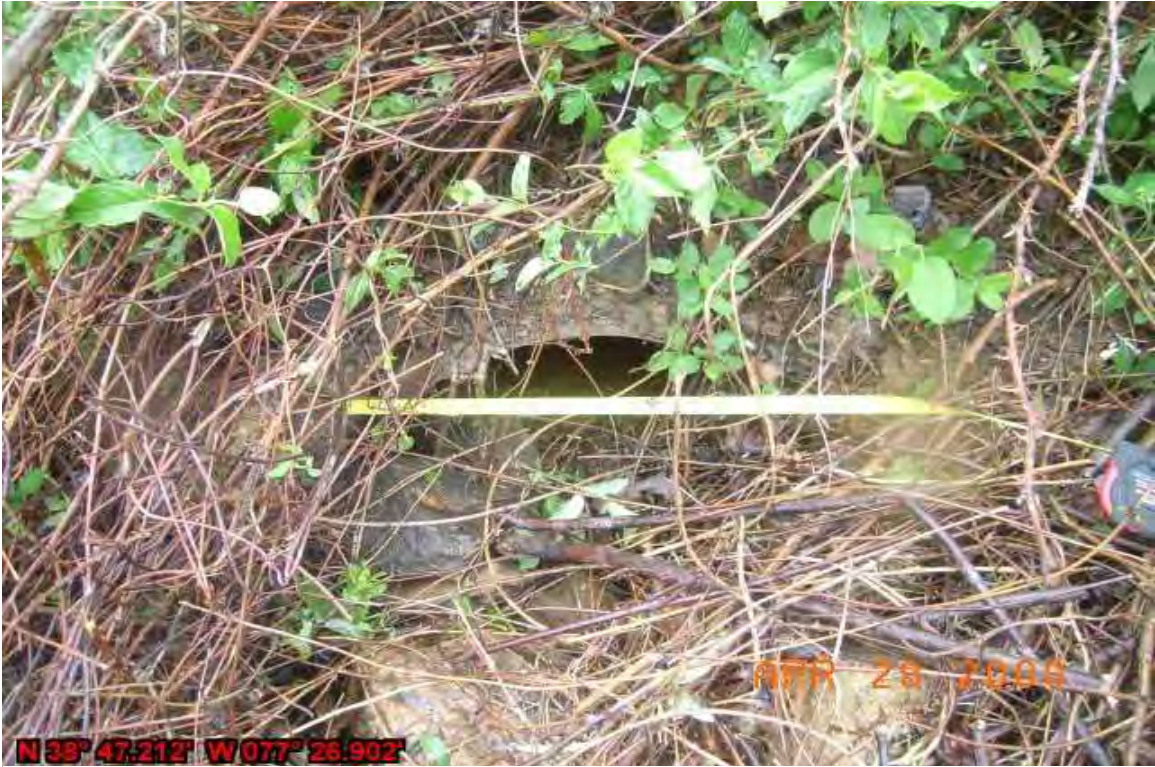
Photo 3: Remove sediments and debris from outfall Y7-P2

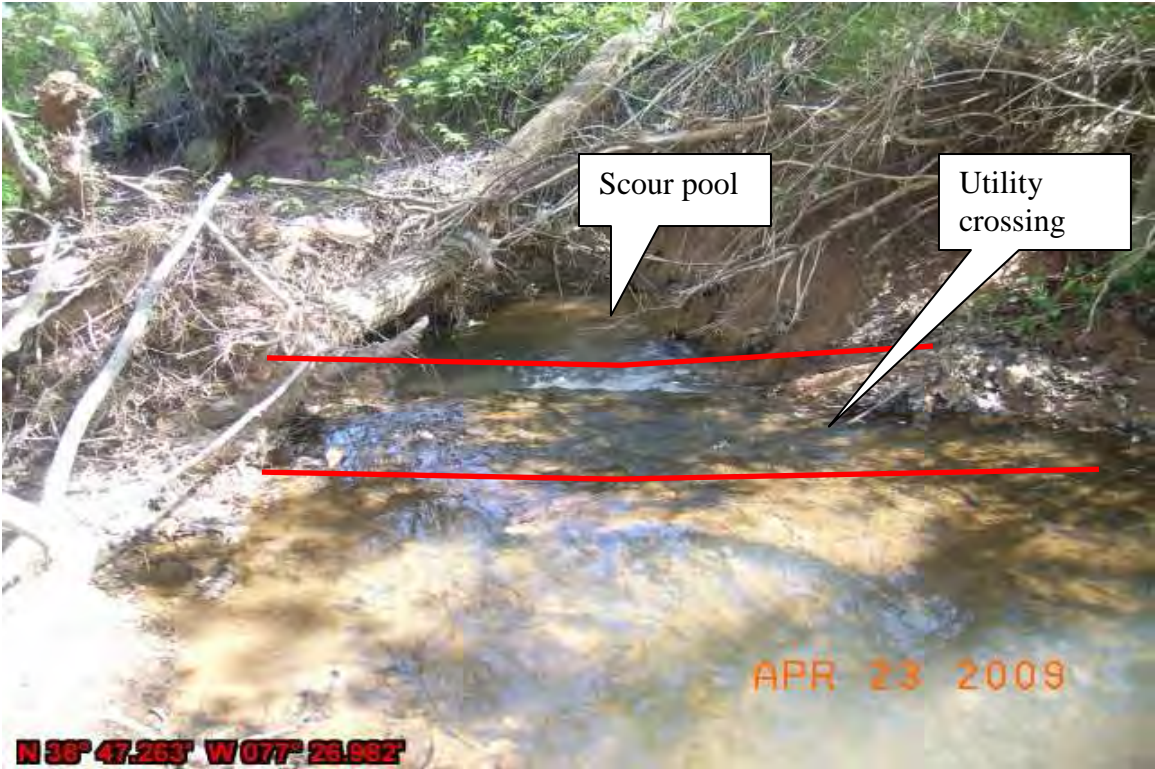
Problem Description: The stream condition assessment score for the entire reach was good, but there is a cluster of issues which warrant repair along the lower 165 feet. The riparian buffer upstream of Centerville Road has been cleared of trees and shrubs. An exposed utility crossing (Y3-U1) has created a large scour pool causing stream bank slumping downstream of the utility crossing. Ditch (Y3-D1) has been filled with woody debris restricting the drainage to the receiving channel.

Photo 1: Utility crossing scour on downstream side

Project Description: The project would stabilize a utility crossing, address bank erosion, and enhance the riparian zone. The condition of the utility crossing and scour pool would be evaluated and a stabilized grade control provided to prevent damage to the utility and excessive scour. The eroded banks would be stabilized and a riparian vegetation plan developed to control invasives and plant woody species.

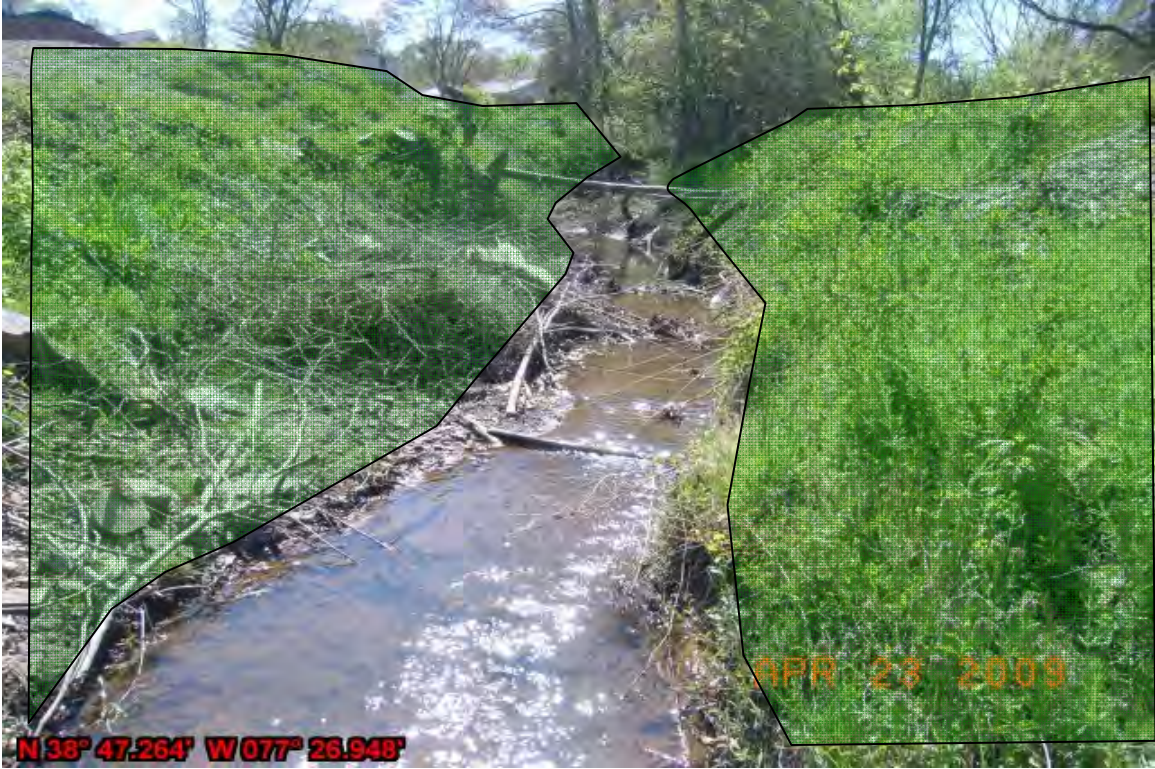
Photo 2: Re-establish buffer with woody vegetation

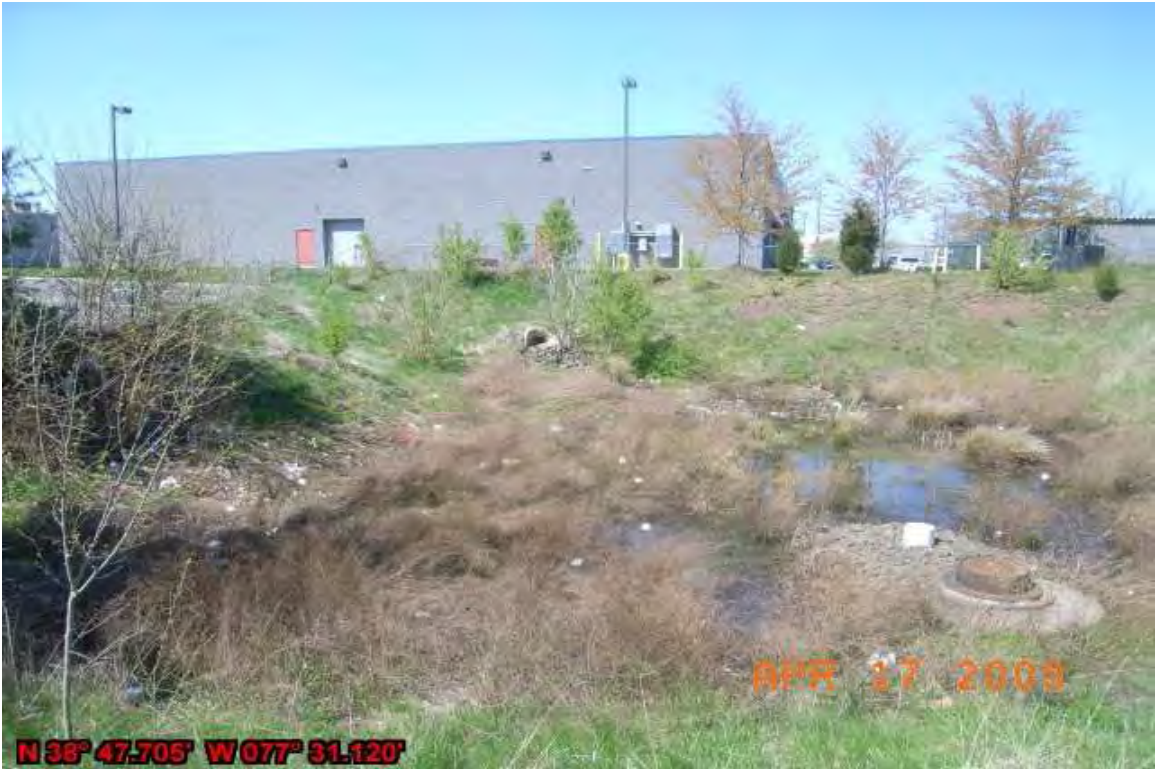
Problem Description: Approximately 4 acres of highly impervious drainage discharges into the stormwater facility. Instead of the 36 inch riser reported in the county's stormwater facility inventory, field inspection identified a 12" PCV pipe that is filled with stone. The riser is clearly undersized and there is no emergency spillway. It is enclosed by a fence that is damaged and has not been maintained. There are rack lines along the southern fence line and erosion on the southern berm; indicating that the facility is actively over topping. In addition the road downstream of the berm is damaged from the apparent overtopping. Upon discussion with an employee in the area it was discovered the facility had overtopped at least once within 4 months of the inspection. Maintenance is poor in part due to lack of equipment access into the facility.

Potential Benefits: This stormwater facility is the most deficient observed in this study. Addressing the immediate safety issues is the primary benefit of this project. The re-design would improve the ability to maintain the site. There would not be significant improvements in water quantity or quality controls.

Photo 1: Showing lack of maintenance and inadequate riser

Project Description: The design of this facility would include an evaluation of the drainage area, required water quantity and quality volume, the design of an adequate rise structure, and an evaluation of the damaged berm. The design would provide an emergency spillway or riser sufficiently sized to act as the emergency spillway. Equipment access would be graded into the steep side slope to insure that the basin could be properly mowed and maintained.

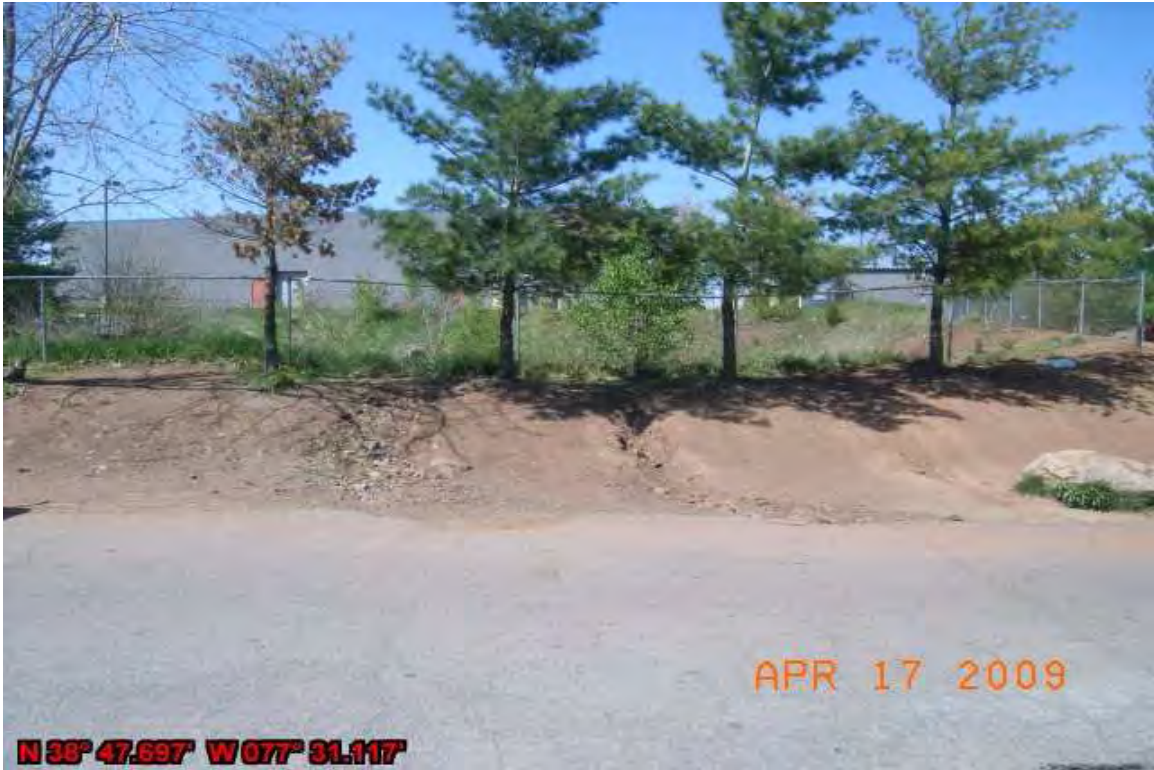
Photo 2: Erosion along backside of berm

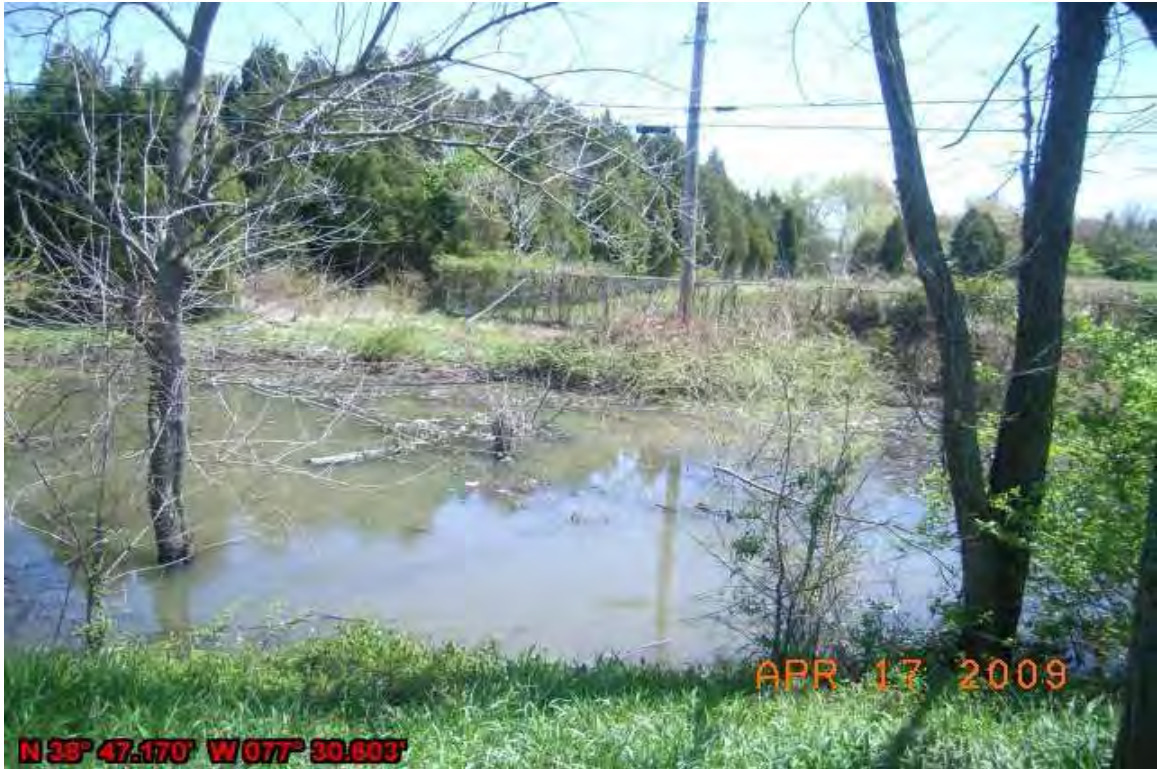
Problem Description: The study area includes a series of stormwater facilities that appear to be either undersized or not functioning to the full design capacity. Three of the facilities are included in the Prince William County inventory (5007, 166-6, & 166-3) and two existing facilities were identified during field inspections (166-2 & 166-5). Facility 166-6 appears to be well maintained, however the riser structure appears to be of inadequate size (less than 18 inches). Stormwater facility 166-3 is well maintained, but has a manually operated shut off valve. Facility 166-2 appears to be inadequately sized and is one of the most deficient facilities inspected within this study. Stormwater facility 166-5 appears abandoned and may no longer receive flow. All five facilities are in close proximity to each other, and are located at the headwaters of a stream.

Photo 1: BMP 166-2 is a poorly functioning stormwater facility

Project Description: A full water quality and quantity evaluation is recommended for this intensely developed area. The study should include an evaluation of the existing stormwater facilities, including how they perform for water both quality and quantity. The study would identify the optimal design approach to correct deficiencies with facility 166-2, address the riser in 166-6, as well as the protection of existing wetlands, and possibly redevelopment of facility 166-5.

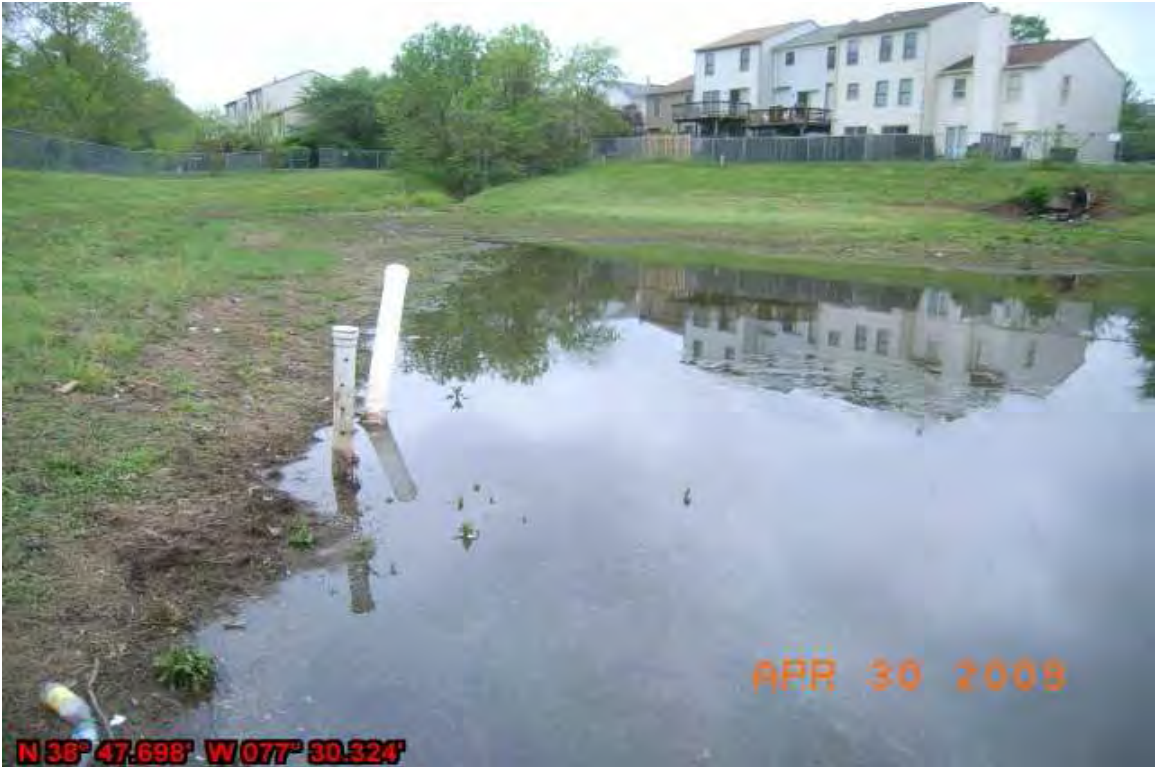
Problem Description: This dry basin was constructed in 2004 and drains approximately 13 acres of multi-family residential development. The basin appears to be routinely ponded. The low flow orifice is an 8 inch PVC pipe which is not connected to the 81 inch main riser but discharges to the receiving channel through a separate outfall. The PVC pipe is not set low enough to drain the basin and it clogs easily. One 30 inch inlet is eroding and under cutting by 2 feet. One of the inlets has a short flow path to the outlet. Shallow bedrock could be contributing to the observed ponding.

Photo 1: Low flow orifice for dry basin is clogged and not connected to riser

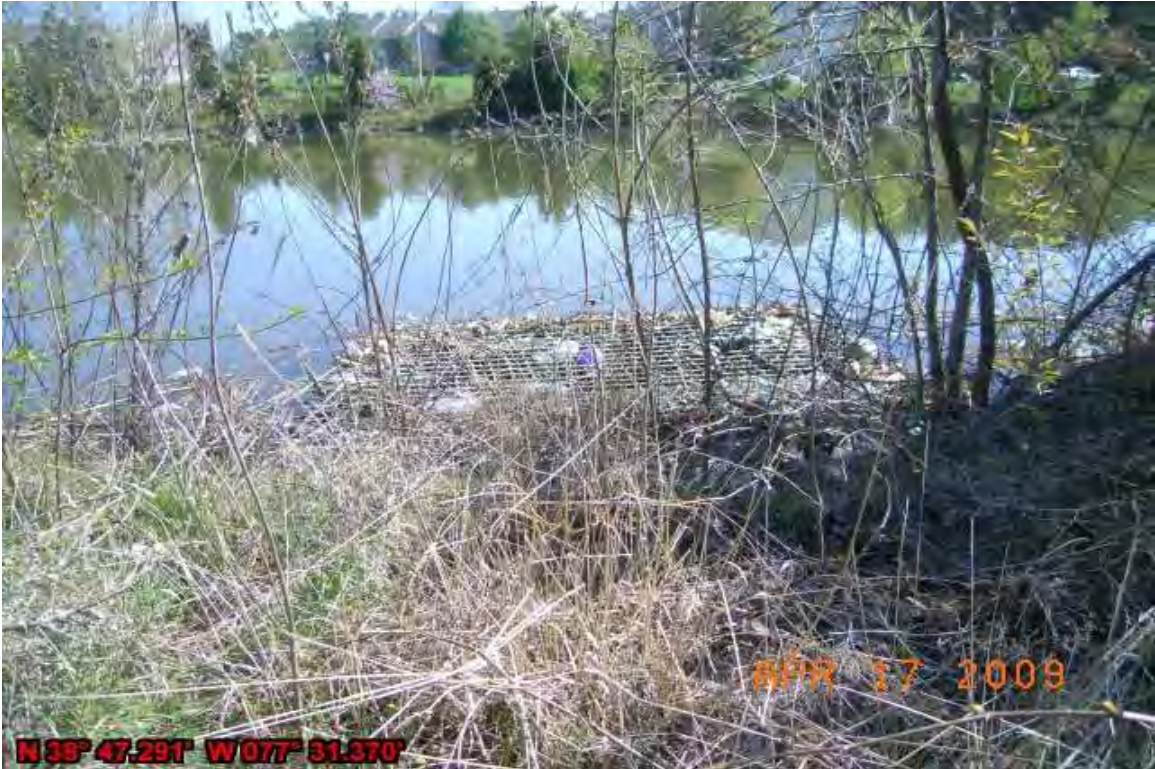
Photo 1: Existing 108 inch riser with flat debris grate

Cost Estimate: This project includes an improved trash rack and two aerators. The total project costs are estimated at approximately \$26,000. There would be long-term operation and maintenance costs associated with the aerators.

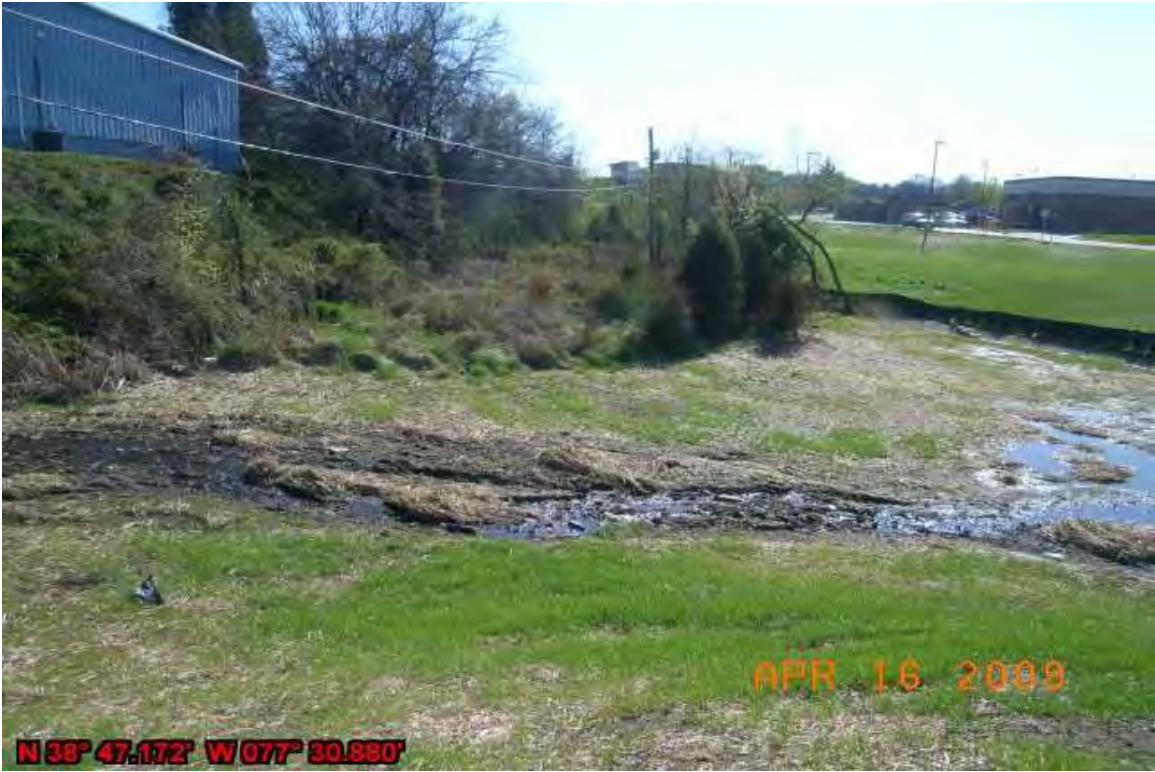
Photo 1: Outfall without adequate channel creating erosion

Cost Estimate: The estimated total cost to retrofit this outfall with a bioretention facility is approximately \$88,000 or approximately \$35,000 per impervious acre. The cost per acre is slightly above the average for this study of \$31,000 per impervious acre.

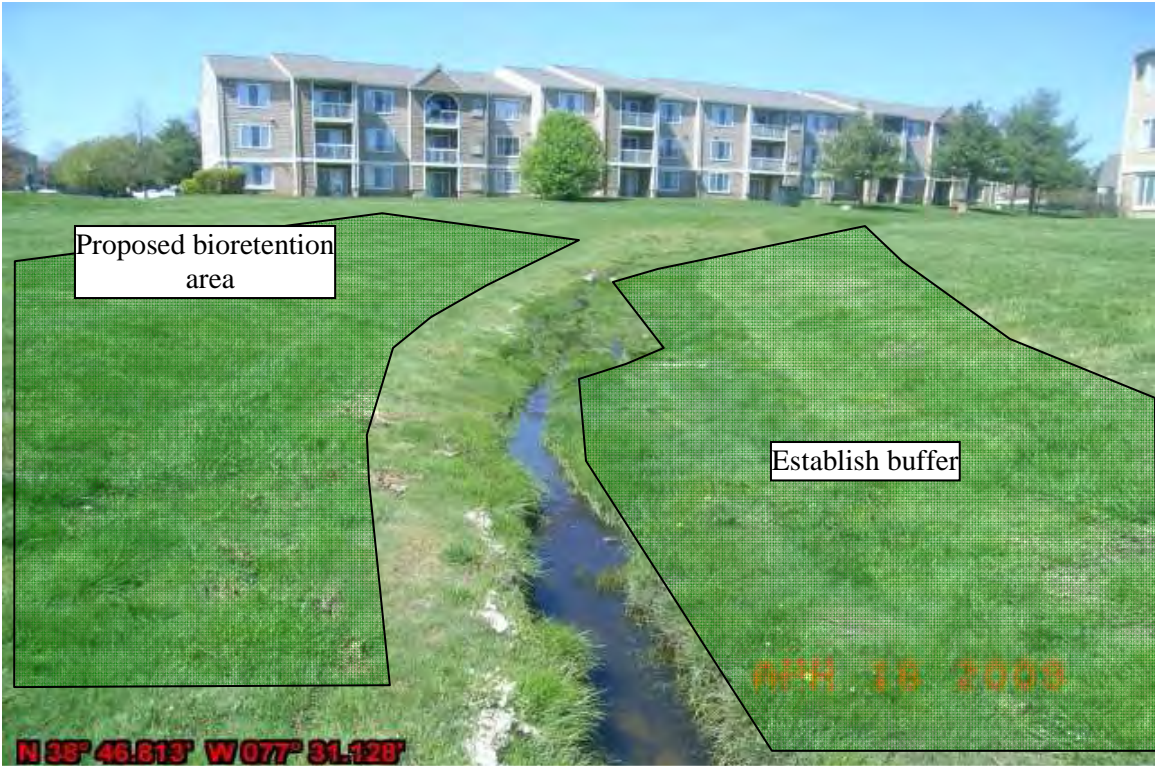
Problem Description: Approximately 28.6 acres of drainage from the apartment complex runs through two swales in an area of common property. The drainage area appears to be approximately 35% impervious without water quality or quantity control. At the confluence of the two swales, the flows run into a 134 foot paved channel, then in to a section of riprapped channel, and eventually flowing to the receiving channel within the park. The stream within the park is in fair condition. Two head cuts are actively down cutting and will eventually migrate upstream to the paved channel. L2-H1 is a moderate head cut and L2-H2 is a severe head cut with over two feet of incision. Outfall L2-P2 is blocked by accumulated sediment.

Photo 1: Drainage swale in common property would be converted to water quality BMP
