PRINCE WILLIAM COUNTY, VA
DEPARTMENT OF PUBLIC WORKS

Bull Run Watershed Study

Appendices

March 2010

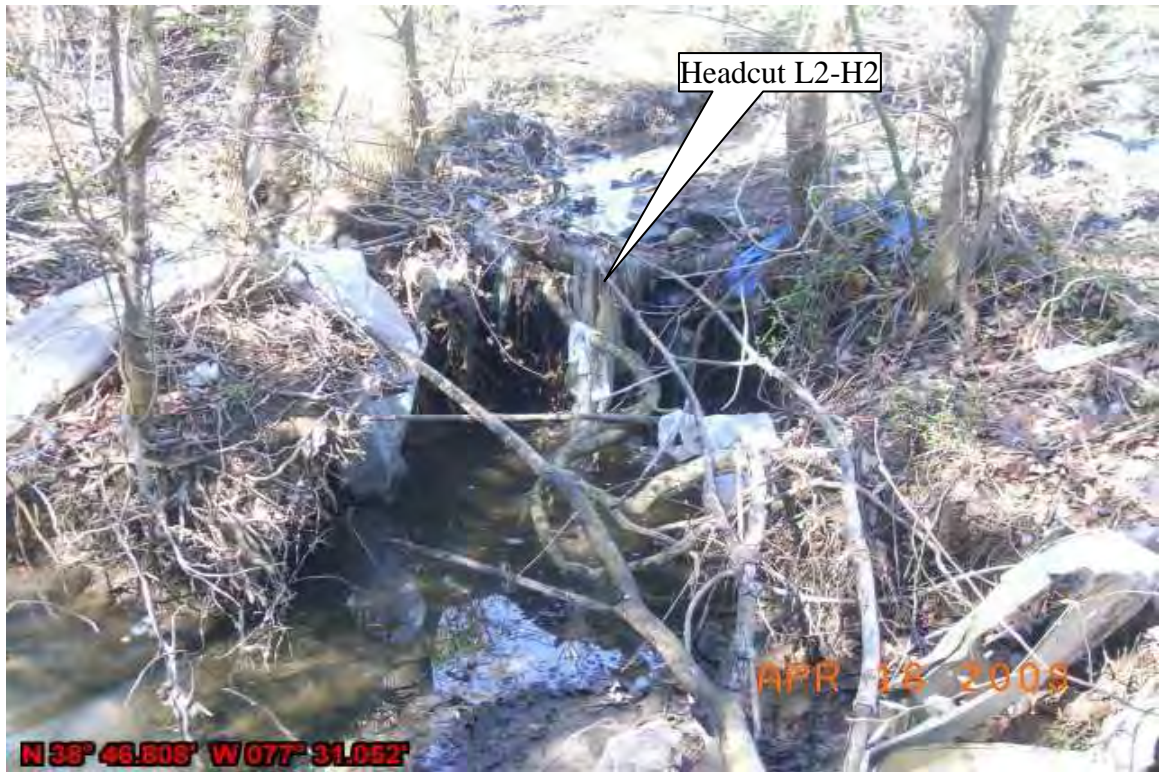
Photo 2: Headcut L2-H2 would be stabilized

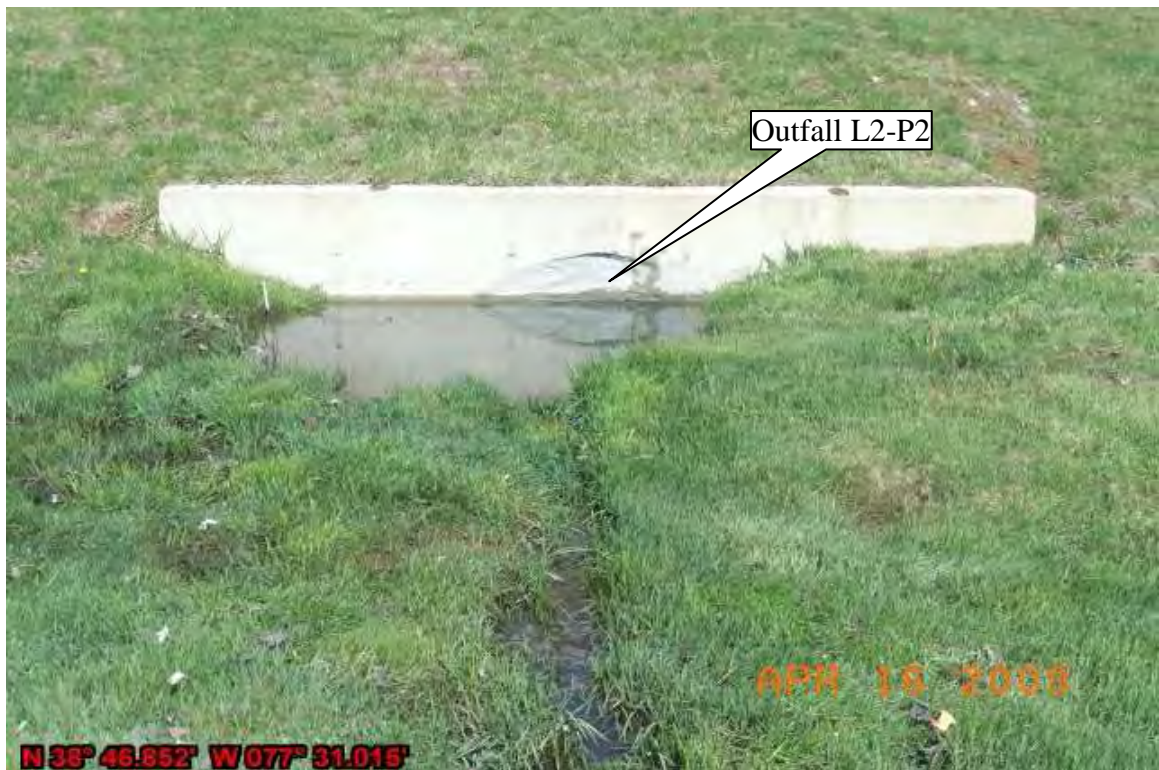
Photo 3: Outfall L2-P2 would be cleaned out

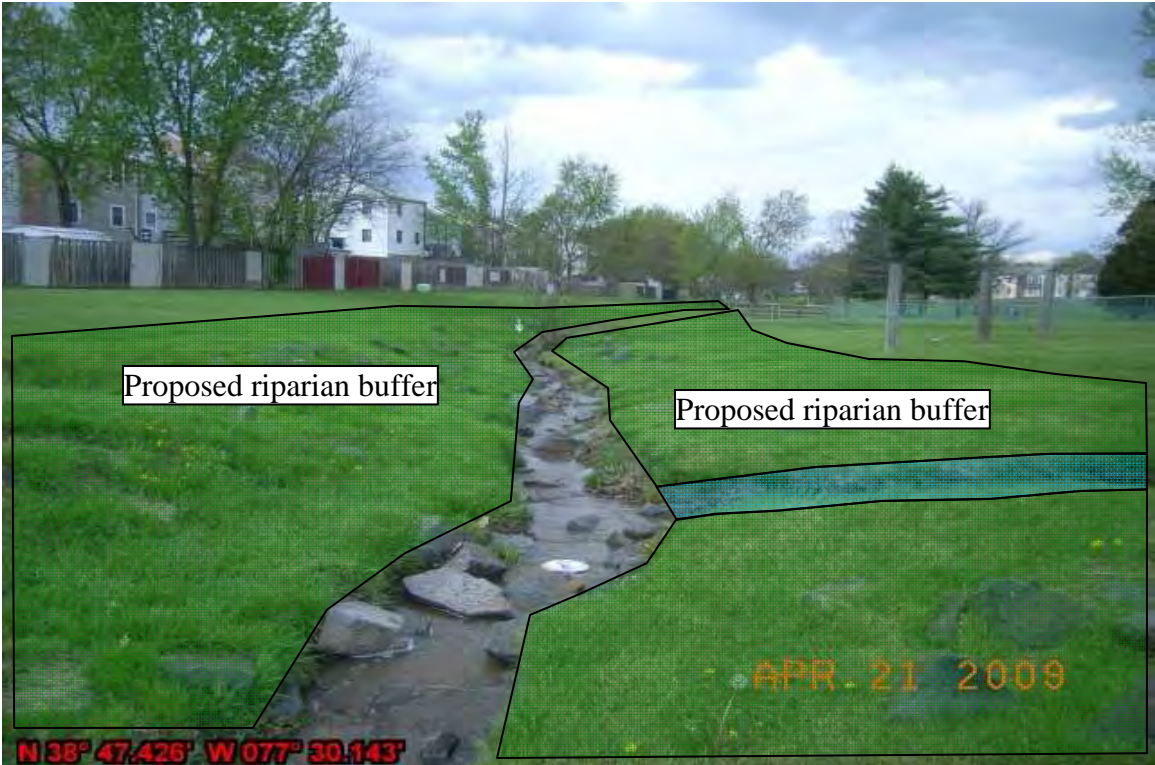
Problem Description: The stream is in fair condition. The channel does not require stabilization, but does lack a woody riparian buffer. The HOA mows the riparian buffer adjacent to the stream channel. The existing channel is lined with riprap which has limited incision and erosion. Maintaining the riparian buffer decreases the water quality and ecology for the channel. A lack of riparian buffer decreases water quality and increases stream temperature. Seven outfalls (L8-P3 to L8-P8) flow indirectly through ditches into the stream without water quality control.

Photo 1: Existing conditions with proposed buffer width

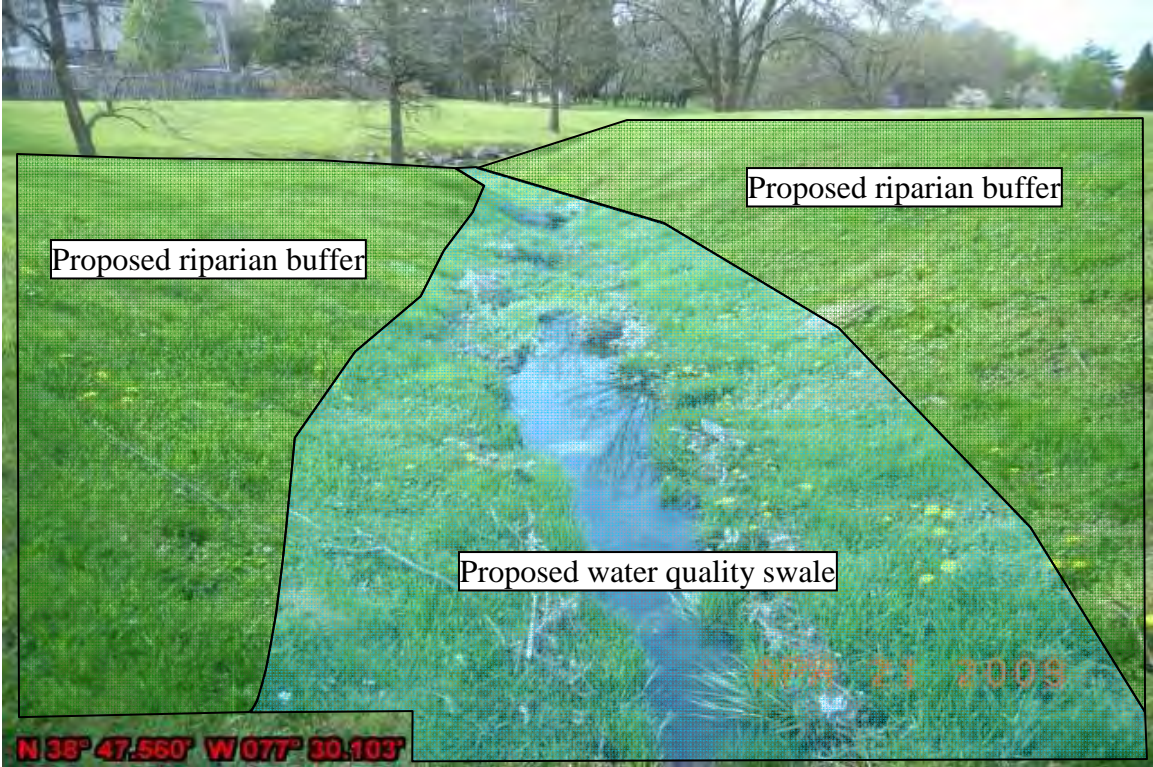
Photo 2: Existing outfall ditch to be converted to water quality swale.

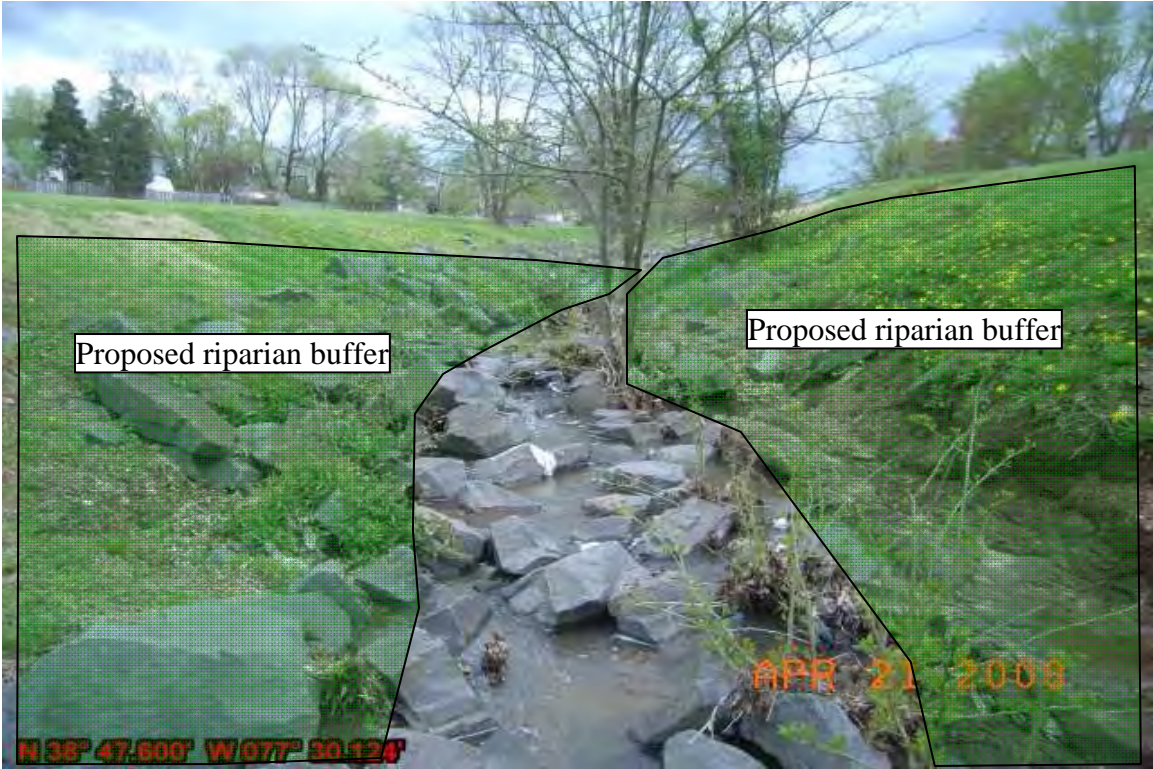
Photo 3: Lower end of channel increases in slope

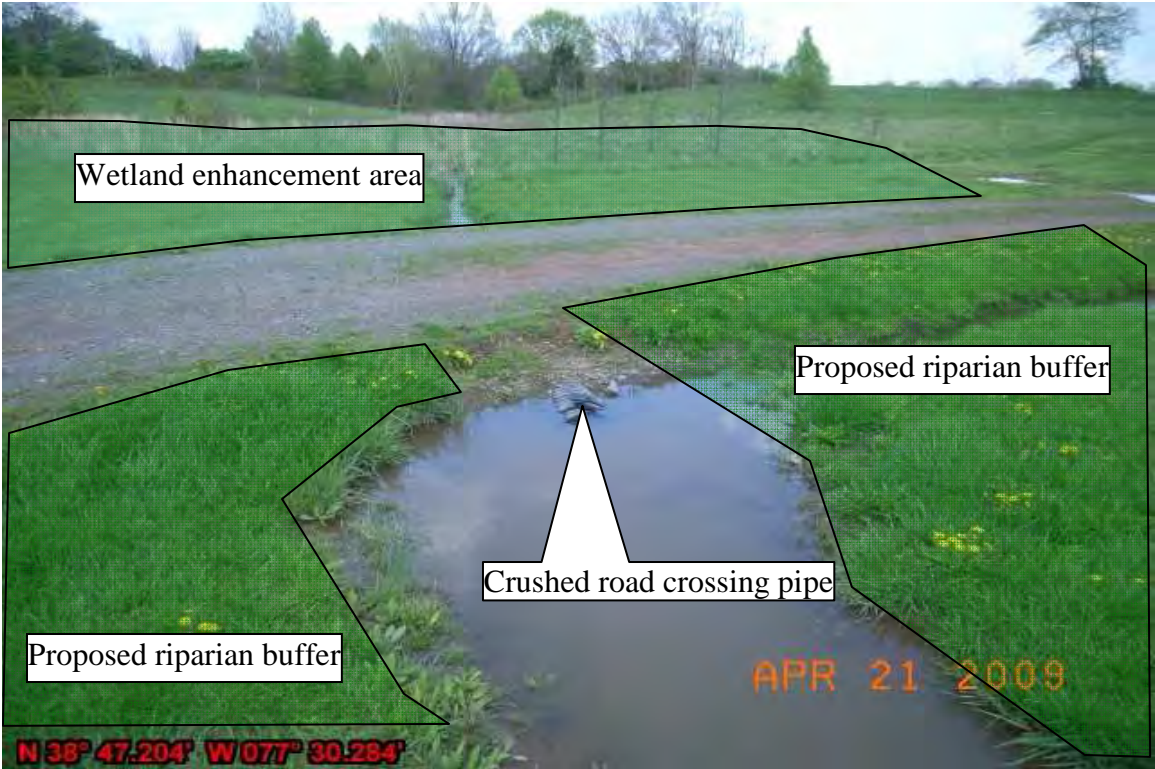
Problem Description: The school board mows the recreational/athletic fields, including the riparian buffer, adjacent to the stream channel. Outfall L7-P1 has an unidentified effluent discharge entering into the stream. The stream within this area is in fair condition. The stream flows under a roadway between recreational fields through a plastic culvert (L7-P2). This pipe is crushed and stream flow has jumped out of its original channel and cut a new channel around the pipe. Water quality and aquatic habitat are limited within the reach. Aquatic habitat throughout the reach is degraded, providing limited habitat for benthic community diversity.

Photo 1: Replacement of crushed pipe

Project Description: This project would enhance the 550 linear feet of stream corridor through the school property. A woody buffer which is compatible with the adjacent recreational fields would be designed and planted. Educational signage would be installed. A Riparian Buffer Management plan would be developed to guide school maintenance crews in proper management of the buffer. The crushed culvert pipe should be replaced. A large wetland area is present adjacent to the stream, in what appears to be the foot print of a basin or pond. This wetland should be evaluated for opportunities to improve its water quality and habitat functions. Possible improvements include wetland tree and shrub plantings, excavation of shallow marsh zones or micro-pools, and installation of nesting boxes.

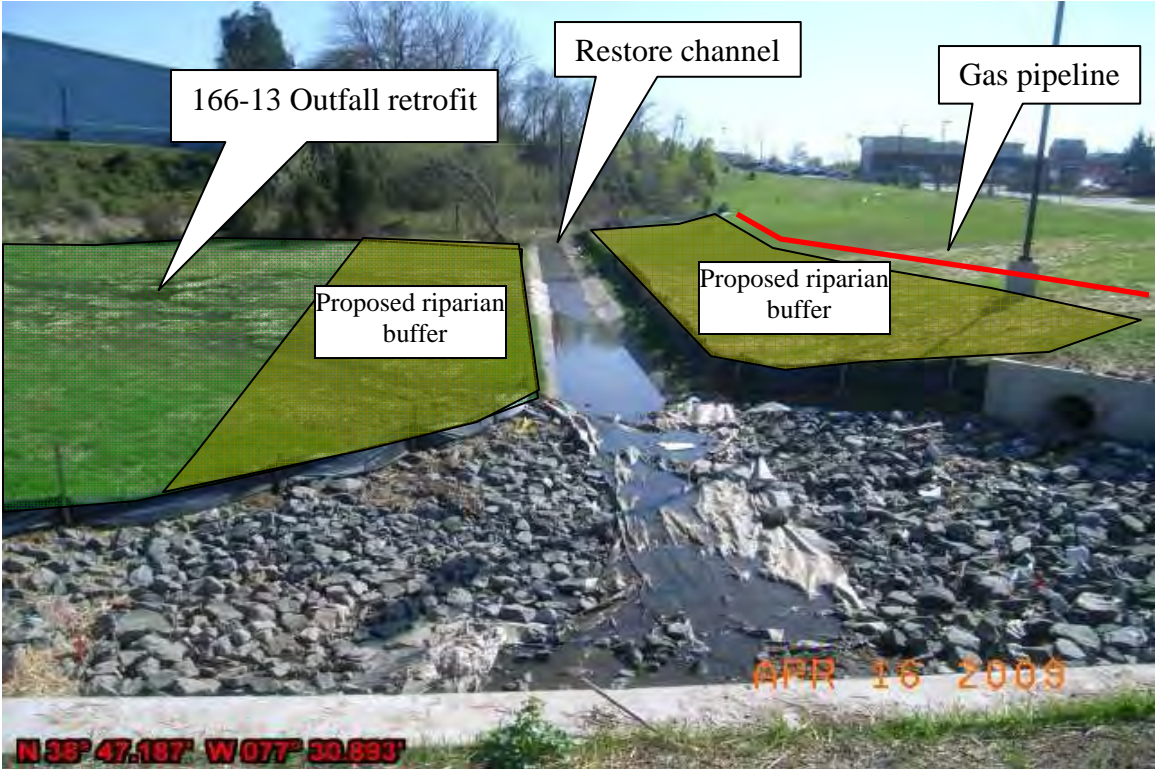
Photo 1: Remove concrete channel and add buffer

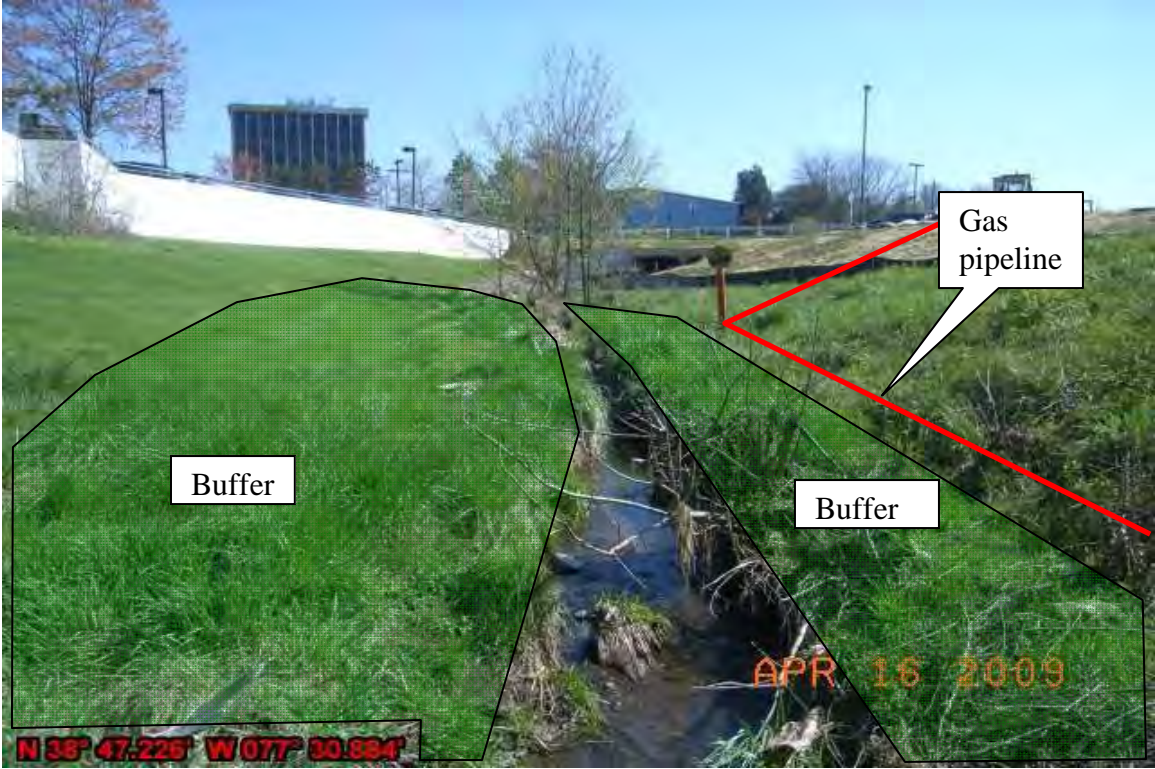
Photo 2: Downstream of recently constructed bridge with proposed buffer.
