# FARM CREEK AND MARUMSCO CREEK WATERSHED MANAGEMENT PLAN

PREPARED FOR:  
PRINCE WILLIAM COUNTY DEPARTMENT  
OF PUBLIC WORKS  
ENVIRONMENTAL SERVICES DIVISION  
WATERSHED MANAGEMENT BRANCH  
5 COUNTY COMPLEX COURT  
PRINCE WILLIAM, VIRGINIA

PREPARED BY:  
PARSONS BRINCKERHOFF  
HERNDON, VIRGINIA

DECEMBER 2009

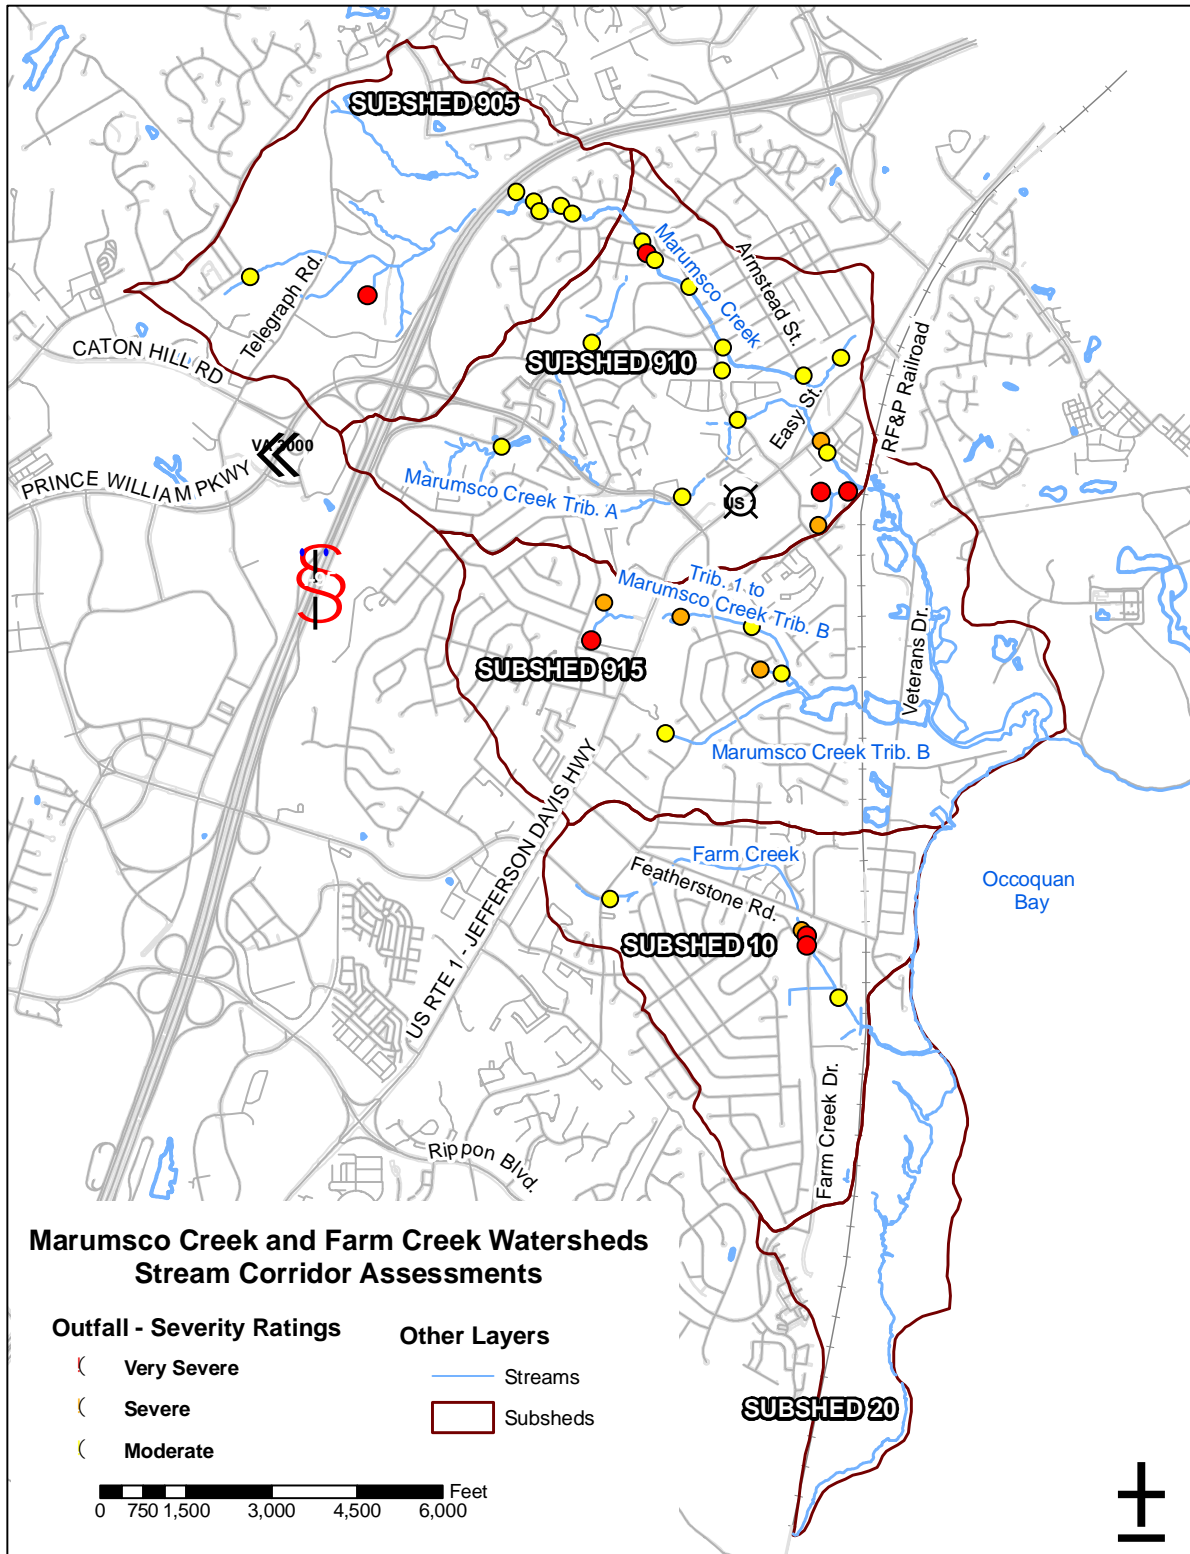
Figure 3-1: Very Severe to Moderately Severe Rated Outfall Locations with Restoration Potential

Of the 88 outfalls documented during the stream corridor assessments, 7 were considered as very severe problems (rating = 5), 6 were severe (rating = 4), and 23 were moderately severe due to the nature of the discharge. These outfalls represent opportunities for either stormwater retrofit or local stream repair/outfall stabilization. Over half of the outfalls assessed (52 out of 88) were considered as low severity or minor issues and most of these outfalls (87%) were not considered potential candidates for restoration. Figure 3-1 shows the location of outfalls that were rated as in the very severe, severe or moderate water quality problems.

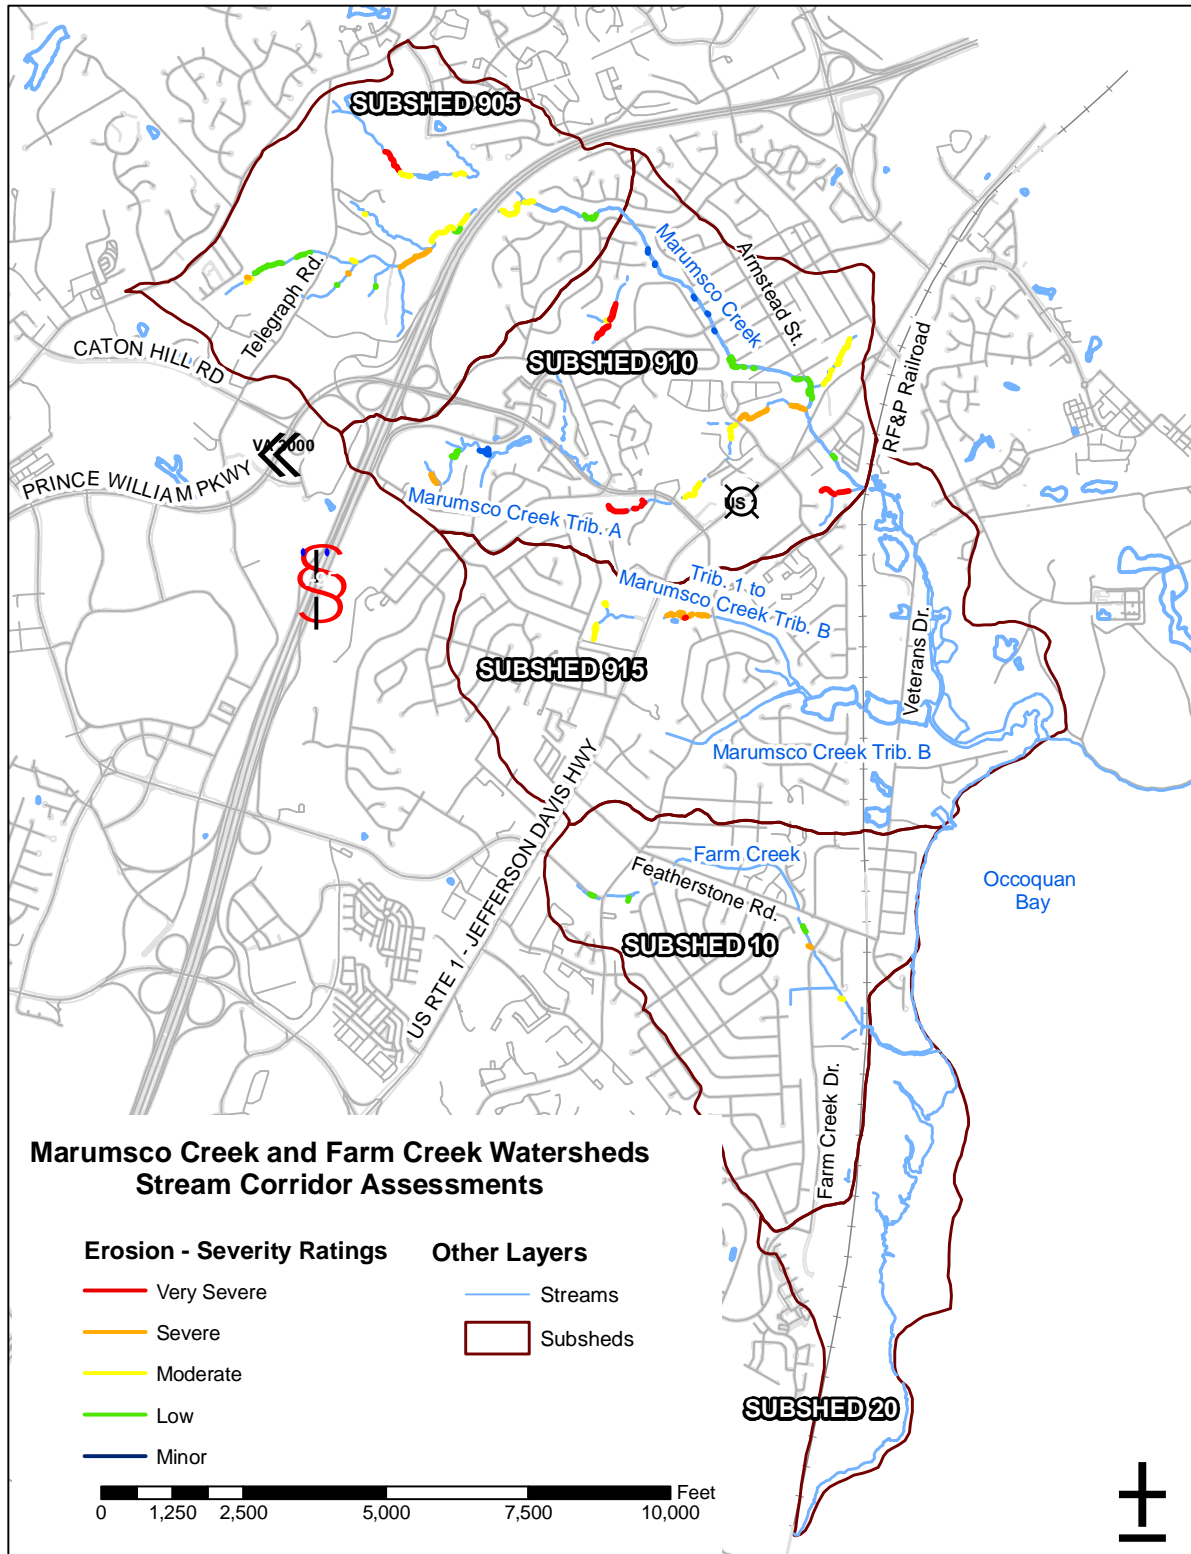
Figure 3-2: Erosion Site Locations

Erosion sites observed total 11,445 feet (2.2 miles) of stream bank with bank heights ranging from 1 to 20 feet. Most erosion sites were documented as moderately severe (rating = 3) and low severity (rating = 2) problems. Location of erosion sites including severity ratings are shown in Figure 3-2.

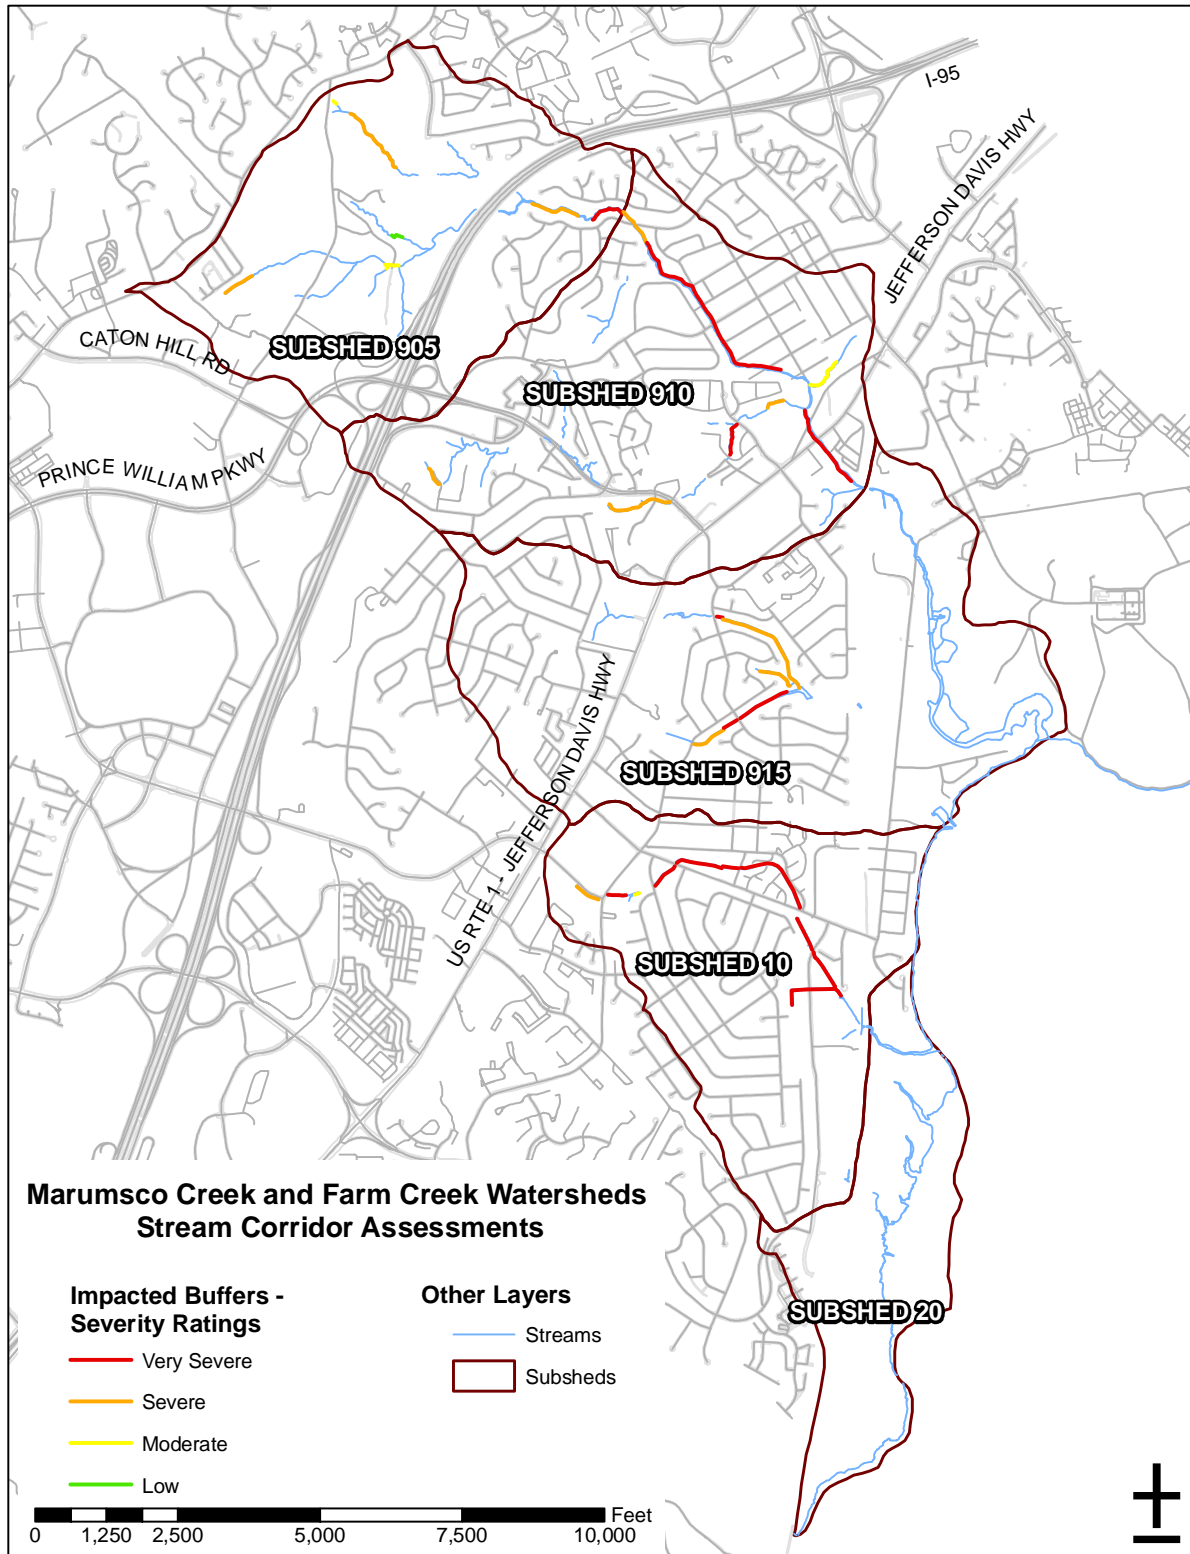
Figure 3-3: Impacted Buffer Site Locations

Impacted buffer sites observed add up to 39,960 feet (7.6 miles). Both sides of the stream corridor were lacking adequate buffers for all but four of these sites. Most of the impacted buffer sites (20 out of 29 sites) were flagged because they were too narrow (i.e., less than 25-feet wide). The remaining sites were identified as impacted buffers due to a lack of vegetation or widespread invasive plants. Most of the sites assessed (24 out of 29) were considered as very severe or severe stream buffer problems. Location of impacted buffer sites including severity ratings are shown in Figure 3-3.

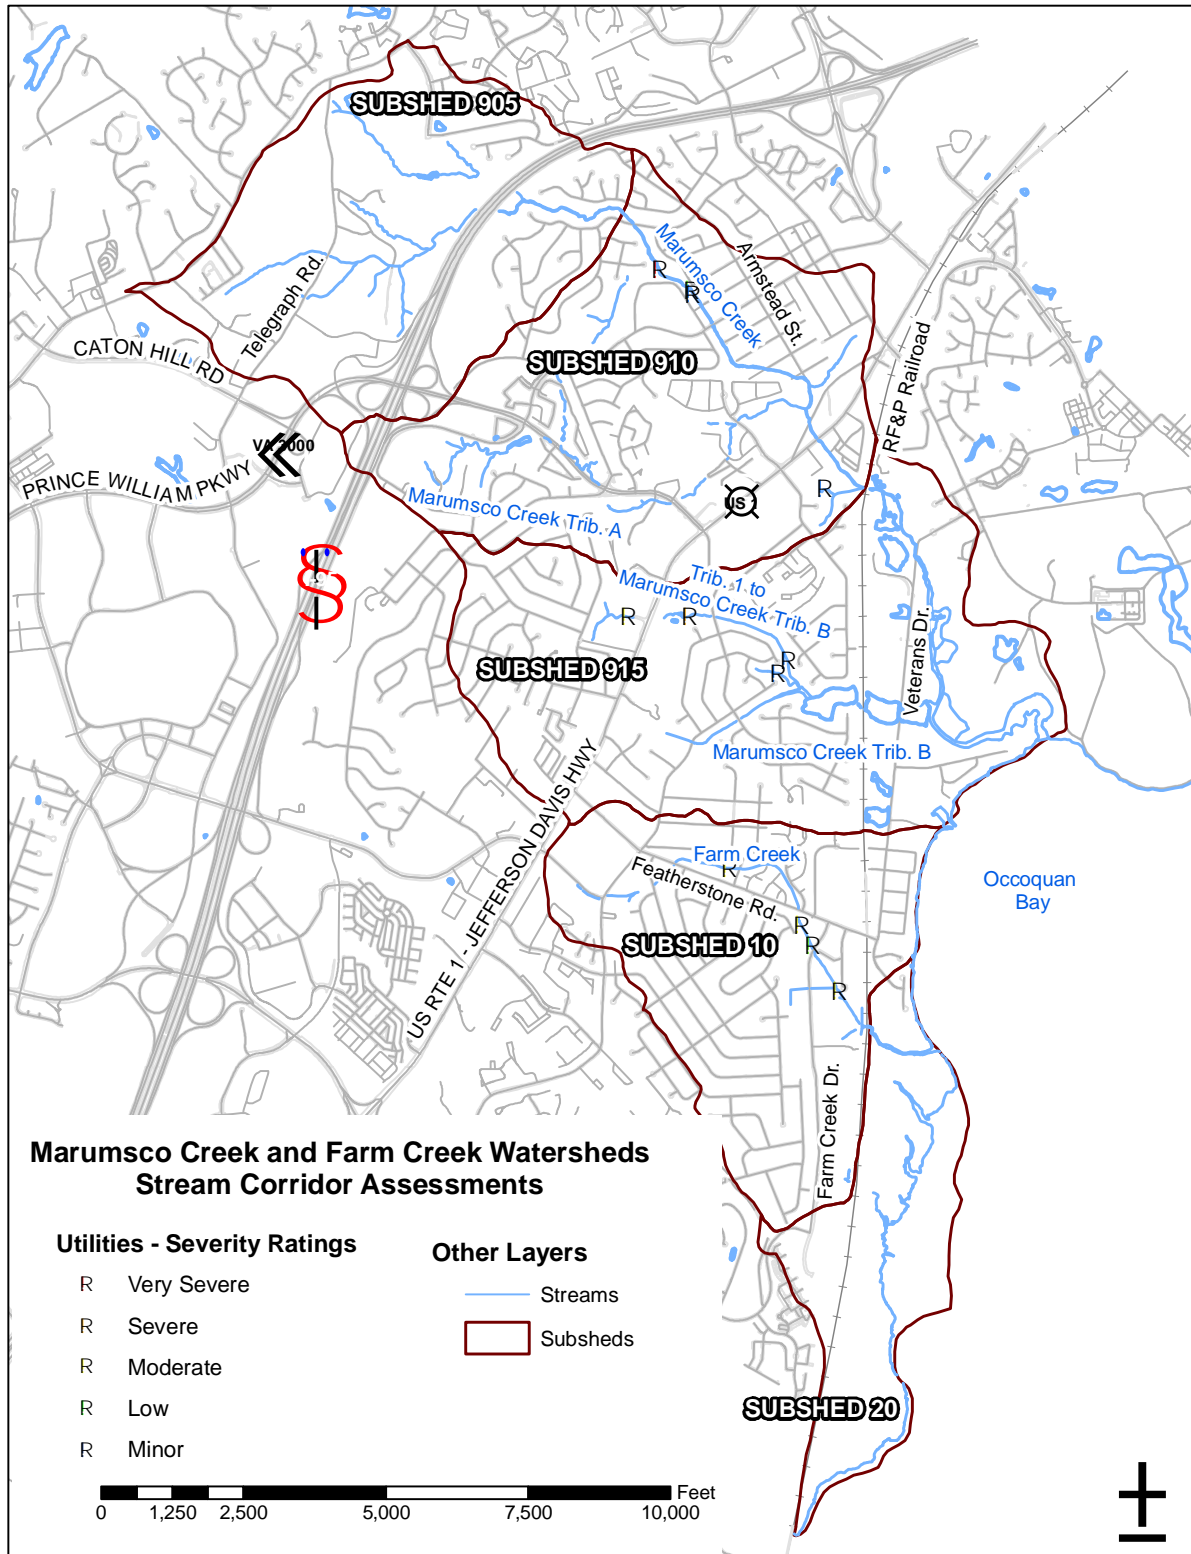
Figure 3-4: Utility Impact Site Locations

Half of the utility crossing sites (6 out of 12) were rated as very severe to moderately severe water quality problems. Location of utility impact sites including severity ratings are shown in Figure 3-4.

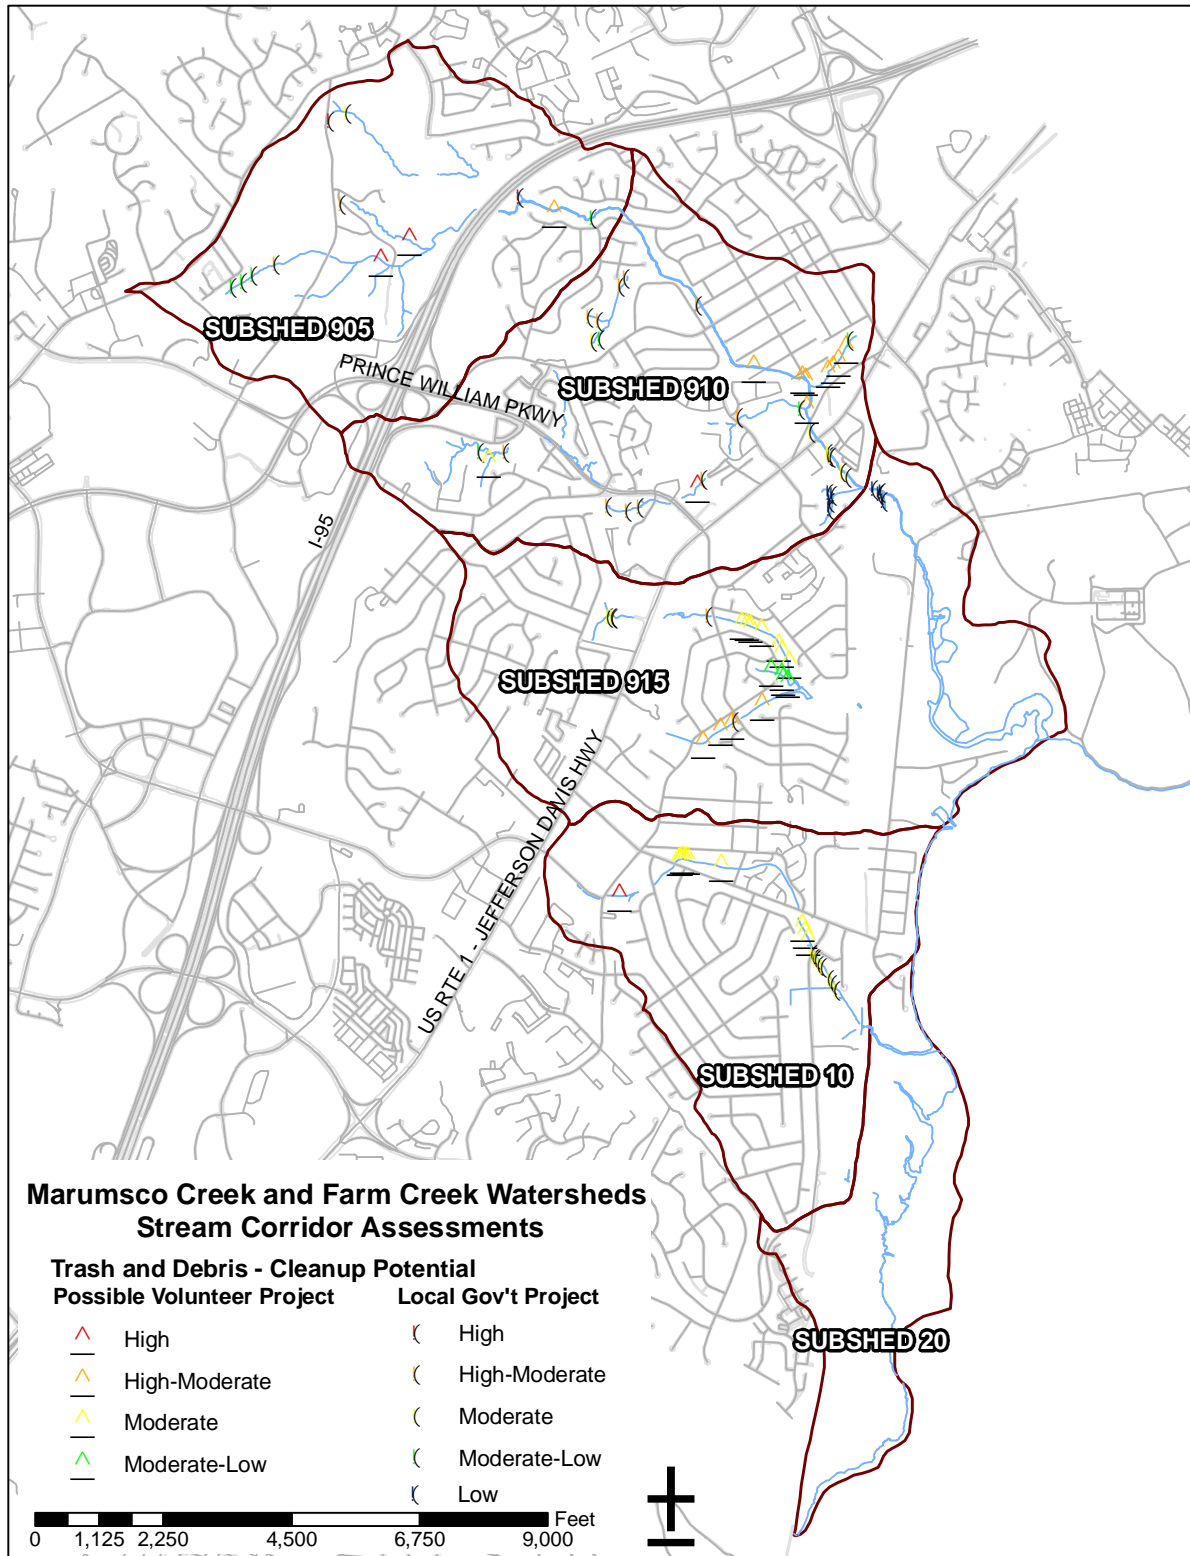
Figure 3-5: Trash and Debris Site Locations

The field team estimated that a total of 163 pick-up truck loads would be necessary to clean up all 29 trash and debris sites. Volunteers or local government were identified as the potential cleanup team for all of the sites identified. Most trash and debris sites were considered as moderate to low severity issues. Location of trash and debris sites including severity ratings and possible volunteer projects (see Chapter 4) are shown in Figure 3-5.

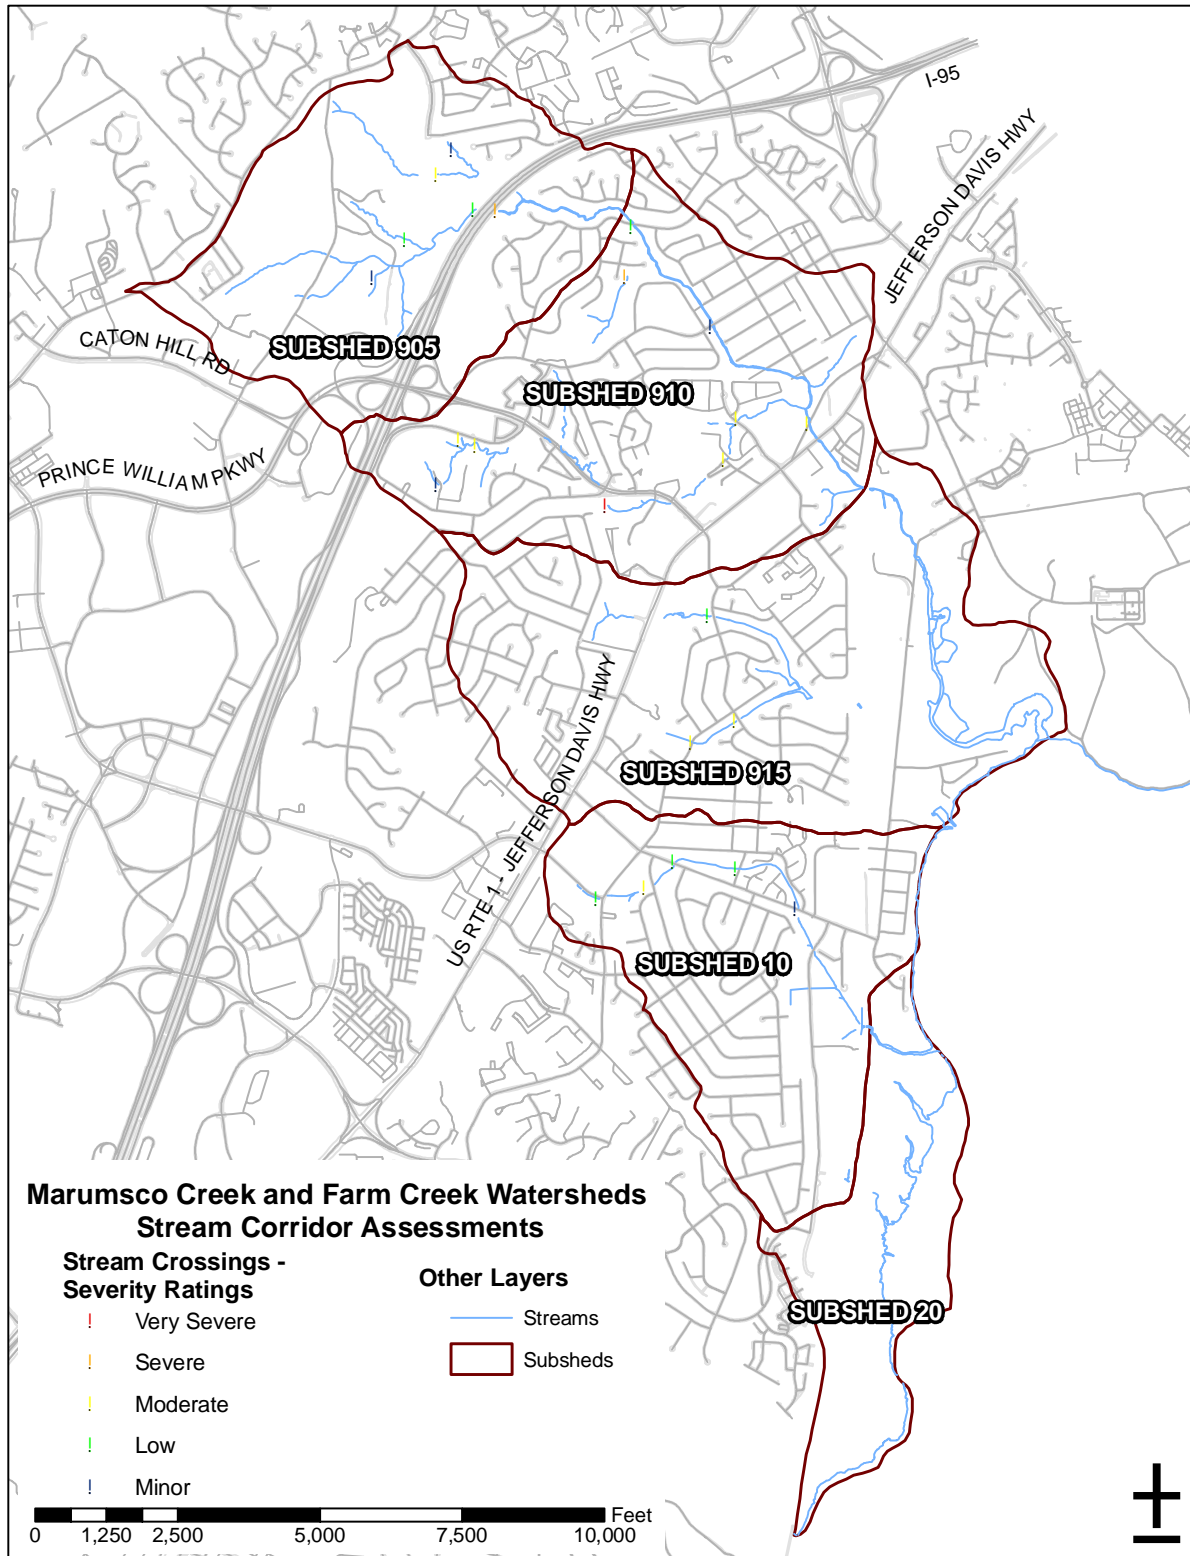
Figure 3-6: Stream Crossing Site Locations

Half of the stream crossing sites (12 out of 24) were rated as very severe to moderately severe water quality problems. Restoration opportunities were limited for most of these sites. Location of stream crossing sites including severity ratings are shown in Figure 3-6.

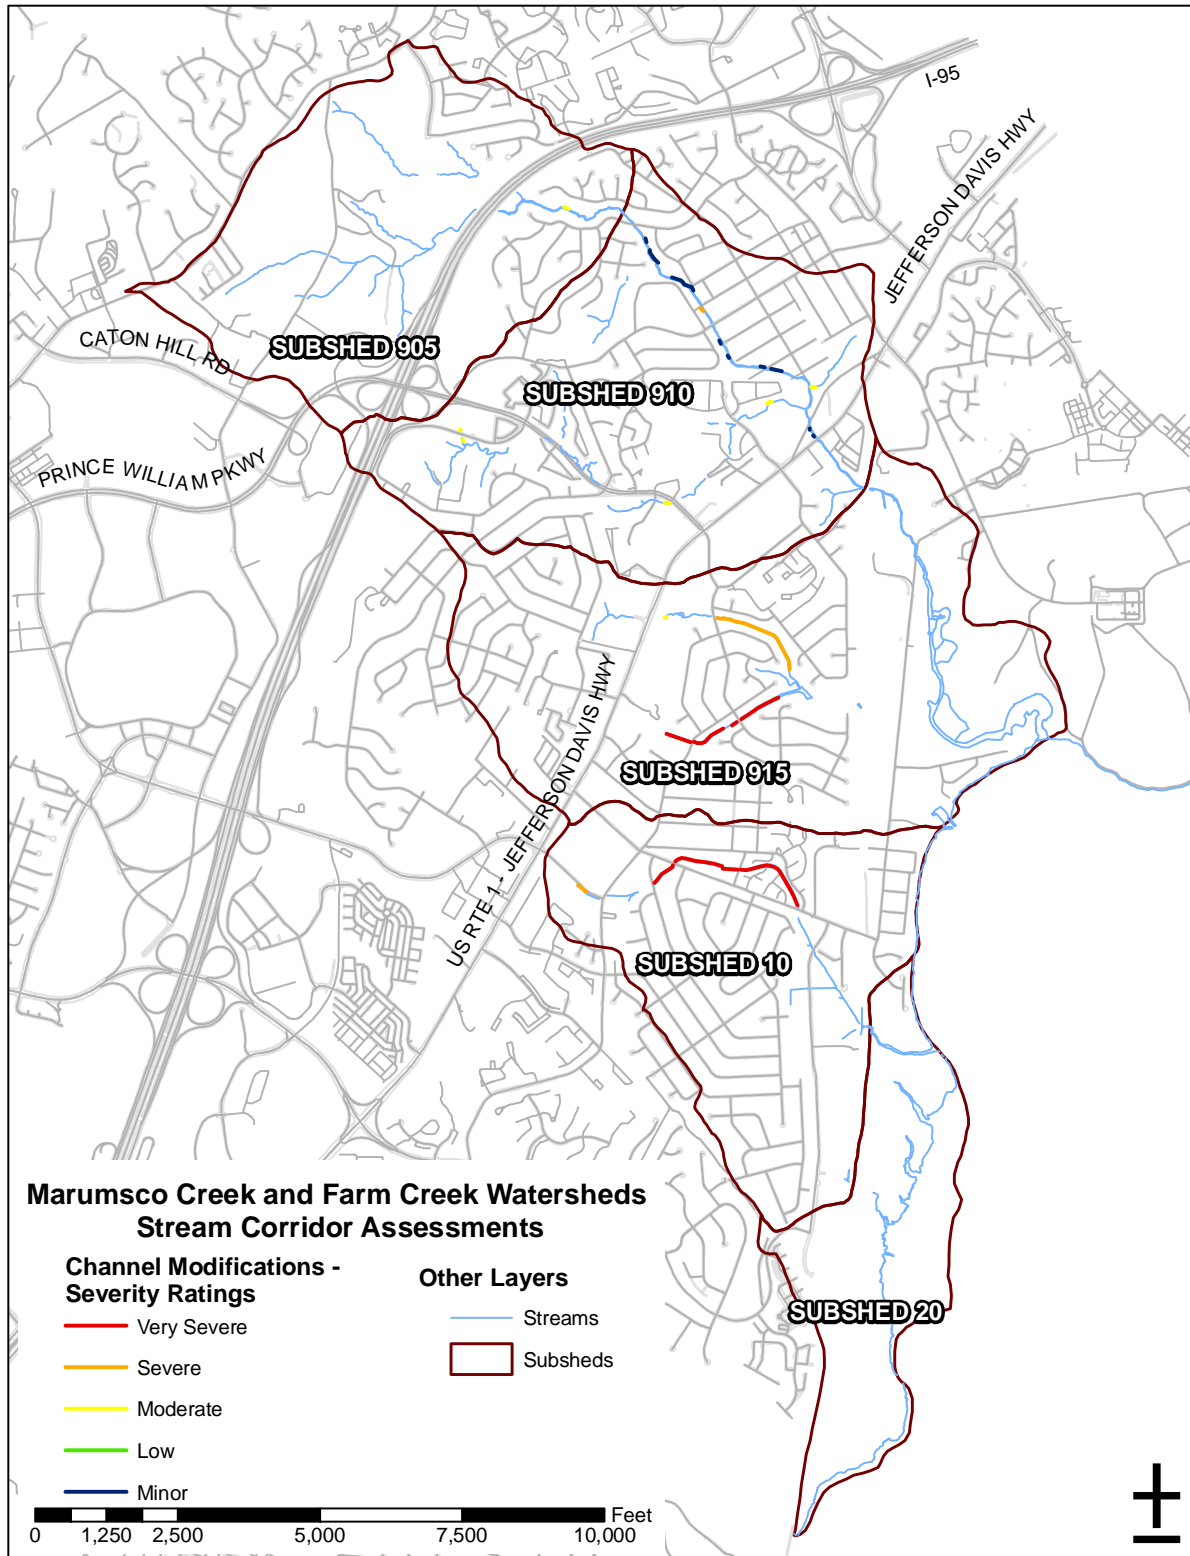
Figure 3-7: Channel Modification Site Locations

Most of the channel modification sites (15 out of 20) were rated as very severe to moderately severe water quality problems. Location of channel modification sites including severity ratings are shown in Figure 3-7.

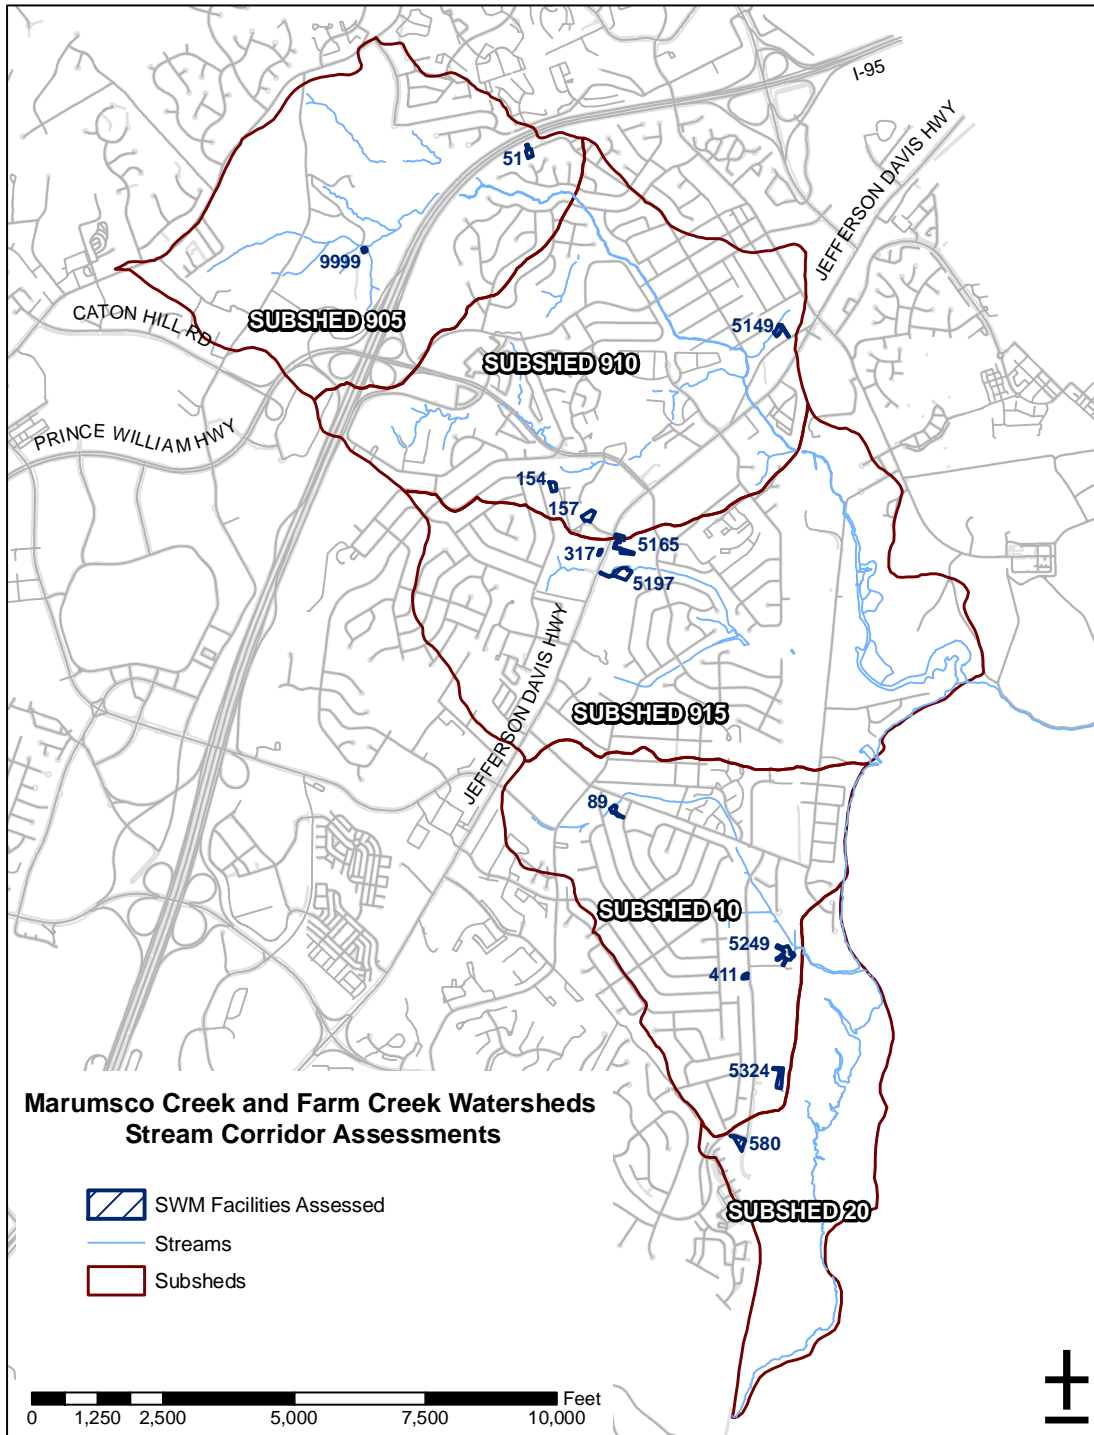
Figure 3-8: SWM Facility Survey Locations

Of the 29 existing SWM facilities, there are 17 dry and 4 wet detention ponds. These types of facilities have the potential for water quality retrofit which may include conversion to an extended detention facility, structural repair/improvement, re-vegetation or enhancement, and/or maintenance. The field team inspected a total of 12 existing SWM facilities (ponds) to identify water quality retrofit opportunities. Facilities were identified for investigation by a GIS-based, pre-screening analysis. The pre-screening was used to identify BMPs in older developments that would have a higher potential for maintenance or retrofit opportunities. The pre-screening identified 13 BMP sites for inspection of which the field team was only able to adequately access 12 of the site for a detailed investigation. For each facility, the field team documented the type of stormwater pond and pretreatment facility. The team also rated the condition of various components of the facilities on a scale of 0 (good) to 3 (serious), where 0 denotes a well maintained facility with no action required and 3 denotes an immediate need for repair or replacement. The components evaluated for pretreatment included maintenance access, trash/debris accumulation, sediment accumulation, clogging, dead vegetation/exposed soil, and erosion. Facility elements evaluated included maintenance access, sediment accumulation, water levels, pollution/hotspot runoff, vegetation and the condition of berms/embankments, risers/outlets, and low flow orifice. Outlet components assessed included stable conveyance, trash/debris/sediment accumulation, and erosion. The team also identified retrofit opportunities and noted any other considerations necessary. Most of the SWM facilities inspected (10 out of 12) were considered to have retrofit potential. Locations of surveyed SWM facilities are shown in Figure 3-8. Further discussion of SWM facility inspections, maintenance needs, and retrofit opportunities is included in Chapter 4.
