Annual Stormwater Management Report

VSMP Permit No. 0088595 – FY 2018

Submitted by:
Prince William County
Department of Public Works

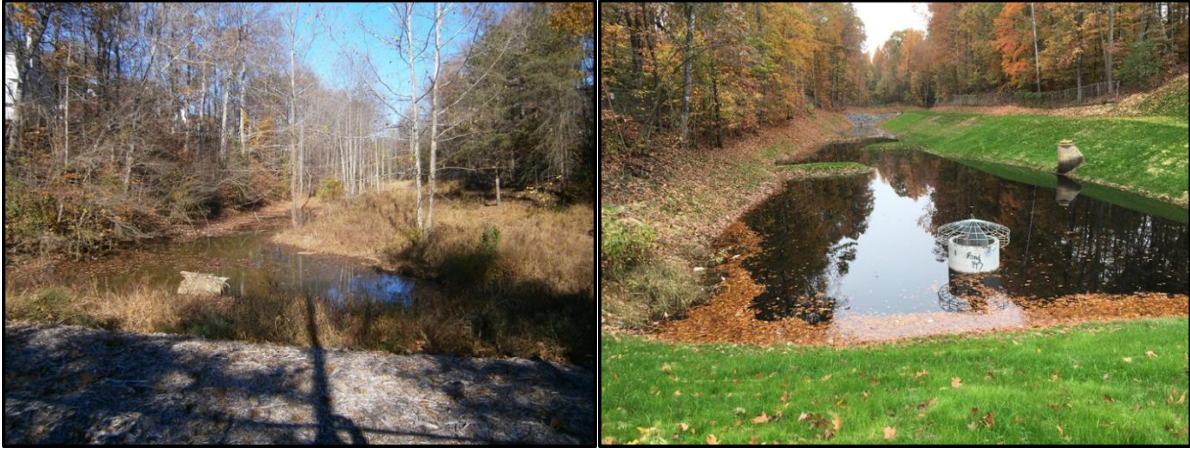
SWM Facility #147

The project entailed the retrofit of an existing dry detention facility with significant sediment accumulation and short circuiting to a level one, constructed wetland. The conversion included a new BMP structure, sediment forebay and micropool.

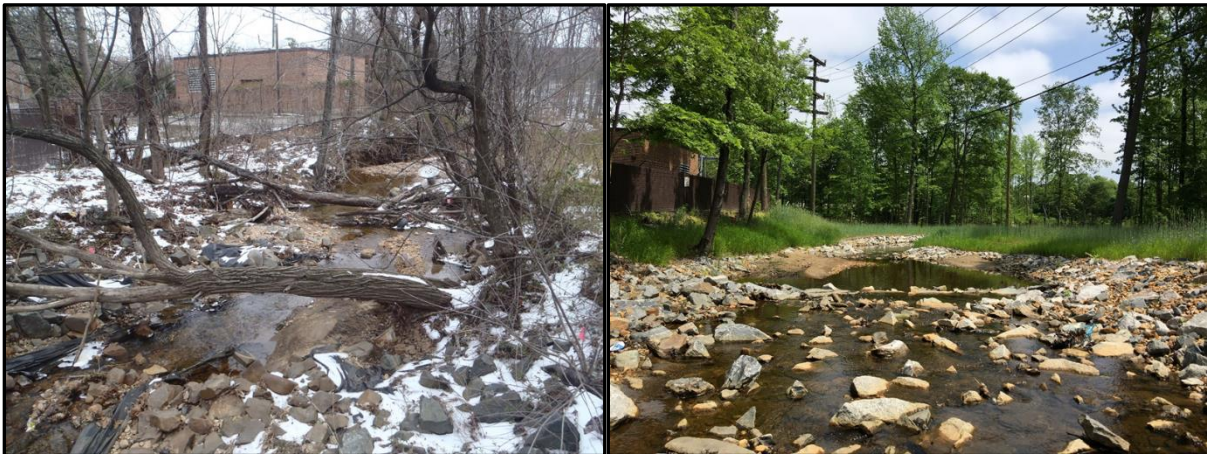
Dewey's Creek Reach 1

Reach 1 of Dewey's Creek began at Route 1 and extended 1,270 linear feet downstream. Dewey's Creek is located in the Quantico Creek watershed. The restoration followed natural channel design methodology and utilized bioengineering techniques to stabilize the channel, reduce bank erosion, provide infrastructure protection and enhance aquatic and terrestrial habitat.

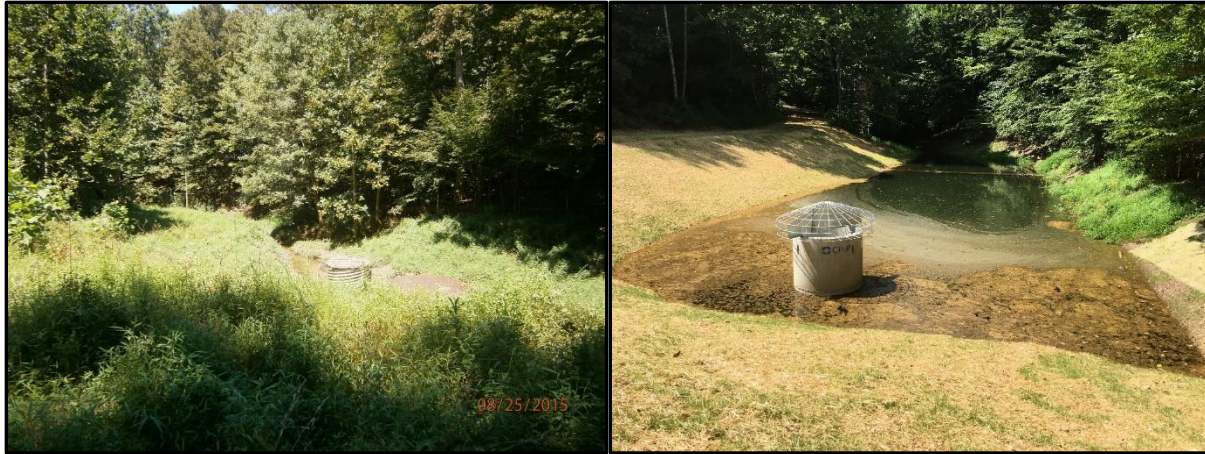
SWM Facility #109

The project entailed the retrofit of an existing dry detention facility with significant sediment accumulation and short circuiting to a level one, wet pond. The conversion included a new BMP structure, sediment forebay and micropool.

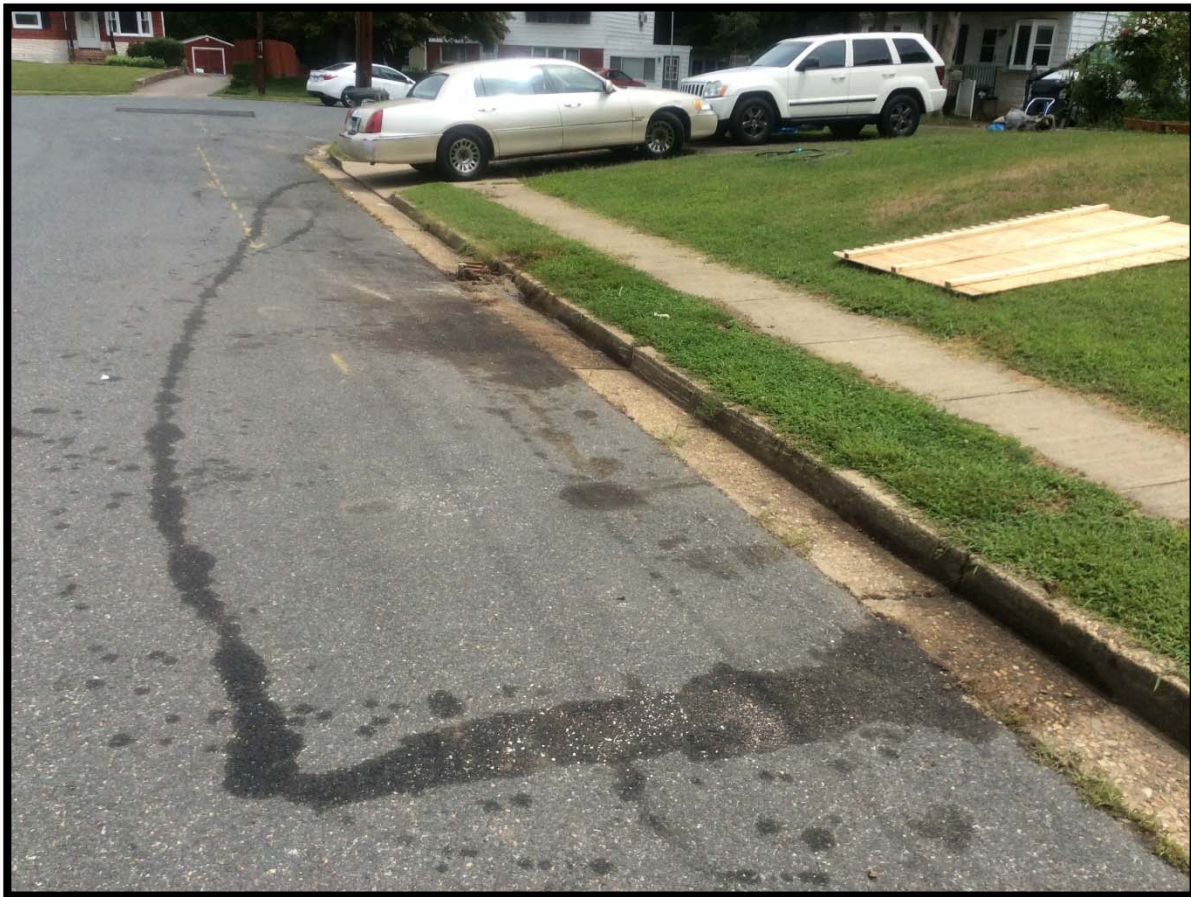
Photo of discharge:

INCIDENT INFORMATION		
Incident Report #: 7/2017-18	Date : 3/8/2017	Time : 2:45 PM
Business : Residential	Report Completed By : Prem Popudel	
Address: 1405 Colchester Rd.	City : Woodbridge, VA	Zip Code: 22191
Complain or Case Received From: PWC Watershed staff got an anonymous complaint regarding oil spill on drive way and street, potential for being washed away into storm sewer system.

pH :NA	Limit: NA	Conductivity :NA	μS/cm Limit: NA	Temp.: °F	Limit: NA
Discharge related Indicators	Odor: Other	Color: NA	Turbidity: NA		
	Floatables: NA	Stains: Oily	Other: NA

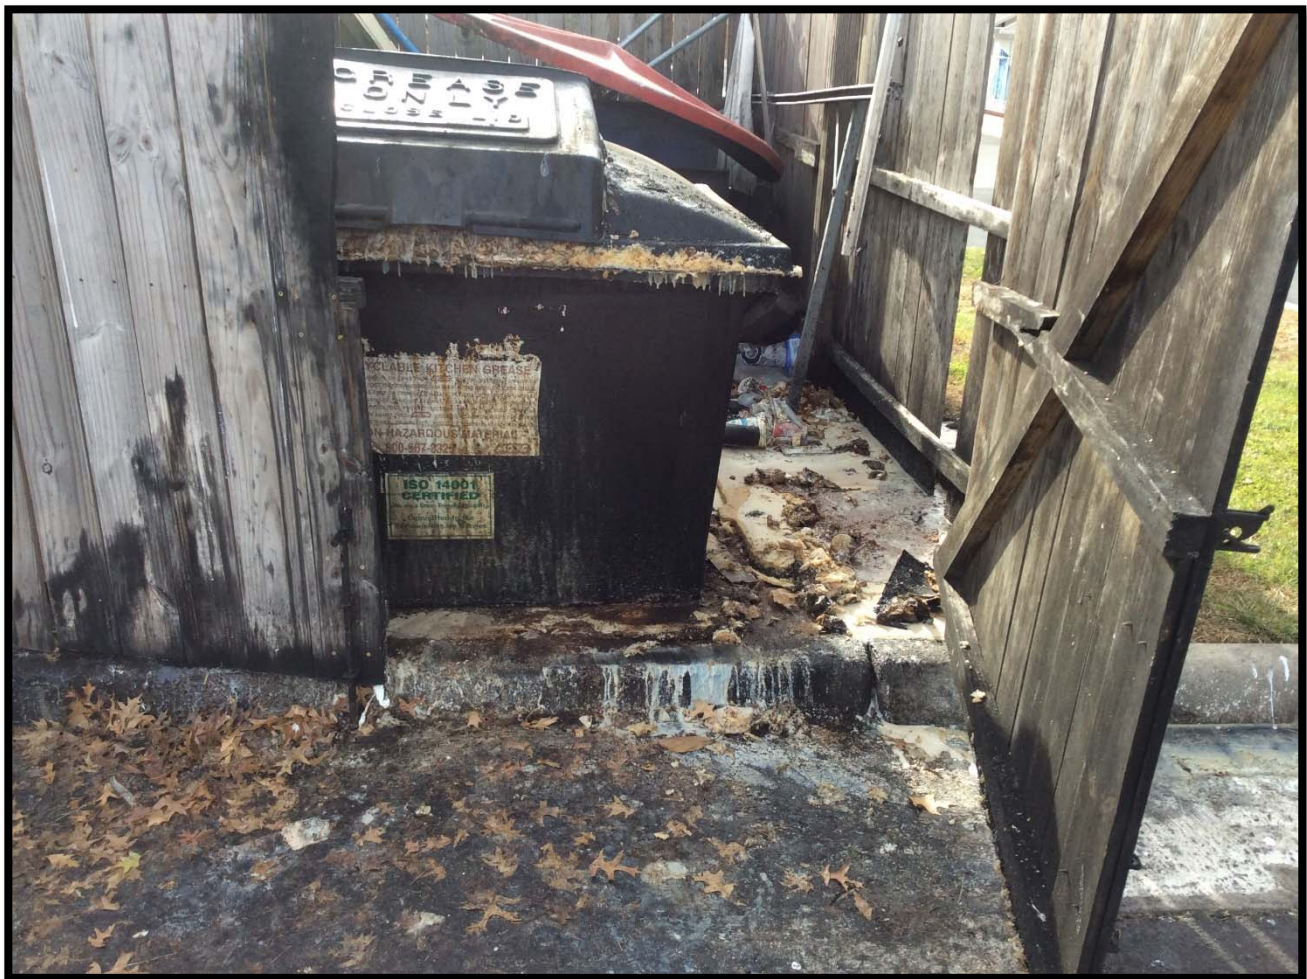
Photo of discharge:

INCIDENT INFORMATION		
Incident Report #: 36-2017/18	Date : 11/21/2017	Time : 1:30 PM
Business : Checkers	Report Completed By : Prem Poudel	
Address: 1920 Daniel Stuart Square	City : Woodbridge, VA	Zip Code: 22191
Case Detail: Noticed a black color and weed growth in the pond located at 2141 Opitz Blvd. There are various restaurants at the catchment drainage areas. Among them, spill of fat and cooking oil observed around grease collection container of Checkers Restaurant and flowing mark was observed towards storm sewer system.

PH: NA Limit NA	Conductivity (µS/cm): NA Limit:NA	Temp.: °F Limit: NA
Discharge related Indicators	Odor: NA	Color: NA
	Floatables: NA	Stains: Oily
		Turbidity: NA
		Deposits: Debris

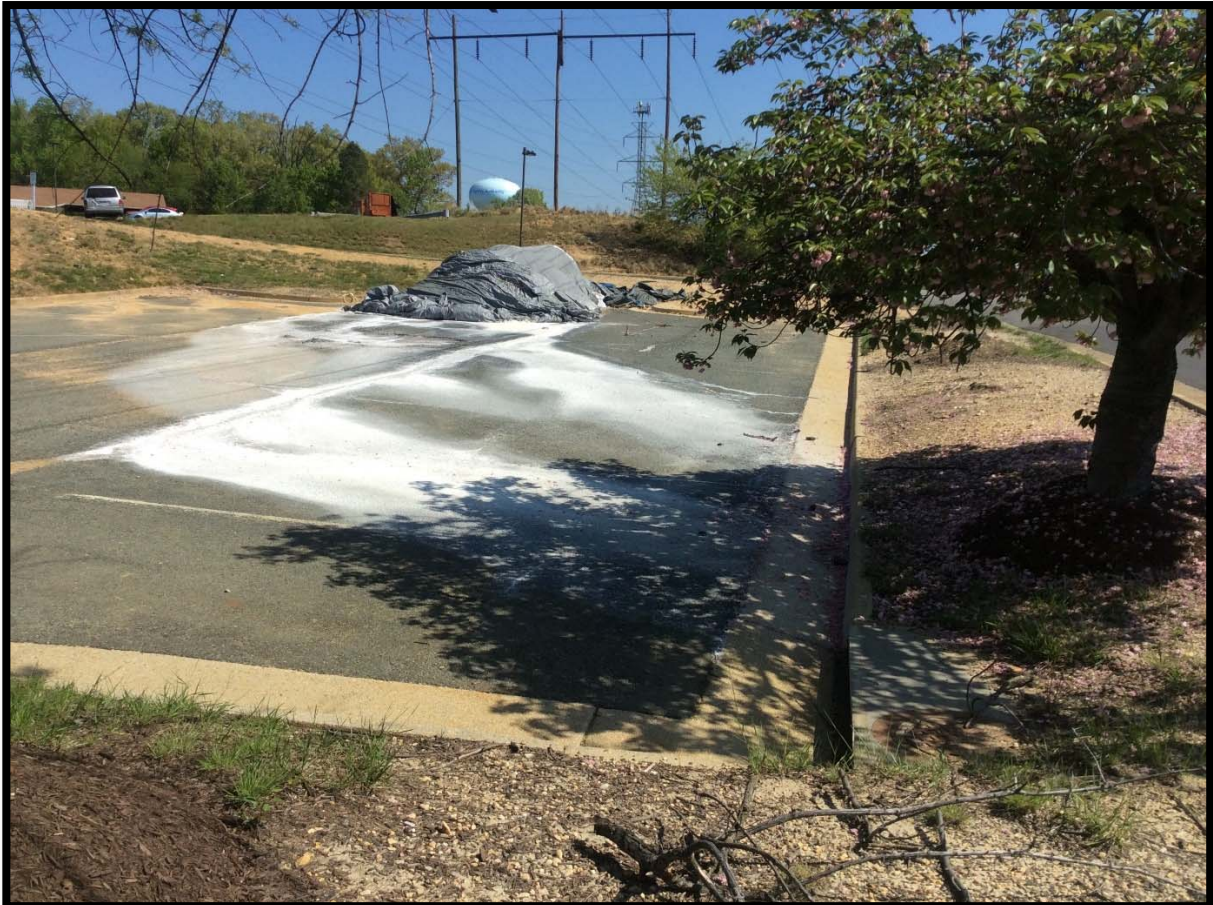
Photo of discharge:

INCIDENT INFORMATION		
Incident Report #: 42/2017-18	Date : 5/3/2018	Time : 10:30 AM
Business : Potomac Mills Shopping Center	Report Completed By : Prem Poudel	
Address: 2700 Potomac Mills Circle	City : Woodbridge, VA	Zip Code: 22192
Complain or Case Received From: Prince William County Watershed Staff received a complaint from DEQ staff regarding salt dumping and leaching into the storm sewer system at the parking lot located near the intersection of Nazarene Way and Potomac Mills Circle on 05/02/2018.

pH : NA Limit: NA	Conductivity : - μ S/cm Limit:NA	Temp.: °F Limit: NA
Discharge related Indicators	Odor: NA	Color: NA
	Floatables: Others	Stains: White
		Turbidity: NA
		Other: Salt

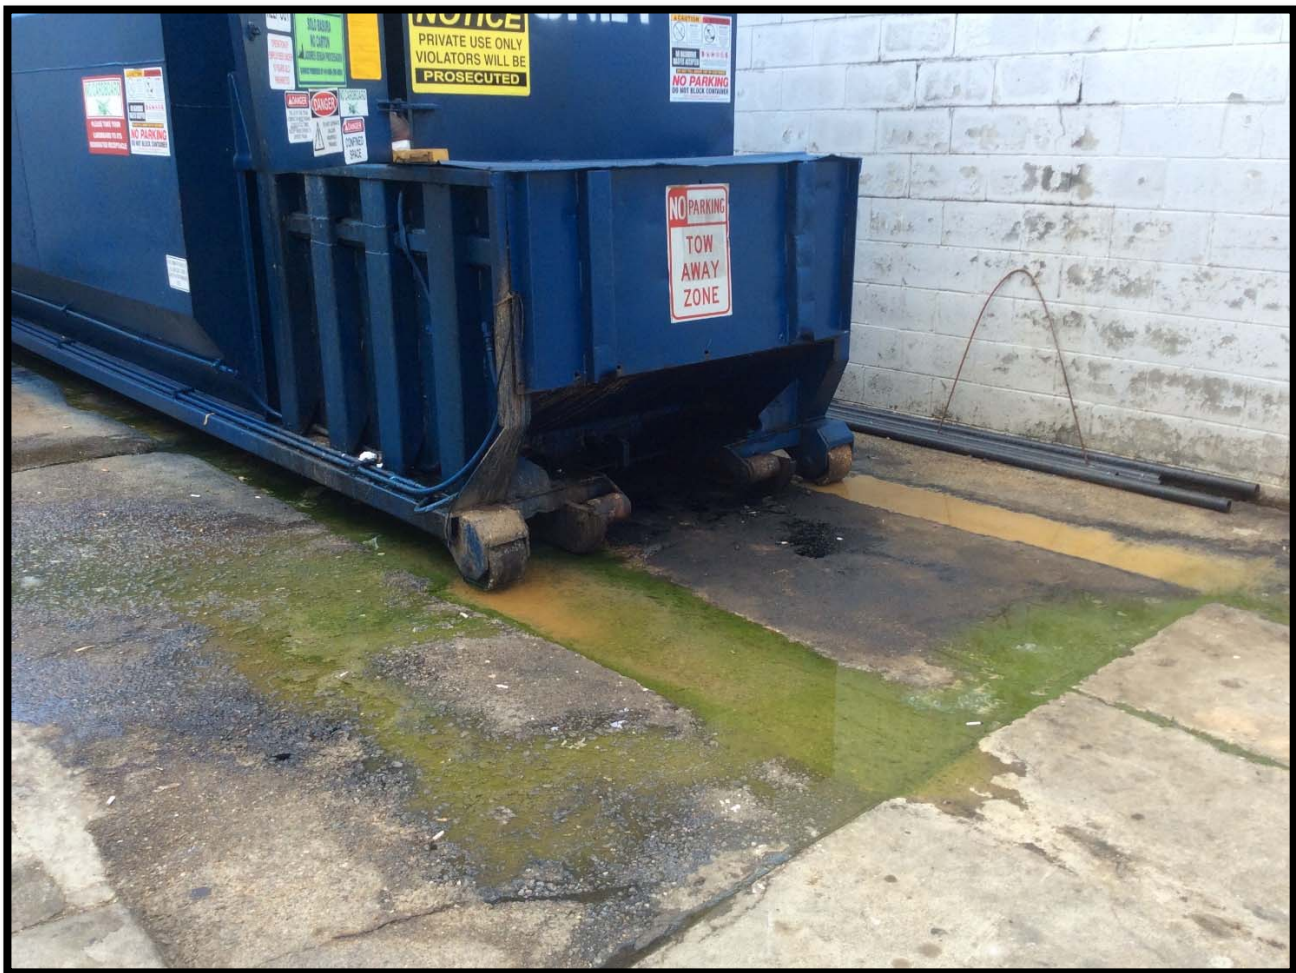
Photo of discharge:

INCIDENT INFORMATION		
Incident Report #: 4-2017/18	Date : 7/19/2017	Time : 3:30 PM
Business : Potomac Mills Shopping Center	Report Completed By : Prem Poudel	
Address: 2700 Potomac Mills Circle Suite - 307	City : Woodbridge, VA	Zip Code:22192
Case Detail: Waste food fluid was leaking from compactor. Waste food debris were spread out and being washed away with both air condense water and waste food fluid leaking from compactor into storm sewer system.

PH: NA	Limit NA	Conductivity (µS/cm): NA	Limit:NA	Temp.: °F	Limit: NA
Discharge related Indicators	Odor: Other	Color: Green	Turbidity: NA		
	Floatables: NA	Stains: Food Waste	Deposits: Debris

County Staff	7/19/2017	Oil and waste food fluid	2700 Potomac Mills Circle	an illicit discharge	7/19/2017	Yes, 12-2017	Periodic 8/10/2017; 8/21/2017	Ac water was mixing with waste food fluid leaking from compactor; grease and cooking oil being spread out on pavement during collection and haulage. Follow up inspection made [8/21]. Deficiencies mentioned in an NOV found to be corrected to resolve the problems.	Closed
Citizen	7/19/2017	Asphalt Tar	2700 Potomac Mills Circle	Petroleum	7/19/2017	Yes, FMO	7/24/2017	The bituminous emulsion was spilled over the road through tar tanker due to leakage during road maintenance. The emulsion ultimately reached into downstream creek through storm sewer system. NOV was issued by the department of fire and rescue (DFR). The case was resolved by the contractor employing certified cleaning contractor "ATLAS".	Closed

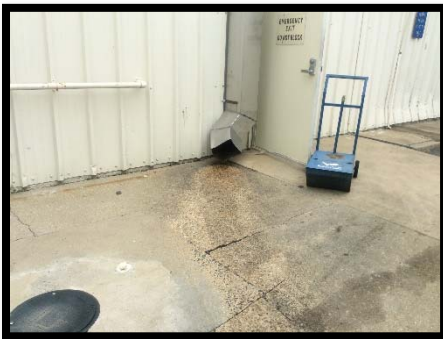
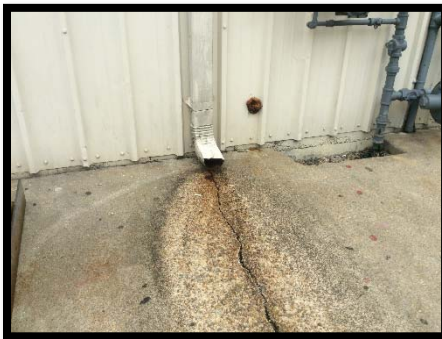
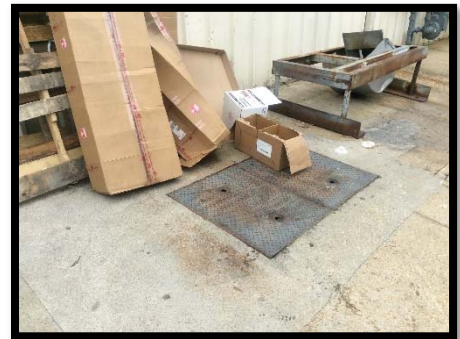
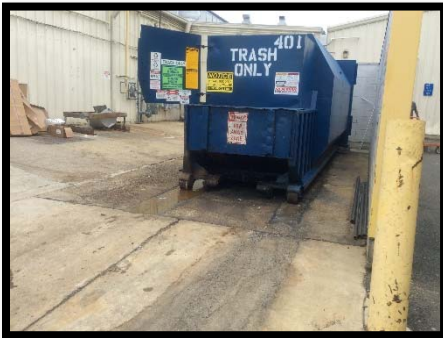
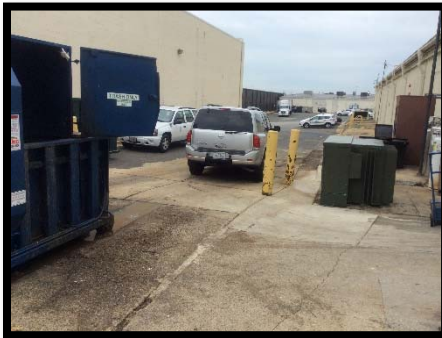
Follow up inspection made on 8/21/2016. The grease inceptor found to be cleaned and stopped flowing water from lid. Food stains and debris had been cleaned. The case has been closed for now but this site is listed a hot-spot and follow up inspection will be continued in future. Please see the picture posted below.

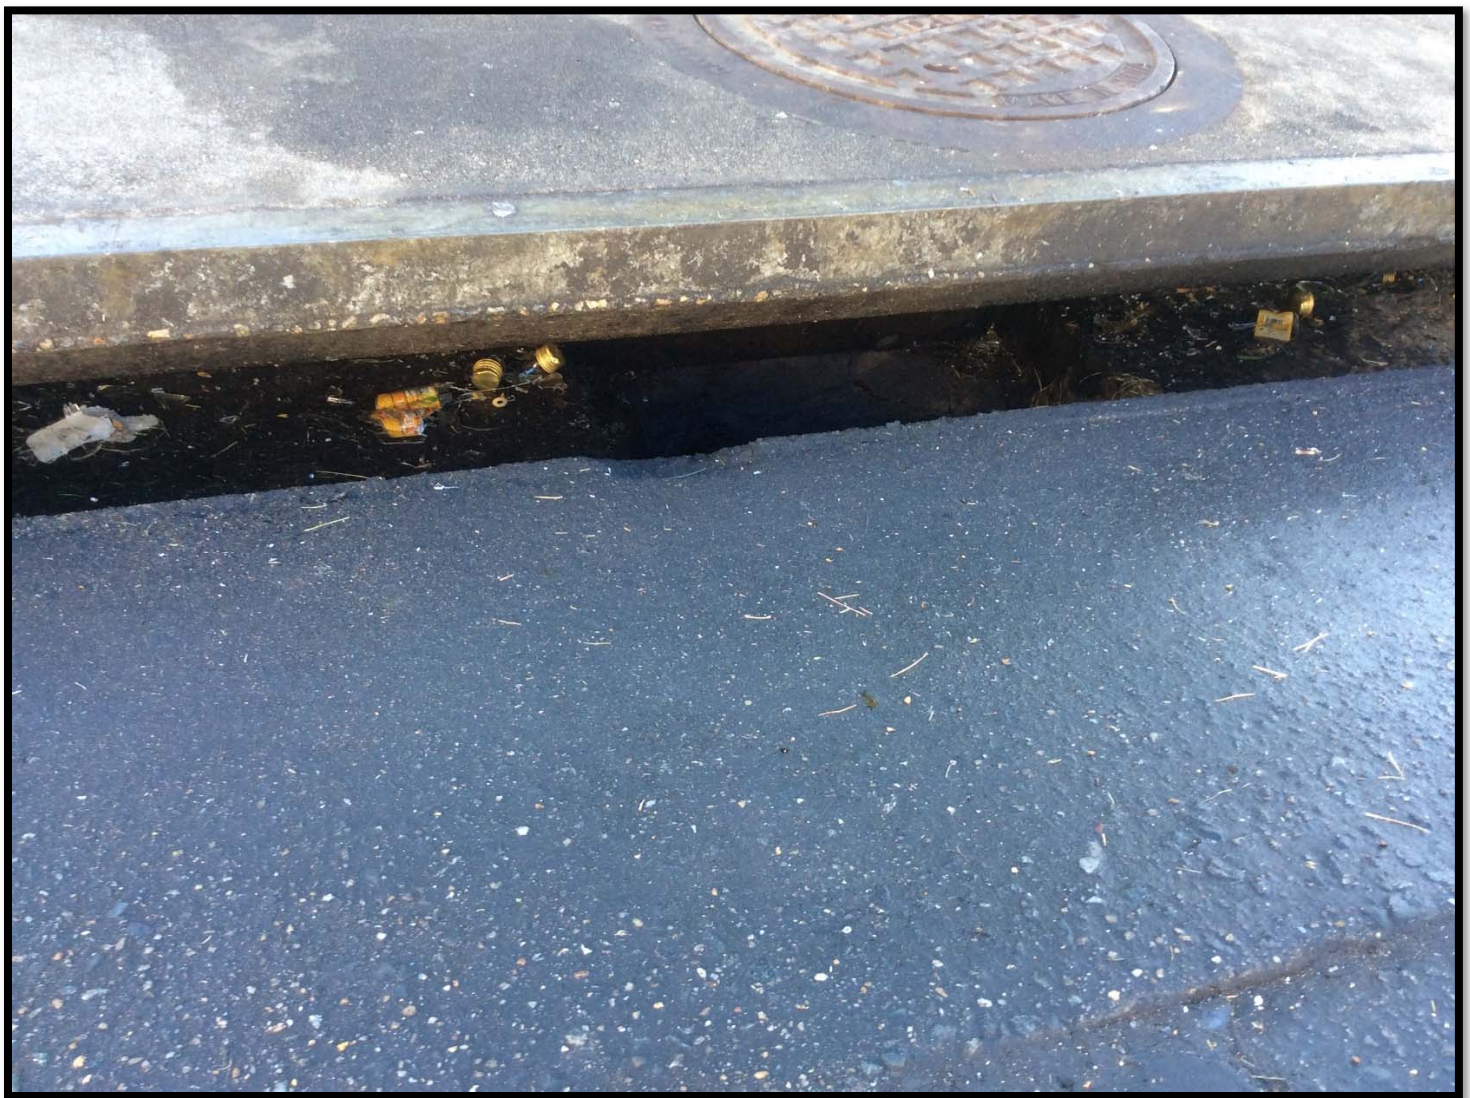
Photo of discharge:

INCIDENT INFORMATION		
Incident Report #: 32/9-28-2017	Date : 9/28/2017	Time : 4:00 PM
Business : Residential	Report Completed By : Prem Poudel	
Address: SW- Inlet (35033) nearby 2937 Stockholm Way	City : Woodbridge, VA	Zip Code: 22191
Case Detail: Cooking oil bottles (glass) being dumped into storm water inlet nearby 2937 Stockholm Way

pH : NA Limit: NA	Conductivity : NA μ S/cm Limit:NA	Temp.: -°F Limit: NA
Discharge related Indicators	Odor: Other	Color: Other
	Floatables: Cooking Oil	Stains: Oily
		Turbidity: NA
		Other: NA

The incident regarding dumping cooking oil bottles (glass) into storm sewer system was initially received on March 27 into storm water inlet across street at 2926 Stockholm Way. Same complaint again received on 09/27/2017. Site was re-inspected on 9/28/2017. Upon arrival, cooking oil bottles observed dumping into storm inlet, located near 2937 Stockholm Way. Black stains were covered with fresh oil. Pieces of bottles were found to be spread out inside the inlet structure. Prince William County Watershed staff received video footage from the complaint.

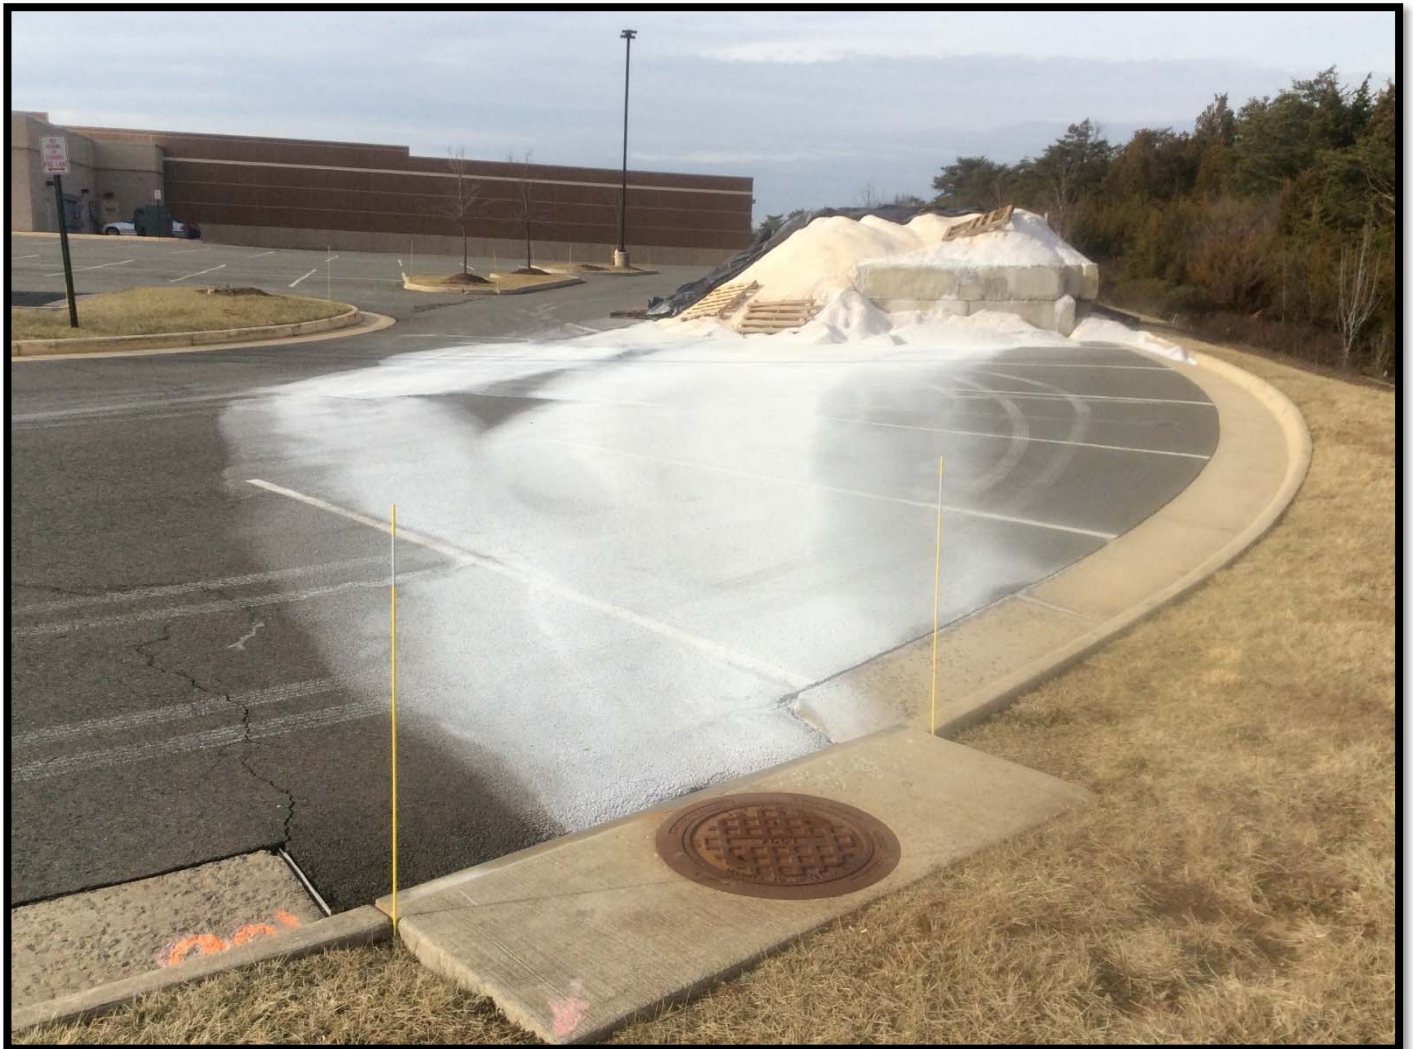
Photo of discharge:

pH : NA	Limit: NA	Conductivity : - $\mu\text{S}/\text{cm}$ Limit: NA	Temp.: °F Limit: NA
Discharge related Indicators	Odor: Choose an item.	Color: Choose an item.	Turbidity: Choose an item.
	Floatables: Others	Stains: White	Other: Salt

Upon arrival, salt pile observed uncovered/non-confined on parking lot and white salt stain directed towards storm sewer system. By the evidence, the runoff with concentrated salt should have flown into storm sewer system in previous rainfall events.

The pile found to be influenced with previous rainfall to create a runoff with high concentrated salt, which ultimately entered into storm sewer system. The concentrated salt solution supposed to be a source of pollutant in storm water system, which affect the plant and aquatic life in a creek and river. The deficiency needs to be addressed by the property owner with following actions:

- 1) Immediately clean salt stain and residual debris from the pavement and dispose properly without allowing discharge into storm sewer system.
- 2) Control pollutant on site after notification.
- 3) Remove salt pile from the parking lot. The storage of salt for the use of property owner should keep under the roof or confined space if needed.

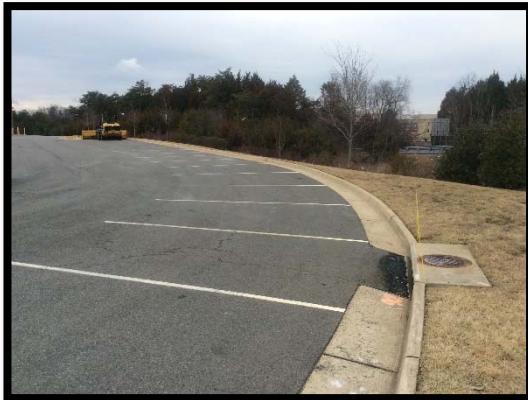
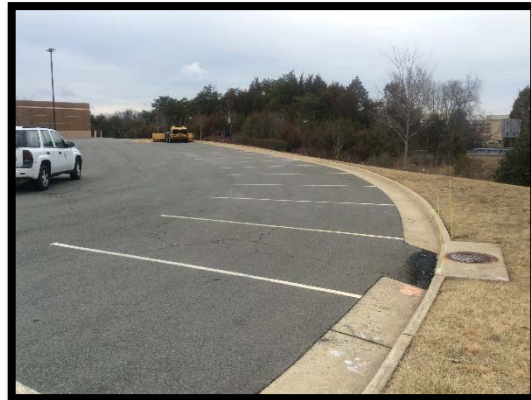
Follow up inspection made on 01/29/2018. The deficiency has corrected by removing salt piles from parking lot and cleaning debris from the pavement. See the following pictures taken after mitigation.

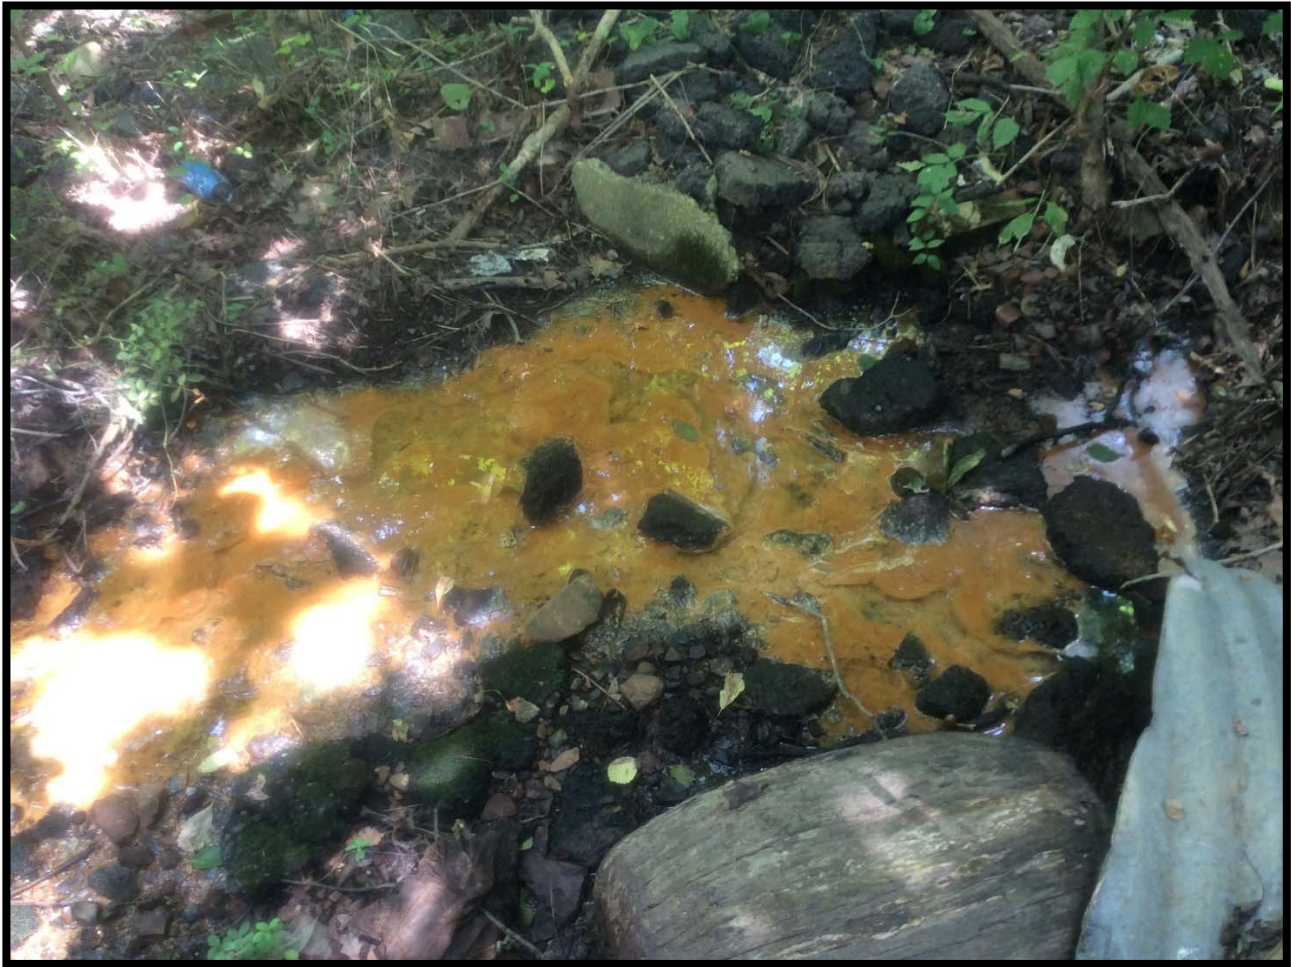
Photo of discharge:

pH : NA Limit: NA	Conductivity : NA μ S/cm Limit:NA	Temp.: °F Limit: NA
Discharge related Indicators	Odor: NA	Color: Orange
	Floatables: NA	Turbidity: NA
	Stains: NA	Other: Algae

Upon arrival, the lid of storm water structure, located at the property 7144 Bull Run Road was found to be displaced from its original position. Displacement may have happened due to clogged storm sewer after the structure. The earthen swale found to be eroded with over flow from the top of the structure during rainfall. The outfall 16547, located at North-East of the property was flowing with trickle discharge which found to be percolated within 10 feet from outfall. Outfall was a rusted corrugated pipe. Significant amount of orange algae found to be developed at flow line.

At point A, non-measurable trickle flow was transferring to the next sewer. Two intermediate Manhole between outfall 35071 to Manhole B could not observe. One of them did not show up and next one was covered with the lid of sanitary manhole. The property 8721 Parkland Street was found poorly maintained with some fertilizer, mulch and equipment on their yard. The stockpiles were partly opened for runoff during rainfall but it is hard to predict a secondary source of algae since the runoff needs to travel long way through turf before entering into storm sewer system. That's why, those piles could not predict as a secondary source of algae growth. Manhole B was dry during inspection.

The corrugated metal pipe was rusted and released iron oxide with trickle flow. Bacteria got favorable condition to grow up with iron oxide.

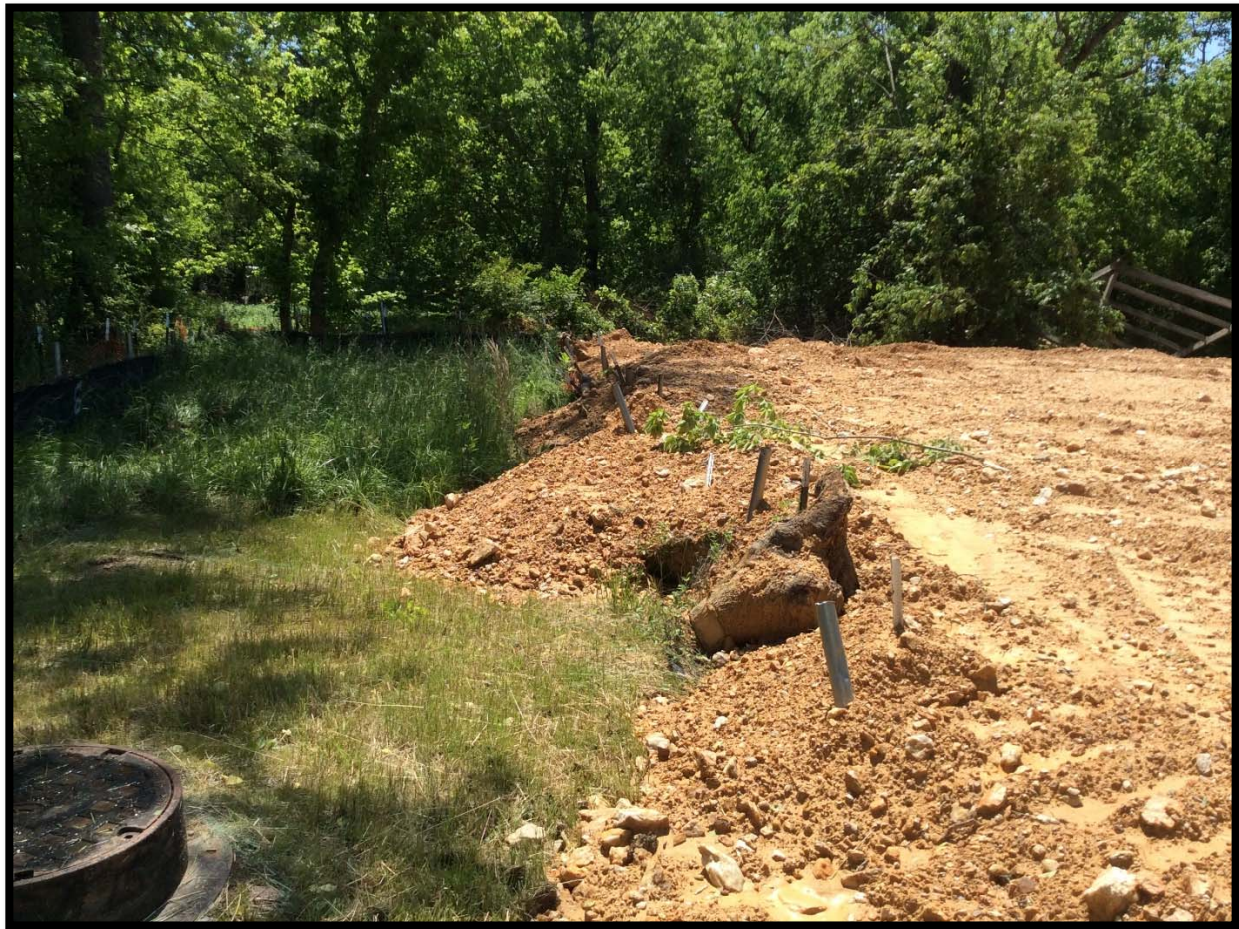
Photo of discharge:

PH: NA Limit NA	Conductivity (µS/cm): NA Limit:NA	Temp.: °F Limit: NA
Discharge related Indicators	Odor: NA	Color: NA
	Floatables: NA	Stains: NA
		Turbidity: NA
		Deposits: Dirt

After getting complaint from a citizen regarding dumping large quantities of mud/dirt on the property adjacent to the property 8103 Levi Court, the site was inspected on 05/19/2017. Dirt found to be dumped into two different private properties 7629 Chestnut Street and 7612 Pine Street. Please see the attached map with highlighted dumping area for details. The entire dumping area was approximately 4' high from existing ground. After reviewing, It came to know that both property owner does not have land disturbance permit. Dumping area was nearly approaching to the creek without containment/silt fence. The case may attract to the scope of Neighborhood Services.

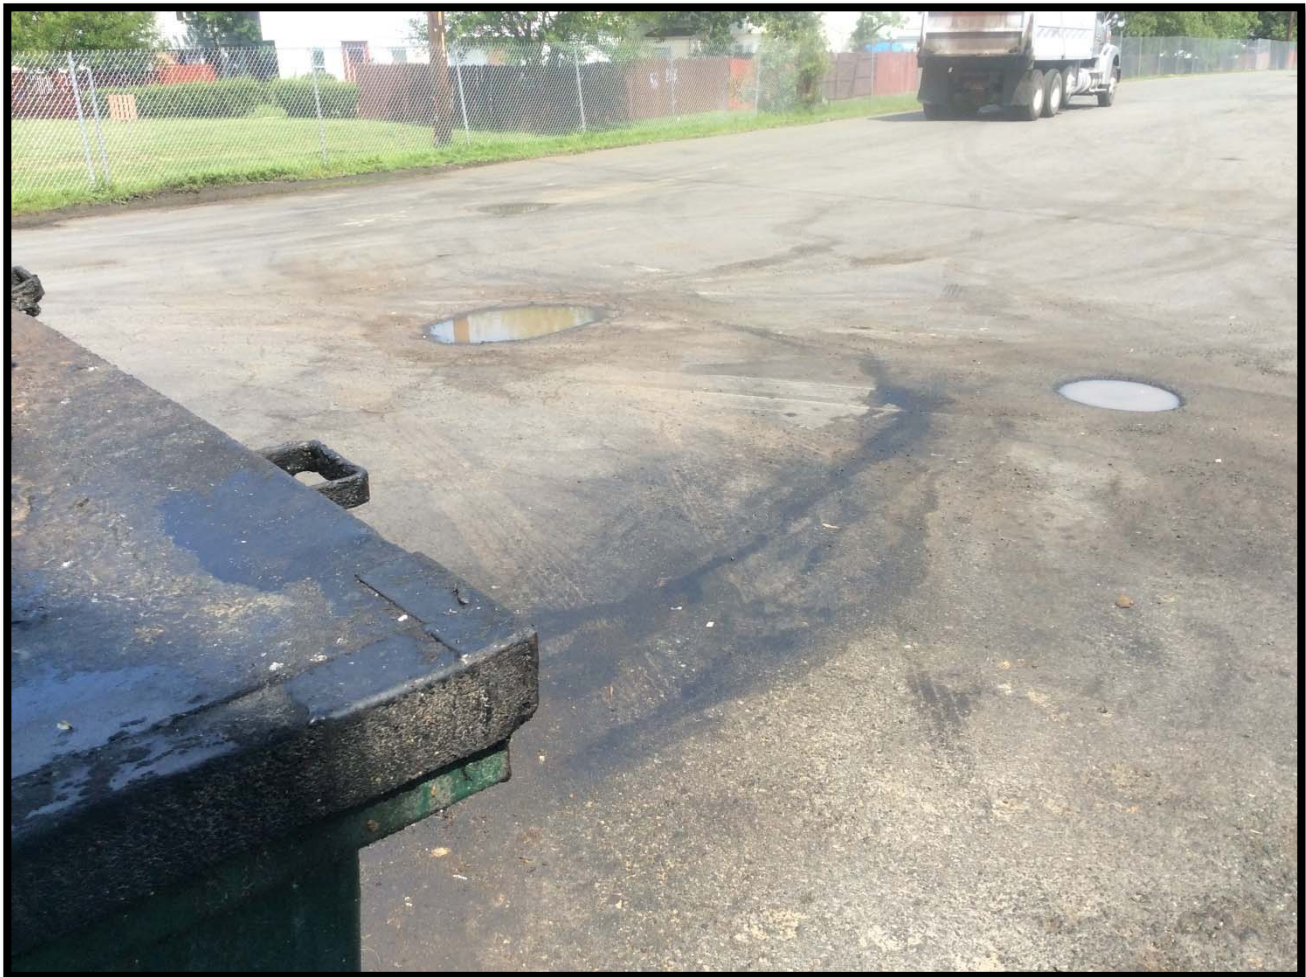
Photo of discharge:

INCIDENT INFORMATION		
Incident Report #: 3-2017/18	Date : 7/17/2017	Time : 10:30 PM
Business : Great American Buffet	Report Completed By : Prem Poudel	
Address: 8356 Sudley Rd	City : Manassas, VA	Zip Code: 20109
Case Detail: Waste food fluid was leaking from compactor. Grease and waste food debris were observed spread out on pavement around container. Waste food fluid was stagnant at two different low points and potential for being wash away into neighboring property of Irongate HOA.

PH: NA Limit NA	Conductivity (μS/cm): NA Limit:NA	Temp.: °F Limit: NA
Discharge related Indicators	Odor: Other	Color: Gray
	Floatables: NA	Stains: Food Waste
		Turbidity: Opaque
		Deposits: Debris

During periodic inspection, the site 8365 Sudley Rd was inspected by the Illicit Discharge Detection and Elimination (IDDE) staff on 07/17/2017. Upon arrival, waste food debris, grease and waste cooking oil found to be stained and, was fresh on pavement around compactor and waste cooking oil collection tank. Those containers found to be used to collect food waste from the restaurant, Great American Buffet. The stagnant water observed on a couple of depression and, was a waste food fluid left over after cleaning with water hose. The cleaning water directly cross over the boundary to the neighboring property of Irongate HOA. We had a same complaint on 03/05/2012.

Discharge of cleaning water or food waste fluid into neighboring property is a violation of County ordinance 23.2-4.1. Notice of Violation (NOV# 11-2017) issued to the restaurant manager to mitigate all deficiencies within 30 days from date of NOV.

The restaurant owner needs to handle food waste properly within the close container compatible to hold all inside without leaking. An unintentional spill or leakage need to be prudently captured with absorbent and put back into the container. If cleaning activities run with liquid like chemicals and water, fluid must be vacuumed and disposed properly. Following actions need to follow to mitigate all deficiencies.

- 1) Capture all potential illicit discharge onsite and maintain all containers (Compactor, Grease Inceptor, grease and waste cooking oil collection tank etc.) compatible to stop leakage.
- 2) Immediately clean waste food debris and stains from the pavement, potential for being washed away into HOA property during rainfall.
- 3) Adopt professional cleaning method and maintain cleaning log for grease inceptor.

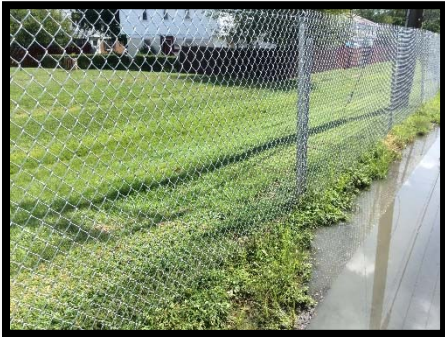
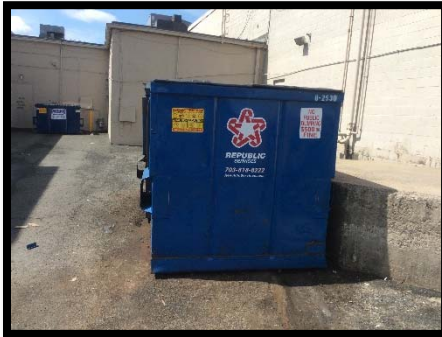
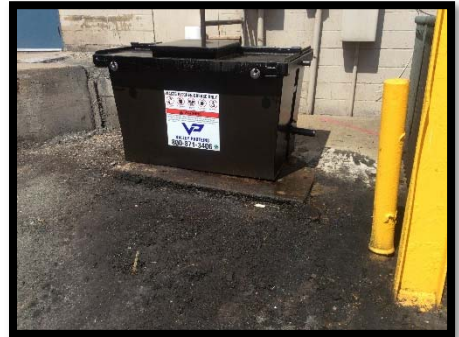
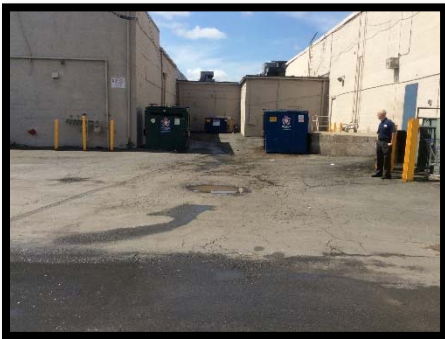
Follow-up inspection made [08/30]. Dumpster found to be replaced with new ones. Oil stain and debris found removed but there were minor spill around container. The case has been closed now but the site was highly potential for releasing waste through container. Follow up inspection will continue in future.

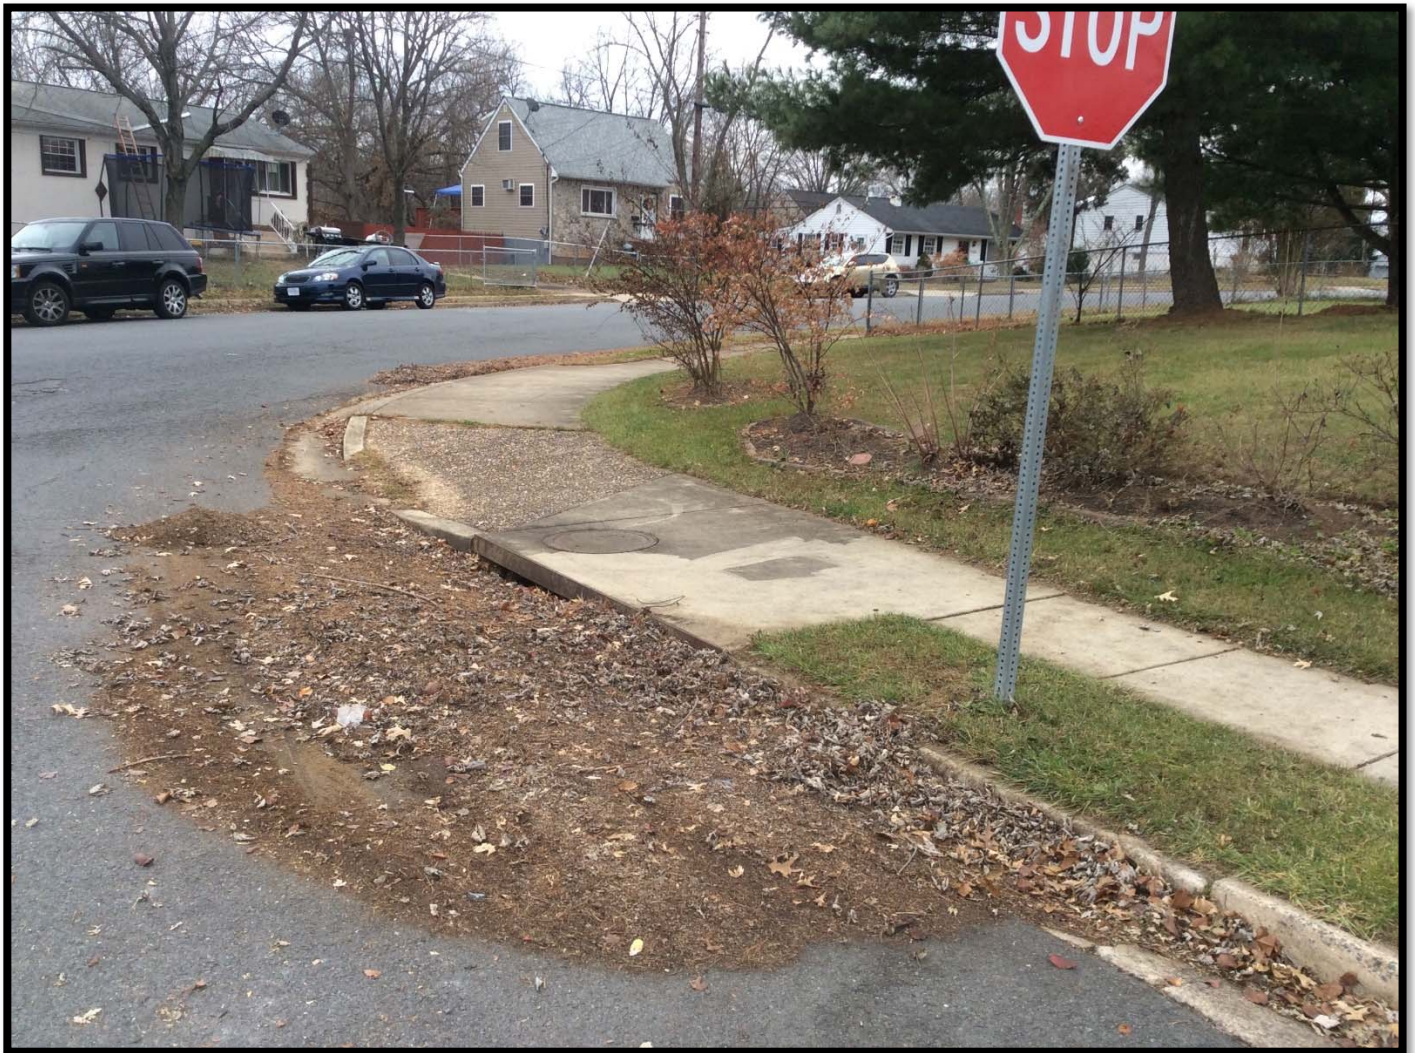
Photo of discharge:

INCIDENT INFORMATION		
Incident Report #: 37/2017-18	Date : 12/7/2017	Time : 11:30AM
Business : Residential	Report Completed By : Prem Poudel	
Address: 9301 Byron St.	City : Manassas, VA	Zip Code: 20111
Complain or Case Received From: PWC, Watershed Staff received a complaint from PWC, Neighborhood Services staff regarding dumping clippings at Road Curbs and Gutters located near by 9301 Byron Street on 12/07/2017.

pH : NA Limit: NA	Conductivity : - μ S/cm Limit: NA	Temp.: °F Limit: NA
Discharge related Indicators	Odor: NA	Turbidity: NA
	Floatables: NA	Stains: NA Other: Dumping Clippings

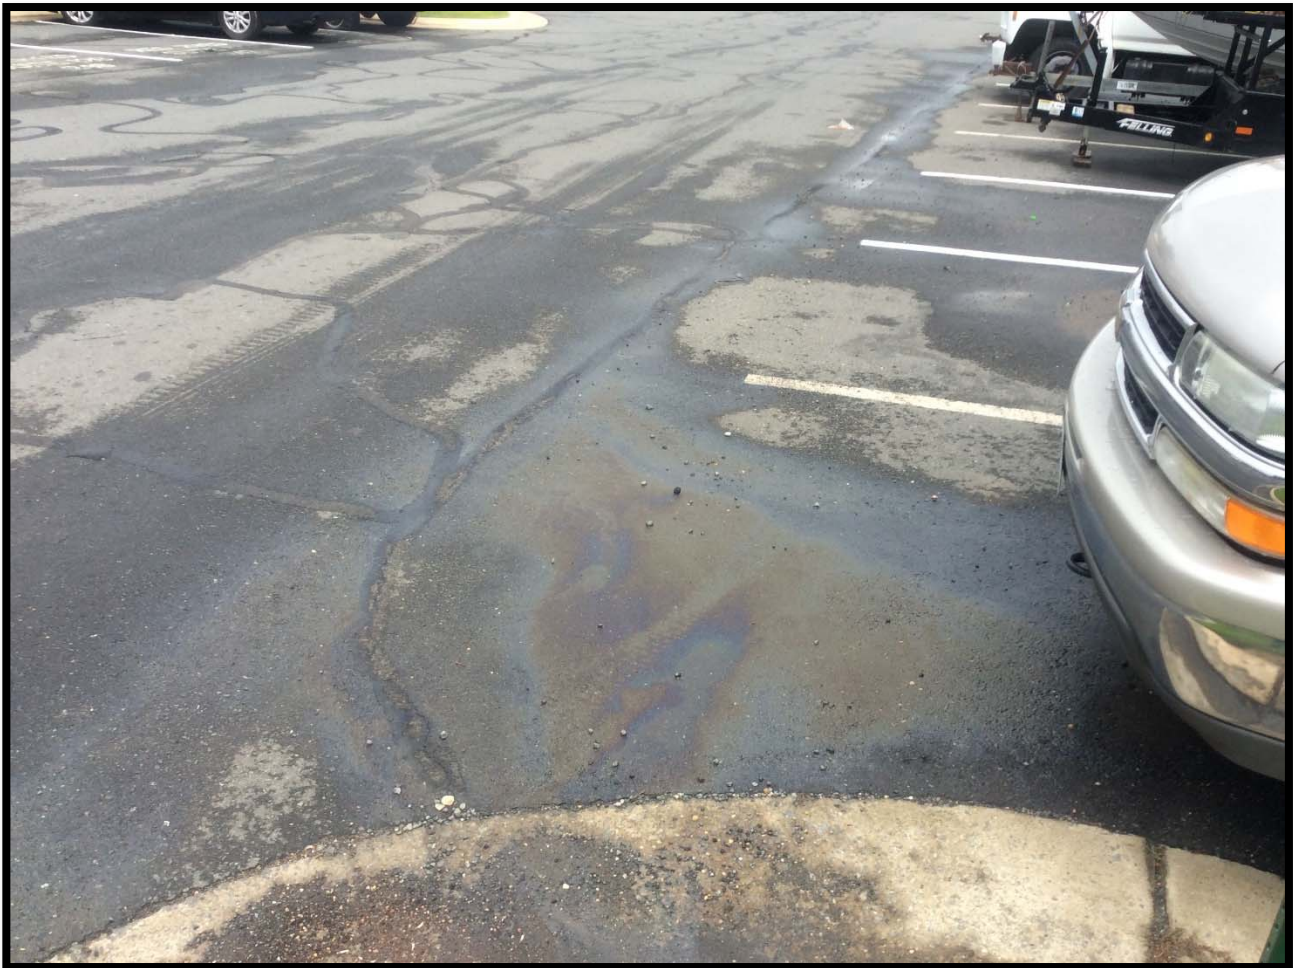
Photo of discharge:

INCIDENT INFORMATION		
Incident Report #:	Date : 8/15/2017	Time : 2:30 PM
Business : Independent Business Center	Report Completed By : Prem Poudel	
Address: 11850 Livingston Rd 139	City : Manassas	Zip Code: 20109
Complain or Case Received From: Ralph Bloom called (703-201-6499) at 1:19 to report a diesel fuel spill along Livingston Road near Wellington Rd, starting at US Foods and ending at 11850 Livingston Rd Lot 38.

Upon arrival, call made for Mr. Ralph Bloom, the complainant of spill onsite to identify exact location because Lot 38 near 11850 Livingston Rd couldn't identify. After conversation, site identified multiple spills; spill-1, spill-2 and spill-3 in three different locations. First and Second sites found with petroleum stains having colorful surface and 3rd one had paint spill. Paint spill found being dry before reach out into water bodies. Petroleum spill observed colorful and spread out due to rainwater. Impact of all of those three spills found local with minor impact on outfall discharge. Interaction made with Mr. Damien Gray, the Manager of Kingsmor Supply Inc. and Manager of Dal-Tile Show Room. Particular violator could not identified.

Spill 1 had immediately converted into dry due to evaporation. Mr. Gray talked with his crew about petroleum spill, happened in spill 2 where he used to park his car regularly even though the car was not leaking during inspection. The car was old and seemed to be potential for leaking at any time. Mechanics agreed to keep his car compatible to stop leakage and capture spill with Kitty Litters. At spill-3, Paint was found leaking through dumpster used for the business of Daltile Tile and Stone Showroom. According to manager, company doesn't sell paints from their showroom. Vendors used to replace dumpster themselves. The dumpster, full with waste was replaced with another dumpster having paint stuck on it. Due to high temperature, thick paint begun flowing after melting. Paint was flowing towards storm sewer system but did not reached out to the water bodies.

All spills were small and particular violator could not identify due to lack of evidences, notice of violation did not issue.
