Annual Stormwater Management Report

VSMP Permit No. 0088595 – FY 2018

Submitted by:
Prince William County
Department of Public Works

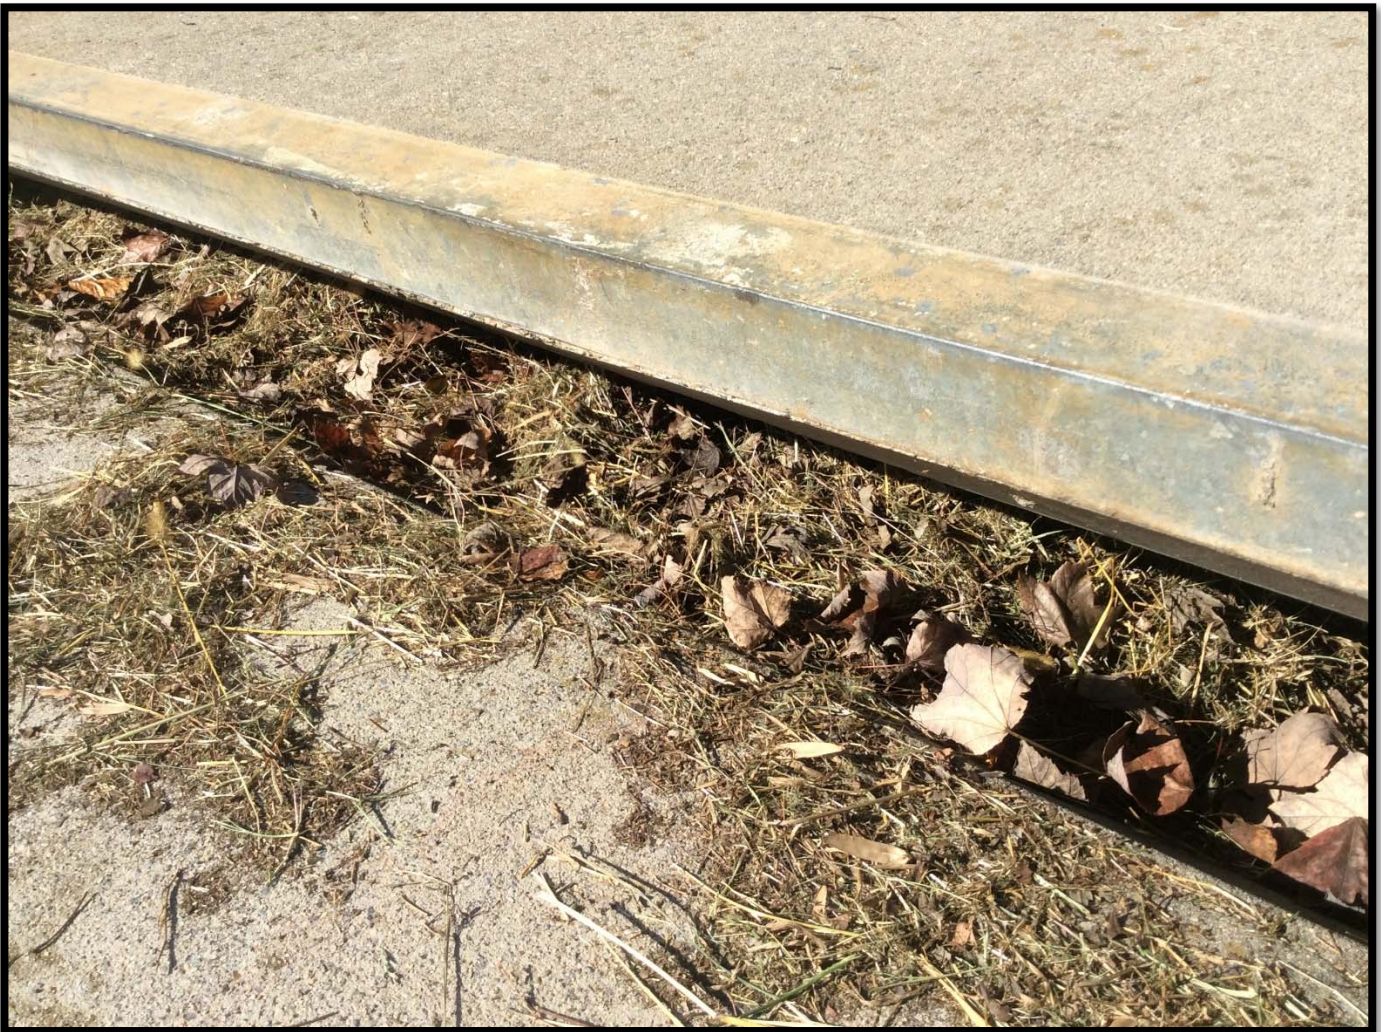
Photo of discharge:

INCIDENT INFORMATION		
Incident Report #: 33/2017	Date : 10/17/2017	Time : 10:30 AM
Business : Residential / Owner – Wells Fargo Bank	Report Completed By : Prem Poudel	
Address: 12124 Paper Birch Ln	City : Gainesville VA	Zip Code: 20155
Complain or Case Received From: Miss Keila Navarro on 10/17/2017, the administrative staff of Property Management Company sequoiamanagement.com, forwarded Citizen complaint regarding dumping clippings into storm sewer system to PWC Environmental Services.

Upon arrival, grass clippings found dumping into inlet of stormwater management system after mowing the yard of 12124 Paper Birch Lane. The volume of clippings is enough to block the drain. According to the complainant, the house has vacated since last two years. County record shows, the house is under the ownership of Wells Fargo Bank.

Any grass clippings, mulch or yard waste that impedes or interferes with the free flow of stormwater is a violation of county code 23.2-4.1. Notice of Violation NOV#14-2017 is issued to the owner to remove clippings from stormwater inlet as soon as possible before 30 days of the date of violation issued.

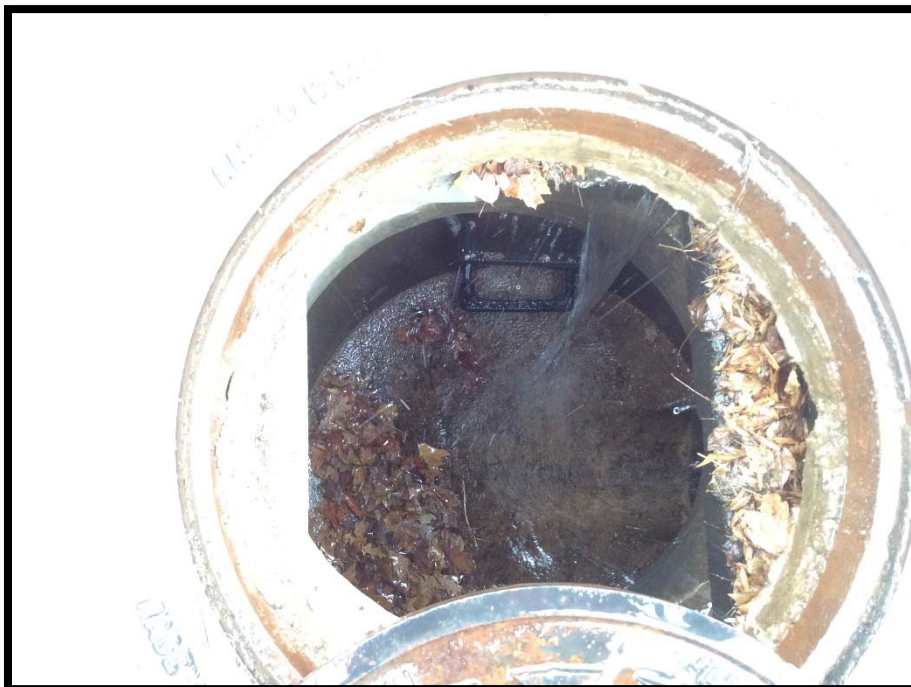
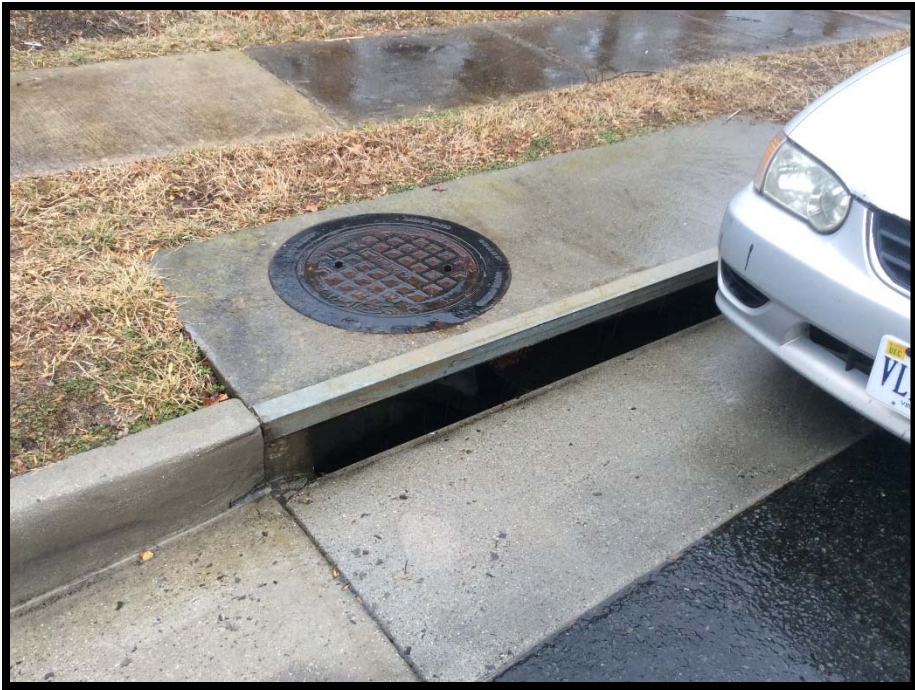
Follow up Inspection:

Follow up inspection made on 02/07/2018. The clippings removed and maintained drainage functional. The case has been closed.

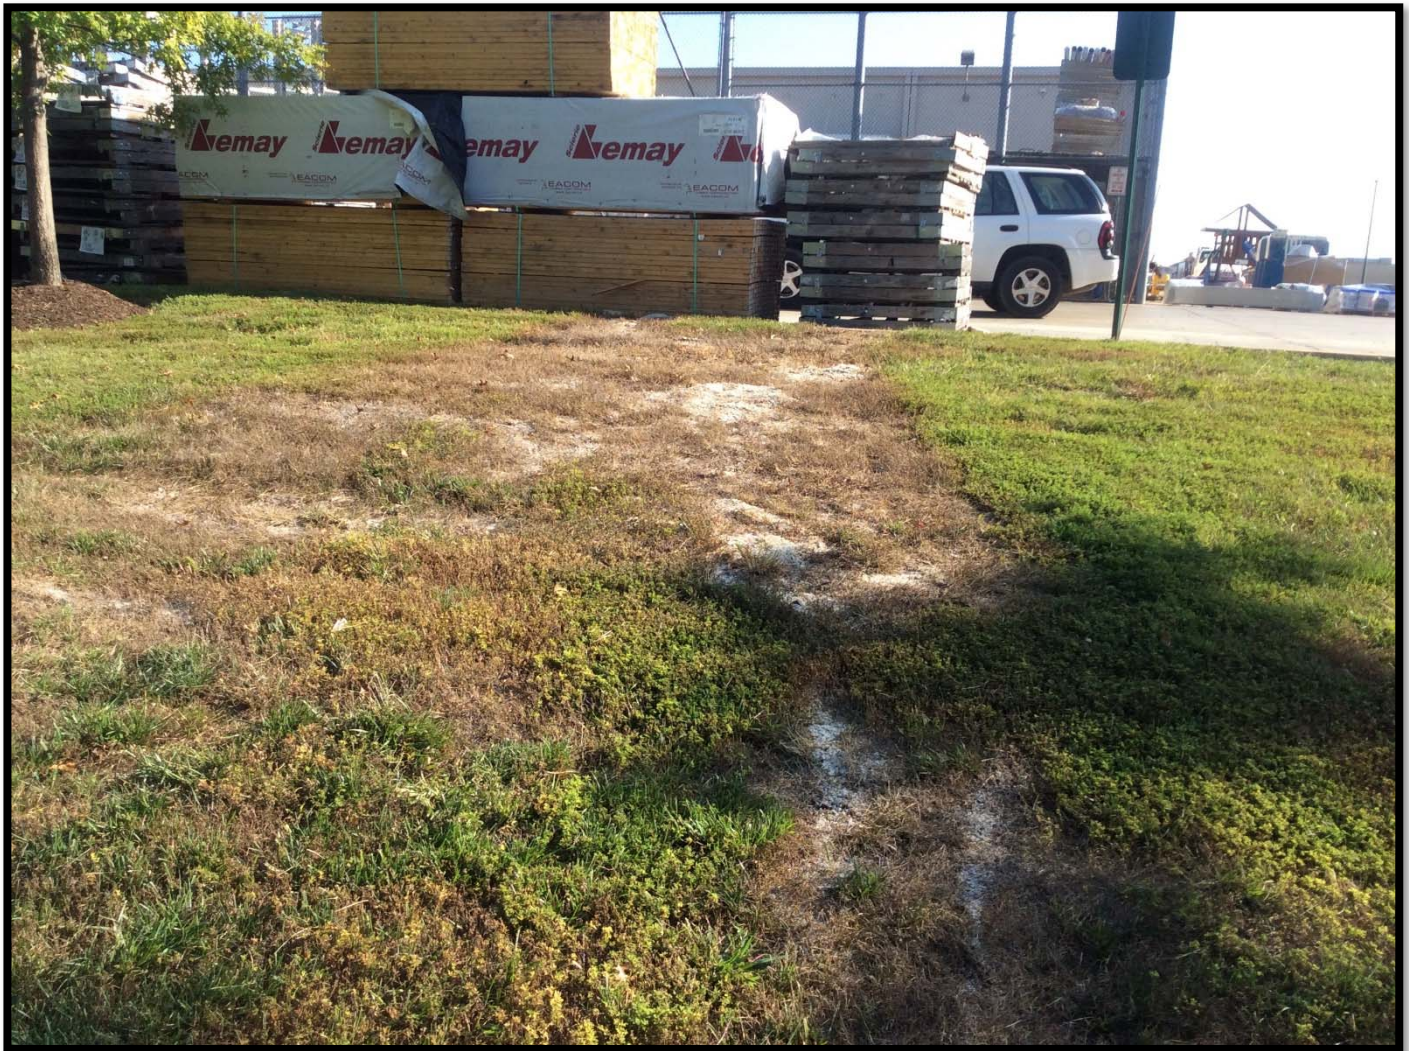
Photo of discharge:

INCIDENT INFORMATION		
Incident Report #: 13/2017-18	Date : 9/21/2017	Time : 10:00 AM
Business : Lowe's Store	Report Completed By : Prem Poudel	
Address: 13720 Smoketown Rd.	City : Woodbridge, VA	Zip Code: 22192
Complain or Case Received From: PWC, Watershed Staff received a phone call from DEQ Staff regarding dumping fertilizer on the ground behind the Lowe's Store which is potential for being washed away into storm sewer system during rain events.

The Lowe's Store located at 13720 Smoketown Road was inspected on 09/21/2017. The fertilizer found to be dumped over the ground behind the Lowe's store. The grass found to be dead with some residual fertilizer. Following inspection, meeting made with the Manager Mr. Anthony Johnston about the case. He agreed to correct deficiencies by removing residual fertilizer with establishment of grass on denuded areas.

NOV was issued to correct deficiencies within 30 days after getting violation letter.

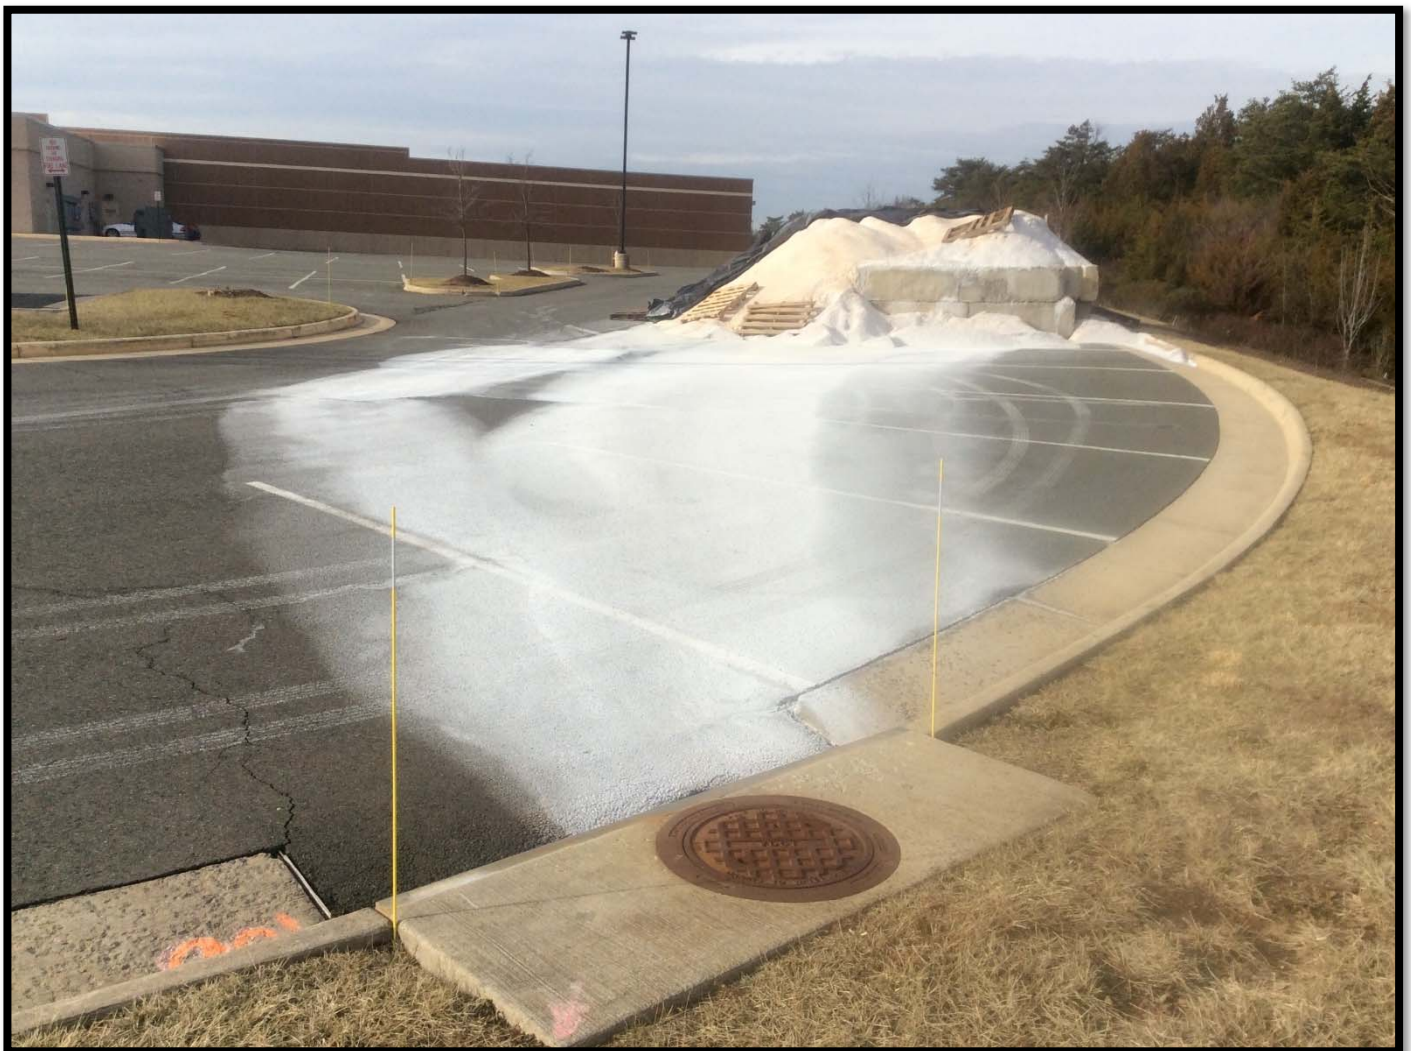
Photo of discharge:

INCIDENT INFORMATION		
Incident Report #: 24/2017-18	Date : 1/16/2018	Time : 2:45 PM
Business : Parking Lot besides Kohl's	Report Completed By : Prem Poudel	
Address: 6450 Trading Square	City : Haymarket, VA	Zip Code: 20169
Complain or Case Received From: Prince William County Watershed Staff received a salt dumping case at parking lot of 6450 Trading Square, Haymarket forwarded by the Department of Fire and Rescue Battalion Chief Mr. Doug A. McCabe on 01/16/2017. Upon arrival, salt pile observed uncovered/non-confined on parking lot and white salt stain directed towards storm sewer system. By the evidence, the runoff with concentrated salt should have flown into storm sewer system in previous rainfall events.

The pile found to be influenced with previous rainfall to create a runoff with high concentrated salt, which ultimately entered into storm sewer system. The concentrated salt solution supposed to be a source of pollutant in storm water system, which affect the plant and aquatic life in a creek and river. The deficiency needs to be addressed by the property owner with following actions:

- 1) Immediately clean salt stain and residual debris from the pavement and dispose properly without allowing discharge into storm sewer system.
- 2) Control pollutant on site after notification.
- 3) Remove salt pile from the parking lot. The storage of salt for the use of property owner should keep under the roof or confined space if needed.

The violator requested to address deficiency as mentioned above however due date of final mitigation mentioned in NOV within 30 days after getting violation letter.

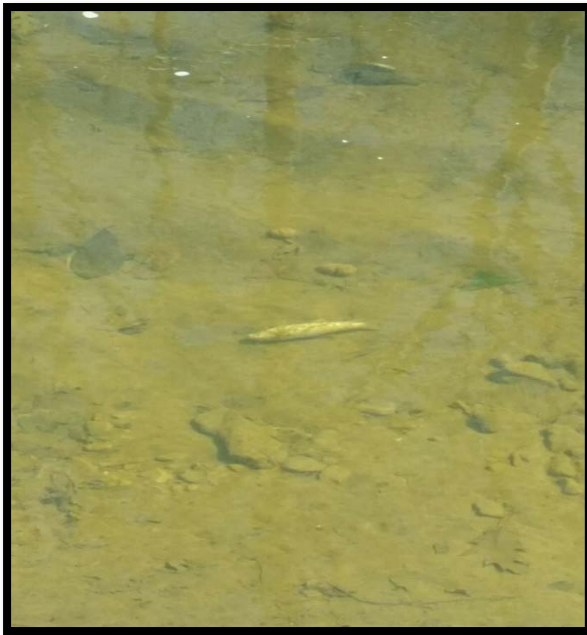
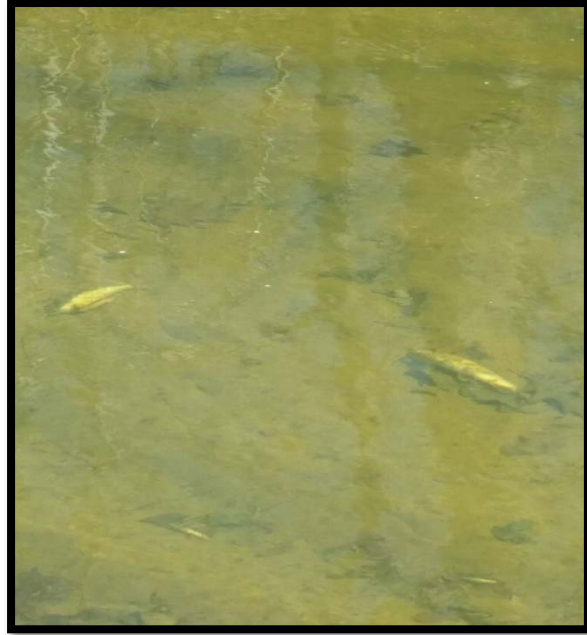
Photo of discharge:

INCIDENT INFORMATION		
Incident Report #: 37/2017-18	Date : 3/28/2018	Time : 11:48
Business : Neabsco Creek at Cloverdale Park	Report Completed By : Prem Poudel	
Address: 15150 Cloverdale Rd	City : Woodbridge VA	Zip Code: 22192
Complain or Case Received From: PWC Park and Recreation Staff Mr. D'Elia Tom noticed dead fish in Neabsco creek at cloverdale on 03/27/2018. The case was Forwarded by Mr. Kevin Flickinger, the Manager of Park and Recreation with two Pictures and received at Environmental Services on 03/28/2017.

After the notification of dying fish in a Neabsco Creek near Cloverdale Park, a field inspection was made on March, 28 and 29. The outfalls indicted with red rectangles were inspected to find out the possible source. During inspection, indicators of high water were observed at the creek located between Claremont and Calexico Ln. The water mark was clearly visible with gulley formation, and layer of down grass. Virginia American Water is suspected to have sanitary leakage at catchment drainage area.

The incident was found to happen unintentionally and was fixed as quickly as possible. Few dead fish retained at bed and some live fish observed during inspection. Virginia American Water was contacted and agreed to notify PWC Environmental Services in the future if similar incidents occur. Since the leak was repaired before it was reported to PWC, no further action is necessary at this time.

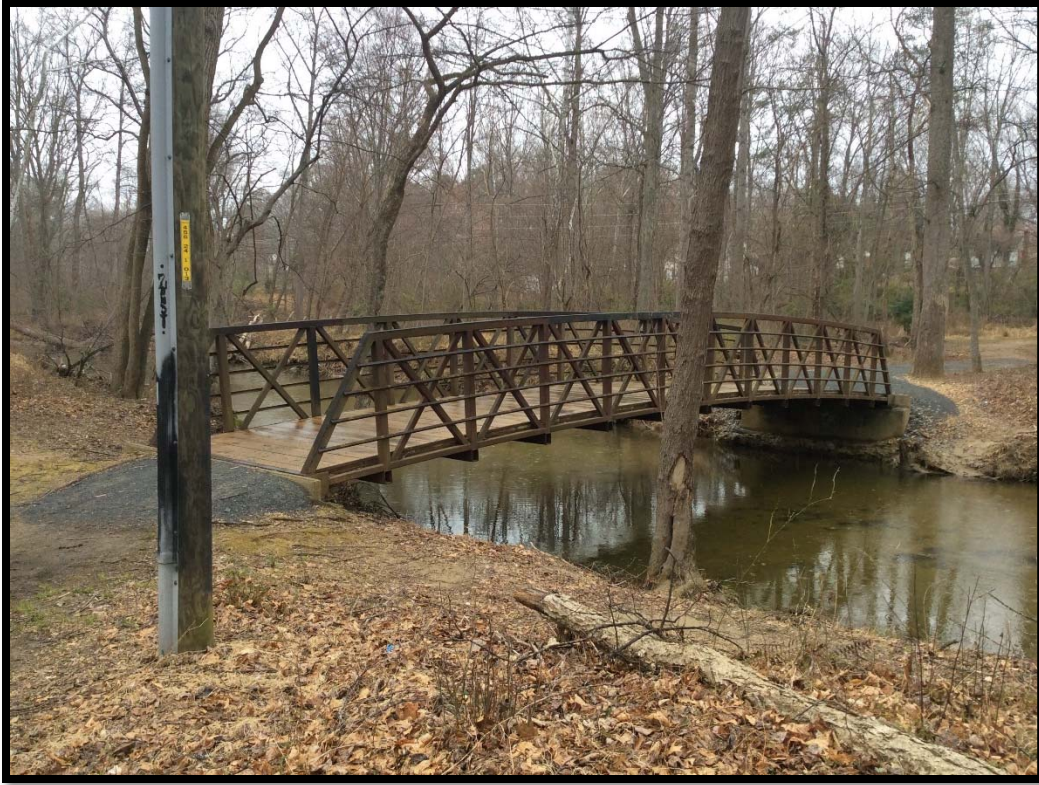
Dying Fish observed at Creek under the Bridge

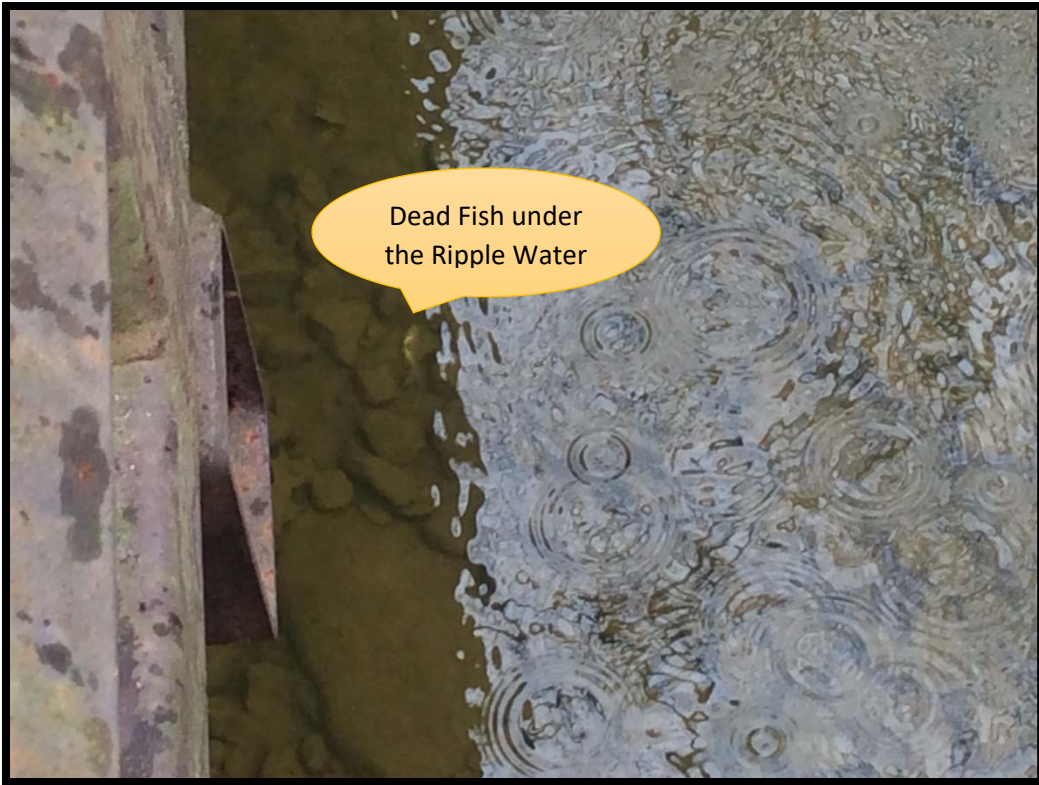
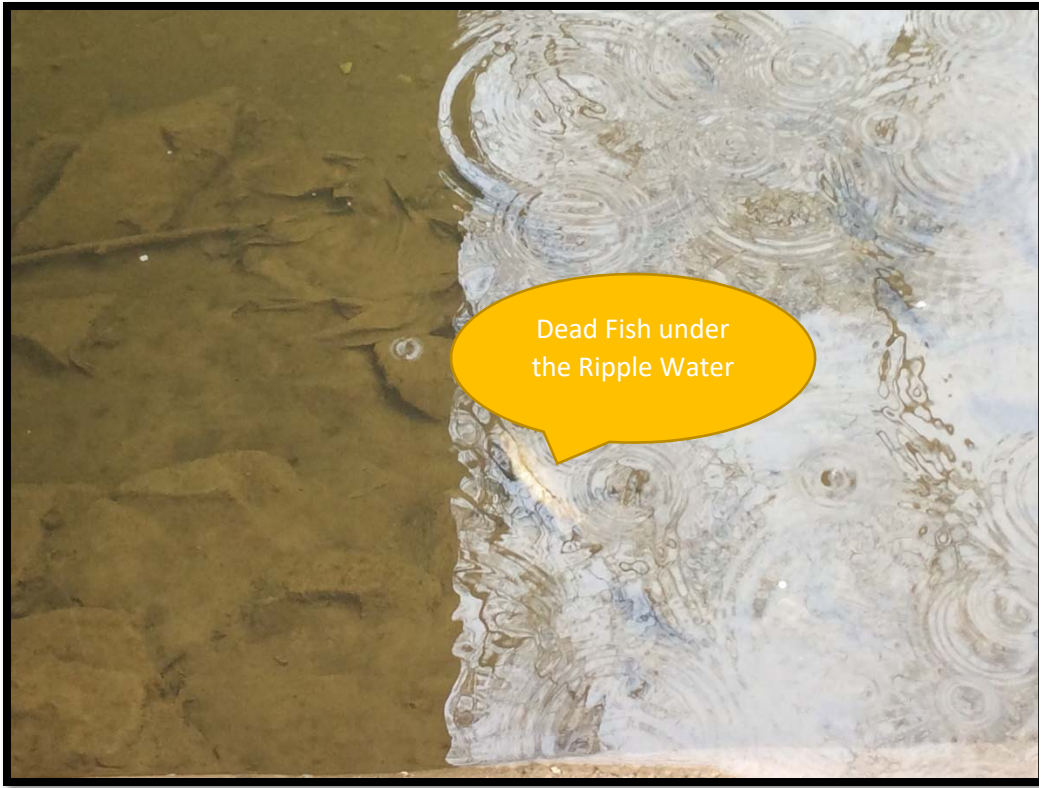
Dead Fish under
the Ripple Water

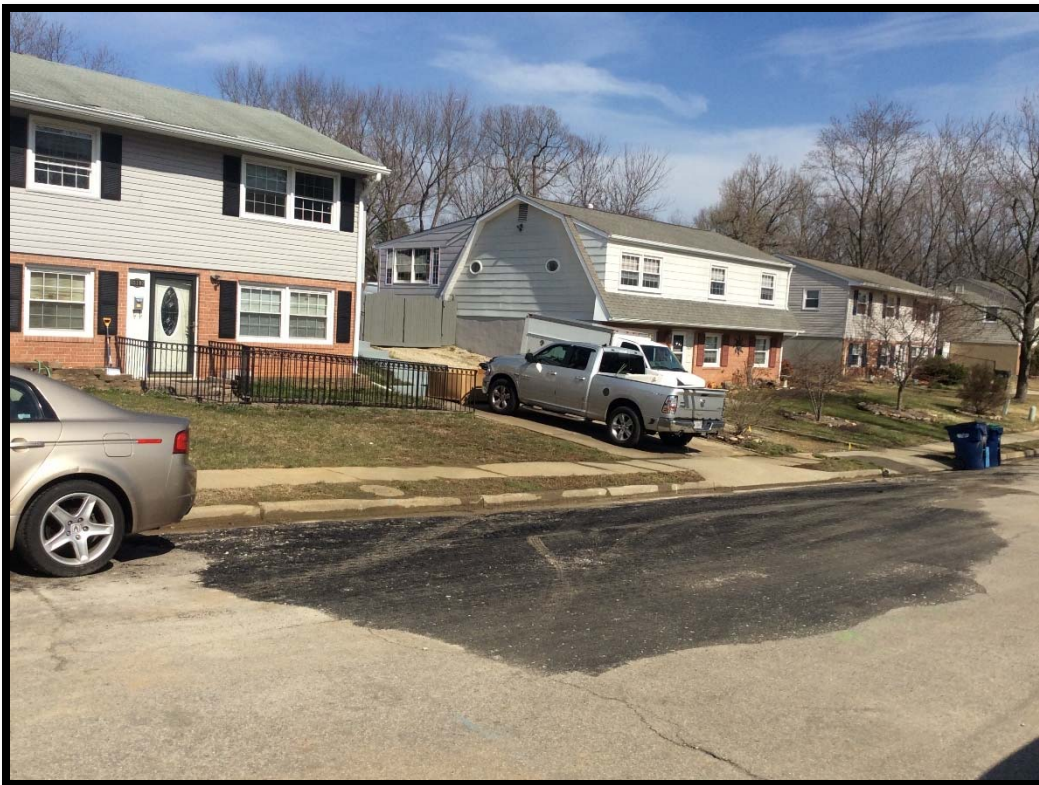
Interview made with local residents was done. The first interview was resident at 3803 Corona Ln. She gave the information about flood happened in aforementioned creek on 3/19/2018 due to water main leakage at Calexico Ln. Second interview made with a resident of 15112 Calexico Ln. According to her, the water main leakage happened on 3/18/2017. Initially, they have a problem of water main leakage at Calexico Ln, nearby the house 15107. According to her, complaint made to VA American Water regarding water main leakage. The construction crews started to fix the problem but sanitary sewer had broken down while doing maintenance. Then combined effluent continued to flow into the storm sewer system for about 4 hours.

Location of Maintenance of Unusual Discharge (15107 Calexico Ln)

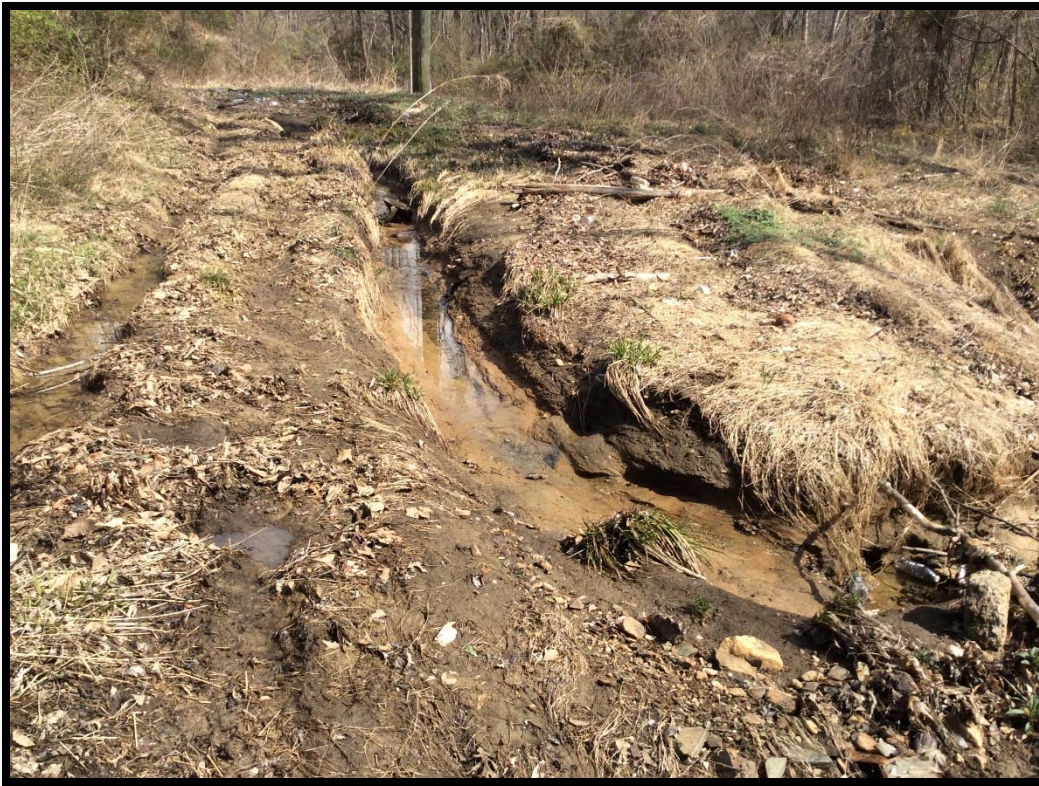
Location of Maintenance of Unusual Discharge (15107 Calexico Ln)

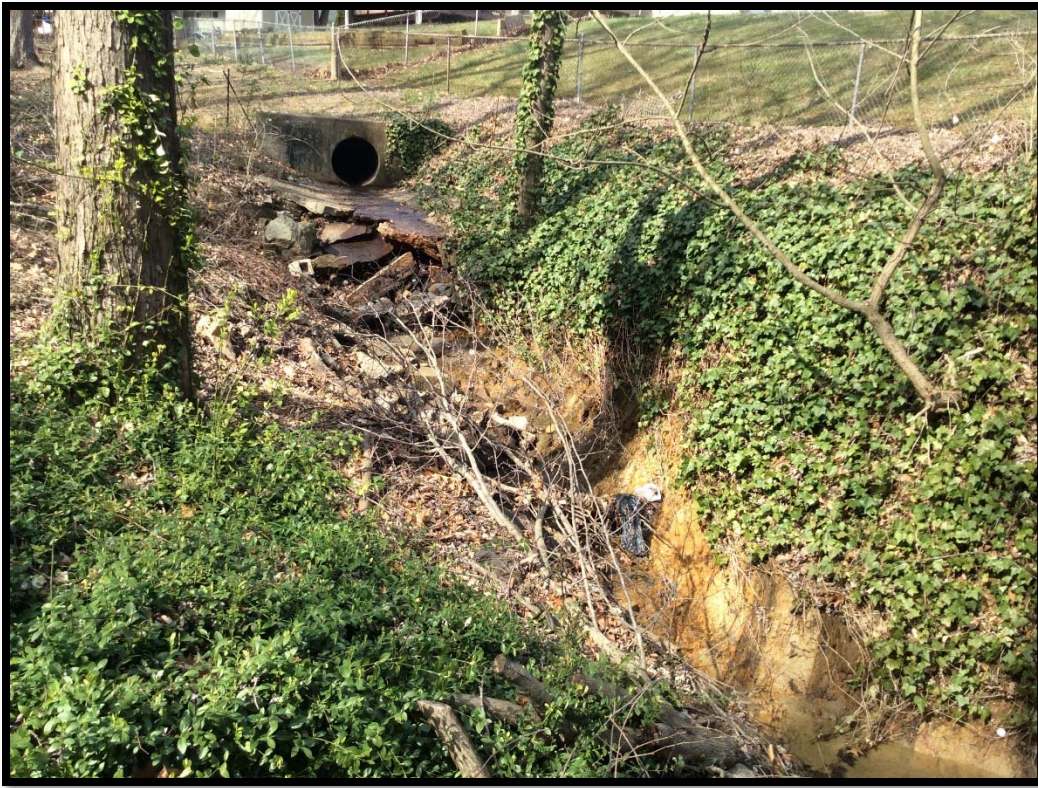
Erosion at downstream channel

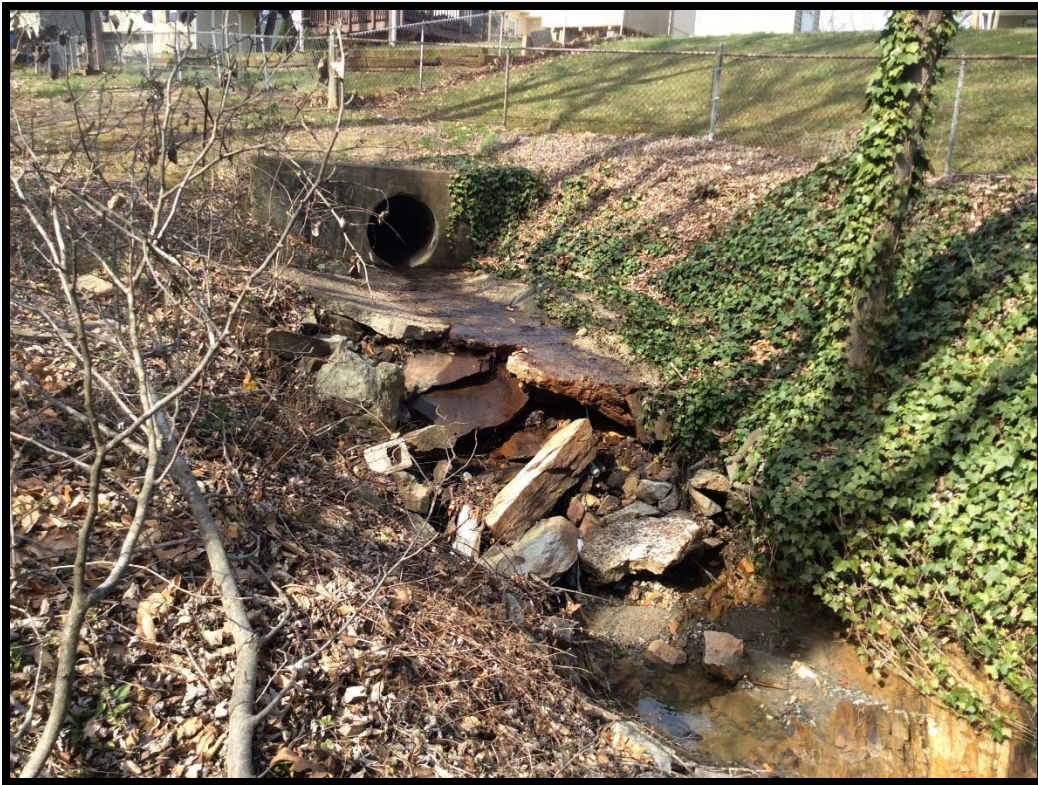
Erosion at downstream channel

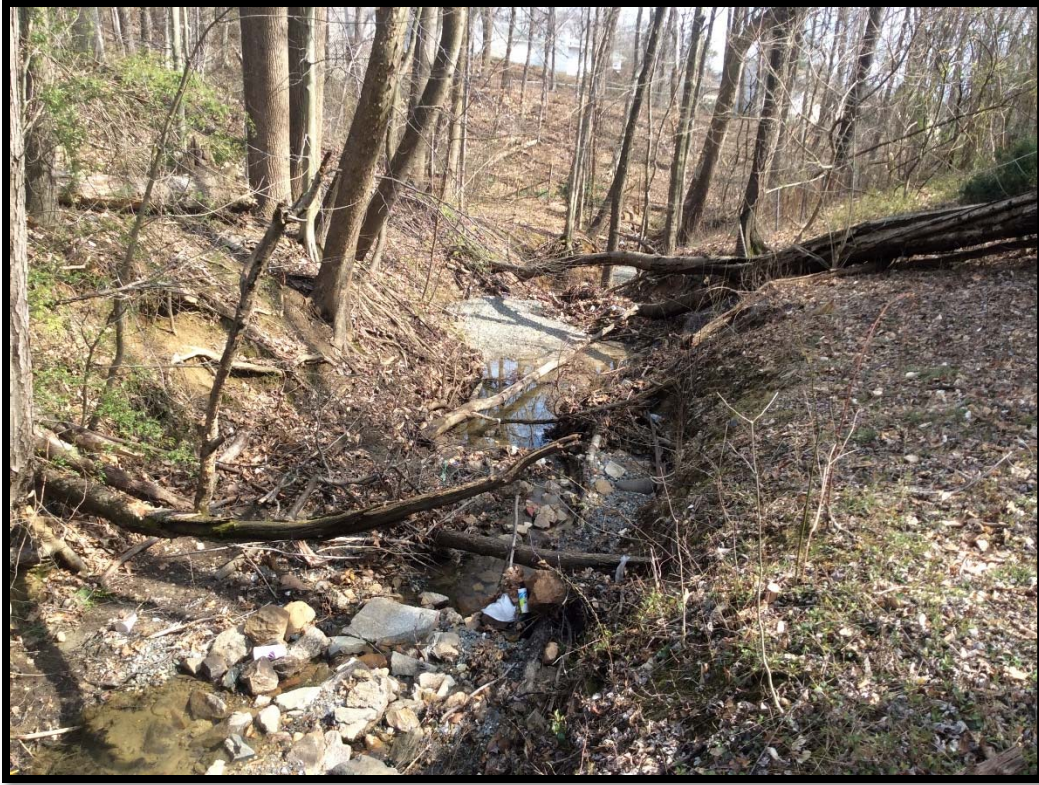
Erosion at downstream channel

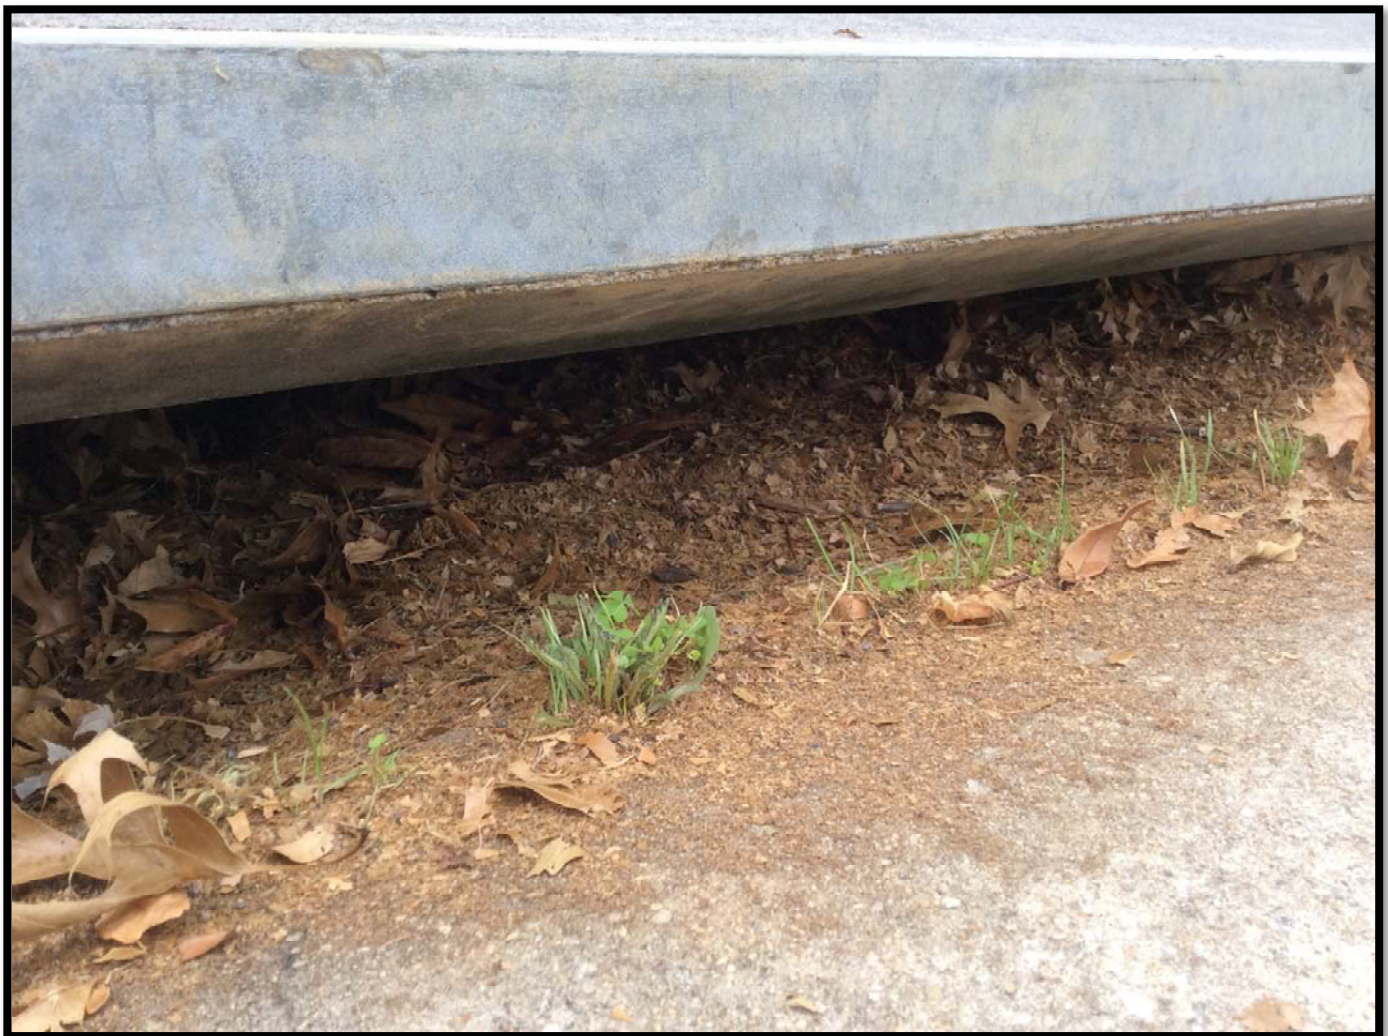
Photo of discharge:

INCIDENT INFORMATION		
Incident Report #: 21/2017	Date : 12/12/2017	Time : 02:00 PM
Business : Residential	Report Completed By : Prem Poudel	
Address: 16109 Olmstead Ln	City : Woodbridge, VA	Zip Code: 22191
Complain or Case Received From: PWC, Environment Services staff got a citizen complaint regarding discharge of yard clippings into storm sewer system by a landscapers after collecting and grinding at the property 16109 Olmstead Ln. The landscaper is also a resident of 16100 Kennedy Street.

Conclusion:	
<p>Dumping clippings into storm sewer system is a violation of county code 23.2-4.1. Notice of violation did not issue since the violator, Mr. George has accepted his fault and ready to mitigate the deficiencies. He promised to stop repetition.</p>

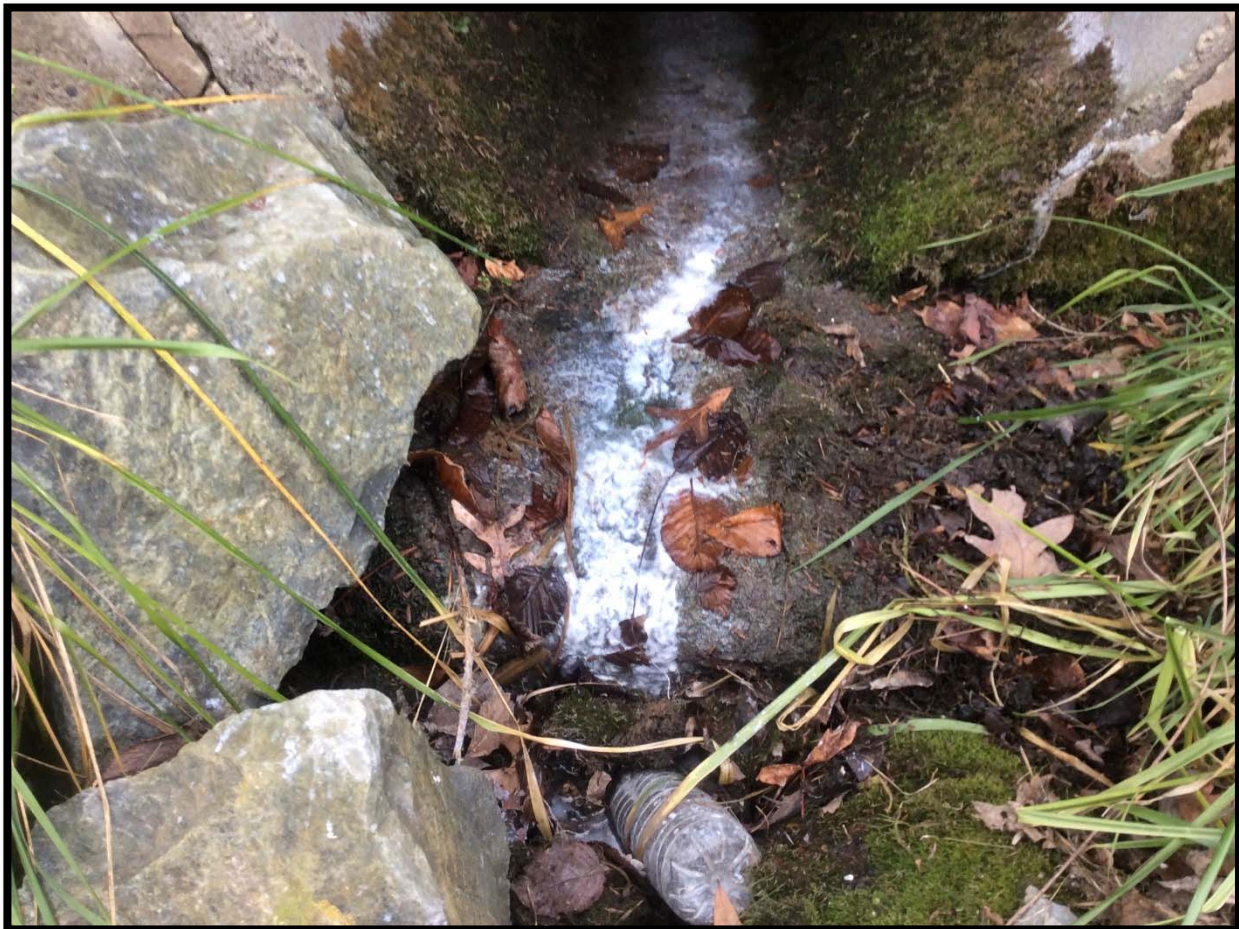
Photo of discharge:

INCIDENT INFORMATION		
Incident Report #: 21/2017-18	Date : 12/8/2017	Time : 3:00 PM
Business : Residential	Report Completed By : Prem Poudel	
Address: 18878 Pier Trail Drive	City : Triangle, VA	Zip Code: 22172
Case Detail: Prince William County (PWC) Environmental Services Staff Gillespie, Daniel observed a white stain at outfall on 12/8/2017.

Responsible Party (Owner/ Institutions)	Other Party (Management Company)
Name: NA	Name:
Company:NA	Company:
Address:NA	Address:
Phone #: NA	Phone #:
Note:	Note:
Notification/Contact (Other agencies contacted (DEQ, NS, FMO?))	
Date:	Date:
Time:	Time:
Name:	Name:
Company/Agency:	Company/Agency:
Notes:	Notes:
<u>Comments/ Deficiencies:</u>	
<p>Upon arrival, white stain observed at the bottom concave of outfall 57896 on 12/8/2017. The white stain was wet and possible to collect sample for laboratory test. Disperse white stain was observed on Riprap placed around outfall. Tracking had complited but there was no evidence of spill at upstream successive manhole located at 30 feet from the outfall. Tracking had complited upto upstream possible dumping points but signs of dumping did not find. There was no adverse effect on grass and pond.</p>	
<u>Conclusion:</u>	
Follow up inspection will continue for further investigations.

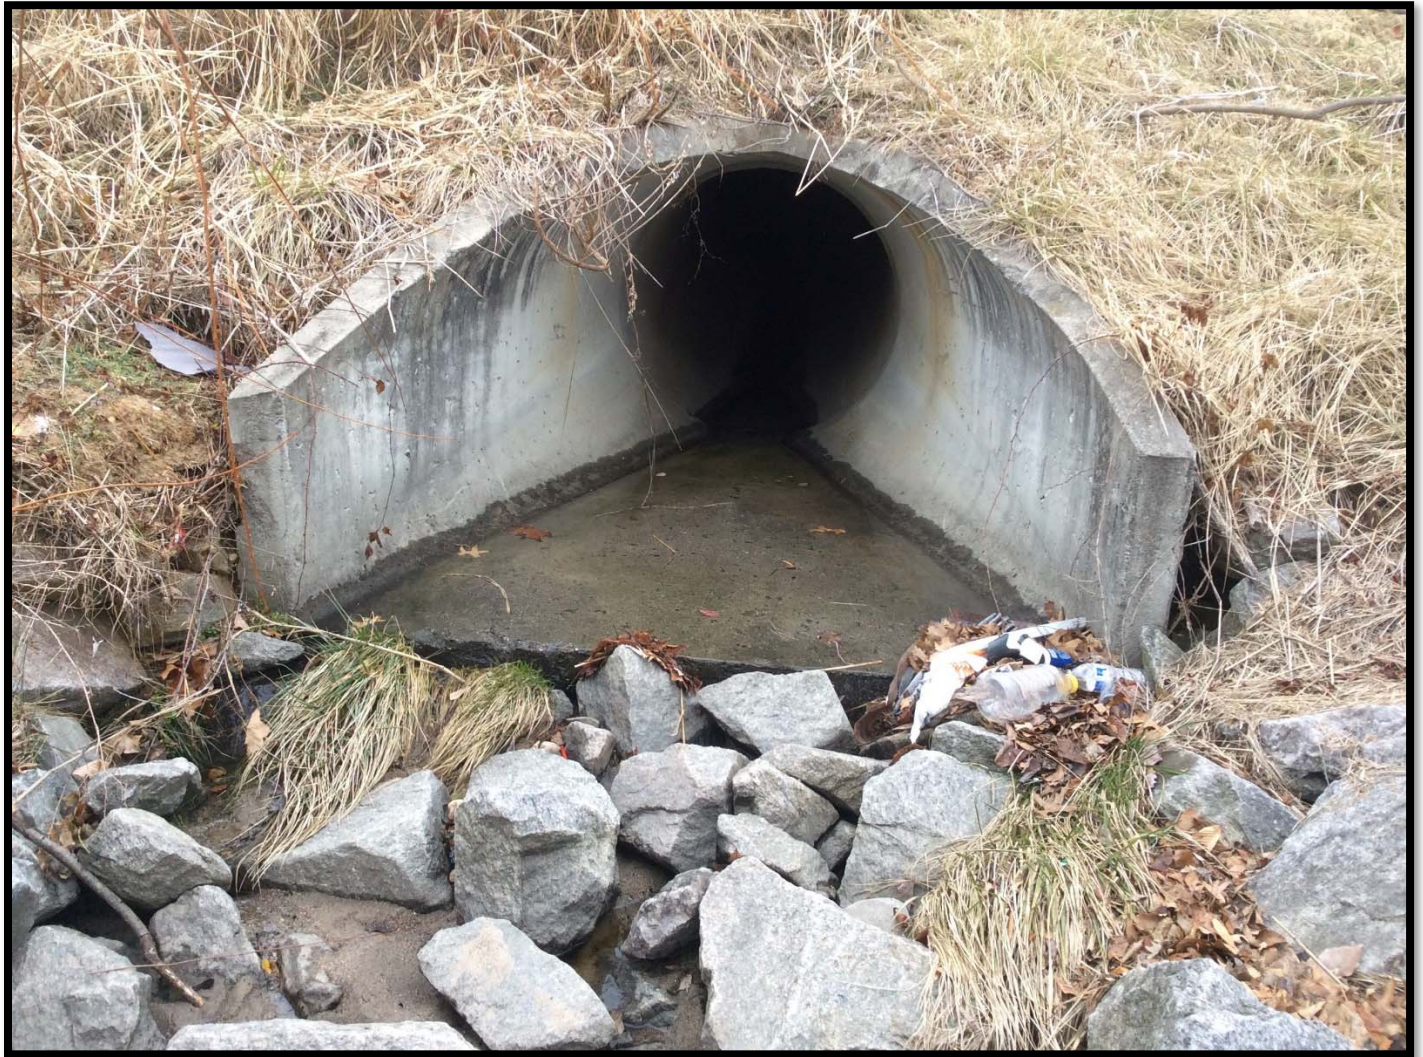
Photo of discharge:

INCIDENT INFORMATION		
Incident Report #: 28/2017-18	Date : 2/6/2018	Time : 9:45 AM
Business : Residential	Report Completed By : Prem Poudel	
Address: 15601 Forest Grove Drive	City : Woodbridge, VA	Zip Code: 22191
Complain or Case Received From: PWC Watershed staff got an anonymous complaint regarding dumping asphalt tar into storm water system in Armitage Court on 2/5/2018.

Upon arrival, reported asphalt tar discharge did not find into storm water system except a dry petroleum stains on parking lot in front of inlet. Storm sewer system had tracked from complaint points "A". Manhole lid could not open at A, since lid did not detached with frame. Very negligible flow observed at manhole "B". At Manhole "C", discharge observed from CB and CD branches but Manhole D was dry. In downstream sewer, flow observed along sewer CEF GHJ and released through outfall 53843 into SWMP 5725. The discharge was clear with no color and odor with standard pH and Conductivity. The ground was moist due to rainfall happened prior field investigations. Discharge supposed to generate due to ground seepage.

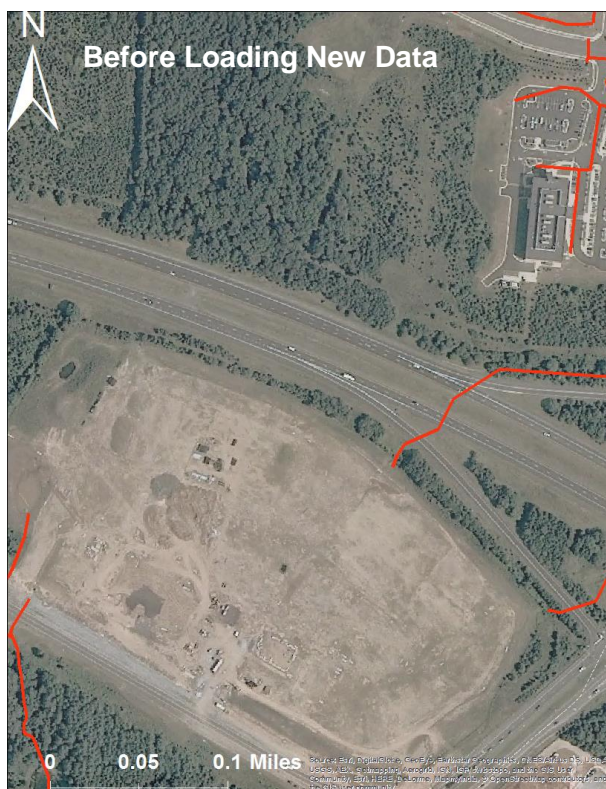
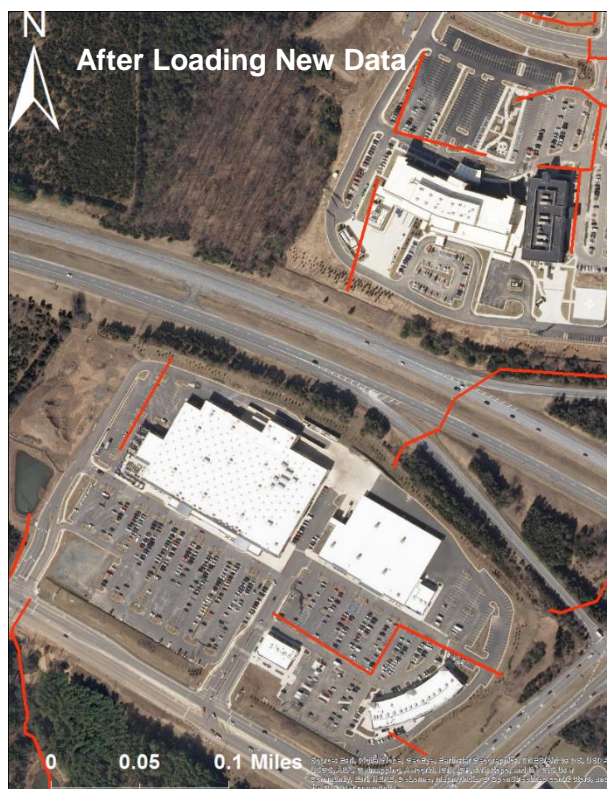
Figure 8. Depicts post-2009 development along Highway 15 and I-66 in Haymarket, VA. The image on the left shows the location in 2009, while the image on the right shows the area in 2015 after loading the new data into the Amec Single Network. Newly added segments still require editing to create a hydrologic connection. Editing procedures for creating this hydrologic connection are described below.

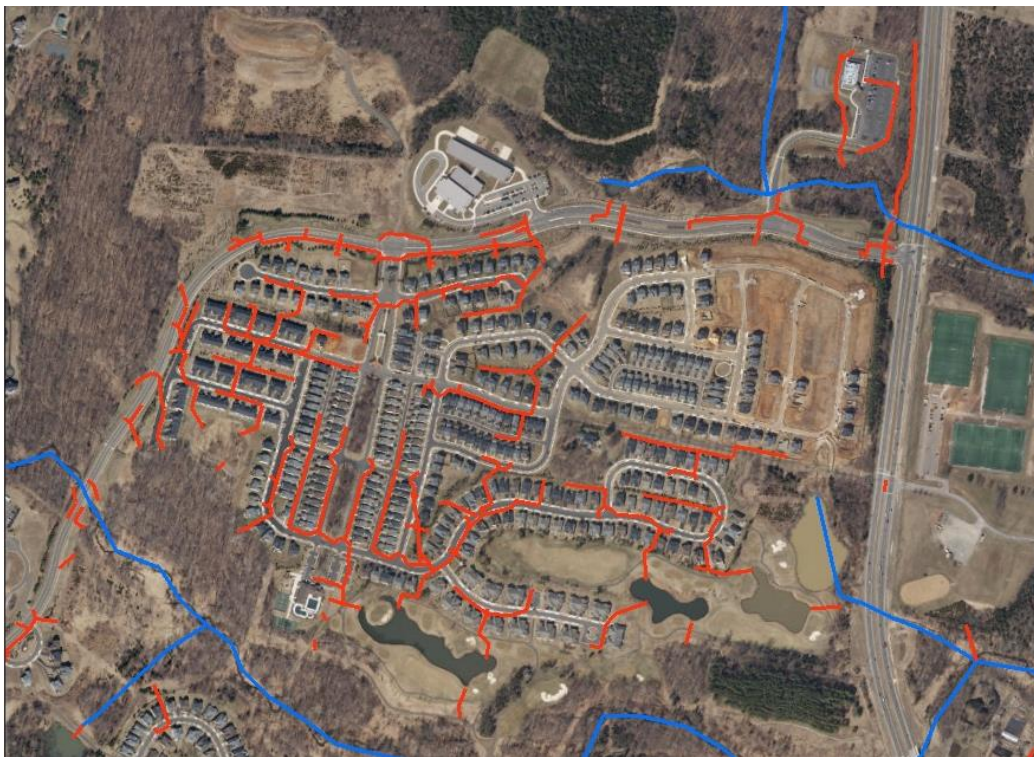
Figure 9. This view shows what the user would see after loading in a new set of stormwater infrastructure into the geodatabase. MS4 outfalls and hydrologic connections still need to be added by the user. Note the stormwater infrastructure is a discontinuous network within itself, but also lacks continuity with the NHD Flowlines.

Consider the position of the BMP within the stormwater drainage network. There are two stormwater pipes draining to the pond, with flow direction heading south. This infrastructure will be connected at a later step, but for now we are concerned with assigning the outfall at the terminus of this system. Examining the NHD confirms that flow is draining south of the BMP, and an outfall is added (Figure 9).

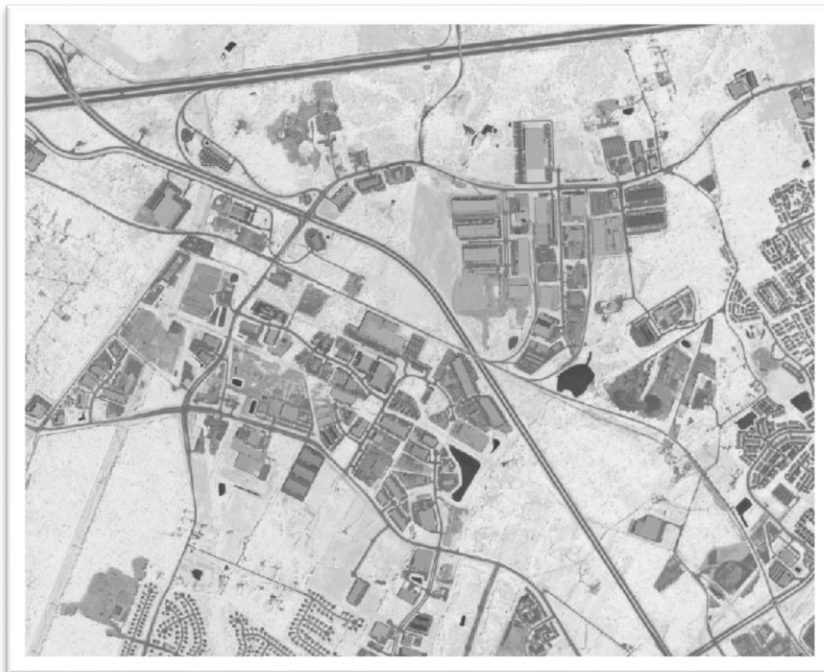
the way chlorophyll reflects energy in the near infrared band by using band math which results in a new raster data set with pixels containing values ranging from -1 to 1. Pixels with values closer to 1 represent vegetation, while those closer to -1 are non-vegetation.

(NDVI Result showing vegetation and non-vegetation)
