Annual Stormwater Management Report

VSMP Permit No. 0088595 – FY 2018

Submitted by:
Prince William County
Department of Public Works

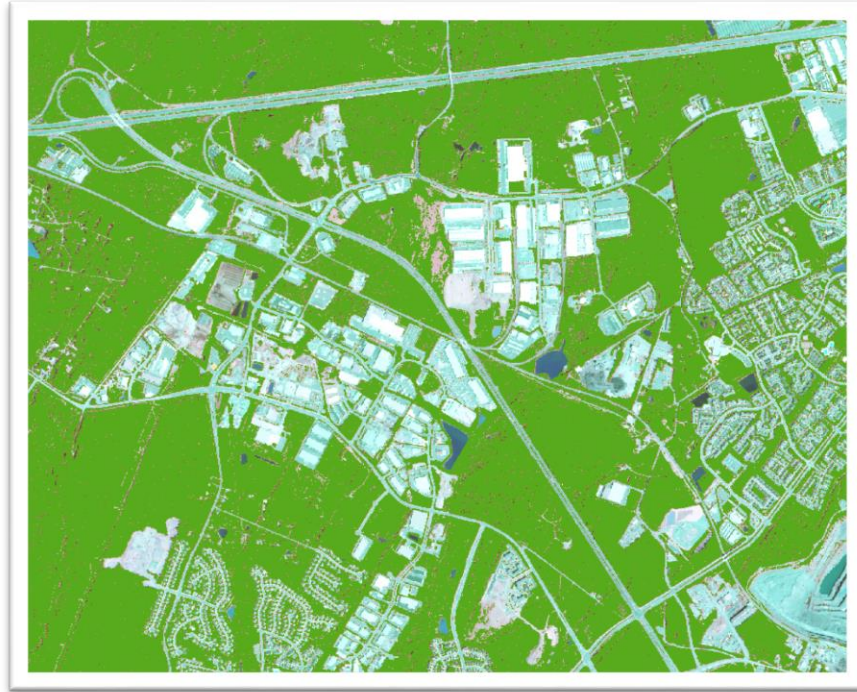
The NDVI result was then reviewed to locate the correct threshold where a representative split between vegetation and non-vegetation could be identified. Once determine, the NDVI dataset was rendered to a 2-class result, where vegetation pixels were utilized as an analysis mask where tree canopy could be identified. The threshold was set a bit higher for this study since trees tend to reflect much higher values (i.e. much closer to 1) given their height and foliage. This result also reduces false detections within open fields, dry grasslands, and shorter shrub areas:

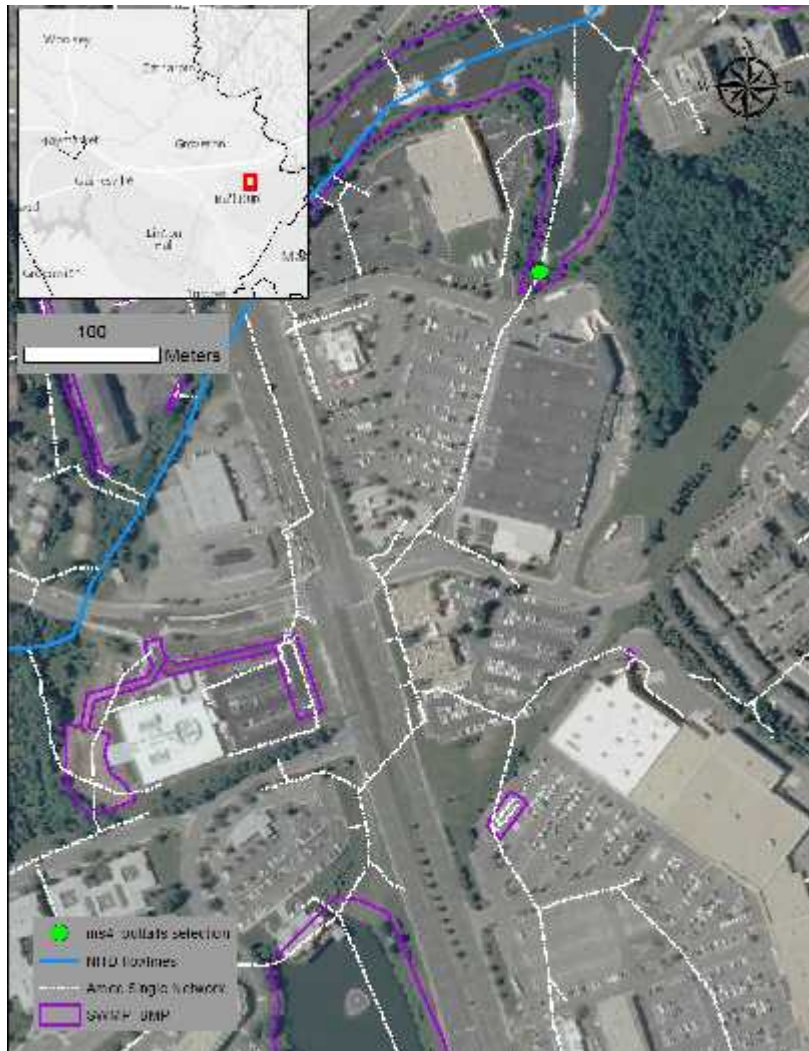
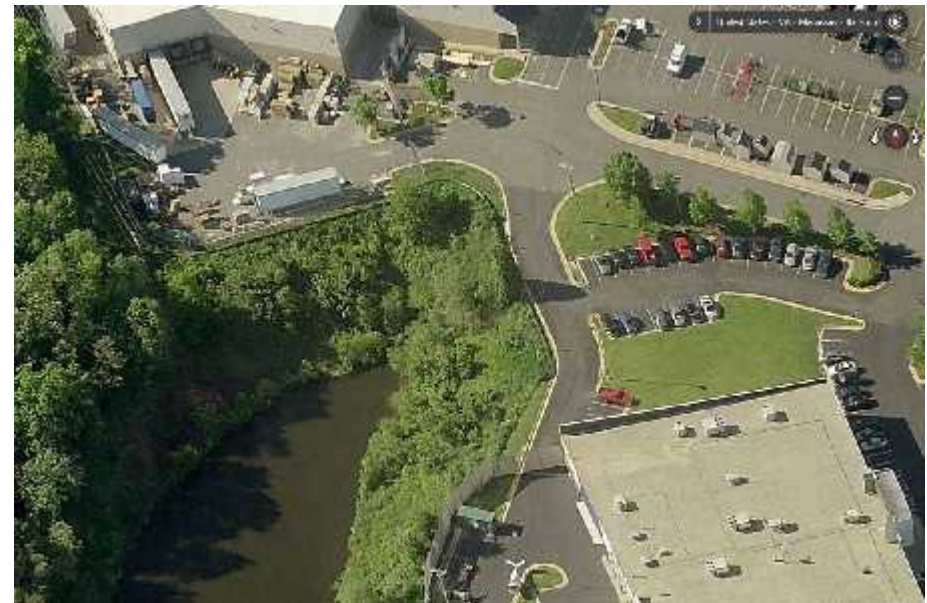
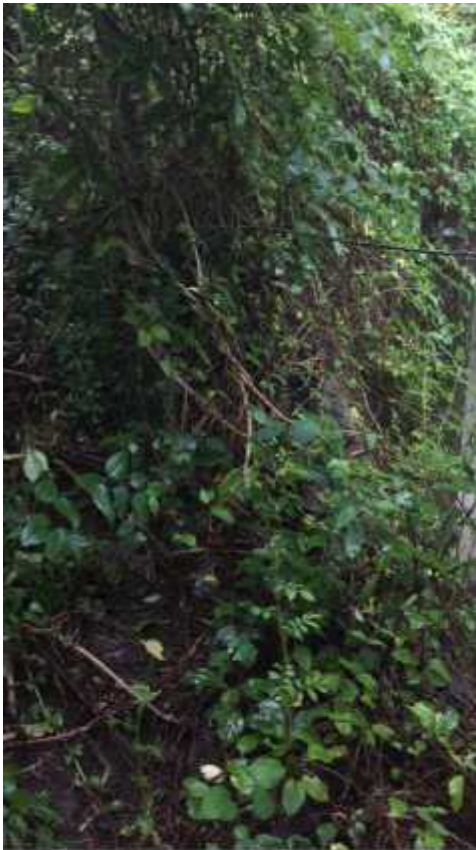
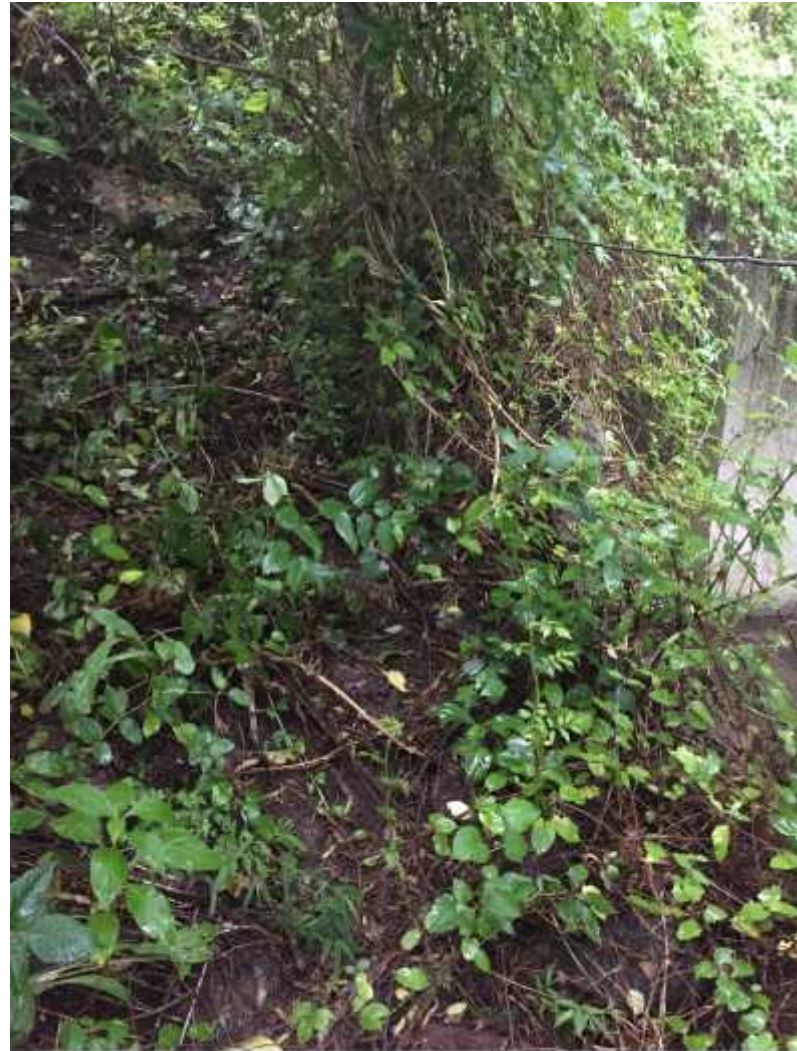
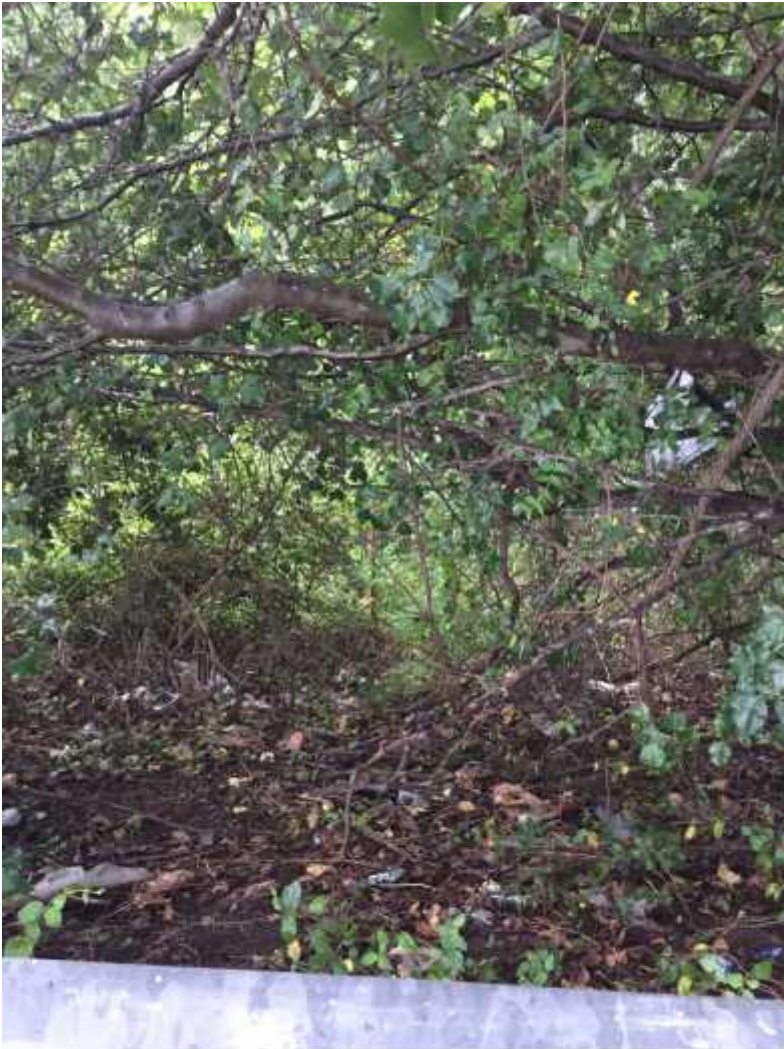
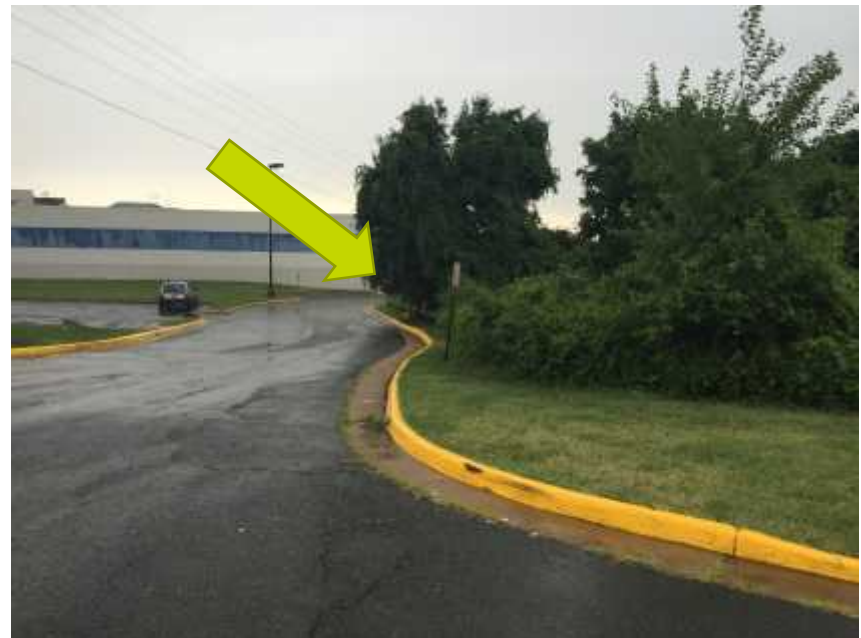
#684: Bull Run, Lowes Parking Lot

- 84" x 54" box culvert
- Contribution from upstream BMP
- ~1" flow during storm (7/18)
- Low visibility, steep slopes

Access: Difficult

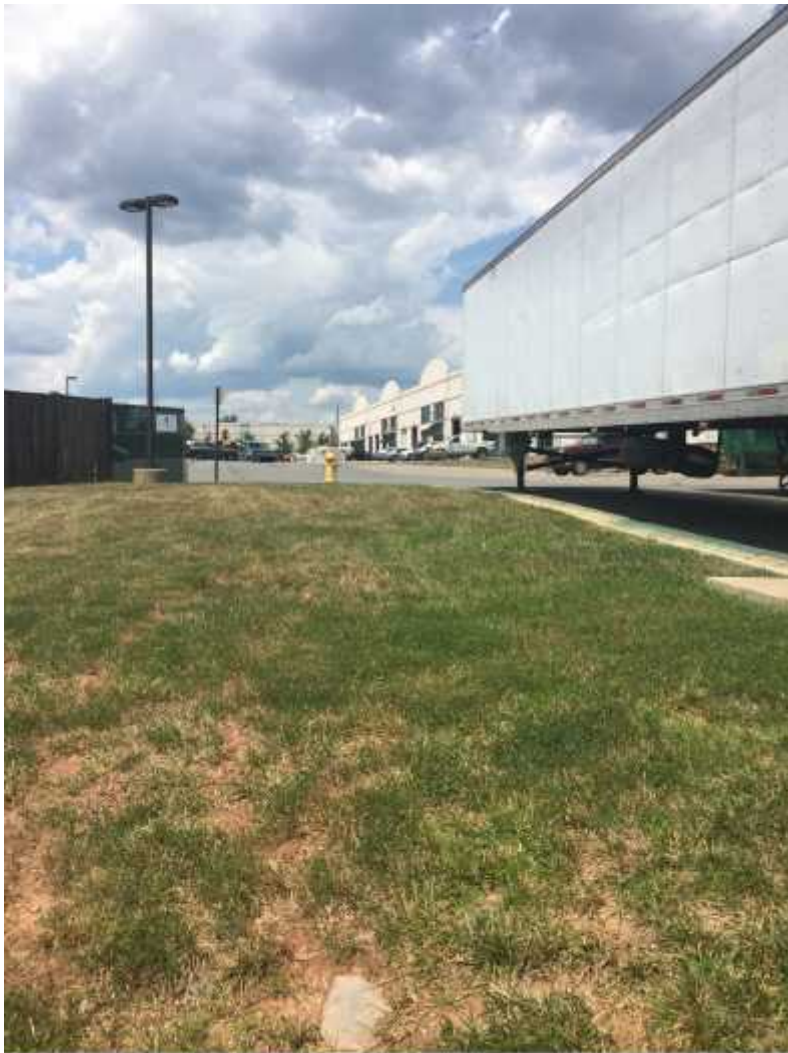
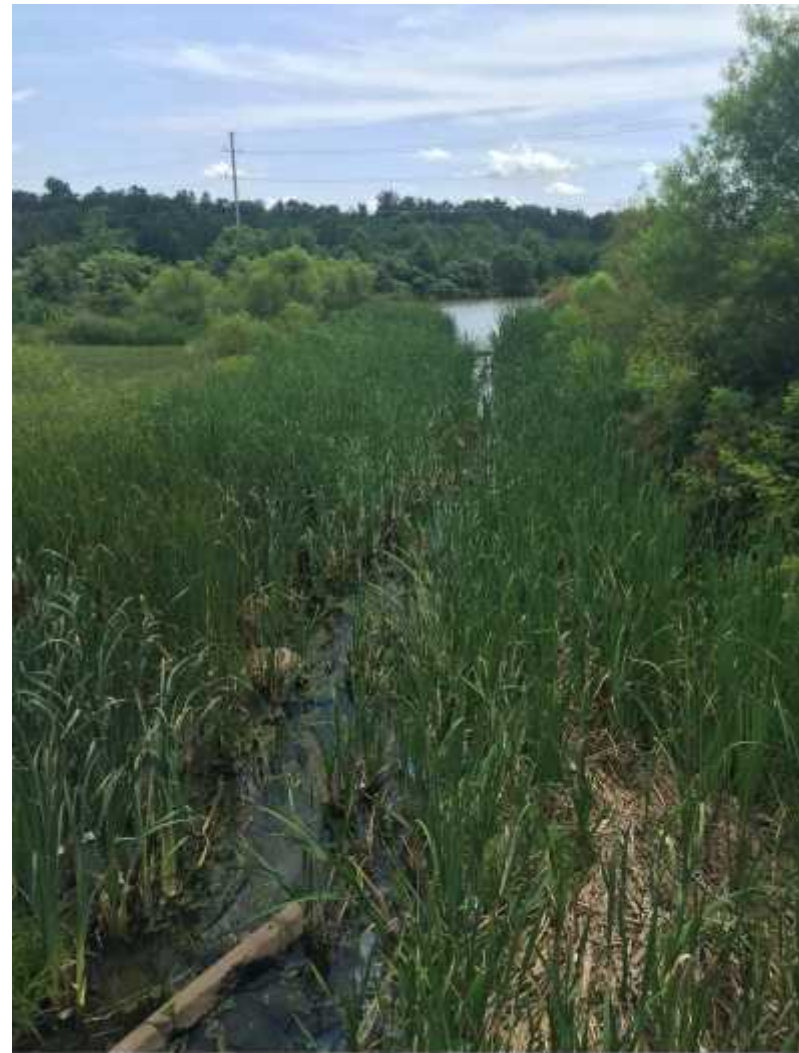
#941: Bull Run, Prince Wm. Parkway

- **54" concrete pipe**
- **Signs of recent repair**
- **1/4" water, level with spillway**
- **Debris in spillway**

Access: Easy

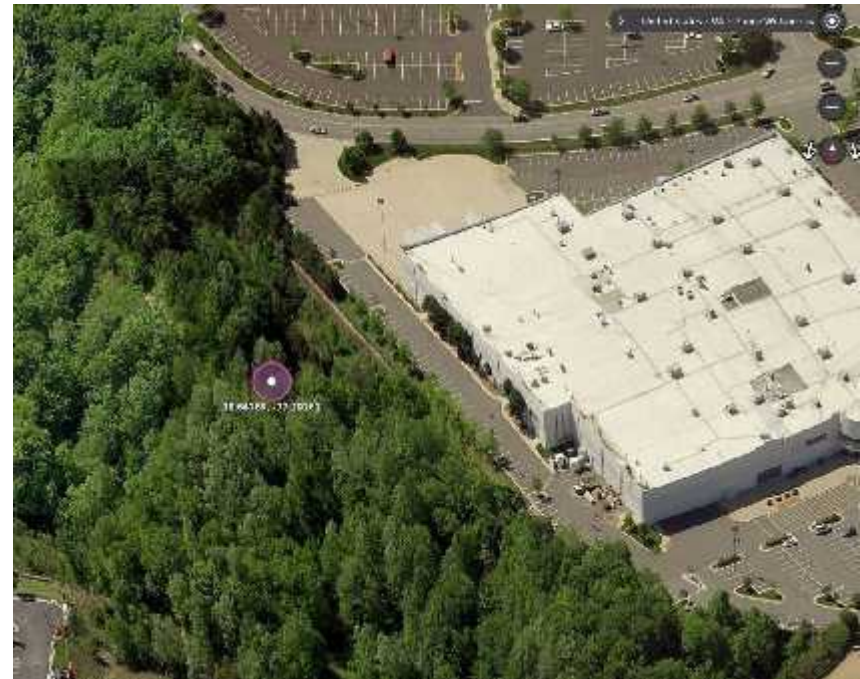
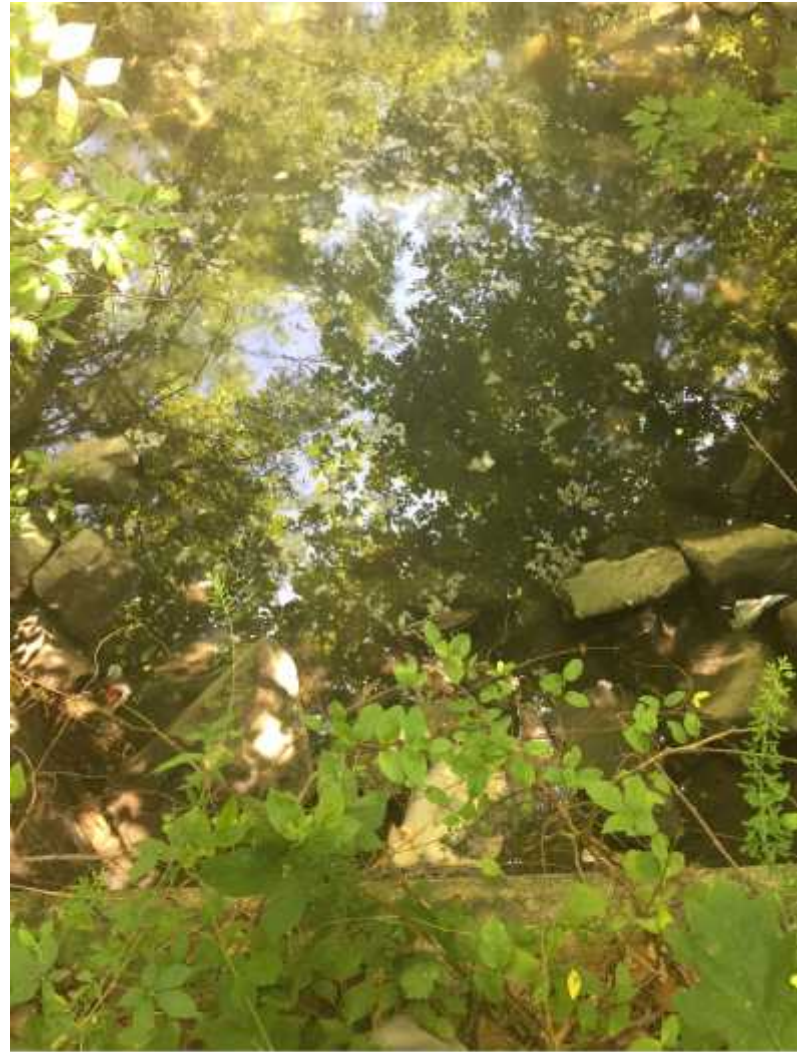
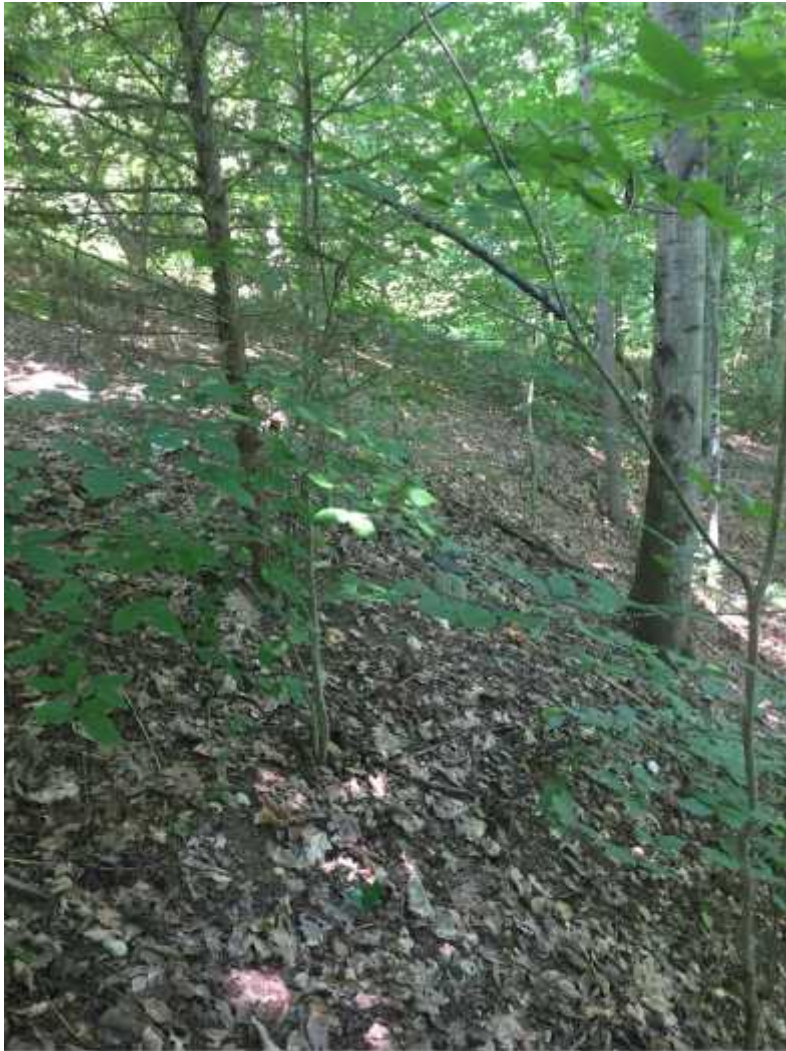
#3471: Woodbridge, Potomac Mills

- 84" concrete pipe
- < 1/4" flow
- Signs of human presence, uncertain frequency

Access: Easy

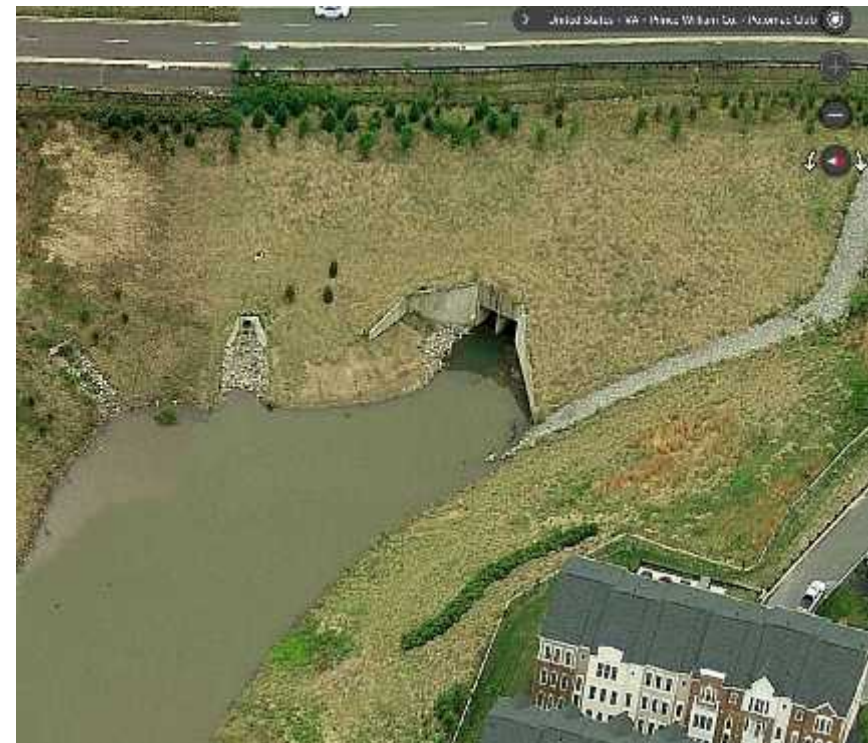
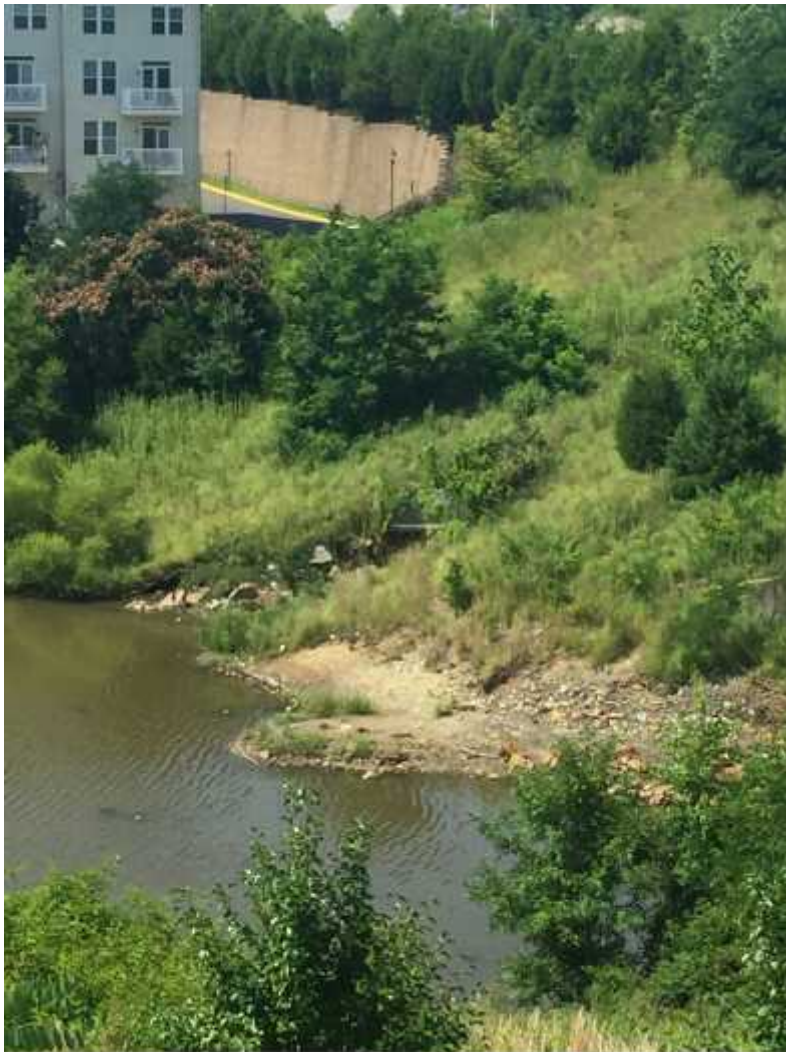
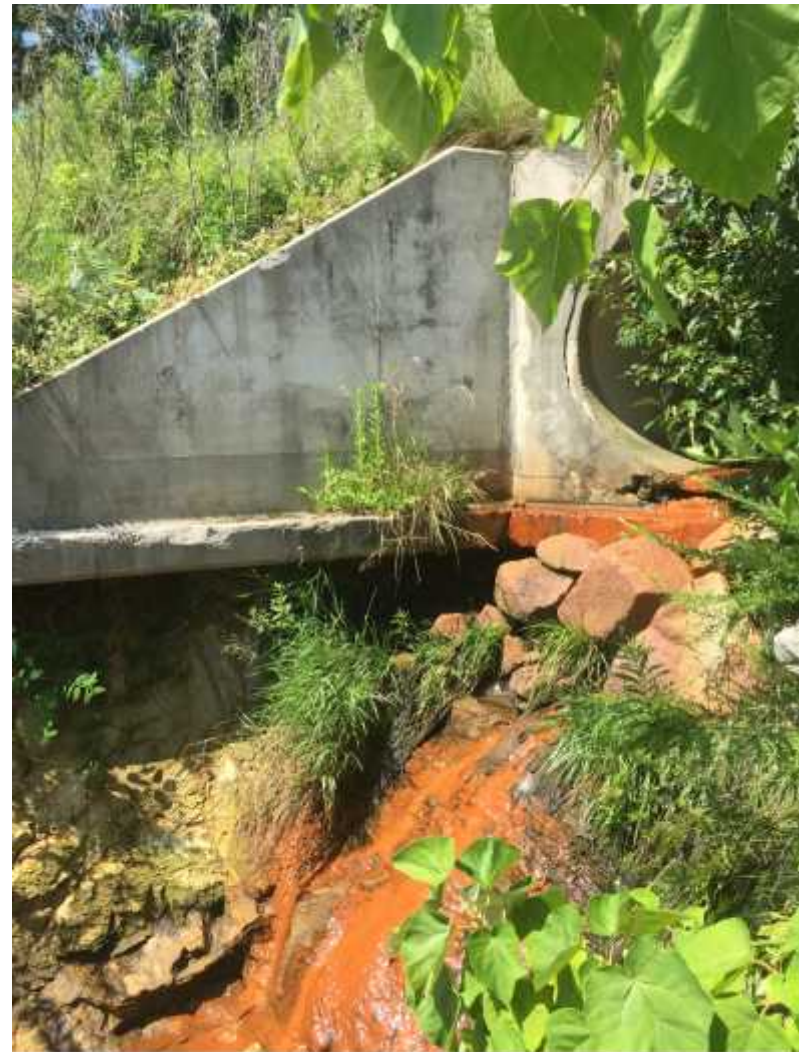
#4684: Dale City

- **54" concrete pipe**
- **Low flow draining to scour pool**
- **Steep banks surrounding outfall**

Access: Moderate

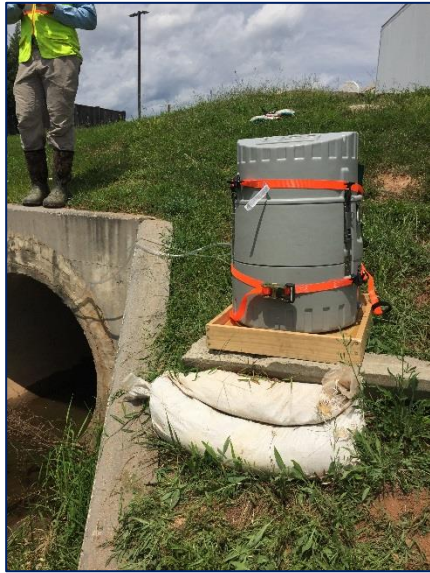
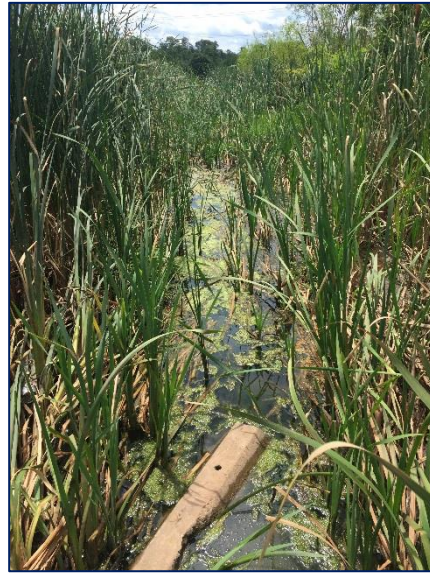
The site is located at the Bull Run water treatment facility drainage for an industrial use area and parking lot. It is a frequent truck traffic outfall. Significant signs of recent repair work are visible. The area is a dry area deployed at the site under clear conditions. The time of installation for the area is a contact of more than one inch of precipitation. The four inch of standing water in the site. The site continues to accumulate in the down stream channel. It is a noticeable increase in algae growth.

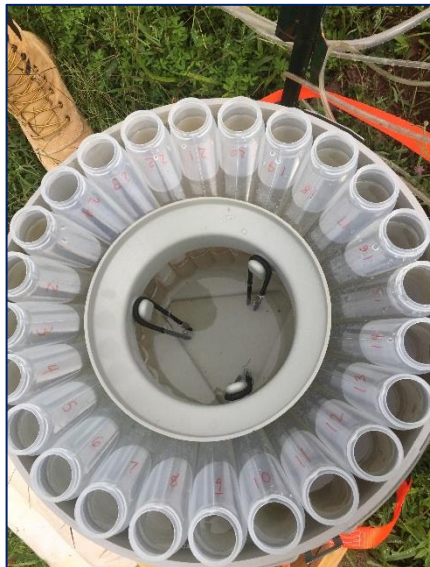
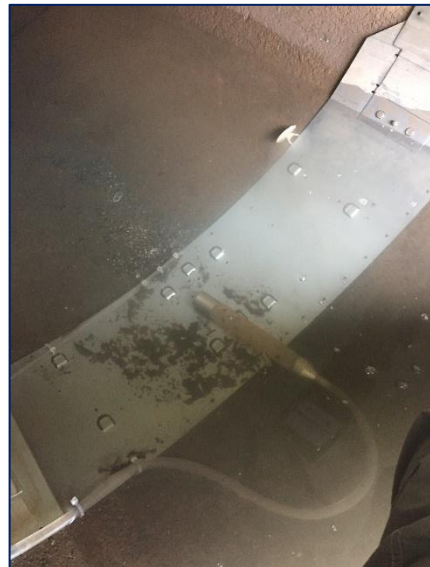
The area is slightly oily. A sample was taken in the standing water at the outfall following the storm. Not that only partial samples were collected for bottles and the results are contained in Section 4.

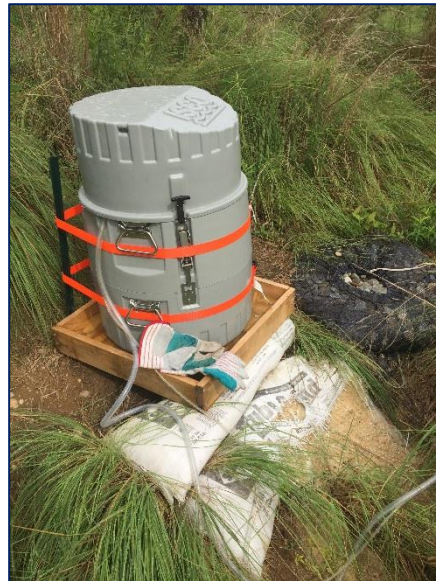
Site is located to the west of the Mill Road and the Stoneridge at Potomac town center development. It is a 54" concrete pipe that drains to a deep scour pool before draining to a large BMP that collects drainage for the Potomac watershed. The BMP is located around the outlet area and will likely require future maintenance work as a deployed at site under clear conditions. The site is in a location that is a forecast of increased precipitation and oily runoff. A recent incident in the scour pool led to iron oxidizing bacteria present in the trickling area.

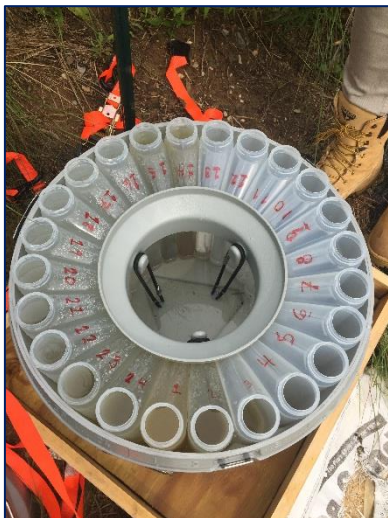
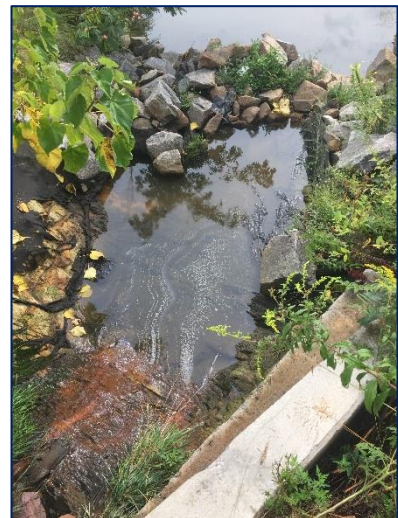
The area is located to the east of the scour pool following the storm water treatment plant. The area is a small amount of water in the scour pool and down the area. The area is not collected or bottled due to insufficient flow.

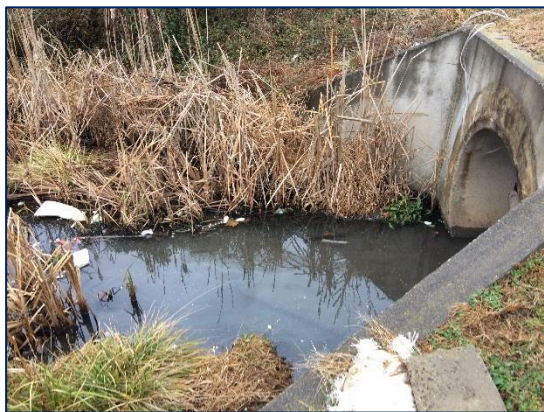
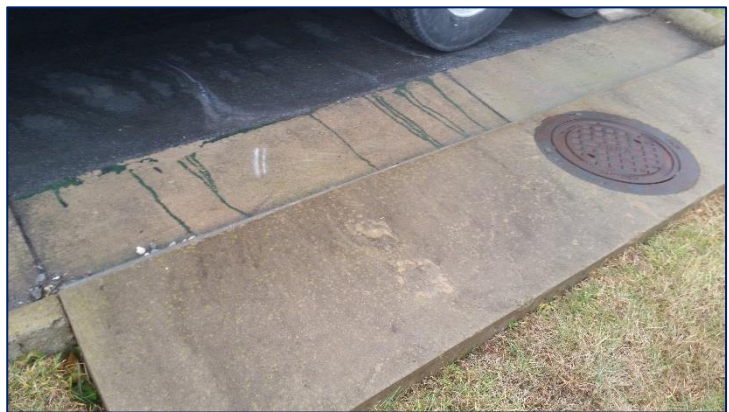
The area is slightly oily in appearance in the standing water. It is in the outfall following the storm.

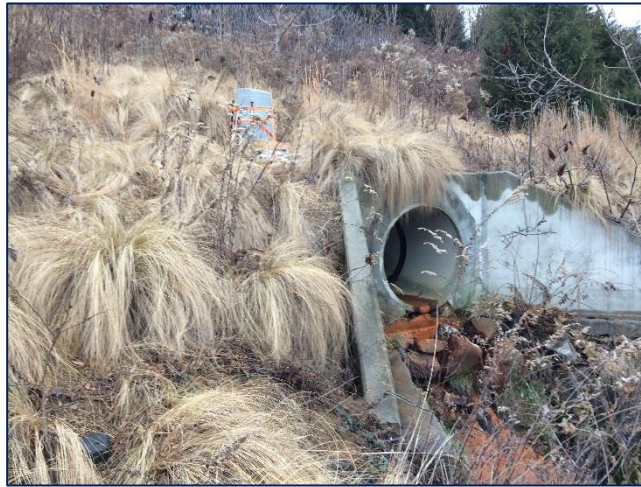
Site is located on the corner of Sacco Mill Road and Stoneridge at Potomac on the
dip side. It is a 54" concrete pipe that drains to a deep scour pool before draining to a large BMP
that collects drainage for the Potomac. It is located around the outlet area continuing
and will likely require future maintenance at the location in the retention pond downstream
from the location and after the event.

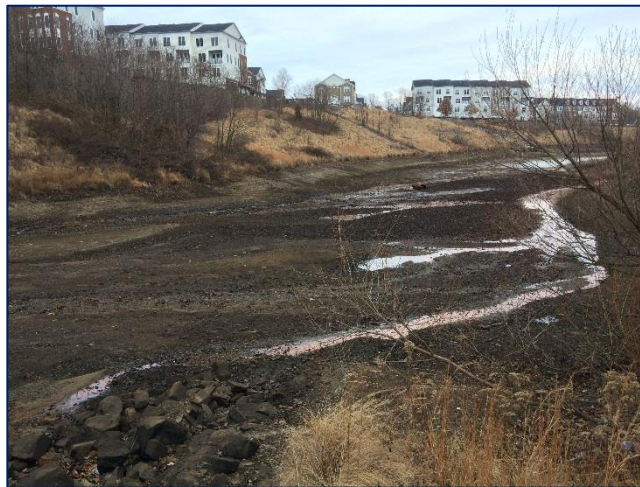
The area is located to the east of the site in the scour pool following the storm event. The
product is all around the site in the scour pool and downstream.

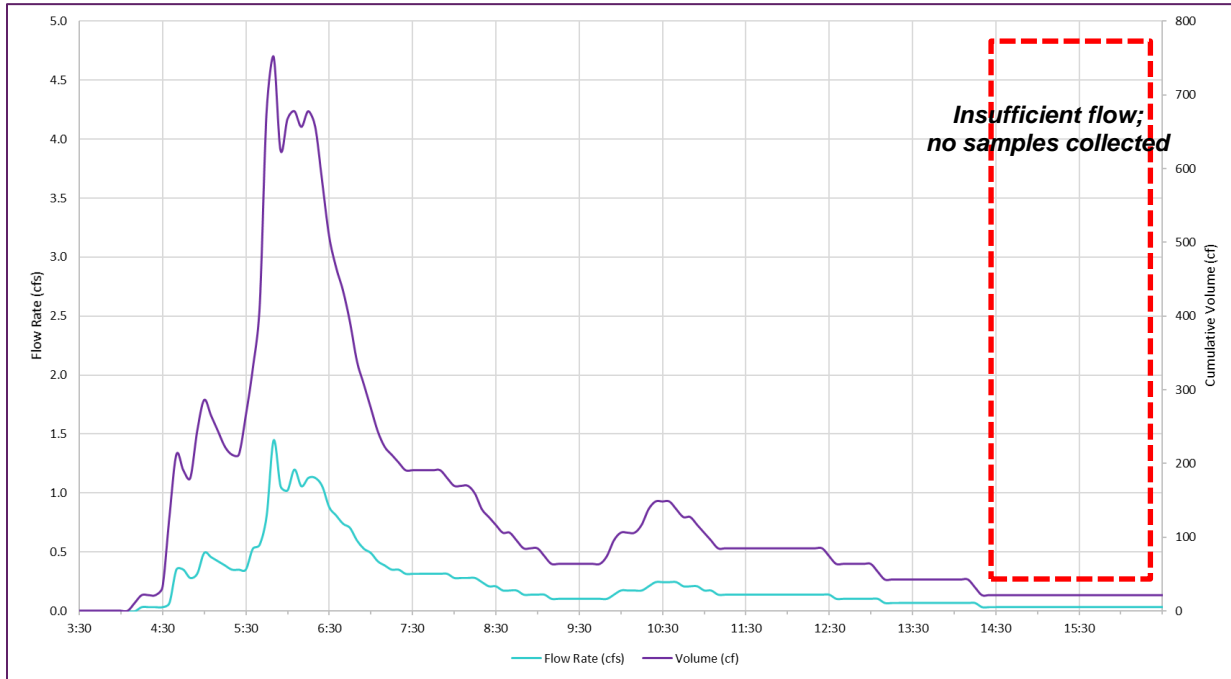
Figure 1. Flow rate data over time for the storm event at Site on January

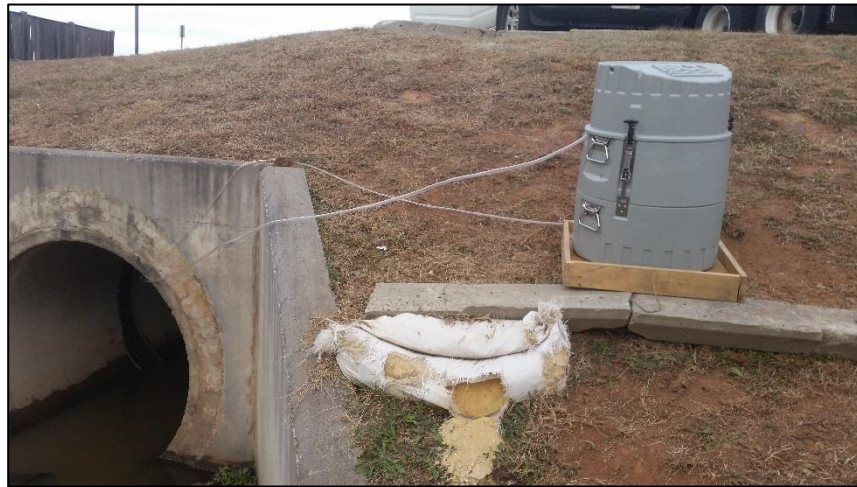
The area is slightly oily in appearance in the standing water at the site in the outfall following the storm.

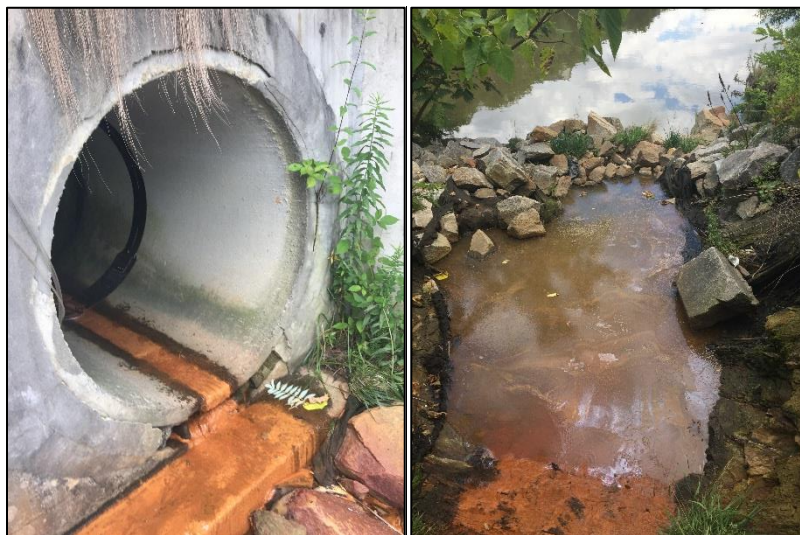
There is a continued contribution of ground water ... at the site ... identified by the apparent iron oxidizing bacteria ... and the scour pool.

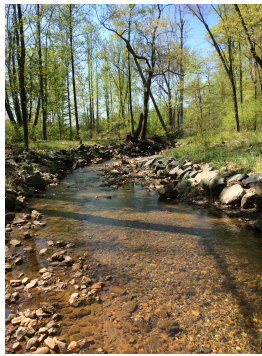
Image 2

Downstream from middle of reach

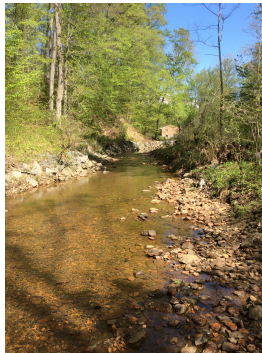
Image 3

Upstream from middle of reach

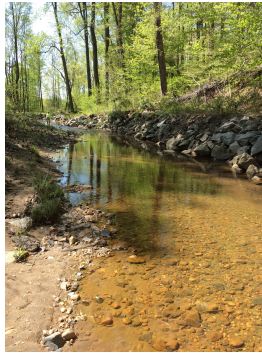
Image 4

Downstream from end of reach

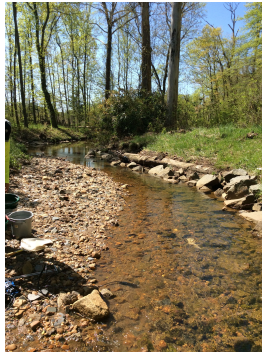
Image 5

Downstream from end of reach. Scour apparent from outfall confluence.

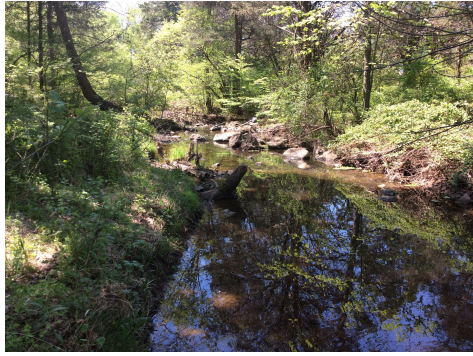
Image 1

Downstream

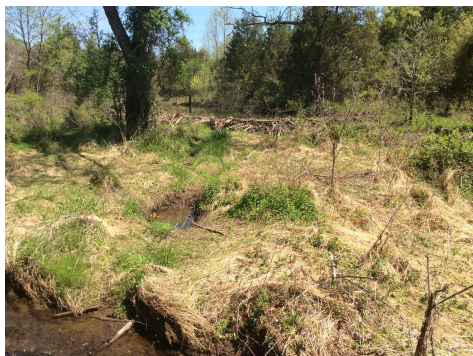
Image 3

Upstream beaver dam

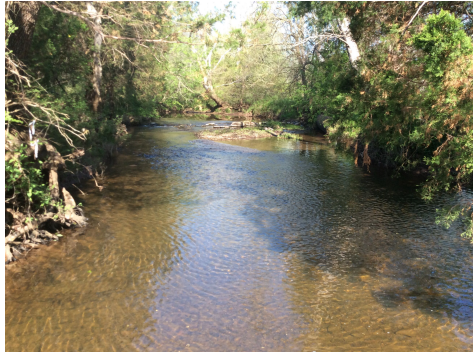
Image 1

Upstream

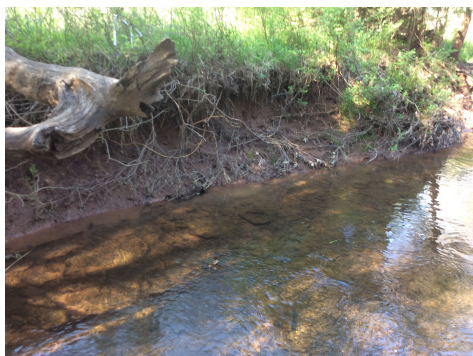
Image 4

Badly eroded bank

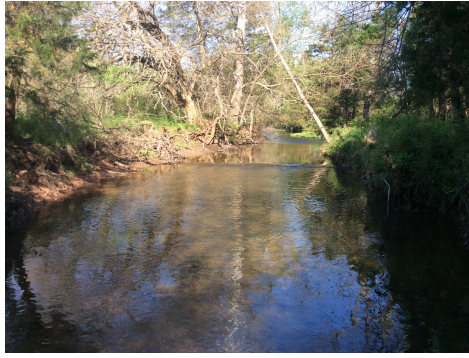
Image 5

Middle

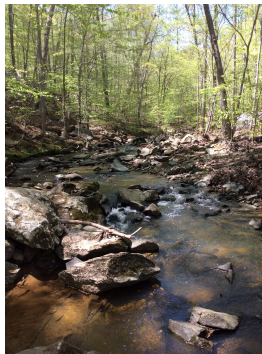
Image 2

Midway upstream.

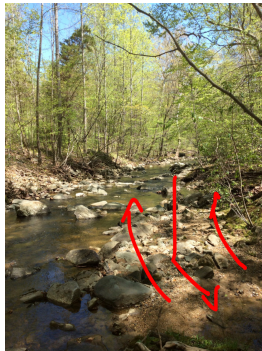
Image 3

Midway downstream. Scour from uphill outfall in foreground.

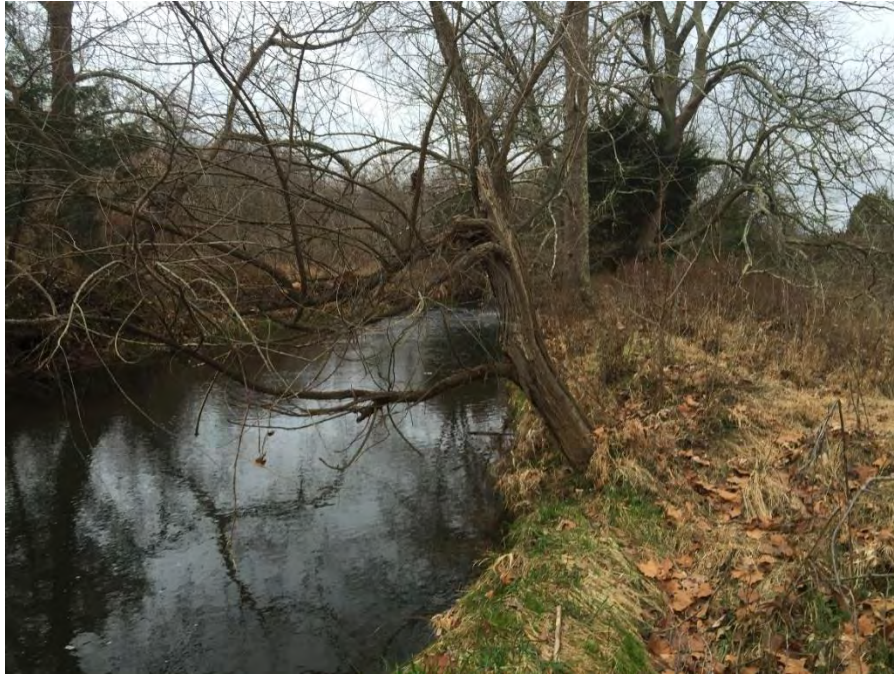
Figure 1: Backwater area created by sanitary sewer crossing. Sampling reach lies upstream.

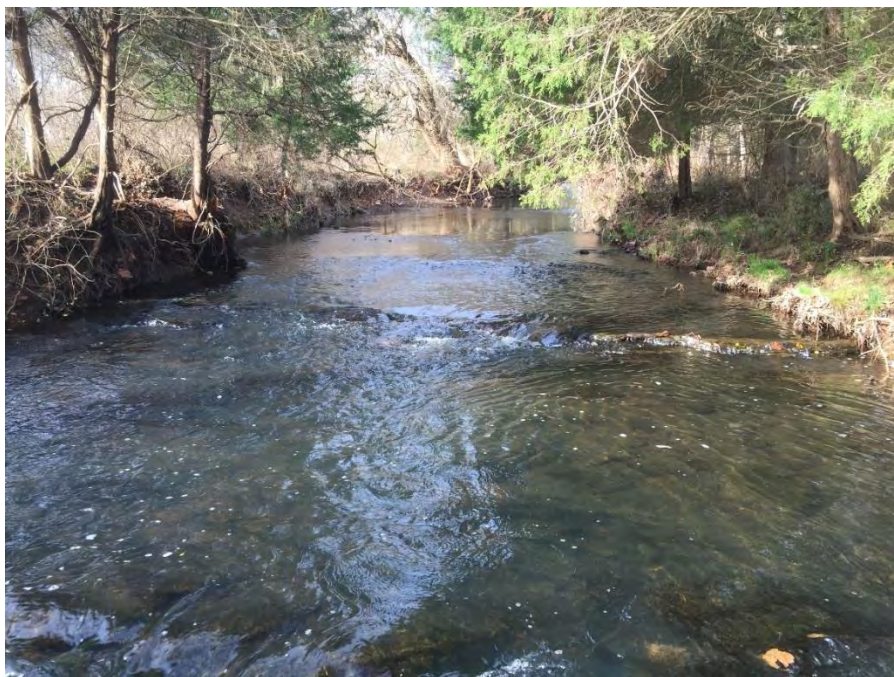
Figure 2: Looking upstream at beginning of sampling reach along the riffle consisting of larger gravel, cobble, and bedrock.

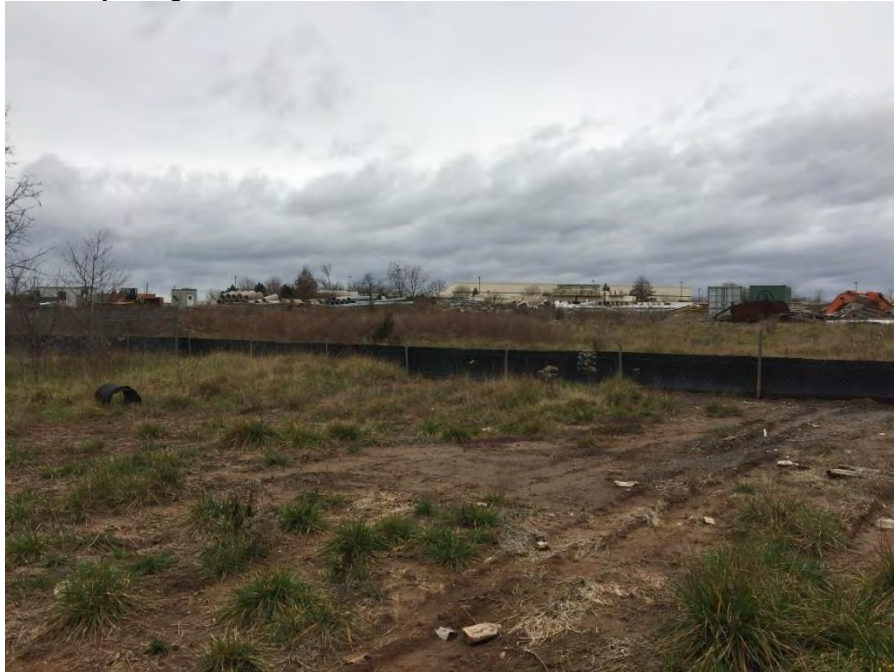
Figure 8: Construction contractor storage site adjacent to stream reach. Site was contributing noticeable amount of silt to stream.

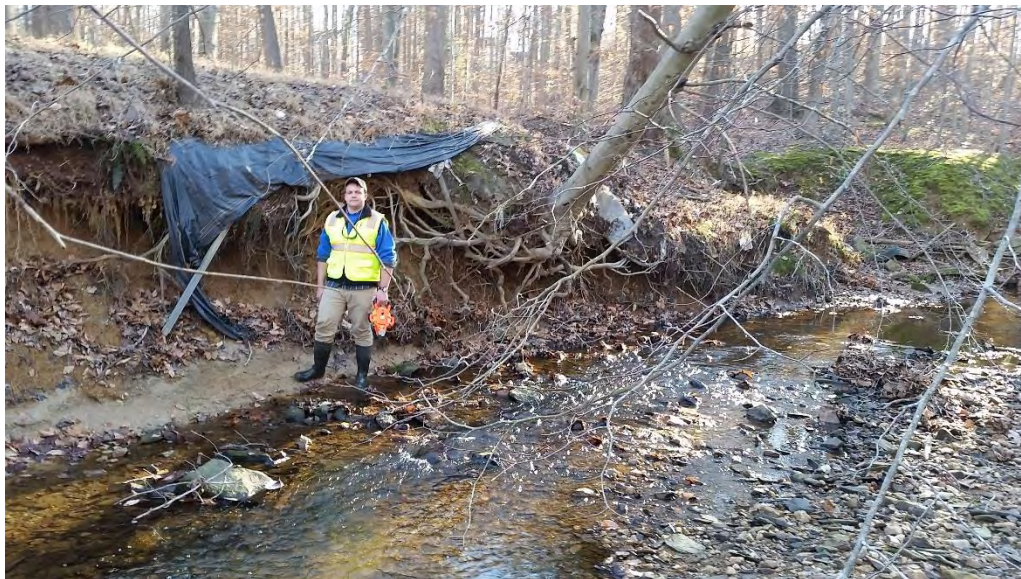
Figure 9: Stream bank incision >6 feet (vertical instability) from bed. Photo was taken downstream from sampling reach.

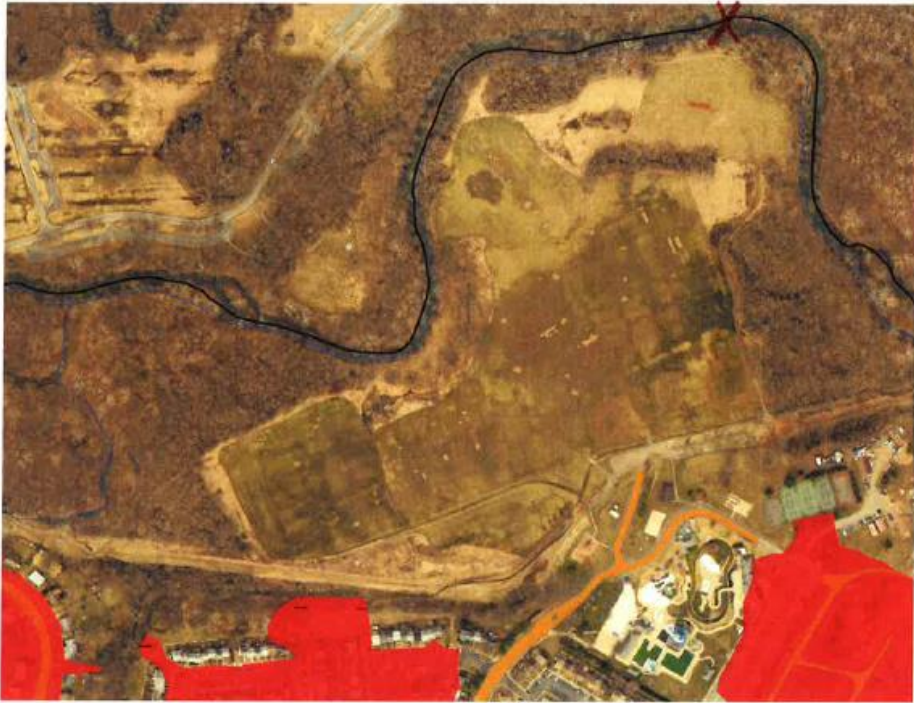
Site 1: Bull Run, Ben Lomond Park

Quality of upstream MS-4 outfalls: No quality upstream outfalls [0]
Upstream land uses: Residential, some commercial [2]
Opportunity to reduce floatables sources: _____ []
Access and feasibility: _____ []
Size of contributing drainage area(s): Large >10ac [3]

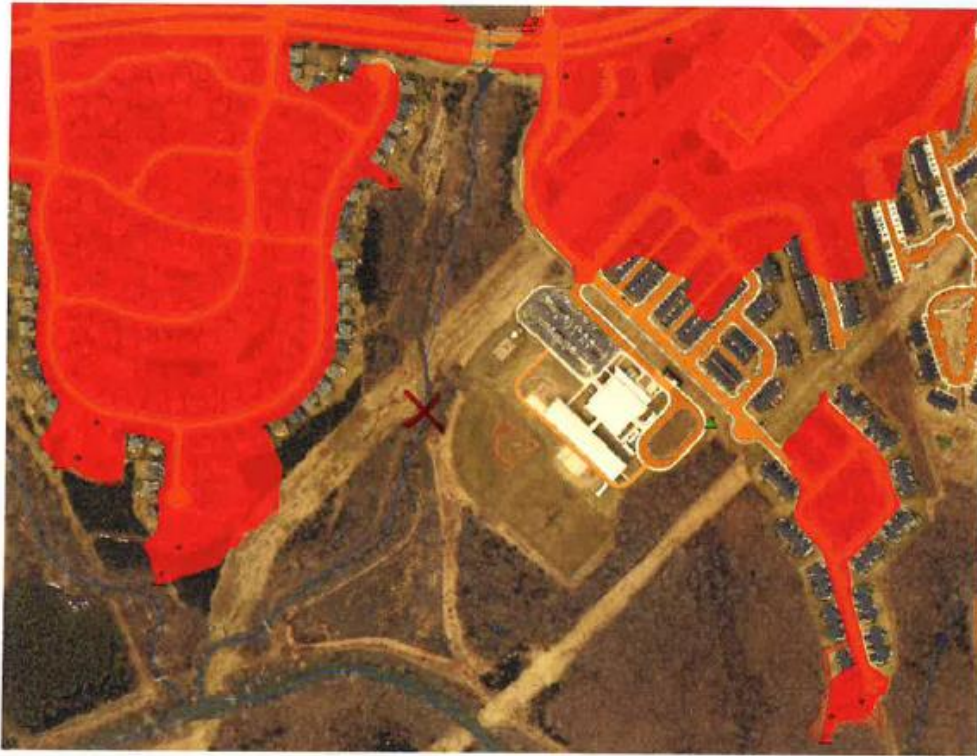
Site 3: Dawkins Branch, Victory Elementary School

Quality of upstream MS-4 outfalls:	<u>2 quality outfalls</u>	<u>[3]</u>
Upstream land uses:	<u>Residential, Schools, Roadway</u>	<u>[3]</u>
Opportunity to reduce floatables sources:	<u>Some floatables, limited But excessive sources</u>	<u>[4]</u>
Access and feasibility:	<u>Path allows easy access, Lotwork access good</u>	<u>[5]</u>
Size of contributing drainage area(s):	<u>Med. large</u>	<u>[3]</u>

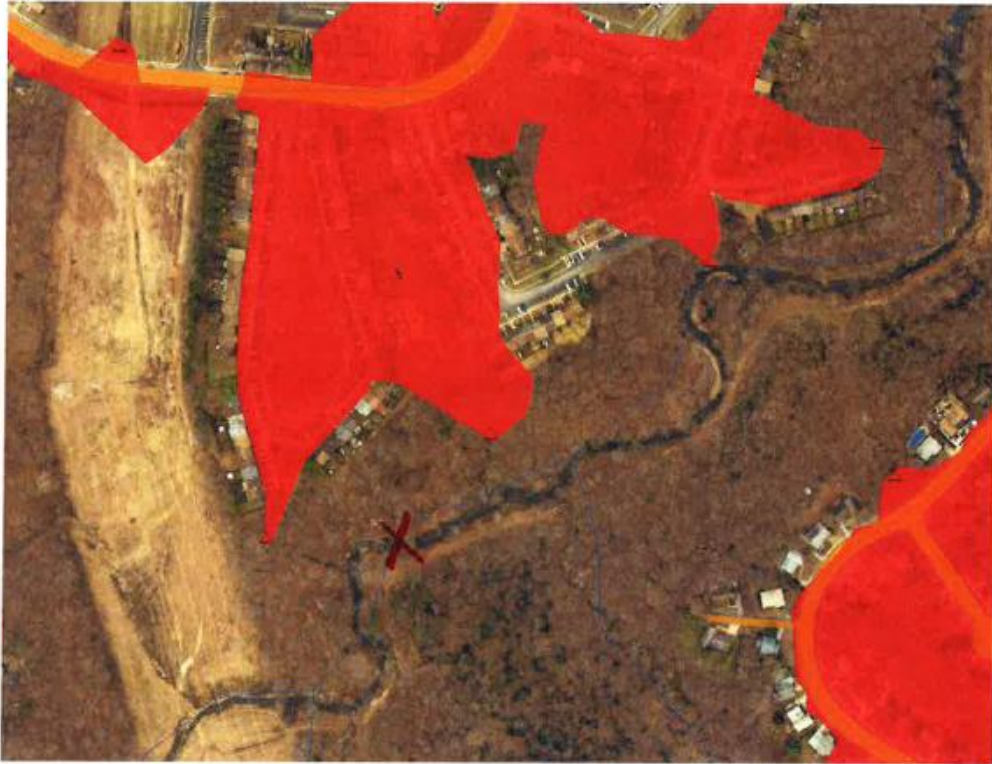
Site 5: Hoes Run, Castile Court

Quality of upstream MS-4 outfalls:	<u>2-3 quality outfalls</u>	[3]
Upstream land uses:	<u>Residential,</u>	[2]
Opportunity to reduce floatables sources:	<u>good amount of trash identifiable sources</u>	[4]
Access and feasibility:	<u>Neighborhood w/ little parking, hill difficult</u>	[2]
Size of contributing drainage area(s):	<u>Medium</u>	[2]
