Annual Stormwater Management Report

VSMP Permit No. 0088595 – FY 2018

Submitted by:
Prince William County
Department of Public Works

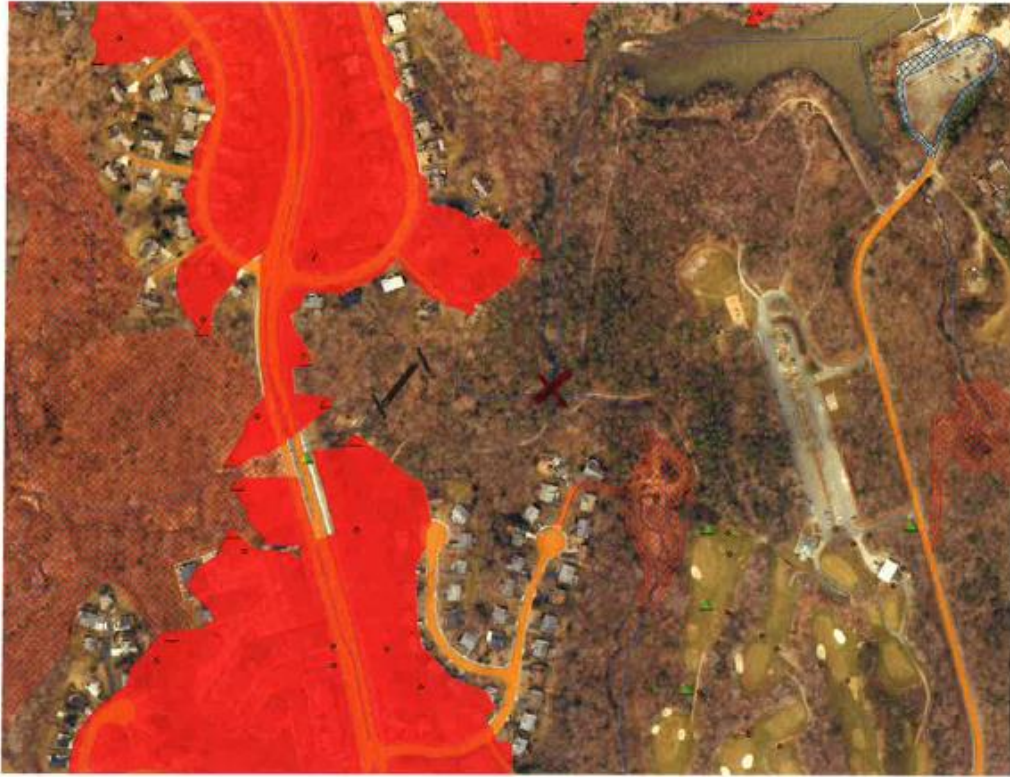
Site 6: Hooes Run, Springwood Drive

- Quality of upstream MS-4 outfalls: 3 quality outfalls [3]
Upstream land uses: Residential [2]
Opportunity to reduce floatables sources: little to no trash [2]
Access and feasibility: hilly area to descend, path helps access [3]
Size of contributing drainage area(s): med-large [3]

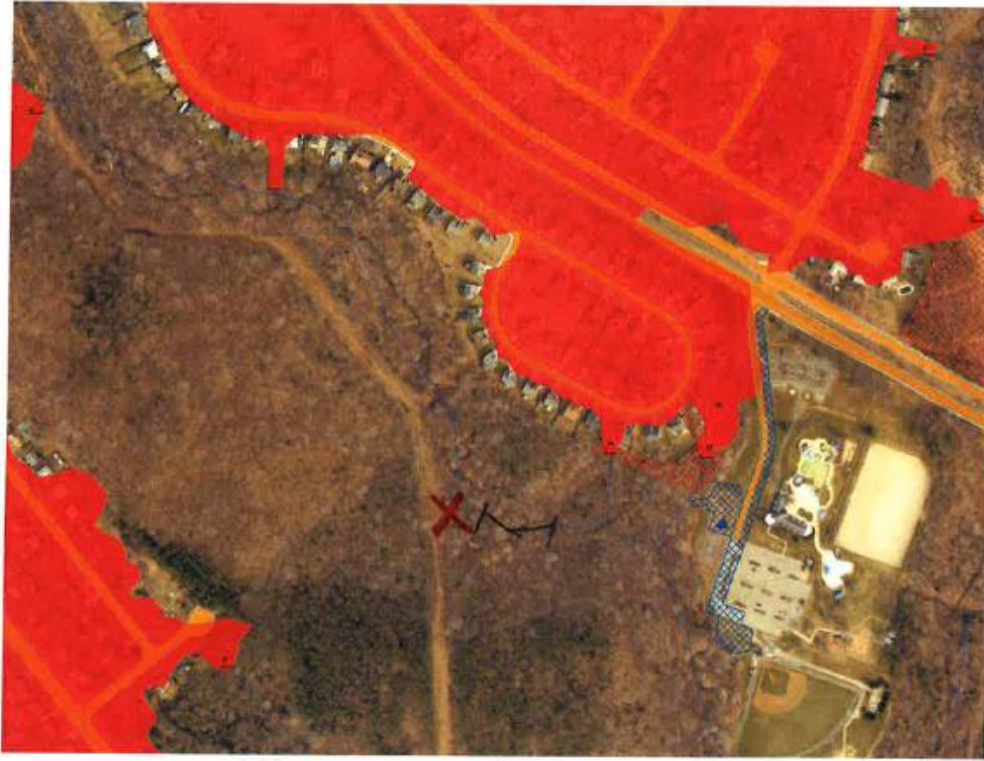
Site 7: Neabsco Creek, Andrew Leitch Park

Quality of upstream MS-4 outfalls: 2 quality outfalls [2]
Upstream land uses: Residential small lot [3]
Opportunity to reduce floatables sources: Low numbers of floatables [4]
Access and feasibility: good access, too few inputs good isolated inputs [10] [5]
Size of contributing drainage area(s): Small - mid [4]

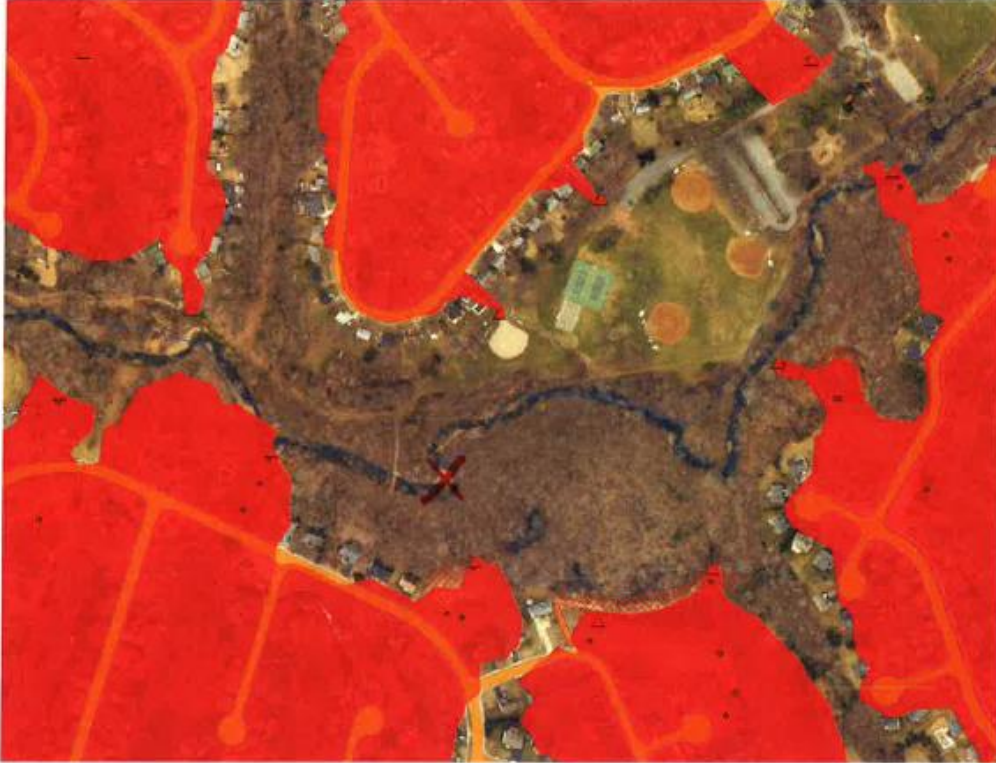
Site 8: Neabsco Creek, Cloverdale Park

Quality of upstream MS-4 outfalls: 2-3 quality [3]
Upstream land uses: Residential [2]
Opportunity to reduce floatables sources: would be difficult to ID sources, little amount of trash [2]
Access and feasibility: long way from parking, wide deep channel [2]
Size of contributing drainage area(s): Med-Large [3]

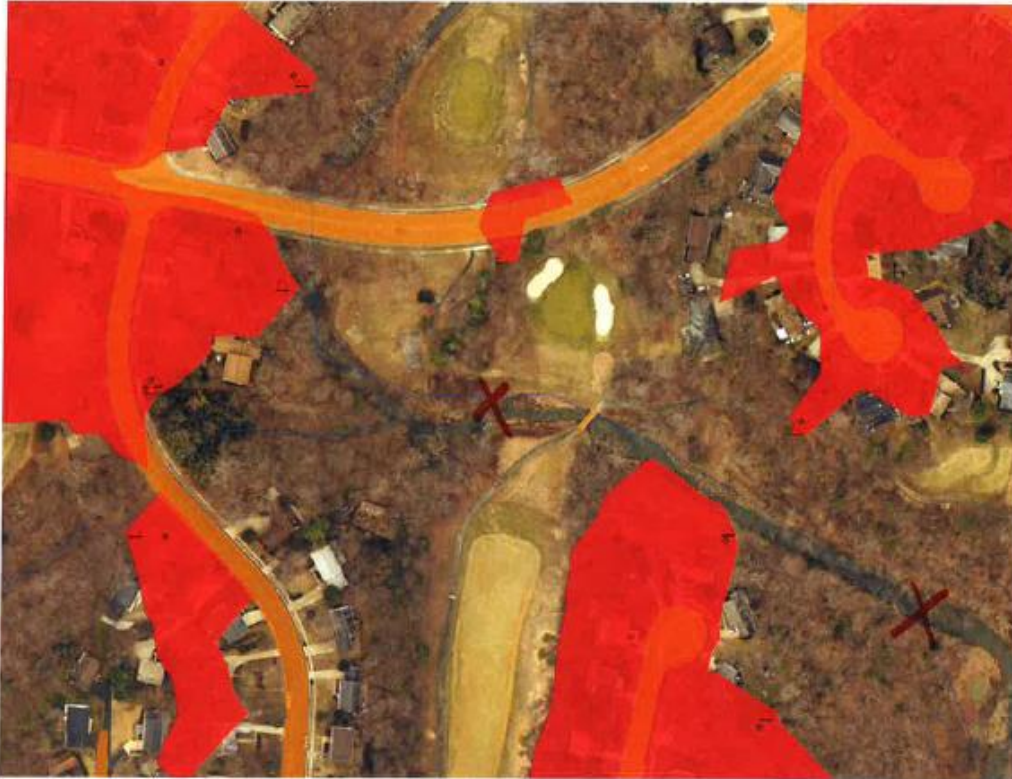
Site 9: Powells Creek, Monclair

Quality of upstream MS-4 outfalls: 1-2 quality outfalls [2]
 Upstream land uses: Residential [2]
 Opportunity to reduce floatables sources: ~~Some trash, difficult to determine~~ [2] *Identifiably sources*
 Access and feasibility: ~~large distance from parking, access through lots~~ *Some trash (3) easy access*
 Size of contributing drainage area(s): Small - med [4]

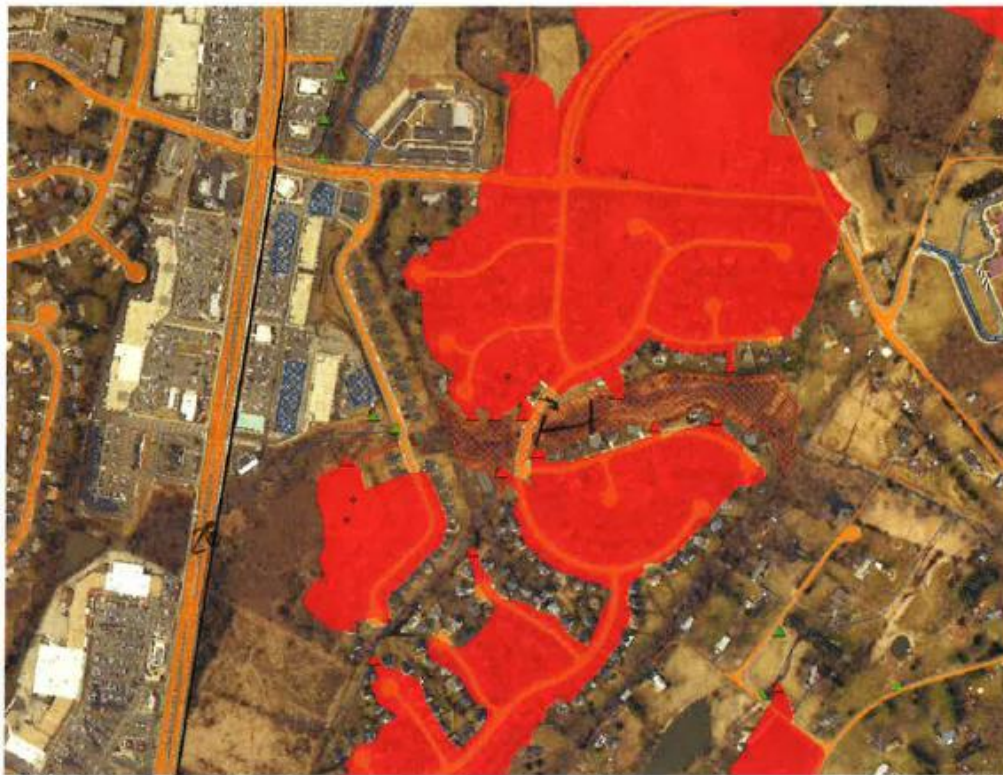
Site 10:

- Quality of upstream MS-4 outfalls: Many upstream outfalls [4]
- Upstream land uses: Commercial/residential [4]
- Opportunity to reduce floatables sources: Some [3]
- Access and feasibility: Fence impedes Access, Litter - before stream [3]
- Size of contributing drainage area(s): Small-med [4]

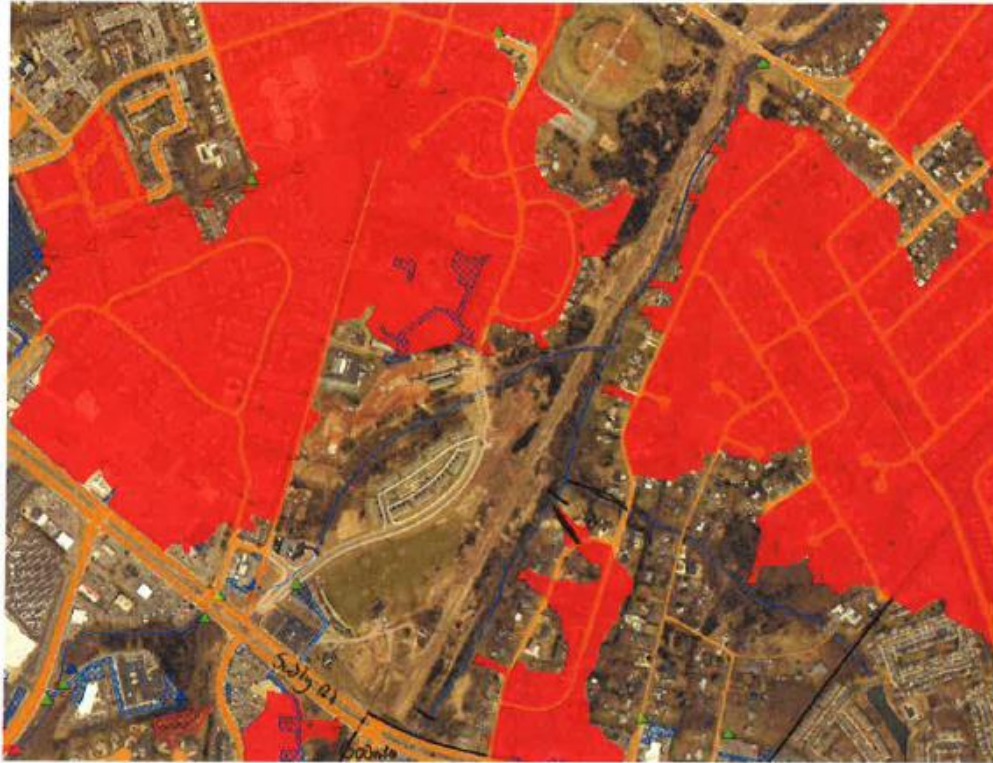
Site 11: Flat Branch

Quality of upstream MS-4 outfalls:	<u>Many</u>	[4]
Upstream land uses:	<u>Commercial/Residential</u>	[4]
Opportunity to reduce floatables sources:	<u>Sufficient floatables</u>	[4]
Access and feasibility:	<u>Ingress/Egress through private property</u>	[3] Lateral access good
Size of contributing drainage area(s):	<u>Large</u>	[2]

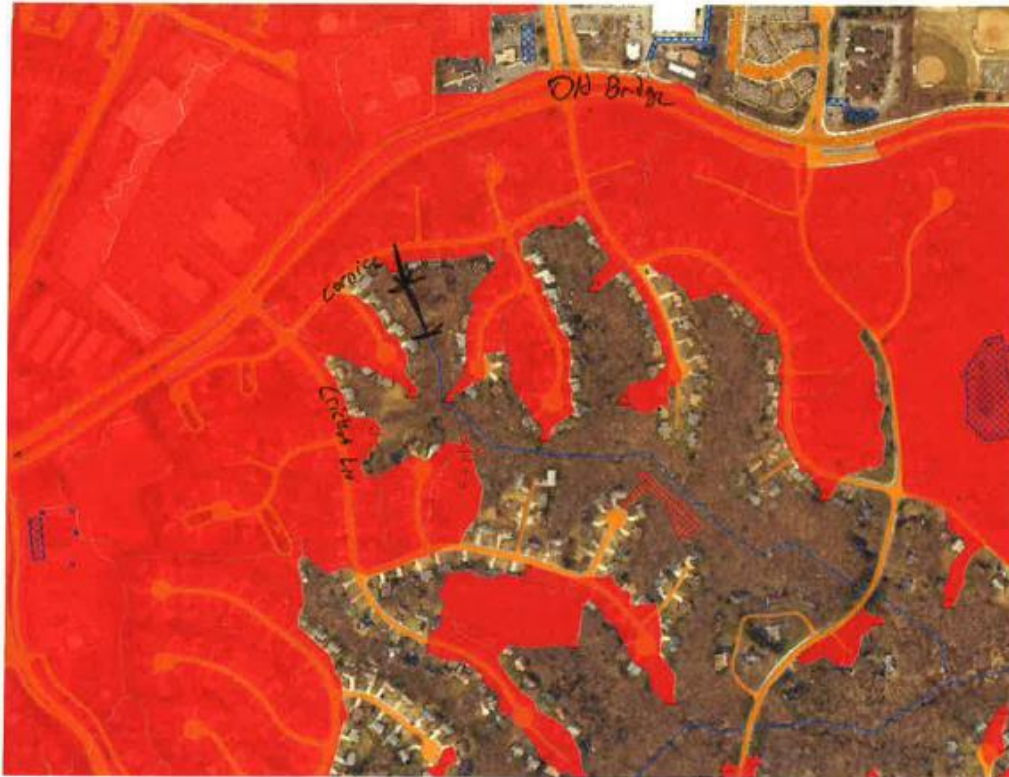
Site 12:

- Quality of upstream MS-4 outfalls: Many [4]
Upstream land uses: Commercial / Residential [4]
Opportunity to reduce floatables sources: Good amount of floatables [4]
Access and feasibility: Small stream, easy access from Roadway [3]
Size of contributing drainage area(s): Very Large [1]
