Annual Stormwater Management Report
VSMP Permit No. 0088595 – FY 2020

Submitted by:
Prince William County
Department of Public Works

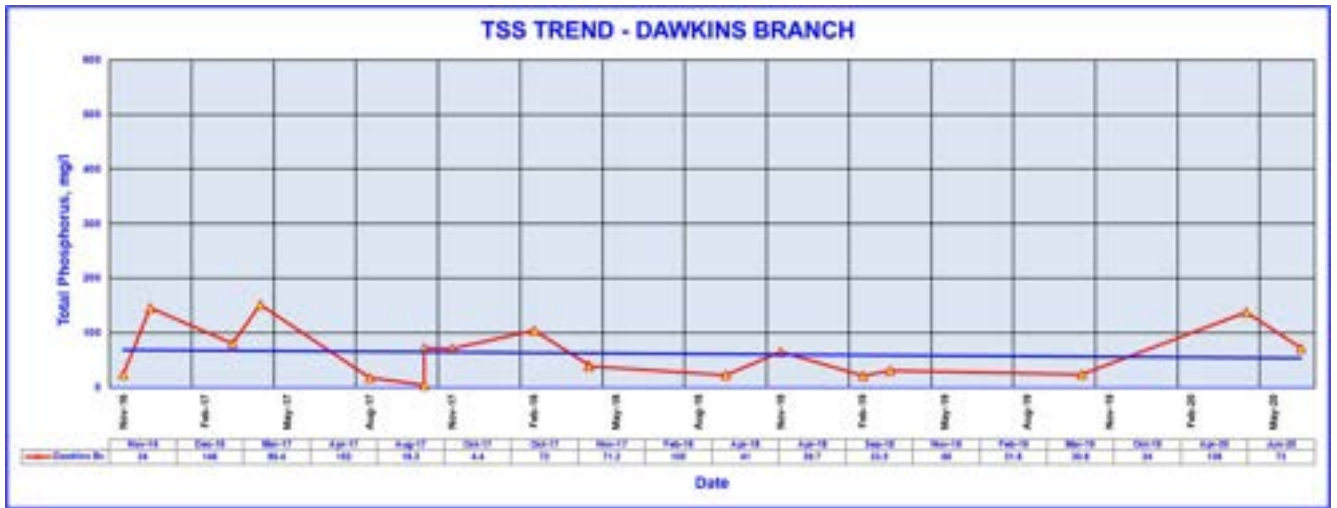
Figure 11 – Long Term TSS trends in the Dawkins Branch Watershed

TSS shows a stable to slightly decreasing trend.

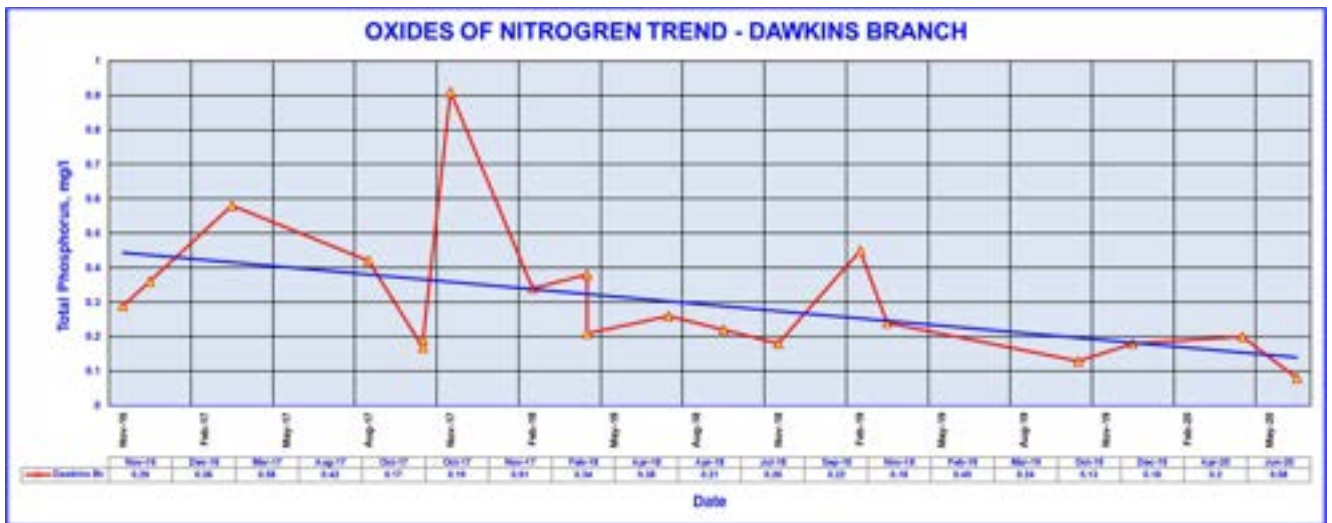
Figure 12 – Long Term Oxides of Nitrogen trends in the Dawkins Branch Watershed

Oxides of Nitrogen show a significant decreasing trend.

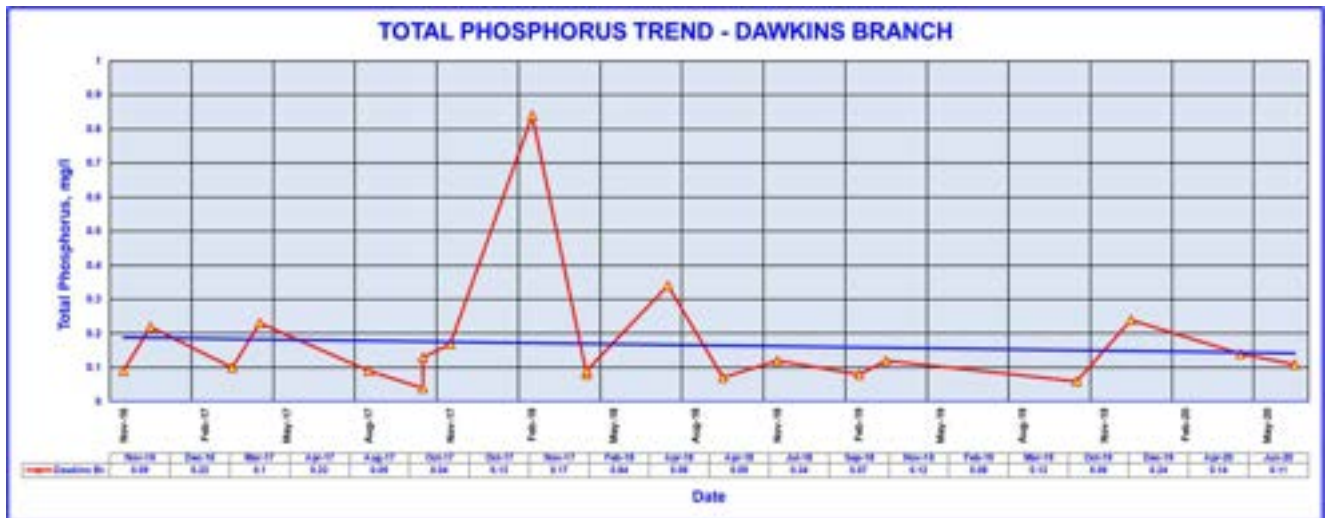
Figure 13 – Long Total Phosphorus trends in the Dawkins Branch Watershed

Total phosphorus shows a slightly decreasing trend.

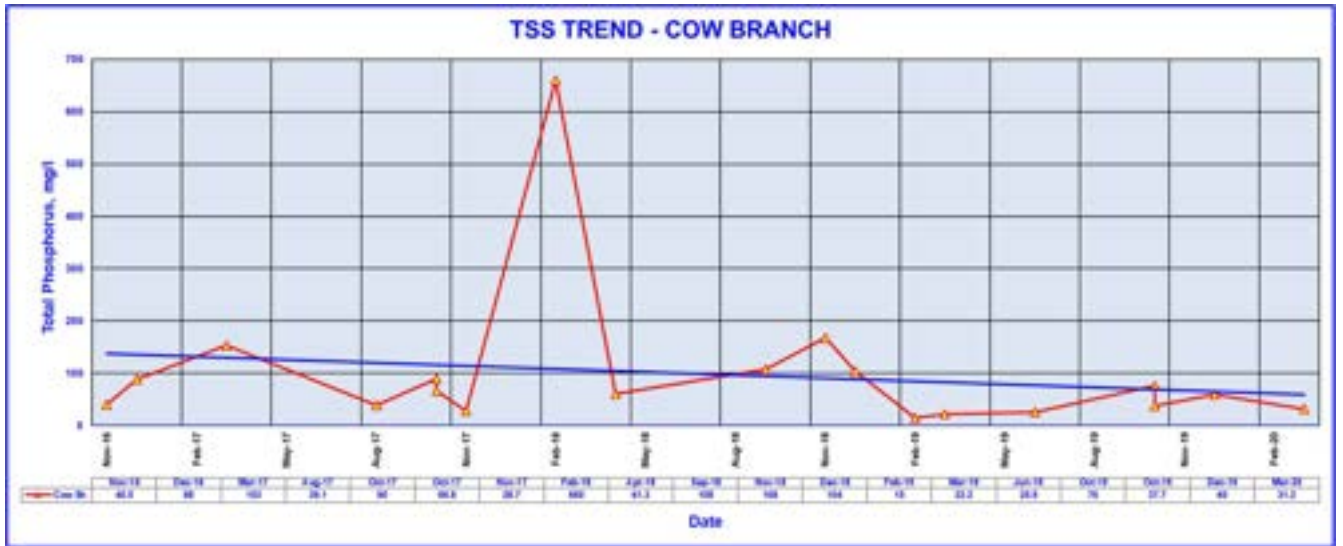
Figure 14 – Long Term TSS trends in the Cow Branch Watershed

TSS shows a decreasing trend.

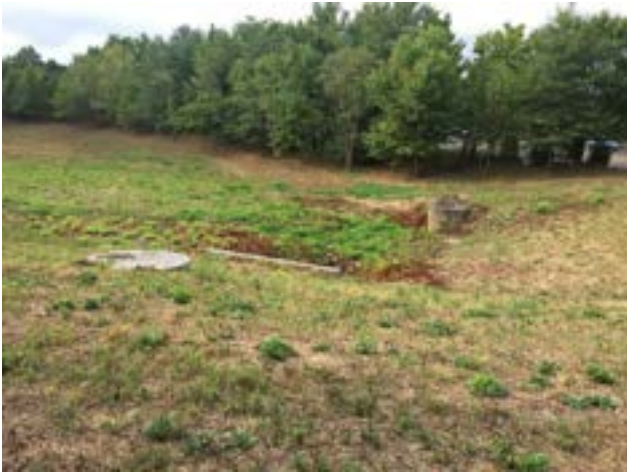
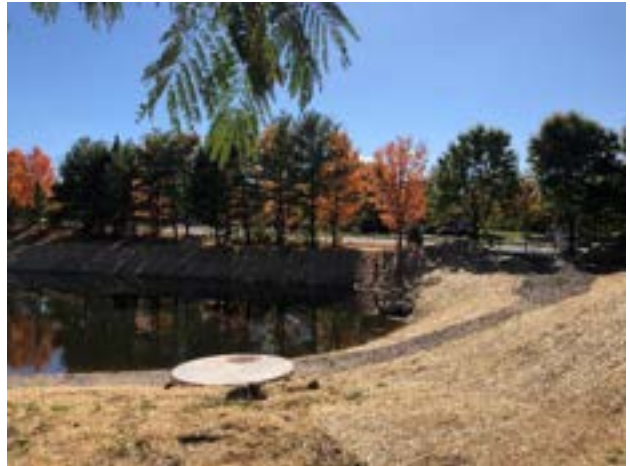
The water quality retrofit of SWM Facility #424 was completed in FY20 and entailed the conversion of a dry detention pond to a level 1, wet pond. The existing detention pond did not have a water quality BMP, lacked a sediment forebay as well as a micropool. The enhanced facility meets the level 1, wet pond standard with sediment forebay and micropool. The area treated is 92 acres and with 42% impervious surface area.

Before

After

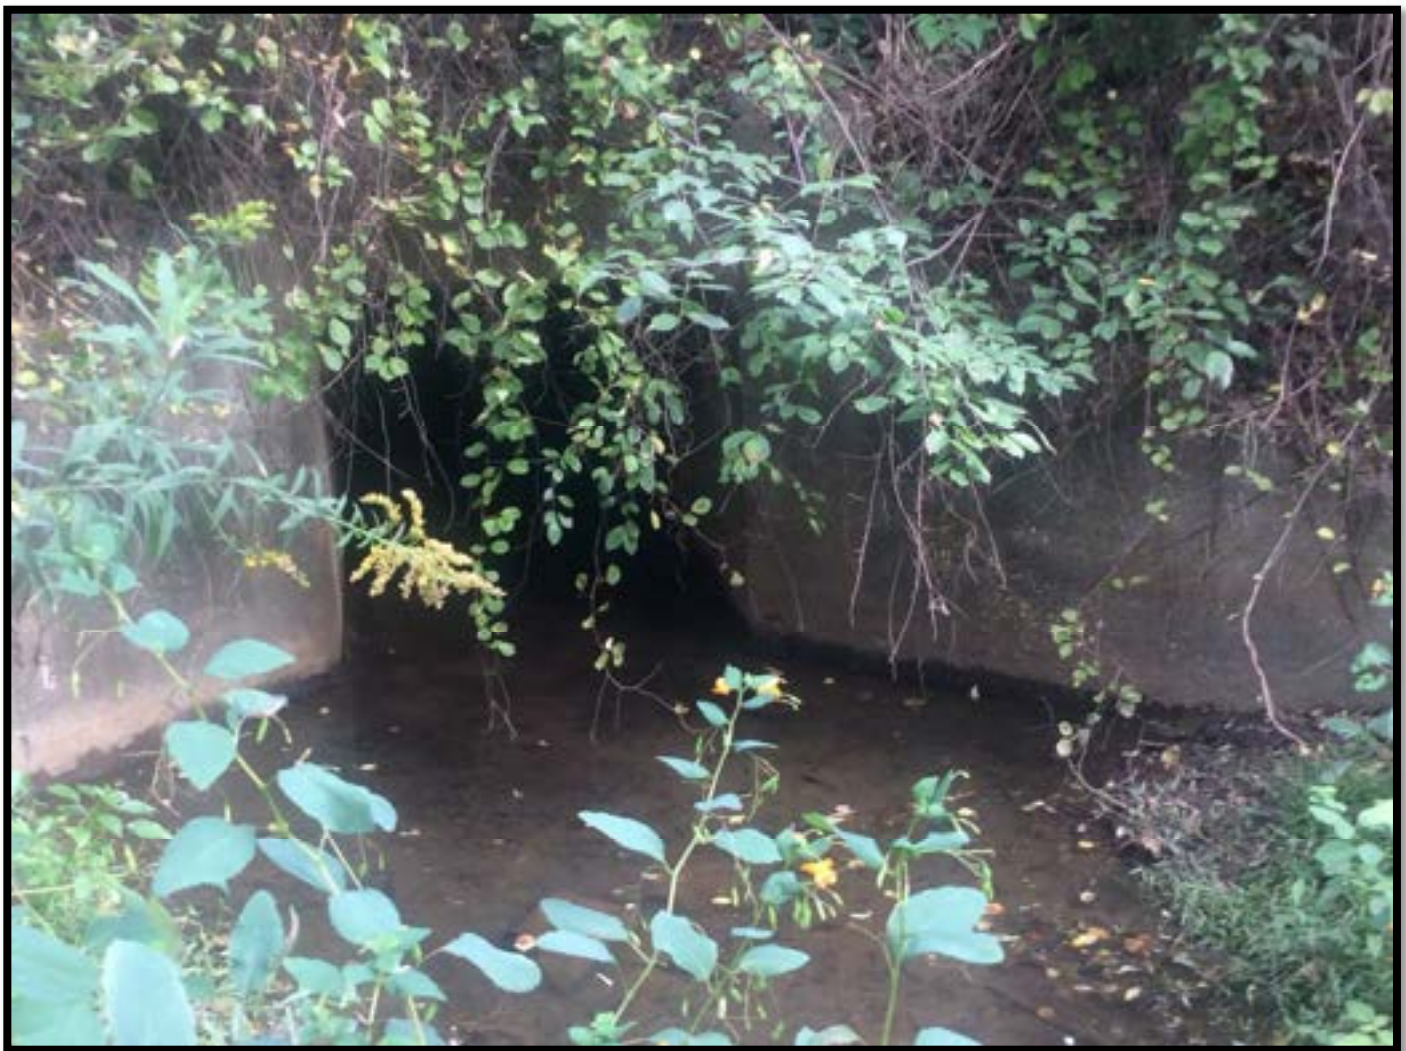
Photo of discharge:

Responsible Party (Owner/ Institutions)	Other Party (Management Company)
Name:	Name: NA
Company:	Company:
Address:	Address:
Phone #:	Phone #:
Note:	Note:
Notification/Contact (Other agencies contacted (DEQ, NS, FMO?) NA	
Date:	Date:
Time:	Time:
Name: TBD	Name:
Company/Agency:	Company/Agency:
Notes:	Notes:
<u>Comments/ Deficiencies:</u>	
Clear discharge was observed flowing from outfall. pH and conductivity were found within the standard limit. Discharge was tracked and found pond discharge of SWMP 859. The source of discharge was surface water, is non-point.

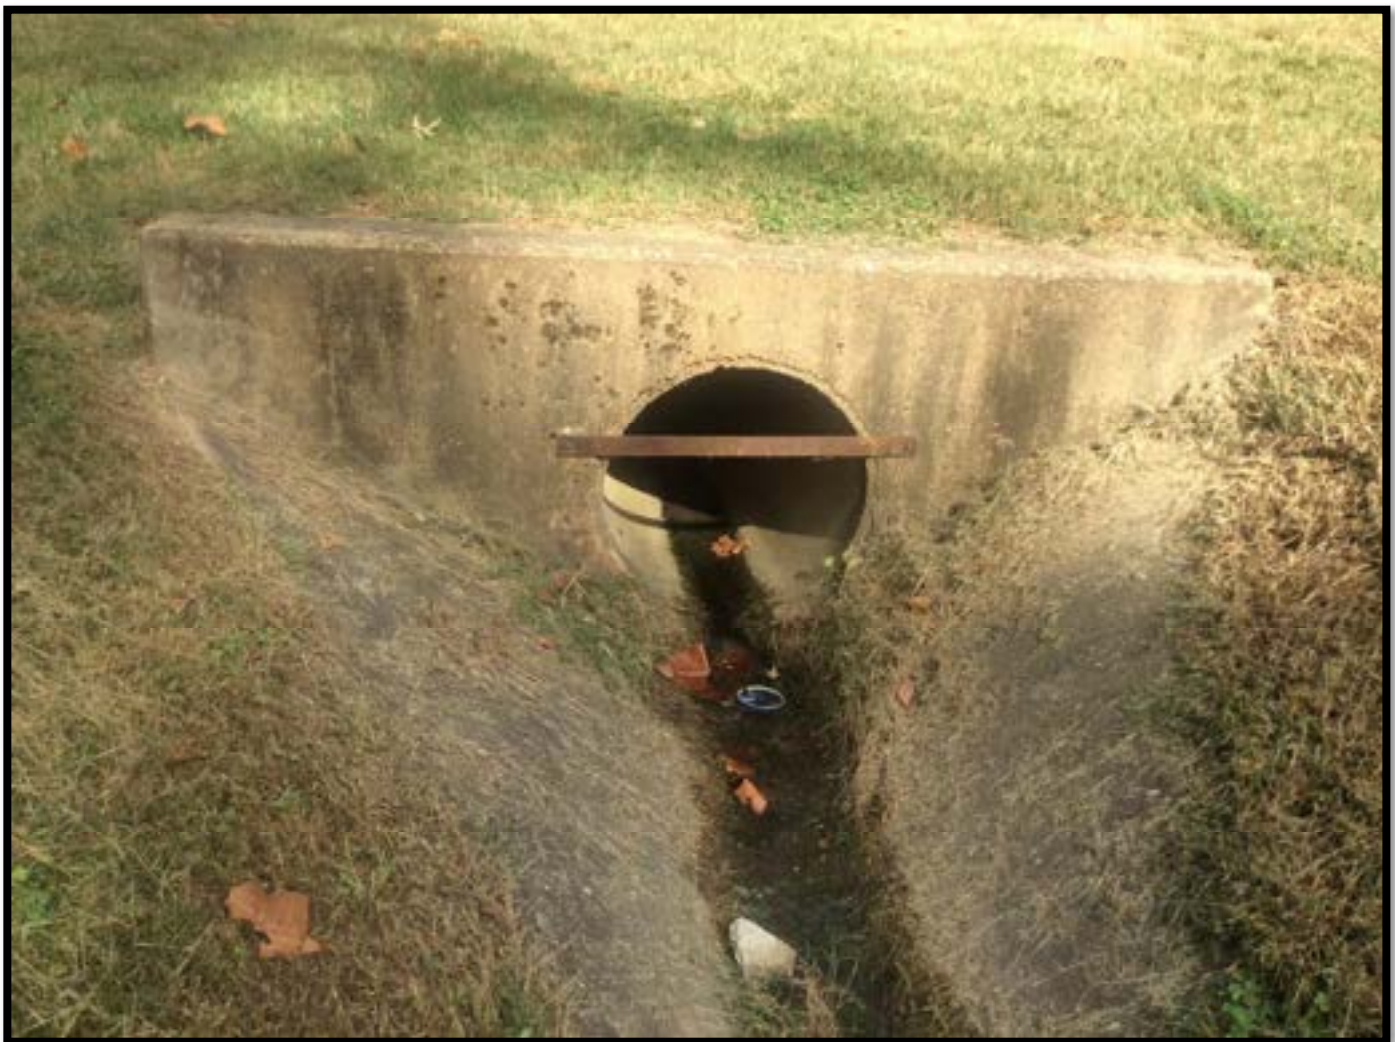
Photo of discharge:

pH: 7.0 Limit: Std.	Conductivity: 217 μ S/cm Limit: Std.	Temp.: 67°F Limit: Std.	
Discharge related Indicators	Odor: NA	Color: NA	Turbidity: NA
	Floatables: NA	Stains: NA	Other: NA

Responsible Party (Owner/ Institutions)	Other Party (Management Company)
Name:	Name: NA
Company:	Company:
Address:	Address:
Phone #:	Phone #:
Note:	Note:
Notification/Contact (Other agencies contacted (DEQ, NS, FMO?) NA	
Date:	Date:
Time:	Time:
Name: TBD	Name:
Company/Agency:	Company/Agency:
Notes:	Notes:
Comments/ Deficiencies:	
Clear discharge was observed flowing from outfall. pH and conductivity were found within the standard limit. Discharge was tracked and found to generated from ground water seepage. At Manhole A, flow was observed from AB branch and continued until C. Manhole C was found to be connected with foundation drain CD. The source of discharge was confirmed ground water from foundation into storm sewer system.

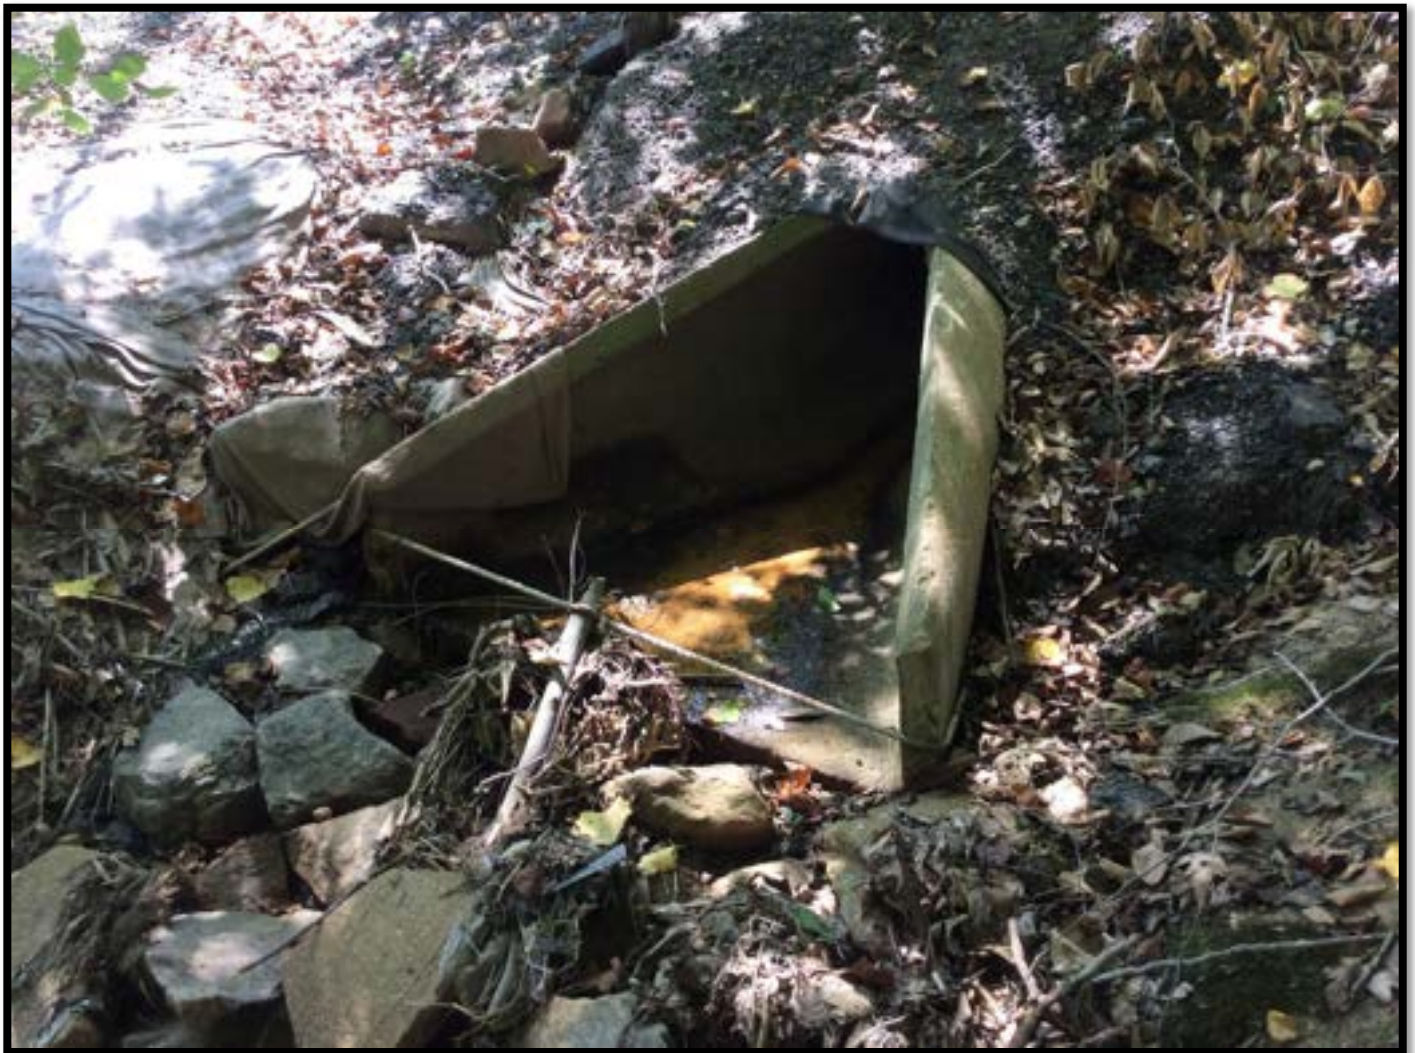
Photo of discharge:

Responsible Party (Owner/ Institutions)	Other Party (Management Company)
Name:	Name: NA
Company:	Company:
Address:	Address:
Phone #:	Phone #:
Note:	Note:
Notification/Contact (Other agencies contacted (DEQ, NS, FMO?) NA	
Date:	Date:
Time:	Time:
Name: TBD	Name:
Company/Agency:	Company/Agency:
Notes:	Notes:
<u>Comments/ Deficiencies:</u>	
<p>Pipe algae observed at outfall. Onsite test results of pH and Conductivity lie within standard limits. Discharge tracked along red line shown in map above. Manhole A had flow from AB branch. Inlet B was receiving flow from BC channel. Ground water was flowing into BC channel from adjoining landscape. Channel was dry beyond point C.</p>

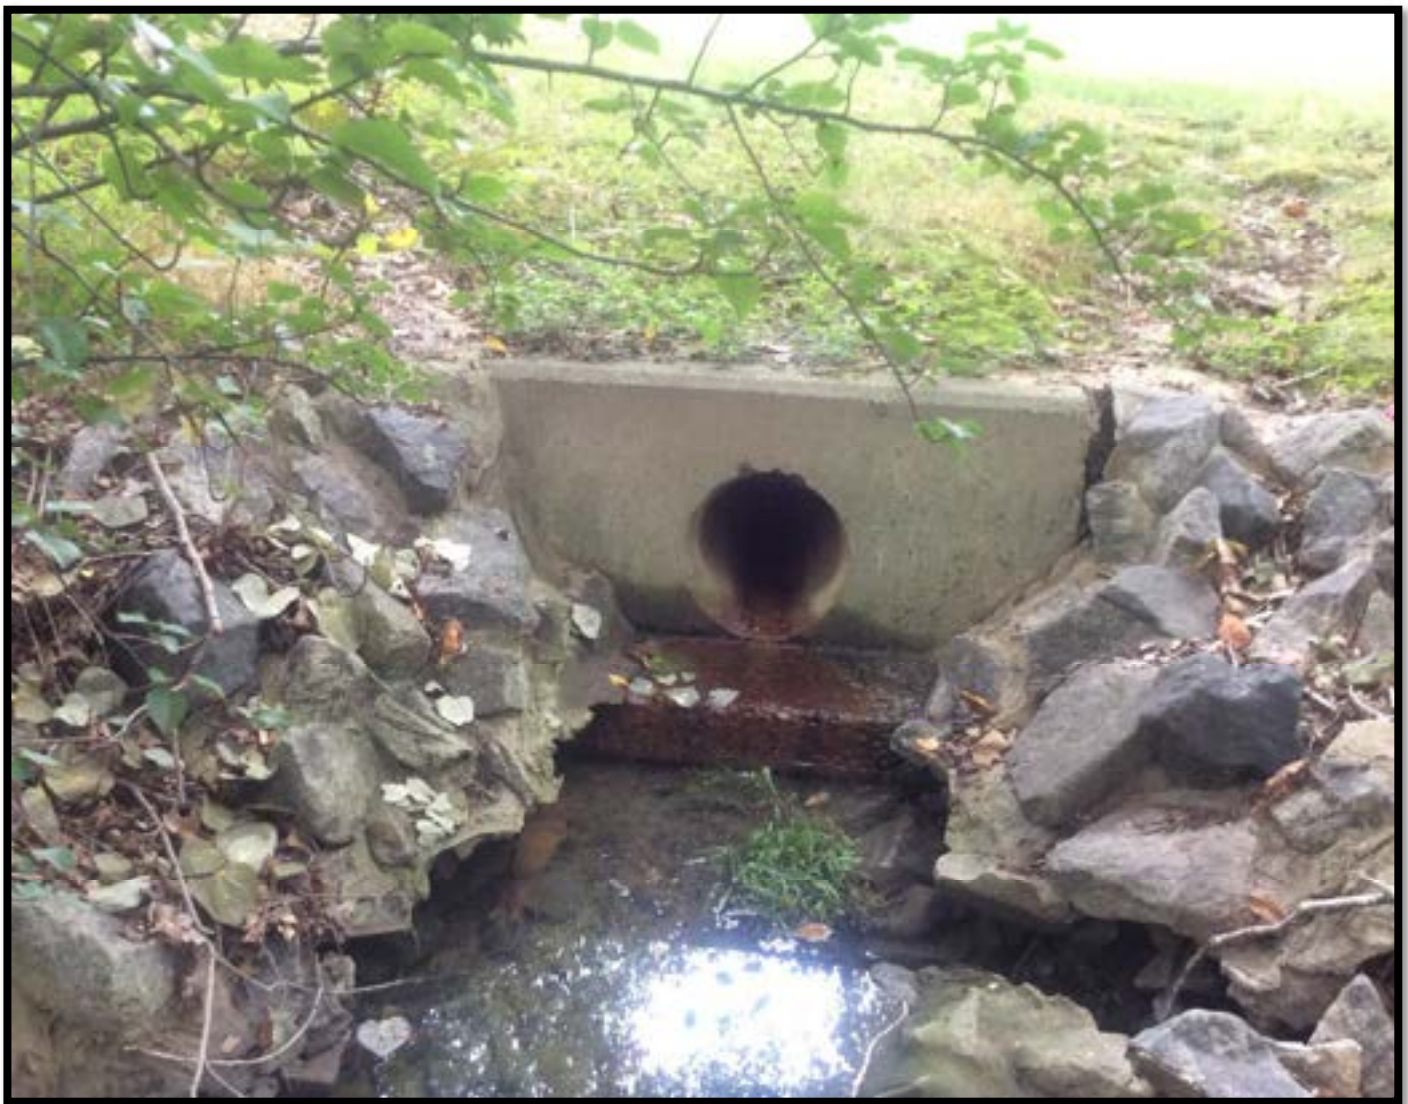
Photo of discharge:

INCIDENT INFORMATION		
Incident Report #: 12-2020	Date: 8/16/2019	Time: 11:00AM
Business Areas: Residential	Report Completed By: Prem Poudel	
Outfall ID# 646 Address: 3376 Flint Hill PL	City, State: Woodbridge, VA	Zip Code: 22192
Complain or Case Received From: Routine Inspection

pH: 7.20 Limit: Std.	Conductivity: 211 μ S/cm Limit: Std.	Temp.: 72°F Limit: Std.
Discharge related Indicators	Odor: NA	Color: NA
	Floatables: NA	Stains: NA
		Turbidity: NA
		Other: NA

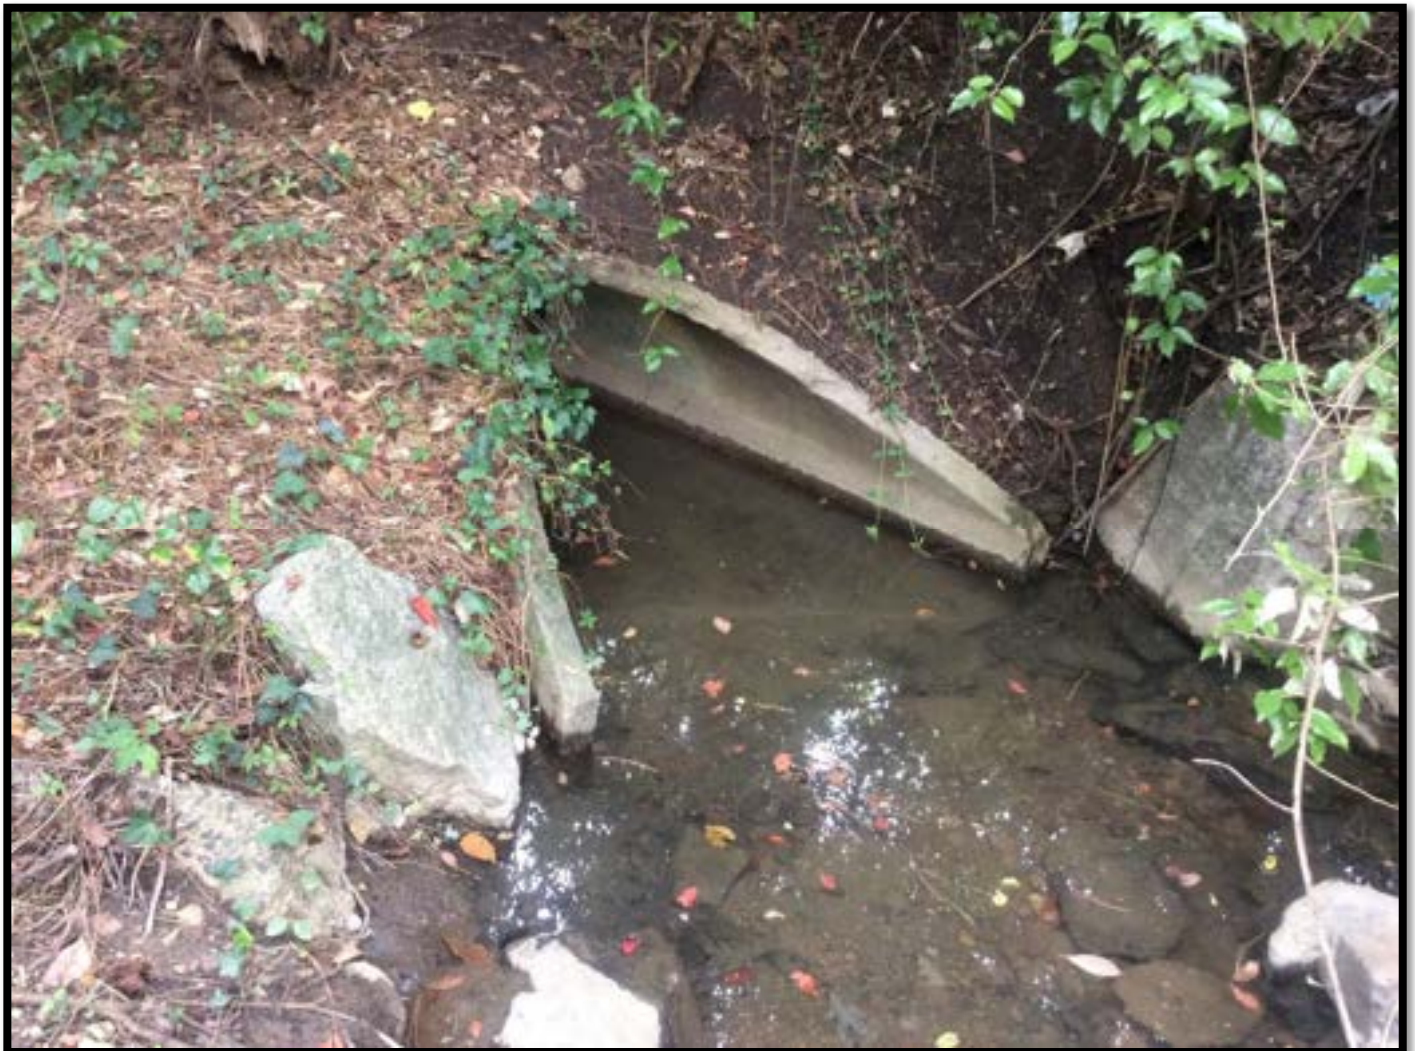
Photo of discharge:

INCIDENT INFORMATION		
Incident Report #: 16-2020	Date: 8/23/2019	Time: 10:45AM
Business Areas: Residential	Report Completed By: Prem Poudel	
Outfall ID# 764 Address: 4525 Edsall Drive	City, State: Woodbridge, VA	Zip Code: 22193
Complain or Case Received From: Routine Inspection

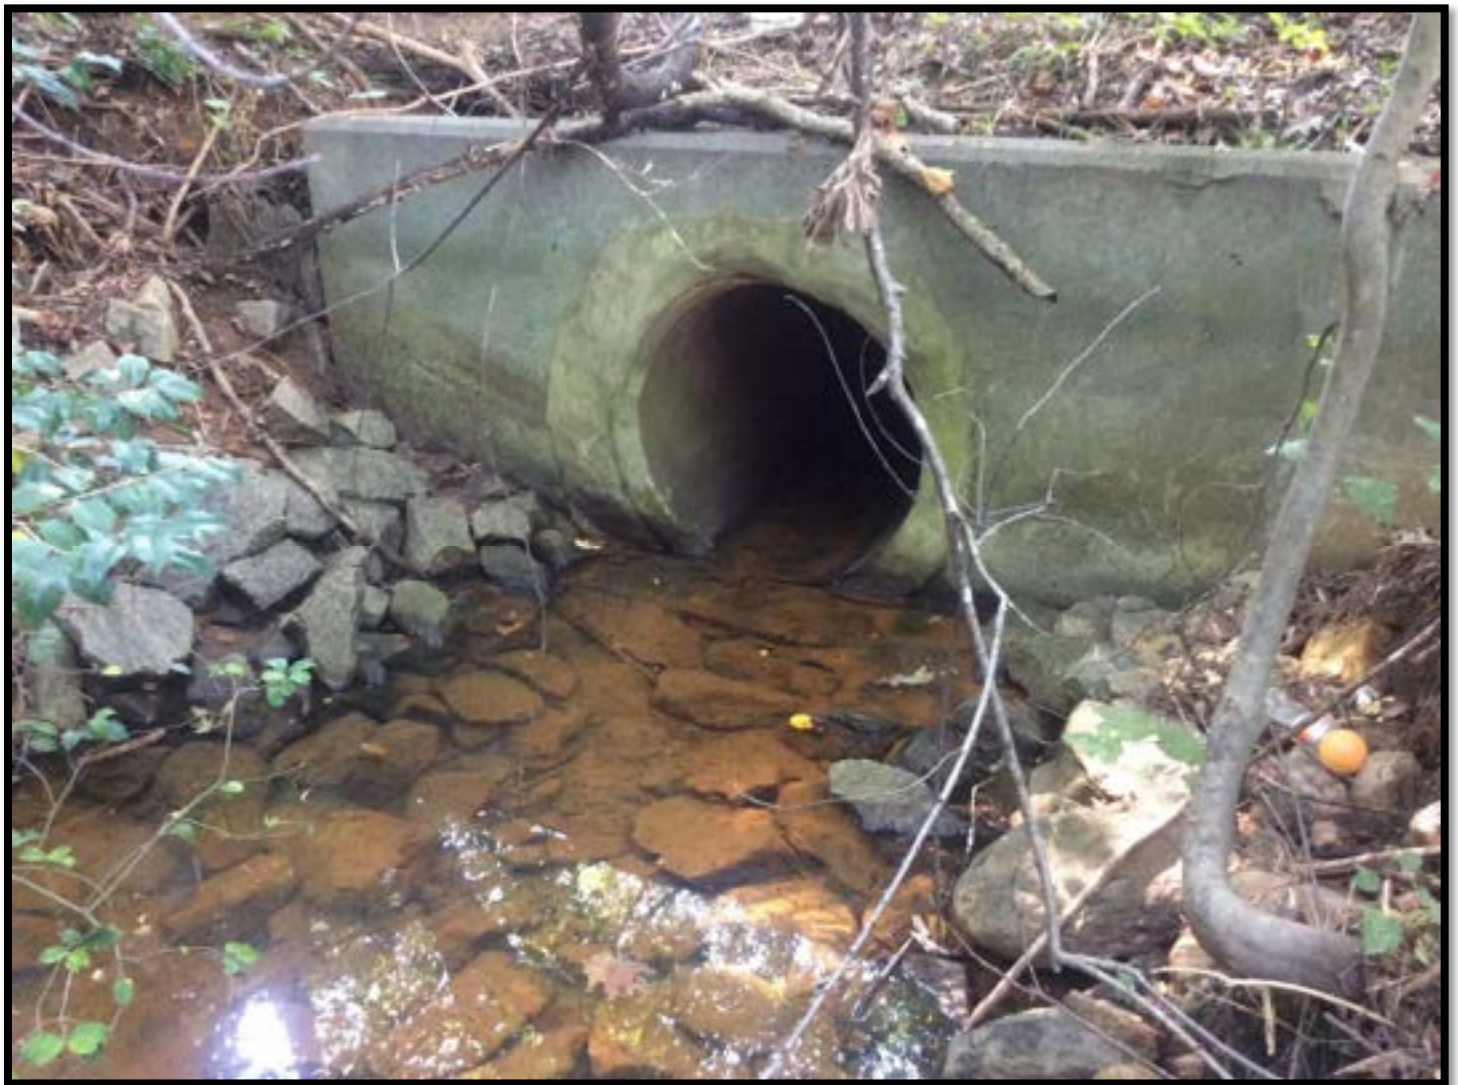
Photo of discharge:

INCIDENT INFORMATION		
Incident Report #: 22-2020	Date: 9/11/2019	Time: 11:55AM
Business Areas: Residential	Report Completed By: Prem Poudel	
Outfall ID#2349 Address: 14355 Salsbury Ct	City, State: Woodbridge, VA	Zip Code: 22193
Complain or Case Received From: Routine Inspection

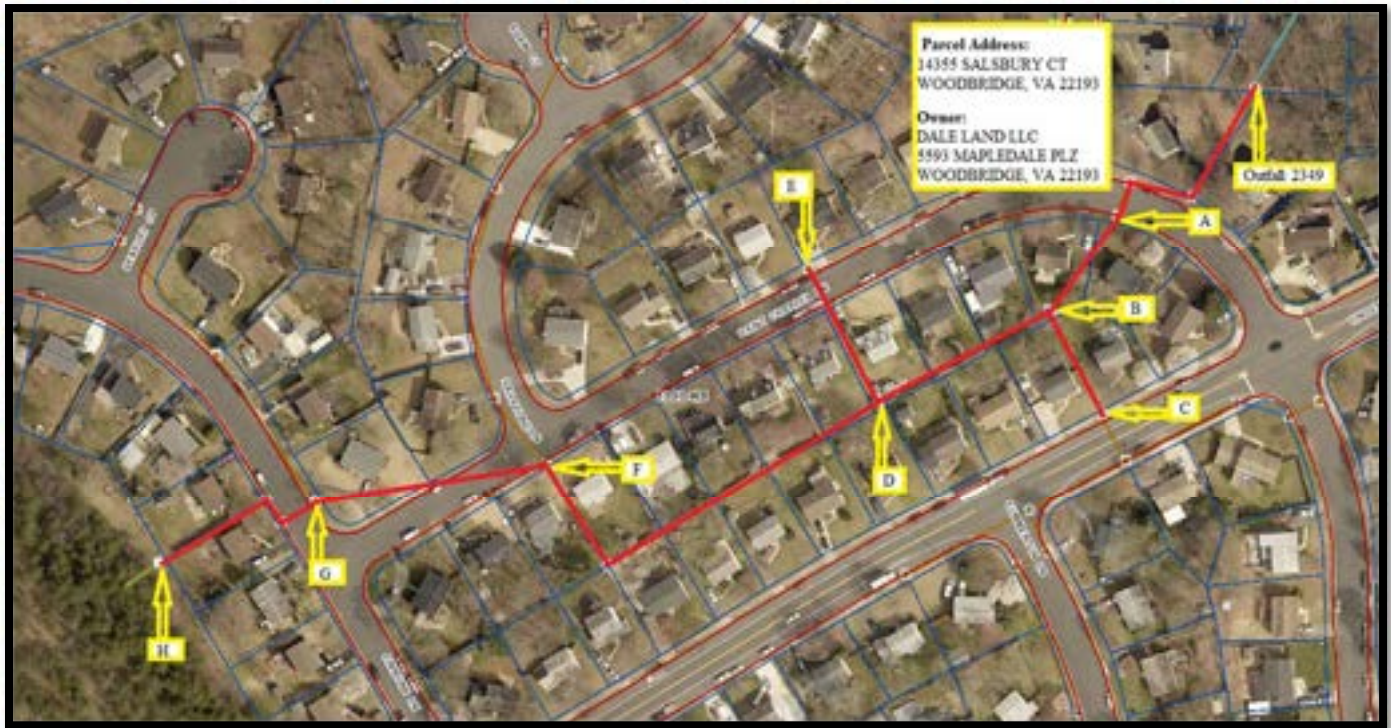
Map of Trackdown Path:

Responsible Party (Owner/ Institutions)	Other Party (Management Company)
Name:	Name: NA
Company:	Company:
Address:	Address:
Phone #:	Phone #:
Note:	Note:
Notification/Contact (Other agencies contacted (DEQ, NS, FMO?) NA	
Date:	Date:
Time:	Time:
Name: TBD	Name:
Company/Agency:	Company/Agency:
Notes:	Notes:
<u>Comments/ Deficiencies:</u>	
pH and conductivity did not exceed the limits during onsite test. Source of discharge was tracked along red line shown in map above. At manhole A, flow observed from AB branch. Access did not get to inspect Manhole B and D, but Manhole C and E were found dry. Tracking was continued along points F, G and H. Upstream inlet E was receiving discharge from VDOT storm water management pond.	
<u>Conclusion:</u>	
The source of discharge was confirmed VDOT pond discharge. Discharge observed at outfall was very common and further investigation is not needed.

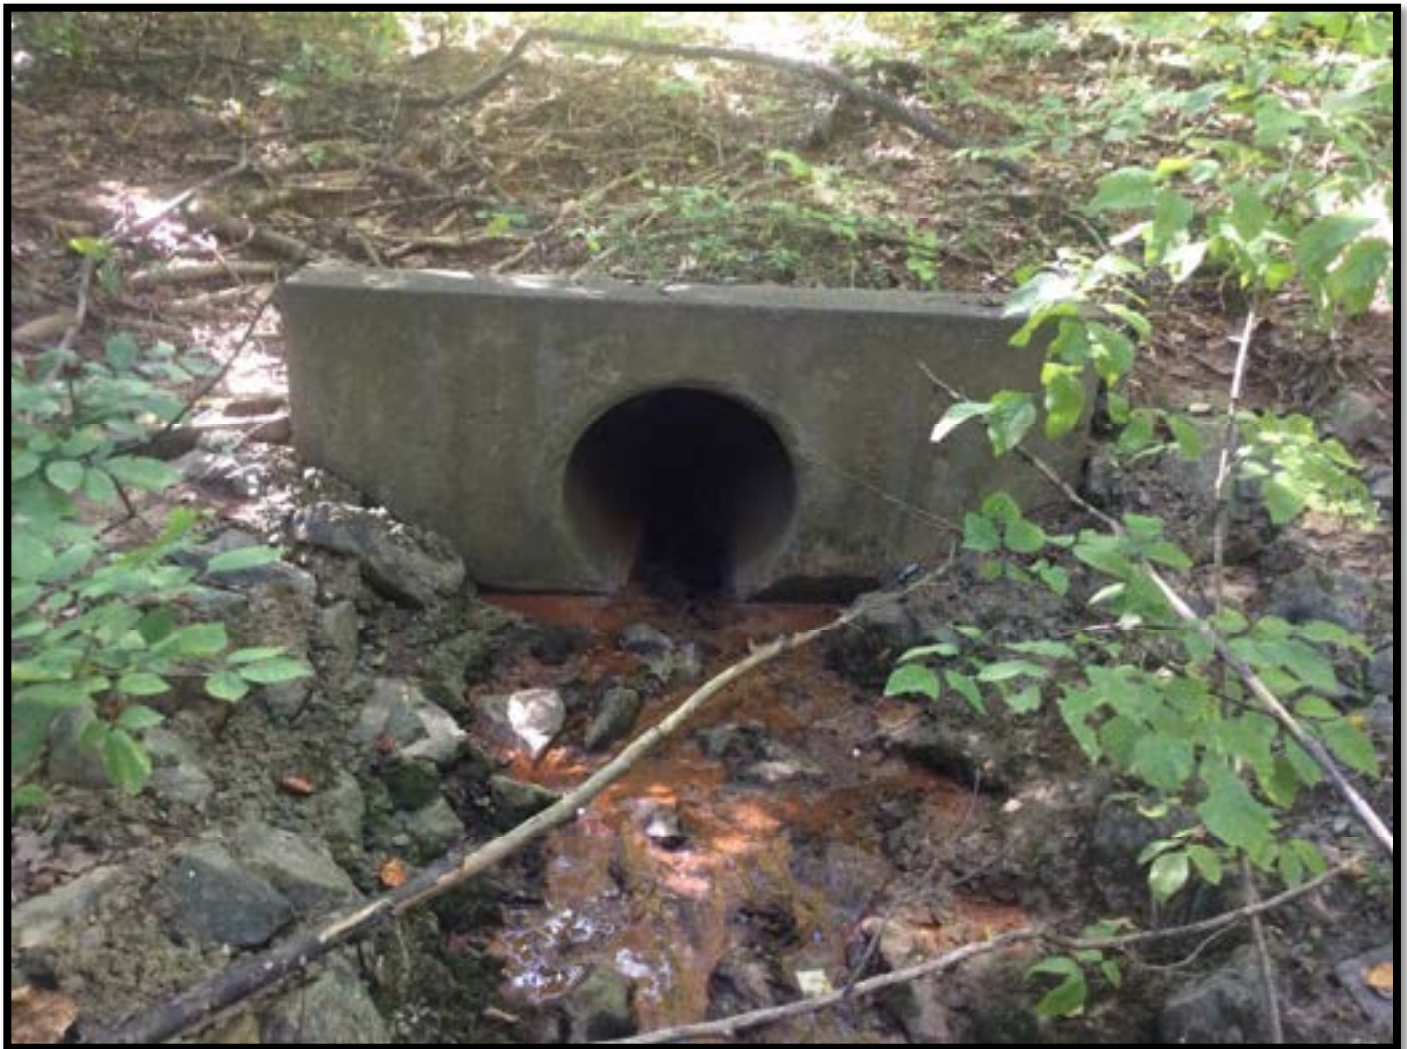
Photo of discharge:

pH: 7.20 Limit: Std.	Conductivity: 491µS/cm Limit: Std.	Temp.: 74°F Limit: Std.
Discharge related Indicators	Odor: NA	Color: NA
	Floatables: NA	Stains: Algae
		Turbidity: NA
		Other: NA

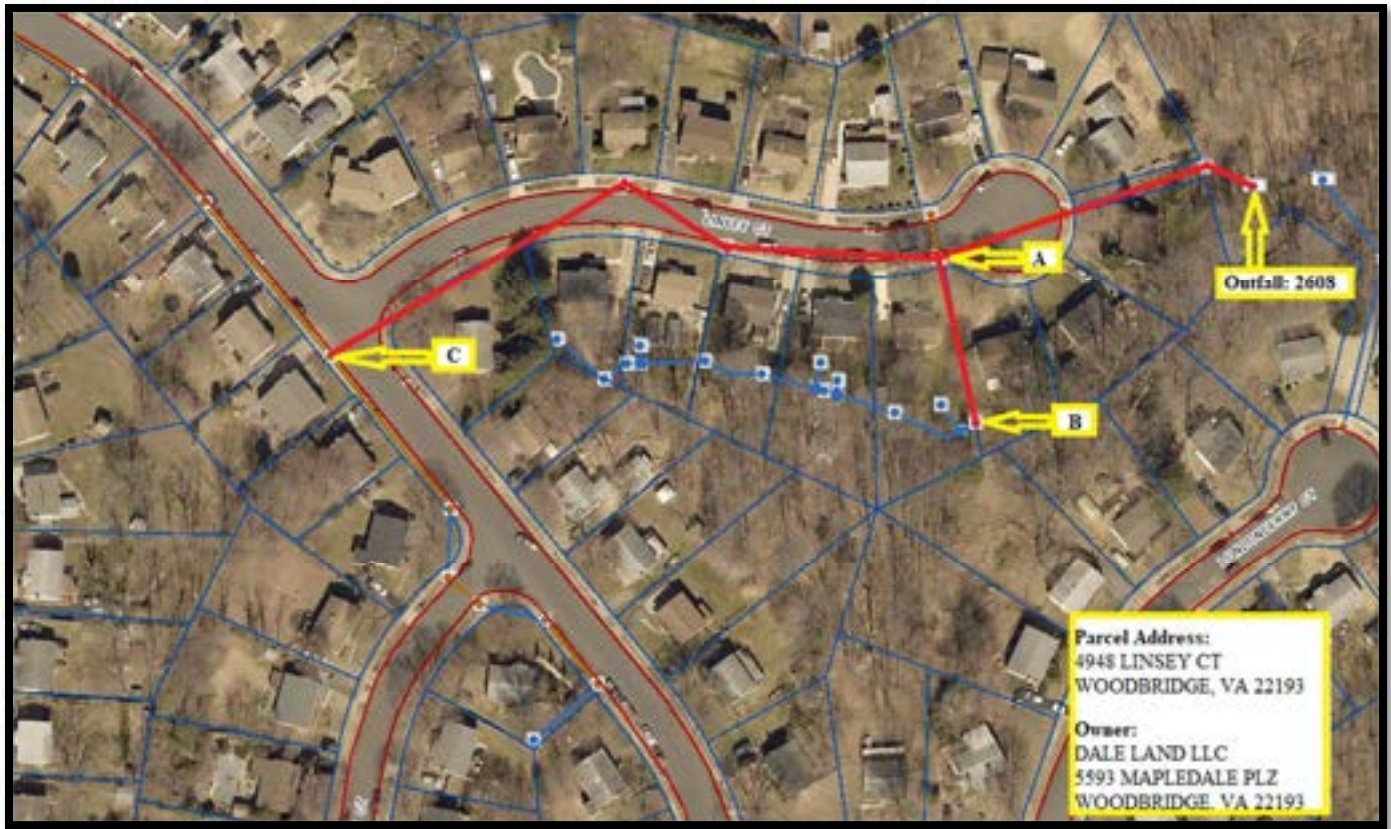
Map of Trackdown Path:

Responsible Party (Owner/ Institutions)	Other Party (Management Company)
Name:	Name: NA
Company:	Company:
Address:	Address:
Phone #:	Phone #:
Note:	Note:
Notification/Contact (Other agencies contacted (DEQ, NS, FMO?) NA	
Date:	Date:
Time:	Time:
Name: TBD	Name:
Company/Agency:	Company/Agency:
Notes:	Notes:
Comments/ Deficiencies:	
pH and conductivity did not exceed the limits during onsite test. Source of discharge was tracked along red line shown in map above. At manhole A, flow observed from both AB and AC branches. Discharge of AB branch was trickle and visually better. Access did not get to inspect Manhole B. Tracking was continued along branch AC. Manhole C was very dry.	
Conclusion:	
The source of discharge was confirmed ground water seepage. The source of algae was suspected from ground minerals. Discharge was seemed very common and no further investigation is needed.

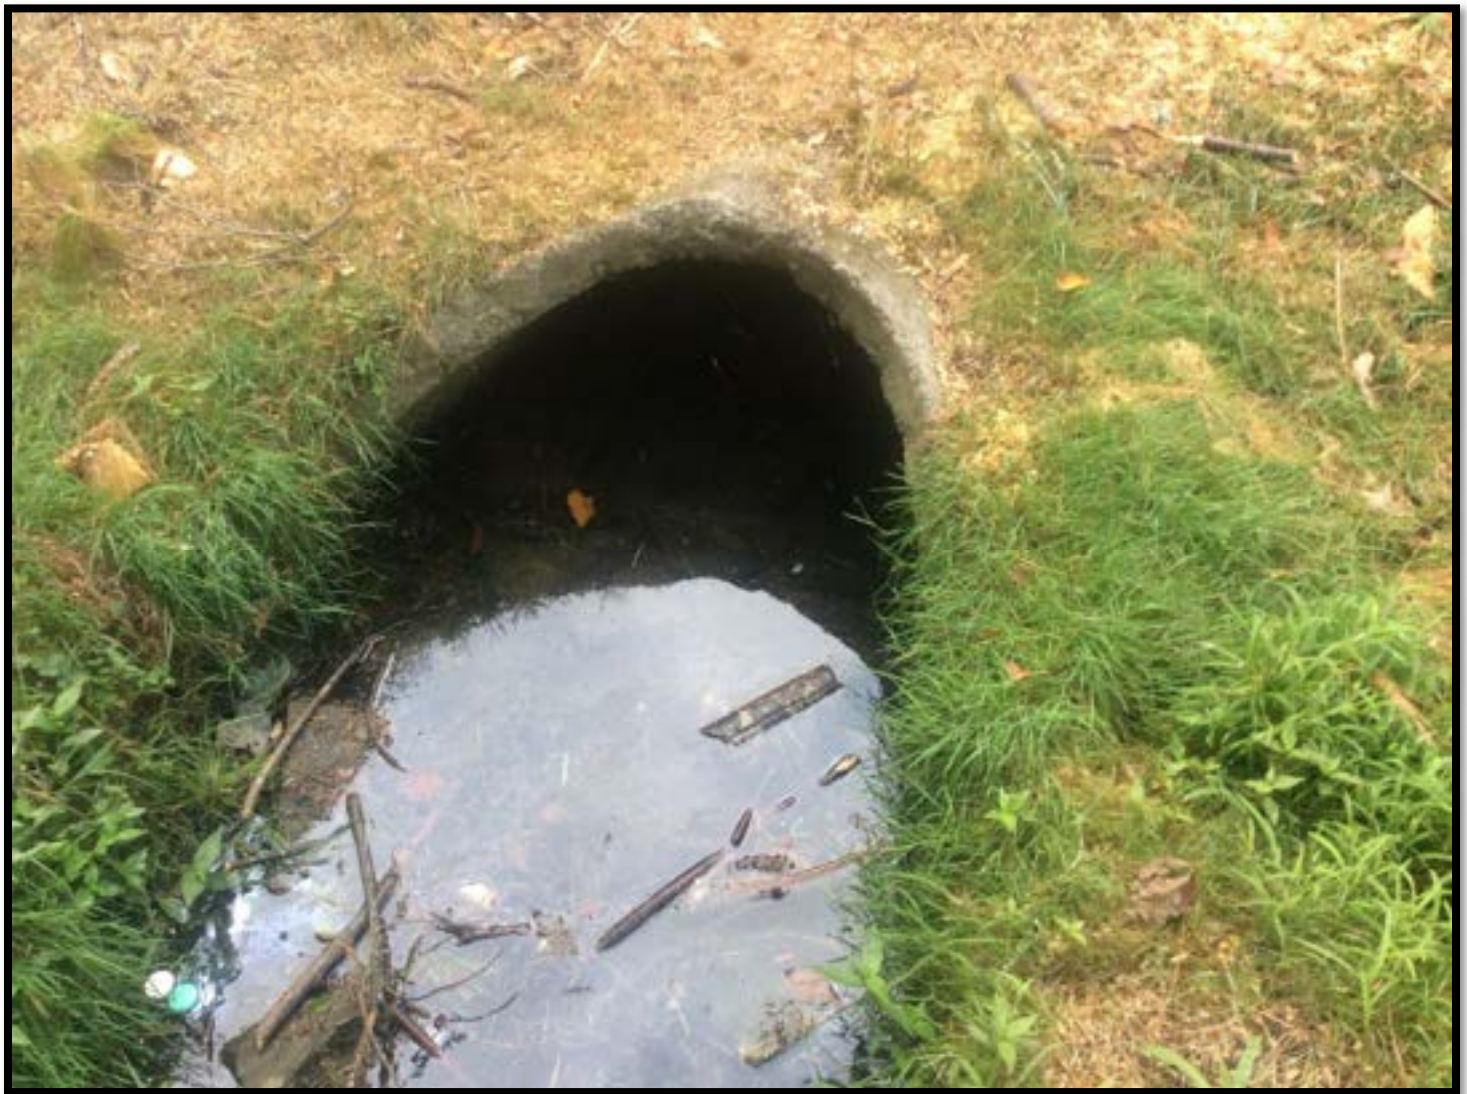
Photo of discharge:

pH: 8.20 Limit: Std.	Conductivity: 312 µS/cm Limit: Std.	Temp.: 71°F Limit: Std.
Discharge related Indicators	Odor: NA	Color: NA
	Floatables: NA	Stains: NA
		Turbidity: NA
		Other: NA

Discharge was found to be stagnant. Onsite test results of pH and Conductivity lie within standard limits. Discharge tracked along red line shown in map above. Manhole A had flow from AB branch only and continued tracking at BC. Inlet C was observed in moist condition only. Discharge was gradually reducing in upstream section. Cross connection did not find in inspection.

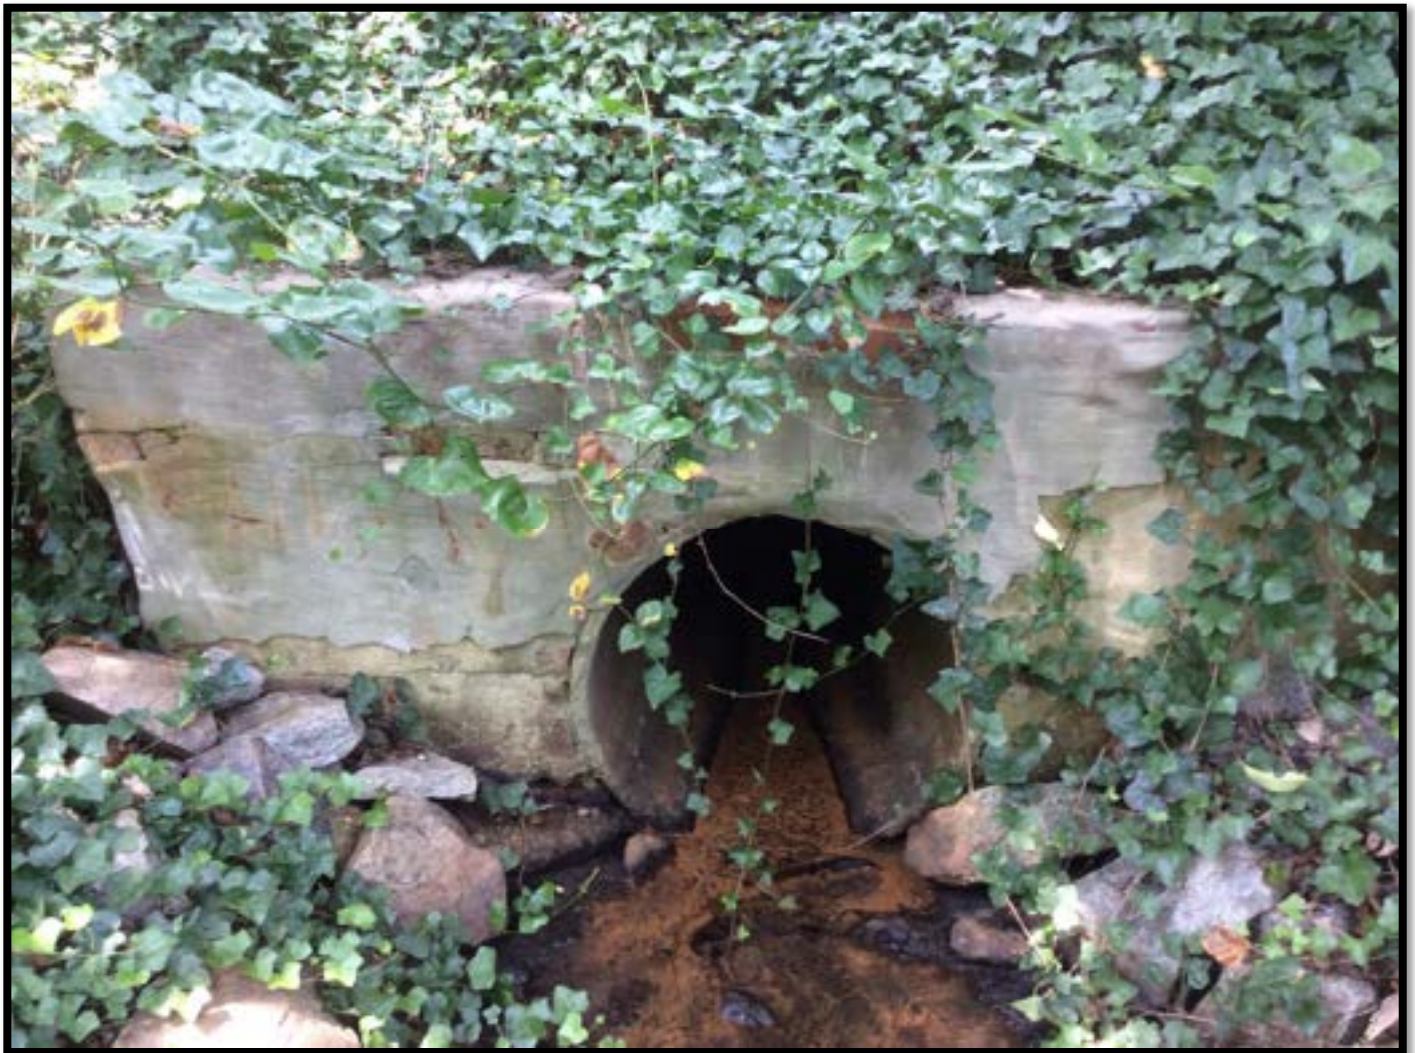
Photo of discharge:

pH: 7.40 Limit: Std.	Conductivity: 218 μ S/cm Limit: Std.	Temp.: 69°F Limit: Std.
Discharge related Indicators	Odor: NA	Color: NA
	Floatables: NA	Stains: Algae
		Turbidity: NA
		Other: NA

After investigation, source of discharge was confirmed from three different sources. Sources were water main leakage, foundation drain and outflow of SWMP. The case will inform to PWCSA for maintenance of watermain leakage.

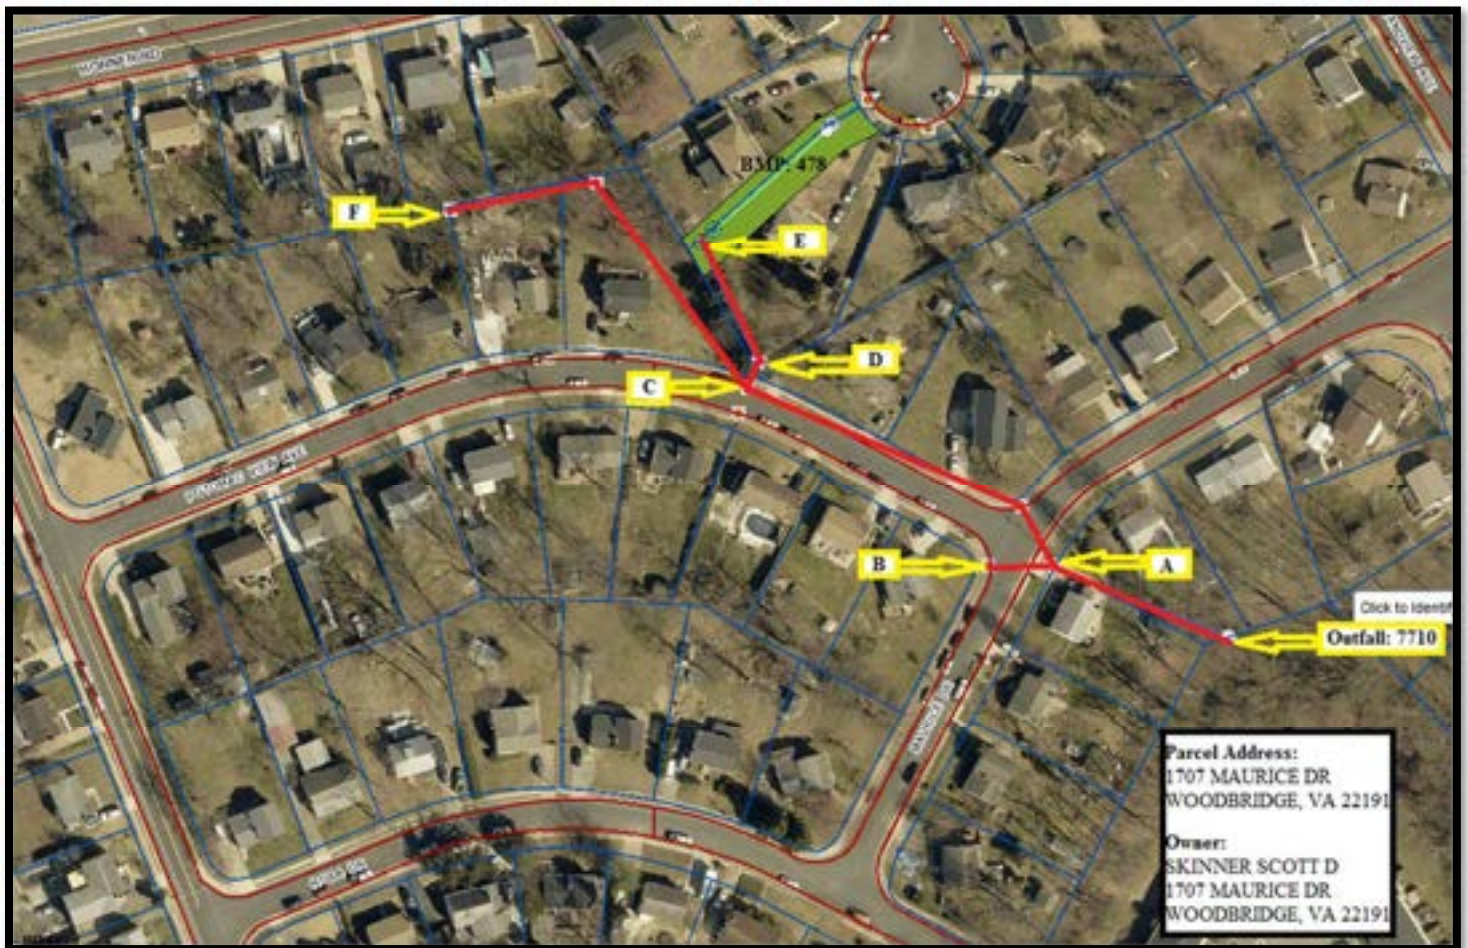
Map of Trackdown Path:

Responsible Party (Owner/ Institutions)	Other Party (Management Company)
Name:	Name: NA
Company:	Company:
Address:	Address:
Phone #:	Phone #:
Note:	Note:
Notification/Contact (Other agencies contacted (DEQ, NS, FMO?) NA	
Date:	Date:
Time:	Time:
Name: TBD	Name:
Company/Agency:	Company/Agency:
Notes:	Notes:
Comments/ Deficiencies:	
<p>Pipe algae observed at outfall. Onsite test results of pH and Conductivity lie within standard limits. Discharge tracked along red line shown in map above. Manhole A had flow from both AB and AC branches. Tracking was continued to AB branch. At manhole B, inflow observed from both curbs and gutters. One of them was water main leakage and another was foundation drain having intermittent flow at certain interval. Tracking was continued to AC branch. At manhole C, flow observed from both CD and CF branches. Drop inlet F was in moist condition only. After that discharge tracked along CDE. E is the outlet of SWMP# 478. Trickle flow was releasing from BMP.</p>
