Annual Stormwater Management Report
VSMP Permit No. 0088595 – FY 2020

Submitted by:
Prince William County
Department of Public Works

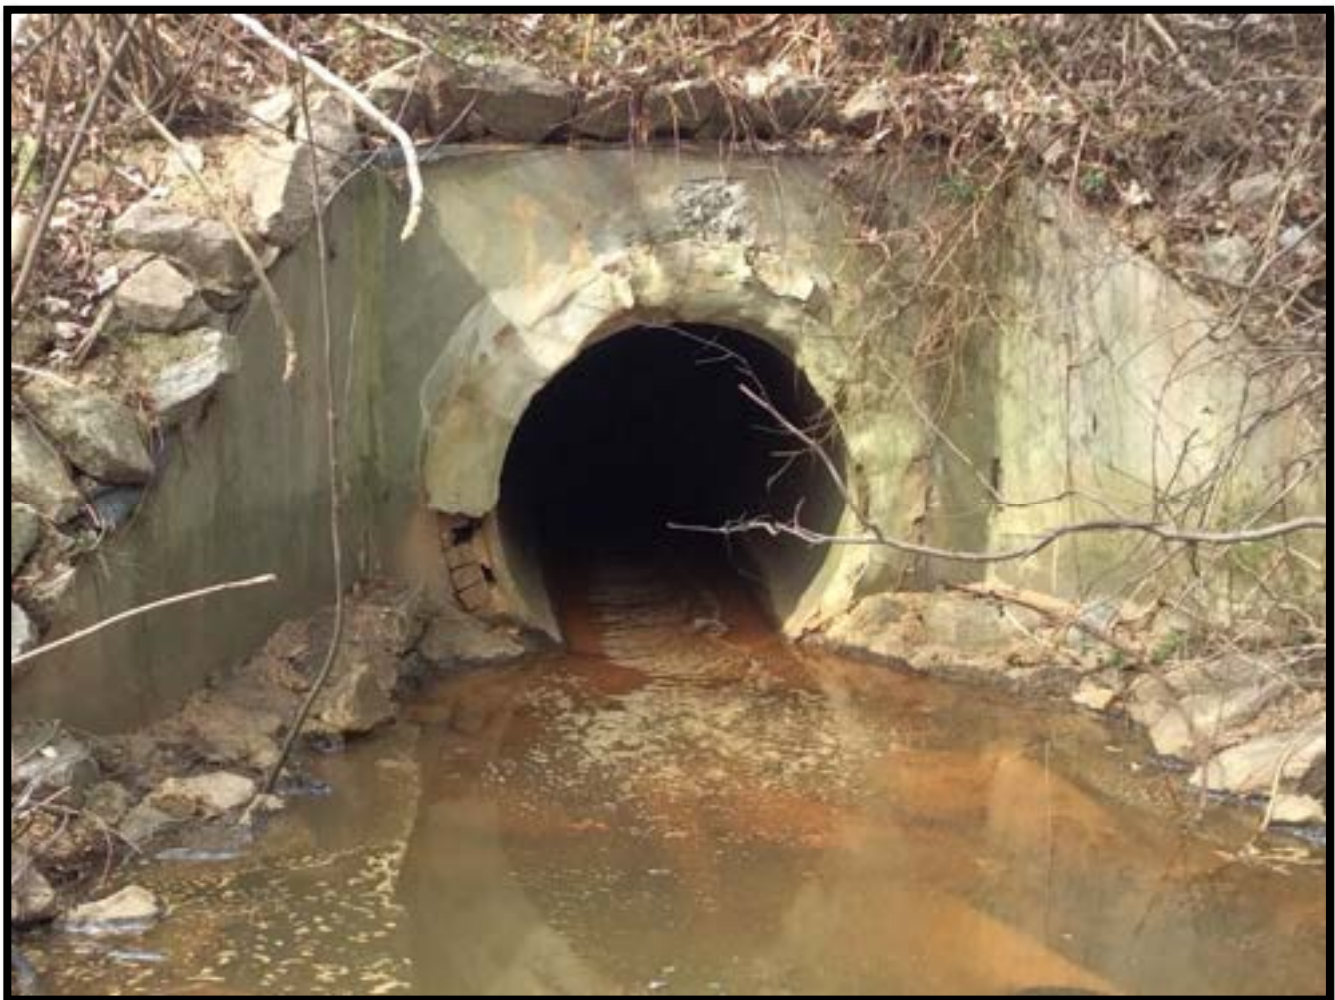
Photo of discharge:

pH: 8.4 Limit: Std.	Conductivity: 417 μ S/cm Limit: Std.	Temp: 54°F Limit: Std.
Discharge related Indicators	Odor: NA	Turbidity: NA
	Floatables: NA	Other: NA
	Color: NA	
	Stains: NA

Hence the discharge from outfall was found to be generated by combine effect of pond discharge and foundation drain.

The source of discharge was discovered foundation drain with channel inflow, is considered a non-illicit discharge.

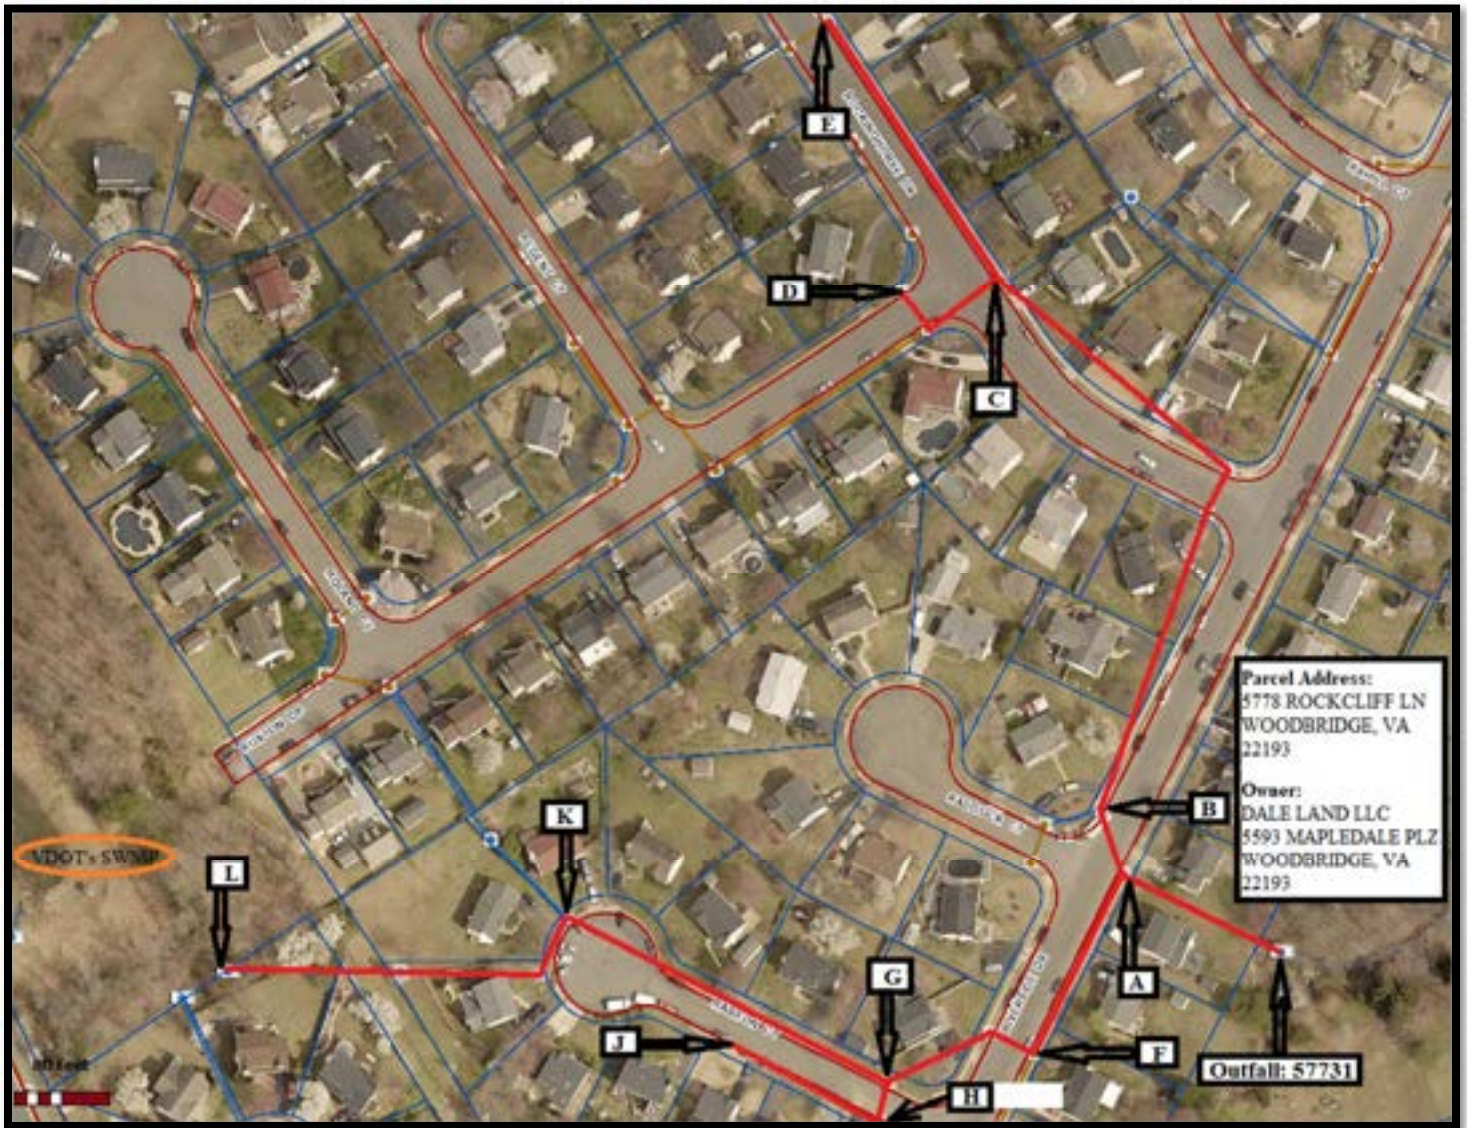
Map of Trackdown Path:

Responsible Party (Owner/ Institutions)	Other Party (Management Company)
Name: NA	Name: NA
Company: Dale Land LLC	Company:
Address: 5593 Mapledale Plaza, Woodbridge VA	Address:
Phone #:	Phone #:
Note:	Note:
Notification/Contact (Other agencies contacted (DEQ, NS, FMO?) NA	
Date:	Date:
Time:	Time:
Name:	Name:
Company/Agency:	Company/Agency:
Notes:	Notes:
Comments/ Deficiencies:	
<p>Discharge was observed with orange algae through outfall having stagnant flow. The conductivity and pH did not exceed the standard limits on test performed on site. Discharge was tracked. Manhole A had flow from ABC and AFG directions. Tracking was started in ABC branch. At Manhole C, Discharge observed from CD and CE branch but both manholes D and E were found very dry respectively.</p>

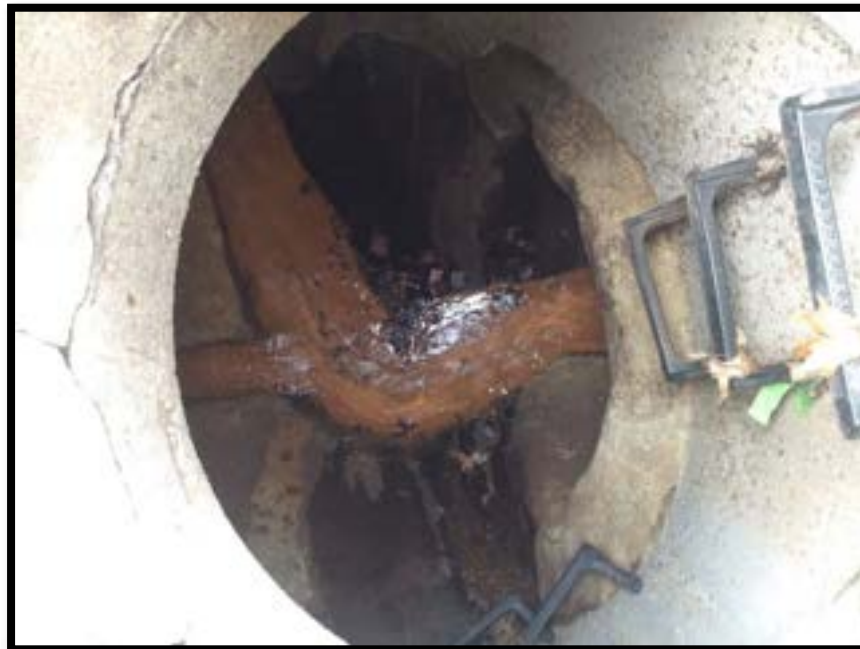
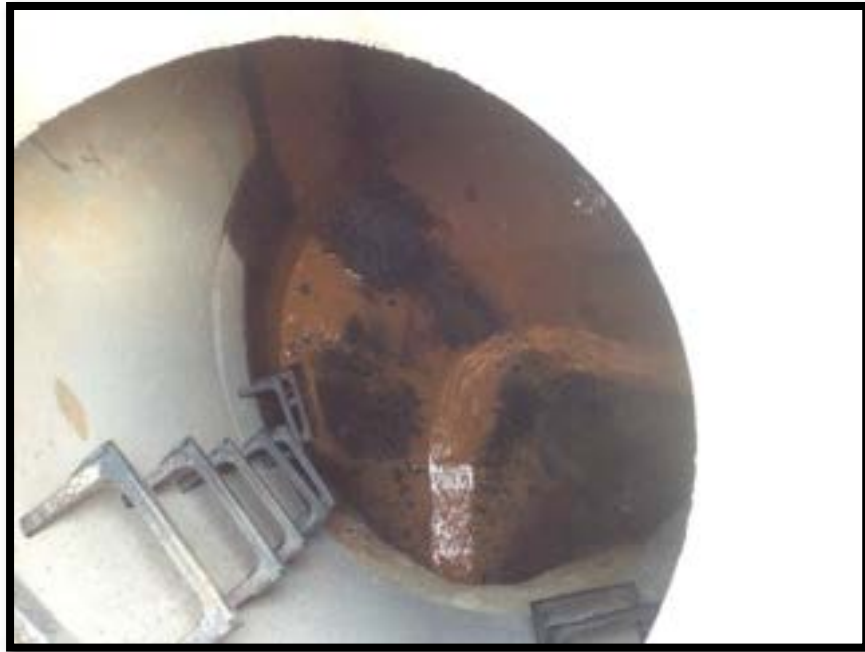
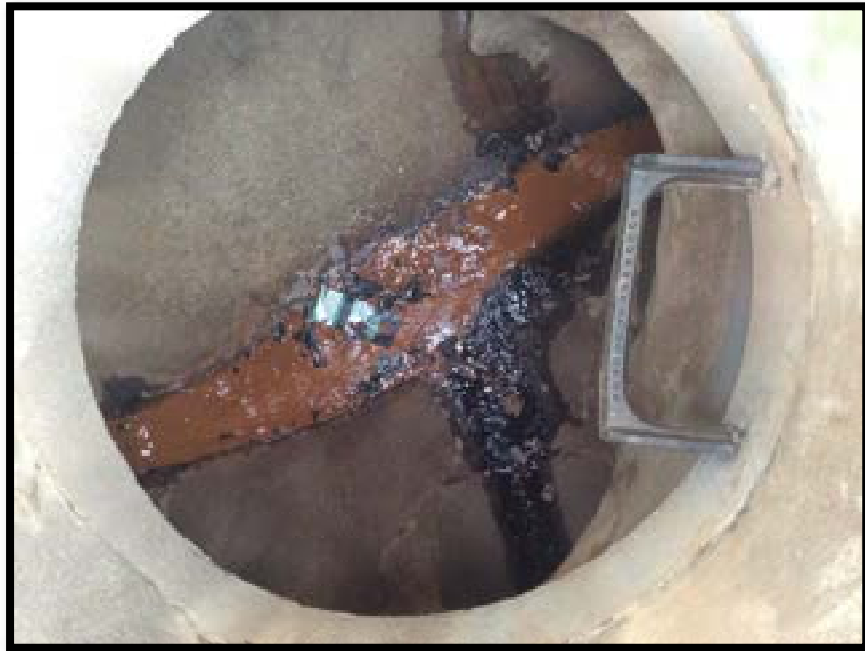
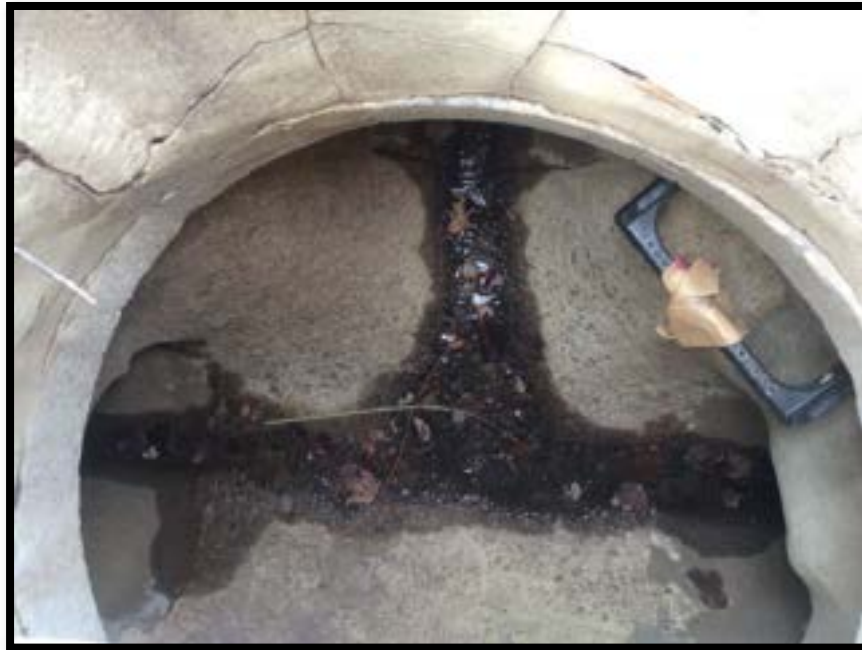
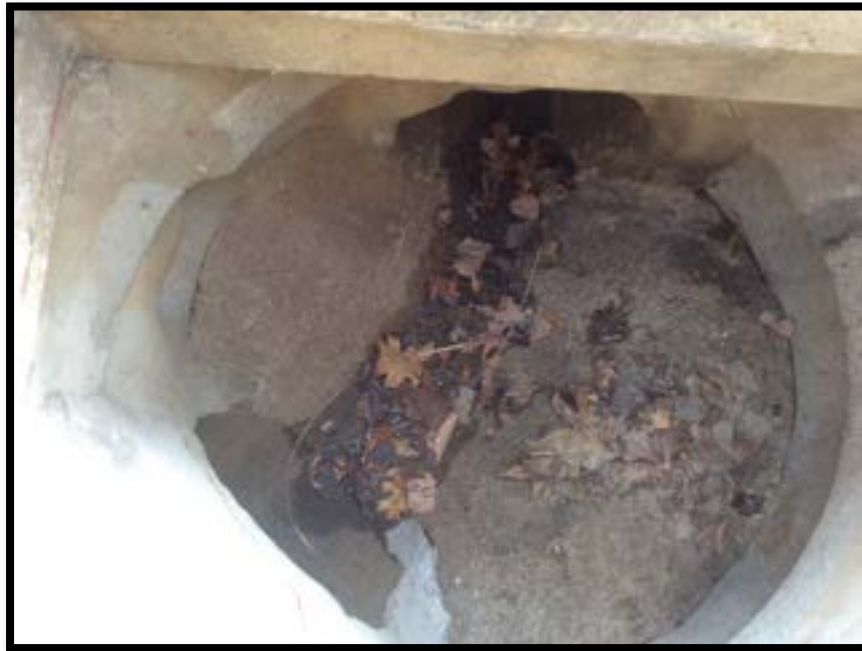
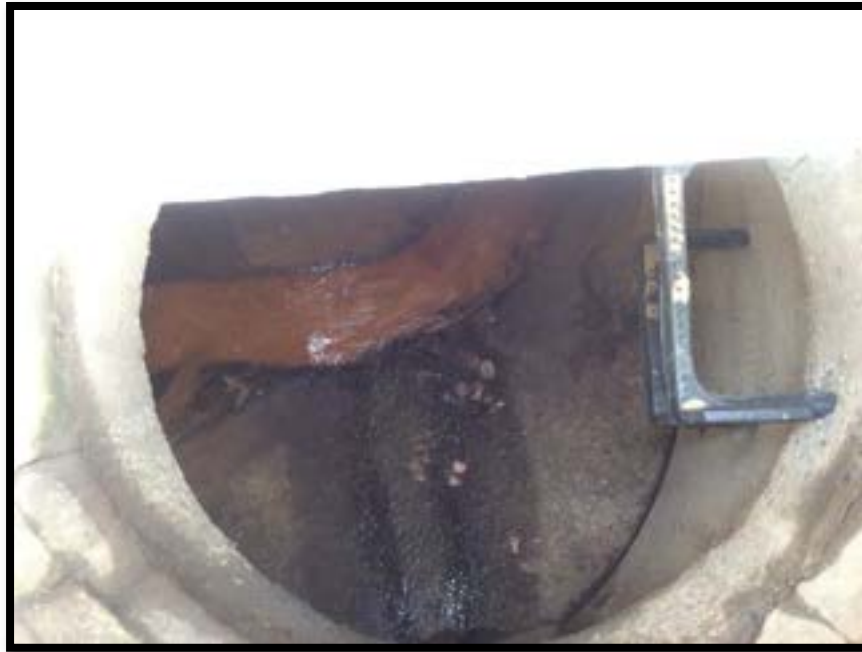
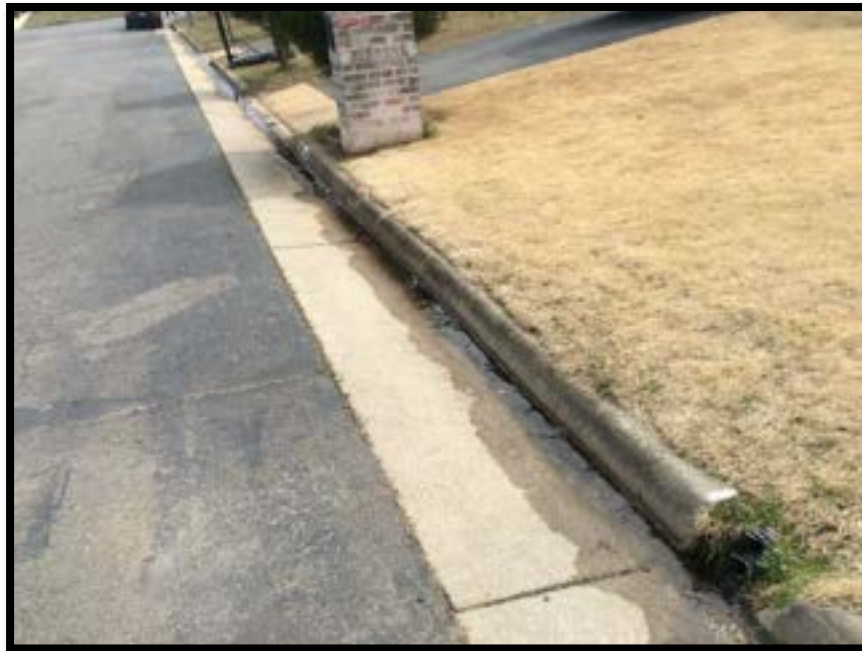
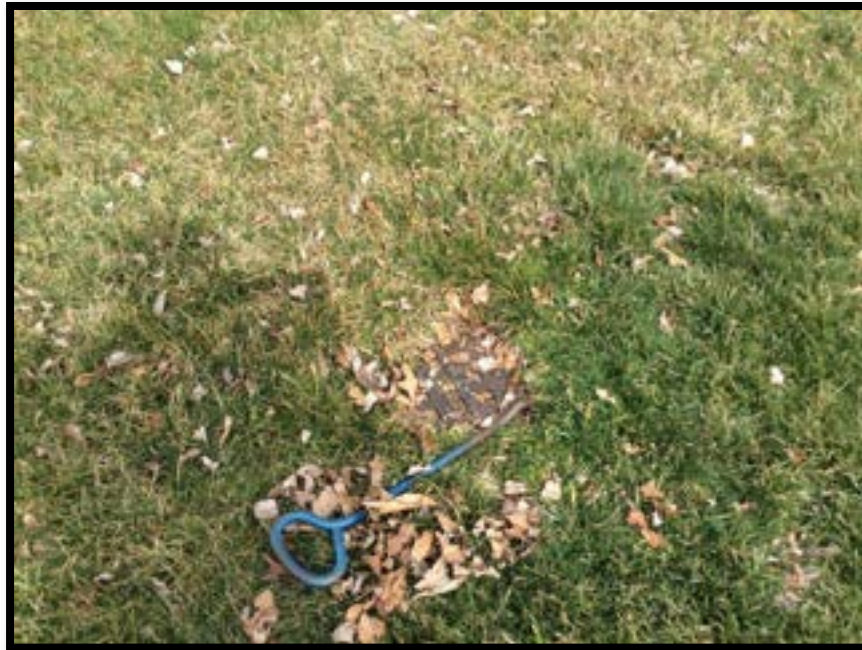
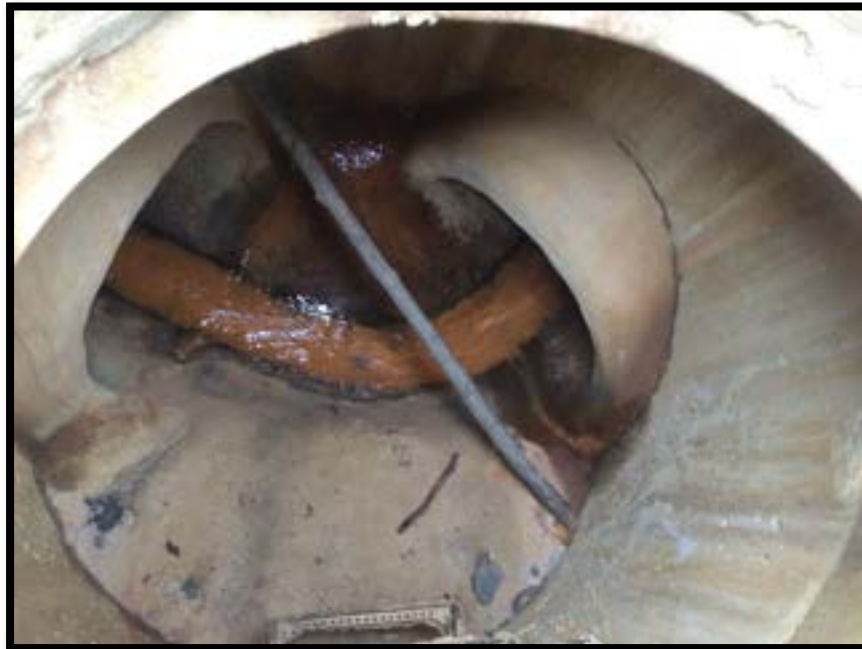
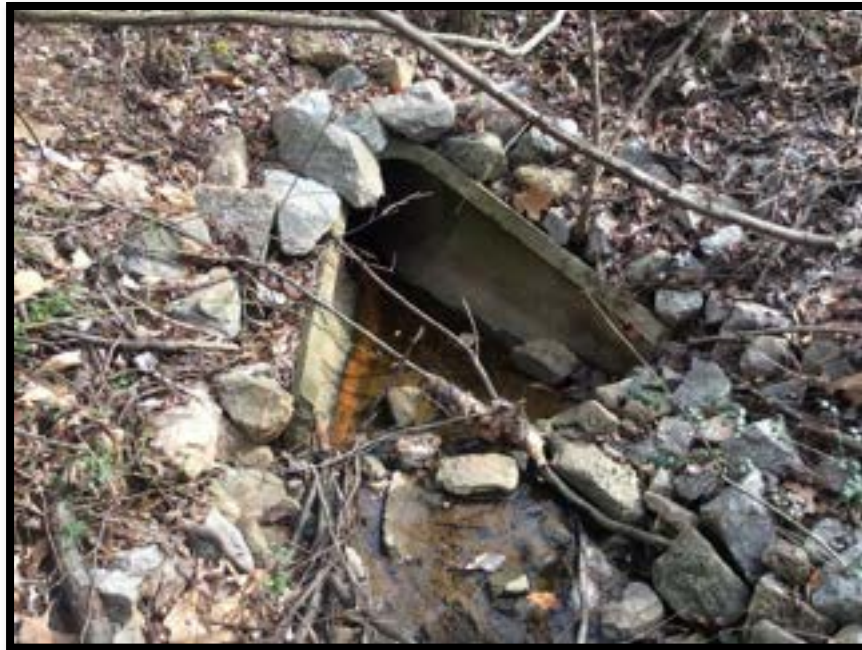
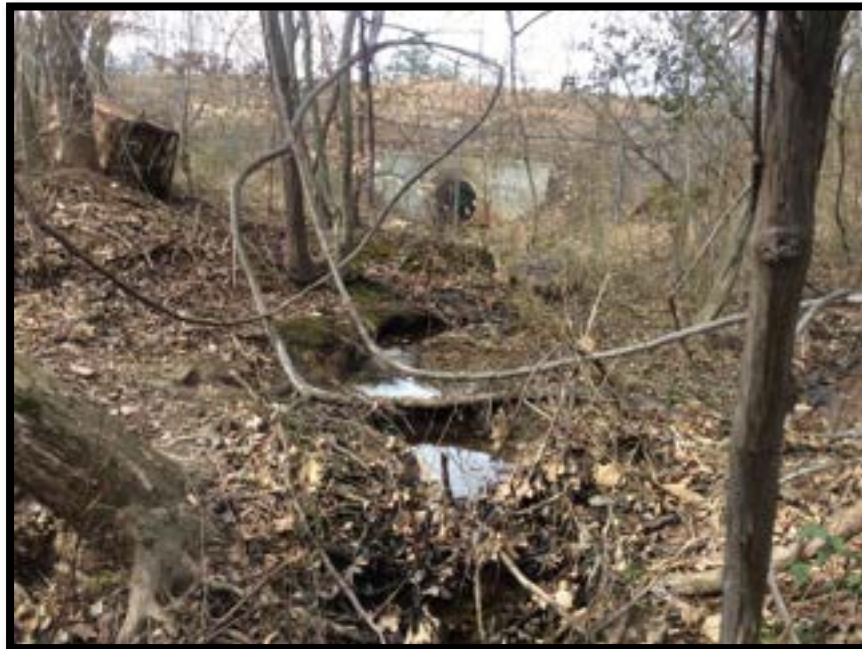
Photos:

Tracking was started in next branch AFG. Manhole G was receiving flow from GHJ and GKL branch respectively. Foundation drains were connecting with curb & gutter discharging water along HJ line. Upstream storm water inlet located at point L was receiving water from the channel having upstream pond discharge. The pond belongs to VDOT.

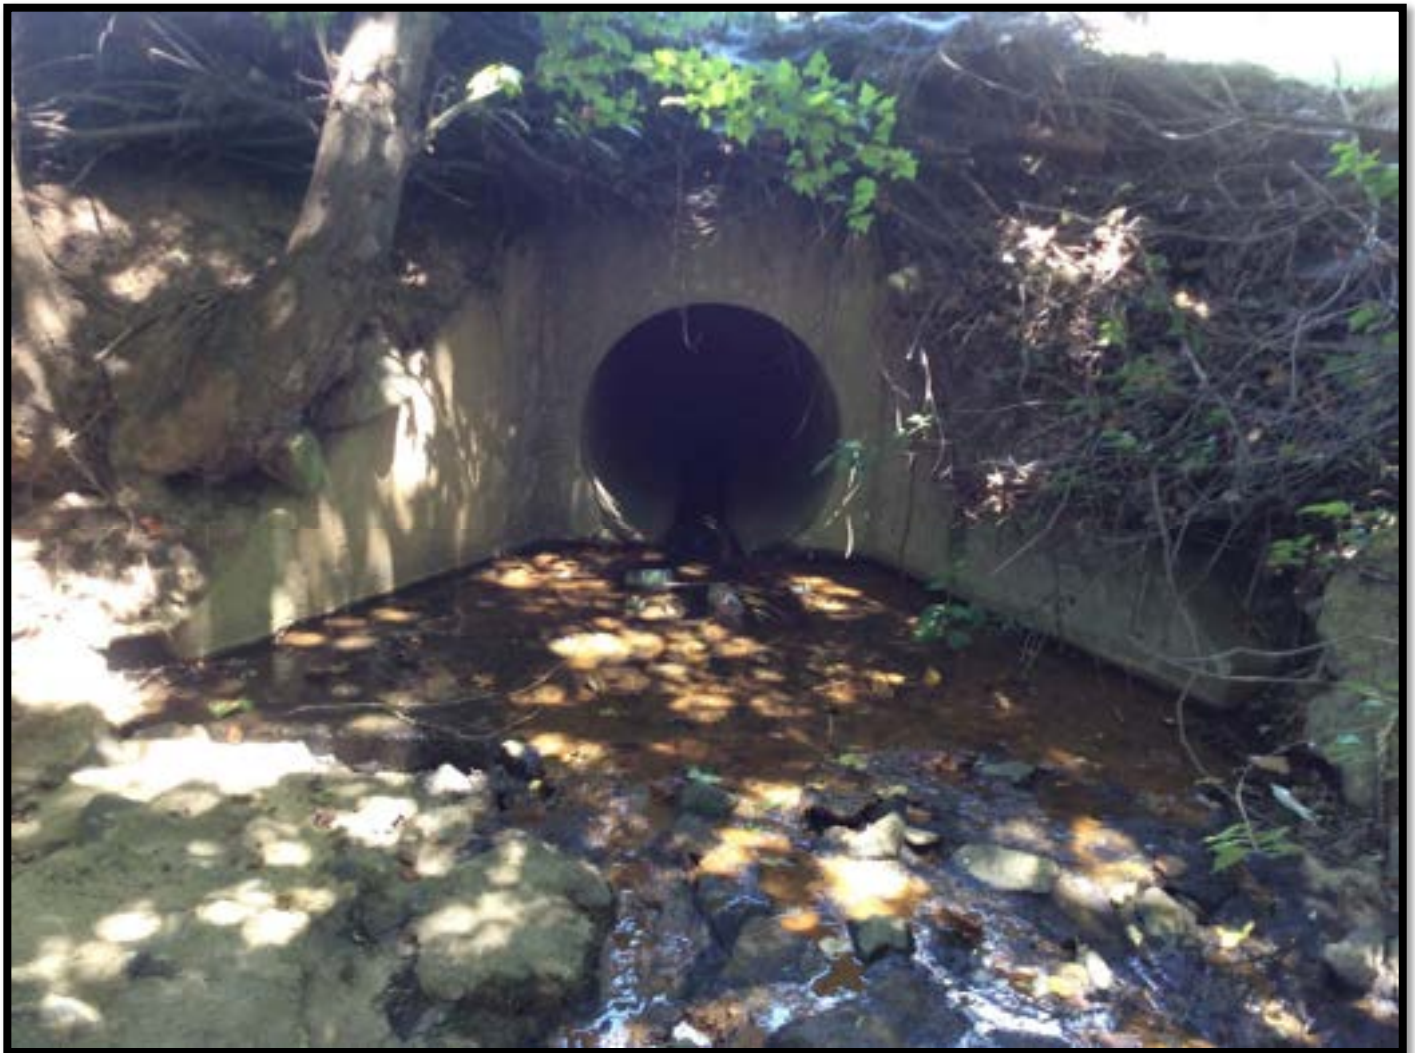
Photo of discharge:

pH: 7.9 Limit: Std.	Conductivity: 614 μ S/cm Limit: Std.	Temp.: 72°F Limit: Std.
Discharge related Indicators	Odor: NA	Color: NA
	Floatables: NA	Stains: NA
		Turbidity: NA
		Other: NA

Discharge was observed through outfall. Algae were observed at downstream channel. Onsite test results of pH and Conductivity lie within standard limits. Discharge tracked along red line shown in map above. Manhole A had flow from AB branch. Discharge tracked along B, C, D, E, and F. At manhole F, discharge observed from both FG and FJ branches. Tracking was continued on GH branch and found ground water seepage with high Algae. After that, tracking was continued to FJ branch. At Manhole J, discharge was observed from both JL and JK branches. Manhole L and K were found dry. Cross connection of sanitary sewer with storm sewer system could not find during inspection. Volume of flow was gradually diminishing in upstream sewer.

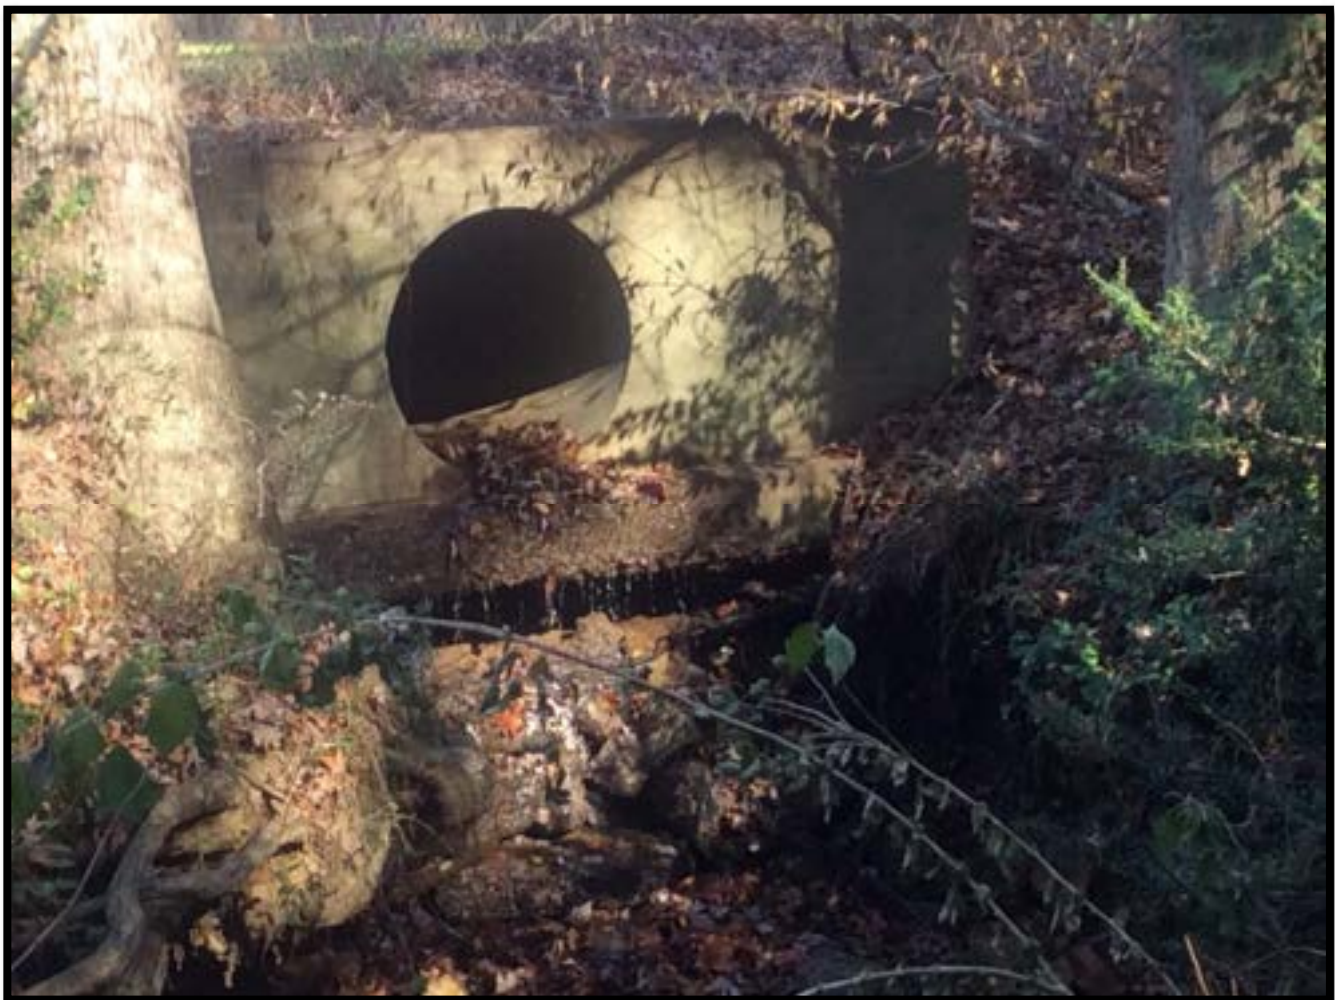
Photo of discharge:

INCIDENT INFORMATION		
Incident Report #: 32-2020	Date: 11/21/2019	Time: 10:30 AM
Business Areas: Residential	Report Completed By: Prem Poudel	
Outfall ID#9965 Address: 4201 Glendale Rd	City, State: Woodbridge, VA	Zip Code: 22193
Complain or Case Received From: Routine Inspection

pH: 7.44 Limit: Std.	Conductivity: 375 μ S/cm Limit: Std.	Temp: 59.6°F Limit: Std.
Discharge related Indicators	Odor: NA	Turbidity: NA
	Floatables: NA	Other: NA
	Color: NA	
	Stains: NA

pH and conductivity were found within the standard limit. Drinking water line connection point is discovered in between B and C points. Tracking was continued in another branch along the points B, D, E, F and G. Manhole G was in pavement and unable to open the lid. Upstream manhole M was observed dry. Tracking was again continued in H-L branch. Trickle flow was observed at Manhole J and K. At manhole K discharge observed from cross road but manhole L was discovered very dry. The source of discharge suspected ground seepage in BL branch. Desktop analysis of water sample was done on 11/22/2019. Fluoride, Chlorine and Copper were found to exceed standard limits of storm water's parameters.

The source of discharge was suspected watermain leakage nearby 4142 Glendale Rd and ground water seepage in BL branch respectively. The case will notify to American Water to investigate from their side.

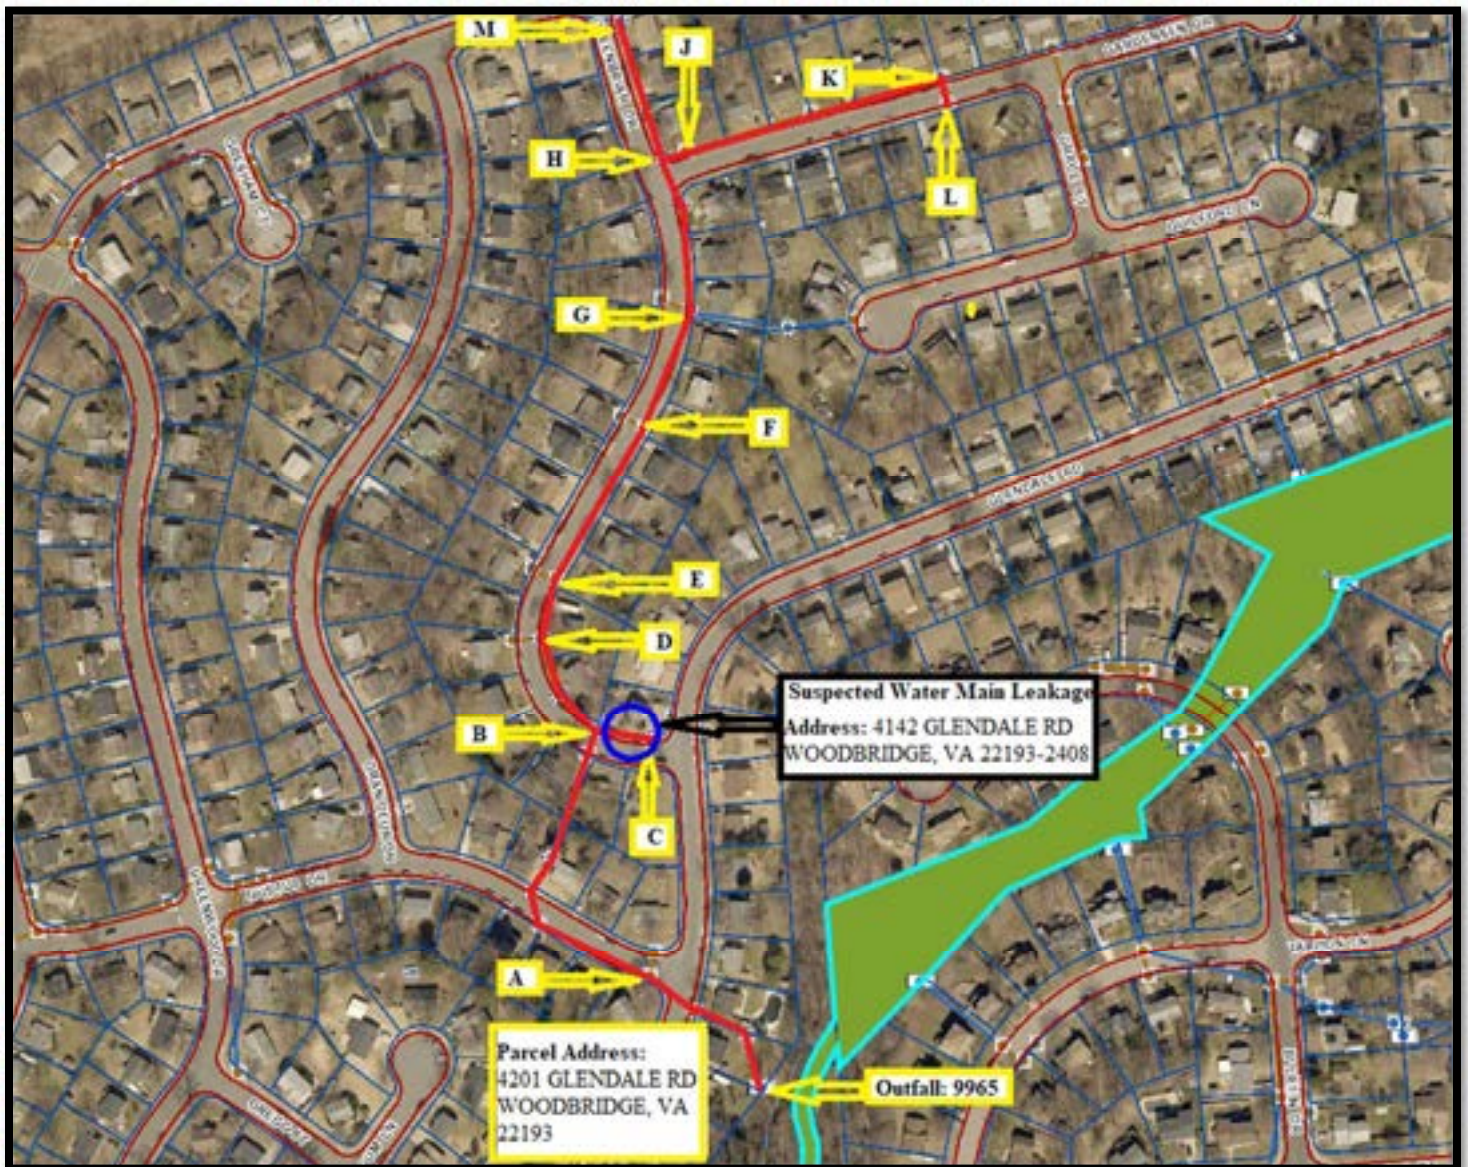
Map of Trackdown Path:

Responsible Party (Owner/ Institutions)	Other Party (Management Company)
Name:	Name: NA
Company:	Company:
Address:	Address:
Phone #:	Phone #:
Note:	Note:
Notification/Contact (Other agencies contacted (DEQ, NS, FMO?) NA	
Date: 11/27/2019	Date:
Time: 11:38 AM	Time:
Name: Ms. Sherri	Name:
Company/Agency: American Water	Company/Agency:
Notes: sherri.abell@amwater.com / (703) 706-3864	Notes:
Comments/ Deficiencies:	
Clear discharge was observed through outfall. Discharge was tracked. Manhole A was receiving discharge from branch AB. At Manhole B, flow was observed from branches BC and BD. Large volume of discharge was discovered from BC branch but manhole C was very dry. Sample was taken at B from the flow of BC branch.

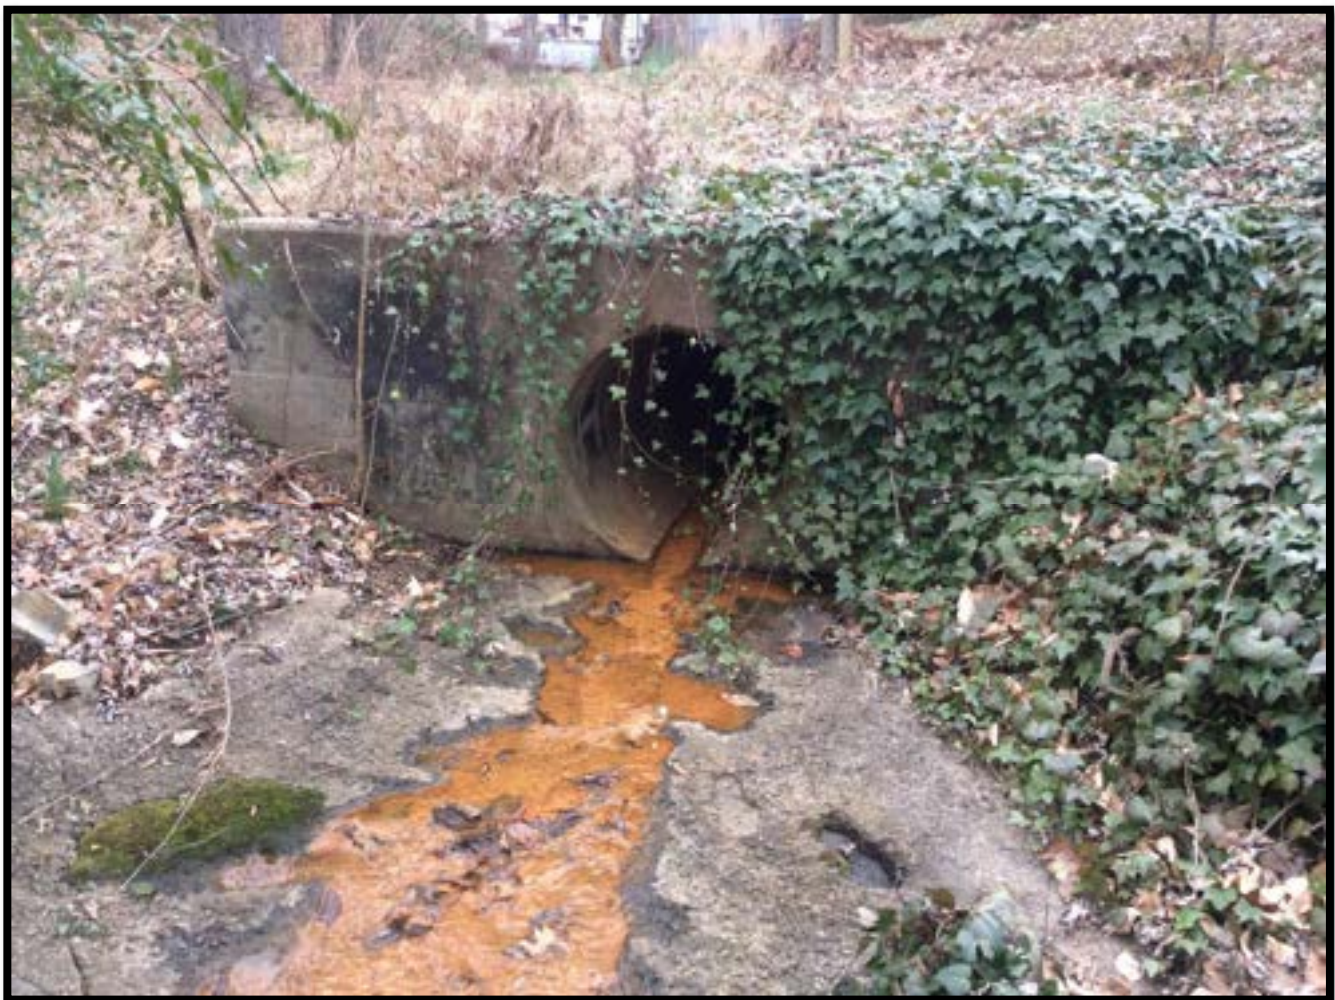
Photo of discharge:

pH: 8.3 Limit: Std.	Conductivity: 611 μ S/cm Limit: Std.	Temp: 54°F Limit: Std.
Discharge related Indicators	Odor: NA	Turbidity: NA
	Floatables: NA	Other: NA
	Color: NA	
	Stains: Algae

Discharge was tracked. Manhole A had flow from AB and ACDEFG branches. At manhole B, the curb and gutter were receiving inflow from foundation drain of three houses. Tracking was continued in next branch ACDEFG. Manhole G was receiving flow from GH and GJ branches respectively. Manhole H and J were discovered extreme manhole being very dry. The discharge was found in diminishing order in upstream lines and cross connection did not notice in inspection, source was confirmed ground water seepage into storm sewer system.

Hence the discharge from outfall was found to be generated by combine effect of ground seepage and foundation drain.

The source of discharge was discovered foundation drain with ground water seepage, is considered a non-illicit discharge.

Responsible Party (Owner/ Institutions)	Other Party (Management Company)
Name: NA	Name: NA
Company: Dale Land LLC	Company:
Address: 5593 Mapledale Plaza, Woodbridge VA	Address:
Phone #:	Phone #:
Note:	Note:
Notification/Contact (Other agencies contacted (DEQ, NS, FMO?) NA	
Date:	Date:
Time:	Time:
Name:	Name:
Company/Agency:	Company/Agency:
Notes:	Notes:
Comments/ Deficiencies:	
Discharge was observed with orange algae through outfall. The conductivity and pH did not exceed the standard limits on test performed on site. The downstream channel was severely eroded. Erosion control measures need to be employed soon to control further damage.

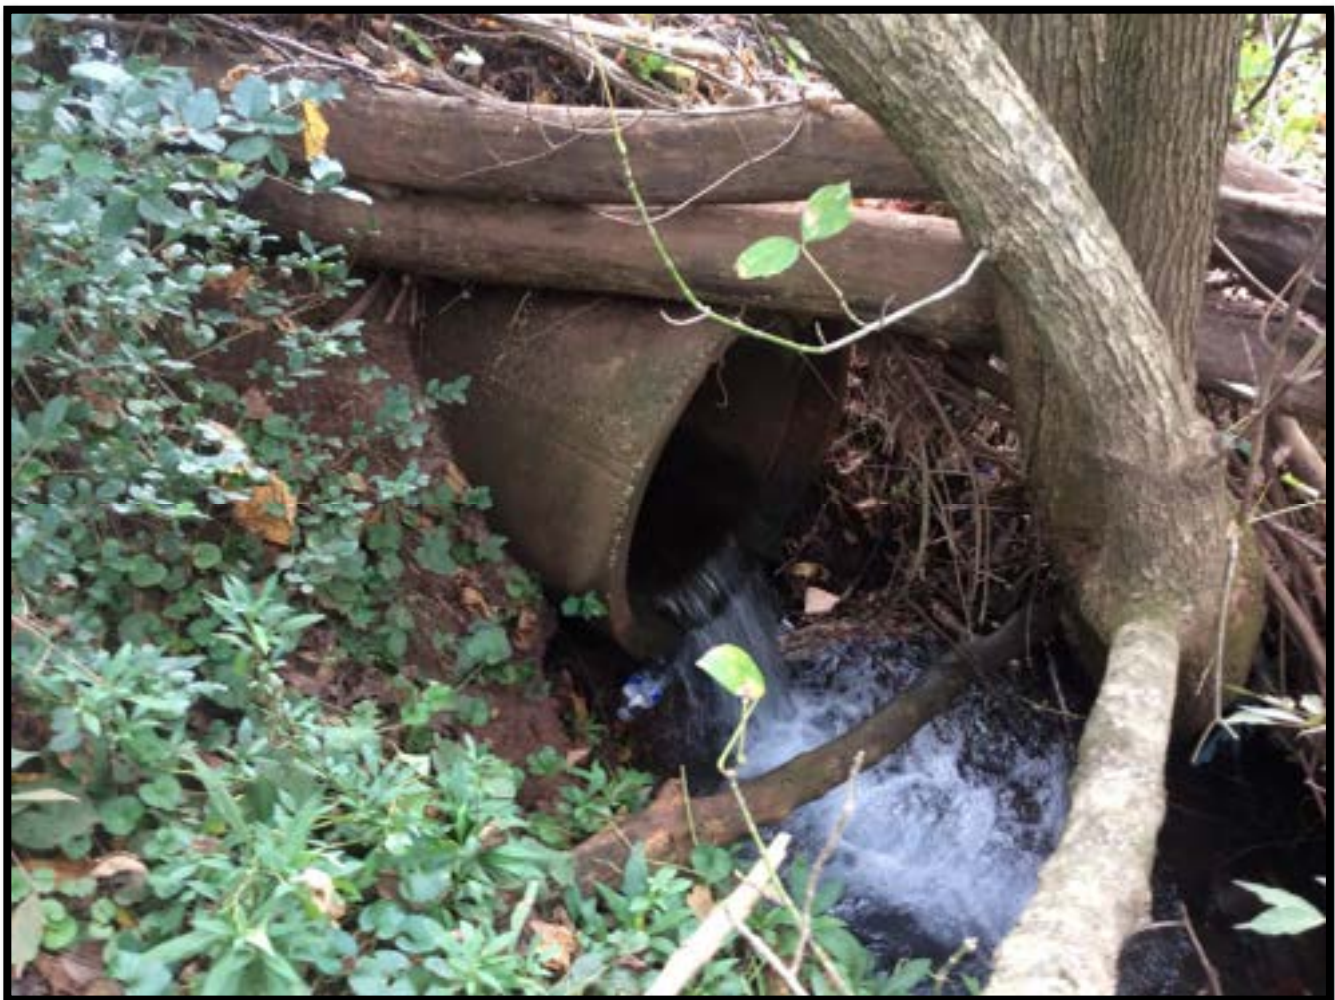
Photo of discharge:

pH: 7.7 Limit: Std.	Conductivity: 318 μ S/cm Limit: Std.	Temp.: 68°F Limit: Std.
Discharge related Indicators	Odor: NA	Turbidity: NA
	Floatables: NA	Other: NA
	Color: NA	
	Stains: NA

The source of discharge was discovered ground water from foundation drain, is non-illicit discharge. Further investigation is not needed.

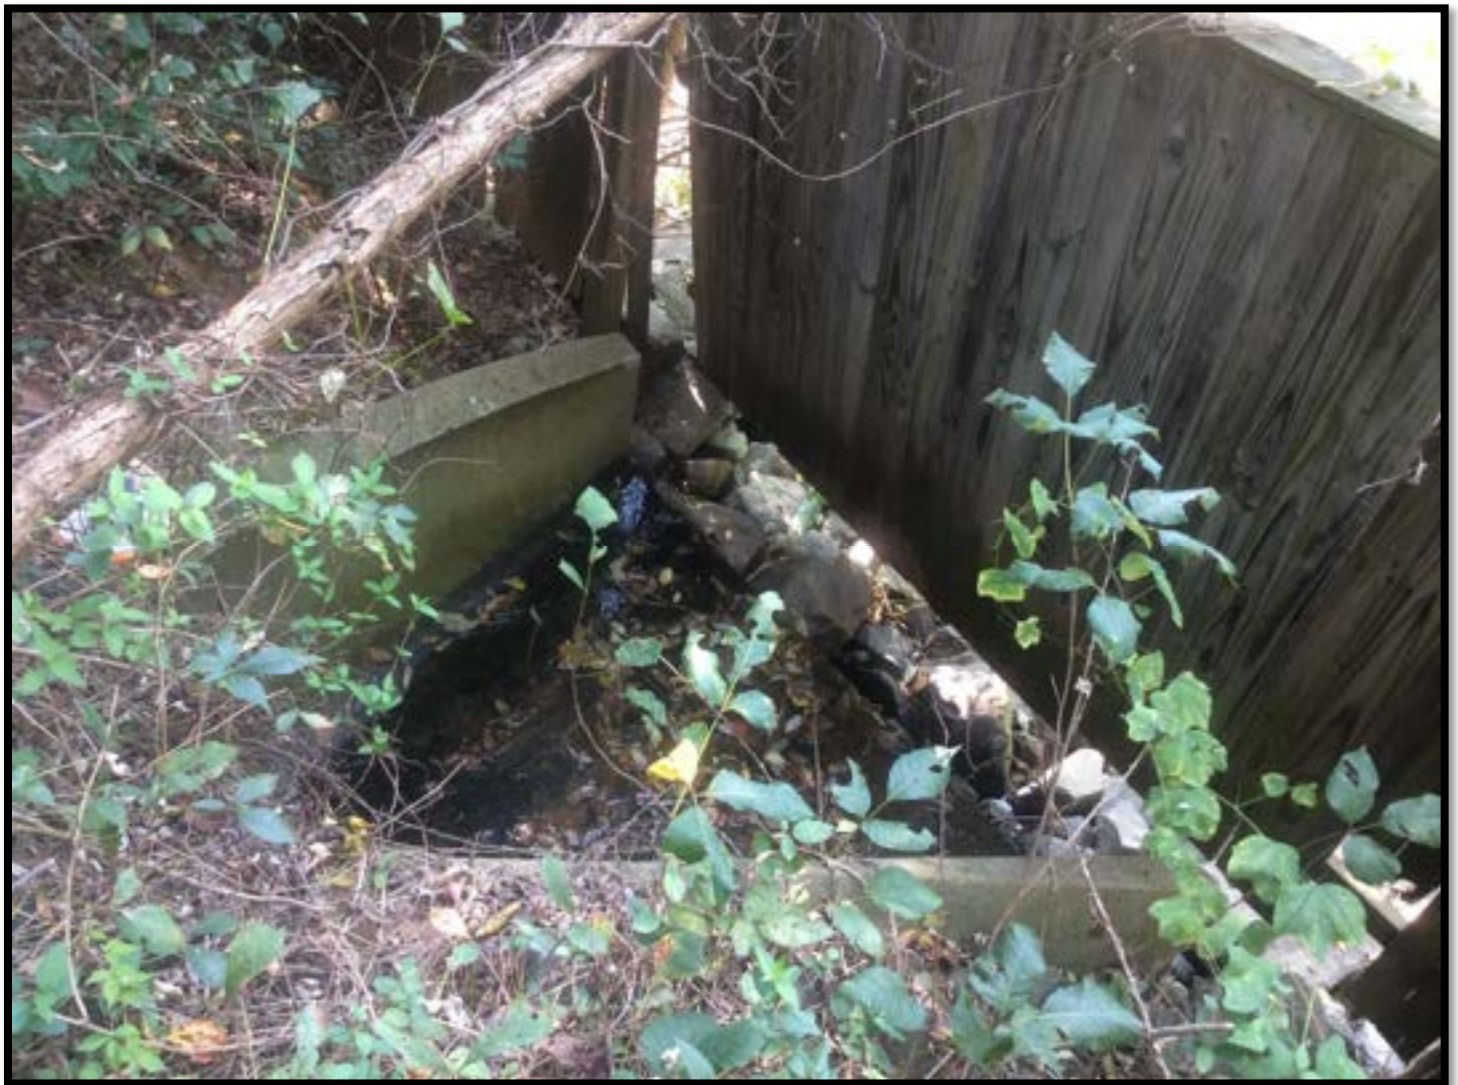
Photo of discharge:

pH: 8.0 Limit: Std.	Conductivity: 313 μ S/cm Limit: Std.	Temp.: 71°F Limit: Std.
Discharge related Indicators	Odor: NA	Turbidity: NA
	Floatables: NA	Other: NA
	Color: NA	
	Stains: NA

pH and conductivity did not exceed the limits during onsite test. Source of discharge was tracked along red line shown in map above. At manhole A, flow observed from both AB and BC branches. Manhole B was found to be dry. Tracking was continued along points C, D and E. The open channel flow with pond discharge was entering through upstream inlet E.
