Annual Stormwater Management Report
VSMP Permit No. 0088595 – FY 2020

Submitted by:
Prince William County
Department of Public Works

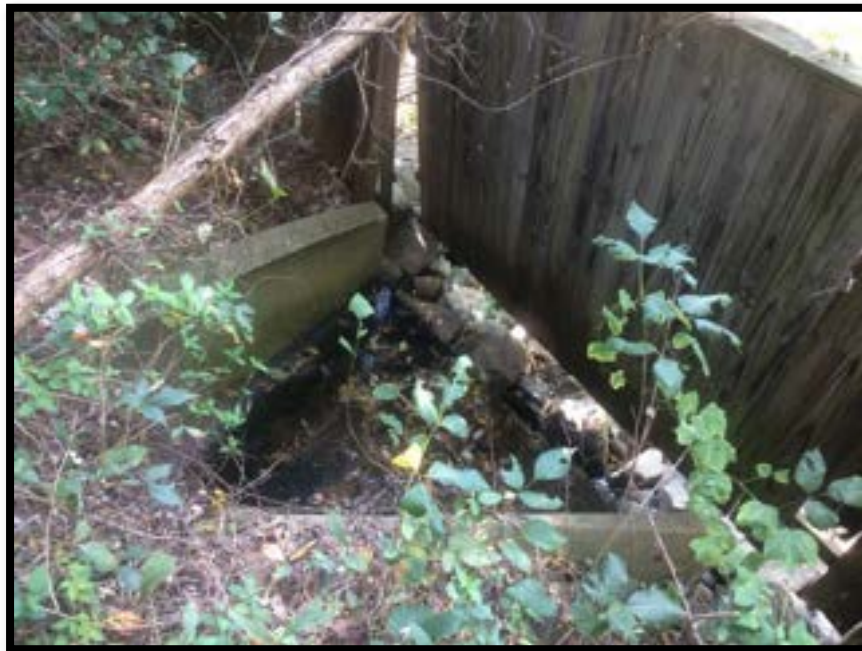
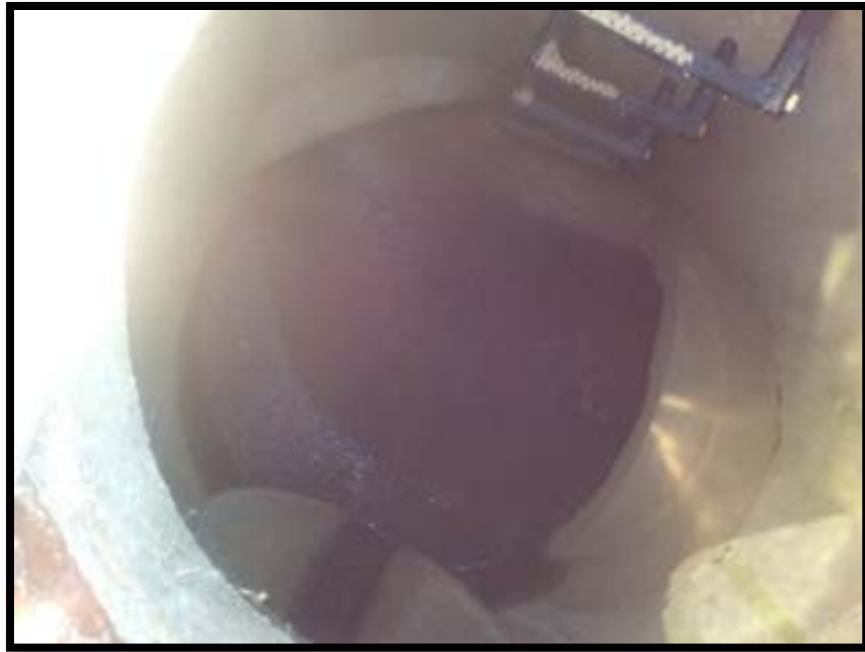
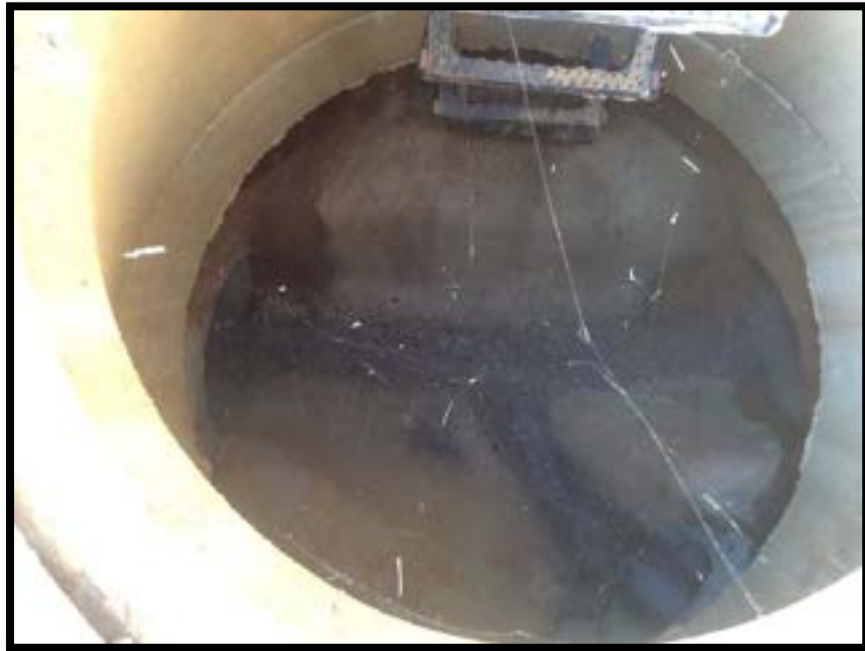
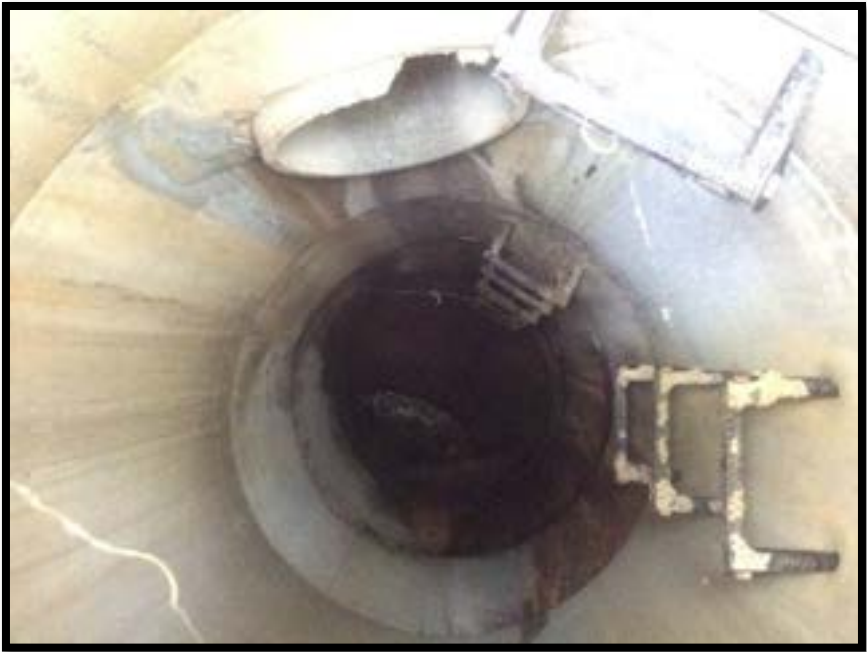
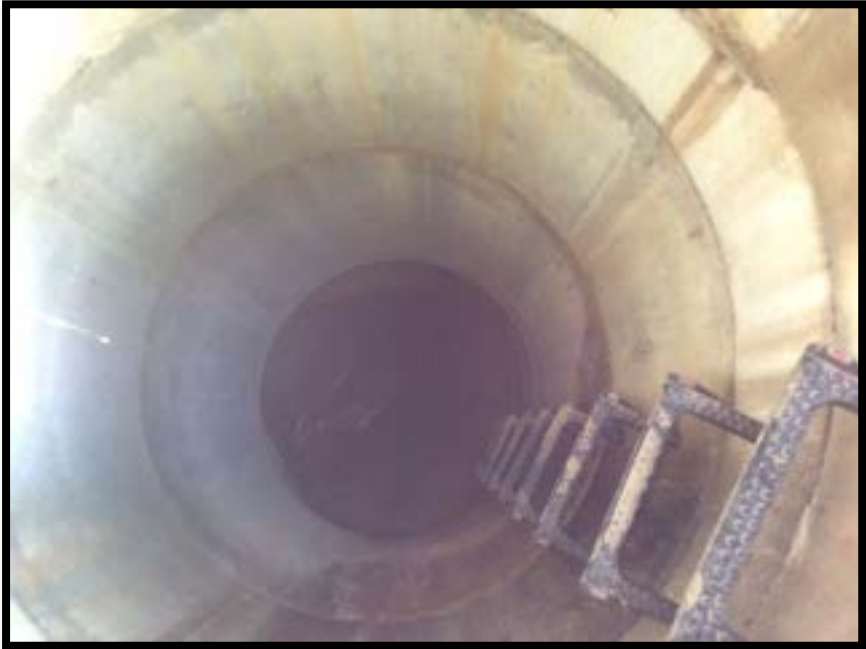
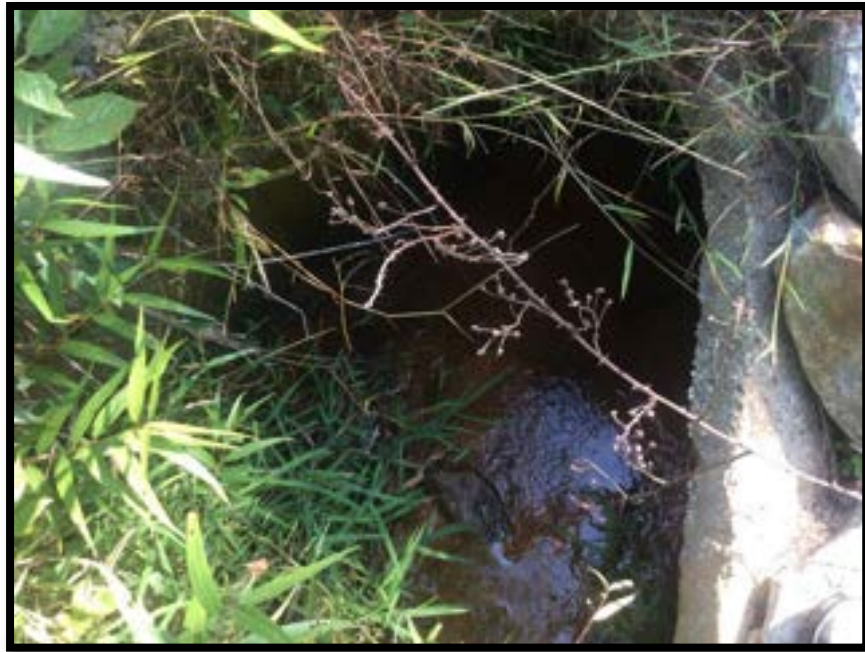
Photos:

pH and conductivity did not exceed the limits during onsite test. Source of discharge was tracked along red line shown in map above. At manhole A, flow observed from both AB and BC branches. Manhole B was found to be dry. Tracking was continued along points C, D and E. The open channel flow with pond discharge was entering through upstream inlet E.

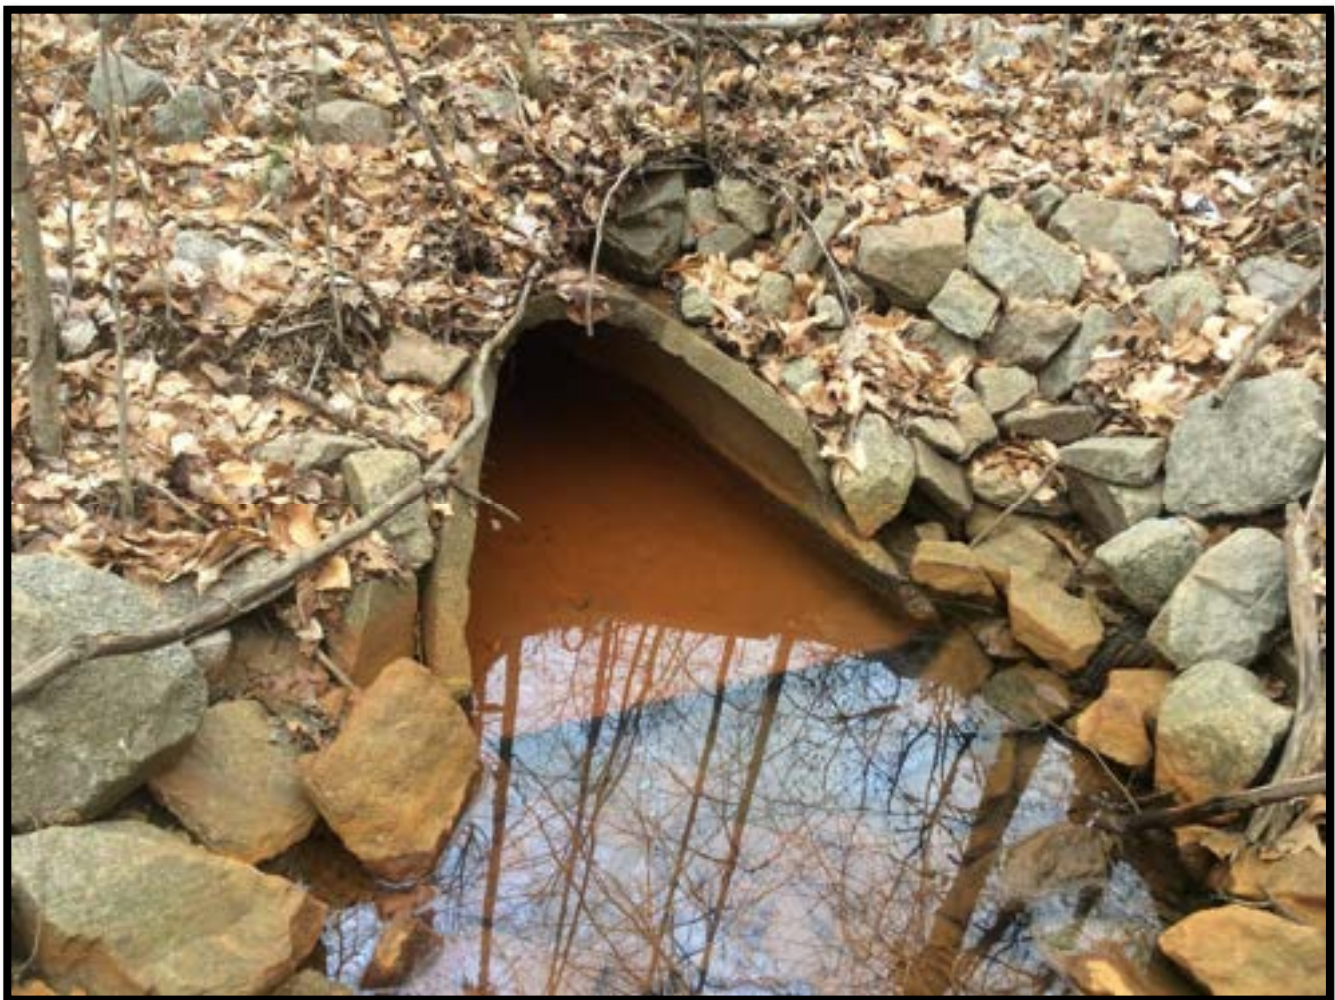
Photo of discharge:

pH: 8.4 Limit: Std.	Conductivity: 312 μ S/cm Limit: Std.	Temp: 52°F Limit: Std.
Discharge related Indicators	Odor: NA	Turbidity: NA
	Floatables: NA	Other: NA
	Color: NA	
	Stains: Algae

Responsible Party (Owner/ Institutions)	Other Party (Management Company)
Name: NA	Name: NA
Company: Cardinal Crest HOA	Company:
Address: PO BOX 1375 Newington, VA 22122	Address:
Phone #:	Phone #:
Note:	Note:
Notification/Contact (Other agencies contacted (DEQ, NS, FMO?) NA	
Date:	Date:
Time:	Time:
Name:	Name:
Company/Agency:	Company/Agency:
Notes:	Notes:
<u>Comments/ Deficiencies:</u>	
<p>Discharge was observed with orange algae through outfall. The conductivity and pH did not exceed the standard limits on test performed on site. There was no special character or sign of illicit discharge at outfall and downstream channel.</p> <p>Discharge was tracked. The upstream successive Manhole A was found totally dry. Cross-connection of sanitary sewer did not notice in an inspection.</p>

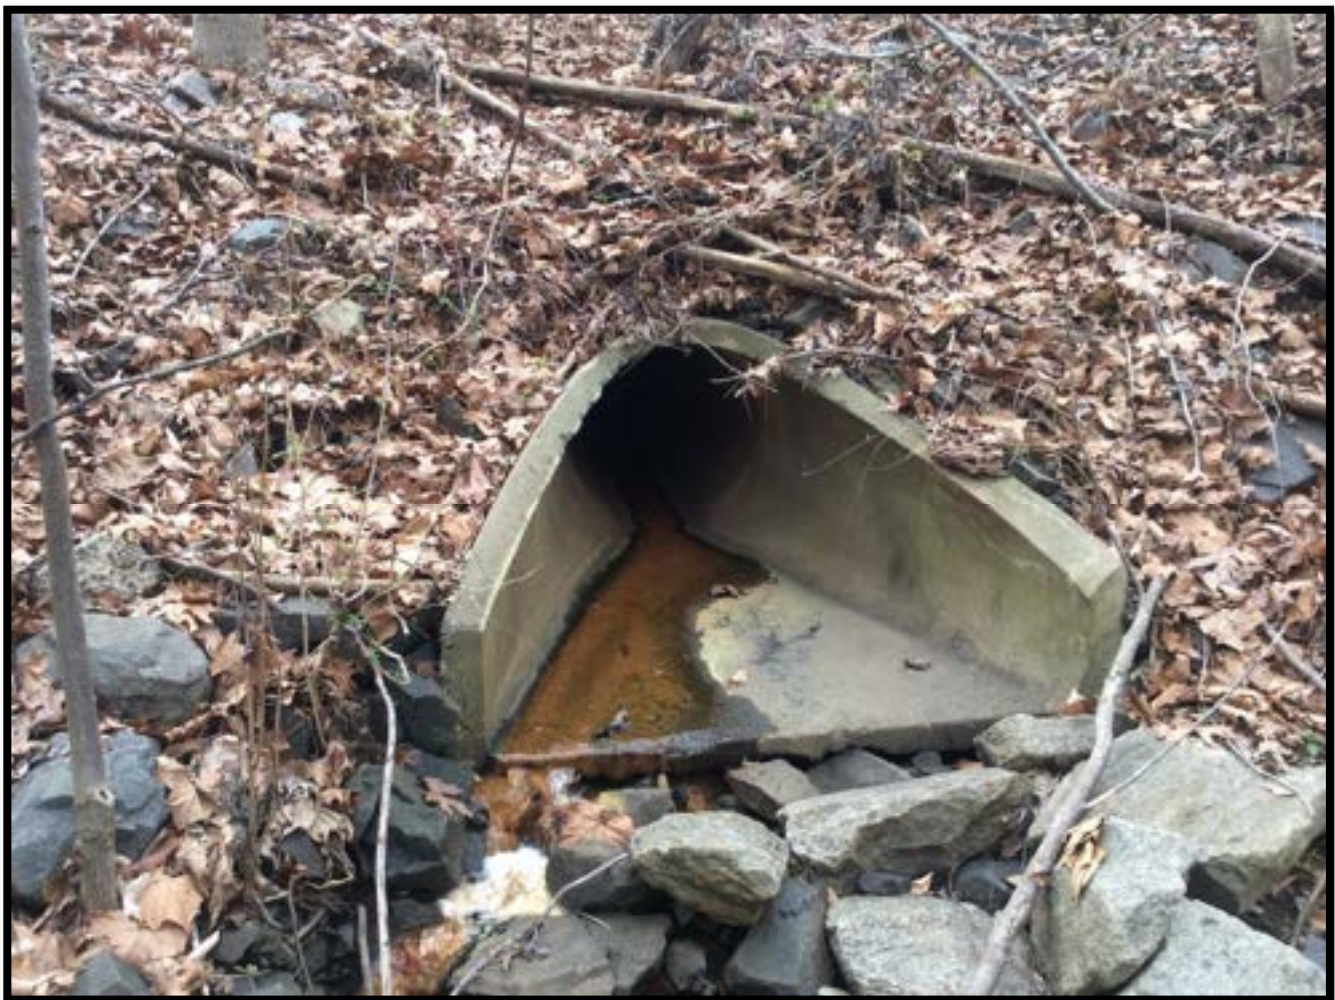
Photo of discharge:

pH: 7.5 Limit: Std.	Conductivity: 514 μ S/cm Limit: Std.	Temp: 51°F Limit: Std.
Discharge related Indicators	Odor: NA	Turbidity: NA
	Floatables: NA	Other: NA
	Color: NA	
	Stains: Algae

Responsible Party (Owner/ Institutions)	Other Party (Management Company)
Name: NA	Name: NA
Company: Cardinal Crest HOA	Company:
Address: PO BOX 1375 Newington, VA 22122	Address:
Phone #:	Phone #:
Note:	Note:
Notification/Contact (Other agencies contacted (DEQ, NS, FMO?) NA	
Date:	Date:
Time:	Time:
Name:	Name:
Company/Agency:	Company/Agency:
Notes:	Notes:
<u>Comments/ Deficiencies:</u>	
<p>Discharge was observed with orange algae through outfall. The conductivity and pH did not exceed the standard limits on test performed on site. There was no special character or sign of illicit discharge at outfall and downstream channel.</p> <p>Discharge was tracked. Manhole A had flow from AB branch. B is the riser of SWMP #235, receiving inflow from ponding water.</p>

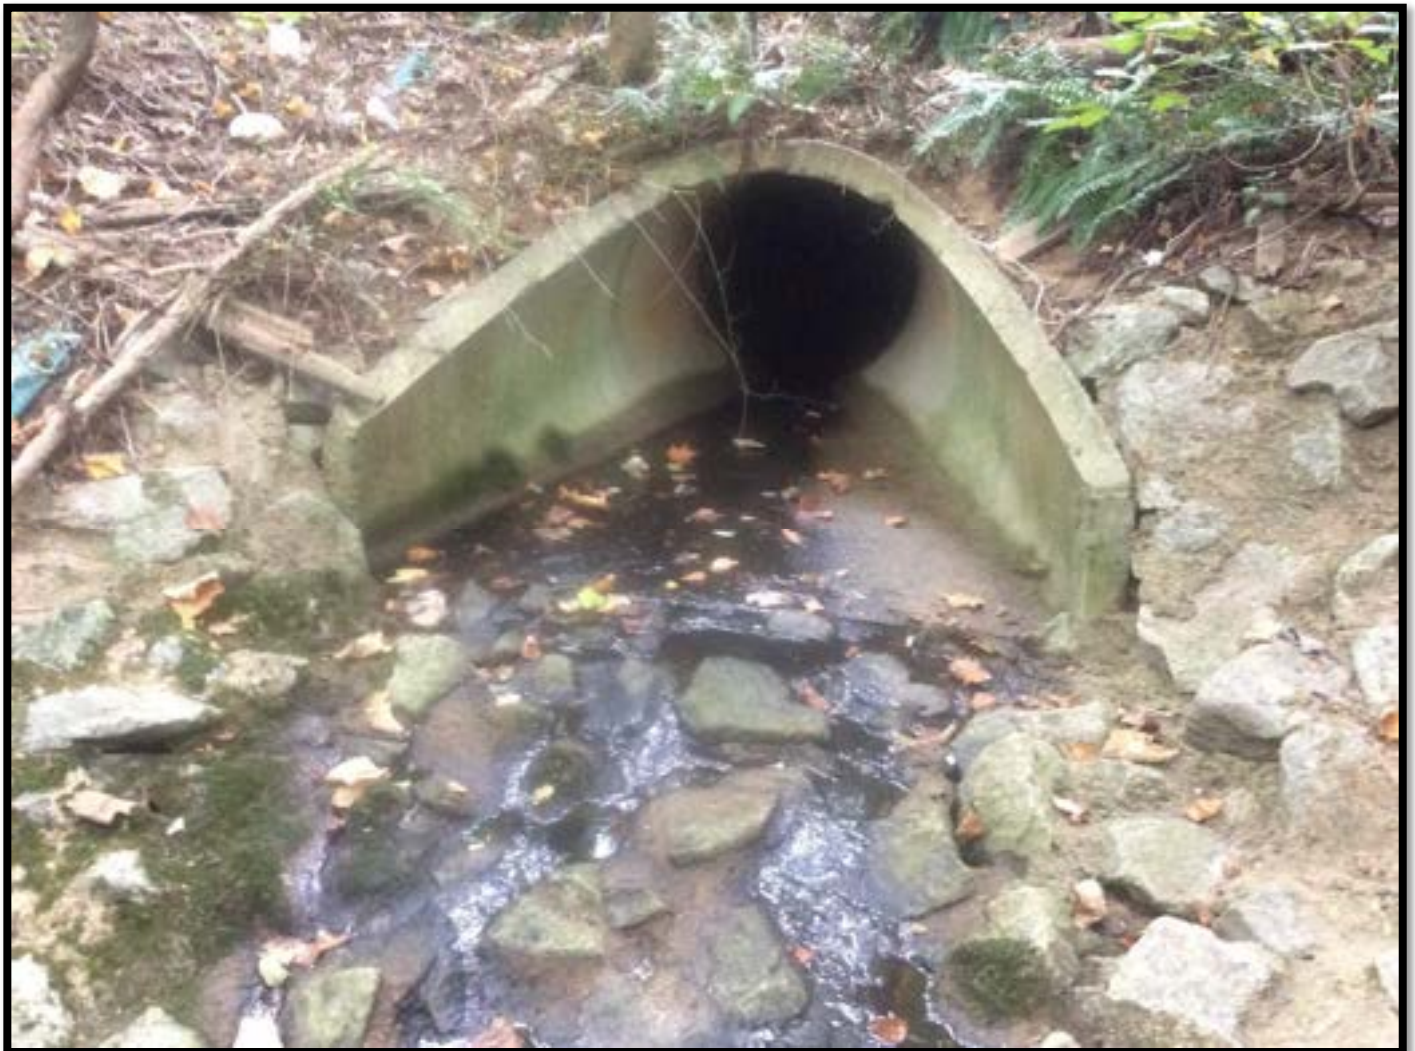
Photo of discharge:

pH: 7.70 Limit: Std.	Conductivity: 218 μ S/cm Limit: Std.	Temp.: 76°F Limit: Std.
Discharge related Indicators	Odor: NA	Color: NA
	Floatables: NA	Stains: NA
		Turbidity: NA
		Other: NA

Responsible Party (Owner/ Institutions)	Other Party (Management Company)
Name:	Name: NA
Company:	Company:
Address:	Address:
Phone #:	Phone #:
Note:	Note:
Notification/Contact (Other agencies contacted (DEQ, NS, FMO?) NA	
Date:	Date:
Time:	Time:
Name: TBD	Name:
Company/Agency:	Company/Agency:
Notes:	Notes:
<p>Comments/ Deficiencies: Onsite test results of pH and Conductivity lie within standard limits. Discharge tracked along red line shown in map above. Manhole A had flow from AB branch only. Tracking was continued along points A, B and C. Discharge was gradually reducing and found manhole C very dry. Cross connection of sanitary sewer could not find during inspection.</p>

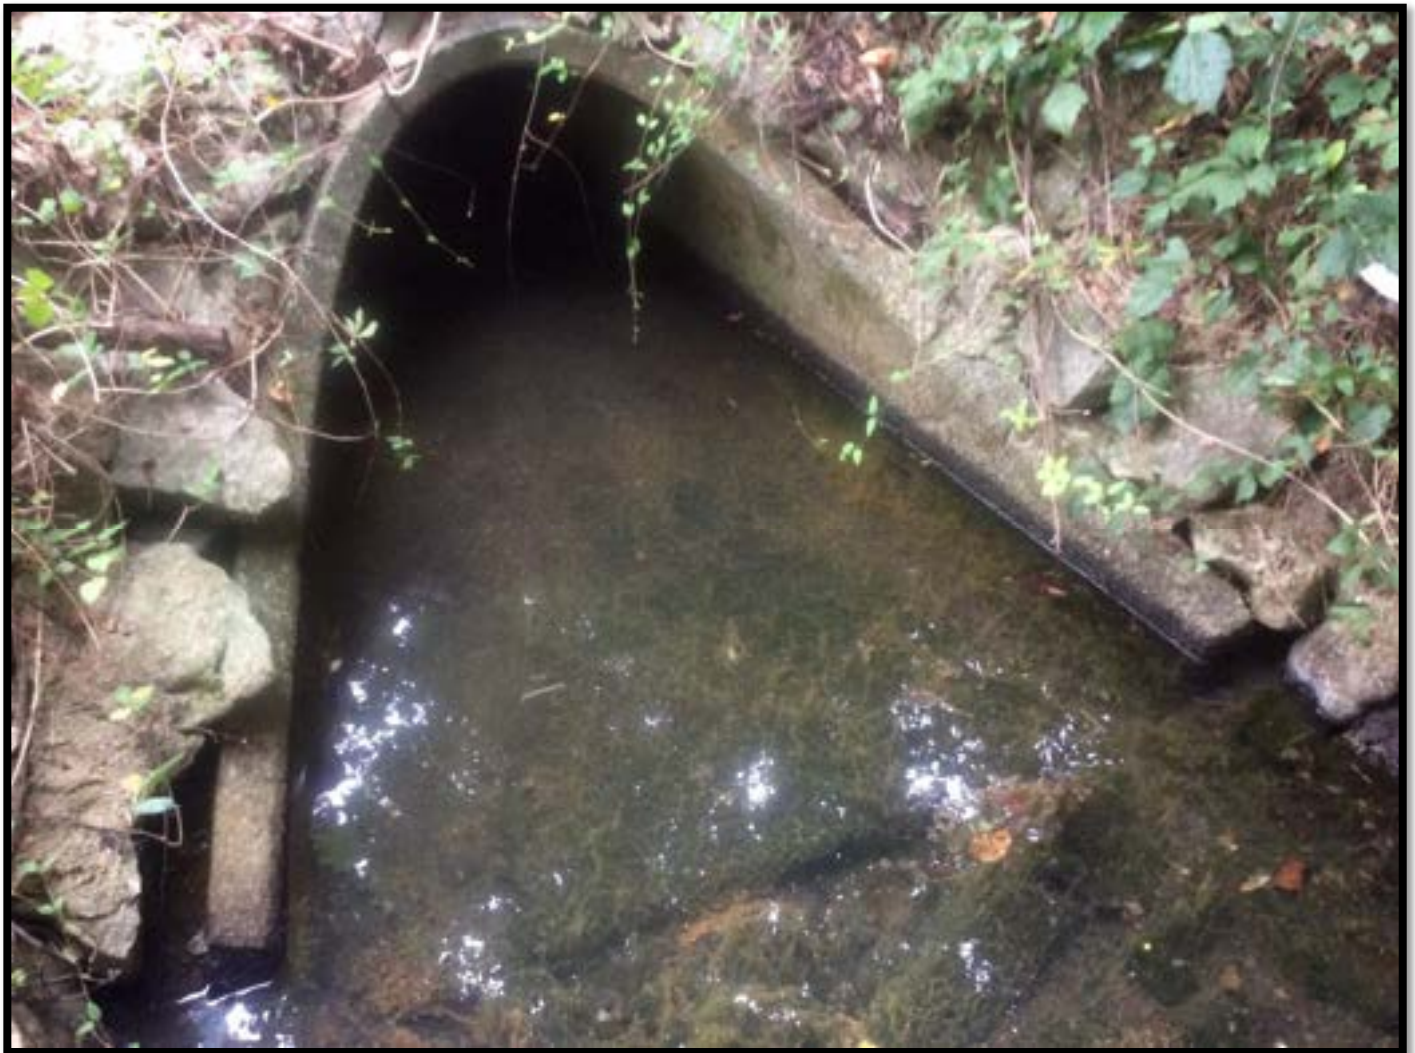
Photo of discharge:

pH: 8.20 Limit: Std.	Conductivity: 304µS/cm Limit: Std.	Temp.: 79°F Limit: Std.
Discharge related Indicators	Odor: NA	Color: NA
	Floatables: NA	Stains: NA
		Turbidity: NA
		Other: NA

Responsible Party (Owner/ Institutions)	Other Party (Management Company)
Name:	Name: NA
Company:	Company:
Address:	Address:
Phone #:	Phone #:
Note:	Note:
Notification/Contact (Other agencies contacted (DEQ, NS, FMO?) NA	
Date:	Date:
Time:	Time:
Name: TBD	Name:
Company/Agency:	Company/Agency:
Notes:	Notes:
Comments/ Deficiencies:	
<p>Onsite test results of pH and Conductivity lie within standard limits. Discharge tracked along red line shown in map above. Manhole A had flow from AB branch only. Tracking was continued along points A and B points. Road Curb and Gutter Inlet A was receiving discharge from water main leakage happened between point A and B. Manhole B was in moist condition only.</p>

After investigation, source of discharge was confirmed water main leakage with ground water seepage.

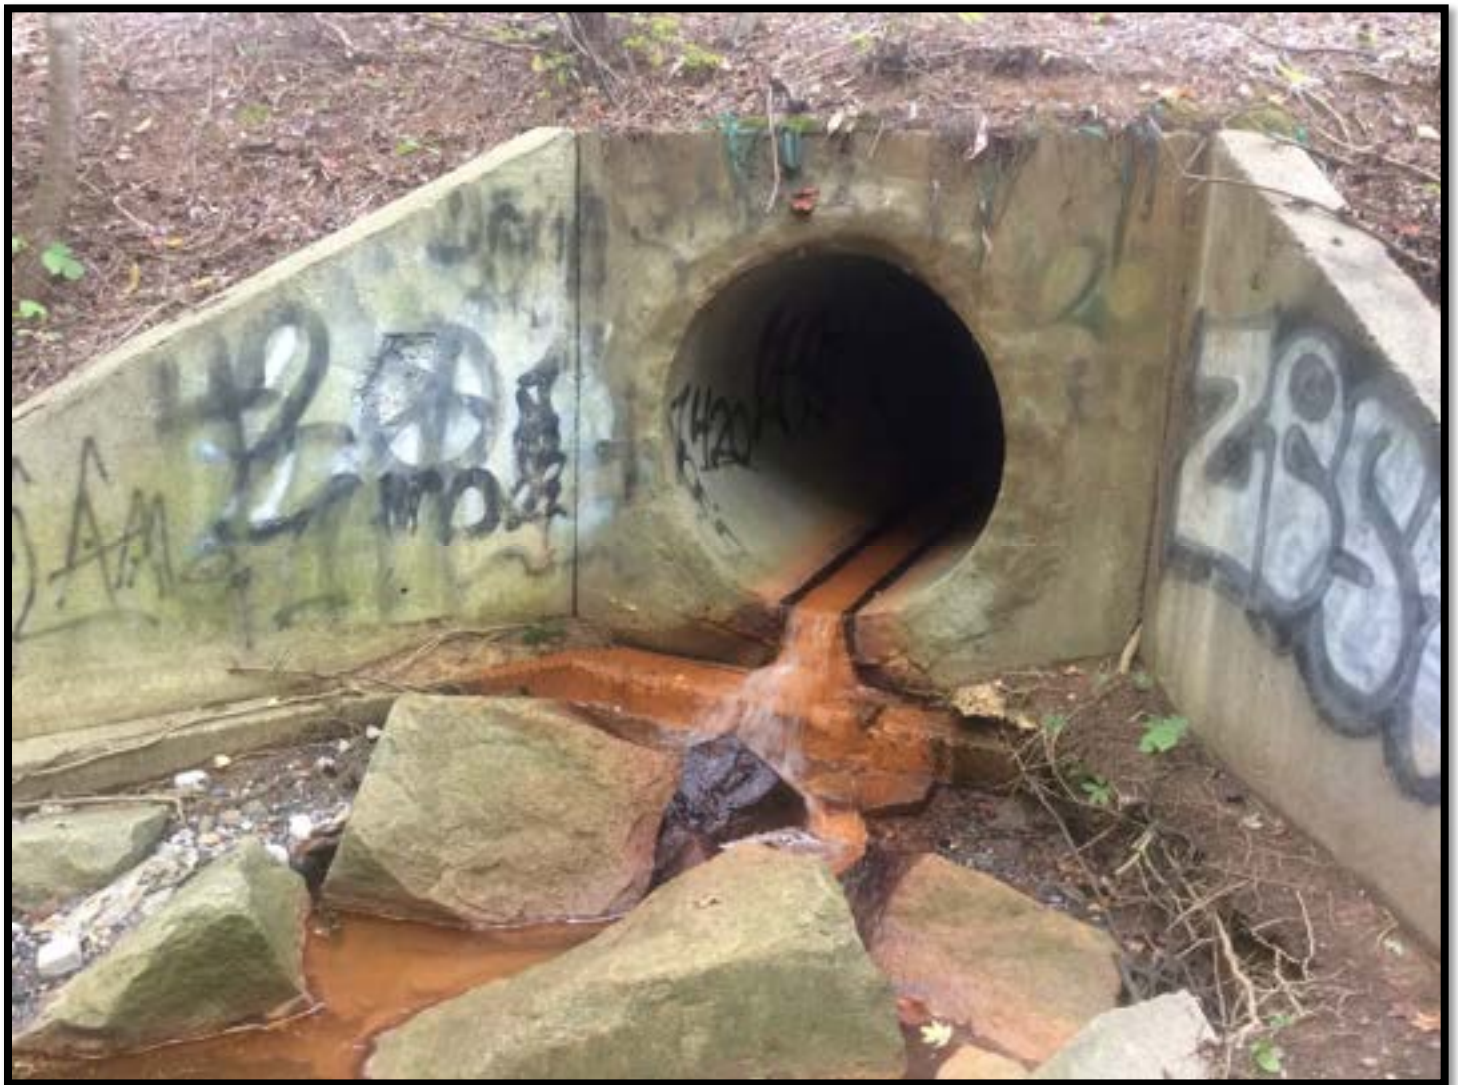
Photo of discharge:

pH: 8.40 Limit: Std.	Conductivity: 618 μ S/cm Limit: Std.	Temp.: 68°F Limit: Std.
Discharge related Indicators	Odor: NA	Turbidity: NA
	Floatables: NA	Stains: Algae
		Other: NA

Responsible Party (Owner/ Institutions)	Other Party (Management Company)
Name:	Name: NA
Company:	Company:
Address:	Address:
Phone #:	Phone #:
Note:	Note:
Notification/Contact (Other agencies contacted (DEQ, NS, FMO?) NA	
Date:	Date:
Time:	Time:
Name: TBD	Name:
Company/Agency:	Company/Agency:
Notes:	Notes:
<p>Comments/ Deficiencies:</p> <p>Orange algae was observed at pipe and downstream channel. pH and conductivity did not exceed the limits during onsite test. Source of discharge was tracked along red line shown in map above. At manhole H, Flow observed from both HA branch only. A is the outlet of SWMP 5771. The discharge had high velocity so that it was seemed some additional source have to be added in storm sewer system. Tracking was continued along point B, C, D, E and F. At manhole F, flow observed from FG direction via PVC pipe. That PVC pipe is found to have discharge from overflow of swimming pool. The pool was seemed to refill with water.</p>

The source of discharge was confirmed combine effect of overflow from pool refill and saturated infiltration of BMP. Algae was developed due to ground water seepage due to overflow from SWMP after being saturated infiltration process. It is a natural phenomenon.

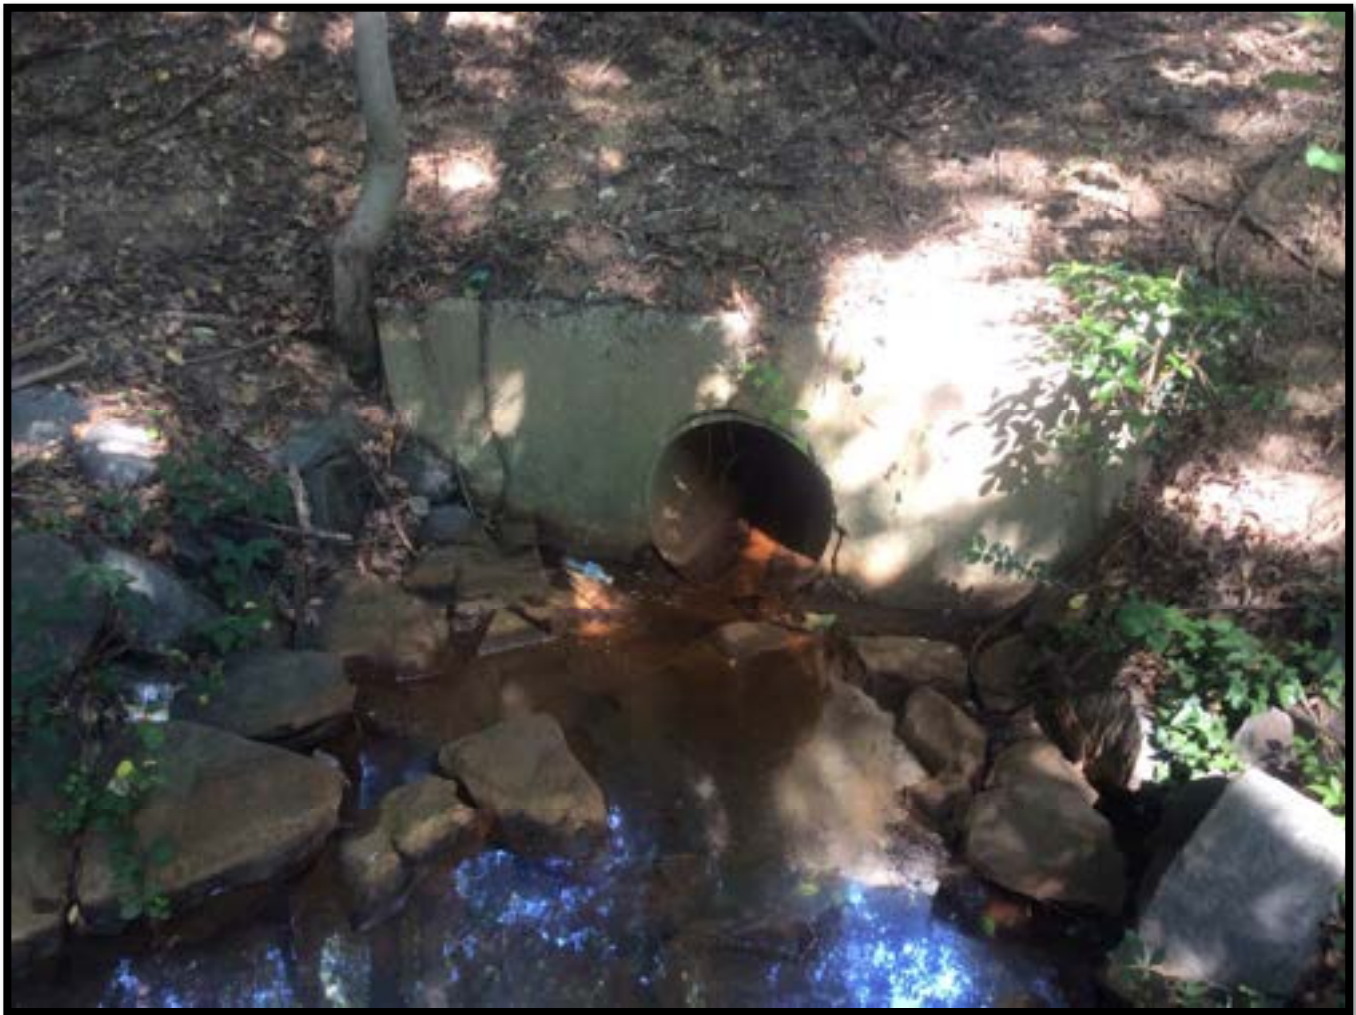
Photo of discharge:

pH: 7.9 Limit: Std.		Conductivity: 581 μ S/cm Limit: Choose an item.	Temp.: 67°F Limit: Std.
Discharge related Indicators	Odor: NA	Color: NA	Turbidity: NA
	Floatables: NA	Stains: NA	Other: NA

Responsible Party (Owner/ Institutions)	Other Party (Management Company)
Name:	Name: NA
Company:	Company:
Address:	Address:
Phone #:	Phone #:
Note:	Note:
Notification/Contact (Other agencies contacted (DEQ, NS, FMO?) NA	
Date:	Date:
Time:	Time:
Name: TBD	Name:
Company/Agency:	Company/Agency:
Notes:	Notes:
Comments/ Deficiencies:	
<p>Pipe algae observed at outfall. Onsite test results of pH and Conductivity lie within standard limits. Discharge tracked along red line shown in map above. Manhole A had flow from AB branch. At B, flow observed from both BC and BD branch. Both Manhole C and D were dry. Cross connection of sanitary sewer did not find during inspection.</p>

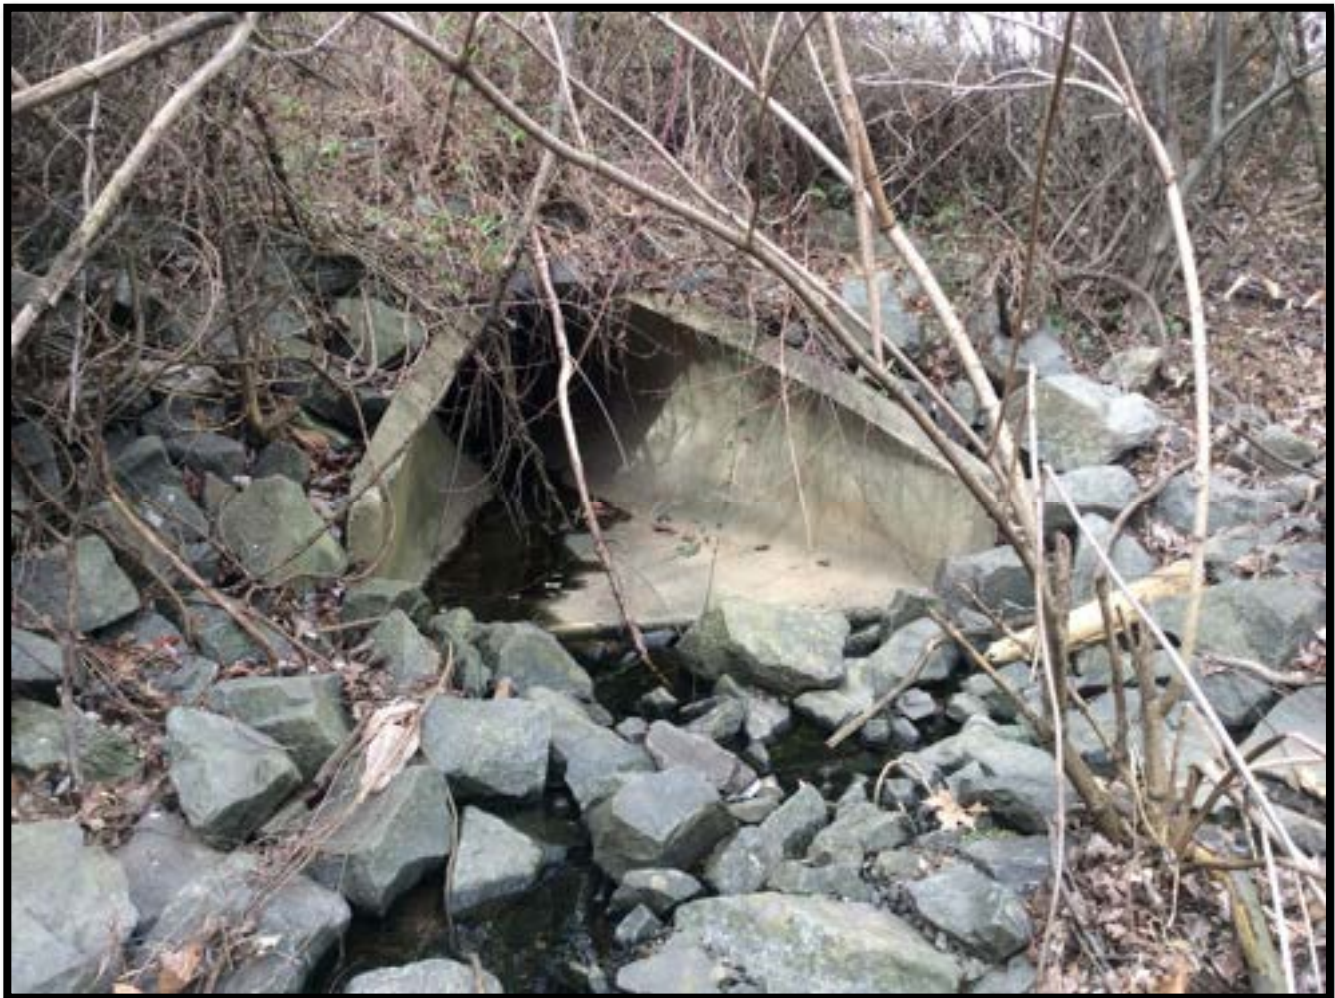
Photo of discharge:

pH: 7.9 Limit: Std.	Conductivity: 318 μ S/cm Limit: Std.	Temp: 56°F Limit: Std.
Discharge related Indicators	Odor: NA	Turbidity: NA
	Floatables: NA	Other: NA
	Color: NA	
	Stains: NA

Responsible Party (Owner/ Institutions)	Other Party (Management Company)
Name:	Name: NA
Company: PWC Board Of County Supervisors	Company:
Address: 1County Complex Ct , Woodbridge VA 22192	Address:
Phone #:	Phone #:
Note:	Note:
Notification/Contact (Other agencies contacted (DEQ, NS, FMO?) NA	
Date:	Date:
Time:	Time:
Name:	Name:
Company/Agency:	Company/Agency:
Notes:	Notes:
<p>Comments/ Deficiencies:</p> <p>Discharge was observed through outfall. The conductivity and pH did not exceed the standard limits on test performed on site. There was no special characters or sign of illicit discharge at outfall and downstream channel.</p> <p>Discharge was tracked. The upstream successive Manhole A had a flow from AB branch. At Manhole B, flow observed from BC branch only. At C, flow observed from CD and Ce Branch. Structure E is a drop inlet and D is an upstream inlet. Both D and E were dry. Cross-connection of sanitary sewer did not notice in an inspection. The source of discharge was confirmed ground water seepage.</p>

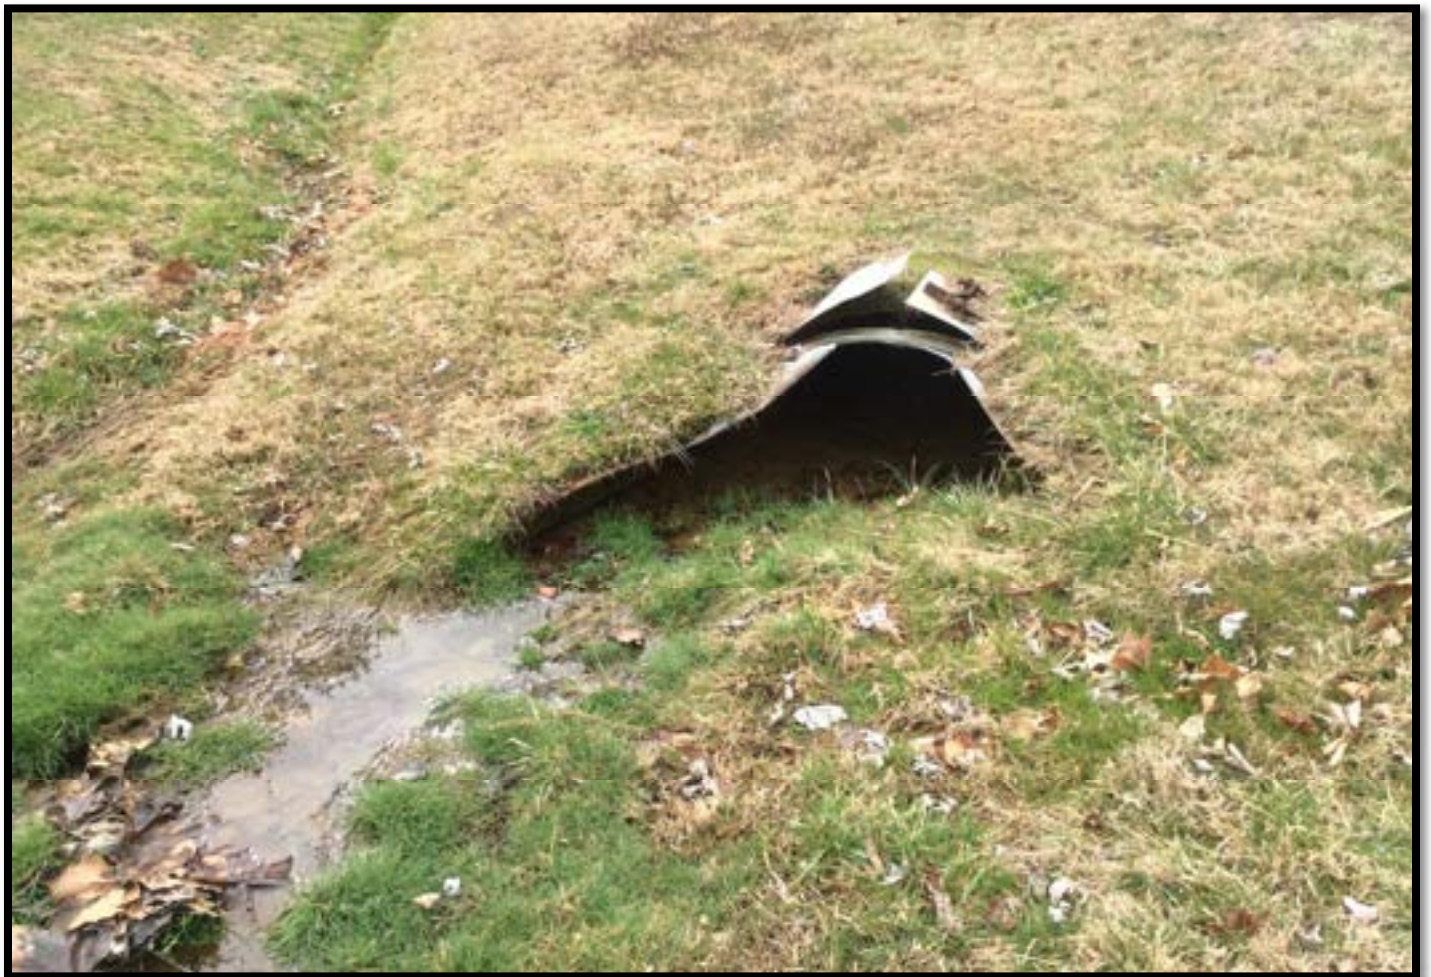
Photo of discharge:

pH: 8.4 Limit: Std.	Conductivity: 315 μ S/cm Limit: Std.	Temp: 58°F Limit: Std.
Discharge related Indicators	Odor: NA	Color: NA
	Floatables: NA	Stains: NA
		Turbidity: NA
		Other: NA

Responsible Party (Owner/ Institutions)	Other Party (Management Company)
Name: Frederich Thiesing	Name: NA
Company:	Company:
Address: 8010 Guy Drive, Manassas VA 20111	Address:
Phone #:	Phone #:
Note:	Note:
Notification/Contact (Other agencies contacted (DEQ, NS, FMO?) NA	
Date:	Date:
Time:	Time:
Name:	Name:
Company/Agency:	Company/Agency:
Notes:	Notes:
Comments/ Deficiencies:	
<p>Discharge was observed through outfall. The conductivity and pH did not exceed the standard limits on test performed on site. There was no special characters or sign of illicit discharge at outfall and downstream channel.</p> <p>Discharge was tracked. The upstream road culvert inlet A had stagnant water seeping from ground. There was no visible inflow from the ground. The source of discharge was confirmed ground water seepage.</p>

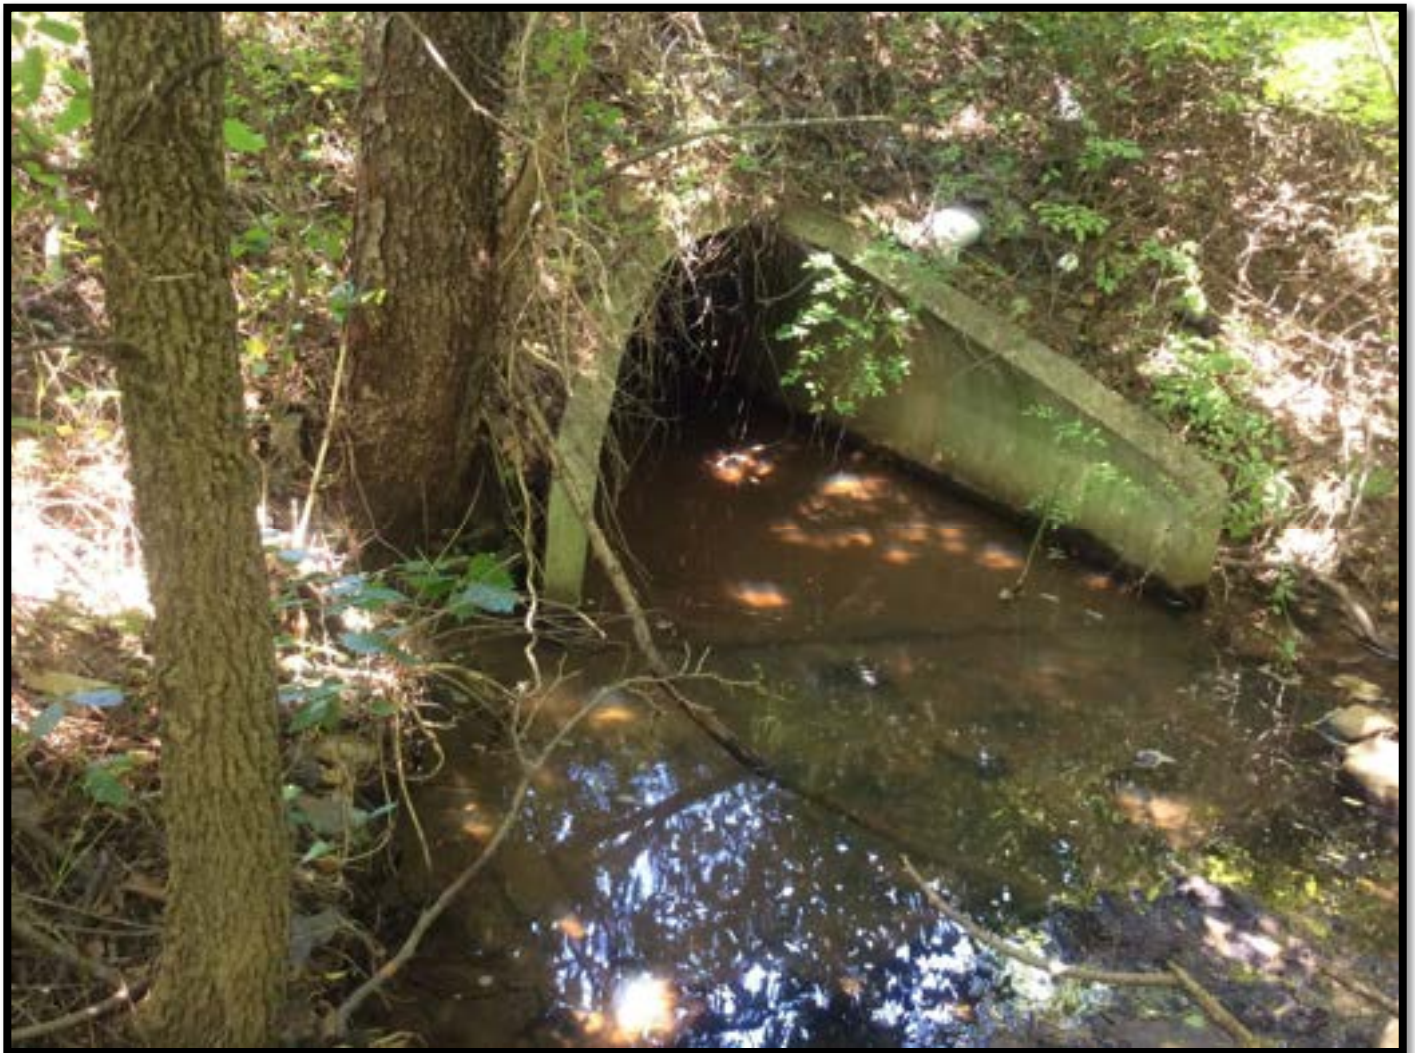
Photo of discharge:

pH: 7.90 Limit: Std.	Conductivity: 811 μ S/cm Limit: Std.	Temp.: 77°F Limit: Std.
Discharge related Indicators	Odor: NA	Color: NA
	Floatables: NA	Stains: NA
		Turbidity: NA
		Other: NA

Responsible Party (Owner/ Institutions)	Other Party (Management Company)
Name:	Name: NA
Company:	Company:
Address:	Address:
Phone #:	Phone #:
Note:	Note:
Notification/Contact (Other agencies contacted (DEQ, NS, FMO?) NA	
Date:	Date:
Time:	Time:
Name: TBD	Name:
Company/Agency:	Company/Agency:
Notes:	Notes:
<p>Comments/ Deficiencies: Discharge was observed through outfall. Onsite test results of pH and Conductivity lie within standard limits. Discharge tracked along red line shown in map above. Manhole A, B and C had flow from AB, BC and CD branches respectively. D is a riser of SWMP 562 releasing discharge into downstream storm sewer system. Source of discharge was discovered pond outflow.</p>

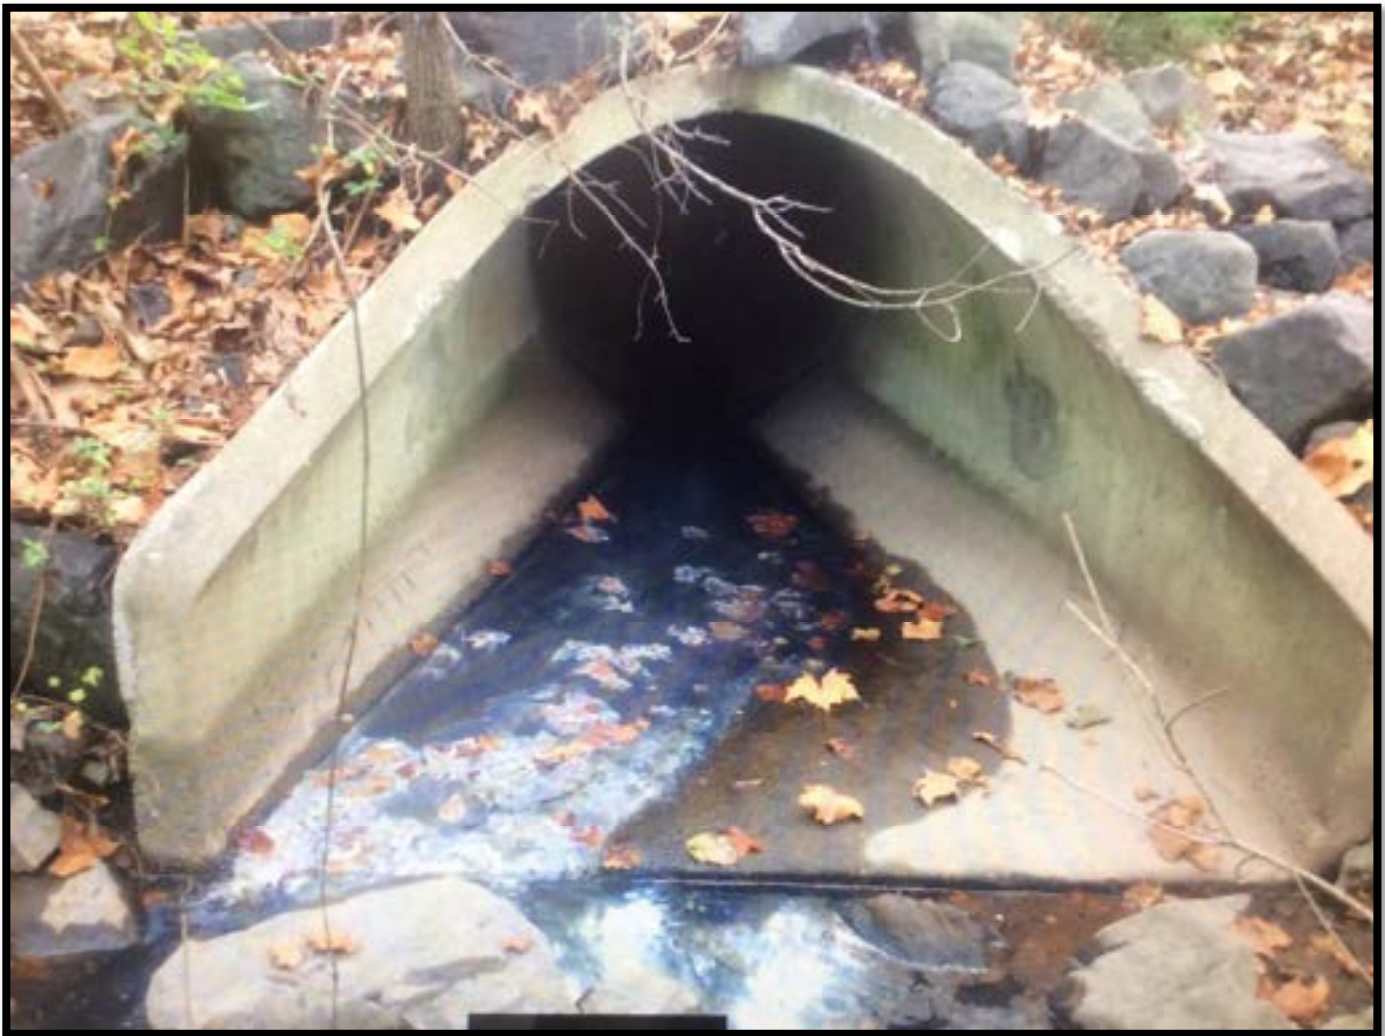
Photo of discharge:

pH: 7.4 Limit: Std.	Conductivity: 1081 μ S/cm Limit: Std.	Temp.: 77°F Limit: Std.
Discharge related Indicators	Odor: Sewage	Color: Black
	Floatables: NA	Stains: Industrial Waste
		Turbidity: Opaque
		Other: NA

The color of discharge was black with sewage smell. Conductivity of discharged water was discovered exceeding the standard limit during onsite test. The outfall is an outlet of CSWMP 5005. Pond water was observed white-green whereas downstream creek was seemed black. The sampling was taken at Riser. White stain was observed at Riser, Pipes and Outfall. Downstream creek was observed black nearby outfall and seemed whitish black at downstream creek. The sewer system is connected with Broad run Construction Waste Recycling Facility, is a VPDES permitted business. The facility was poorly maintained. Contact was made with one of the property owner Mr. Andrew, it came to know that the pavement surface usually washes twice a week and allow discharge into storm sewer system. The odor may be developed due to eutrophication happened due to industrial discharge. Discharge was being disappeared in downstream channel before reaching to the creek.
