Annual Stormwater Management Report
VSMP Permit No. 0088595 – FY 2020

Submitted by:
Prince William County
Department of Public Works

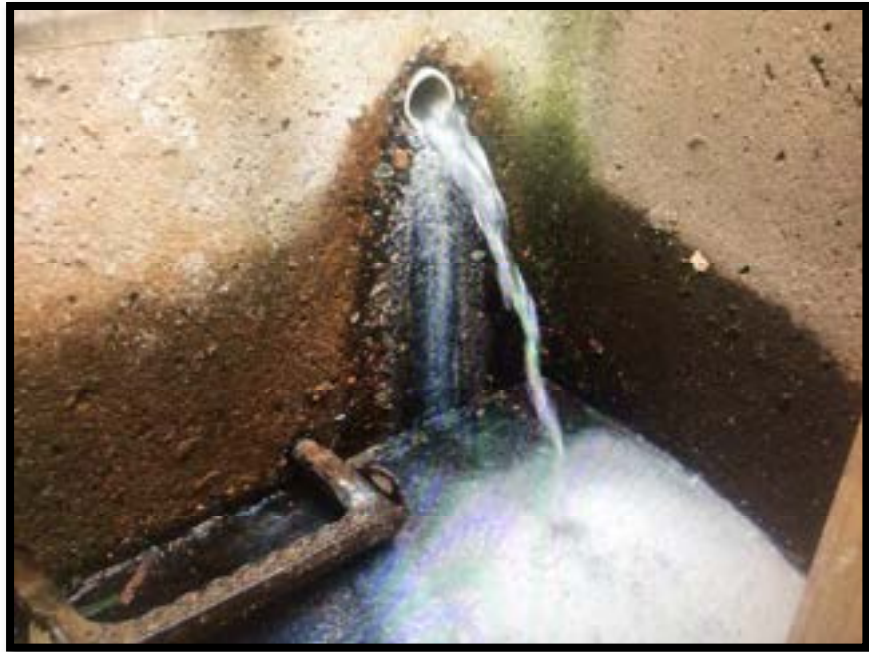
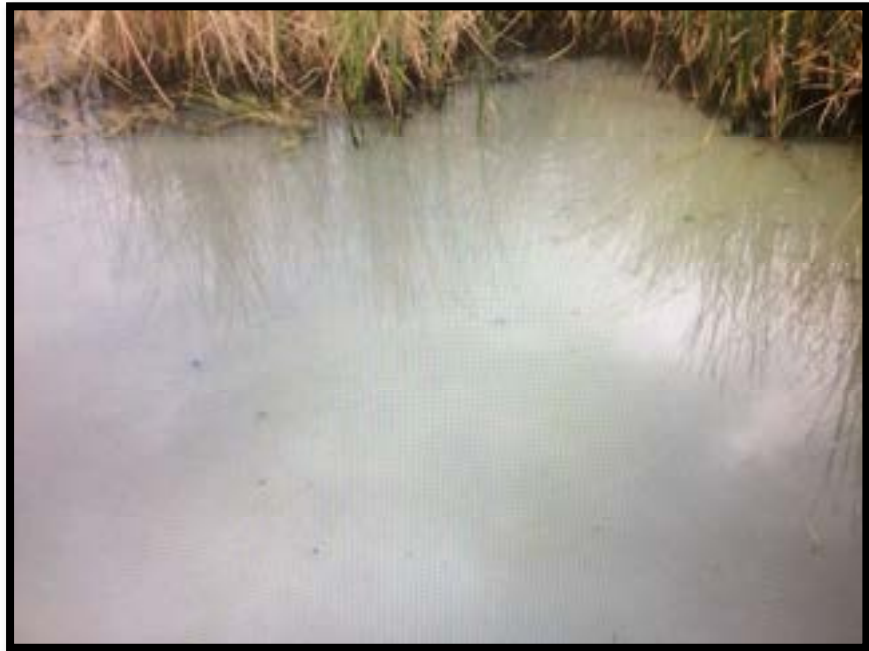
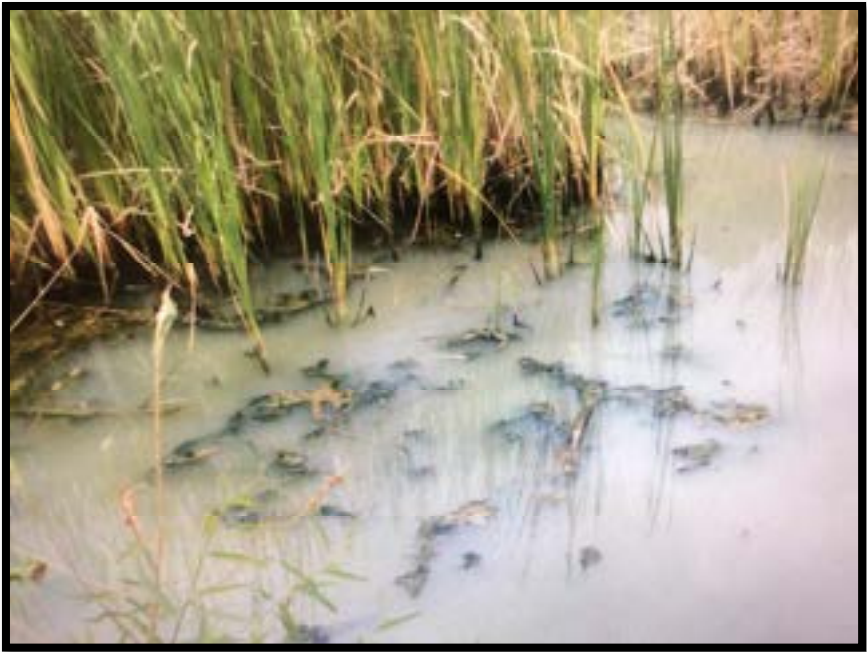
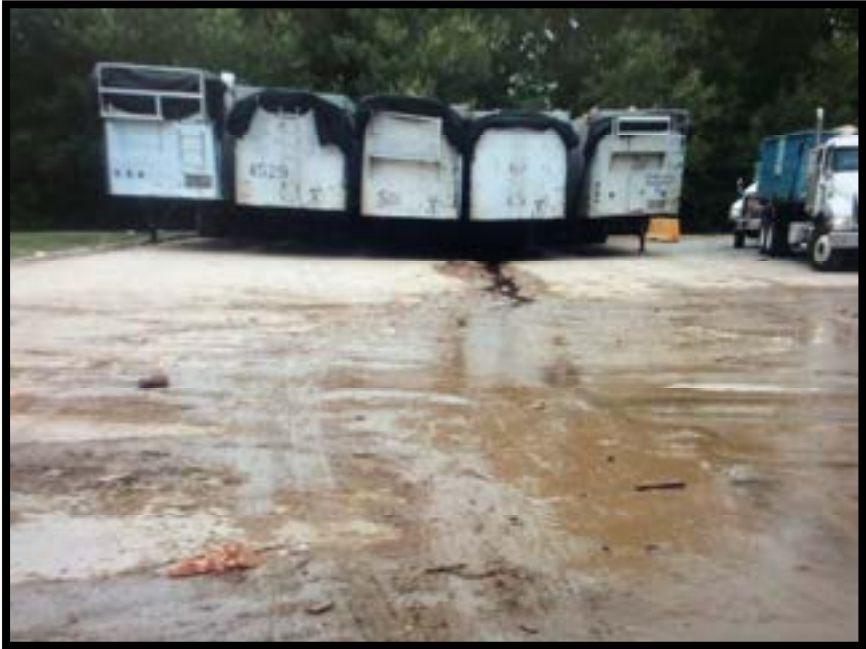
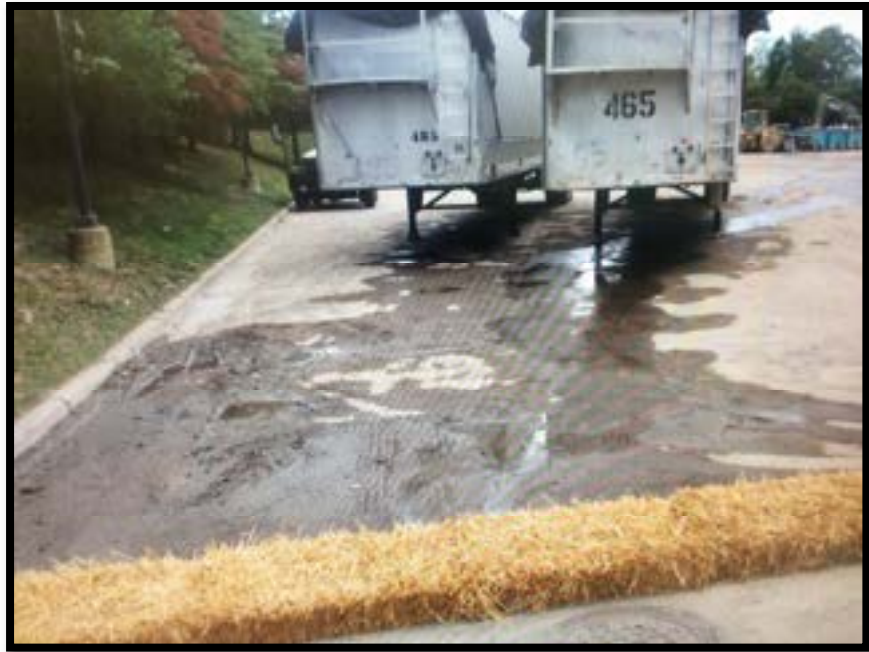
Photos:

The color of discharge was black with sewage smell. Conductivity of discharged water was discovered exceeding the standard limit during onsite test. The outfall is an outlet of CSWMP 5005. Pond water was observed white-green whereas downstream creek was seemed black. The sampling was taken at Riser. White stain was observed at Riser, Pipes and Outfall. Downstream creek was observed black nearby outfall and seemed whitish black at downstream creek. The sewer system is connected with Broad run Construction Waste Recycling Facility, is a VPDES permitted business. The facility was poorly maintained. Contact was made with one of the property owner Mr. Andrew, it came to know that the pavement surface usually washes twice a week and allow discharge into storm sewer system. The odor may be developed due to eutrophication happened due to industrial discharge. Discharge was being disappeared in downstream channel before reaching to the creek.

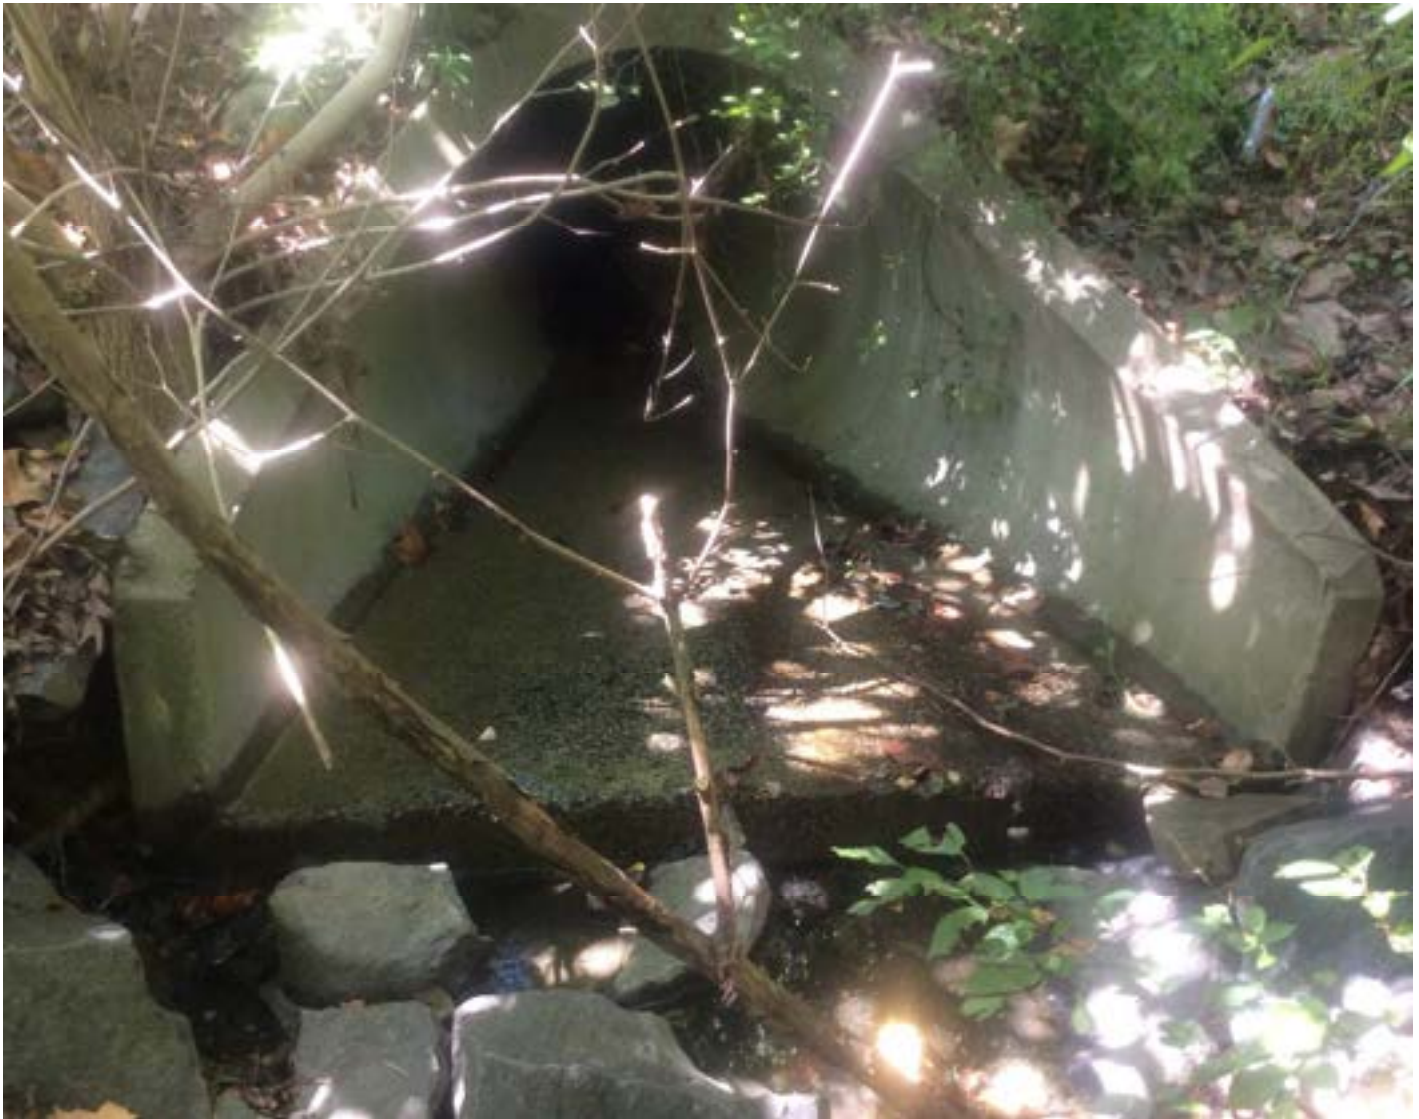
Photo of discharge:

pH: 10.40 Limit: Std.	Conductivity: 319 μ S/cm Limit: Std.	Temp.: 67°F Limit: Std.
Discharge related Indicators	Odor: NA	Color: NA
	Floatables: NA	Stains: NA
		Turbidity: NA
		Other: NA

Responsible Party (Owner/ Institutions)	Other Party (Management Company)
Name:	Name: NA
Company:	Company:
Address:	Address:
Phone #:	Phone #:
Note:	Note:
Notification/Contact (Other agencies contacted (DEQ, NS, FMO?) NA	
Date:	Date:
Time:	Time:
Name: TBD	Name:
Company/Agency:	Company/Agency:
Notes:	Notes:
<u>Comments/ Deficiencies:</u>	
<p>Discharge was seemed to be intermittent. pH found exceeding the limit during onsite test. Source of discharge was tracked along red line shown in map above. At manhole A, Flow observed from both AB and AC direction. Branch AC was drain pipe found to be connected with fountain. Tracking was continued in AB branch. Manhole B was just holding water at low point without flow. There was significant flow at AC branch. The source was identified overflow from water fountain. Crews of Harmony Pond Inc were working for cleanup fountain basin applied chlorine. The way was nonprofessional. Crews of Harmonic Pond Inc were educated and hand over education material to stop releasing chlorinated water into storm sewer system.</p>

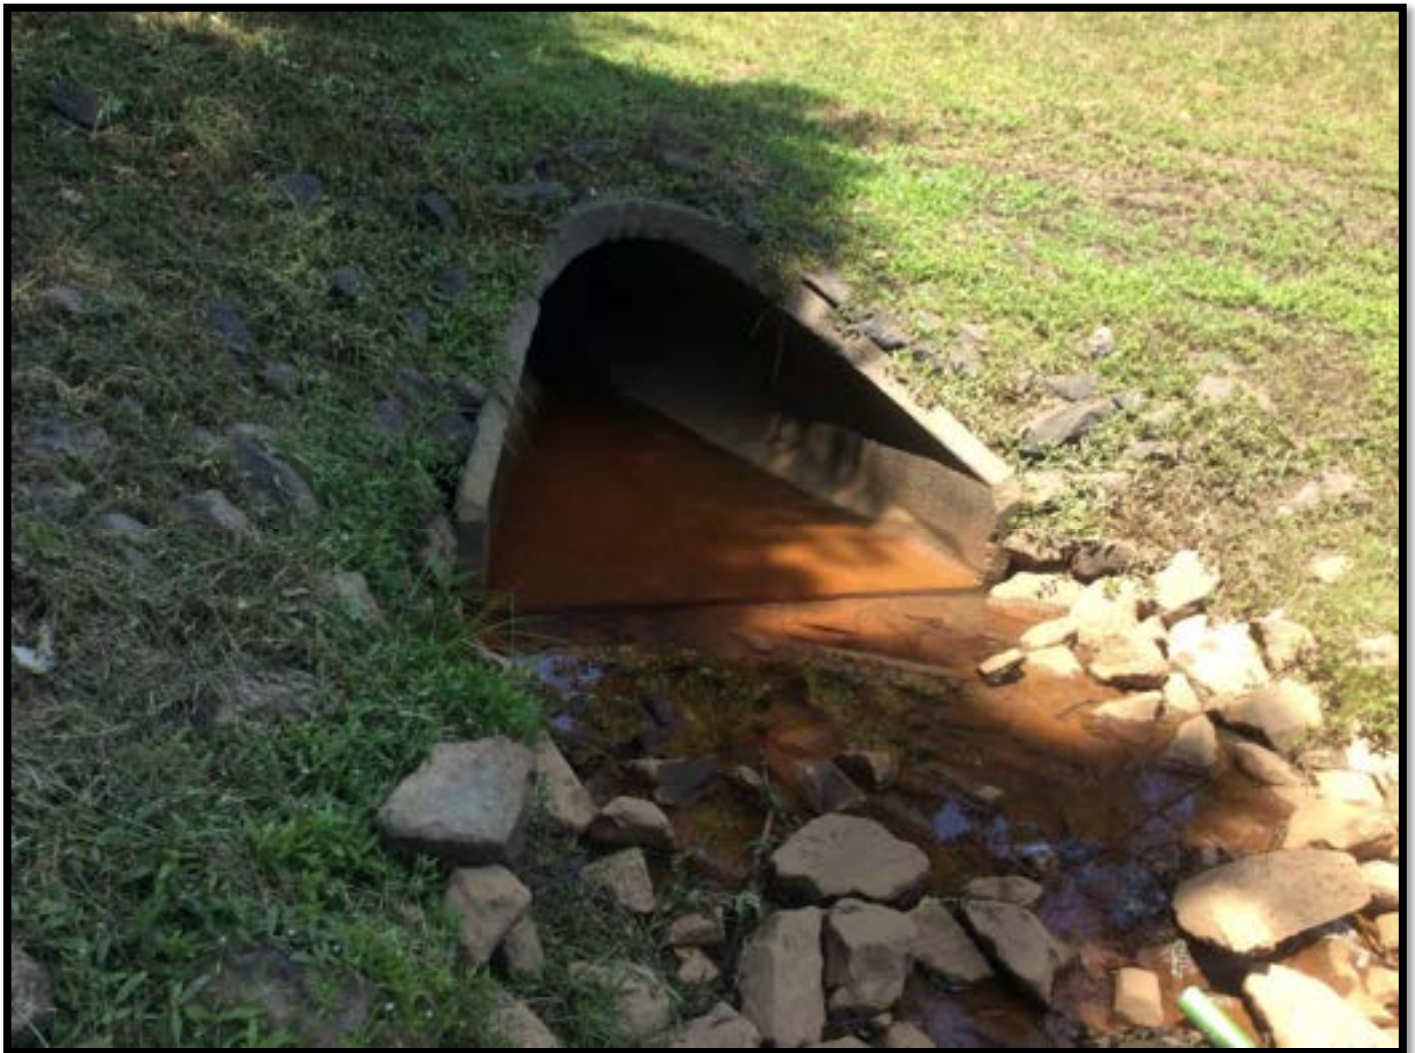
Photo of discharge:

pH: 7.50 Limit: Std.	Conductivity: 814 μ S/cm Limit: Std.	Temp.: 78°F Limit: Std.
Discharge related Indicators	Odor: NA	Color: NA
	Floatables: NA	Stains: NA
		Turbidity: NA
		Other: NA

Discharge was observed through outfall. Outfall was an inlet of SWMP 562. Onsite test results of pH and Conductivity lie within standard limits. Discharge tracked along red line shown in map above. Manhole A and B had flow from AB and BC branches respectively. At manhole A and B, ground water seepage was observed through joints into storm sewer system. Excessive algae were developed with seepage. Drop inlet C was very dry.

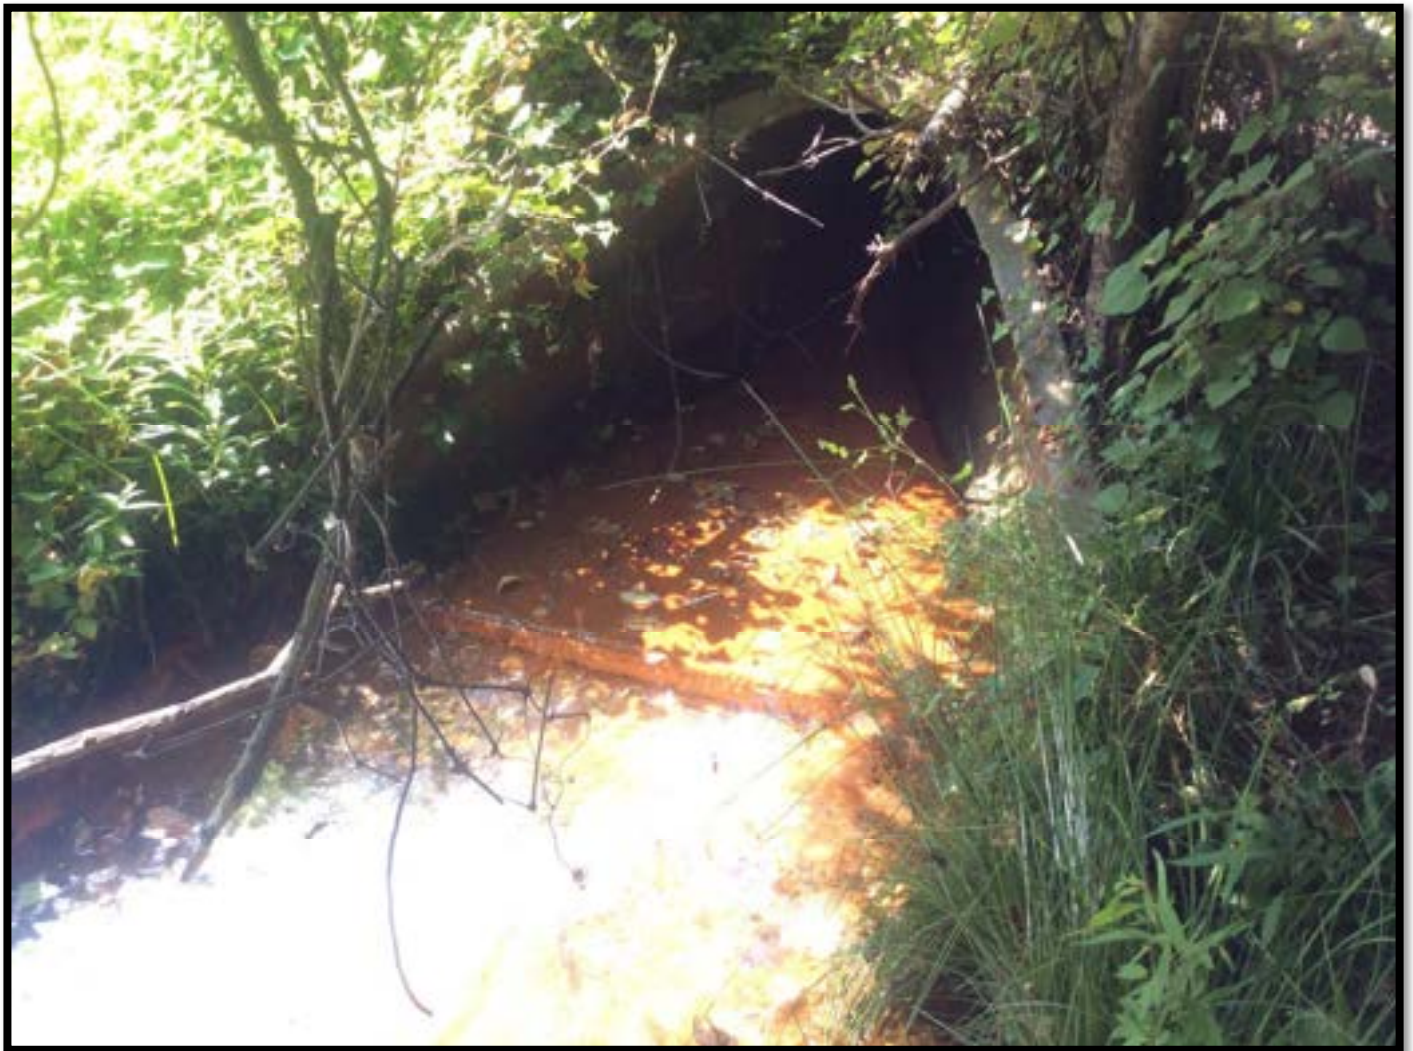
Photo of discharge:

Responsible Party (Owner/ Institutions)	Other Party (Management Company)
Name:	Name: NA
Company:	Company:
Address:	Address:
Phone #:	Phone #:
Note:	Note:
Notification/Contact (Other agencies contacted (DEQ, NS, FMO?) NA	
Date:	Date:
Time:	Time:
Name: TBD	Name:
Company/Agency:	Company/Agency:
Notes:	Notes:
<u>Comments/ Deficiencies:</u>	
<p>Pipe algae observed at outfall. Onsite test results of pH and Conductivity lie within standard limits. Discharge tracked along red line shown in map above. Manhole A had flow from AB branch. Discharge tracked along points A, B, C, D, E and F. F is a storm inlet of the system. Cross connection of sanitary sewer did not find during inspection. Discharge found to generate from upstream inflow as well. Source of algae was confirmed surface water. Source of contaminant promoting algae could not confirm.</p>

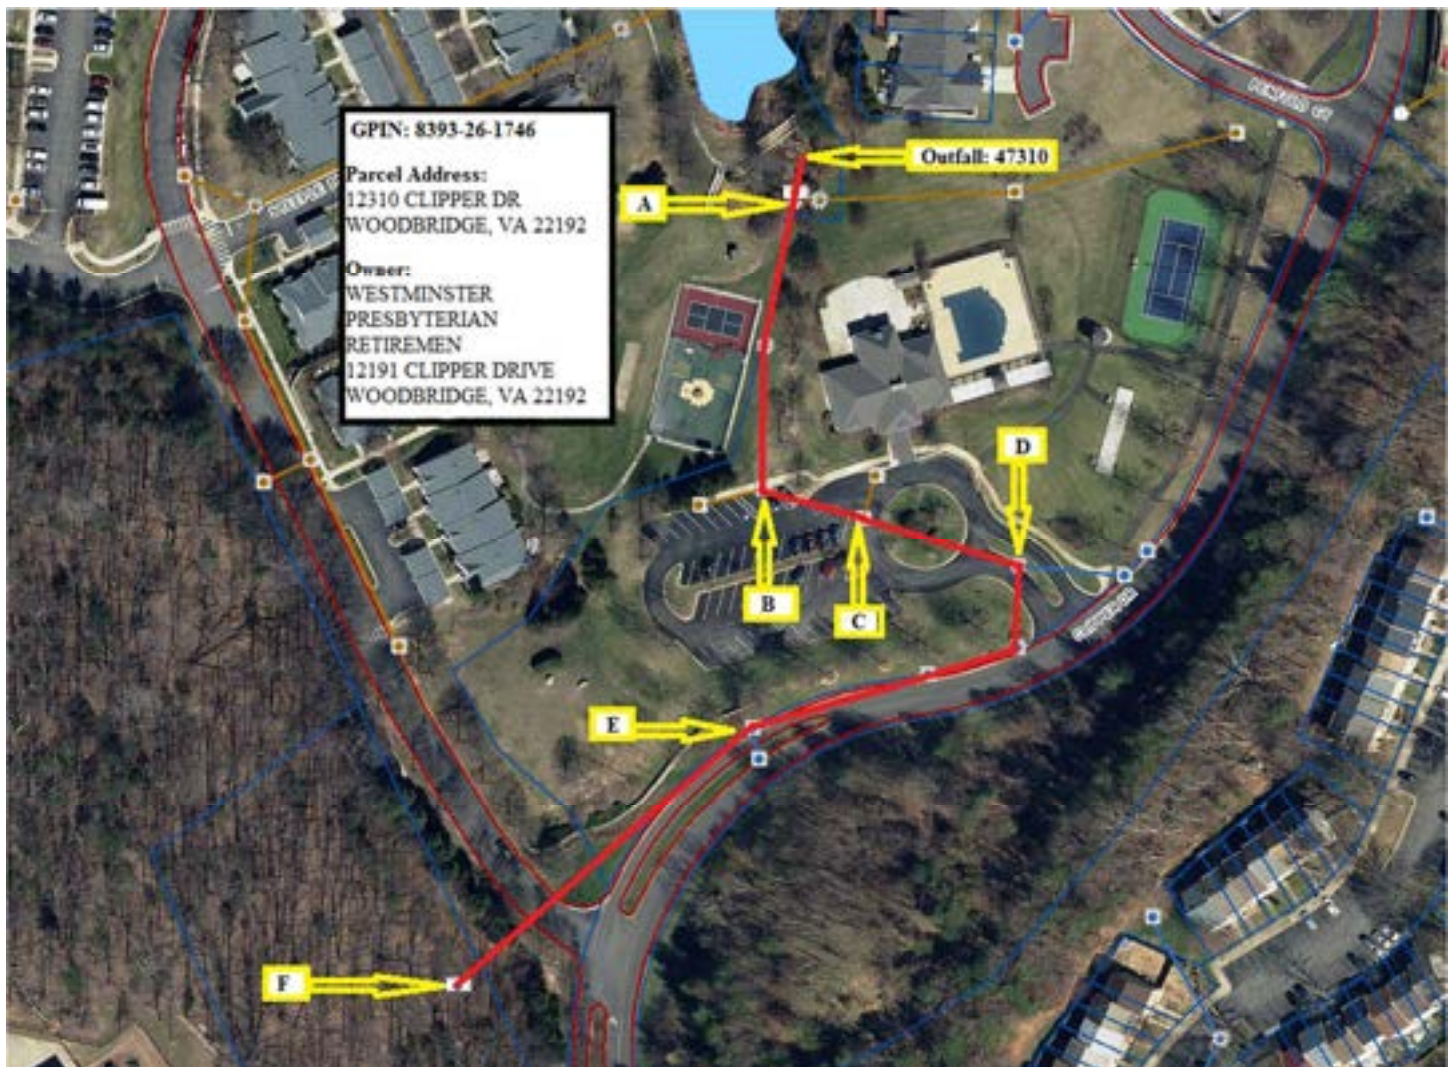
Map of Trackdown Path:

Source of discharge was confirmed surface water combined with ground water seepage into storm sewer system. Algae found to be developed. Runoff over polluted ground could promote algae at the outfall and downstream channel. Specific source of contaminant did not show up during inspection. Follow up inspection will continue in following years.

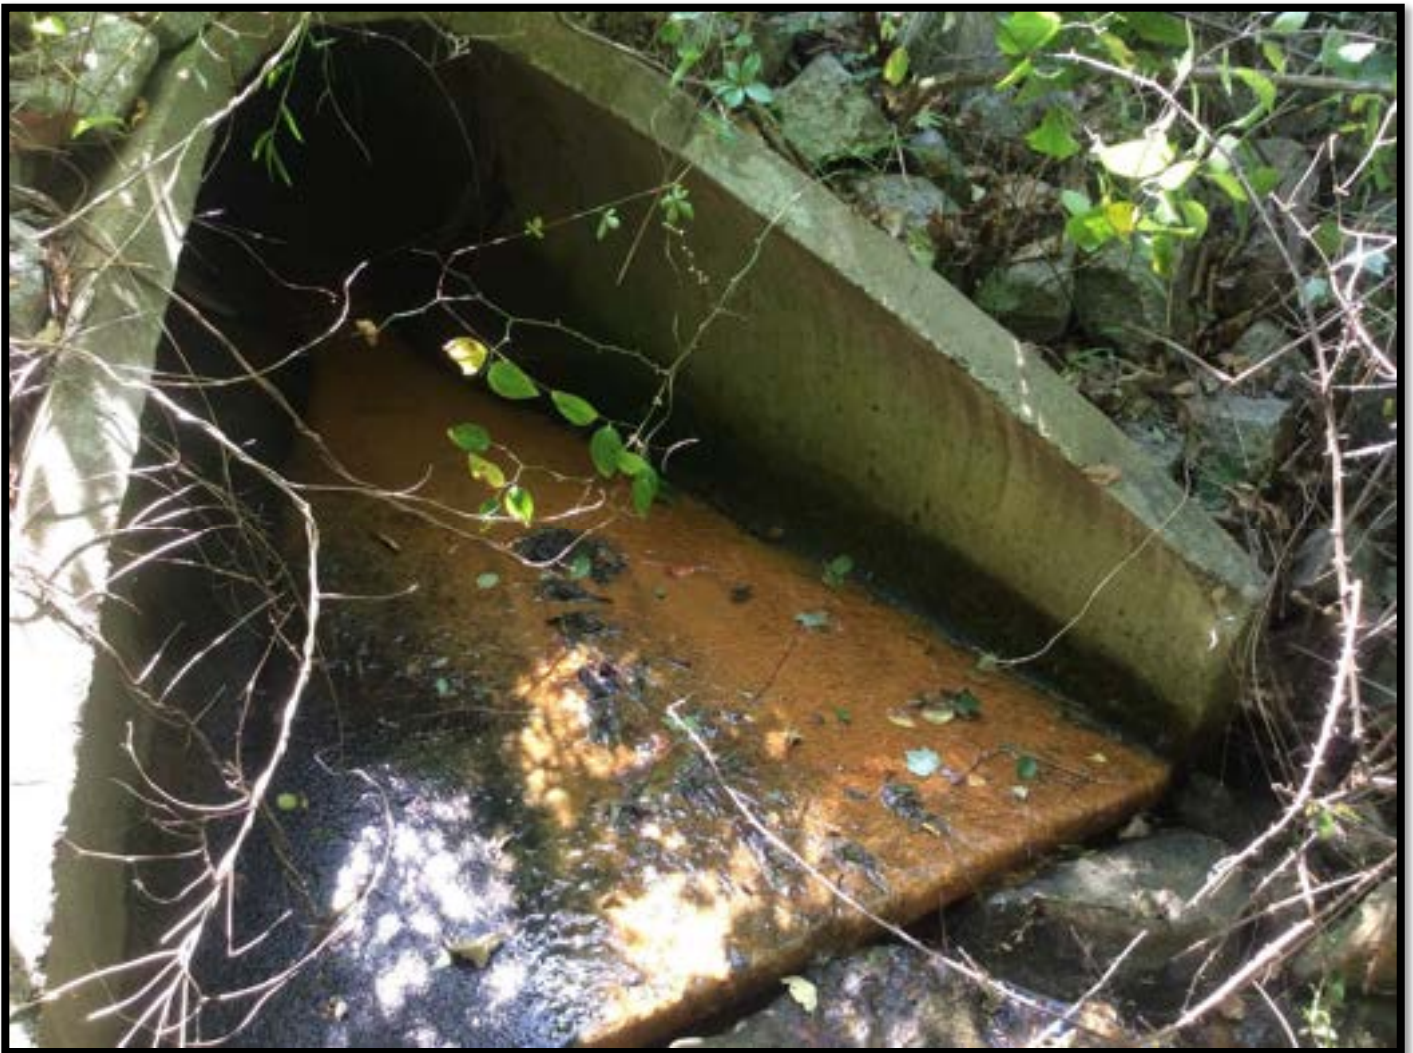
Photo of discharge:

pH: 8.06 Limit: Std.	Conductivity: 104 μ S/cm Limit: Std.	Temp.: 69°F Limit: Std.
Discharge related Indicators	Odor: NA	Color: NA
	Floatables: NA	Stains: NA
		Turbidity: NA
		Other: NA

Pipe algae observed at outfall. Onsite test results of pH and Conductivity lie within standard limits. Discharge tracked along red line shown in map above. Drop Inlet A had flow from upstream branch of drop inlet B. Drop Inlet B was found very dry. Major part of outfall discharge was found to generate in small stretch between Drop Inlet 1 to 2. Source of discharge could not figure out during inspection. Storm Sewer was cross over to the Sanitary Sewer at two different locations below the Drop inlet B.

Desktop analysis has performed on 8/7/2019 and found exceeding limit of copper only. Source of algae could not determine.

Excessive algae formation at outfall, significant discharge generated in small stretch, exceeding standard limit of copper and cross over storm sewer with sanitary sewer system have create suspicious condition of cross connection of sanitary sewage. CCTV inspection is needed for inclusive investigation.

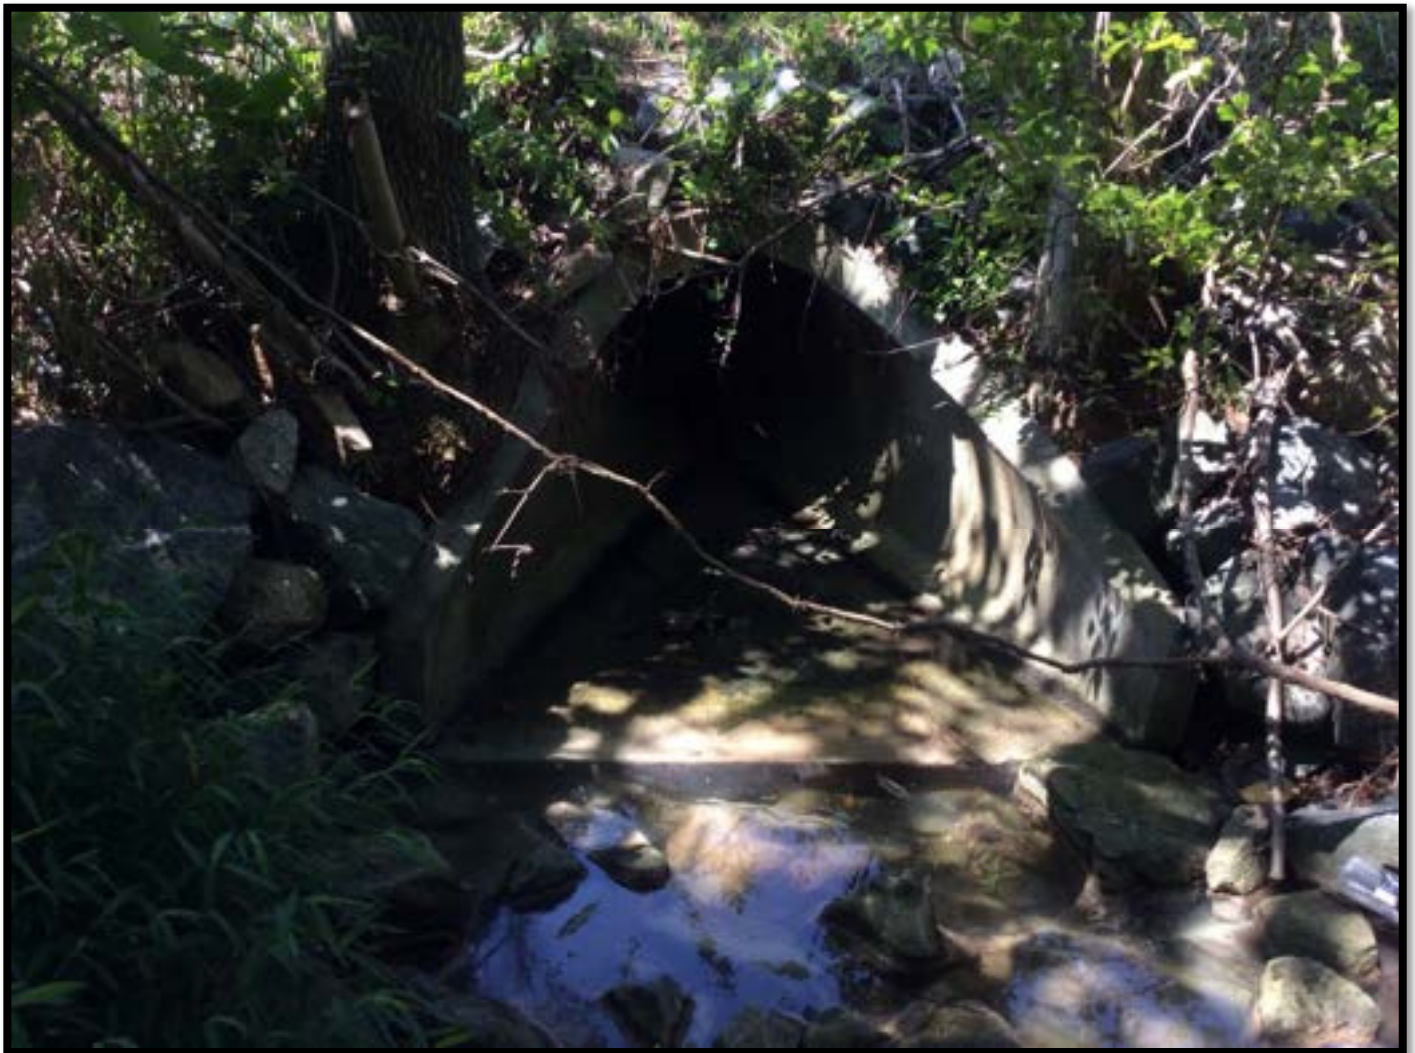
Photo of discharge:

Responsible Party (Owner/ Institutions)	Other Party (Management Company)
Name:	Name: NA
Company:	Company:
Address:	Address:
Phone #:	Phone #:
Note:	Note:
Notification/Contact (Other agencies contacted (DEQ, NS, FMO?) NA	
Date:	Date:
Time:	Time:
Name: TBD	Name:
Company/Agency:	Company/Agency:
Notes:	Notes:
<u>Comments/ Deficiencies:</u>	
Discharge was observed through outfall. Lime stain was observed at downstream channel. Onsite test results of pH and Conductivity lie within standard limits. Discharge tracked along red line shown in map above. Manhole A was very dry. There was no cross connection of sanitary sewer with storm sewer system having flow. Landscape was too steep backfill areas. The constituents of backfill material may have lime which ultimately entered into storm sewer system with ground water seepage.

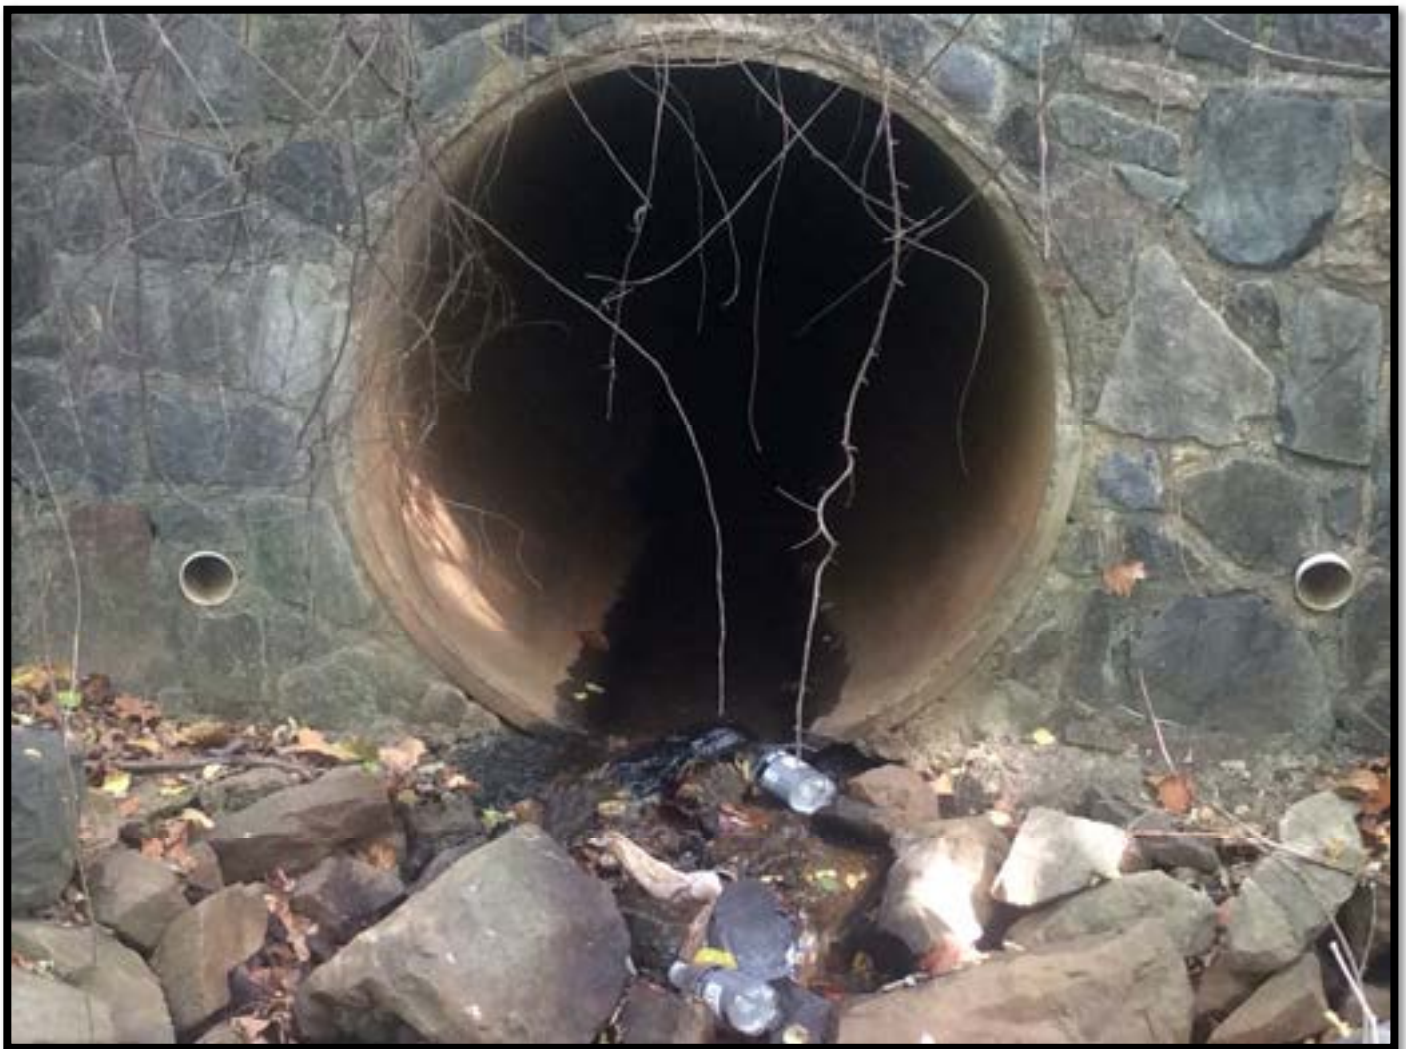
Photo of discharge:

INCIDENT INFORMATION		
Incident Report #: 29-2020	Date: 9/27/2019	Time: 1:20 PM
Business Areas: Residential	Report Completed By: Prem Poudel	
Outfall ID#59391 Address: 19240 Potomac Crest Dr	City, State: Triangle, VA	Zip Code: 22172
Complain or Case Received From: Routine Inspection

pH: 7.9 Limit: Std.	Conductivity: 412 μ S/cm Limit: Std.	Temp.: 65°F Limit: Std.
Discharge related Indicators	Odor: NA	Color: NA
	Floatables: NA	Stains: NA
		Turbidity: NA
		Other: NA

Responsible Party (Owner/ Institutions)	Other Party (Management Company)
Name:	Name: NA
Company:	Company:
Address:	Address:
Phone #:	Phone #:
Note:	Note:
Notification/Contact (Other agencies contacted (DEQ, NS, FMO?) NA	
Date:	Date:
Time:	Time:
Name: TBD	Name:
Company/Agency:	Company/Agency:
Notes:	Notes:
<p>Comments/ Deficiencies: Clear discharge was observed flowing from outfall. pH and conductivity were found within the standard limit. Discharge was tracked. Manhole A was receiving discharge from branches AB, AE and AC. Manhole B was dry and cross connection did not observe with AB sewer, so discharge should be ground water seepage. Next tracking continued at ACD branch. Volume of flow was gradually reducing until manhole D. Manhole D was in moist condition. Next tracking continued in AE direction. Inlet E was receiving discharge from upstream storm water management pond, was the main source of outfall discharge.</p>

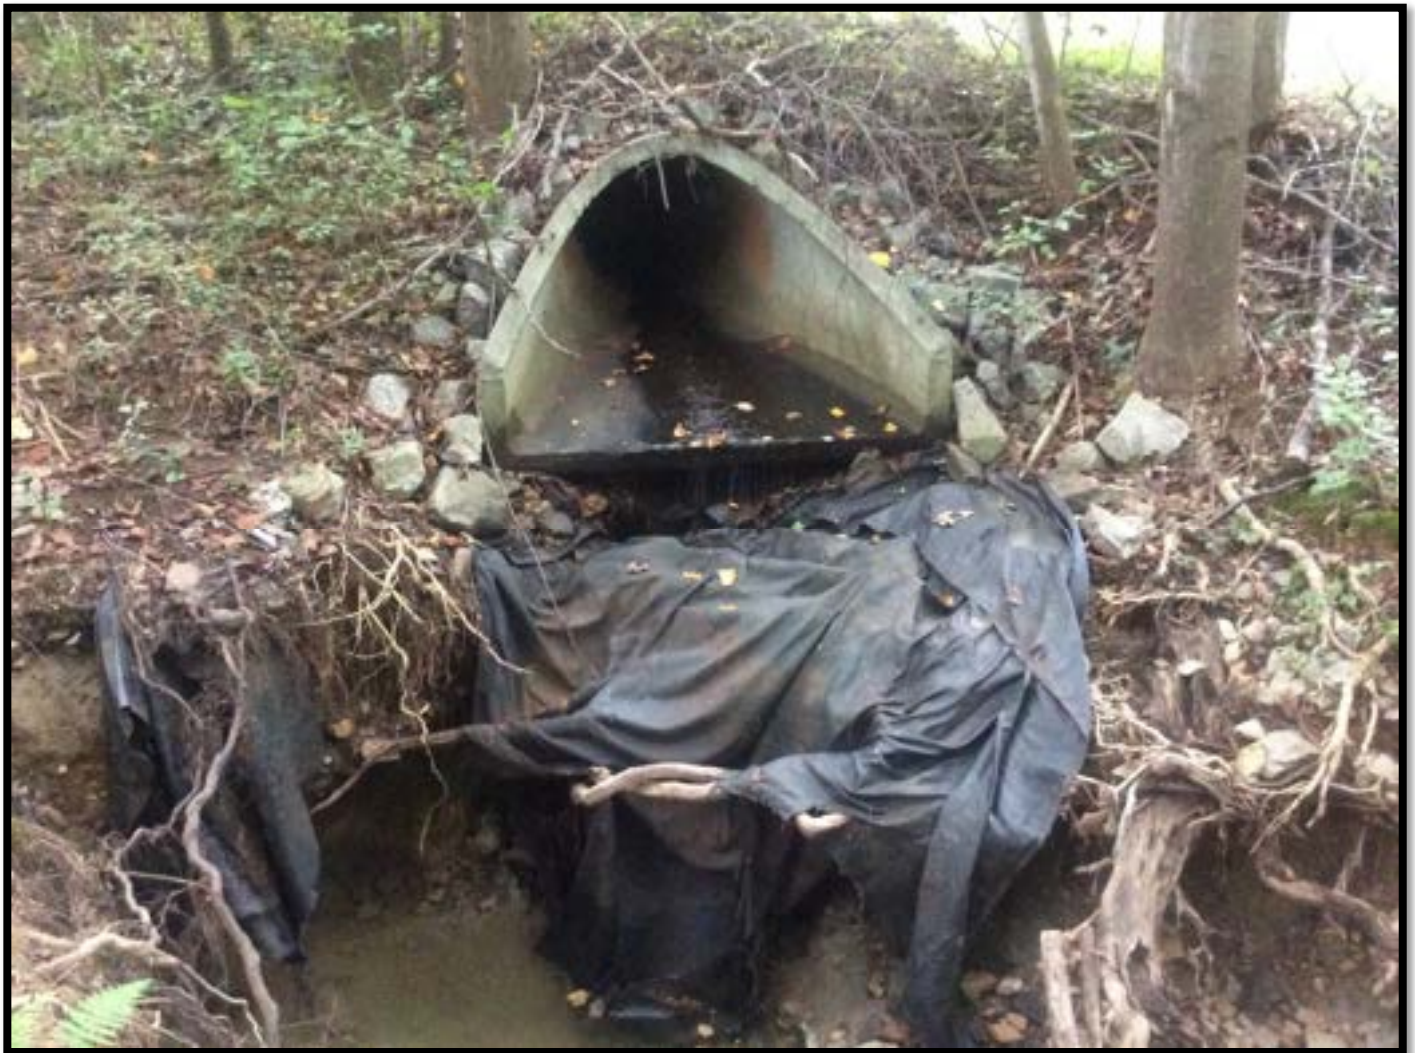
Photo of discharge:

INCIDENT INFORMATION		
Incident Report #: 15-2020	Date: 8/23/2019	Time: 11:45AM
Business Areas: Residential	Report Completed By: Prem Poudel	
Outfall ID# 57472 Address: 13486 Princedale Dr	City, State: Woodbridge, VA	Zip Code: 22192
Complain or Case Received From: Routine Inspection

pH: 7.50 Limit: Std.	Conductivity: 217 μ S/cm Limit: Std.	Temp.: 68°F Limit: Std.
Discharge related Indicators	Odor: NA	Color: NA
	Floatables: NA	Stains: NA
		Turbidity: NA
		Other: NA

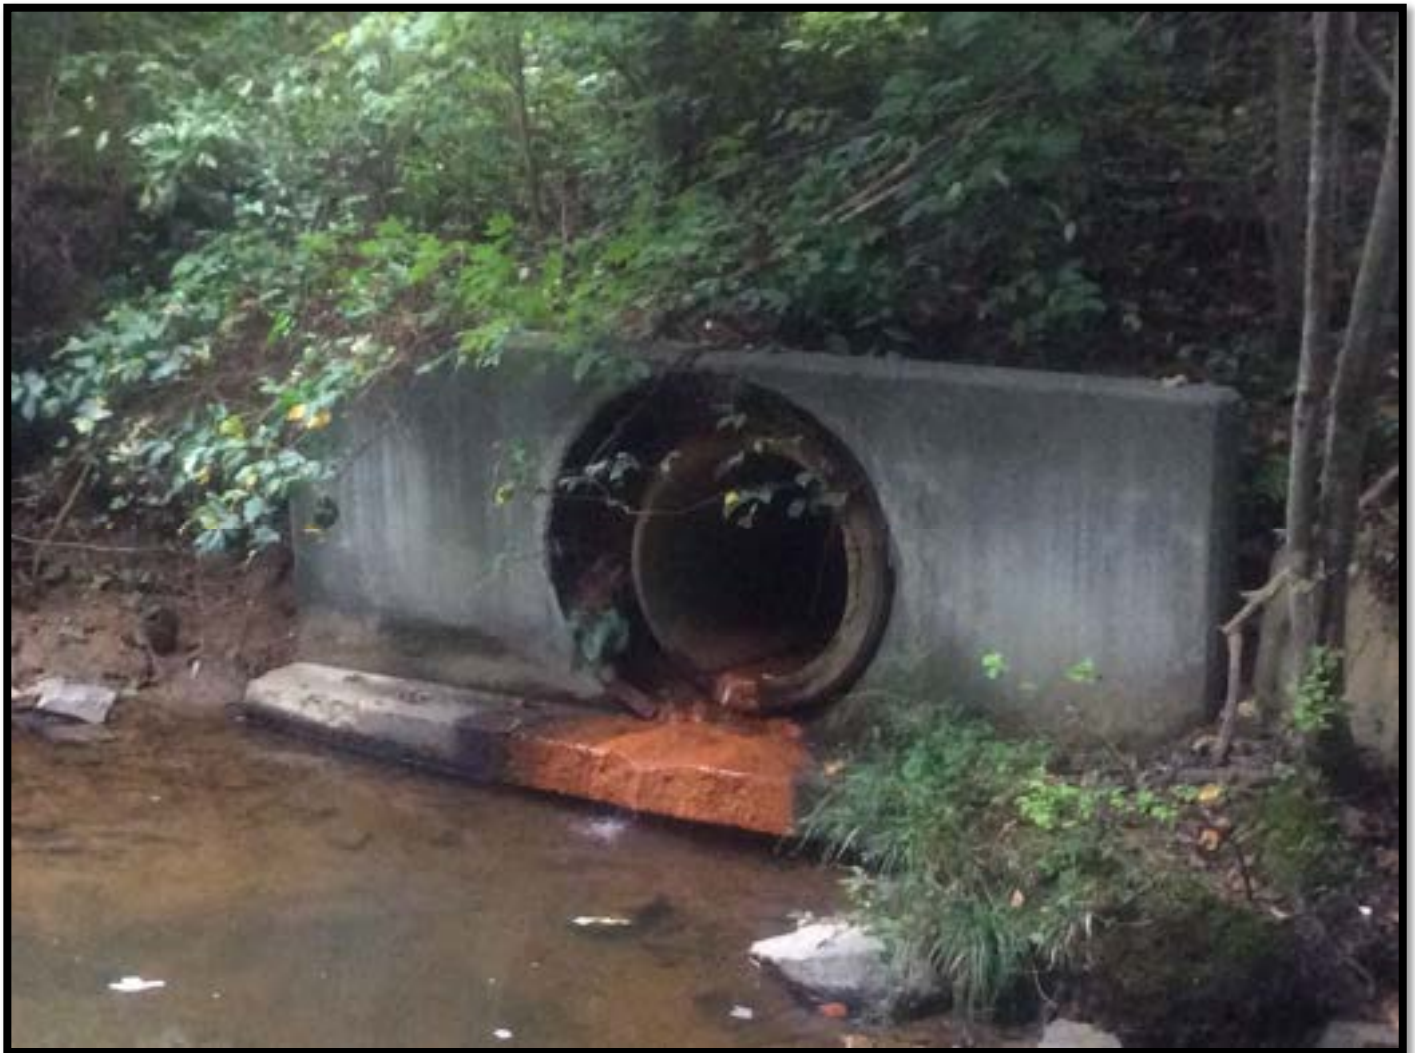
Photo of discharge:

INCIDENT INFORMATION		
Incident Report #: 14-2020	Date: 8/23/2019	Time: 11:00 AM
Business Areas: Residential	Report Completed By: Prem Poudel	
Outfall ID# 57613 Address: 5301 Dale Blvd	City, State: Woodbridge, VA	Zip Code: 22192
Complain or Case Received From: Follow up Inspection

pH: 7.70 Limit: Std.	Conductivity: 311 μ S/cm Limit: Std.	Temp.: 68°F Limit: Std.
Discharge related Indicators	Odor: NA	Color: NA
	Floatables: NA	Stains: Algae
		Turbidity: NA
		Other: NA

Onsite test results of pH and Conductivity lie within standard limits. Algae was developed at outfall. Discharge tracked along red line shown in map above. Manhole A had flow from AB branch only and continued tracking at BC, CD and DE. E is a drop inlet having foundation outflow pipe connection from the top. Access did not get to track EF branch, but it was tracked in previous inspection and drop inlet F was in moist condition. Branch EF lies in valley with steep landscape.

After investigation, source of discharge was confirmed foundation discharge from DF branch.

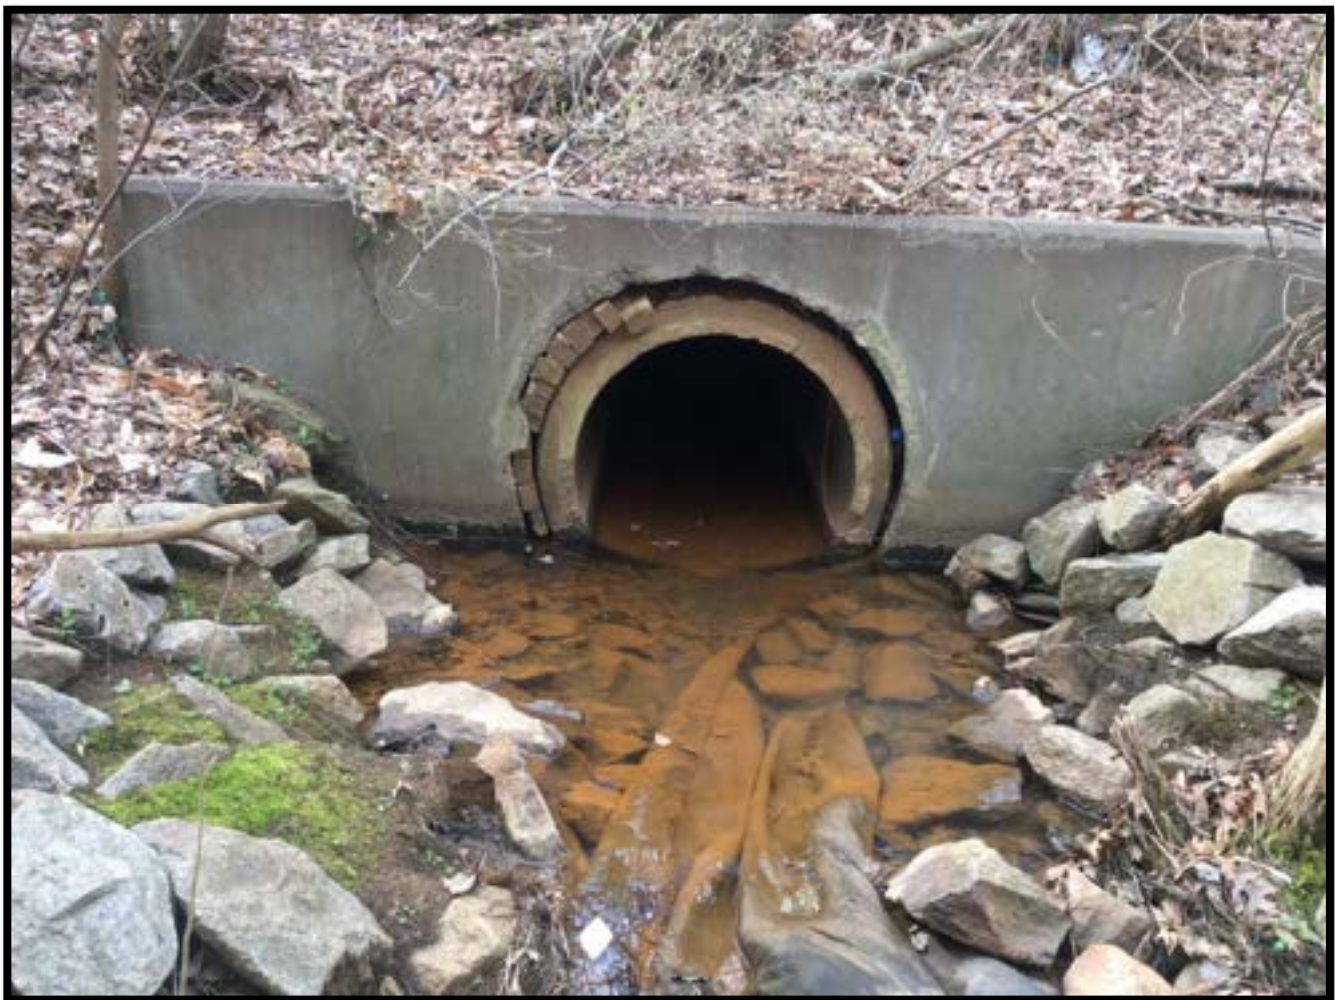
Photo of discharge:

INCIDENT INFORMATION		
Incident Report #: 33-2020	Date: 2/19/2020	Time: 10:30 AM
Business Areas: Residential	Report Completed By: Prem Poudel	
Outfall ID#57731 Address: 13540 Princedale Drive	City, State: Woodbridge, VA	Zip Code: 22193
Complain or Case Received From: Routine Inspection

pH: 7.8 Limit: Std.	Conductivity: 218 μ S/cm Limit: Std.	Temp: 53°F Limit: Std.
Discharge related Indicators	Odor: NA	Turbidity: NA
	Floatables: NA	Other: NA
	Color: NA	
	Stains: NA

Responsible Party (Owner/ Institutions)	Other Party (Management Company)
Name: NA	Name: NA
Company: PWC School Board,	Company:
Address: PO BOX 389, Manassas, VA 20108	Address:
Phone #:	Phone #:
Note:	Note:
Notification/Contact (Other agencies contacted (DEQ, NS, FMO?) NA	
Date:	Date:
Time:	Time:
Name:	Name:
Company/Agency:	Company/Agency:
Notes:	Notes:
<u>Comments/ Deficiencies:</u>	
<p>Discharge was observed with orange algae through outfall having stagnant flow. The conductivity and pH did not exceed the standard limits on test performed on site. Discharge was tracked. Manhole A had flow from AB branch. Tracking was started and found discharge from BC and Bd branches at Manhole B. Manhole C was found very dry. Tracking was continued in BDEF branch. Foundation drains were found to relate to road curbs and gutters along DE line contributing discharge into storm sewer system through inlets. F is an inlet structure receiving discharge from drainage catchments having concrete swale. Hence the discharge from outfall was found to be generated by combine effect of upstream inflow and foundation drain.</p>

The source of discharge was discovered foundation drain with channel inflow, is considered a non-illicit discharge.

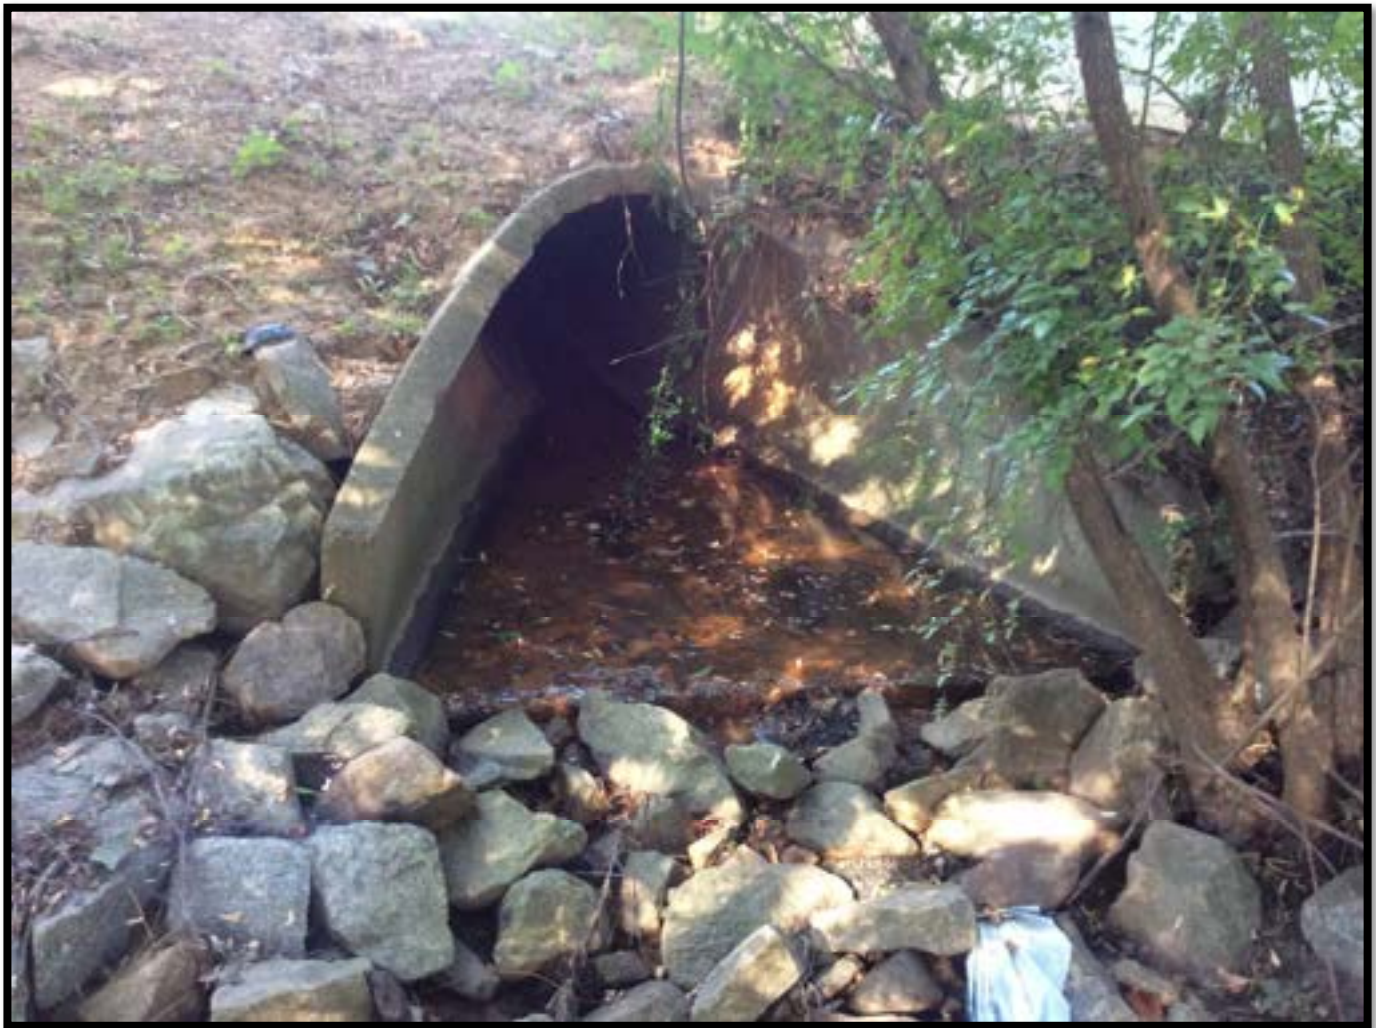
Photo of discharge:

INCIDENT INFORMATION		
Incident Report #: 26-2020	Date: 9/25/2019	Time: 11:30AM
Business Areas: Industrial	Report Completed By: Prem Poudel	
Outfall ID#59810 Address: 13527 Quate Ln	City, State: Woodbridge, VA	Zip Code: 22193
Complain or Case Received From: Routine Inspection

pH: 7.8 Limit: Std.	Conductivity: 315µS/cm Limit: Std.	Temp.: 65°F Limit: Std.
Discharge related Indicators	Odor: NA	Color: NA
	Floatables: NA	Stains: Algae
		Turbidity: NA
		Other: NA

Responsible Party (Owner/ Institutions)	Other Party (Management Company)
Name:	Name: NA
Company:	Company:
Address:	Address:
Phone #:	Phone #:
Note:	Note:
Notification/Contact (Other agencies contacted (DEQ, NS, FMO?) NA	
Date:	Date:
Time:	Time:
Name: TBD	Name:
Company/Agency:	Company/Agency:
Notes:	Notes:
<u>Comments/ Deficiencies:</u>	
Algae was found to develop at outfall. pH and conductivity were found within the standard limit. Discharge was tracked and found to generated from ground water seepage. At Manhole C, significant number of algae was developed with trickle flow at cracks of structure. The source of discharge was confirmed ground water seepage into storm sewer system.	
<u>Conclusion:</u>	
The source of discharge was ground water seepage. Algae was found to develop at outfall due to ground water. Further investigation is not needed. Follow up inspection will continue in future.
