Annual Stormwater Management Report
VSMP Permit No. 0088595 – FY 2020

Submitted by:
Prince William County
Department of Public Works

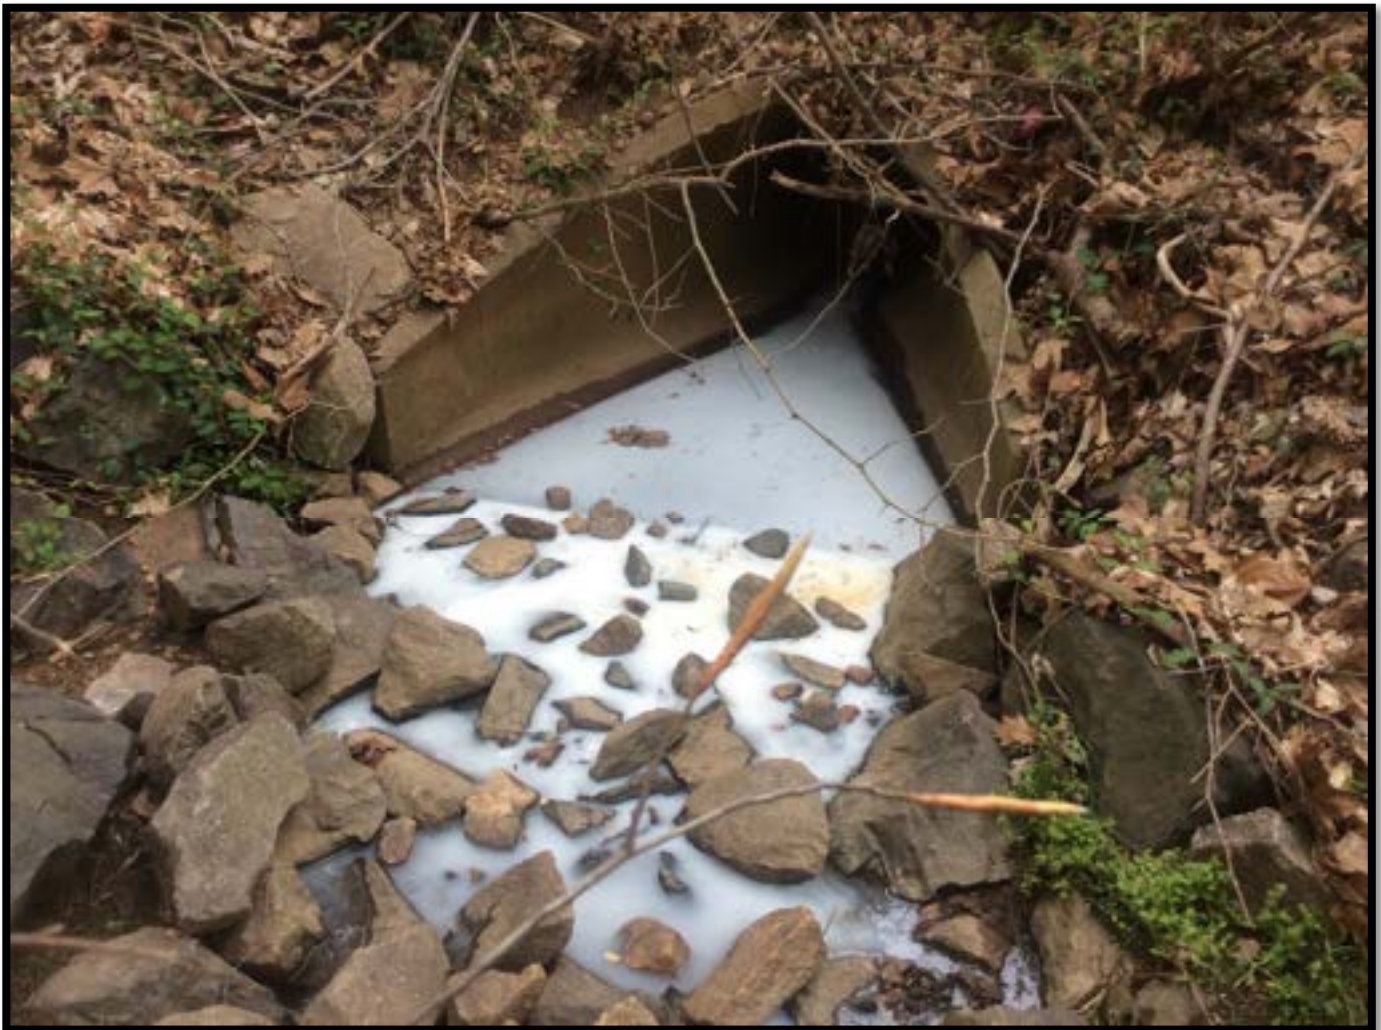
Photo of discharge:

INCIDENT INFORMATION		
Incident Report #: 41-2020	Date: 4/17/2020	Time: 10:45 AM
Business Areas: Residential	Report Completed By: Prem Poudel	
Outfall ID#59899 Address: 15064 Copper Turtle Pl	City, State: Woodbridge, VA	Zip Code: 22193
Complain or Case Received From: Routine Inspection

pH: 8.9 Limit: Std.	Conductivity: 913 μ S/cm Limit: Std.	Temp: 56°F Limit: Std.
Discharge related Indicators	Odor: NA	Turbidity: Opaque
	Floatables: NA	Stains: NA
		Other: Paint Discharge

During routine inspection, white discharge was observed flowing from stormwater outfall (ID: 59899). The discharge was tracked along the storm sewer line at points A, B, C, and D, shown on the map above. The stormwater drop inlet located at the back yard of 5122 Leatherback Rd was found to be the site of the illicit discharge, which was a white paint. The staff members of the contractor employed for painting house were responsible for the discharge. The County inspector explained that discharging paint is a violation of the law. The contractor staff were asked to take action to capture the white discharge immediately, but no action was taken. The County inspector was warned by one of the contractor's staff members to leave the site. Information on the contractor responsible for the discharge will be provided at a later date.

Dumping paint into the storm sewer system is a violation of County Code (23.2-4.1). The abatement and cleanup work were completed by Atlas Environmental. A court summons has been issued to the violator.

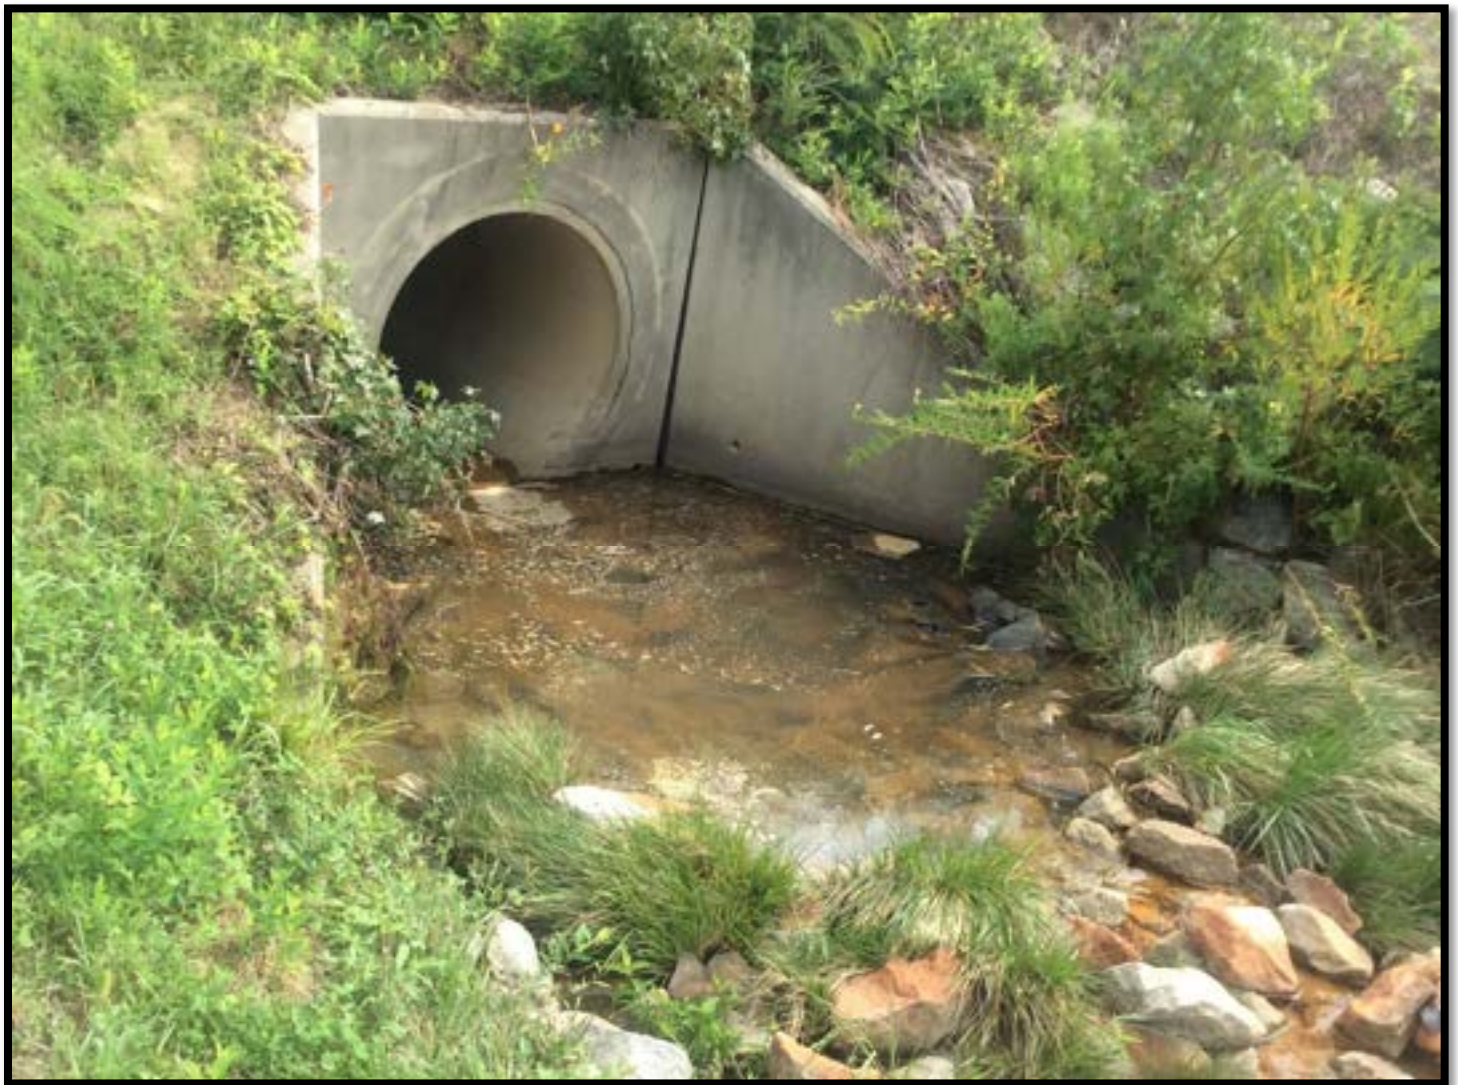
Photo of discharge:

pH: 8.40 Limit: Std.	Conductivity: 318 μ S/cm Limit: Std.	Temp.: 69°F Limit: Std.
Discharge related Indicators	Odor: NA	Turbidity: NA
	Floatables: Suds	Other: NA
	Color: NA	
	Stains: Algae

Suds with orange algae was observed at outfall. pH and conductivity did not exceed the limits during onsite test. Source of discharge was tracked along red line shown in map above. At manhole A, Flow observed from both AB branch only. Tracking was continued along point C and D. At manhole D, flow observed from both DE and EF branches. Manhole E was found dry. Manhole F was receiving flow from both FG and FH branches. Both drop inlets were observed receiving trickle flow from landscape. Volume of flow was observed gradually reducing in upstream section. Cross connection of sanitary sewer did not find during inspection.

The source of discharge was discovered ground water seepage. Algae and suds found to be developed at the outfall. Specific source of illicit discharge did not find but application of fertilizer and chemicals on landscape with parking lot runoff may responsible for suds and algae. Discharge with high vertical drops in different sections is also responsible for forming sod due to turbulence flow. Follow up inspection will continue in following year.

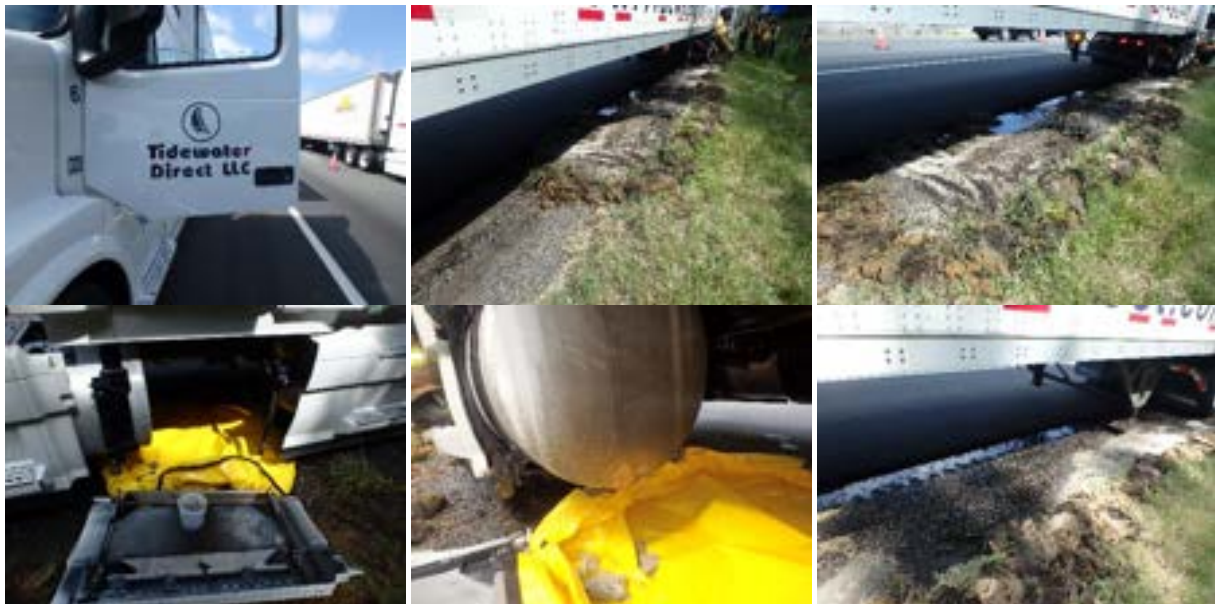
INCIDENT DESCRIPTION	
<p>HM506 was requested for a phone consult by E503. E503 advised that they were on scene of a tractor trailer that had ruptured one of its saddle tanks and had an active leak. E503 advised that around 75 gallons had leaked out of the tank. HM506 advised E503 to perform defensive measures to contain the leak. HM506 responded to the call. HM506 arrived on scene and found a saddle tank leaking from the bottom seam. E503 had built a damn around the product that leaked out to contain it. HM506 placed a popup pool under the tank to collect the leaking diesel fuel. HM506 isolated the tanks by shutting the valve between the tanks. HM506 used Plug N Dike to stop the leak. HM506 handed the driver an LEPC form to pick a clean up contractor. The Driver chose Atlas for the clean up company. HM506 remained on scene until Atlas arrived. HM506 turned the scene over to Atlas.</p>	
RESPONSIBLE PARTY	OTHER PARTY

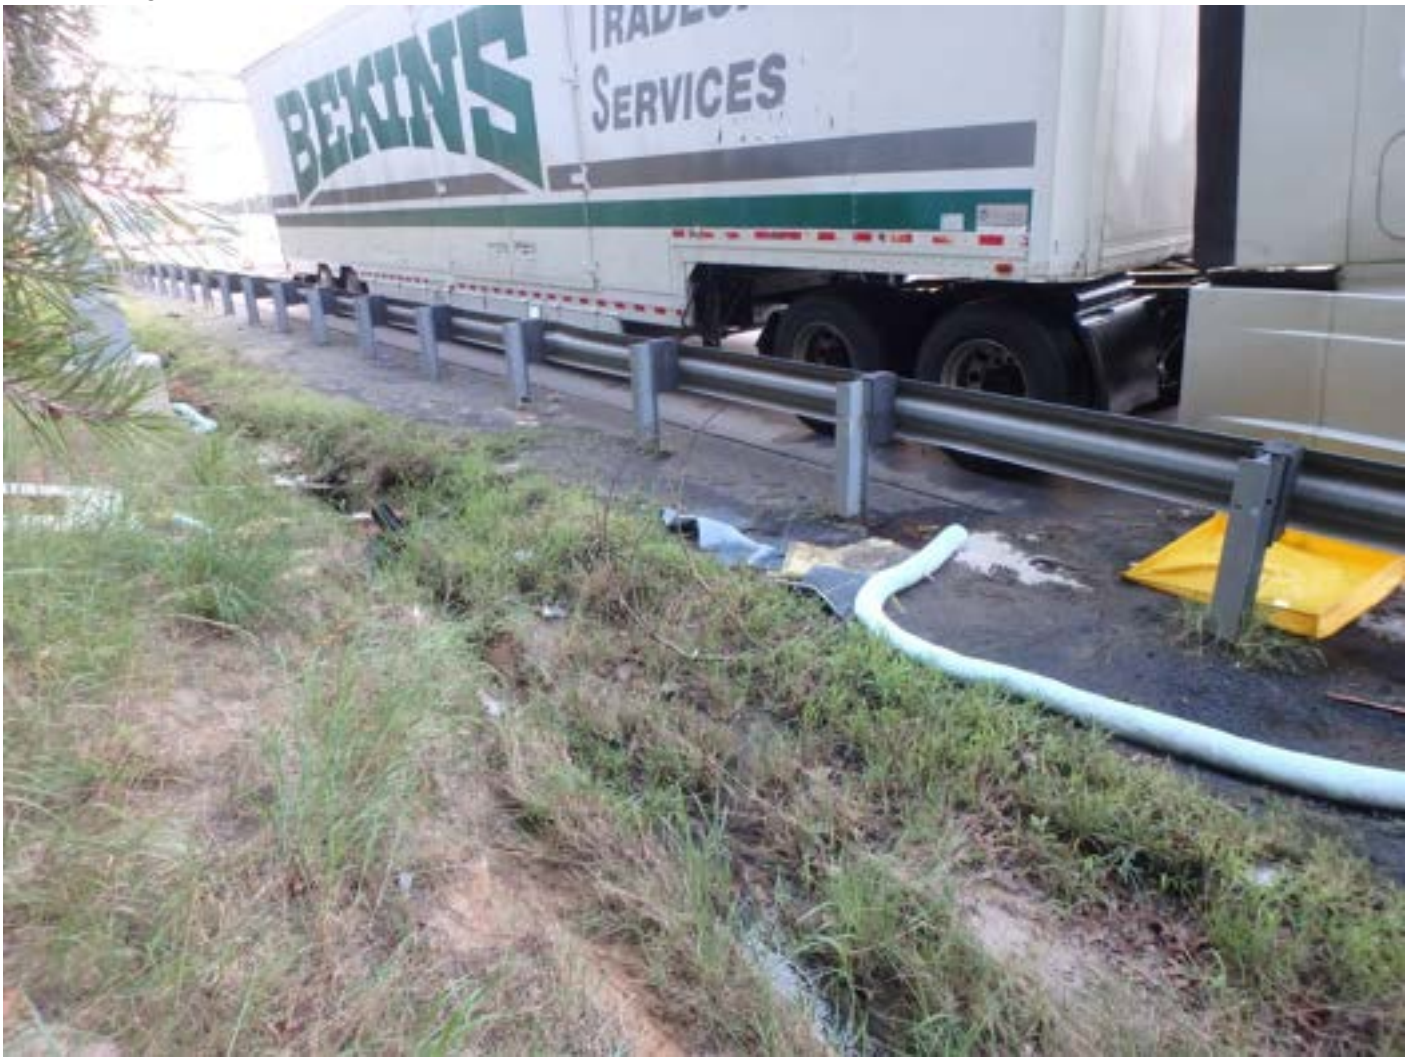
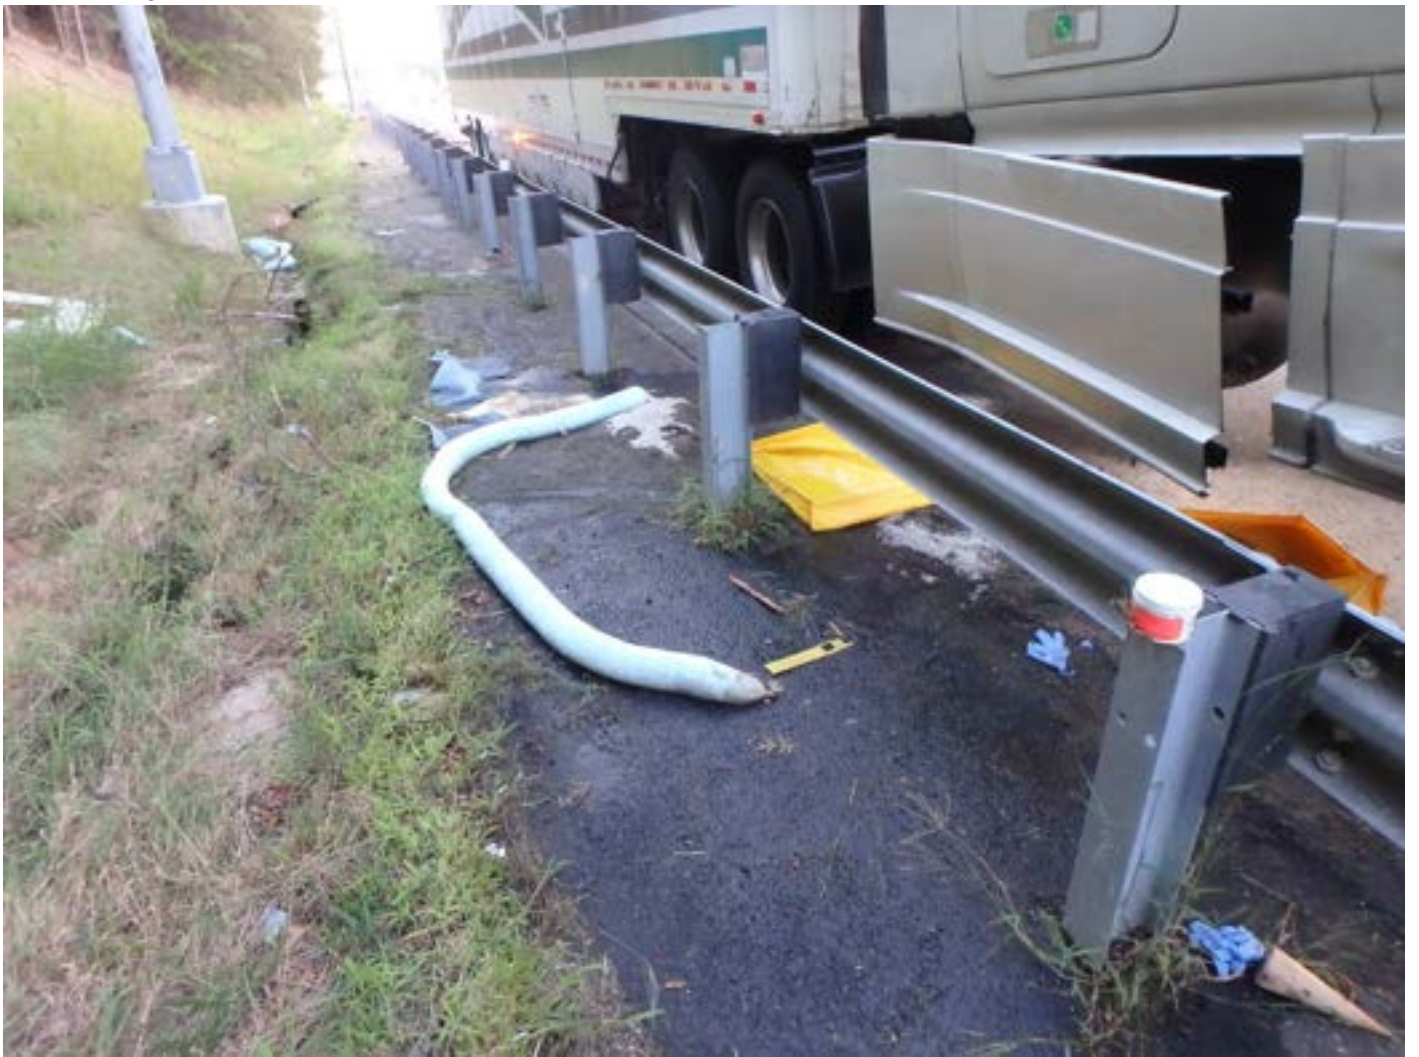
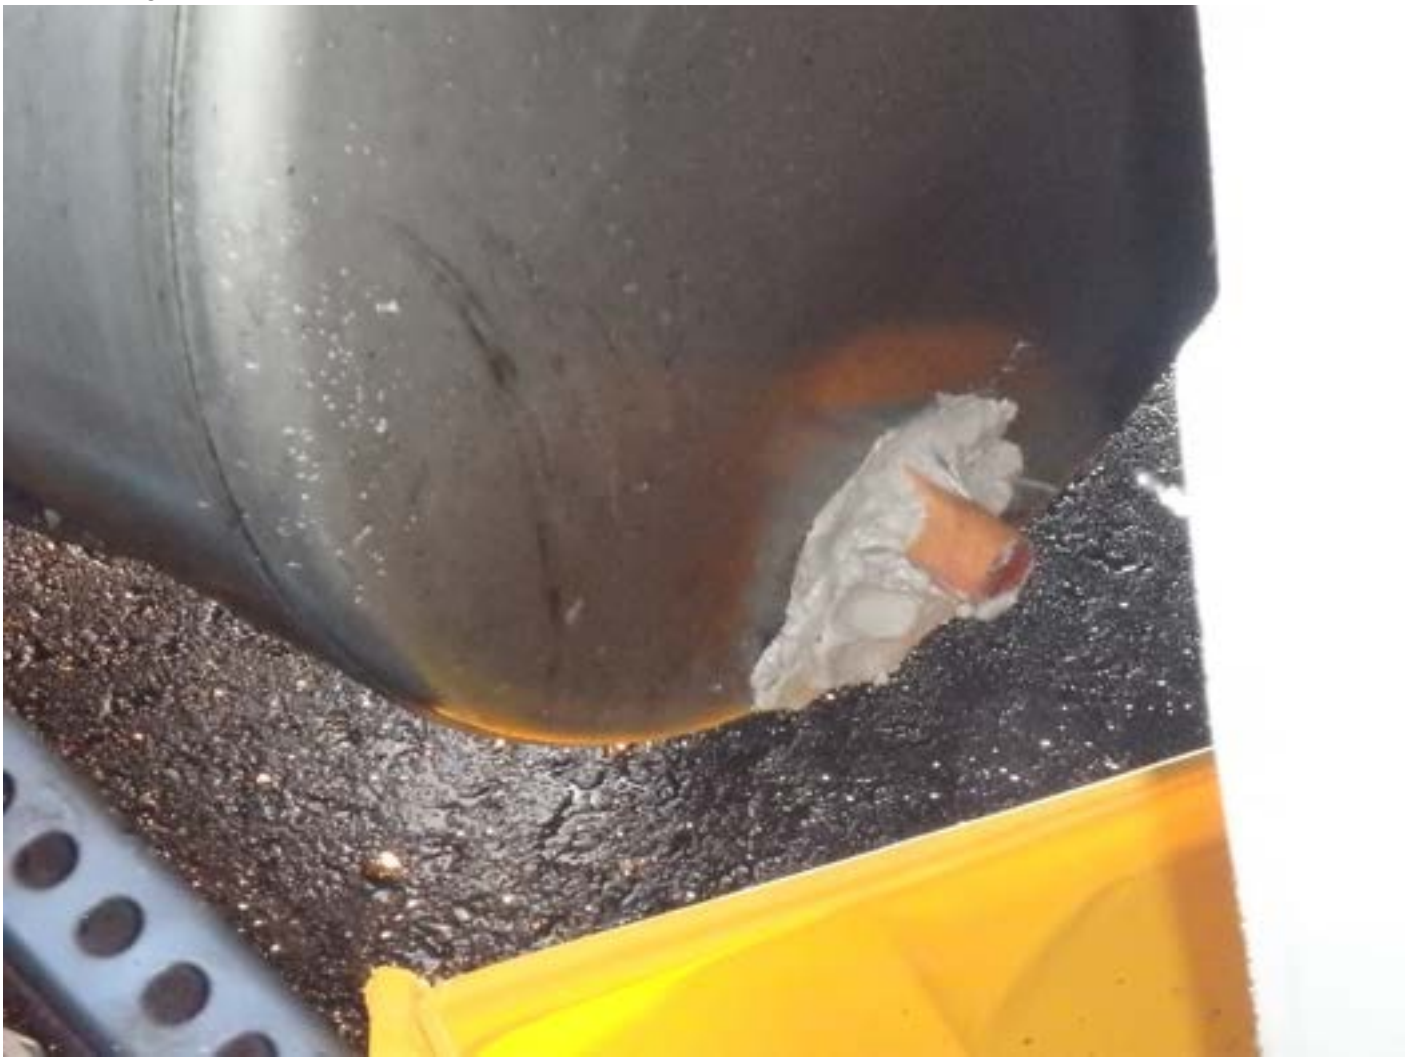
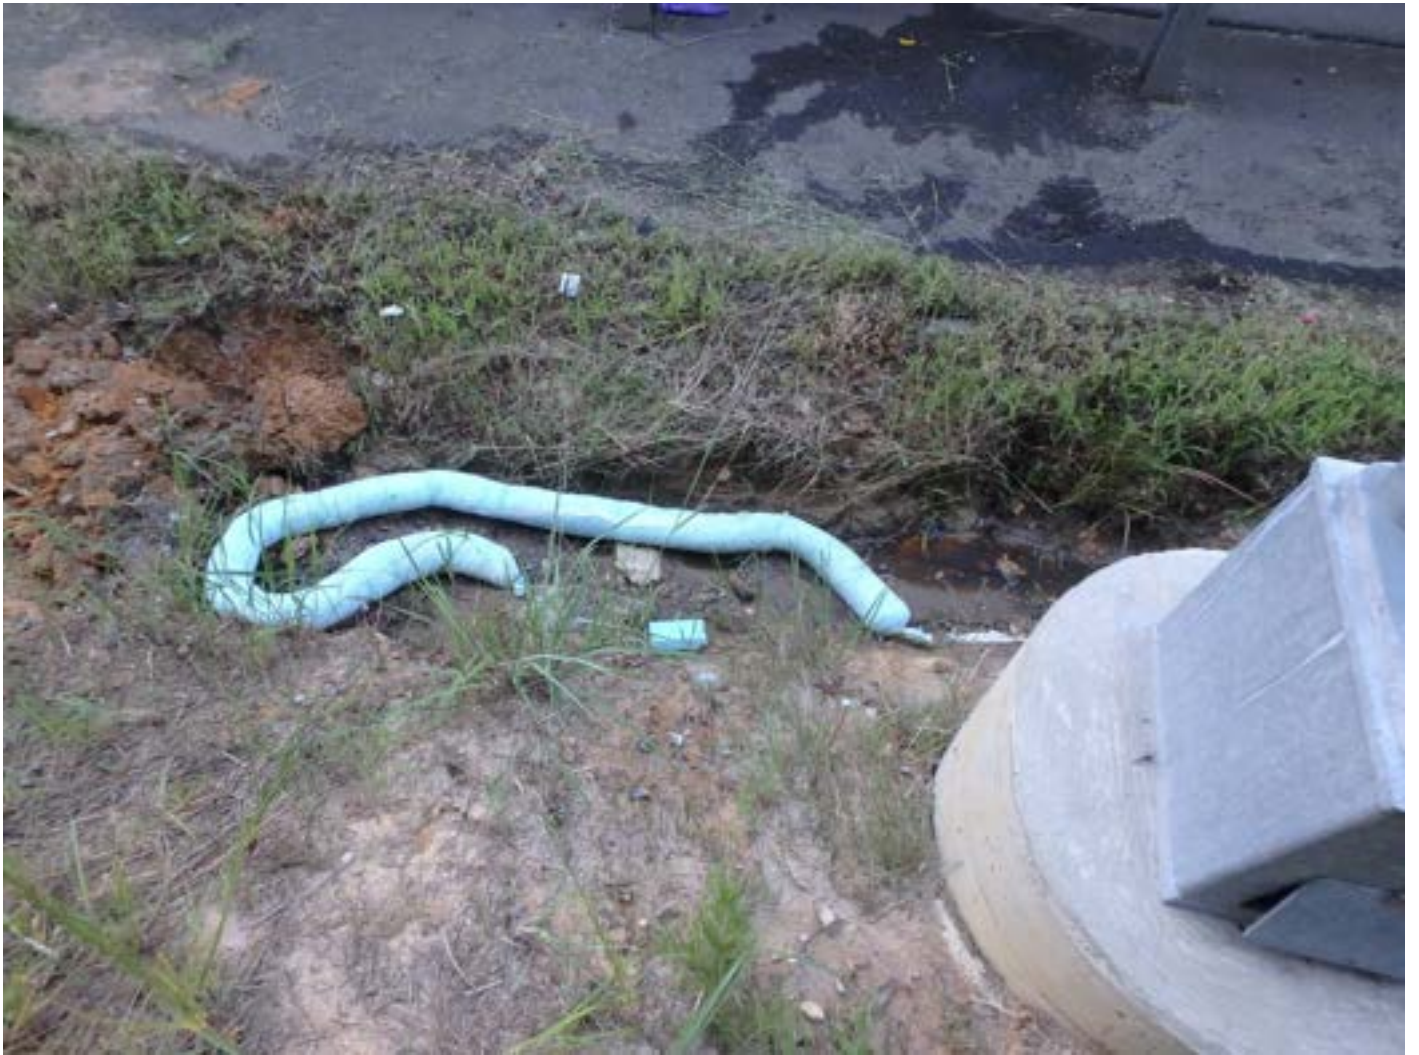
INCIDENT DESCRIPTION	
<p>Incident # 170025803. HM506 was dispatched to a fuel spill from the right saddle tank of an 18 wheeler. E512 was first onscene and began defensive operations by putting absorbent near the saddle tank and absorbent pads in the drainage ditch. H506 arrived onscene and saw that the diesel fuel was flowing into the dirt of the ditch and not near the storm drain. HM506 placed two portable pools under the saddle tank to catch the fuel and overflow. HM506 also placed booms into the drainage ditch to keep the fuel from flowing any further. HM506 found that there was a hole at the bottom front of the right saddle tank and stopped the leak with a wooden plug and putty. After talking to the driver of the 18 wheeler it was found that there was approximately 100 gallons of diesel fuel in the saddle tanks. Bekins trucking Manager Doug Lagrath stated that he and his company could not be able to contact a clean up company until Monday August 21, 2017. After explaining to the truck driver and his manager that they had to get the diesel spill cleaned up they still refused to do it in a timely manner. Mike Wood from VDOT and Hazmat Officer 502 were contacted and informed of the situation. VDOT assumed responsibility of the spill and contacted Atlas Environmental to conduct the clean up.</p>

Additional Notes/Information: Equipment used: Two booms , pads, plug and dike putty, wooden mallet, four wooden plugs.
HAZMAT Officer Comments:

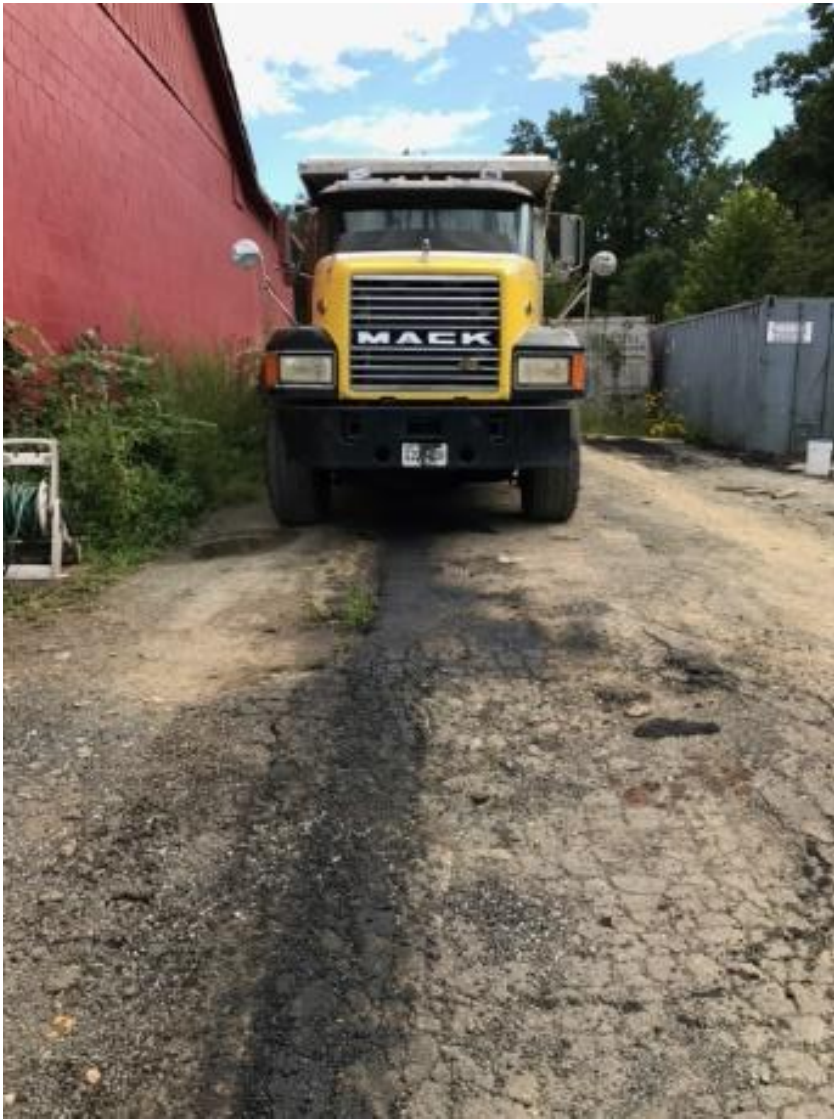
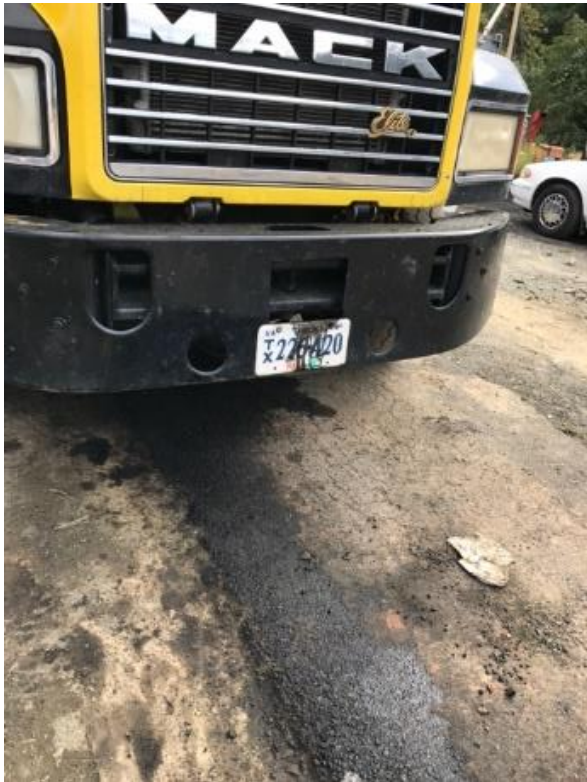
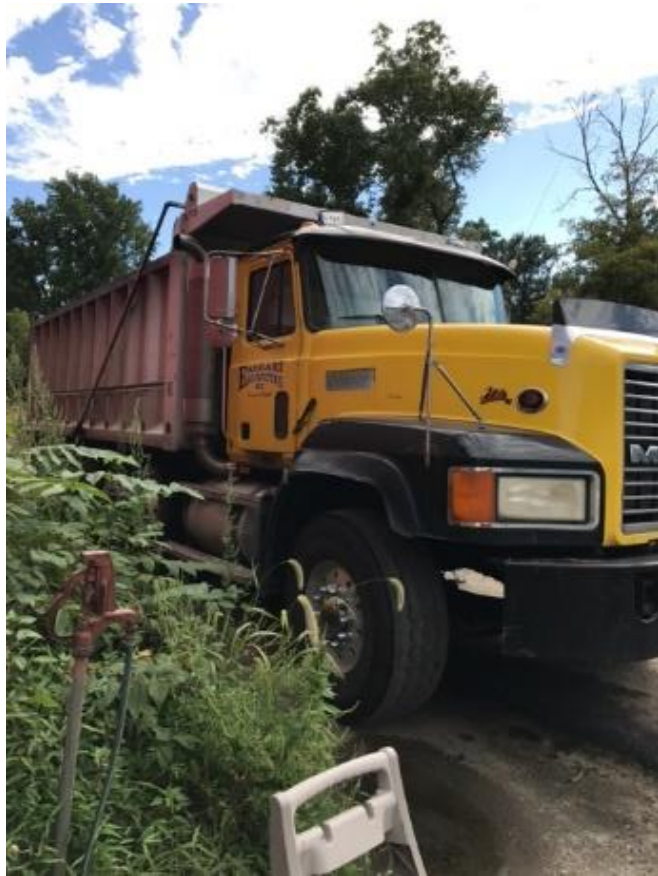
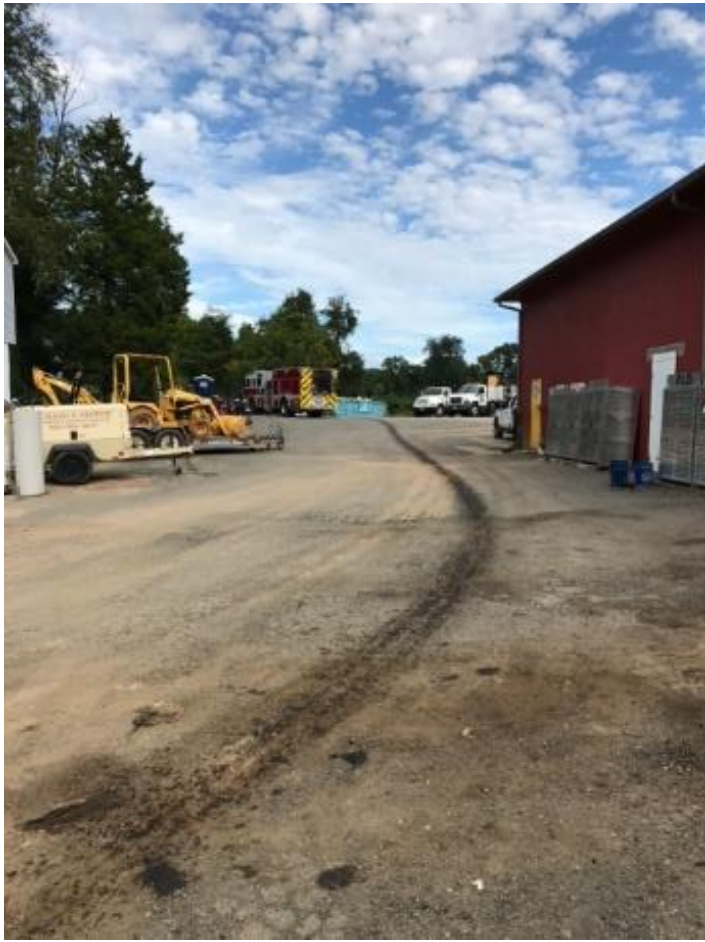
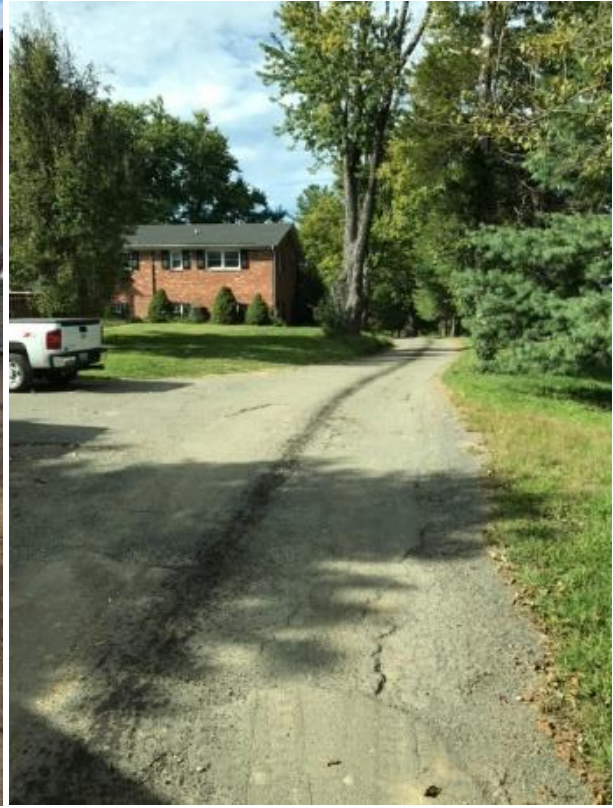
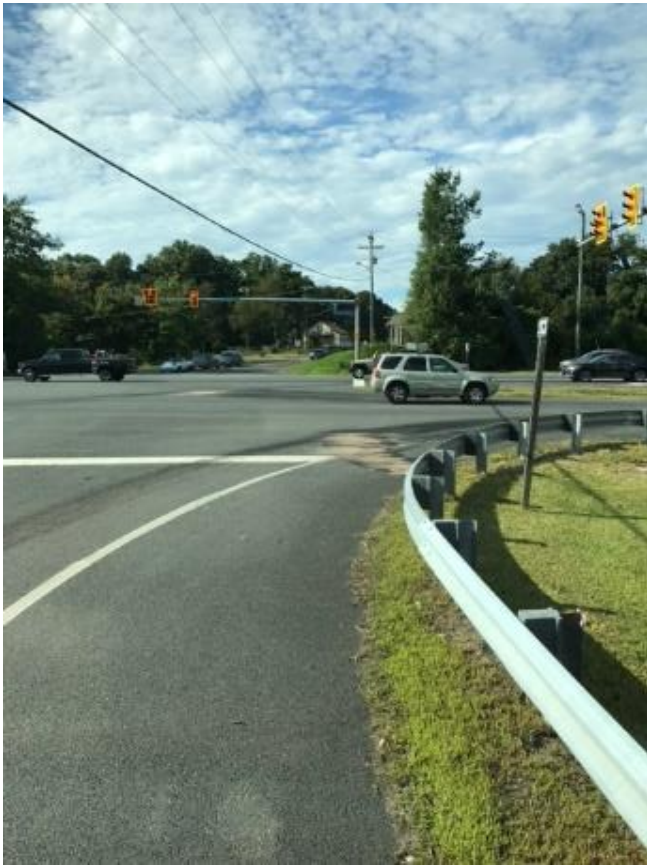
INCIDENT DESCRIPTION	
E516 AOS to find a dump truck leaking fuel. The vehicle was parked on a dirt pad, but had left a trail of fuel, occasionally pooling, on a 2 mile trail of Prince William Parkway. Lt. Reader, OIC of E516, called for a Hazmat Consult with HM506 and R506. Lt. Reader advised that there was no more than 5 gallons of fuel spilled in total, based on fuel level readings from the dump truck. Lt. Reader also advised that there was no recoverable product, due to its dispersion across 2 miles of highway. Lt. Reader advised that there were no resources that HM506 could bring that they did not have already (namely, absorbant). HM506 advised giving the driver an LEPC form. HM506 cleared the call at 1545 with no further services to be delivered. The vehicle had a VA registration of PX226420.	
RESPONSIBLE PARTY	OTHER PARTY
Name: Marshall Martin	Name: Kevin Eaheart (Owner)
Company: Eaheart Excavating, Inc.	Company:

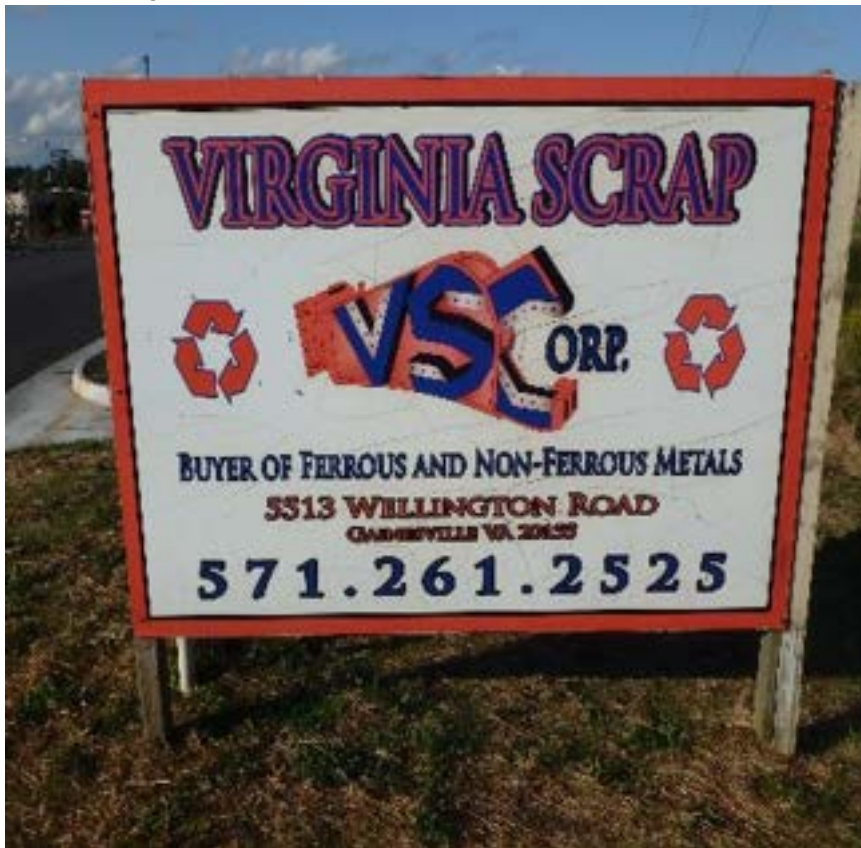
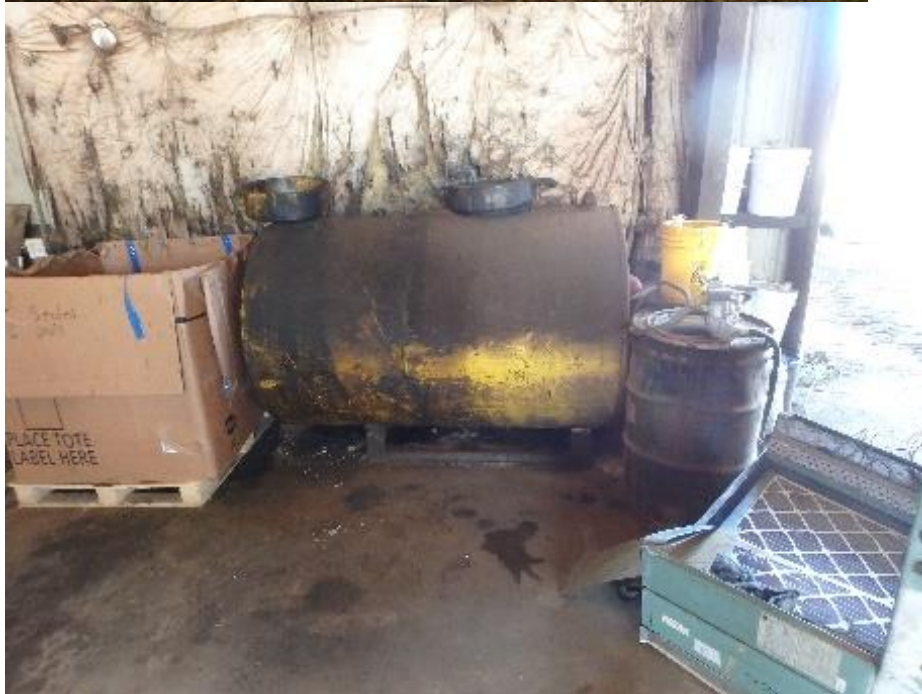
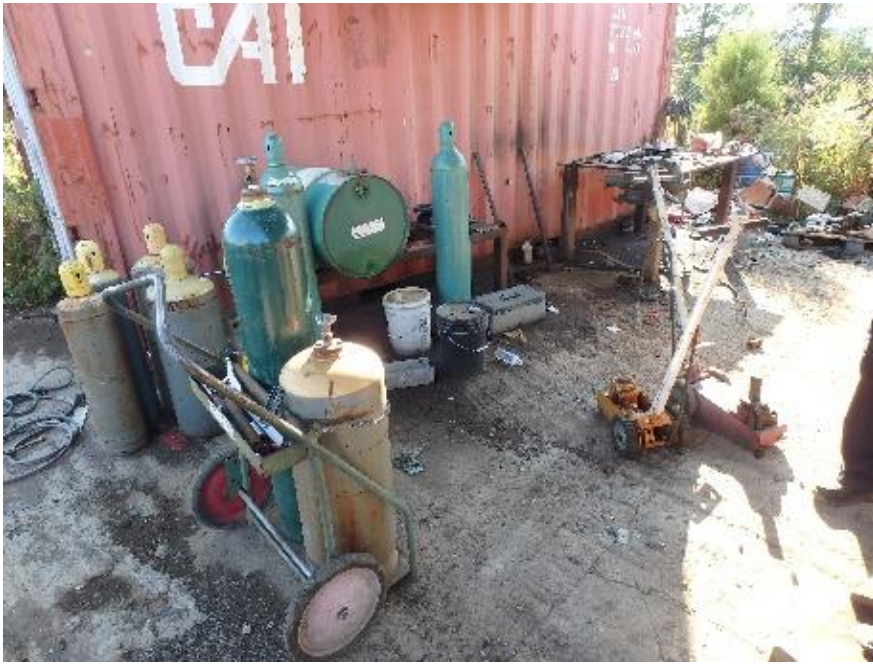
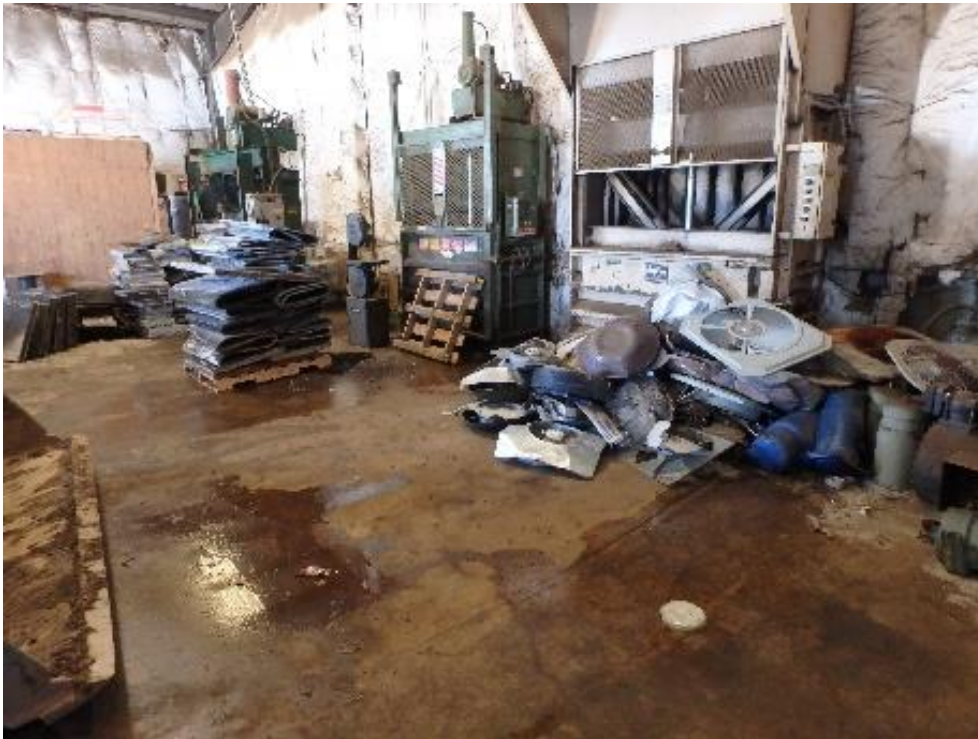
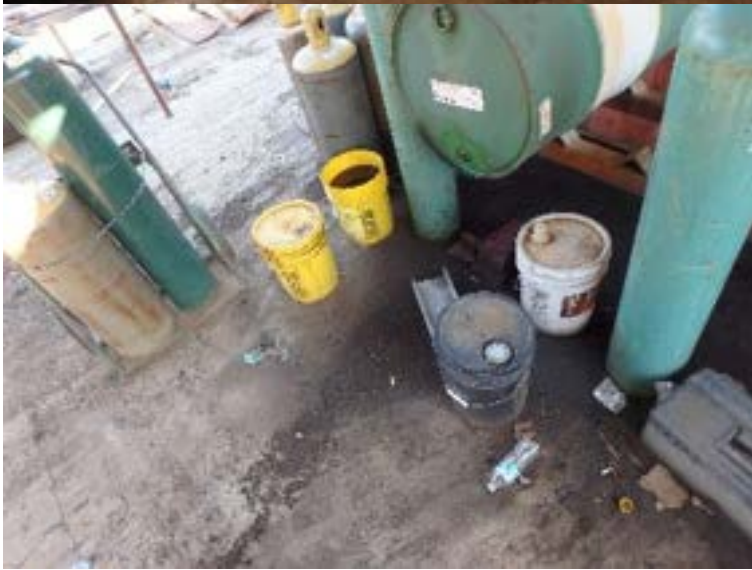
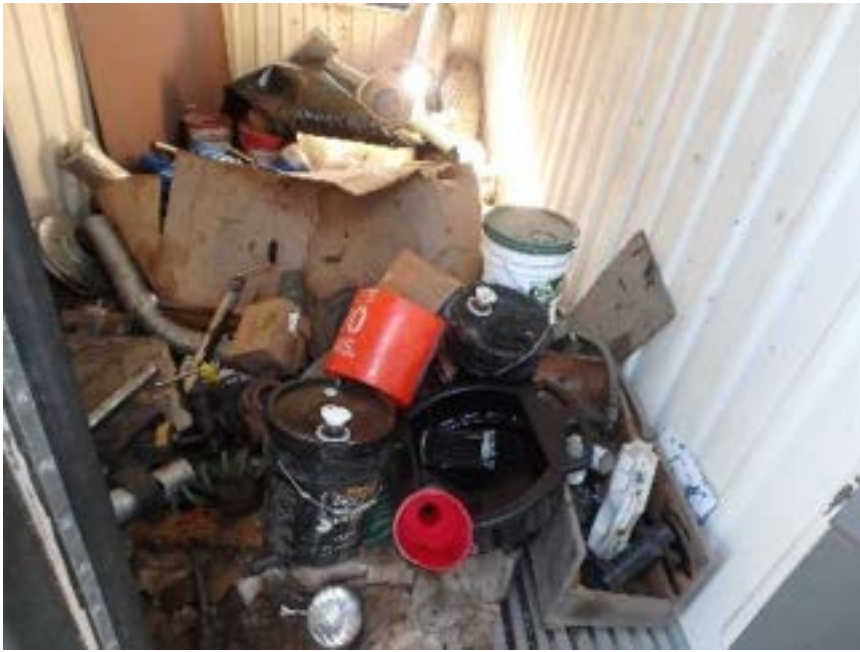
INCIDENT DESCRIPTION	
At approx 1640 we conducted a phone consult with Lt. Knonebusch from the FMO in regards to conditions at the above address. She stated that there were fluids/oils that had leaked out onto the ground at the location. She also stated that there were no active leaks and no waterways were compromised and that she simply wanted a consult to address her concerns. HM506 responded as a courtesy and found no recoverable product and no actions were needed by us. Instructed FMO's to advise owner of the use of booms, pads and absorbants.	
RESPONSIBLE PARTY	OTHER PARTY
Name: John Earl Smelser	Name:
Company: Virginia Scrap Corporation	Company:
Address: 5513 Wellington Road Gainesville, VA 20155	Address:
Phone#: 571-261-2525	Phone#:
Notes:	Notes:
