Annual Stormwater Management Report
VSMP Permit No. 0088595 – FY 2020

Submitted by:
Prince William County
Department of Public Works

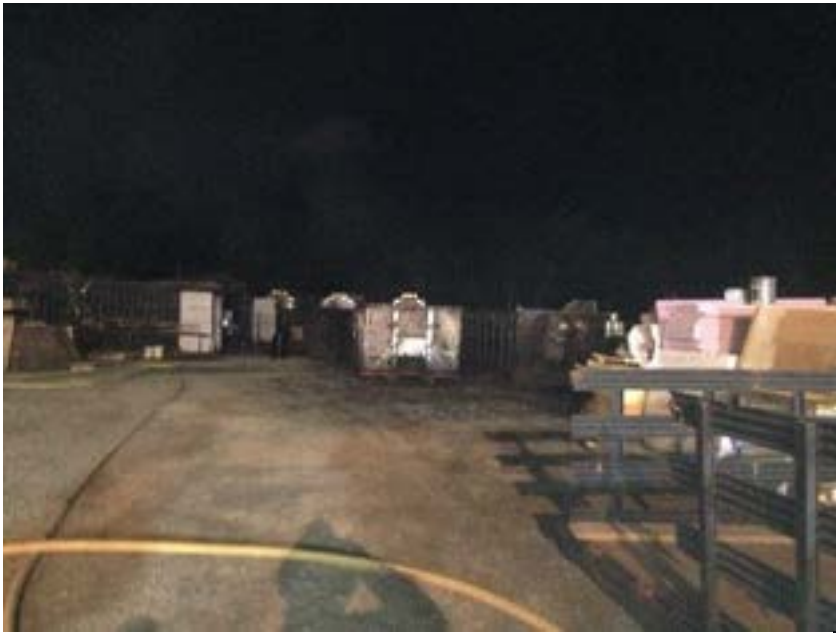
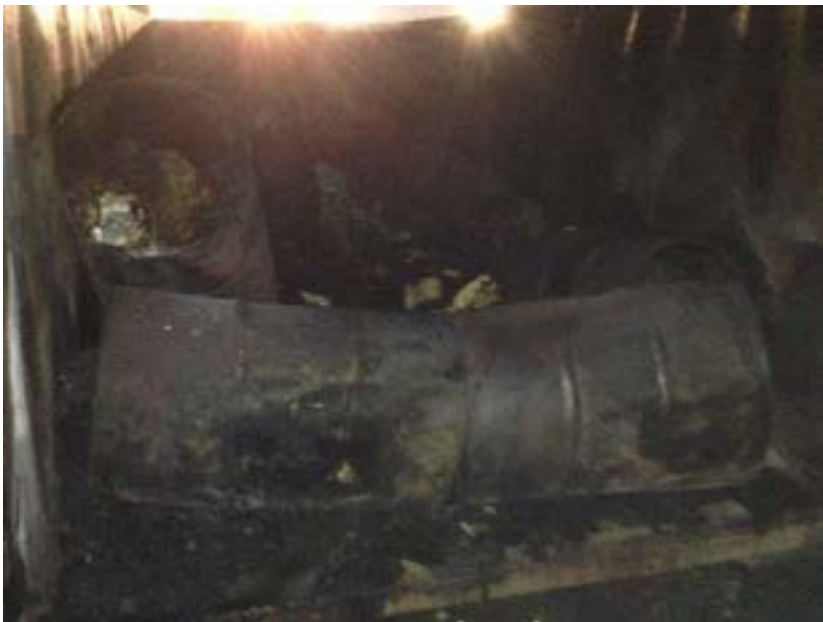
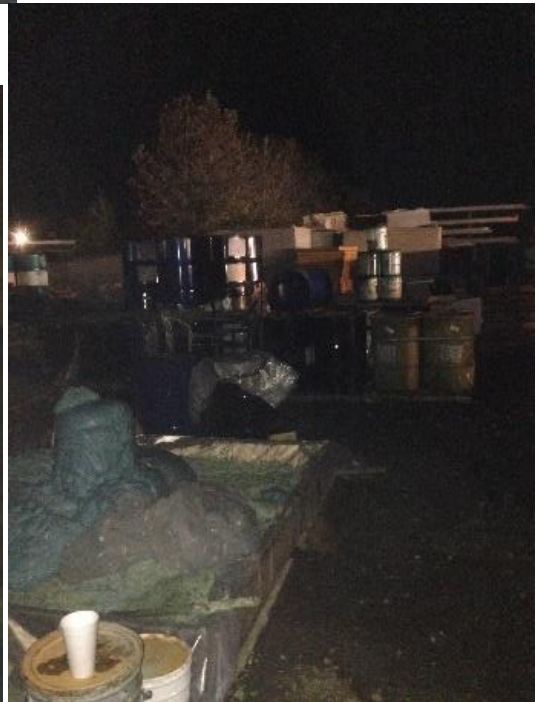
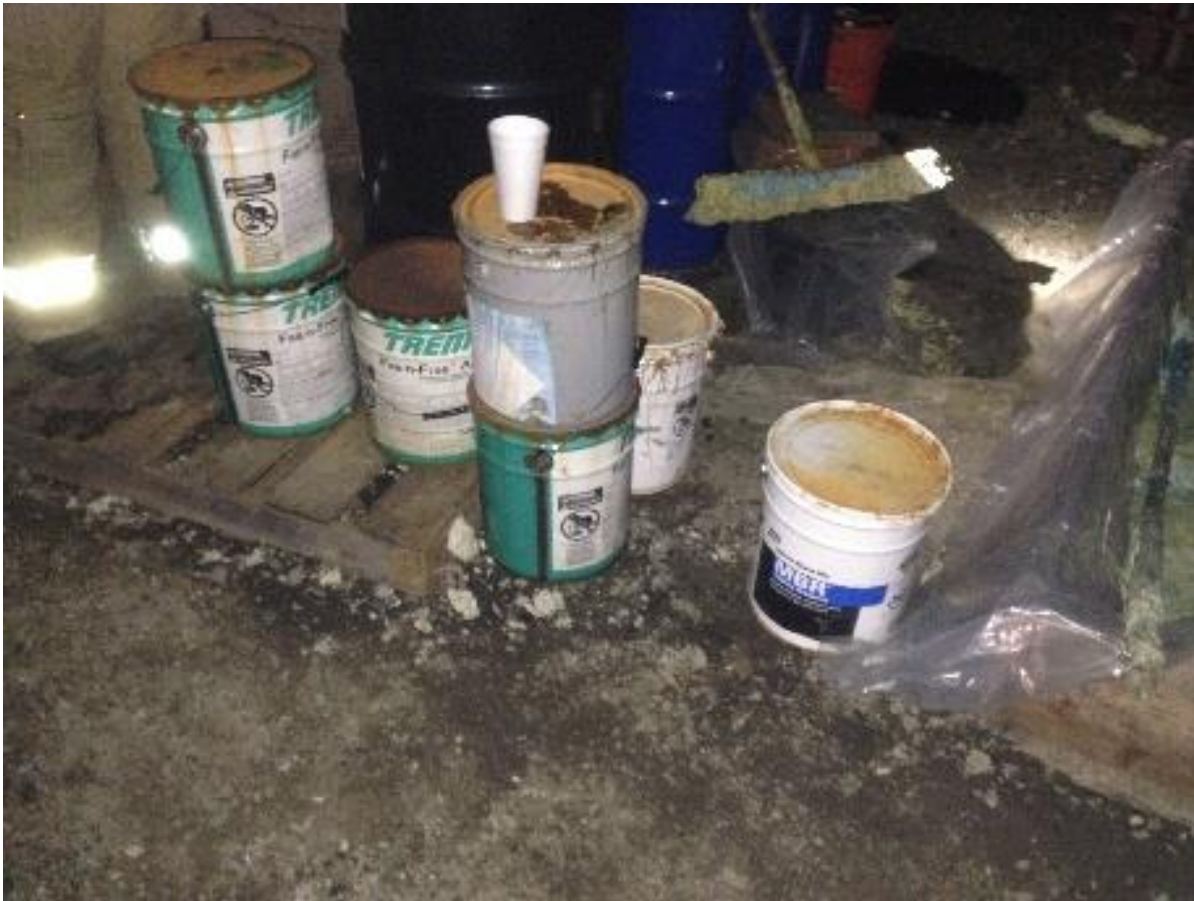
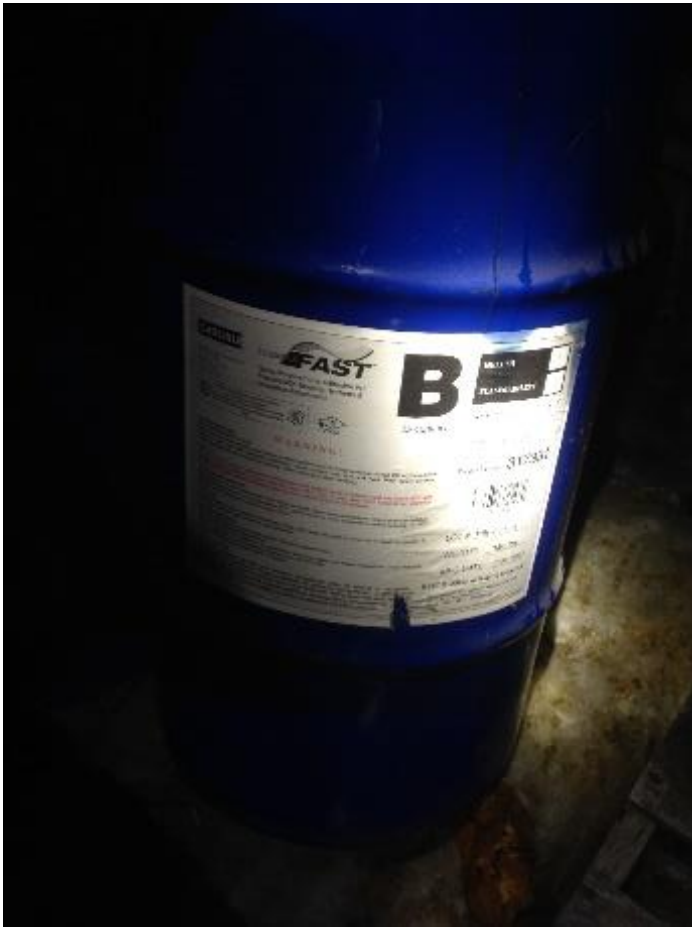
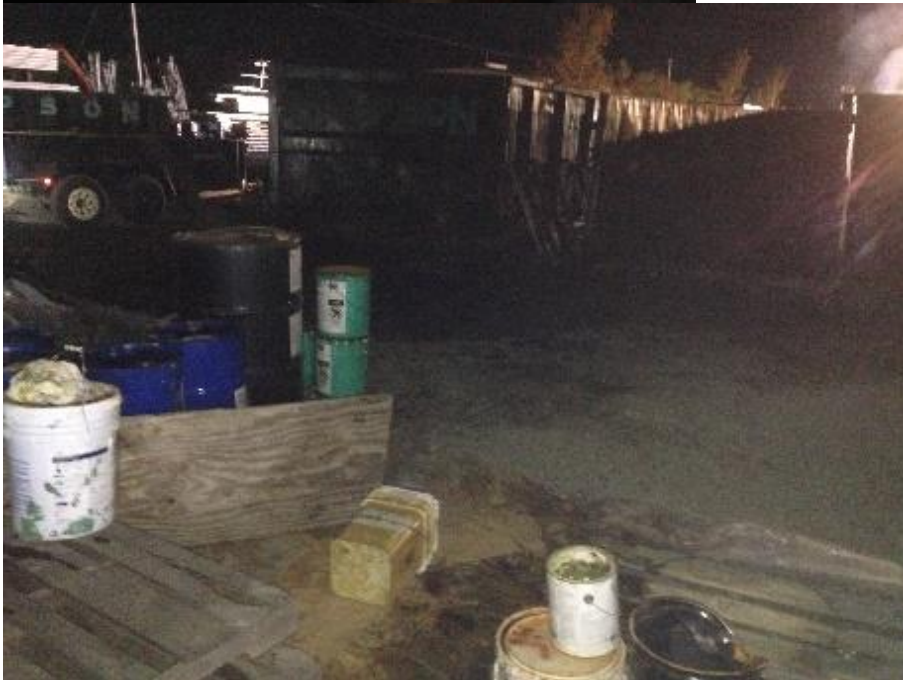
INCIDENT DESCRIPTION	
<p>HM506 was dispatched to assist with a dumpster fire investigation. E525 was initially dispatched to a dumpster fire, and once fire was extinguished, E525's officer noticed some storage drums inside of garbage dumpster. E525 requested a hazmat consult and HM506 to be dispatched to the scene. Upon arrival HM506 found dumpster where fire had been extinguished and where drums were still inside. Minor smoke was present, and containers was not hot according to thermal imaging camera.</p> <p>HM506 arrived on scene and was briefed by E525, BC 501, and FM523. E525's officer stated that he noticed the drums inside of dumpster and also many drums out in the yard. E525 wanted to make sure none hazardous substances were present. Using structural PPA and SCBA, E506 obtained samples from water run of and from some product that remained inside of one of the containers. Technician II Pereira and Technician I Malone used the following monitors to survey the area; Q-Rae2, PID, Identifinder2, and Ph paper. No abnormal substances or abnormal readings were found .</p> <p>By the end of monitoring , representatives from the company had arrived on scene and wre giving information to FM523. Accordinging to company representatives, the drums found in the dumpster were a combination of two different types of adhesive that were mixed together to make a solid, so it then could be sent to the landfill as solid waste.</p> <p>Without any abnormal readings, E506 turned scene over to E525.</p> <p>For any further information in regards to this incident, please see FM523 report.</p>

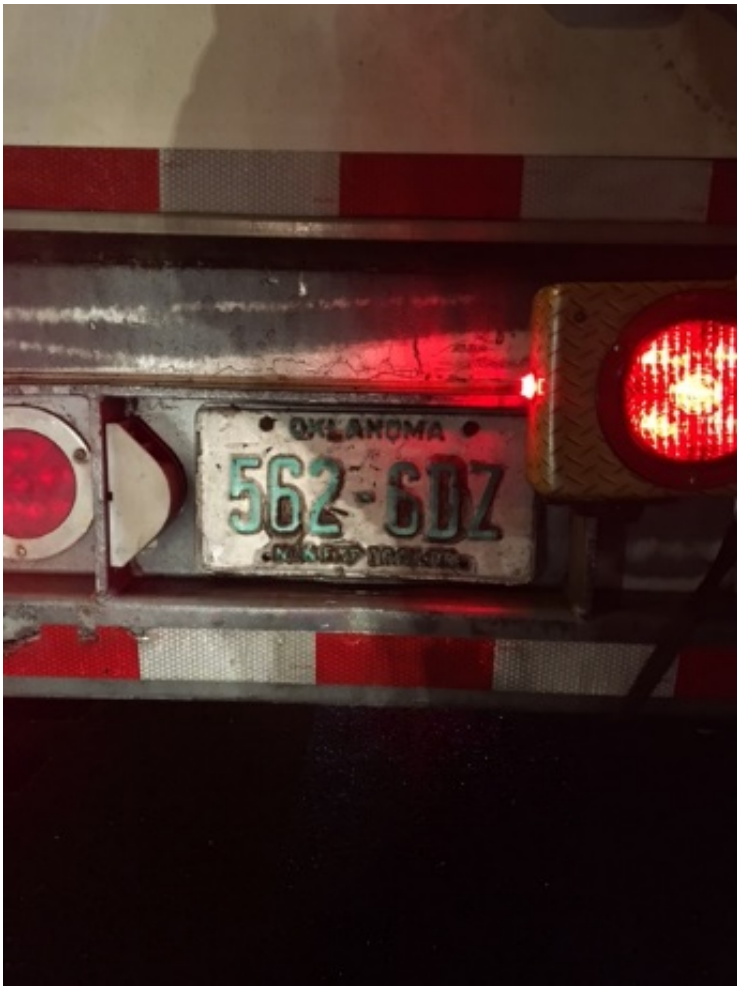
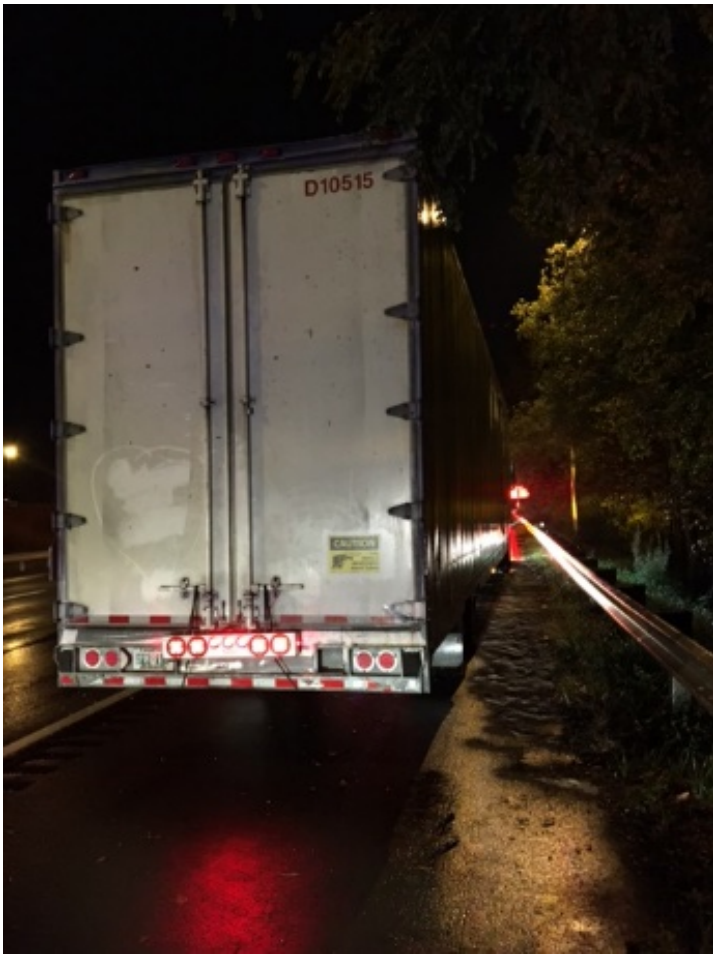
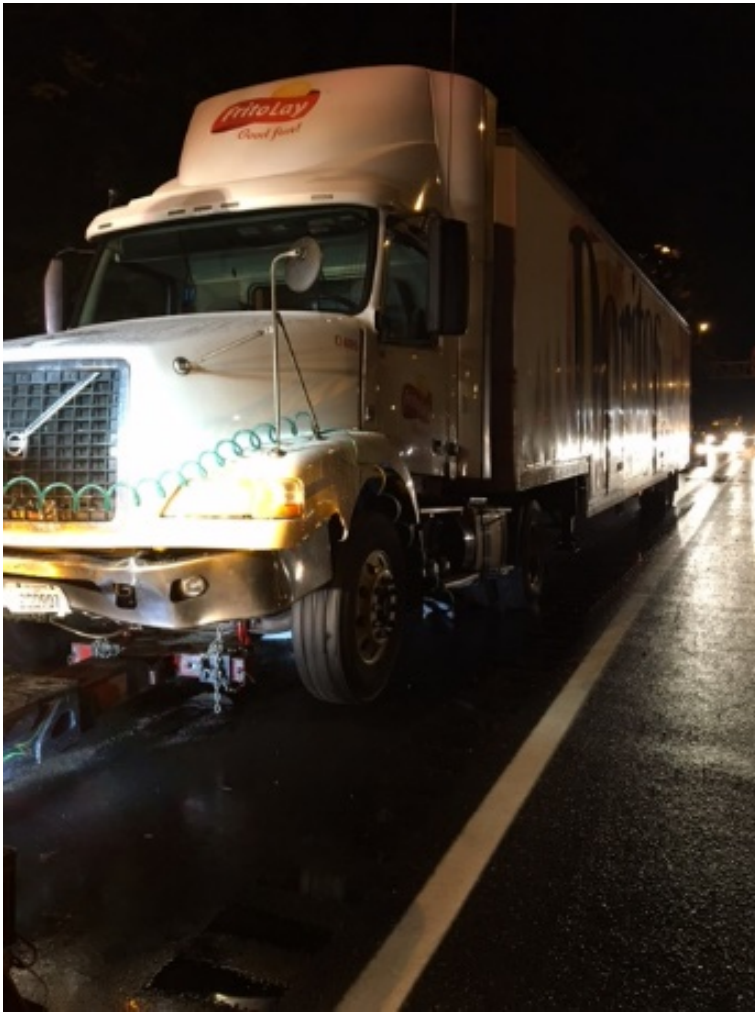
INCIDENT DESCRIPTION	
<p>DHM received a phone consult from E512's officer. He reported that approximately forty quarts of oil had leaked out from the engine bay of a tractor trailer. The officer also stated that absorbent had been put down and no waterways were effected. Hazmat 506 AOS to find a Tractor trailer on the right shoulder of I-95 south bound near mile marker 154. It had damage to the front end due to rear ending a passenger car, causing the loss of oil. The oil was on the shoulder and stopped at the edge of the grass. E512 along with VDOT had placed booms and covered the spill with absorbent. No active leaks were found so Hazmat 506 looked for any environmental concerns. Upon investigation we found that no waterways were impacted and no vegetation concerns were present. The driver of the tractor trailer was given a LEPC form and he chose to use Atlas for the site clean up. HM 506 cleared the scene and went in service. After returning to the station the VAEOC was informed of the incident</p>

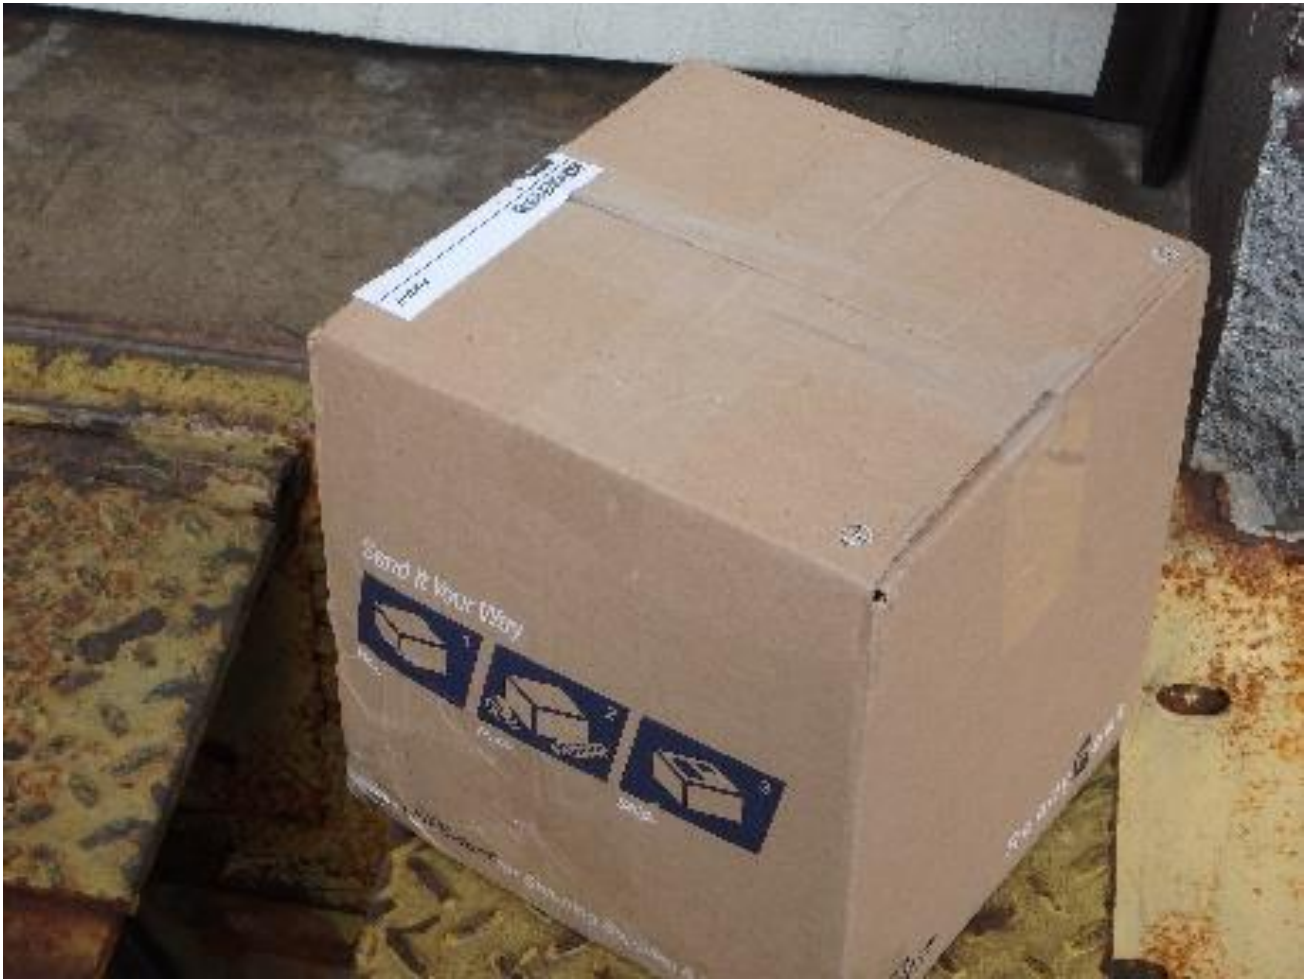
INCIDENT DESCRIPTION	
<p>HM506 was dispatched to assist with an inside gas leak at a post office. E501 together with E521 did initial investigation and reported no abnormal readings inside the post office, but found a possible source of smell from two boxes that was inside of a mail cart. E521 moved two boxes to outside loading dock and closed bay doors, the smell was reported to be similar to Natural Gas. The post office was evacuated and HAZMAT response was requested. Upon arrival HM506 and HM516 were briefed by HMO 501 on the situation, HM506 took background samples to ready monitors (09:17). PRD= 3µr/h; PID= 0ppb; Identifinder2= 6µr/h; Ludlum= 10µr/h; QRAE=all normal HM506 entry team 1 made entry (09:22) to area where packages were located using bunker gear and SCBA. HM516 provided the back up team and emergency DECON was established by E521. HM506 entry team approached location of the boxes and noticed no leaks or any smells coming from the boxes. No abnormal readings were found: PRD= 3µr/h; PID= 0ppb; Identifinder2= 4µr/h; Ludlum= 10µr/h; QRAE=all normal HM506 entry team 1 also used pH paper, water paper, fluoride paper, and M8 paper to sample around boxes (09:32) and no abnormal finding were noted. HM506 entry team one relayed the findings to command and the entry team leader then entered the building to check readings for any other possible sources. Readings in the post office were normal/background, PRD= 3µr/h; PID= oppb; Identifinder2= 6µr/h; Ludlum= 10µr/h; QRAE=all normal. HM506 entry team 1 exited the post office and reported to command. Postal service made contact with the sender of the package (09:23) and found contents of the package was food for the chinese new year. Scene was turned over to postal service employees and HM506 was placed in service by BC582.</p>

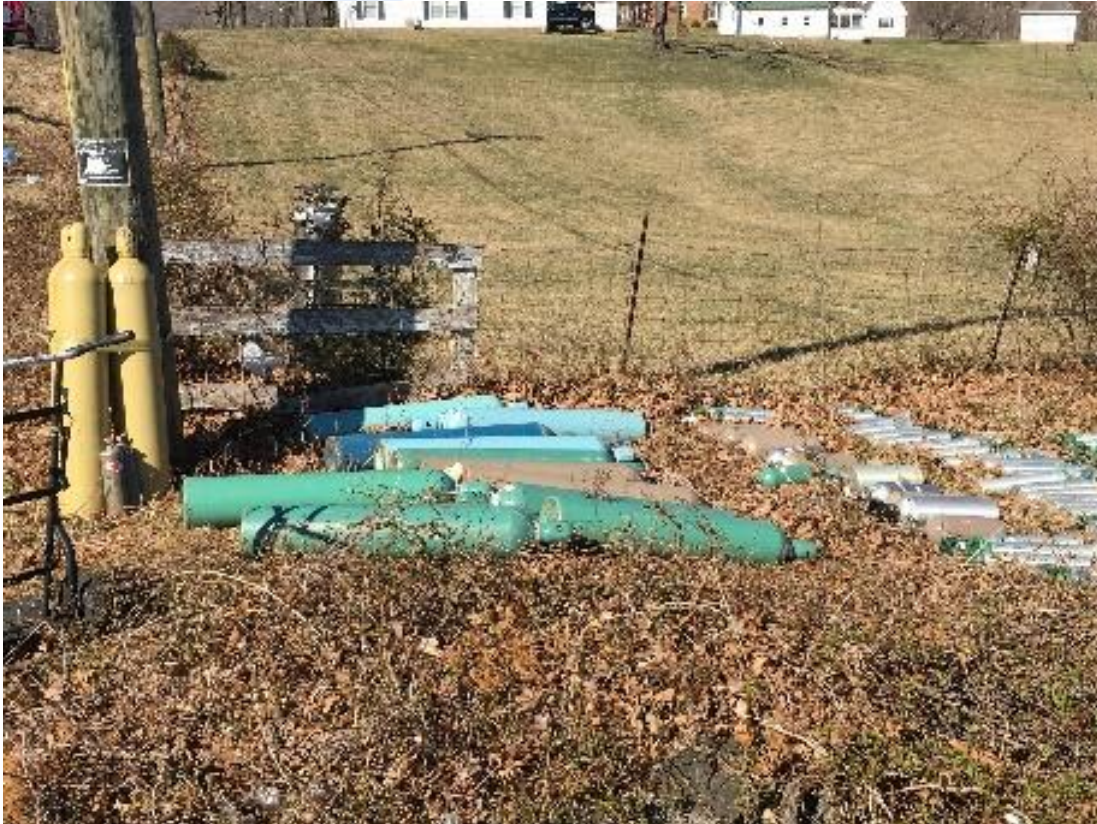
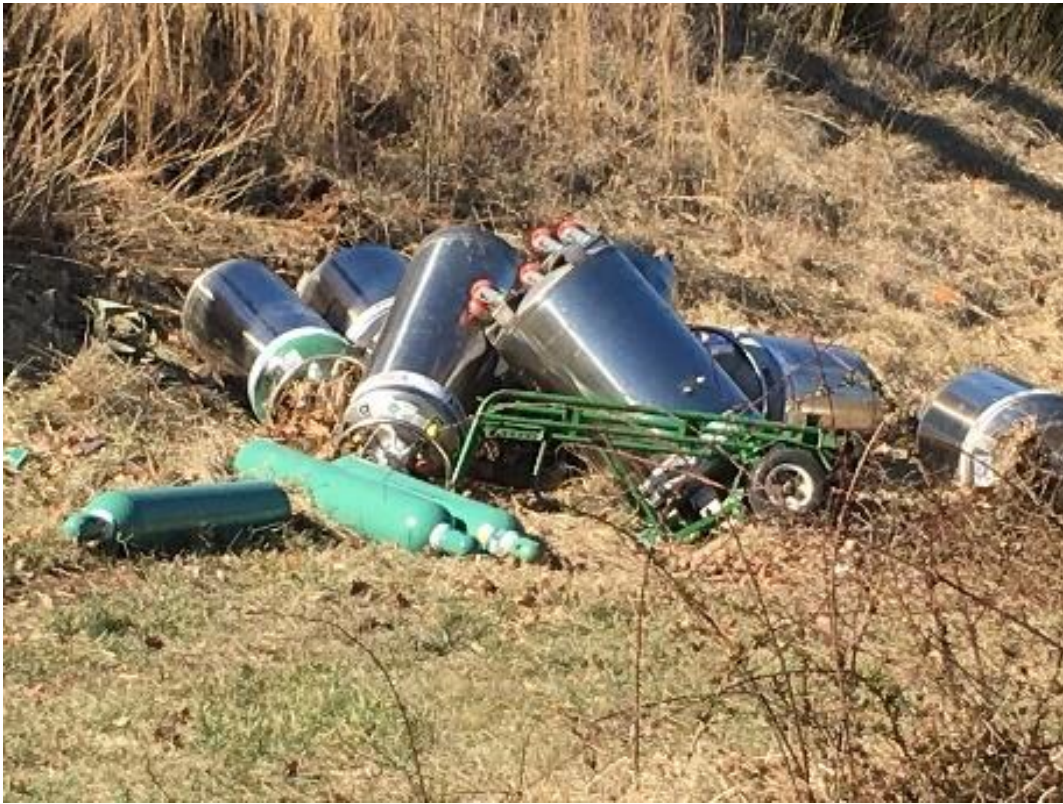
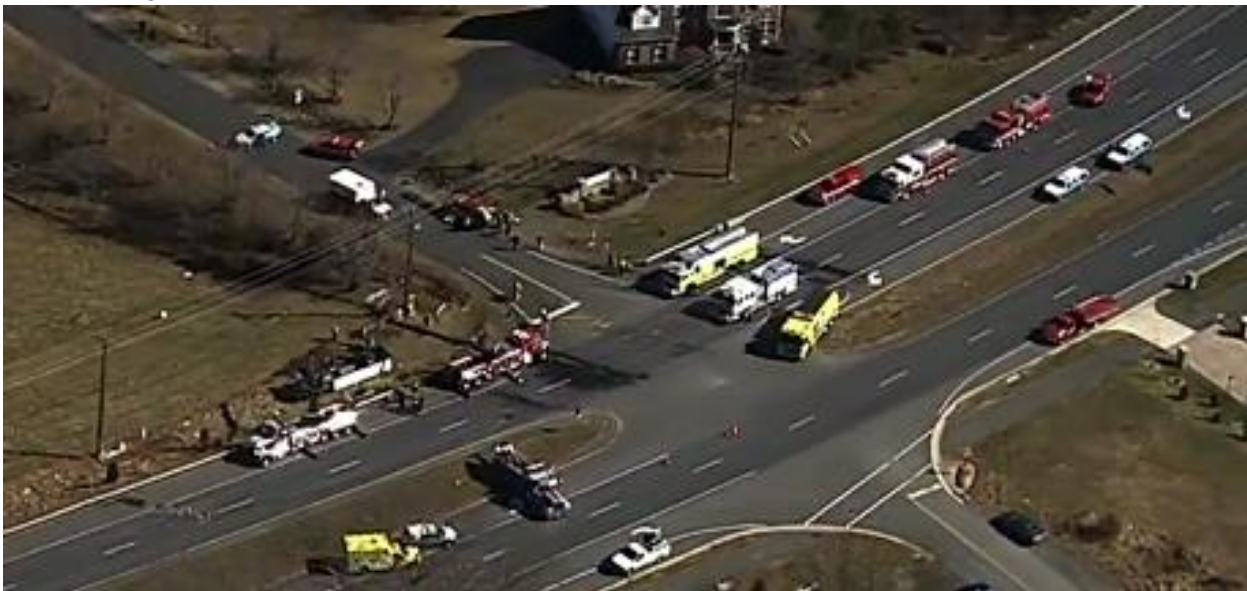
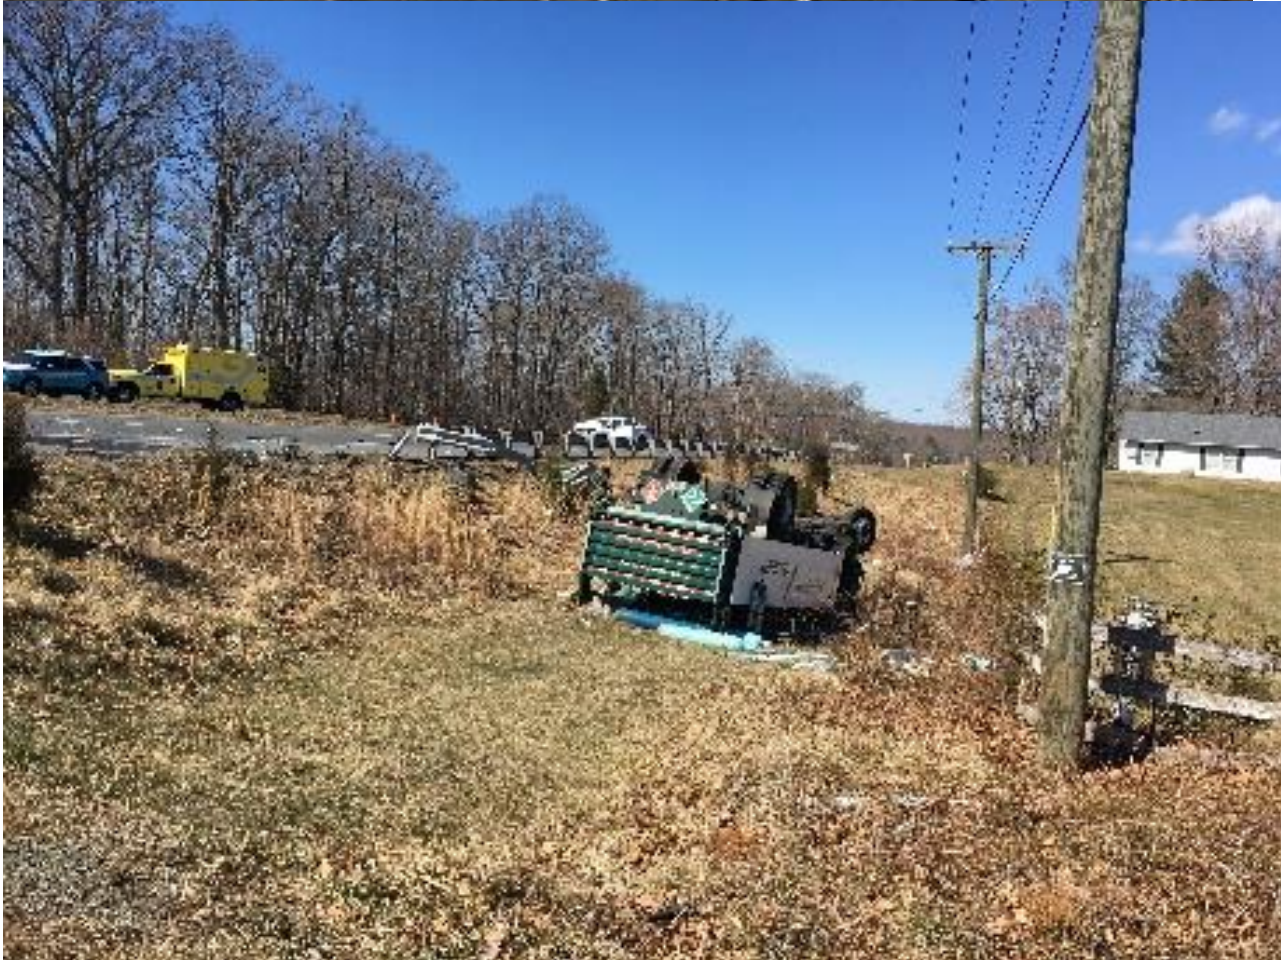
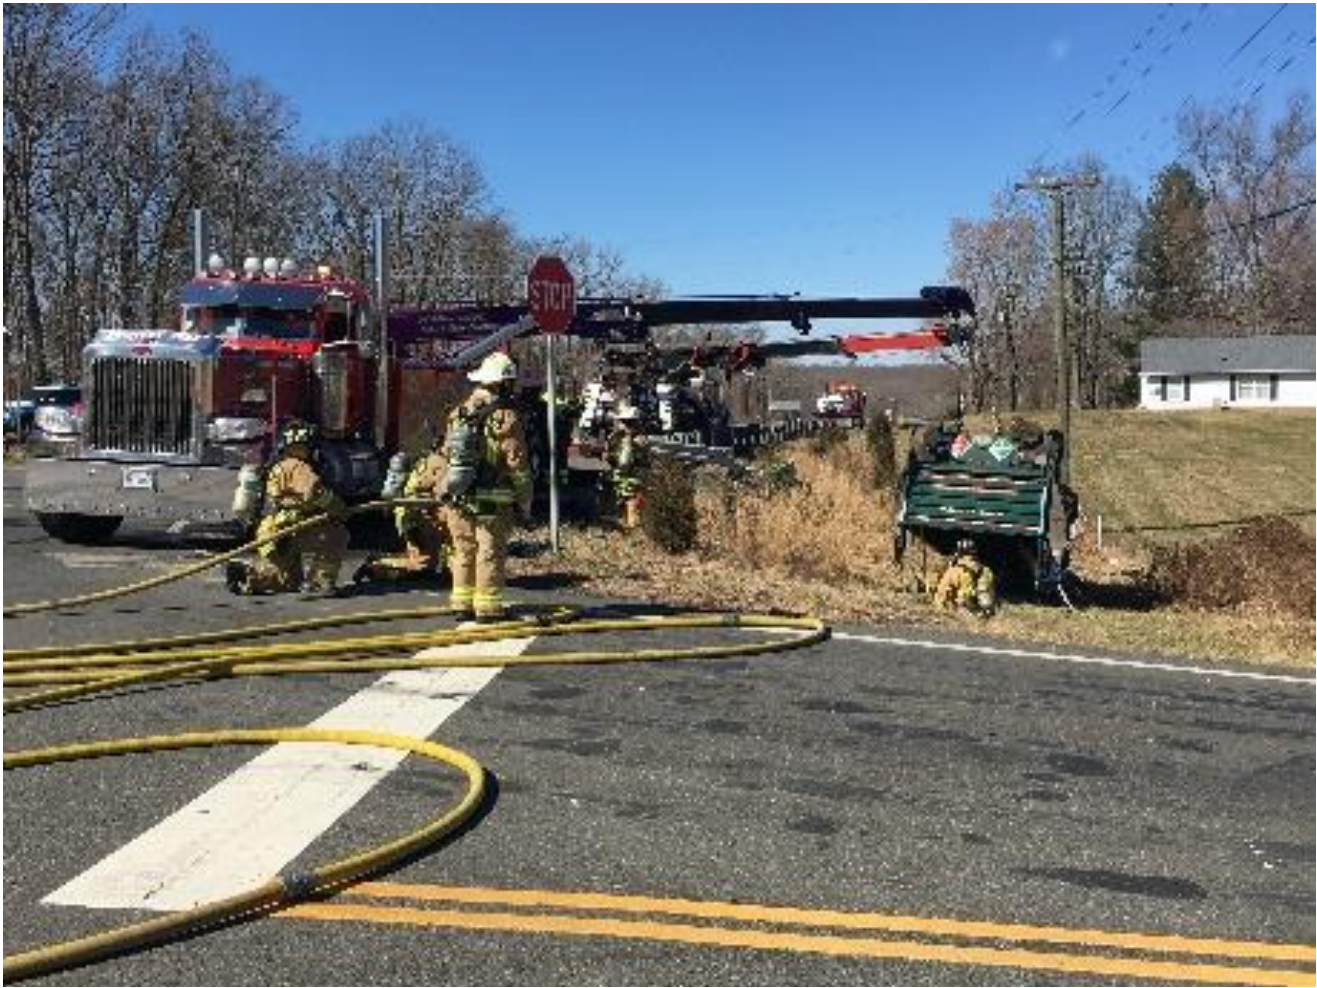
INCIDENT DESCRIPTION	
<p>R506/HM506 arrived on scene to find an overturned mixed use compressed gas cylinder deliver truck. There were multiple cylinders thrown from the truck with additional cylinders still under the truck. You could see one cylinder venting a white gas upon arrival. R506 officer made contact with the driver who was uninjured. He advised that he was carrying Acetylene (3 cylinders), Oxygen and liquid Nitrogen. Once we established an entry team, back-up team and had DECON in place we sent two HMT to investigate what was leaking. With the report of what was on the truck R506's Officer felt comfortable monitoring with a 4 Gas monitor. The entry team was able to retrieve the Bill of Lading. The Bill of Lading confirmed the contents of the truck. All 3 acetylene cylinders were accounted for, none of them were damaged or leaking. The entry team was able to confirm the leak was from a venting Liquid Nitrogen tank. They were able to upright the tank and stop the valve from venting. Once PD was done conducting their investigation we moved all of the loose cylinders to a safe area while continuing atmospheric monitoring. Once all of the loose tanks were moved we coordinated with the tow company to pick the truck up and move it to the road way. The effort was carefully coordinated because we still had inverted liquid nitrogen and liquid oxygen tanks. The tow company was able to move the truck with little issue. We did experience some additional venting from one of the liquid nitrogen tanks but it was not a large enough release to cause a hazard. All of the remaining tanks were up righted and the scene was turned over to PD, VDOT, and the Roberts Oxygen Rep that was on scene. The tow company advised that they were able to handle any liquids that had already leaked or could leak from the truck.</p>

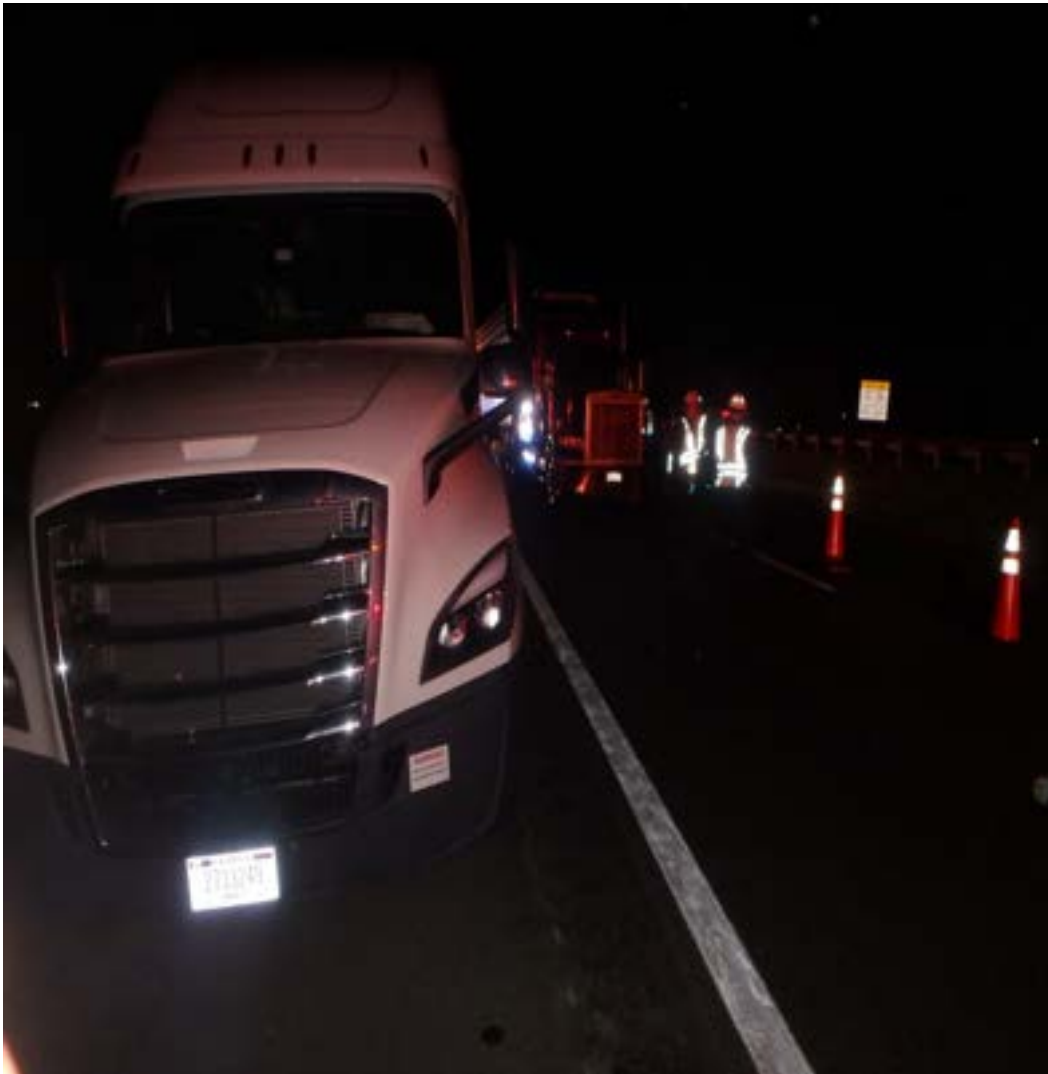
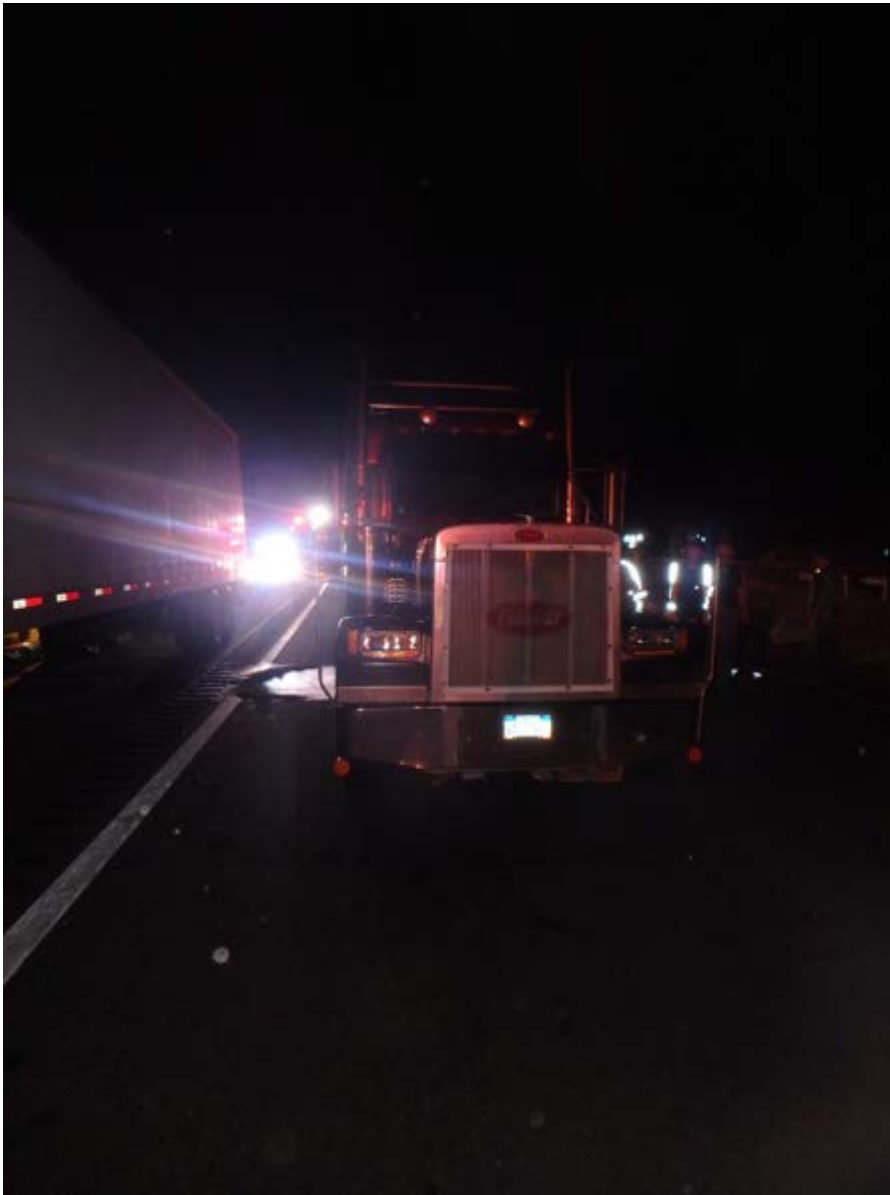
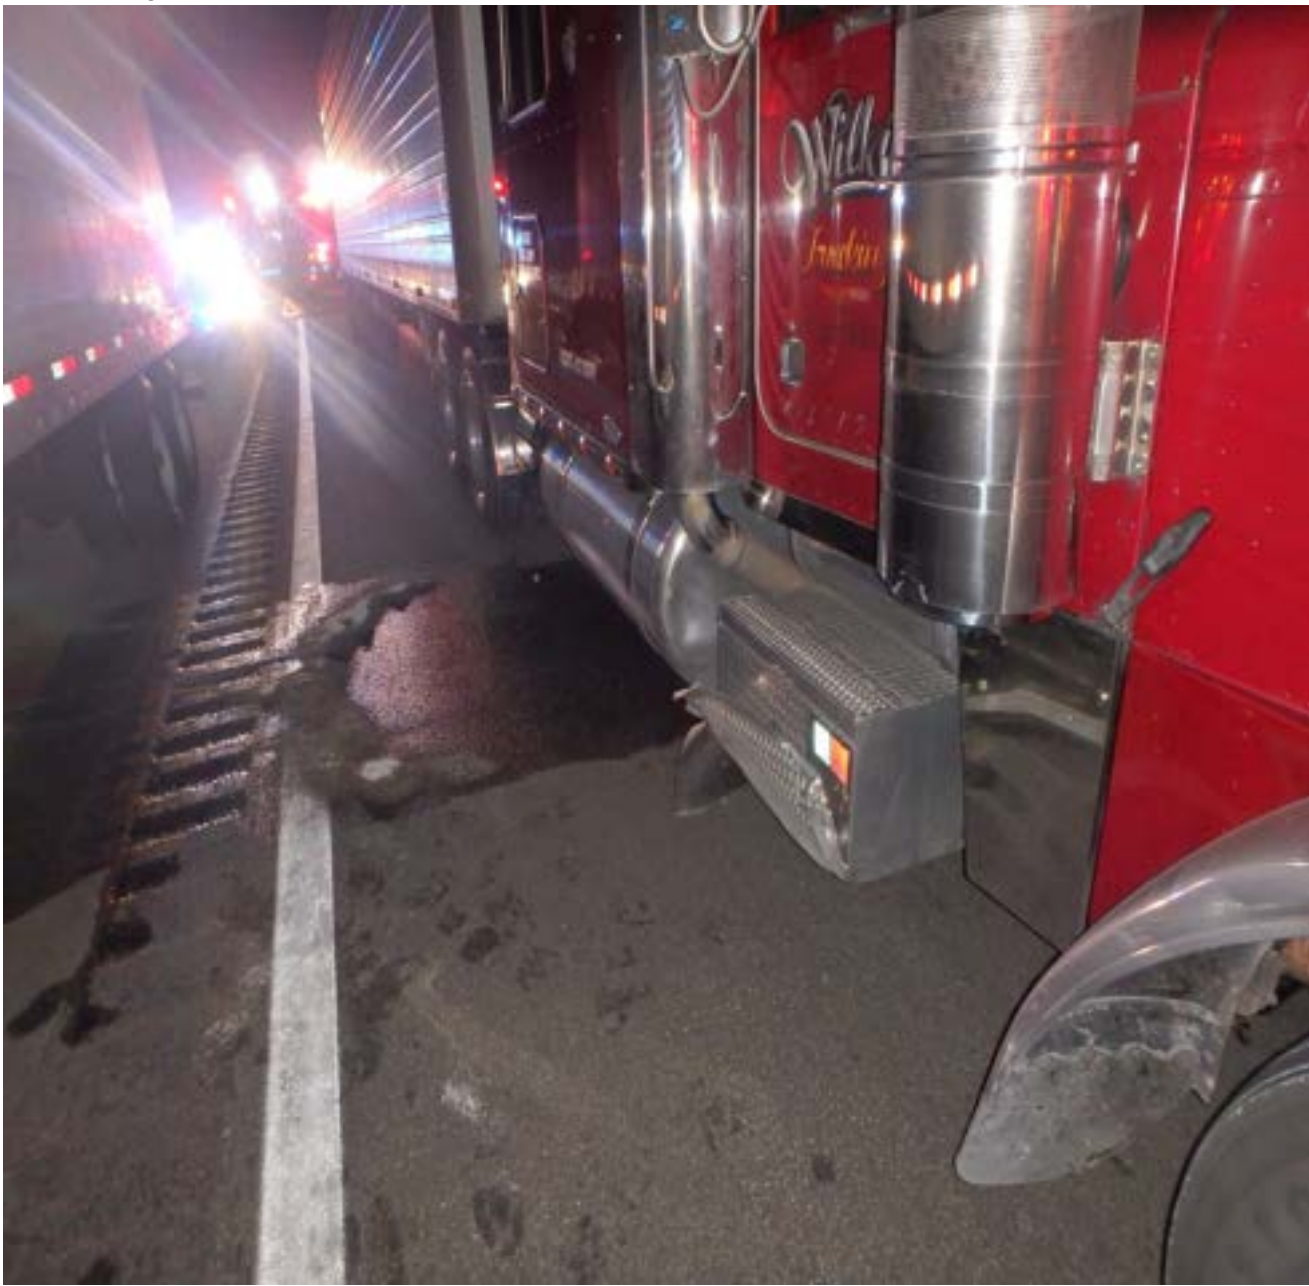
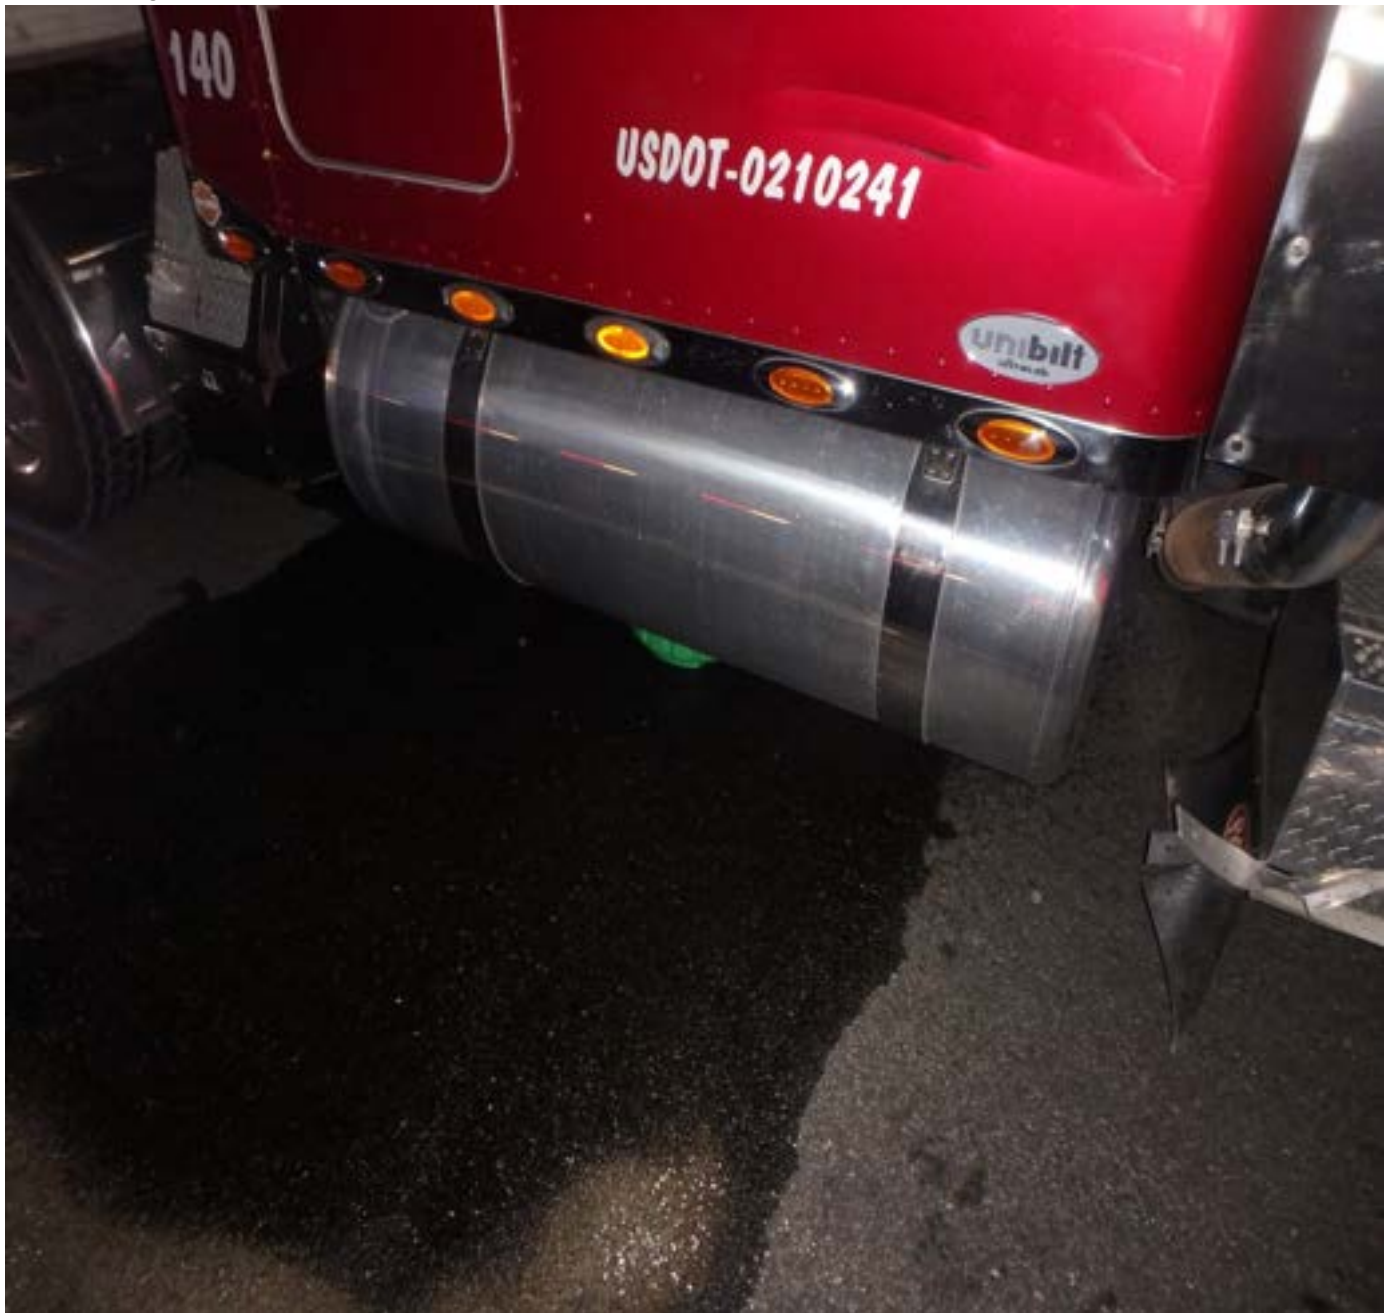
INCIDENT DESCRIPTION	
HM506 was dispatched to an 18-wheeler leaking diesel fuel from the passenger side saddle tank. The saddle tank had been pierced on the bottom left side. The driver had just filled the the saddle tanks with diesel and each tank carried 150 gallons. E524 began defensive operations by placing an oil catch pan under the leak, placing an absorbent dike between the leak and the grass shoulder, and digging a 24' ditch in the grass. Lt. Reader plugged the saddle tank with a wooden plug. The driver's side saddle tank was shut off so that no further fuel was transferred to the leaking tank. There was no further hazard. Driver was provided an LEPC form and chose Atlas to perform the clean up.	
RESPONSIBLE PARTY	OTHER PARTY
Name: Riley Thomas Myer	Name: Patricia Rogers
Company: Wilkins Trucking	Company: Wilkins Trucking Supervisor
Address: 1535 Lost River St. Pk. Rd., Moorefield, WV 26836	Address:

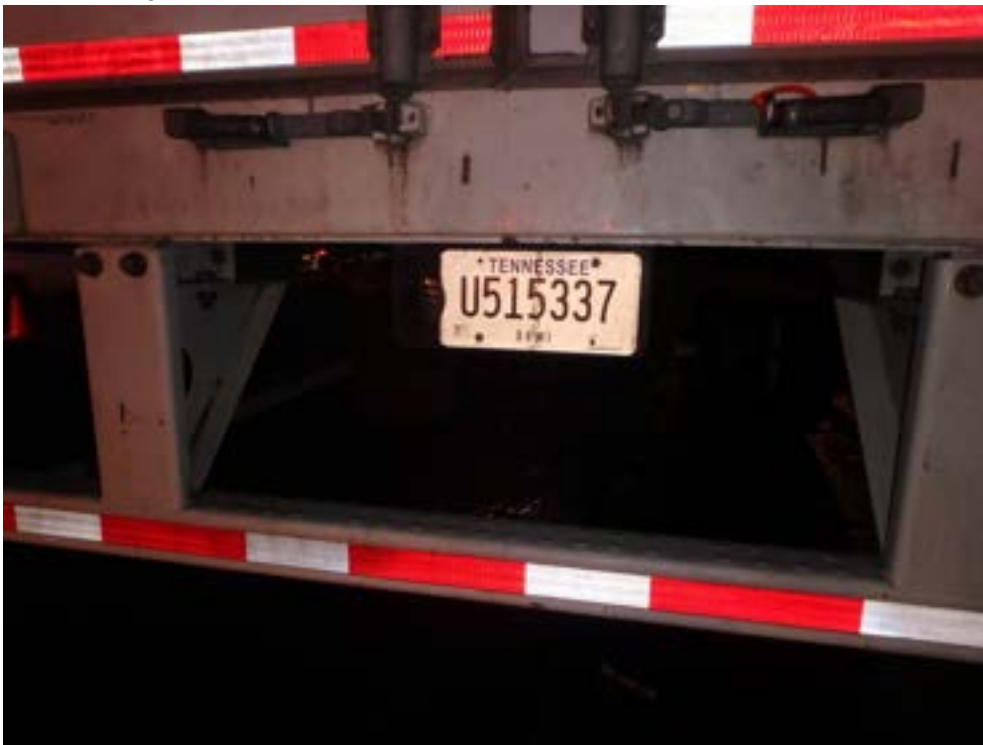
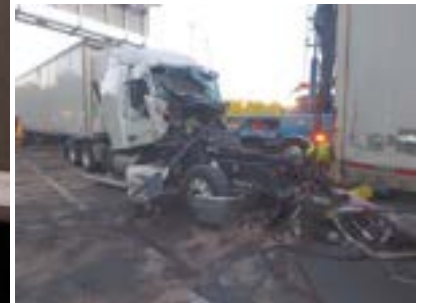
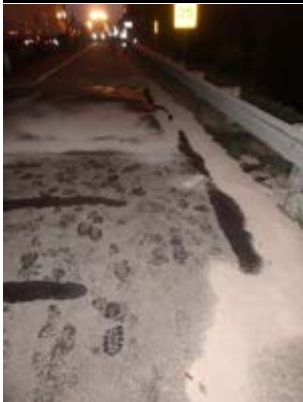
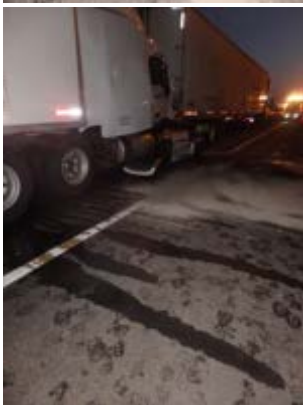
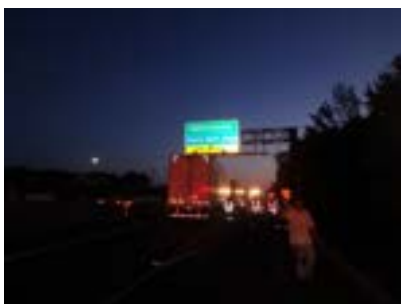
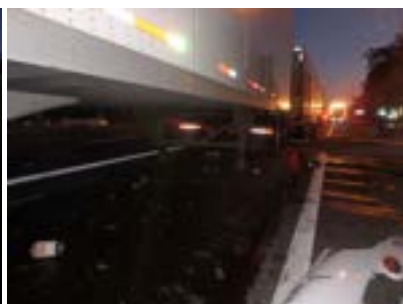
INCIDENT DESCRIPTION	
<p>HM506 was dispatched to an auto accident that got upgraded to a hazmat. Two tractor trailers were involved, one under riding the other. E523 reported that the saddle tanks were leaking and that they were full with approximately 400 gallons of fuel, according to the driver. E523 had taken defensive measures by placing absorbent around the truck and the edge of the road. E523's crew was unable to access the fuel shut off due to the truck being stuck underneath the trailer. Upon arrival at the scene HM506's crew met up with T523's officer and E523's officer, they were able to confirm that only one of the tanks was leaking on the driver side. There was a wet spot on the road that appeared to be a mixture of engine, transmission oil and diesel fuel. Most the spill was from the engine oil and transmission oil due to the damage of the drive train. A slow leak was noted from the driver's side tank and a pop up pool was placed to capture the fuel. The fuel shut off switch was located on the driver's side tank and was also shut off. There was a creek on the side of the road, but was not affected by the spill. A small amount of product got into the drainage rock on the edge of the interstate but no more than 8-10 ft. away, and far away from any waterways. HMO502 spoke with the driver and representatives from the trucking company and they got a cleanup contractor (HEPACO) on the way. Redman's towing company separated the two trucks and HM506's crew checked for any additional hazards, none were found. Scene turned over to Police.</p>
