Annual Stormwater Management Report
VSMP Permit No. 0088595 – FY 2020

Submitted by:
Prince William County
Department of Public Works

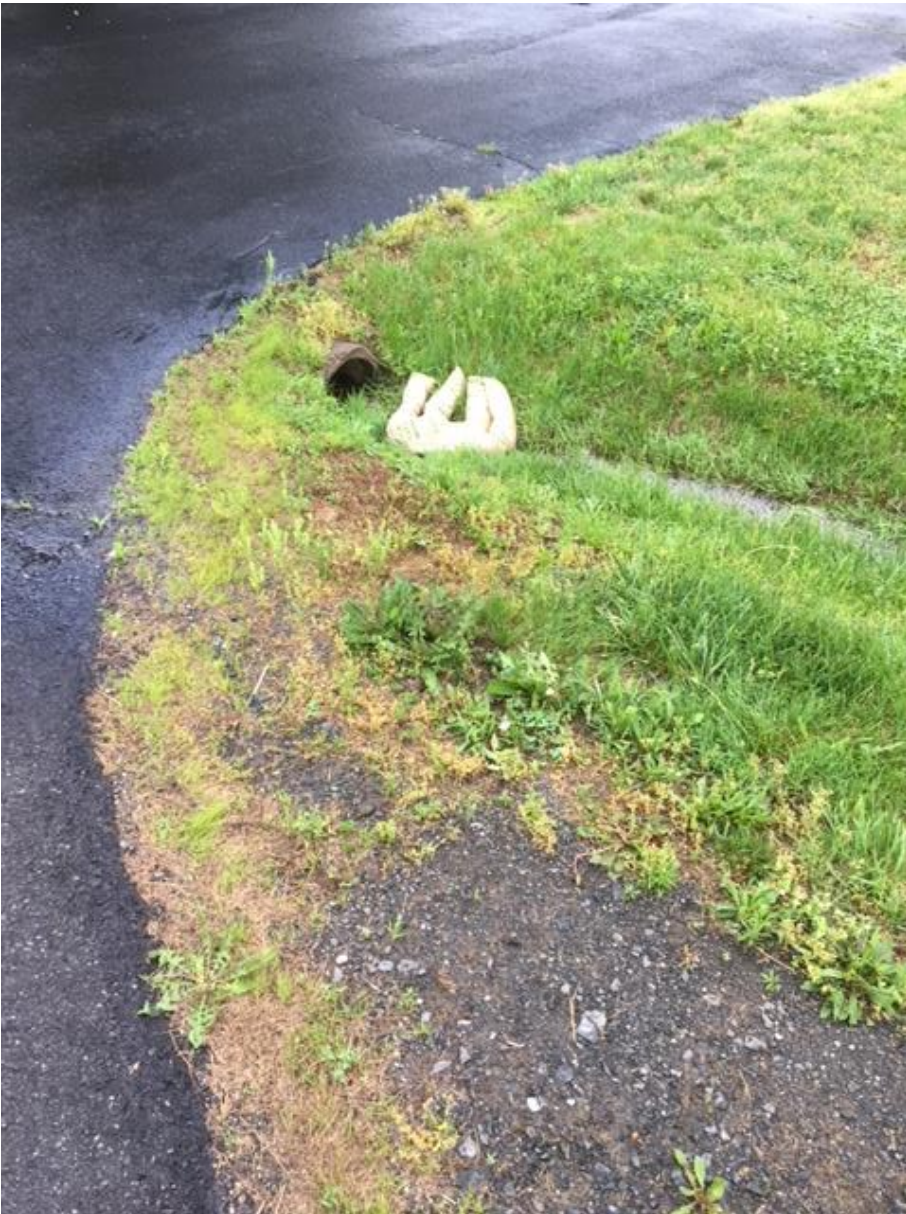
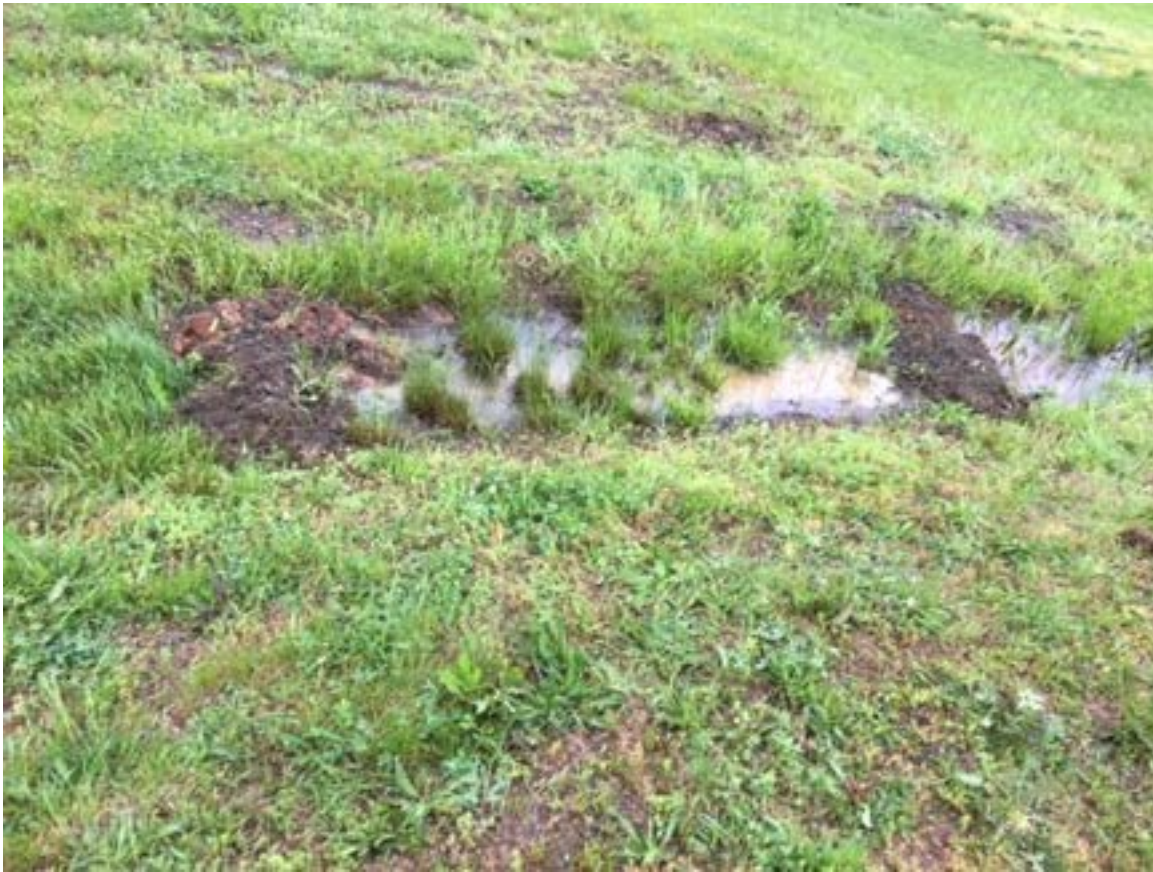
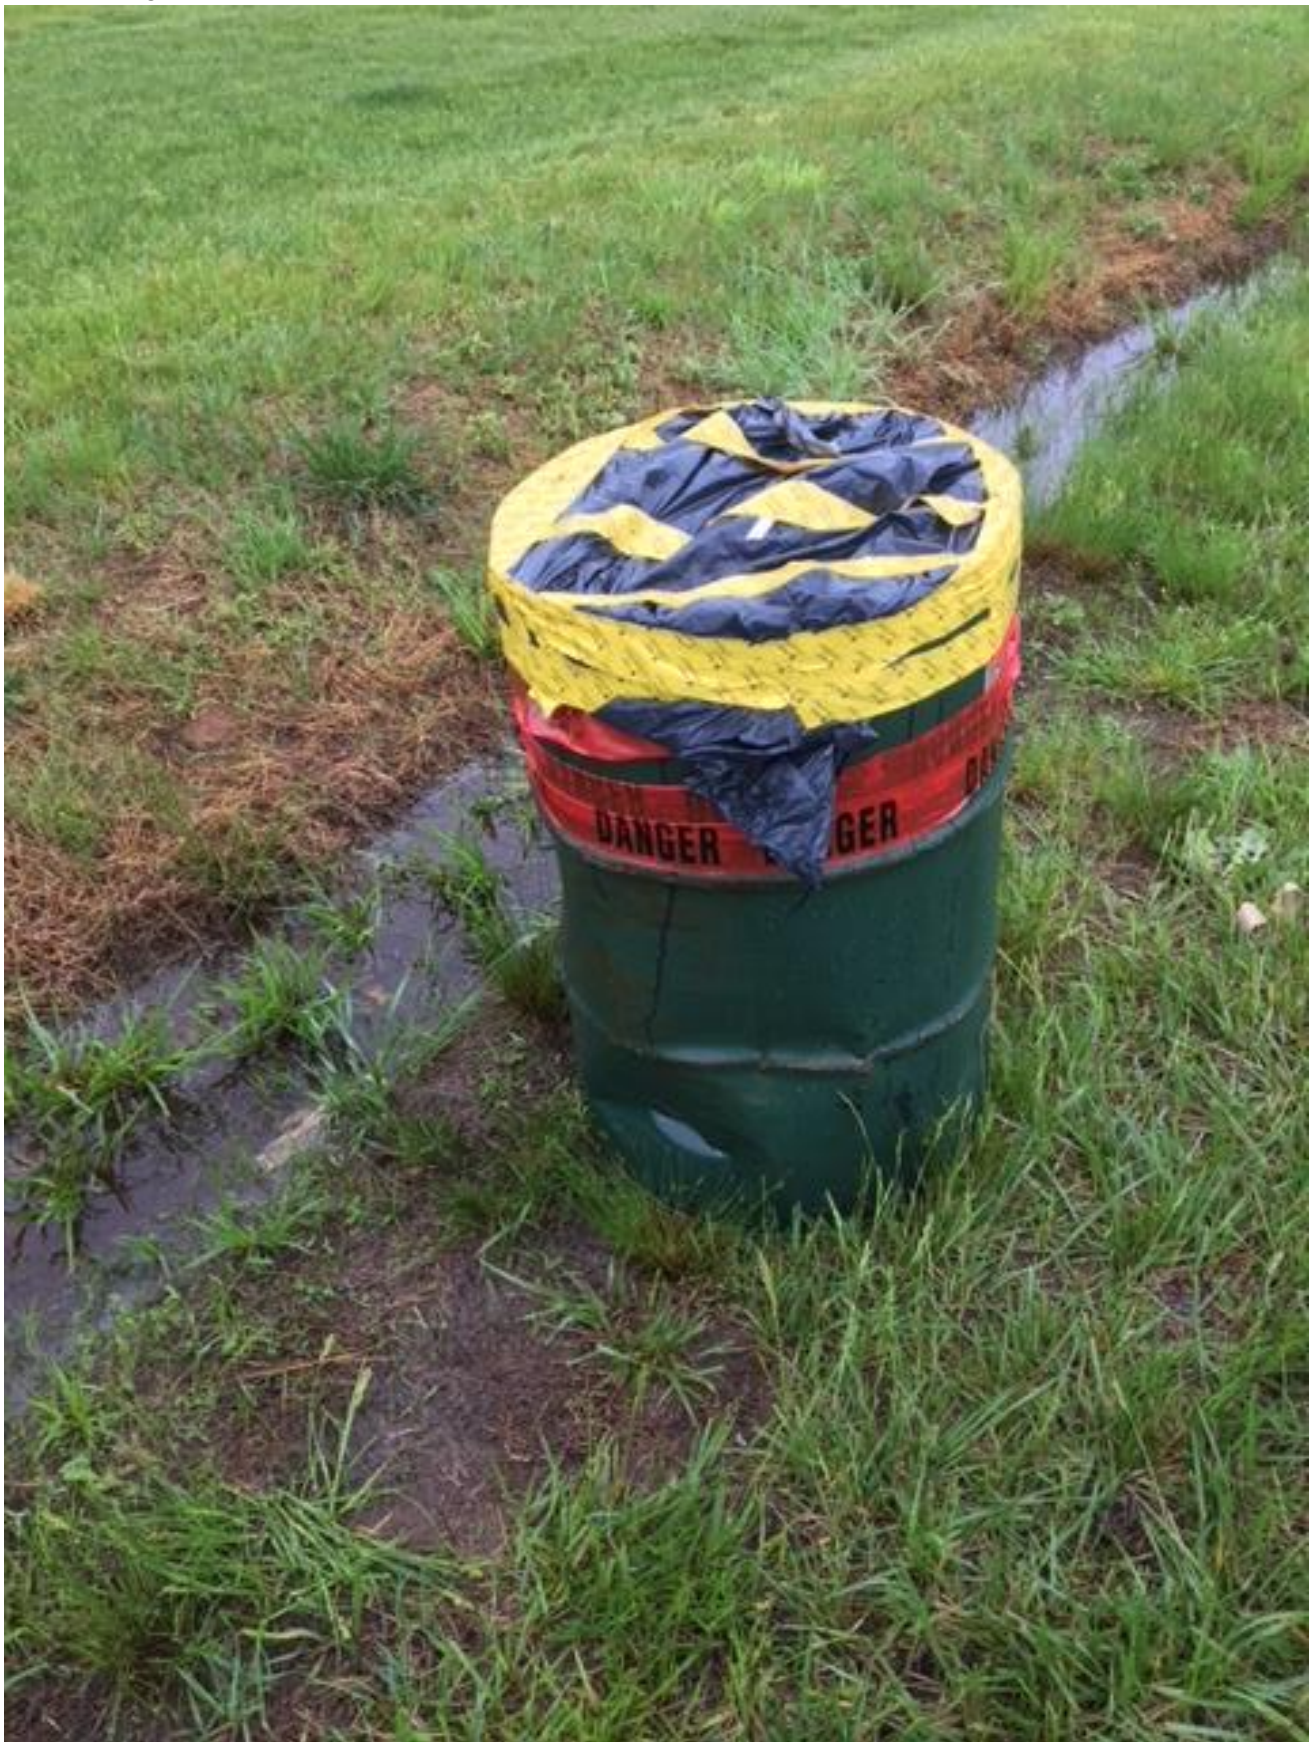
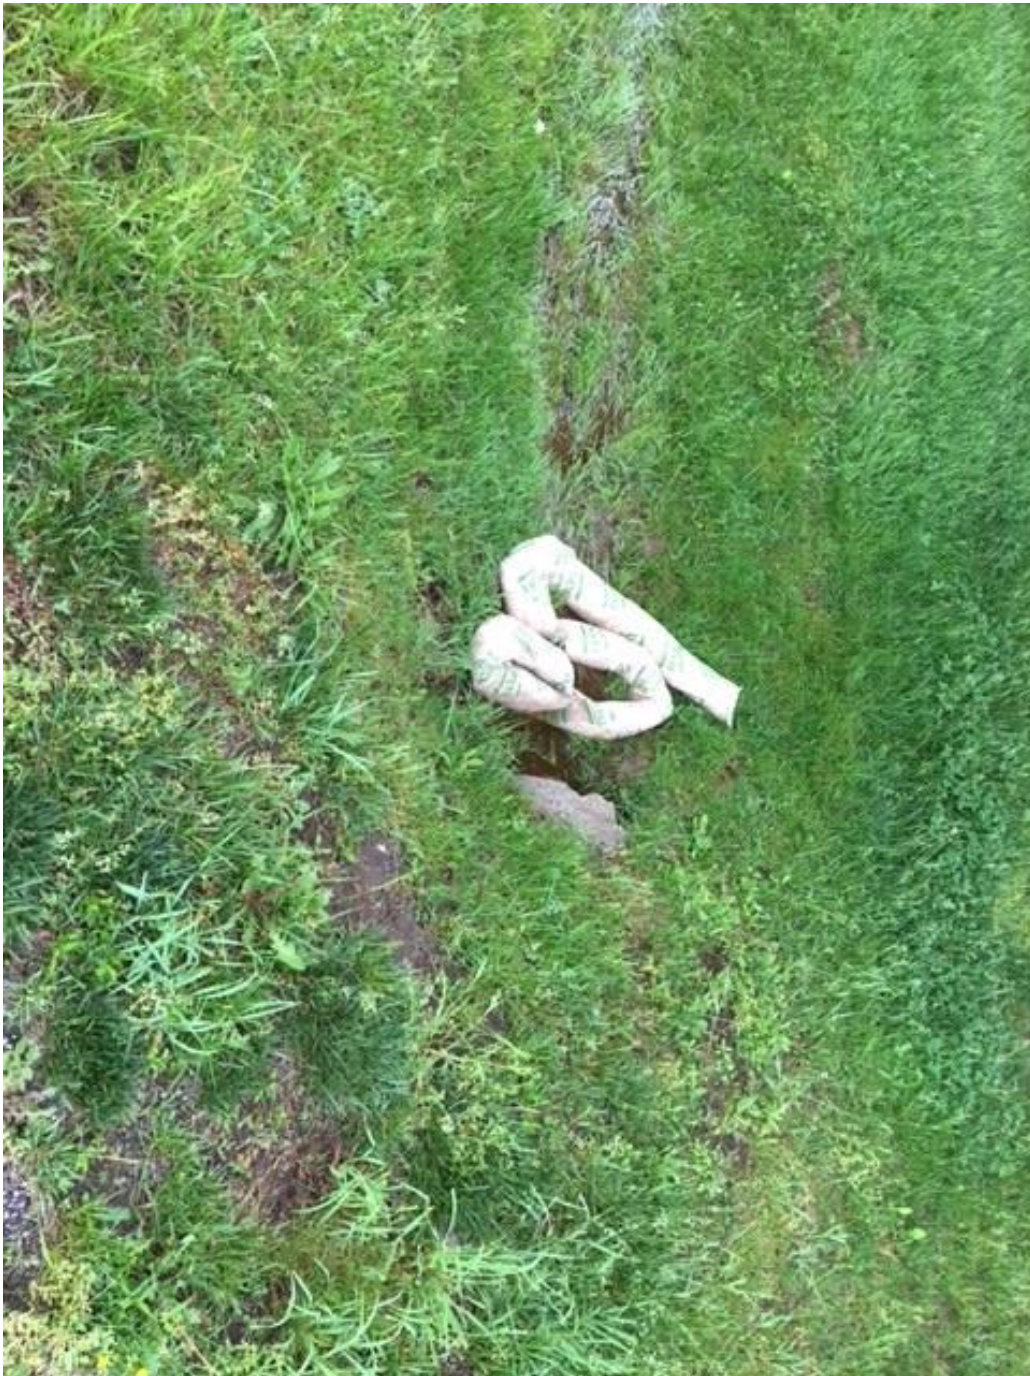
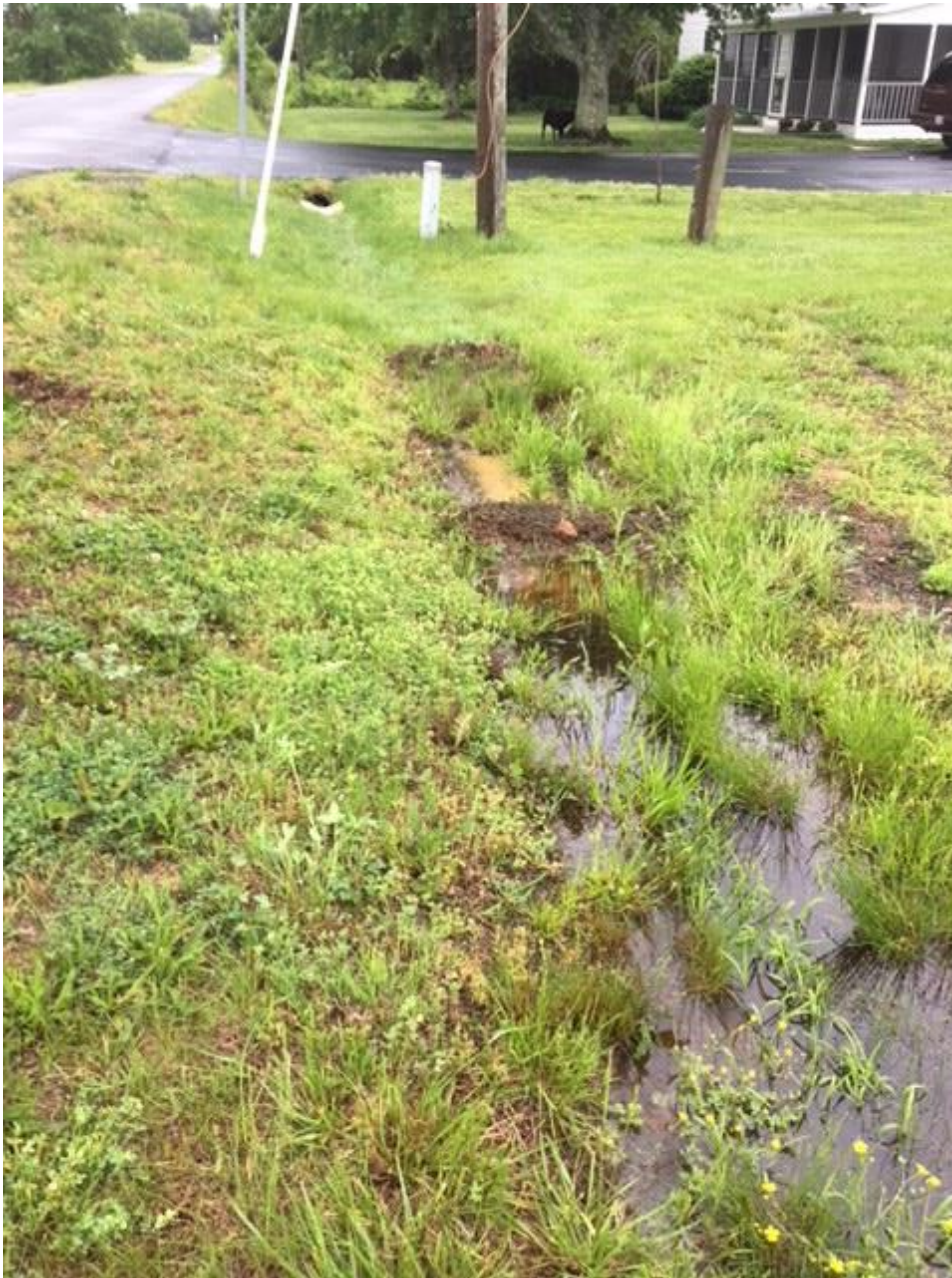
INCIDENT DESCRIPTION	
E505 responded to reports of a 55-gallon drum which fell off the backup of a pickup truck. Caller advised that a white pickup, with the tail gate down, had multiple drums in the bed of their truck. With one falling out. E505 arrived on scene to find that there was a sheen on the road from the drum. Upon inspection of the drum there was discovered multiple punctures in it. The drum was placed upright by E505 which stopped the leak. The drum was inspected for any form of identifying marks and was unsuccessful. E505 upgraded to a HAZMAT call. HM506 and R506 responded to the incident. Once HM506 arrived on scene, the 55-drum was inspected by HM506 and R506 personnel. No active leak detected. E505 dammed the ditch where the drum leaked into and HM506 placed booms to prevent the spilled liquid from draining further. Plastic was placed and secured on the drum to prevent rain from getting into the drum. VDOT was also notified. After which all units on scene went in service.

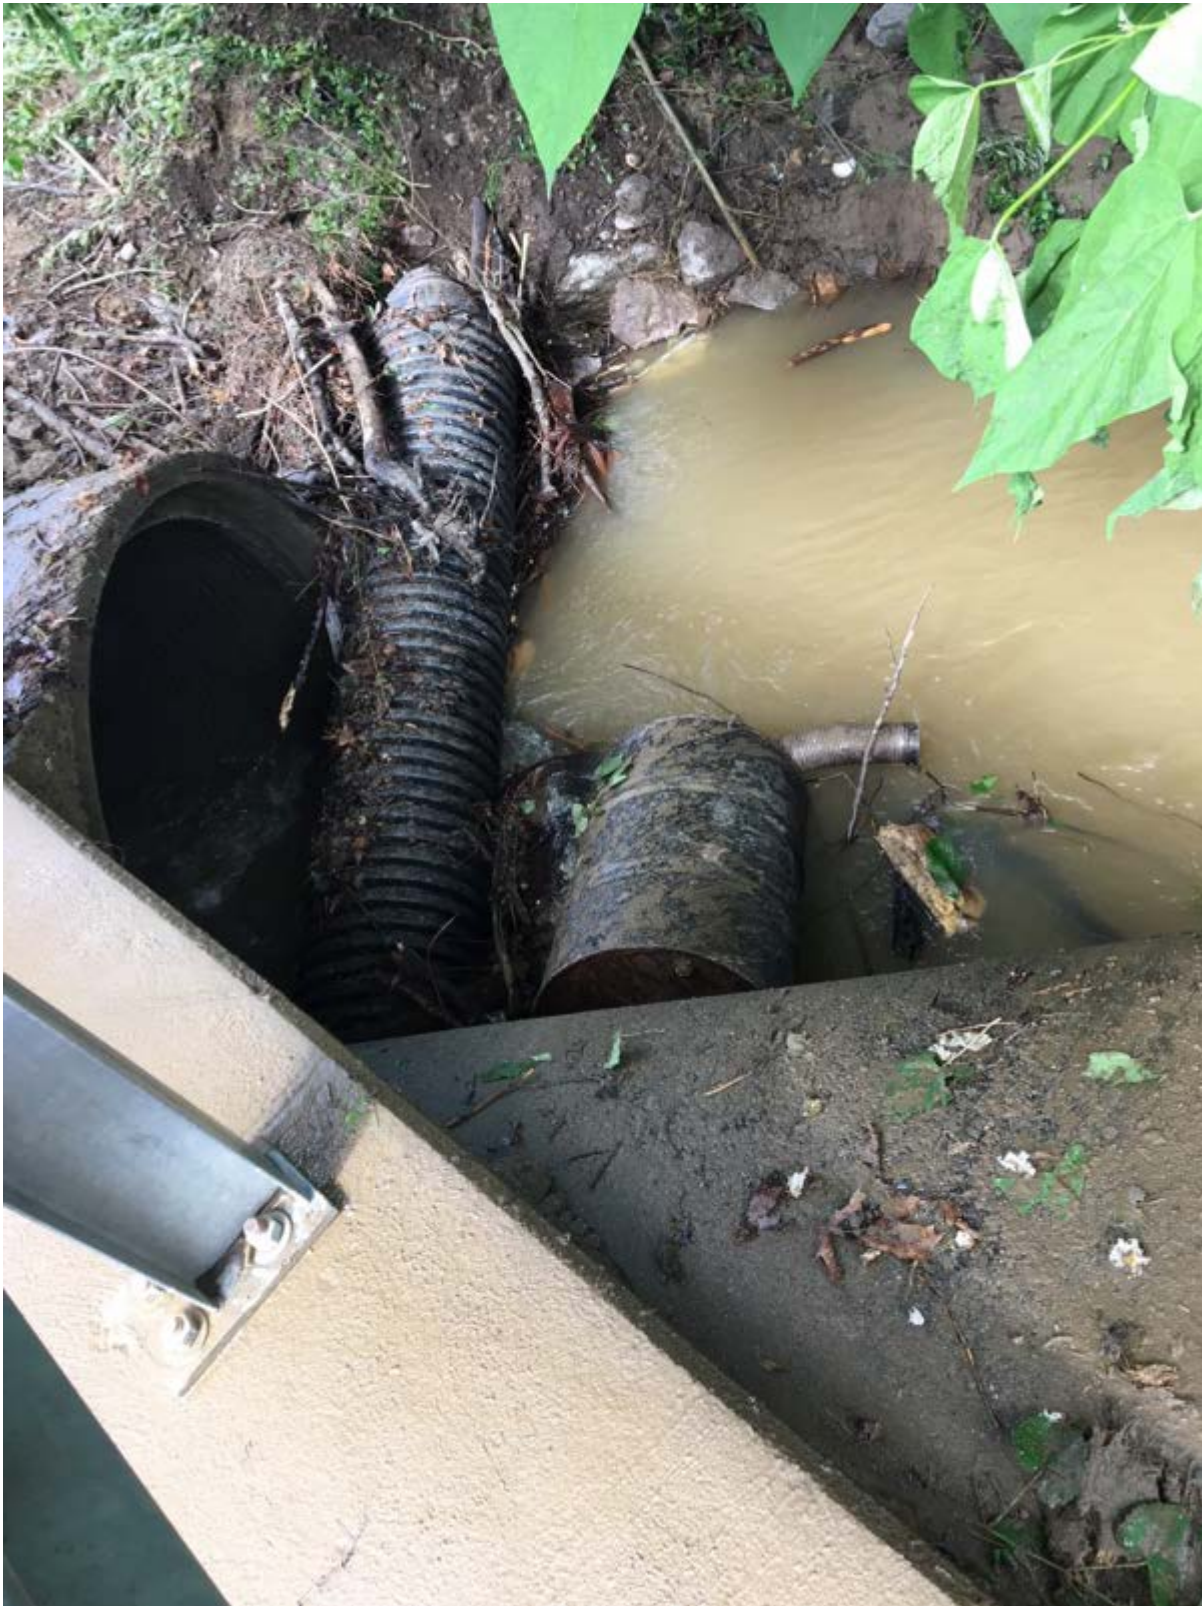
INCIDENT DESCRIPTION	
<p>Outside Gas Leak - Storm Drain Construction crew severed a 4 inch gas main on Old Bridge Road near Antietam Rd. Release of gas was forced into storm drain system, resulting in % of LEL readings in numerous locations. Engine Crews initial reported 98% of LEL at the top of the trench, 38% of LEL was reported at man hole cover near a row of town houses and additional increased % of LEL was observed at other storm drains in the area. Suppression and specialty units checked numerous structures, evacuated a number of the town homes and also conducted assessment of the Middle School across the street. BC Artone requested HAZMAT support to insure that all aspects of the release were fully assessed. HMO501 responded and provided consultation. Washington Gas responded and secured the leak. Additional readings were taken given time for gas to dissipate. Units were released once normal readings returned at all locations.</p>

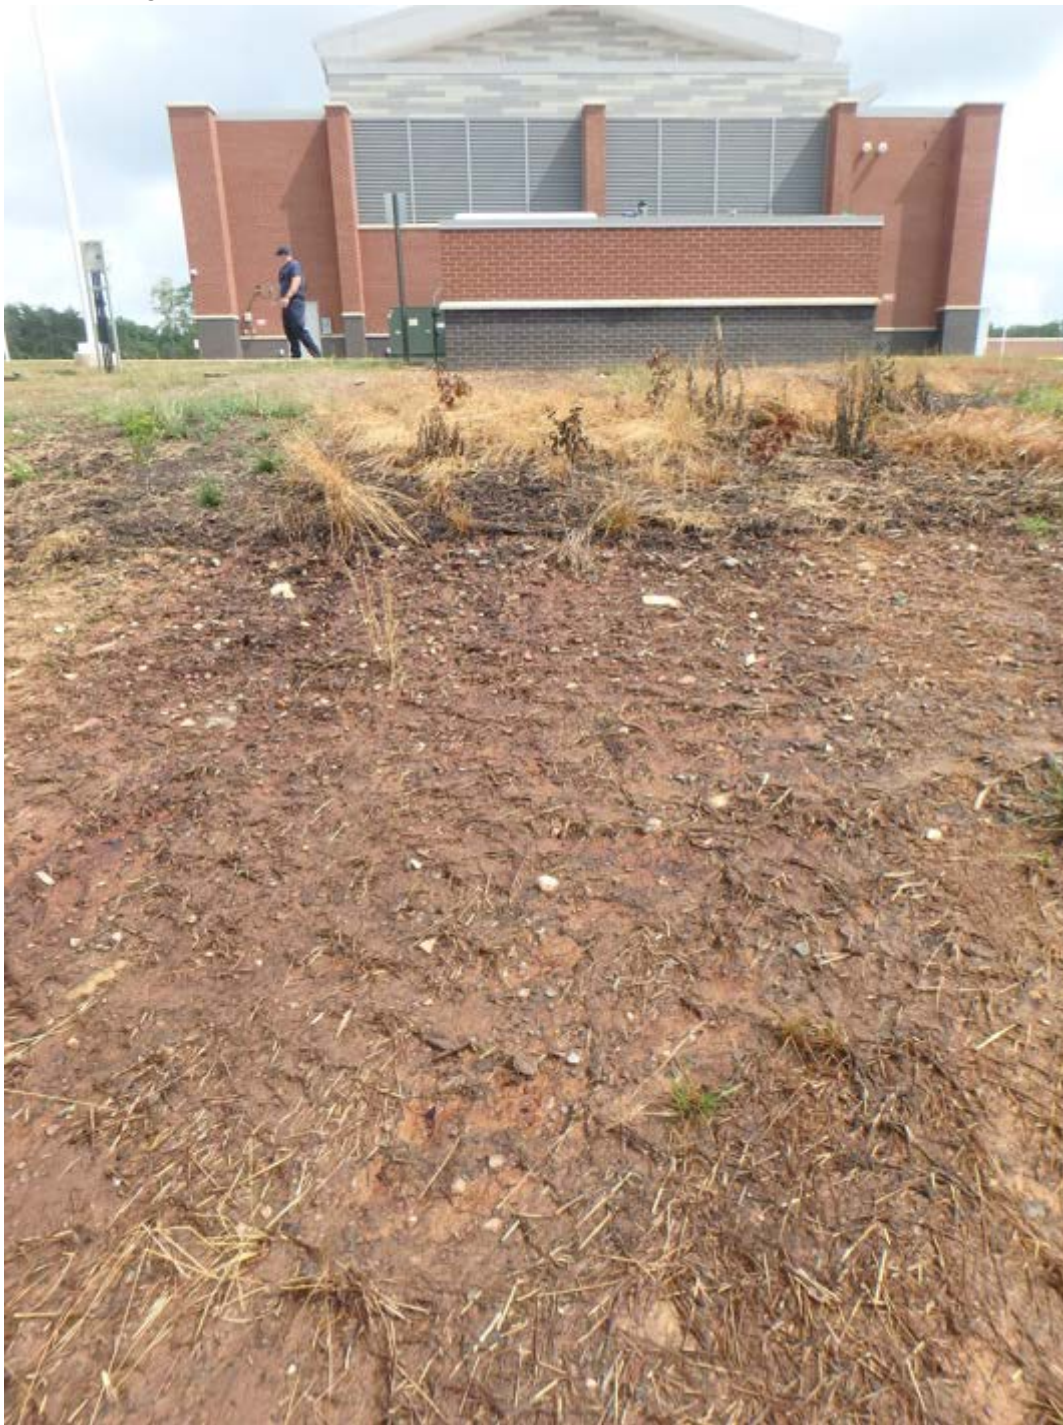
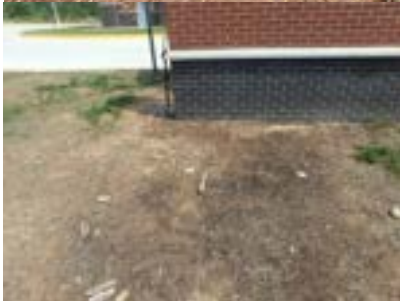
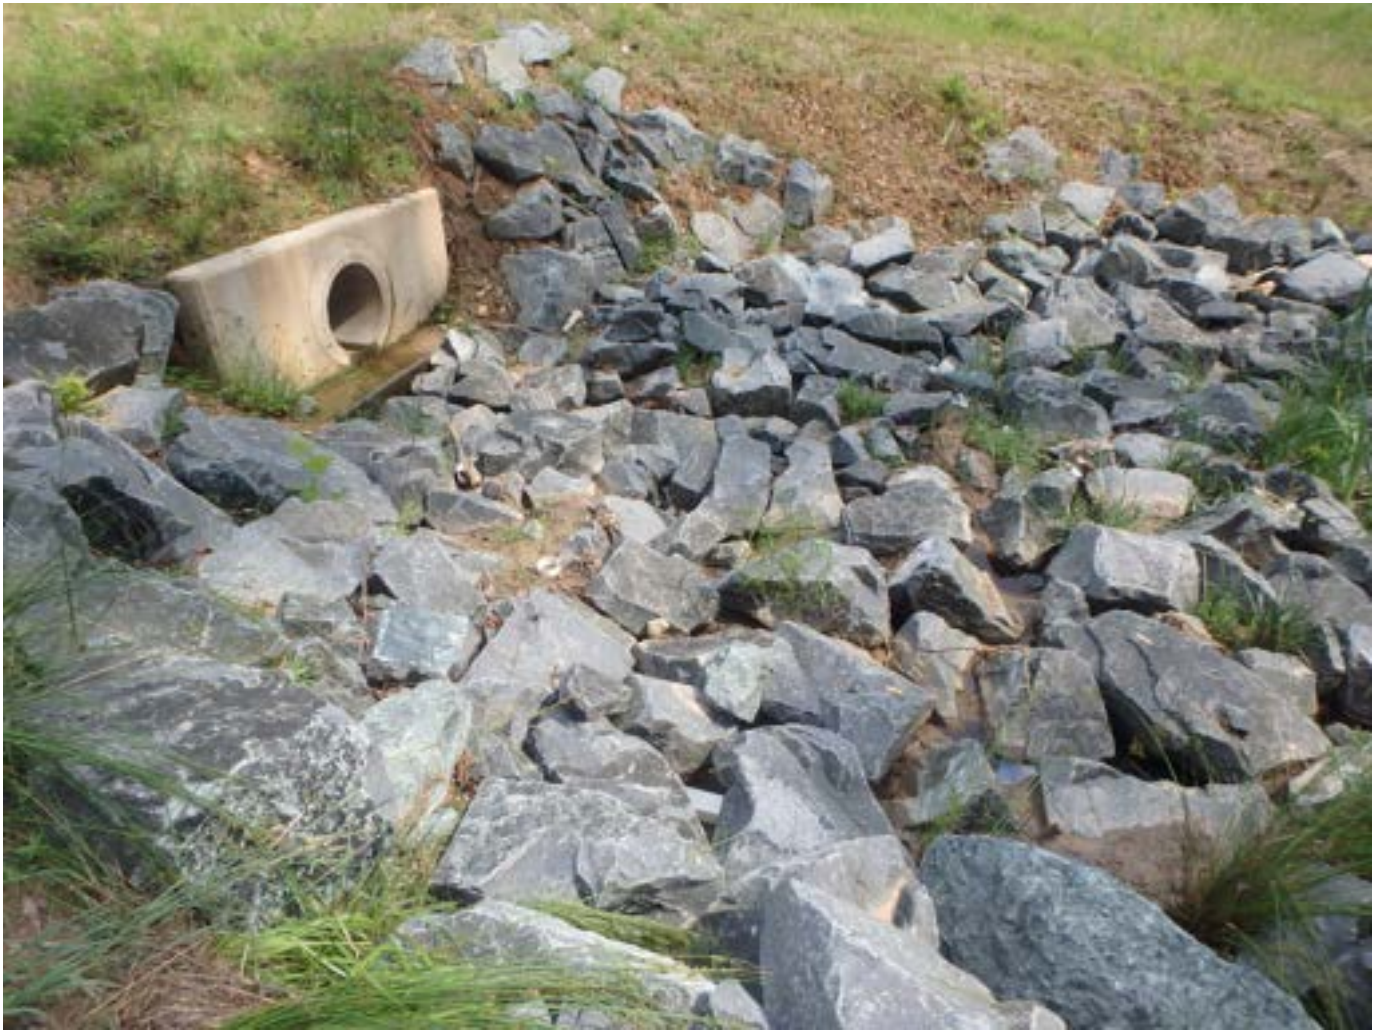
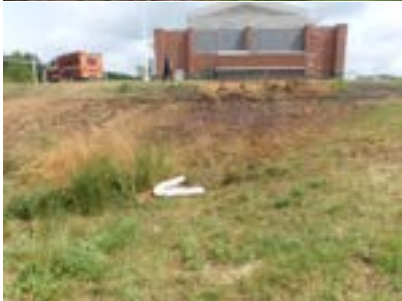
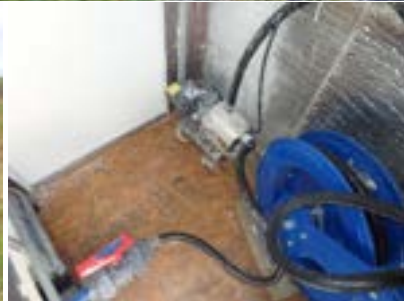
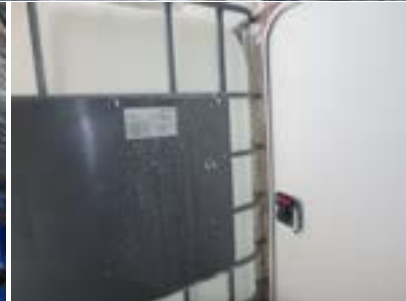
INCIDENT DESCRIPTION
<p>HM506 and HS516 responded to the dispatched address for the report of a diesel exhaust fluid (DEF) spill behind Fire Station 26. Upon arrival we were greeted by FS 26 personnel, and directed to the areas inside and behind the housing for their DEF pump system. Inside the pump system housing, we noted a large container/tote that appeared to be capable of storing approximately 250 gallons of fluid. There was no DEF remaining inside the container. E526 advised that the container was roughly 3/4 full when they checked it about 2 weeks ago. We estimated that approximately 200 gallons of DEF leaked out of the container.</p> <p>Inspection of the pump system housing did not reveal any obvious cracks or damage, but the inside was coated with crystalized/dried DEF.</p> <p>Due to recent rainfall, there did not appear to be any significant amount of DEF remaining above ground in the affected area. However, there was damage to vegetation and soil which clearly marked the path of the fluid, which we followed down to both of the retention ditches behind FS 26. PH paper was used in several locations in the soil and retention ditches but did not register a positive hit for an acid or base (DEF has a PH of 9.5).</p> <p>HMO 502 was notified of our findings and actions while on scene, and Lt. Loftus (E526 officer) was advised to complete a Spill Report Form and submit it to Risk Management.</p>

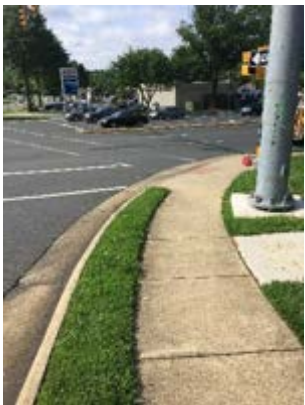
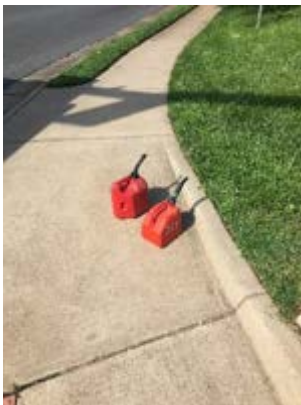
INCIDENT DESCRIPTION	
<p>E-513B was dispatched for a "hazard" at the intersection of Minnieville Rd. and Dale Blvd. They arrived to find two, 2 gallon gas cans sitting on the side walk near the intersection. There was a stain from a product on the roadway which did not enter any storm drains or sewers. There was no need to place absorbent on roadway stain as product had dried already. It was apparent that the two gas cans had fallen off a vehicle and struck the roadway only one can had leaked its contents which was determined to be gasoline and was under 2 gallons in amount. E-513B notified Duty Hazmat Tech for phone consult. Duty Hazmat Tech informed E-513B officer that VDOT has responsibility for retrieval of both gas cans. VDOT was notified through UFRO and arrived on scene to collect both gas cans. E-513B cleared the scene. Duty Hazmat Tech. notified Va-EOC as a courtesy.</p>	
RESPONSIBLE PARTY	OTHER PARTY

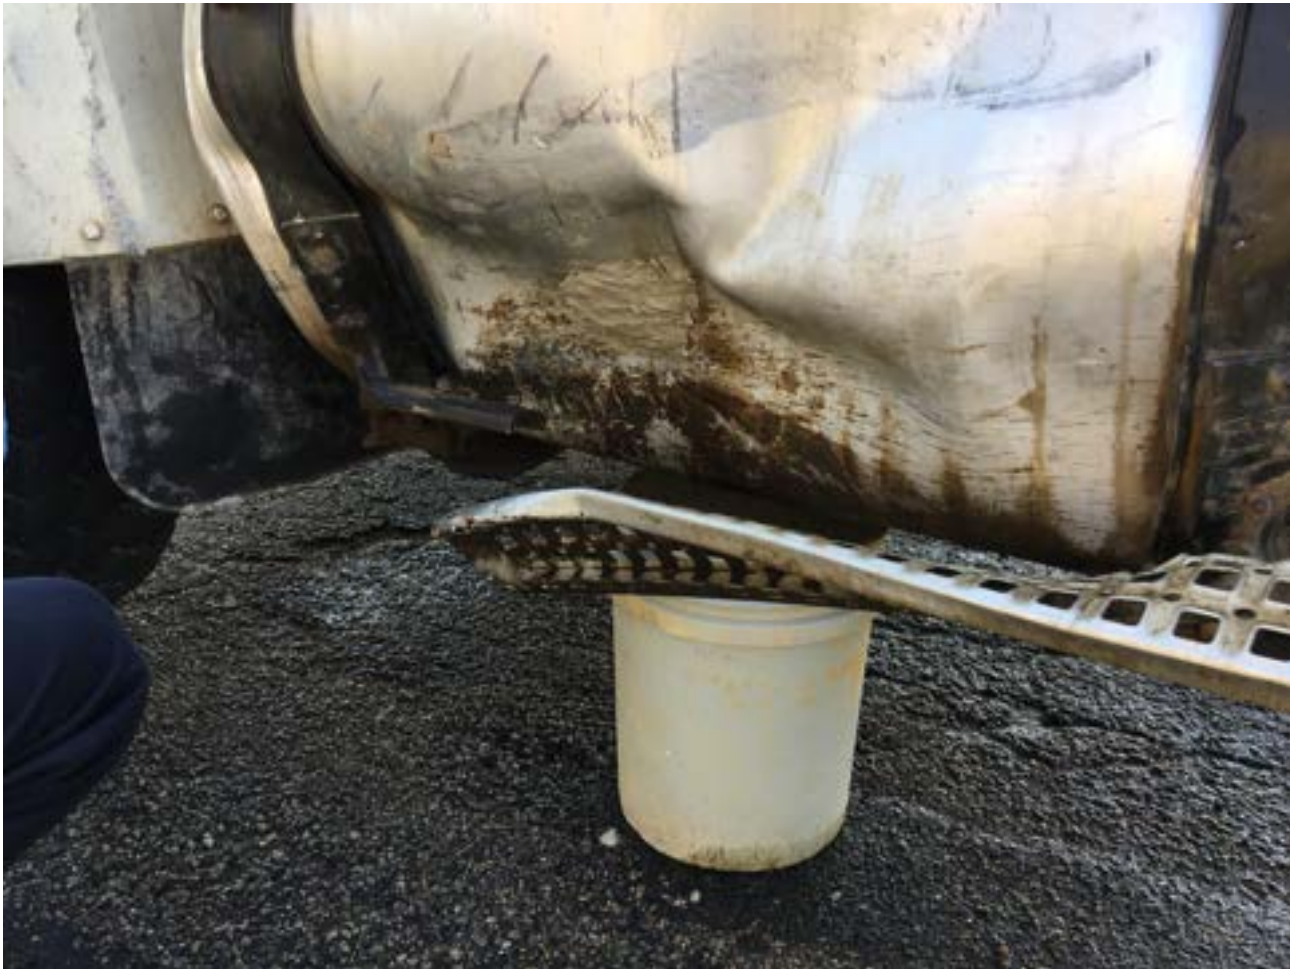
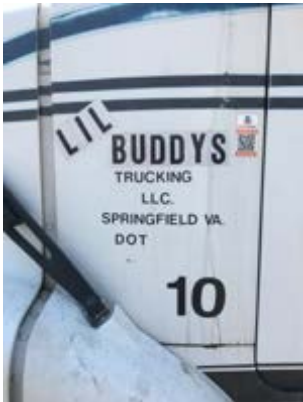
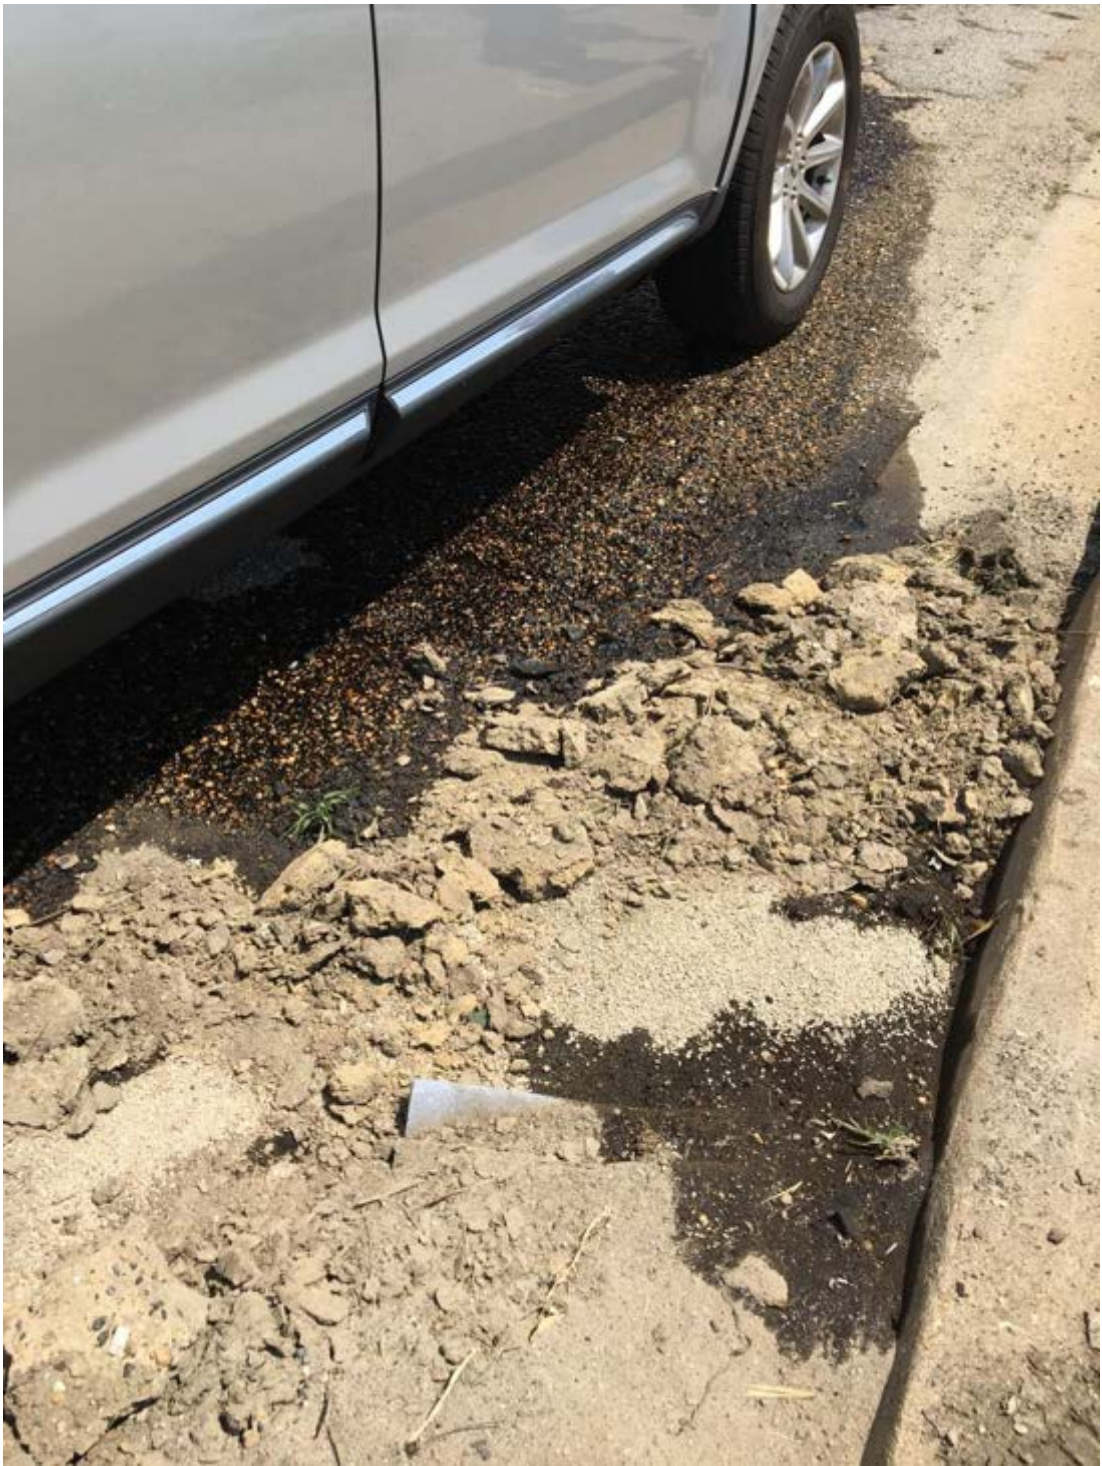
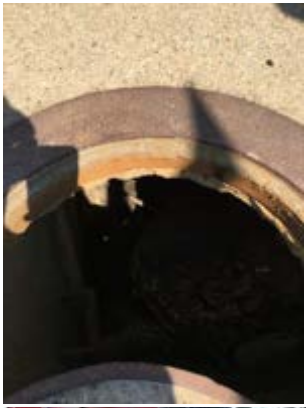
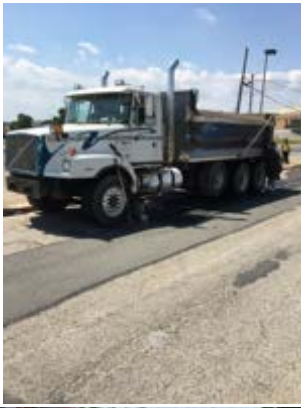
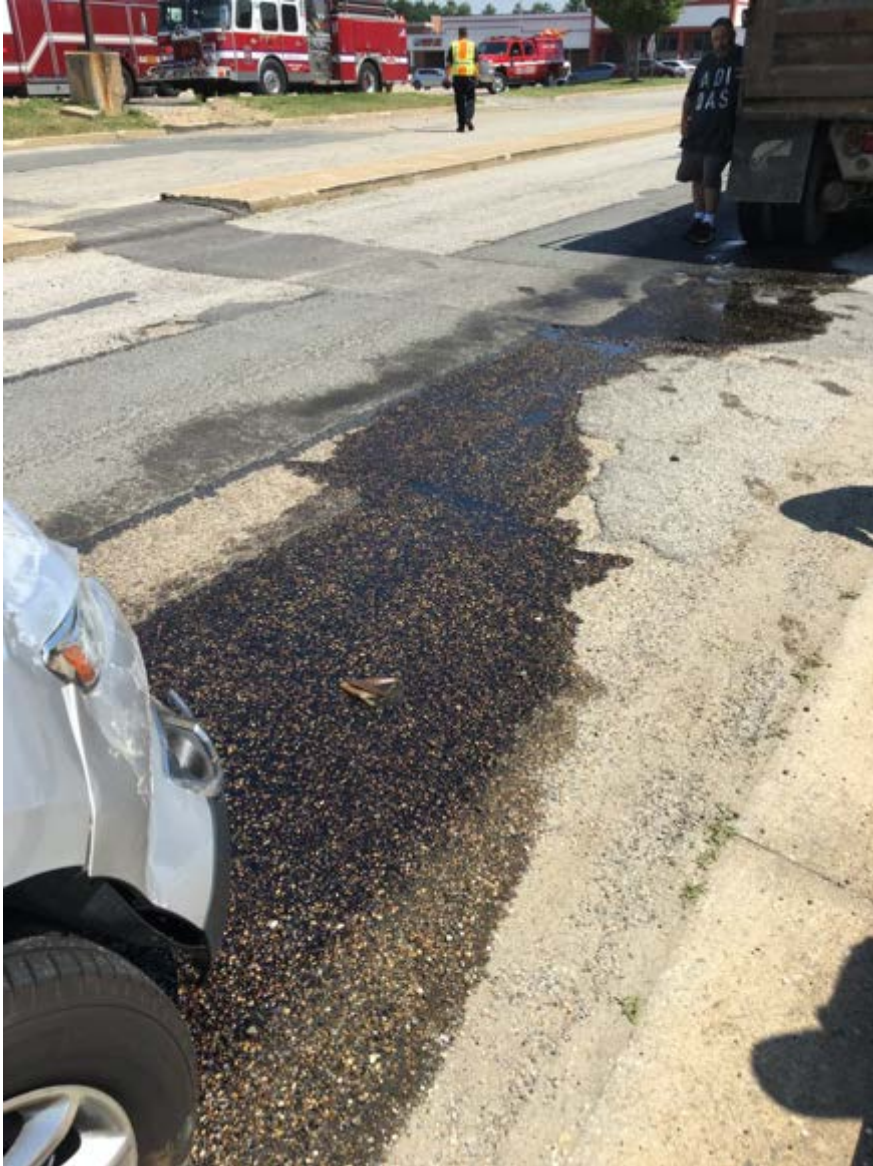
INCIDENT DESCRIPTION	
<p>Received a phone consult from Engine 502 who was on scene of two vehicles that were involved in a collision. A car had run a red light and T-boned a dump truck which punctured the saddle tank. Both vehicles were moved into Gordon Plaza, prior to any Fire Department personnel. Diesel fuel had leaked out of the tank, according to the driver there was about 20 gallons of fuel left in the tank prior the incident. Upon Engine 502's arrival they noticed that there was a streak of diesel fuel about 35' long that was leading into the storm drain. HM506 added themselves to the call to investigate, E506 also added themselves since they were clearing a call in 10's first due. When Engine 506 arrived on scene they investigated the storm drain to find a small amount of diesel fuel had leaked inside, but did not enter the drain pipe. They placed the 4-gas in the storm drain and all readings were normal. Engine 502's crew dammed the area around the drain to keep any other fuel from entering, prior to our arrival. There was dirt and debris in the storm drain box that absorbed the diesel fuel. The police charged the driver of the car at fault and she was given a list of cleanup contractors to call, Atlas was contacted with a 45 min ETA. HM506's crew plugged the leak on the diesel tank so the dump truck could be moved out of the way of traffic. The truck was moved and a 5-gallon bucket placed underneath the tank in case it started to leak again. No further services needed.</p>
