Annual Stormwater Management Report
VSMP Permit No. 0088595 – FY 2020

Submitted by:
Prince William County
Department of Public Works

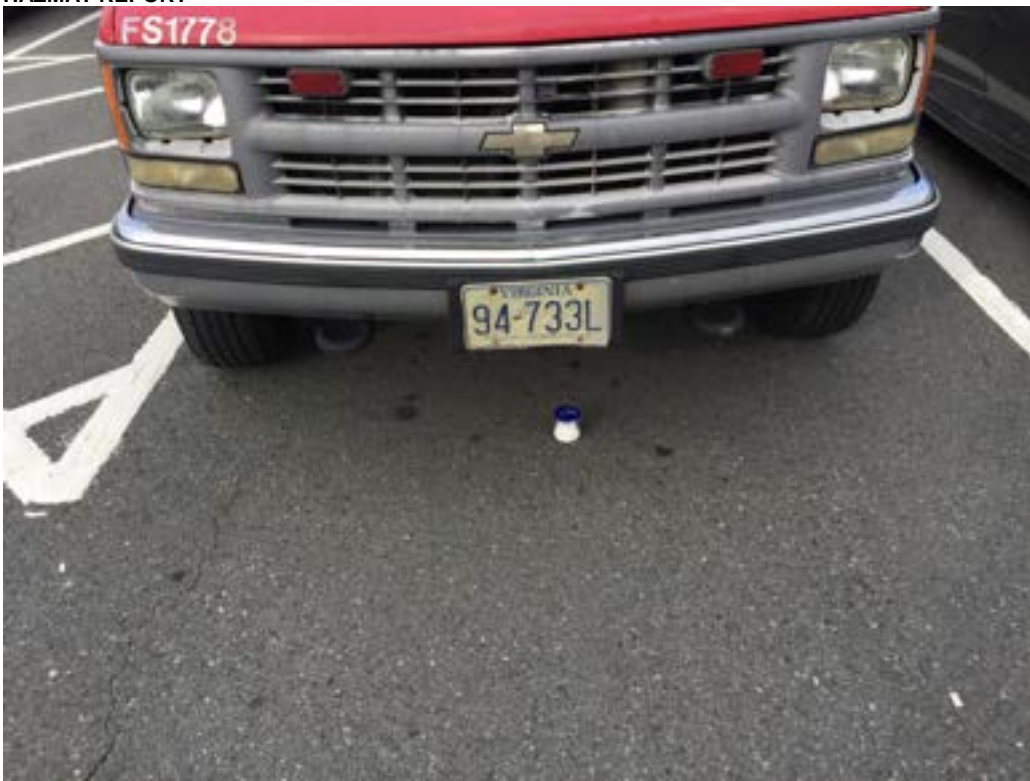
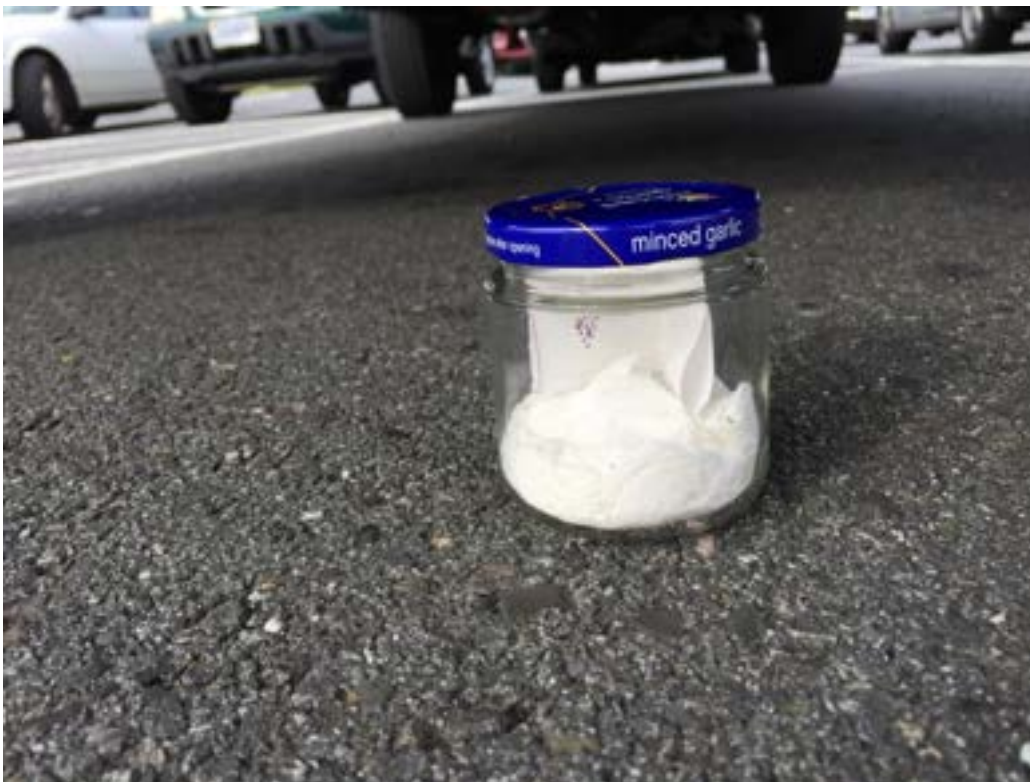
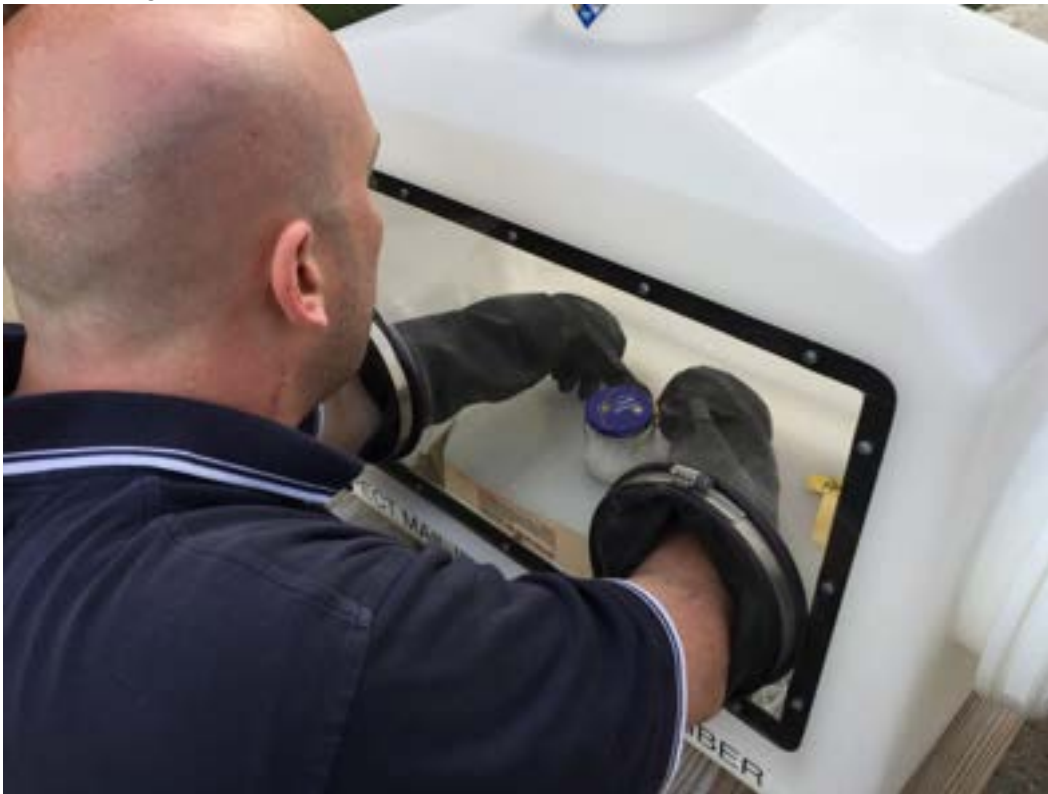
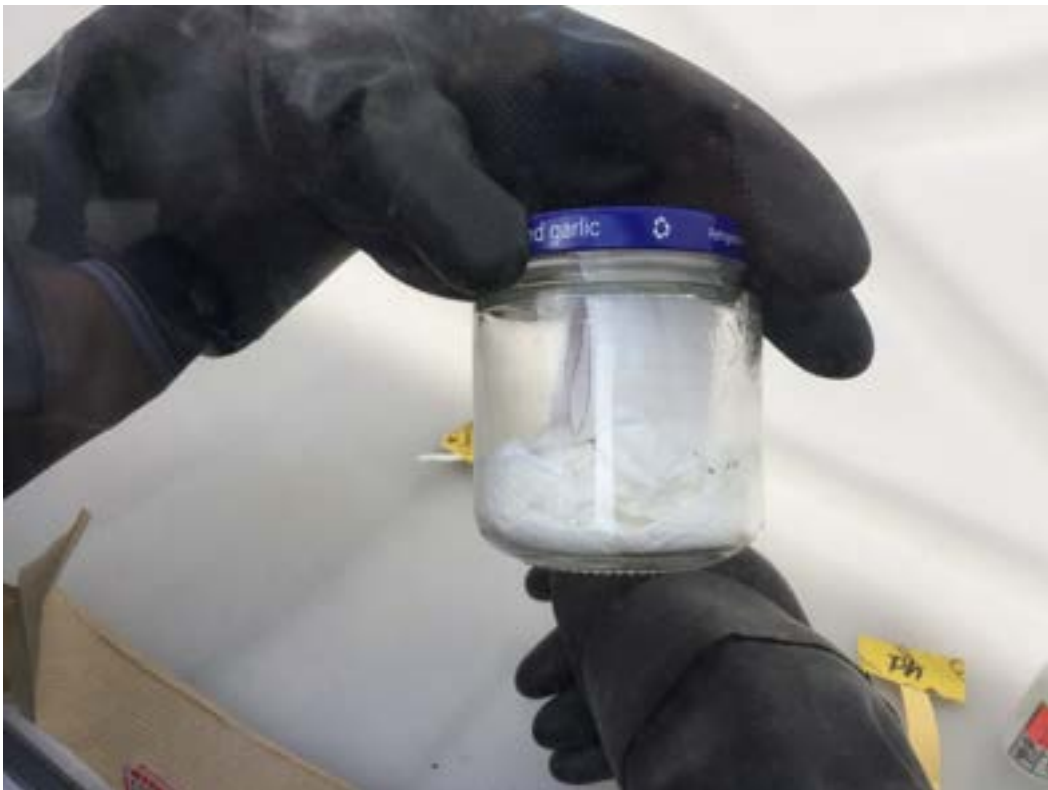
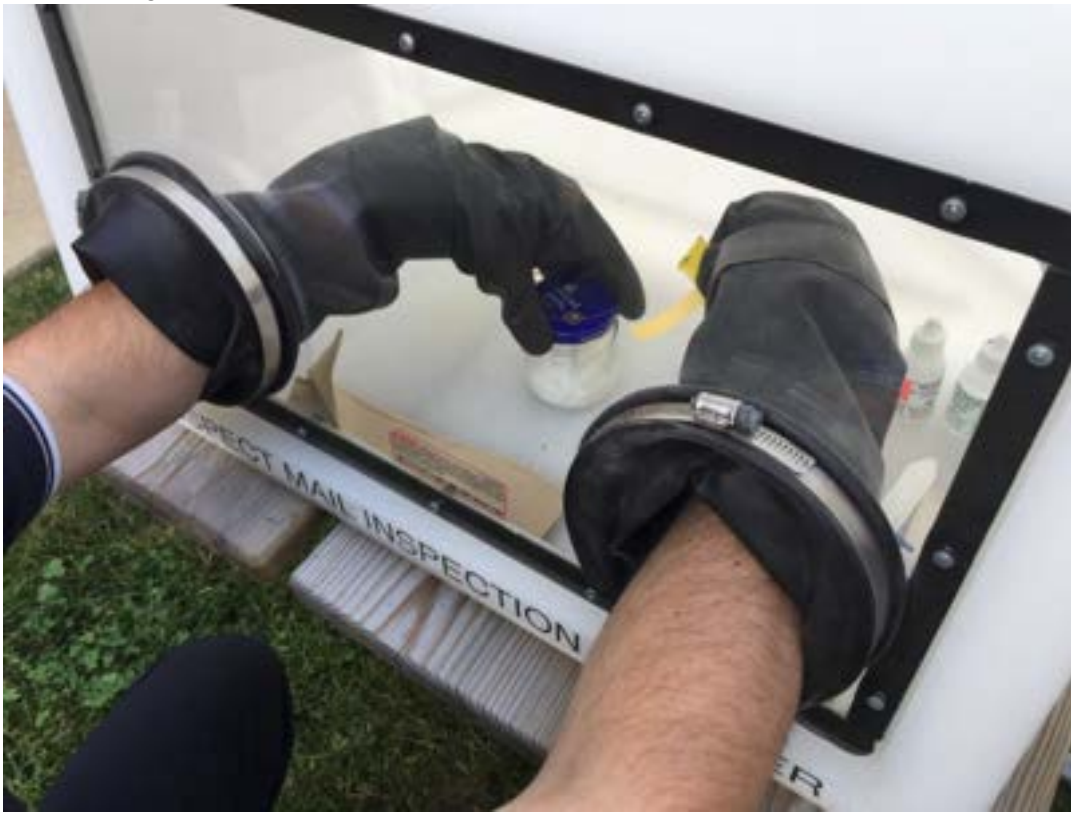
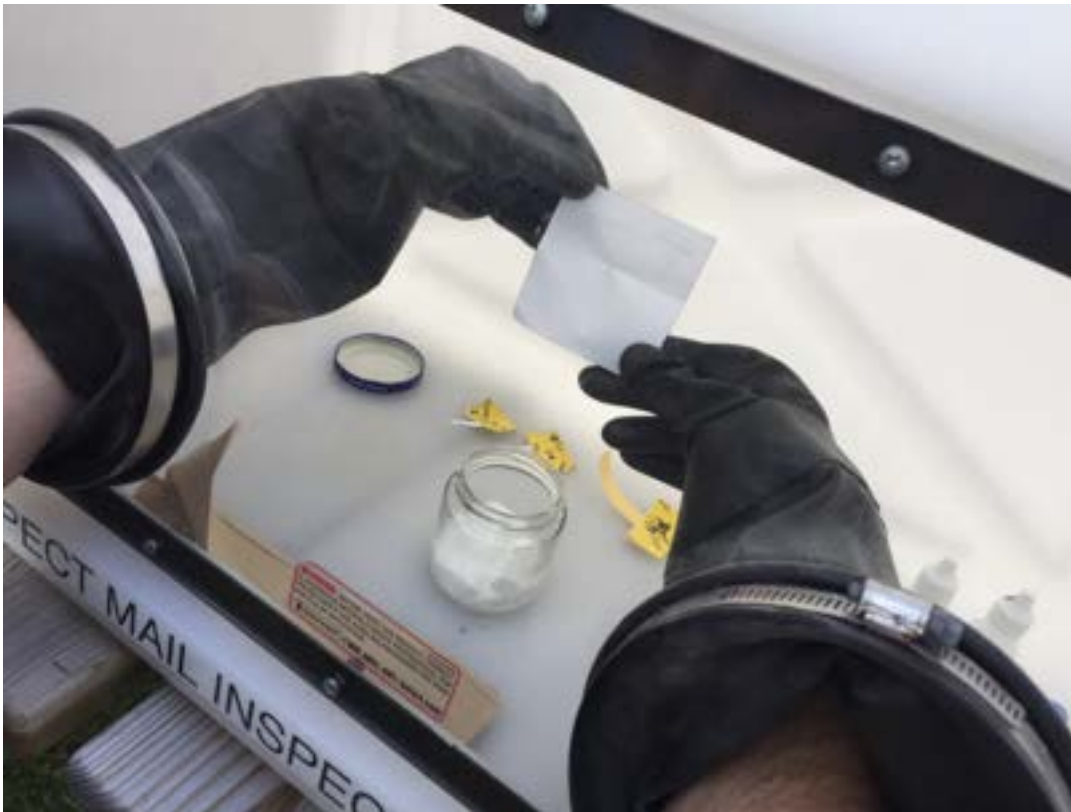
INCIDENT DESCRIPTION	
<p>FM Dustin Miner reported to HMO501 Adkins that a suspicious container was noted placed underneath an EMS Operations Vehicle parked at this location. Location is the Office for FMO, HAZMAT and EMS Operations. This location also houses Office of Elections, today is the first day of absentee balloting. The Container appeared to be a small glass jar with what appeared to be a paper towel in the bottom and a note folded inside the jar. The jar was a container for minced garlic based on the label on the lid. There appeared to be no other items or hazard associated with the jar. HAZMAT units were not dispatched on this call due to another working incident that was ongoing. HMO Adkins and Lt. Moreau were already on scene and assumed the responsibilities for HAZMAT adjudication. PWC PD was contacted and responded. First Sergeant Jimmy Pearce arrived and assigned officers to canvas the area for additional containers or suspicious activities. After this canvas and consulting with Detective M.Y. Armstrong, it was determined the container could be safely moved and it was taken to the rear of the complex and placed into a glove in box container for additional assessment. Prior to removal, all gas and radiation detection was normal. After placing the container into the box, Lt. Moreau swabbed for pH, Oxidizer, and conducted a visual inspection for other hazards. PID readings were also normal. Upon determining it was safe to open the container, it was opened so PD could inspect the note. There was no writing on the note. Lt. Moreau did another set of tests found all indications normal and that there was no chemical hazard associated with this container. PD took pictures and did not intend to take the container into evidence. HMO Adkins took care of properly disposing of the package and testing materials. Contact was made with FBI-WMD and Police Department will file a report. Voter Registration was advised of the situation and this incident did not impact access to the site for voters.</p>

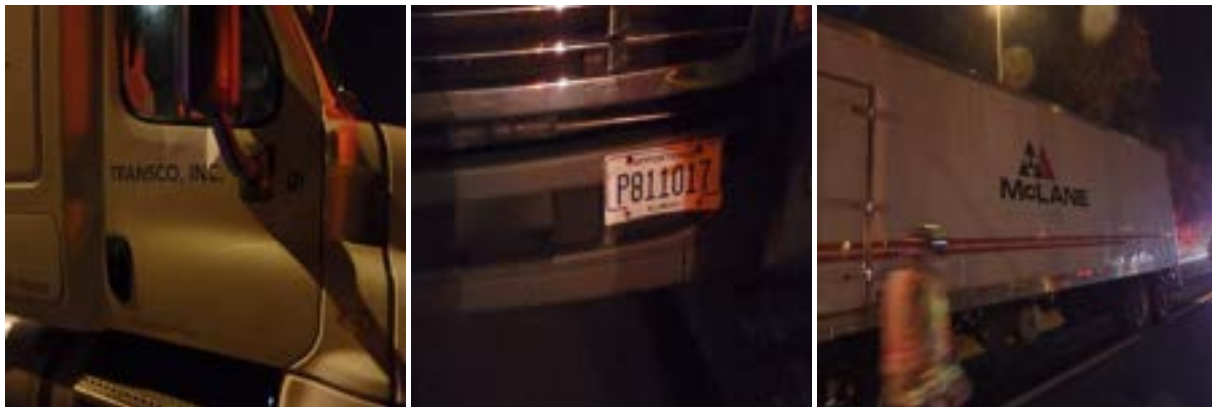
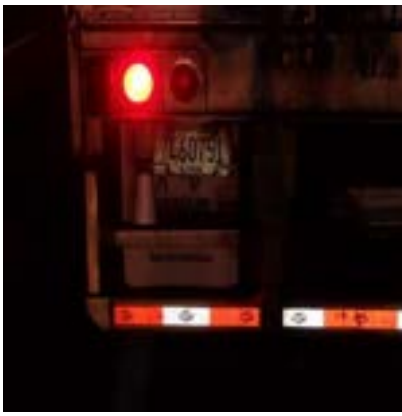
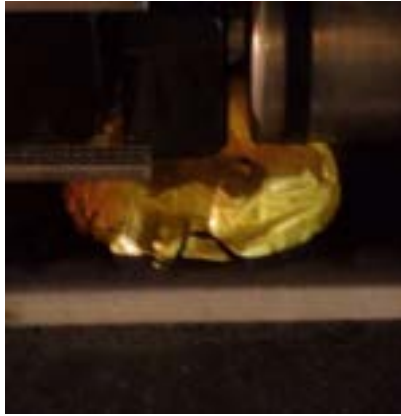
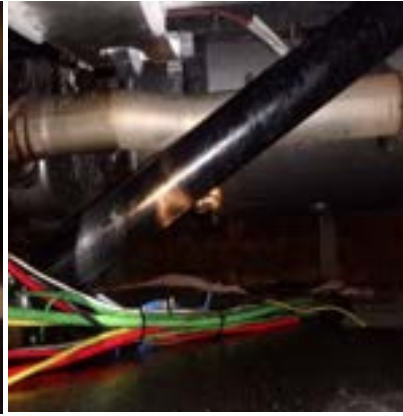
INCIDENT DESCRIPTION	
<p>Hazmat 506 was dispatched to a hazardous materials incident on I95N at the 152.4-mile marker. A tractor-trailer had a mechanical breakdown and broke a fuel line that was connected to the driver side saddle tank. The trucks saddle tanks each held 100 gallons of fuel, and the driver reported the tanks to be full. There was approximately 20-30 gallons of fuel that leaked from the driver side fuel tanks. The fuel line was plugged this slowed the leak; a pop-up pool was used to contain the remainder of the leaking fuel. The fuel was contaminated to the roadway and grass shoulder; no waterway or storm drains was affected by the leak. The driver was provided a LEPC form and after his clean up companies could not make a timely response he contracted with Atlas Environmental to handle the cleanup.</p>	
RESPONSIBLE PARTY	OTHER PARTY
Name: Alberto Barahona	Name: Floyd Ellmore
Company: Mclane Food	Company: VDOT

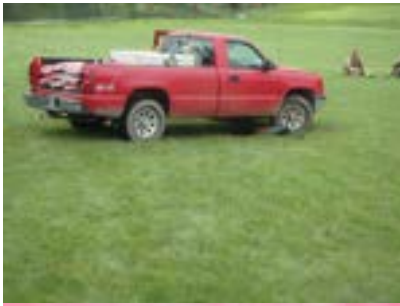
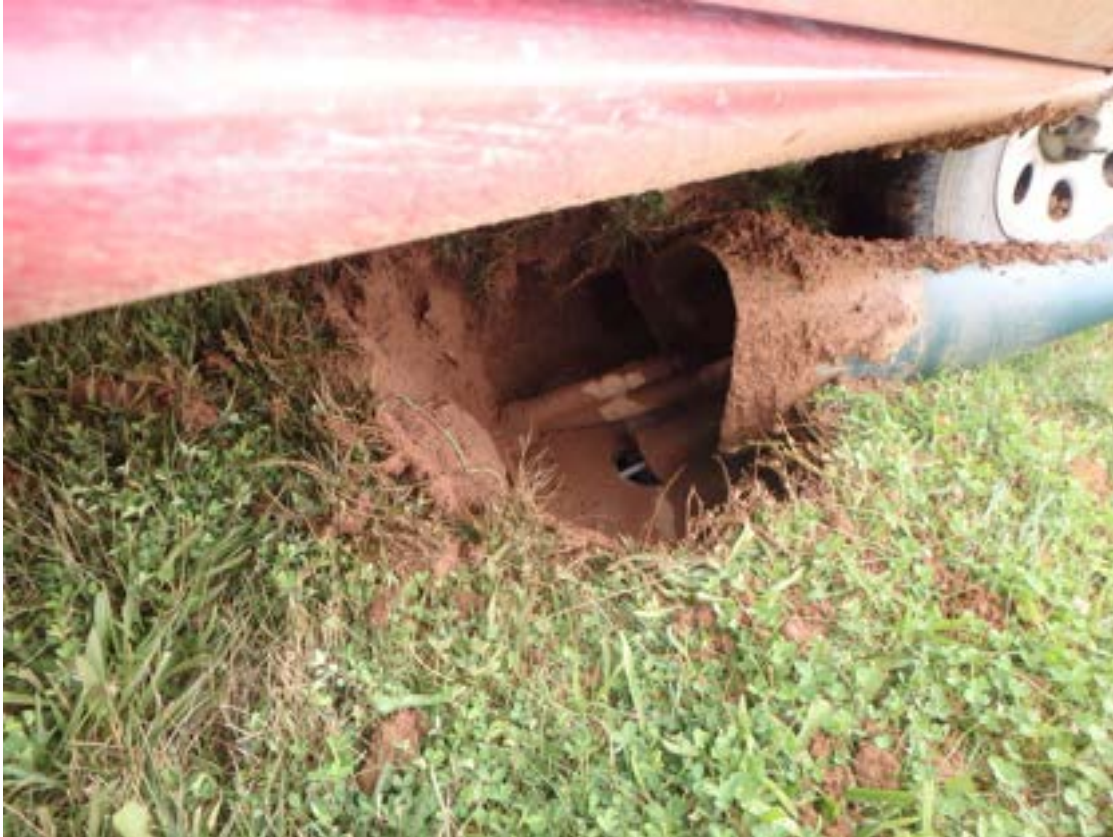
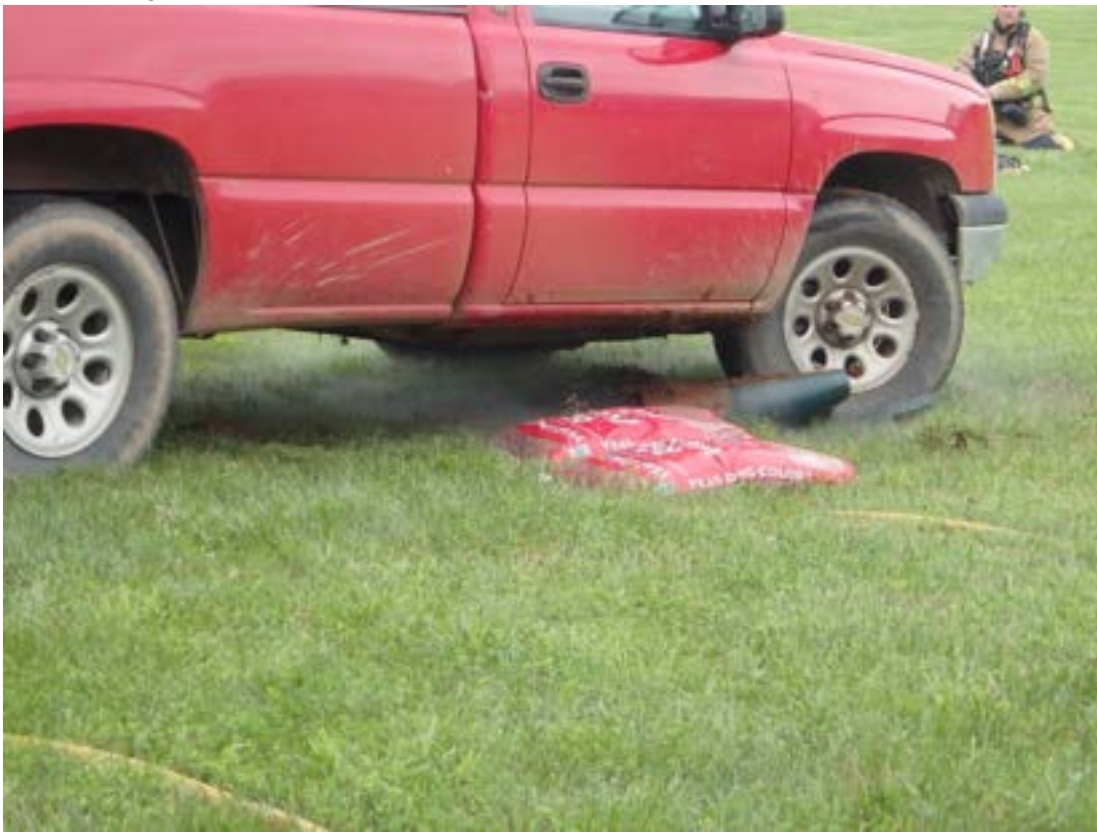
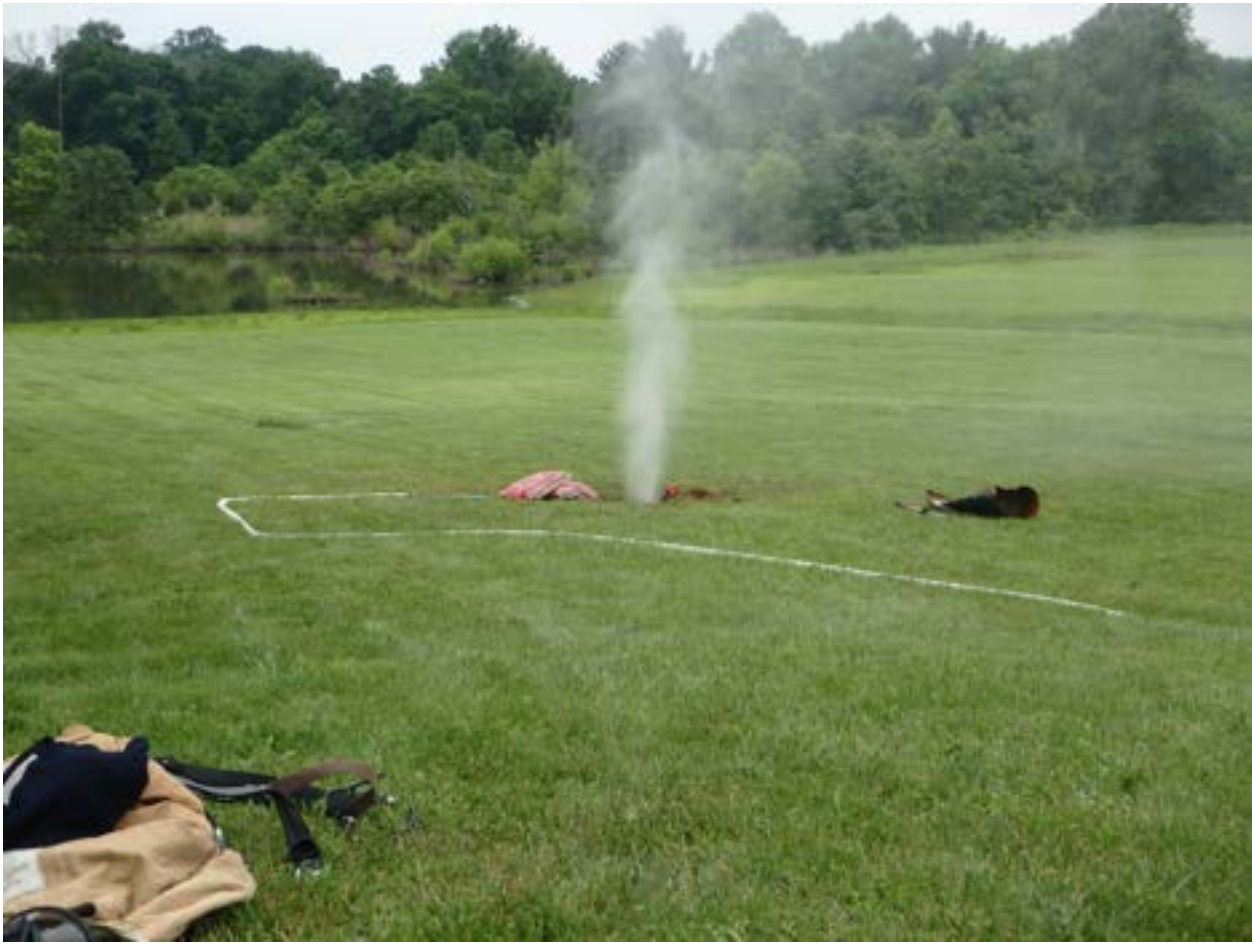
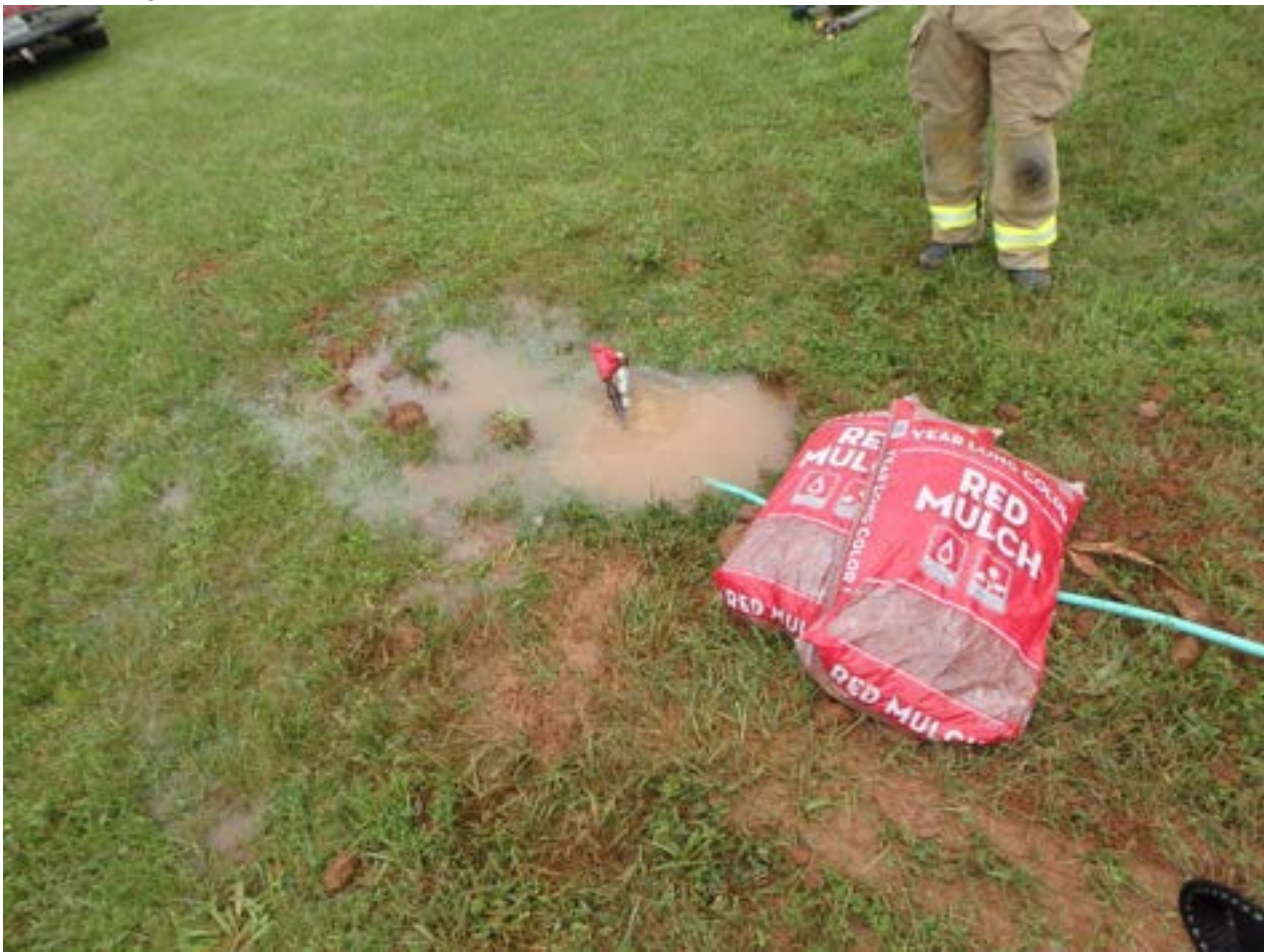
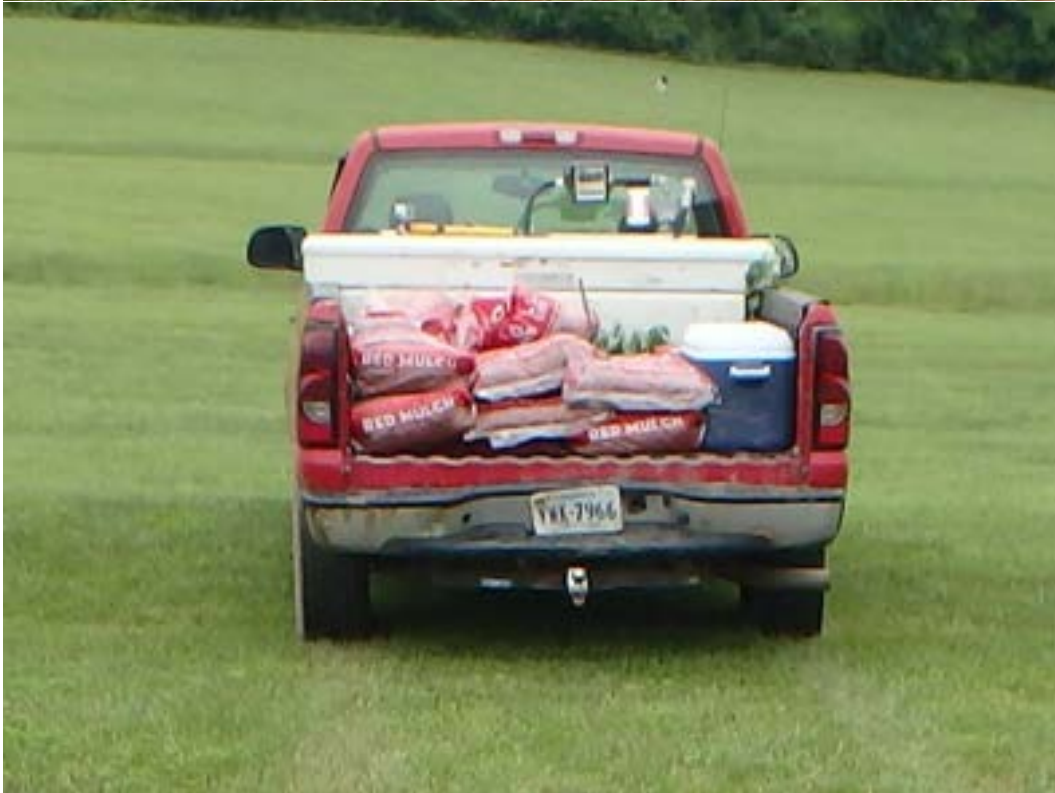
INCIDENT DESCRIPTION	
<p>HM506 and HS506 arrived to the dispatched address for the report of a 1000 gallon underground propane tank leak. E515 officer (Lt. Horvath) and BC Mirabile stated that the tank cover had been struck by a work pickup truck, which resulted in extensive damage to the valves. The driver of the vehicle, as well as the homeowner remained on scene during the incident. The homeowner advised that the tank was filled within the last week. The home was continuously monitored by FD personnel for the remainder of the incident.</p> <p>Lt. Horvath initially noted a white vapor cloud at the scene, but the vapor had since dissipated by the time HAZMAT units arrived. Hot, warm, and cold zones were established and a hoseline was in place prior to our arrival. Upon inspection of the tank, we noted that the propane was leaking through a hole that was approximately 3 inches in diameter. The involved pickup truck was still in place over the damaged tank.</p> <p>Valley Energy, the company who installed the propane tank, was contacted. They advised a 1 hour ETA for representatives to arrive on scene. The decision was made to force the remaining propane out by placing a hoseline into the hole, and using water to fill the tank. We remained on scene until the tank was full of water, and the atmosphere around the tank no longer contained hazardous amounts of propane.</p>

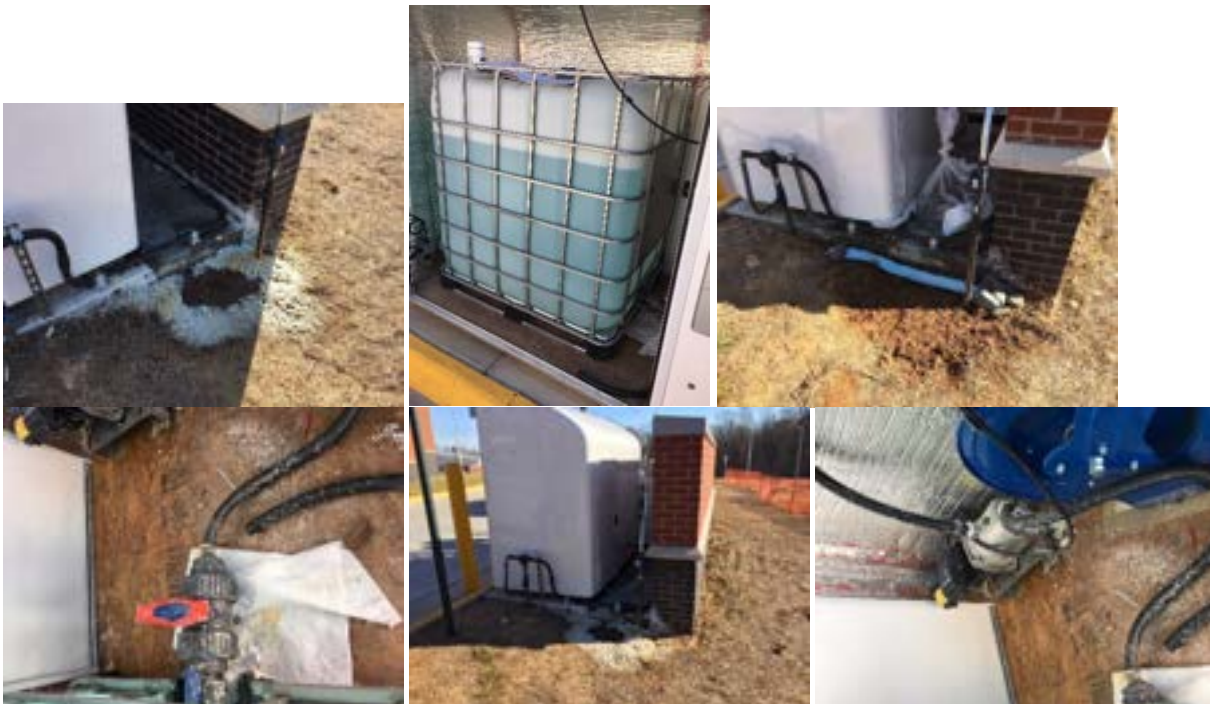
INCIDENT DESCRIPTION	
<p>LT. Hart from station 26 called station 6 stating that he found that the large tote full of DEF outside of the station was leaking and heading towards the retention pond. He asked that station 6 personnel come look at it since there was a threat of the product going into the retention pond. Rescue/Hazmat 6 went over to station 26 along with safety 502. When we arrived LT Hart had already shut off the valve to the system and turned the breaker off. The leak stopped after those steps were taken. Rescue/Hazmat 506 confirmed the leak had stopped and that no chemical had reached the retention pond. Pictures were taken and are attached to this report. HM501 and Safety 502 assisted station 26 with filling out the proper forms. LT Hart's spill report form is attached to this email as well. Per HM501 the EOC did not need to be contacted for this incident.</p>	
RESPONSIBLE PARTY	OTHER PARTY

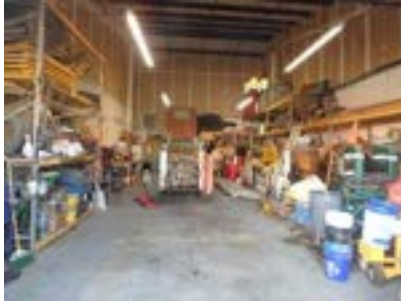
Rear of 6989 Gateway Court looking from charlie to alpha sides of building.

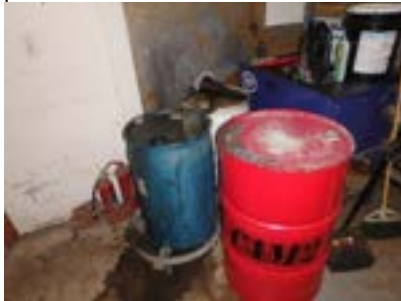
into.

Red 55 gallon drum that business owner was pouring 5 gallon buckets of MEK

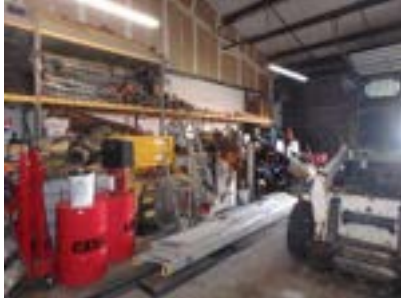
Entrance into rear of 6989 Gateway Court looking from alaph to charlie sides of building. Two empty red 55 gallon drums.

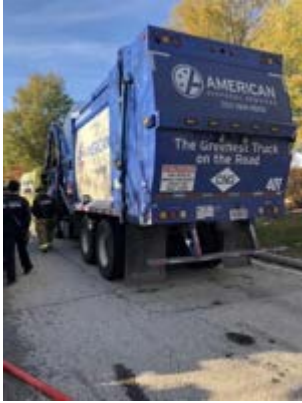
Rear of trash truck.

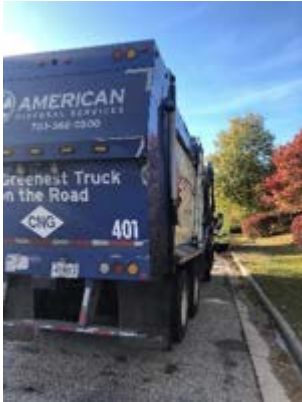
Rear of trash truck.

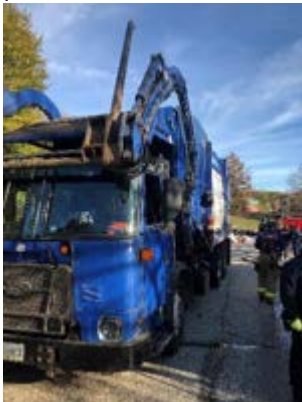
Front of trash truck.

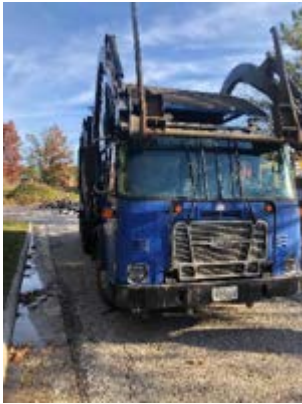
Front of trash truck.

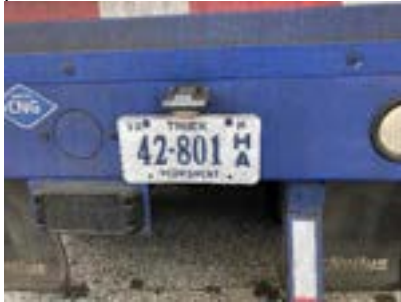
Rear plate of trash truck.

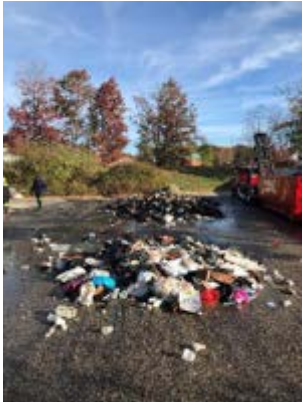
Trash that was dumped from truck onto street. Equipment located in right of picture belonged to the clean up contractor.

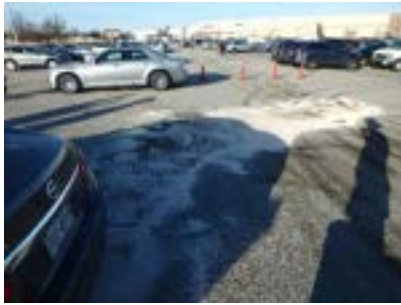
View of leak with absorbent, pads, and booms.

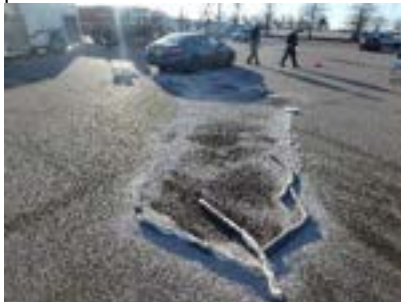
View #2 of leak with absorbent, pads, and booms.

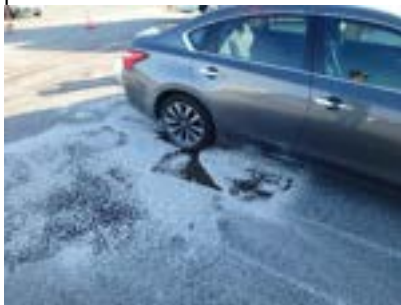
View #3 of leak with absorbent and pads.

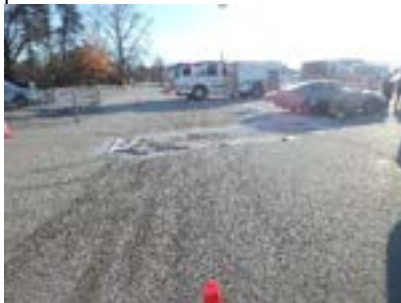
View #4 of leak with absorbent, pads, and booms.

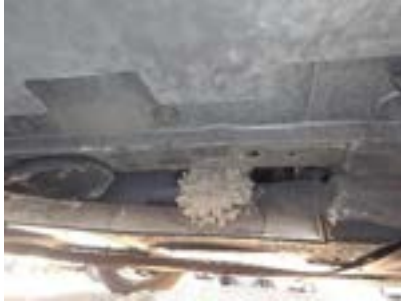
View of Plug N Dike on cracked fuel tank.

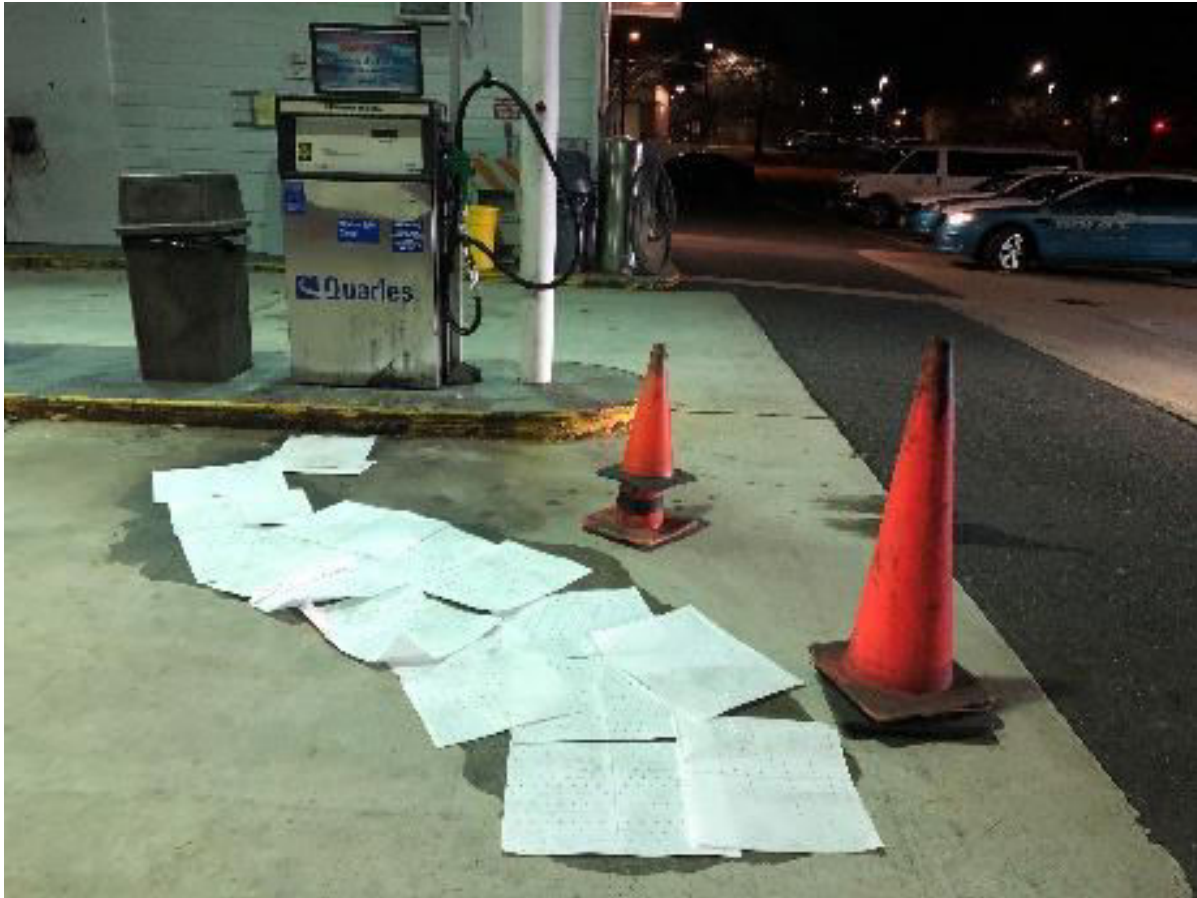
Fuel spil at Garfeild Sub Station.

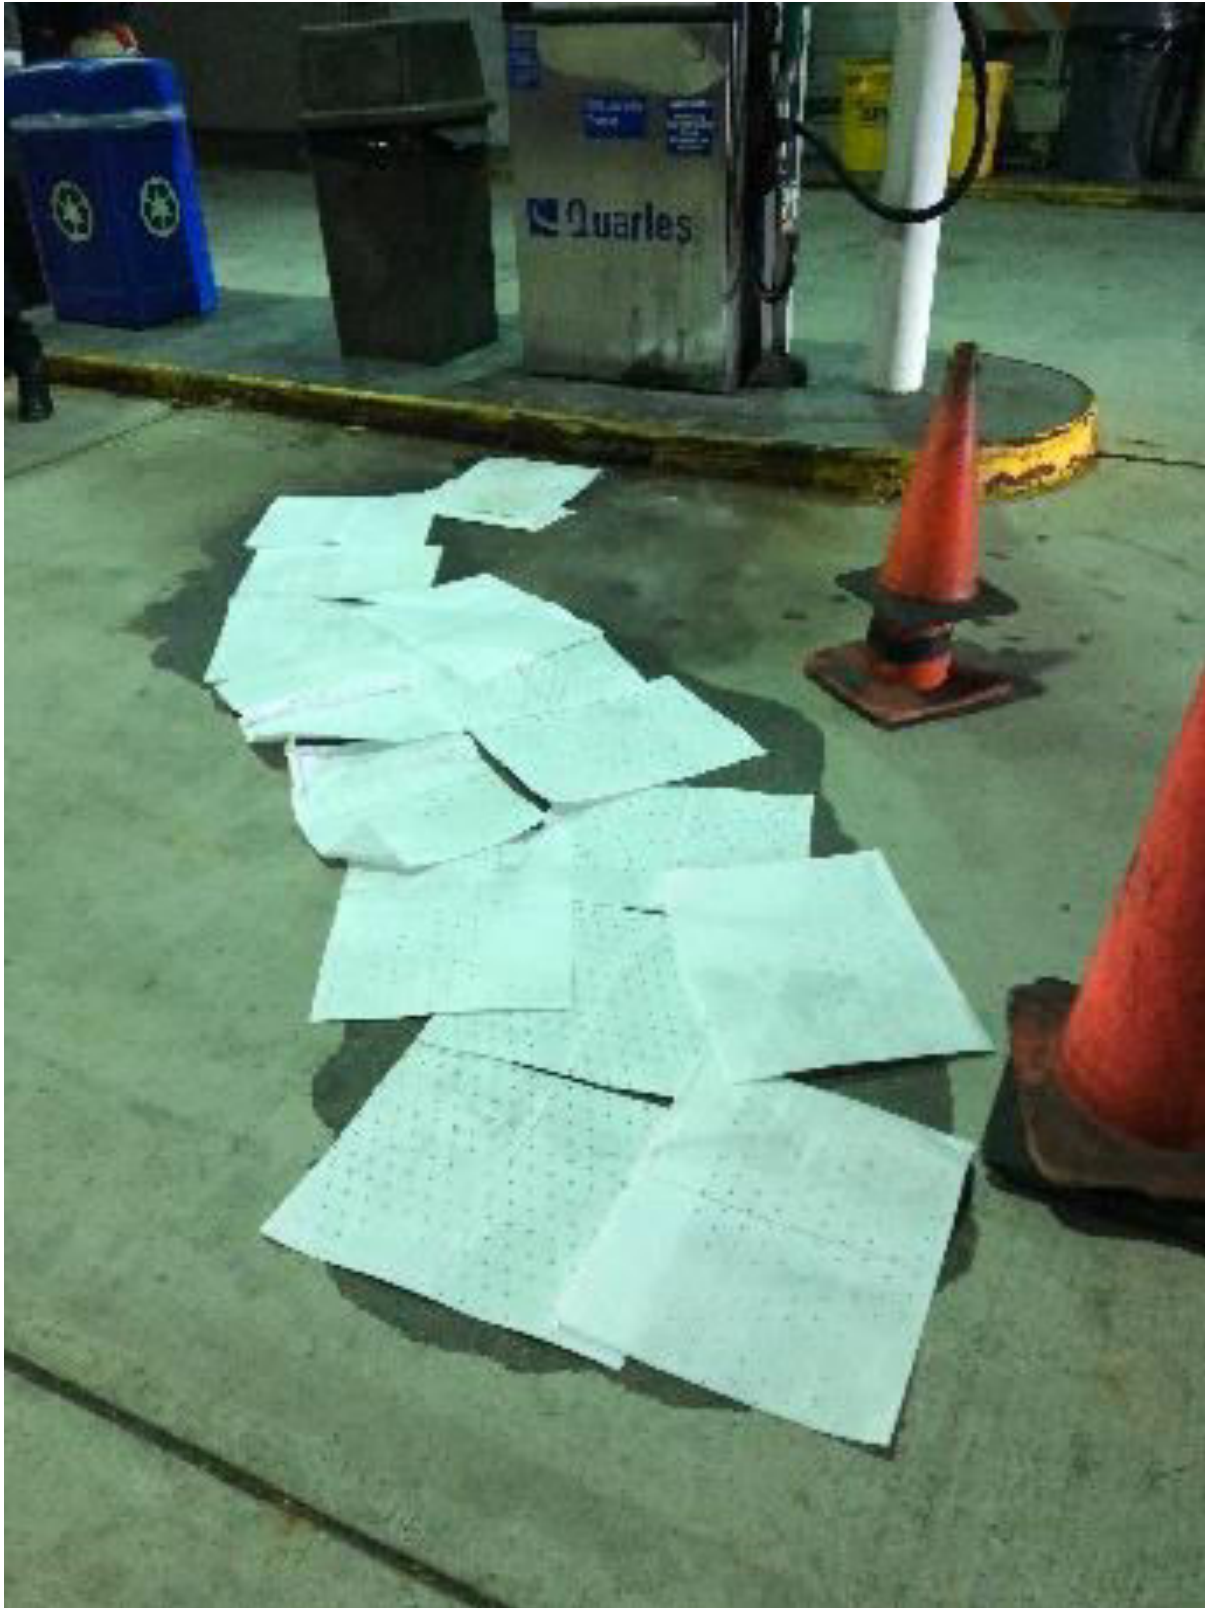
Fuel spill at Garfeild Sub Station.

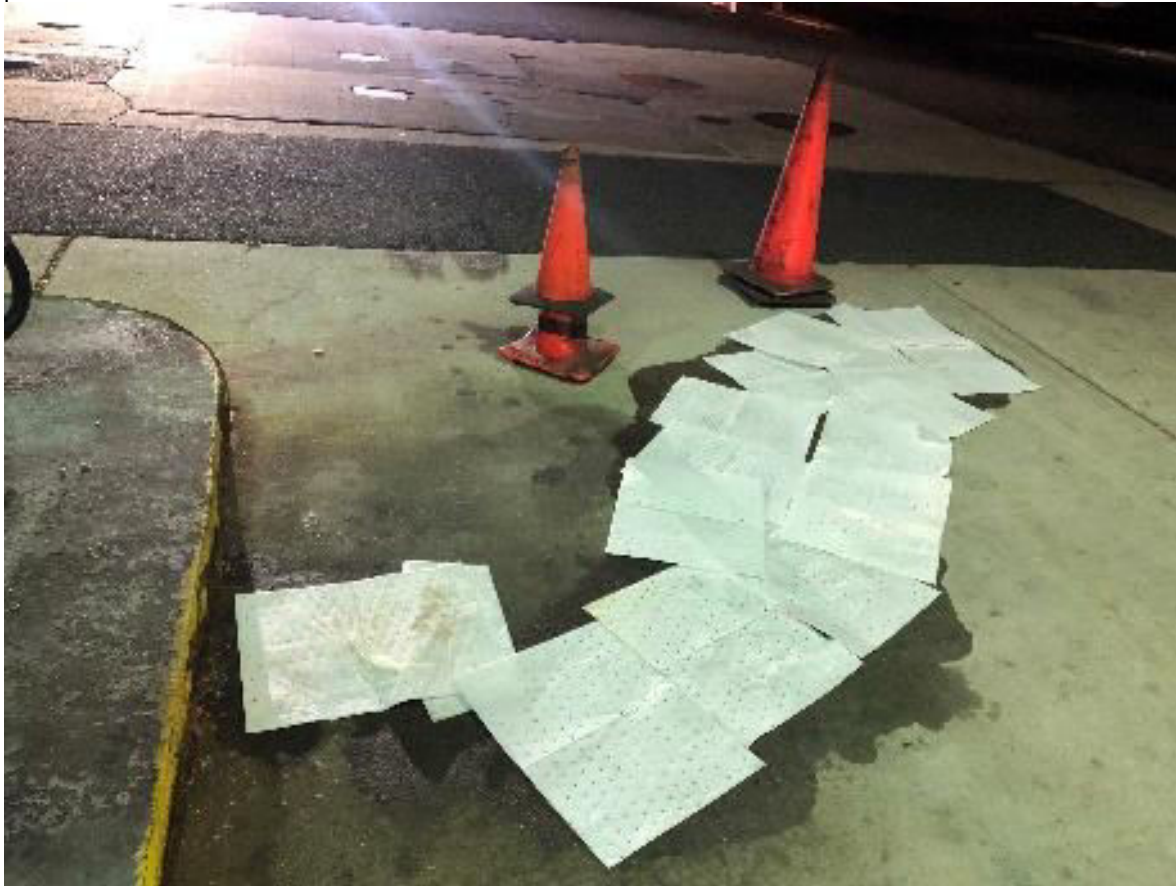
Fuel spil at Garfeild Sub Station.

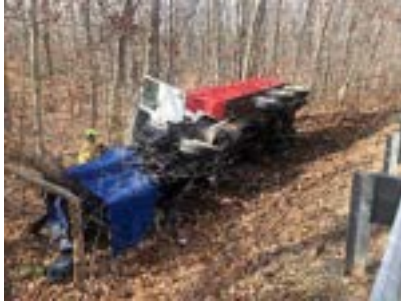
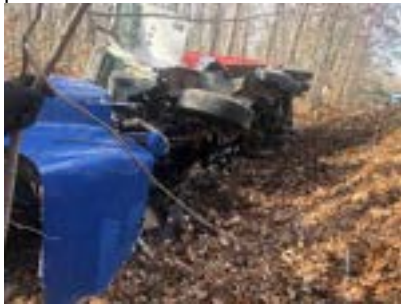
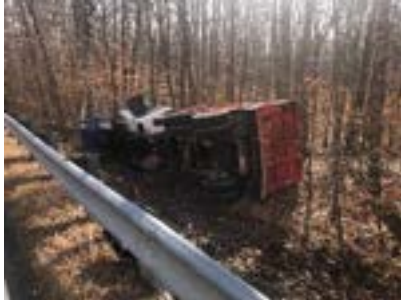
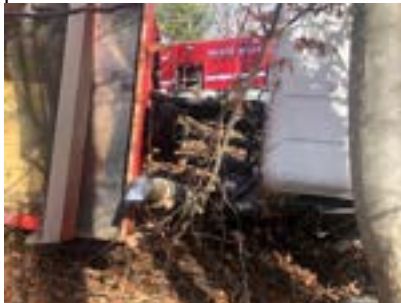
Overturned dump truck.

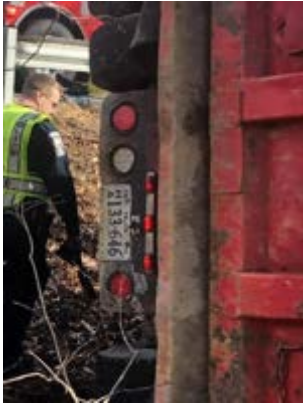
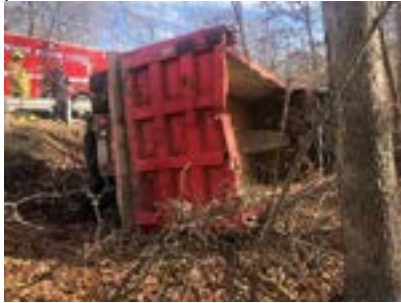
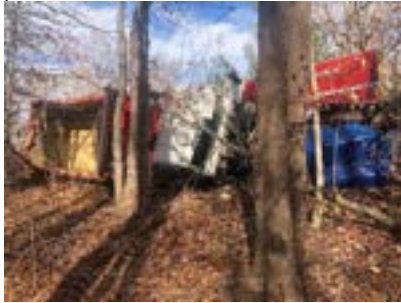
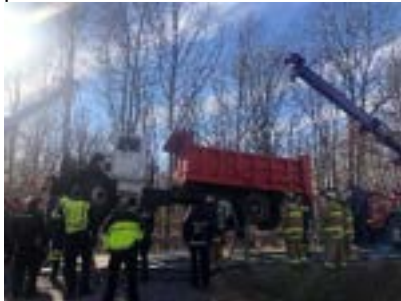
Overturned dump truck.

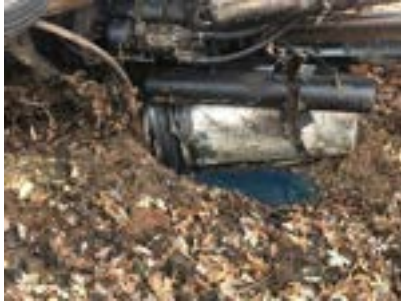
Leak of fuel tank and other vehicle fluids.

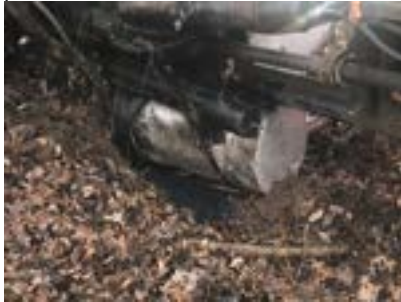
Leak of fuel tank and other vehicle fluids.

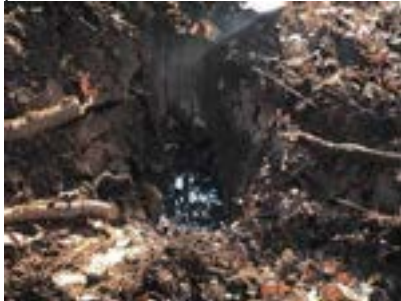
Leak of fuel tank and other vehicle fluids.

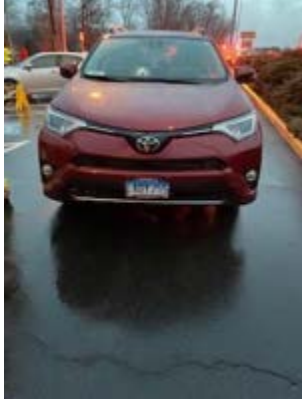
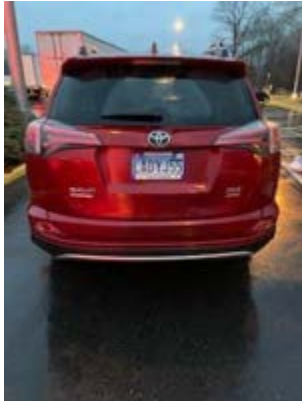
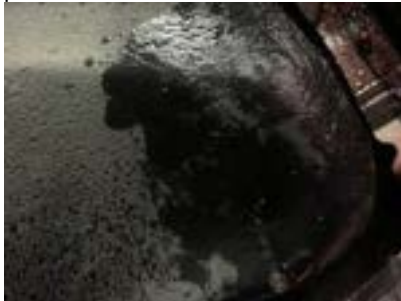
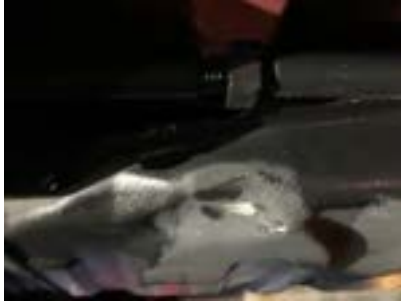
INCIDENT NARRATIVE
<p>Captain Newell and myself answered a phone consult from E511B for a Toyota RAV4 leaking gasoline onto the roadway and possibly into the storm drain system. E511B officer, Captain Melvin was given direction to dam and dike the affected area and utilize absorbant on the fuel spilled on the ground and to get the vehicle owner's information and give an LEPC form. It was determined that there was approximately half a tank of fuel in the car when the leak was noticed. E511B's crew determined that between 1 to 8 gallons of gasoline possibly spilled out.</p> <p>E511B statement Here is the information for Inc. 200002802</p> <p>Incident was at I66 EB Car Rest Area, rainy condition, standing water in parking area in front of Car rest station. Driver/Owner of vehicle stated she had struck something in the road and then pulled into the car rest area, another citizen looked at vehicle for driver saw a small stream of fuel coming from under vehicle. Arrived on scene, vehicle in parking space, smell of gasoline noticed along with sheen on top of standing water at the curb, water and fuel possibly went down drain prior to arrival, damming was performed to stop fuel and water from entering the drain, drain daylighted behind rest station to above ground spill into soil, no odor of fuel detected at daylight location. Spill of fuel contained in standing water at curb. Vehicle examined and found to have damage to fuel tank, in location other citizen saw fuel leaking, no active leak now, fuel probably under pressure but not now, vehicle owner stated she had approximately same amount of fuel (1/2 tank) as she did when she struck the object in the road, possible 1-2 gallons of fuel possibly leaked from vehicle.</p>

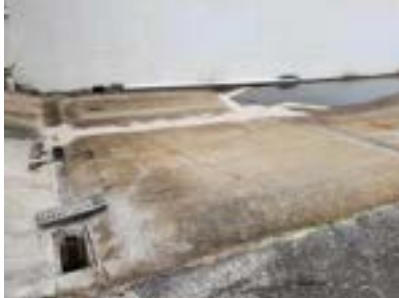
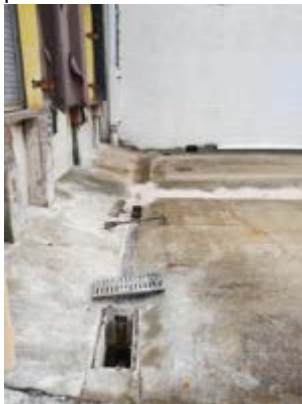
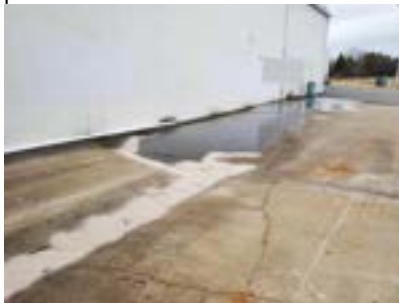
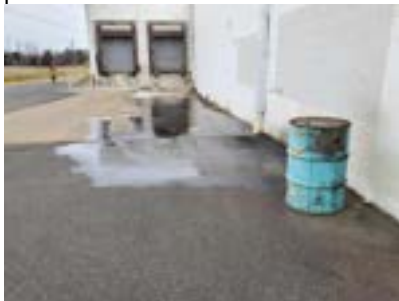
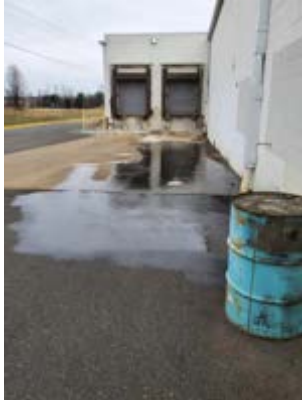
INCIDENT NARRATIVE
<p>Arrived on scene with E511B. E511 crew reports a 55 gallon metal drum that was on its side leaking approximately 30-35 gallon of what appears to be waste motor oil onto a blacktop loading dock. The barrel contained no identifying marks or shipping papers. Defensive measures were put in place preventing entry into drains. Phone conversation with HMO502. Contacted property management company who contacted their own clean up company. Spoke to the store manager who stated that he had never noticed the drum there before today. Requested FM due to suspicious circumstances. Remained on scene awaiting arrival of clean up contractor. Scene turned over to clean up contractor.</p>
