Annual Stormwater Management Report
VSMP Permit No. 0088595 – FY 2020

Submitted by:
Prince William County
Department of Public Works

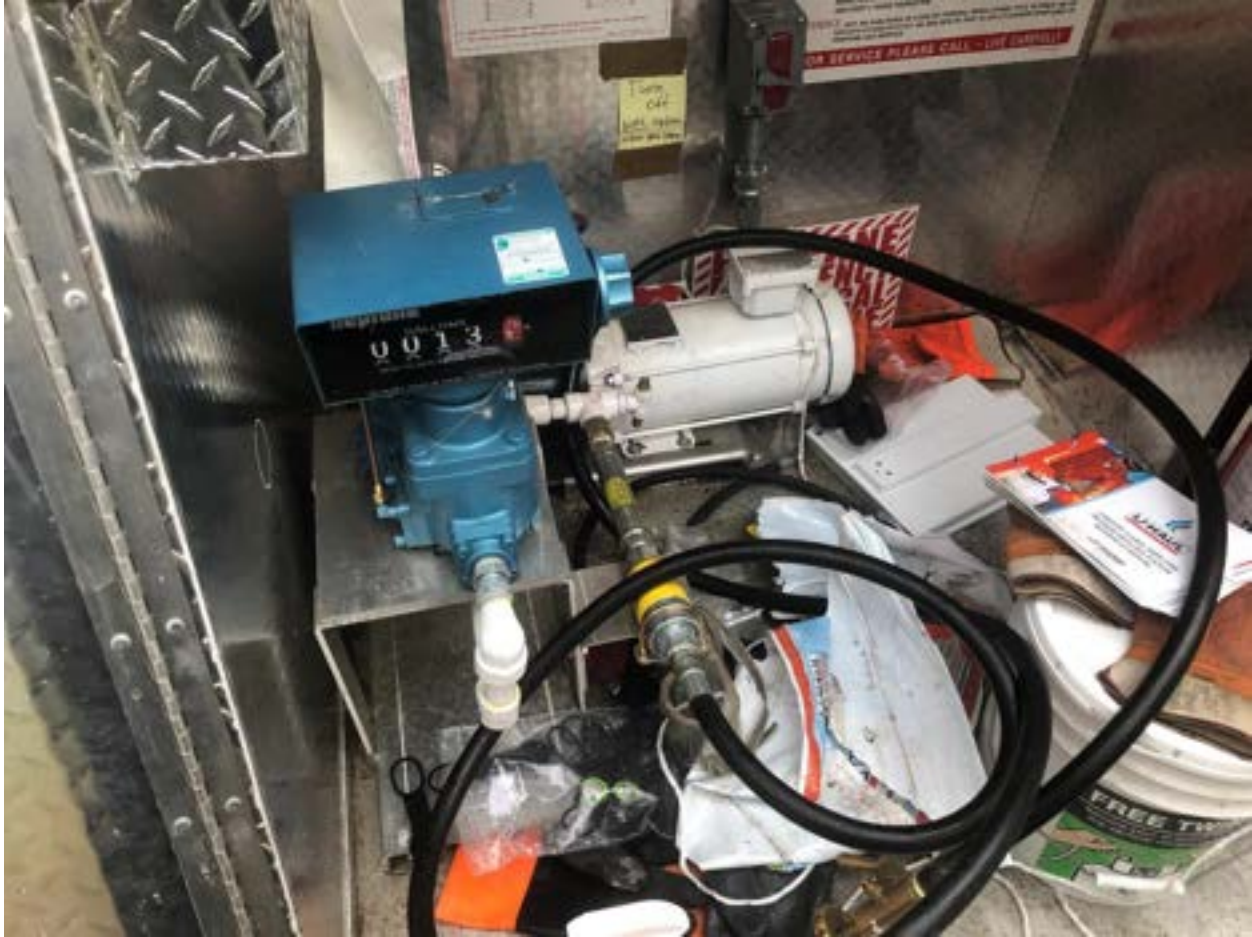
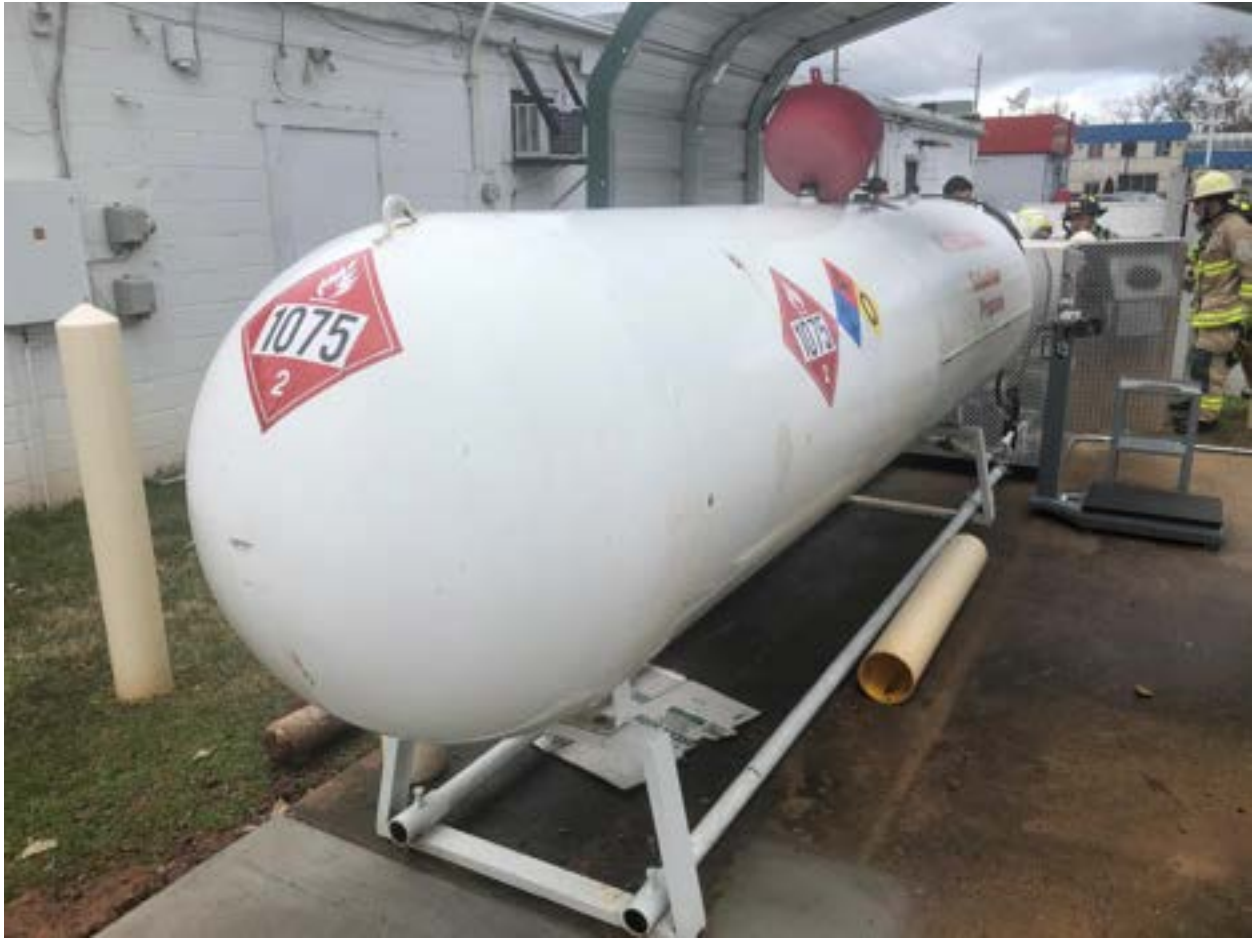
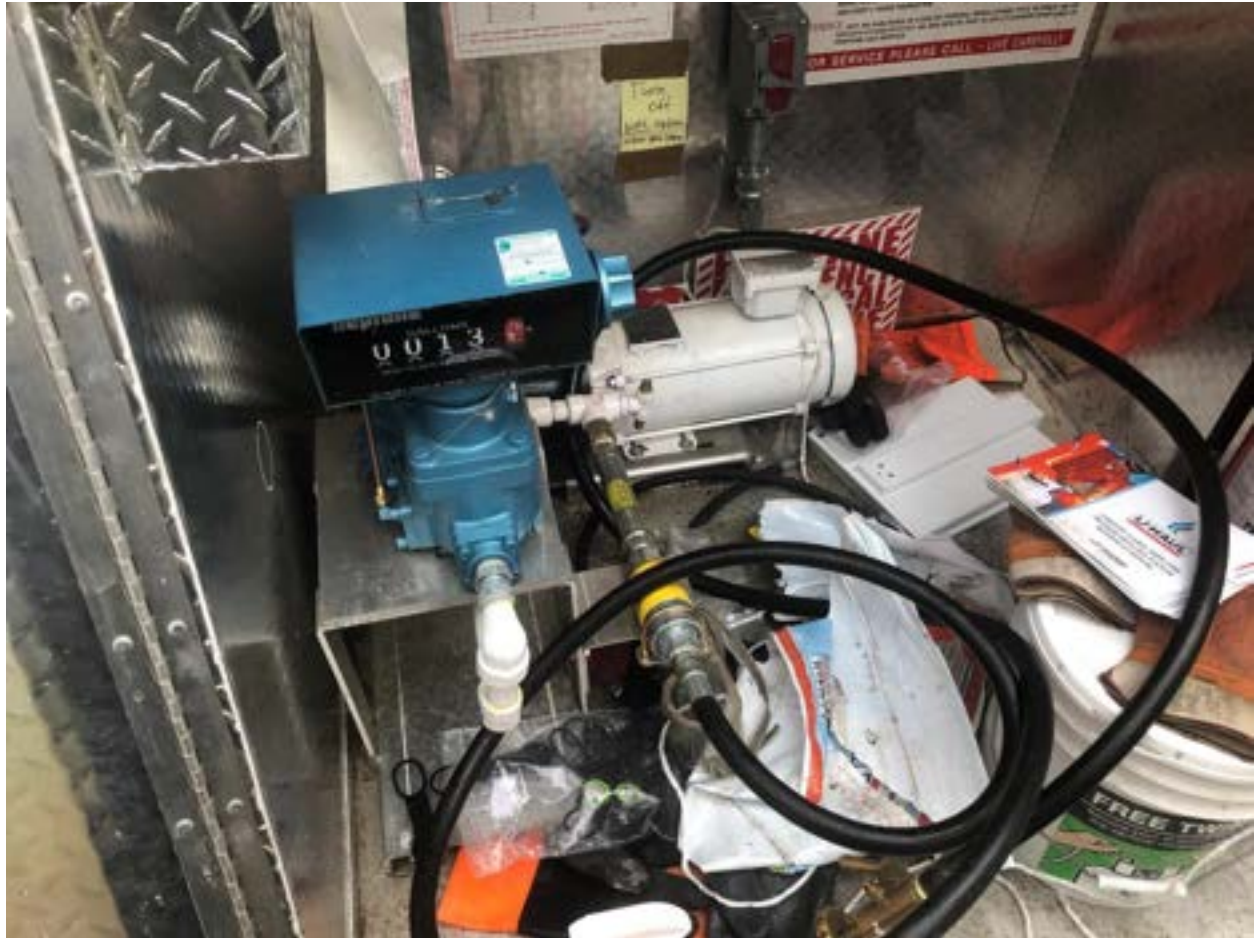
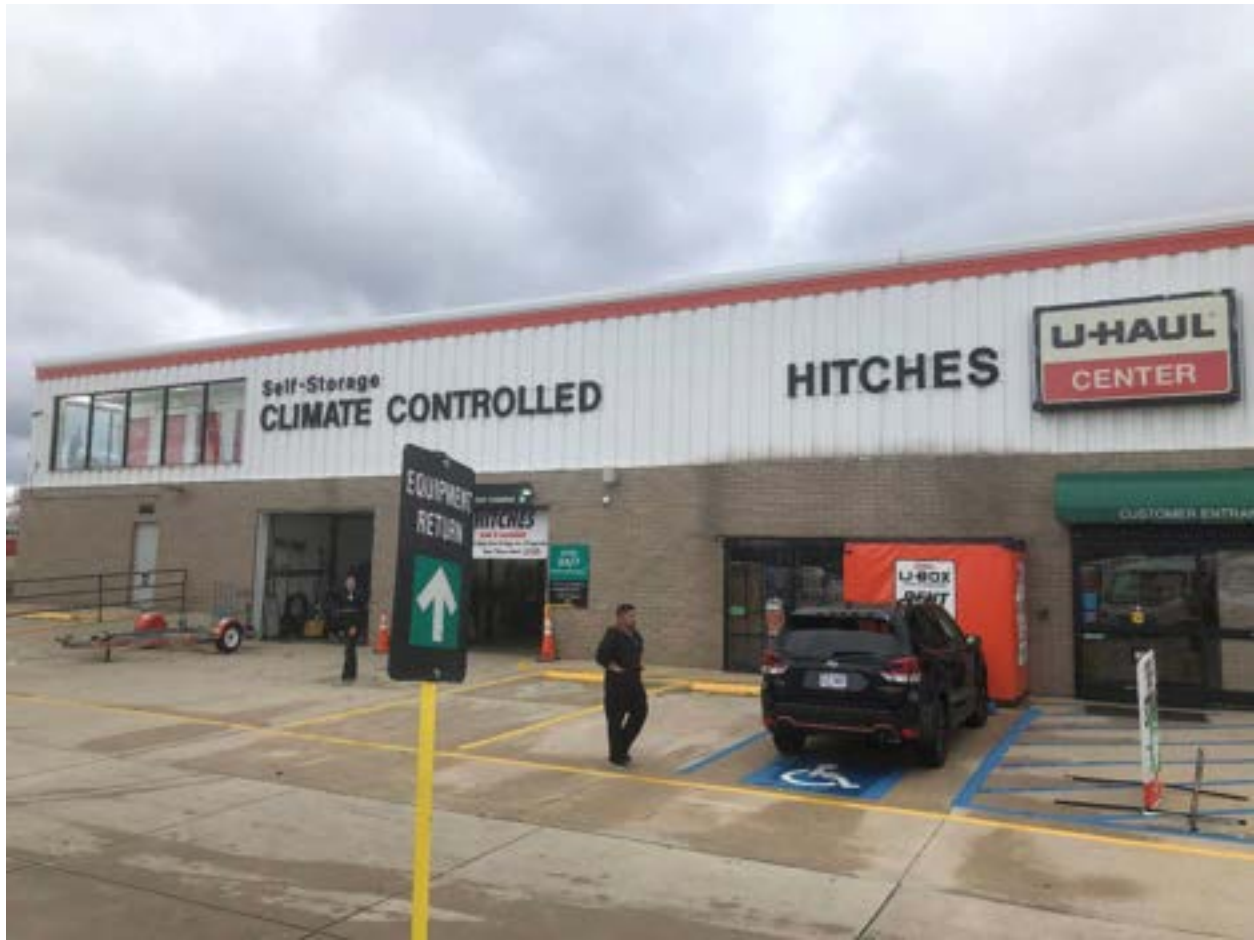
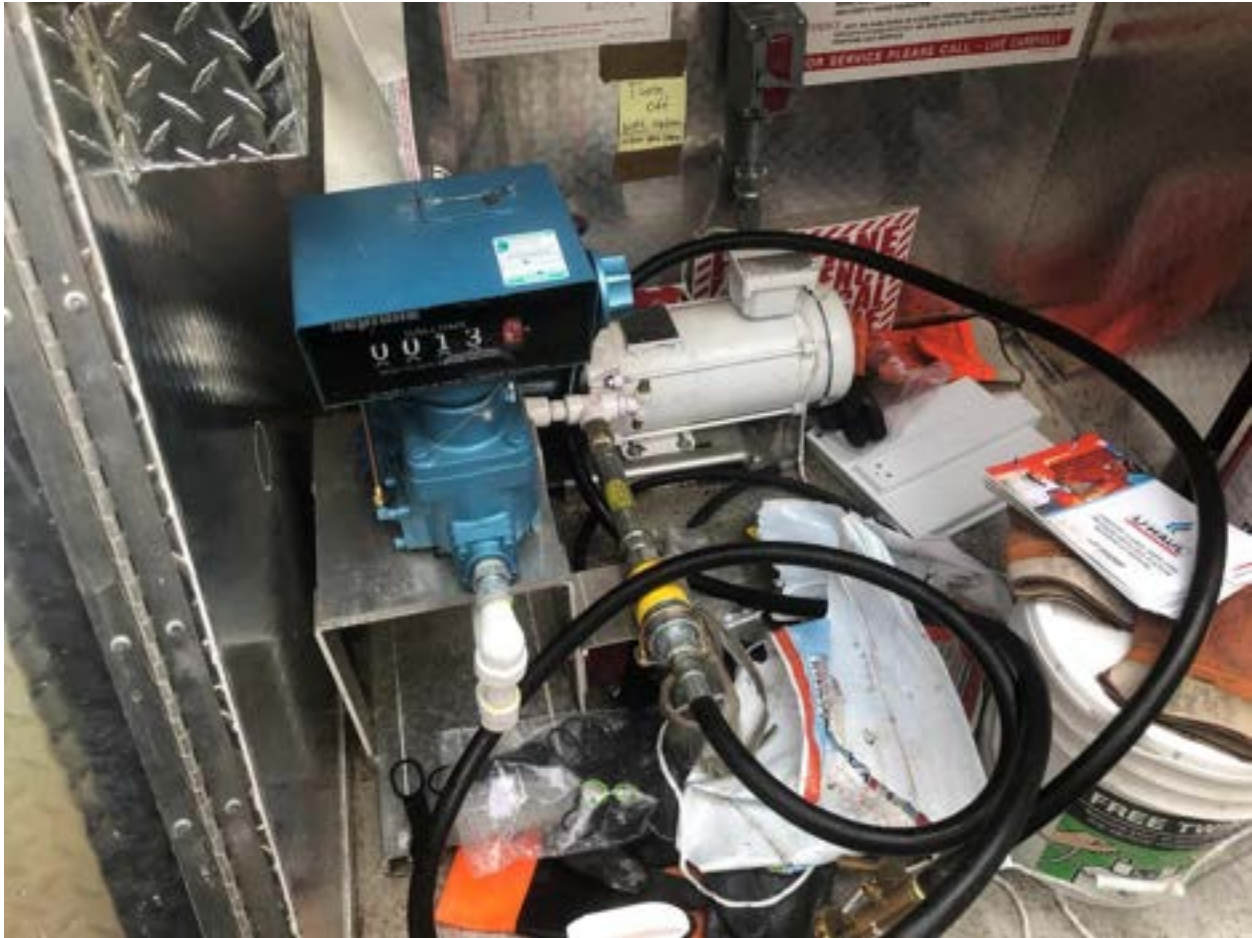
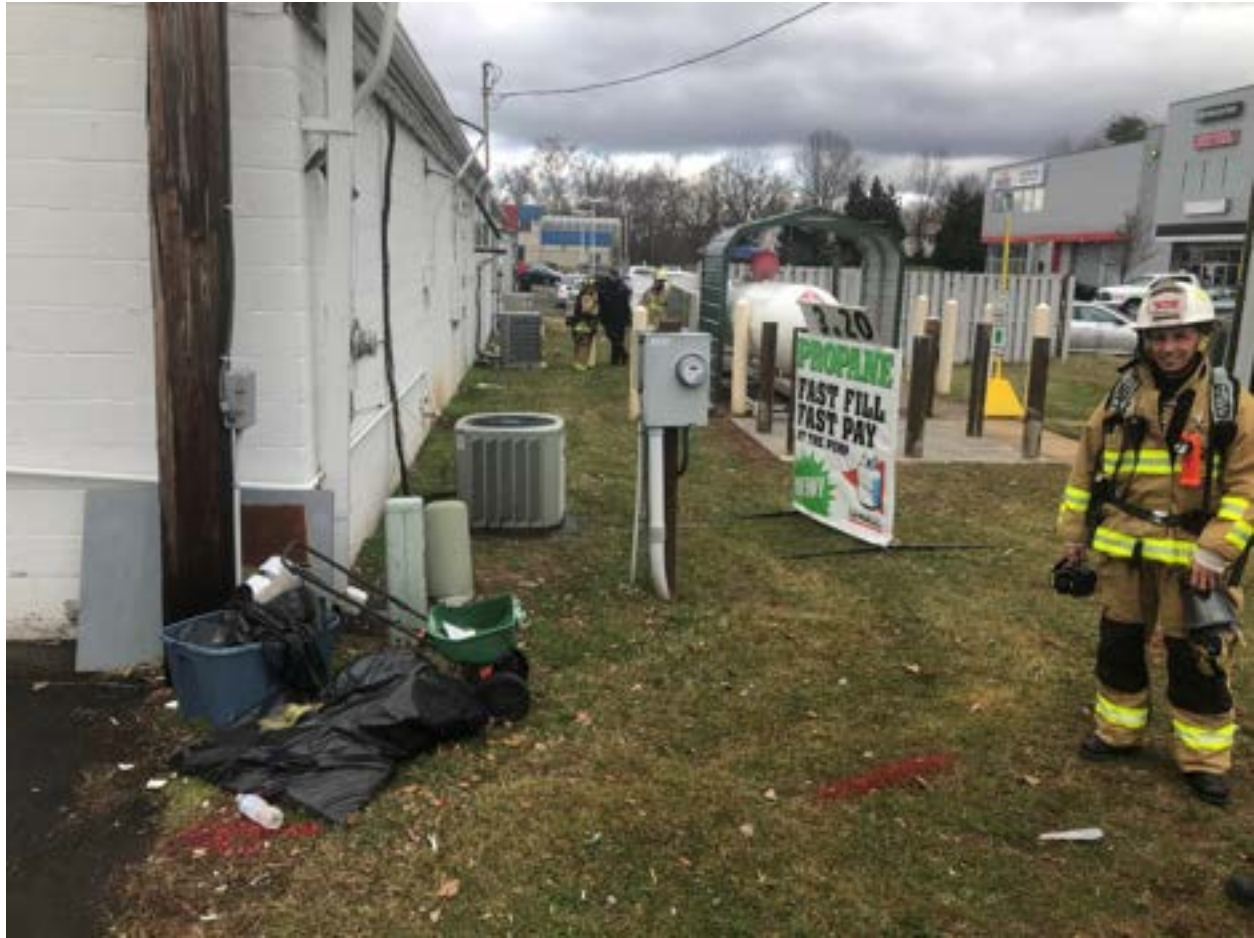
INCIDENT NARRATIVE
<p>Dispatched to a Suburban Propane fill tank owned by U-haul at the above location. U-haul employee (John Nessessary) noticed the cabinet frozen and the smell of propane. John pulled the emergency sop and did not feel that it worked so he dialed 911. E508 arrived and assessed and shut the leaking fill line with its ¼ turn valve. Hazmat response continued and assessed. Determined the the hazard was mitigated. U-haul rep stated that Suburban propane was direct and en route. Returned to service.</p>

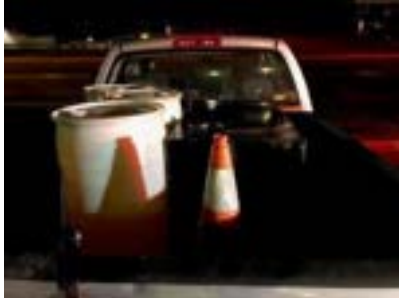
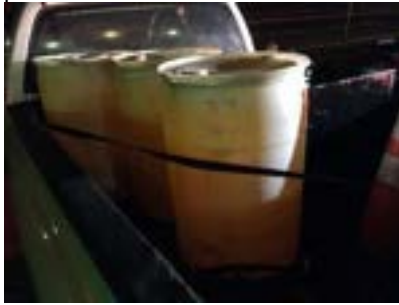
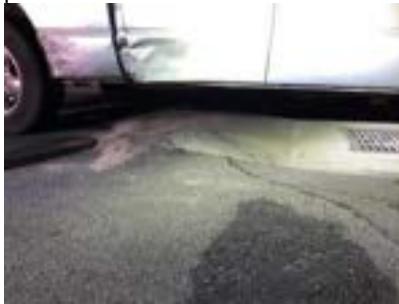
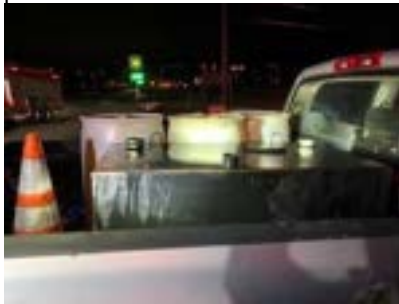
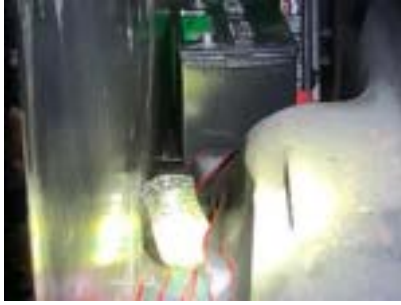
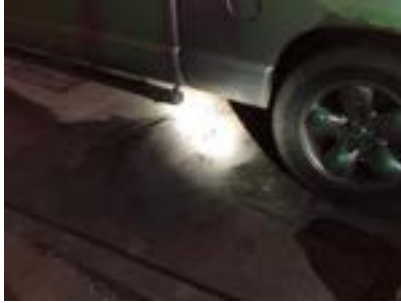
INCIDENT NARRATIVE
<p>E523 requested phone consult for pickup truck leaking fuel out of the bed. DHM spoke to Capt. Phillips (E523) and he advised they had 3 55 gallon drums leaking fuel, as well as another container that held approximately 40 gallons leaking. E523 they had a pin hole leak and that it had not made into any storm drain. They were advised to perform defensive measures (damming and diking) until the arrival of hazmat. E506, R506 and HM506 responded to scene. Upon arrival it was determined that the vehicle owner had been transported by police for unrelated matters. The vehicle had 3 35 gallon drums of diesel fuel along with another metal container that held approxitally 50 gallons. The drums were not leaking and the 50 gallon container was. E523 had placed a plastic bottle under the leak to catch it and placed absorbant on the ground to protect the storm drain. The other plastic drums were not leaking. An acquaintance of the vehicle owner was there and advised that he would be taking responsibility of the leak and the subseqant off loading of the diesel fuel. HM 506 placed more absorbant into the bed of the pickup truck. Due to the uncertain nature of the call and the containers not being labeled for fuel the duty fire marshall was requested. After talking to Capt. Adams and FM 514 (Lt. Hornaday) it was deteremined that no hazmat services were needed and the the fire marshall would remain on scene and handle overseeing the clean up.</p>

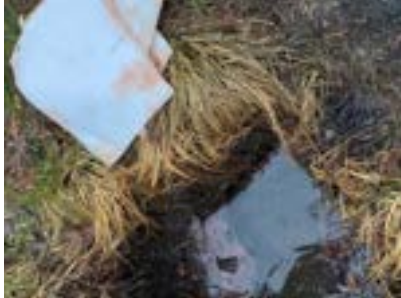
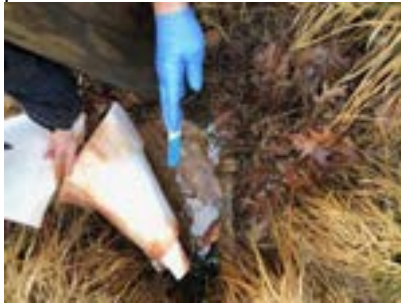
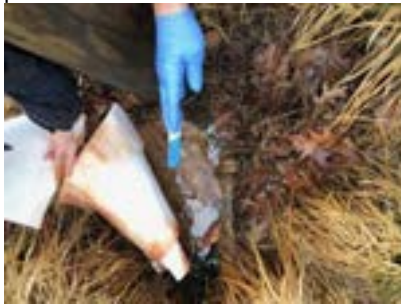
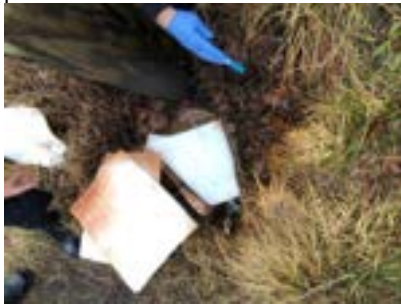
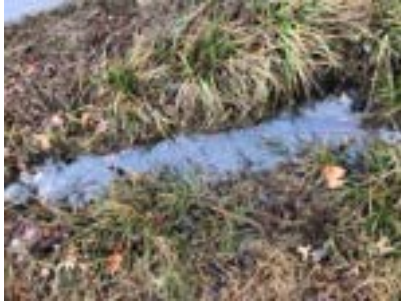
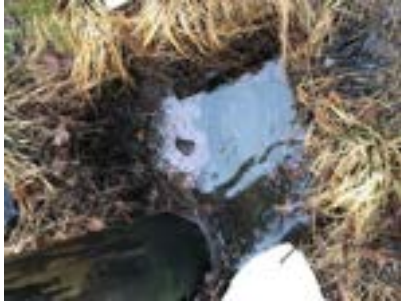
INCIDENT NARRATIVE
<p>FM525 requested phone consult for a sheen on the water in the drainage ditch along Aden Rd. This was noticed by the employees of Atlas cleaning up a diesel spill at Brentsville School. (This was uphill from the incident at Brentsville Highschool). HM, Engine and Rescue 506 and HMO 502 went enroute to the scene. Upon arrival we found a sheen in the drainage ditch stretching approximately 300 yards up the road. We tested the water in several places with oil finding paper and ph paper. Oil paper was positive and ph was neutral. Atlas had already placed down absorbant pads. The source of the sheen was not able to be located. With no other services needed we returned to service. Captain Adams stated he would take care of notifying VDOT, DEQ and watershed. The situation will be monitored several times over the next week or so when it is not inclement weather.</p>

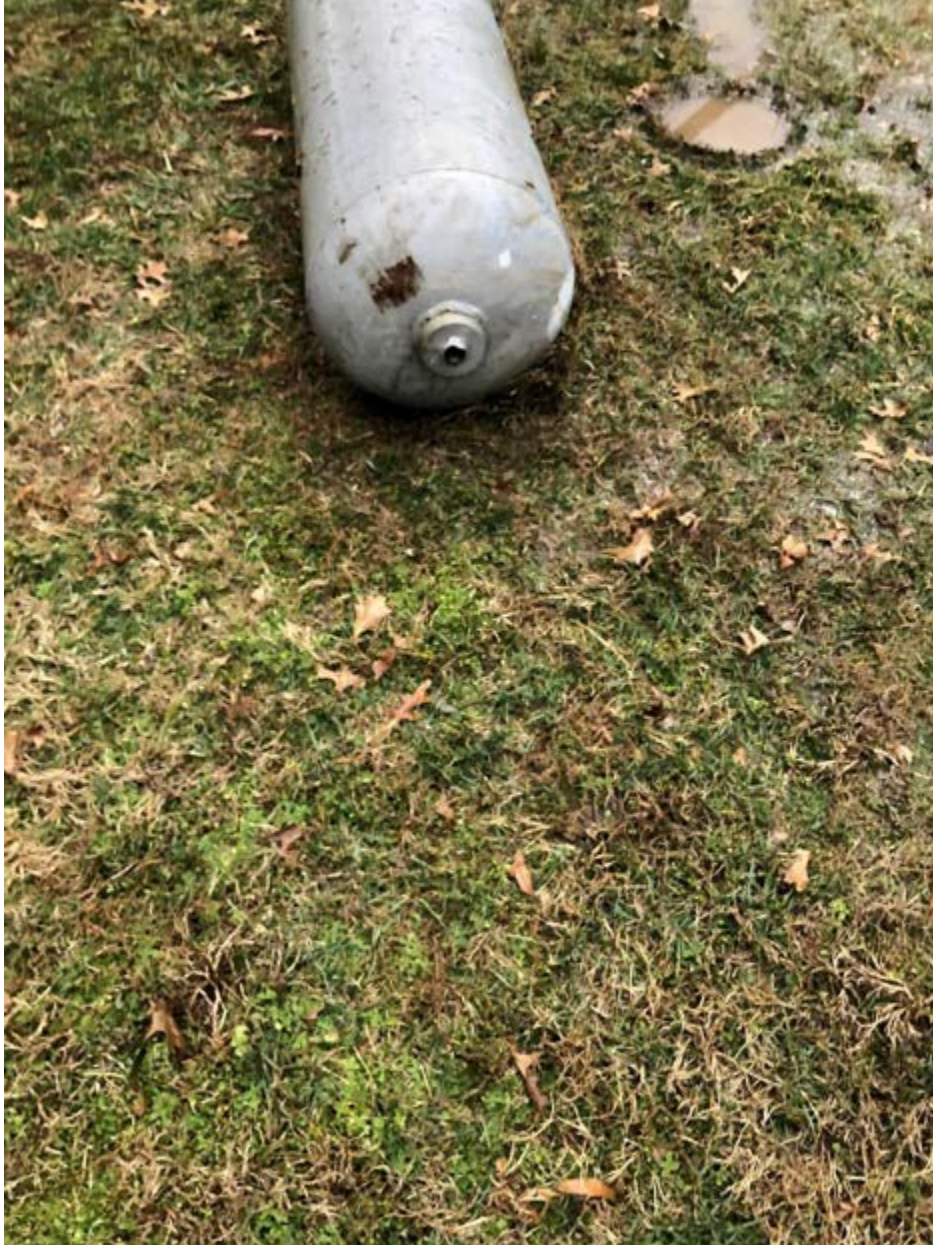
INCIDENT NARRATIVE
On the above date. E506 was dispatched for an outside gas leak. Upon arrival we found a 100lb propane tank that was leaking near the bottom. The tank was recently filled. The owner stated he had smelled gas and called several companies to pump the product out of the tank. It was determined that the best course of action was to flare the product off. No issues encountered during the operation. The valve was removed from the tank prior to turning over to property owner.

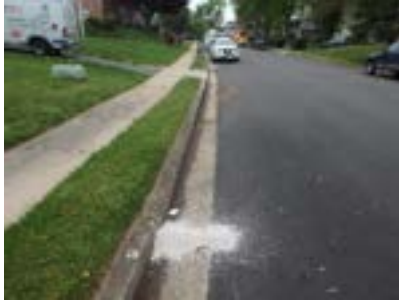
Spill on Kenny Court between 4701 and 4703

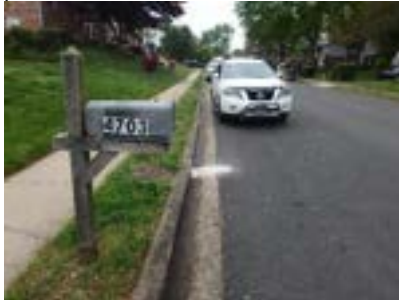
Spill in front of 4703 Kenny Court

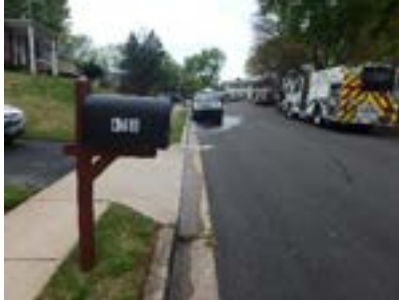
Spill in front of 4705 Kenny Court

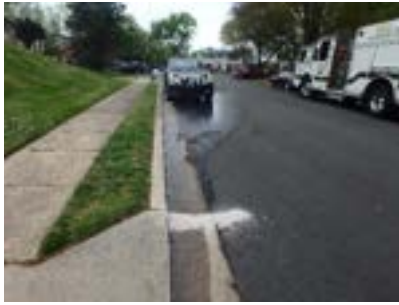
Spill in front of 4705 Kenny Court # 2

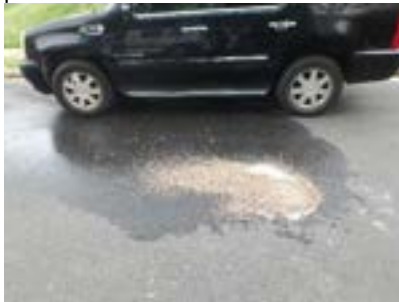
Spill in front of 4705 Kenny Court # 3

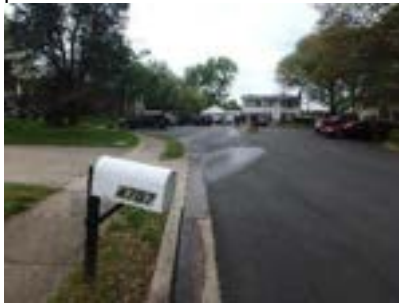
Spill in front of 4707 Kenny Court

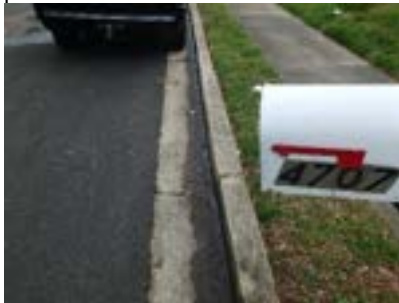
Spill and staining in front of 4707 Kenny Court

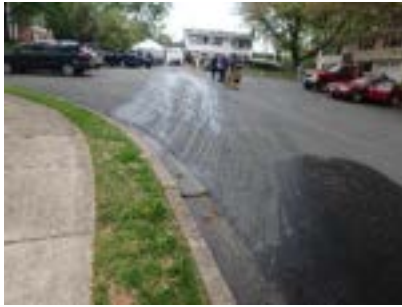
Spill in cul de sac of Kenny Court

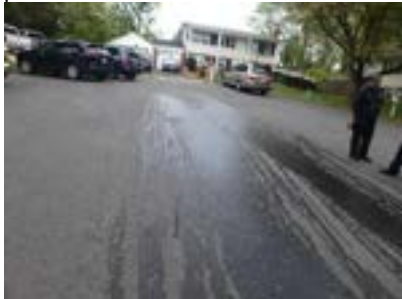
Spill in cul de sac of Kenny Court #2

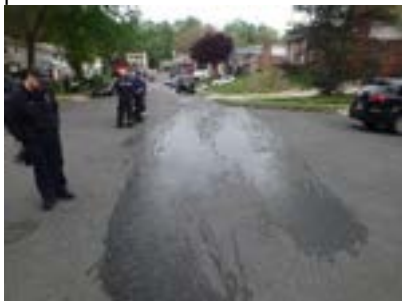
Spill in cul de sac of Kenny Court #3

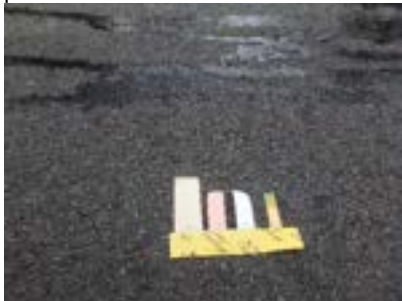
Paper testing on spill in cul de sac of Kenny Court

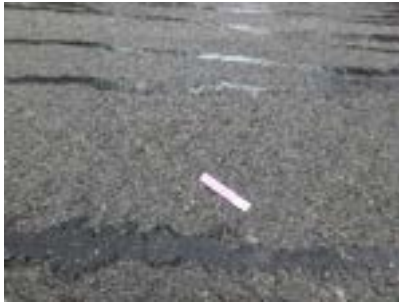
Water paper testing on spill in cul de sac

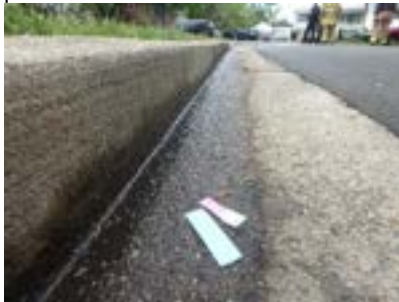
Water paper and oil finder paper testing on spill in front of 4707 Kenny Court

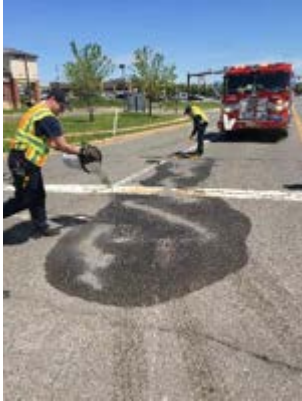
Fuel spill in interesection of Whitney rod and Old Linton Hall Road.

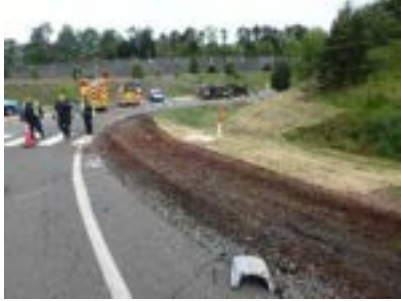
photos:Overview of incident from Prince William Pkwy turn lane.

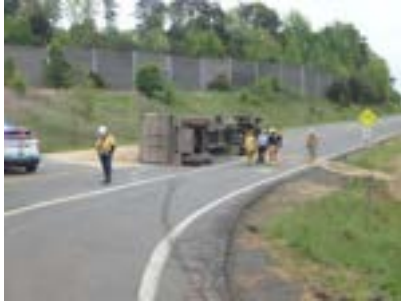
photos:Overview of incident from Prince William Pkwy turn lane #2.

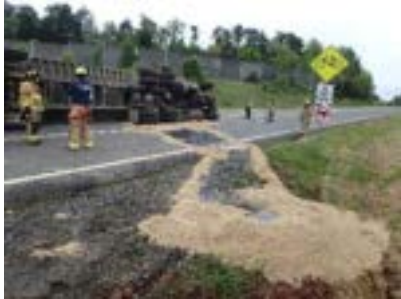
photos:Overview of incident and defensive measures.

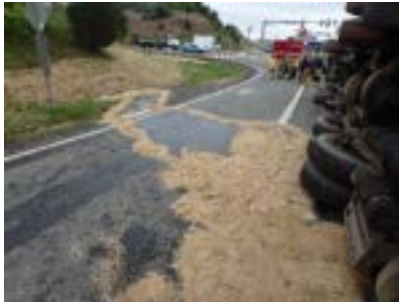
photos:Overview of spill.

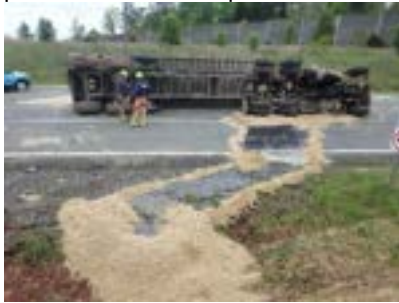
photos:Saddle tank leak.

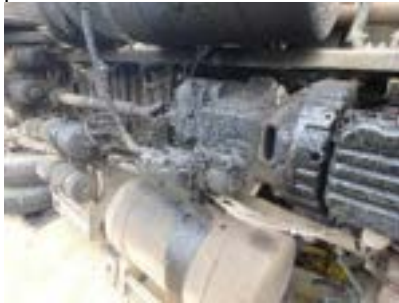
photos:Saddle tank leak.

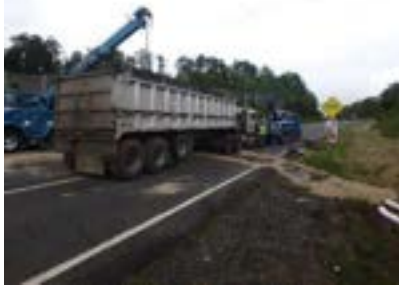
photos:Booms placed by Atals.

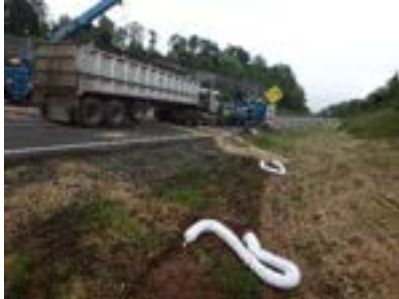
photos:Clover Hill Road after truck was removed.

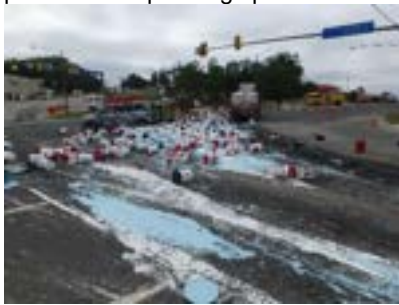
photos:Waterproofing spill overview

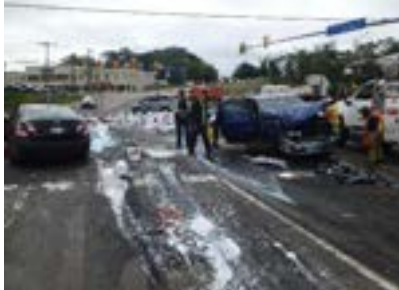
photos:Waterproofing spill overview #2

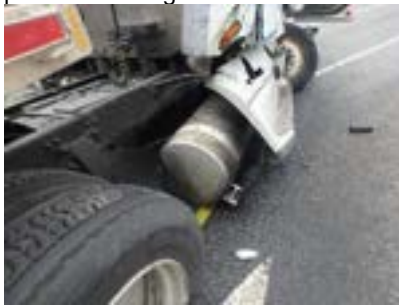
photos:Passenger side saddle tank

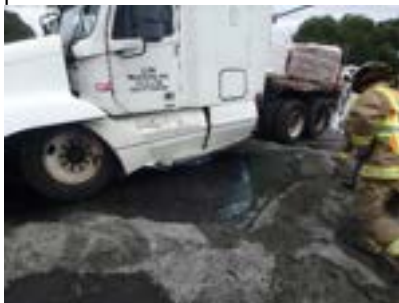
photos:Diesel fuel leak

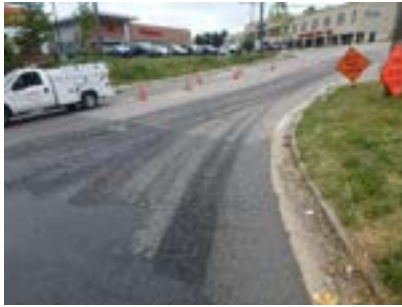
photos:Diesel fuel spread looking E Longview Dr

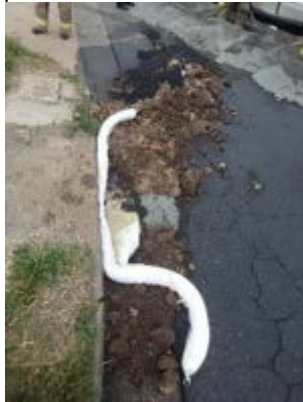
photos:Storm drain defensive ops

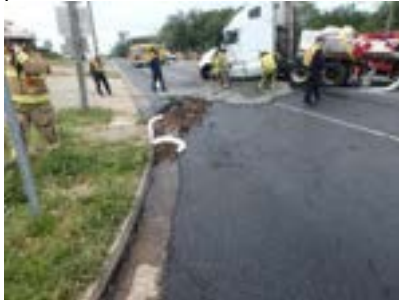
photos:Storm drain defensive overview

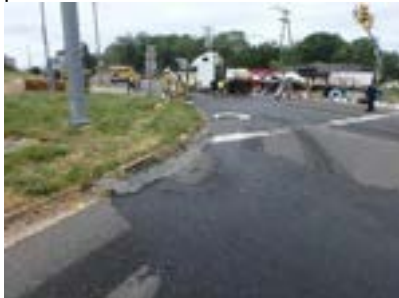
photos:Storm drain defensive overview # 3 with daming of diesel fuel

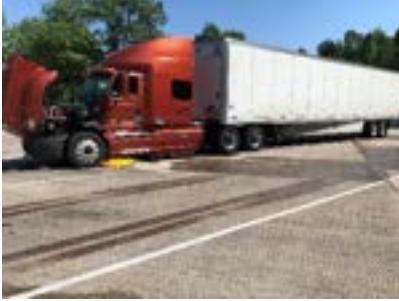
photos:Drivers side.

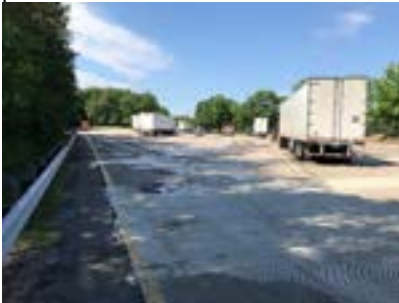
photos:Overview from rear of truck.

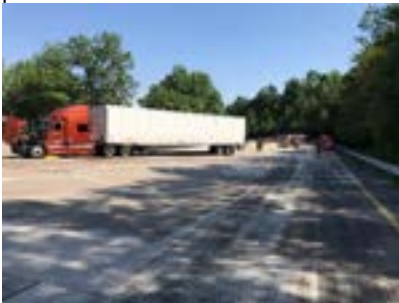
photos:Overview from front of truck.

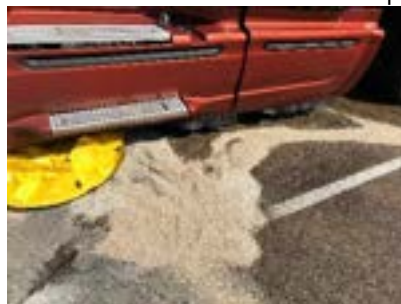
photos:Leak and defensive ops.

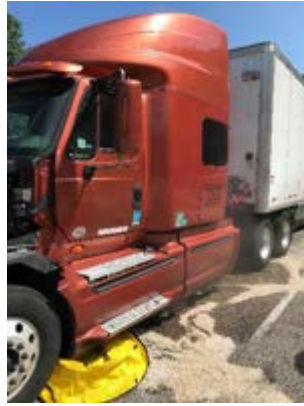
photos:Leak and defensive ops.

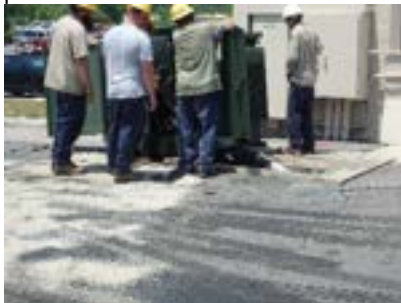
photos:Transformer

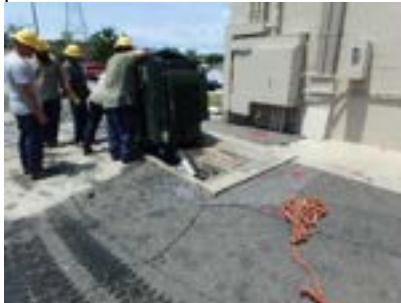
photos:NOVEC deployed absorbant socks

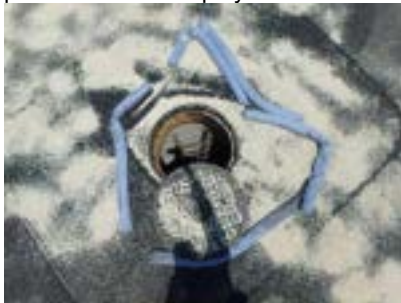
photos:NOVEC deployed absorbant socks

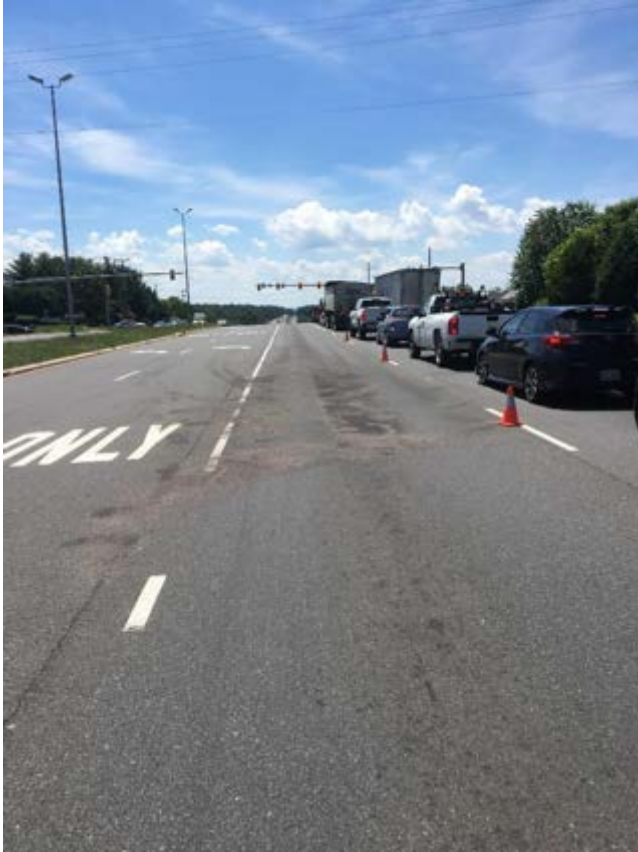
photos:Spill Overview

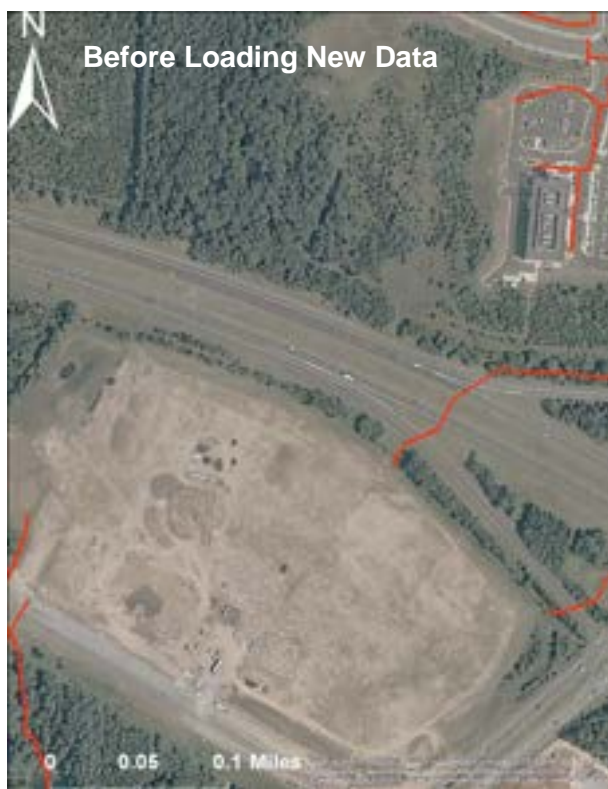
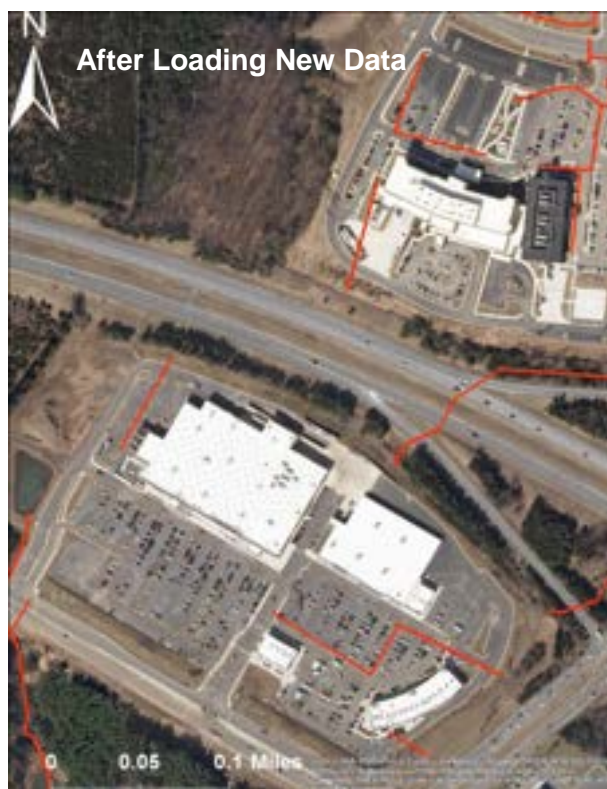
Figure 8. Depicts post-2009 development along Highway 15 and I-66 in Haymarket, VA. The image on the left shows the location in 2009, while the image on the right shows the area in 2015 after loading the new data into the Amec Single Network. Newly added segments still require editing to create a hydrologic connection. Editing procedures for creating this hydrologic connection are described below.

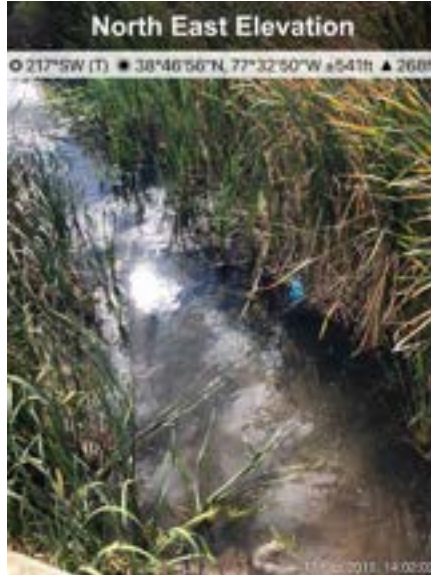
Manassas (#941)

Site #941 is located within the Bull Run watershed. It receives drainage from an industrial use area and parking lots with frequent truck traffic. Water levels are persistently found to be above 6 – 10 inches in the monitoring outfall. There was a similar level of standing water prior to the storm event.

Following the storm, the spillway draining to the pond had a number of fish and turtles swimming around. A slight oily sheen was apparent when retrieving the sampling ring.

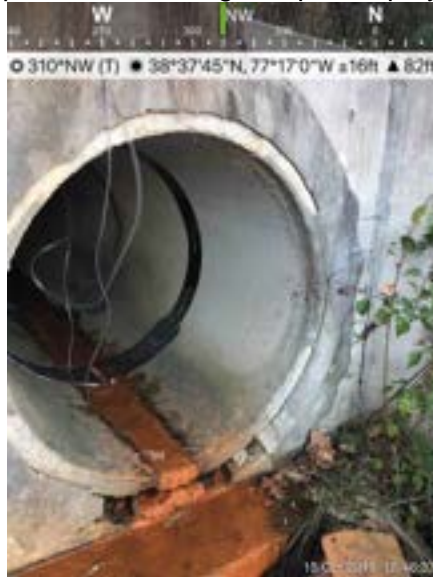
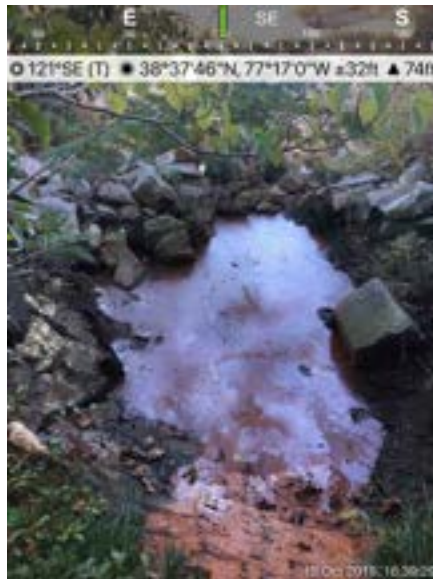
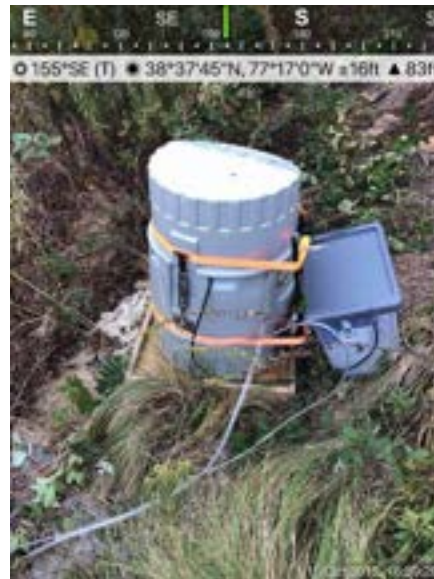
Dale City (#4684)

Site #4684 receives flow from Neabsco Mills Road and the Stonebridge at Potomac Town Center development. It is a 54" concrete pipe that drains to a deep scour pool before draining to a large BMP that collects drainage for the Potomac Club development. Erosion around the headwall and apron of the outfall at this site continues to pose a risk during sampler deployment and retrieval.

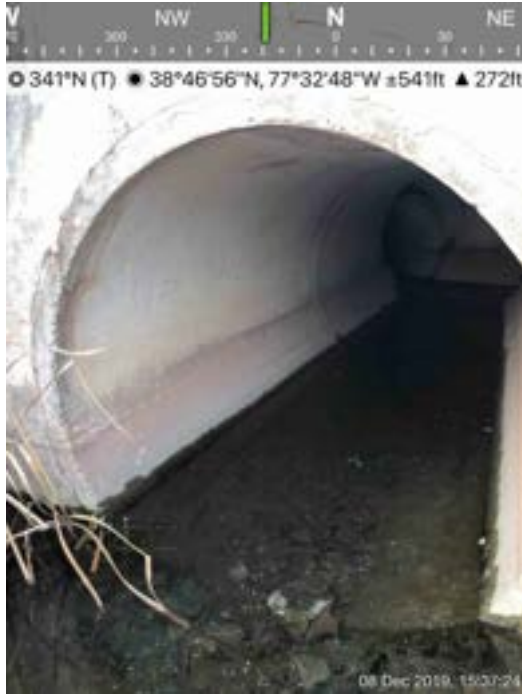
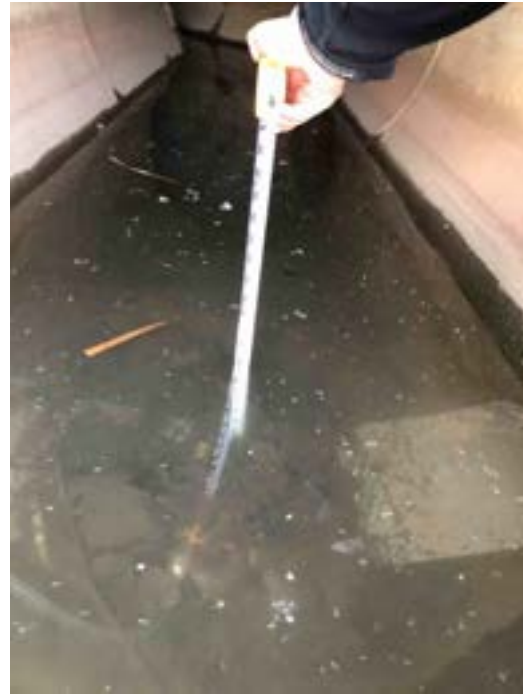
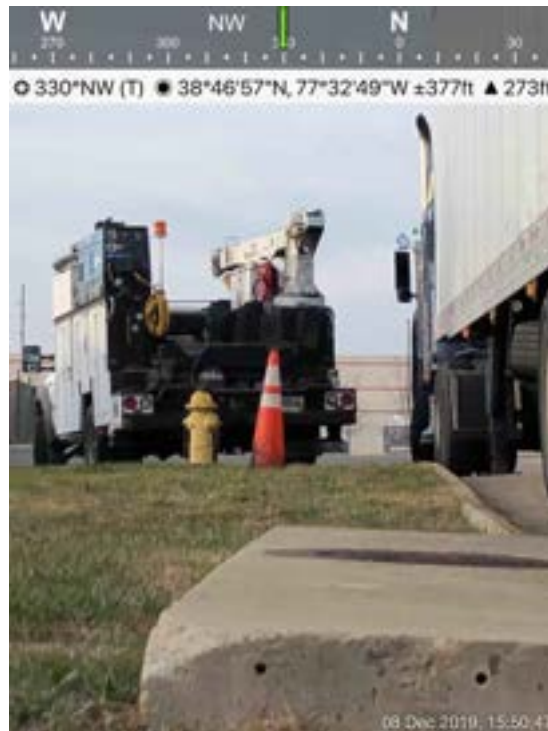
Manassas (#941)

During the most recent monitoring event, the field team noticed maintenance conducted on trucks parked in the lot draining to the outfall. Water levels at Site #941 are persistently found to be above 6 – 10 inches in the monitoring outfall. Backwater effects have made it increasingly difficult to perform wet weather monitoring.

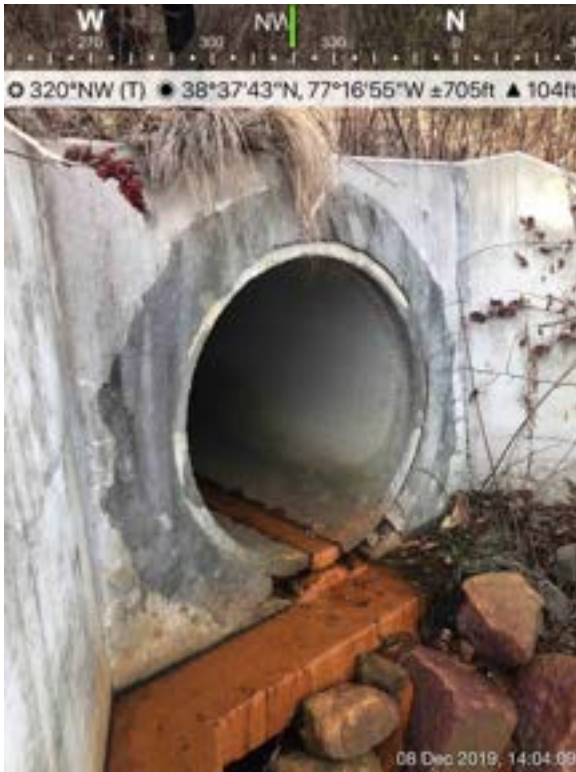
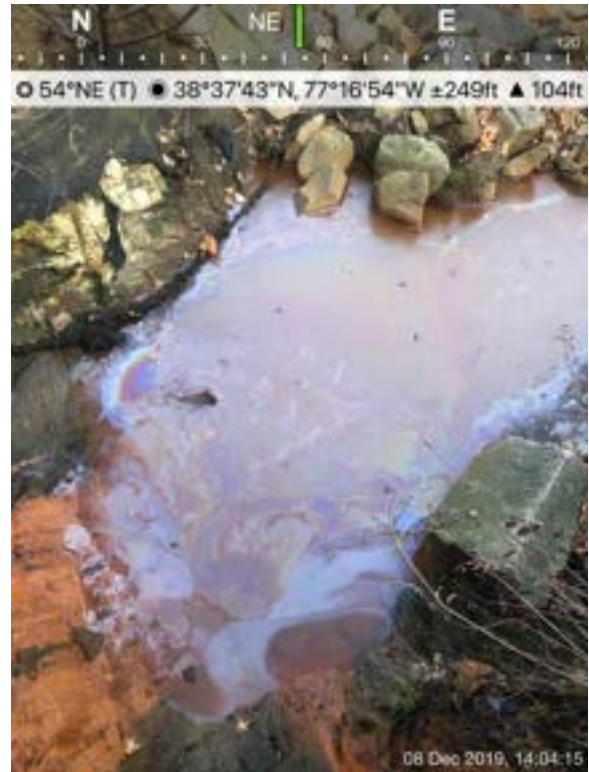
Dale City (#4684)

Site #4684 consists of a 54" concrete pipe that drains to a large retention pond draining the Potomac Club development. Erosion around the headwall and apron of the outfall at this site continues to pose a risk during sampler deployment and retrieval. Oily sheens and iron oxidizing bacteria are common occurrences in the scour pool.

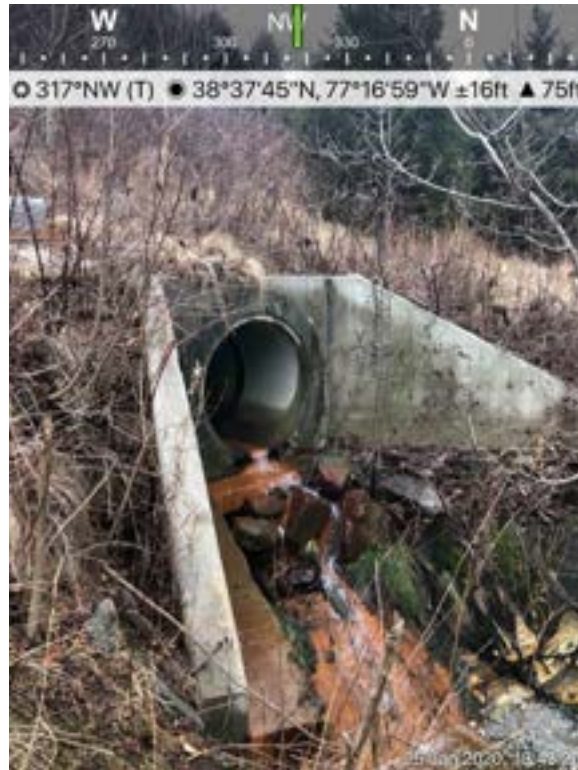
Dale City (#4684)

Site #4684 receives flow from Neabsco Mills Road and the Stonebridge at Potomac Town Center development. It is a 54" concrete pipe that drains to a deep scour pool before draining to a large BMP that collects drainage for the Potomac Club development. Erosion around the headwall and apron of the outfall at this site continues to pose a risk during sampler deployment and retrieval.

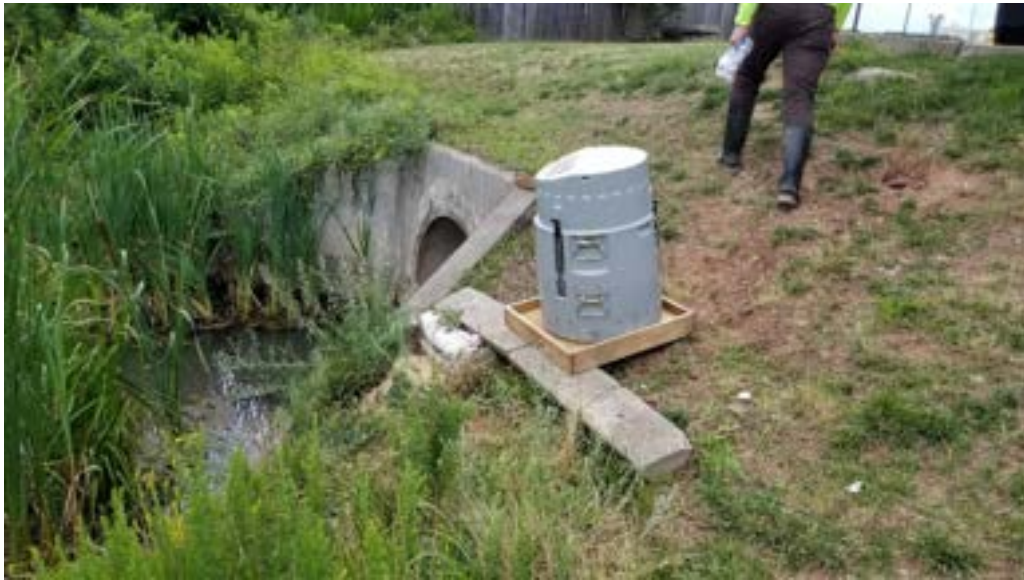
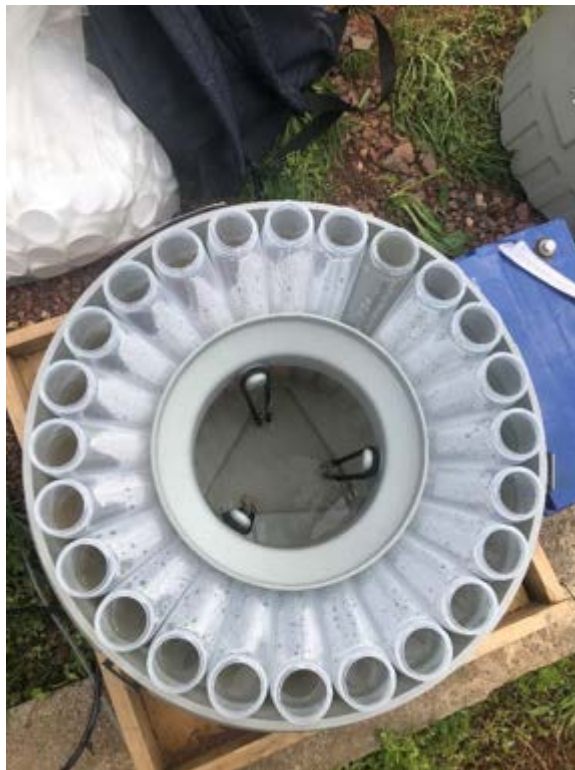
Manassas (#941)

Site #941 is located within the Bull Run watershed. It receives drainage from an industrial use area and parking lots with frequent truck traffic. Water levels are persistently found to be above 6 – 10 inches in the monitoring outfall.
