Annual Stormwater Management Report
VSMP Permit No. 0088595 – FY 2020

Submitted by:
Prince William County
Department of Public Works

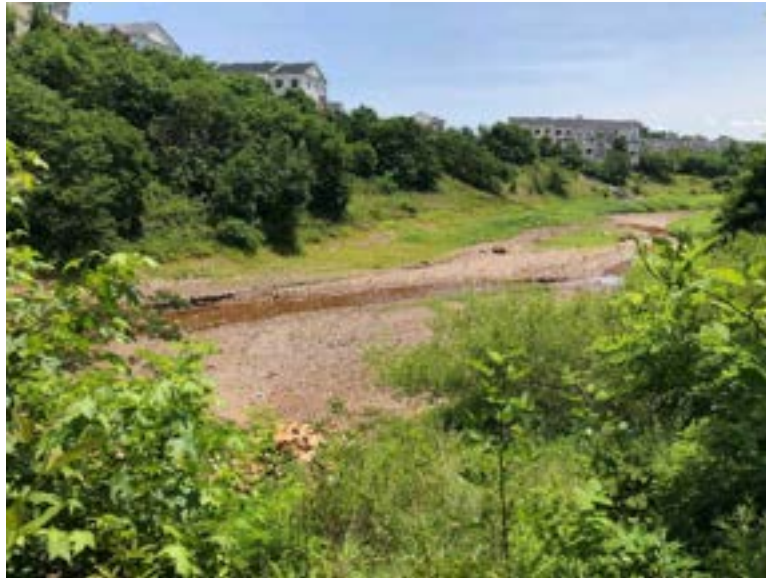
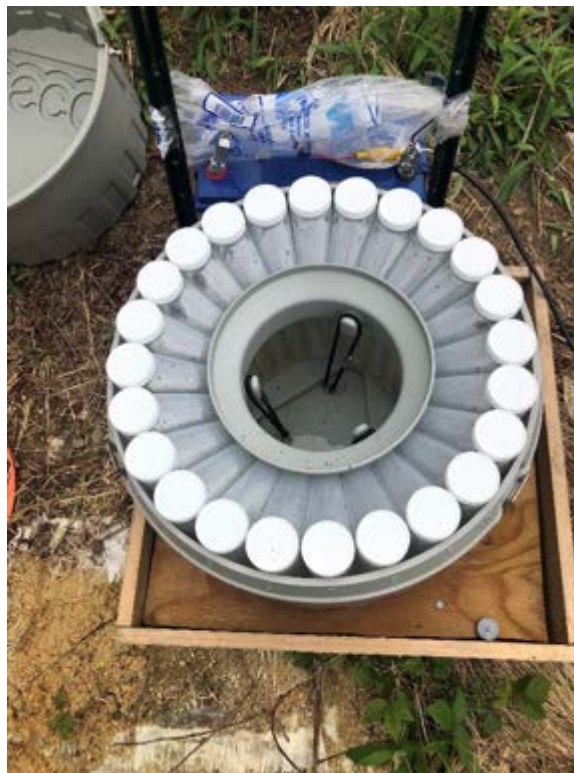
Dale City (#4684)

Site #4684 receives flow from Neabsco Mills Road and the Stonebridge at Potomac Town Center development. It is a 54" concrete pipe that drains to a deep scour pool before draining to a large BMP that collects drainage for the Potomac Club development. Erosion around the headwall and apron of the outfall at this site continues to pose a risk during sampler deployment and retrieval.

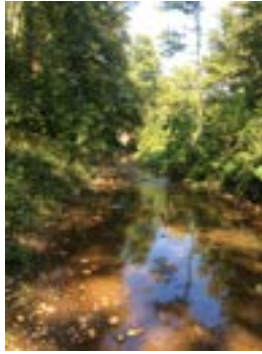
Image 1

Mid point looking upstream

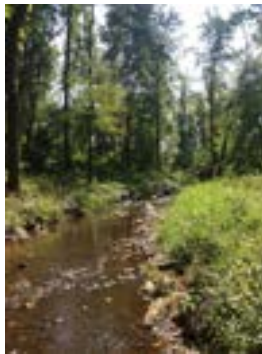
Image 2

Midpoint downstream.

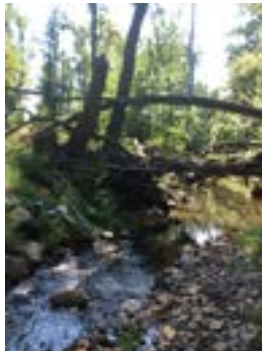
Image 3

Downstream from sample beginning. Tree has fallen on sample original point. Moved slightly upstream.

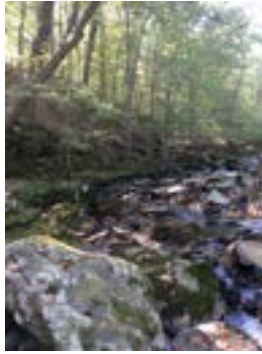
Image 1

Upstream end, looking upstream. Marker visible in foreground.

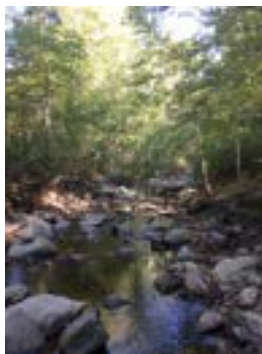
Image 2

Downstream at midpoint.

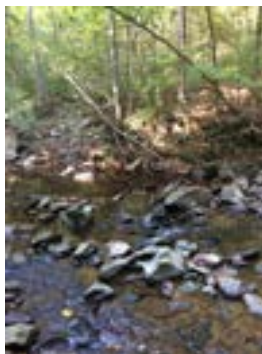
Image 3

Downstream extent.

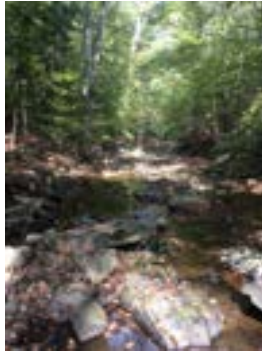
Image 1

Looking downstream from upstream end of reach

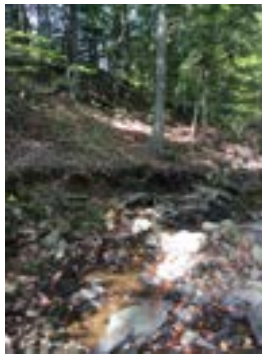
Image 2

Erosion at upstream end of sampling reach.

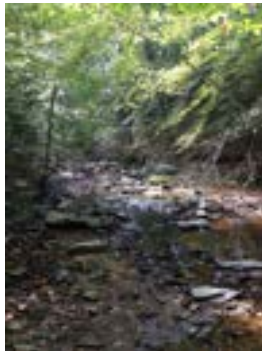
Image 3

Upstream from midpoint.

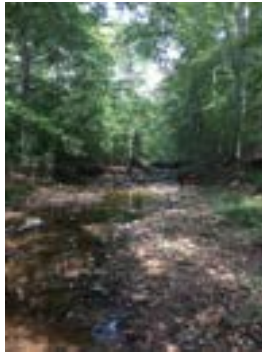
Image 4

Downstream from midpoint.

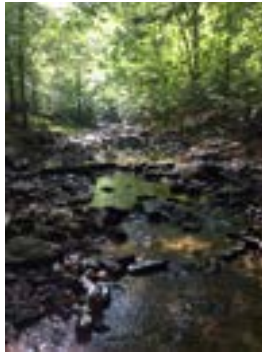
Image 5

Looking upstream from downstream extent of sampling reach.

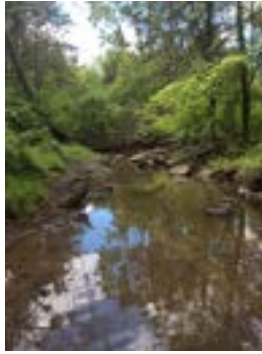
Image 1

Looking downstream from sample point. Beaver dam appears to have blown out.

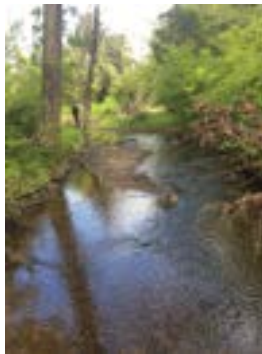
Image 2

Looking upstream from downstream extent of sampling reach. Stake cannot be located.

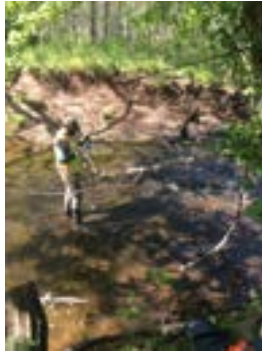
Image 1

End of reach

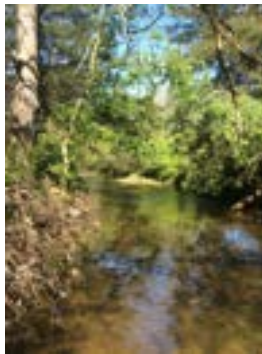
Image 2

Looking upstream towards end of reach. Note bar on left bank has grown.

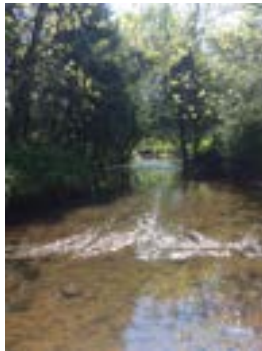
Image 3

Looking downstream about midway through the reach.

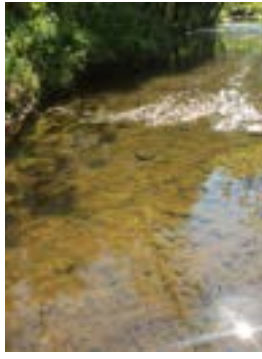
Image 4

High embeddedness. Attached algae spans stream reach. Likely from residential developments and golf course upstream.

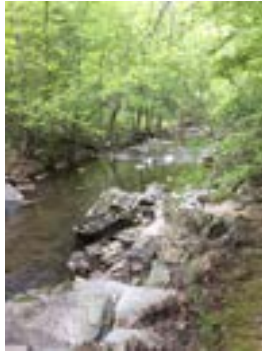
Image 1

End of reach

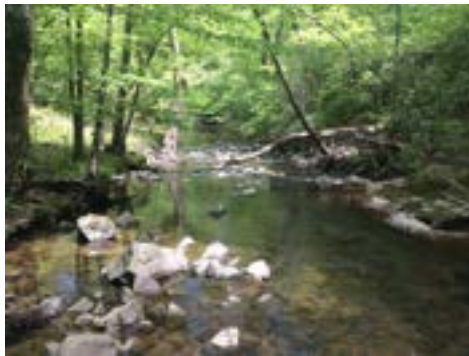
Image 2

Below reach

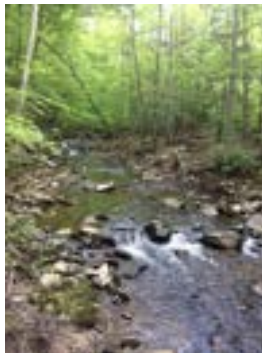
Image 3

Upstream

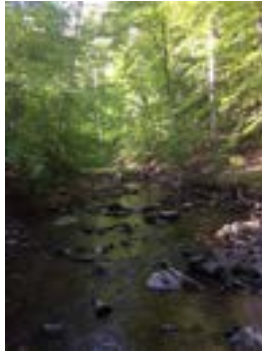
Image 1

Looking upstream from end of reach.

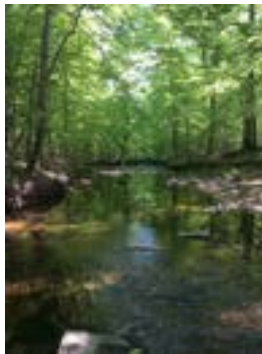
Image 2

Looking downstream towards end of reach. Note blowout on right bank.

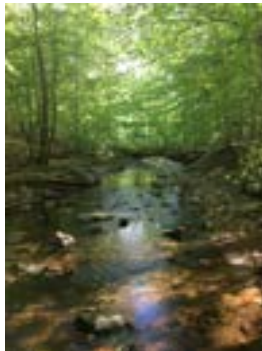
Image 3

Looking downstream towards recently finished stormwater pond. End of sampling reach.

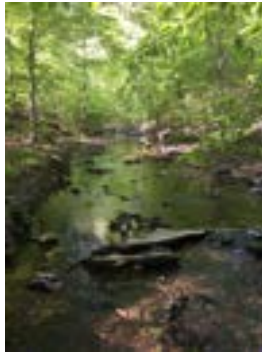
Image 4

Looking upstream from downstream extent of sampling reach.

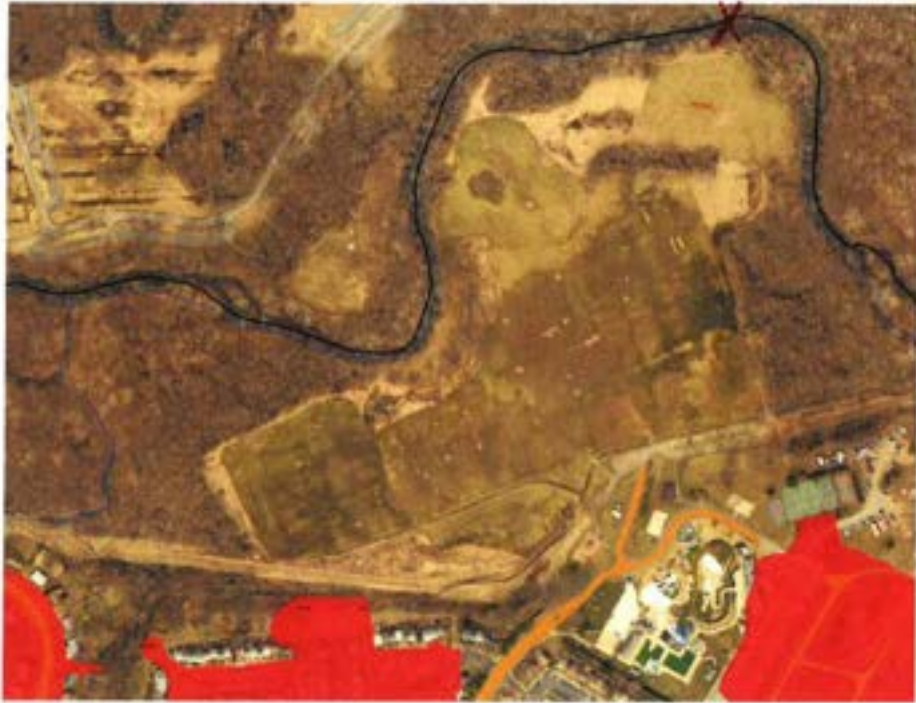
Site 1: Bull Run, Ben Lomond Park

Quality of upstream MS-4 outfalls: No quality upstream outfalls [0]
Upstream land uses: Residential, some Commercial [2]
Opportunity to reduce floatables sources: _____ []
Access and feasibility: _____ []
Size of contributing drainage area(s): Large >10ac [1]

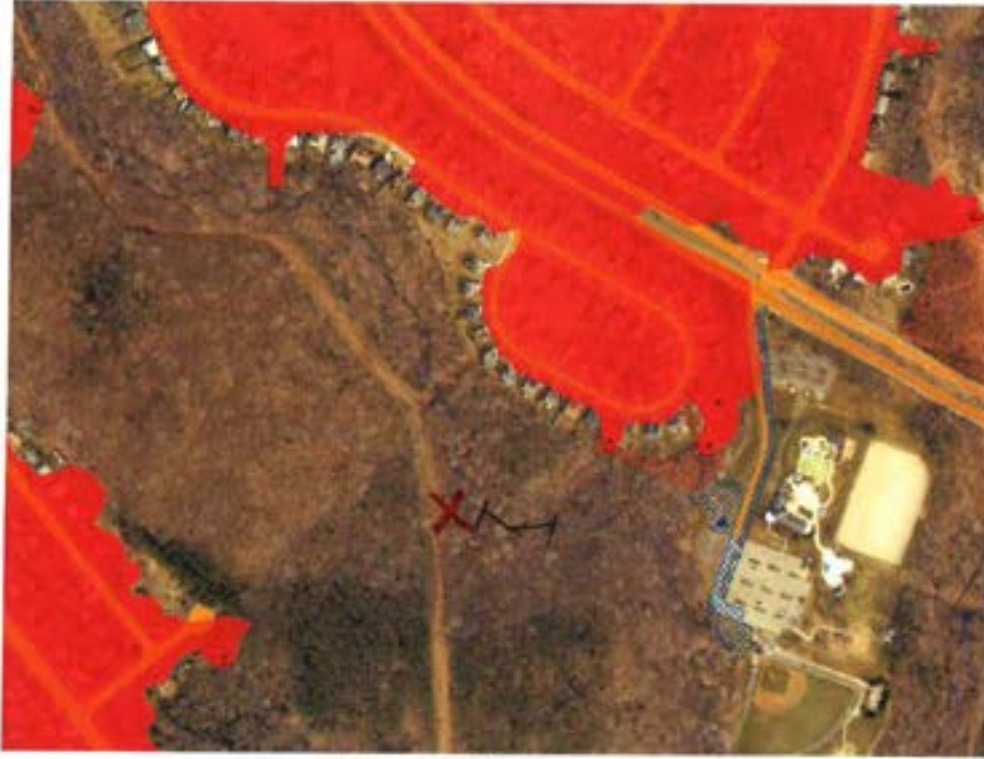
Site 7: Neabsco Creek, Andrew Leitch Park

Quality of upstream MS-4 outfalls: 2 quality outfalls [2]
Upstream land uses: Residential small lot [3]
Opportunity to reduce floatables sources: Low numbers of floatables [4]
Access and feasibility: good access, too few inputs good isolated inputs [10] [5]
Size of contributing drainage area(s): Small - Mid [4]

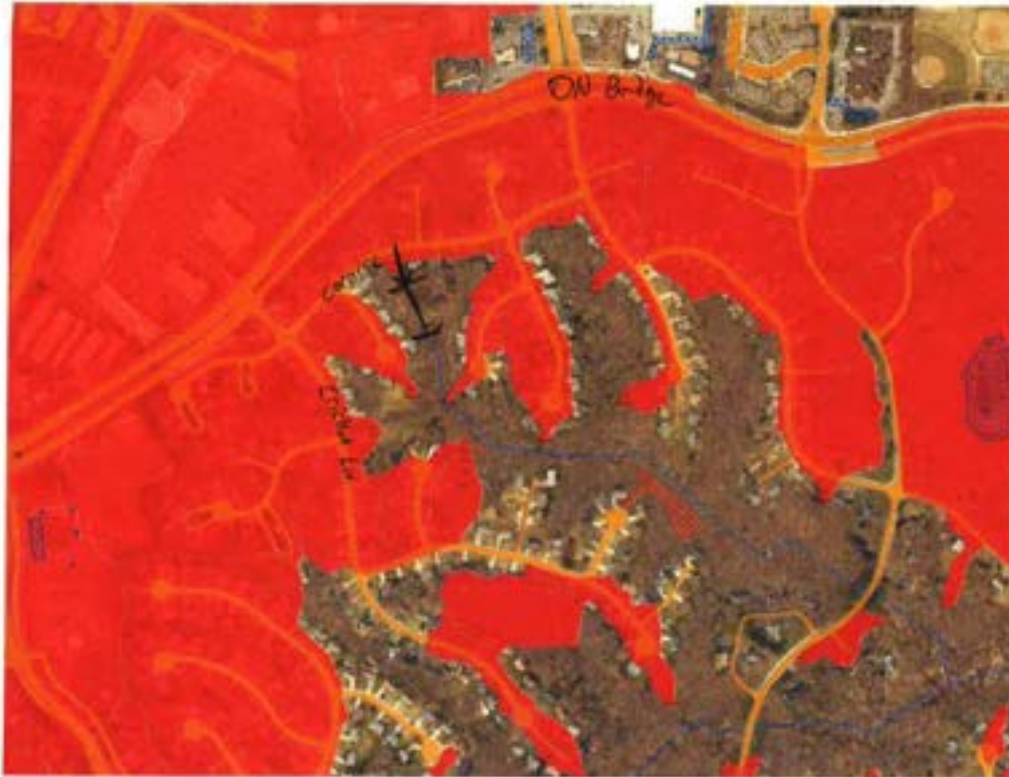
Site 12:

Quality of upstream MS-4 outfalls: Many (4)
Upstream land uses: Commercial/Residential (4)
Opportunity to reduce floatables sources: Good amount of floatables (4)
Access and feasibility: Small stream, easy access from Roadway (3)
Size of contributing drainage area(s): Very Large (1)
