**Annual Stormwater Management Report
VSMP Permit No. 0088595 – FY 2021**

Submitted by:
Prince William County
Department of Public Works

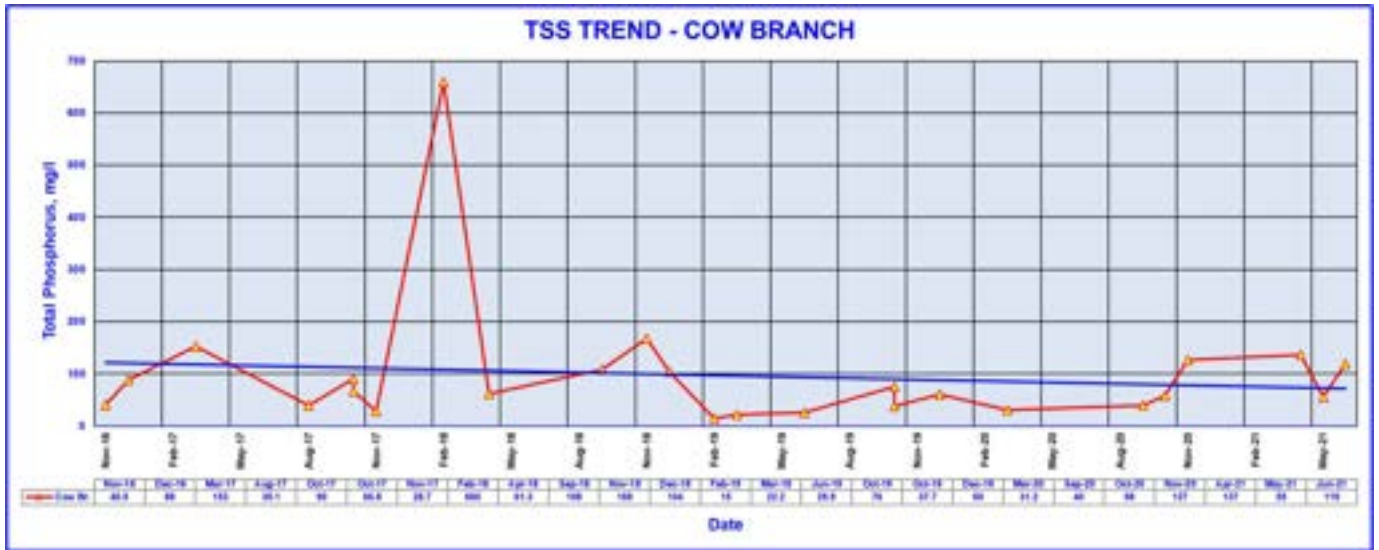
Figure 14 – Long Term TSS trends in the Cow Branch Watershed

TSS shows a decreasing trend.

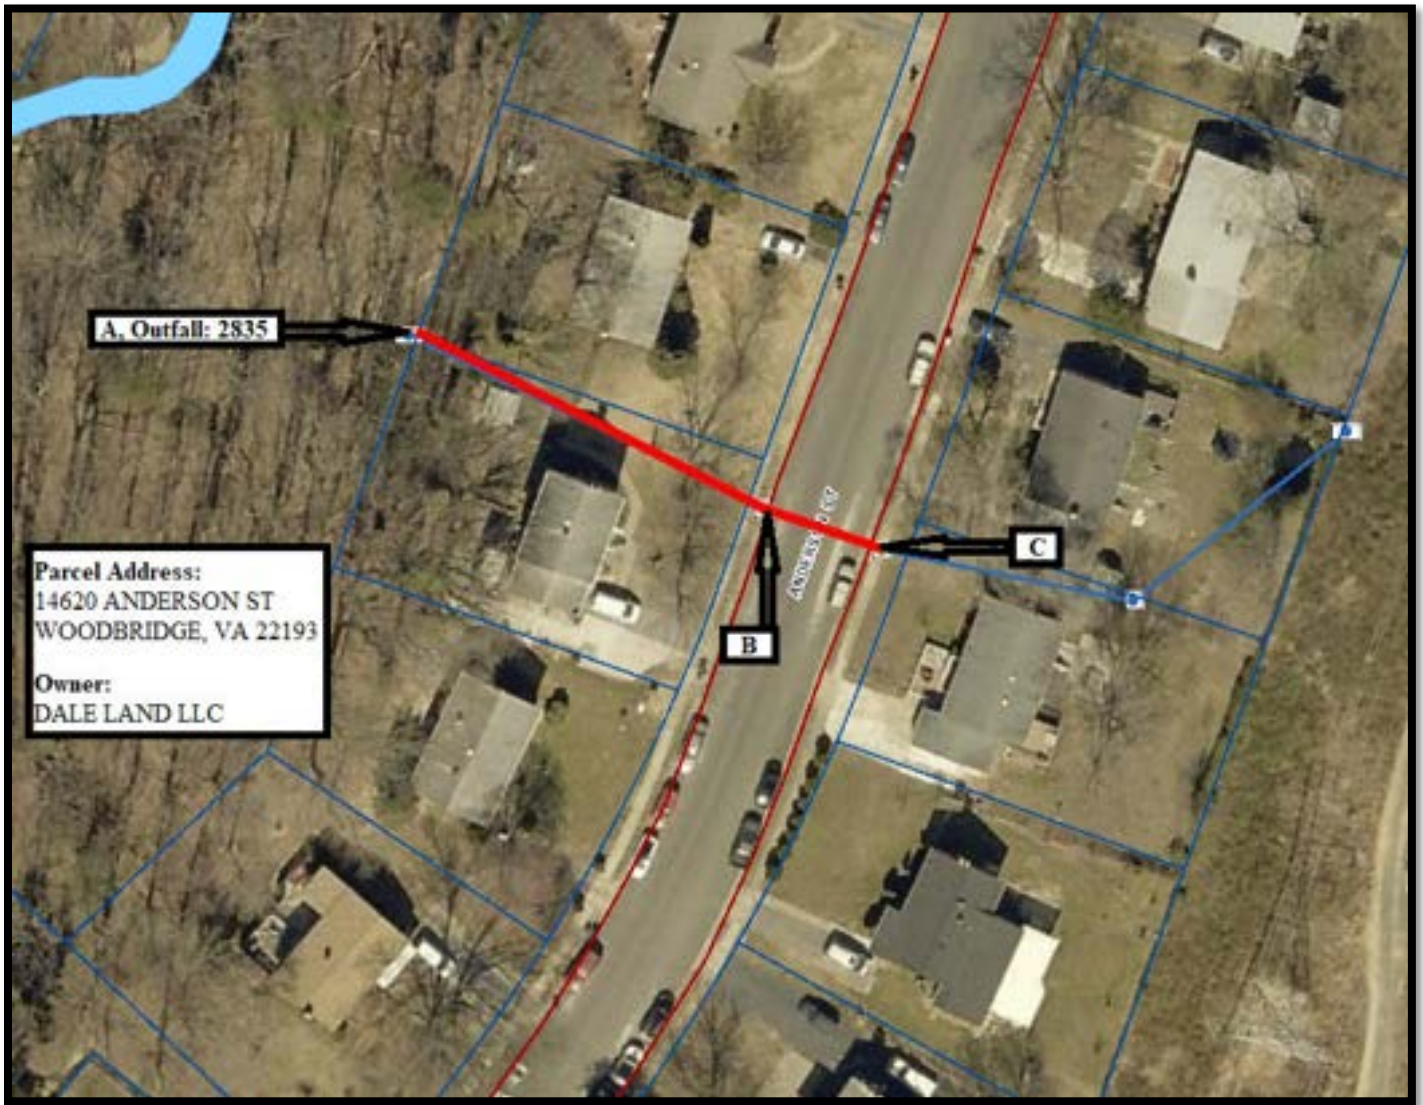
Map of Trackdown Path:

Comments/ Deficiencies:

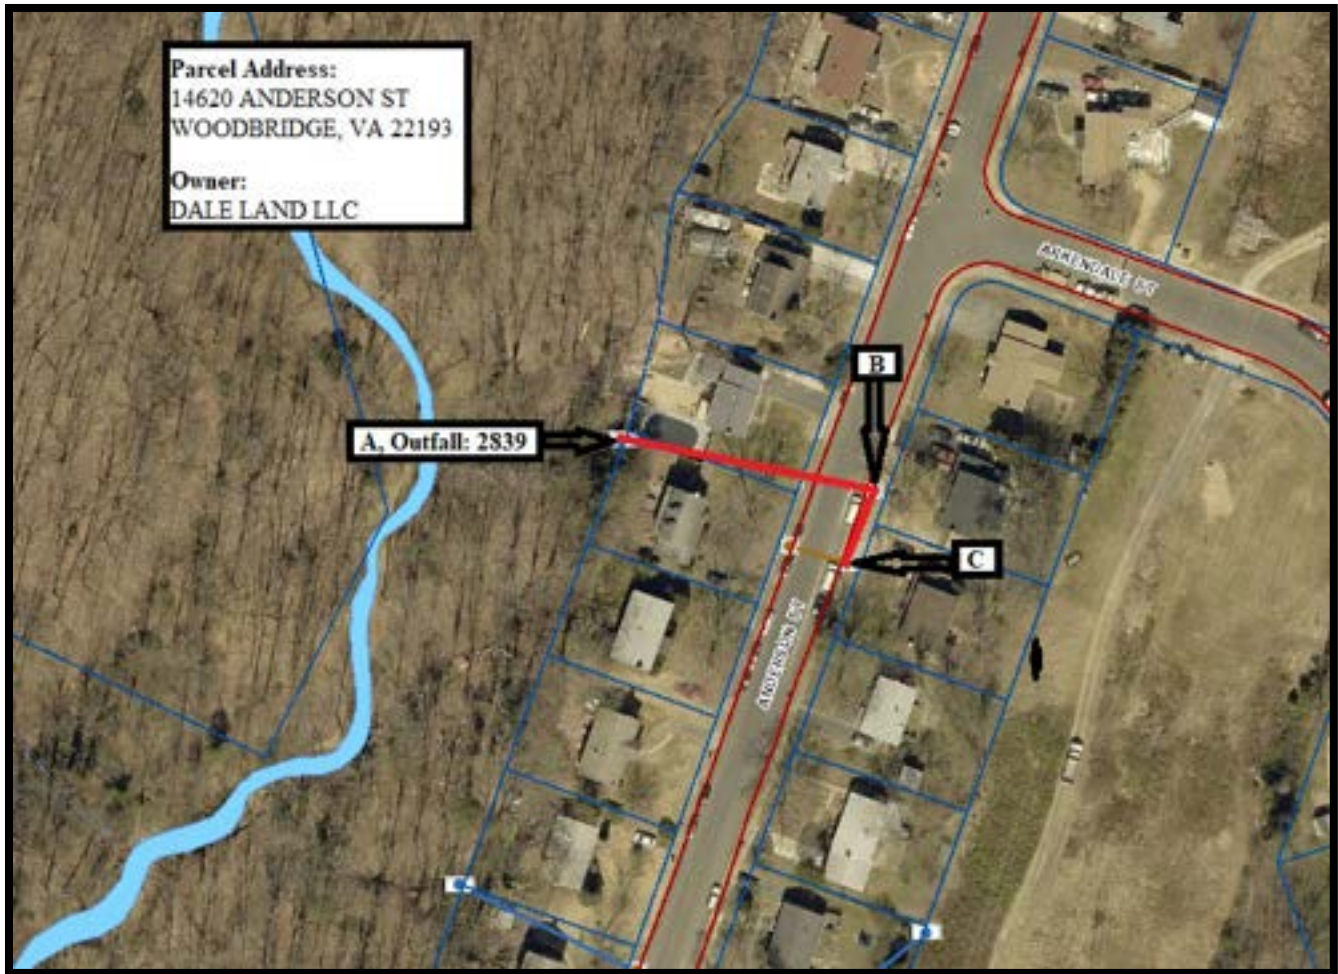
Map of Trackdown Path:

Responsible Party (Owner/ Institutions)	Other Party (Management Company)
Name: NA	Name: NA
Company:	Company:
Address:	Address:
Phone #:	Phone #:
Note:	Note:
Notification/Contact (Other agencies contacted (DEQ, NS, FMO?) NA	
Date:	Date:
Time:	Time:
Name: NA	Name:
Company/Agency:	Company/Agency:
Notes:	Notes:
<u>Comments/ Deficiencies:</u>	
<p>Flow was observed through the outfall. Algae bloomed at outfall. pH and Conductivity did not exceed the standard limits. Discharge was tracked along storm sewer marked with red line in map above. Manhole B had flow from BC branch. Ground seepage was discovered at manhole C. Cross connection of sanitary sewer did not find during inspection.</p>

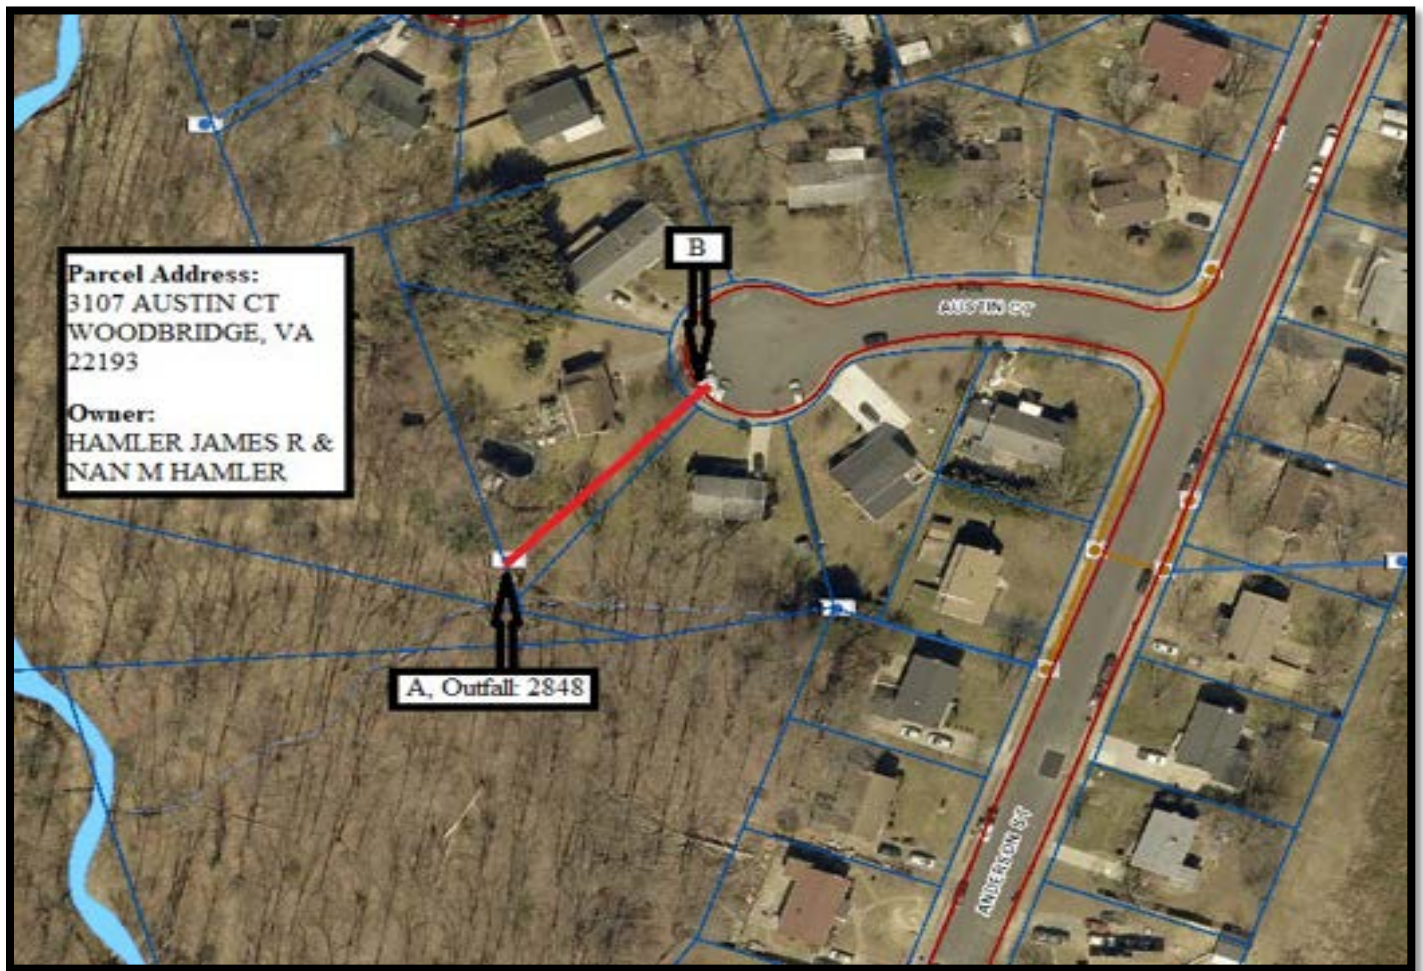
Map of Trackdown Path:

Responsible Party (Owner/ Institutions)	Other Party (Management Company)
Name: NA	Name: NA
Company:	Company:
Address:	Address:
Phone #:	Phone #:
Note:	Note:
Notification/Contact (Other agencies contacted (DEQ, NS, FMO?) NA	
Date:	Date:
Time:	Time:
Name: NA	Name:
Company/Agency:	Company/Agency:
Notes:	Notes:
<u>Comments/ Deficiencies:</u>	
<p>Flow was observed through the outfall. pH and Conductivity did not exceed the standard limits. Discharge was tracked along storm sewer marked with red line in map above. Manhole B was found dry. Cross connection of sanitary sewer did not find during inspection.</p>

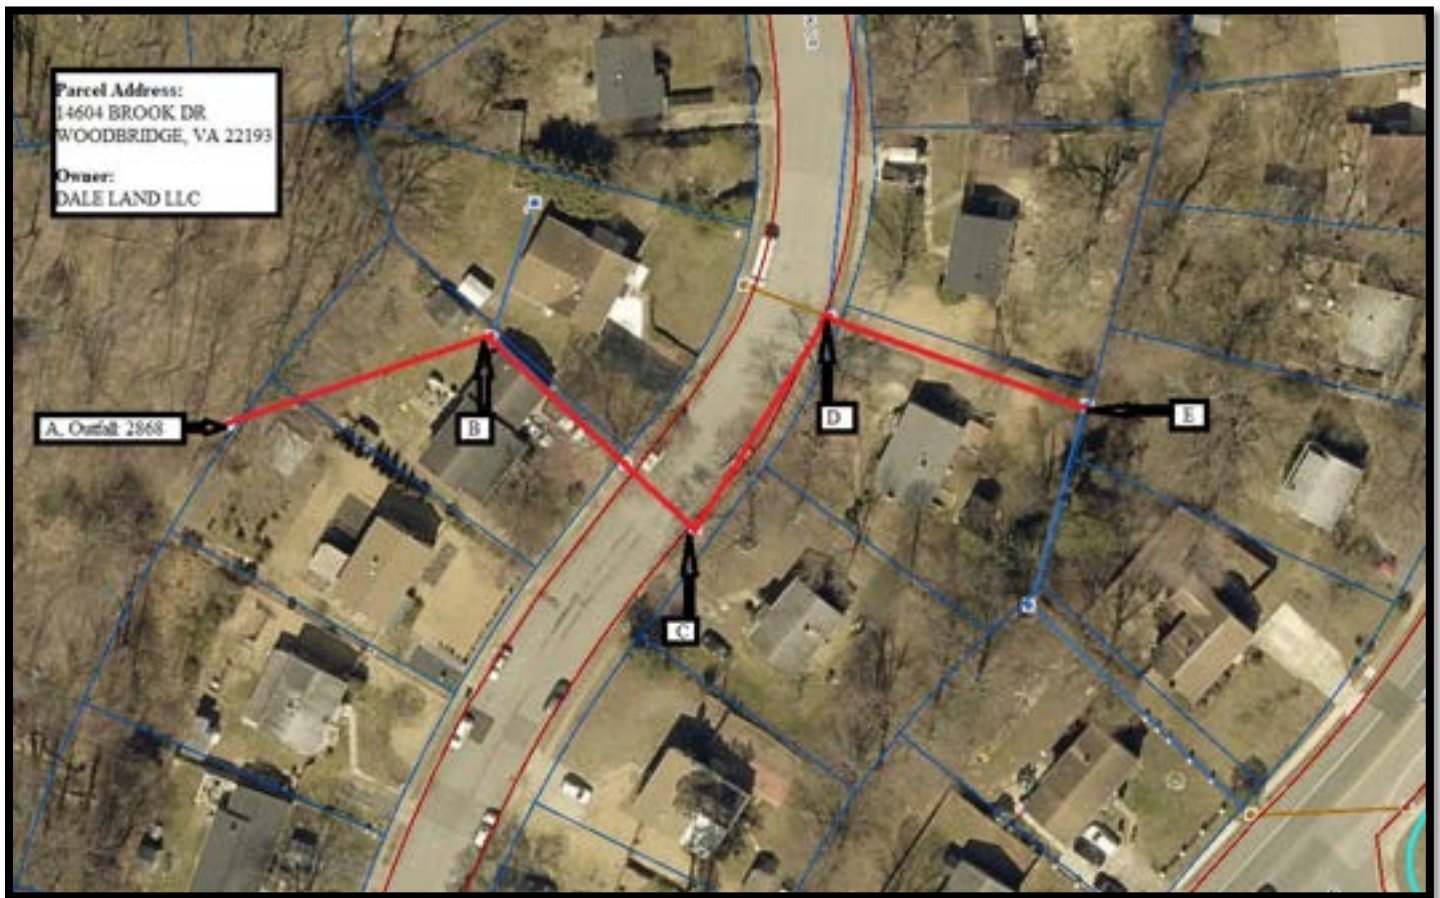
Map of Trackdown Path:

Responsible Party (Owner/ Institutions)	Other Party (Management Company)
Name: NA	Name: NA
Company:	Company:
Address:	Address:
Phone #:	Phone #:
Note:	Note:
Notification/Contact (Other agencies contacted (DEQ, NS, FMO?) NA	
Date:	Date:
Time:	Time:
Name: NA	Name:
Company/Agency:	Company/Agency:
Notes:	Notes:
<u>Comments/ Deficiencies:</u>	
<p>Flow was observed through the outfall. pH and Conductivity did not exceed the standard limits. Discharge was tracked along storm sewer marked with red line in map above. Manhole B was receiving discharge from BC direction. Tracking was continued until point E. Manhole E was receiving discharge from open channel. Manholes were found with minor ground water seepage. Cross connection of sanitary sewer did not find during inspection.</p>

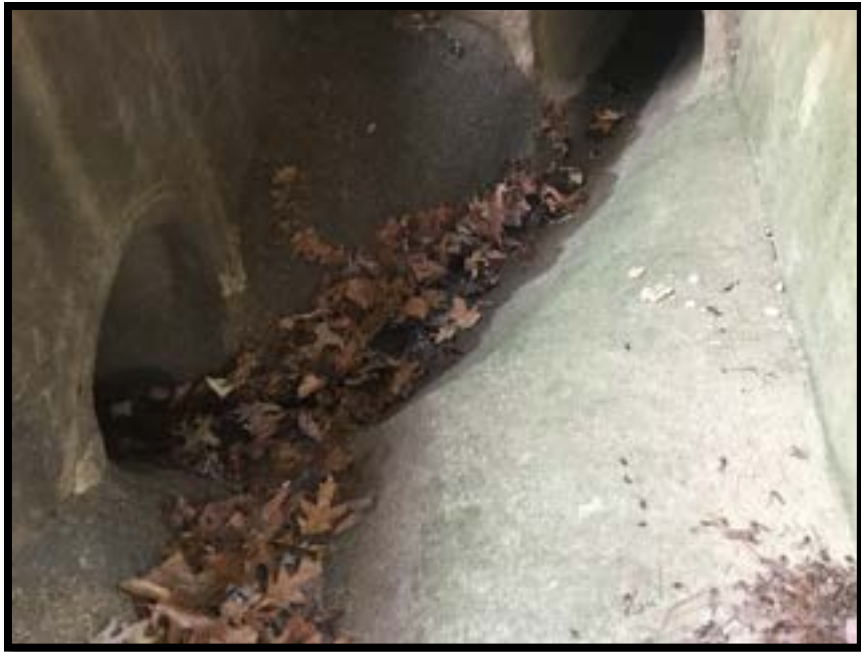
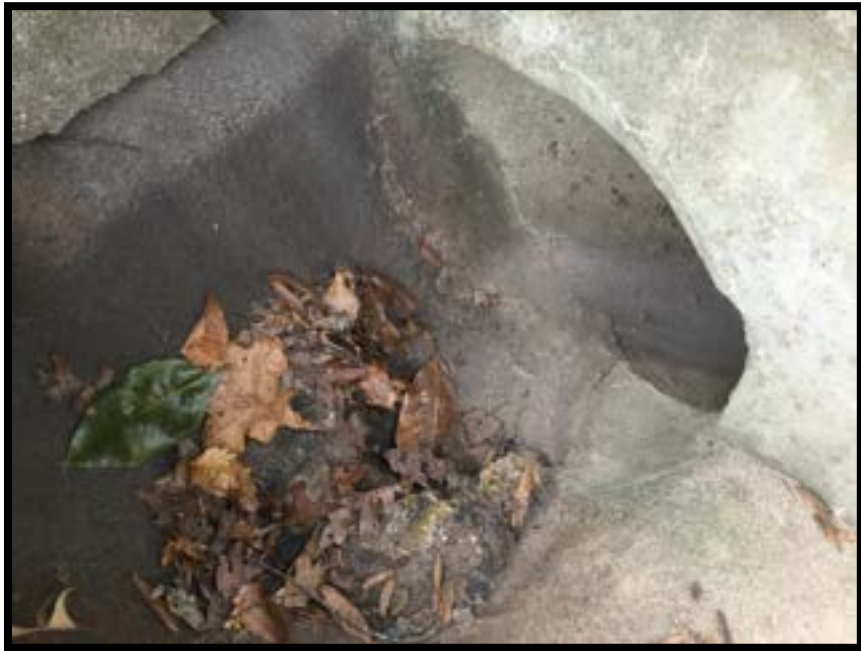
Flow was observed through the outfall. pH and Conductivity did not exceed the standard limits. Stagnant pool was observed at outfall. Oil scene was developed on pool surface due to bacteria.

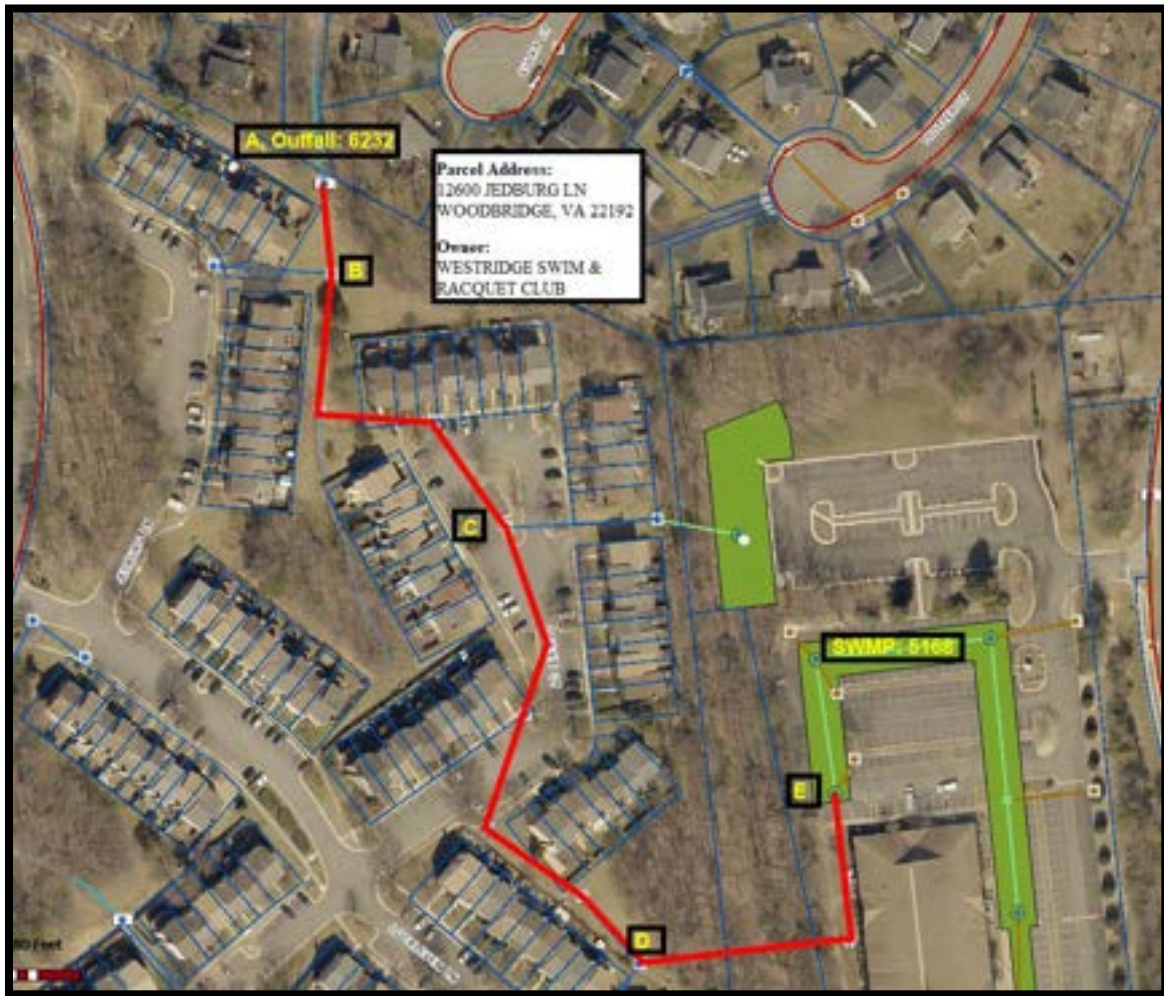
Map of Trackdown Path:

Responsible Party (Owner/ Institutions)	Other Party (Management Company)
Name: NA	Name: NA
Company:	Company:
Address:	Address:
Phone #:	Phone #:
Note:	Note:
Notification/Contact (Other agencies contacted (DEQ, NS, FMO?) NA)	
Date:	Date:
Time:	Time:
Name: NA	Name:
Company/Agency:	Company/Agency:
Notes:	Notes:
<u>Comments/ Deficiencies:</u>	
<p>Flow was observed through the outfall. pH and Conductivity did not exceed the standard limits. Stagnant pool was observed at the outfall.</p> <p>Discharge was tracked along storm sewer marked with red line in the map above. Manhole B had flow from BC direction, and continued tracking along BCDE. E is the outlet of underground storm water outlet. Source of discharge is water holding by upstream pond during rainfall.</p>

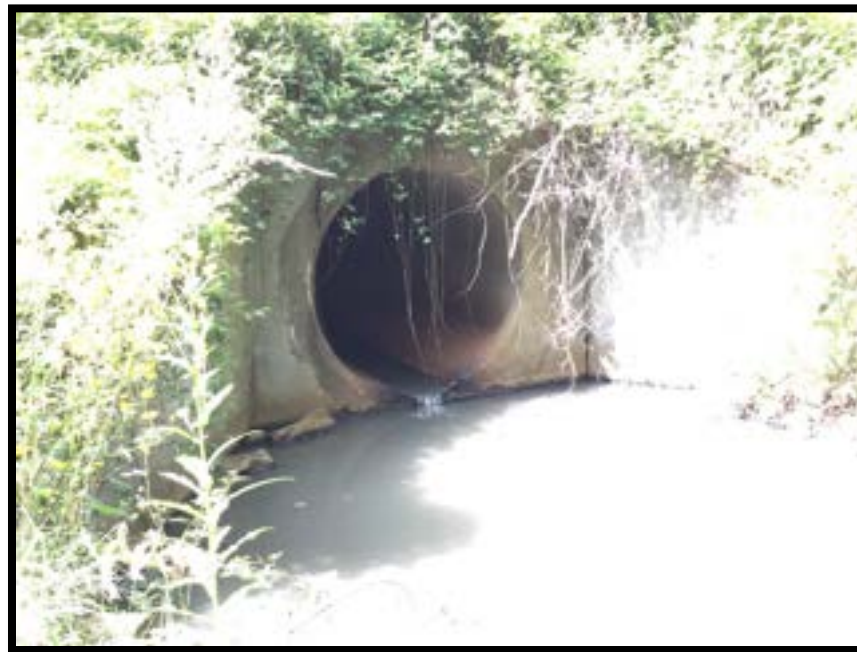
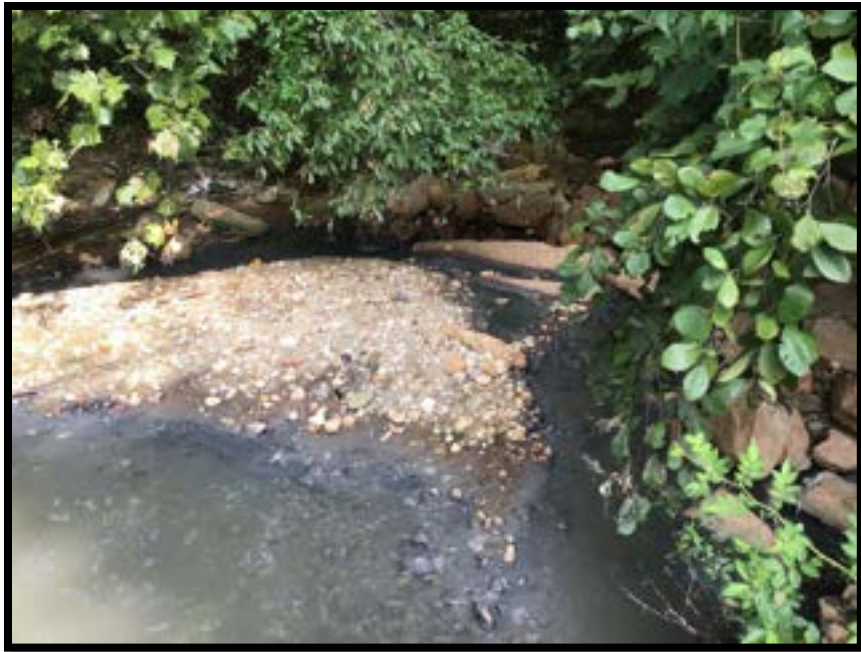
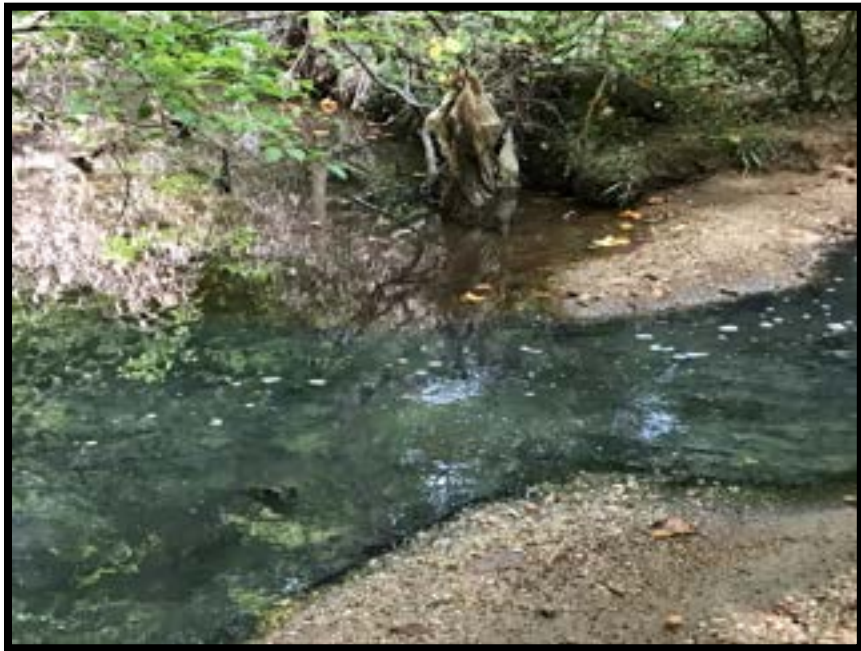
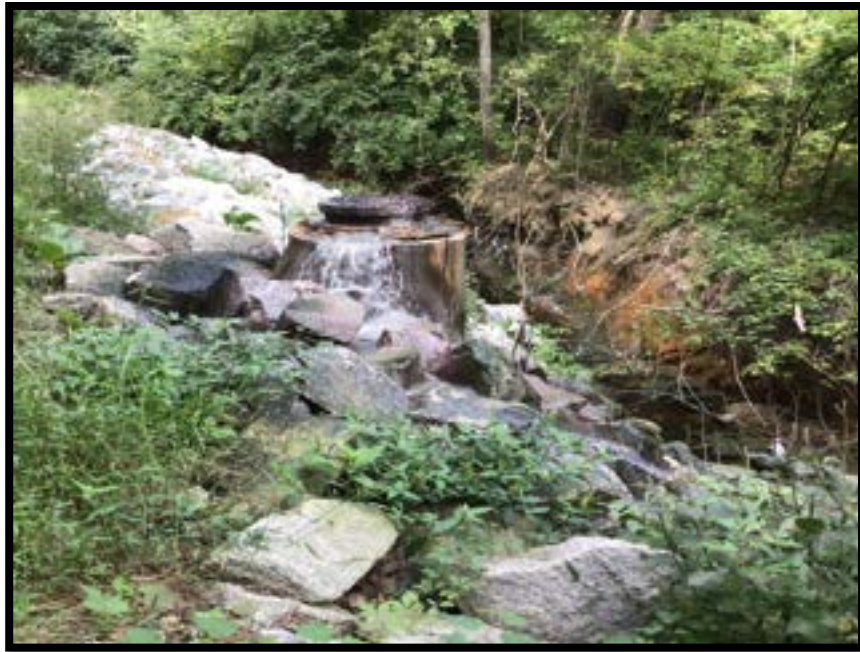
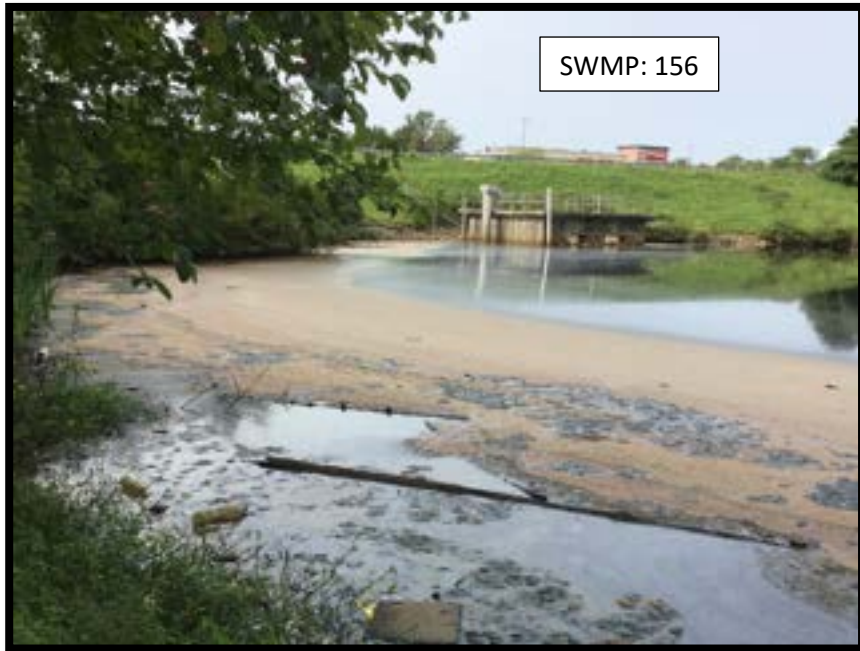
Photos:

Outfall is an outlet of CSWMP 5086. Discharge was observed at outfall A with sewage smell. pH and Conductivity exceeded the standard limits. The pond was receiving grey water from the creek. Discharge was tracked along the creek. At the upstream catchment, sanitary manhole was overflowing from the broken lid.

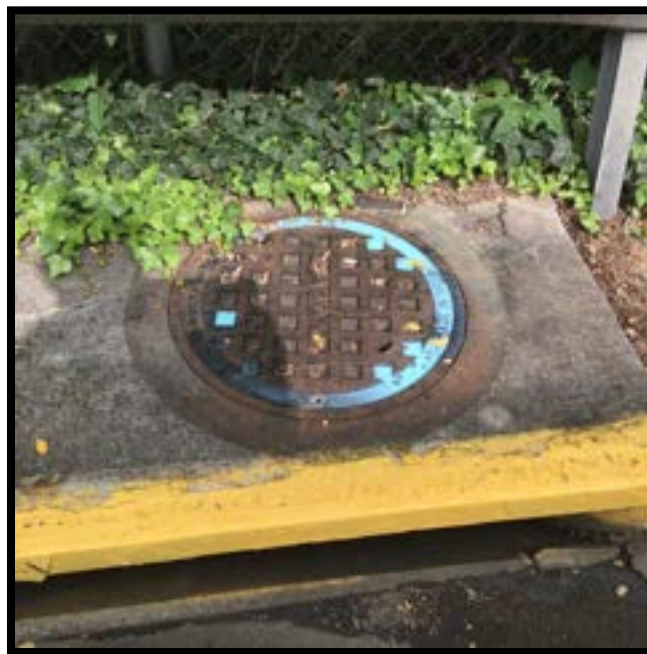
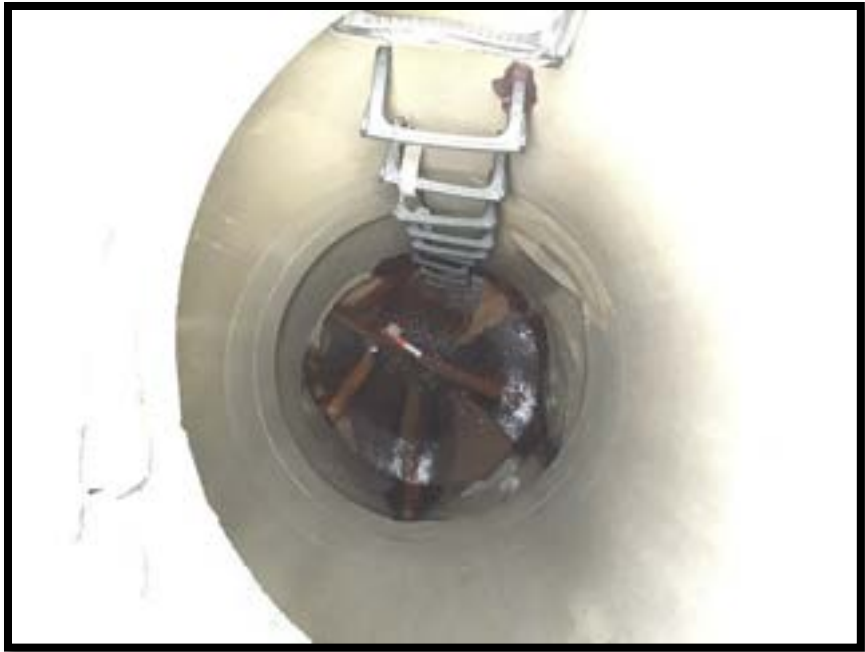
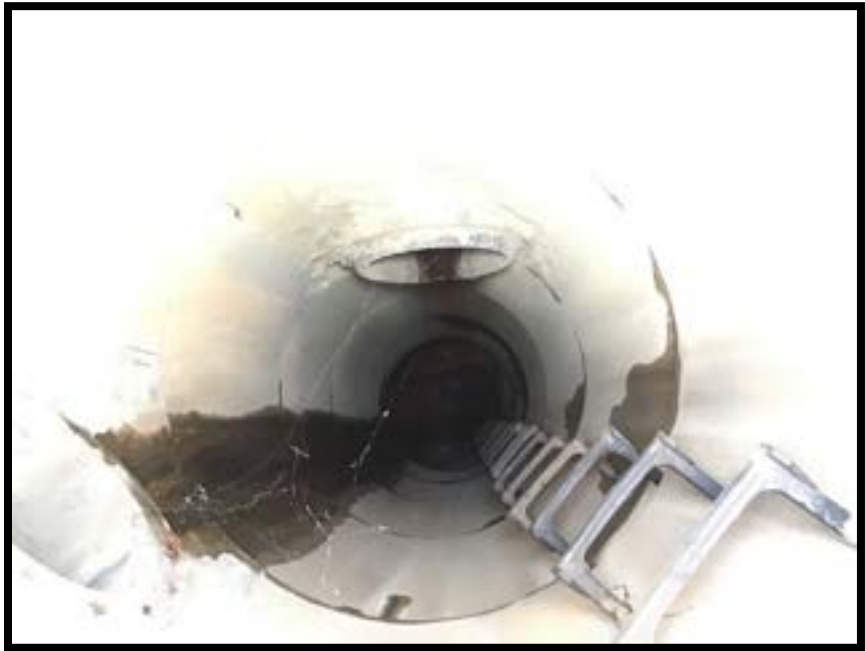
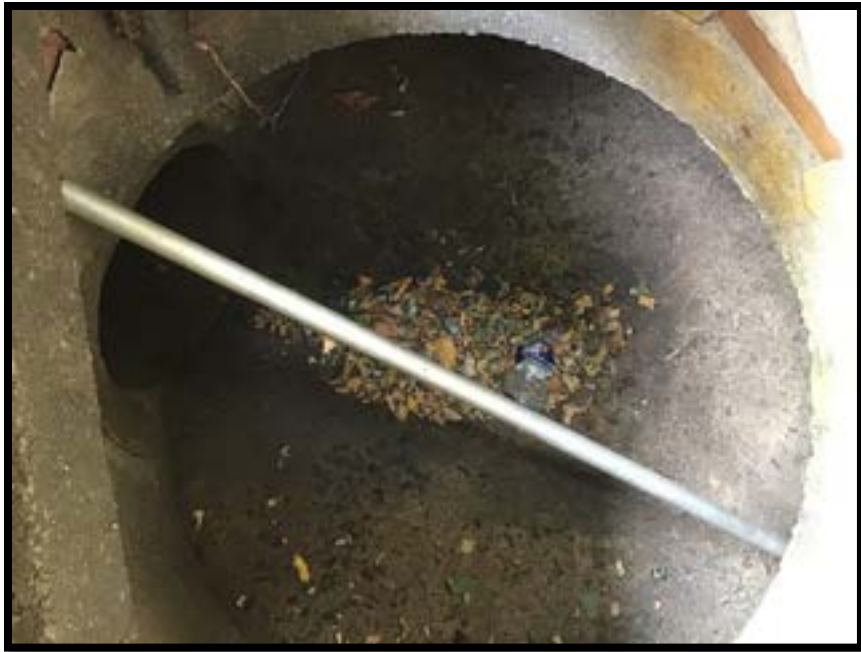
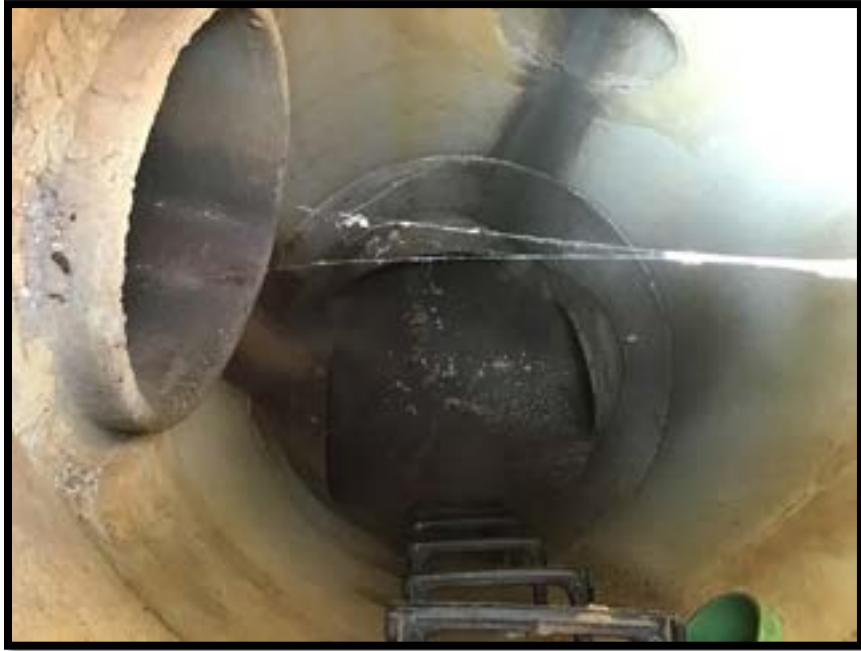
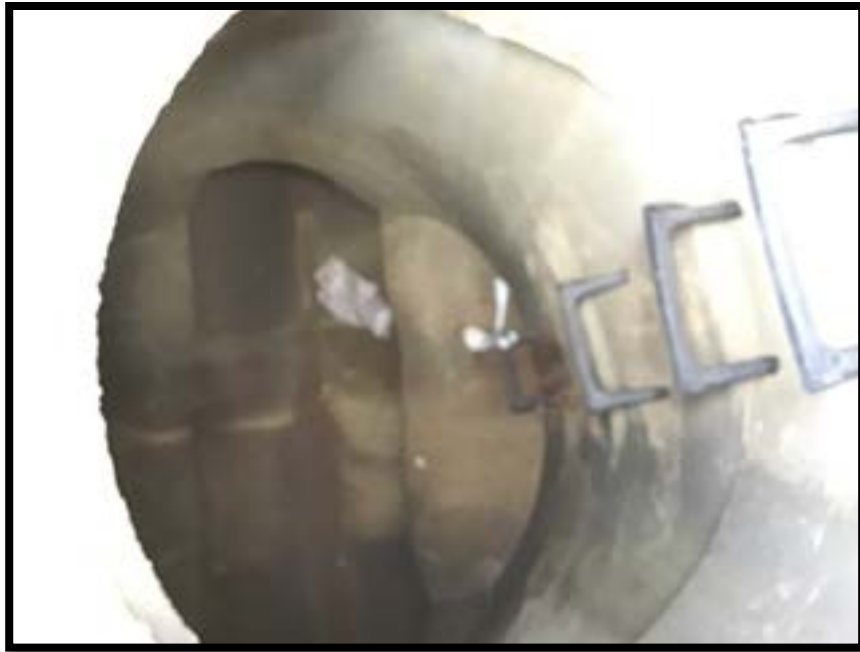
Photos:

Discharge observed with algae at outfall and downstream channel. pH and Conductivity did not exceed the standard limits. Discharge was tracked along storm sewer marked with red line. Manhole B was inaccessible due to dense vegetation. Tracking was continued to manhole C. Manhole was dry, but the curb and gutter and lid of manhole was colored with paint. Though paint was dry, somebody already spilled paint in the past. Tracking was continued at branch BD. Manhole D had a significant flow from DE branch. At E, flow was observed from EF and EG directions. Manhole F was dry. At G, trickle flow was observed from both GH and GJ branch. Manhole H and J were found dry. Flow was gradually reduced in upstream system until finding dry manhole.

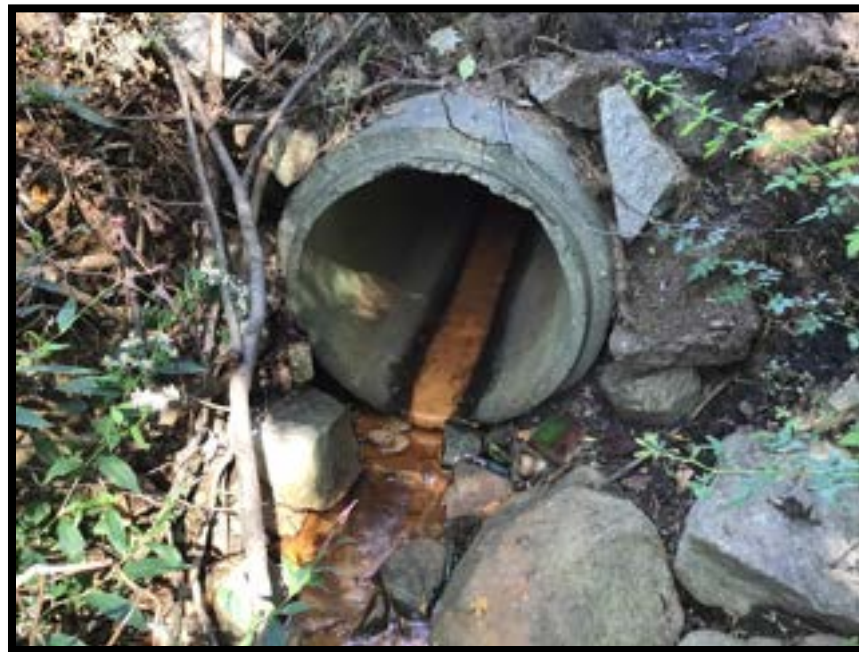
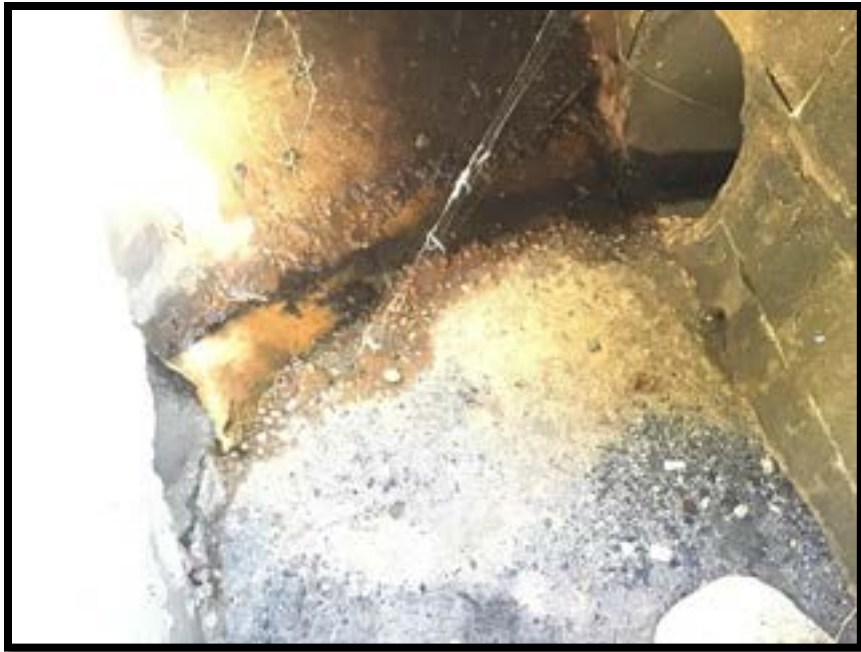
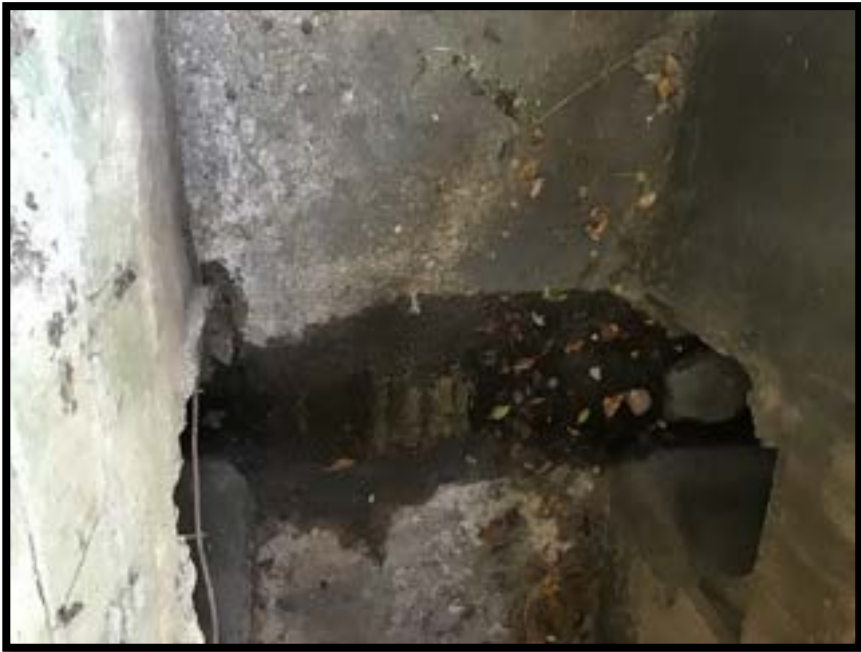
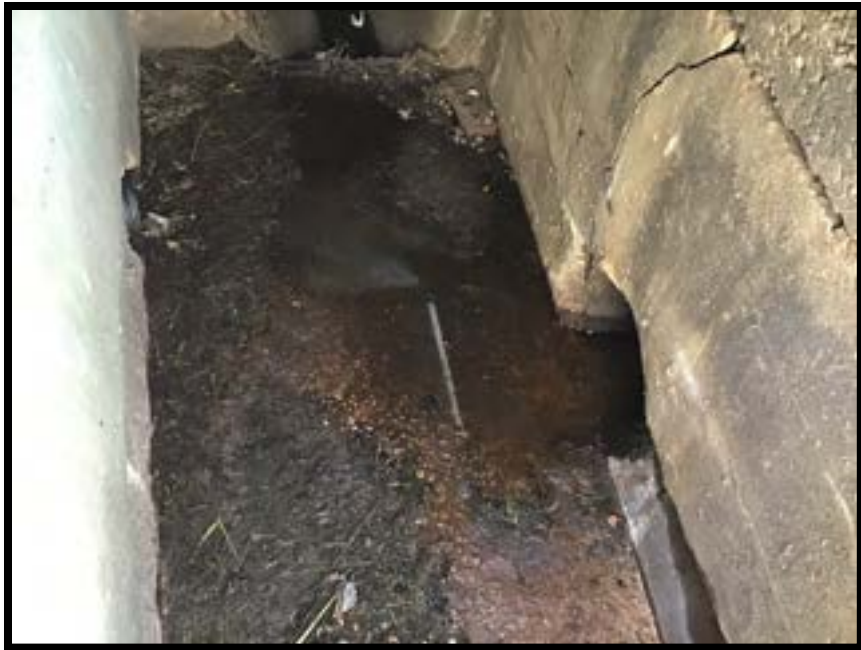
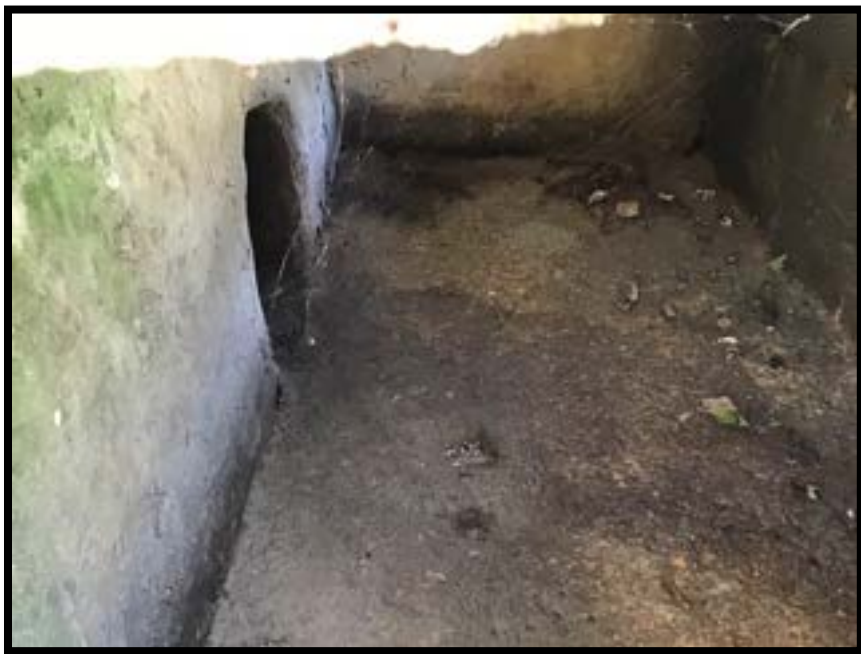
Photos:

Flow was observed with algae through the outfall. pH and Conductivity did not exceed the standard limits. Discharge was tracked along storm sewer marked with red line in map above. Manhole B was receiving discharge from BC. Tracking was continued until point D. Manhole D was found dry. Cross connection of sanitary sewer did not find during inspection.

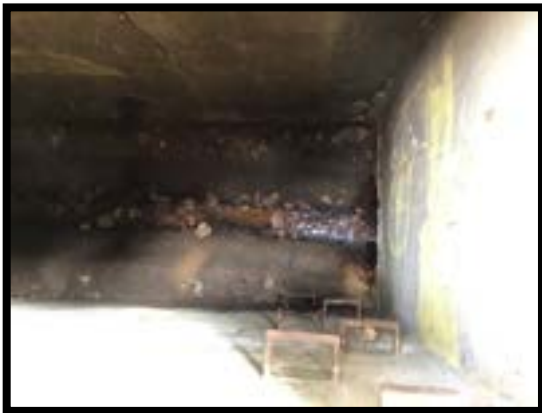
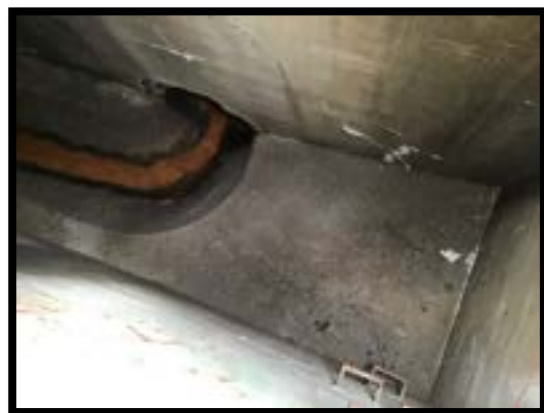
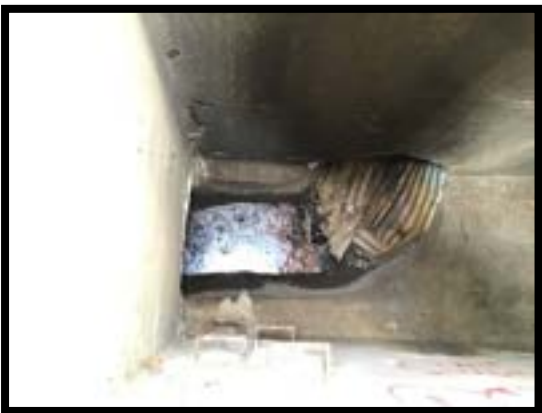
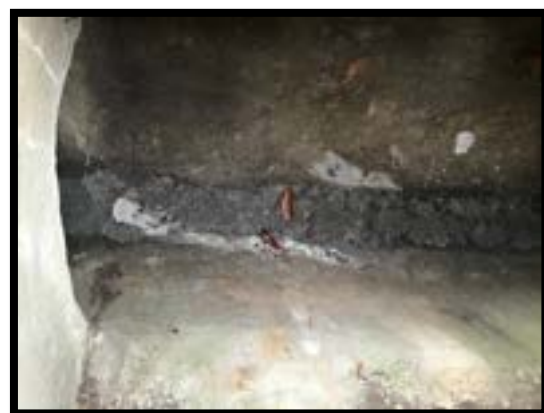
Photos:

Responsible Party (Owner/ Institutions)	Other Party (Management Company)
Name: NA	Name: NA
Company: PWC BOC Supervisor	Company:
Address: 1 County Complex Court	Address:
Phone #: NA	Phone #:
Note: NA	Note:
Notification/Contact (Other agencies contacted (DEQ, NS, FMO?) NA	
Date:	Date:
Time:	Time:
Name: TBD	Name:
Company/Agency:	Company/Agency:
Notes:	Notes:
Comments/ Deficiencies:	
<p>Access could not get to inspect outfall due to overgrown vegetation. Inspection was made at upstream Manhole A. Sample could not grab due to very trickle flow. Orange algae was being developed at the beneath of Manhole. Discharge was tracked along sewer line ABCD. Volume of discharge was gradually reducing in upstream line and Manhole D was discovered completely dry. Cross connection with stormwater system did not find.</p>

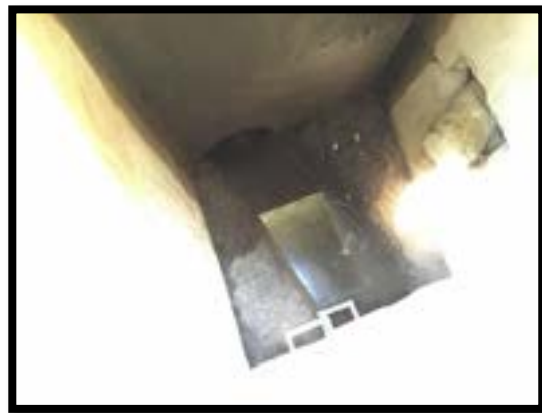
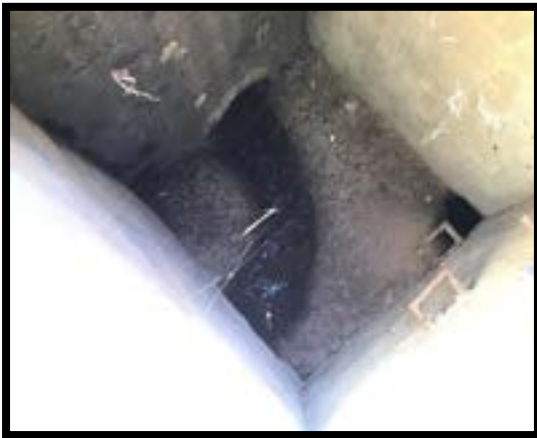
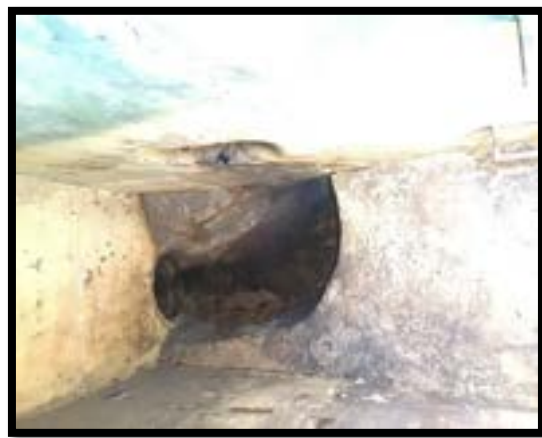
Photos:

Responsible Party (Owner/ Institutions)	Other Party (Management Company)
Name: Santos Ana	Name: NA
Company: NA	Company:
Address: 9421 Lafayette Ave	Address:
Phone #: NA	Phone #:
Note: NA	Note:
Notification/Contact (Other agencies contacted (DEQ, NS, FMO?) NA	
Date:	Date:
Time:	Time:
Name: TBD	Name:
Company/Agency:	Company/Agency:
Notes:	Notes:
<u>Comments/ Deficiencies:</u>	
<p>Upon arrival, very transparent stagnant pool was observed at outfall. Sample was taken very close to outfall and tested for pH and conductivity. Both parameters did not exceed the standard limits. Discharge was tracked along sewer line ABCD. Discharge was stagnant at Manhole A as well. Volume of discharge was gradually reducing in upstream line and Manhole D was discovered moist only. Cross connection with stormwater system did not find.</p>

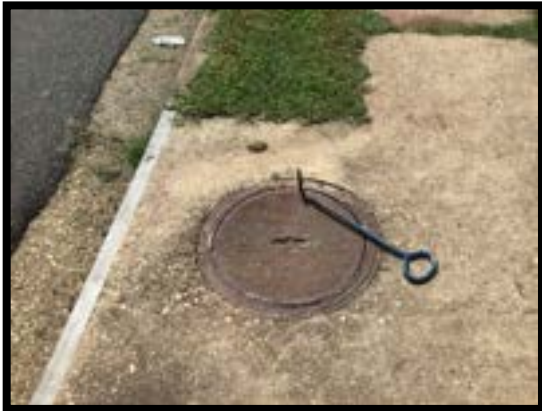
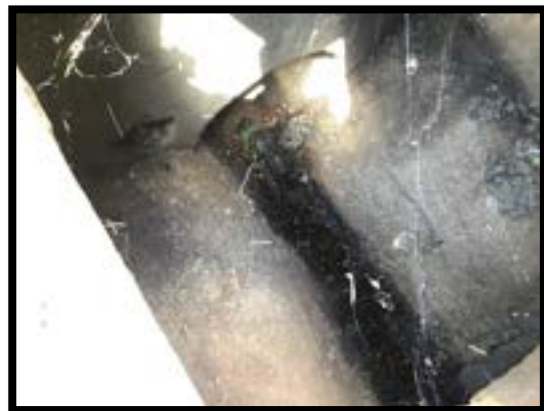
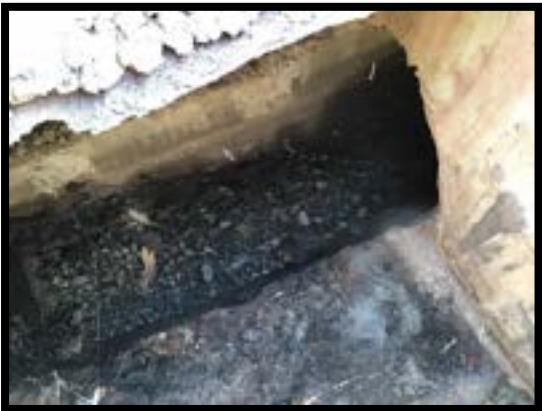
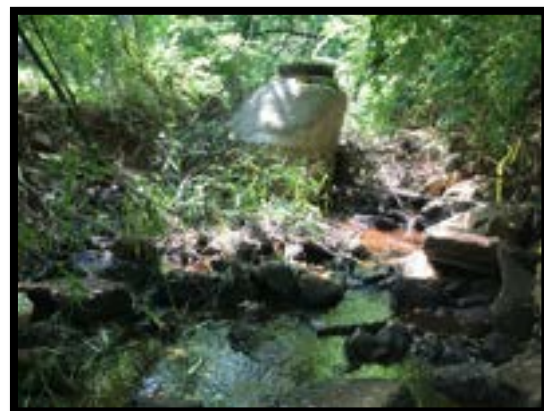
Photos:

Responsible Party (Owner/ Institutions)	Other Party (Management Company)
Name: Margaret Pye	Name: NA
Company: NA	Company:
Address: 9355 Victoria Street	Address:
Phone #: NA	Phone #:
Note: NA	Note:
Notification/Contact (Other agencies contacted (DEQ, NS, FMO?) NA	
Date:	Date:
Time:	Time:
Name: TBD	Name:
Company/Agency:	Company/Agency:
Notes:	Notes:
Comments/ Deficiencies:	
<p>Upon arrival, discharge was found through outfall. The outfall was slightly hanging on stream. Sample was tested for pH and conductivity. Both parameters did not exceed the standard limits. Discharge was tracked along sewer line ABC and BD respectively. The cover of Manhole B was attached with frame and could not open. Tracking performed in BC and BD respectively and both Manholes C and D were found dry. Cross connection with stormwater system did not find. Discharge confirmed ground water seepage into storm sewer system.</p>
