**Annual Stormwater Management Report
VSMP Permit No. 0088595 – FY 2021**

Submitted by:
Prince William County
Department of Public Works

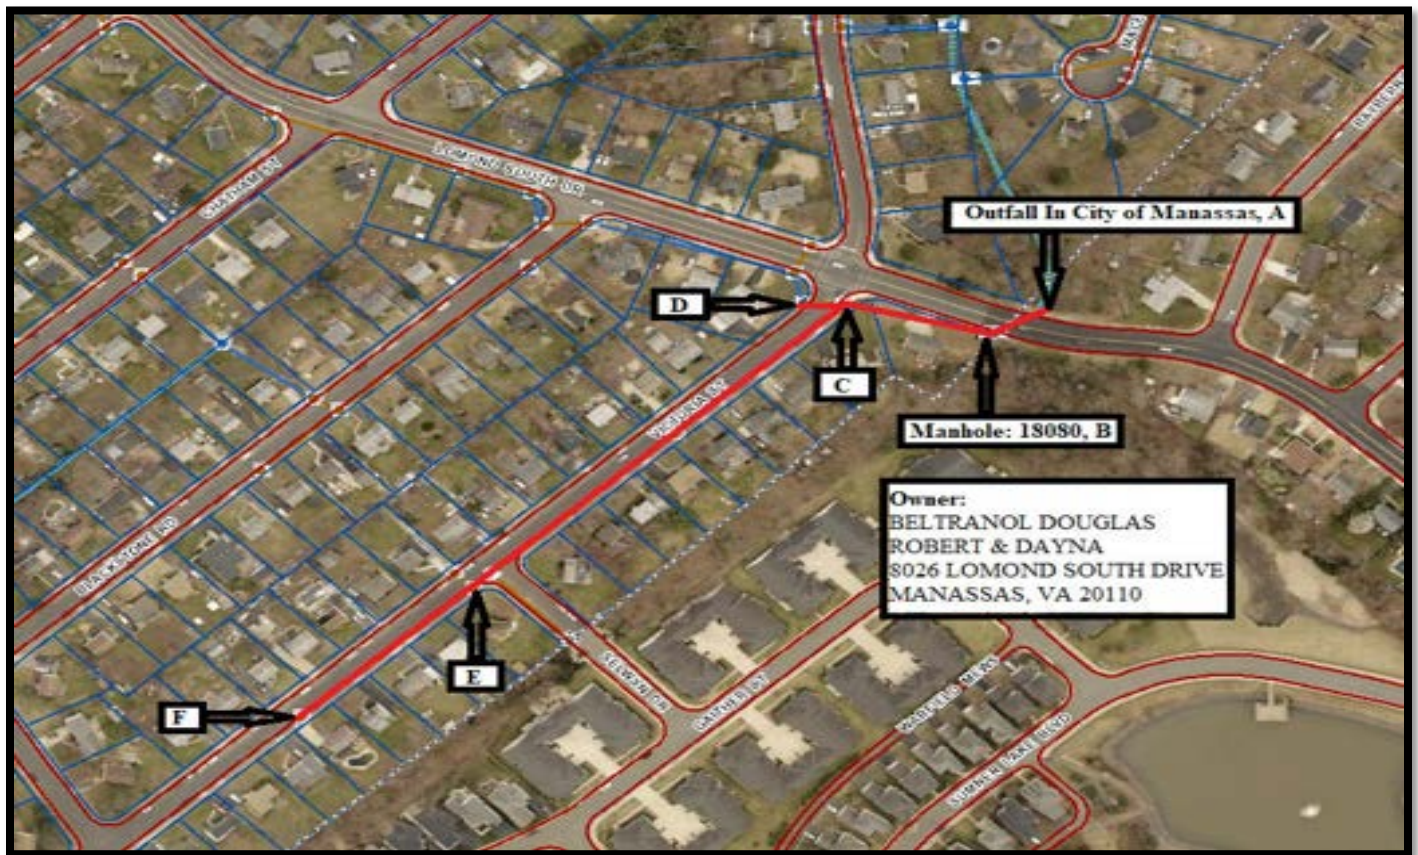
Map of Trackdown Path:

Responsible Party (Owner/ Institutions)	Other Party (Management Company)
Name: Robert Douglas	Name: NA
Company: NA	Company:
Address: 8026 Lomond S Dr	Address:
Phone #: NA	Phone #:
Note: NA	Note:
Notification/Contact (Other agencies contacted (DEQ, NS, FMO?) NA	
Date:	Date:
Time:	Time:
Name: TBD	Name:
Company/Agency:	Company/Agency:
Notes:	Notes:
Comments/ Deficiencies:	
<p>Upon arrival, very transparent stagnant pool was observed at outfall. The outfall lies in City of Manassas. Sample was taken very close to outfall and tested for pH and conductivity. Both parameters did not exceed the standard limits. Discharge was tracked along sewer line ABCEF and CD respectively. Volume of discharge was gradually reducing in upstream line and Manholes F and D were discovered moist only. Cross connection with stormwater system did not find.</p>

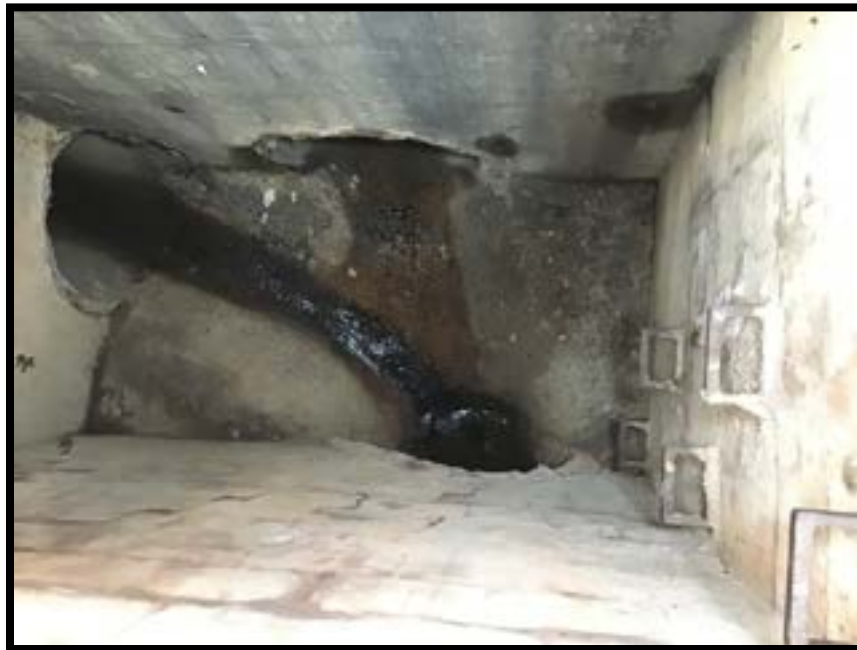
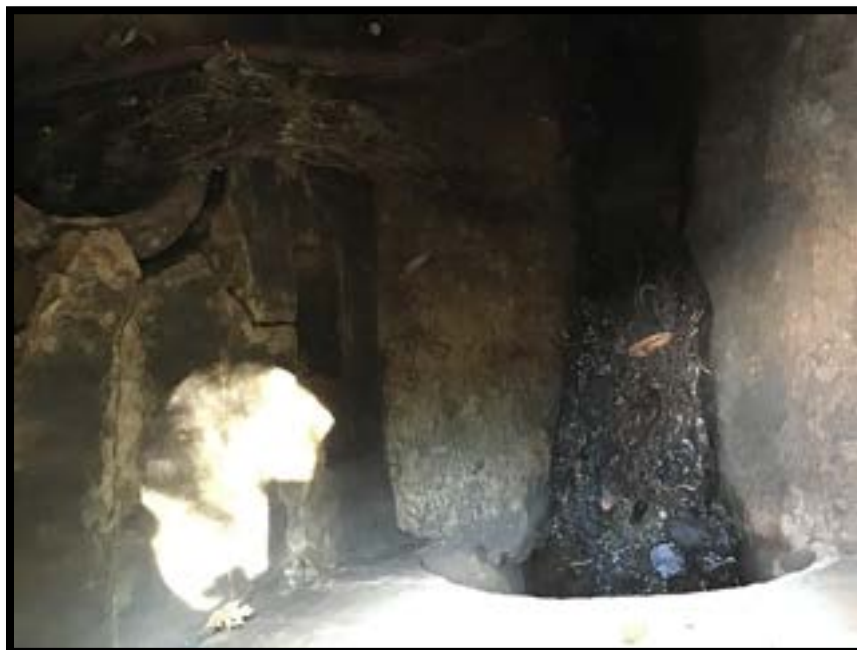
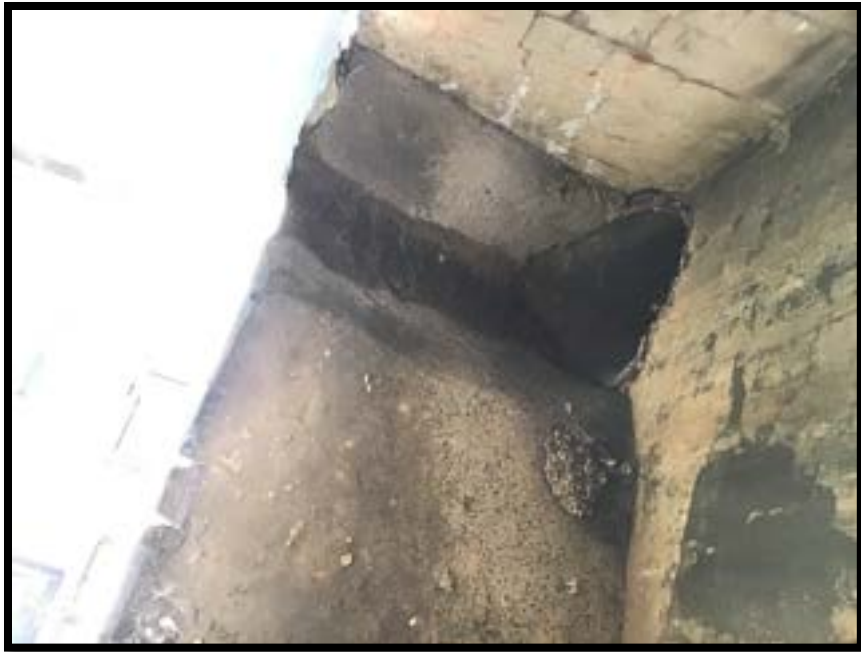
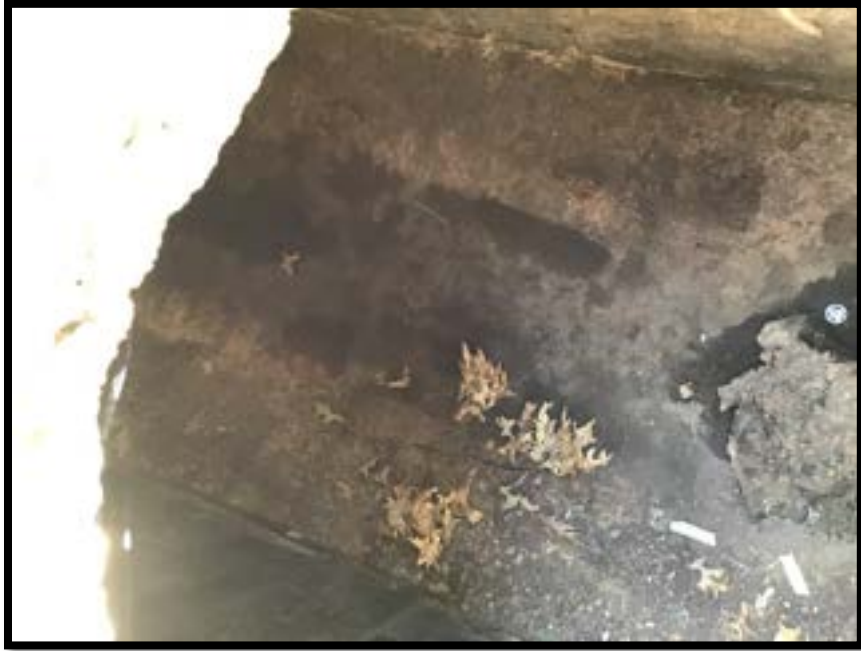
Photos:

Responsible Party (Owner/ Institutions)	Other Party (Management Company)
Name: NA	Name: NA
Company:	Company:
Address:	Address:
Phone #:	Phone #:
Note:	Note:
Notification/Contact (Other agencies contacted (DEQ, NS, FMO?) NA	
Date:	Date:
Time:	Time:
Name: TBD	Name:
Company/Agency:	Company/Agency:
Notes:	Notes:
<u>Comments/ Deficiencies:</u>	
<p>Discharge was tracked along red line sewer. Manhole A has flow from AB and AC direction. Manhole B was in dry condition. Manhole C could not open since the lead has stuck with the frame. Manhole D and E were found dry. Volume of flow was gradually reducing until getting dry manhole. The source could be ground water seepage into storm water system. There were no additional signs of illicit discharge at outfall and channel.</p>

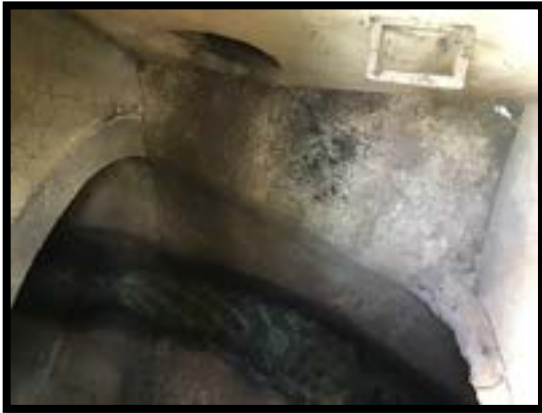
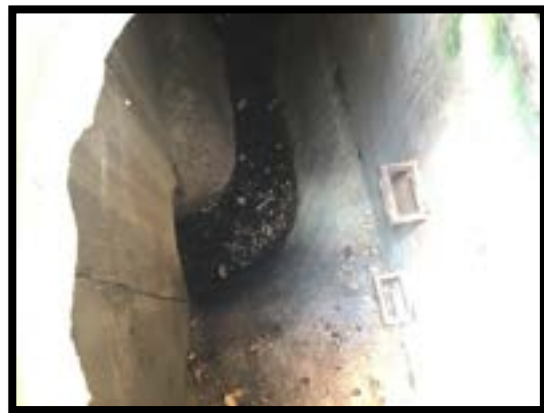
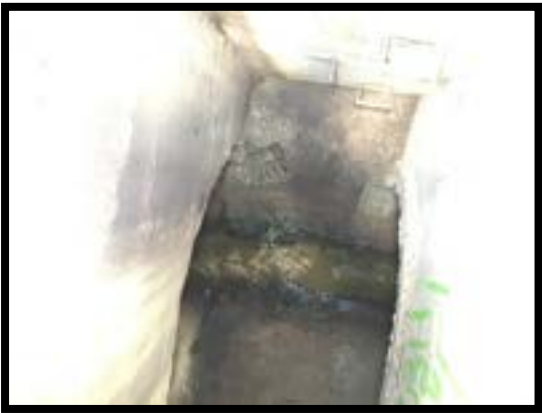
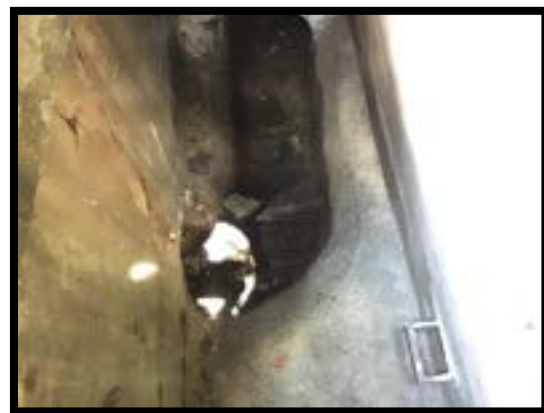
Photos:

Responsible Party (Owner/ Institutions)	Other Party (Management Company)
Name: Donald Baker	Name: NA
Company: NA	Company:
Address: 8006 Mace Circle	Address:
Phone #: NA	Phone #:
Note: NA	Note:
Notification/Contact (Other agencies contacted (DEQ, NS, FMO?) NA	
Date:	Date:
Time:	Time:
Name: TBD	Name:
Company/Agency:	Company/Agency:
Notes:	Notes:
<p>Comments/ Deficiencies:</p> <p>Upon arrival, discharge was found through outfall. Sample was tested for pH and conductivity. Both parameters did not exceed the standard limits. Discharge was tracked along sewer line ABCDE. There was a trickle flow at manhole E. Point E lies in City of Manassas so further tracking was disregarded. It was reported that ATV was washed on street nearby storm water inlet and mud was discharged into storm water system. The complaint found to be real and Mr. Donald Baker had accepted by ATV washing and discharging mud into system. He was educated that any activities causing pollution or impeding flow into stormwater system or water of the County is a violation. Mr. Baker promised to clean mud and debris from curb and gutter inlet and street as well. Cross connection with stormwater system did not find. Discharge confirmed ground water seepage into storm sewer system from neighboring jurisdiction.</p>

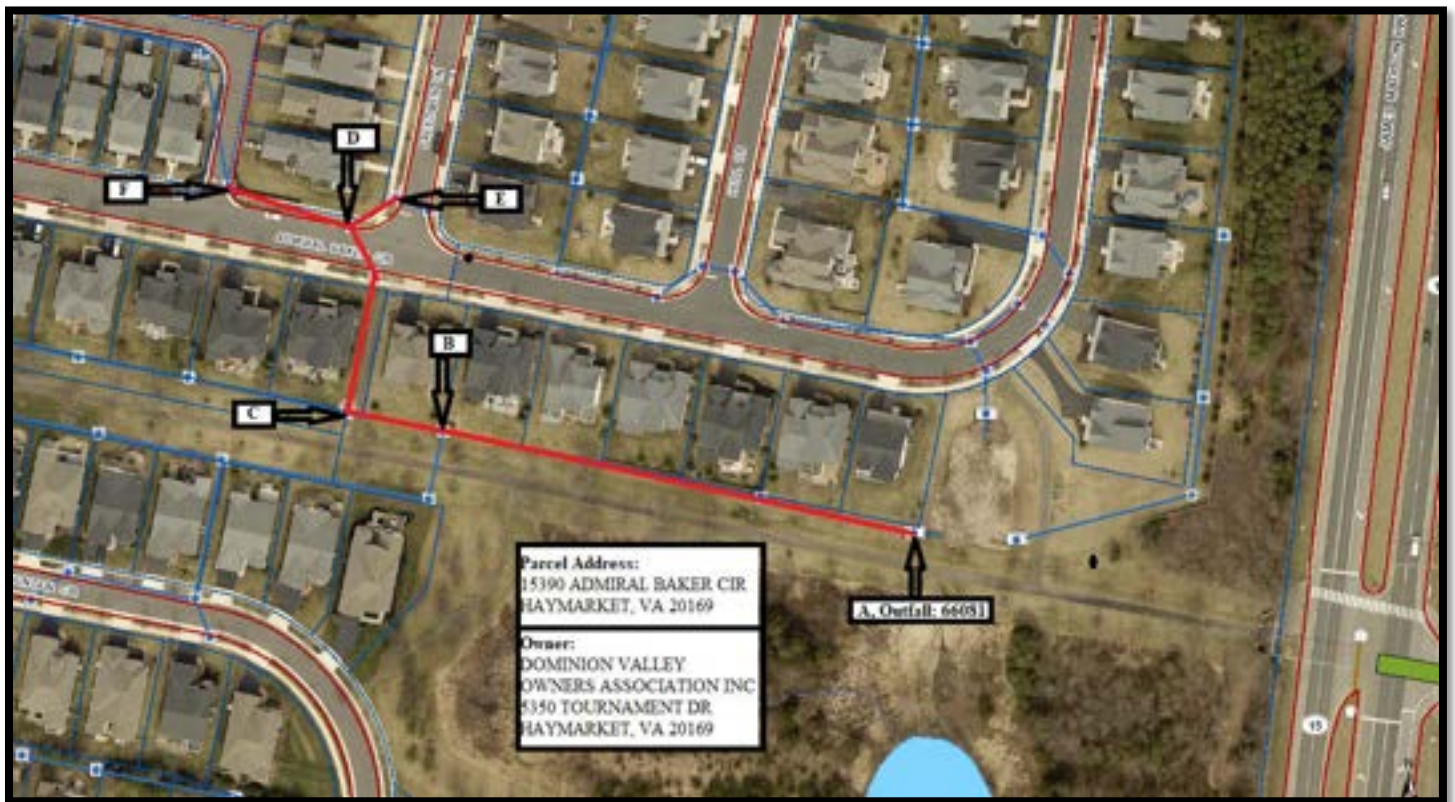
Map of Trackdown Path:

Responsible Party (Owner/ Institutions)	Other Party (Management Company)
Name: NA	Name: NA
Company:	Company:
Address:	Address:
Phone #:	Phone #:
Note:	Note:
Notification/Contact (Other agencies contacted (DEQ, NS, FMO?) NA	
Date:	Date:
Time:	Time:
Name: TBD	Name:
Company/Agency:	Company/Agency:
Notes:	Notes:
<u>Comments/ Deficiencies:</u>	
<p>Discharge was observed at outfall A. Discharge was tracked along red sewer line. Manhole B had flow from BC direction only. Manhole C had flow from CD direction. Manhole D had flow from both DE and DF directions, but manholes E and F were discovered dry. Volume of flow was gradually reducing until getting dry manhole. The source could be ground water seepage into storm water system. There were no additional signs of illicit discharge at outfall and channel.</p>	
<u>Conclusion:</u>	
<p>The source of discharge confirmed ground water seepage.</p>

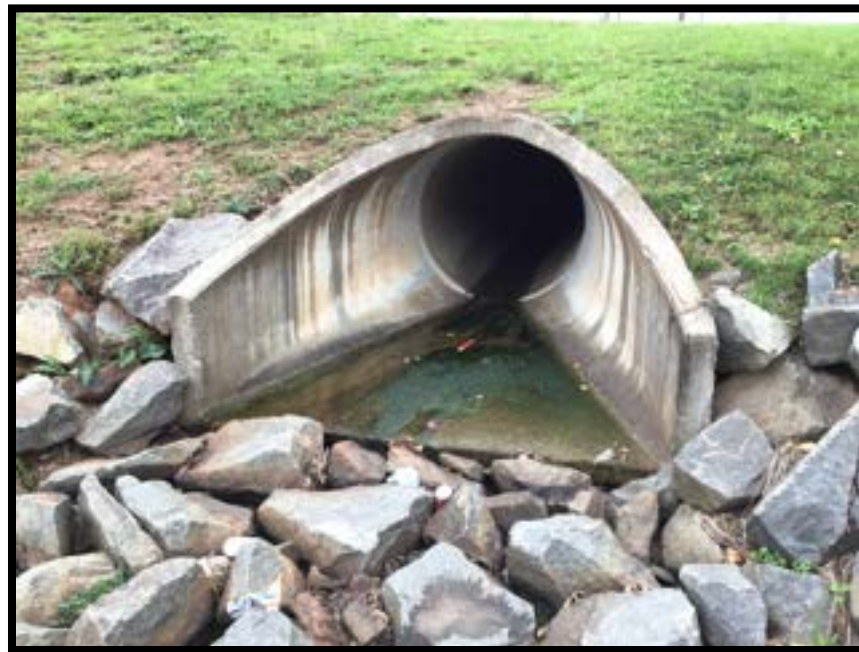
Outfall

Flow was observed with algae through the outfall. pH and Conductivity did not exceed the standard limits. Discharge was tracked along storm sewer marked with red line in map above. Manhole B was receiving discharge from BC. Tracking was continued until point D. Manhole D was found dry. Cross connection of sanitary sewer did not find during inspection.

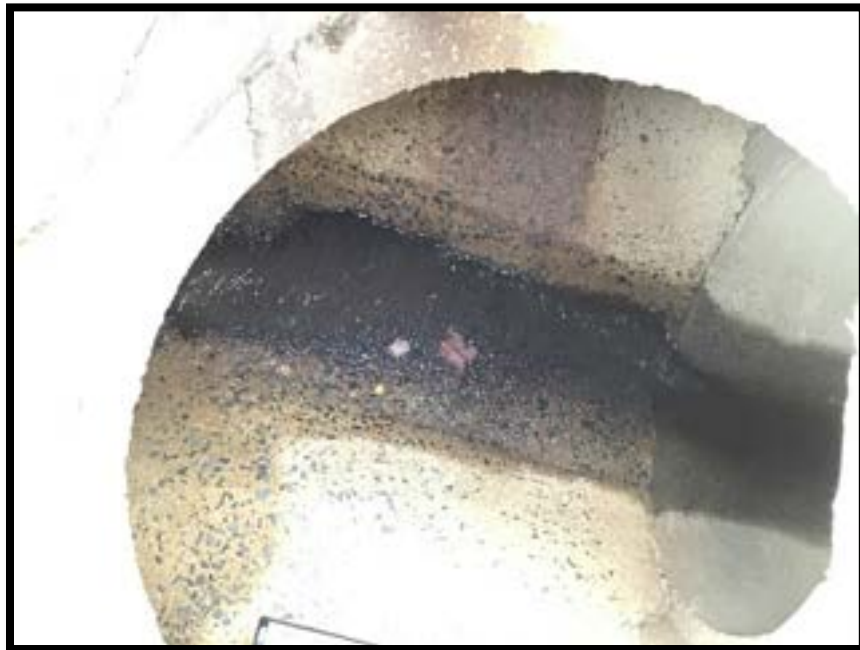
Outfall

Flow was observed with algae through the outfall. pH and Conductivity did not exceed the standard limits. Discharge was tracked along storm sewer marked with red line in map above. Manhole B was receiving discharge from BC. Tracking was continued until point C. Manhole C was found dry. Cross connection of sanitary sewer did not find during inspection.

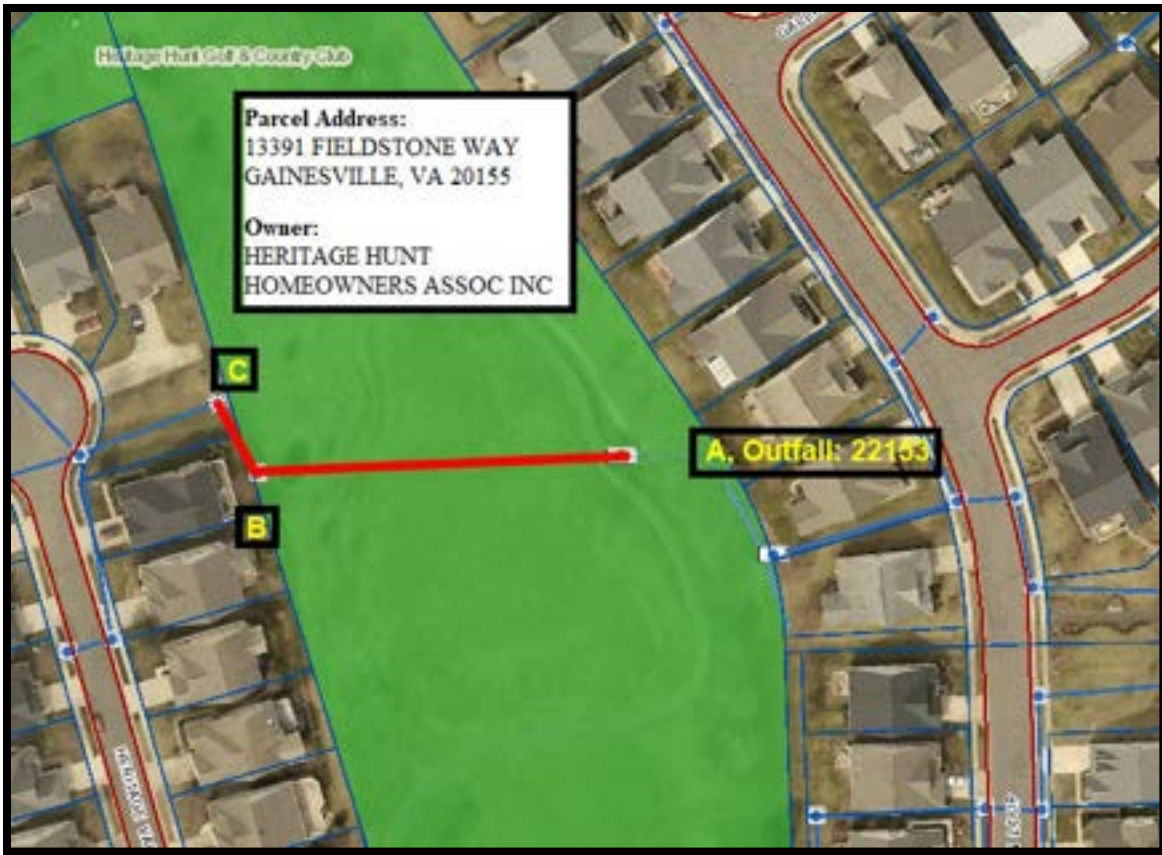
Map of Trackdown Path:

Responsible Party (Owner/ Institutions)	Other Party (Management Company)
Name: NA	Name: NA
Company:	Company:
Address:	Address:
Phone #:	Phone #:
Note:	Note:
Notification/Contact (Other agencies contacted (DEQ, NS, FMO?) NA	
Date:	Date:
Time:	Time:
Name: NA	Name:
Company/Agency:	Company/Agency:
Notes:	Notes:
Comments/ Deficiencies:	
<p>Flow was observed through the outfall. pH and Conductivity did not exceed the standard limits. Stagnant pool with orange algae was observed at the outfall.</p> <p>Discharge was tracked along storm sewer marked with red line in the map above. Manhole B had flow from BC direction, and continued tracking along BC. Manhole C was found dry.</p>

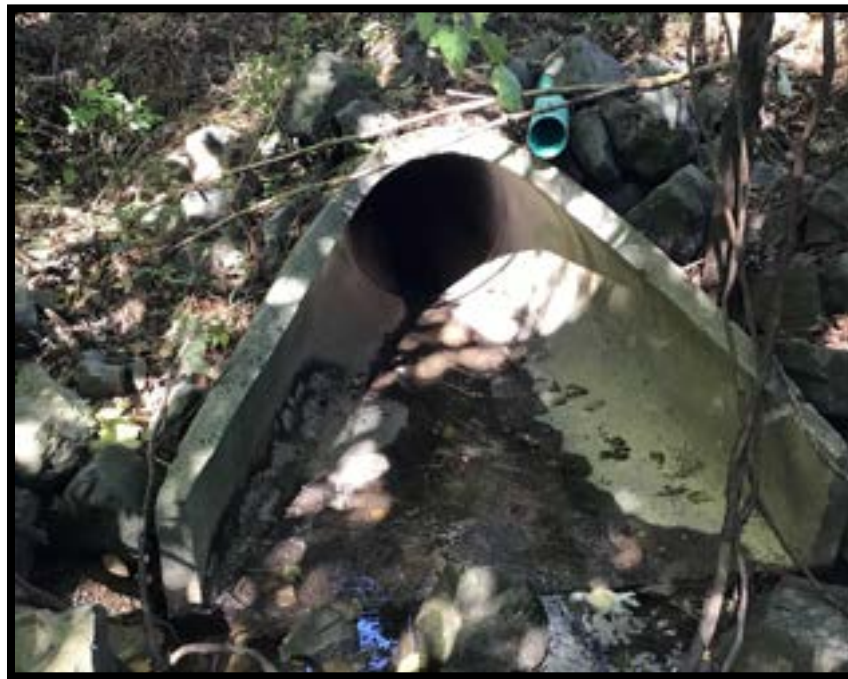
Outfall

Flow was observed through outfall. pH and Conductivity did not exceed the standard limits. Discharge was tracked along storm sewer marked with red line in map above. Manhole B was receiving discharge from BC. C is an inlet receiving discharge from open channel. Cross connection of sanitary sewer did not find during inspection.

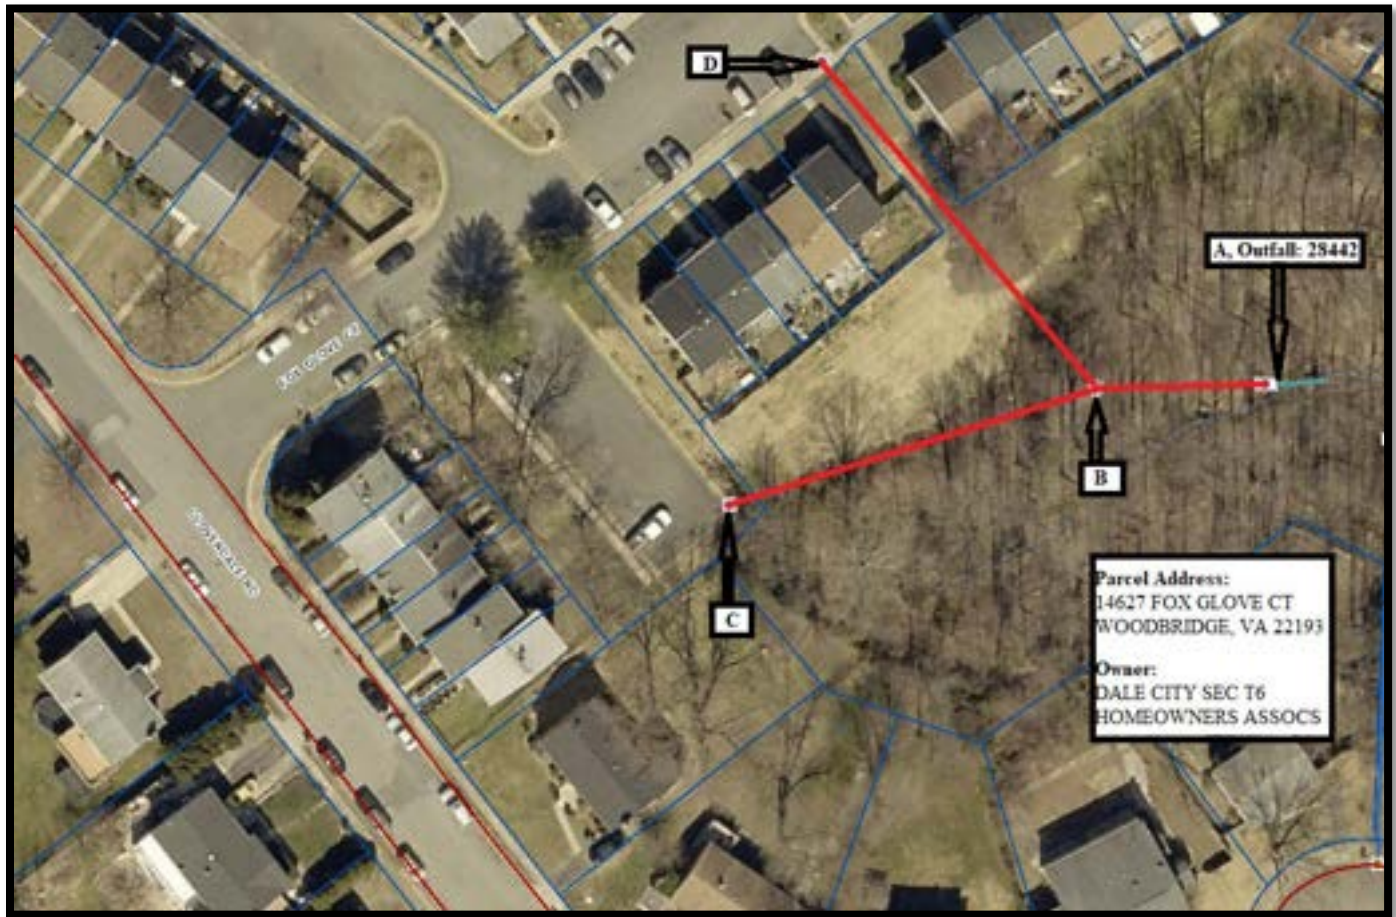
Map of Trackdown Path:

Responsible Party (Owner/ Institutions)	Other Party (Management Company)
Name: NA	Name: NA
Company:	Company:
Address:	Address:
Phone #:	Phone #:
Note:	Note:
Notification/Contact (Other agencies contacted (DEQ, NS, FMO?) NA	
Date:	Date:
Time:	Time:
Name: NA	Name:
Company/Agency:	Company/Agency:
Notes:	Notes:
Comments/ Deficiencies:	
<p>Trickle flow was observed through outfall. pH and Conductivity did not exceed the standard limits. Discharge was tracked along storm sewer marked with red line. Manhole B was receiving discharge from BC and BD directions. Both manhole C and D were found completely dry. Cross connection of sanitary sewer did not find during inspection.</p>

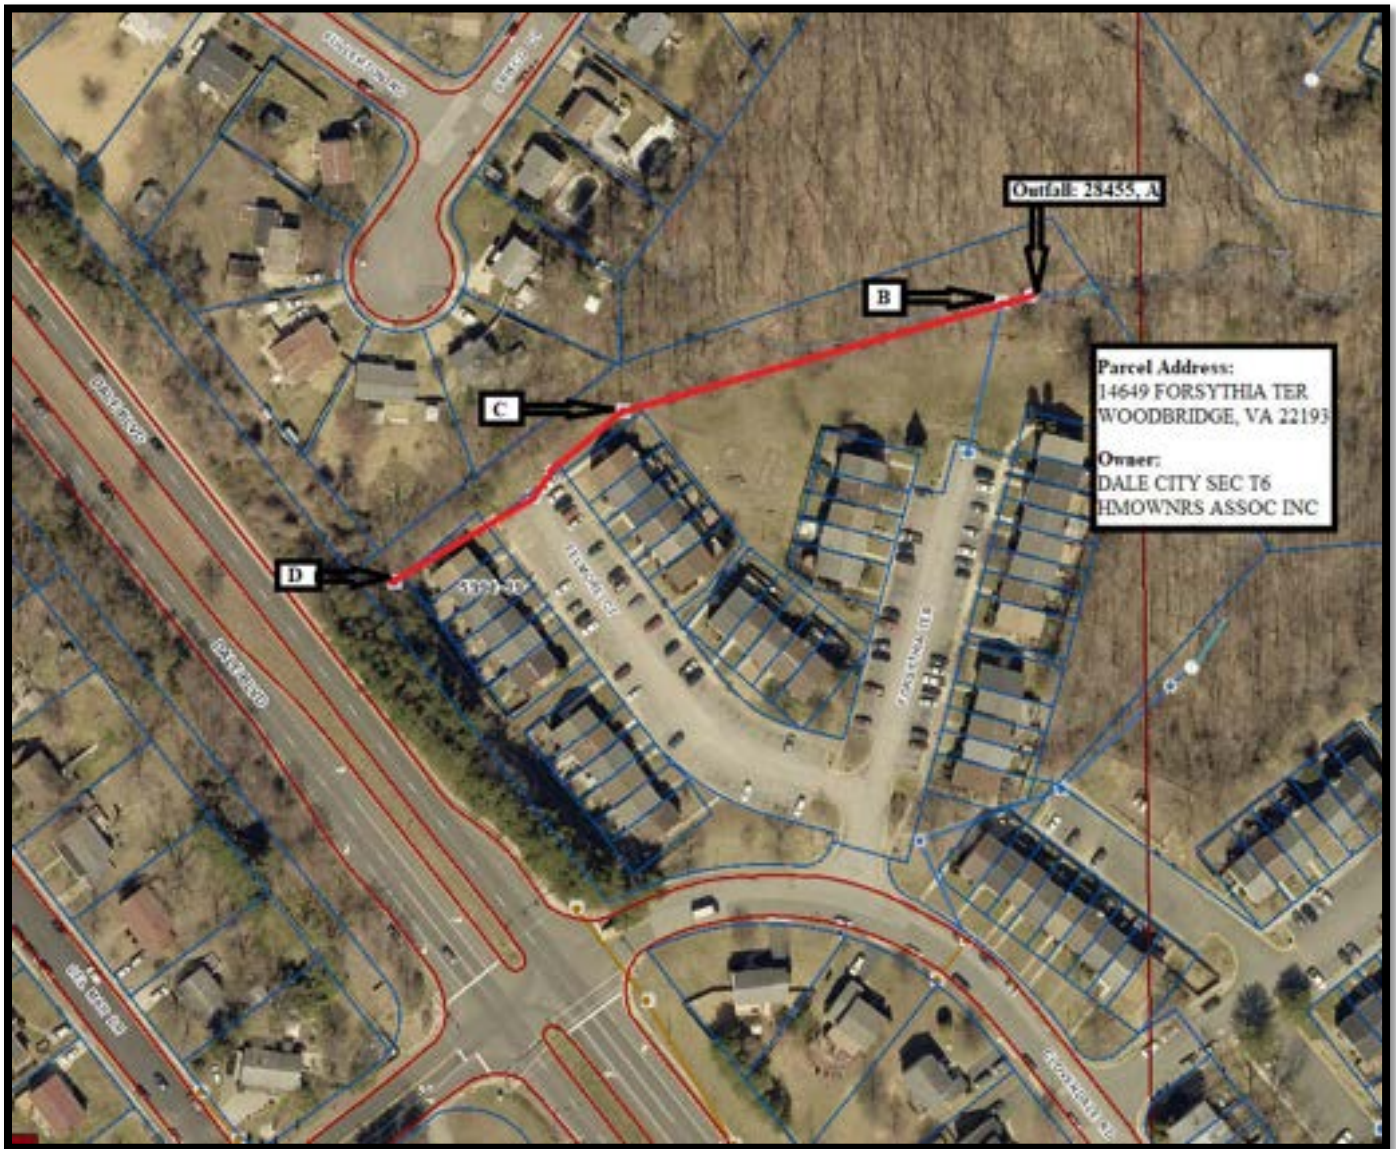
Map of Trackdown Path:

Discharge was observed at outfall A. Orange algae was observed at outfall and downstream channel. pH and Conductivity did not exceed the limit. Discharge was tracked along red sewer line. Manhole B had flow from BC direction only. Manhole C had flow from CD direction. Drop inlet D was dry and located in forested areas for receiving runoff during rainfall. Volume of flow was gradually reducing until getting dry drop inlet D. The source could be ground water seepage into storm water system.

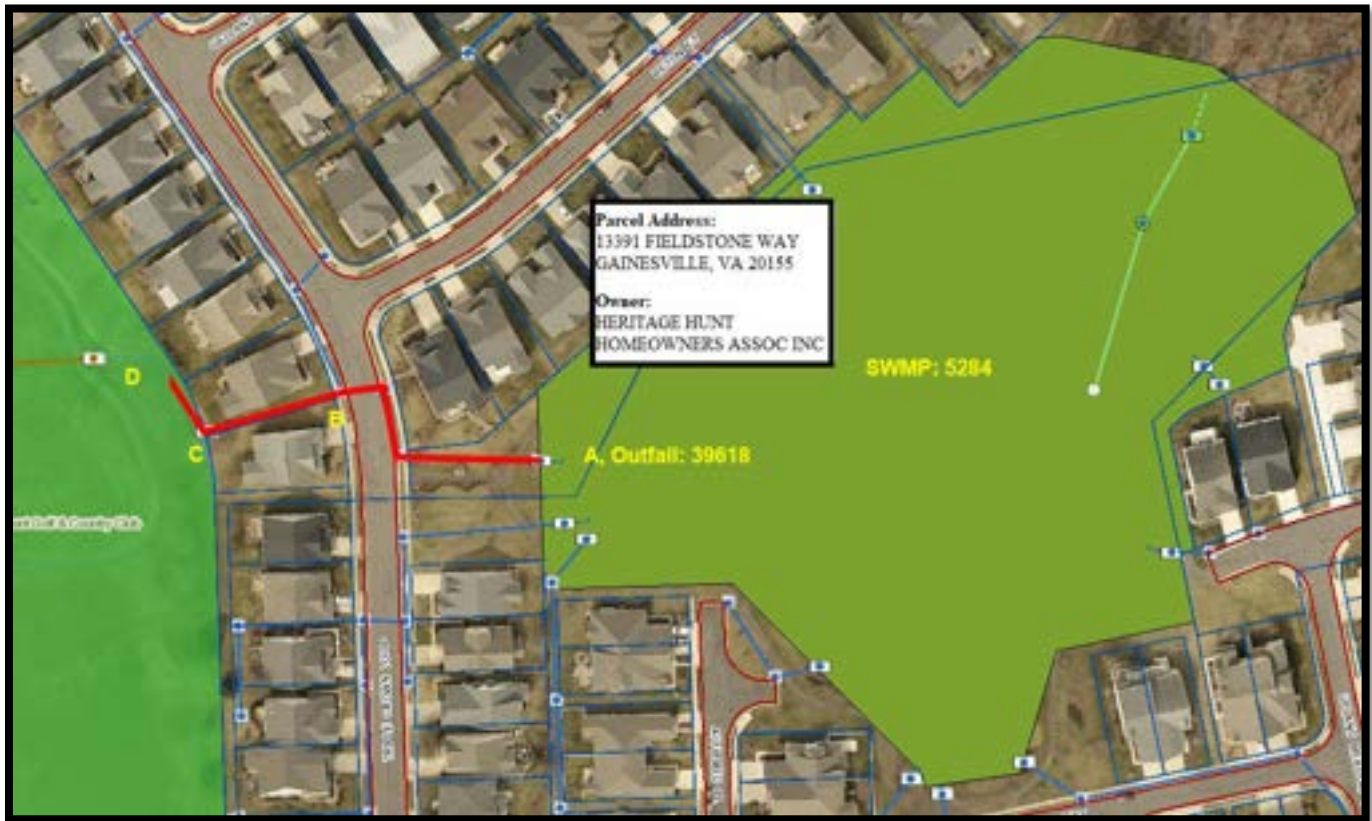
Map of Trackdown Path:

Responsible Party (Owner/ Institutions)	Other Party (Management Company)
Name: NA	Name: NA
Company:	Company:
Address:	Address:
Phone #:	Phone #:
Note:	Note:
Notification/Contact (Other agencies contacted (DEQ, NS, FMO?) NA	
Date:	Date:
Time:	Time:
Name: NA	Name:
Company/Agency:	Company/Agency:
Notes:	Notes:
<u>Comments/ Deficiencies:</u>	
<p>Flow was observed through the outfall. pH and Conductivity did not exceed the standard limits. Stagnant pool was observed with green algae at the outfall.</p>	
<p>Discharge was tracked along storm sewer marked with red line in the map above. Manhole B had flow from BC direction and tracking was continued along BCD. D is the inlet receiving discharge from open channel. Cross connection of sanitary sewer did not find during inspection.</p>	
<u>Conclusion:</u>	
<p>The source of discharge was discovered upstream inflow through inlet.</p>

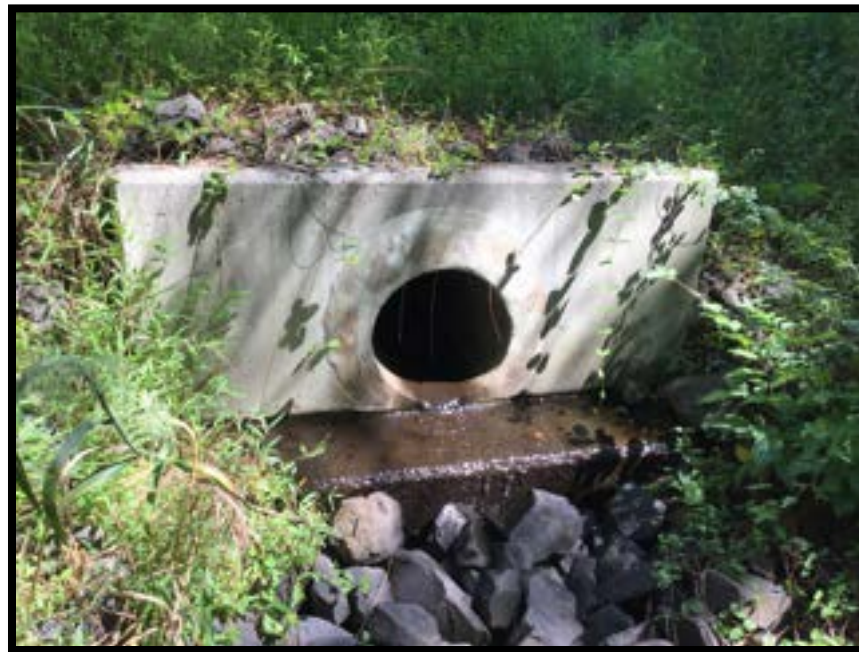
Discharge was observed at outfall A. Discharge was tracked and the outflow of CSWMP 5912 is discovered the source. The pond is located at the middle of community and surrounded with gulf course.

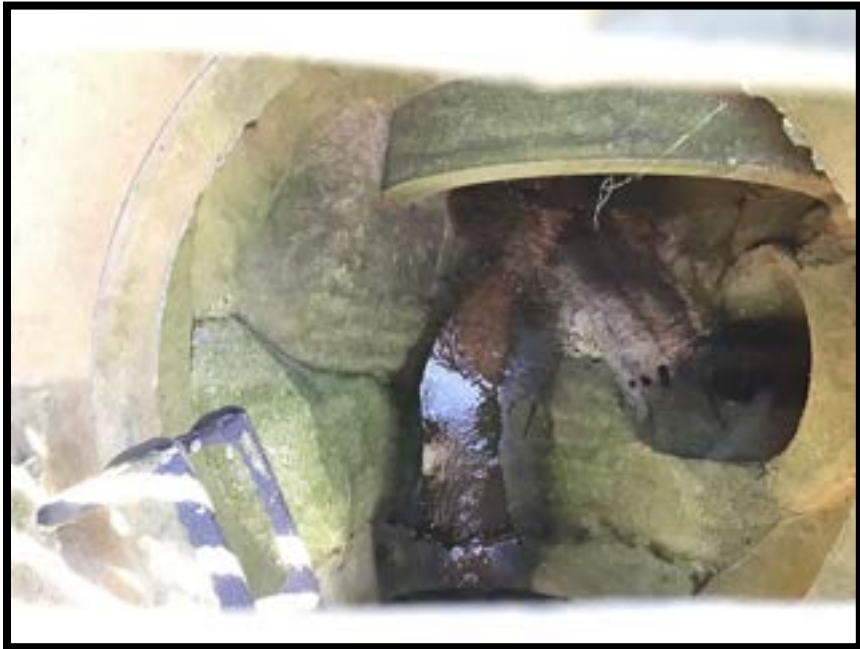
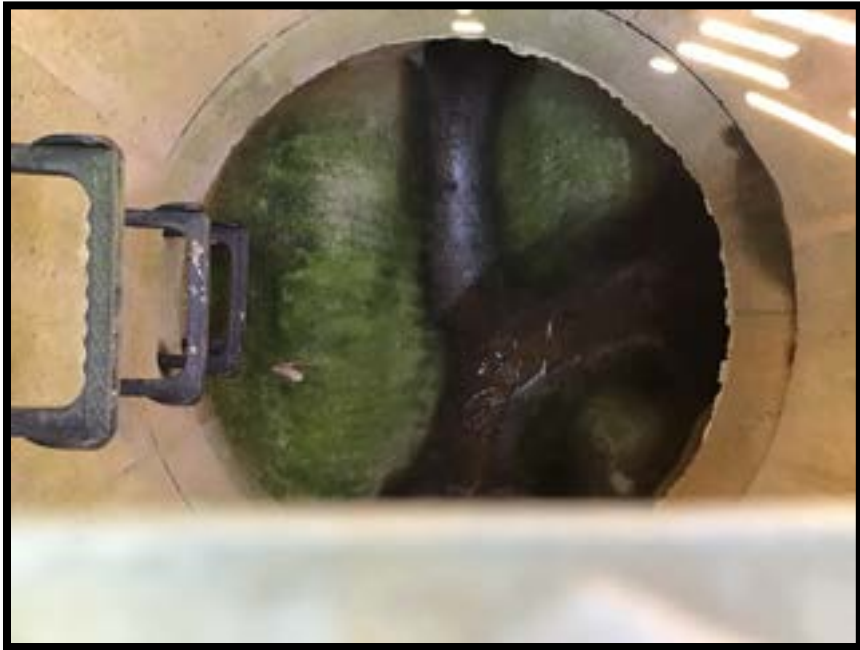
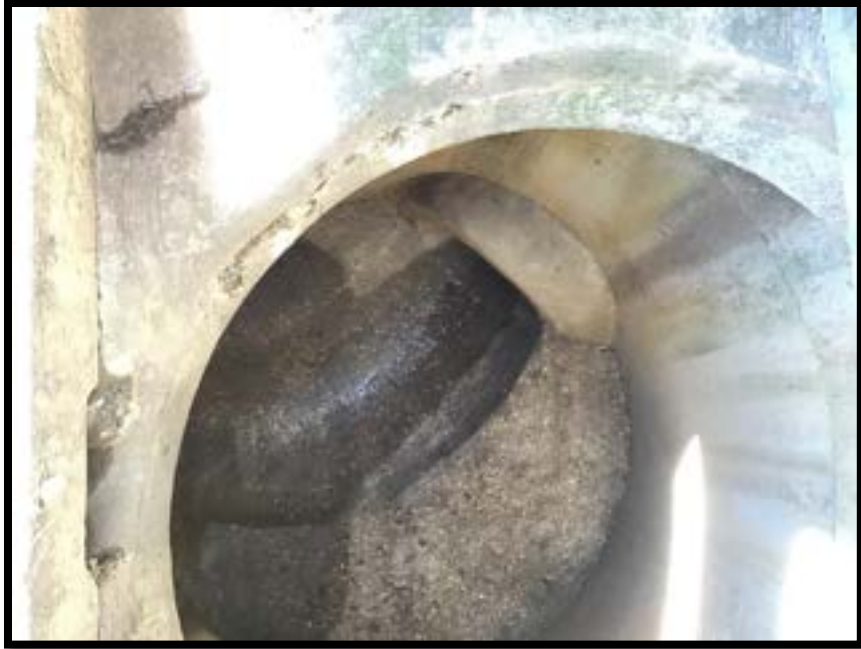
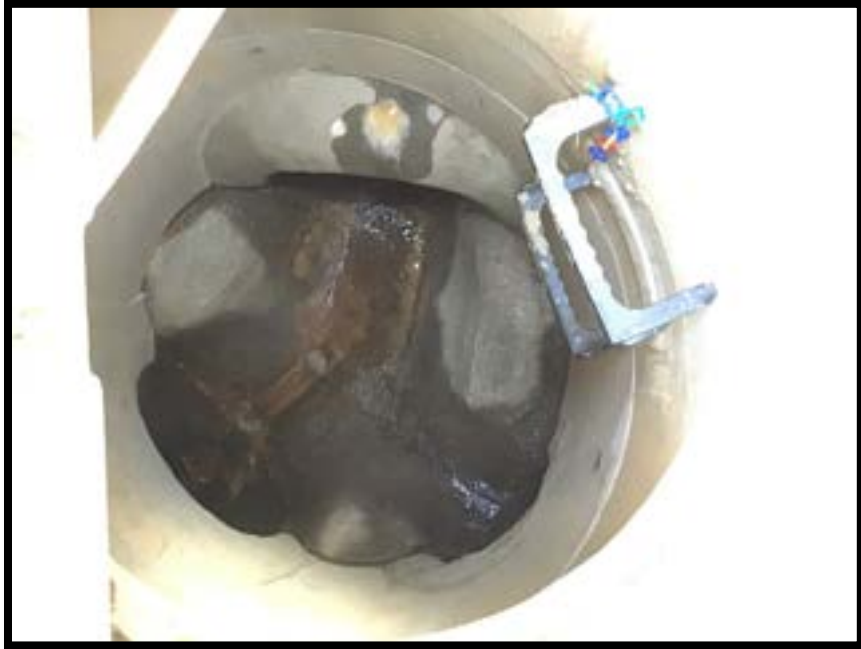
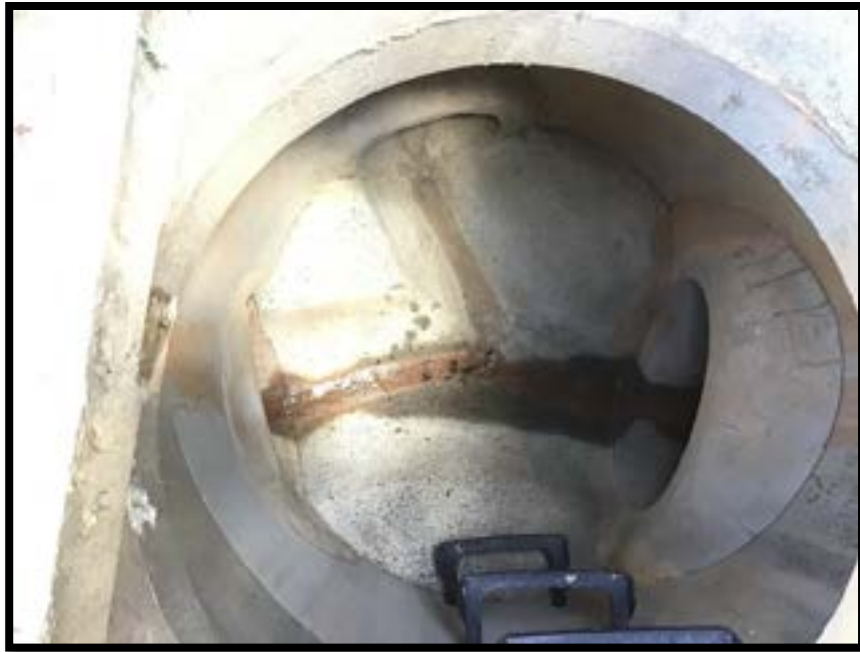
Responsible Party (Owner/ Institutions)	Other Party (Management Company)
Name: NA	Name: NA
Company:	Company:
Address:	Address:
Phone #:	Phone #:
Note:	Note:
Notification/Contact (Other agencies contacted (DEQ, NS, FMO?) NA	
Date:	Date:
Time:	Time:
Name: TBD	Name:
Company/Agency:	Company/Agency:
Notes:	Notes:
<u>Comments/ Deficiencies:</u>	
<p>Discharge was observed at outfall A. Discharge was tracked along red sewer line. Manhole B had flow from BC direction only. Manhole C had flow from CD direction. Manhole D had flow from both DE and DF directions, but manholes E and F were discovered dry. Volume of flow was gradually reducing until getting dry manhole. The source could be ground water seepage into storm water system. There were no additional signs of illicit discharge at outfall and channel.</p>	
<u>Conclusion:</u>	
<p>The source of discharge confirmed ground water seepage.</p>

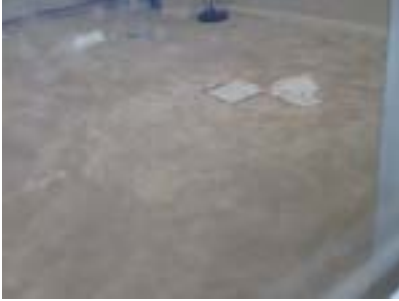
photos: View from outside of the basement.

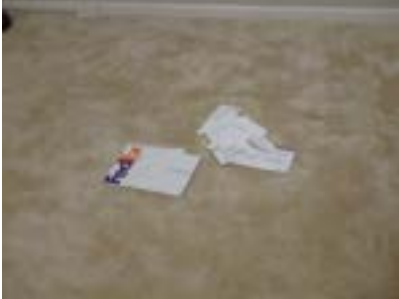
photos: View from inside of the basement.

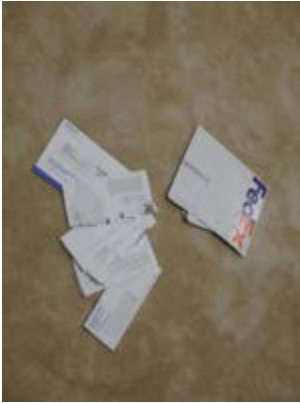
photos: View from inside of the basement.

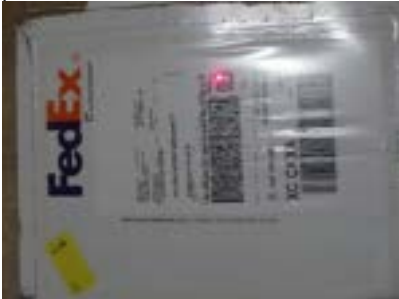
photos: View from inside of the basement.

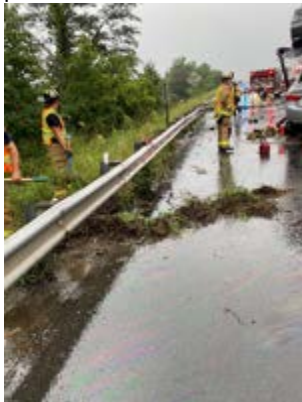
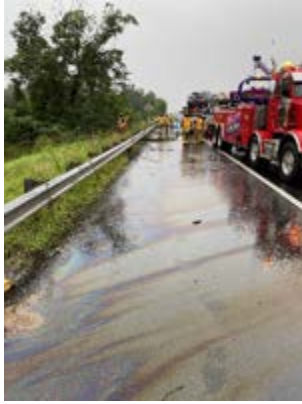
photos: Oil Sheen

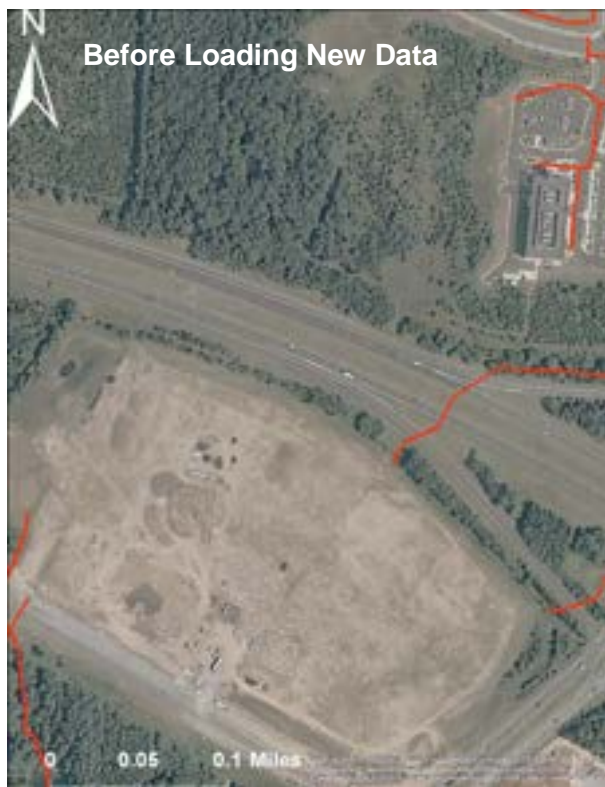
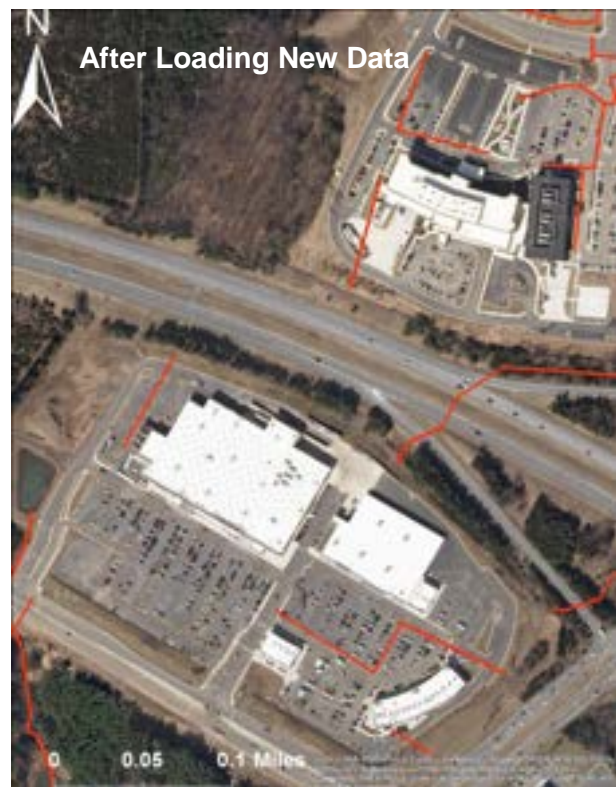
Figure 8. Depicts post-2009 development along Highway 15 and I-66 in Haymarket, VA. The image on the left shows the location in 2009, while the image on the right shows the area in 2015 after loading the new data into the Amec Single Network. Newly added segments still require editing to create a hydrologic connection. Editing procedures for creating this hydrologic connection are described below.

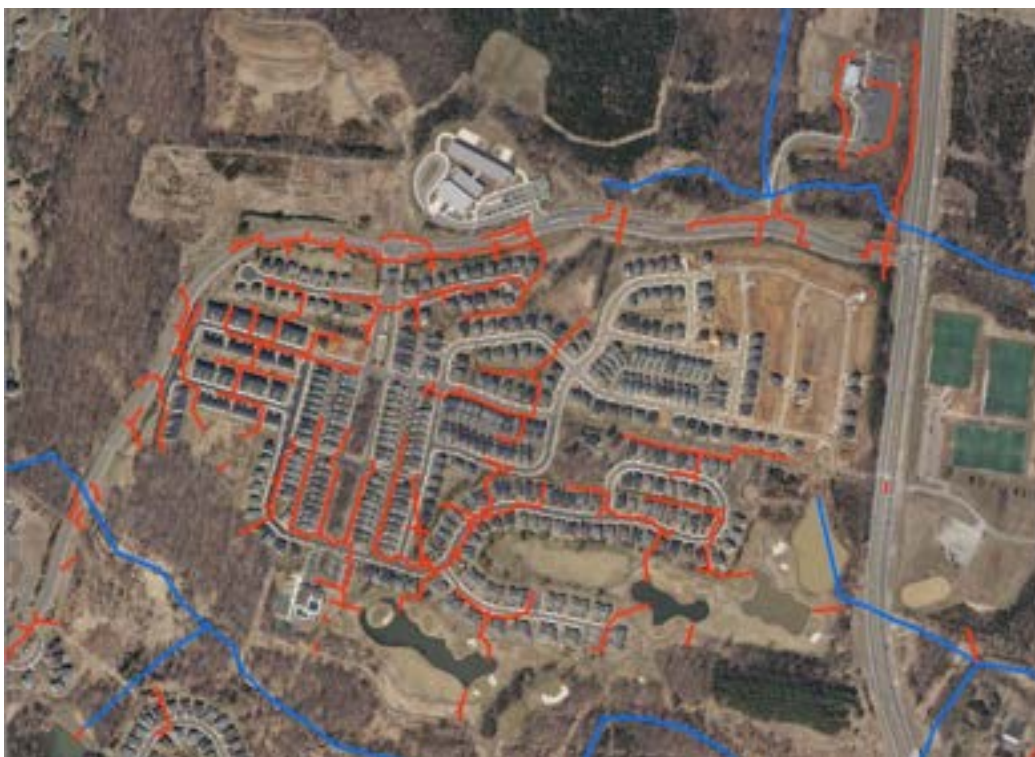
Figure 9. This view shows what the user would see after loading in a new set of stormwater infrastructure into the geodatabase. MS4 outfalls and hydrologic connections still need to be added by the user. Note the stormwater infrastructure is a discontinuous network within itself, but also lacks continuity with the NHD Flowlines.

The first step in preparing the newly loaded infrastructure for analysis within the Stormwater Tool is identifying jurisdictional outfalls and assigning proper ownership. The following examples illustrate two common situations a user may encounter where a jurisdictional outfall must be assigned: BMPs (Figure 10) and grass swales or ditches extending from subsurface pipes (Figure 11). Before we add outfalls, we must begin an editing session that will allow us to add to the infrastructure network.

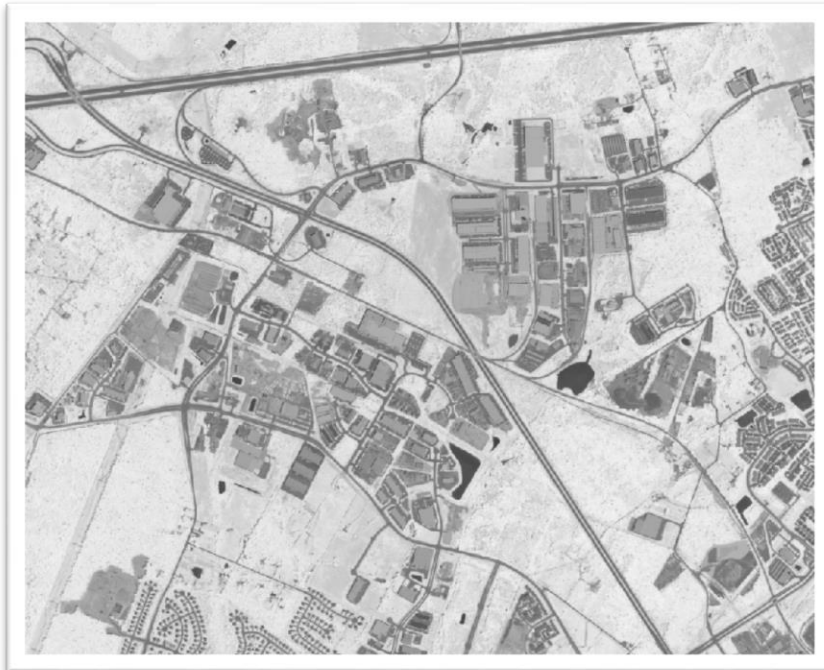
the way chlorophyll reflects energy in the near infrared band by using band math which results in a new raster data set with pixels containing values ranging from -1 to 1. Pixels with values closer to 1 represent vegetation, while those closer to -1 are non-vegetation.

(NDVI Result showing vegetation and non-vegetation)

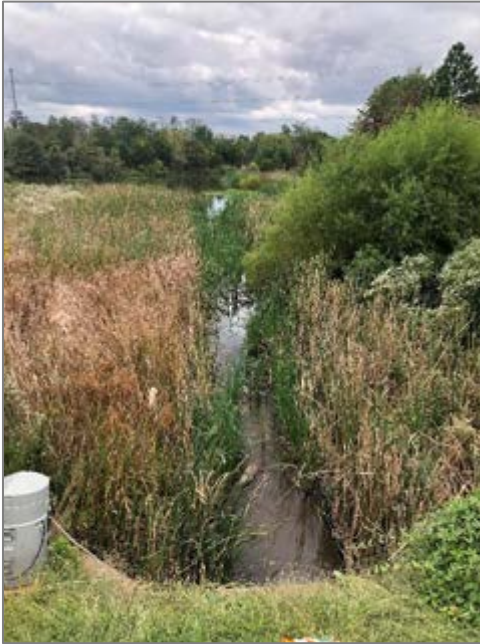
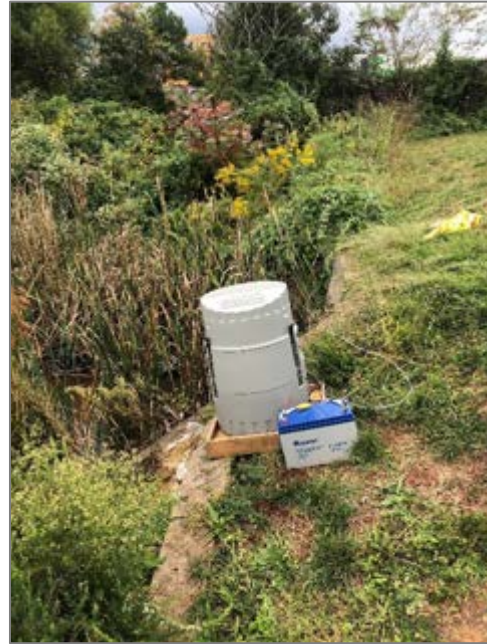
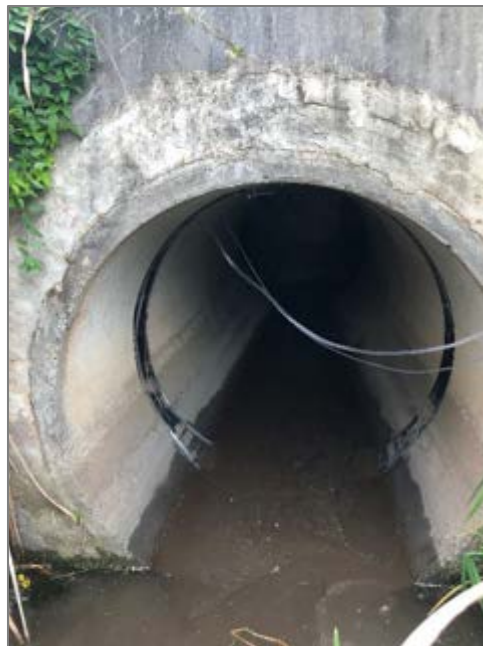
Manassas (#941)

Site #941 is located within the Bull Run watershed. It receives drainage from an industrial use area and parking lots with frequent truck traffic. Water levels are persistently found to be above 6 – 10 inches in the monitoring outfall.
