**Annual Stormwater Management Report
VSMP Permit No. 0088595 – FY 2021**

Submitted by:
Prince William County
Department of Public Works

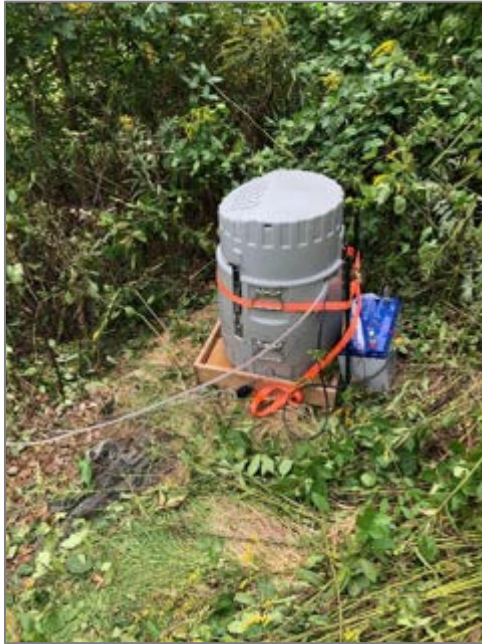
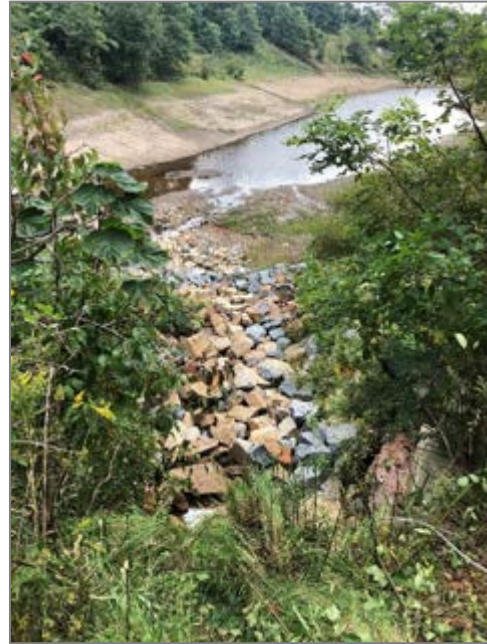
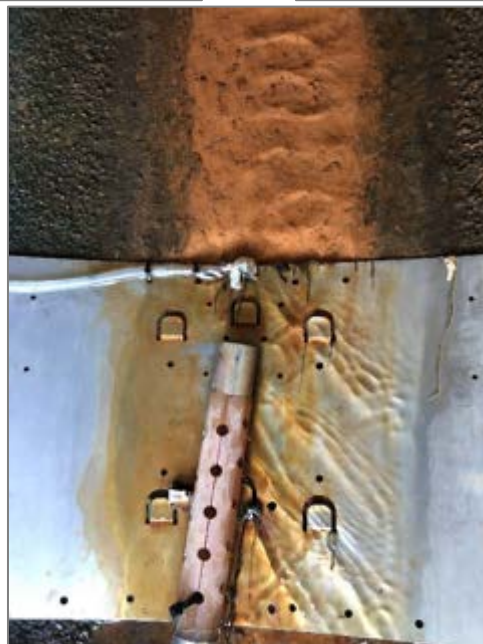
Dale City (#4684)

Site #4684 receives flow from Neabsco Mills Road and the Stonebridge at Potomac Town Center development. It is a 54" concrete pipe that drains to a deep scour pool before draining to a large BMP that collects drainage for the Potomac Club development. The bottom photo shows low flow levels falling below the suction line of the standard flow probe previously used in the sampler installation at the Dale City site.

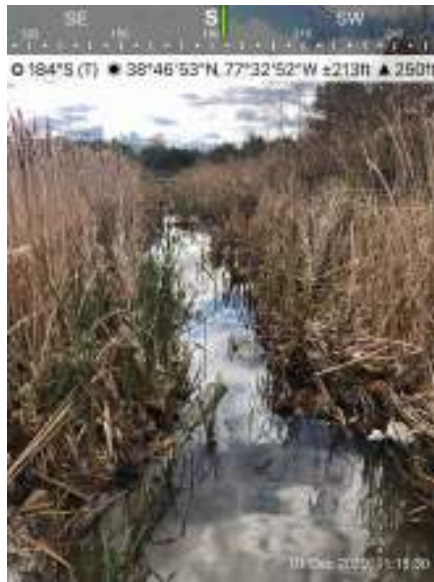
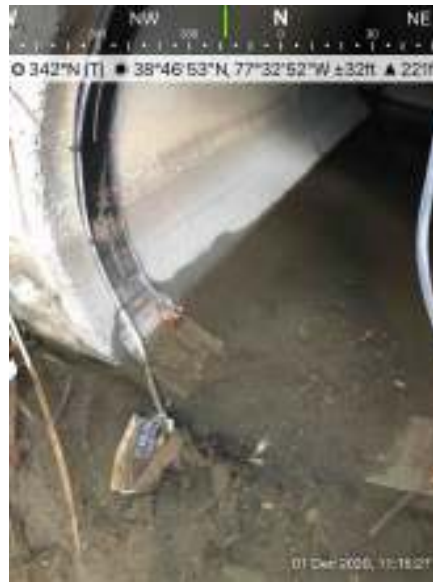
Manassas (#941)

Site #941 is located within the Bull Run watershed. It receives drainage from an industrial use area and parking lots with frequent truck traffic. Water levels are persistently found to be above 6 – 10 inches in the monitoring outfall.

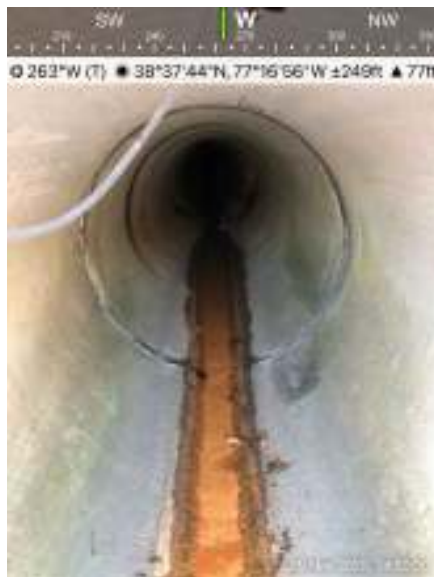
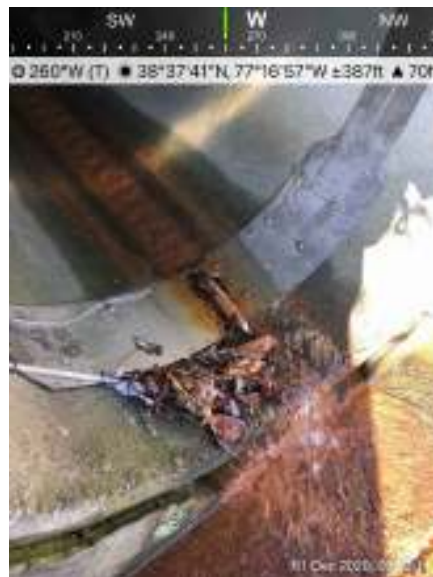
Dale City (#4684)

Site #4684 receives flow from Neabsco Mills Road and the Stonebridge at Potomac Town Center development. It is a 54” concrete pipe that drains to a deep scour pool before draining to a large BMP that collects drainage for the Potomac Club development. Erosion around the headwall and apron of the outfall at this site continues to pose a risk during sampler deployment and retrieval.

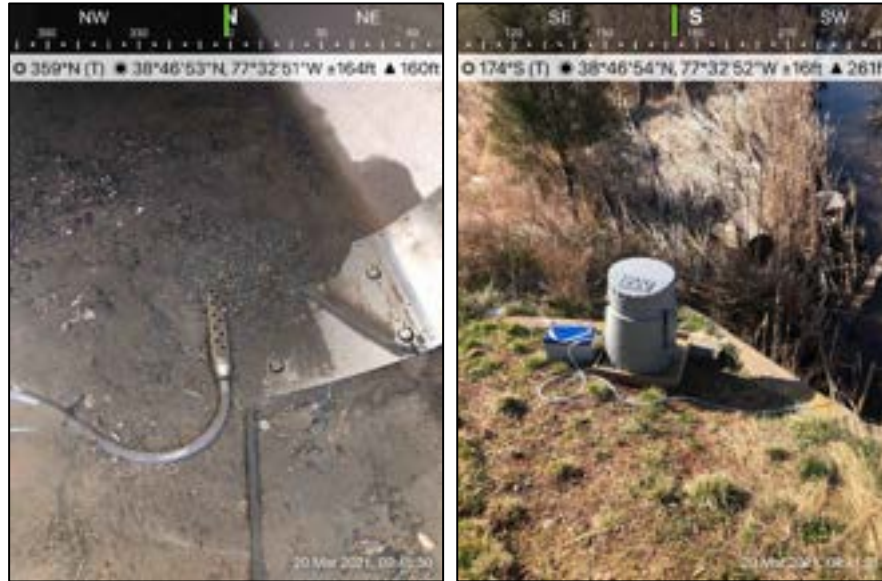
Manassas (#941)

Site #941 is located within the Bull Run watershed. It receives drainage from an industrial use area and parking lots with frequent truck traffic. Water levels are persistently found to be above 6 – 10 inches in the monitoring outfall.

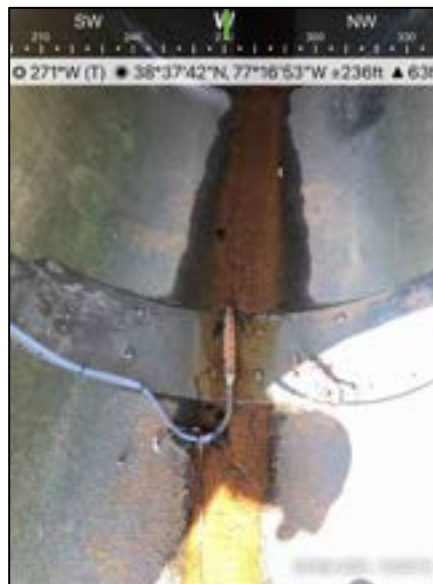
Dale City (#4684)

Site #4684 receives flow from Neabsco Mills Road and the Stonebridge at Potomac Town Center development. It is a 54" concrete pipe that drains to a deep scour pool before draining to a large BMP that collects drainage for the Potomac Club development. Erosion around the headwall and apron of the outfall at this site continues to pose a risk during sampler deployment and retrieval.

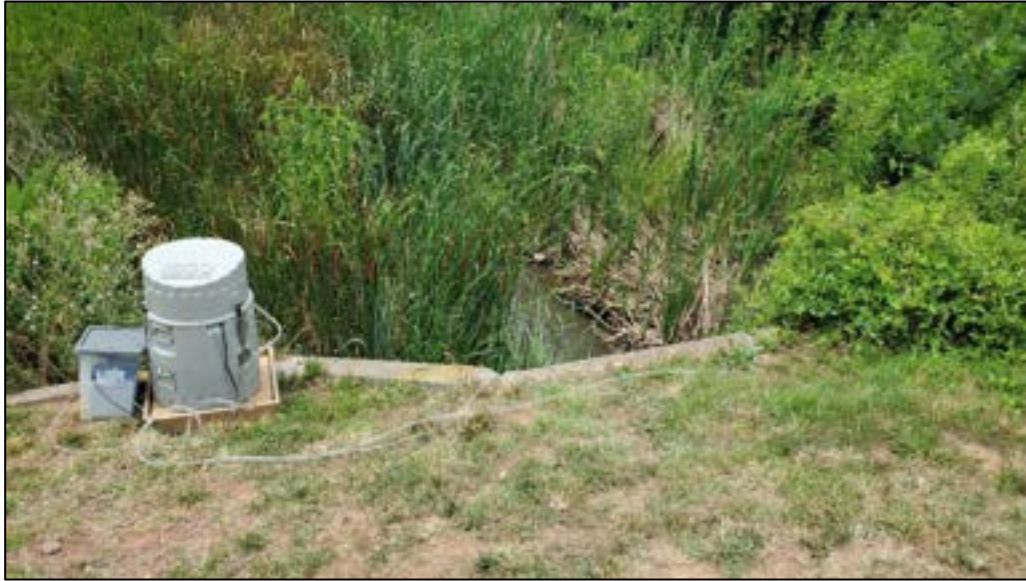
Manassas (#941)

Site #941 is located within the Bull Run watershed. It receives drainage from an industrial use area and parking lots with frequent truck traffic. Water levels are persistently found to be above 6 – 10 inches in the monitoring outfall.

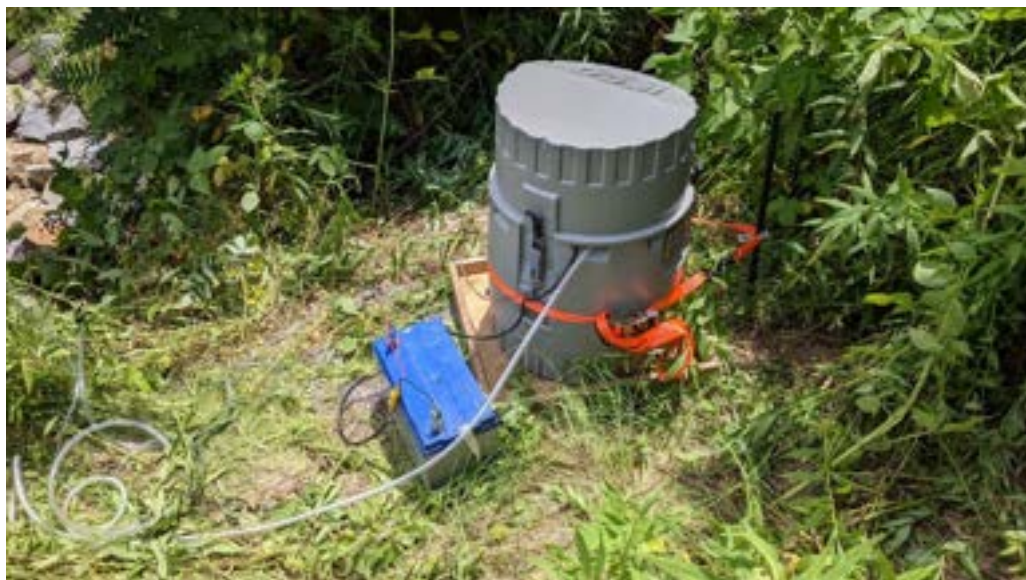
Dale City (#4684)

Site #4684 receives flow from Neabsco Mills Road and the Stonebridge at Potomac Town Center development. It is a 54" concrete pipe that drains to a deep scour pool before draining to a large BMP that collects drainage for the Potomac Club development. Erosion around the headwall and apron of the outfall at this site continues to pose a risk during sampler deployment and retrieval.

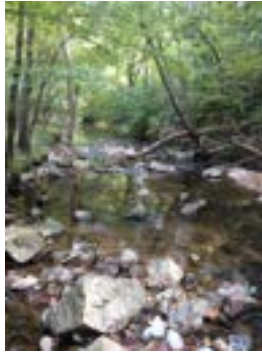
Image 1

Downstream

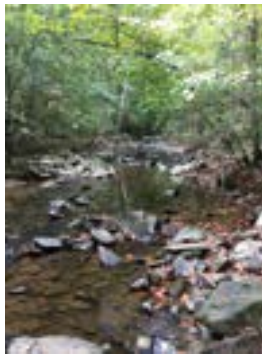
Image 2

Upstream of starting point

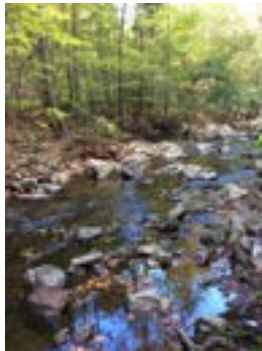
Image 3

Tire in stream

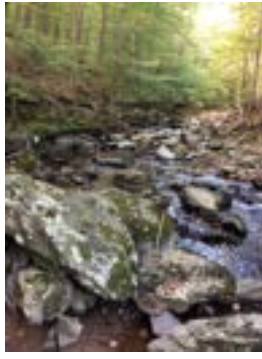
Image 4

Upstream extent

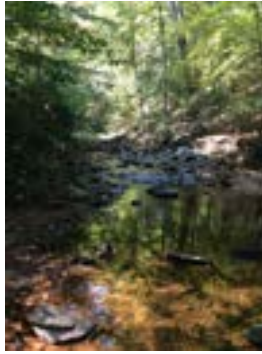
Image 1

Upstream for mid

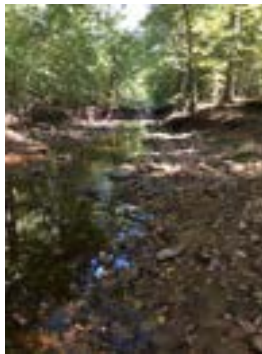
Image 2

Downstream from midpoint

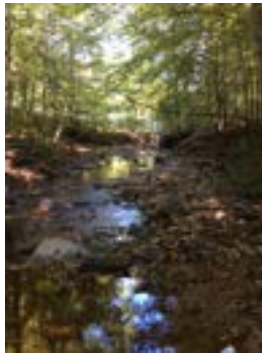
Image 3

Downstream from downstream end

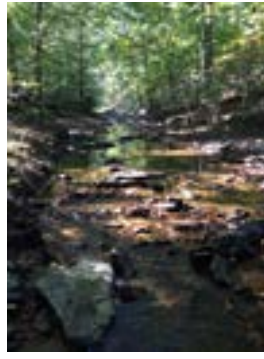
Image 4

Upstream from downstream end of reach.

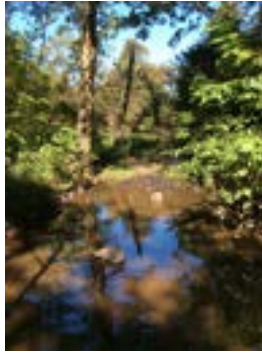
Image 1

Looking upstream from sample point

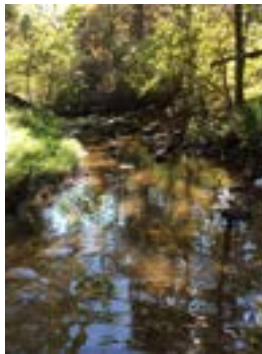
Image 2

Looking downstream from Monitoring point.

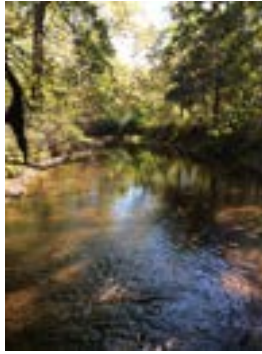
Image 1

Downstream from downstream point of reach.

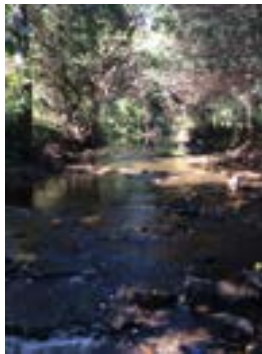
Image 2

Looking upstream from downstream point of reach.

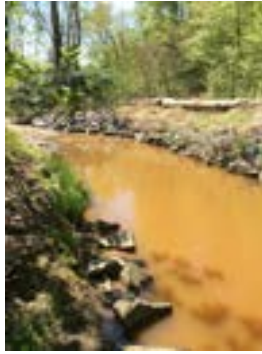
Image 1

Downstream. From downstream extent.

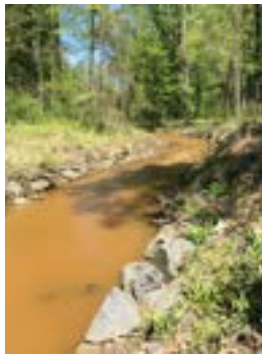
Image 2

Upstream. From downstream extent.

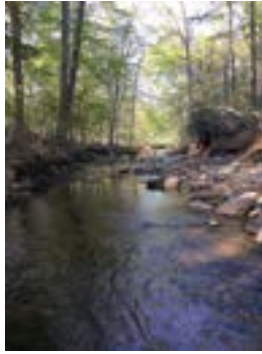
Image 1

Looking downstream from upstream extent.

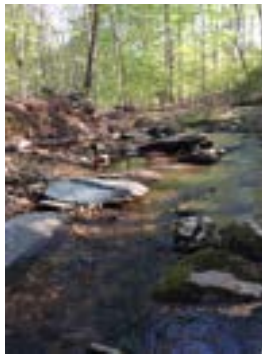
Image 2

Looking upstream from upstream extent.

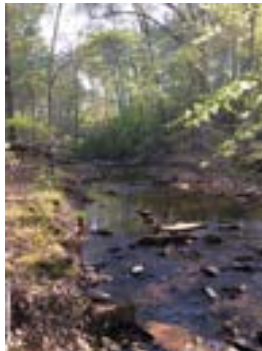
Image 3

Looking upstream from downstream extent.

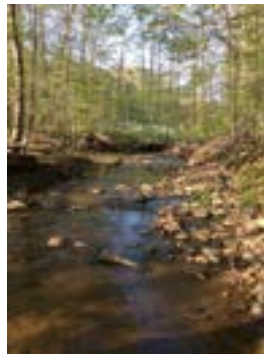
Image 4

Looking downstream from downstream extent.

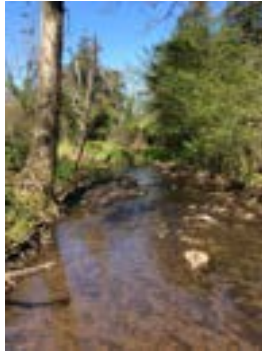
Image 1

Looking upstream, apparent tree loss.

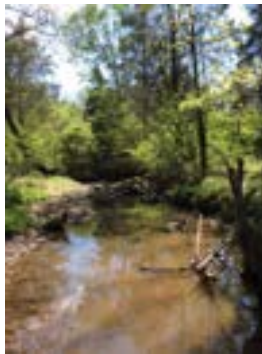
Image 2

Looking downstream from downstream extent. Increasing number of trees falling into stream.

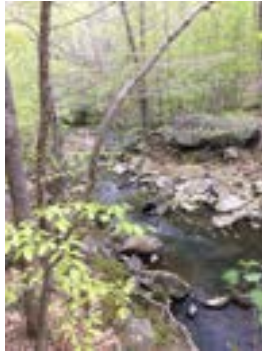
Image 1

Looking upstream of the upstream extent of reach

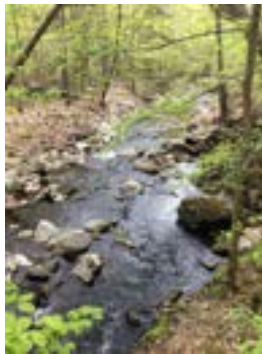
Image 2

Looking downstream of upstream extent of reach

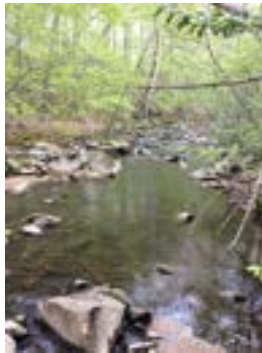
Image 3

Looking upstream from downstream extent of reach

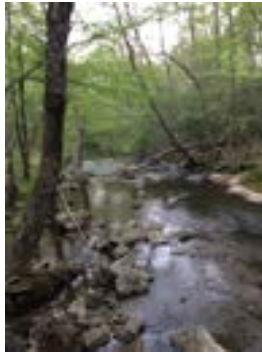
Image 4

Looking downstream from downstream extent of reach

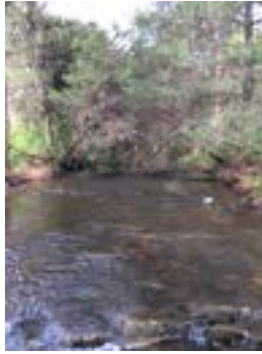
Image 1

Looking upstream from downstream extent of reach. New fallen tree.

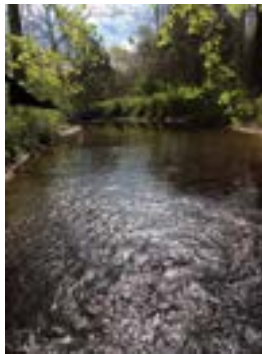
Image 2

Looking downstream of downstream extent of reach.

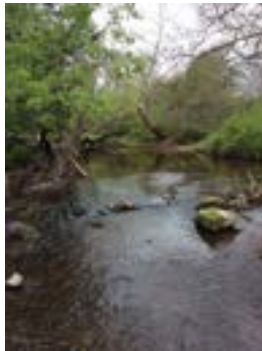
Image 3

Looking upstream from upstream extent of reach.

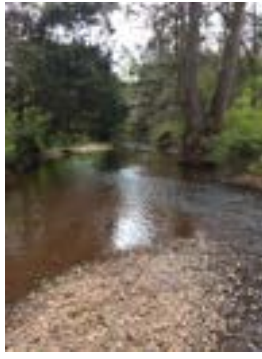
Image 4

Looking downstream from upstream extent of reach.

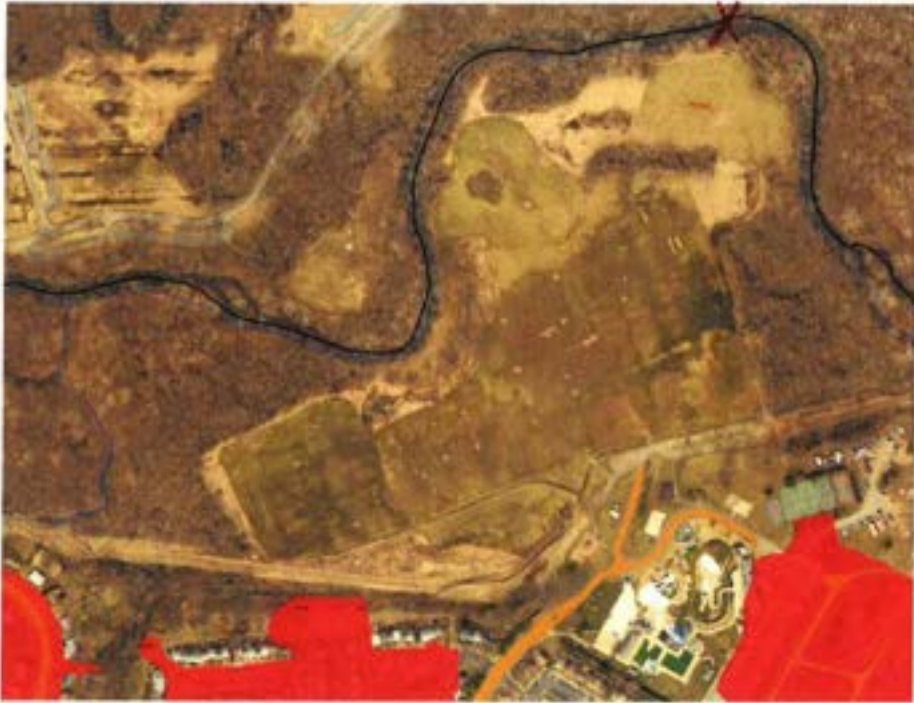
Site 1: Bull Run, Ben Lomond Park

Quality of upstream MS-4 outfalls: No quality upstream outfalls [0]
Upstream land uses: Residential, some Commercial [2]
Opportunity to reduce floatables sources: _____ []
Access and feasibility: _____ []
Size of contributing drainage area(s): Large >10ac [1]

Notes:
No MS-4 outfalls eliminates this site from the floatables monitoring program.

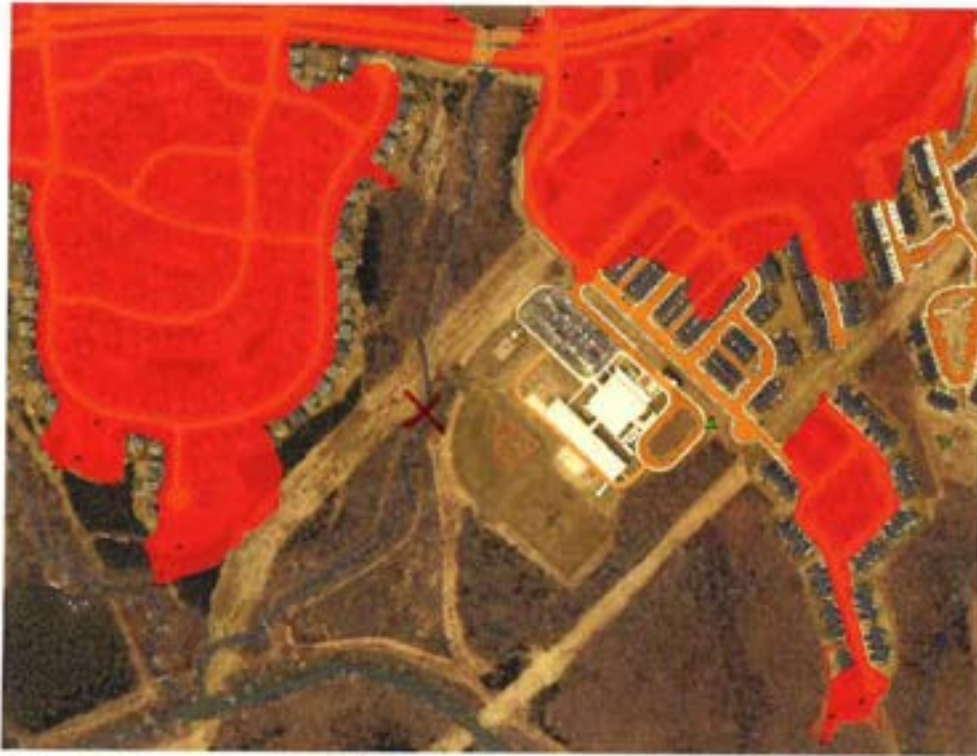
Site 3: Dawkins Branch, Victory Elementary School

Quality of upstream MS-4 outfalls:	<u>2 quality outfalls</u>	<u>[3]</u>
Upstream land uses:	<u>Residential, Schools, Roadway</u>	<u>[3]</u>
Opportunity to reduce floatables sources:	<u>Some floatables, limited but excessive sources</u>	<u>[4]</u>
Access and feasibility:	<u>Potential access across, lot access good</u>	<u>[5]</u>
Size of contributing drainage area(s):	<u>Med. large</u>	<u>[3]</u>

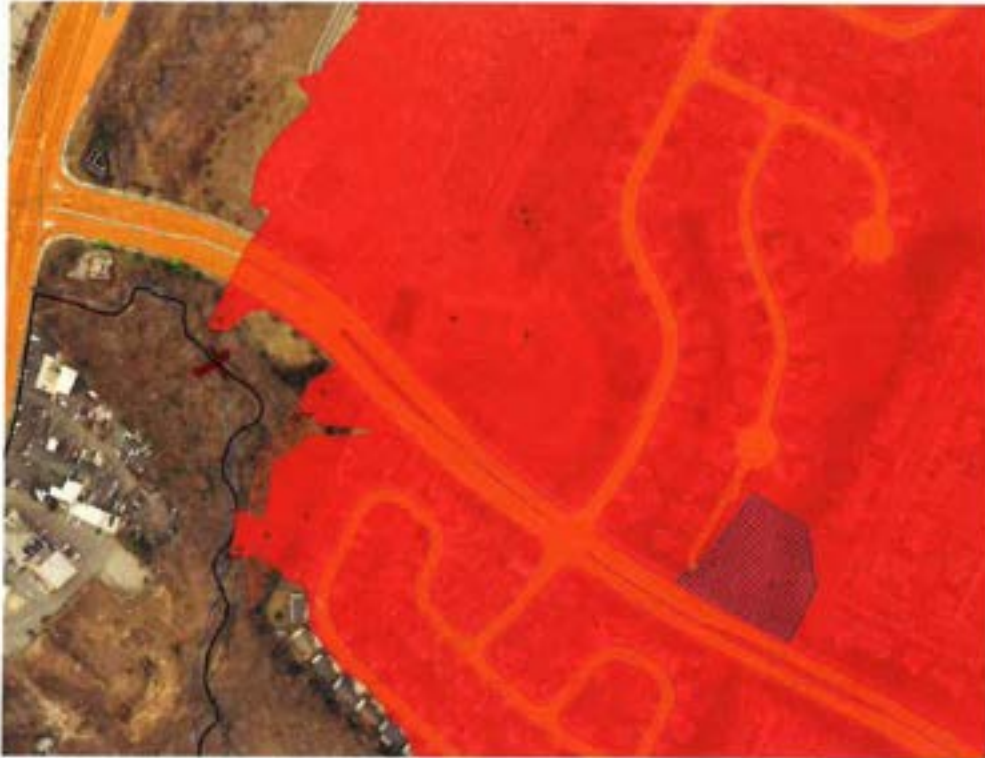
Site 4: Dewey's Creek, Wayside Drive

Quality of upstream MS-4 outfalls:	One sanitary outfall,	[3]	
Upstream land uses:	Residential, Commercial, Roadway	[4]	
Opportunity to reduce floatables sources:	Large amount of traps	[3]	Traps Source from Stormwater
Access and feasibility:	Available parking, easy access	[3]	
Size of contributing drainage area(s):	Large	[3]

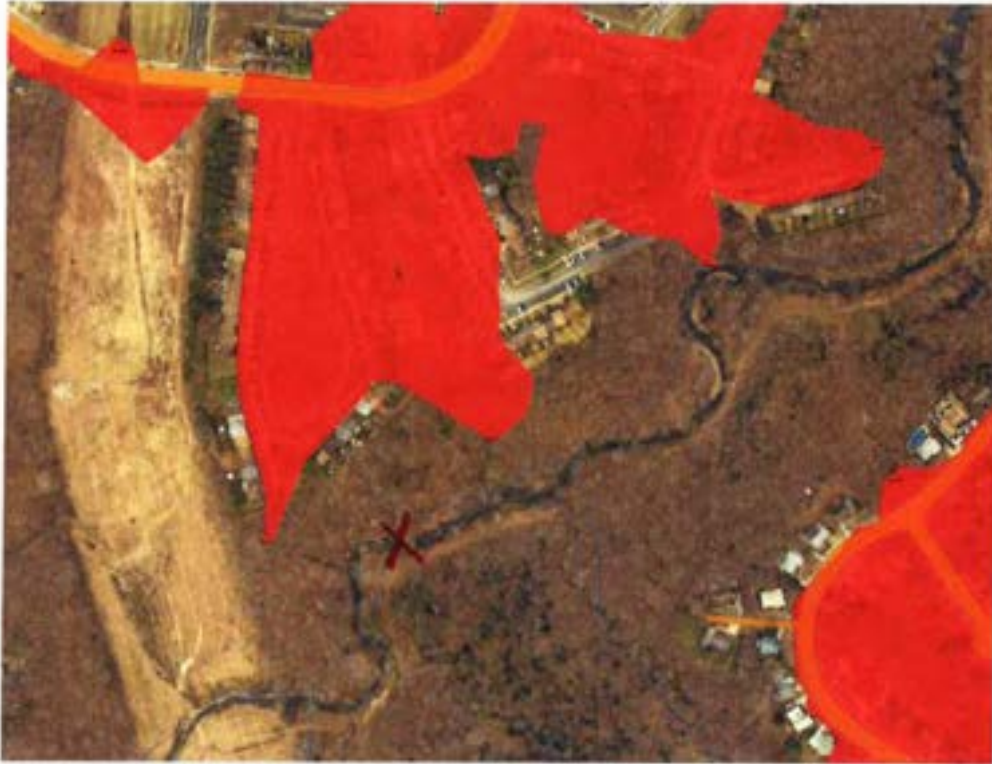
Site 5: Hooes Run, Castile Court

Quality of upstream MS-4 outfalls:	<u>2-3 quality outfalls</u>	[3]
Upstream land uses:	<u>Residential</u>	[2]
Opportunity to reduce floatables sources:	<u>good amount of trash identifiable sources</u>	[4]
Access and feasibility:	<u>Neighborhood w/ little parking, hill difficult</u>	[2]
Size of contributing drainage area(s):	<u>Medium</u>	[2]

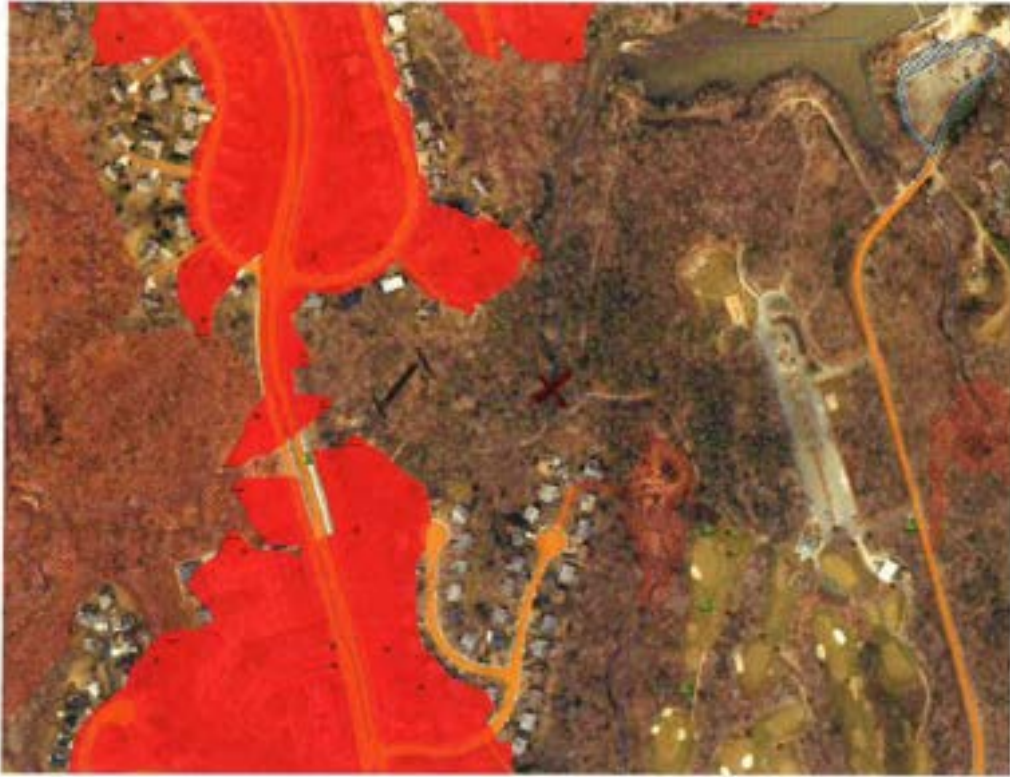
Site 6: Hooes Run, Springwood Drive

Quality of upstream MS-4 outfalls: 3 quality outfalls [3]
Upstream land uses: Residential [2]
Opportunity to reduce floatables sources: little to no trash [2]
Access and feasibility: hilly area to descend, path helps access [3]
Size of contributing drainage area(s): med-large [4]

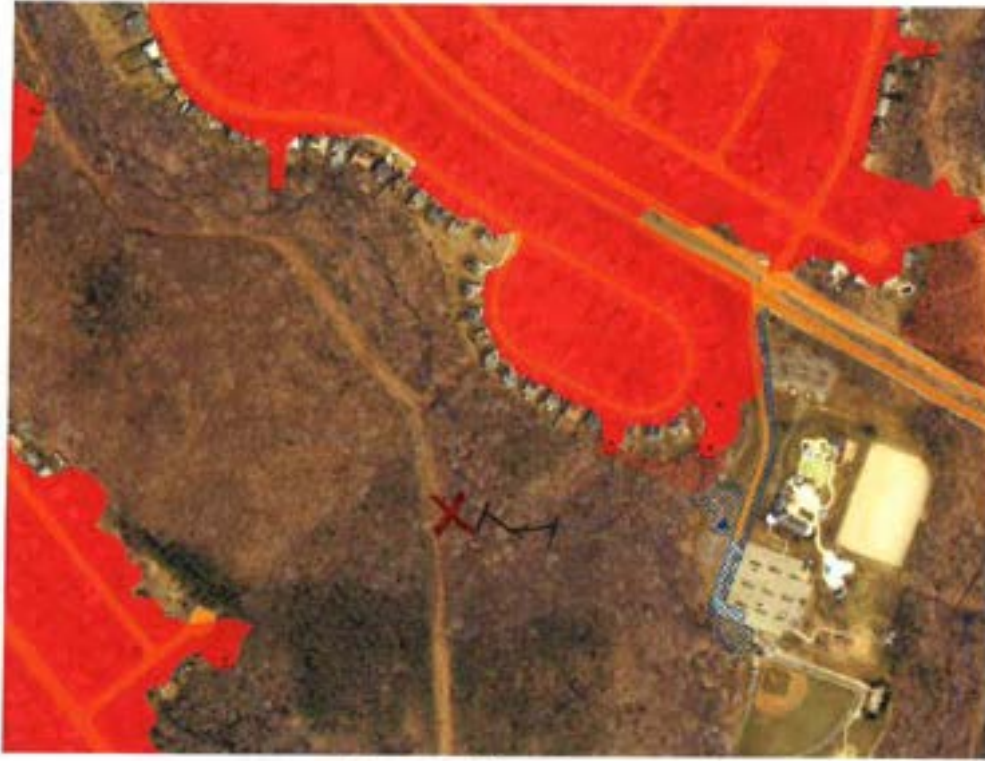
Site 7: Neabsco Creek, Andrew Leitch Park

Quality of upstream MS-4 outfalls: 2 quality outfalls [2]
Upstream land uses: Residential small lot [3]
Opportunity to reduce floatables sources: Low numbers of floatables [4]
Access and feasibility: good access, too few inputs good isolated inputs [10] [5]
Size of contributing drainage area(s): Small - Mid [4]

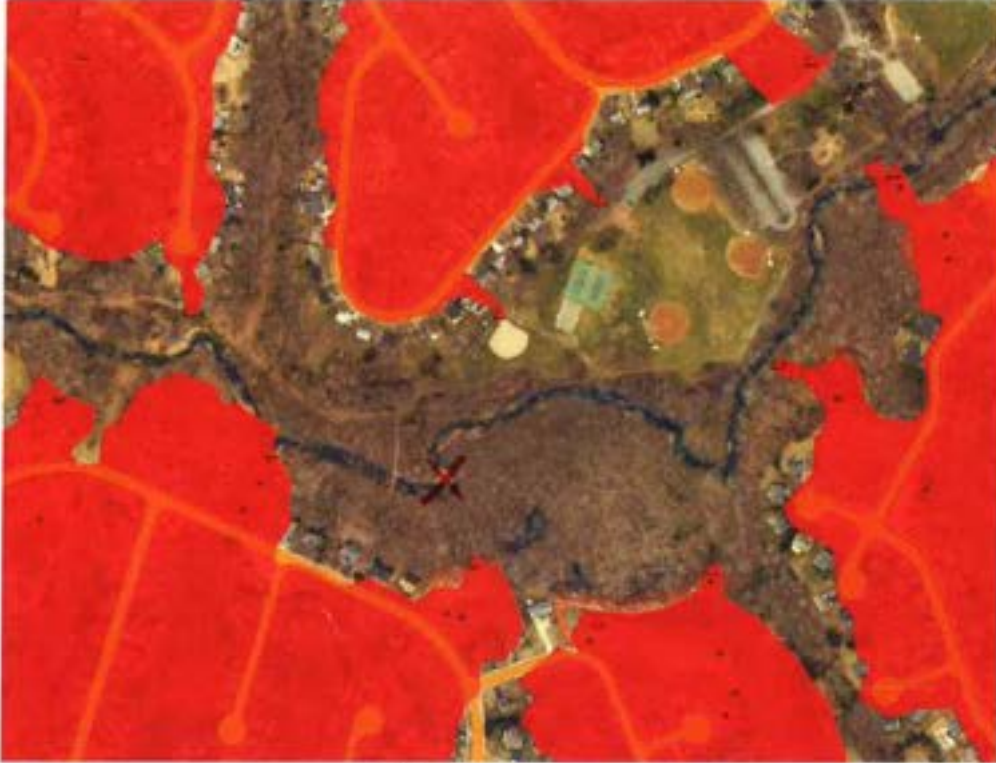
Site 8: Neabsco Creek, Cloverdale Park

Quality of upstream MS-4 outfalls: 2-3 quality [2]
Upstream land uses: Residential [2]
Opportunity to reduce floatables sources: would be difficult to ID sources [2] *little amount of trash*
Access and feasibility: big way from parking, wide deep channel [2]
Size of contributing drainage area(s): Mid-Large [3]

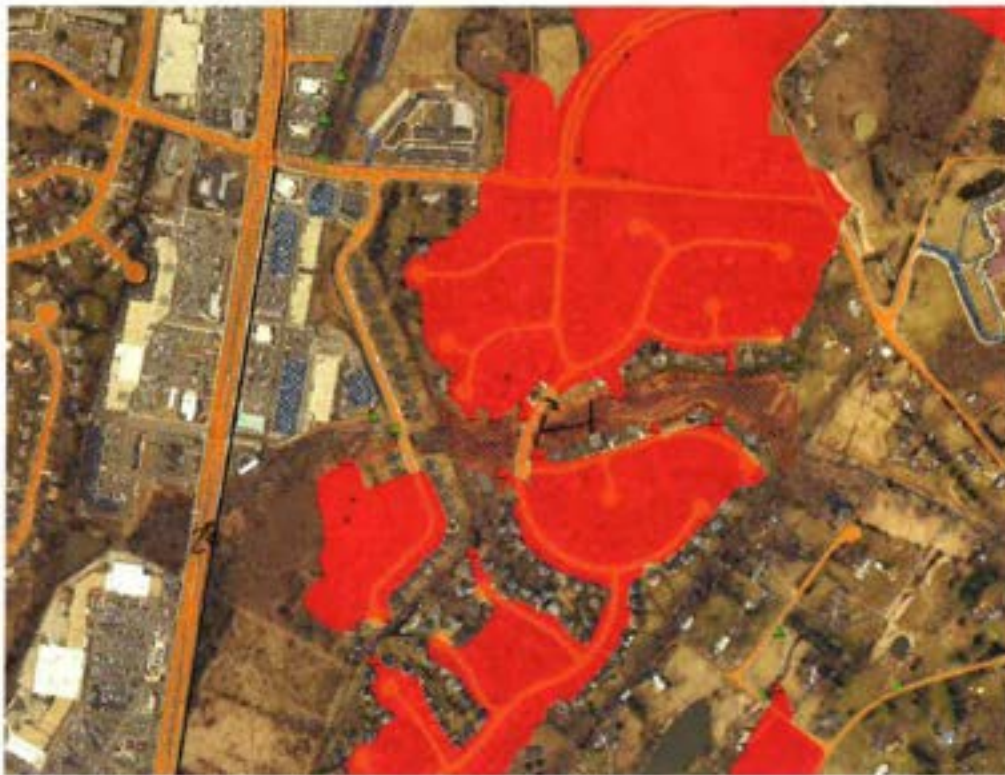
Site 10:

Quality of upstream MS-4 outfalls: <u>Many upstream outfalls</u>	[4]
Upstream land uses: <u>Commercial/Residential</u>	[4]
Opportunity to reduce floatables sources: <u>Some</u>	[3]
Access and feasibility: <u>Fence impedes Access, utility before stream</u>	[3]
Size of contributing drainage area(s): <u>Small-med</u>	[4]

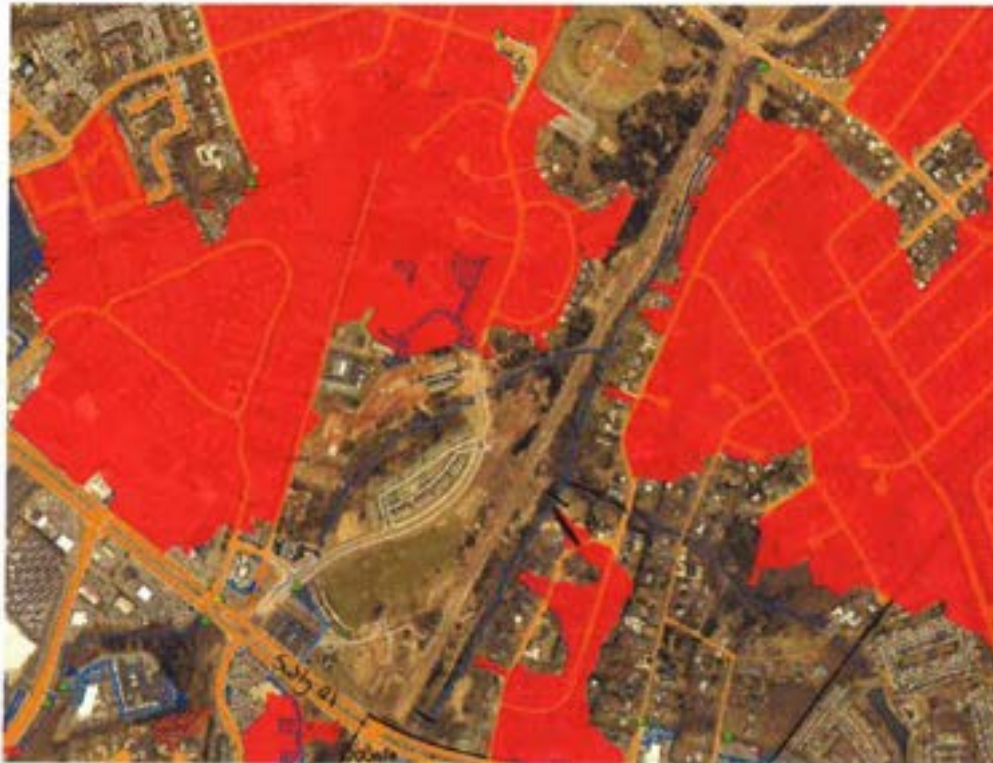
Site 11: Flat Branch

Quality of upstream MS-4 outfalls:	<u>Many</u>	(4)
Upstream land uses:	<u>Commercial/Residential</u>	(4)
Opportunity to reduce floatables sources:	<u>Sufficient floatables</u>	(4)
Access and feasibility:	<u>Ingress/Egress through private property</u>	(3) Local access good
Size of contributing drainage area(s):	<u>Large</u>	(2)

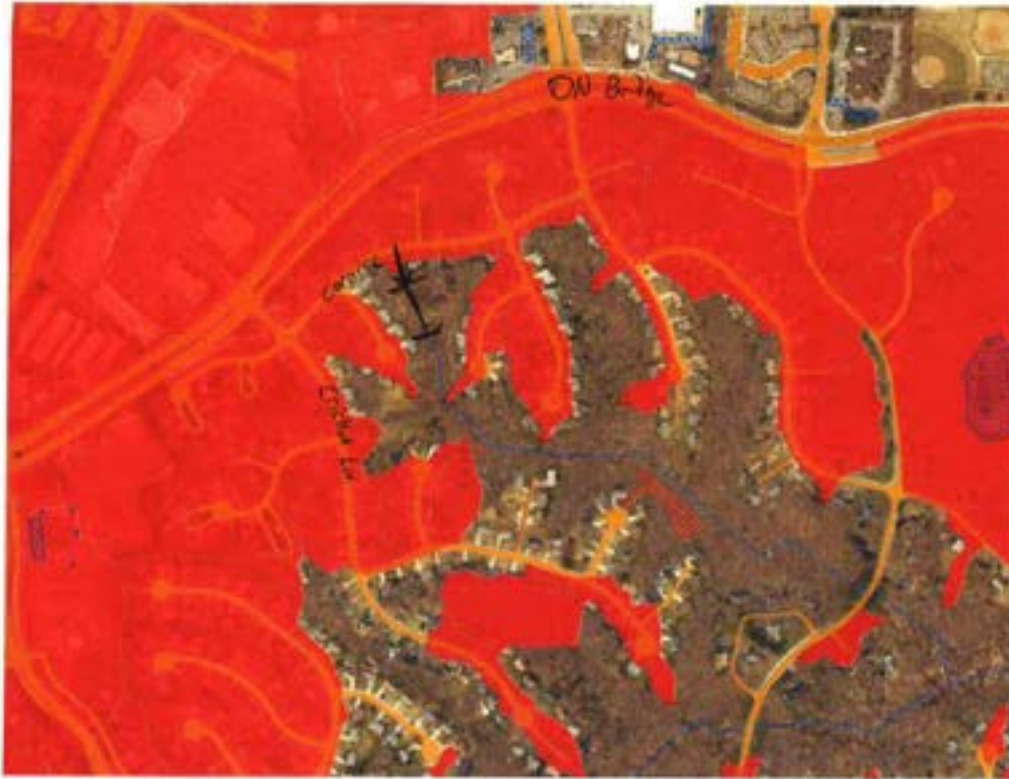
Site 12:

Quality of upstream MS-4 outfalls: Many (4)
Upstream land uses: Commercial/Residential (4)
Opportunity to reduce floatables sources: Good amount of floatables (4)
Access and feasibility: Small stream, easy access from Roadway (3)
Size of contributing drainage area(s): Very Large (1)
