NEABSCO CREEK WATERSHED STUDY, PRINCE WILLIAM COUNTY, VIRGINIA

Prepared by

Versar, Inc.
9200 Rumsey Road, Suite 1
Columbia, Maryland 21045

March 31, 2017

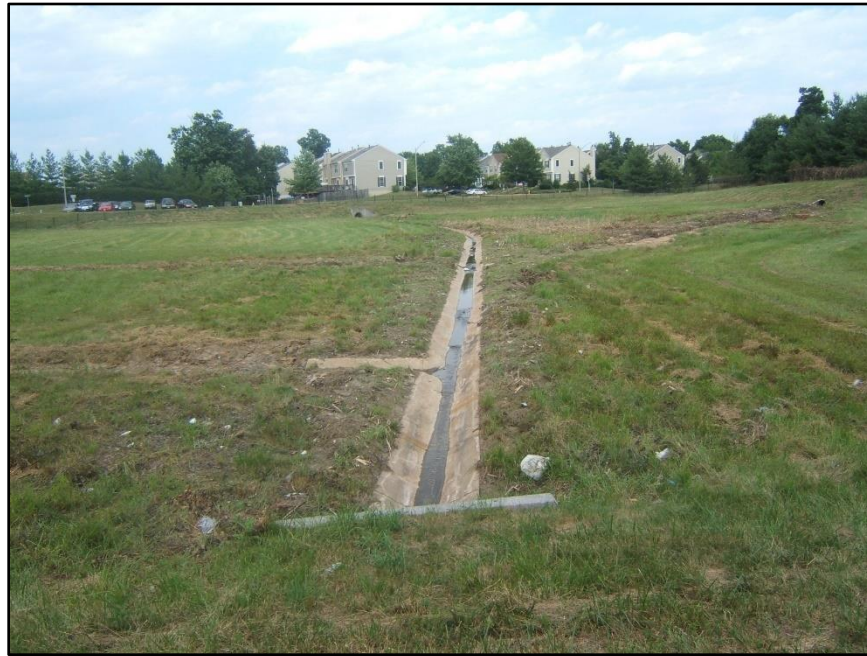
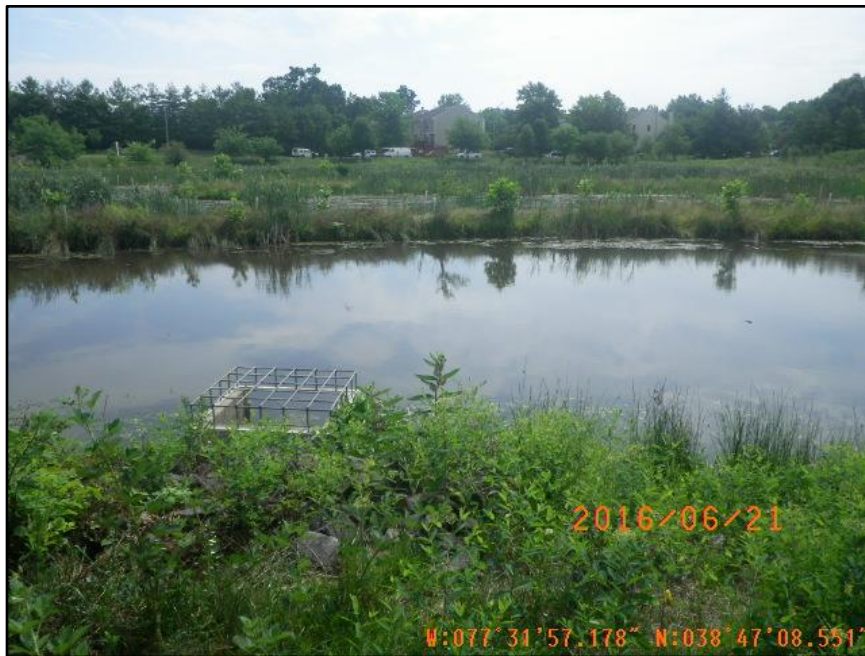
Figure 3–1. Example of stormwater facility conversion. Dry Pond facility (top) converted to constructed wetland with riser structure (bottom). Photo credit Prince William County

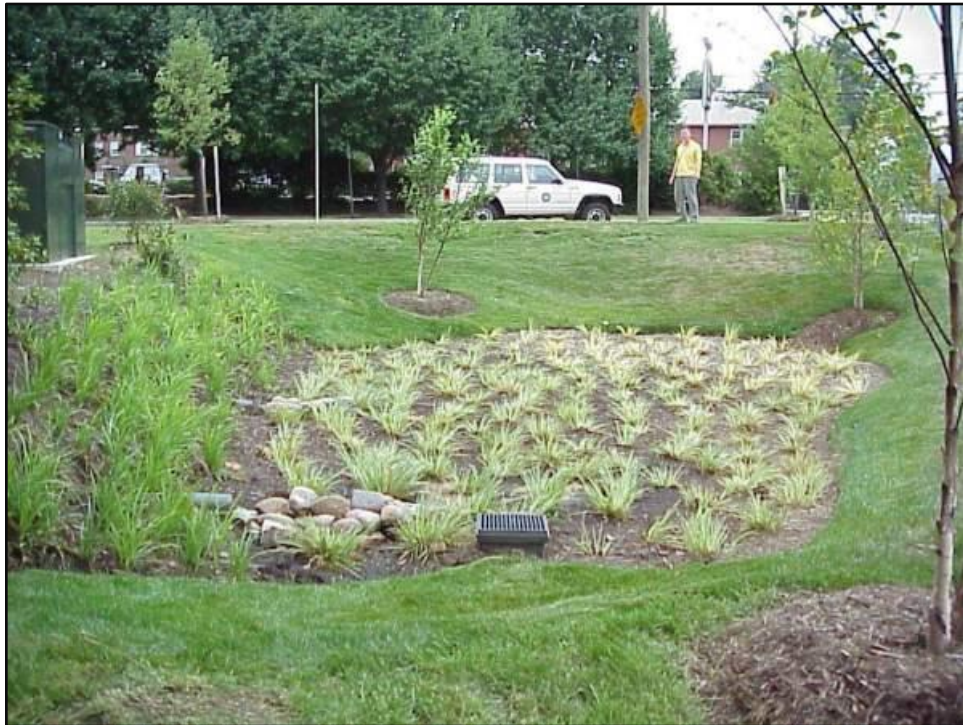
Figure 3–2. Example of bioretention facility. Photo credit Virginia Water Resources Research Center

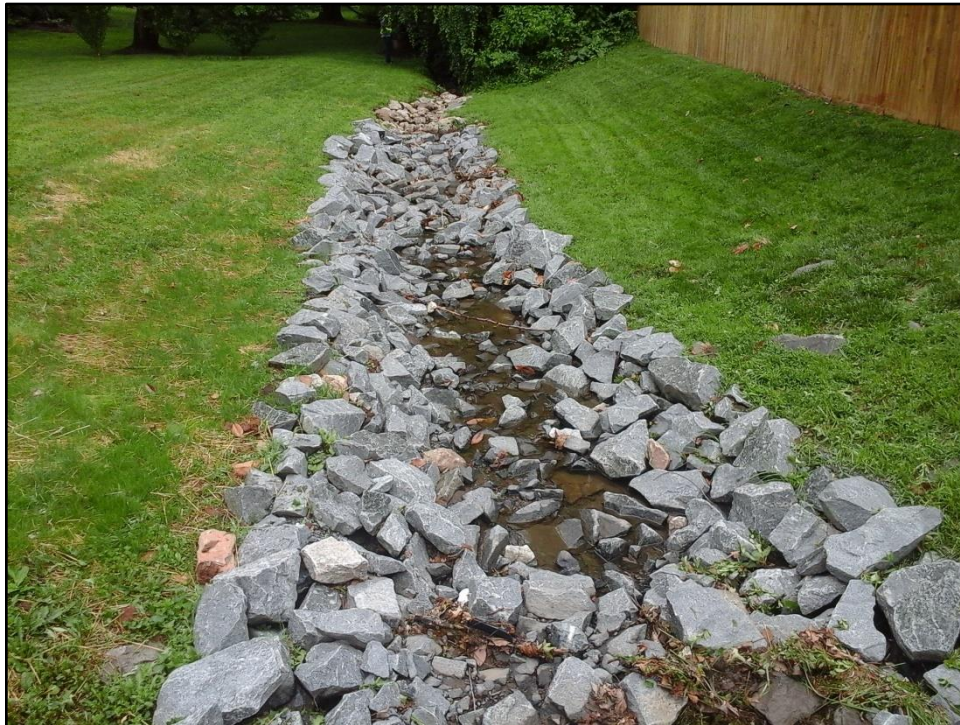
Figure 3-3. Example of outfall rip-rap stabilization. Photo credit Versar.

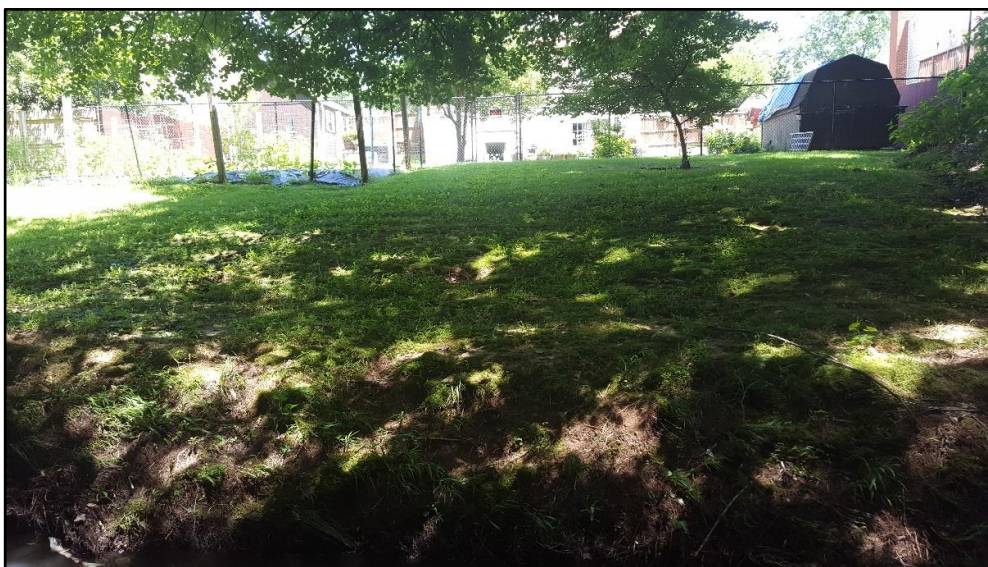
Figure 6–9. Example of lack of riparian buffer vegetation. Photo from inadequate buffer point ib001.
