# Annual Stormwater Management Report

## VSMP Permit No. 0088595 – FY 2017

Submitted by:  
Prince William County  
Department of Public Works

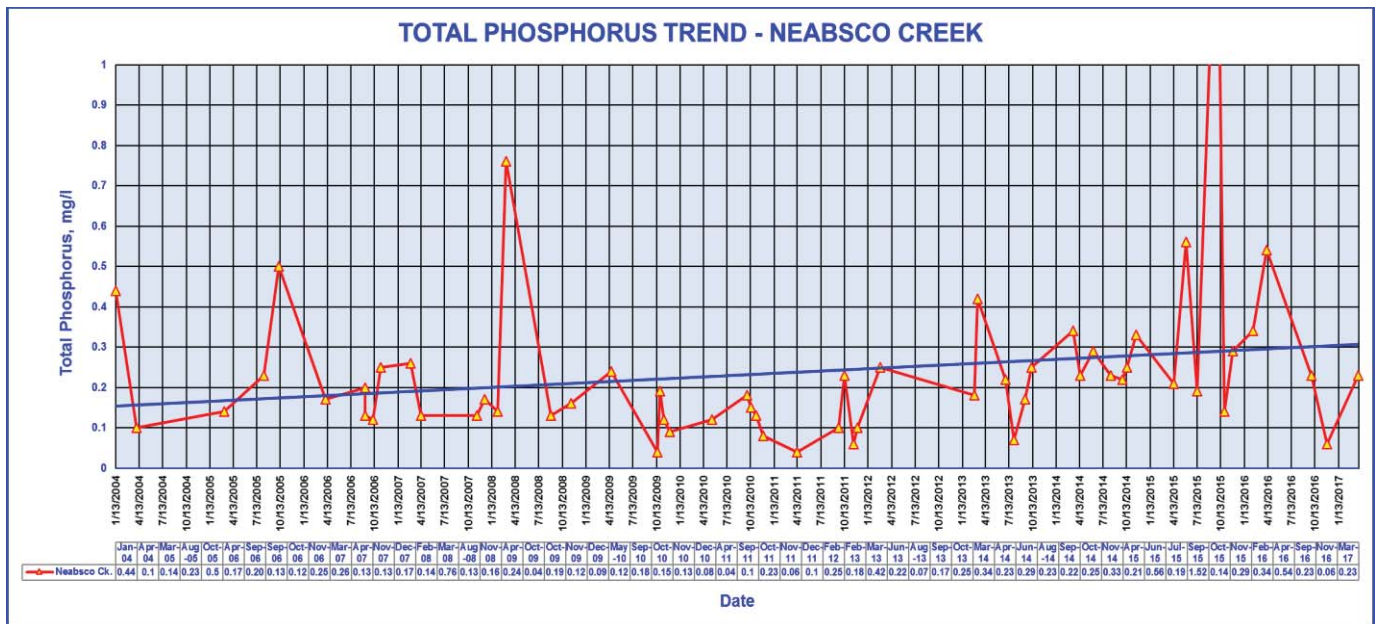
Figure 7 – Long Term TP trends in Neabsco Creek Watershed

Total Phosphorus shows an increasing trend within the Neabsco Creek Watershed. This data may be skewed more towards an increase due to several outlying peaks caused during large storm

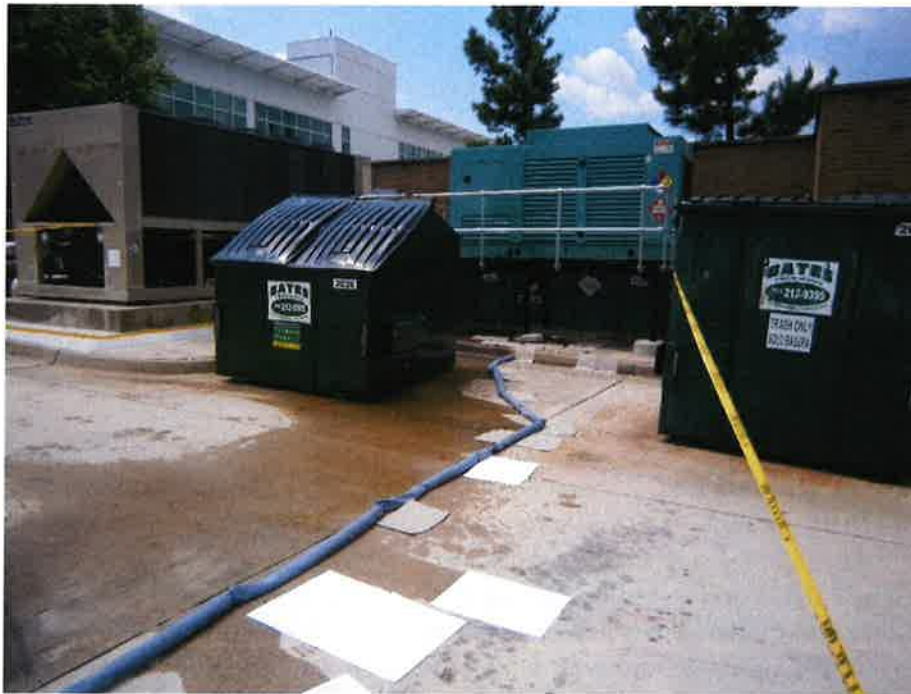
**Figure 1: Photo of Discharge.**

On July 19th, 2016 County staff observed a large (~20 gal) hydraulic fluid spill outside the Development Services Building at 5 County Complex Court. The spill was the result of a ruptured hydraulic fluid line belonging to a Bates Trucking garbage collection truck. The effective spill area was found to extend from up against the dumpster and nearby diesel generator, to along the loading dock area and out into the roadway surround the County Complex parking lots. The driver of the Bates trucking vehicle left the scene of the spill and drove the truck down to the baseball stadium, leaving a small line of hydraulic fluid along the way. The spill was first detected by County Buildings and Grounds staff, and preventative measures were put in place immediately before allowing discharge to reach the stormsewer system.

No trackdown was needed as the source of the discharge was observed before it was able to enter the stormsewer system.

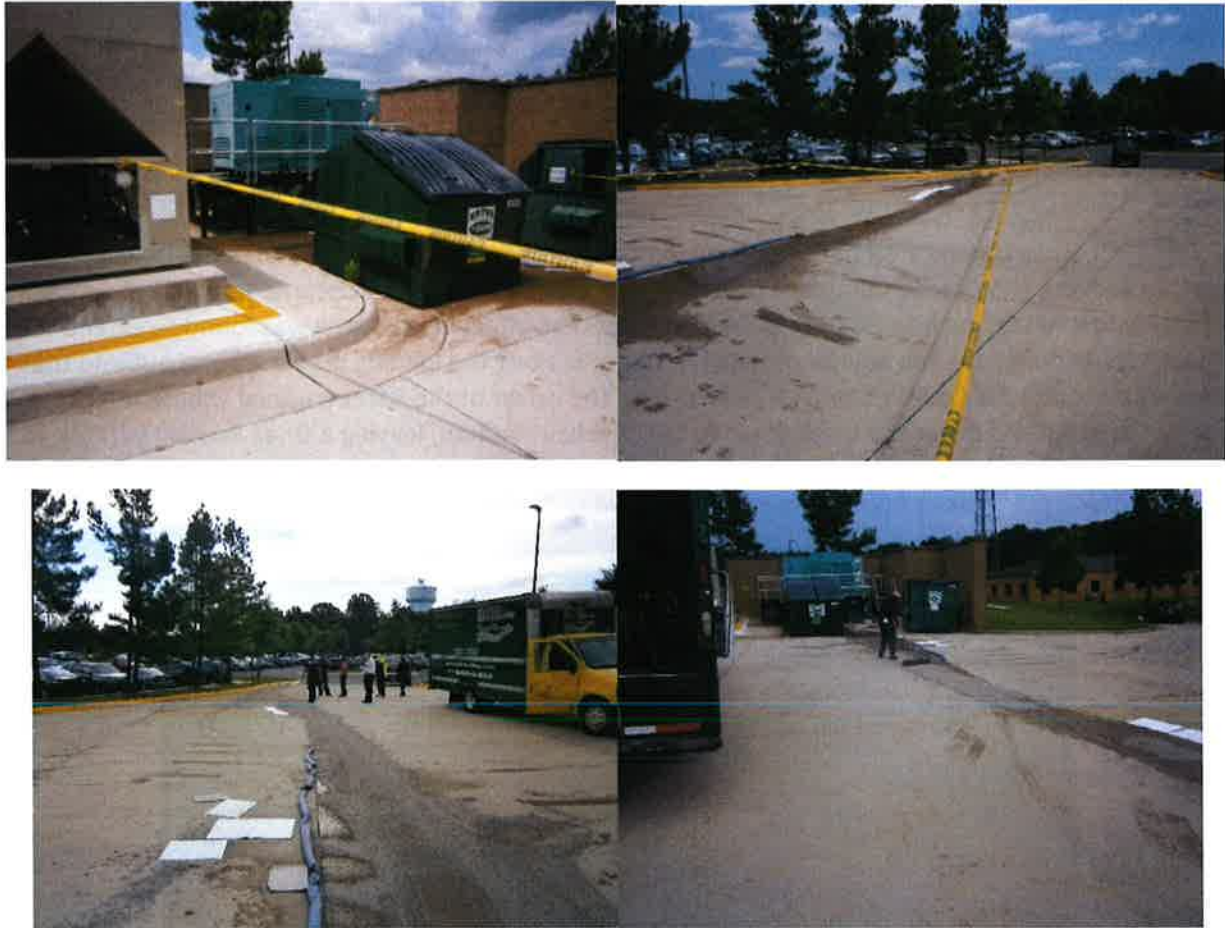
**Figure 3: Trackdown Photos**

On scene of the discharge were PWC Watershed Management, Risk Management, Buildings and Grounds, and Fire Marshall Staff. Bates Trucking was contacted as the responsible party for the spill. It took 3 hours for Bates Trucking staff to arrive on scene to address the spill. Absorbent material was place on the spill by Bates Trucking, but no cleanup of the material took place. County staff were informed a certified environmental cleanup company was contracted by Bates to complete the job; however, by the morning of July 20<sup>th</sup> no such company arrived. Communication with the company bates reported to the County as contracted to complete the cleanup, informed County staff that they had not received a retainer from Bates to clean up the spill, and therefore were not responding to the spill. At this point County staff contracted Atlas Environmental to complete the cleanup. Atlas arrived on site on July 20<sup>th</sup> and completed the cleanup of the hydraulic fluid spill. The Prince William County Fire Marshalls office issued 2 violations for leaving the scene of a spill. As the FMO took the lead on the case, and no material entered the stormsewer system, no NOV was issued to Bates trucking. Since cleanup of the spill has taken place, this case is considered closed.

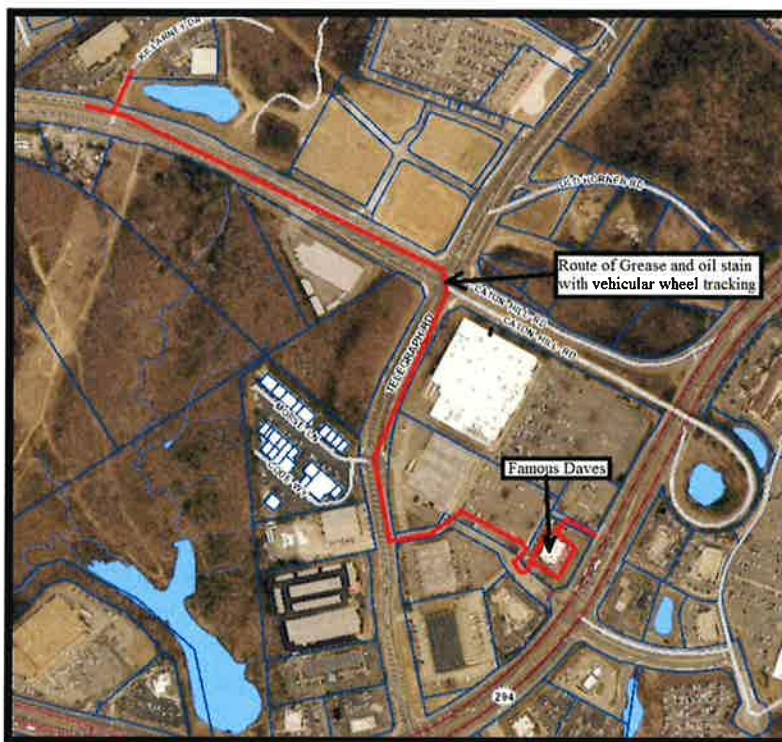
**Figure 1: Map of Discharge.**

At 10:42 pm on July 15, 2016 Environmental Services received an email from Doug McCabe, Captain PWC DFR, regarding a cooking oil spill. The discharge was first reported by Dr. Mike Clark of DEQ while on route to Famous Dave's Restaurant located at 2430 Prince William Parkway. Cooking oil was observed around the Famous Dave's Restaurant parking lot and along the road towards intersection of Caton Hill Road and Killarney Drive. The site was inspected by PWC staff on 18th July, 2016. Upon arrival, oil stains were observed to have dried and vehicular tracks were observed to spread the discharge on connected roads.

Following the inspection, a meeting was made with Mr. Florentino Perez, the manager of Famous Dave's Restaurant. He was not on duty while the incident occurred. As per his employee, the spill could be attributed to improper handling of material during pickup. The truck had been driven without closing the control valve of the tanker. Valley Protein Company was notified of the incident by the restaurant Manager. Valley Protein Company sent their crews to disperse absorbent on spilled surface around the

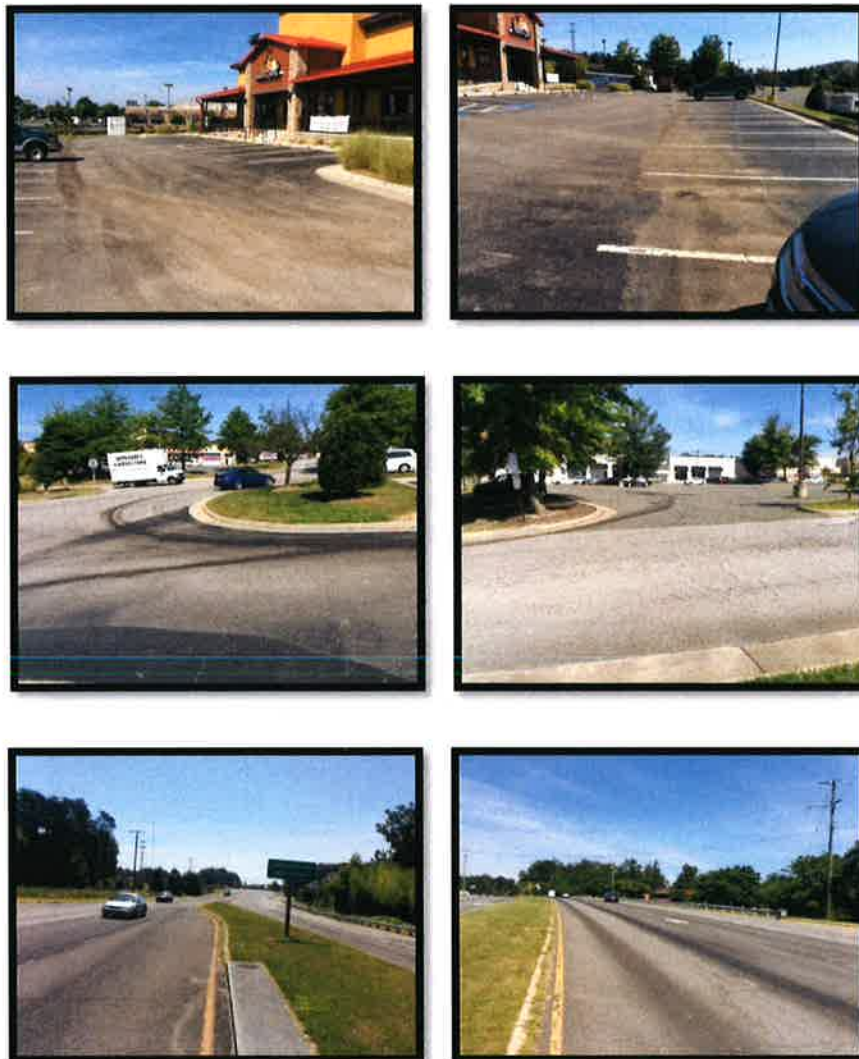
**Figure 2: Track down Photos**

The mitigation activities were reported to be employed around the heavily spilled restaurant areas. The stain from the road and parking lot areas were partially dried and partially washed away by heavy rain of last week. The impact of incident on storm water and water of the county observed insignificant due to diluted volume. The educational materials including county ordinances will be sent to the Valley Protein Company for control repetition of such activities in future. NOV was not issued since the impact has been appropriately mitigated. Since the spill extended out of PWC's service area and onto VDOT MS-4 jurisdiction. VDOT was notified of the spill on Tuesday 7/19/16.

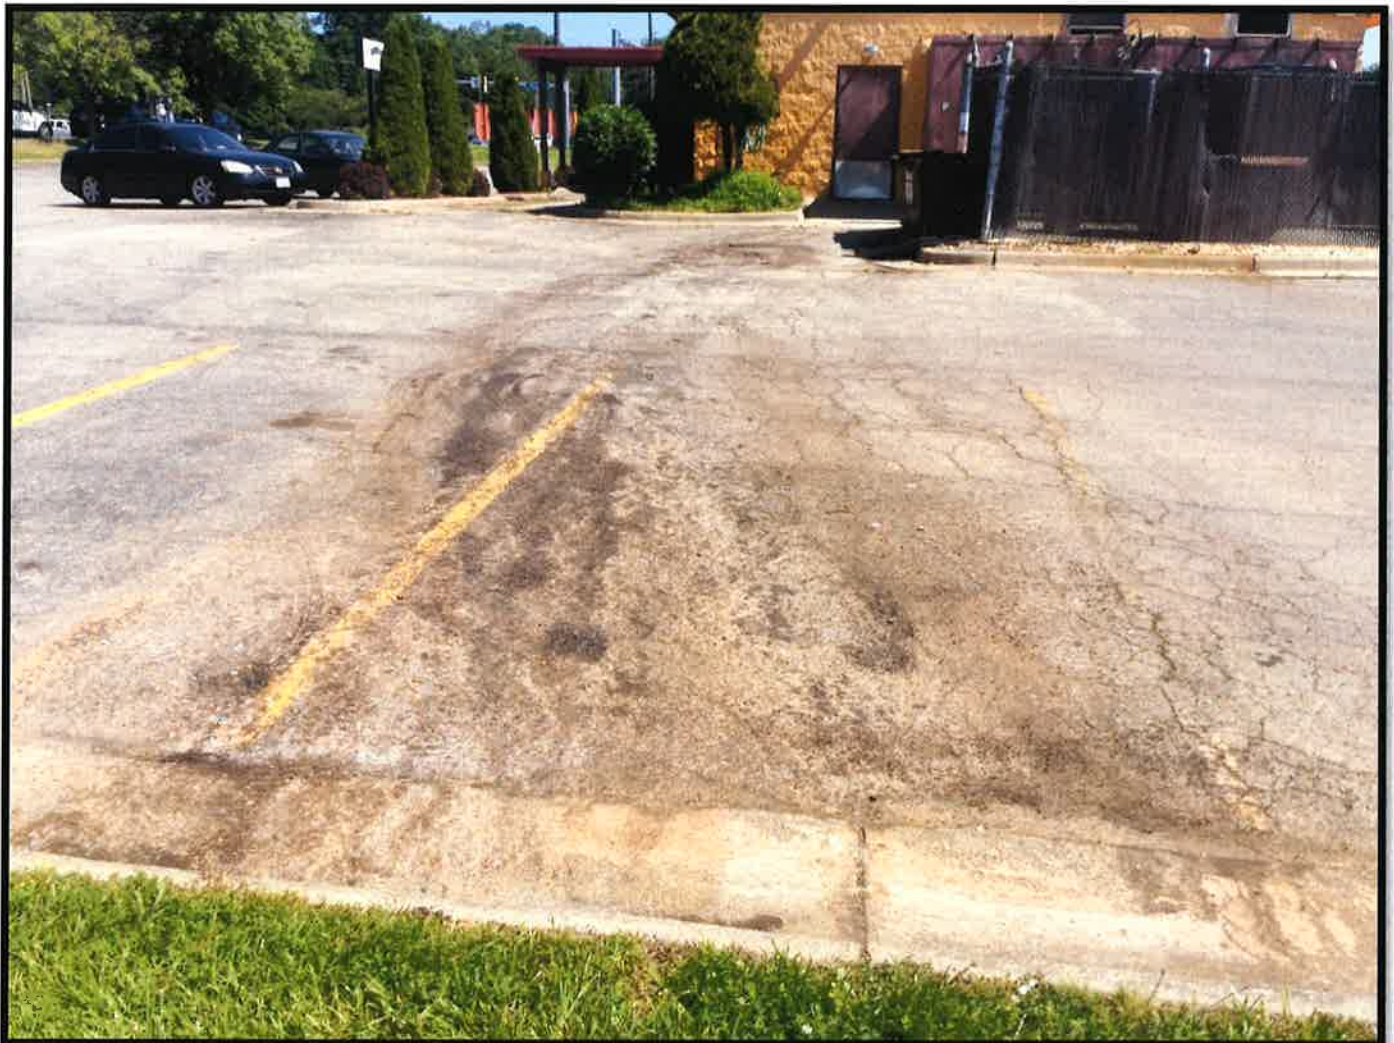
**Photo of discharge:**

PH: NA	Limit NA	Conductivity (µS/cm): NA	Limit:NA	Temp.: °F	Limit: NA
Discharge related Indicators	Odor: Sanitary	Color: Other	Turbidity: Cloudy		
	Floatables: NA	Stains: Oily	Deposits: Debris

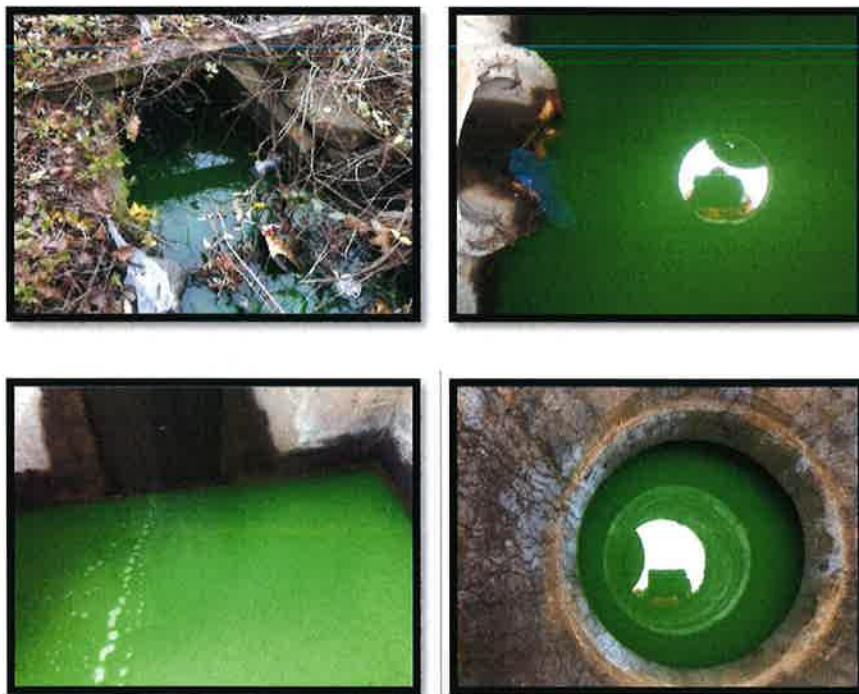
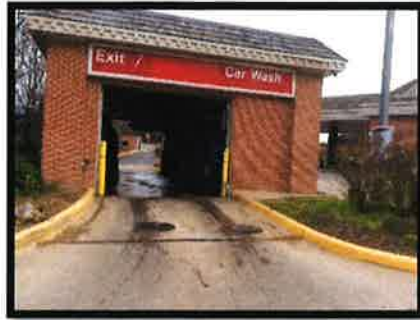
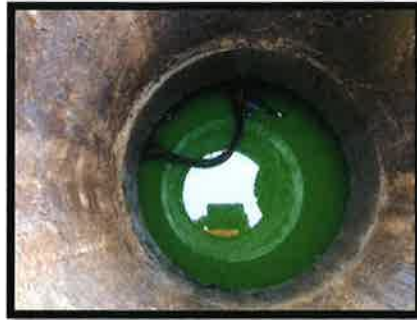
higher depth. A sample was collected from middle compartment of facility. The field test conductivity and pH were found to be within the standard limits. Tracking was continued up to points A and B which are manholes adjacent to the car wash facility. Both manholes contained green water up to the neck of the facility. Hence the source of discharge was ultimately confirmed to be from the car wash. Two possible contaminants were suspected. One, due to the green color, the discharge could be antifreeze. Two, the car wash uses an industrial and pressure cleaning chemical called "Simoniz Ultra". Following the investigation, meeting made with Mr. Jeff MacPherson, the owner of the business, as we notified that the owner of business was willing to run up cleaning activities for CSWM facilities and drainage system with the conversation with DFR officials on Sunday. For Inclusive legal and chemical investigations, as built plan of Exxon gas facility was pulled over and reviewed. The CSWM facility was pumped out on 12/20/2016. The car wash discharge is supposed to be connected with sanitary sewer but it has vigilant to be connected with storm water management system while pumping.

The collected sample (ID: 5991J1-19640-1) was analyzed with desktop analysis on 12/14/2016. The Phenol, Chlorine, Fluoride and Copper were found to exceed the standard limits. Another sample was taken from the same place on 12/19/2016 and sent to H. L. Mooney Laboratory of PWCSA for inclusive investigation. Among tested parameters, two of them were found to be in exceedance and hence desktop analysis was verified.

The source of discharge was confirmed to be the car wash discharge containing soap, detergent and chemical with water. Notice of violation has been already issued by PWC DFR on 12/19/2016 and we are coordinating our responses. The camera van inspection was performed by county crews on 1/12/2017. Our goal with the camera was to try to help the owner identify the misconnection, but various impediments prevented a good view. A violation notice (NOV 6-2017), citing Sec. 23.2-4.1(a)4 has issued on 01/12/2017 to the business owner to comply deficiency with following action plan.

- 1) Immediately cease car wash discharge into storm sewer system.
- 2) Disconnect car wash discharge pipe, connect with storm sewer system within 30 days of NOV received date.

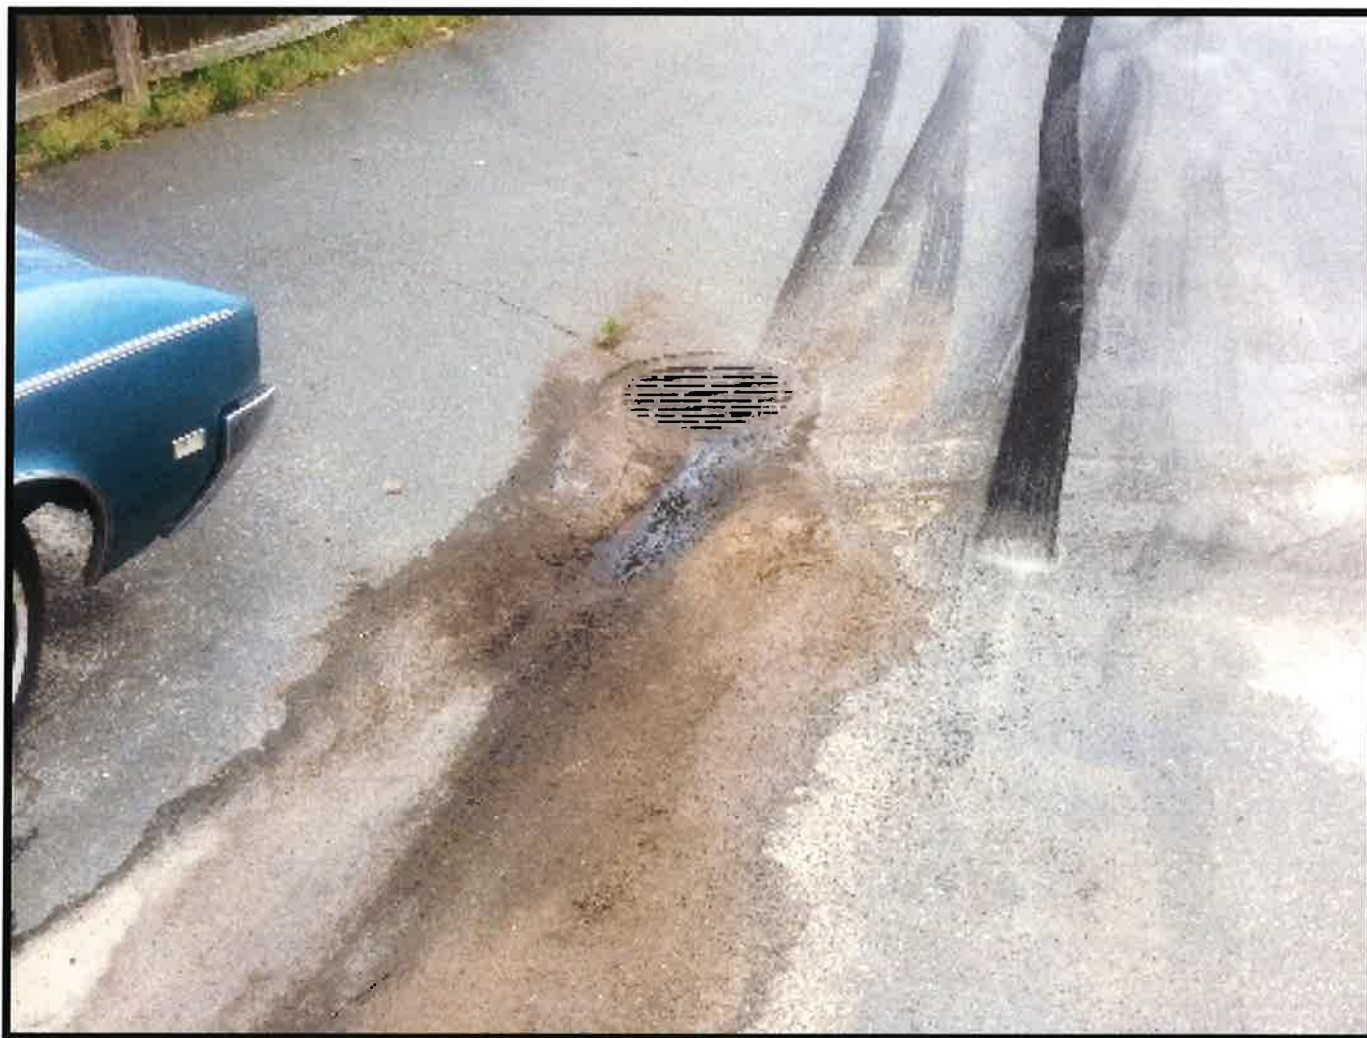
**Photo of discharge:**

INCIDENT INFORMATION		
Incident Report #: 45-2017	Date : 5/22/2017	Time : 3:30 PM
Business : Old Hickory Golf Course/ River Fall HOA	Report Completed By : Prem Poudel	
Address: 4656 Asdee Ln	City : Woodbridge, VA	Zip Code: 22192
Case Detail: PWC IDDE staff got a complaint about petroleum spill into stormwater system.

PH: NA Limit NA	Conductivity (µS/cm):NA Limit:NA	Temp.: °F Limit: NA
Discharge related Indicators	Odor: NA	Color: NA
	Floatables: NA	Stains: Oily
		Deposits: Debris

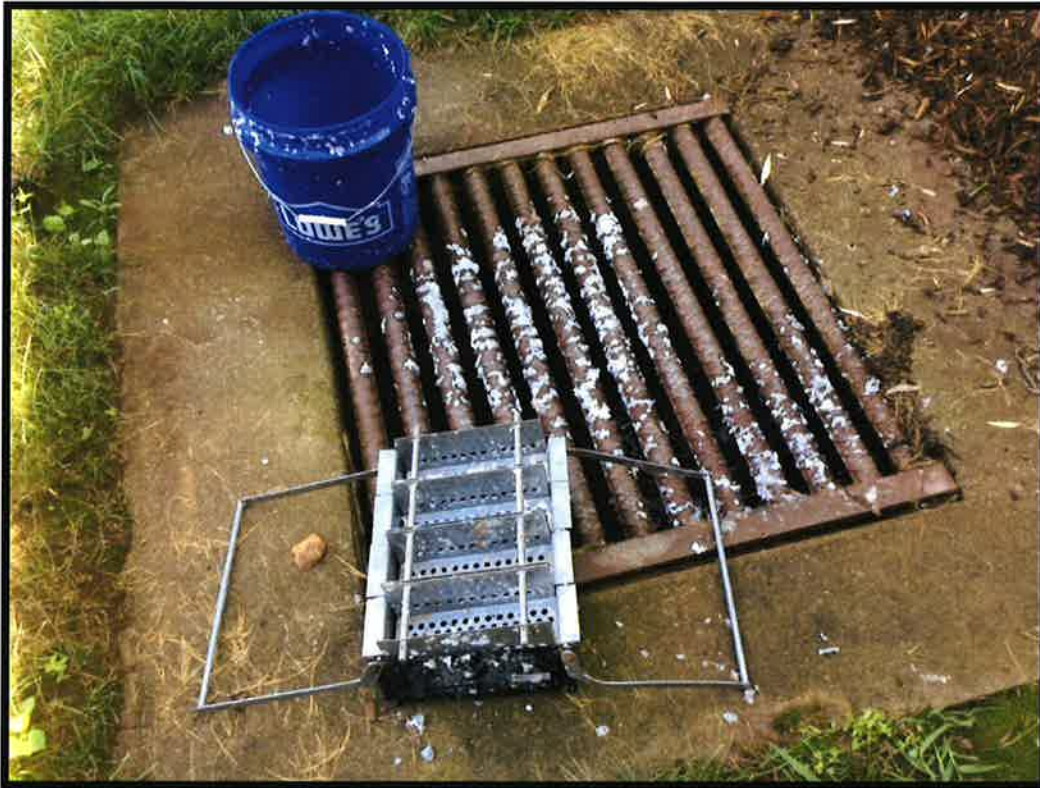
**Figure 1: Photo of Discharge.**

On July 22, 2016 Pat McGuire, Prince William County Drainage Crew Supervisor, entered a complaint concerning the dumping of paint and plaster into storm sewer system at 5157 Oliva Way. The field investigation was made on same day. The storm water drop inlet was located inside the property. Mrs. Rebecca Birdsong was at home and helped to investigate the problem. Household waste paper was found to be used for making paper bricks in their house. The paper brick was found to produce paper paste through the mixing and stirring of paper waste with water. Excess water was found to be squeezed out of the paste after pouring paste into mold. Homeowners were doing this above the grate lid on the storm water drop inlet. According to Mrs. Birdsong, brick fabrication occurs once a week. Process water including some paper debris was observed to be discharged into storm water system.

The discharge of process water and paper debris is a violation of county ordinance as per Sec. 23.2-4, but the scale of discharge was minor and Mrs. Birdsong agreed to stop discharging paper debris and process water in the future, as well as clean up the debris from drop inlet trash rack. For these reasons an NOV was not issued. Follow up inspections will be continued to make sure such actions are not repeated again. If an unlawful discharge is observed discharging into storm sewer system in future, an NOV will be issued.

The follow up inspection was made on 08/16/2016. Further activities for discharging paper debris and paper brick process water were stopped so the case has been closed now.

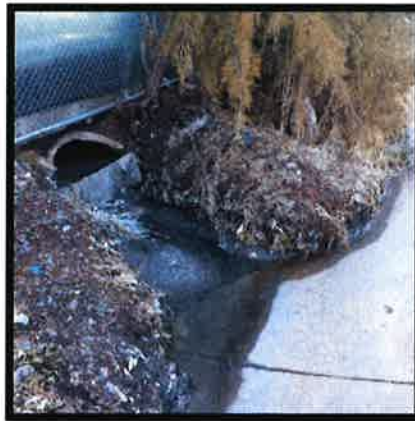
**Figure 1: Photo of Discharge.**

On Jan 4, 2017 PWC Watershed received a case regarding an illicit discharge generated by Northern Virginia Material Recovery Facility (Republic Services) from the Captain Mr. Brian Ferguson of Fire Marshal Office. It was reported that the recycling facility is well beyond capacity with material stored outside. During the recent rain event, water was observed flowing off of the pile of debris and into the storm water drains onsite. Moreover, the property has received numerous complaints and violations so the Fire Marshall is going to actively pursue criminal charges against the facility.

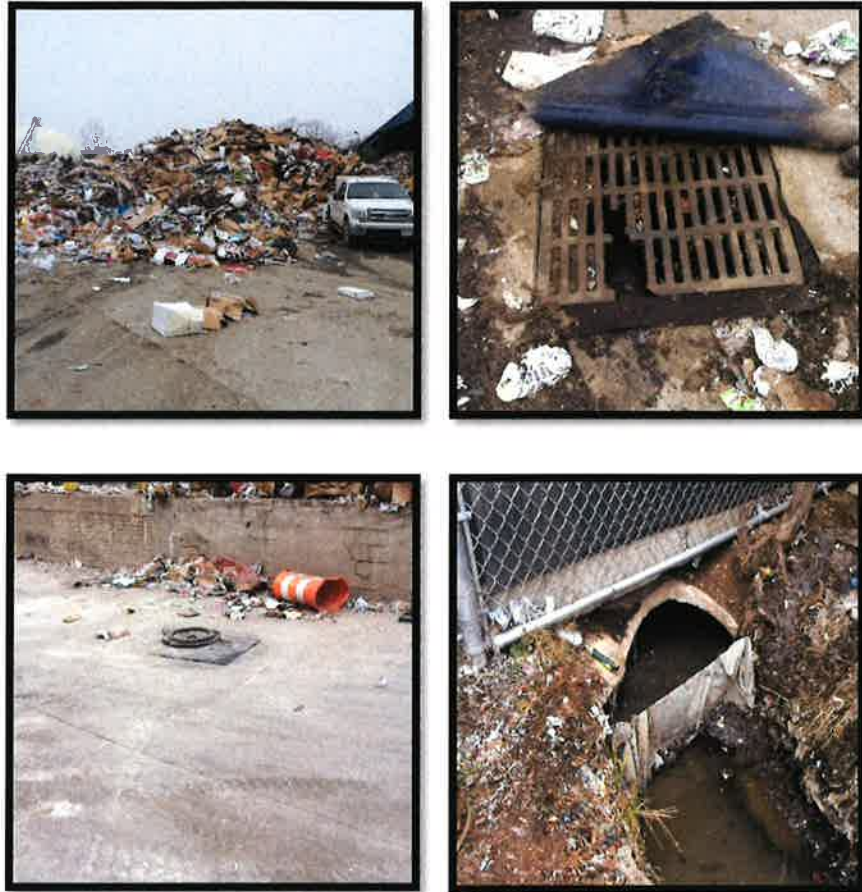
**Figure 3: Trackdown Photos**

The reported site was visited same day. On arrival, rain stopped from last day and most of the pile of recycling materials was already pushed into recycling plant. Debris and residue were observed on front yard having storm water drop inlet.

On Jan 5th, large stock pile was again observed piled out of the roof at 2:30 PM. Onsite meeting was organized in between stakeholders by DFR. Following meeting, Joint inspection was made with Captain Mr. Brian Ferguson, Lieutenant Mr. Mike Hubbel from DFR, the Property Code Inspector Mr. Huffman Celli from Neighborhood Services, the Building Code Inspector Mr. Andrew Kellerman from Building Division, Mr. Clay Morris and me from Watershed Branch and from the facility side the Division Manager Mr. Tim Kinnett, the General Manager Daniel P. Dumas, the Environmental Manager Mr. Timothy Torrez (PE), the Environmental Specialist Mr. Michael Easter. Mr. Dumas has claimed multiple improving works carried out into the facility since they had taken this facility and willing to do improvement work in future as well.

Department of fire and rescue has already issued the notice of violations in fifteen different issues. Similarly, PWC building division had identified alteration and renovation of building facility without taking permit. Exposed recycling materials and product out of the roof for long time is being washed away and responsible for generating an unlawful discharge to the storm sewer system and water of the county which is also a violation of VPDES Permit VAR052074, Part IV C.2 (b) so the case has been forwarded to DEQ for further enforcement action.

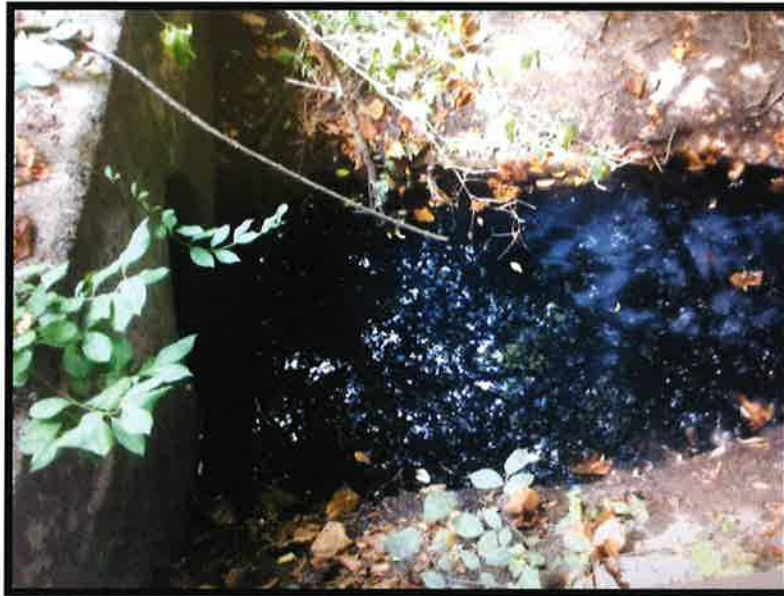
**Figure 1: Photo of Discharge.**

On September 15<sup>th</sup>, PWC IDDE program received a complaint from Mr. Nathaniel Nagle, the Assistant Branch Chief of PWC Mosquito and Forest Pest Management regarding a suspected an illicit discharge. The discharge was described as having black color with bad odor and was found within a plunge pool located on the west and north ends of 10008 Lomond Drive 20109 where it meets with the school bus parking lot.

The field investigation was made on same day. Upon arrival, the plunge pool was confirmed to have a dark blue color with bad odor and was observed downstream of the outfall located behind the property 10008 Lomond Drive adjacent to Stonewall Middle School. The plunge pool was developed by sediment deposited around the outfall. The flow path after the berm indicated that the discharge had recently flowed through the outfall.

The discharge generated from laundry operation is an unlawful discharge into storm sewer system and violation of county ordinance Section 23.2-4.1, NOV 5-2017 was issued to Mr. Benito, the home owner of 10021, to stop the discharge of laundry wash water into storm sewer system immediately, and remove the unauthorized connection to the storm sewer systems within 30 days. Further enforcement actions will be taken on failure to comply the deficiencies.

Mr. Benito reported the completion of corrected deficiency on 09/23/2016. A follow up inspection was made on 09/26/2016 and the deficiency was found to be corrected. It was confirmed that the black corrugated HDPE pipe was installed for rain water discharge from building and ground. The case has been closed as all required mitigation on the site has been completed.

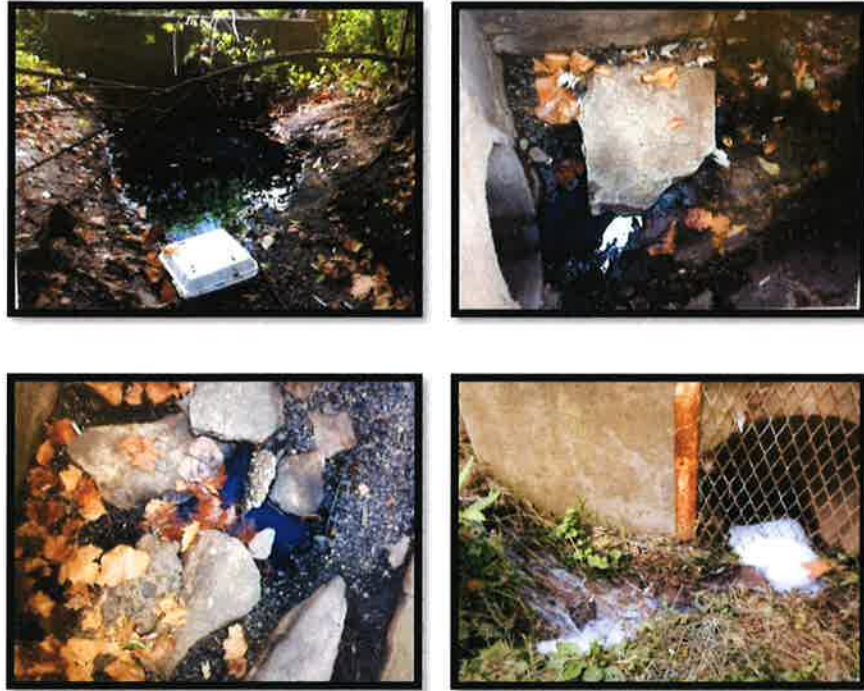
**Figure 3: Track down Photos**

The source of the discharge was tracked from outfall following the colorful stains on surfaces of upstream sewers. The flow path was tracked along points A, B and C. The smell of detergent was easily noticeable in each manhole. The flow was tracked to 10021 Lomond Drive. No home owner was present at that time although a couple of visitors were at the home at the time. Permission was given from visitors to investigate the property. It was found that two pipes which supposed to be connected from the washer dryer to the sanitary sewer were connected with storm sewer inlet at point C. It was

confirmed that the intermittent flow had been received during laundry operations only. Field test of laundry discharge was performed on site and sample was collected for desktop analysis to identify the rest of water quality parameters.

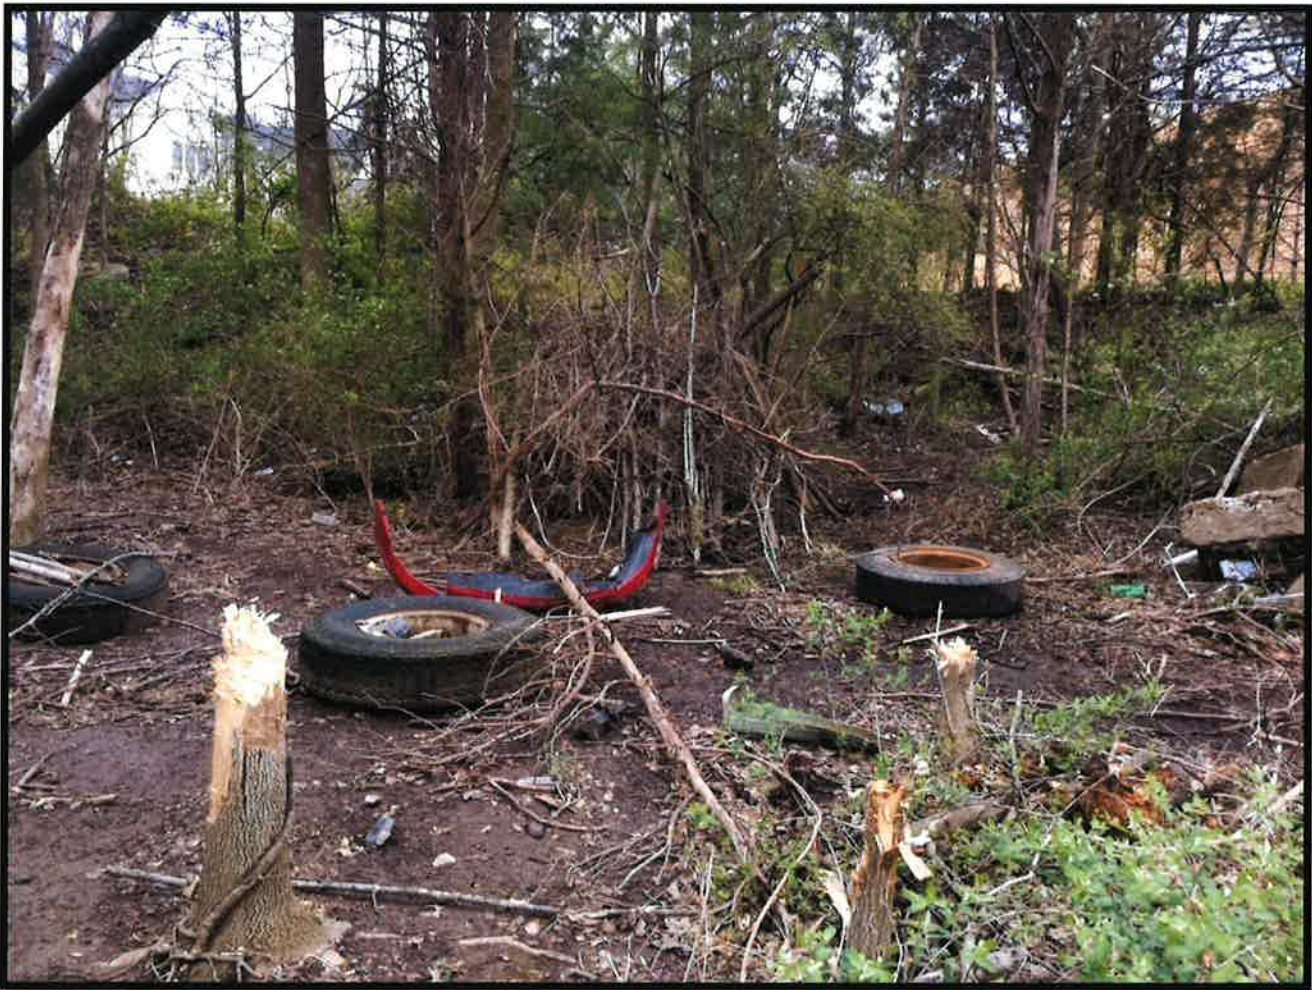
**Photo of discharge:**

INCIDENT INFORMATION		
Incident Report #: 35/ 4-5-2017	Date : 3/10/2017	Time : 1:15 pm
Business : HOA Property/ Greenery open space	Report Completed By : Prem Poudel	
Address: 10603 Andrew Humphreys Ct.	City : Bristow	Zip Code: 20136
Case Detail: Dumping construction materials, sharp metal objects, tires, heavy machinery parts in the woods

PH: NA	Limit NA	Conductivity (μS/cm): NA	Limit: NA	Temp.: _ °F	Limit: NA
Discharge related Indicators	Odor: NA	Color: NA	Turbidity: NA		
	Floatables: NA	Stains: NA	Deposits: Trash

Unless detecting the violator, HOA is responsible to mitigate the deficiencies by removing those trash and debris. The case was forwarded to HOA of New Bristow Village to clean and maintain the property. Follow up call was made with HOA Manager on 4/20/2016. Ms. Meghan said, HOA try to find the vender to fix the problem. Follow up action will be continued in future. The incident seemed to be happened continuously from long ago and HOA willing to resolve the problem after notifying them, NOV didn't issue.

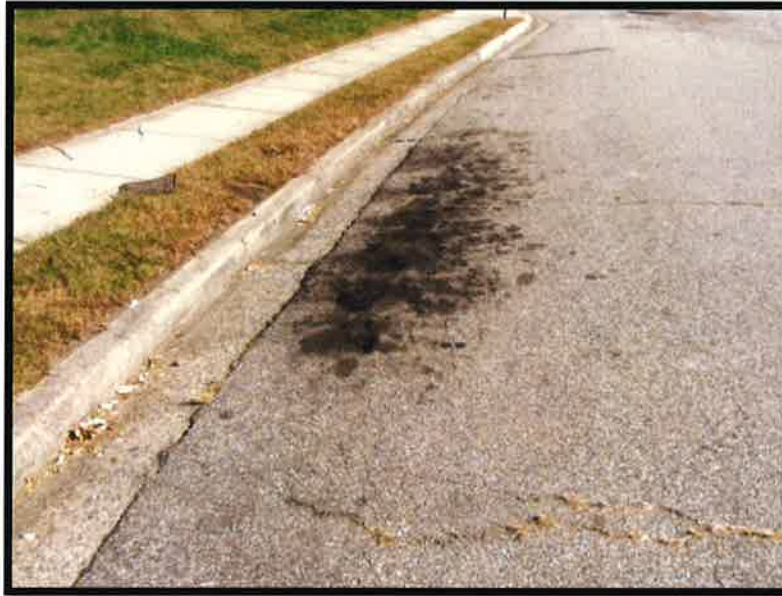
**Figure 1: Photo of Discharge.**

On October 18, 2016 citizen complaint was received at PWC Environment services regarding an oil spill on sidewalks and causing mess during oil change in street parking at the intersection of Kirkland Ct and Kittredge Ct. The complaint was specially made for resident of 13116 Kittredge Ct.

The site was visited same day. Upon arrival, several oil stain spots were observed on road parking beside the house 13116, 13114, 13115 and 13113 at Kittredge Court. Most of them were seemed to be leaked from old vehicles during parking and some of them by spilling during oil change. Oil stains were localized so that there was no flowing footprint on pavement towards storm sewer system.

No NOV was issued due to responsible party not being on seen and has no sound evidence for enforcement as well. Meeting was made with complainant and talked about the issue. The education materials were left over the aforementioned houses. Follow up inspection will be continued to control further oil spill in future.

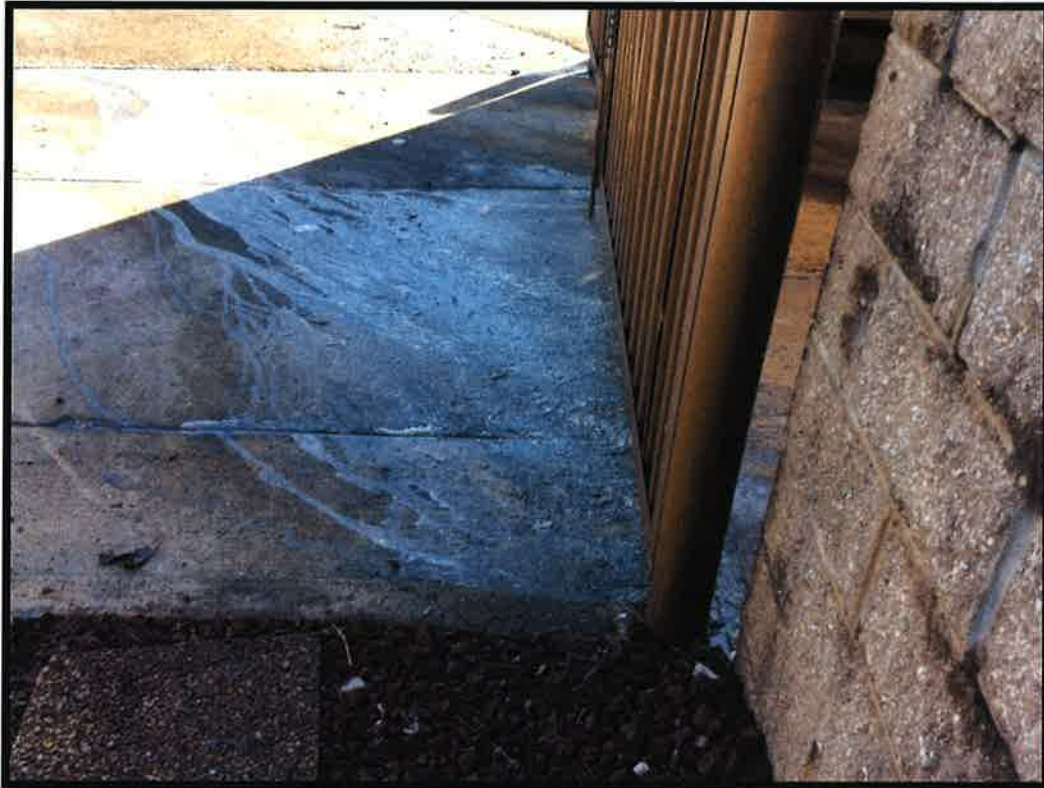
**Figure 1: Photo of Discharge.**

On January 25, 2017 PWC Environmental Services received a complaint from County Staff Mr. Lo Chao regarding a cooking oil spill while he was on route for county business at 13201 Worth Ave on January 24th.

The site was inspected by Environmental Compliance Inspector on 25th January. Upon arrival, grease and cooking oil was spilled over the pavement around the collection tank, located behind the TGI Friday and Bento Cafe Sushi restaurants. The waste food fluid was leaking through the compactor and flowing towards the storm sewer system. Grease and oil stains, observed on drive way and parking lot were potential for being washed way into storm sewer system during rain events. Poor waste handling practice, leaky container or overflow from under sized container could be the potential reason for incident. Significant amount of trash and litters were spread out on adjoining property (2681 Prince William PKWY), owned by the of same owner. Some of the trash may be released unintentionally during routine collection & hauling and possibly from individual consumers of the shopping center.

Discharging waste food fluids, fats, oils and grease to the storm sewer and water of the county is a violation of county ordinance as per sec. 23.2-4.1; a notice of violation (NOV 6-2017) is issued to the property owner or Management Company to correct the deficiencies within 30 days.

- 1) Immediately cease discharge of waste food fluid, oil and grease into storm sewer system.
- 2) Clean stains and debris from the pavement being washed away into storm sewer system.
- 3) The management company has to identify and employ BMPs to keep trash control at point of generation to minimize the impact on the adjoining creek and pond.
- 4) Maintain integrity of waste collection compactor and oil container to stop further leakage, and avoid potential illicit discharge being washed away into storm sewer system.

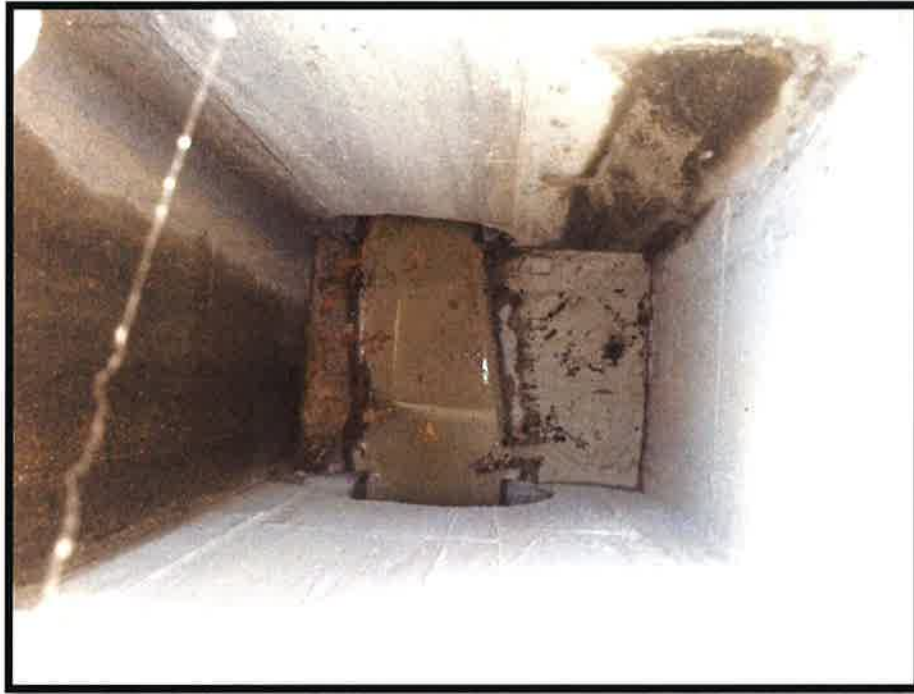
**Figure 1: Photo of Discharge.**

On November 15, 2016 a case of dumping down storm drain at 13426 Occoquan Road was forwarded to Environment service, IDDE staff by the Fire Marshal Captain Kim Stewart at 5:02 PM. Moreover, the incident was cached live and immediately talked to owner and contractor to stop discharging turbid water and sludge into storm sewer systems.

The site was inspected on Nov 16, 2016. Upon arrival, the facility was found to be rented for FedEx and closed. The manhole of storm sewer systems, located beside the house was opened. The sludge stain was observed on wall and floor like a thin paint. The surrounding of curb and gutter inlet was observed wet. The storm sewer system was tracked and found no flow through outfall towards ground swale. The storm sewer system was seemed to be old and didn't updated in county mapper as well.

The source of discharge should be generated with minor renovation into the building. The case was seemed to be prudently handled onsite by Kim to stop further discharge into storm drain systems. The impact of discharge into storm sewer system was insignificant and there was no flow through outfall towards downstream swale. The incident was single time event and Mr. Kim. Already award to the owner about unlawful activities. For these reasons, NOV was not issued.

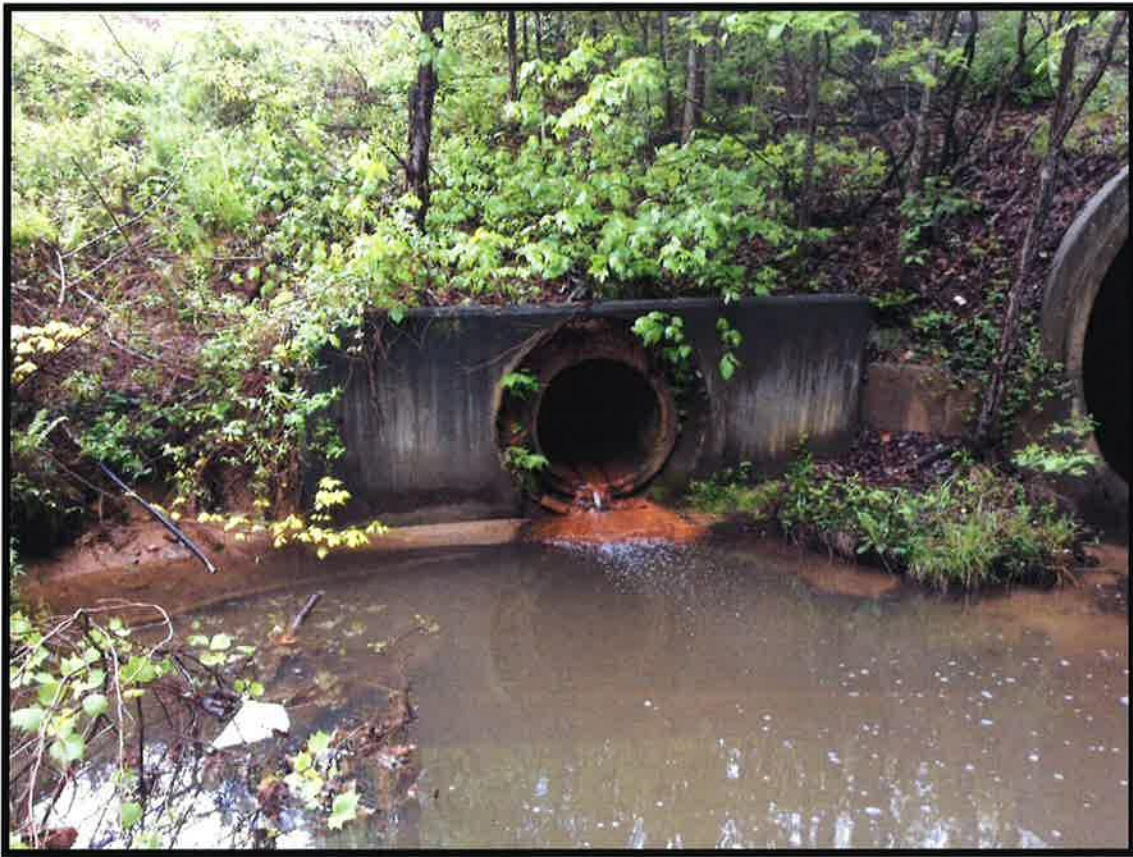
**Photo of discharge:**

INCIDENT INFORMATION		
Incident Report #: 39/ 04-25-2017	Date : 3/10/2017	Time : 3:00 pm
Business : Dumping chemicals at storm sewer system	Report Completed By : Prem Popudel	
Address: 13491 Princedale Drive	City : Woodbridge, VA	Zip Code: 22193
Case Detail: Angela's cleaning service was anonymously reported for dumping cleaning chemicals from their vans and cars down into the stormwater inlet, located nearby their house 13491 Princedale Drive.

PH: NA	Limit NA	Conductivity (µS/cm): NA	Limit: NA	Temp.: _ °F	Limit: NA
Discharge related Indicators	Odor: NA	Color: NA	Turbidity: Slightly Cloudiness		
	Floatables: Suds	Stains: NA	Deposits: NA

The complaint site was inspected on same day. As per complainant, the owner of both 13491 Princedale Drive and Angela's Cleaning is the same. It was hard to investigate dumping incident since everything had been washing away due to heavy rain continuing from last two days. The corresponding outfall discharge was observed with some white suds and orange pipe algae. From our previous records, the outfall was observed to be dry on 2/4/2013 and 3/12/2016 respectively.

The complaint was briefly describe with visitor to convey message to the owner. Moreover, the informative education materials will be mailed to the cleaning company regarding unlawful discharge into storm sewer system and to make them aware on its consequences with legal and enforcement actions to mitigate the deficiency if happened in future. Follow up inspection will be continued to investigate the problems.

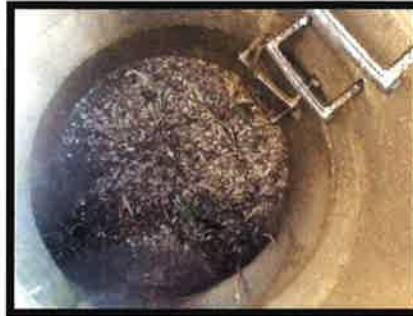
Figure 1: Photo of Discharge.

A citizen complaint concerning the dumping of woodchips into the storm sewer system at property 14514 Silverdale Drive was received at PWC Neighborhood Services. The case was forwarded to Environmental services by Paul Lynch on July 21, 2016 and a field investigation was made on same day. A tree cutting company was employed by Mr. Bryan Livengood, owner of 14514 silverdale drive, to cut down a tree from his front yard. Wood chips and other debris were observed to be dumped or blown into a nearby drop inlet.

Following the inspection, a meeting was made with Mr. Livengood. It was made known that any litters, trash, clippings, or yard waste dumped into the storm sewer system is a violation of county ordinance as per Sec. 23.2-4. As a result NOV 1-2017 was issued to the property owner to clean, collect, and dispose of debris from the storm sewer system as soon as possible. This was to be completed no later than 30 days from receipt of the NOV.

Mr. Livengood reported the completion of corrected deficiency on same day as the NOV was issued. A follow up inspection was made on 7/22/2016 and the deficiency was found to be corrected. The case has been closed as all required mitigation on the site has been completed.
