# Annual Stormwater Management Report

## VSMP Permit No. 0088595 – FY 2017

Submitted by:  
Prince William County  
Department of Public Works

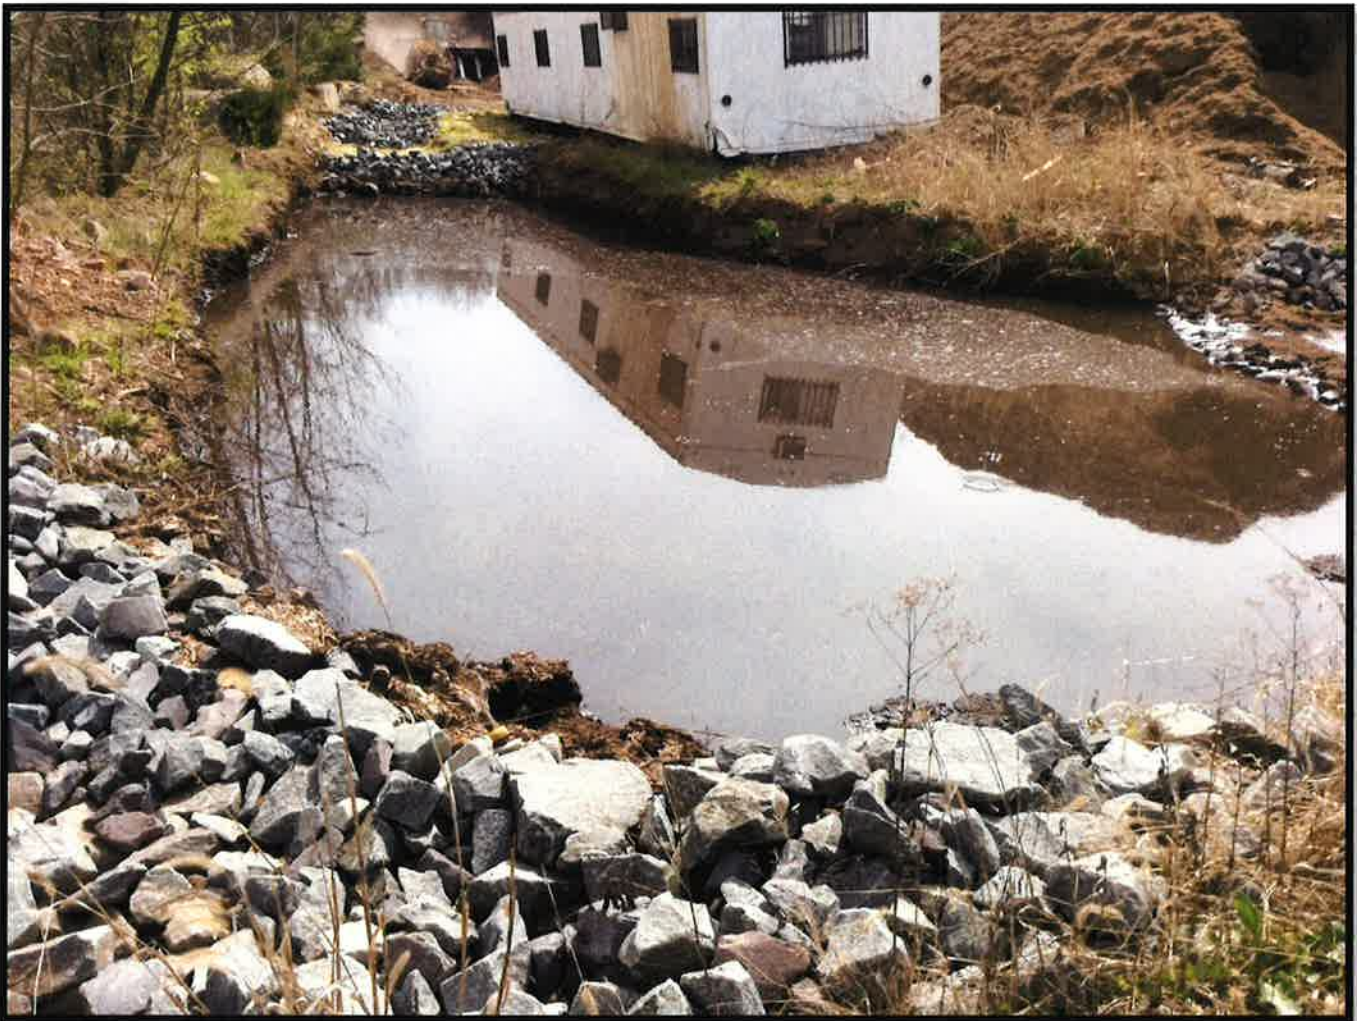
**Photo of discharge:**

INCIDENT INFORMATION		
Incident Report #:	Date : 4/5/2017	Time : 3:30 PM
Business : Remington Mulch Company	Report Completed By : Prem Poudel	
Address: 14601 Lee Highway	City, State : Gainesville, VA	Zip Code: 20155
Case Detail: No containment of Leachate /Green colored discharge/ Strong odor

PH: NA    Limit NA	Conductivity (µS/cm):NA    Limit:NA	Temp.: -°F    Limit: NA
Discharge related Indicators	Odor: Decaying Organic	Color: NA      Turbidity: NA
	Floatables: NA	Stains: NA      Deposits: NA

The site was observed to have several piles of timbering waste and some of which was placed in RPA buffer. Mulch was produced at several locations. The service road was developed on RPA buffers. The detention pond was found to be placed near stream crossing which was about 15 feet apart from live stream. The pond had shallow black water with odor of decaying organic materials. Pond was filled with sediments and wooden debris. Generators were running in open space to pump water from creek at the bank and gas containers were found to be spread out randomly. Leachates found to be released at the toe of each pile and sludge developed by running vehicles. Leachate, debris and sludge have high potential for being washed away into creek during rainfall.

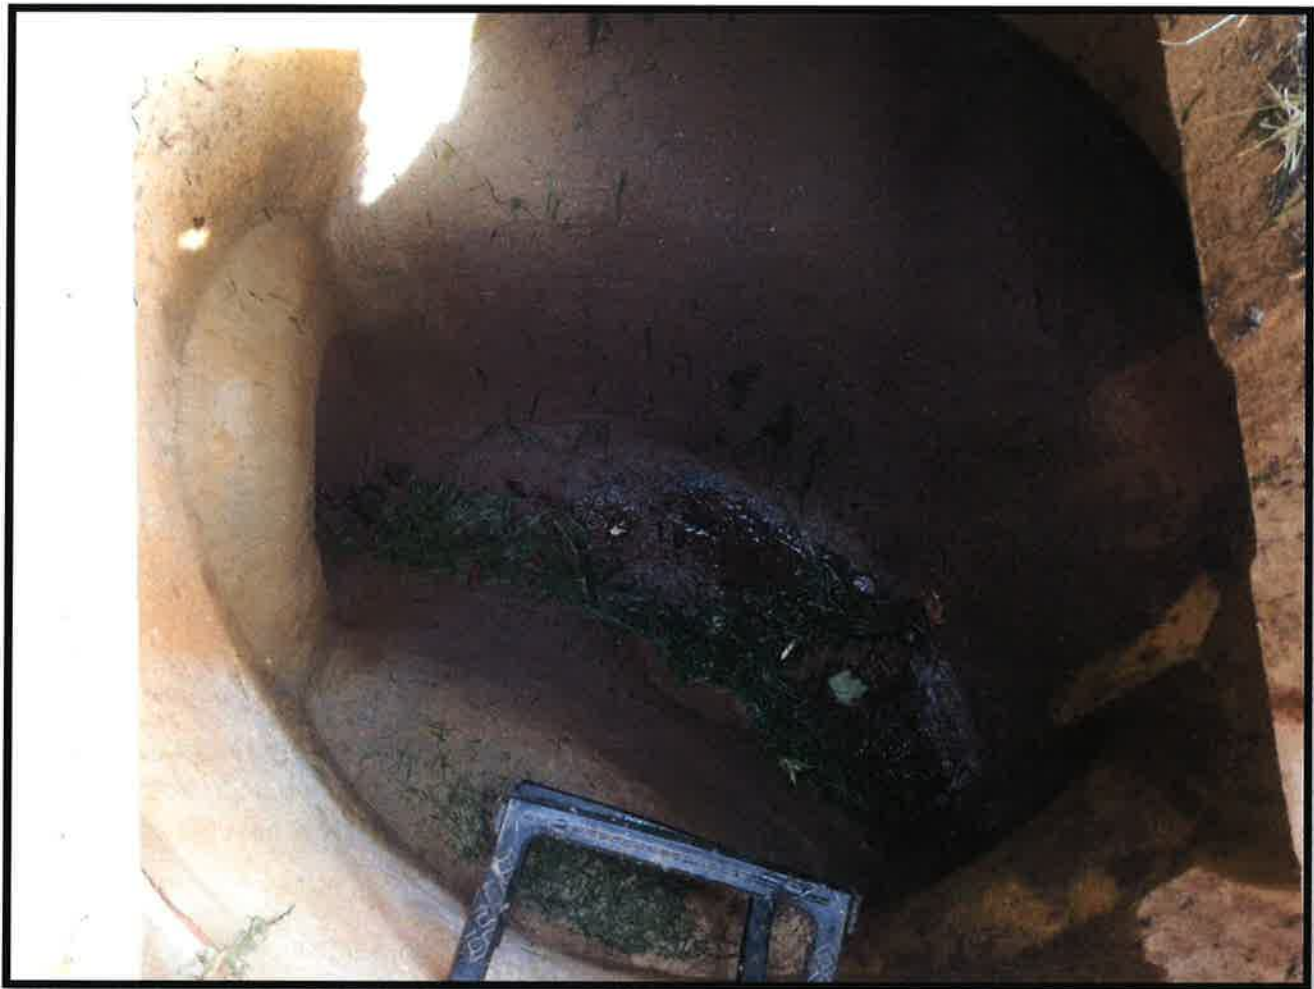
**Photo of discharge:**

INCIDENT INFORMATION			
Incident Report #: 47/2017	Date : 6/5/2017	Time : 2:30 PM	
Business : Residential Areas		Report Completed By : Prem Poudel	
Address: 15414 Gossoms Store Rd		City : Haymarket, VA	Zip Code: 20169
Case Detail: Mrs. Roberta Gould was experiencing a foul odor coming from the storm drains near her house 15414 Gossom Store Rd since last few days. The case was reported on 06/01/2017.

PH: NA	Limit NA	Conductivity (µS/cm): NA	Limit:NA	Temp.: ---- °F	Limit: NA
Discharge related Indicators		Odor: Other	Color: NA	Turbidity: NA	
		Floatables: NA	Stains: NA	Deposits: NA

Follow up inspection made on 7/5/2017. According to complainant, bad odor is continuing through out last month. Storm sewer system was decided to inspect by CCTV (Closed Circuit Television) to identify whether dead animal stuck into storm sewer system or not. CCTV inspection was completed on 7/13/2017. After video inspection, dead animal did not observe sticking into storm sewer system. The complainant will be informed about observed conditions. Case has been closed now.

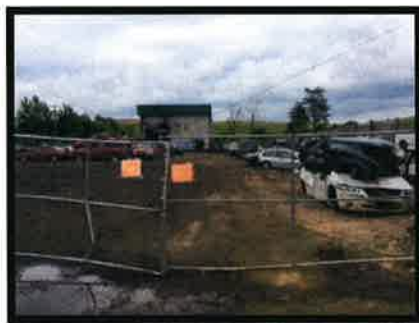
Locked Gate

A visual inspection of the facility was made from the outside since legal access was not permitted. The property was found to be mostly used for parting and storing junk vehicles. Stains of grease, oils, and other chemicals were observed at multiple locations within the facility. Junk cars were observed leaking where stored. The main building on the property was observed to be partially damaged by fire. Mrs. Susan Mackert briefly described the past history of ASAP Auto Recycling and Salvage. Moreover, DEQ had already sent a letter to the owner of 14823 to apply for appropriate VPDES, but received no response. In describing pollution control measures at the site, Capt. Kim Stewart stated earthen berms were used to contain flow while absorbent rolls were used to absorb hydrocarbons from firefighting discharge. The pH was found within 7 to 8 on sample taken in multiple places. There is no storm sewer system within the property of 14823 Dumfries Rd. The storm water passes over to adjacent properties as a surface runoff. The property found to be surrounded three sides by another property as described in the following paragraph.

In conclusion, it was determined that the ASAP Auto Recycling and Salvage Company needs to apply for appropriate VPDES permits. The case will be handled by DEQ, led by Susan Mackert. It was found during field investigations that the adjacent property, 234 PICK-UR-PART located at 14843 Dumfries Rd, also doesn't hold applicable VPDES permits. 234 PICK-UR-PART was determined to need to apply for more appropriate VPDES permits, better pertaining to operations occurring at that facility.

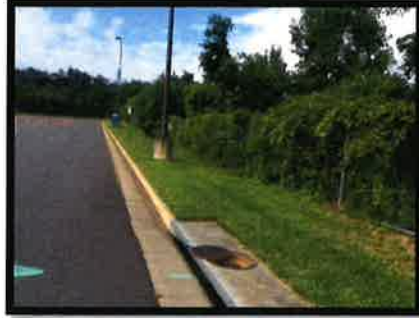
East-1

In addition to the visual inspection of 14823 Dumfries Rd, a field inspection was made for the surrounding property, 14843 Dumfries roads. The surrounding property, and associated business 234 PICK-UR-PART, is used for similar processes (parting and storage of junk vehicles). A phone contact (703-314-7710) was made with Mr. Omar Amrit, owner of 234 PICK-UR-PART. He claimed that DMR reports are periodically sent to the DEQ. During field investigation, the property 14843 Dumfries Rd was found to be connected with PWC Public School MS4 system at its eastern side. The northwest portion the property is found to be sloped towards PWC fleet services and landfill. A vegetative buffer was found to be exist at all three borders of the property excluding the south boarder. See the following photographs for more detail on violations.

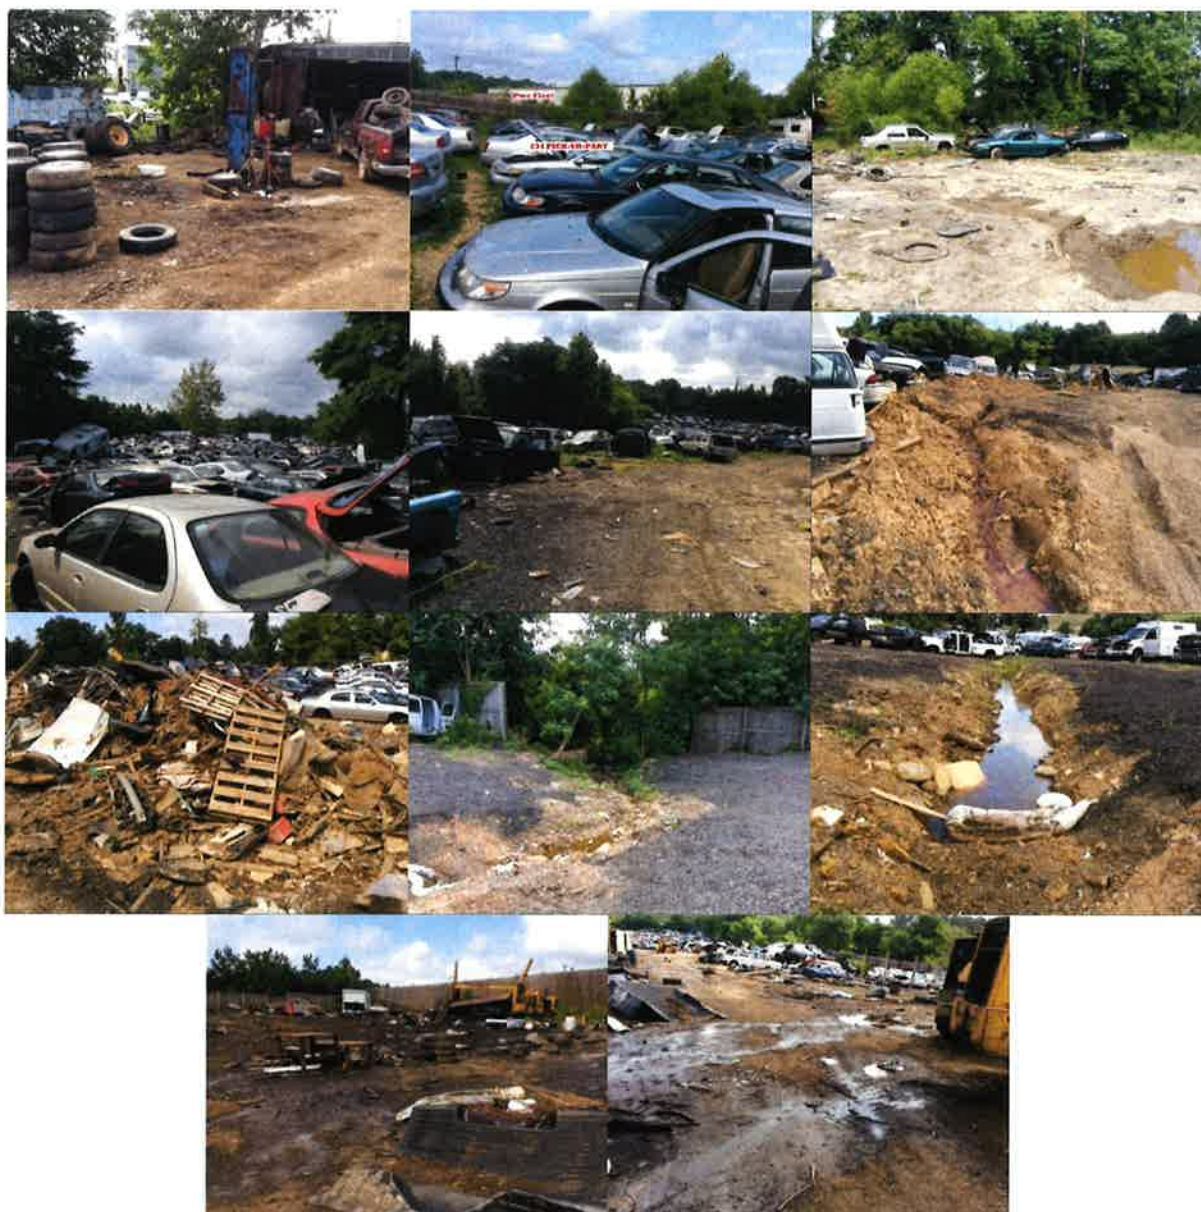
Figure 3: Trackdown Photos

Pictures inside the property of 234-PICK-UR-PART, 14843 Dumfries Road

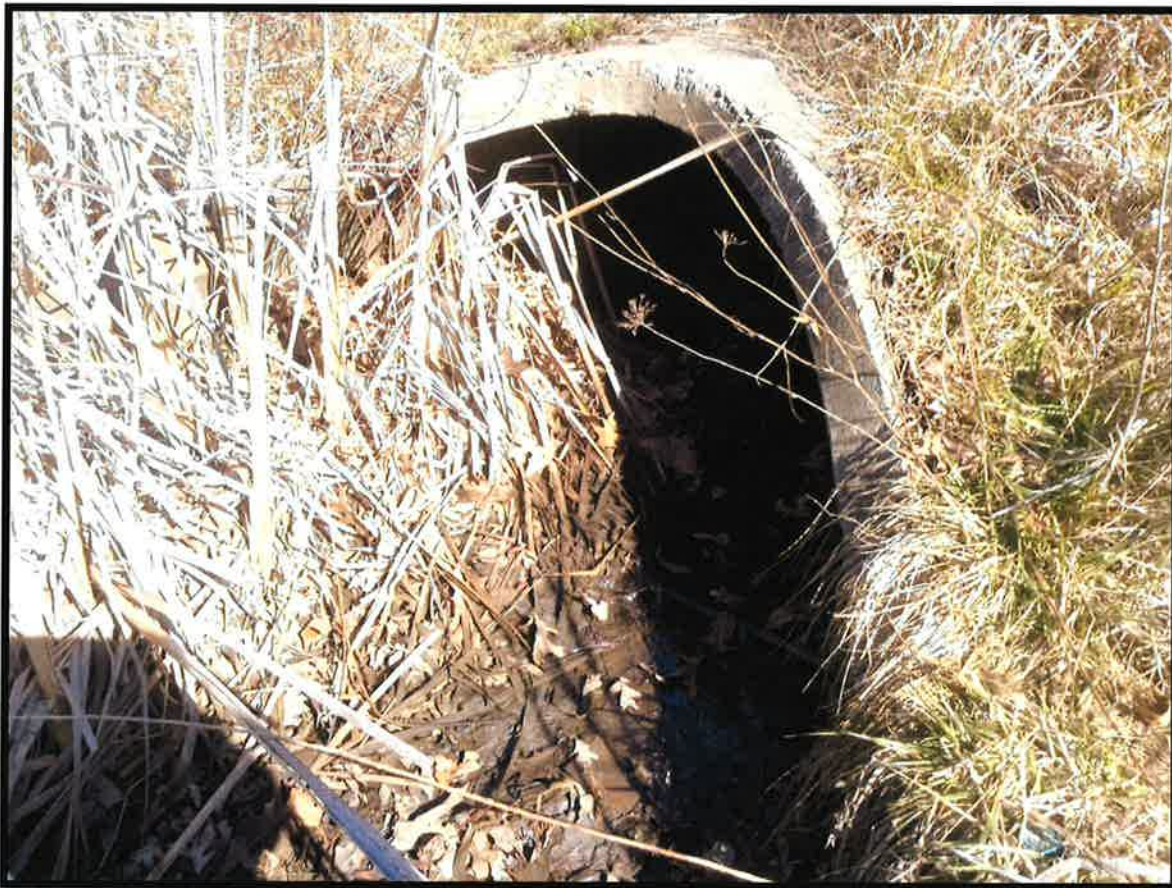
**Photo of discharge:**

INCIDENT INFORMATION		
Incident Report #:	Date : 3/22/2017	Time : 11:00 am
Outfall: 27640	Business : FINLEY [ Milling, Paving, Stealing, Site Concrete]	Report Completed By : Prem Poudel
Address: 7861 David Williams Way, P.O. Box 1710	City : Manassas	Zip Code: 20108
Complain or Case Received From: T. Dombrowski	Date: 3/21/2017	County Employee: Yes
Reported Case: Creek has significant turbid flow with suds and petroleum waste passing through road culverts at Rolling Ford Rd nearby Willington Rd.

pH :	Limit: NA	Conductivity (µS/cm) Limit: NA	Temp.: °F Limit: NA
Discharge related Indicators	Odor: Petroleum/Gas	Color: Black	Turbidity: NA
	Floatables: NA	Stains: Oily	Deposits: Debris

During inspection, debris was observed to be deposited on outfall (#27640) in storm water management pond 5369. The petroleum odor was easily noticed from debris. The storm sewer system was tracked to identify the source. At point A, debris observed to be transported and deposited from AB branch. All storm sewer points from points B to G are located on the property 7681 David Williams Way, running business of Finley Asphalt and Sealing Company. Manhole B was invisible due to stacking construction materials. As per Mr. Rick Norman, the Finley Safety Officer, he has never noticed manhole at point B. Petroleum stains were observed in several points inside the facility. Asphalt tar sprayer truck and other construction equipment were parked on the graveled ground inside the property. Manhole E was also unseen and buried into the ground. Several stains of grease and oil-spilled spots were observed on the pavement and had potential to be washed away into storm sewer system during rainfall.

- 1) Install perimeter control around storm water inlets with grease and oil absorbent booms.
- 2) Minimize spills on open ground and keep unavoidable spills far from storm sewer inlet so that it can be captured before reaching the storm sewer system. Maintain graveled surface after each spill or leakage.
- 3) Remove construction materials stacked over storm sewer system and keep manhole B and E open (See on track down map).
- 4) Keep oil, grease and chemicals in closed container.

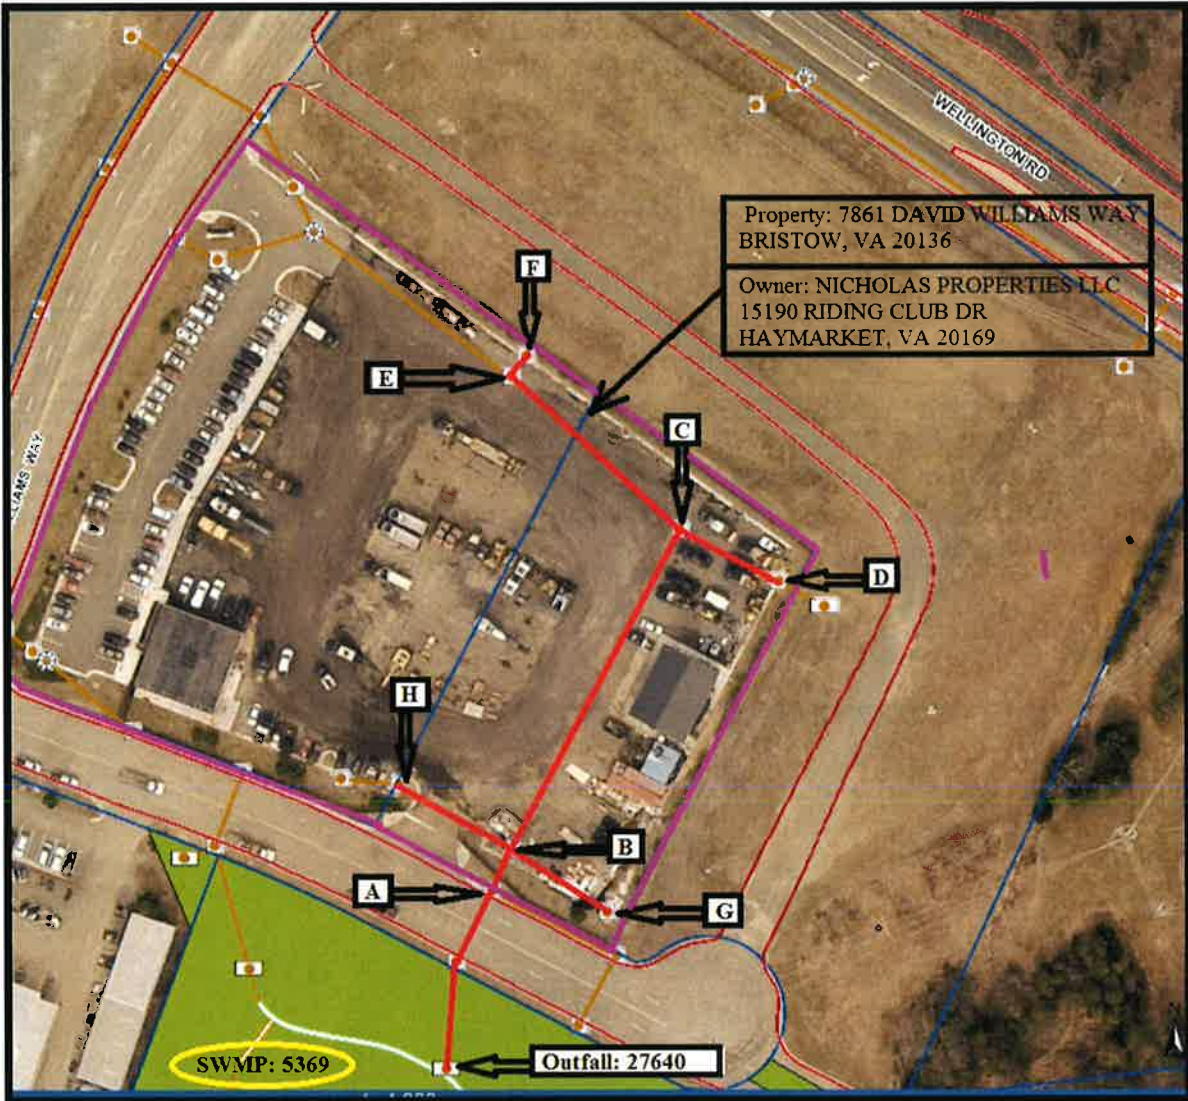
**Map of Trackdown Path:**

The petroleum waste and debris were found to be transported with runoff discharge during rainfall through the storm sewer system from Finley Asphalt and Sealing Company. Following inspection, a meeting was held with Mr. Ron Lane, the Vice President of Finley Company. Education materials were handover to Mr. Lane and he was willing to control pollutants onsite by using appropriate mitigation activities. Mr. Lane has requested a punch list for corrective actions.

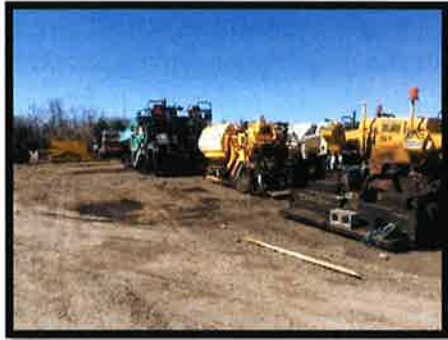
**Oil and grease spill on the ground**

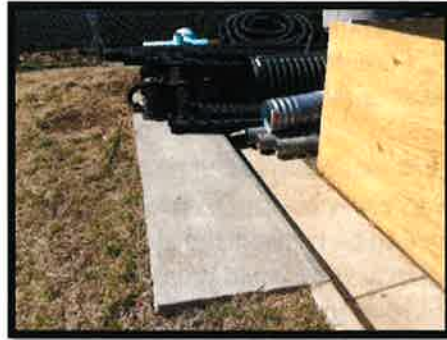
**Materials- stacked over structure**

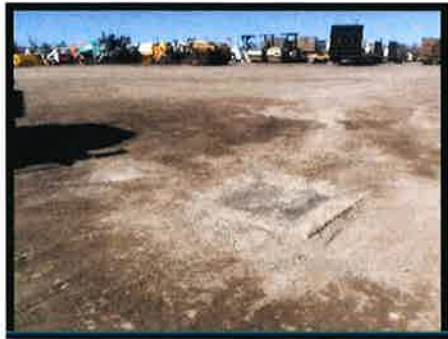
**Unprotected drop inlet**

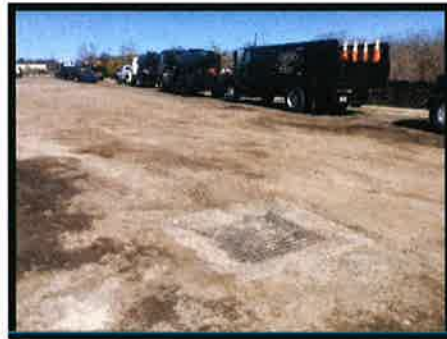
**Tar stain under sprayer truck**

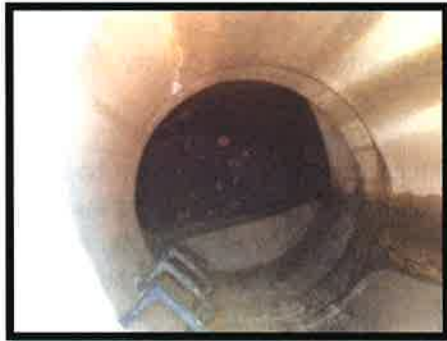
**Debris at Manhole A**

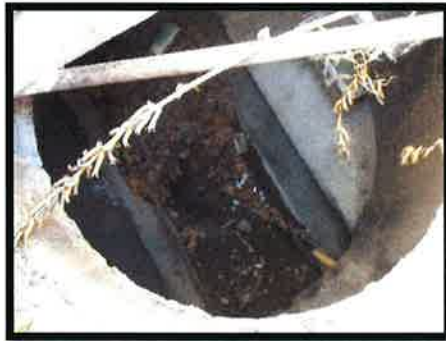
**Debris at Manhole D**

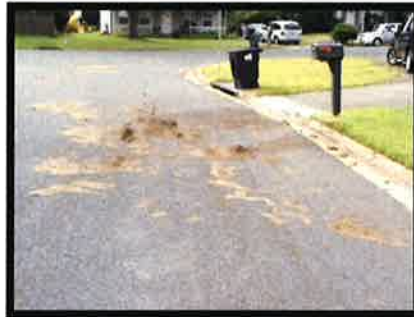
Figure 1: Photo of Discharge.

At 9:59 am on August 22, 2016 Environmental Services received an email from Lee Chraska, , regarding a dumping grass clippings on the street by the home owners of 5710 and 5708 Sailstone Lane. The site was inspected on 23rd August, 2016. Upon arrival, grass clippings were observed on the pavement in-between properties 5710, 5708, 5709, and 5559. Each household member was met to talk about the issue and hand over educational materials. The street adjacent to 5709 was immediately cleaned up by the responsible home owner. According to the home owner of 5709, they don't have HOA for management.

Members of property 5710 and 5708 agreed that they were responsible for dumping clippings after mowing their lawns and promised to clean it up within few days. NOV was not issued since both responsible parties were found highly responsive to cleaning the street and typically the County makes education the first priority with homeowners on these types of cases.. A follow up inspection will be made on the following week to inspect for corrective actions. If the issues still exists, successive investigations will be made for enforcement in future.

Follow-up inspection was made on 08/29/2016. The problem of discharging clippings on street was satisfactorily cleaned by the community members.

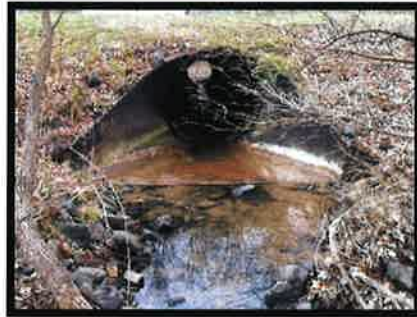
**Photo of discharge:**

INCIDENT INFORMATION		
Incident Report #: 29/3_27_17	Date : 3/10/2017	Time : 11:15 AM
Business : NA	Report Completed By : Prem Poudel	
Address: Creek near intersection of Robling Ct & Sheraton Dr	City : Manassas	Zip Code: 20112
Complain or Case Received From: Kathy Hildebrand	County Staff: yes

<b>Responsible Party ( Owner/ Institutions)</b>	<b>Other Party (Management Company)</b>
Name: NA	Name: NA
Company: VALLEY VUE ASSN OF HOMEOWNERS INC	Company: NA
Address: 13482 Natick Dr. Manassas, VA 20112	Address:
Phone #:	Phone #:
Note:	Note:
<b>Notification/Contact (Other agencies contacted (DEQ, NS, FMO?) – Not necessary</b>	
Date:	Date:
Time:	Time:
Name:	Name:
Company/Agency:	Company/Agency:
Notes:	Notes:
<b><u>Comments/ Deficiencies:</u></b>	
<p>PWC IDDE staff received a complaint regarding significant amount of white foam on creek passing through Sheraton Drive before the intersection of Sheraton Rd and Robling Ct while driving S-W direction. Site was visited by IDDE staff on 03/27/2017. The facility was a road culvert for a creek through scattered residential areas. The reported white foam did not observe at creek. Upstream creek was inspected to investigate the potential runoff but remarkable source for suds could not observe. It may be washed away due to rainfall, happened before inspection.</p>

<b><u>Conclusion:</u></b>	
Follow up inspection will be continued for further investigation.

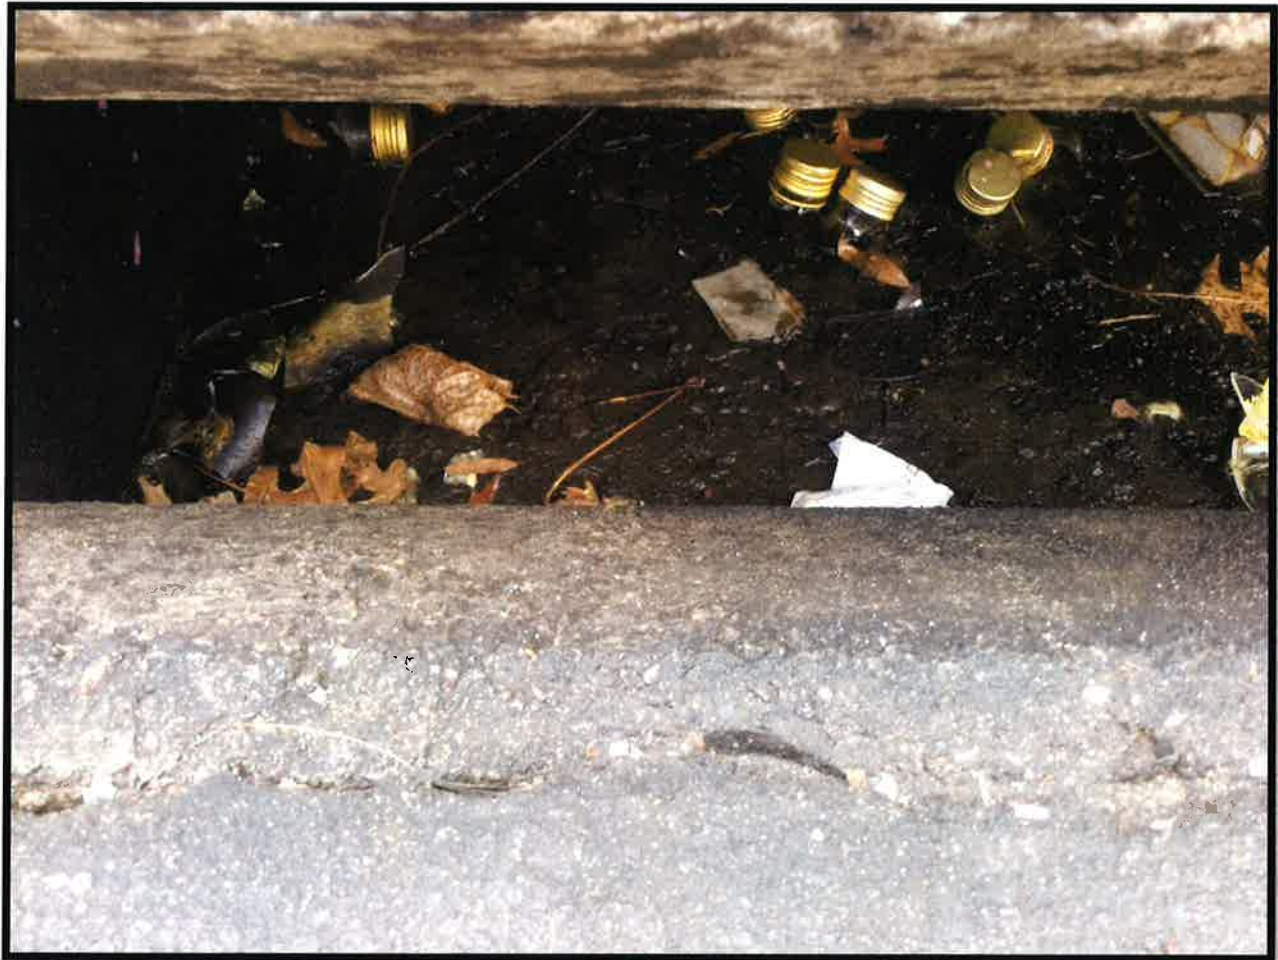
**Photo of discharge:**

INCIDENT INFORMATION		
Incident Report #: 30/3-28-17	Date : 3/28/2017	Time : 2:00 PM
Business : Residential	Report Completed By : Prem Poudel	
Address: SW- Inlet (35033) nearby 2937 Stockholm Way	City : Woodbridge	Zip Code: 22191
Case Detail: Cooking oil bottles (glass) being dumped into storm water inlet across street 2926 Stockholm Way

PH: NA	Limit NA	Conductivity (µS/cm): NA	Limit: NA	Temp.: -°F	Limit: NA
Discharge related Indicators	Odor: NA	Color: NA	Turbidity: NA		
	Floatables: NA	Stains: Oily	Deposits: Litters

On March 27, PWC IDDE staff received a complaint regarding cooking oil bottles (glass) being dumped into storm water inlet across street 2926 Stockholm Way. Site was inspected on 3/28/2027. Upon arrival, cooking oil bottles observed dumping into storm inlet, located near 2937 Stockholm Way. Black stains were covered with fresh oil. Piece of bottles were seemed to be spread out and few bottle neck were observed with cap after breaking on flat surface of inlet structure. It is an evidence of dumping waste cooking oil after filling and capping. Visual condition proved that the incident was not a single and had happened repeatedly. Conversation made with three different residents, but nobody gave the clues to identify the violator.

Dumping oil into storm sewer system is a violation of law. The property management company is responsible make residents aware about those unlawful activates. The case needs to inform to the property management company to investigate and take an action on this issue. The case may be happen due to ignorance about unlawful activities among residents. Since the case has received first time, the case has forwarded to property management company to mitigate the deficiencies. Failure to comply deficiency within 30 days after receiving letter from County, NOV will be issued to the Property Management Company. Follow up inspection will be continued to monitor the mitigation activities.

1. Immediately stop dumping oil into storm sewer system.
2. Clean the stain, debris and trash from storm water inlets.
3. Maintain good trash collection and haulage practices.

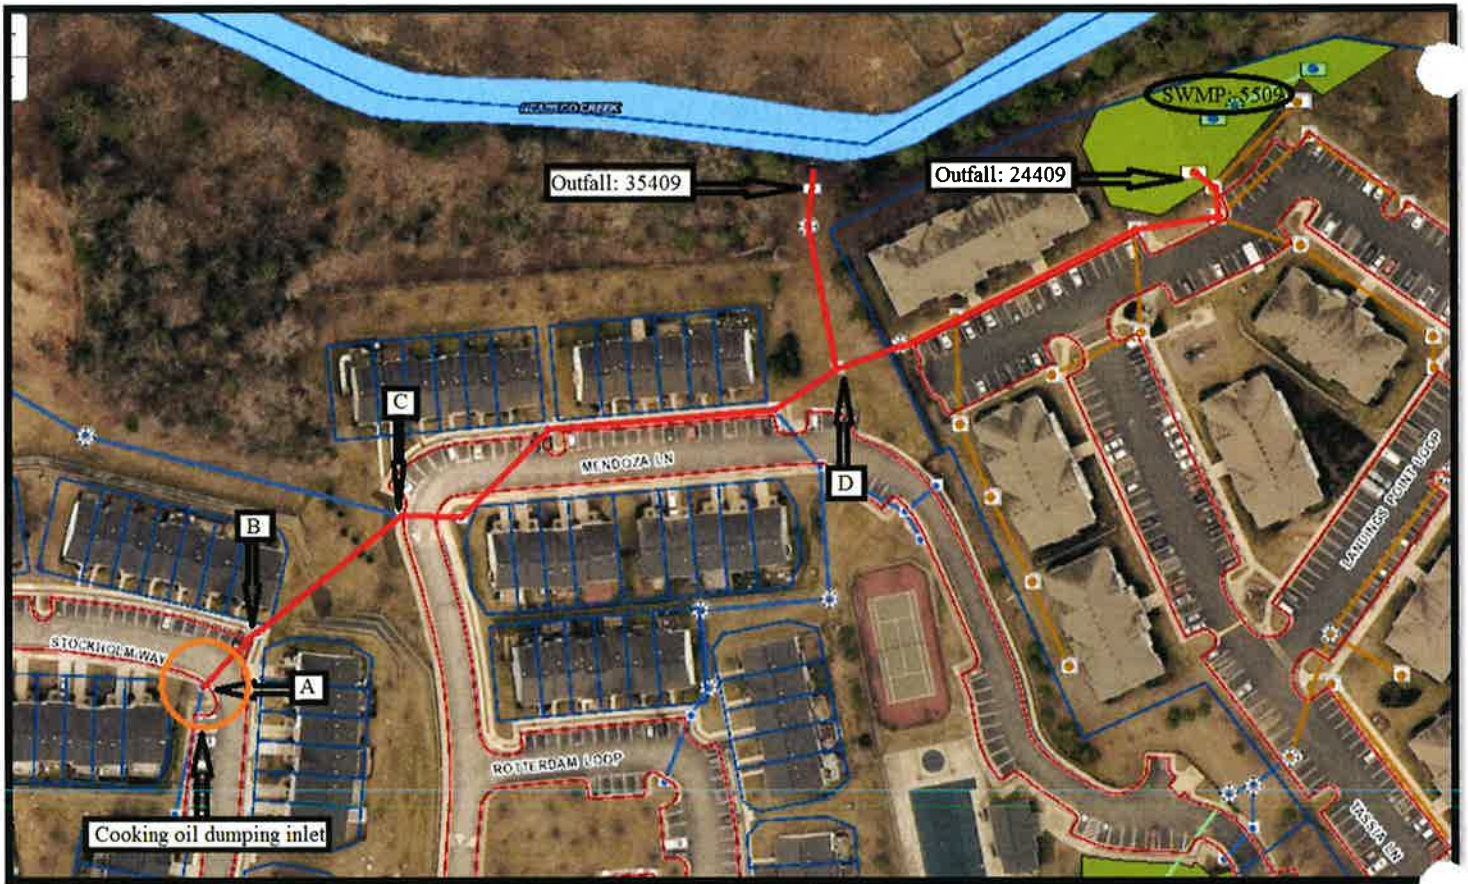
**Map of Trackdown Path:**

After tracking storm sewer system, the impact of dumping was found to be localized between two curbs and gutters inlets. Grease and oil debris didn't observe at successive downward manhole B and even didn't observe significant impact on downstream outfalls.

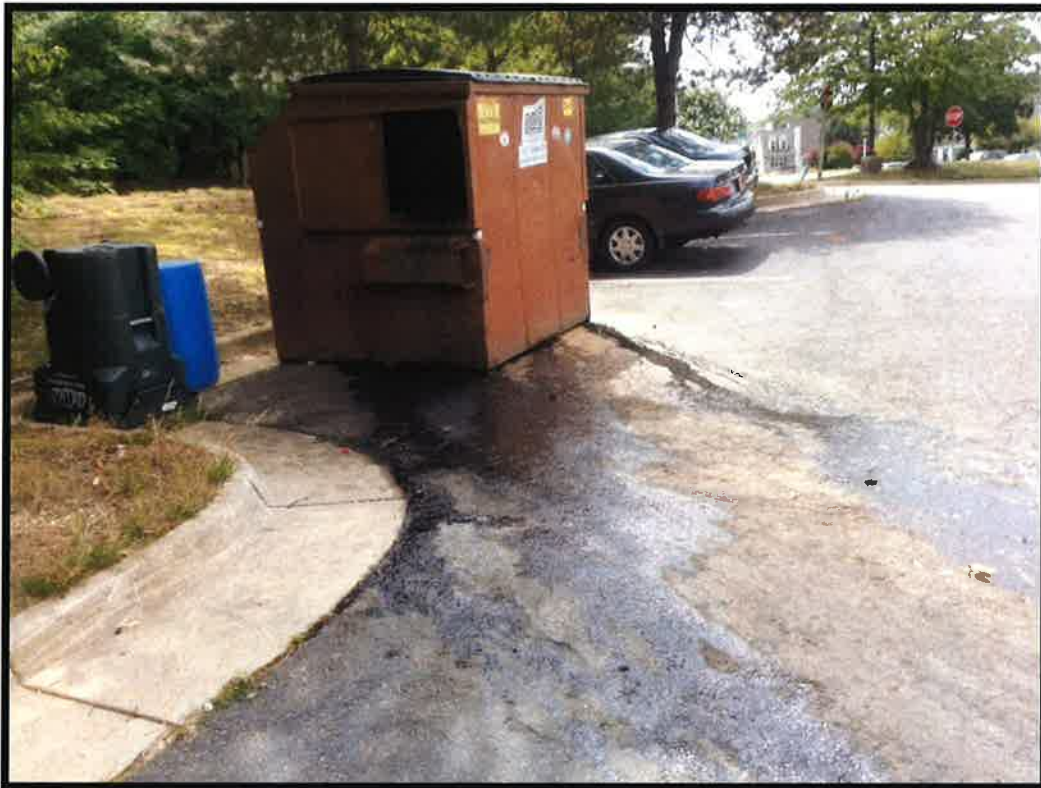
**Figure 1: Photo of Discharge.**

On July 28, 2016 PWC Environmental Services received a call from Arika Davidson of Prince William County Neighborhood Services concerning an illicit discharge. Fluid from a leaky dumpster was found to be flowing towards the storm sewer system at Tacketts Mill Car Wash, located at 12831 Harbor Drive. A field inspection was made on same day. Upon arrival, black sludge pulled from the car wash area during a cleanout operation was found to be discarded into the dumpster located beside south entrance of the property. Fluid was leaking out of the dumpster and observed flowing towards storm sewer inlet.

Following the inspection, a meeting was made with Mr. Javed Butt, the manager Tacketts Mill Car Wash. According to him, the sludge, approximately 6/7 buckets worth, was removed from a drainage tunnel within the car wash property and dumped into the dumpster. The fluid extracted from sludge was starting to flow through dumpster. Cotton towels were immediately used to absorb leachate flowing on the pavement to cease the flow directed towards storm drain.

As per county ordinance sec. 23.2-4.1 any non-stormwater discharge to the stormsewer system is considered a violation. As a result NOV 3-2017 was issued to Tacketts Mill Car Wash. The corrective action plan should include:

- 1) Capture the leaking fluid as soon as possible.
- 2) Clean the stain from pavement without allowing washed fluid flow into storm sewer system.
- 3) Maintain the integrity of dumpster to prevent future leakage

Follow up inspections were made on 8/1/2016 and 8/8/2016 respectively. Discharge was stopped but cleaning activities were not completed during 1<sup>st</sup> follow-up inspection. The leaky dumpster was replaced and stains were cleaned from underneath pavement and asphalt following the 2<sup>nd</sup> follow up inspection. The Case is now closed.

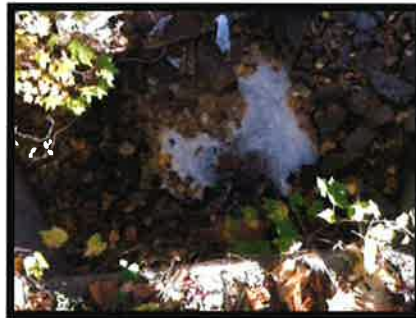
**Figure 1: Photo of Discharge.**

On November 7th 2016, the site inspector of PWC Environment Services Mrs. Sandra Adams reported a chlorinated illicit discharge into storm sewer system through SWM pond (454) outlets located at 1282 Corbelt Pl with attached picture shown in figure 1. The site was visited on same day. Upon arrival, faint odor of chlorine was felt at pond outlet and suds were not on scene. Water quality was tested with YSI professional for pH, DO, Conductivity and temperatures. Tested all results were within standard limits. Desktop analysis was made on collected sample and chlorine was found 0.015 mg/l which is slightly higher than the standard limit (0.01 mg/l). Pond inlets were inspected to identify the potential source of contamination. Among four, downstream three outfalls 30030, 30028 and 30024 were dry and only upstream stream sewer was flowing. The upstream stream sewer should be connected with storm sewer laid within shopping center but it doesn't show up in the county mapper. The potential source of illicit discharge couldn't identify in first visit. Follow up inspection was made to identify potential source of chlorinated discharge on 11/10/2016. There is a swimming pool made for Woodbridge Forest Apartments, located at 13250 Gordon Blvd. The concrete swale with riprap at its end was observed directed into pond. The facility was inspected but there was no foot print of discharge on the ground and swale.

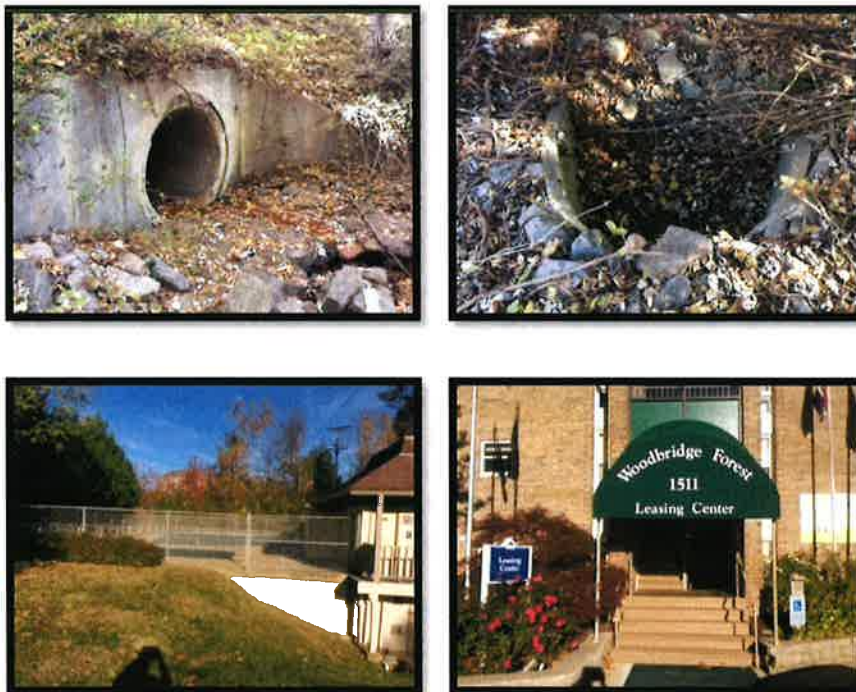
Figure 3: Trackdown Photos

The potential source could be the chlorinated pool water discharged into storm sewer system but there were no sufficient evidences to prove it. Following the inspection, meeting made with property management team and talked about the issues. The educational materials were handover to the property management team for making them aware about an illicit discharge. NOV didn't issue since the violator couldn't identify. Follow up inspection will be continued periodically for inclusive investigations.

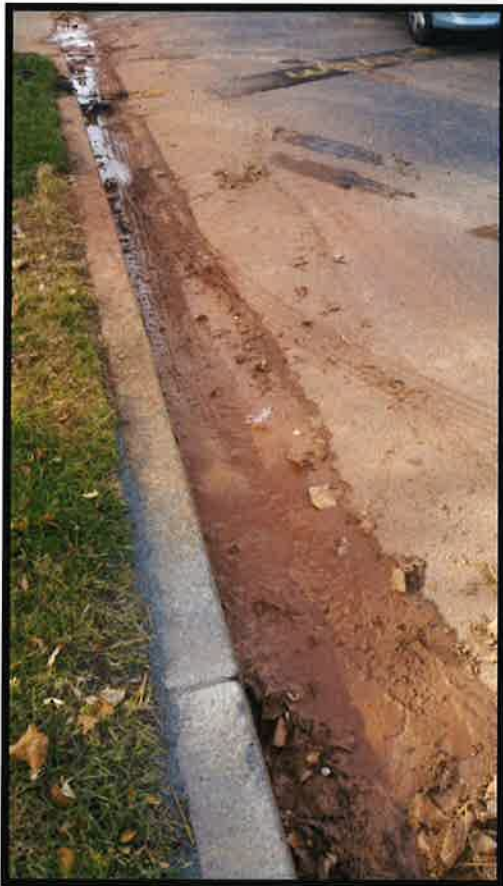
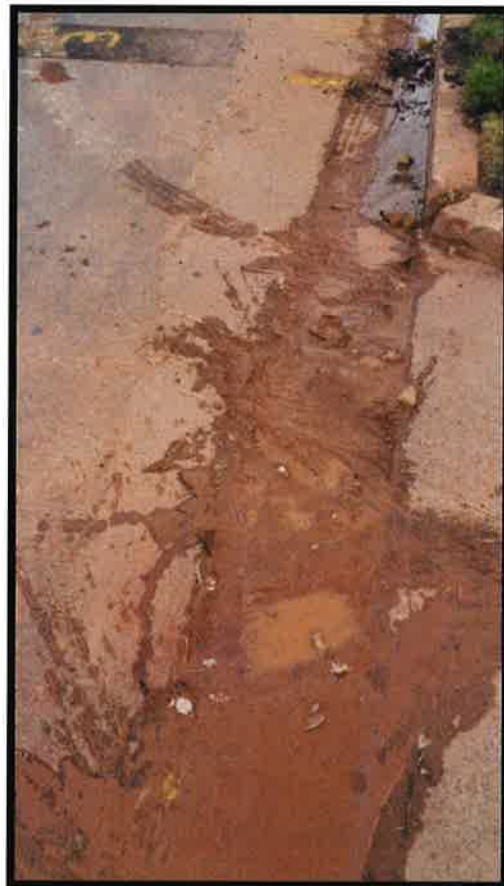
**Figure 1: Photo of Discharge.**

On October 31, 2016 PWC Environmental Services received a complaint regarding the mud that the contractor for Washington Gas put into the street and was washing down the storm sewer system. The facility in question was the street in front of 9813 Lomond DR. The site was visited by PWC Environmental Services staff on Nov 1, 2016. Upon arrival, mud sludge was cleaned from road curbs and gutters and only minor dust and stains were left over.

The major deficiencies were found to be corrected after complaining by the residents. So notice of violation didn't issue and the case is closed.

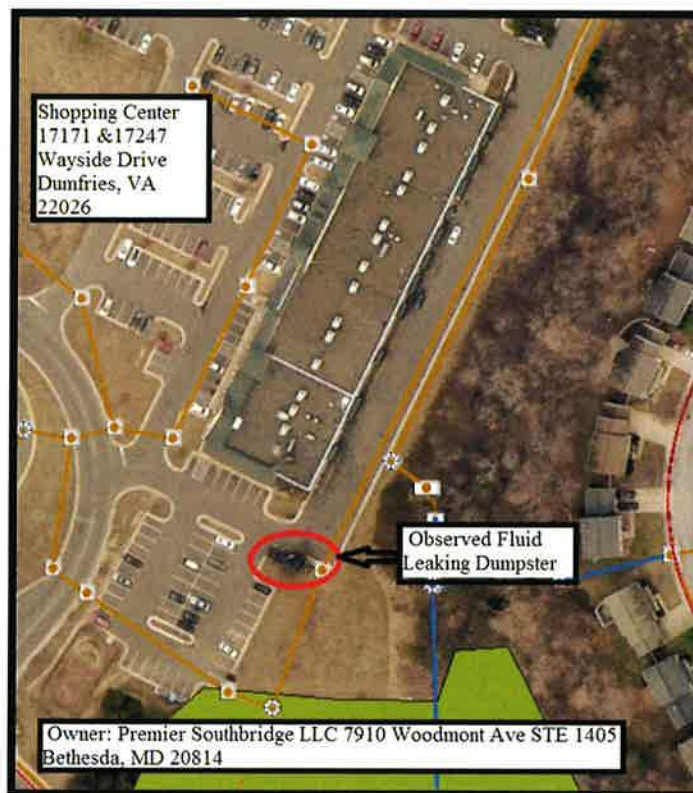
**Figure 1: Site map showing discharge flow path through the storm sewer system.**

During a routine inspection, the dumpster located at 17247 Wayside Drive was observed leaking and discharging grease and waste food fluid into storm sewer drop inlet. Fats, oils, and greases were observed spilling on the pavement around a grease collection tank. The stain of fats, oils, and greases was also directed towards storm drain. This incident was a re-occurrence from NOV 2015-08 issued on 10/08/2015.

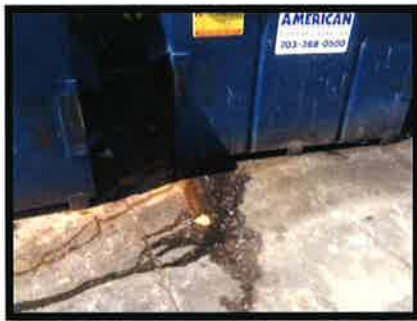
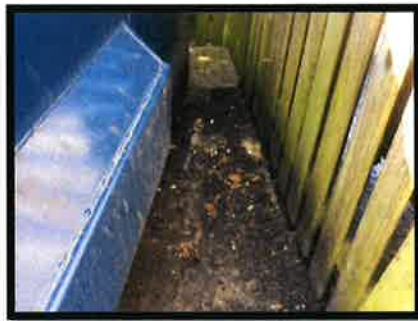
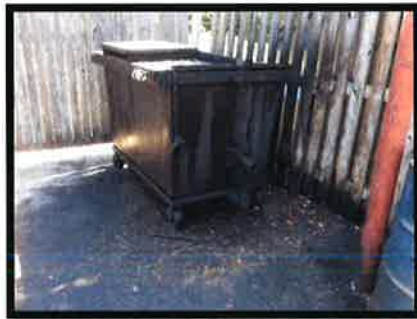
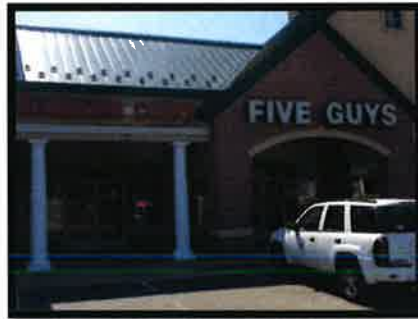
Fats, oils, and grease were observed flowing towards the storm sewer system. The debris and residue were observed having washed away into storm sewer system during rain events. The meetings were

made with both manager of Five Guys and Mandarin Court particularly located enclosure to the dumpster. Both of them didn't accept the mishandling of waste while using those facilities. The bottom of the dumpster was observed to be broken.

Discharging waste food fluids, fats, oils and grease is a violation of county ordinance as per sec. 23.2-4.; NOV will be issued to the property owner or Management Company to correct the deficiencies.

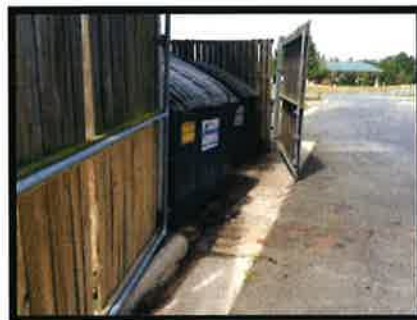
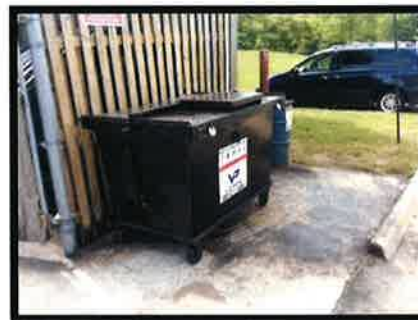
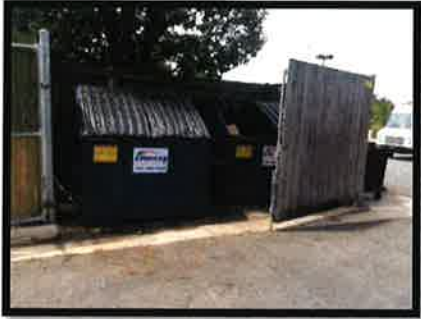
A Follow-up inspection was made on 8/8/2016. The integrity of dumpsters and grease container was corrected by replacing old damaged equipment. The grease and waste food fluid stains were cleaned. The case has now been closed. See attached pictures.

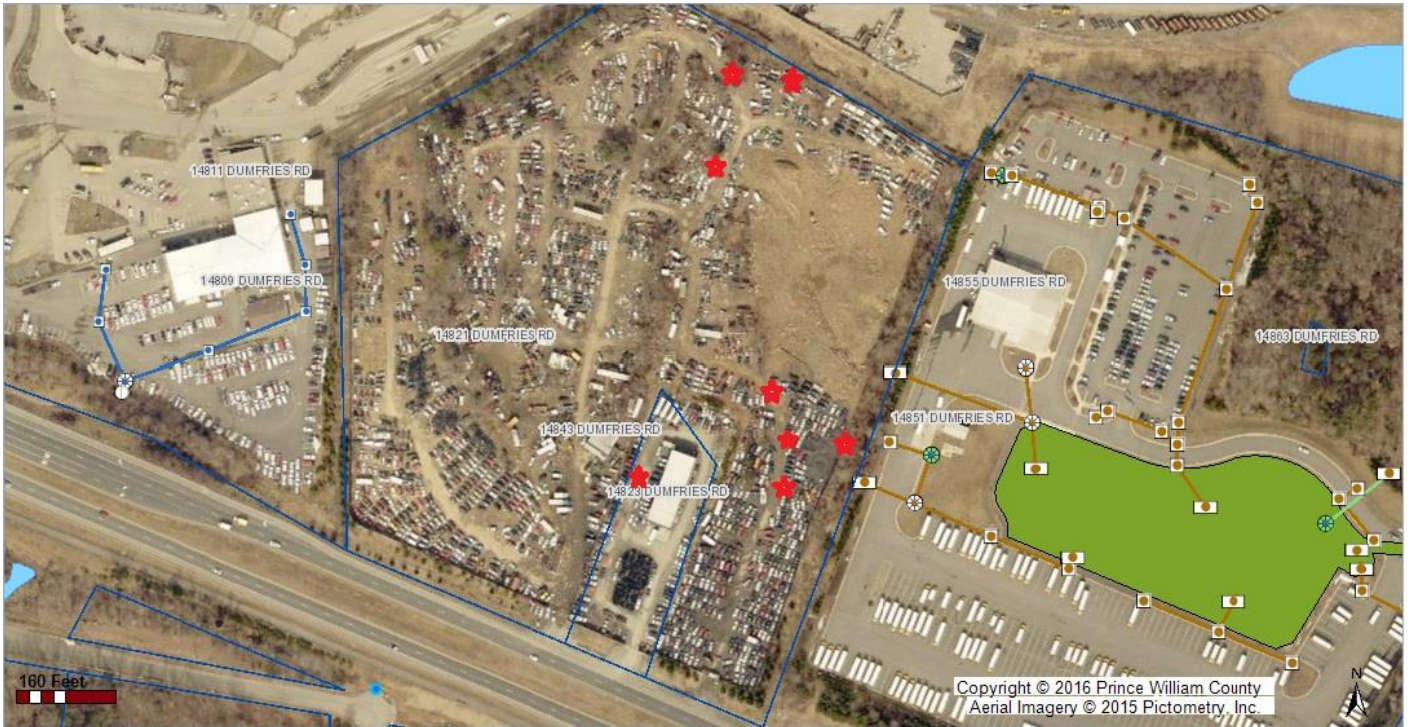
\*\* Picture with map - Red Stars indicate location of booms or other spill control methods taken at the site.

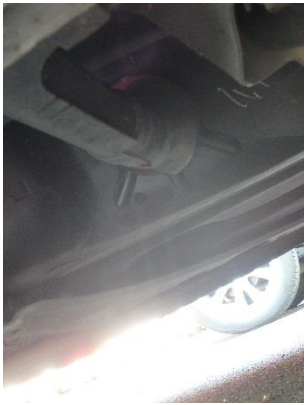
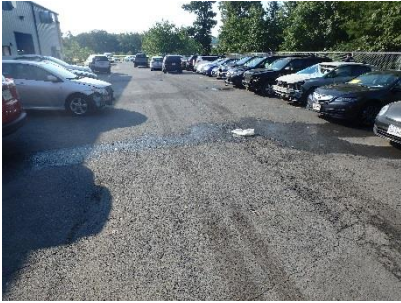
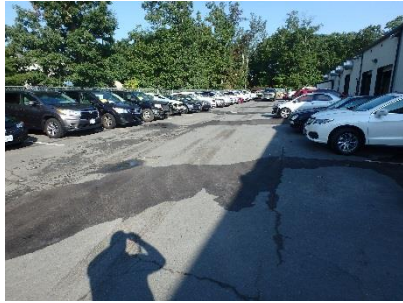
INCIDENT DESCRIPTION	
<p>Safety 504 came upon a box truck broken down on the side of the road. He noticed a good amount of oil, approximately 5 gallons that had leaked out of the vehicle. The driver stated the driveshaft broke and cracked the oil pan on the truck. The driver had already placed absorbent on the oil and it was contained to the street, no drains or waterways were effected. The driver had already notified VDOT and Waggy's towing company was on scene to help with the cleanup. Safety 504 gave the driver and LPEC form so they could notify a cleanup contractor.</p>	
RESPONSIBLE PARTY	OTHER PARTY
Name:	Name:
Company: Vantage Moving	Company:
Address:	Address:
Phone#: 703-392-6260	Phone#:
Notes:	Notes:

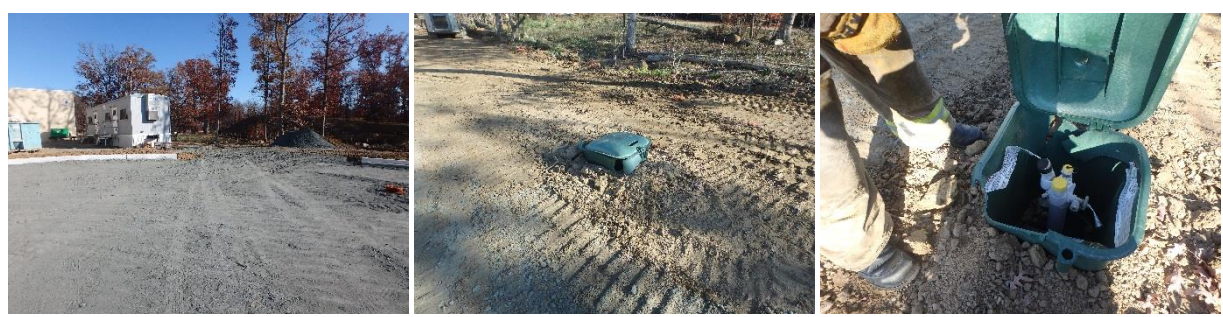
It was their workers who struck the dome and caused the issue, one could argue that they are the responsible party but Matt Adkins wants to put the Gas company as that person, he is going to do some followup with them about their policies and procedures.
