# Annual Stormwater Management Report

## VSMP Permit No. 0088595 – FY 2017

Submitted by:  
Prince William County  
Department of Public Works

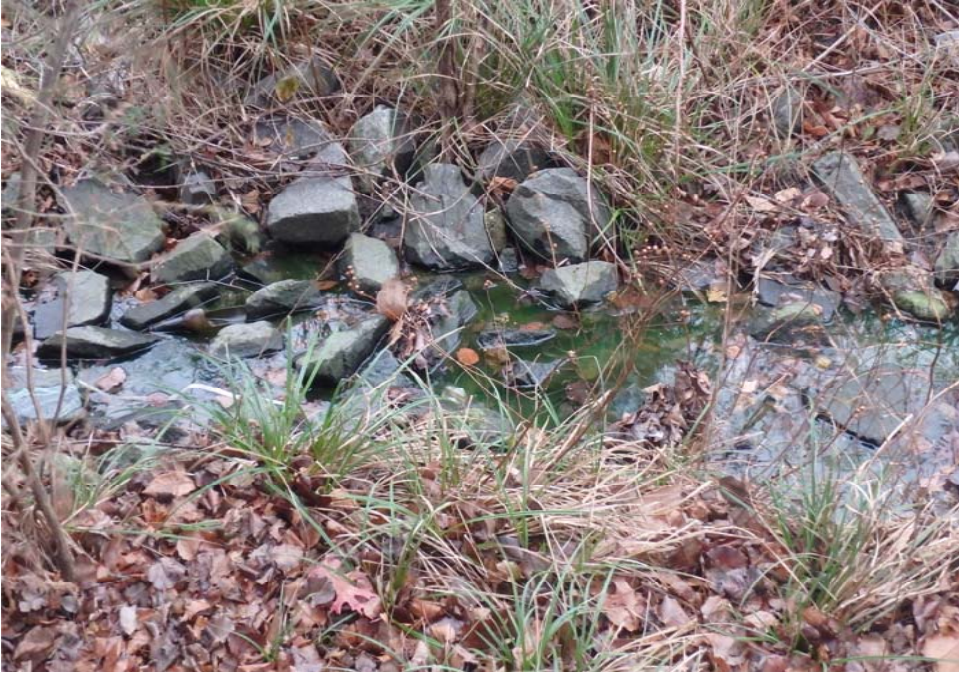
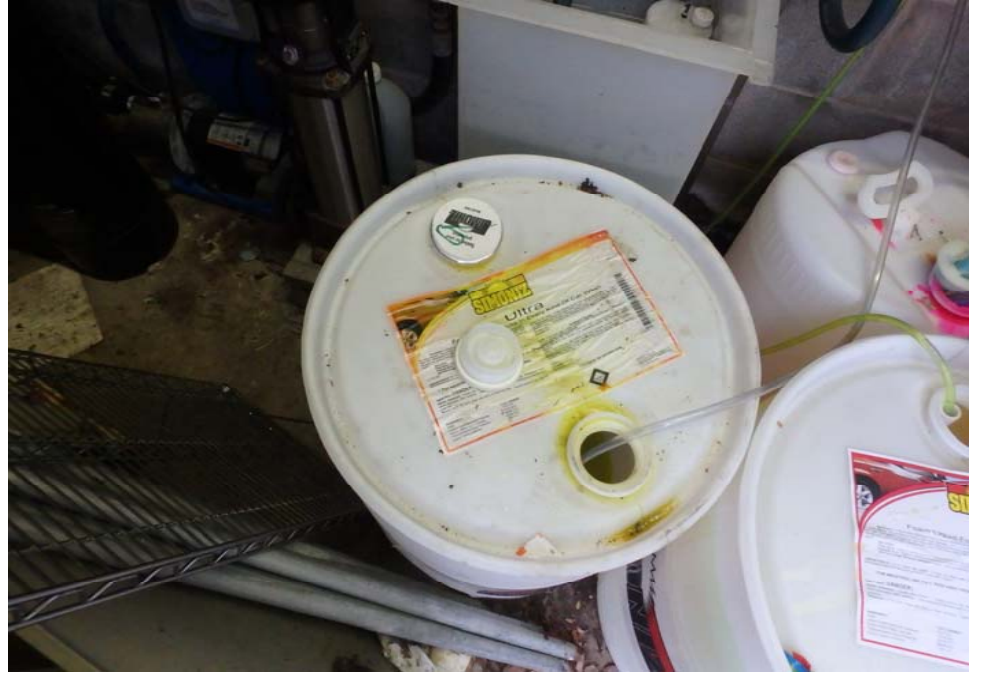
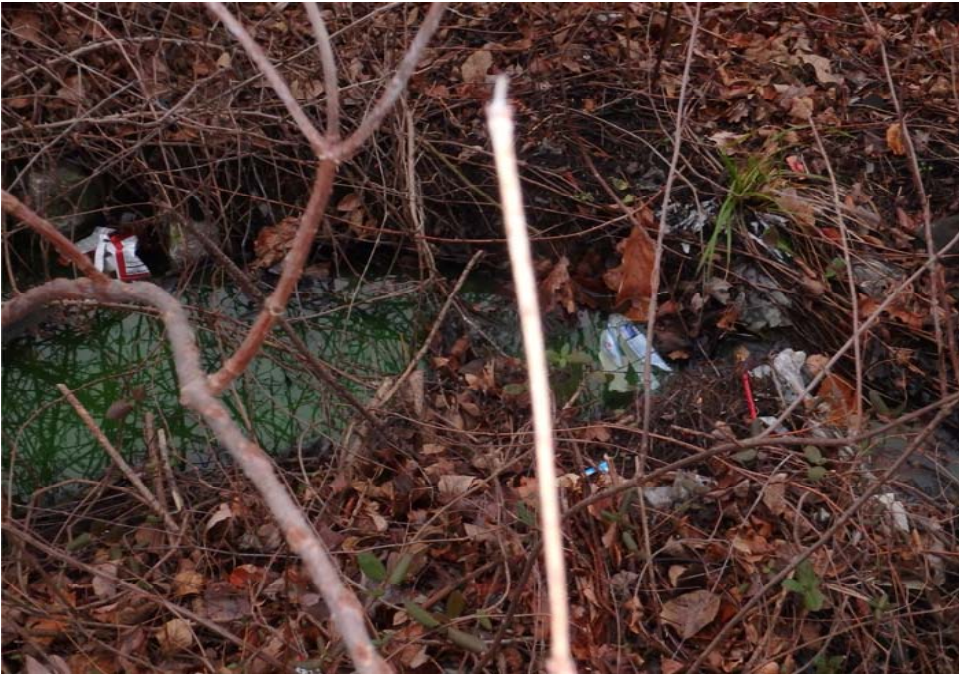
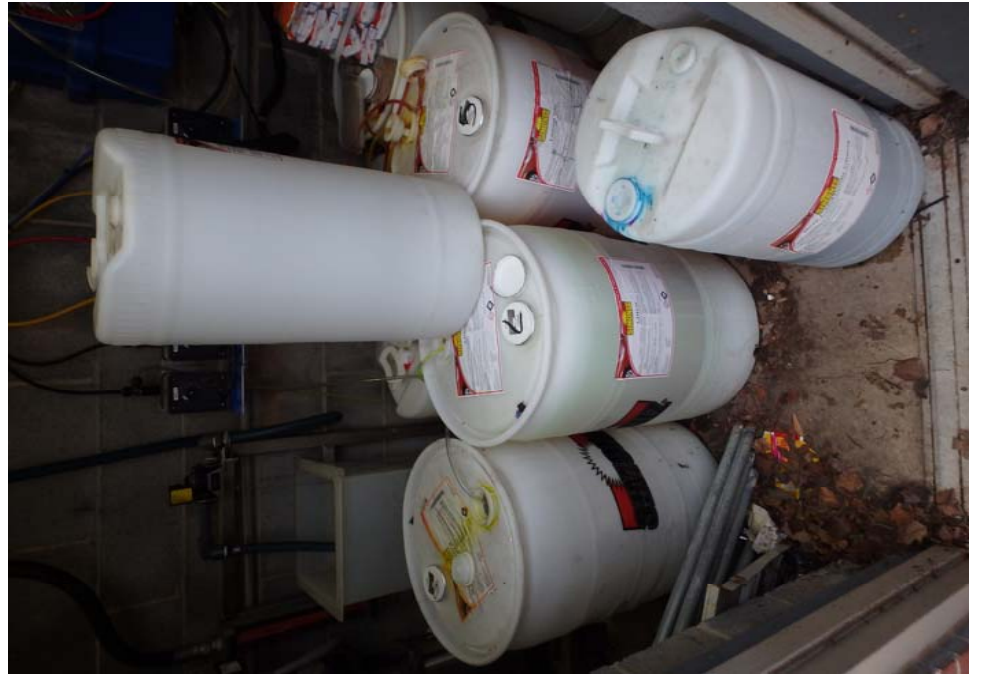
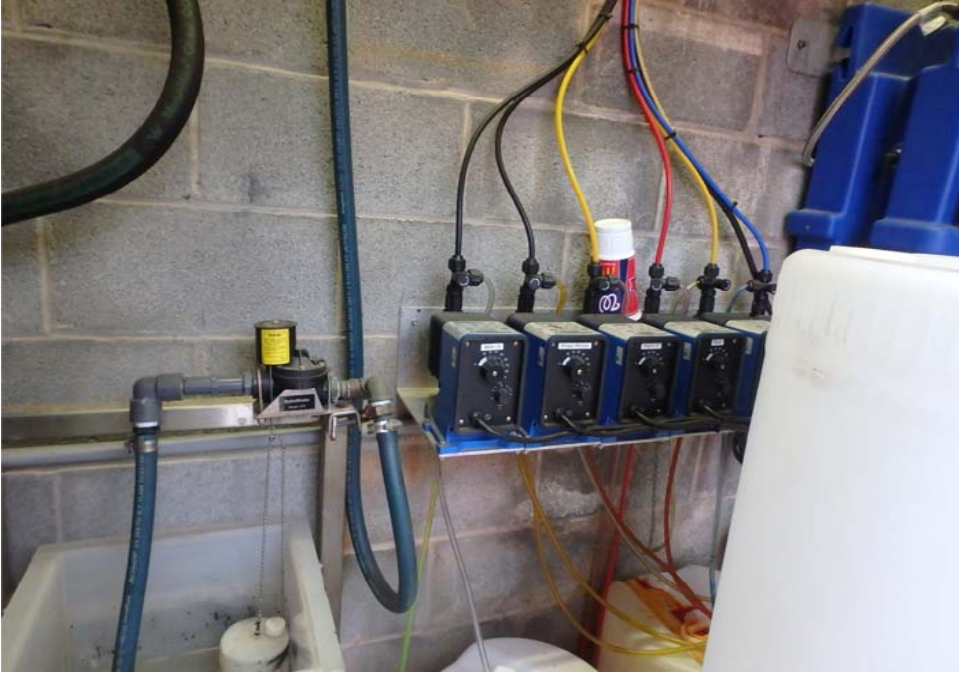
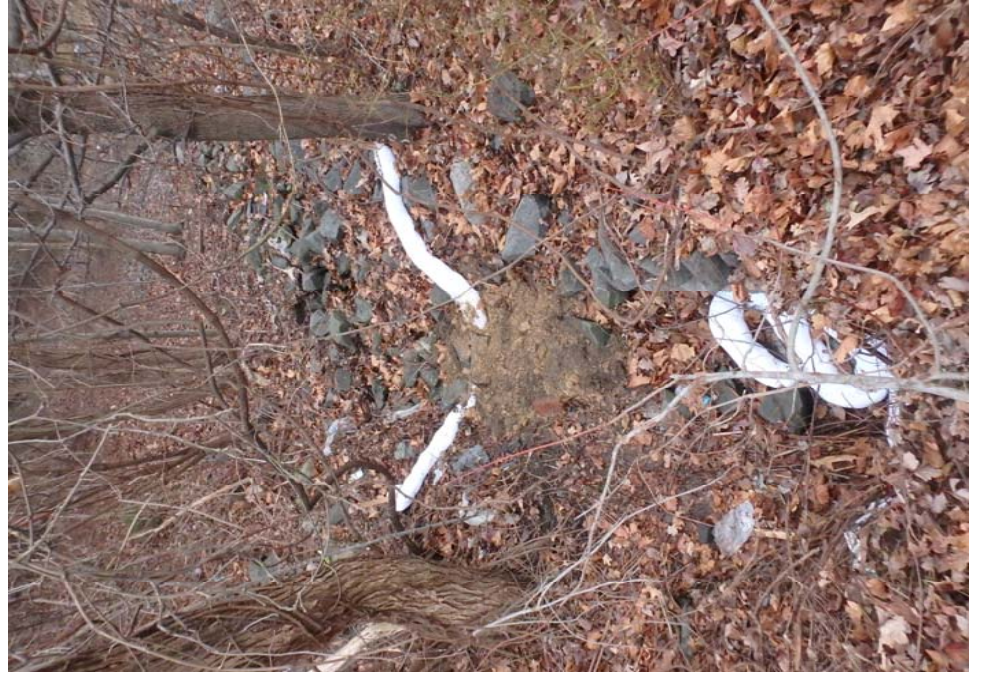
INCIDENT DESCRIPTION	
HM506 was called out to Exxon Old Bridge for substance that was in the storm drain that looked like coolant. Enroute HM506 was informed that Hazmat was out on this call last Sunday Dec 11 for the same call. HM506 found that the car wash was leaking soap into the storm drain and was running down the ditch. HM506 damned at farthest point to keep any product from going any further. On the previous call HM506 had placed booms to keep product from going down the water way. HM502 arrived onscene and worked with store owner on cleaning up the product. He was advised to not use the car wash till the product was cleaned up. DEQ arrived onscene and was working with HM502 to resolve the issue. HM501 notified watershed that the incident had not been resolved.	
RESPONSIBLE PARTY	OTHER PARTY
Name:	Name:
Company: Exxon Old Bridge	Company:
Address: 3514 Old Bridge Rd, Woodbridge VA 22192	Address:

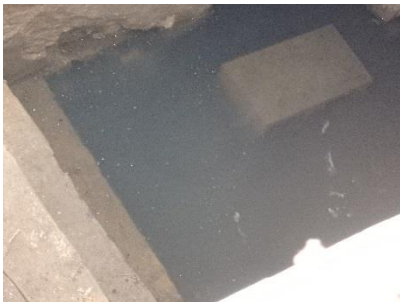
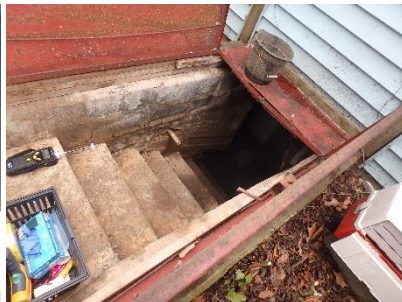
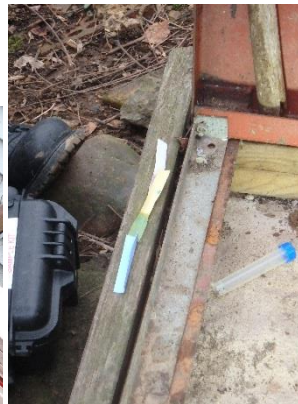
INCIDENT DESCRIPTION	
<p>BC501 responded to a reported house fire at 15210 Haymarket Drive. E504 found liquid in the cellar and reported seeing a green/blue color sheen floating on the liquid and assumed it could be oil contaminated water. BC501 requested a phone consult with duty hazmat tech. Technician II Snitwongse took the phone consult and BC501 reported the house had a 250 gallon above ground oil tank and was concerned it had leaked into the basement. BC501 reported that there was no visible runoff and normal readings were reported by E504's 4 gas. BC501 stated the homeowners had just placed 10 gallons of fuel into the tank. BC501 Stated that the tank was approximately 1/4 full.</p> <p>HM506 self dispatched to the scene based on the information provided by BC501. Upon arrival HM506 conducted monitoring with the 4 gas and PID. Normal readings were noted on the 4 gas and the PID reading was 286ppm. Two samples were collected in sample tubes and tested for the presence of hydrocarbons or oil. PH was 7, water paper was positive turning from white to pink and oil paper was negative. Both samples appeared clear to visual inspection and no odor was present. The oil tank was visually inspected and no leaks were noted. HM506 determined that there were no hazards and returned the scene to E504.</p>

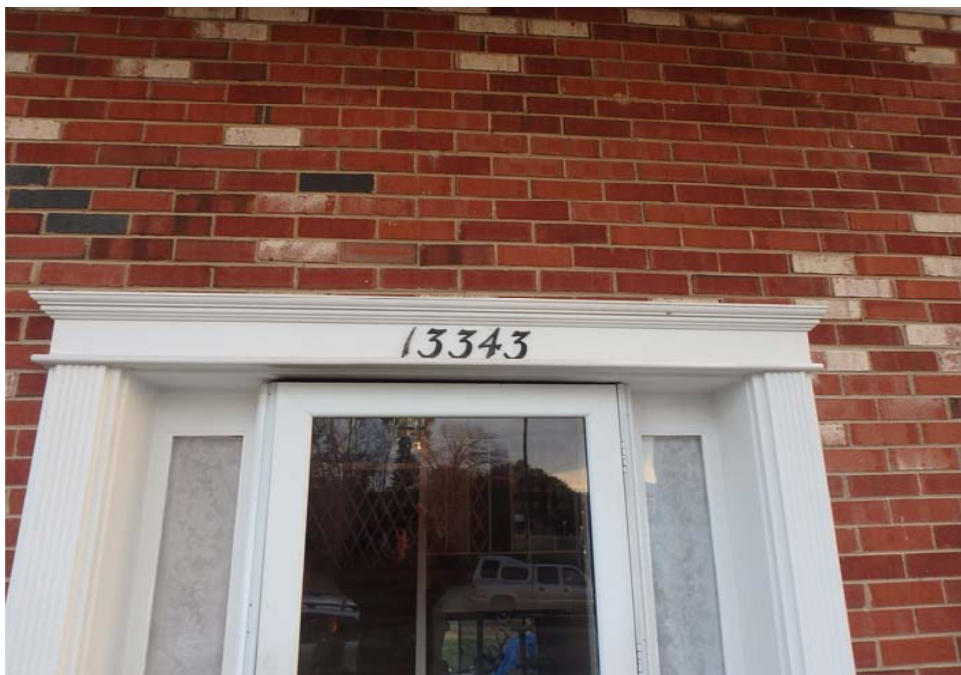
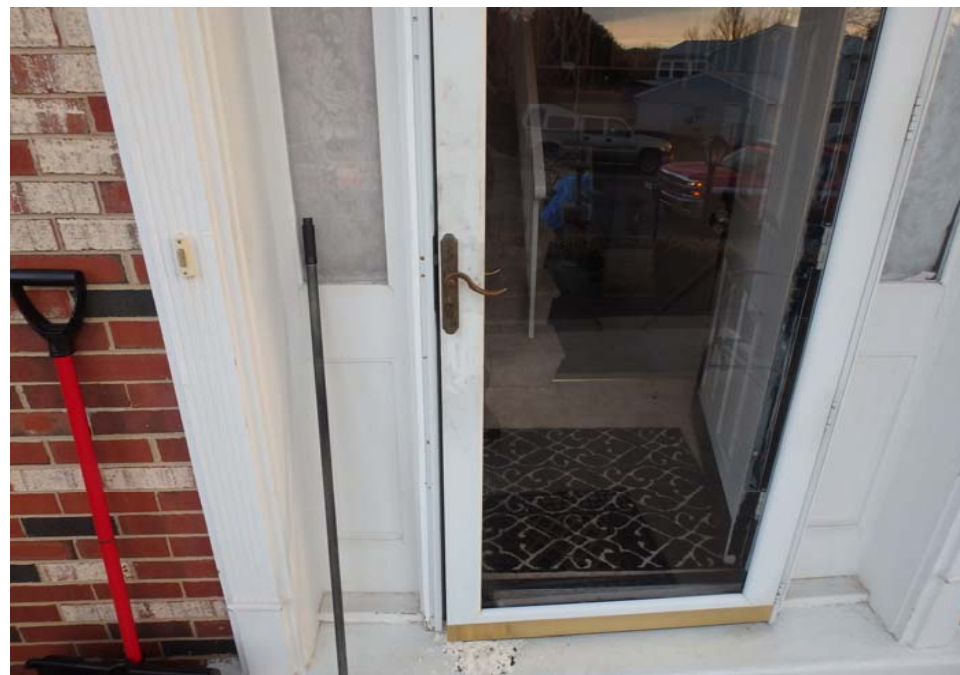
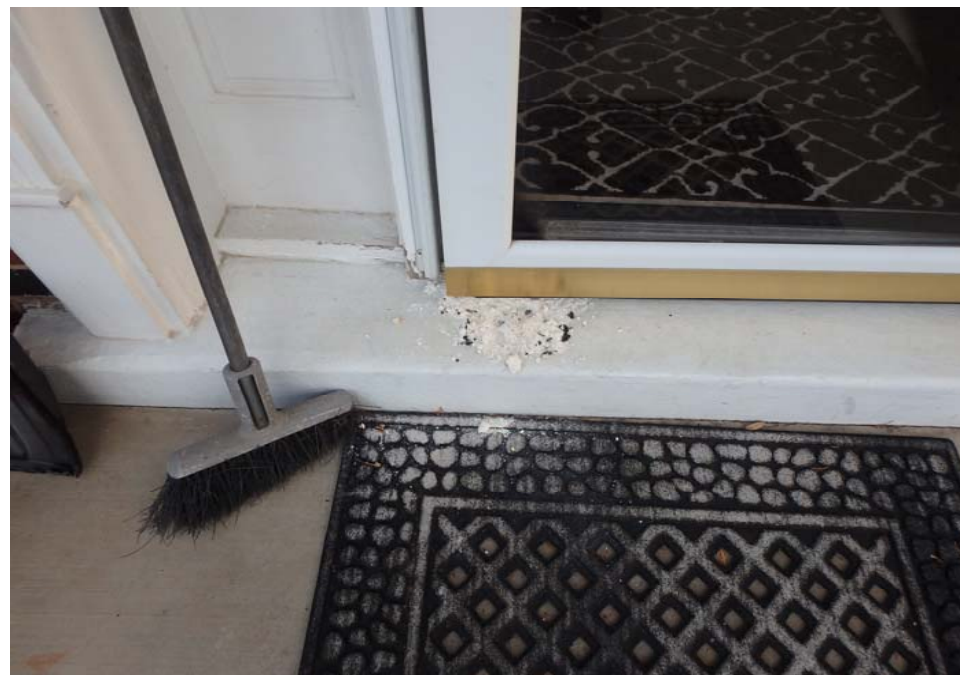
INCIDENT DESCRIPTION	
<p>Received a phone call from HMO 501 regarding an incident that FM525 was investigating. Someone had filled two tube socks full of a white powdery substance and gasoline, then tied them to the front and rear doors of the home. They were then set on fire and extinguished themselves before the homeowners had found them. FM525 wanted to confirm that the substance was not hazardous to the public. HM506 arrived on scene and spoke with FM525. She had already obtained a sample for their investigation. She did not notice any smell originally and though the white powder was from a dry chem that the homeowners used to extinguish the fire. After speaking with the homeowners she realized that powder was from the material used in the fire. The homeowners did not notice any unusual smells or odors. HM506 personnel monitored the material with 4-gas, PID, PH paper, and Temp gun. There was only a hit with the PID which spiked to 55 PPB and averaged around 35 PPB. All other readings were within normal limits. A sample was taken from the front door and ran on the HAZMAT ID, it came back as bleached flour. The results were given to the FM and the scene turned over to them.</p>

#	Compound Name(s)	CAS #	Score
1	Bleached Flour (Carbohydrate...		.984
2	Corn Starch (Carbohydrates)		.970
3	Glycogen	9005-7...	.967
4	Dextran	9004-5...	.965
5	Beta-cyclodextrin hydrate	68168-...	.948
6	Rice Cereal (Carbohydrates)		.945
7	Starch	9005-2...	.891
8	Deodorant Powder (Carbohyd...		.871
9	Amylose	9005-8...	.864

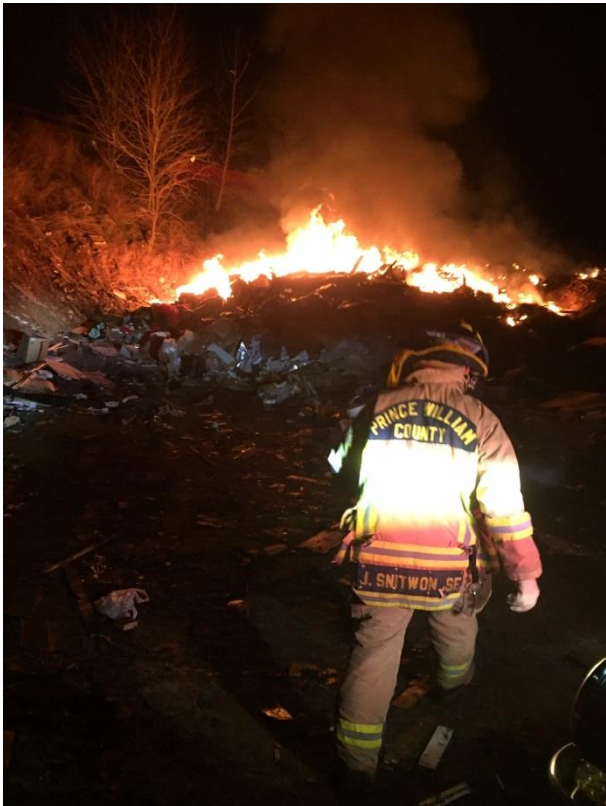
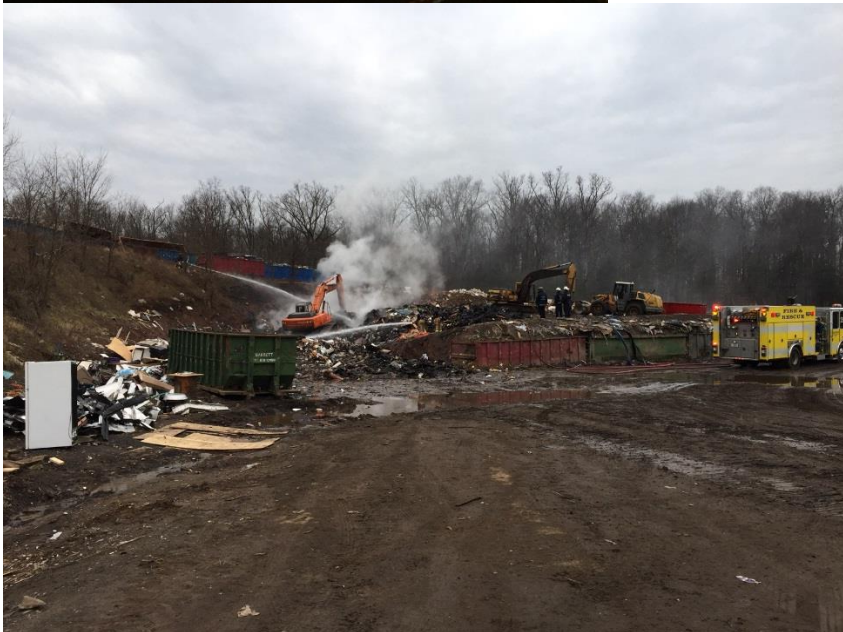
HAZMAT Officer Comments: Initially consulted over the phone with HM Specialist Snitwongse who was staffing E525. HMO501 requested Specialist Snitwongse to initiate the HM Report and provided a HAZMAT overview of the situation. Based on Specialist Snitwongse's report and pictures from the scene. Assistant Chief McClintock requested HMO501 respond to the location to coordinate notifications and agency response. Consulted with FMO, DEQ and County Property Code Enforcement. The activity at this site appears to the HMO to be a landfill operation, however there are concerns that some of the activity may actually be permitted. DEQ, FMO and Property Code will consult regulations and legal authorities in regards to the process that is ongoing. FMO will not be providing a summons or NOV. DEQ is the lead agency.

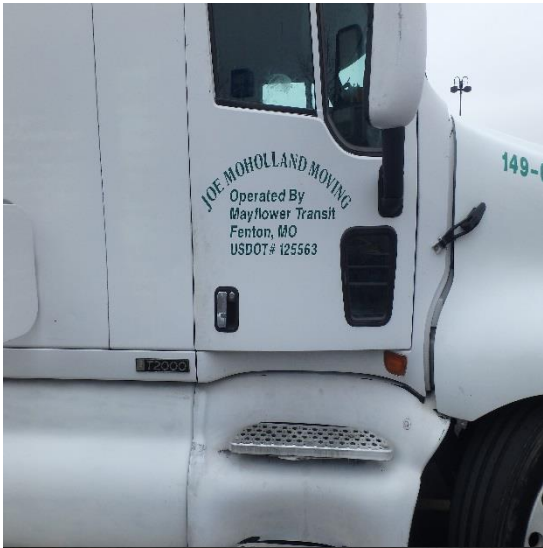
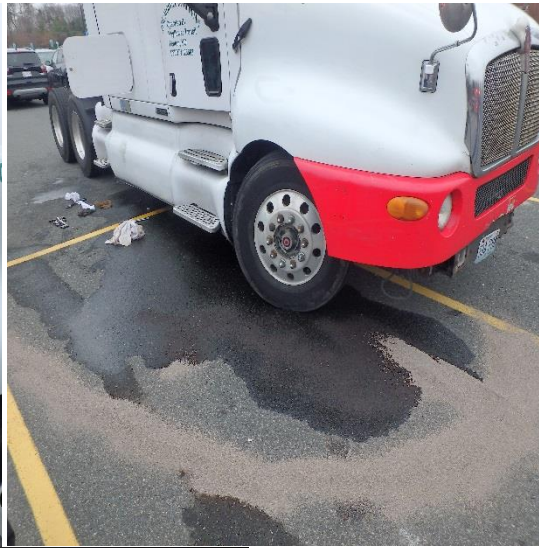
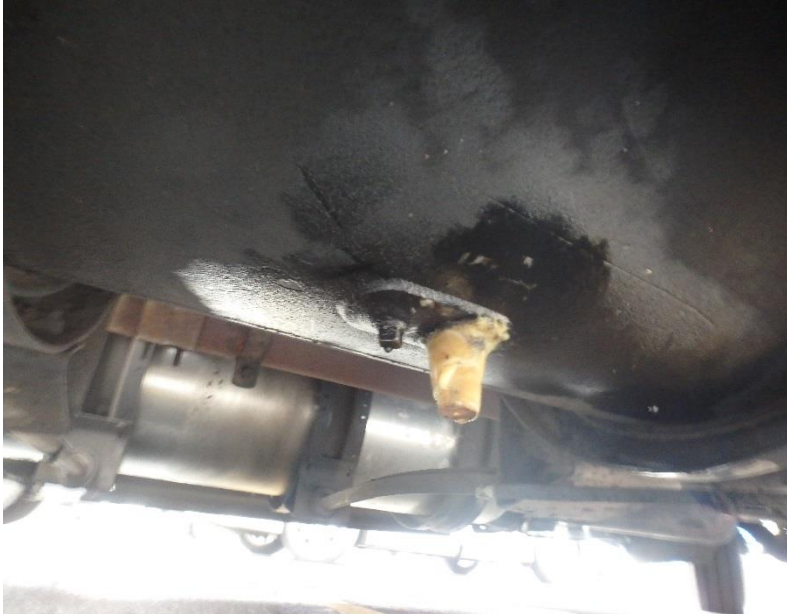
INCIDENT DESCRIPTION	
<p>T523 dispatched for a tractor trailer leaking fuel in a Walmart parking lot. They found a truck (no trailer) parked in the middle of the lot, leaking fuel from one of the saddle tanks. The driver of the truck unscrewed the plug to the saddle tank to see how much fuel was in it. He then managed to accidentally drop the plug into the saddle tank. T523 had dammed the area and the driver was actively collecting the leaking fuel with a plastic container. HM506 was added to the call after a phone consult. While in route, the driver of the truck managed to stop the leak using a wooden dowel and putty. The driver of the truck was given a current LEPC. The driver called Atlas to clean up the spill. Manager of Walmart on site and appraised of situation. Approximately 5 gallons spilled on pavement. Spill contained, and leak stopped. VA EOC notified.</p>	
RESPONSIBLE PARTY	OTHER PARTY

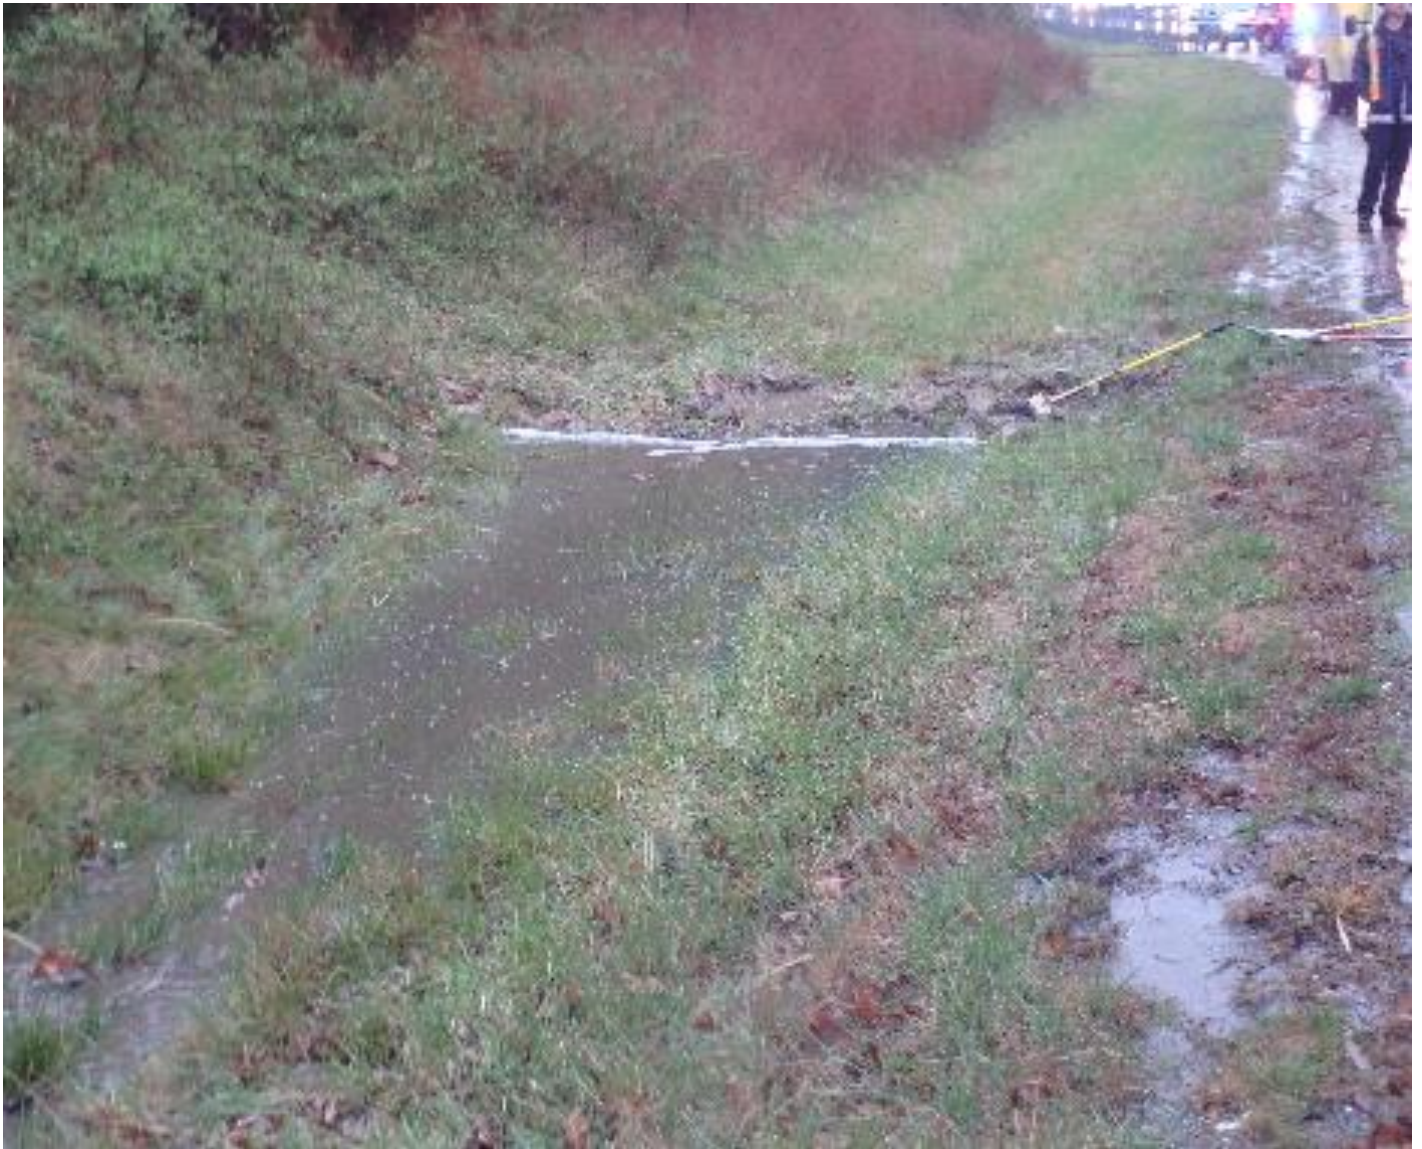
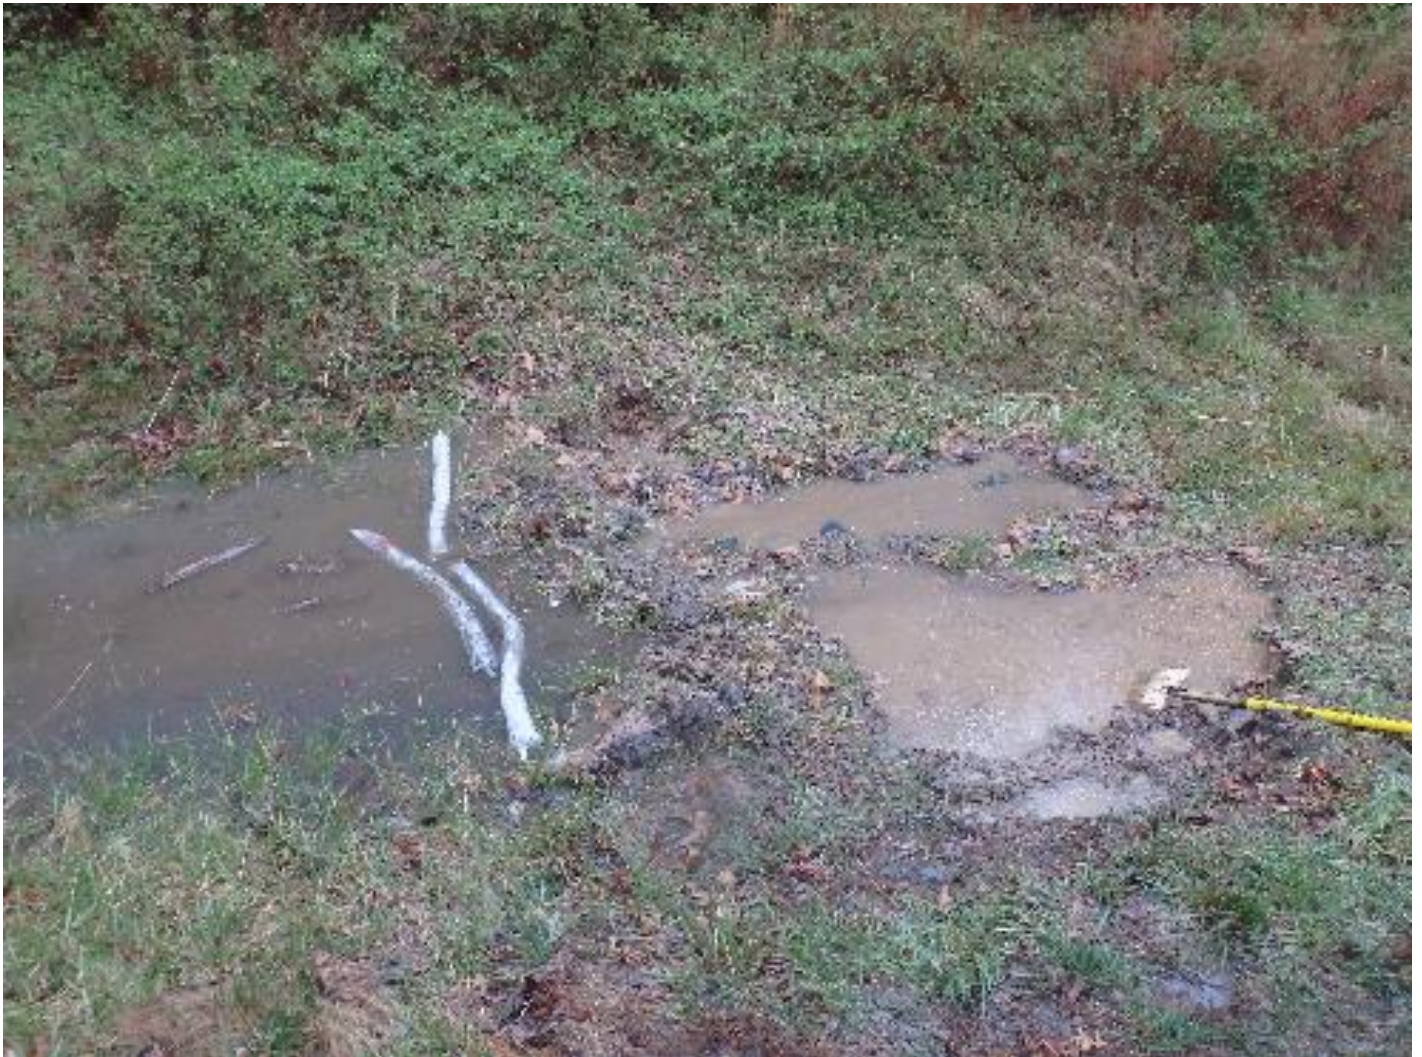
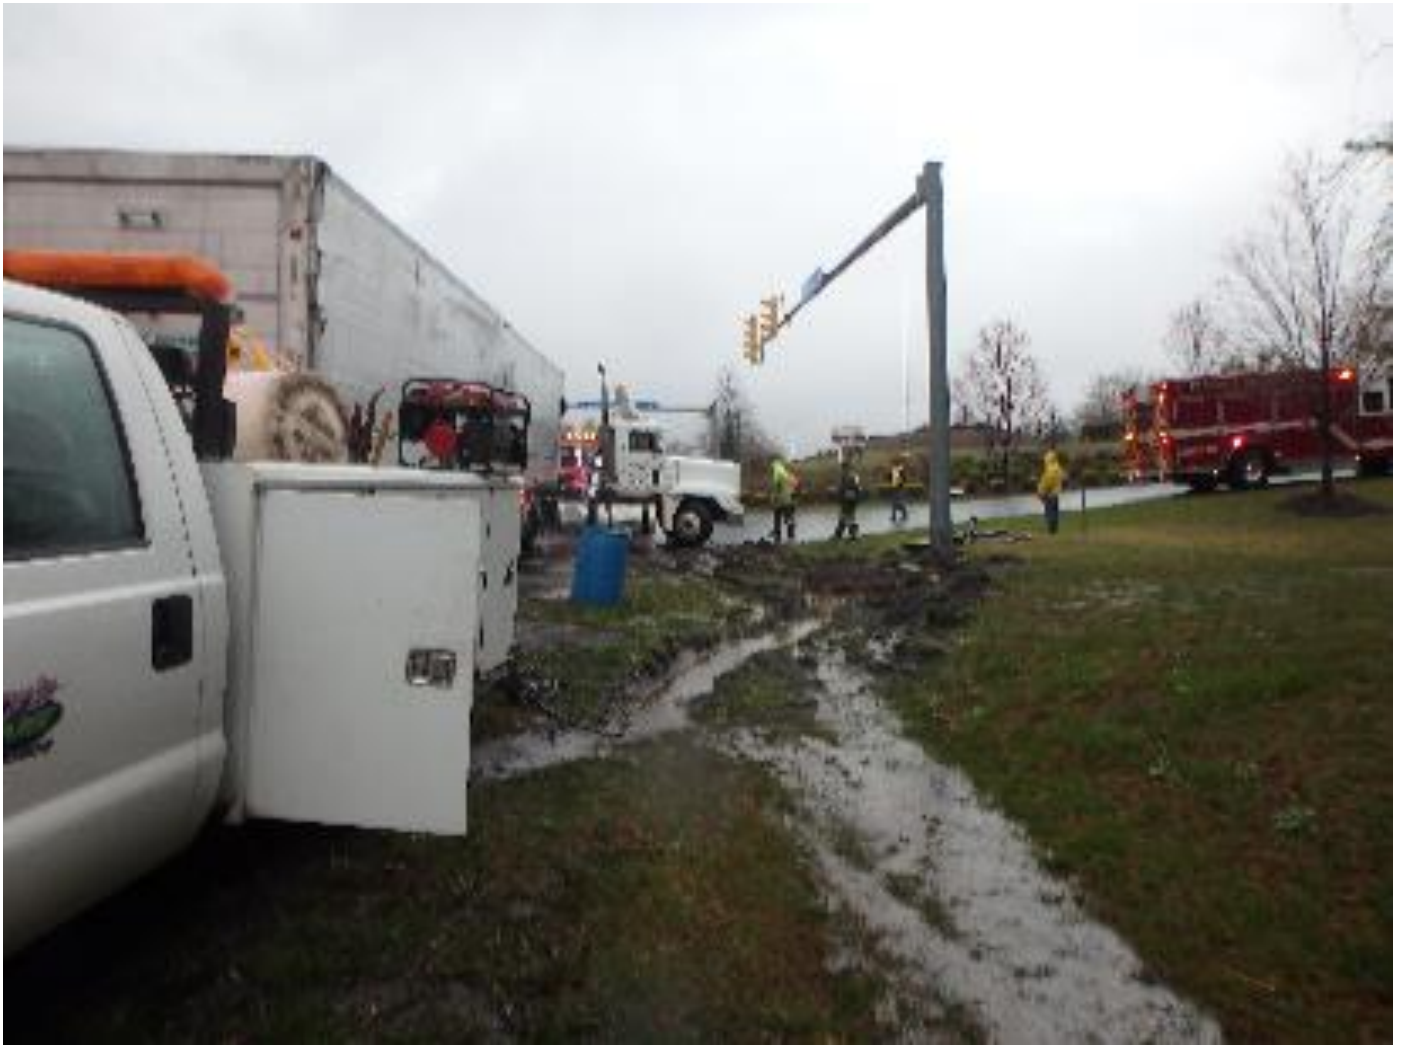
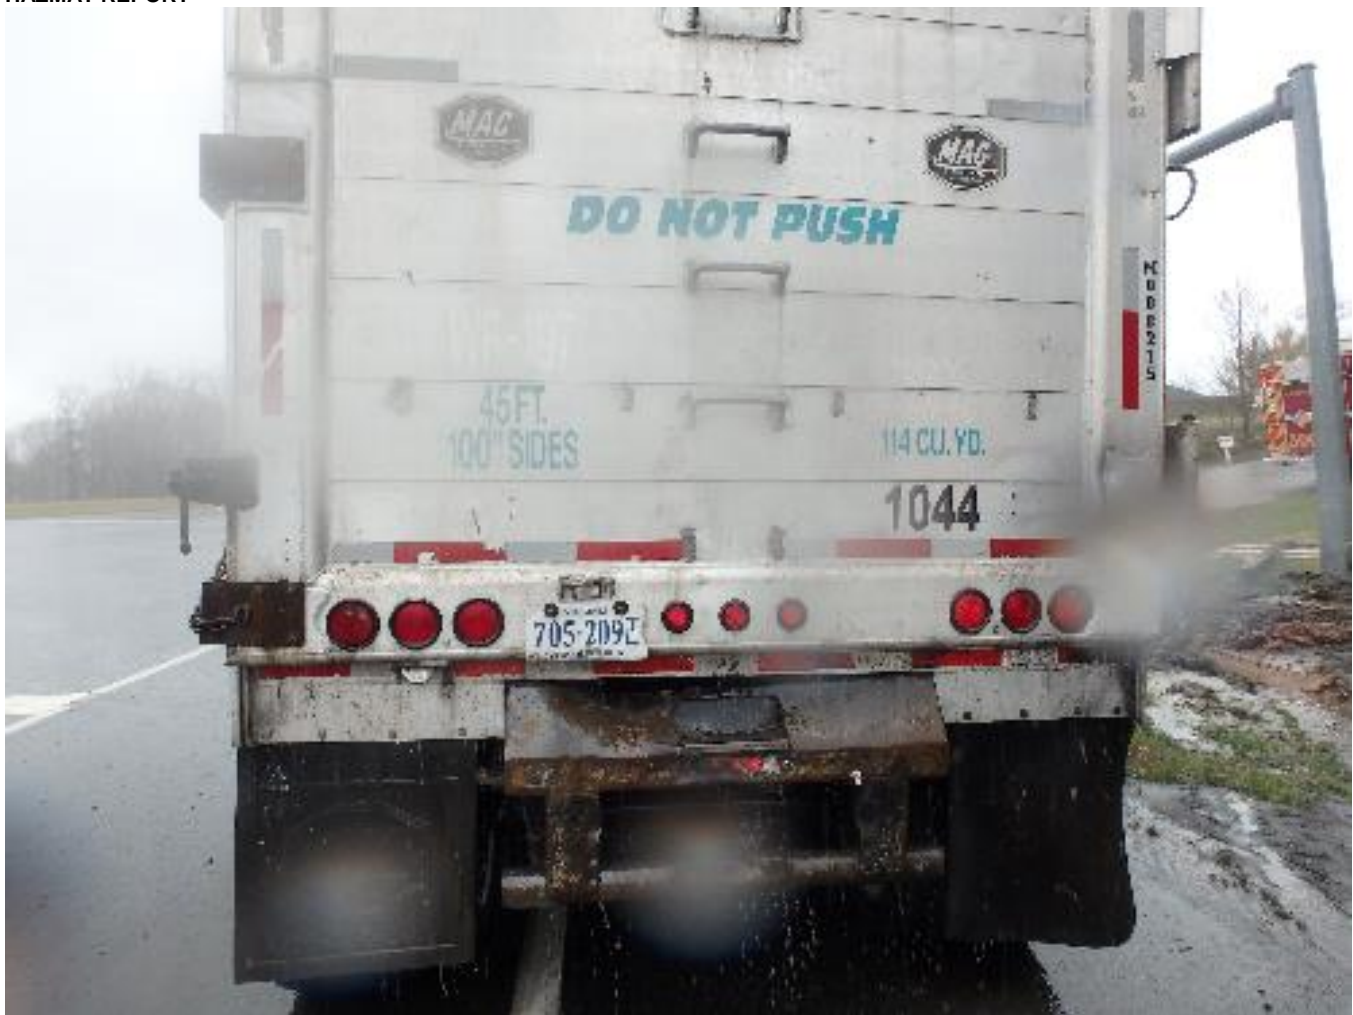
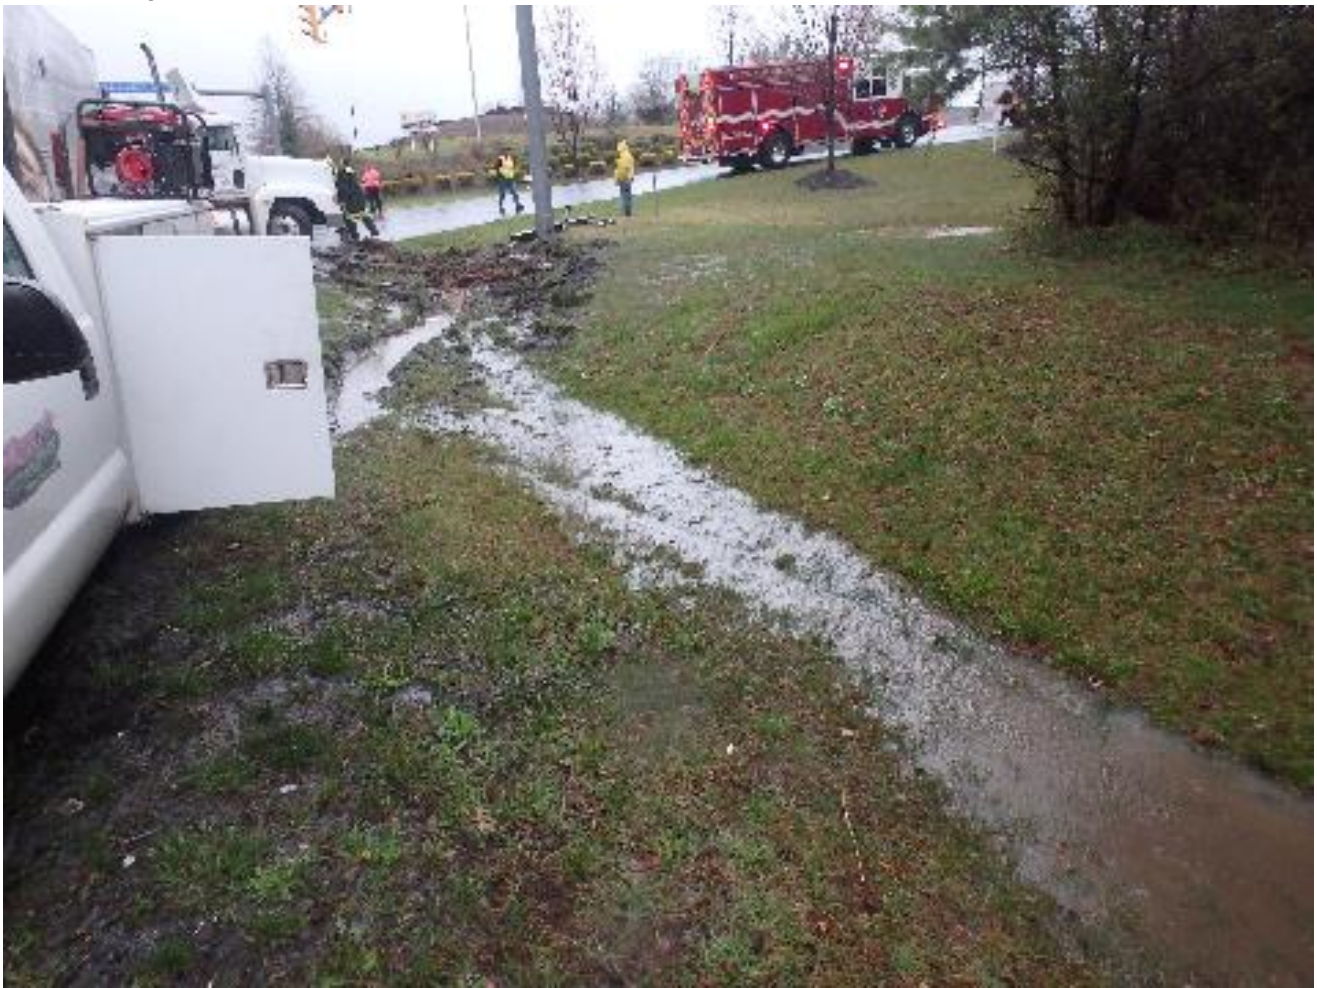
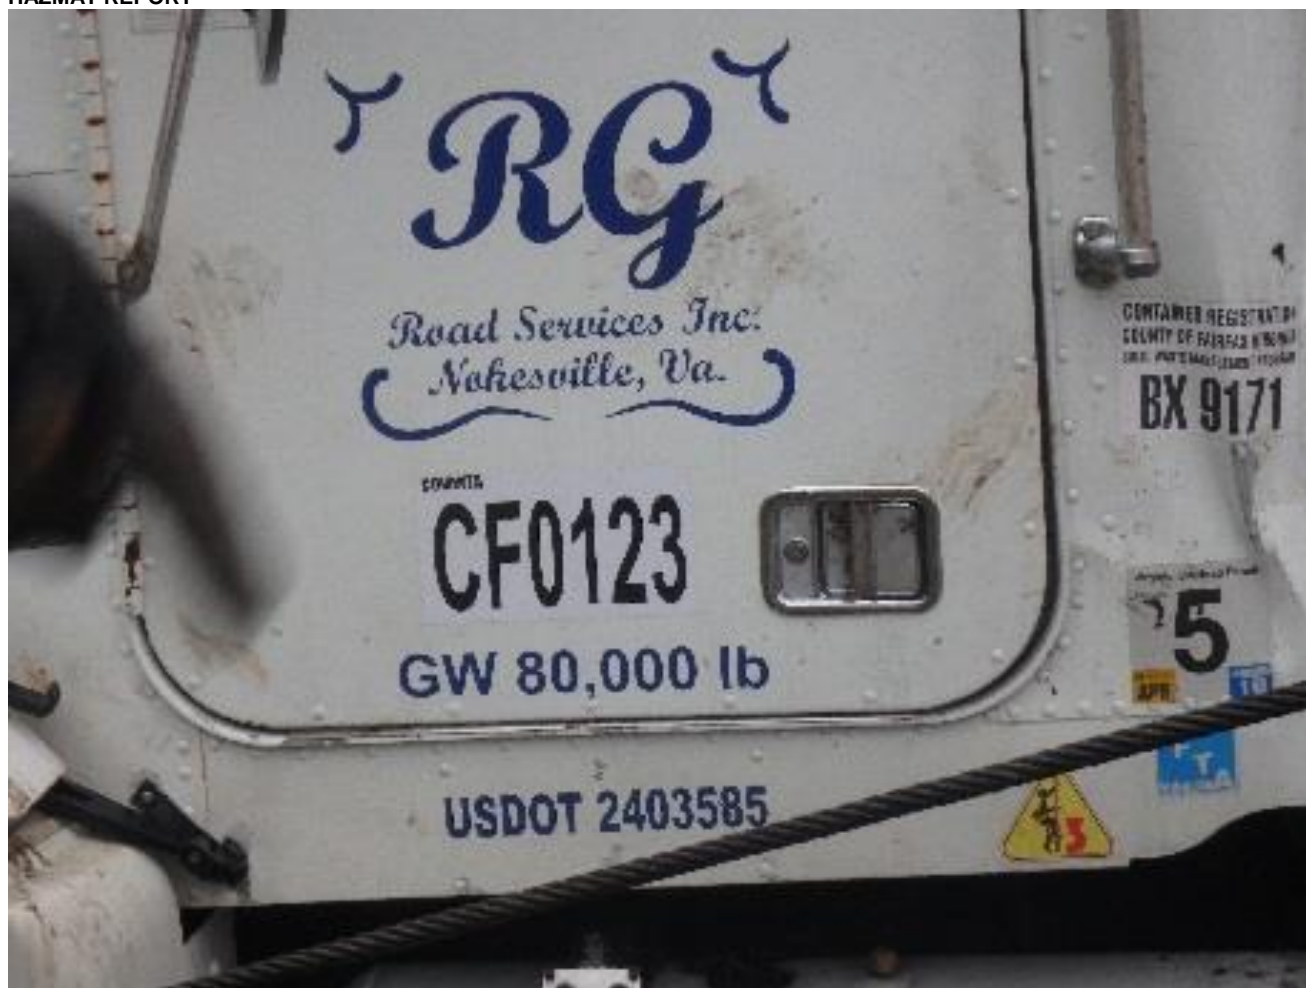
INCIDENT DESCRIPTION	
<p>Incident # 170010498. Dispatched for auto accident with a tractor trailer off the road northbound 234 at Independent Hill Dr. Arrived on scene to find 1 tractor trailer off the road, jack-knifed at the dispatched location. Truck ran over street information sign and came to a stop just short of the stop light pole. Truck driver was not injured and was able to get out of the truck through the window. The passenger side saddle tank was ruptured with fuel pouring out consistently at a decent flow. The fuel was pouring into a ditch along side of 234 and running into a storm drain just south of the intersection. E506 Bucket FF was directed to immediately start construction of dam to retain as much of the fuel as possible. Fuel was already flowing constantly into the storm drain upon our arrival. While bucket FF began defense operations, E506 officer questioned driver about amount of fuel in tank. Driver stated the tanks were only half full. E506 requested the HAZMAT unit for equipment. E506 kept A506 on scene for personnel to help with defense ops. With the heavy rain at the time, the fuel with the water was flowing fast towards the drain. E506 officer requested E516 and HS516 for equipment and personnel. Just after requesting 16 units, the flow from the saddle tank stopped due to the tank being emptied to below the hole in the side of the tank. Placed station 16 units in service. E506 crew with A506 crew worked on the dam and were able to place tarps/plastic over the storm drain and cover outside with dirt from the ground near the incident. BC502 arrived on scene to take over command. Lighting strikes near incident forced crews to return to apparatus until lightening passed per BC502. After returning to work, the tow company had already begun to move the truck. We were able to follow the flow of water pass the storm drain led us to another storm drain farther south down 234 and appeared to flow into a retention pond approx 300' south of the intersection where the accident occurred. Informed VA EOC, VDEM, VDOT and DEQ of situation as well as approx 40 gallons of diesel fuel made it into the retention pond. A manger for the trucking company arrived on scene and stated he would call one of the clean up companies listed on the LEPC form. Manager contacted Atlas Environmental. Slight language barrier when speaking with driver and manager (spanish first language for both). Manager handed E506 officer his phone to speak with Atlas. Unable to hear rep from Atlas using his phone - no volume. E506 officer called Atlas using the HazMat phone to speak with Paul Stoecklin. While on the phone with Atlas, the truck was towed away and the driver of the truck and the manager of the trucking company left the scene without giving us any more information. VDOT stated they would work with PD to get any additional information needed. E506 and HS506 remained on scene until Brad Miller at VDOT took control of scene nad released us. Heard back from Atlas around 1500 hours. Paul from Atlas stated he was not able to get in contact with the trucking company. He also stated that the address given by manager and the website information he found show this to be a residential office. Paul said he would not do any clean up until they hear from the insurance company of the trucking company. Currently, there is not a set clean up company for the spill. I called Brad Miller at VDOT to update him on this information.</p>

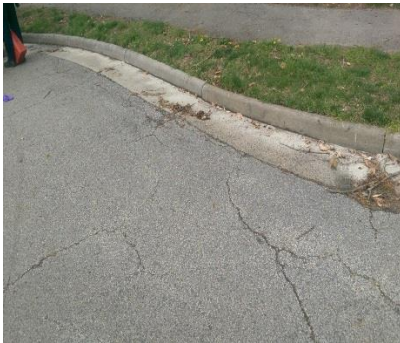
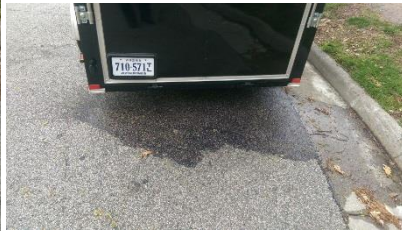
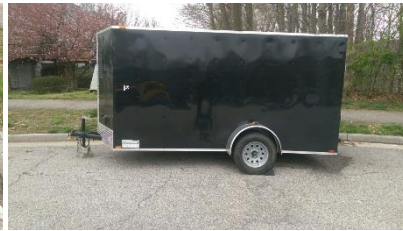
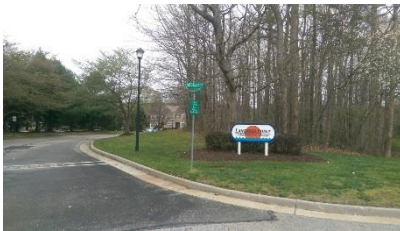
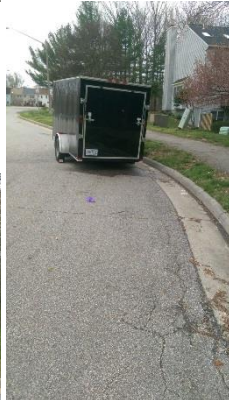
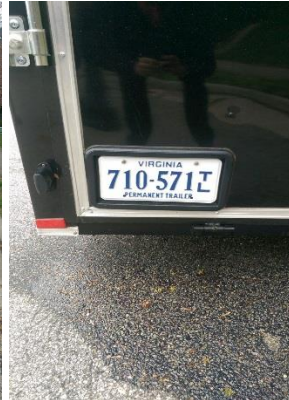
INCIDENT DESCRIPTION	
<p>E514 was dispatched for a hazard at Hedges Run Drive and Aegean Terrace. Once on scene they requested a phone consult with the on duty hazmat tech. The on duty tech called E514 officers. E514 officer stated they had a 7-foot black trailer with no markings leaking an unknown fluid from the rear. It was parked along a curb in a cul de sac, not attached to a vehicle. Approximately 1 gallon of product leaked out on to the pavement. E514 officer stated the product traveled approximately 25 feet along the curb where they used absorbent to build a dam to contain the product. No product made it to any waterway. E514 crew discovered the door to the trailer was not locked and was able to gain access to the inside. Once inside they determined the leak was from a can of bar oil that was laying on its side. Container was found completely empty and was 1 gallon was in size. No other product was found to be leaking. E514 turned the scene over to county PD to run the plate found on the trailer to find the responsible party for cleanup. VA EOC was notified, no other notifications needed.</p>
