# Annual Stormwater Management Report

## VSMP Permit No. 0088595 – FY 2017

Submitted by:  
Prince William County  
Department of Public Works

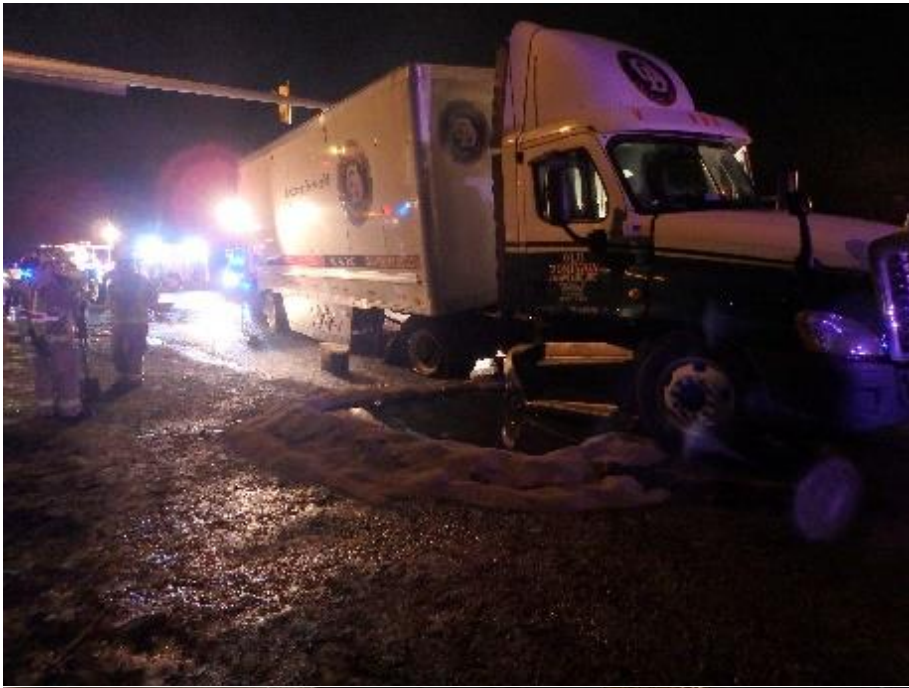
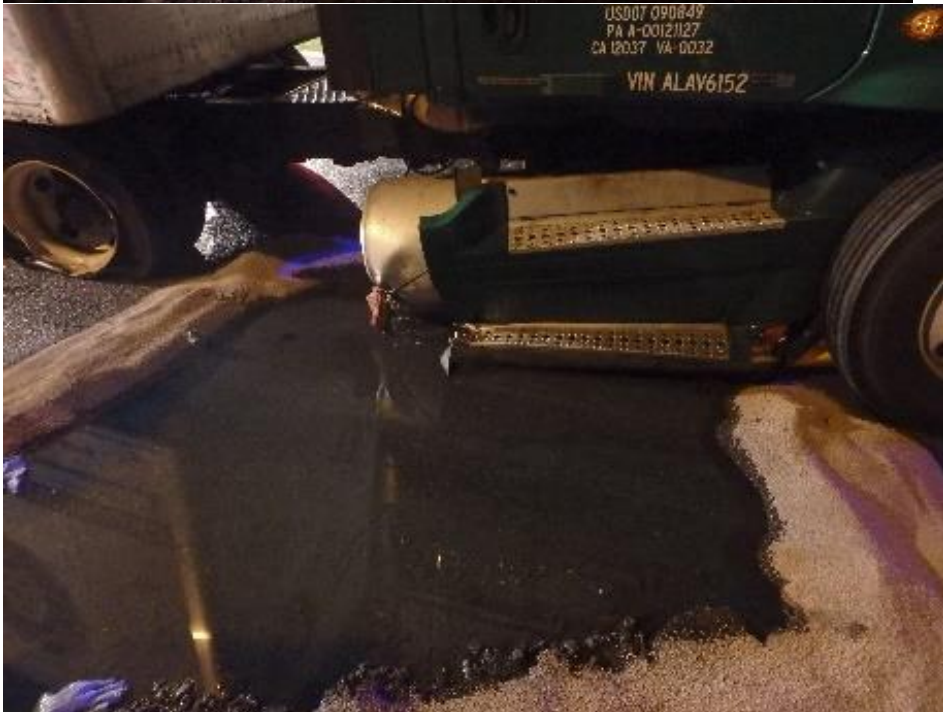
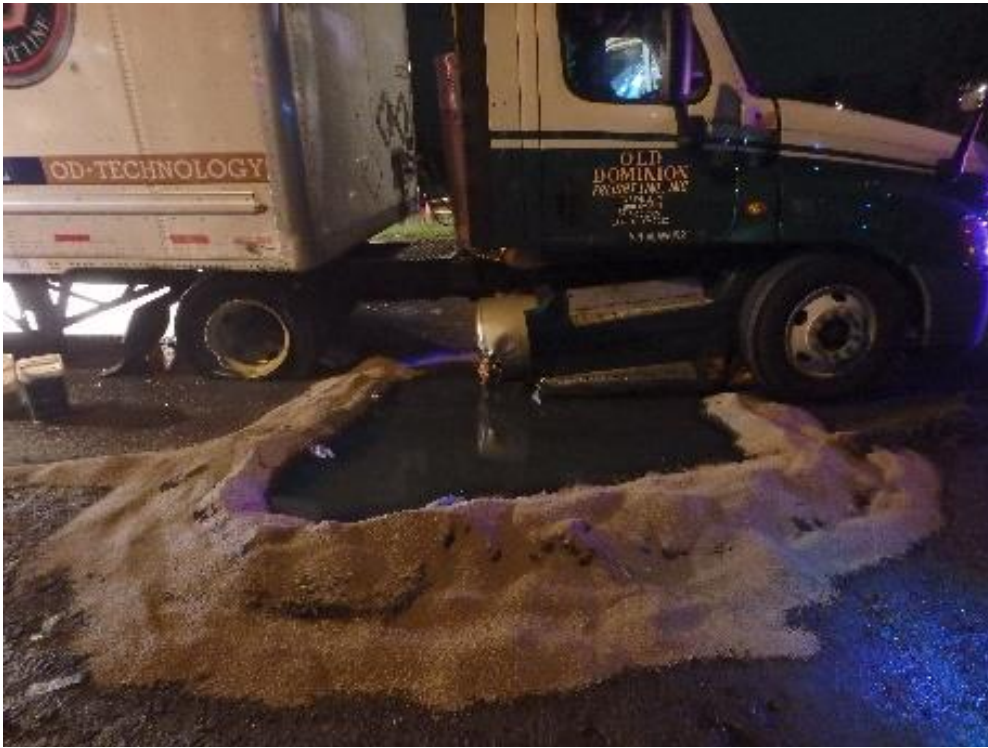
INCIDENT DESCRIPTION
<p>BC591 requested HM506 for a fuel spill due to an accident with fatality. A sedan t-boned a tractor trailer on the passenger side at the saddle tank and tire area. HM506 responded. While in route, requested update from BC591 who stated approx 80 gallon diesel saddle tank was leaking due to accident. Fuel in the road and on side of the road with no impact on the waterway or drains. Storm drains in the area were already blocked off with booms and sand due to construction in the area.</p> <p>Arrived on scene to find R504 and E525 crews had built up a dam (about 3/4 of a circle) on the side of the road where the saddle tank was leaking. The dam was doing a good job of retaining the majority of the product being released. Still product seeping underneath the dam as well as a large amount of fuel already on the roadway. Fuel ran down Balls Ford Rd going East on the west bound lanes. There was one stream of fuel going along the median in the middle of the road and one stream going along the dirt side of the road. The one going down the median was blocked by a dam (built by R504 and E525 crews) at the end of the already blocked storm drain and was pooling up. Some product still going around dam and seeping through dam that was running across the lanes at the intersection for the 7-11 and going across the east bound lanes. The stream going down the other side of the west bound lanes stayed along the dirt for about 100 feet and then began to run into the road until the intersection at the 7-11 where it also started to go across the east bound lanes. Had crews built up the dam by the storm drain for these and another dam in front of the storm drain.</p> <p>Back at the tractor trailer, HM506 used a collection pool off of the hazmat unit. Placed pool under the ruptured tank. Due to the passenger side of the truck being off the road way and the axle of the truck being bent, the saddle tank was low to the ground. Unable to get the pool to hold full capacity with height constraints. Unable to collect all of the leaking fuel with pool, but majority of the leak was flowing into the pool. Had E525 and R504's crews use absorbent off of HM506 to build up dam around the saddle tank. Also, had the crews with HM506 crew build a trench in the ground a few feet away to collect and product that seeped through the dam or was already on the ground pass the dam prior to arrival of fire dept. HM506 ran out of absorbent, but the dam appeared to be more than sufficient to retain what was left to leak out of the saddle tank and pool.</p> <p>Spoke with truck driver to find out that they were using Atlas Environmental as the clean up company. HM506 officer spoke with Matt from Atlas to give details on what was happening and how much product was on the ground. Full saddle tank - truck driver had just fueled up. Approx 70-80 gallons on the ground with about 20 gallons being collected in the pool. The right side of PW Pkwy north bound just north of Balls Ford rd to Balls Ford rd had some fuel in the dirt and ground there with the majority of the product flowing down the Pkwy and Balls Ford Rd. It looked like the booms around the storm drains were keeping the product out of the drains. It did not appear to have any fuel in the waterway or drain system. Atlas Environmental in route to begin clean up. PD on scene for investigation. HM506 cleared the scene with E525 and PD remaining on scene.</p>

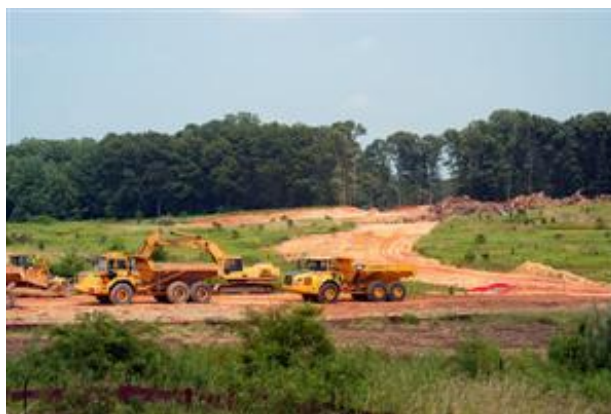
Figure 7 New Urban Development

Amec Foster Wheeler received stormwater infrastructure data from the County in October of 2015. Existing stormsewer data from this time served as the basis for the creation of the Amec Single Network<sup>4</sup>. Since the County's existing stormsewer system lacked hydrologic connections to the stream network, Amec Foster Wheeler edited the stormsewer system to create hydrologic connections between the stream network and stormwater infrastructure.

Additional data editing - such as eliminating hydrologic loops, clarifying flowpaths, etc. - further modified the County's existing stormsewer network. The result of these efforts was the creation of the Amec Single Network, which represents a contiguous, hydrologically connected stormsewer system.

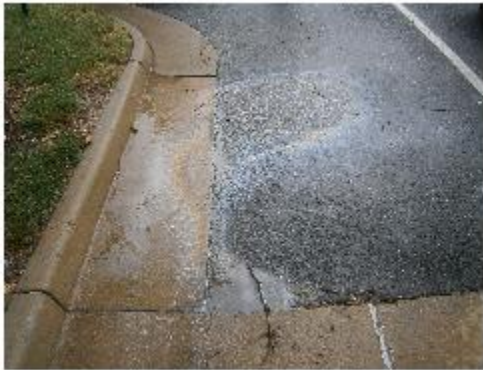
## Oil and/or Fuels

- Color: Rainbow sheen floating on top of water surface
- When disturbed, sheen will swirl together
- Odor: May have strong petroleum or gasoline smell
- Turbidity and Floatables: Oil sheen, red, brown, black streaks

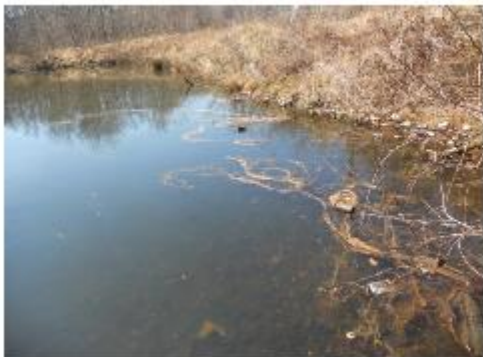
## Grease

- **Color: Yellow, Golden, Brown**
- **Odor: Stale greasy smell, petroleum, cooking grease**
- **Turbidity and Floatables: Material typically clumps/strings together, will most likely have other material floating within**

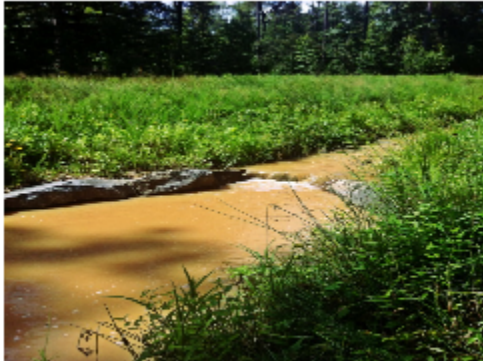
## Sediment

- **Color:** Orange, Yellow, Red, chocolate milk
- **Odor:** None
- **Turbidity and Floatables:** Typically find deposits settled to bottom, water can be very turbid, may not be able to see bottom of stream

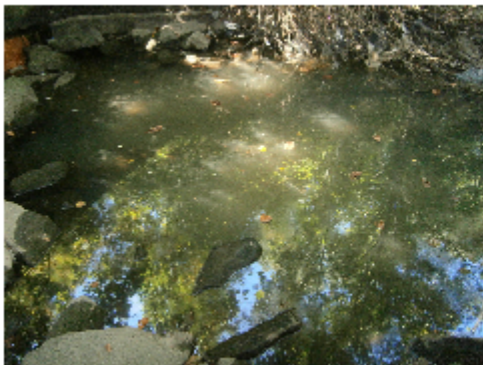
## Sewage

- **Color:** Grey
- **Odor:** Strong sewage smell, Sulfur, Fecal matter
- **Turbidity and Floatables:** Foam, Bubbles, fecal solids, food wastes, toilet paper, etc.

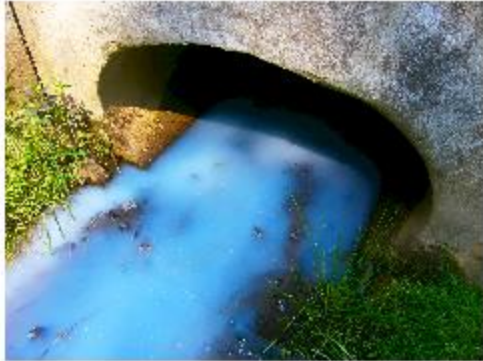
## Soaps and Detergents

- **Color:** Milky White, Grey, Cloudy
- **Odor:** Fragrance like laundry detergent/soaps, or none at all
- **Turbidity and Floatables:** Bubbles, foam, highly turbid

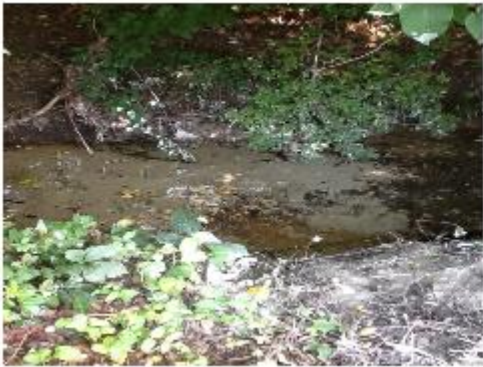
## Cement, Construction runoff

- **Color:** Grey, cloudy, milky, muddy
- **Odor:** None
- **Turbidity and Floatables:** Unlike soaps and detergents, runoff from these activities should be void of floatables such as bubbles and foam, high turbidity and sediment should be present.

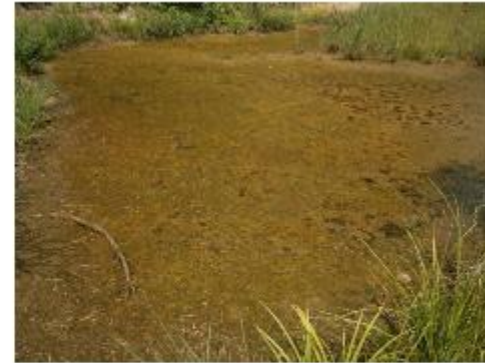
## Bacteria

- Color: Red, Rust color
- Texture: Clumpy, thick layer on surface of water
- Odor: None
- Turbidity and Floatables: Rainbow Sheen, clumpy red deposits, when disturbed rainbow sheen "shatters" instead of swirling like oil deposits
- Typical Timeframe of Occurrence: Early summer through early fall

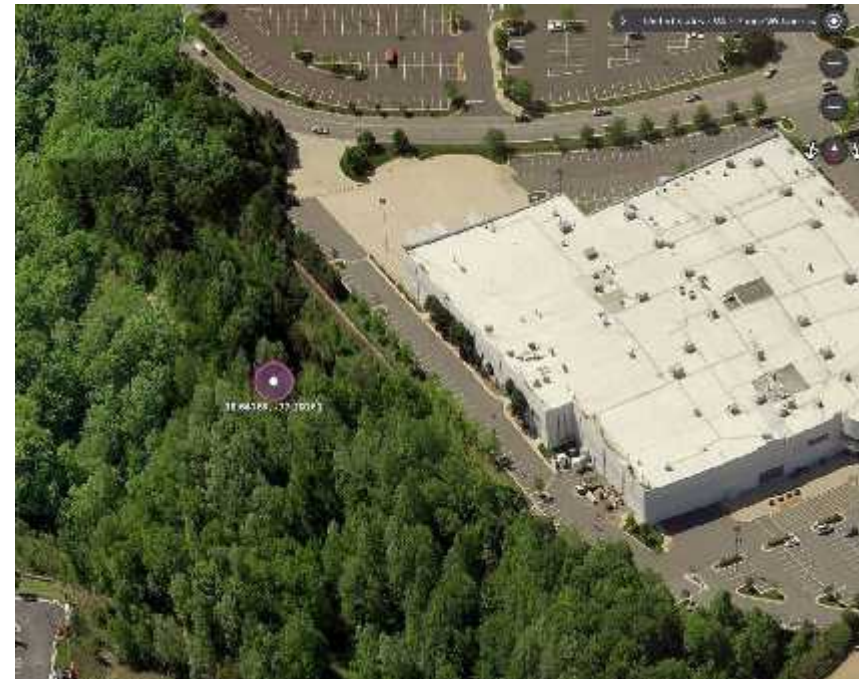
# #3471: Woodbridge, Potomac Mills

- 84" concrete pipe
- < 1/4" flow
- Signs of human presence, uncertain frequency

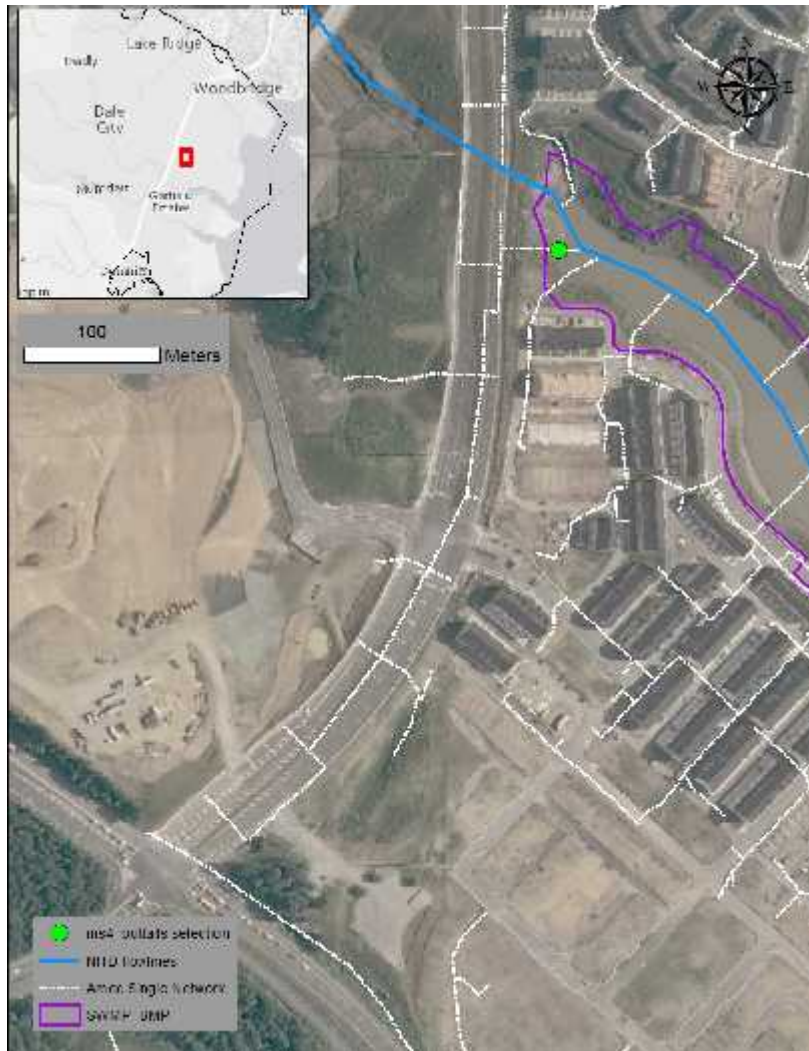
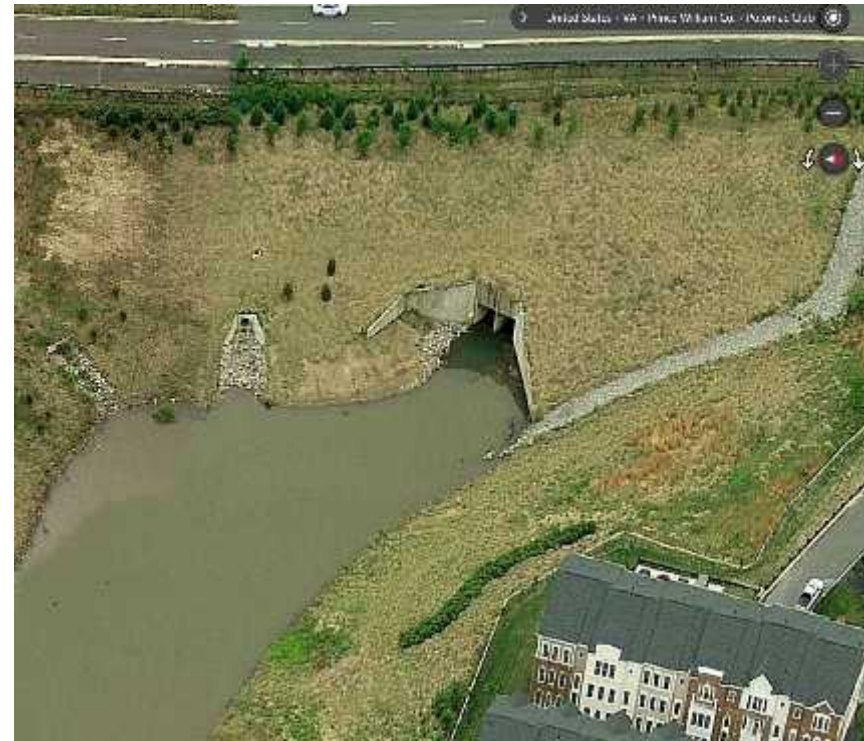
# #4684: Dale City

- **54" concrete pipe**
- **Low flow draining to scour pool**
- **Steep banks surrounding outfall**

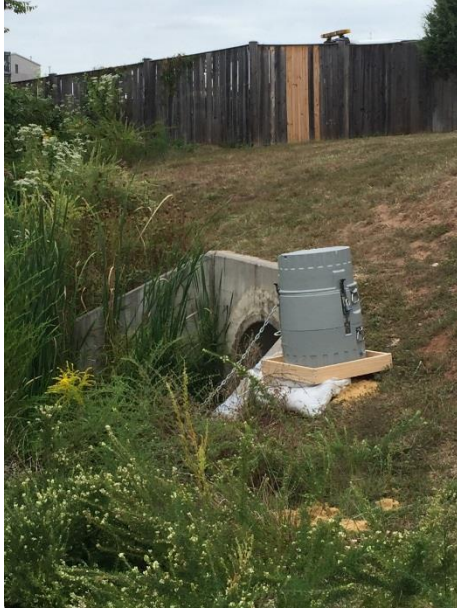
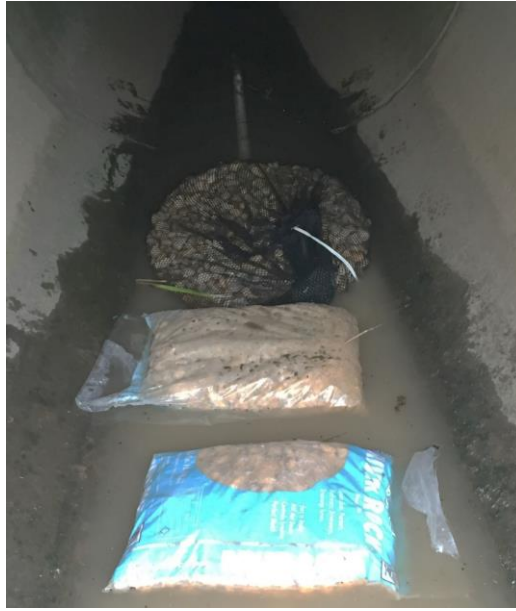
**Manassas (#941)**

Site #941 is located within the Bull Run watershed. The outfall exhibited signs of recent repair, although there was some debris found in the pipe. There was less than 0.5 inch of water in the pipe when the ISCO sampler was deployed, but sampling was not initiated until the water exceeded 0.25 feet.

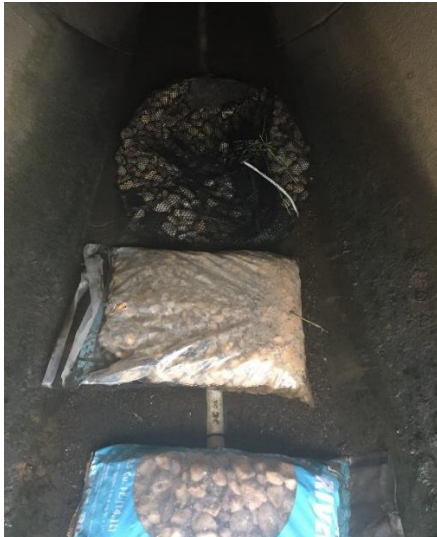
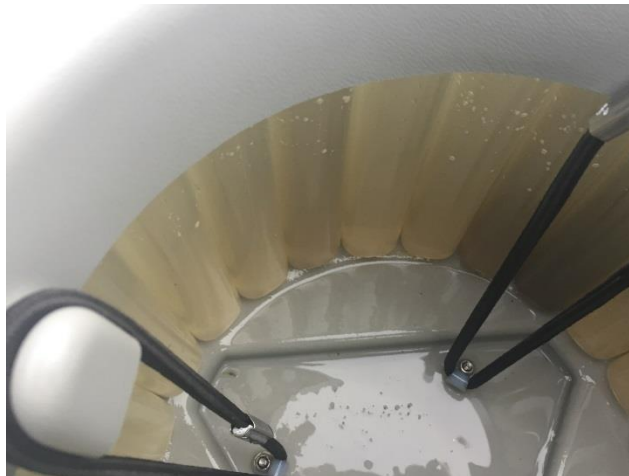
Following the storm event, the sampler was firmly in place with little disturbance to the rocks weighing down the sampling hose.

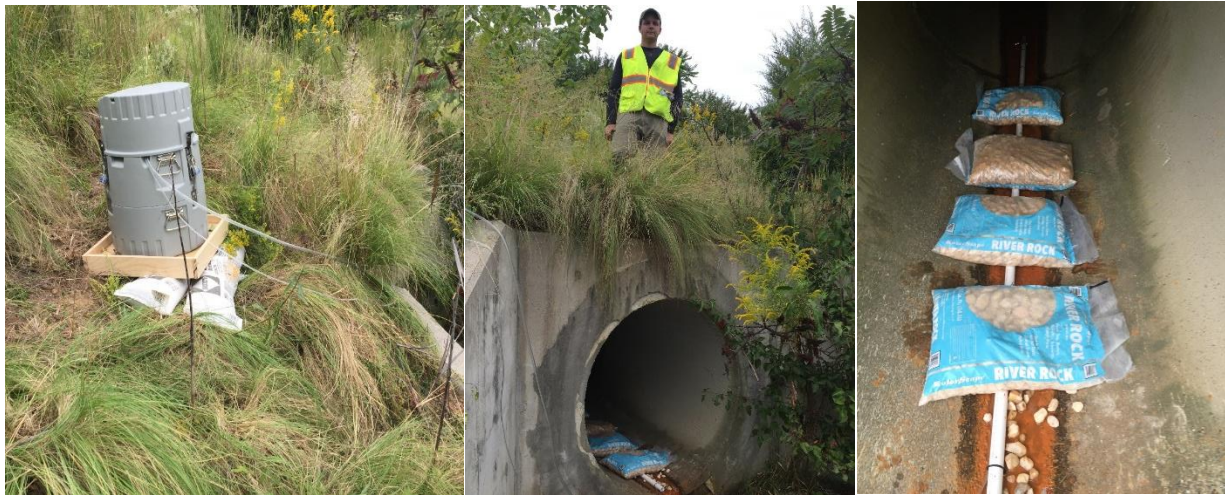
**Dale City (#4684)**

Site #4684 receives flow from Neabsco Mills Road and the Stonebridge at Potomac Town Center development. It is a 54" concrete pipe that drains to a deep scour pool before draining to a large BMP that collects drainage for the Potomac Club development.

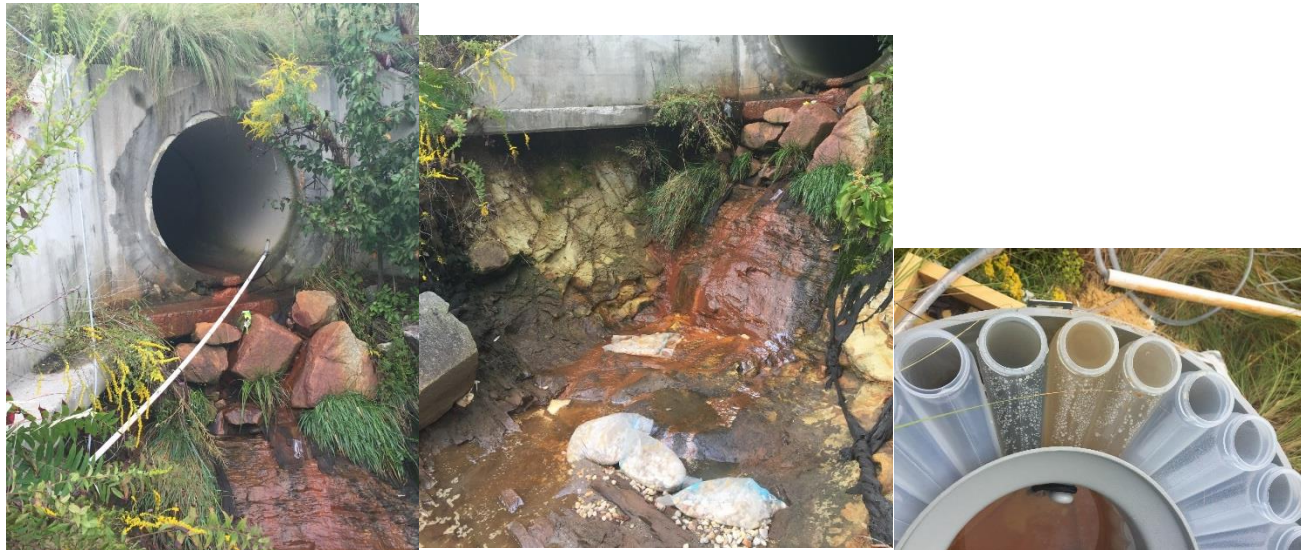
Storm flow through the pipe dislodged the gravel bags holding the sample collection equipment in place. Future applications will rely on a mesh gravel bag to secure the equipment in place, as was used at Site #941. The first three samples were successfully collected by the ISCO sampler, spanning the first 1.5 hours of the storm event.

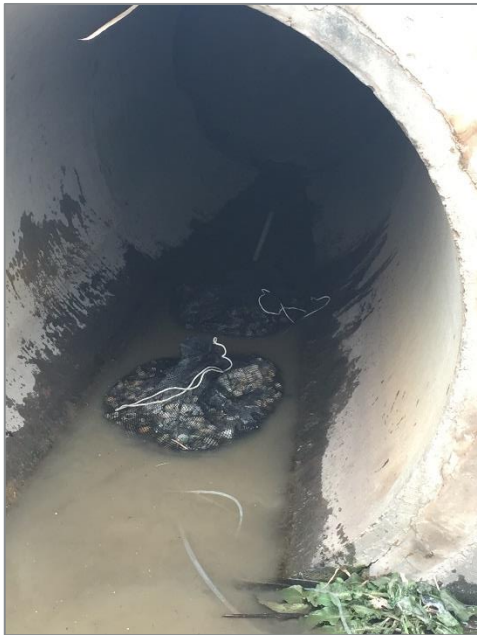
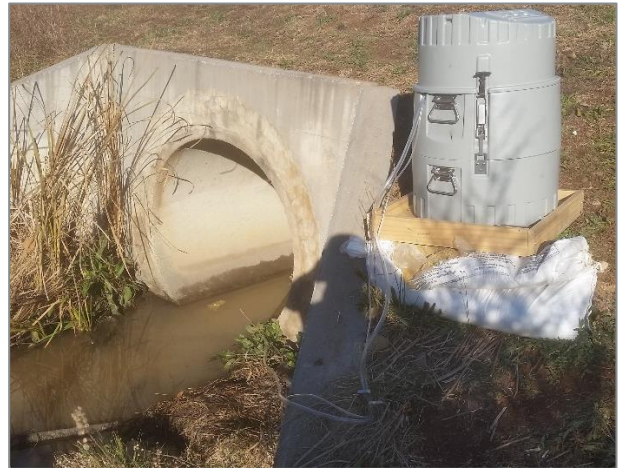
**Manassas (#941)**

Site #941 is located within the Bull Run watershed. The outfall exhibited signs of recent repair, although there was some debris found in the pipe. There was less than 0.5 inch of water in the pipe when the ISCO sampler was deployed, but sampling was not initiated until the water exceeded two inches.

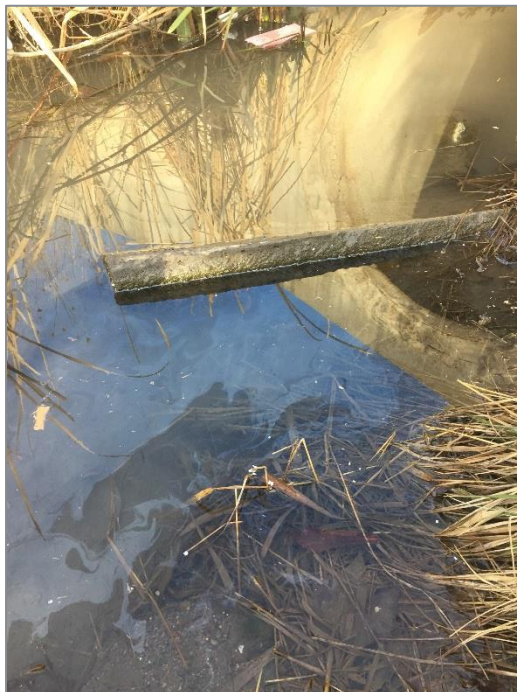
Following the storm event, the sampler was firmly in place with little disturbance to the rocks weighing down the sampling hose.

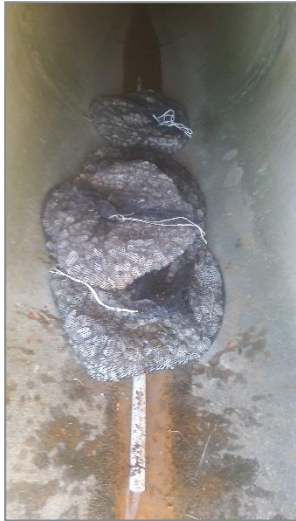
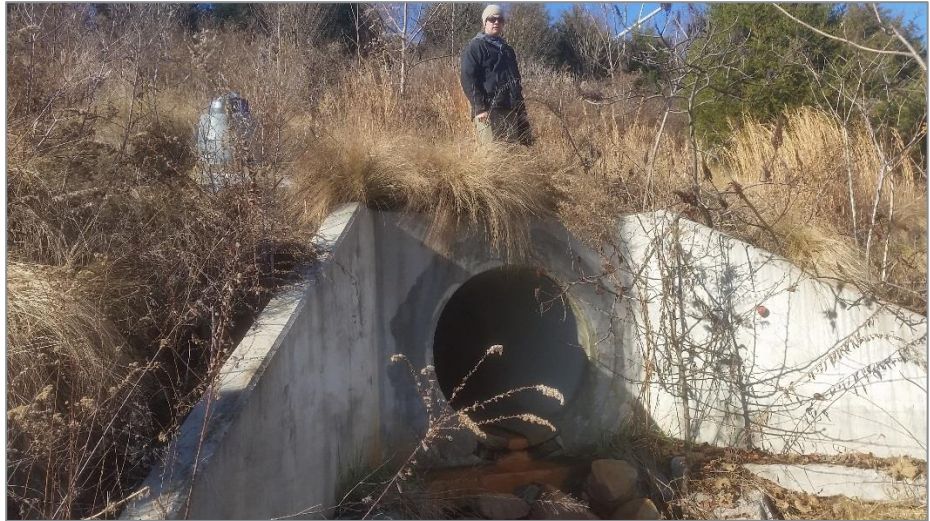
### Dale City (#4684)

Site #4684 receives flow from Neabsco Mills Road and the Stonebridge at Potomac Town Center development. It is a 54" concrete pipe that drains to a deep scour pool before draining to a large BMP that collects drainage for the Potomac Club development. Amec Foster Wheeler staff noted that some areas surrounding the headwall/curtain were eroding away, likely requiring future maintenance.

Adjustments were made in the amount of weight used on the sampling installation. The sampling probe remained in place throughout the event. Storm flow through the pipe dislodged the gravel bags holding the sample collection equipment in place. Future applications will rely on a mesh gravel bag to secure the equipment in place, as was used at Site #941. The first three samples were successfully collected by the ISCO sampler, spanning the first 1.5 hours of the storm event.

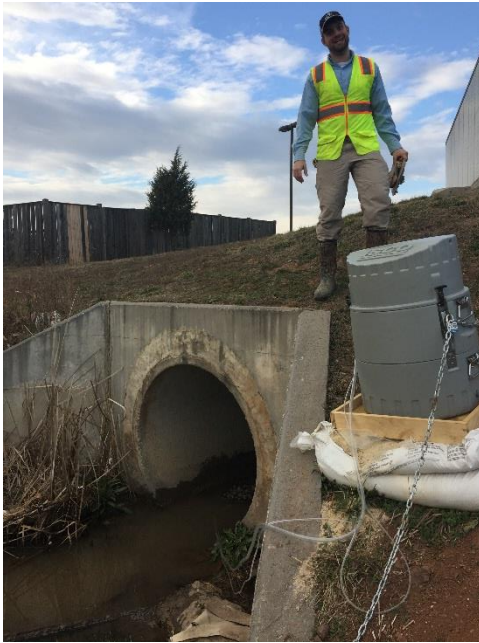
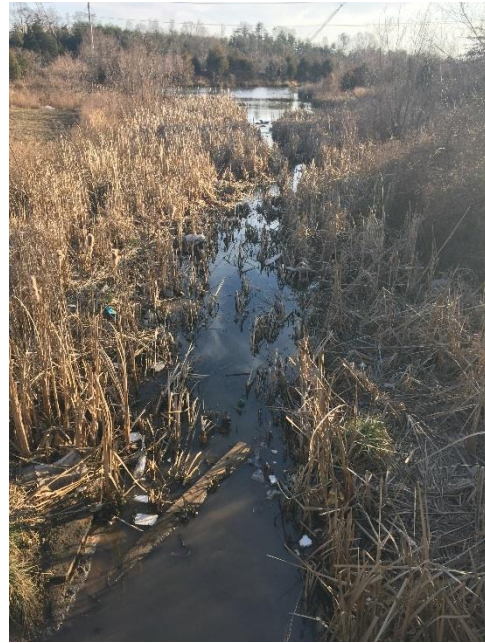
### Manassas (#941)

Site #941 is located within the Bull Run watershed. It receives drainage from an industrial use area and parking lots with frequent truck traffic. The outfall exhibited signs of recent repair, but some cracks are evident. There was less than 0.5 inch of water in the pipe when the ISCO sampler was deployed, but sampling was not initiated until the water exceeded two inches. Sediment is accumulating within the channel leading from the outfall at an increasing rate, although it is uncertain how this may change in the warmer season.

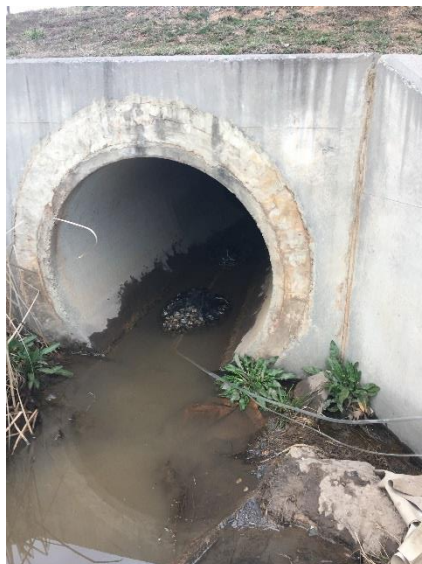
Following the storm event, the sampler was firmly in place with little disturbance to the rocks weighing down the sampling hose.

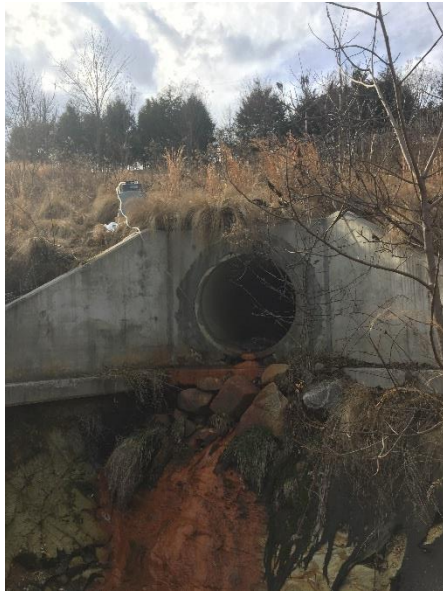
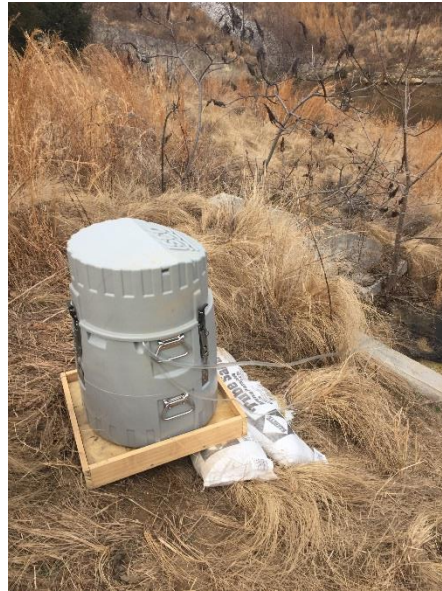
**Dale City (#4684)**

Site #4684 receives flow from Neabsco Mills Road and the Stonebridge at Potomac Town Center development. It is a 54" concrete pipe that drains to a deep scour pool before draining to a large BMP that collects drainage for the Potomac Club development. Erosion around the outfall apron is continuing, and will likely require future maintenance. An oily sheen was noted in the scour pool prior to the storm event. There was no standing water noted in the pipe.

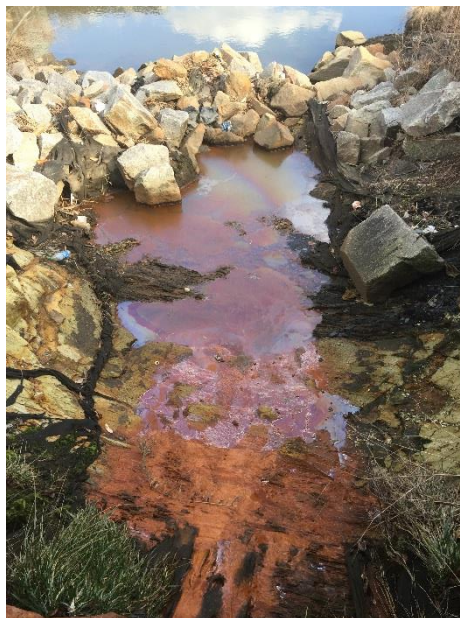
Following the storm event, the sampler was firmly in place with little disturbance to the rocks weighing down the sampling hose.

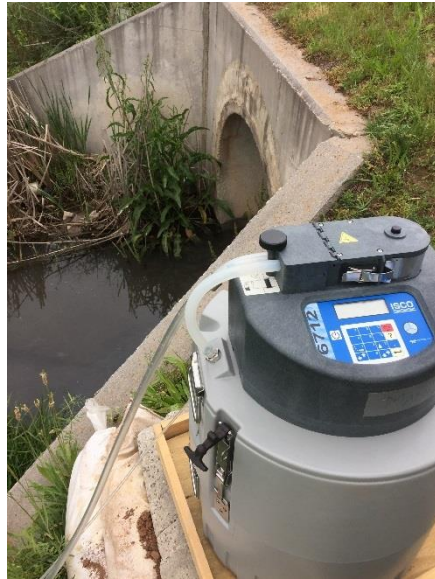
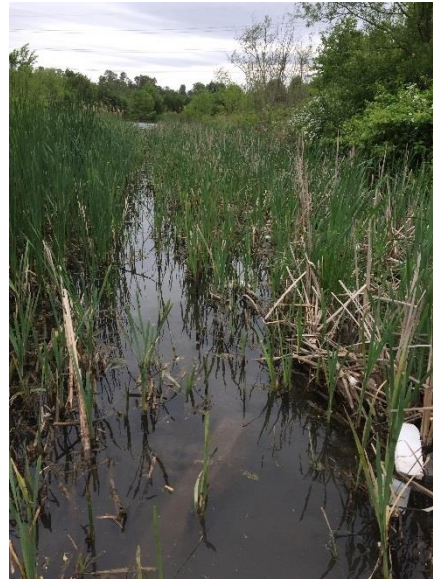
**Manassas (#941)**

Site #941 is located within the Bull Run watershed. It receives drainage from an industrial use area and parking lots with frequent truck traffic. The outfall exhibited signs of recent repair, but some cracks are evident. There were two inches of standing water in the pipe when the ISCO sampler was deployed, but sampling was not initiated until the water exceeded seven inches. Sediment continues to accumulate within the downstream channel, and the water level was higher than the previous quarter.

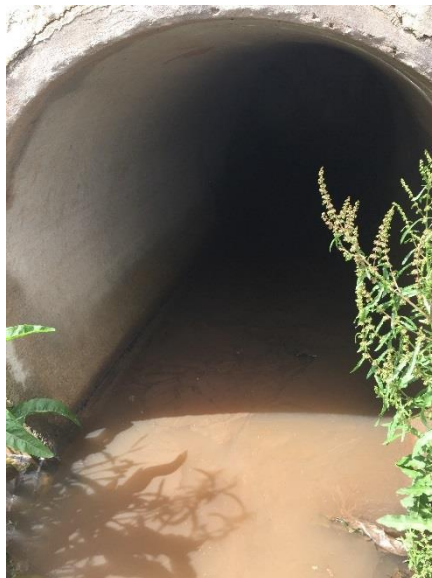
There was a slightly oily sheen apparent in the standing water within the outfall following the storm.

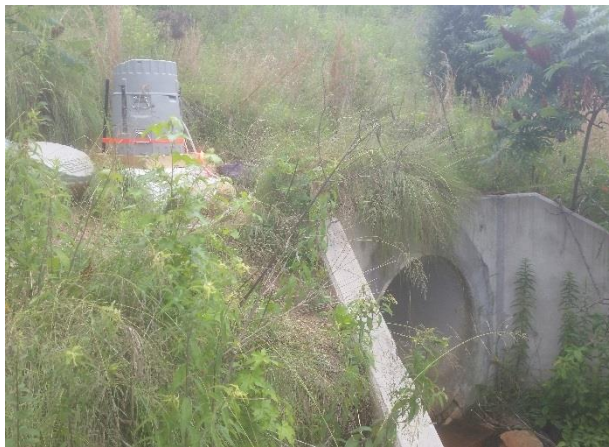
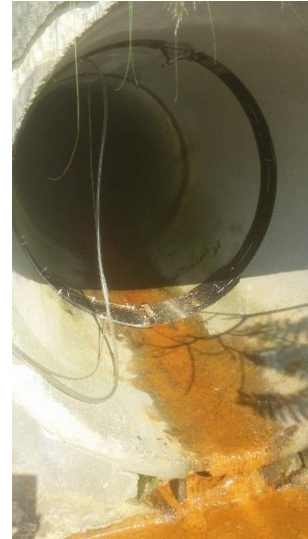
### Dale City (#4684)

Site #4684 receives flow from Neabsco Mills Road and the Stonebridge at Potomac Town Center development. It is a 54" concrete pipe that drains to a deep scour pool before draining to a large BMP that collects drainage for the Potomac Club development. Erosion around the outfall apron is continuing, and will likely require future maintenance. Following the initial failed sampling event, Amec Foster Wheeler successfully implemented the scissor ring installation for the contingency sample. There continues to be a noticeable amount of iron oxidizing bacteria resulting from nondetectable groundwater baseflow.

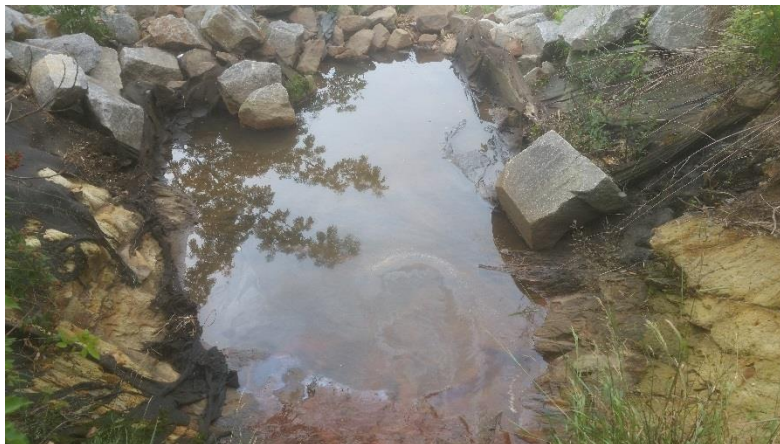
There was an oily sheen present in the scour pool following the storm. Each storm event produces a small amount of trash within the scour pool and downstream riprap.

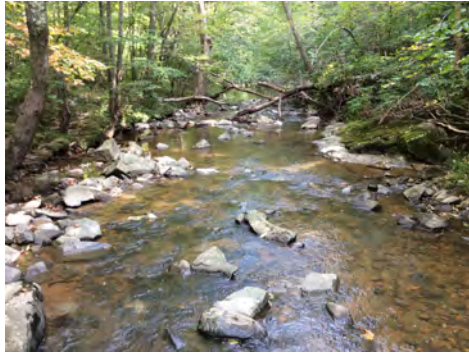
**Image 1**

Downstream of sample reach

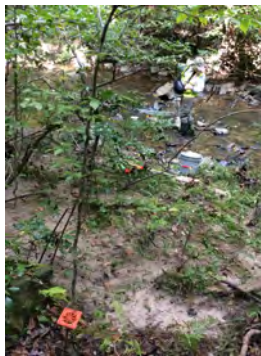
**Image 2**

Downstream marker

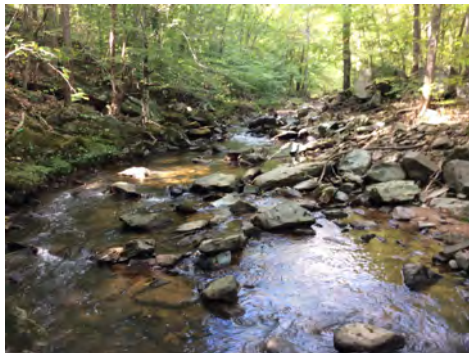
**Image 3**

Upstream extent, orange marker on left

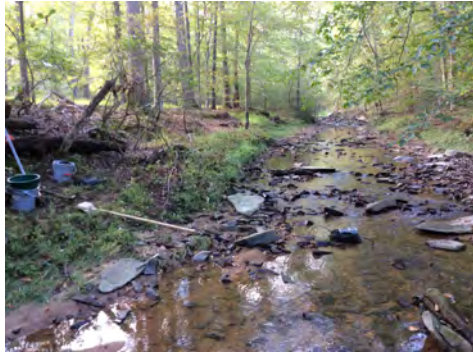
**Image 1**

Downstream, marker on left

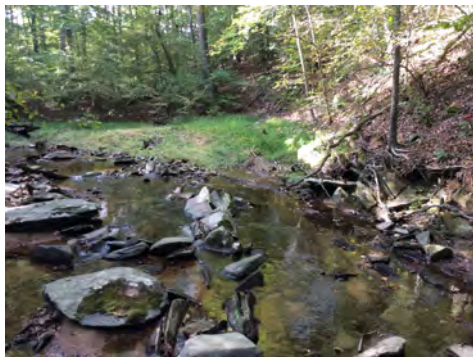
**Image 2**

Upstream extent, marker on right at bend

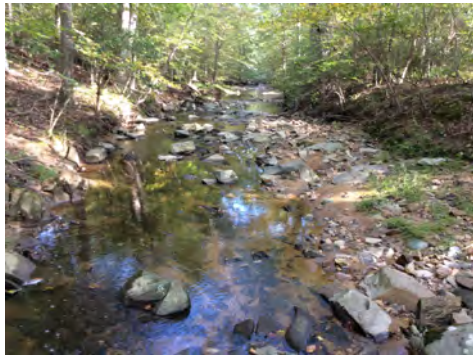
**Image 3**

Sampling reach

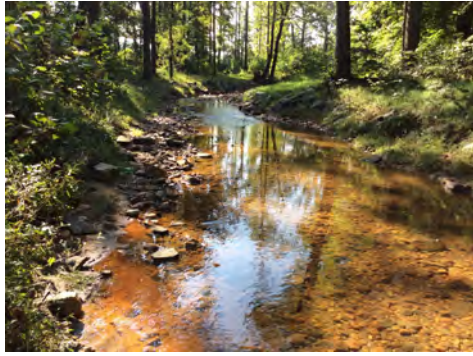
**Image 1**

Downstream

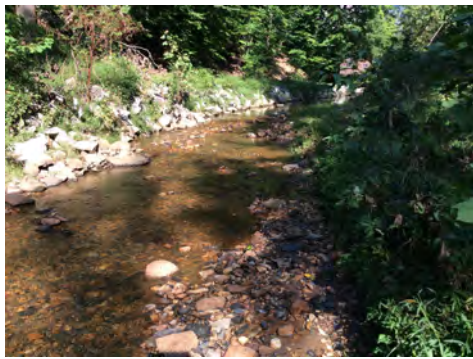
**Image 2**

Upstream

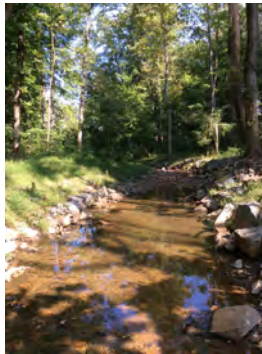
**Image 3**

U/S start of reach

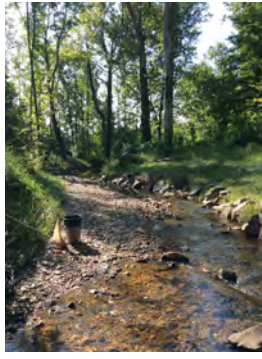
**Image 4**

D/S start of reach

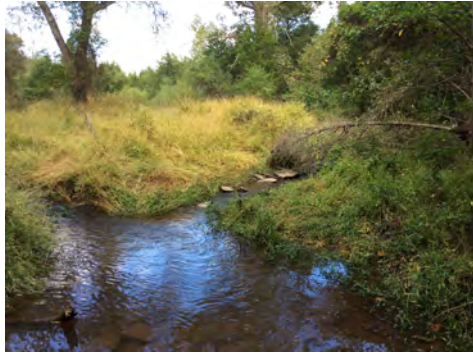
**Image 1**

Upstream at end of reach. Marker on right

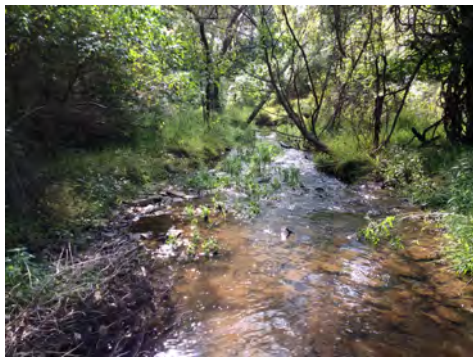
**Image 2**

Downstream at upper end of reach

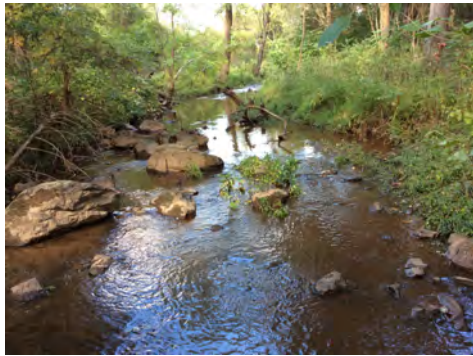
**Image 3**

Upstream from bottom of reach. Marker on right

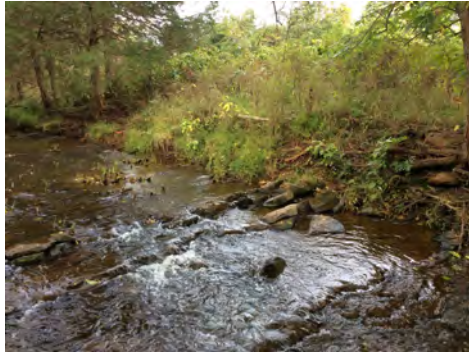
**Image 1**

Downstream extent, marker on right

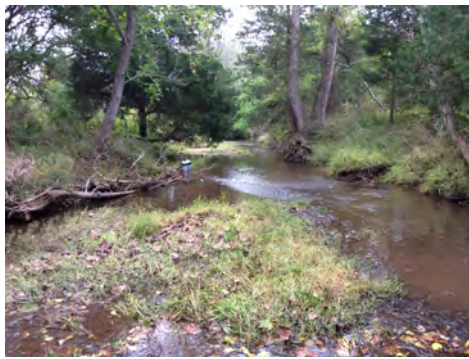
**Image 2**

D/s from top of reach

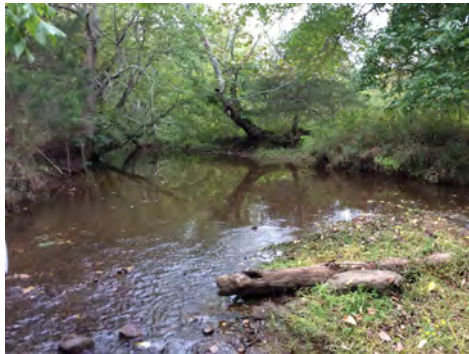
**Image 3**

U/s from top of reach

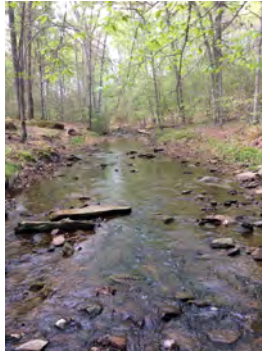
Image 1

Upstream from WQ point.

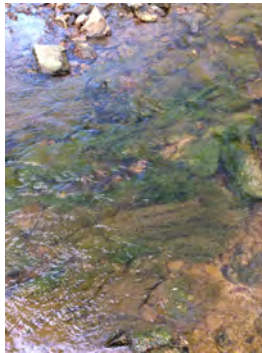
Image 3

More prevalent veg at sampling point.

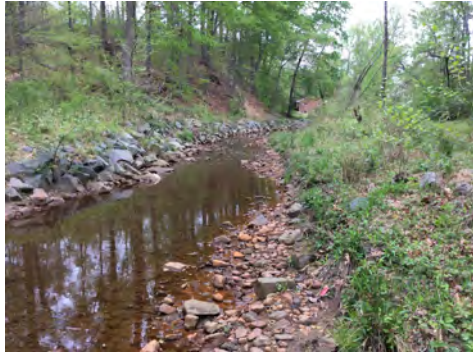
Image 1

Upstream

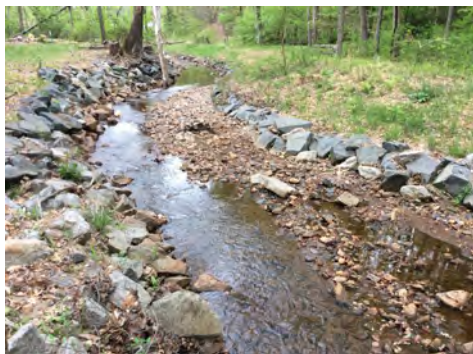
Image 3

Large bar

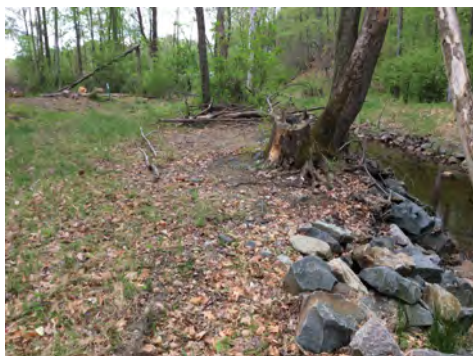
Image 4

Pipeline land disturbance left bank.

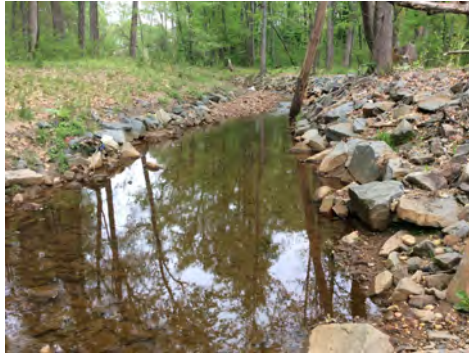
**Image 5**

Start of sampling reach

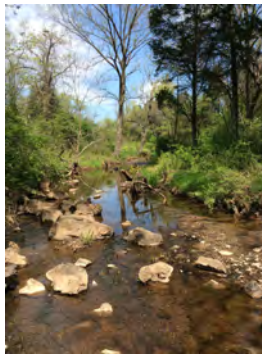
Image 2

Upstream from WQ point.

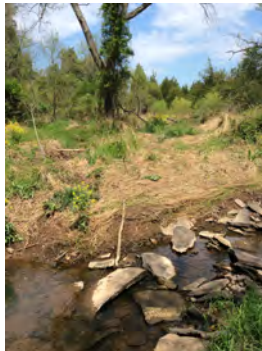
Image 3

Upstream from WQ point, beaver dam in background.

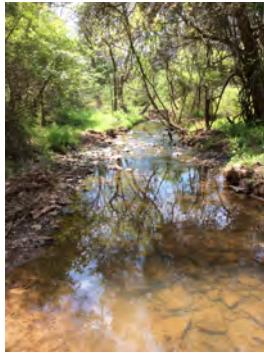
**Image 4**

Downstream from WQ point.

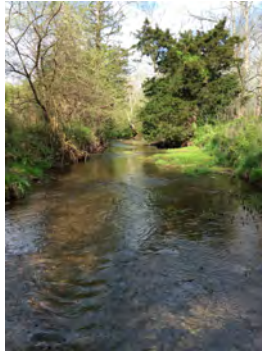
**Image 1**

Looking towards upstream extent

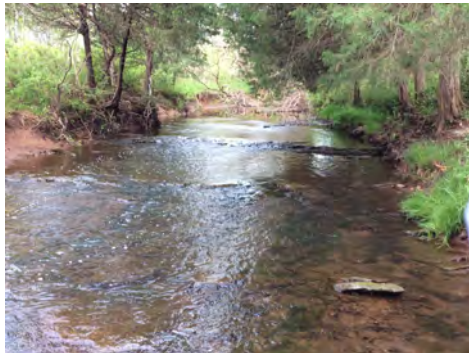
**Image 3**

Start of sampling reach

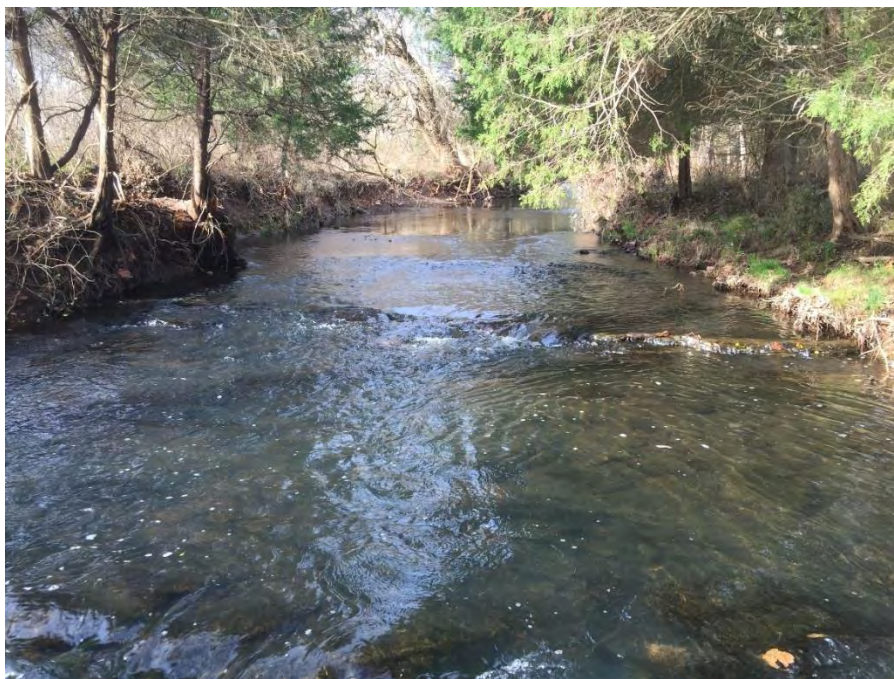
Figure 2: Looking upstream at beginning of sampling reach along the riffle consisting of larger gravel, cobble, and bedrock.

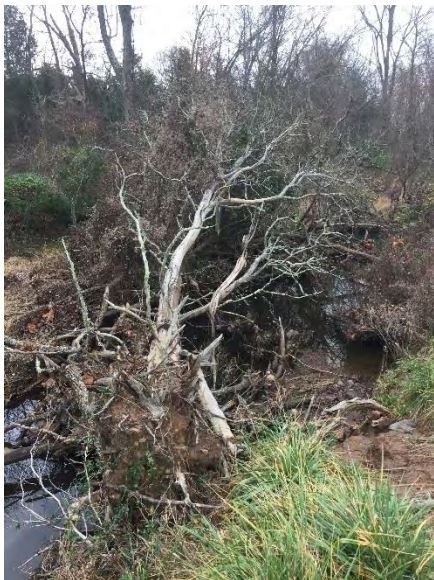
Figure 4: Large woody debris downstream from sampling reach.

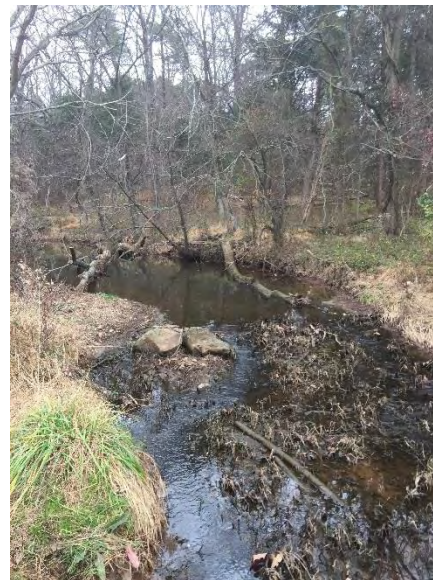
Figure 5: Looking upstream near beginning of sampling reach.

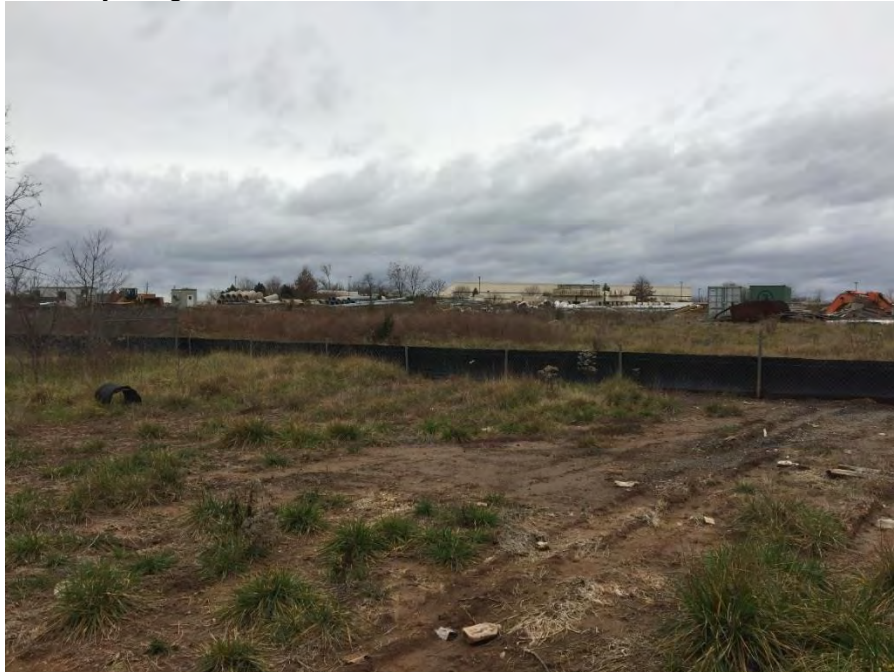
Figure 8: Construction contractor storage site adjacent to stream reach. Site was contributing noticeable amount of silt to stream.

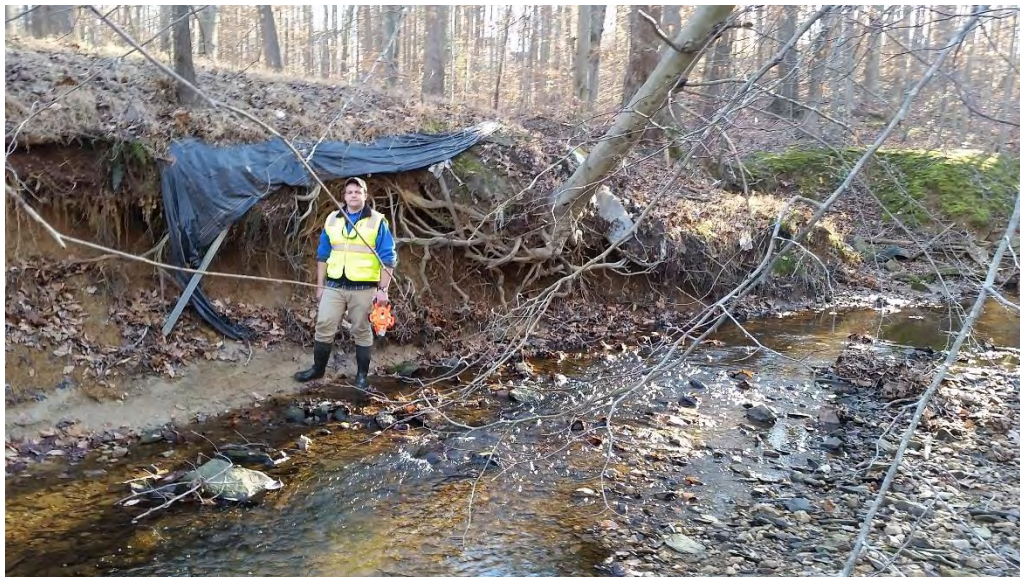
Figure 9: Stream bank incision >6 feet (vertical instability) from bed. Photo was taken downstream from sampling reach.
