# Annual Stormwater Management Report

## VSMP Permit No. 0088595 – FY 2017

Submitted by:  
Prince William County  
Department of Public Works

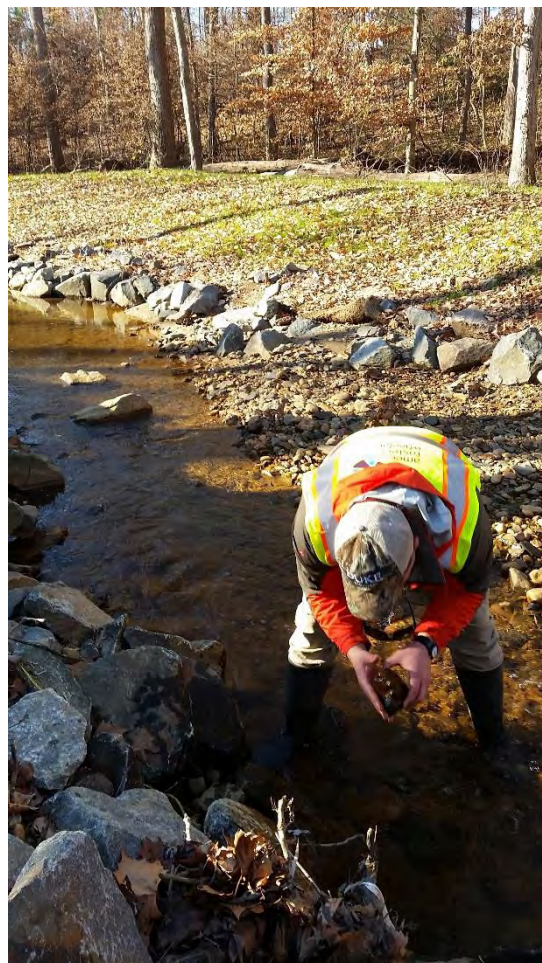
Figure 17: Brief inspection of benthic macroinvertebrate habitat upstream from initial sampling point.

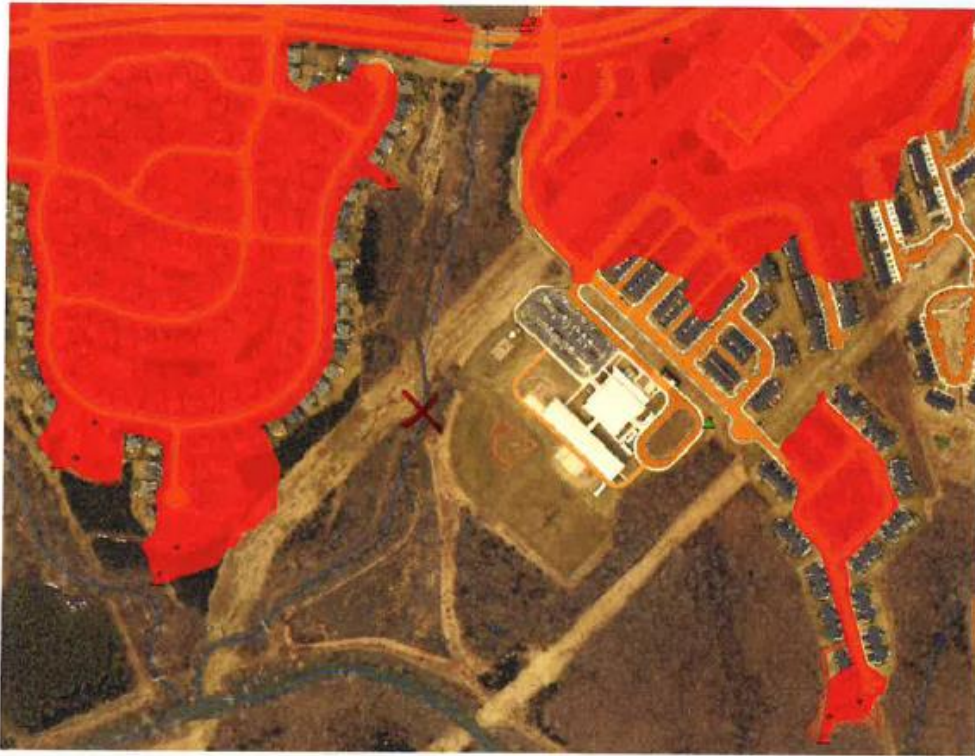
Site 3: Dawkins Branch, Victory Elementary School

Quality of upstream MS-4 outfalls:	<u>2 quality outfalls</u>	<u>[3]</u>
Upstream land uses:	<u>Residential, Schools, Roadway</u>	<u>[3]</u>
Opportunity to reduce floatables sources:	<u>Some floatables, limited But excessive sources</u>	<u>[4]</u>
Access and feasibility:	<u>Path allows easy access, Lot and access good</u>	<u>[5]</u>
Size of contributing drainage area(s):	<u>Med. large</u>	<u>[3]</u>

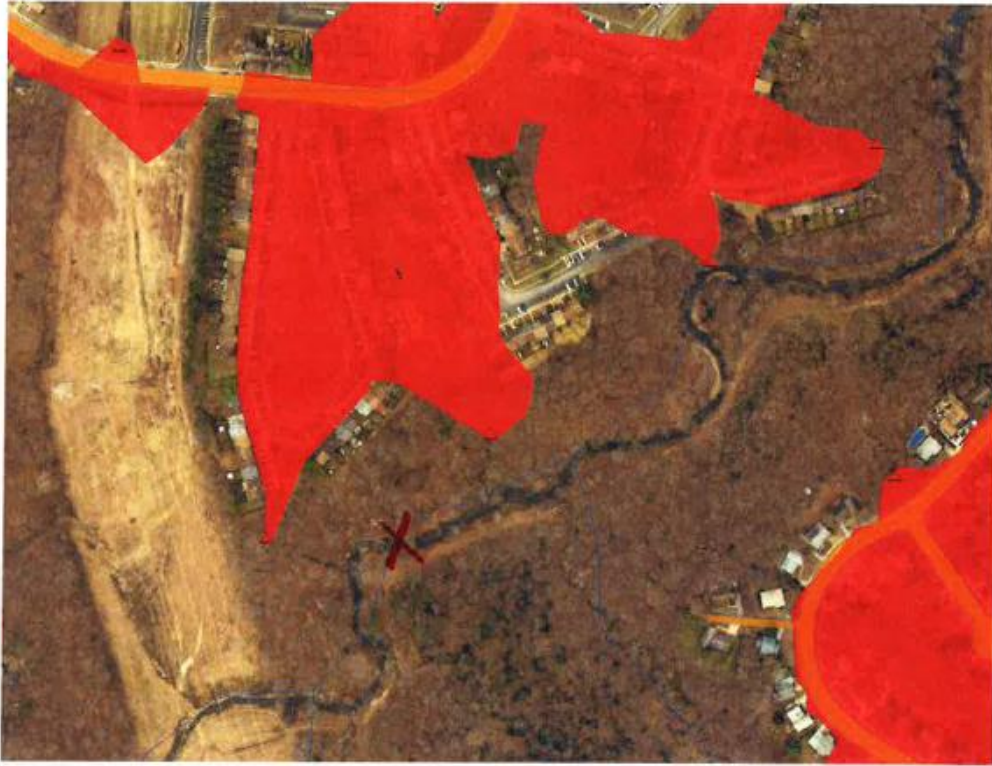
Site 5: Hooes Run, Castile Court

Quality of upstream MS-4 outfalls:	<u>2-3 quality outfalls</u>	[3]
Upstream land uses:	<u>Residential,</u>	[2]
Opportunity to reduce floatables sources:	<u>good amount of trash identifiable sources</u>	[4]
Access and feasibility:	<u>Neighborhood w/ little parking, hill difficult</u>	[2]
Size of contributing drainage area(s):	<u>Medium</u>	[2]

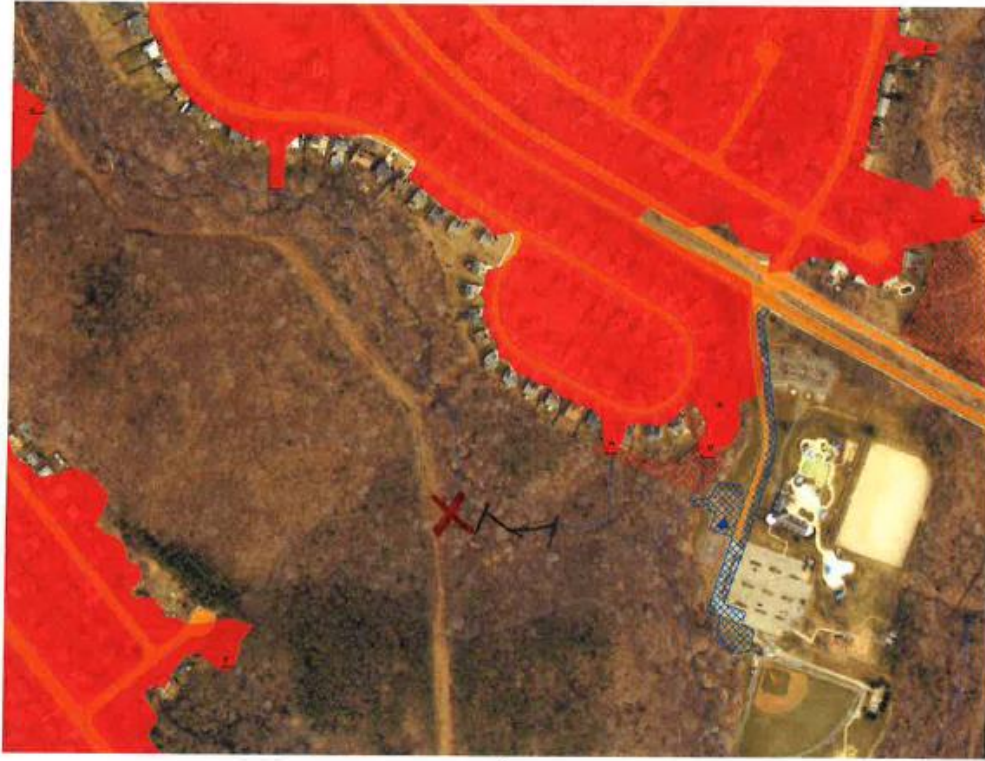
Site 7: Neabsco Creek, Andrew Leitch Park

Quality of upstream MS-4 outfalls: 2 quality outfalls [2]  
Upstream land uses: Residential Small lot [3]  
Opportunity to reduce floatables sources: Low numbers of floatables [4]  
Access and feasibility: good access, Too few inputs good isolated inputs [5]  
Size of contributing drainage area(s): Small - Mid [4]

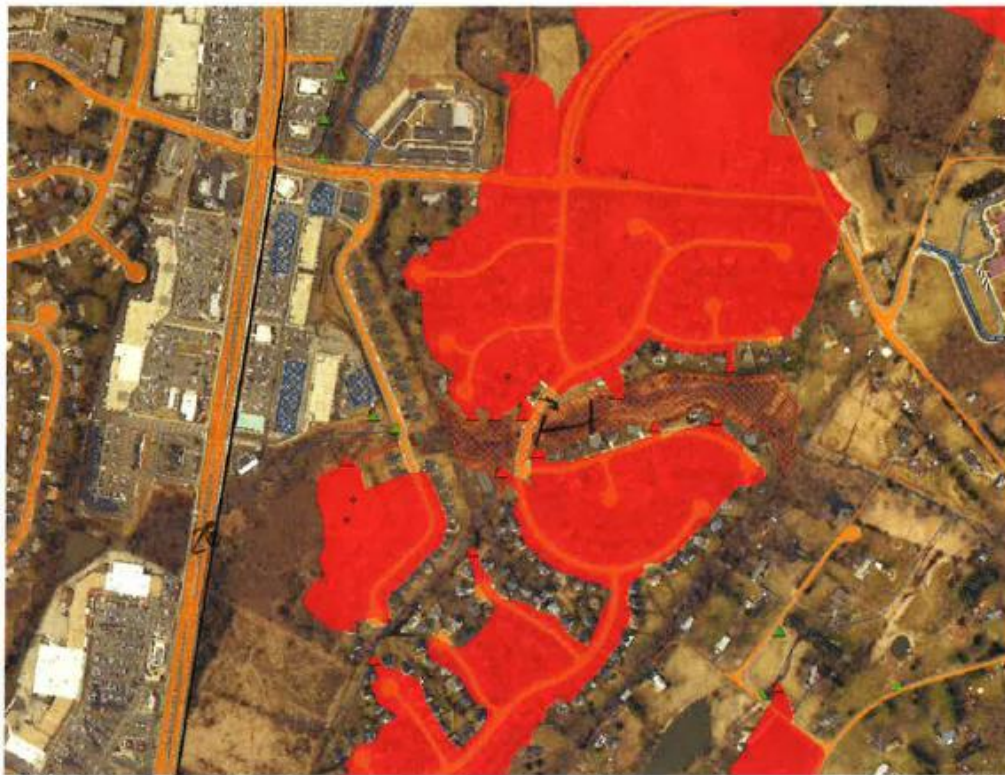
Site 10:

- Quality of upstream MS-4 outfalls: Many upstream outfalls [4]
- Upstream land uses: Commercial/residential [4]
- Opportunity to reduce floatables sources: Some [3]
- Access and feasibility: Fence impedes Access, Litter - before stream area [3]
- Size of contributing drainage area(s): Small-med [4]
