Annual Stormwater Management Report

VSMP Permit No. 0088595 – FY 2016

Submitted by:
Prince William County
Department of Public Works

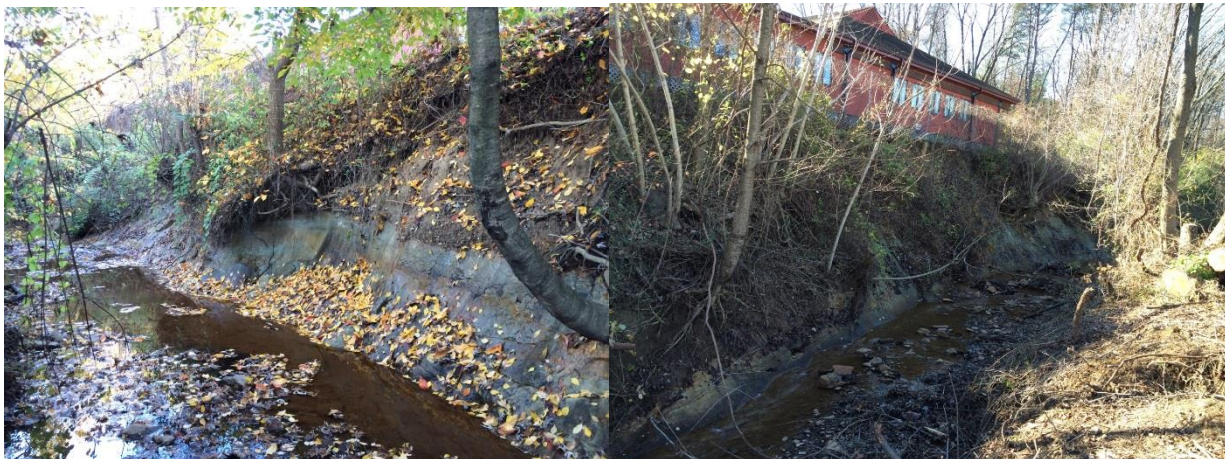
The project reach begins at the outlet of a 72-inch culvert southeast of West Longview Drive and flows for approximately 1,000 feet over gravel-cobble bed and marine clay before it passes through culverts below Church Hill Drive. Much of the upper portion of the project reach has severe erosion with 5-7 foot vertical banks that lack vegetation cover. Approximately 300 feet from the culvert, the Senior Center building is situated on a terrace beyond the right bank. A nearly vertical 15-foot high eroding slope separates the stream channel from the concrete pad behind the Senior Center. Further downstream, approximately 500-600 feet from the culvert, the stream channel is about 15-20 feet from the outfield fence of a baseball field. A sanitary sewer line approaches the right bank about 600 feet below the culvert outlet and continues along the channel until it crosses beneath it 850 feet below the culvert, or 50 feet upstream from the Church Hill Drive culvert.

The existing topography is representative of a wider valley through which the stream has cut a deeper channel. The reach-wide channel slope is 1.0%, which is not considered to be steep for the geographic setting. The riparian vegetation is very minimal on the streambanks, which are eroding and often close to vertical. Beyond the streambanks, mature hardwood trees, including poplar, maple and oak, are relatively abundant.

The project design incorporates bankfull floodplain benches, limited meander pattern, and structural measures to stabilize the existing eroding stream channel.

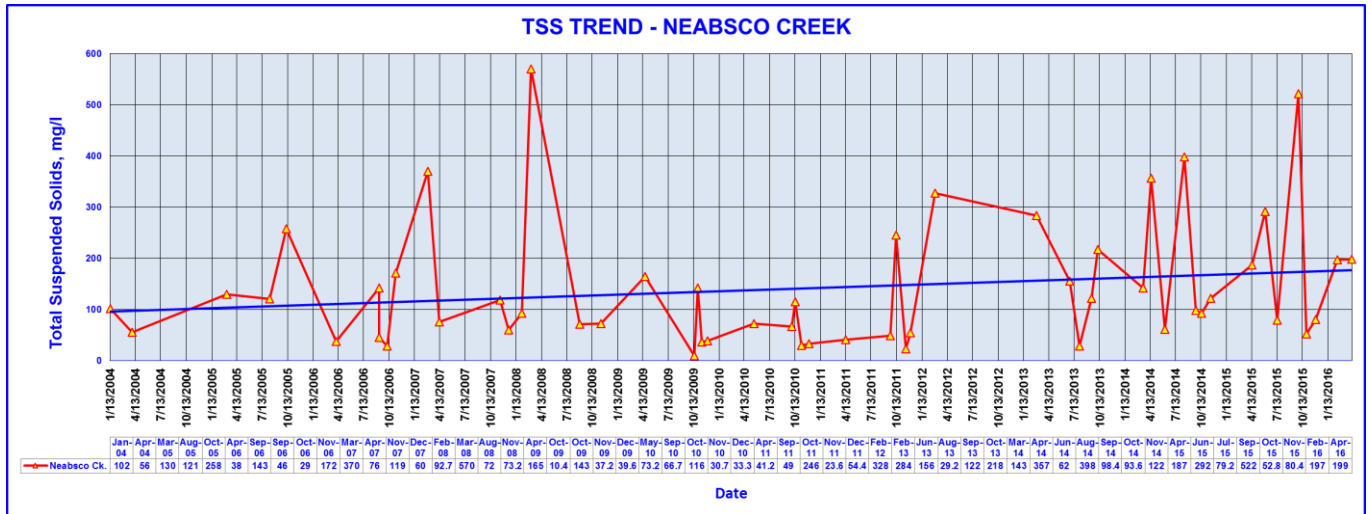
Figure 6 – Long Term TSS trends in Neabsco Creek Watershed

TSS samples show an increasing trend in the Neabsco Creek Watershed. This is slightly skewed by a large spike during a large storm event during September sampling. This spike also contributed to excess Phosphorous levels in the September sample as seen below. When removing the outlying data points the trend becomes much more neutral.

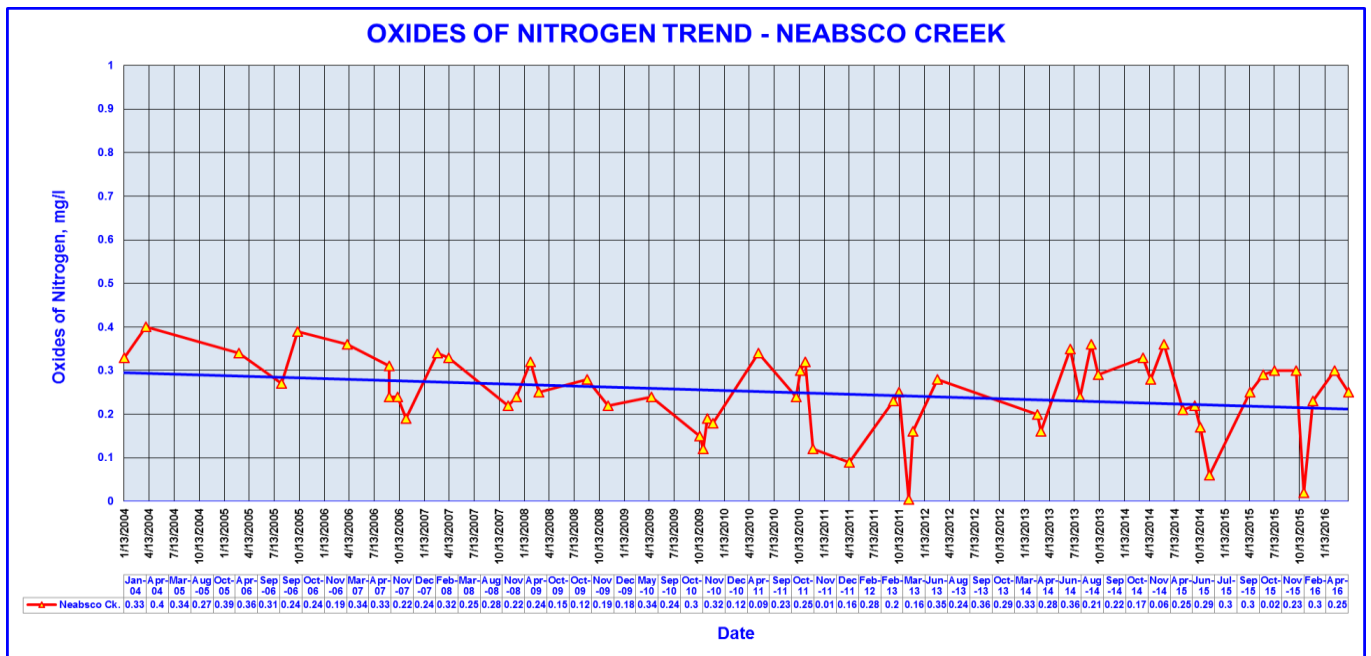
Figure 7 – Long Term TN trends in Neabsco Creek Watershed

Nitrogen is showing a decreasing trend within the Neabsco Creek Watershed. This can be interperated that stormwater control measures are making an impact within the watershed; however, with increases in total Phosphorous and TSS it may not be the case. Unlike TSS and TP, large flow rates resulted in a severe drop in concentrations. Removing this outlier brings the trend much closer to neutral.

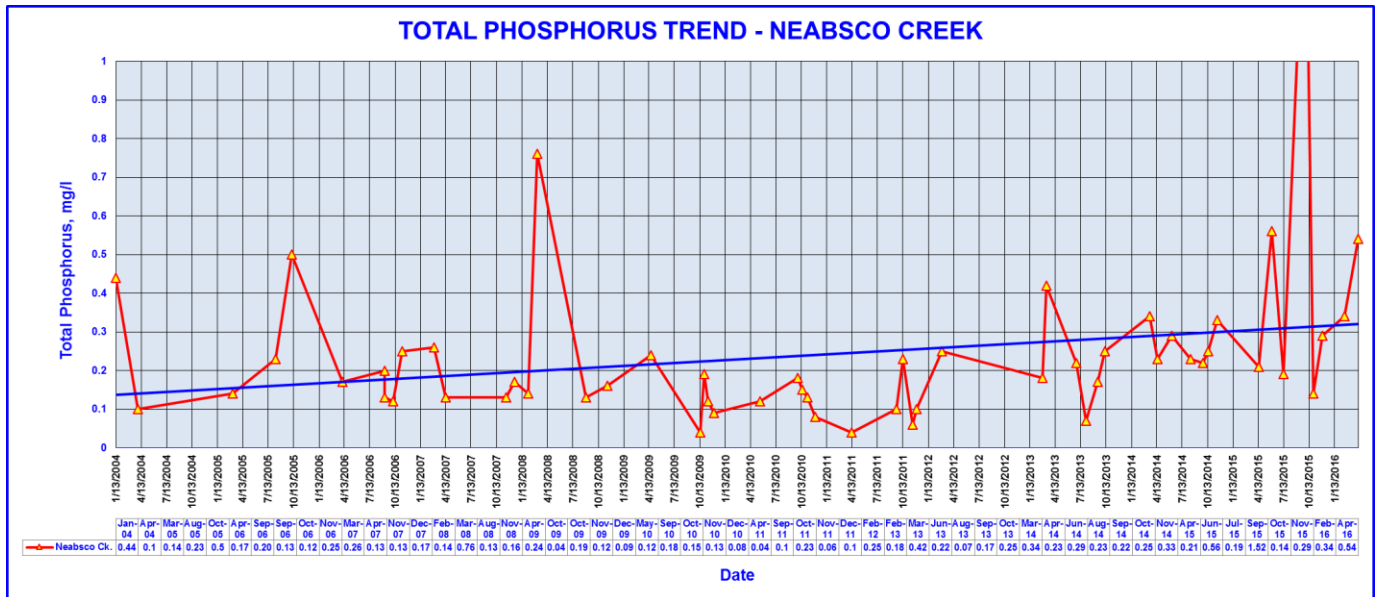
Figure 8 – Long Term TP trends in Neabsco Creek Watershed

Total Phosphorous shows an increasing trend within the Neabsco Creek Watershed. This data may be skewed more towards an increase due to several outlying peaks caused during large storm events. The most recent sample resulting in a reading of 1.52 mg/L corresponds with the reporting period’s largest flowrate through the station. It also mirrors spikes in TKN, and TSS. This sample is also preceded by an abnormally dry July resulting in an abnormally large “flush” of pollutants during the rainstorm. Reasons for volatility in phosphorous readings during the reporting period are an unknown to the County, and are being looked in to.

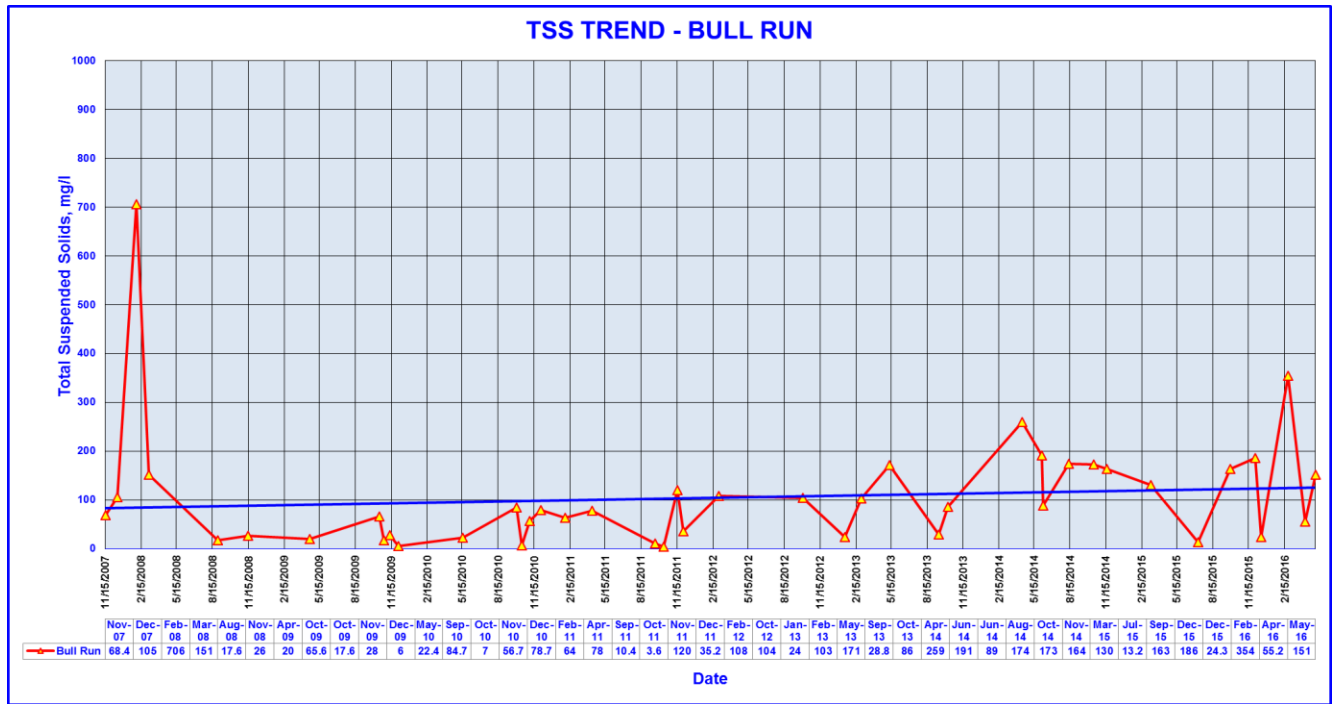
Figure 9 – Long Term TSS trends in the Bull Run Watershed

TSS in the Bull Run watershed trend slightly increasing to steady. Two outlying data points skew the results to a slight increasing trend. This is a result of large storms that occurred during the time period.

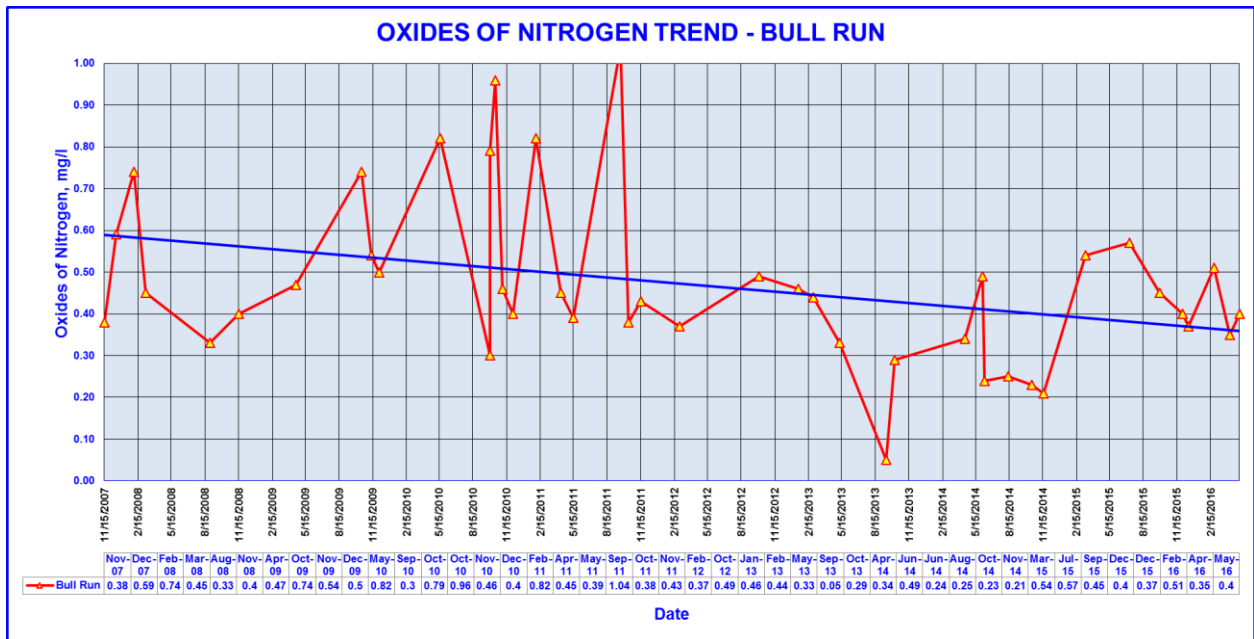
Figure 10 – Long Term TN trends in the Bull Run Watershed

As with the Neabsco Creek watershed, Oxides of nitrogen show a strong decreasing trend. This could indicate the effectiveness of stormwater controls, but as with Neabsco Creek, this trend is not reflected in concentrations of TP and TSS.

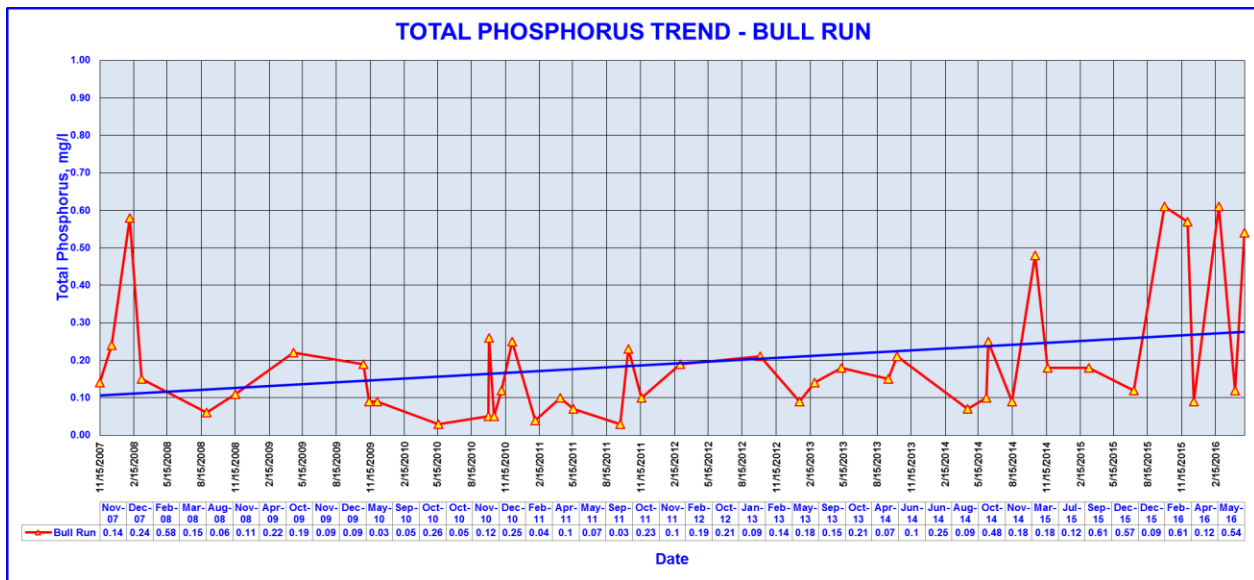
Figure 11 – Long Term TP trends in the Bull Run Watershed

TP has a strong increasing trend within the Bull Run watershed. The volatility observed in the Neabsco Creek watershed is again observed here. This seems to relate to increases in flow through the watershed due to storm events.

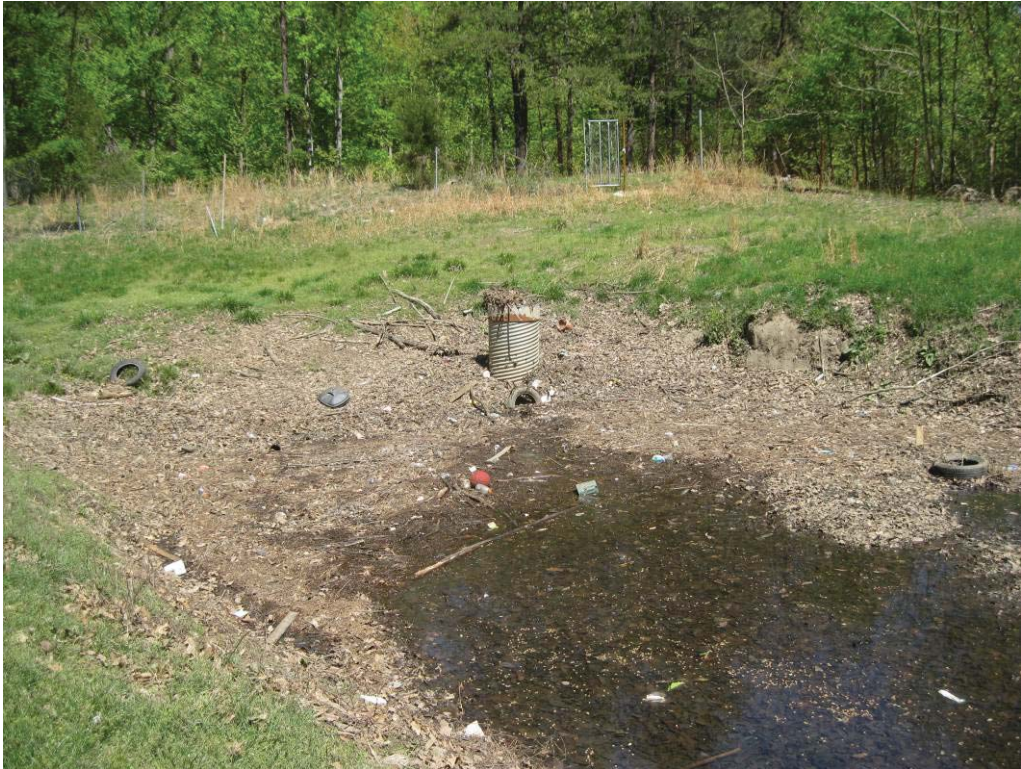
Facility 28. Downstream view of existing sediment basin with riser structure

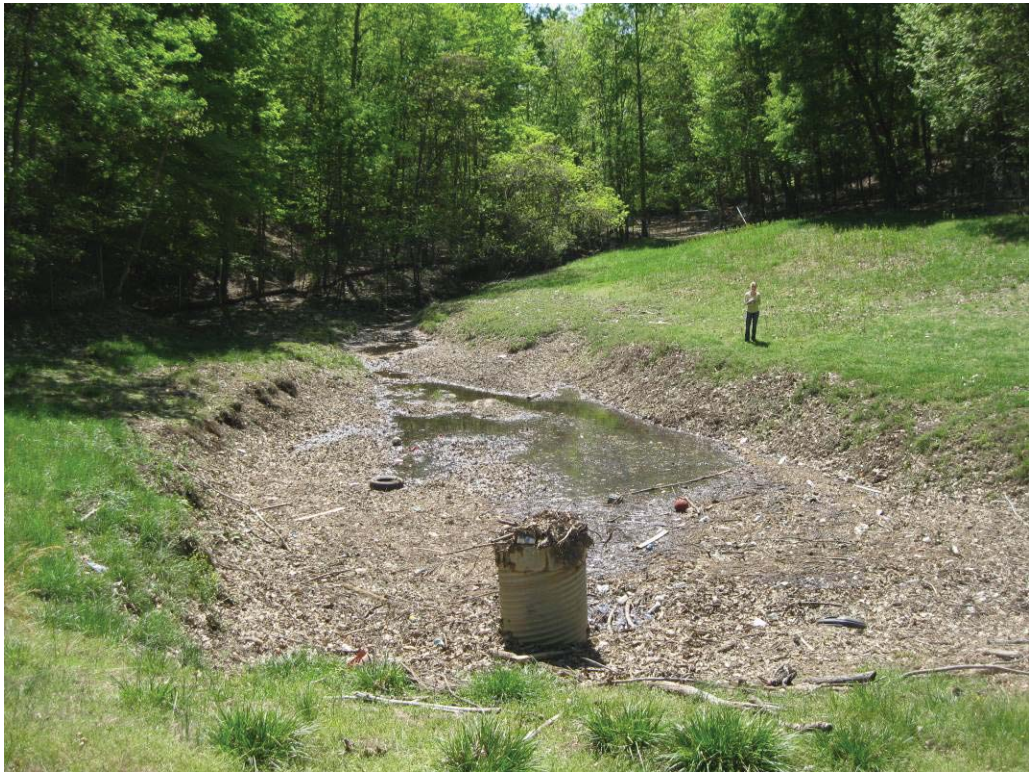
Facility 28. Upstream view of existing sediment basin with riser structure

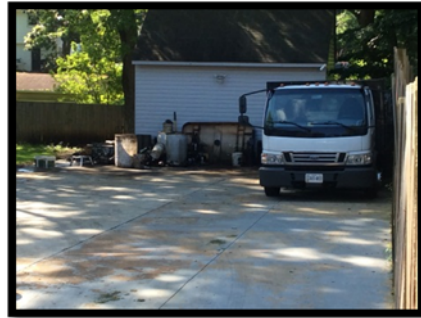
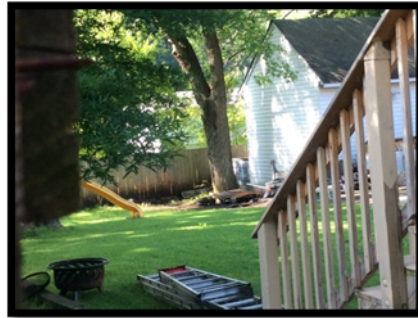
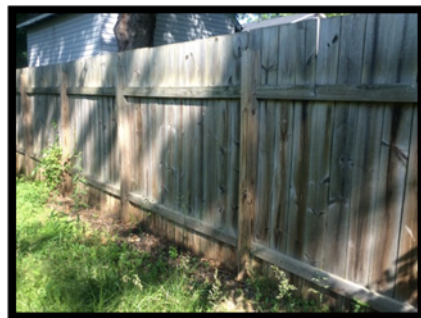
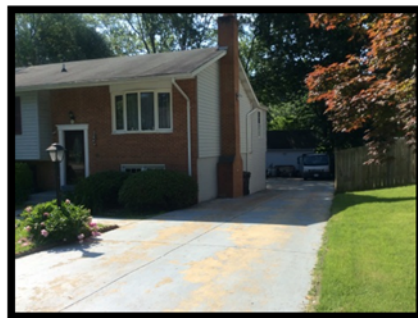
No one was present at home during inspection. The property was inspected from outside the boundary. The rear fence was observed from back of 3906 Forest Dale Avenue. Automotive fluids were found to be spilled within the owner's property. Although it is possible the spilled grease and oil could have been

washed away into storm water drop inlet located nearby that location, it is observed that these discharges would be negligible and hard to prove causation/quantify discharge volumes.

Spilling oil and grease on open ground and pavement, keeping oil and grease contained in vessels without lids, and leaving rusted motor parts and metals kept in the open without cover are all poor pollution prevention good housekeeping practices. The home owner should control such activities responsible for generating pollutants to soil within his property; however, this is not a clear violation of County illicit discharge ordinance at this time. Outreach for good pollution prevention practices will be distributed to the homeowner and the situation will continue to be monitored by Watershed Management staff for clear discharges to the storm sewer.

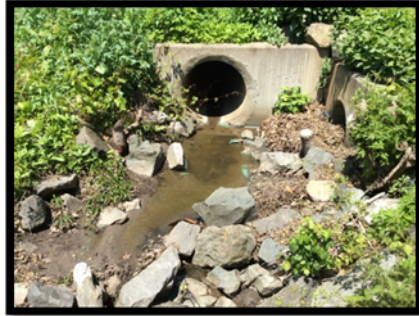
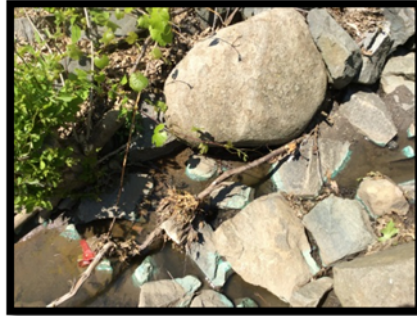
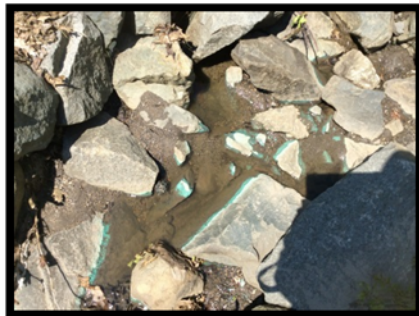
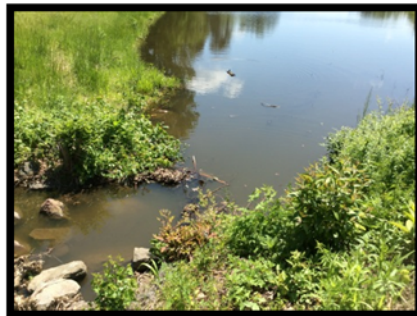
As a result of the investigation, the paint stain was found only at the outfall 23443 to pond 5091. Outfall 23443 is located within the Virginia Oaks Golf Club, and as a result a meeting was made with Mr. Glenn T. Payne, the General Manager of golf club to further investigate the discharge. During field

The observed green stain may be developed either dumping paint in storm sewer system or hydro seeding. Follow up inspection will be continued to further investigate and identify a possible source. Notice of violation was not issued due to an inability to identify the source of the discharge.

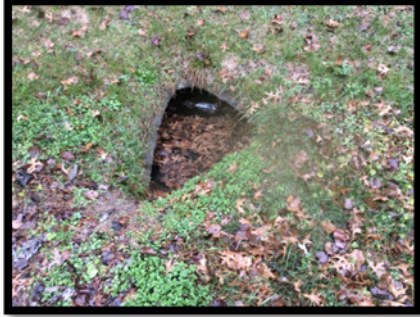
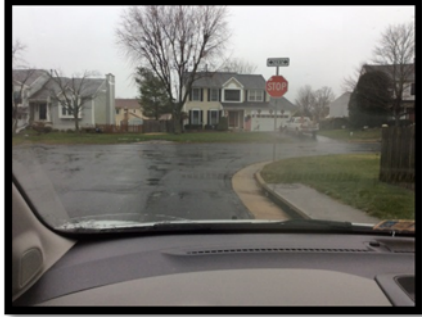
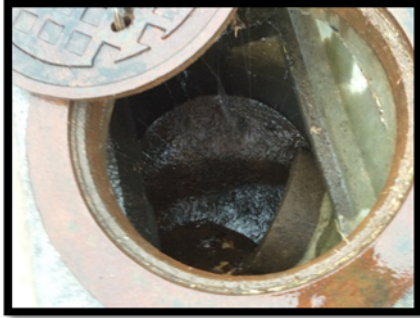
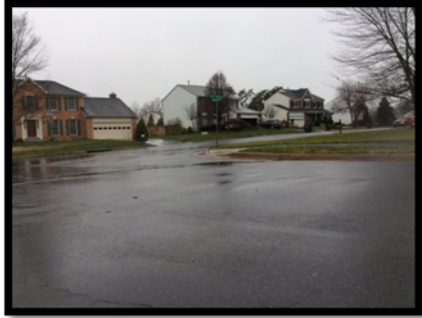
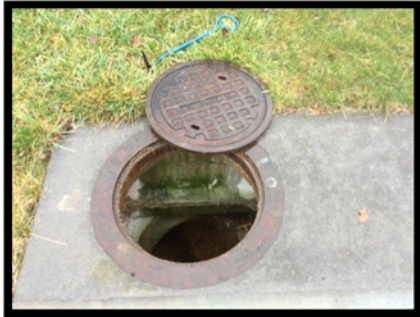
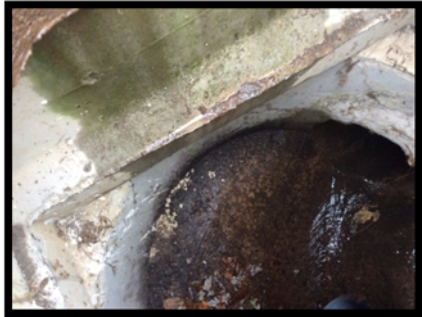
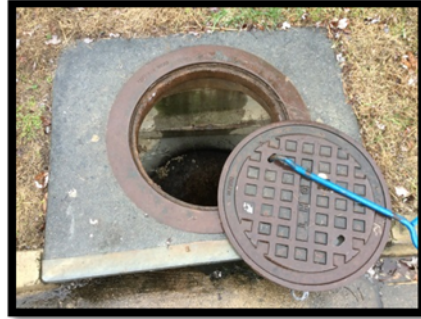
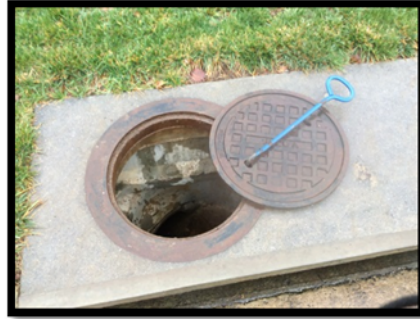
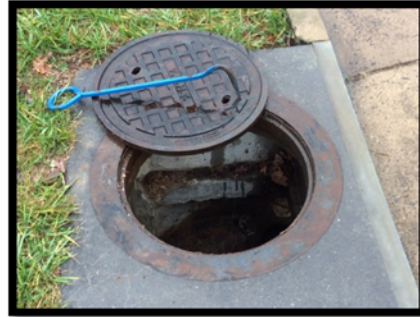
Storm sewer had started to inspect from outfall. Even though it was raining there was no flow thru outfall since the sediment deposition had developed negative flow by forming dyke around outfall. There was no noticeable odor at manhole A. The faint odor had felt in manhole B. The easily noticeable odor felt at manhole C, D and E. The odor found to be gradually increased from B to E. The manhole F found to be free from odor.

In my investigation, the odor mainly associated with chemicals rather than sanitary sewage or decayed dead body of animals. The odor pretty much close to excessive chemicals and the intensity of odor found more around manhole E. From this scenario, the over application of fertilizers and chemicals in the lawn surrounding manhole E could be one of the reasons which had been wash way into storm drain which retained in as a small pockets formed in last rain fall event happened ten days ago. The spilling of chemicals nearby manhole E could be the second reasons which retained into storm sewer by the same way as explained earlier. Even though the husband of complainer request for camera VAN testing into the storm sewer system, the main reasons should be wash way chemicals thru curb and gutter inlet trapped into storm sewer as in small pockets around manhole E to B. The source of odor didn't exactly identify due to lack of evidence. The follow up action will be taken in future.

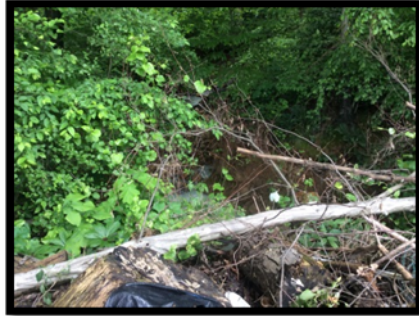
Point D

The complaint received at PWC Environment Service from Mr. Randy Merritt about creek contamination by white substances on 05/13/2016. The email has received with attached pictures approximately at point D and E as shown in map below. Field inspection was made on 05/13/2016. On arrival, the creek found to be still contaminated with white substance at aforementioned point D and E. The white substance supposed to be paint spilling into storm water.

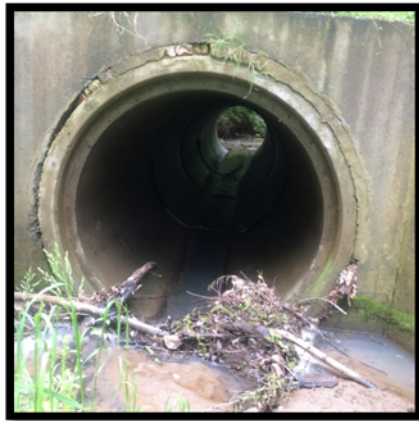
Point C

The creek found to be flowing thru upstream community. Discharge started to track down towards upstream. The SWM Facility 60, located at point C found getting white discharge from inlet creek. Tracking kept continue along the creek. At point B, the white substance observed intermingled to the creek by the discharge getting from outfall 3529. After tracking storm sewer, the paint found to be dump at storm sewer inlet at point A. The house 13711 supposed to be renovating by visual outlook but

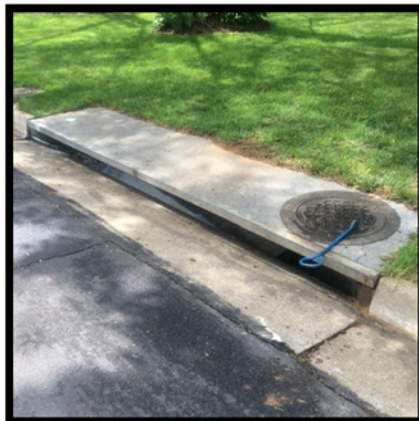
Point A

The source of creek contamination confirmed to be dumping paint on storm sewer drop inlet located beside the property 13712 Bluefin Drive. The violator couldn't identify at the visit. It seemed to be a

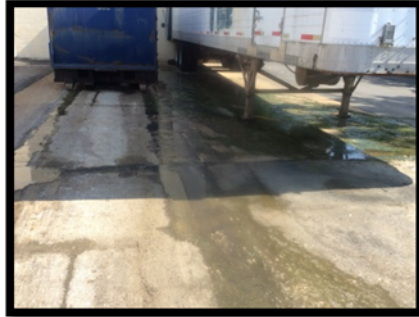
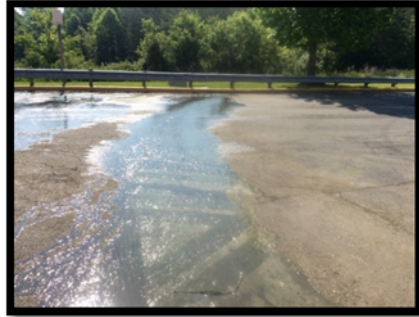
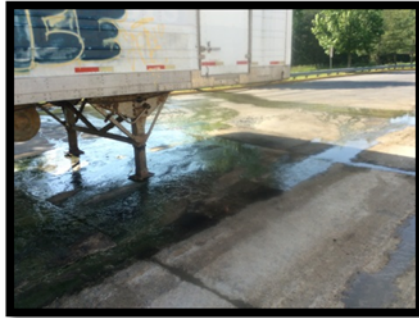
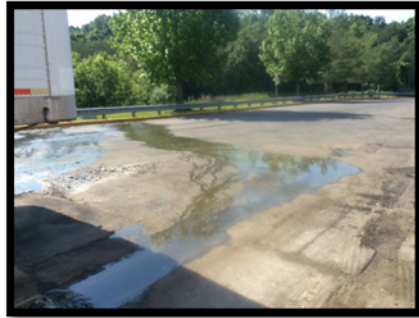
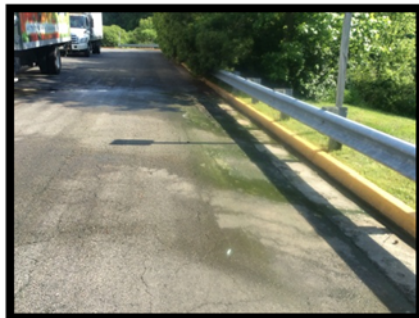
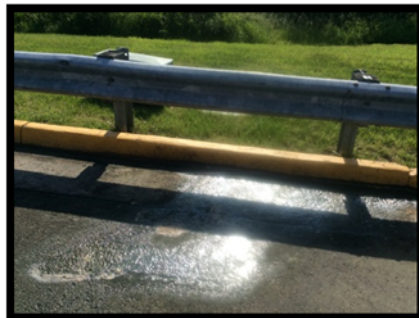
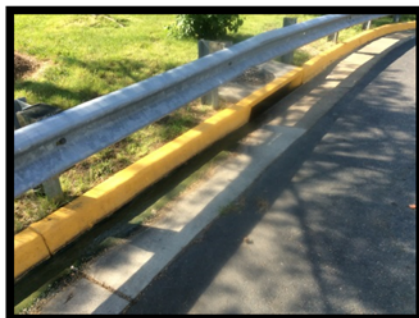
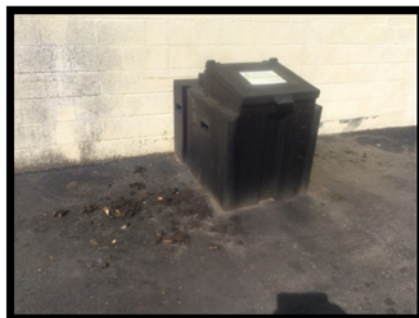
The compactor was observed to be leaking substantially. Food waste fluid was found flowing down the roadway and directly into a nearby storm sewer drop inlet. Green algae were found to be developing over pavement surface in areas where flows were found. In addition, a greasy residue was found to be staining the pavement on both sides of the flow path towards the drop inlet. The greasy fluid was observed to be spread out in a larger area due to incursion via vehicle traffic. The origin of observed waste oil and grease was identified to be due to spills around a nearby grease collection tank.

Contact was made with Global Foods managing staff. The manager stated that waste handling practices were currently handled by PWC Service Authority, but the developed green algae and stain prove that observed discharges had been occurring for more than a couple of weeks. The manager was informed that the Prince William County Service Authority is not responsible for the mishandling of food wastes on private property and that it is the business owner's responsibility to properly manage and identify maintenance issues to his compactor and grease trap. In conclusion, the leakage of waste oil, food

waste, and grease debris were found to be due to the improper disposal of food and waste oils by Global Foods. This resulted in an illicit discharge, as non stormwater contaminants were allowed to be discharged into storm sewer system. As per county ordinance sec. 23.2-4.1, NOV (NOV 9-2016) was issued in order to assure compliance. PLEASE REMOVE ALL RESIDUE AND DEBRIS FROM BEHIND COMPACTOR and surrounding pavements. Put into place measures that ensure prevention of grease discharge to surrounding areas outside the grease receptacle. Periodic inspections will be performed to ensure maintenance to compactor and further resolution of the Violation.

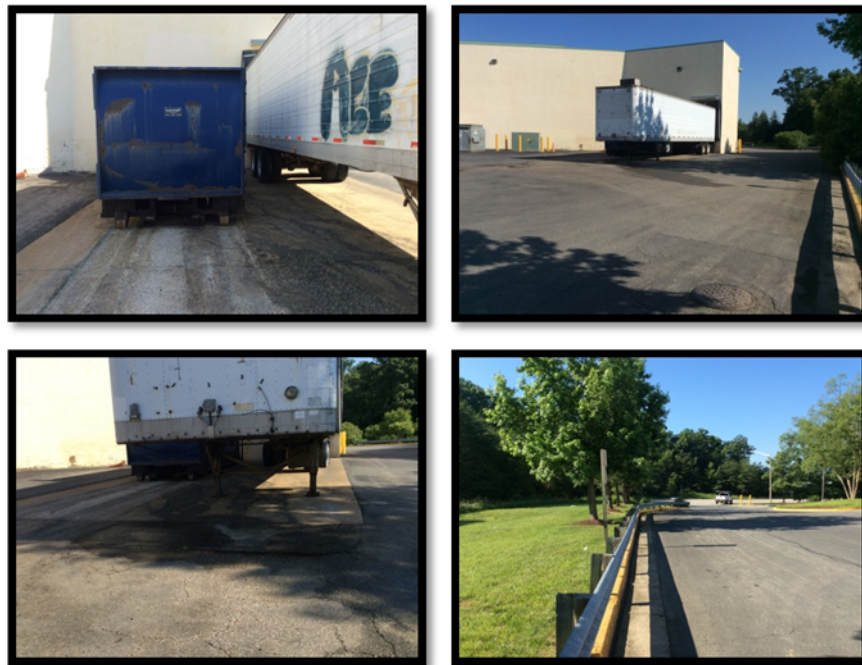
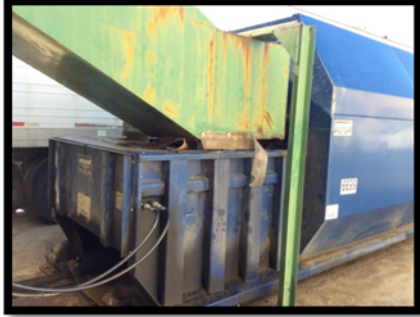
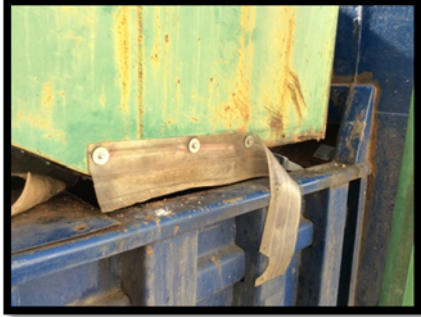
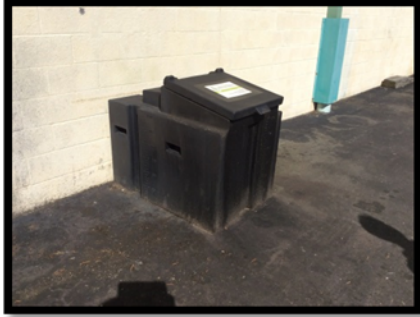
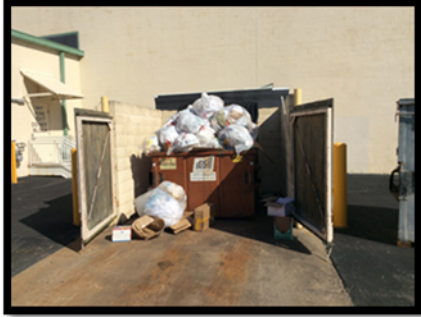
Reinsertion made on 06/07. The deficiency mentioned in NOV 9-2016 found to be corrected as desired. The meeting made with management staff asked to pay regular inspection and attention in proper waste management practices. Minor correction were suggested for re-fixing rubber washer mounted at inlet barrel of compactor and asked the vender to pick up the load if collected early than regular pick up days. The case closed on 06/08/2016. The site will be regularly inspected in future. Following pictures were taken before closing the case.

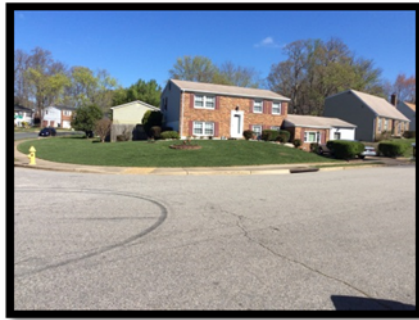
Inlet-1 in front of property 13816

The aforementioned property, 13816 Meadowbrook Road and its surrounding storm drainage inlets were inspected on 04/04/2016. Storm inlet-2 was found to have some grass clippings inside. Re-inspection made for further verification as per complainant on 04/07/2016. The rest of the curb and gutter inlets were found to be clean. The lawn of 13816 found to be recently mowed.

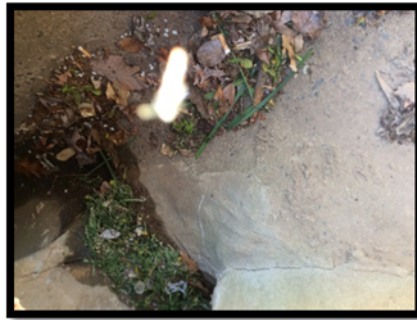
A meeting was made with the property owner of 13816. According to him, the lawn mower dispersed cut out clippers to the street while mowing which may have blown into the inlet unintentionally. As I inspected, the amount of clippers observed insignificant in inlet-2.

Inlet-2 with some clippers

Due to lack of sufficient evidence it was difficult to figure out whether the discharge had happened intentionally or non-intentionally. Educational materials were distributed to the home owner with a briefing on dumping clippings into storm sewer system. At this point, I feel uncomfortable to issue a notice of violation (NOV), both due to a lack of sufficient evidence to prove intent of discharge, and the County policy to educate homeowners for a first offence. Follow-up inspections will be continued in the future.

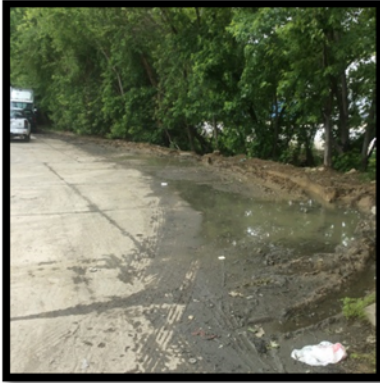
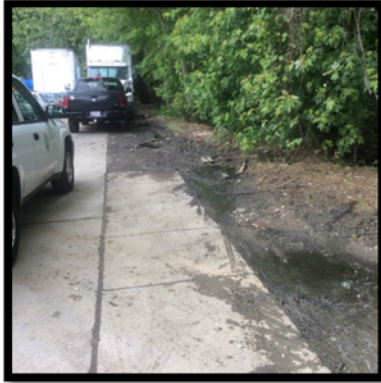
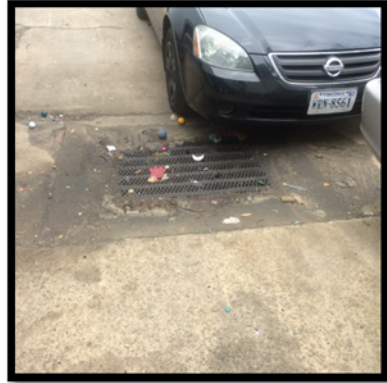
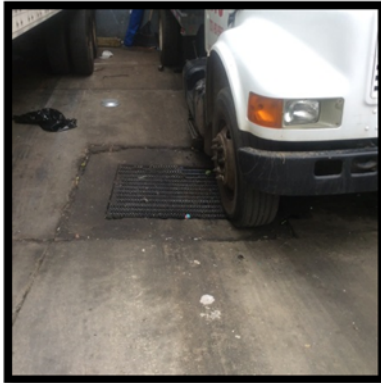
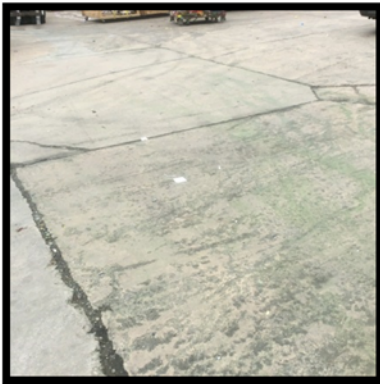
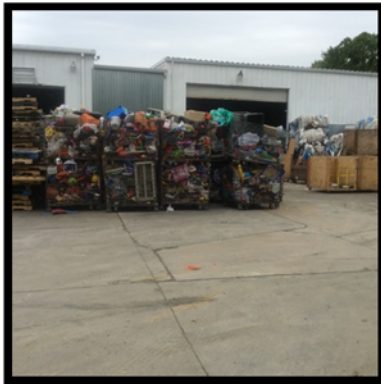
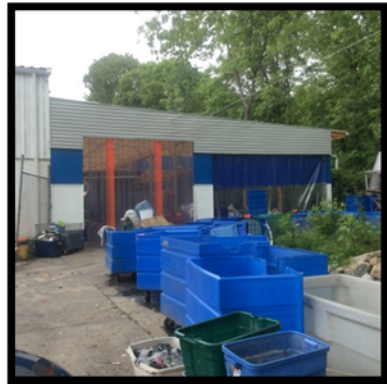
Upon inspection, the creek found to be contaminated by the observed sludge, wash away grease and debris found on the World Trade Company property. A meeting was made with Mr. Rafic Eldin, the business owner, to talk about observed deficiencies. Mr. Eldin found to be very positive to address the aforementioned deficiencies.

In Conclusion, World Trade Company was found responsible for unlawful discharges to the storm sewer system and waters of the county, a notice of violation (NOV 04-2016) was issued to the company as per county law section 23.2-4 and is required to mitigate damages and correct deficiencies no later than 30 days from receipt of NOV. The corrective action plan should include:

- 1) Clean grease and oil stain from pavement and take appropriate measures to control unlawful discharge flowing into storm drain inlets.
- 2) Avoid ground encroachment generating sludge discharge into the creek.
- 3) Enact good housekeeping practices immediately to prevent further discharges.

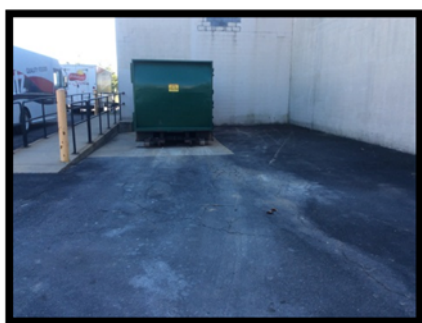
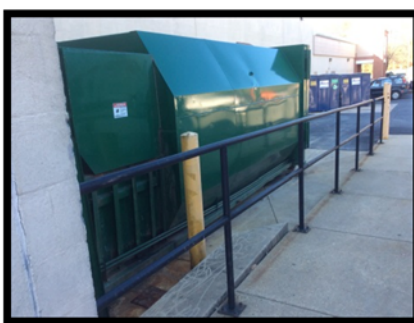
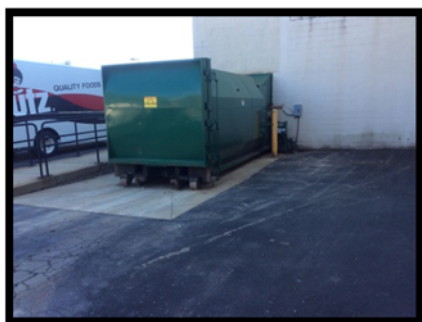
Pictures:

Inspected Facility: Price Rite	Address: 2090 Daniel Stuart Square Woodbridge, VA 22191
Inspected By: Prem Poudel	Date of inspection: 12/04/2015
Inspection Note: Price Rite Grocery/ Produce facility was re-inspected finally to verify the mitigation measures, on issued NOV 2015-07, taken by the facility owner on 12/04/2015. The successive inspections had been made on 09/24 and 10/20 respectively. The prompt steps had been taken to stop dumping waste around compactor and drive way as well as the integrity of the compactor to prevent future leaking in 1 st reinsertion (9/24). The mitigation measures found to be effective in 2 nd re-inspection (10/20). There was no leakage thru compactor and the accumulated greasy debris and stained residue found to be removed and cleaned as directed. Hence the case has been closed after 3 rd reinsertion(12/04) .

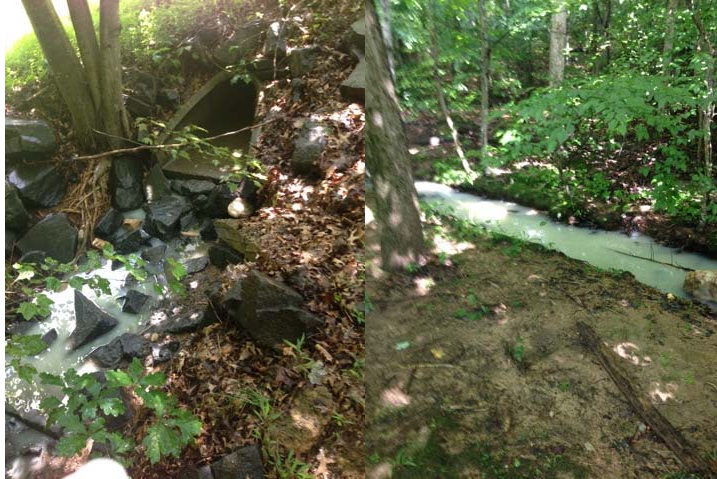
Pictures by Homeowner

Upon reaching the aforementioned location, contact was made with Mrs. Knepper and the source of discharge was tracked down to a storm water drop inlet near the downstream creek. The truck had already left upon inspector arrival. The creek water found to be faint white colored as compared to the pictures provided by Mrs. Knepper. This is assumed to be a result of a recent rain event. There was no visible severe impact at downstream creek.

The field inspection found washing activities had violated County ordinance 23.2-4.1 (a). The truck had already left and picture did not specifically show dumping activities taking place. According to the complainant the crews of Patriot Painting were responsible to the discharge. Because illicit discharge activities were not directly observed by PWC staff, or documented by the homeowner, no NOV will be issued; however, a letter stating the potential violation and indicating possible consequences of Illicit discharges along with educational material will be distributed to Patriot Painting.

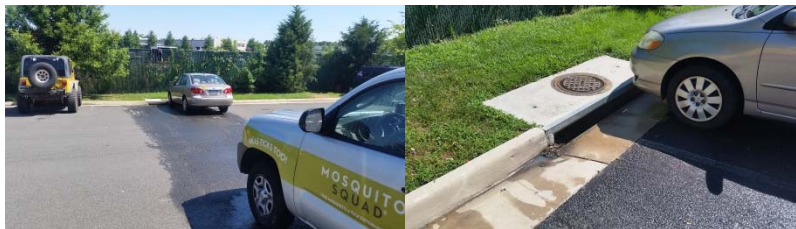
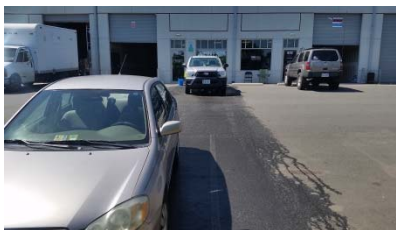
During a routine drive by inspection along Mike Garcia Drive an employee of Mosquito Squad was observed washing his work truck, allowing runoff to enter a nearby storm sewer. No trackdown was needed as the discharge was identified at its source.

Upon discovery of the discharge the employee was informed of the violation to County ordinance and instructed to cease washing operations. Tyler Buckingham, a field supervisor for Mosquito Squad, was also informed of the discharge and the violation to County ordinance 23.2-4.1. It was agreed upon that Mosquito squad would find alternative methods of washing vehicles in the future, mitigating actions responsible for the violation. This site will continue to be monitored for future violations.

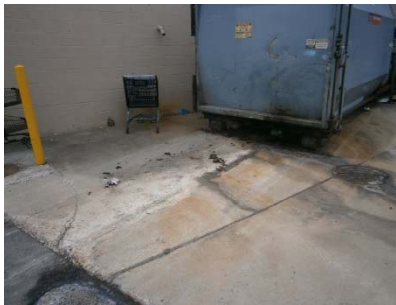
On July 29th, 2015 Prince William County Watershed management staff received a complaint regarding a leaky dumpster behind Shoppers Warehouse in Dumfries Virginia. Upon arriving on site the dumpster was located behind the Shoppers Warehouse food store. The reported dumpster was discovered to be a trash compactor upon arrival on site.

Figure 1: Site map showing discharge flow path through the storm sewer system.

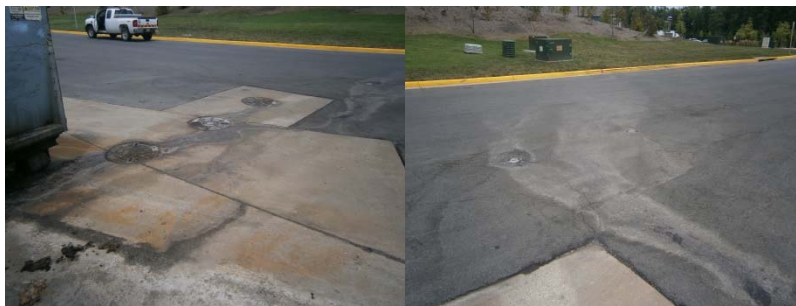
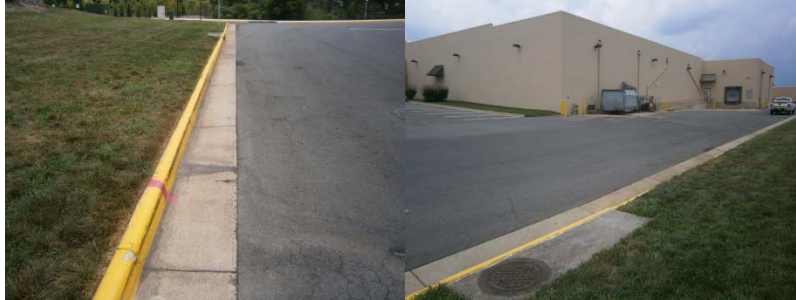
Oil/grease residue was found to be staining the asphalt behind the compactor in the direction of the storm drain. In addition, greasy debris was found below the back end of the compactor. It was clear that the compactor was leaking contents which were being washed into the storm drain during rain events. After discovery contact with a shopper's food manager was made.

The manager stated that the compactor had been repaired that morning. Upon further inspection It did appear that the dumpster had been fixed via a weld at the bottom of the back of the compactor. A NOV (NOV 2015-4) was issued in order to assure compliance. Periodic inspections will be performed to ensure maintenance to compactor resolves discharge problem. **PLEASE REMOVE ALL RESIDUE AND DEBRIS FROM BEHIND COMPACTOR.** This ensures no further contaminants will be washed into the storm drain during rain events.

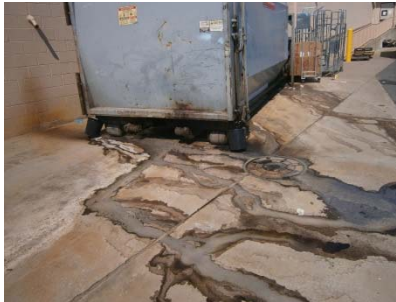
On August 17, 2015 follow up inspection had been conducted upon getting citizen complain of an illicit discharge thru compactor placed behind Shoppers Warehouse in Dumfries Virginia. Notice of violation (NOV#2015-4) had been already issued to shopper on 07/30/15. Upon arriving on site, compactor was found to be significantly discharged pungent gray greasy leachate in to hanging two bucket at the bottom corner which was continuously overflowing. Minor flow found all around the compactor.

Figure 1: Site map showing discharge flow path through the storm sewer system.

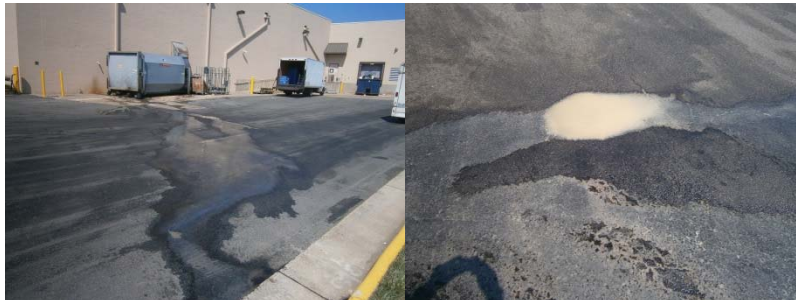
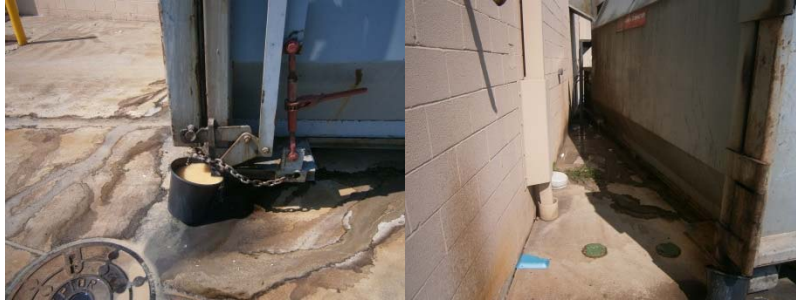
The flow found to be reached up to curb and gutter inlet of storm drain located beside the drive way. Marks and flow of greasy discharge found to be extended towards storm water curbs and gutters inlet on asphalt pavement. In addition, greasy debris was found below the back end of the compactor. After discovery contact with a shopper's customer service manager Mr. Carlos Harris was made.

The manager stated that the compactator will be repaired after taking away the collected waste of compactator today. For the time being, the discharge has been collected in hanging bucket and use to discharge manually into grease inceptor. But nobody was looking for those hanging bucket at site even though it was over flowing. The minor trickle flow found to be discharged all around the compactator. A NOV (NOV 2015-5) was again issued in order to assure compliance. Periodic inspections will be performed to ensure maintenance to compactator resolves discharge problem. PLEASE REMOVE ALL RESIDUE AND DEBRIS FROM BEHIND COMPACTOR. This ensures no further contaminants will be washed into the storm drain during rain events.

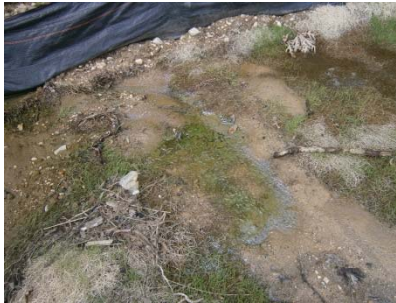
Mr. Bob Barr, currently the developer of property 14005 Telegraph Rd complained about algae formation around his newly under construction storm water management facilities.

Figure 1: Site map showing discharge flow path through the storm sewer system.

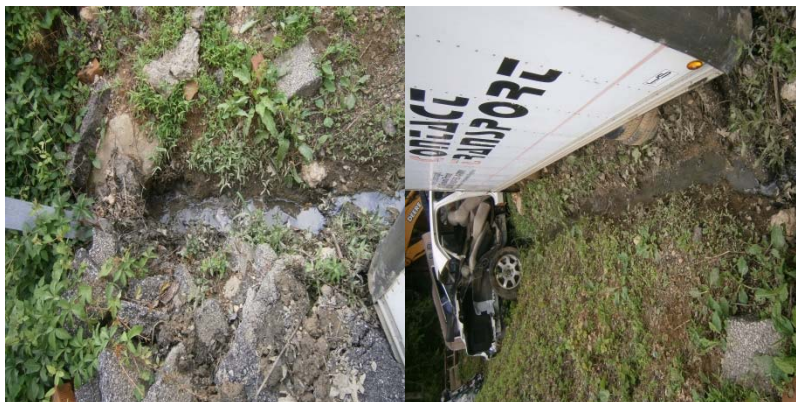
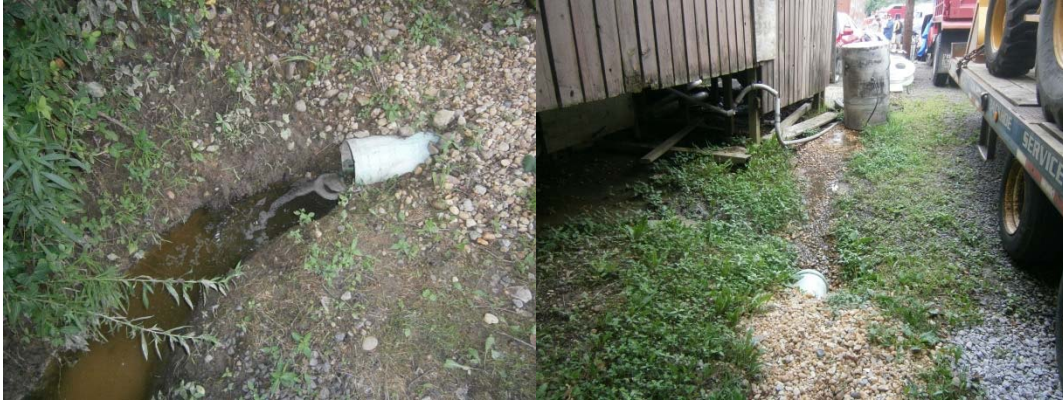
Undersigned observed algae development on recently stabilized ground. I also observed continuous flow towards silt fence from property 13901 Telegraph Road to 14005 Telegraph Rd. Water sample has been taken for preliminary test. I tracked down the source of inflow.

The property 13901 Telegraph Road was found to be used for multiple purposes. Undersigned observed junk car storage in open ground, Vehicle repair and maintenance workshop, storing and selling compost fertilizers, mulch, sand and parking large commercial truck. The ground surface mostly found graveled. The discharge found to be generated by vehicle washing, cleaning and ground water as well. There was no responsible person to talk about the issues and got information he will be back on 07/07/2015. I took the water sample for preliminary tests. The photometer test has been completed and found that the phenol exceeded the limits. From my field investigation, the property 14005 Telegraph Rd was found to be affected by the illicit discharge generating thru property 13901 Telegraph Road. The enforcement action would be better to start from whether the owner of property 13901 is properly following zoning ordinances or not.
