Annual Stormwater Management Report

VSMP Permit No. 0088595 – FY 2016

Submitted by:
Prince William County
Department of Public Works

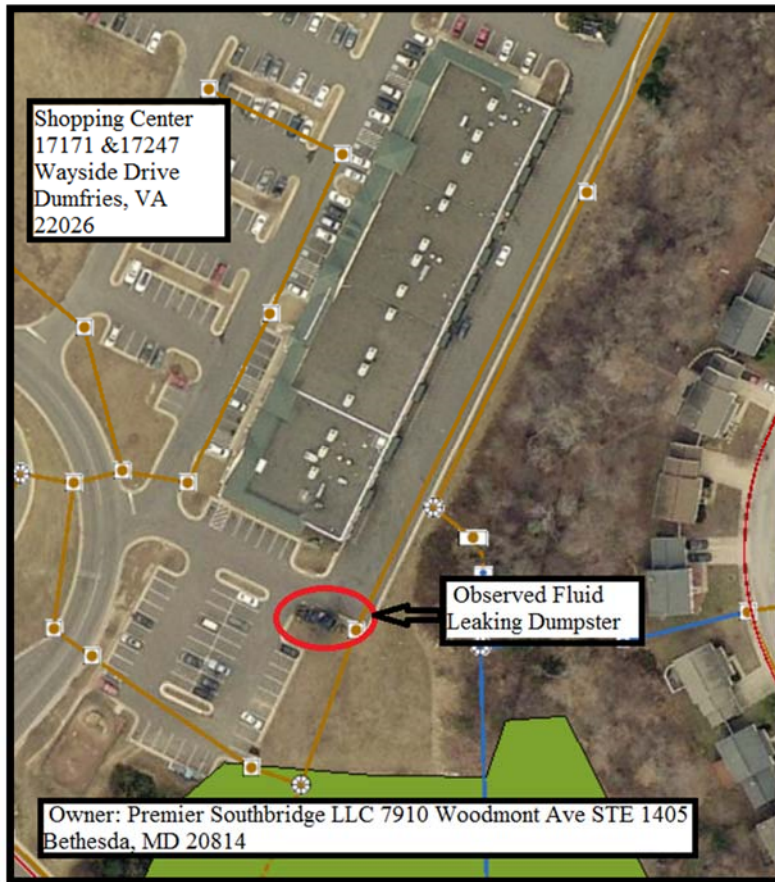
Upon arrival on site in routine inspection on 10/08/2015, the dumpster located at 17247 Wayside Drive found leaking and discharging grease and waste food fluid in to storm sewer drop inlet. Oil/grease residue was found to be staining the asphalt in the direction of the storm drain.

Figure 1: Site map showing discharge flow path through the storm sewer system.

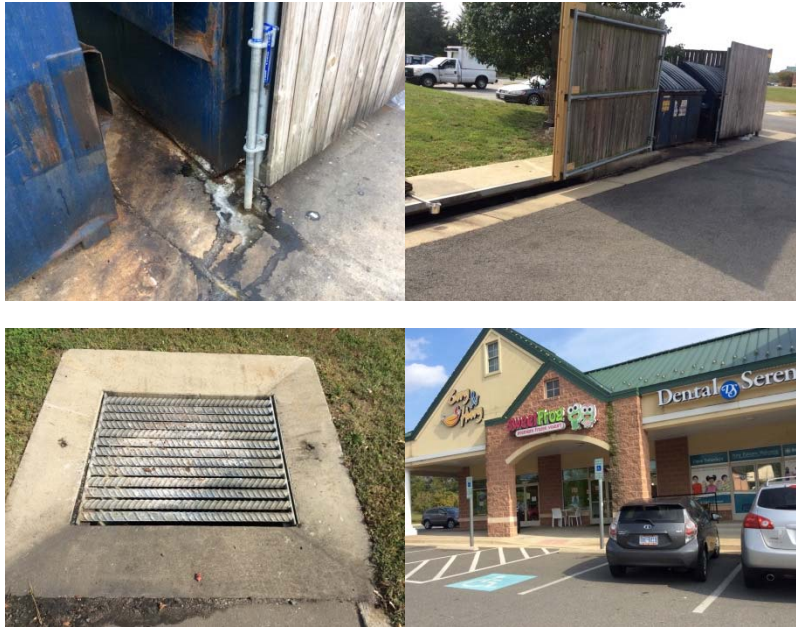
It was clear and visible that the dumpster was leaking contents which were being washed into the storm drain during rain events. Moreover the drop inlet located behind restaurant the Curry in Hurry and Sweet Frog found to have stain of waste food dumping on its gratings.

The meetings with the employee of various restaurants located in this property were made to aware them about an unlawful dumping and discharge. The owner managed the property from outside so meeting couldn't possible with the owner during inspection.

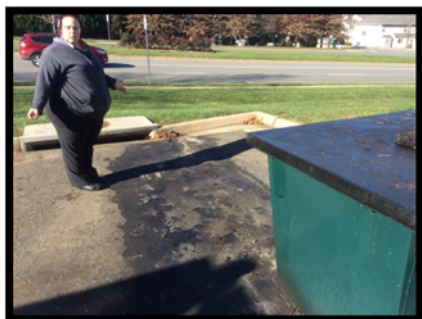
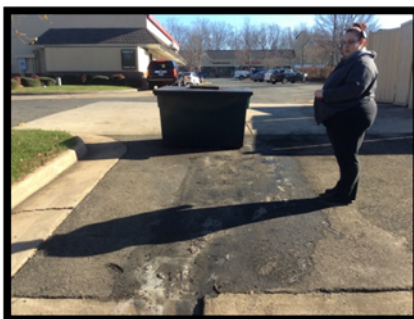
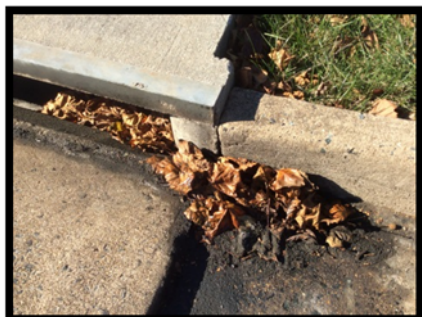
Pictures:

Inspected Facility: Burger King	Address: 5301 Waterway Drive Montclair, VA 22191
Date of inspection: 12/04/2015	Inspected By: Prem Poudel
Inspection Note: Aforementioned Burger King facility was re-inspected to verify the continuation of mitigation measures, on issued NOV 2015-09, taken by the facility owner on 12/04/2015. After getting call from Manager Rina, re-inspection made (11/12). Mitigation measures found to be completed as requested except removal of grease collection tank far from storm drainage inlet. Re-inspection again made (12/04). Grease and oil again found to be spilled and flowing towards storm drain. Even though it was corrected in 1st re-inspection, the case was repeated again so NOV 2015_10 issued to mitigate deficiency as per NOV. Assistant Manager Nadalie Woolfrey said; the emergency call made to the cleaning company this morning. She promised, the problem will be solved on 12/07 including relocation of tank far from storm drain.

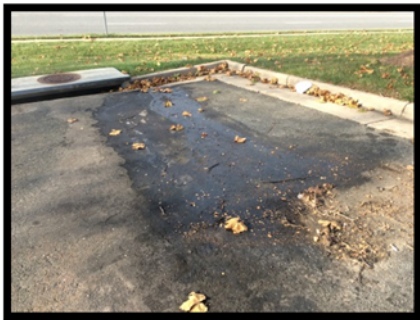
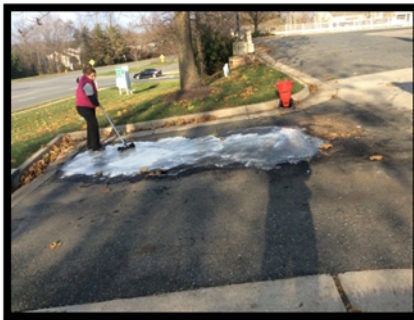
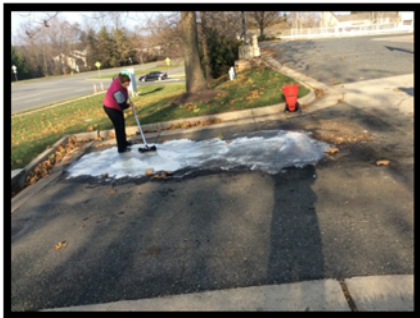
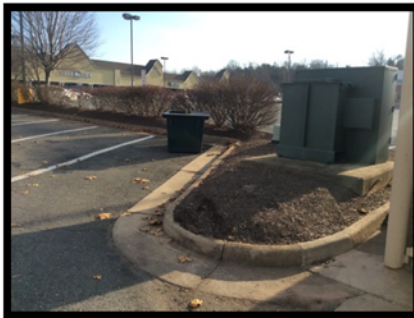
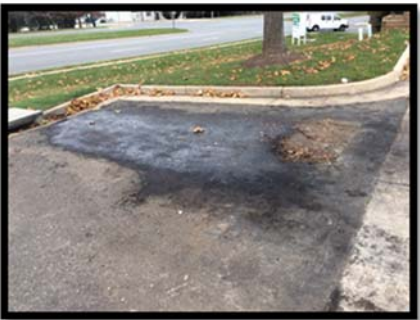
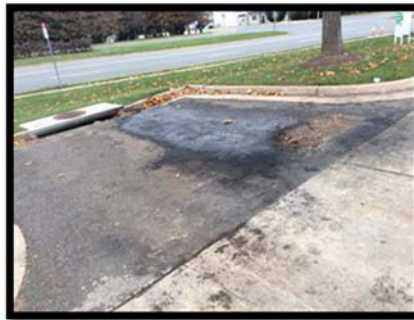
The business facility was re-inspected on 12/11/2015 and 12/14/2015. The grease and oil collection tank found to be removed from close to far of storm sewer inlet. The store manager had begun cleaning herself on my arrival on 12/11/2015 (Picture 2nd & 3rd). The cleaning chemicals was found to be absorbed with cleaning device and squeezed into red container for disposal into sanitary sewer. The 1st picture was existing condition after removal of tank. Grease and oil collection tank found to be removed in new location as shown in 4th picture below. The site was again re-inspected on 12/14/2015 and found as shown in picture 5th and 6th.

Now the tenant found to be aware to protect storm sewer system from spilling and dumping an illicit discharge. The case has been closed but periodic inspection will be continued in future to assure mitigation effectively.

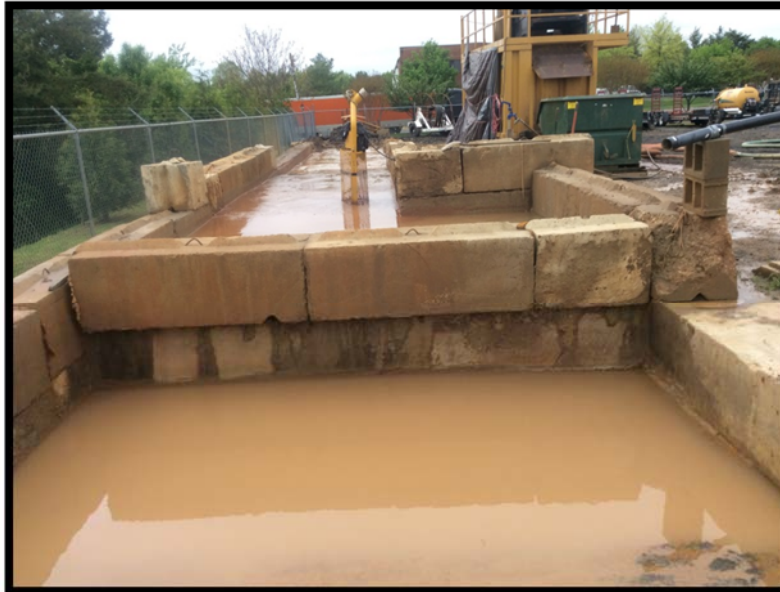
Zone-1 (Dump sludge into Settling Chamber)

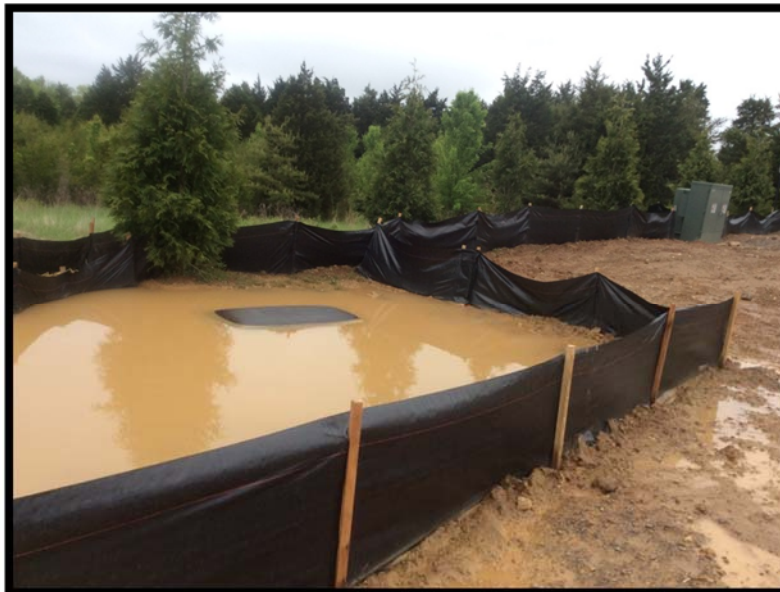
Zone -2 (Silt fence around outlet of settling basin with mud bag)

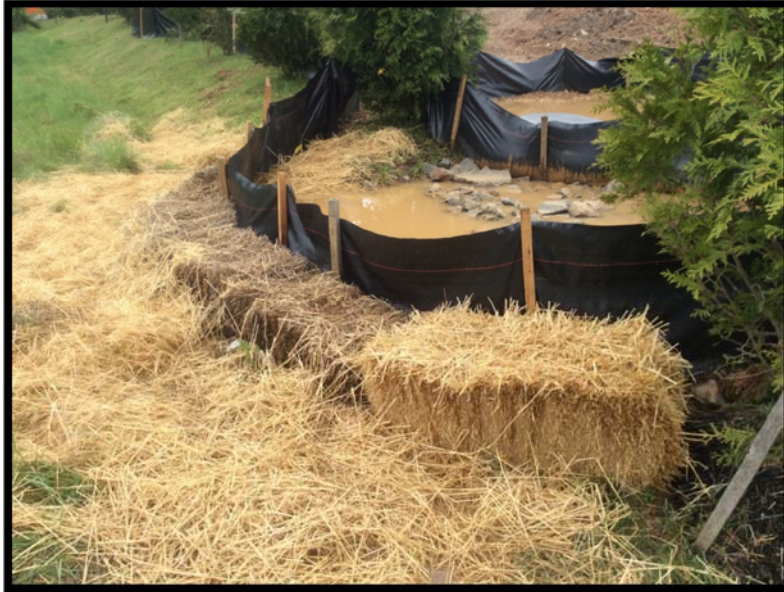
Zone -2 (Silt fence around outlet –Double step with additional Straw Bale Barrier)

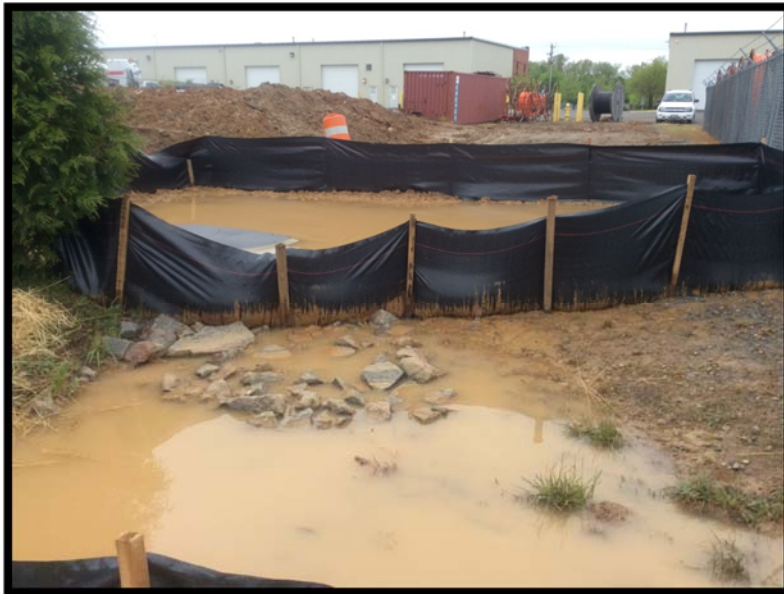
Zone -2 (Silt fence around outlet –Double step)

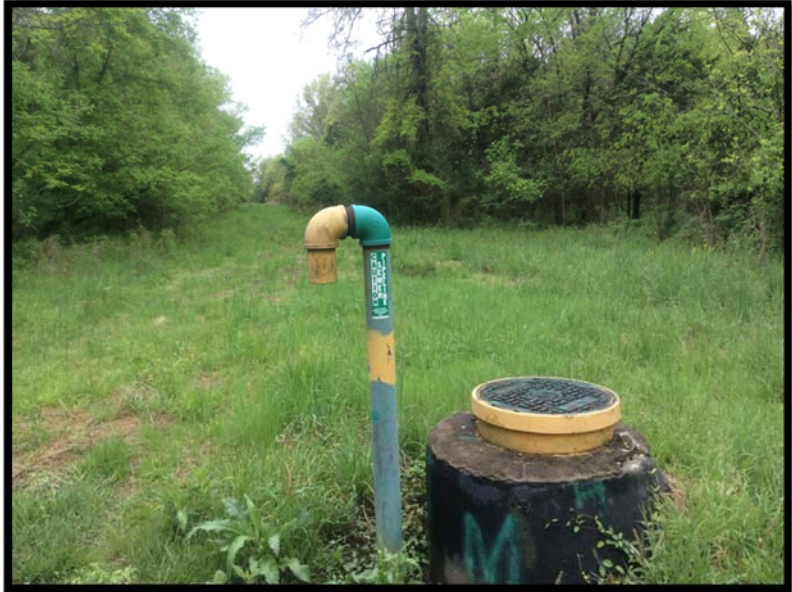
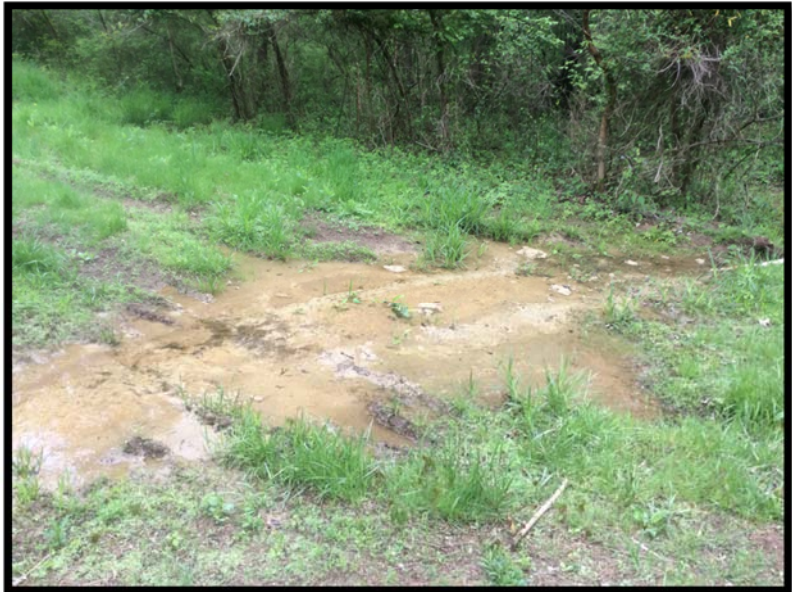
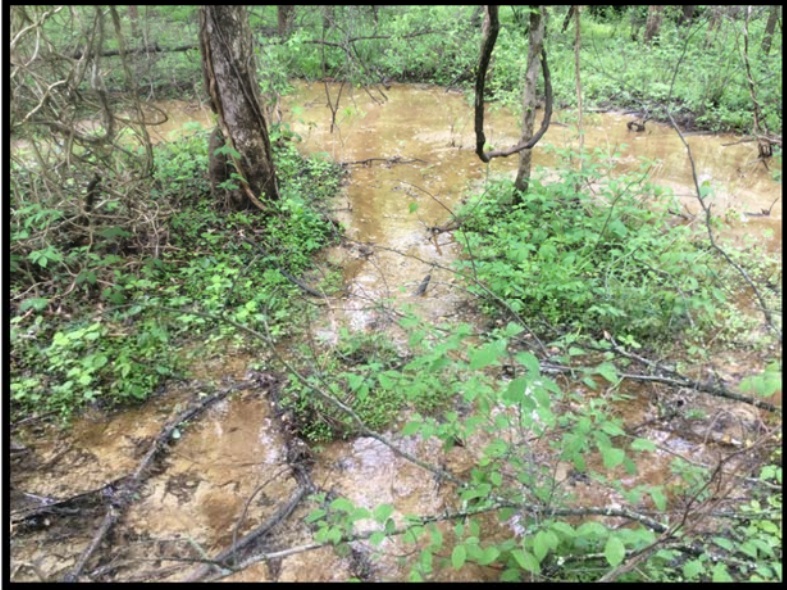
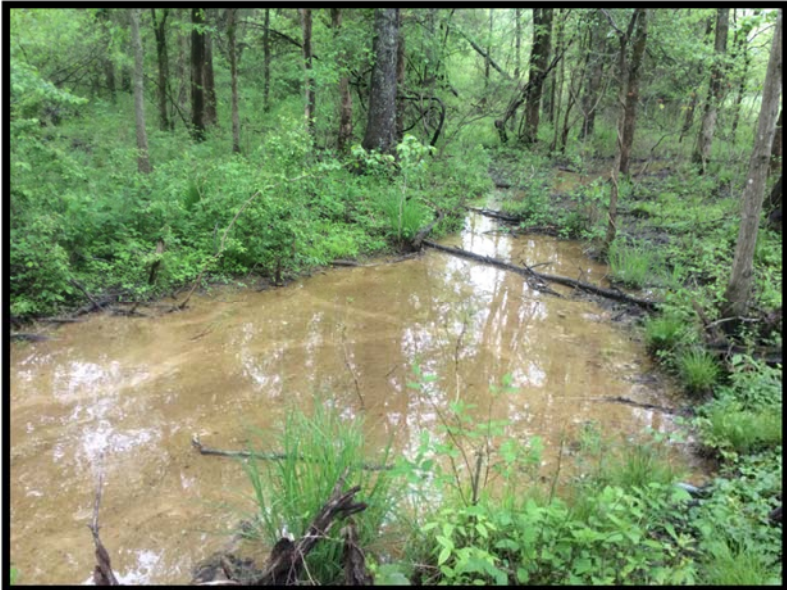
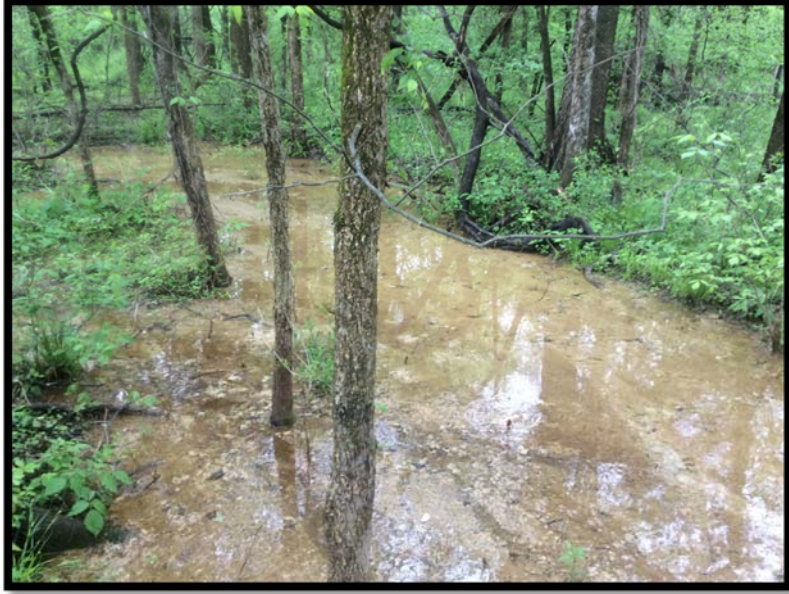
Re-inspection made on 5/2/2016. Company N TO N CORE LLC has been started sediment control measures with Silt Fence and Straw Bale Barrier. Field inspection was made together with N to N Fiber Inc. President, Mr. Stephen Noone, his supervisor and me. Mud Bag found to be used for outlet pipe. Still there was some minor deficiency in perimeter control. Immediate corrective actions were suggested to make more effective sediment control. After the rain event of this week, company had a plan of sediment control with Diversion Dyke with permanent stabilized with turf, Mr. Noone said. Sediment found to be found to be controlled within their boundary. The clean water observed flowing into downstream shrubs and channel. The follow up inspection will be performed after 15 days.

Second re-inspection made on 5/24/2016. Because of continuous rain events in last two weeks, the company didn't get enough time to adopt permanent sediment control measures. Discharge of sludge found to be controlled flowing over their property. The step found to be started making permanent control.

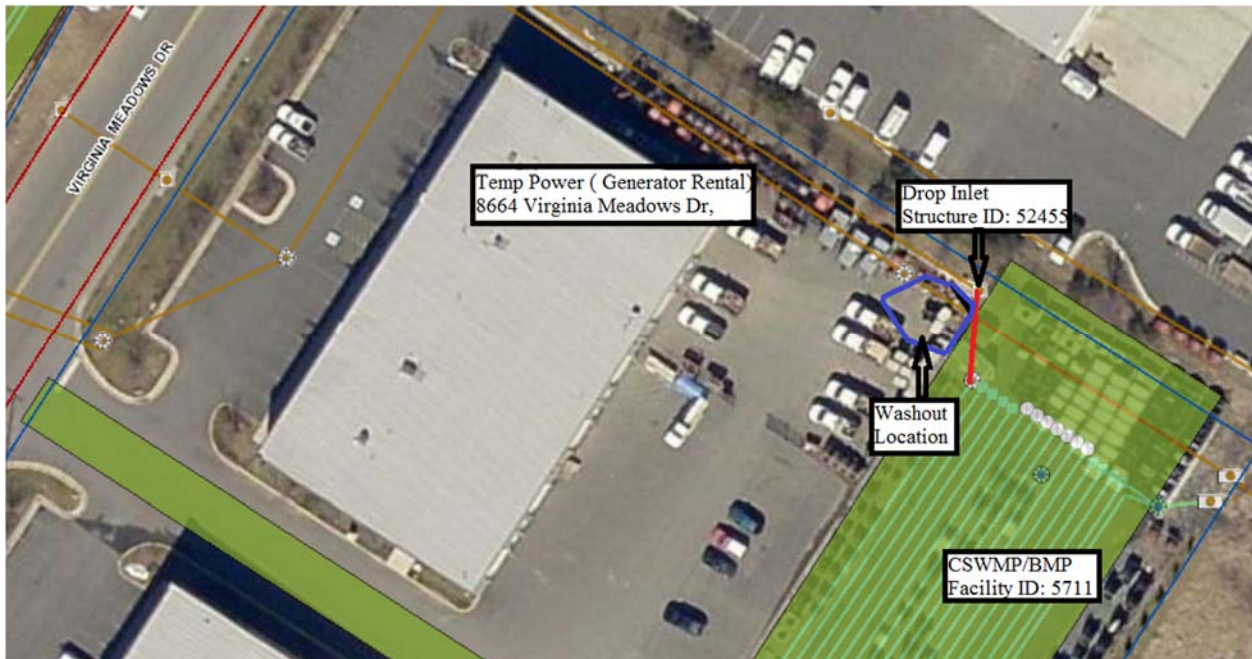
Upon arriving on site for routine inspection for dry weather discharge screening, the employee of Temp Power (Generator Rental) company was washing their commercial generators with chemicals nearby drop inlet and wash water found to be directly discharged into drop inlet.

Figure 1: Site map showing discharge flow path through the storm sewer system.

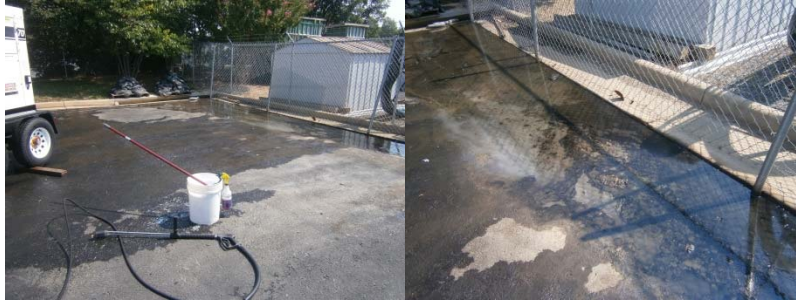
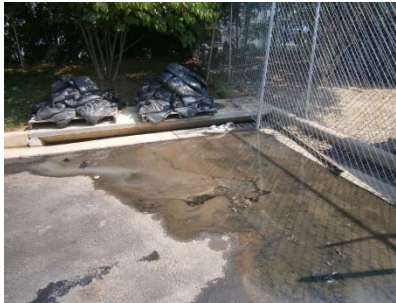
Track down of the discharge was not necessary as the discharge was discovered at its source. The discharge received at drop inlet 52455 found to be discharged in to commercial storm water management pond/BMP before discharging to the field.

The activities confirmed to be an illegal. The request made to stop those activities immediately and meeting made with responsible representative Mr. Chris Crafton. A NOV (#2015-06) was issued. Temp Power is responsible to immediately stop discharging of pollutants to the storm sewer system, and mitigate any effects from such discharges according to County Ordinance 23.2-41 Unlawful discharge to the storm sewer system. Mitigation should occur within 30 days of receipt of NOV as identified by receipt of Certified mail. Periodic re-inspections of the site will be conducted to confirm compliance. Code Case # MSSS2016-00001

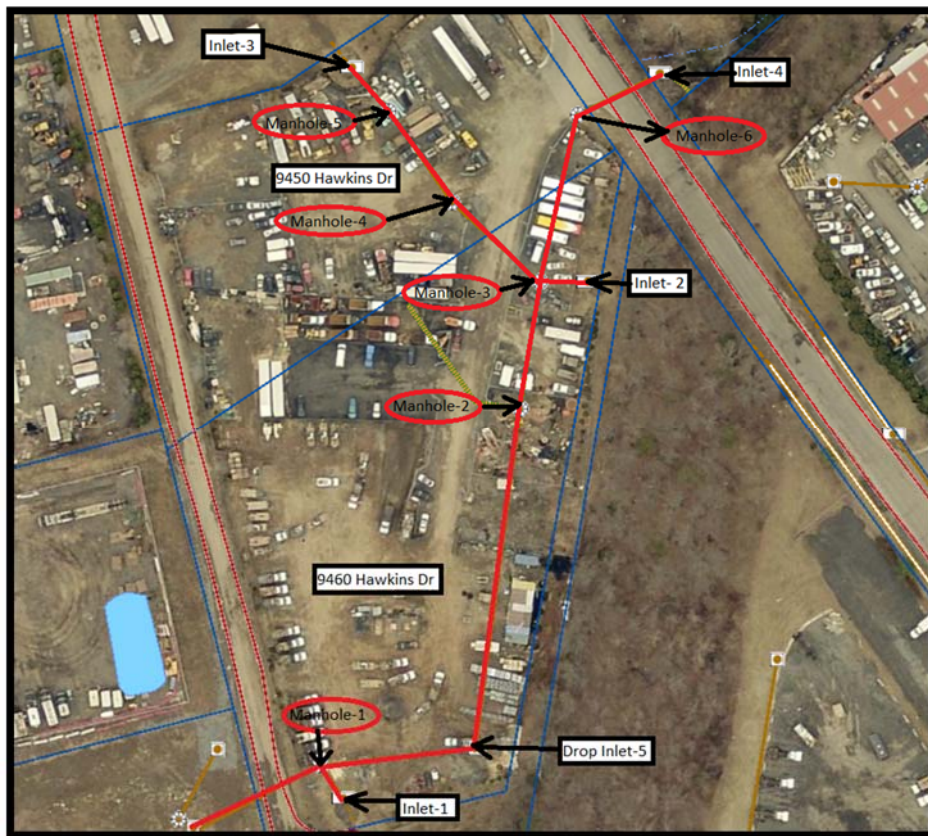
Figure 1: Site map showing discharge flow path through the storm sewer system.

The inspection made for Muller Erosion & Site Services, Inc. The inlet-1, Manhole-1 and Dropinlet-5 found to be located inside their compound. Manhole-1 found to be located along stream sewer. Inlet-1 found to be dry and well maintained. The sand and aggregate found to be stocked much closed to drop inlet-5. The aggregate and sand found to be slightly dropped into drop inlet. The gas tank found to be used for fueling. The surrounding gravel and ground of gas tank found to be stained with spilled gas and oil. The Muller has their own shade for repair and maintenance of their vehicle. The fueling activities don't meet the minimum requirement of fueling center i.e., no double tank, no safety post around the tank etc. The Operations Manager of Muller Mr. Lazaro Torres agreed to protect drop inlet-5 with silt fence and prohibit stocking and receiving vehicles moving over the drop inlet. Inlet 2 and 3 found to be located at the two extreme boundary of the property, getting storm water from adjacent properties. Both inlets found to be more or less free from litters also. Inlet 4 was receiving discharge from open channels.

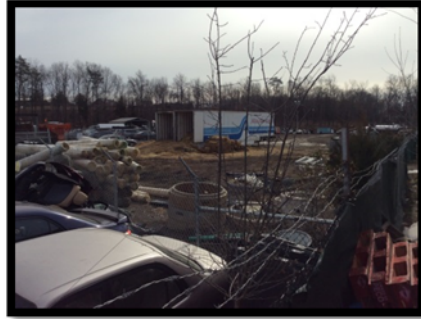
Junk Car Storage

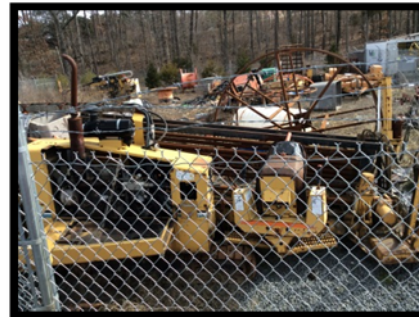
Machine, Cables, soil & org. fertilizer dumping

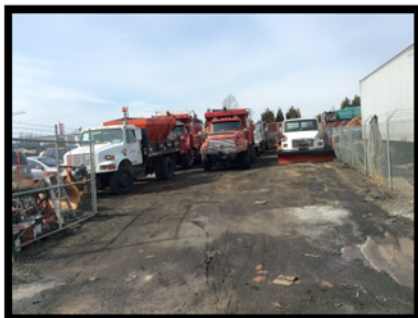
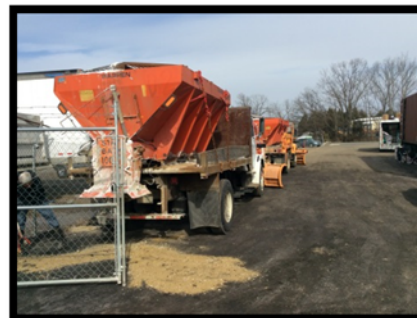
Machine and Materials Storage

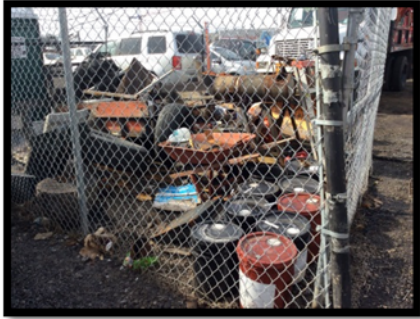
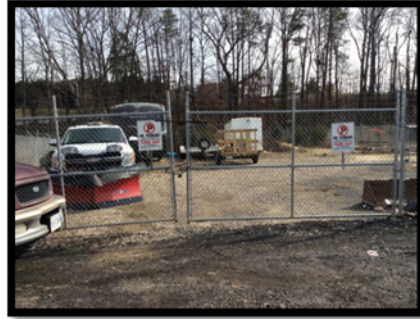
Snow Removal Vehicle Parking

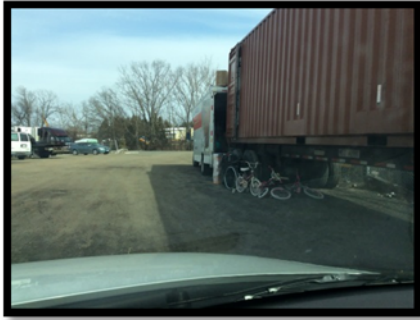
Necessary stuffs (Oil) and Snow Removal Vehicle Parking

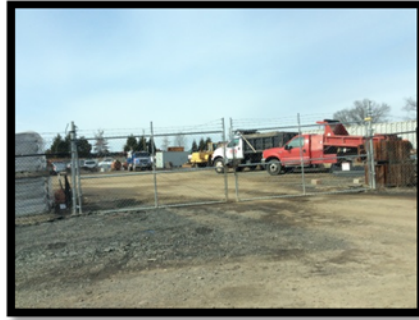
Transferring used stuffs

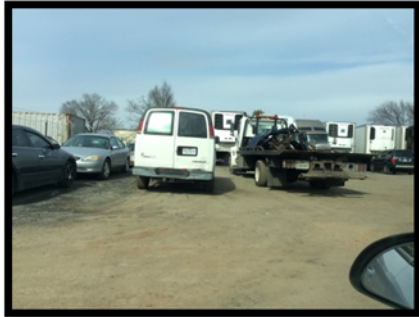
Parking Vehicle & Construction Materials

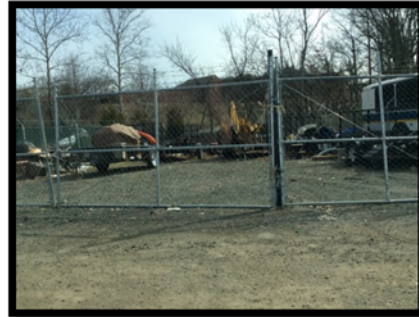
Junk Car and Its parts loading

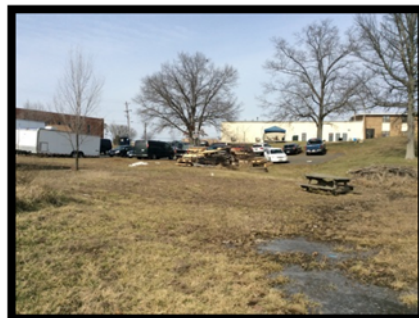
Upstream of Inlet-3

Vehicle and other associated Materials Storage

The ground found to be contaminated with performed business activities which ultimately contaminated storm water runoff as well as ground water due to percolation in rainy season. The zoning section need to be verified whether such business activities allow in this property or not. Since it has located in industrial park, the property owner must have business permit with storm water pollution prevention plan which didn't display at site. Even though there was no flow thru inlet 1, 2, 3 and 5, the runoff during rain event ultimately enters into storm sewer system. Categorically following deficiency need to be immediately corrected to prevent an illicit discharge into storm drainage system.

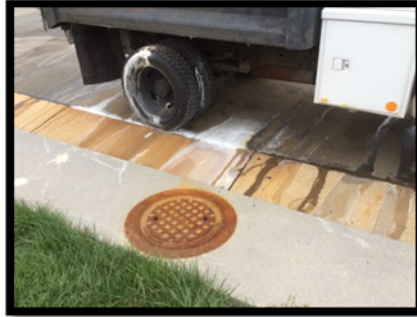
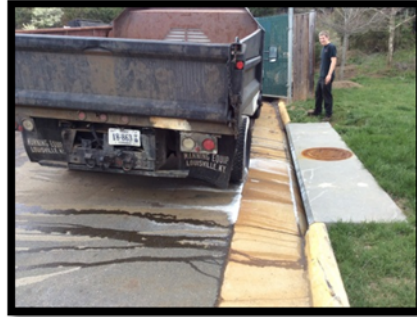
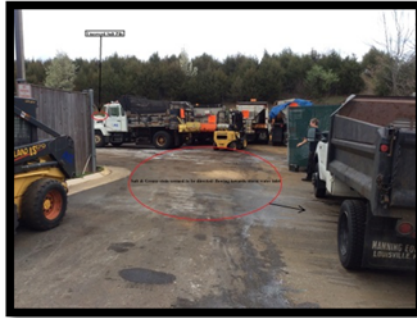
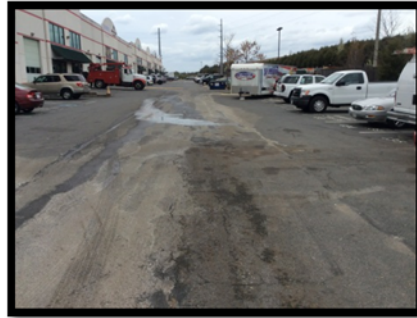
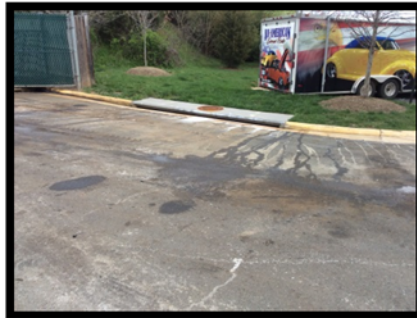
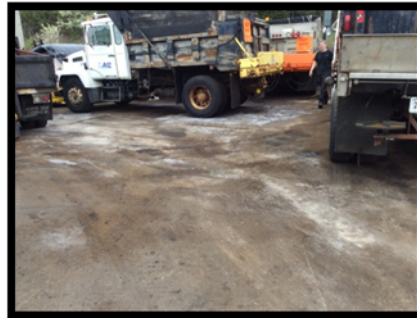
Upon arriving on site, The Shane Enterprises facility found to be much messed by keeping salt pile uncovered, spreading salt residue and leaving grease stain everywhere. Moreover, the mark of grease and salt stain found to be washed away into the storm water drop inlets, located at curb and gutter outside their storage boundary. Even though, undersigned didn't observe the cleaning activities, water has to be applied before my arrival which can be seen wet marks towards storm water inlet. The truck found to be standing beside storm water inlet having plenty salt stain on its wheel.

Track down of the discharge was not necessary as the discharge was observed at its source. The storm sewer travels thru the industrial complex having multi business including automotive services before discharging into a SWM facility. The meeting made with in charge of Shane Enterprises who found to be aware about environmental hazards due to their work practice.

As the practice of Shane Enterprise confirmed to be violation of county code 23.2-4.1, the notice of violation (NOV, 2-2016) has been issued to the company to correct the deficiency with following corrective action plan.

- 1) Immediately cover or remove the salt piles to prevent being washed away into storm sewer during rain events.
- 2) Stop spilling & spreading grease and salt on pavement surface to prevent being washed away into storm sewer during rain events.
- 3) Clean the stains of grease and salt debris having on asphalt pavement to prevent being washed away into storm sewer during rain events.

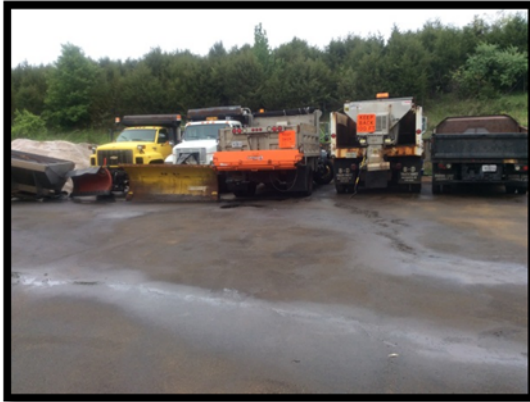
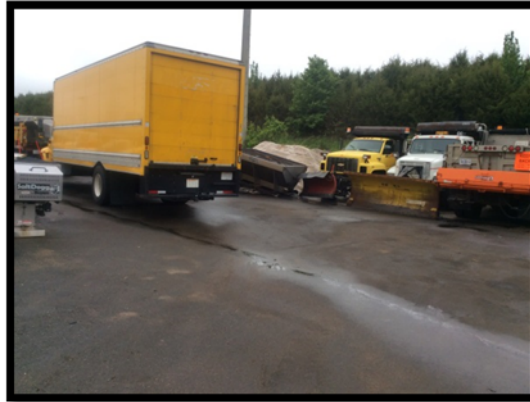
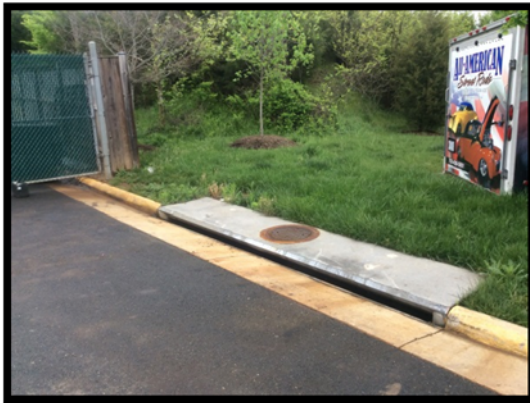
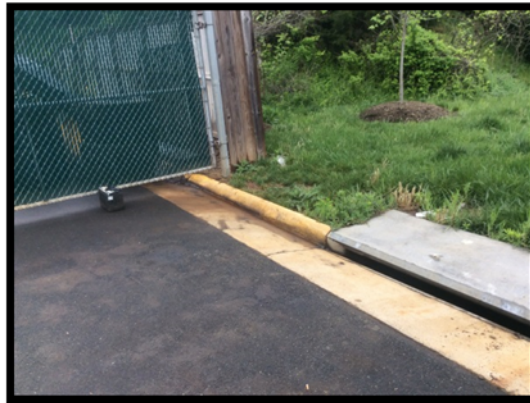
A Follow-up inspection was made [5/2] for corrective measures related to NOV#2-2016 issued on 04/04/2016. Corrective action for cleaning of salt stains adjacent to the drop inlet was completed but the salt stock pile inside the compound was still found to be uncontained, and allowed to be washed away during storm events and to flow towards the storm water inlet. This was identified as the main source of the illicit discharge violation. Current corrective measures were found to be inappropriate to control an illicit discharge from the property. Please install appropriate measures to ensure the confinement of salt to prevent further discharge. Following pictures were taken on 05/02/2016. The follow up email has been sent in aforementioned contact info.

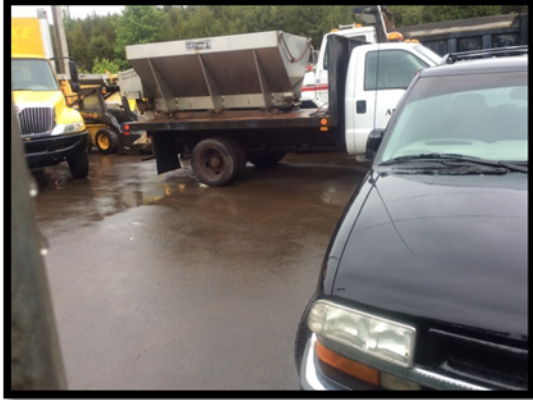
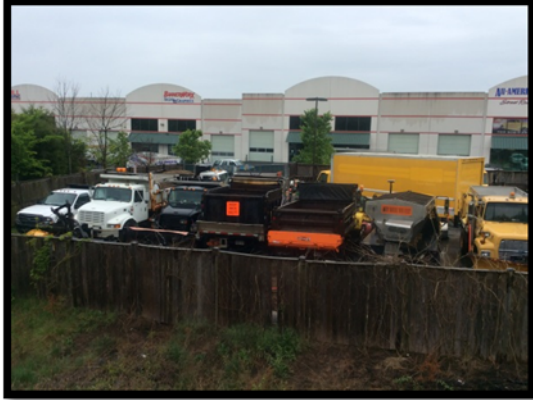
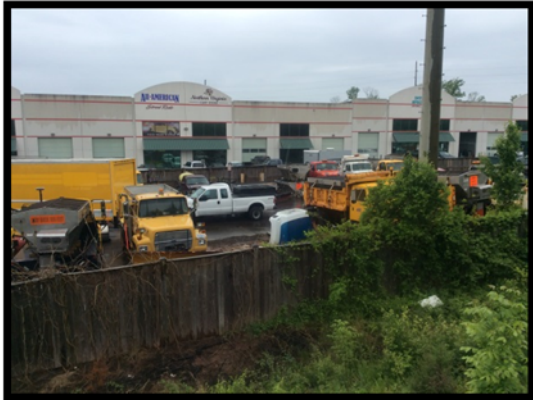
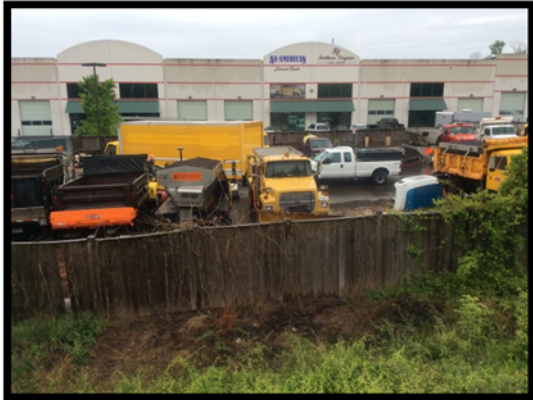
Second follow-up inspection was made [5/6] for corrective measures related to NOV#2-2016 issued on 04/04/2016. Corrective action for cleaning of salt stains adjacent to the drop inlet was completed before first re-inspection but the salt stock pile inside the compound was still found to be uncontained. Follow up email had sent to Mr. Jim, the Manager of Shane Enterprises to employ an appropriate corrective action for deficiency mitigation. The salt stock pile found to be removed before second re-inspection. Since it has found to be one of the hot spots of unlawful discharge into storm sewer system, the follow up inspection will be continued in future. Following pictures were taken on 05/06/2016. The case has been closed for now.

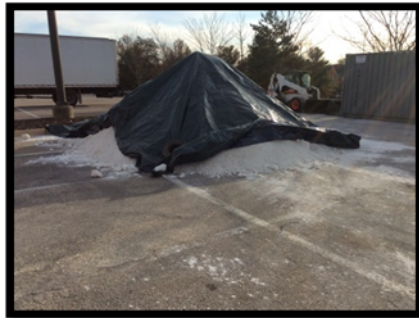
Before correction

The complaint, about uncovered salt piles on parking lot beside Lowes of smoke town plaza, has been reported by Mr. Dan Michaelson of DEQ on 02/11/2016. Upon arrival, a large pile found to be partly covered on top with small blanket. The noticeable another spot observed, that must be the location of previous stock pile used before but still there was some residue left over.

Partly covered salt pile

2) Collect and confine the residue from previous stock pile so that it does not wash way by snow or rain water.

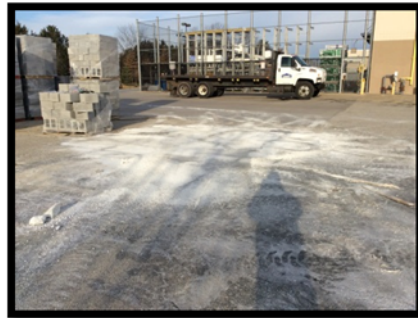
Residue left over the another pile location

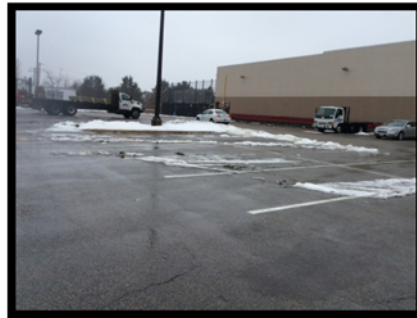
After Correction

No sign of stock piles

The property management company agreed to correct the deficiency at the end of day. Since the management company located offsite, NOV didn't issue.

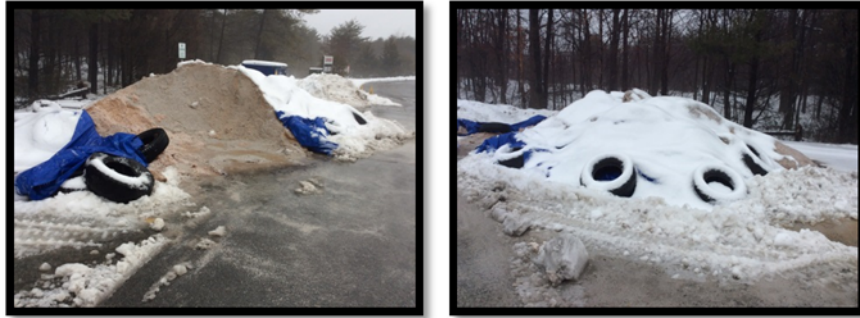
Before correction

The complaint, about uncovered salt piles on parking lot beside Auto Spa Car Wash, had reported by Mr. Dan Michaelson of DEQ on 02/16/2016. Upon arrival, the site found to be located behind the Aerobics Center instead of Auto Spa Car Wash. A large pile found to be partly covered and left without recovered after taking salt from stock pile. Three crews were found working for snow removing from side walk. The foreman gave me the name and phone number of contractor. The contractor known to be Emery Snow Removal and responsible person was Mr. Jim Emery (Cell phone- (571)212-2030) to maintain this shopping center.

Partly covered salt pile

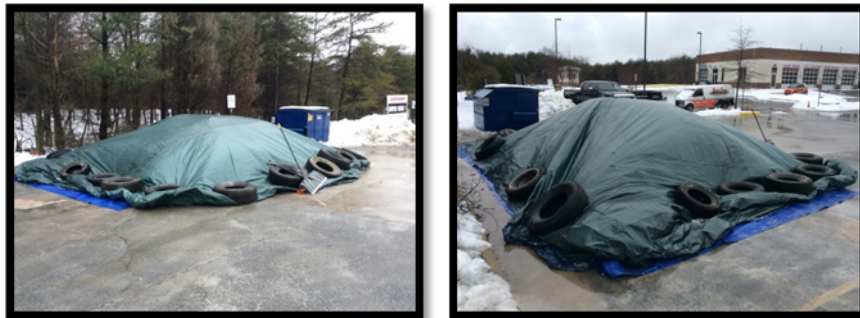
After Correction

Properly covered & no contact with flowing water

The call made for contractor. Mr. Jim immediately arrived at site and started work for correction. The mitigation measure suggested completing by covering and protecting the pile from wash way into storm drainage system. The mitigation activities immediately conducted while snow and ice begun melting so the impact of uncovered situation supposed to be negligible. Followings are the pictures before and after deficiency mitigation.

Since the correction made immediately and the impact of uncovered time window supposed to be negligible, NOV didn't issue and case has been closed.

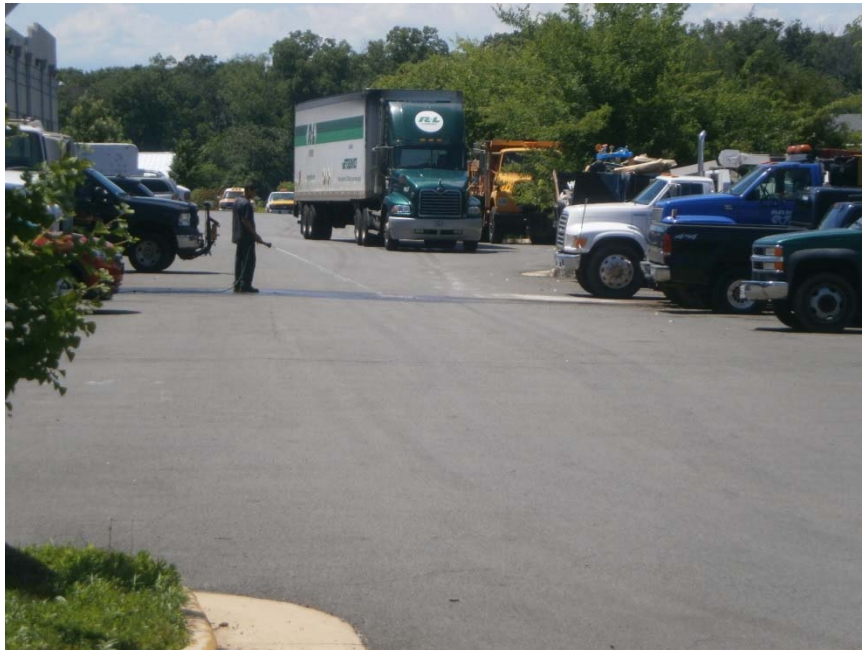
On June 29th, 2015 a complaint was received by Prince William County staff detailing issues with the discharge of pollutants into the stormsewer system at a property on Mike Garcia Drive. Upon arriving on site and meeting with the complainant, it was explained that this issue was ongoing. Video and photos from security cameras was provided to the County displaying previous discharge incidents. Once arriving at the suspected discharge location, an employee was observed washing sediment off of a company vehicle into the curb and gutter, and subsequently a storm drain inlet (See photos). The employee was asked to stop and informed of a violation of County Ordinance. A supervisor was not present and no supervisor information was provided by the employee.

Figure 1: Photo of Discharge.

According to Vehicle markings, employee observation, and discharge location, RAM Hauling inc. was identified as the responsible party for the discharge. A NOV (#2015-01) was issued (included in this packet). RAM Hauling is responsible to immediately stop the discharging of pollutants to the stormsewer

system, and mitigate any effects from such discharges according to County Ordinance 23.2-41 Unlawful discharge to the stormsewer system. Prince William County holds the right to investigate storm sewer system using closed circuit television in order to assess damages at the discharger's expense. Mitigation should occur within 30 days of receipt of NOV as identified by receipt of Certified mail. Periodic re-inspections of the site will be conducted to confirm compliance.

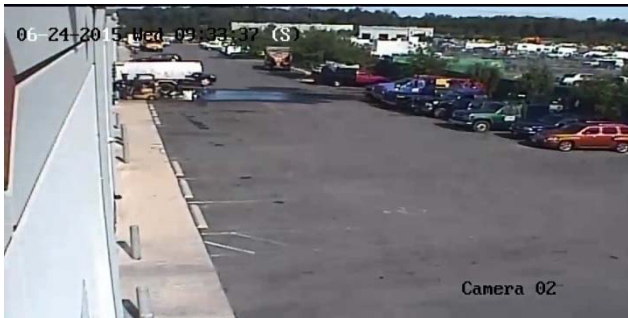
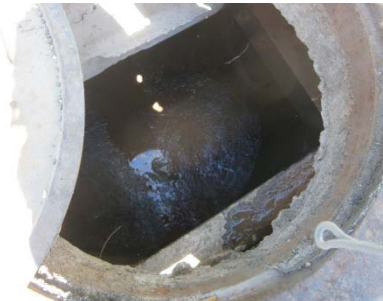
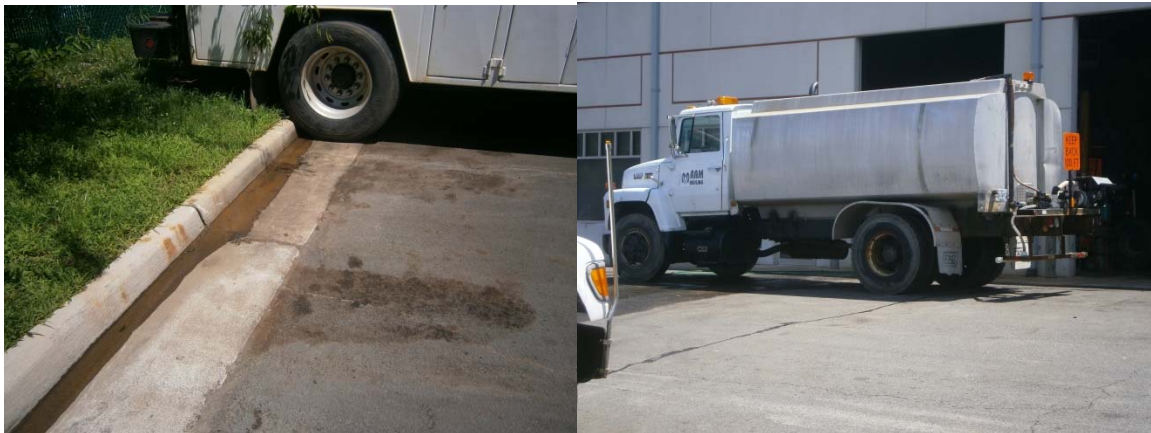
Trackdown of the discharge was not necessary as the discharge was discovered at its source. The stormsewer travels alongside a commercial/industrial complex before discharging into a sedimentation basin/BMP which is currently on bond.

Figure 3: Trackdown Photos

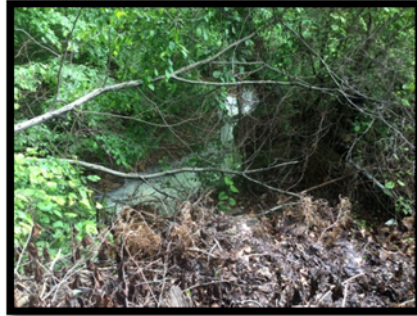
Point D

The creek found to be flowing thru upstream community. Discharge started to track down towards upstream. The SWM Facility 60, located at point C found getting white discharge from inlet creek. Tracking kept continue along the creek. At point B, the white substance observed intermingled to the creek by the discharge getting from outfall 3529. After tracking storm sewer, the paint found to be dump at storm sewer inlet at point A. The house 13711 supposed to be renovating by visual outlook but

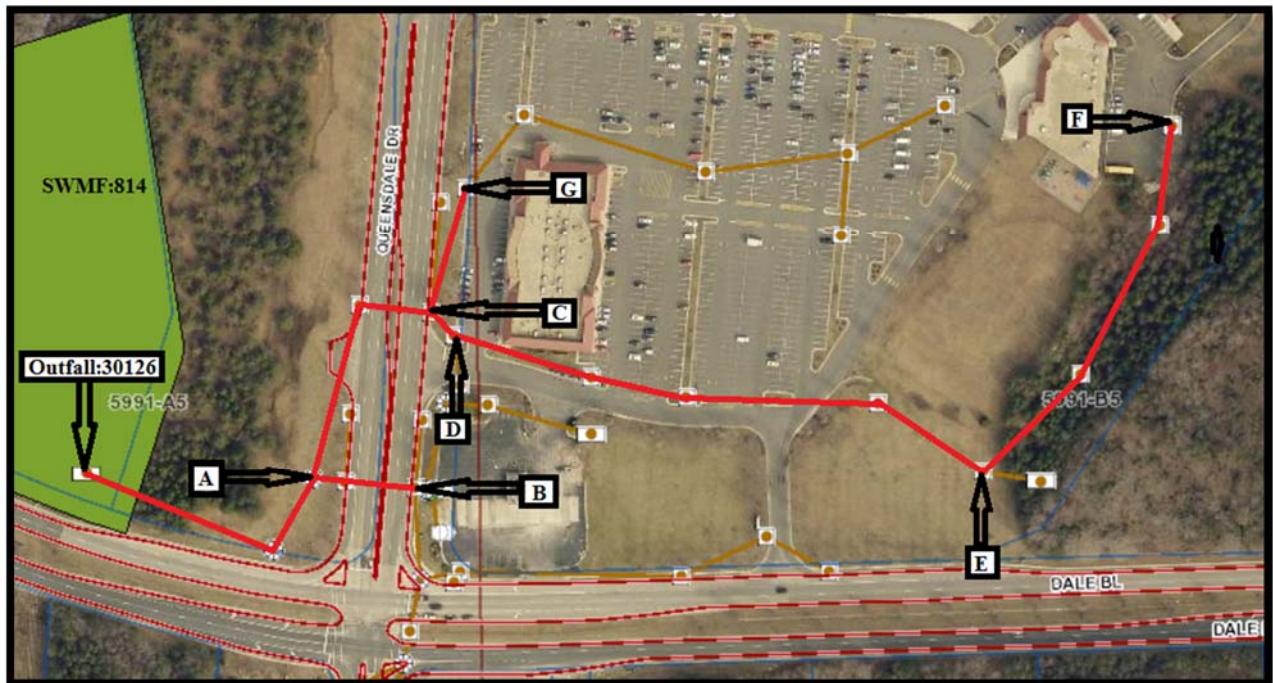
During routine inspection, County staff observed discharge of a greasy substance through outfall 30126 to SWM Facility 814. A Yellow greasy substance was observed floating on the downstream pool and channel. The discharge found to be moderate. Upon initial discovery, the greasy substance appeared to be waste oil with chemicals.

Figure 1: Site map showing discharge flow path through the storm sewer system.

The discharge was then tracked down from the outfall. Manholes A, B, C, D, E, F and G were opened and observed for flow during tracking. At point A, discharges were found to be flowing from both AB and AC directions. At point B, the manhole was found to be moist and clean, leading the inspector to believe that the flow between section AB was due to groundwater seepage. Meanwhile, at manhole C, flow was found to be occurring from the CD direction and a black stain was observed at the bottom surface of pipe GC. Flow was observed coming from the ED direction at point D, and also at manhole E from the EF direction. Manhole F was found to be dry. This led the inspector to believe the main source of flow from the DF direction to be ground water seepage in the pipes between Manhole E and F from located in the low lying woody area on the east side of the shopping center. Also adding to this assumption is the fact that the volume of discharge was found to be gradually diminished as the inspection proceeded toward manhole F. It was determined that the source of the discharge was not from this direction, due to the

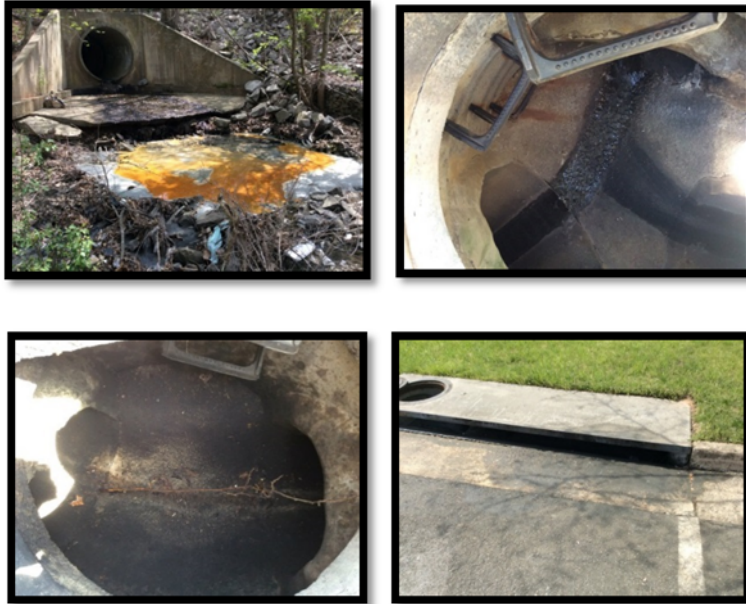
Upon further inspection, a greasy black stain was observed leading to the drop inlet at point G. This was determined to be the source for the illicit discharge observed at outfall 30126. In addition, the grass around the drop inlet at point G was found to show signs of additional dumping and attempted cleanup.

A meeting onsite was made with Ms. Liz Tucker, the property manager of Mapledale Plaza, and subsequently a notice of violation (NOV 3-2016) was issued to Interstate Management Inc. for the discharge of pollutants to the storm sewer system. Interstate management Inc. will be responsible for the cleanup and mitigation of the grease and other contaminants discharged into the stormsewer as manager of the Mapledale Plaza. Action should be taken as soon as possible, but not to exceed 30 days from receipt of the NOV violation packet. Interstate management is also responsible for preventing any future discharges. The County will assist Interstate Management on any training/outreach needed to prevent future discharges if requested.

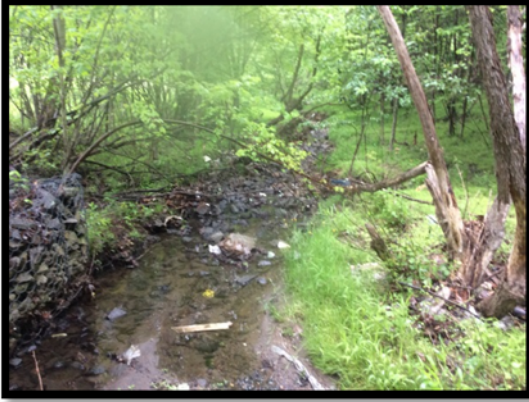
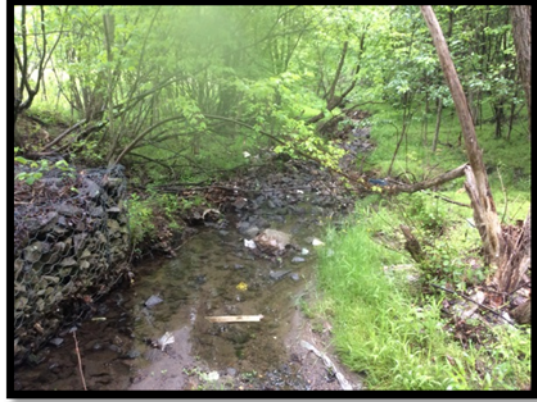
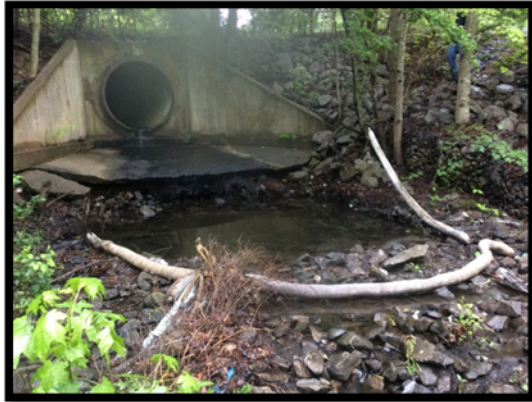
Follow up inspection made [5/11], the greasy materials found to be curtailed and captured by absorbent sock around downstream pool. Downstream channel seemed to be reinstated as pre-contaminated condition.

In-person meeting made with Property Manager Liz Tucker. According to her, one of the county listed cleaning companies; Hepaco, LLC was haired to capture the floating scum on 4/21/2016. The work was completed on same day. The education materials of an illicit discharge attached with NOV were shared with their tenants to create awareness. The case has been closed but follow up inspection will be continued for effective control in future. Following pictures were taken during visit.
