Annual Stormwater Management Report

VSMP Permit No. 0088595 – FY 2016

Submitted by:
Prince William County
Department of Public Works

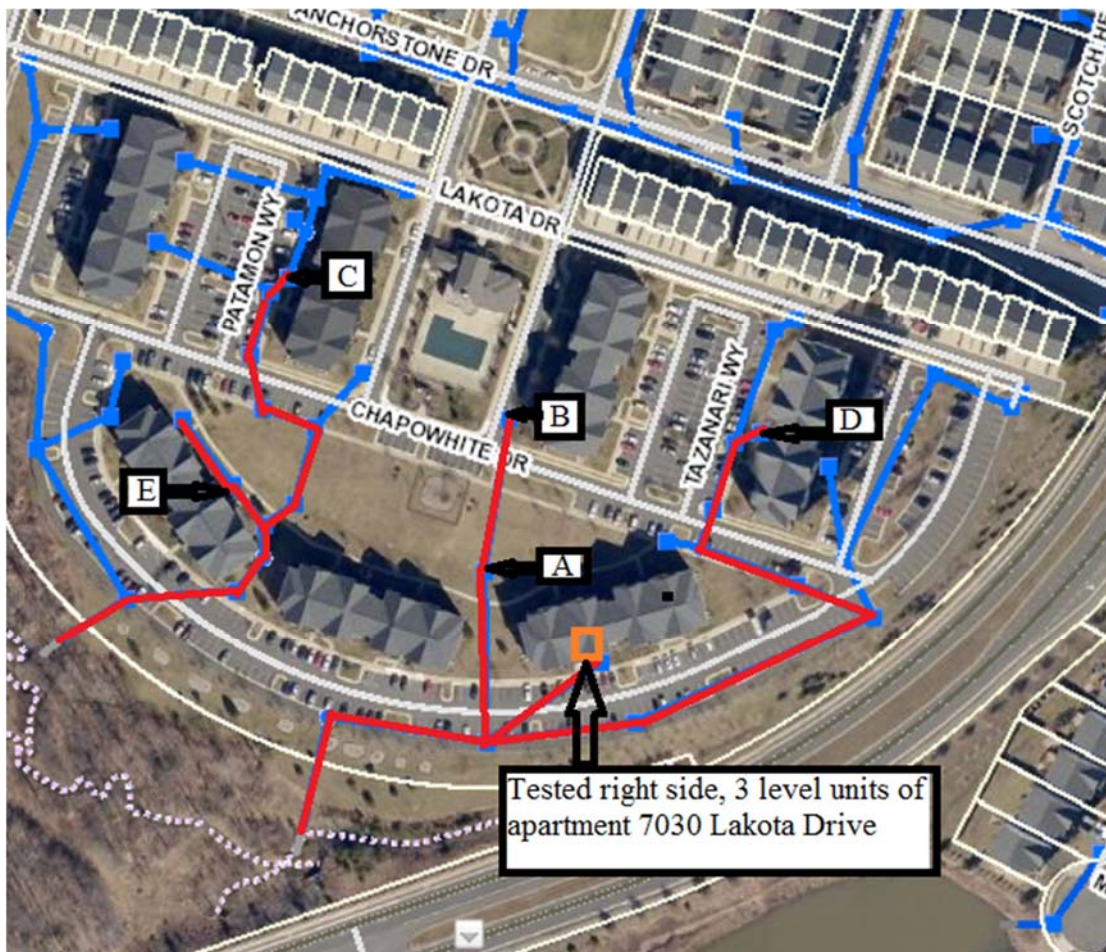
A meeting with County Crossing Center apartment staff was conducted on August 18th to track the illicit discharge reported previously. Along with maintenance supervisor, inspectors employed dye testing at apartment 7030 in south faced right side three level units, and one left side unit. Testing concluded that all tested units are discharging grey water into storm sewer system from the laundry room washing machine drain. It was assumed all apartments in this complex were discharging grey water to the storm sewer system.

Figure 1: Site map showing discharge flow path through the storm sewer system.

It is assumed that gray water connections existed from initial construction and investigations into other similar complexes' on the site was commenced. At drop inlet A, observed flow having detergent odor and stain from AB direction. At Manhole B, PVC pipe found to be connected discharging grey water. Similarly Grey water found to be discharge at points C, D and E via PVC pipe from apartment no 13104, 13001, 13101 and 7050 as well.

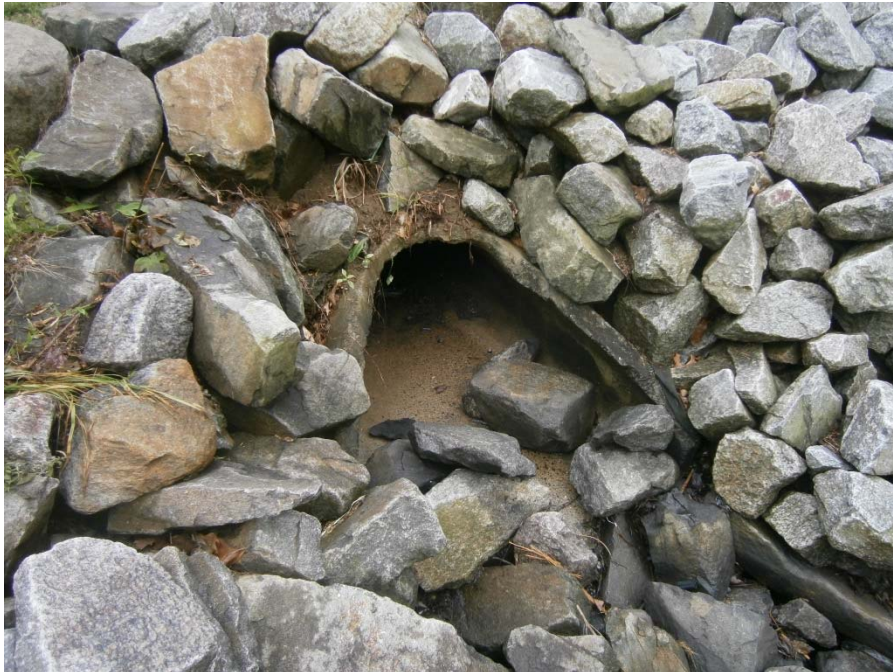
Undersigned observed cleaning of spilt oil stain at the curb inlet, conveyance sewer and outfall. That oily stain found to be reached up to outfall from curb inlet.

Figure 1: Site map showing discharge flow path through the storm sewer system.

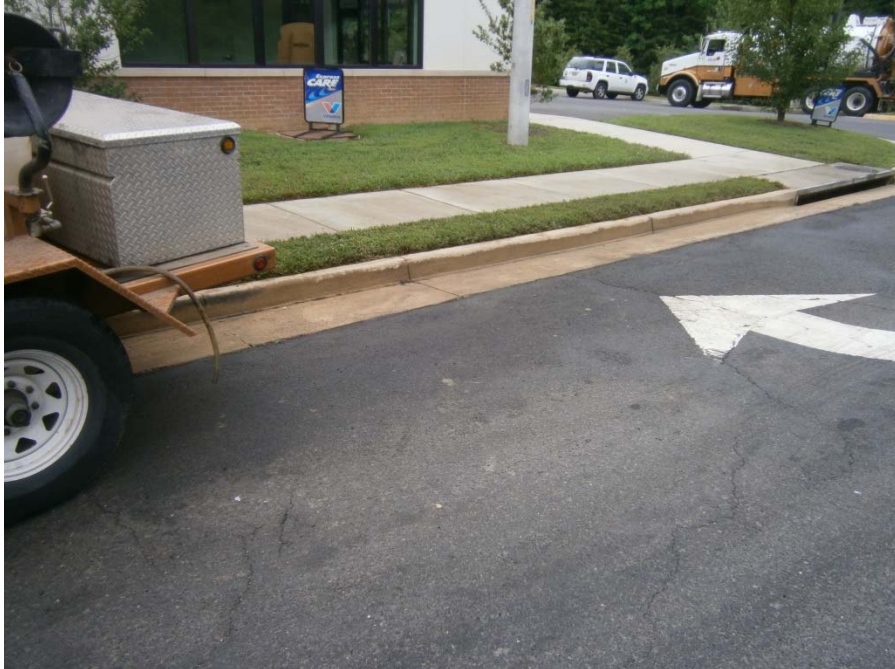
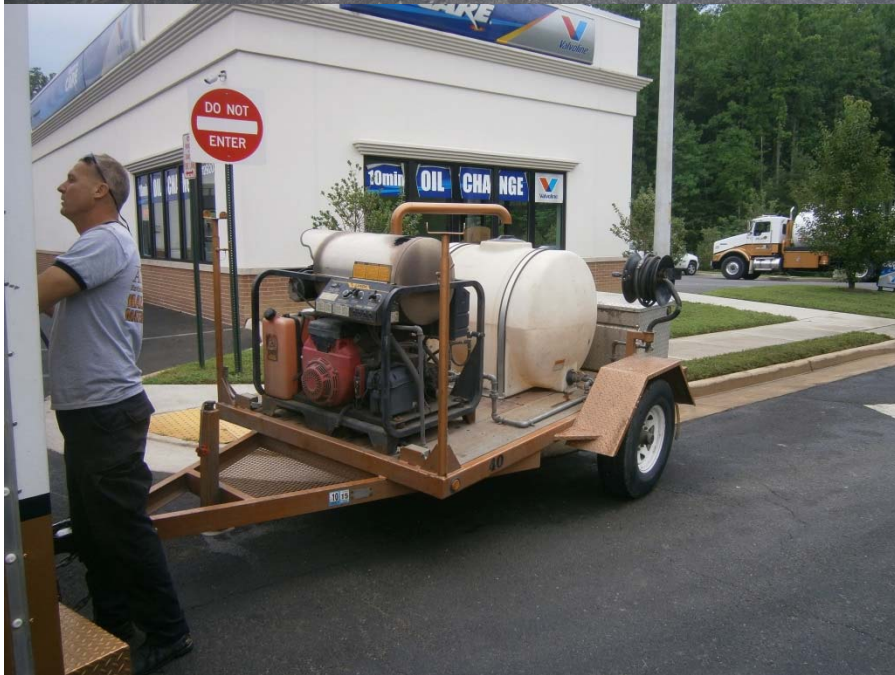
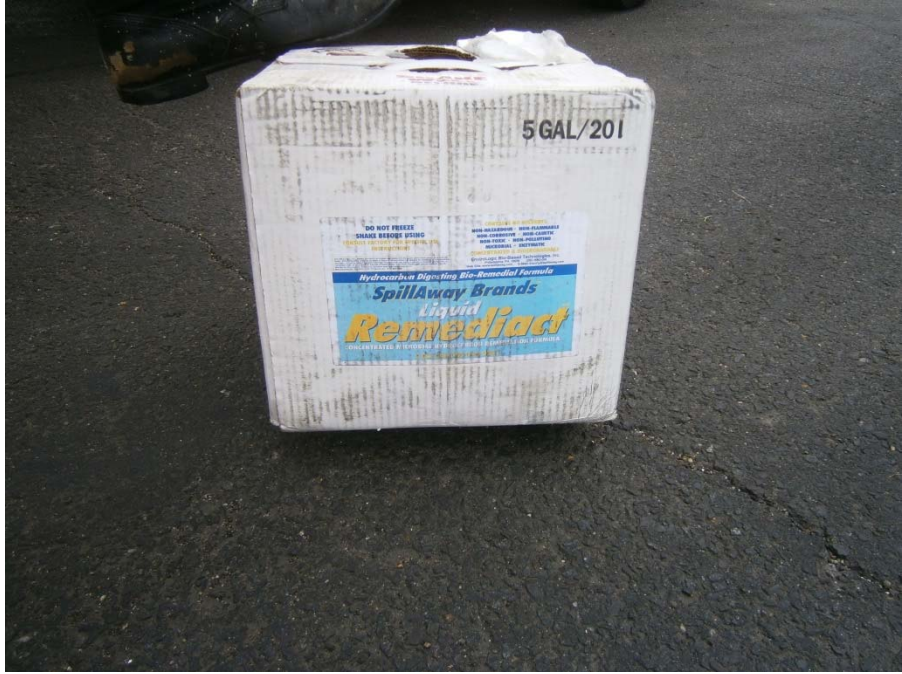
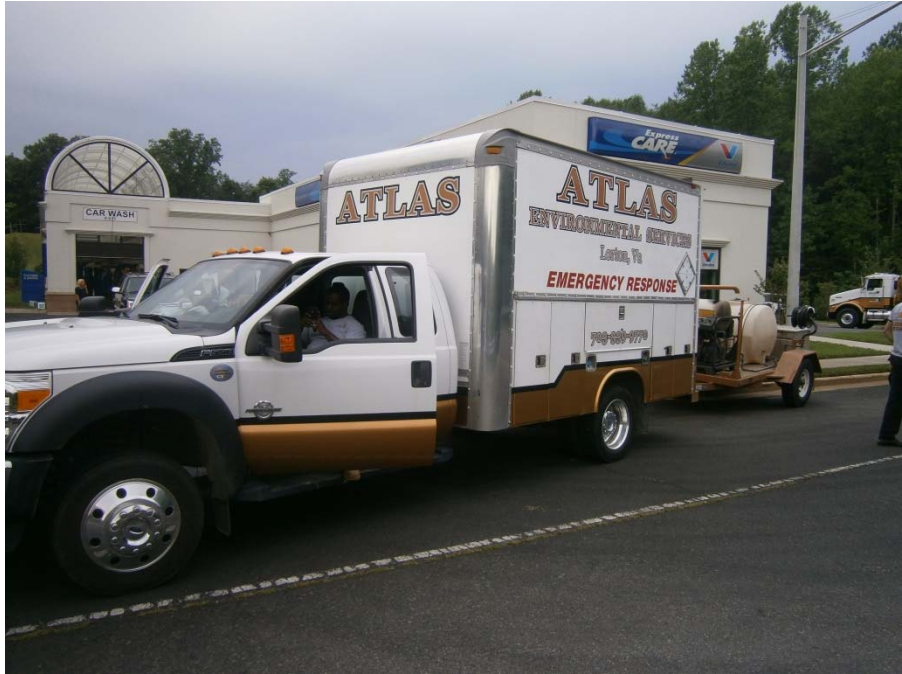
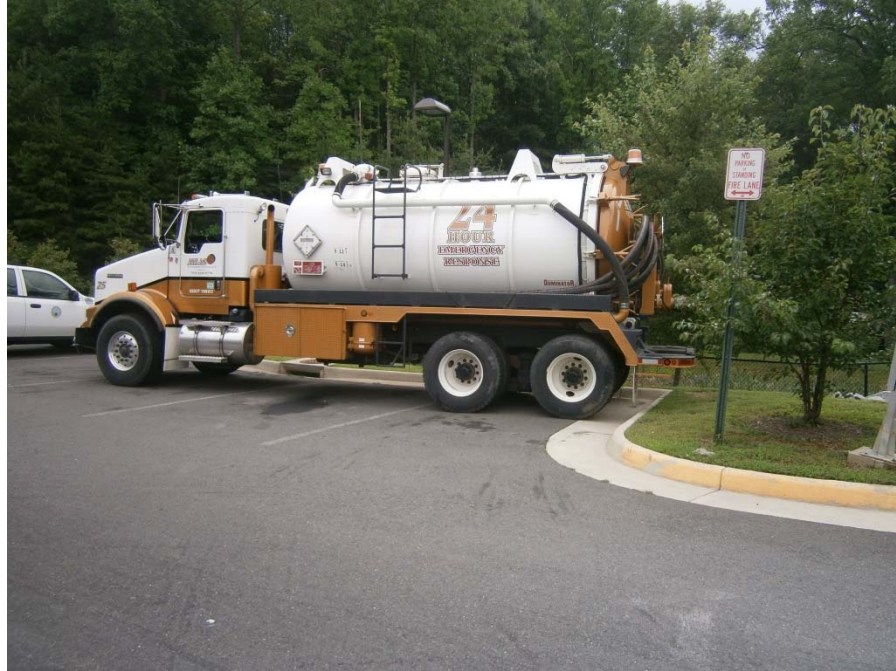
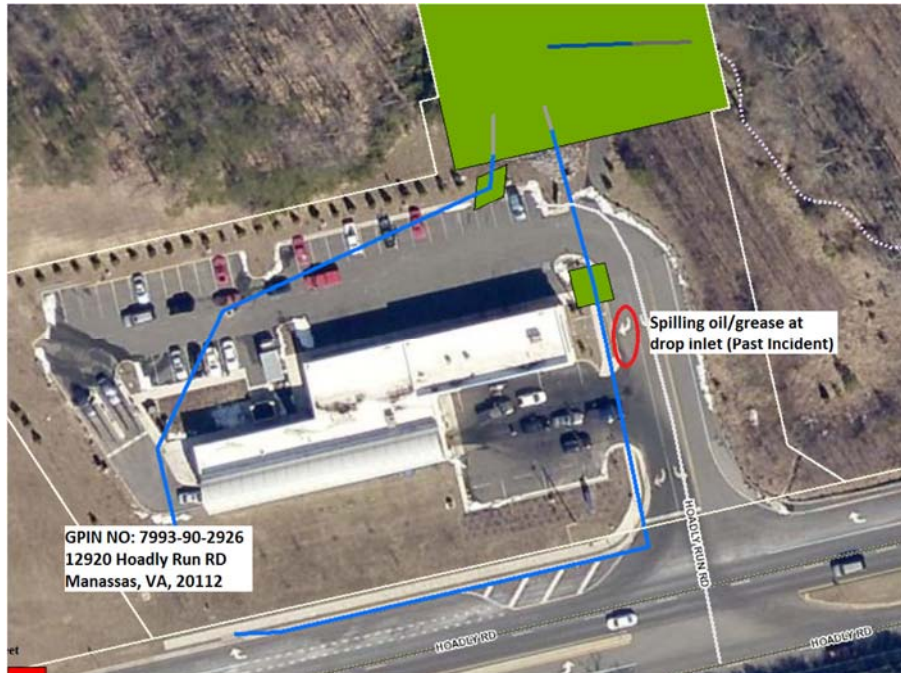
Spilled oil mark found to be cleaned in and around curbs inlet, storm sewer and outfall by professionals of Atlas Environmental Services. The washed chemicals, oily substances and used water pumped into dump truck while cleaning and taken way for properly haulage.

The cleaning of spoilt oil and grease has been completed properly.

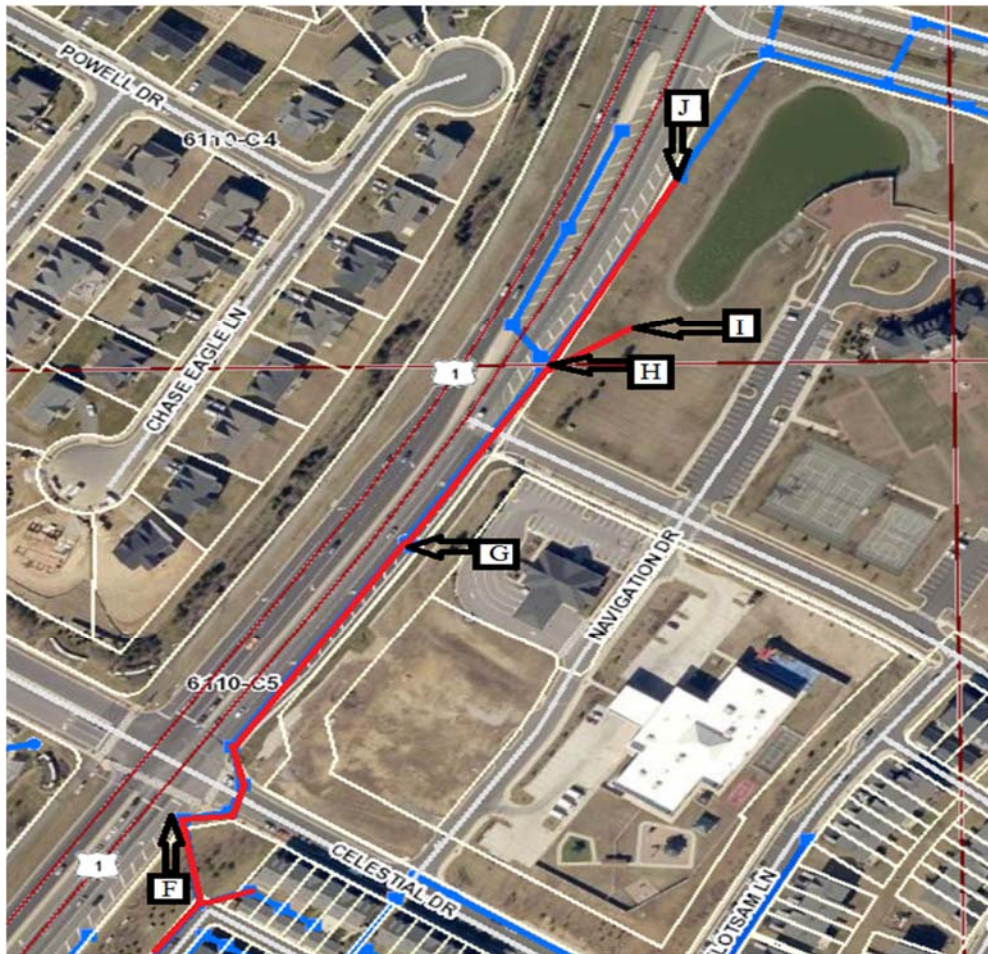
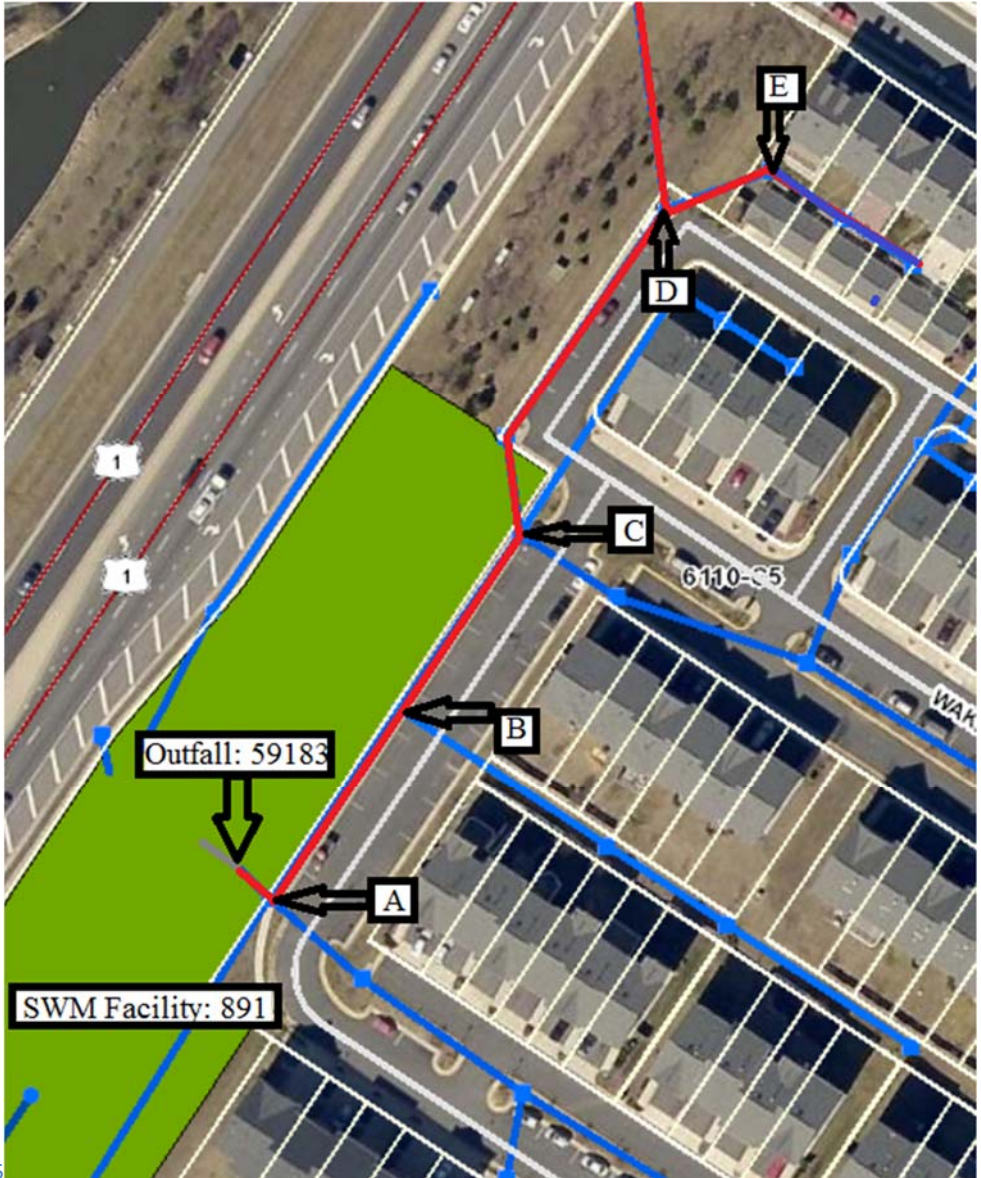
During routine inspection for dry weather screening, outfall found to be discharged flow in detention basin. The nature of flow was shallow. Foam observed on filter fabric placed after outfall but the water sample found to be color and odor less. Storm sewer belongs to outfall 59183 was combine residential, Road and open space areas.

Figure 1: Site map showing discharge flow path through the storm sewer system.

Source of discharge had tracked from outfall. Vault A had baffle wall specially designed for diverting initial flow during rainfall toward pond thru outfall 59182 and pick flow divided both outfall 59182 and 59185 respectively. Flow was observed at points A, B, C, D, F, G and H. The access didn't get thru private property towards branch DE, even though it contained flow. The vault J and drop inlet I found to be dry. There was a fountain at artificial pool of Port Potomac apartment just beside the vault J and drop inlet I. The water quality parameters were found within the standard limits.

Foam found to be developed on filter fabric laid after outfall in detention basin. After tracking discharge it had been concluded that the significant amount of discharge generated by ground seepage thru leaky joints along storm sewer. The inclusive investigation will need to inspect storm sewer, laid in- between houses and parking garage of house no 2739 to 2731 Celestial Drive, in which access was not available at this inspection. Observed foam gassed to be produced by singular events of washing and cleaning with soap, detergent or chemicals in storm sewer commanding areas because there was no permanent stain on structural surfaces and the result of water quality parameter found within the standard limits. The violator could not identify so the case has been closed. However, Periodic inspections need to be done for inclusive investigation since it had been kept in suspected outfall in future.

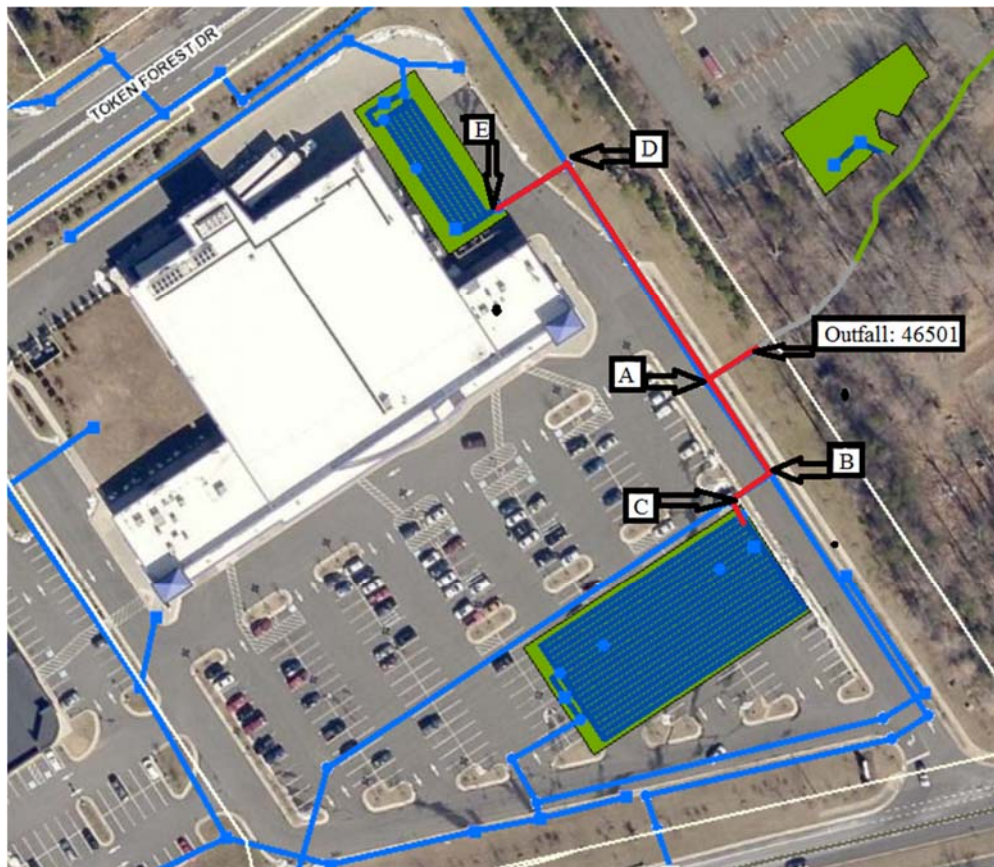
During routine inspection for dry weather screening, outfall found to be discharged flow in stream. The nature of flow was shallow. Algae found to be grown on pipe and pool. Storm sewer belongs to outfall 46501 was shopping center. The storm sewer system found to be connected with two different underground SWM Facilities.

Figure 1: Site map showing discharge flow path through the storm sewer system.

Discharge had tracked down from outfall. Vault A received two different flow from AB and AD direction. At point B, flow observed from BC direction only. At point C, flow received from underground SWM Facility. On the other side, discharge found to be generated from Point E and flowing along EDA. The

field test water quality parameters (Temperature, Conductivity and pH) were found within the standard limits.

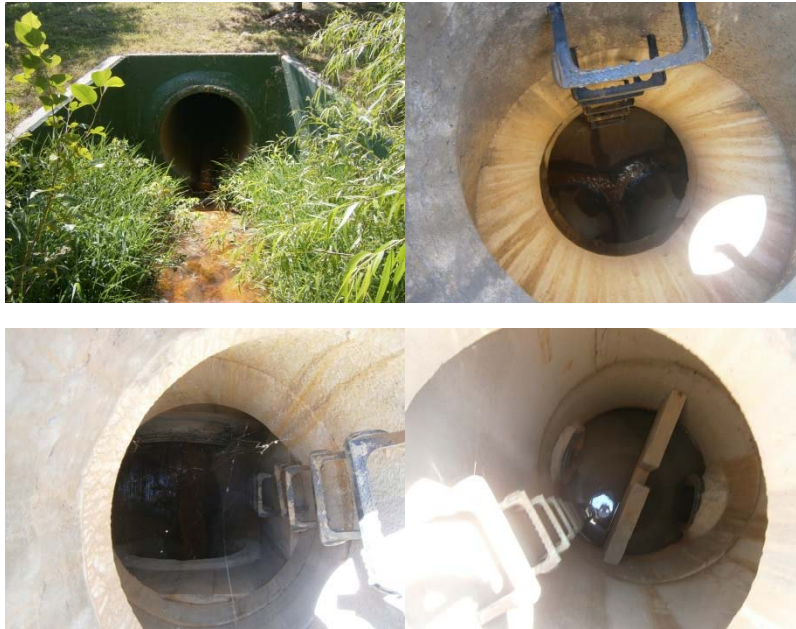
The discharge supposed to be generated from both underground SWM Facilities. Inclusive additional investigation needed to confirm the exact source of discharge. The investigation is under the process. No violation latter issued at this time.

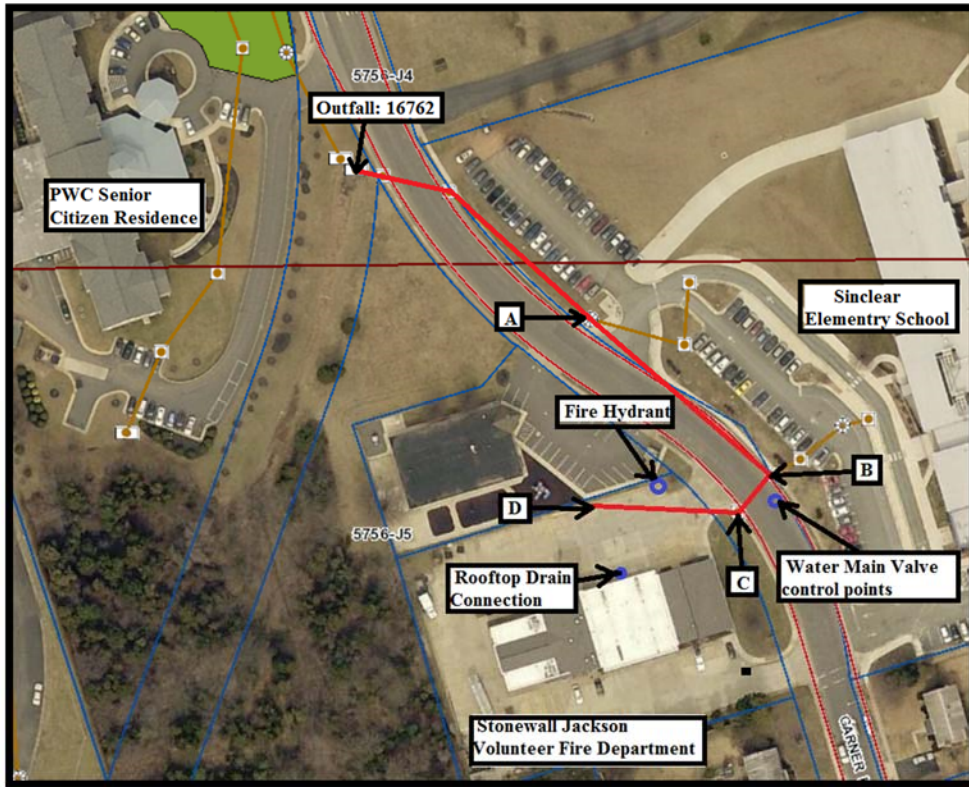
Figure 1: Site map showing discharge flow path through the storm sewer system.

The source of discharge was tracked from the outfall. Manhole A had flow from AB direction only. At point B, flow observed from BC direction only. At manhole B, discharge found forcefully flowing from the BC direction with moderate quantity. The Manhole C found almost dry but the sound of water could be heard when keeping an ear close to manhole. At point D, the drop inlet was observed to be dry. Across point B and C, a drinking water control valve could be observed slightly above storm sewer

alignment. Across point C and D, a fire hydrant could be seen slightly below the storm sewer alignment. Points B and C were located at two sides of road in small stretch but the discharge found to be generated in-between while tracking. The sound of flowing water can be heard in Manhole C, sound from downstream stormsewer pipe may be due to leakage in water main between point B and C.

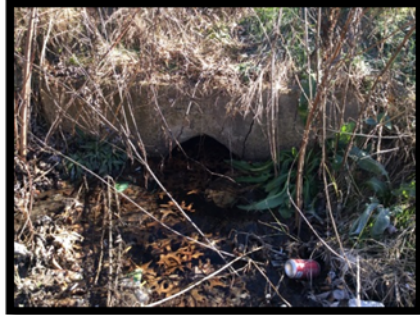
Outfall

During routine inspection for dry weather screening, outfall 16762 was found to be discharging flow to an open channel. The nature of flow was moderate or stagnant. The color visually observed clear. The field test parameters are found within standard limits.

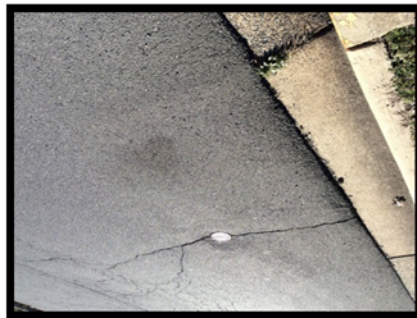
Water Main control valve

The discharge was observed in a small stretch having high velocity with odorless and colorless nature. After investigation, discharge is suspected to be generated by leakage thru water supply transmission main. No sanitary sewer cross connection was observed to the storm sewer system. NOV was not issued since the source of discharge still unidentified. Inclusive investigation needs additional assistance. This issue will be forwarded to water supply authority of this locality for investigation. Further inspection and investigation will be periodically continued from PWC IDDE program. The case was taken over by PWC service authority. The leakage thru transmission main towards fire hydrant found to be leaked and corrected it on 01/11/16, reported by PWCSA.

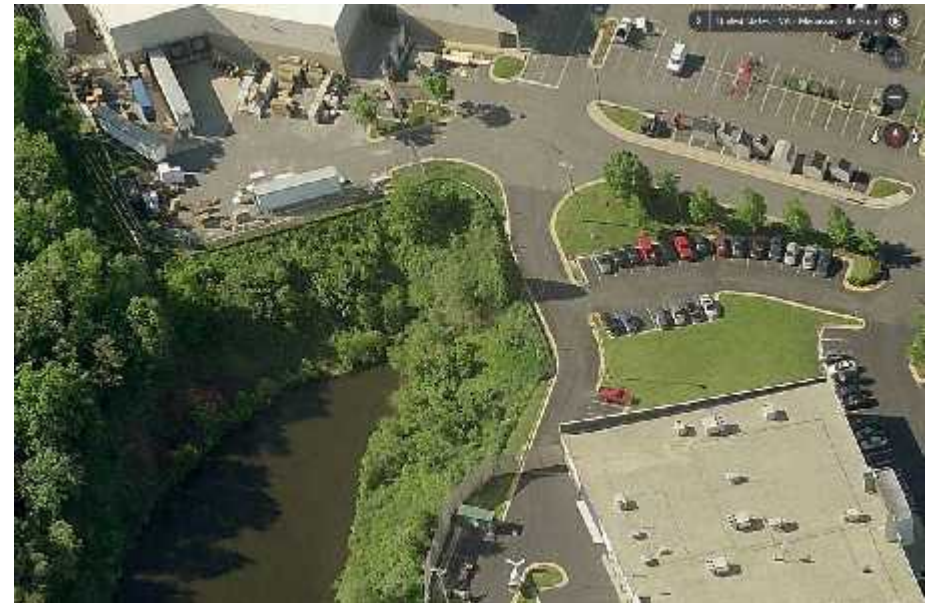
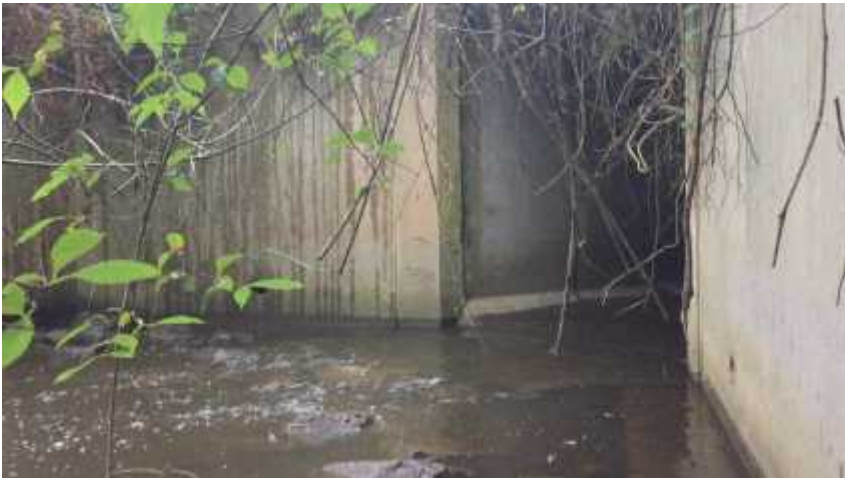
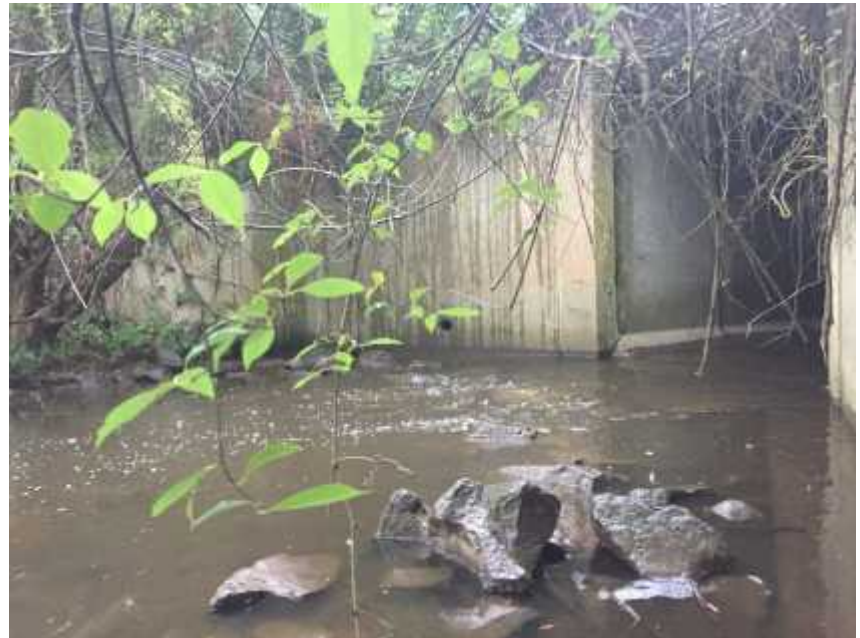
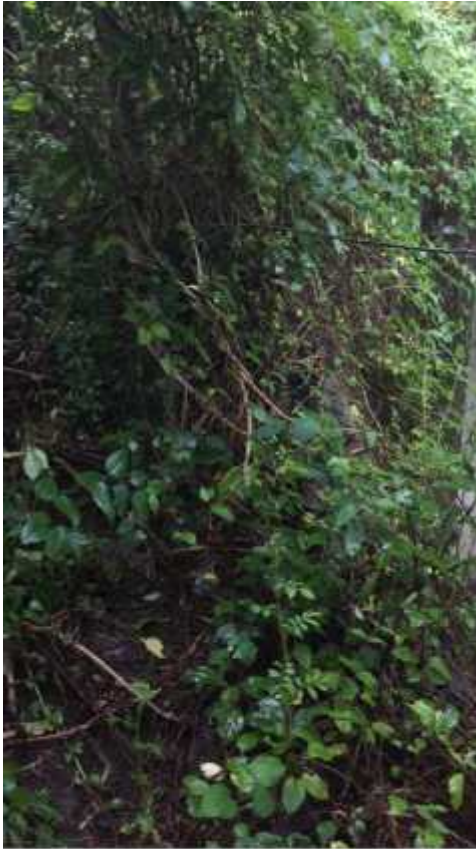
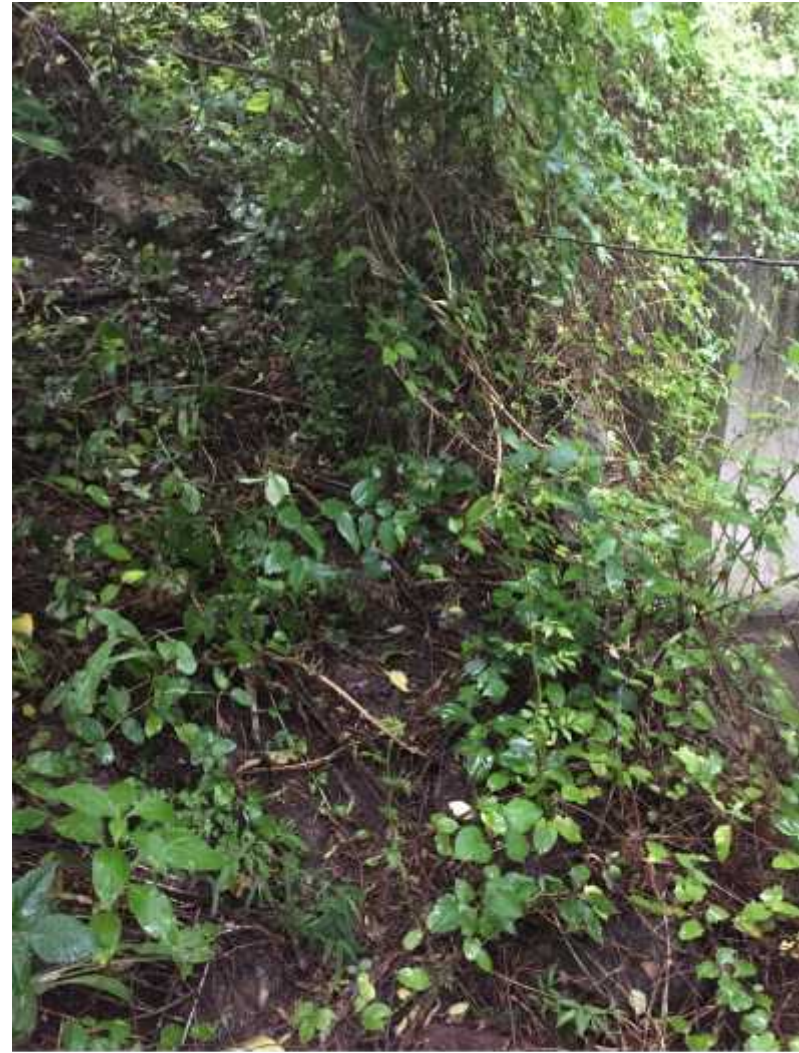
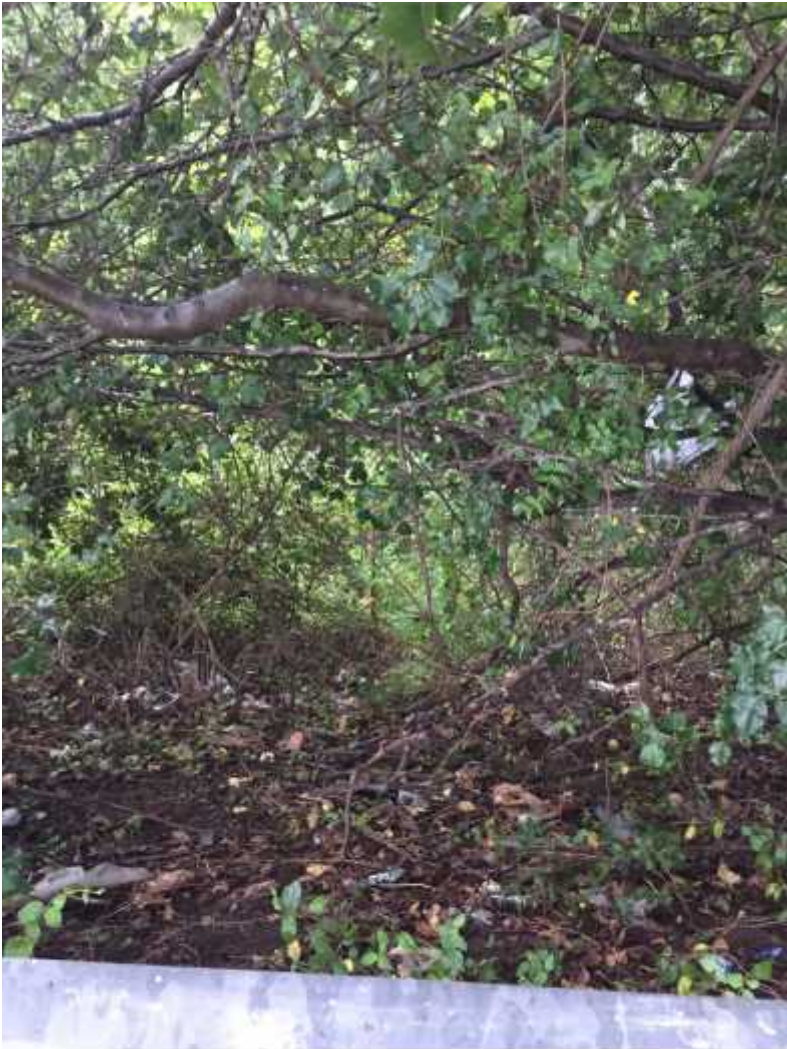
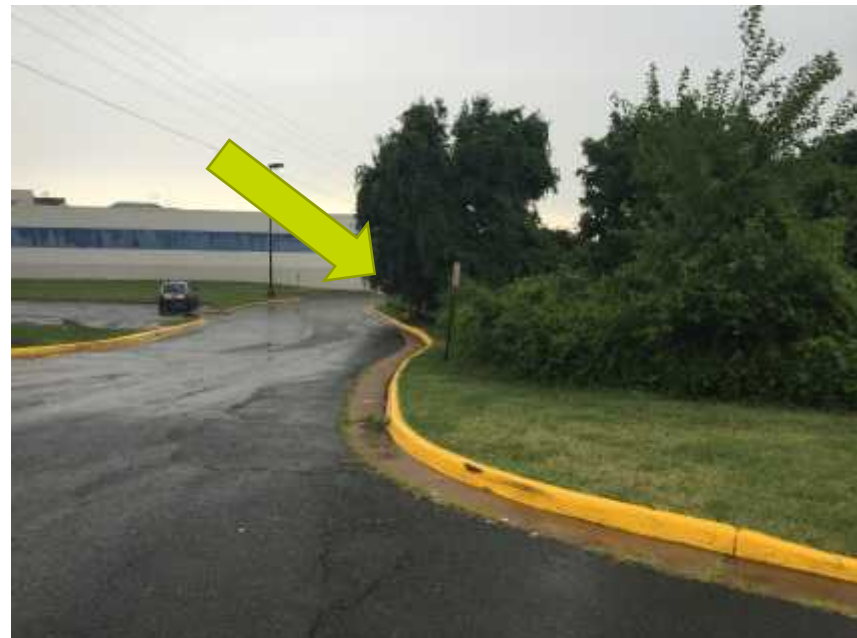
- 84" x 54" box culvert
- Contribution from upstream BMP
- ~1" flow during storm (7/18)
- Low visibility, steep slopes

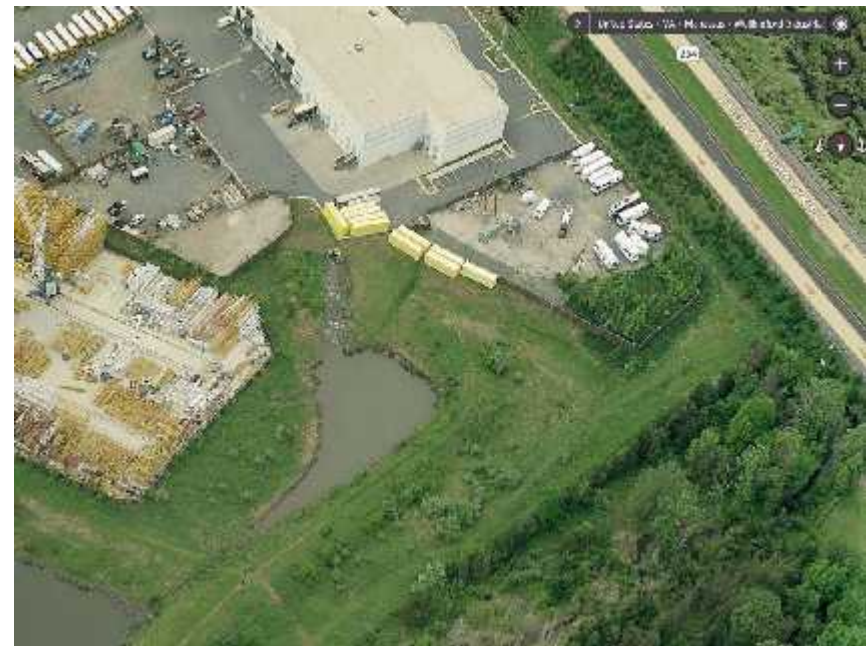
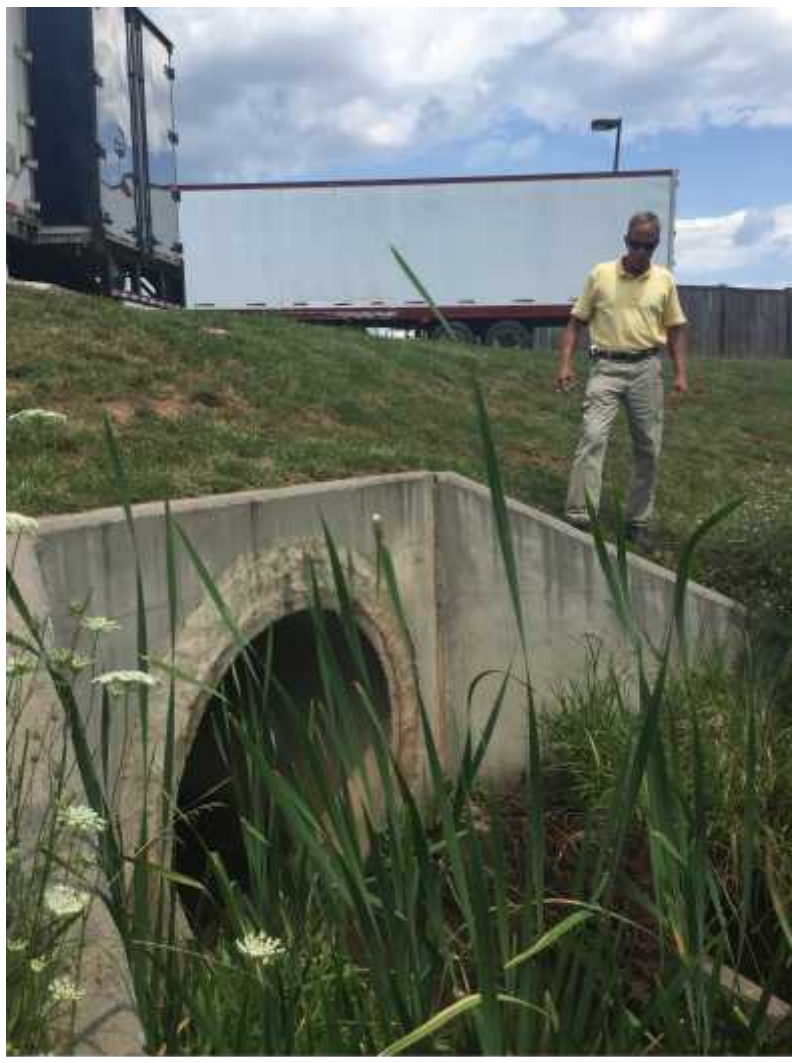
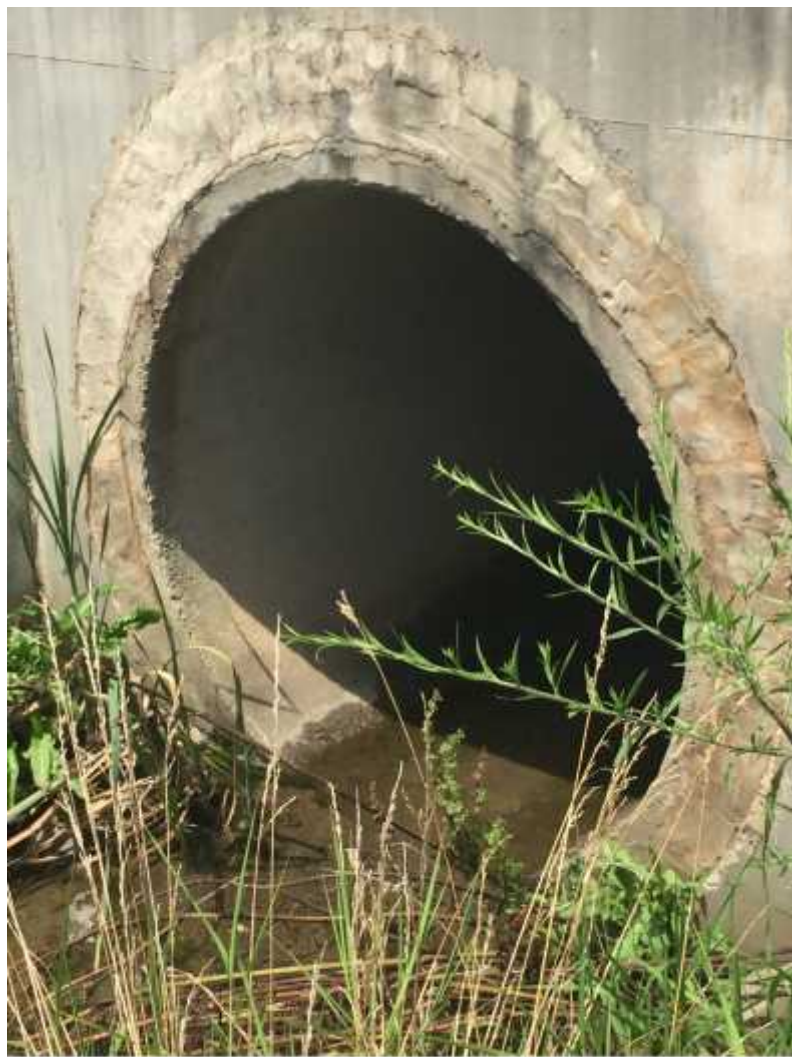
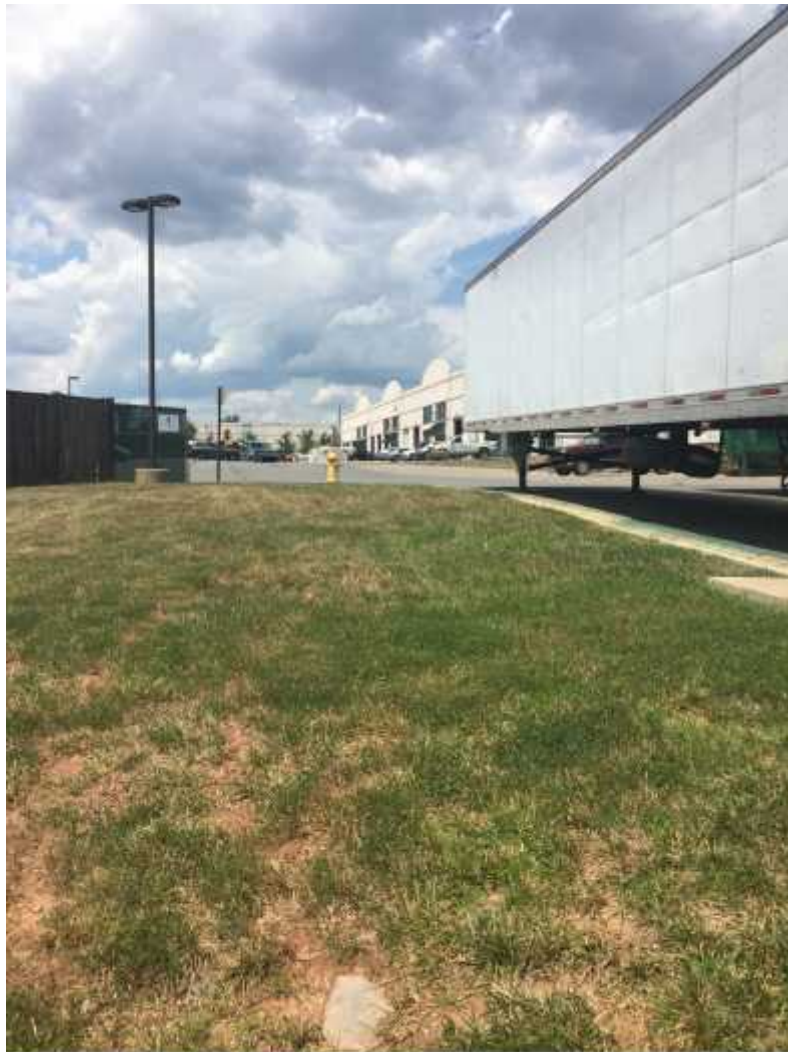
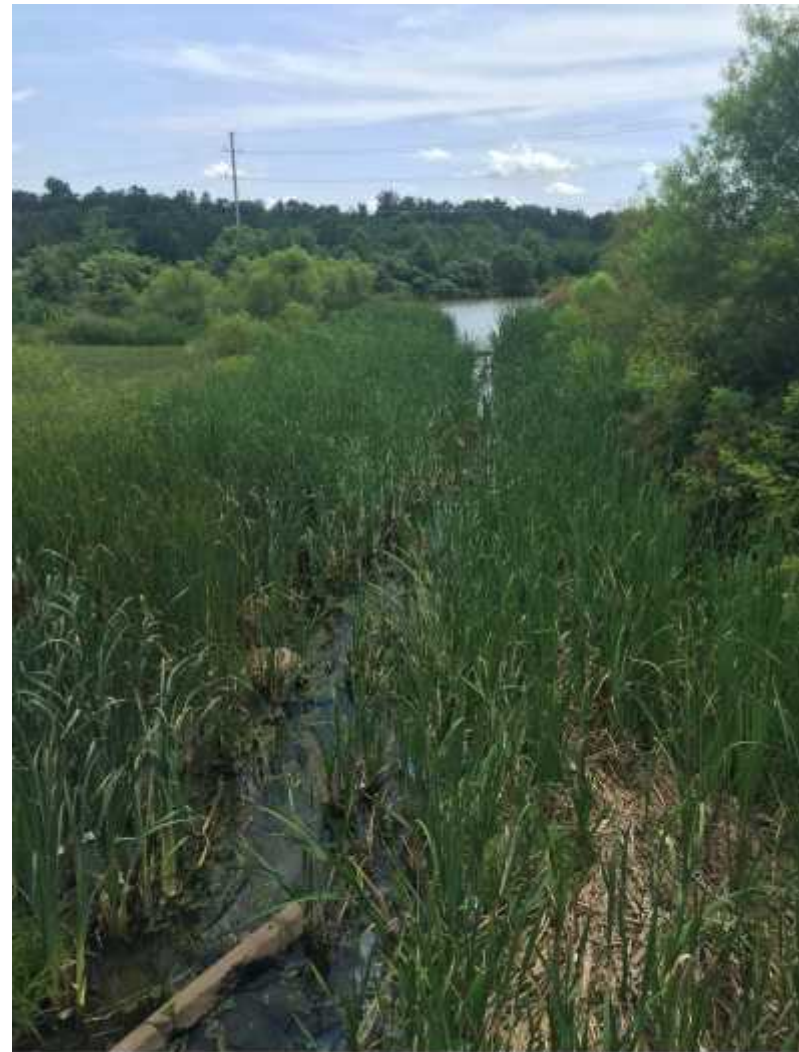
#941: Bull Run, Prince Wm. Parkway

- **54" concrete pipe**
- **Signs of recent repair**
- **1/4" water, level with spillway**
- **Debris in spillway**
