Annual Stormwater Management Report

VSMP Permit No. 0088595 – FY 2016

Submitted by:
Prince William County
Department of Public Works

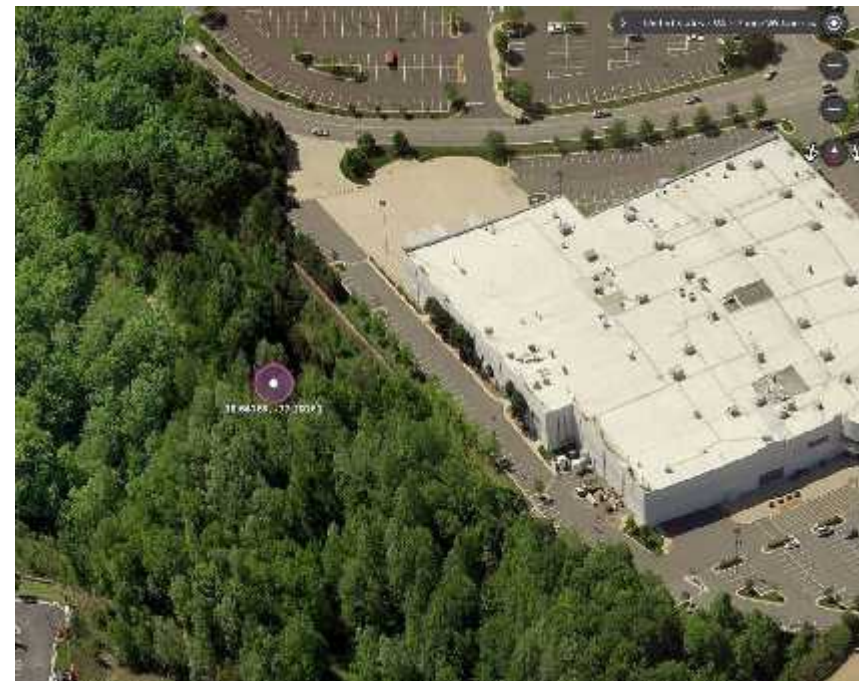
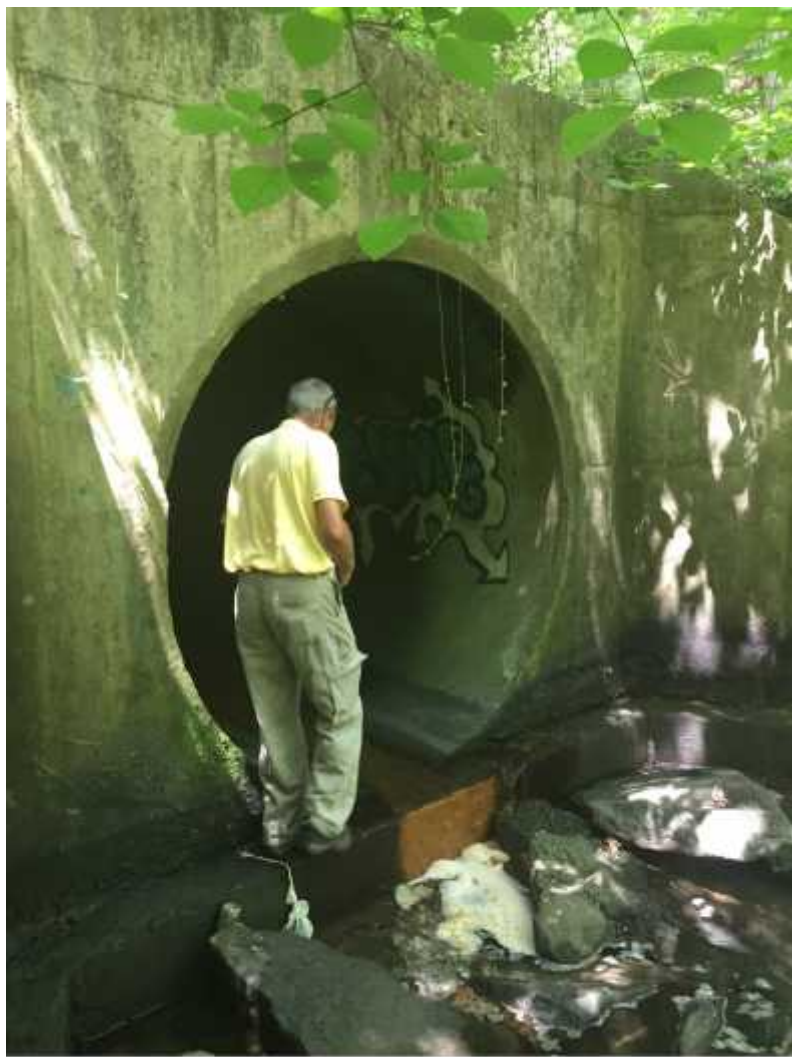
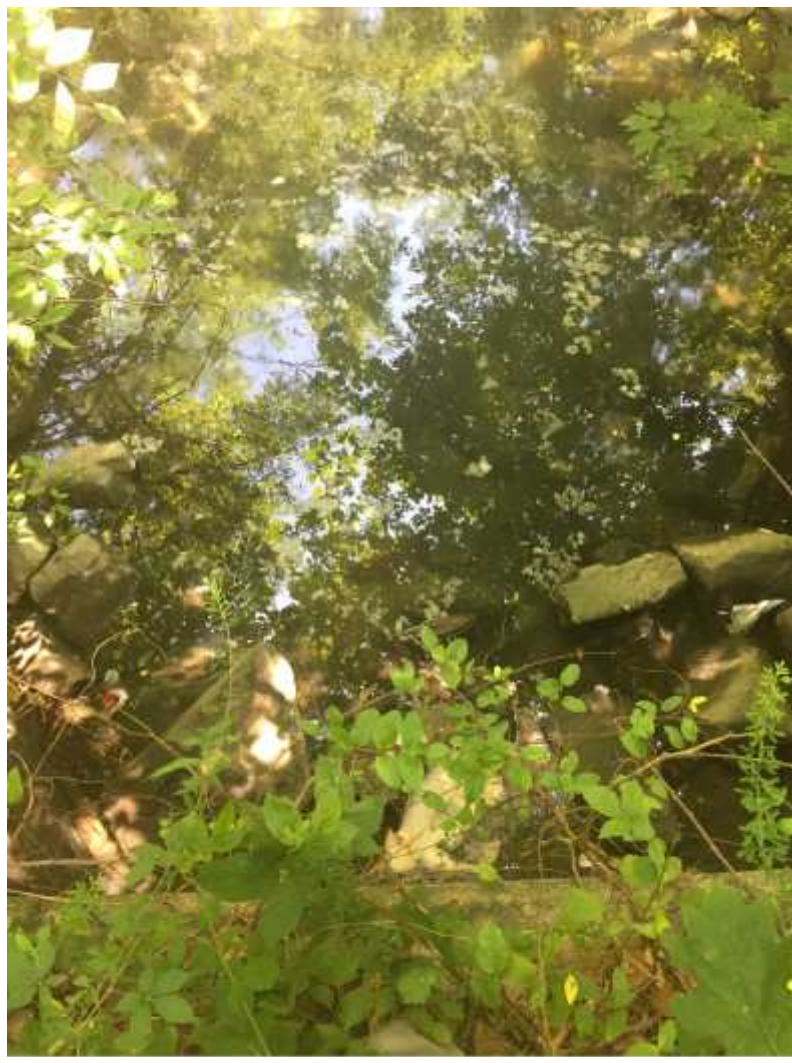
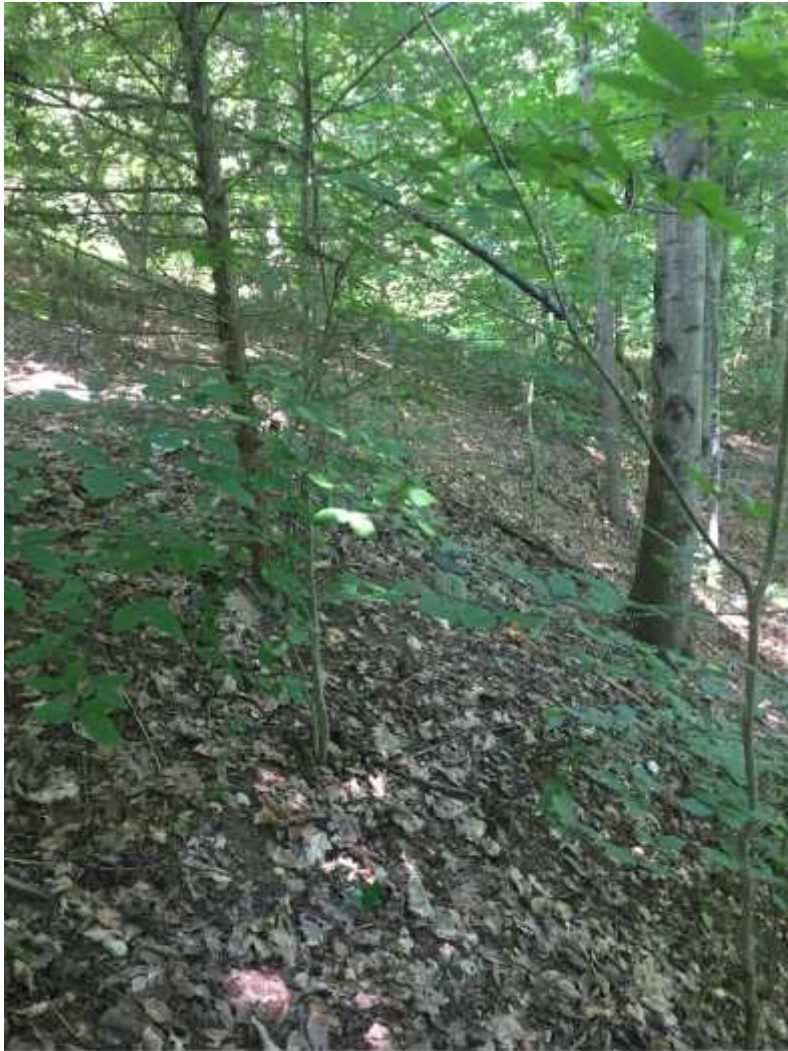
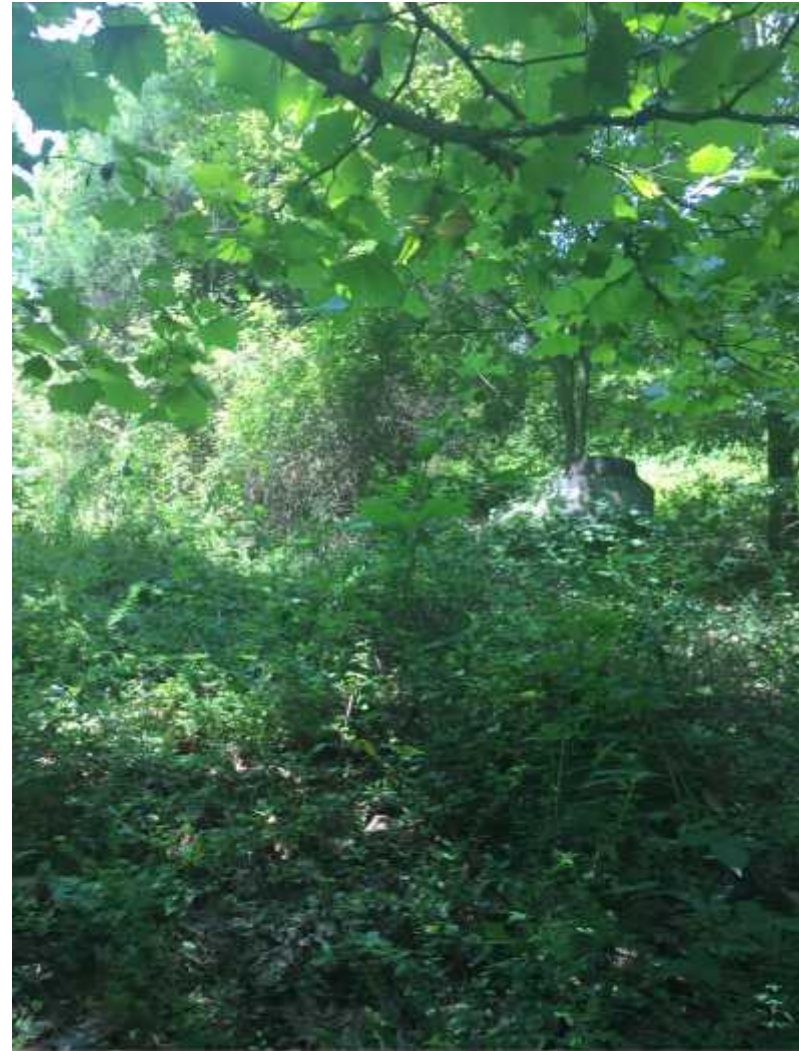
#3471: Woodbridge, Potomac Mills

- 84" concrete pipe
- < 1/4" flow
- Signs of human presence, uncertain frequency

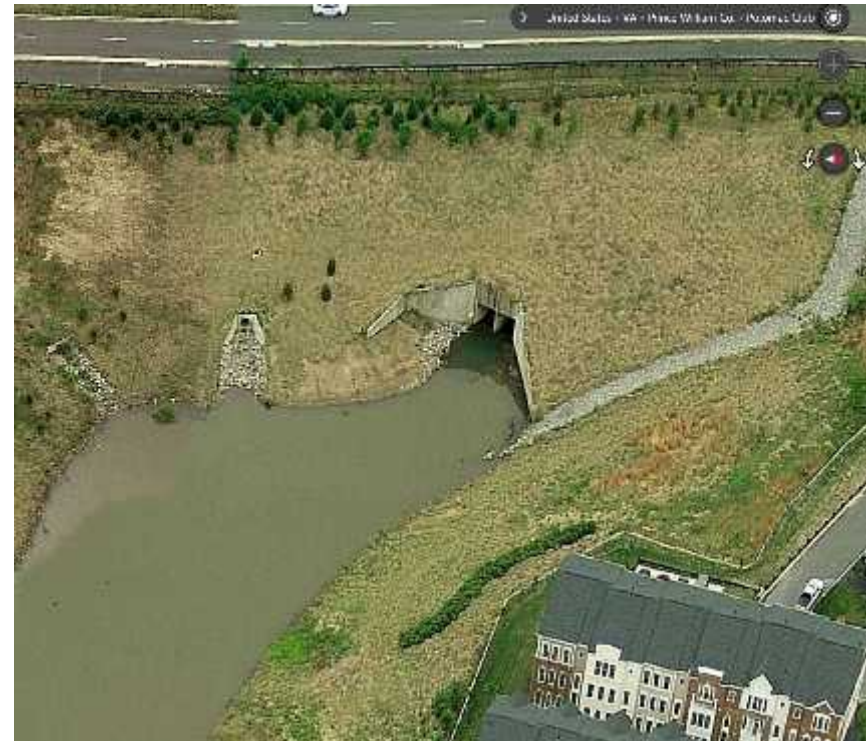
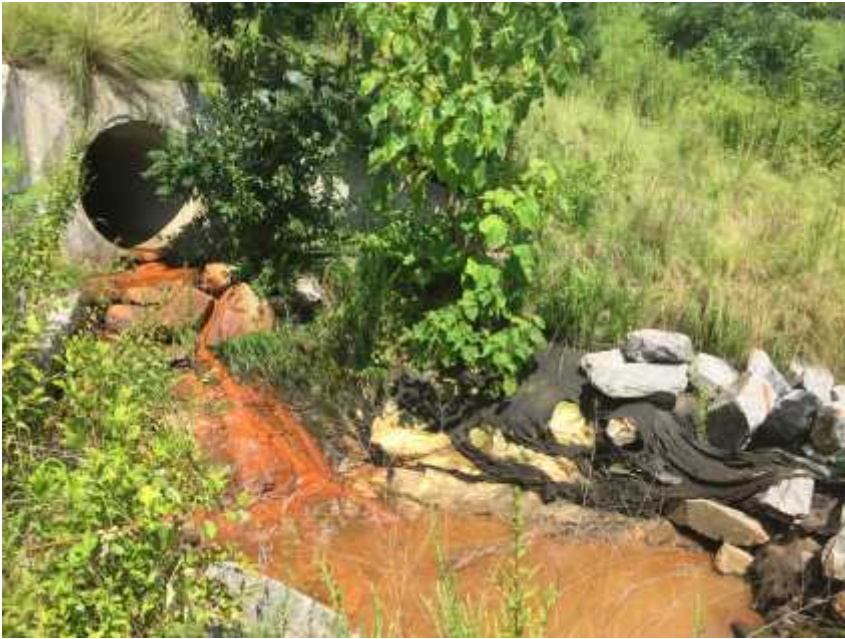
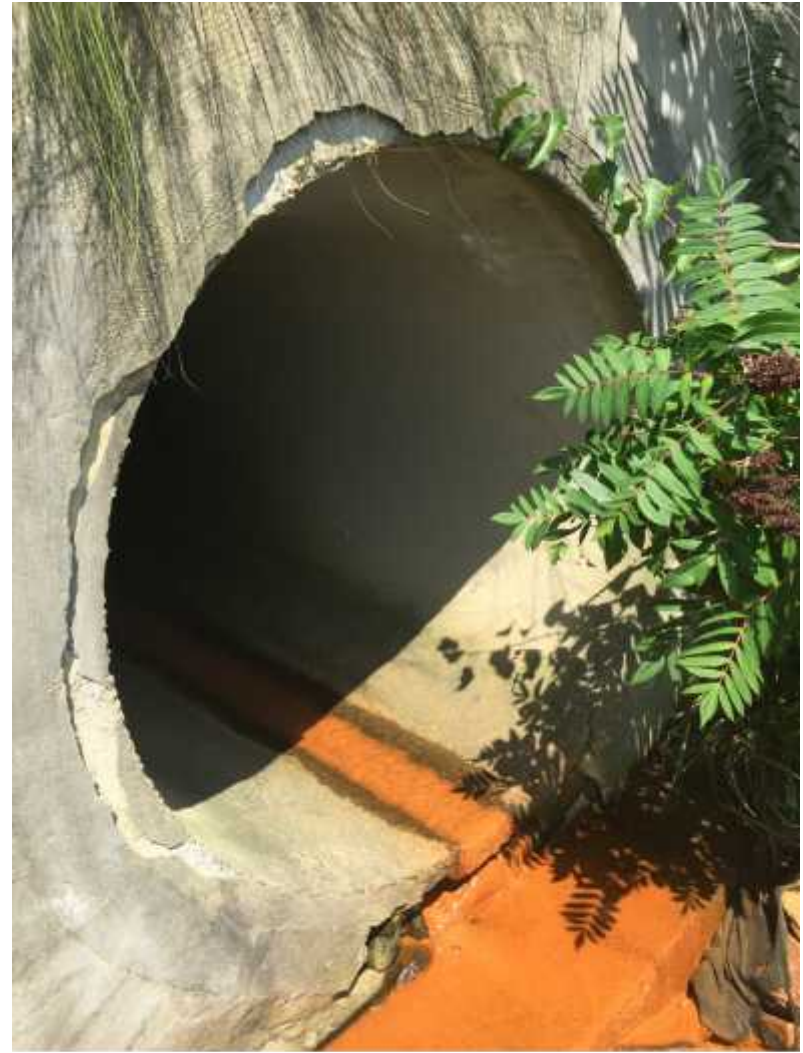
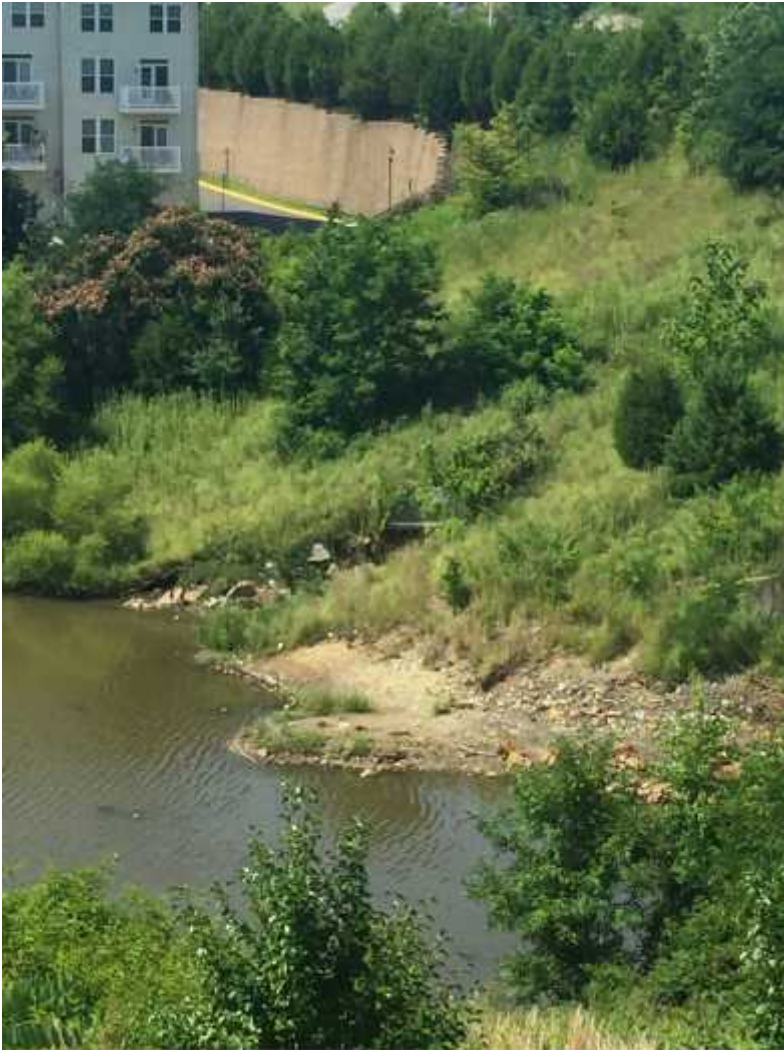
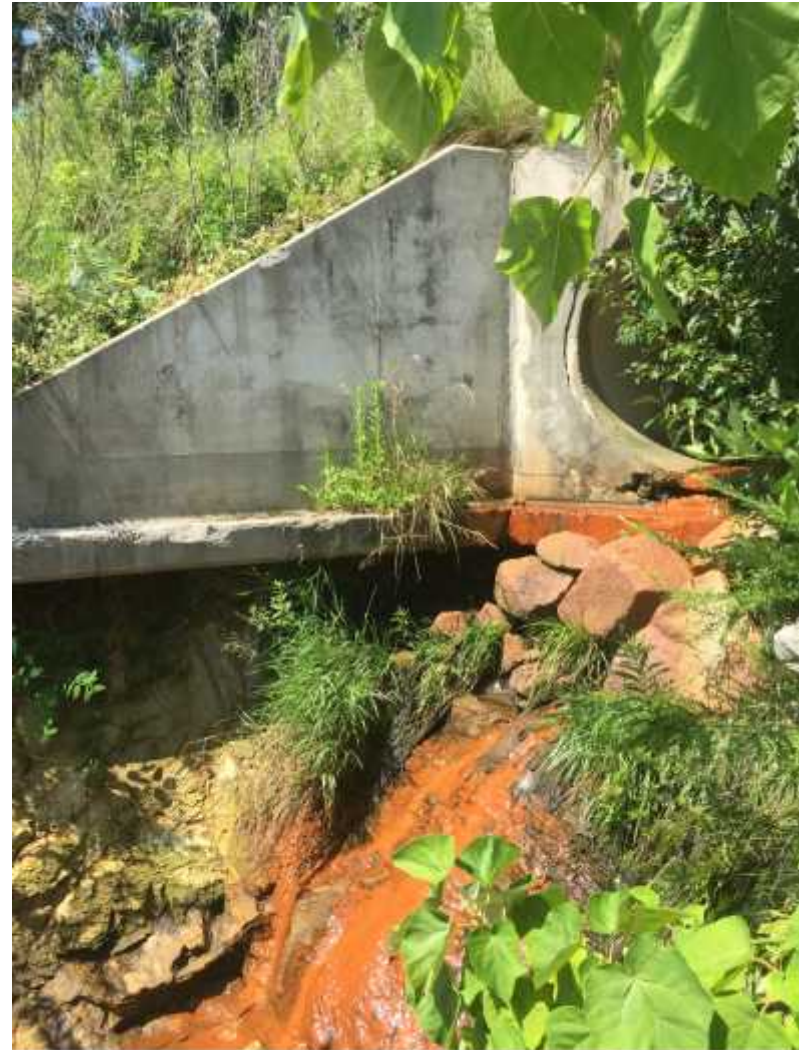
#4684: Dale City

- **54" concrete pipe**
- **Low flow draining to scour pool**
- **Steep banks surrounding outfall**

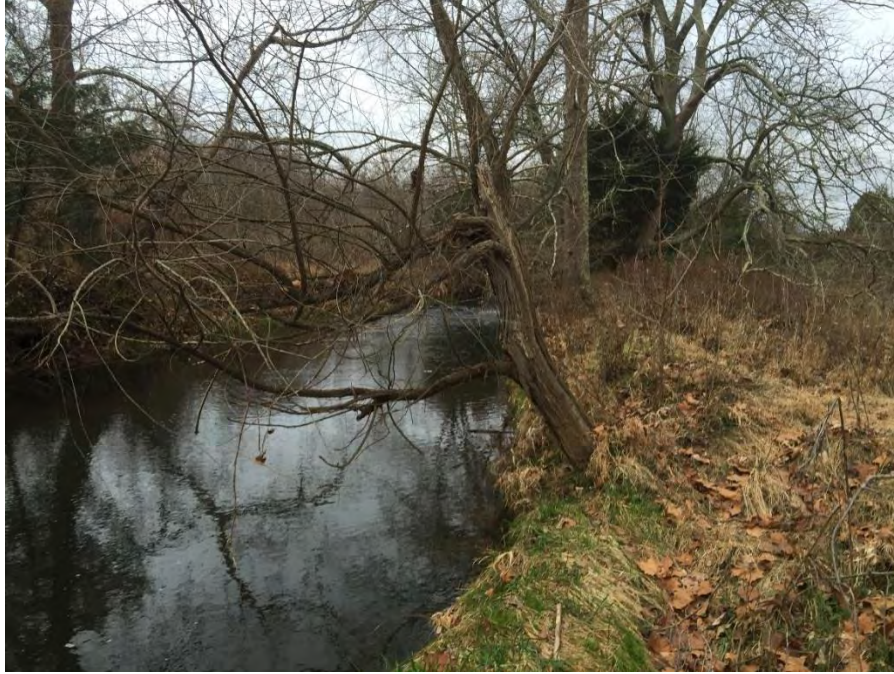
Figure 1: Backwater area created by sanitary sewer crossing. Sampling reach lies upstream.

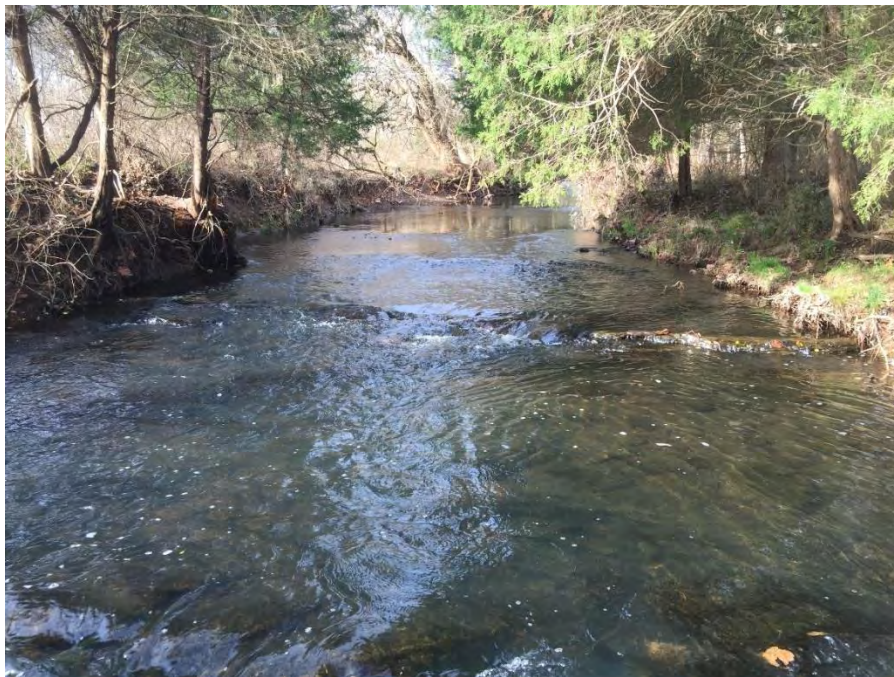
Figure 2: Looking upstream at beginning of sampling reach along the riffle consisting of larger gravel, cobble, and bedrock.

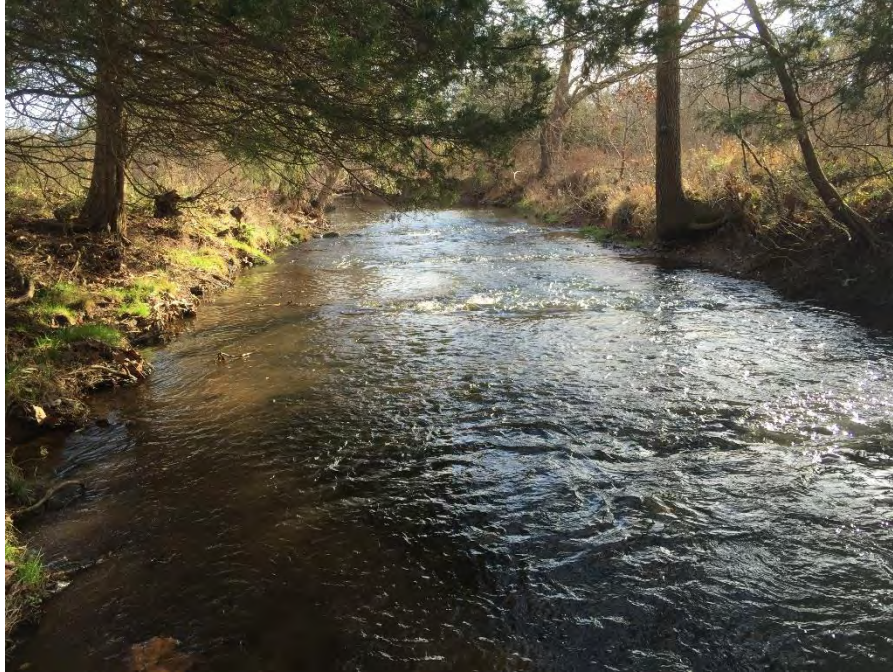
Figure 3: Looking downstream near beginning of sampling reach along the riffle containing large gravel, cobble, and bedrock.

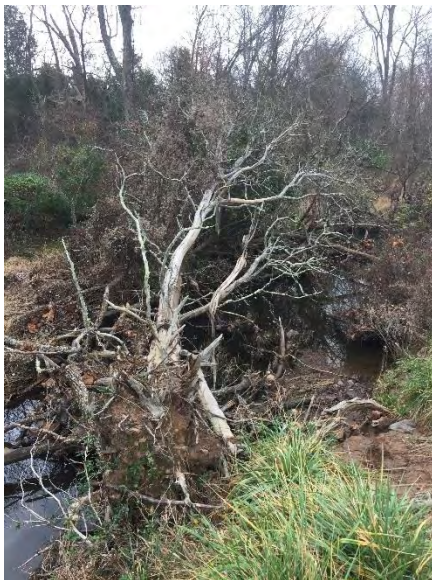
Figure 4: Large woody debris downstream from sampling reach.

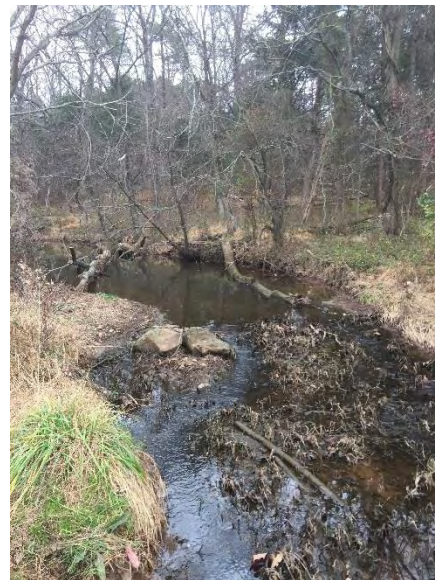
Figure 5: Looking upstream near beginning of sampling reach.

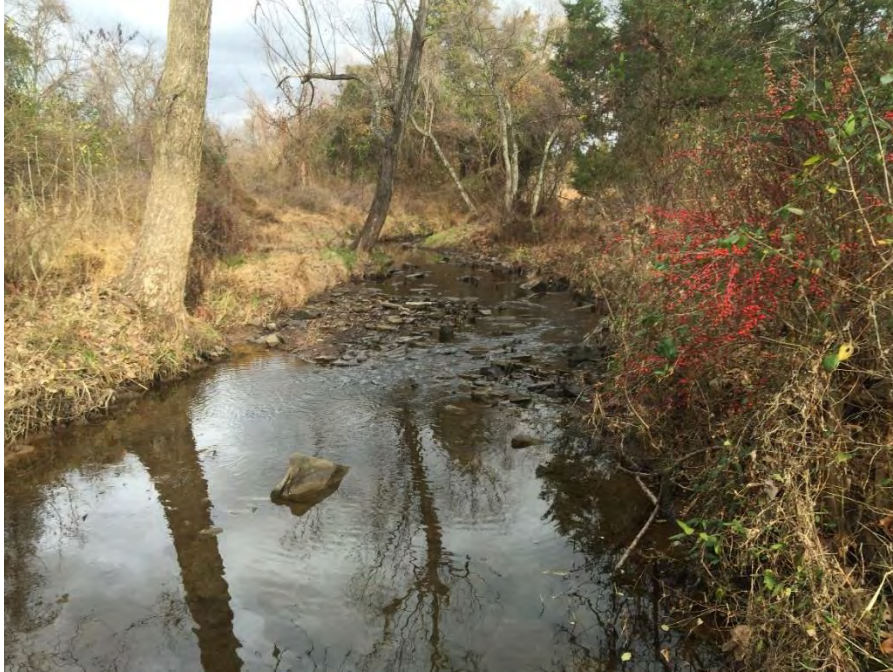
Figure 6: Upstream from initial sampling point.

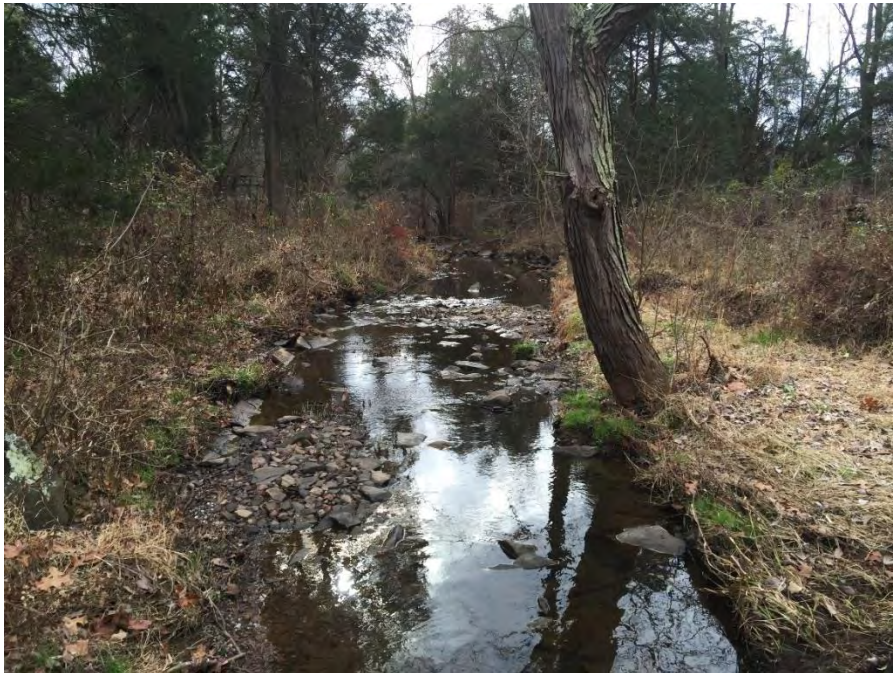
Figure 7: Looking downstream towards Figure 6.

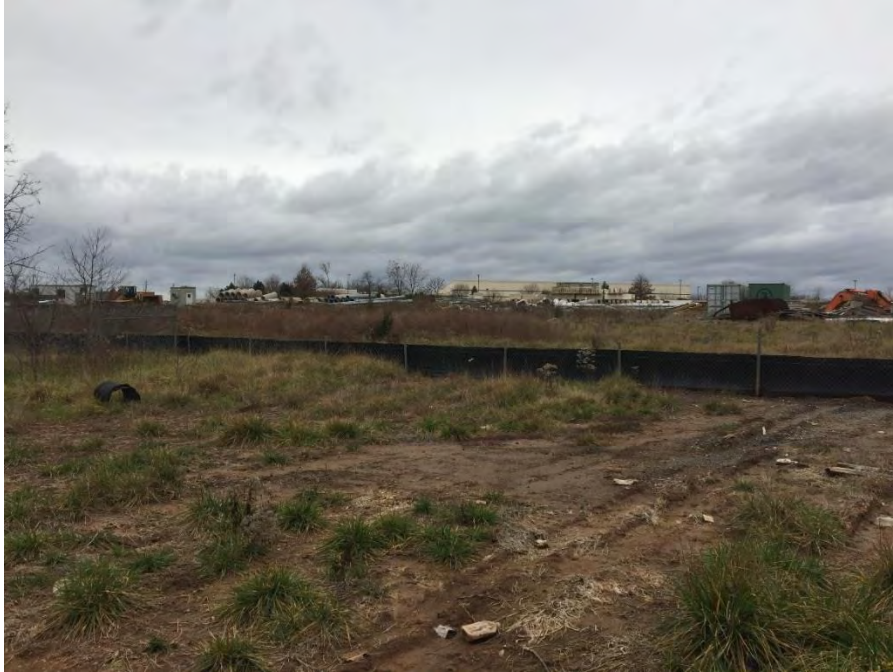
Figure 8: Construction contractor storage site adjacent to stream reach. Site was contributing noticeable amount of silt to stream.

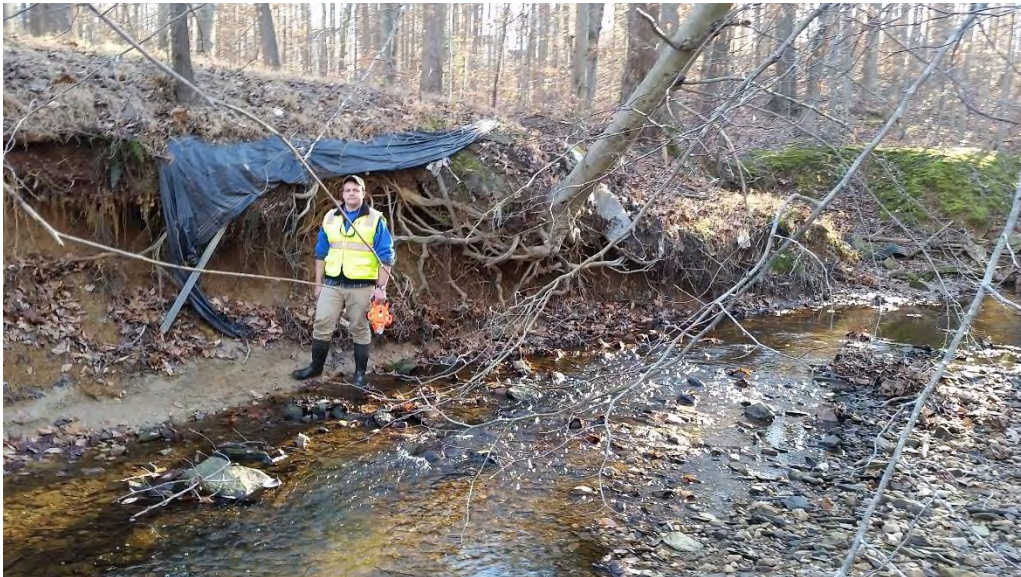
Figure 9: Stream bank incision >6 feet (vertical instability) from bed. Photo was taken downstream from sampling reach.

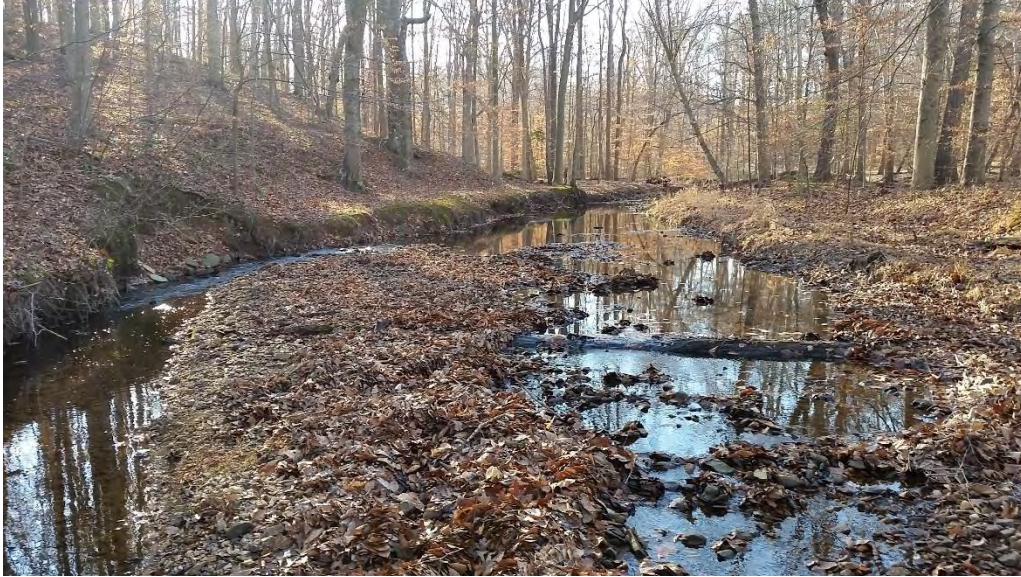
Figure 10: Upstream view of large pool filled with leaf pack. Photo was taken downstream of sampling reach.

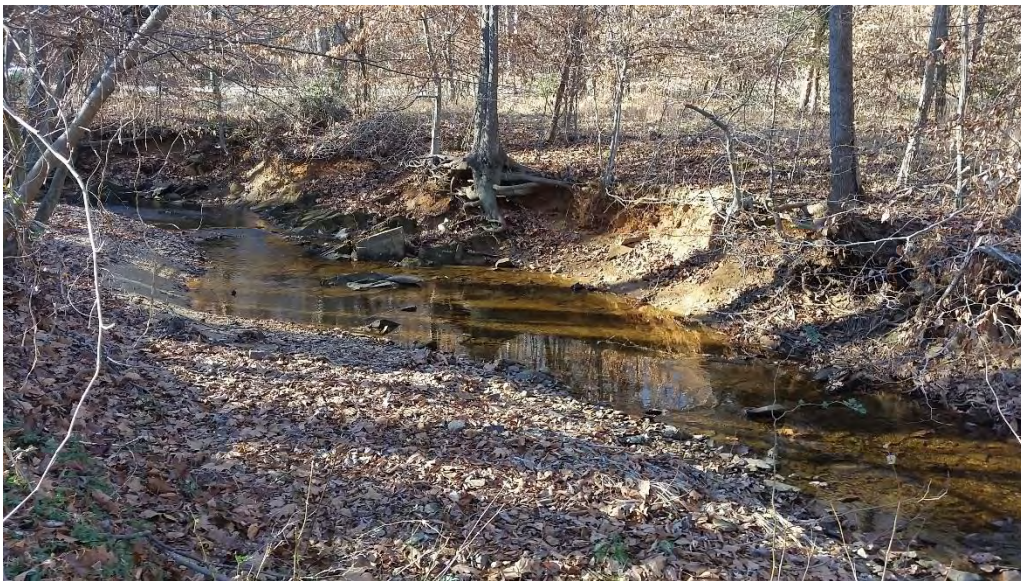
Figure 11: Past leaf-packed pool, looking upstream towards initial sampling point.

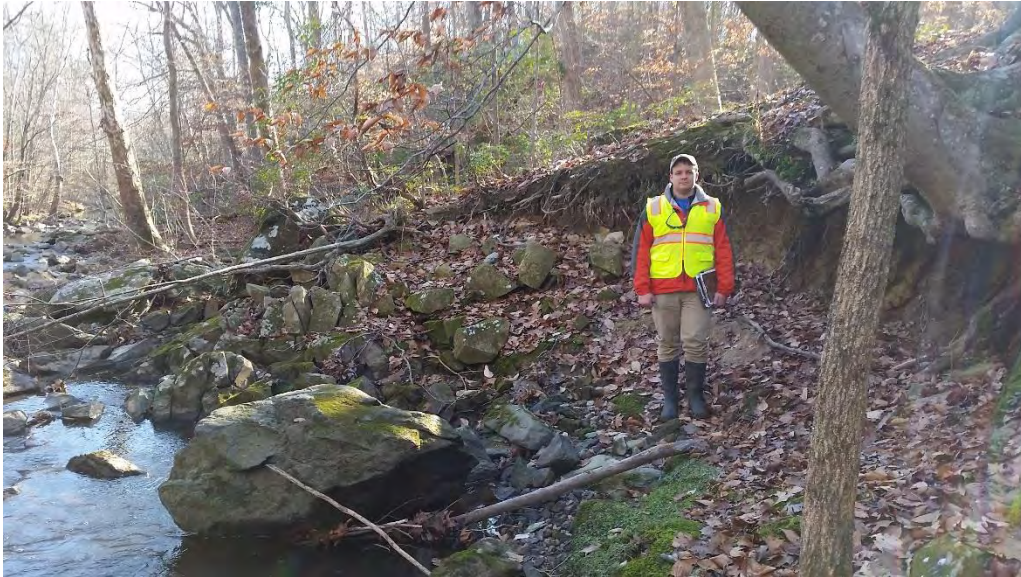
Figure 12: Bank incision upstream of sampling reach. Suspected cause of incision is boulder creating flow redirection and backwater eddies, located behind photographer, impeding flow during high energy events.

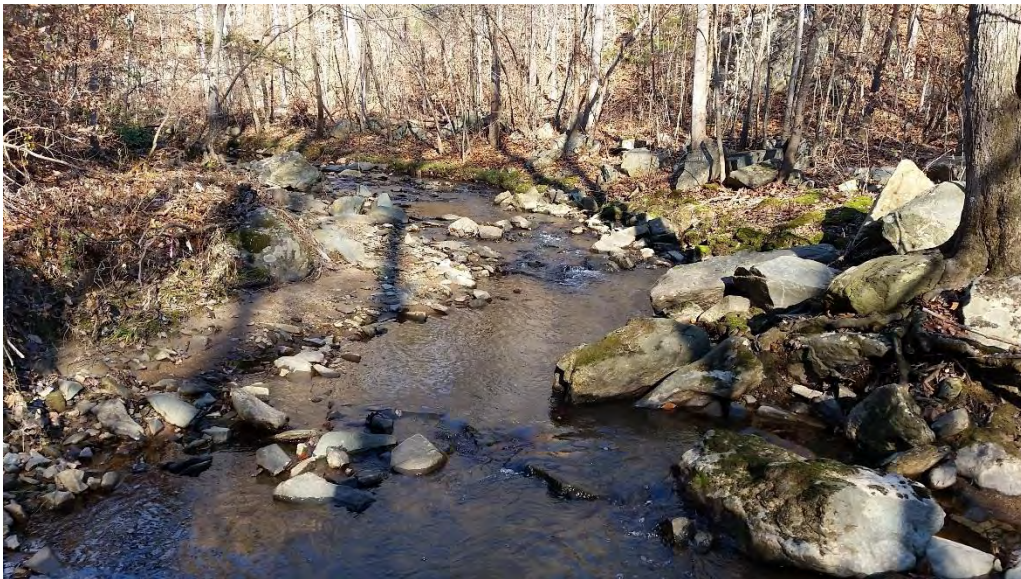
Figure 13: Upstream view about 75 meters from initial sampling point.

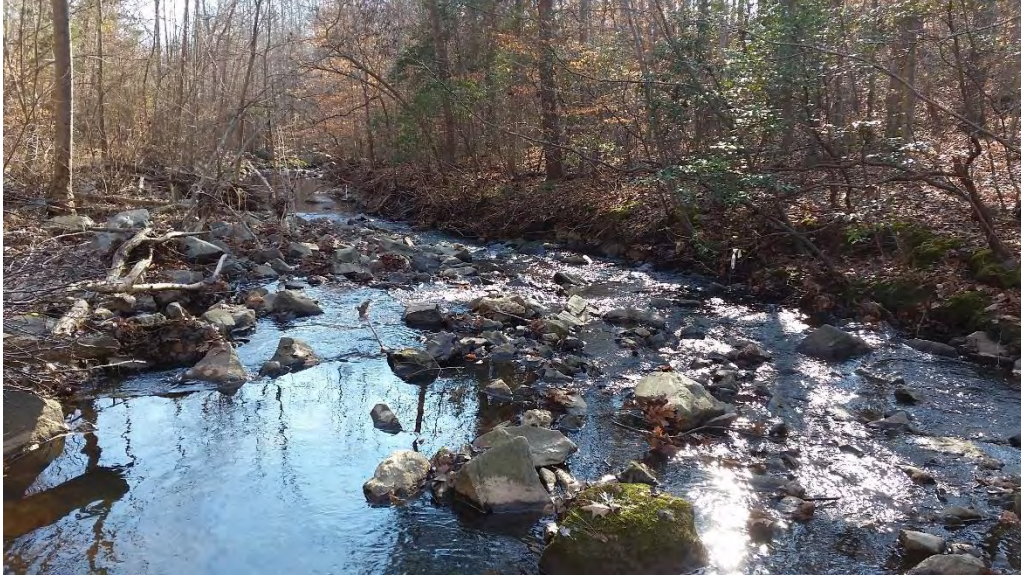
Figure 14: Looking downstream through sampling reach from approx. same location as Figure 13.

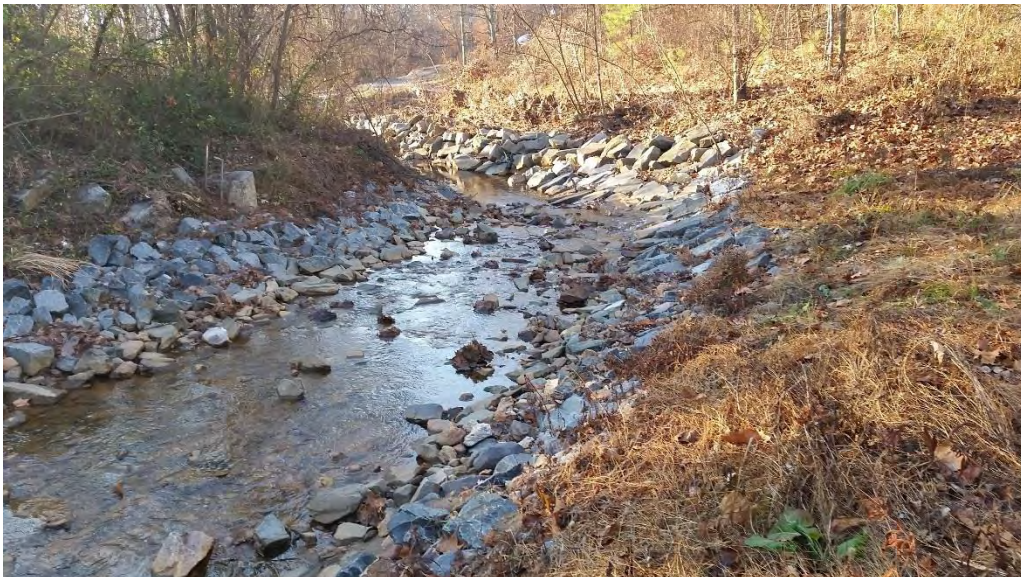
Figure 15: Looking downstream from most recent bed and bank armoring. Sampling reach lies downstream from where photo location.

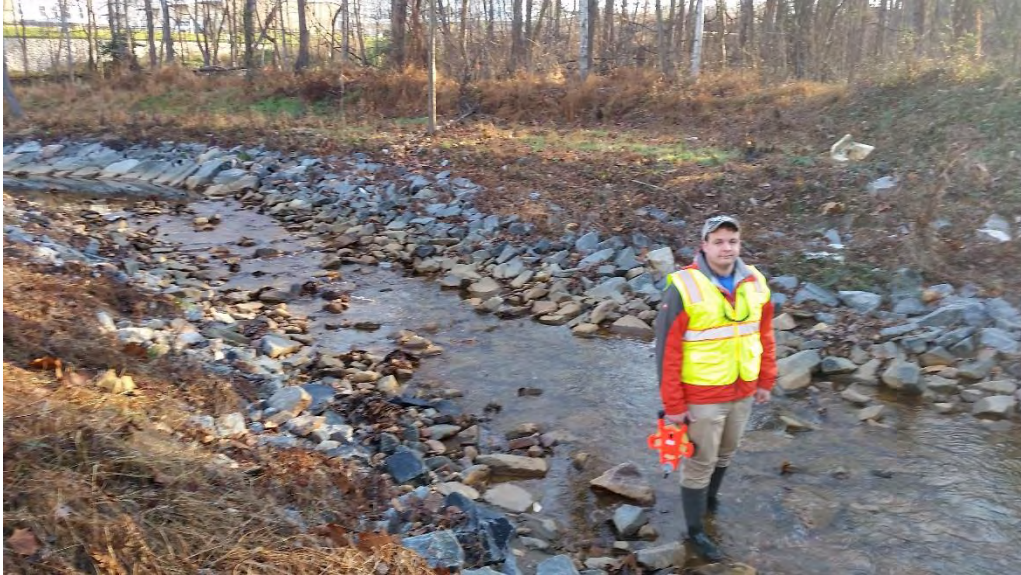
Figure 16: Technician standing at initial sampling point. Jefferson Davis Hwy. lies in the background.

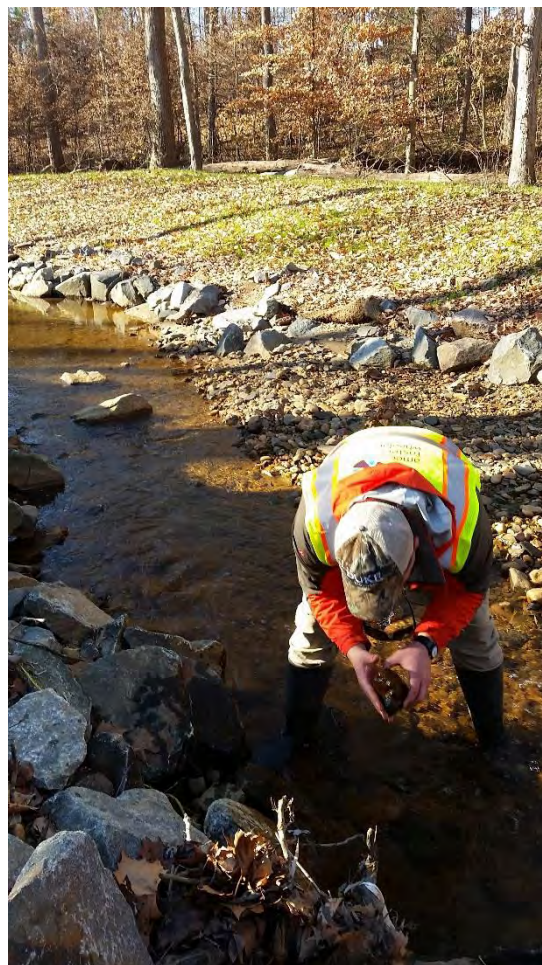
Figure 17: Brief inspection of benthic macroinvertebrate habitat upstream from initial sampling point.

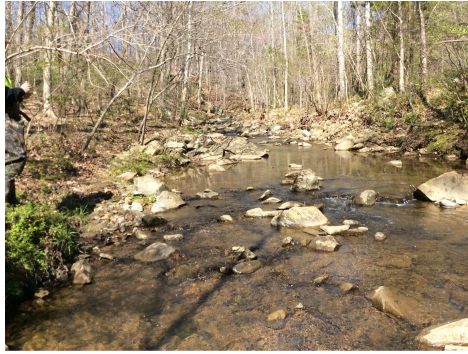
Image 1

Upstream. Riffle in foreground marks sampling point.

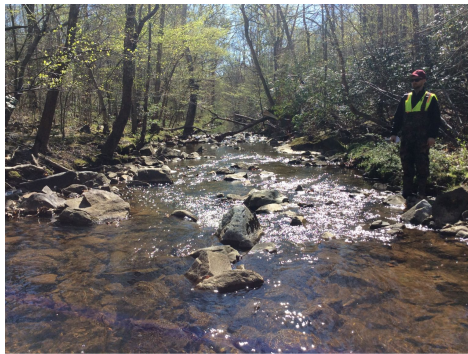
Image 2

Downstream, sampling point at beginning or reach in foreground.

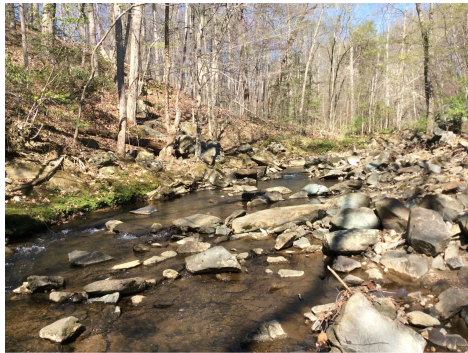
Image 3

Upstream, slightly more than mid way through reach

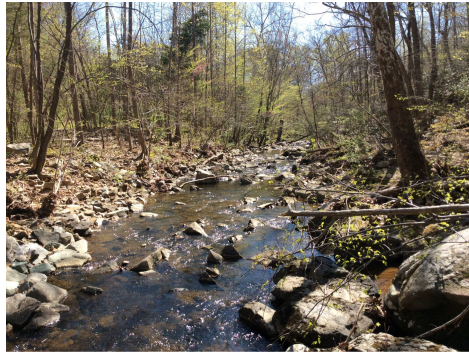
Image 4

Downstream slightly above midway through reach

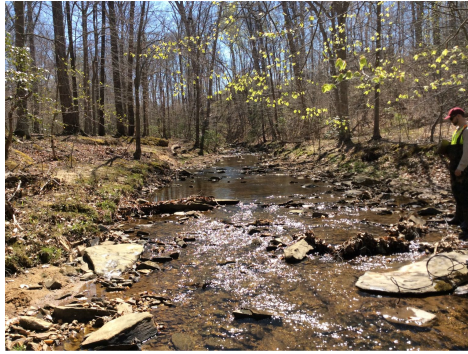
Image 1

Upstream from staked beginning point

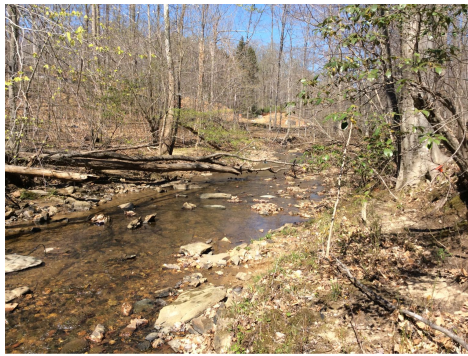
Image 2

Downstream from staked beginning point.

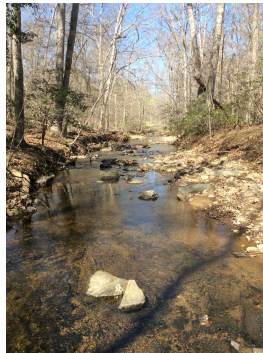
Image 3

Middle of reach facing downstream

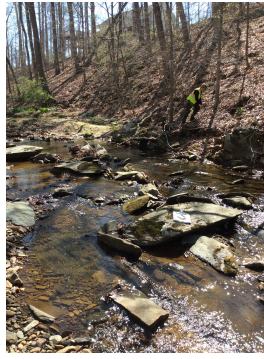
Image 4

Upstream survey bar
