PRINCE WILLIAM COUNTY, VA
DEPARTMENT OF PUBLIC WORKS

Bull Run Watershed Study

Appendices

March 2010

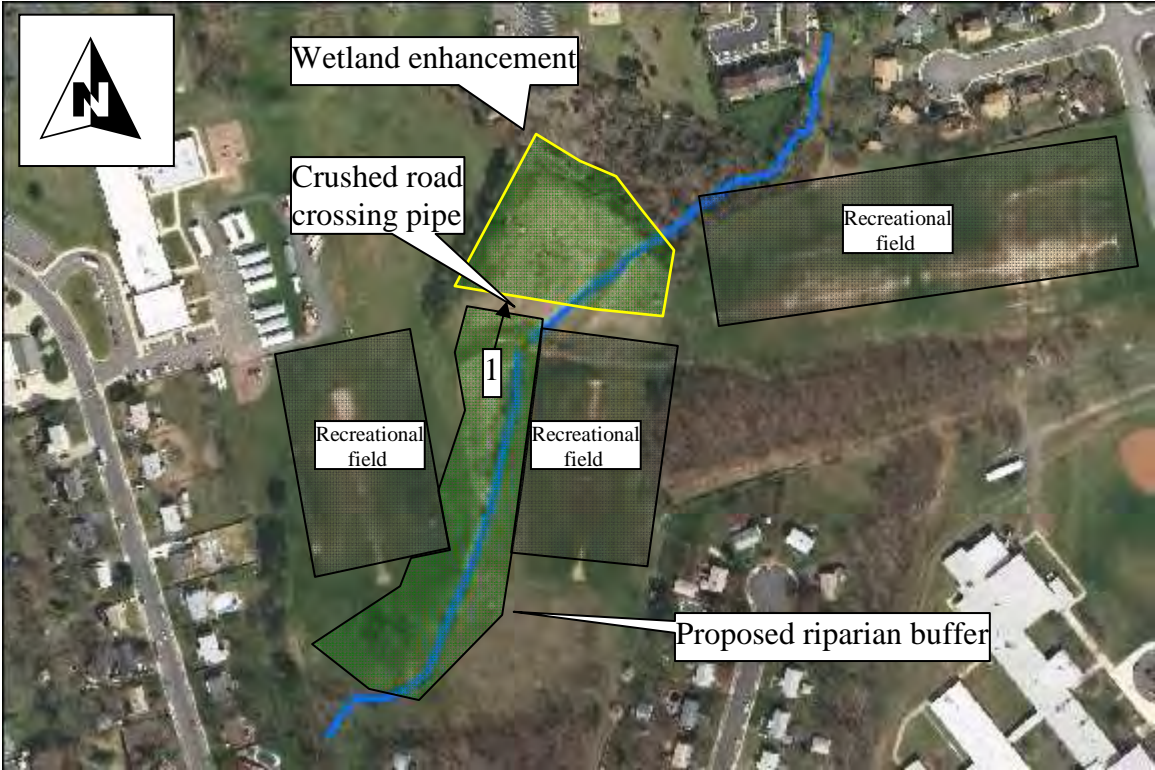
Watershed: Linden
Site ID #: L7
ADC Map (25th edition): Map 8, page 13, grid coordinate K3

Problem Description: The school board mows the recreational/athletic fields, including the riparian buffer, adjacent to the stream channel. Outfall L7-P1 has an unidentified effluent discharge entering into the stream. The stream within this area is in fair condition. The stream flows under a roadway between recreational fields through a plastic culvert (L7-P2). This pipe is crushed and stream flow has jumped out of its original channel and cut a new channel around the pipe. Water quality and aquatic habitat are limited within the reach. Aquatic habitat throughout the reach is degraded, providing limited habitat for benthic community diversity.

Project Description: This project would enhance the 550 linear feet of stream corridor through the school property. A woody buffer which is compatible with the adjacent recreational fields would be designed and planted. Educational signage would be installed. A Riparian Buffer Management plan would be developed to guide school maintenance crews in proper management of the buffer. The crushed culvert pipe should be replaced. A large wetland area is present adjacent to the stream, in what appears to be the foot print of a basin or pond. This wetland should be evaluated for opportunities to improve its water quality and habitat functions. Possible improvements include wetland tree and shrub plantings, excavation of shallow marsh zones or micro-pools, and installation of nesting boxes.

Conceptual Plan: Buffer management and road crossing pipe replacement

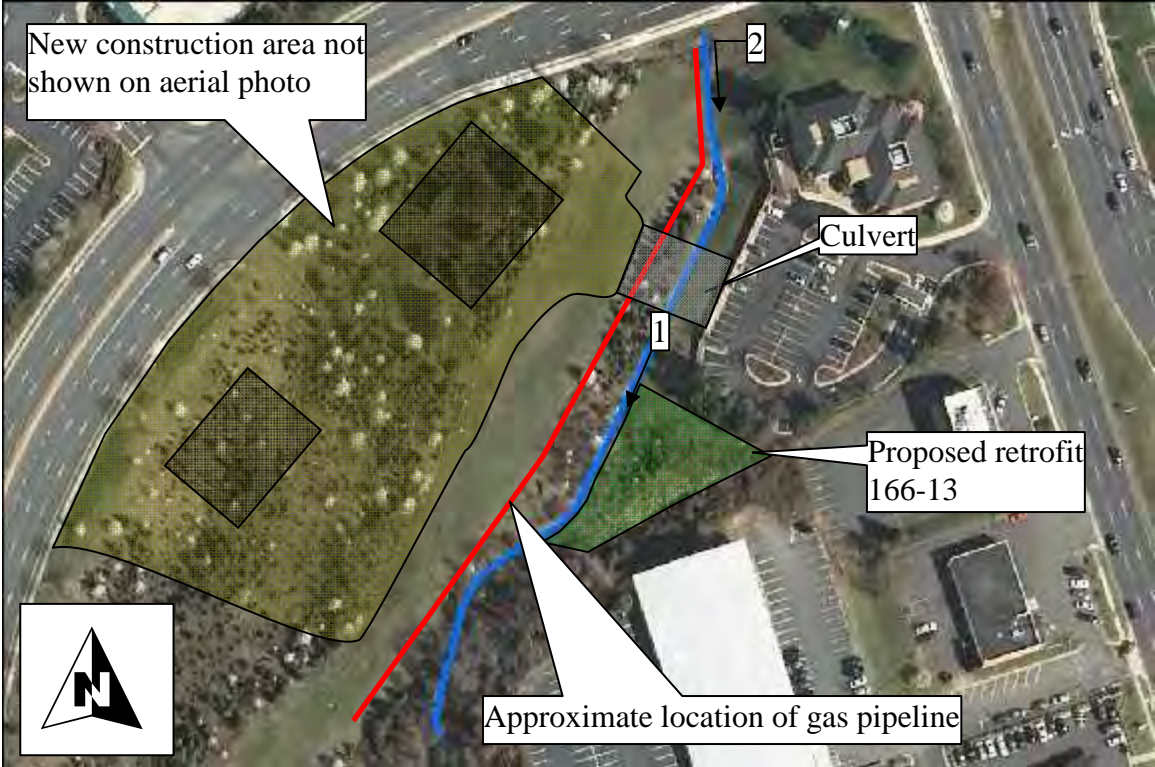
Watershed: Linden
Site ID #: L4
ADC Map (25th edition): Map 8, page 13, grid coordinate H3

Problem Description: This stream reach is a concrete trapezoidal channel, scoring poor on the stream condition assessments. Recent construction has installed a box culvert in the middle of the reach. Riprap installed during the new construction is unstable on the upstream side of the box culvert. Commercial property owners mow the riparian buffer zone adjacent to the channel. Outfall L4-P6 does not have an adequate outfall channel to the receiving stream. Channelization removed the natural stream characteristics resulting in poor water quality and aquatic habitat.

Existing Condition

Project Description: This project would include removal of the concrete channel, installation of a riparian buffer, and providing a connection to the proposed L4 Outfall Retrofit. This project also addresses the existing failing riprap stabilization at the culvert. Removal of the concrete channel and constructing a natural riffle pool system will improve the water quality and aquatic habitat.

Design Considerations: Channel stabilization is necessary to keep the stream from migrating into the gas pipeline on the left side of the stream. The project could be combined with outfall L4 retrofit. Construction access would be from adjacent commercial properties.
