Appendix F Index

Stream Assessment Photographs

Appendix F
Stream Assessment Photographs
Occoquan Watershed – Study of Four Subsheds
WSSI #25156.01

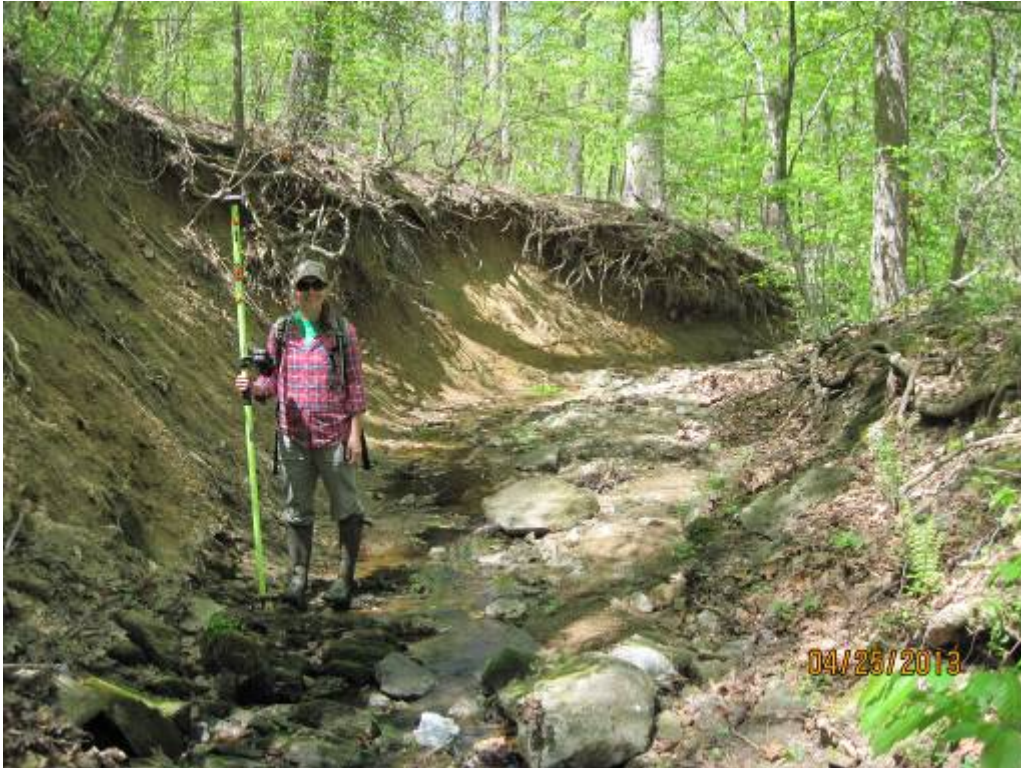
33. Looking downstream at massive erosion present along a section of Stream Reach 9.

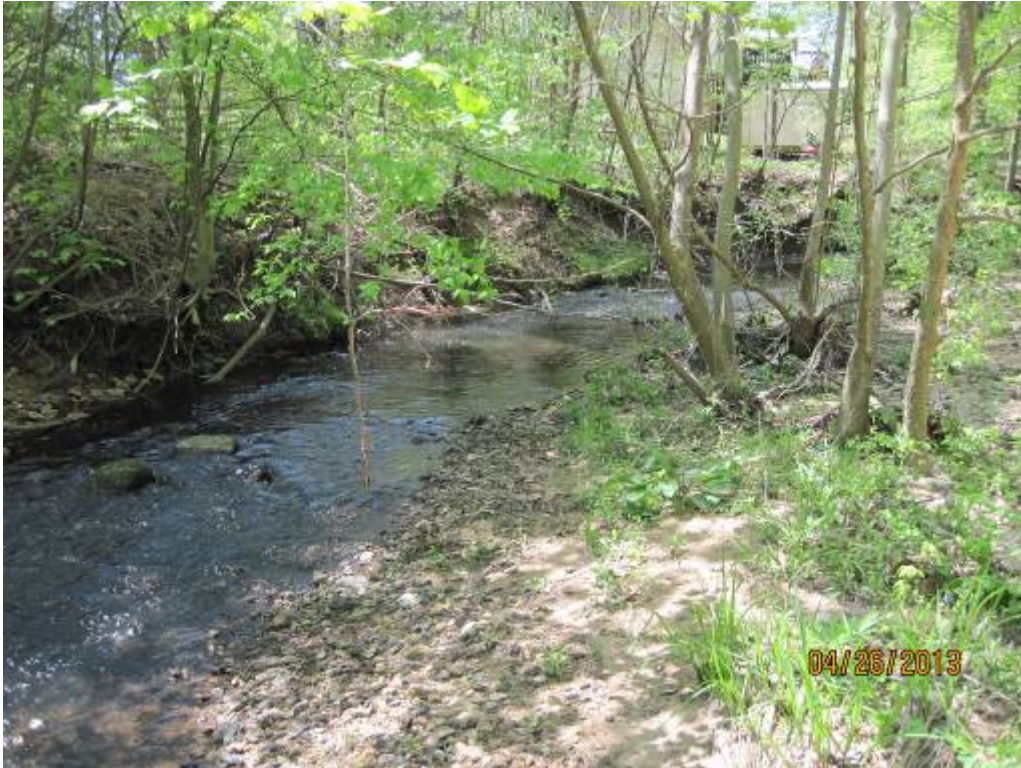
41. Looking upstream at a typical section of Stream Reach 11. This portion is incised, but only exhibits instability along one bank. Residential development is visible in the background.

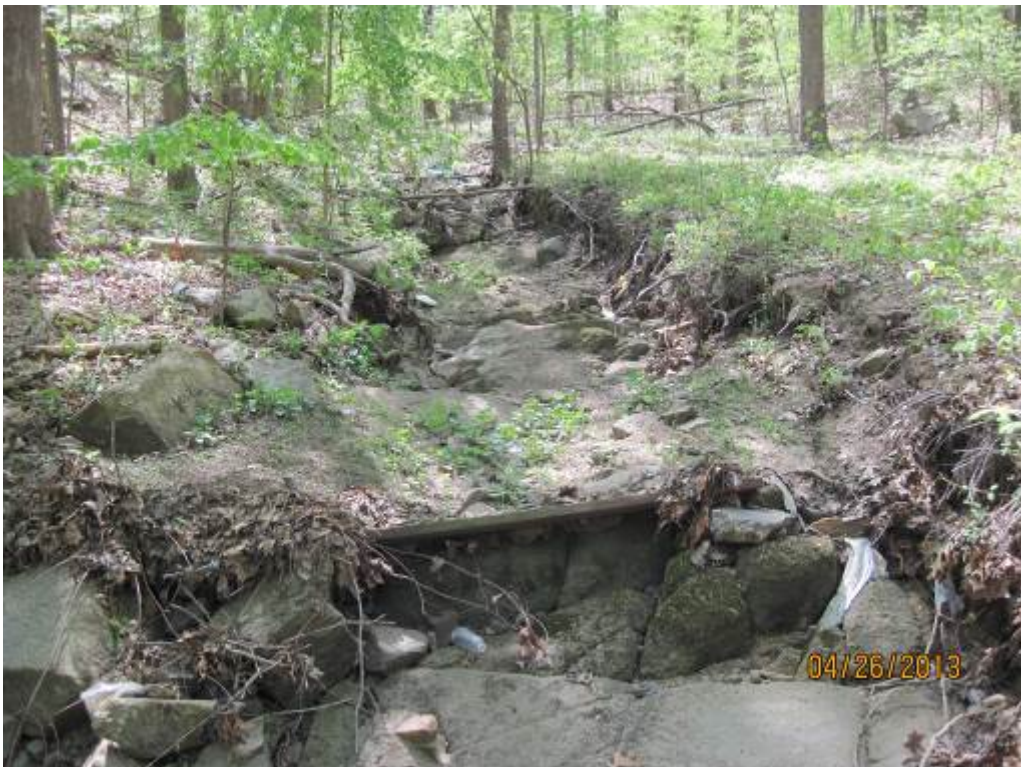
42. Looking upstream at a typical section of Stream Reach 12. Incision is present along most of this stream.

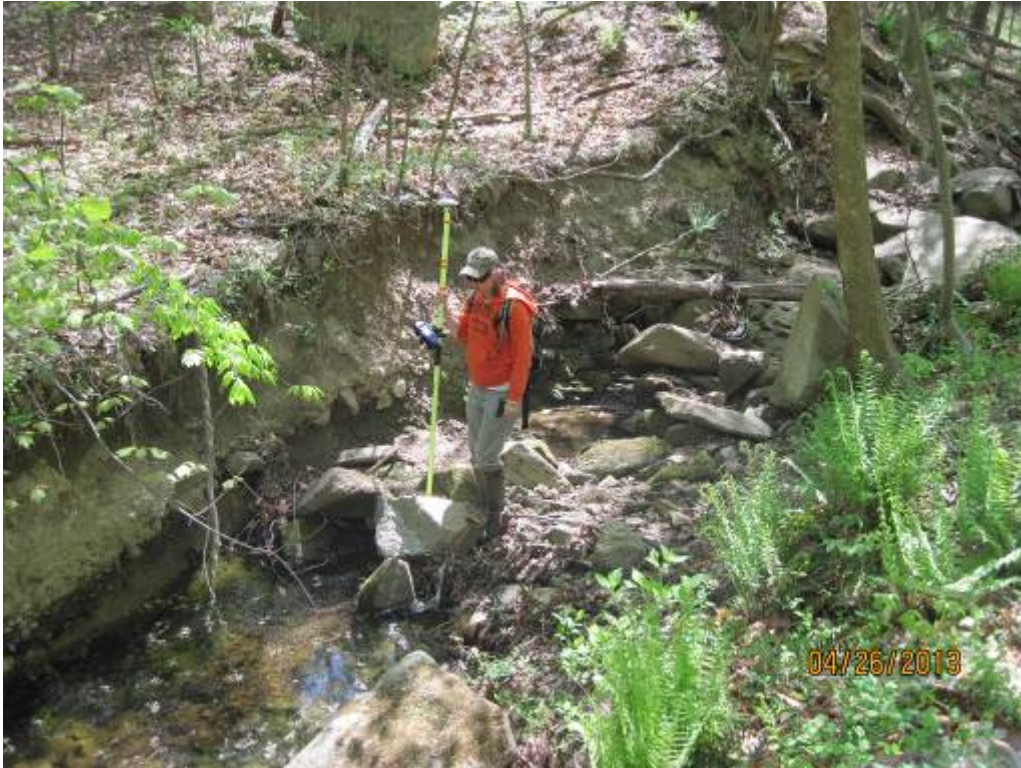
43. Looking upstream at a typical section of Stream Reach 12. This portion shows significant incision along the banks.

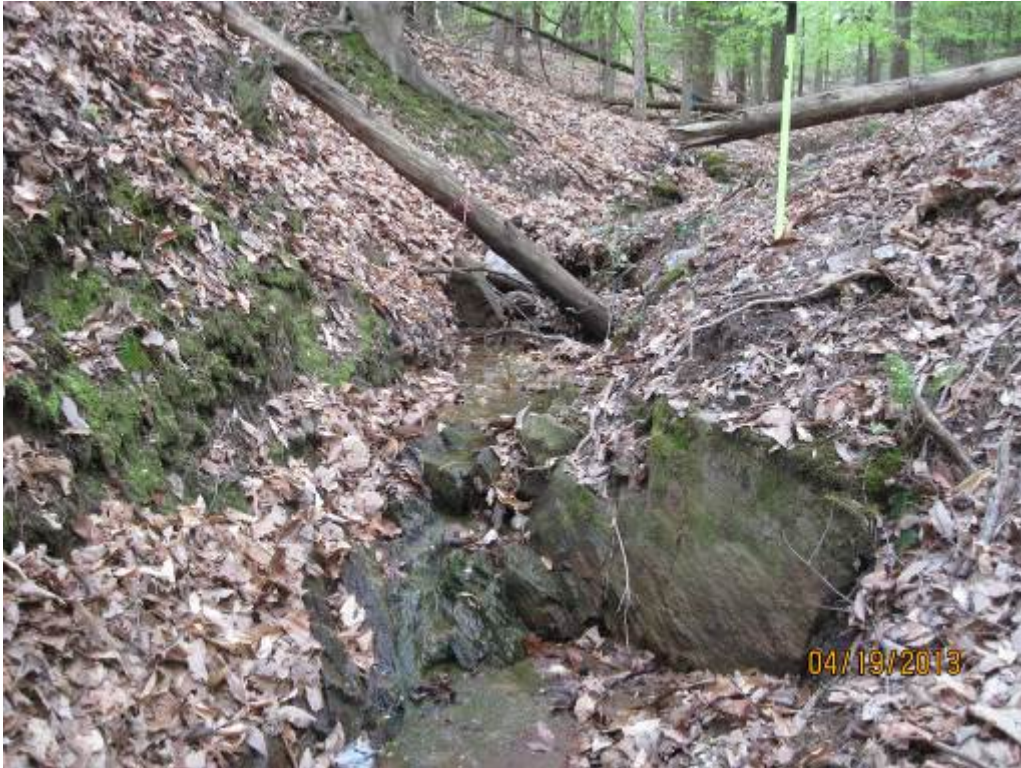
49. Looking upstream at a typical section of Stream Reach 16. This stream is relatively stable, due, in large part, to the presence of shallow bed rock.

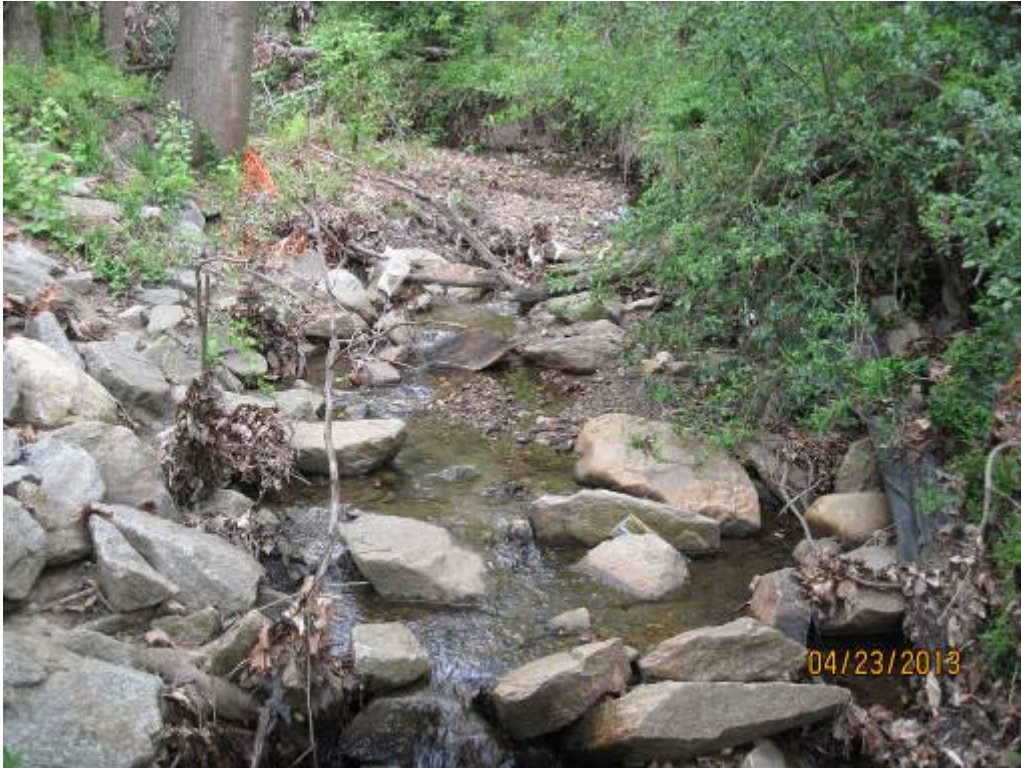
55. Looking upstream at a typical section of Stream Reach 18A. This portion of the stream is somewhat incised.

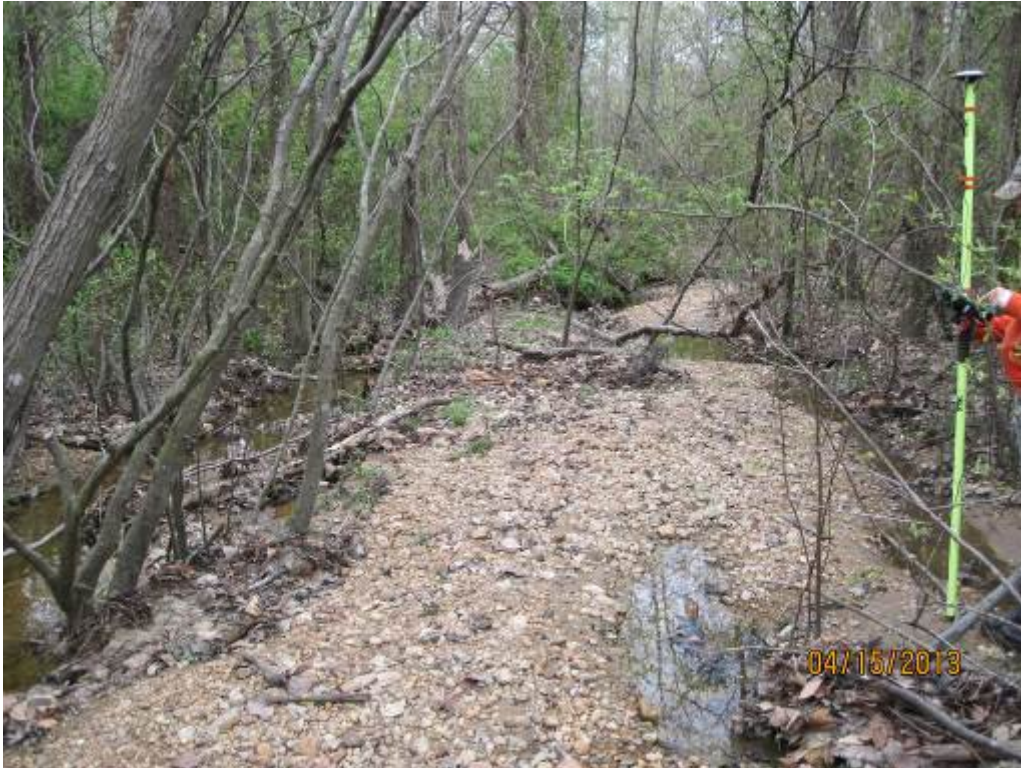
63. Looking downstream at Stream Reach 19A. This section of channel is severely aggrading.
