Broad Run Watershed

an Assessment of Stream
Corridors and Stormwater
BMPs in Five Representative
Subwatersheds

Whitman, Requardt & Associates, LLP
Engineers • Architects • Planners
9030 Stony Point Parkway, Suite 220
Richmond, Virginia 23235

September 2012

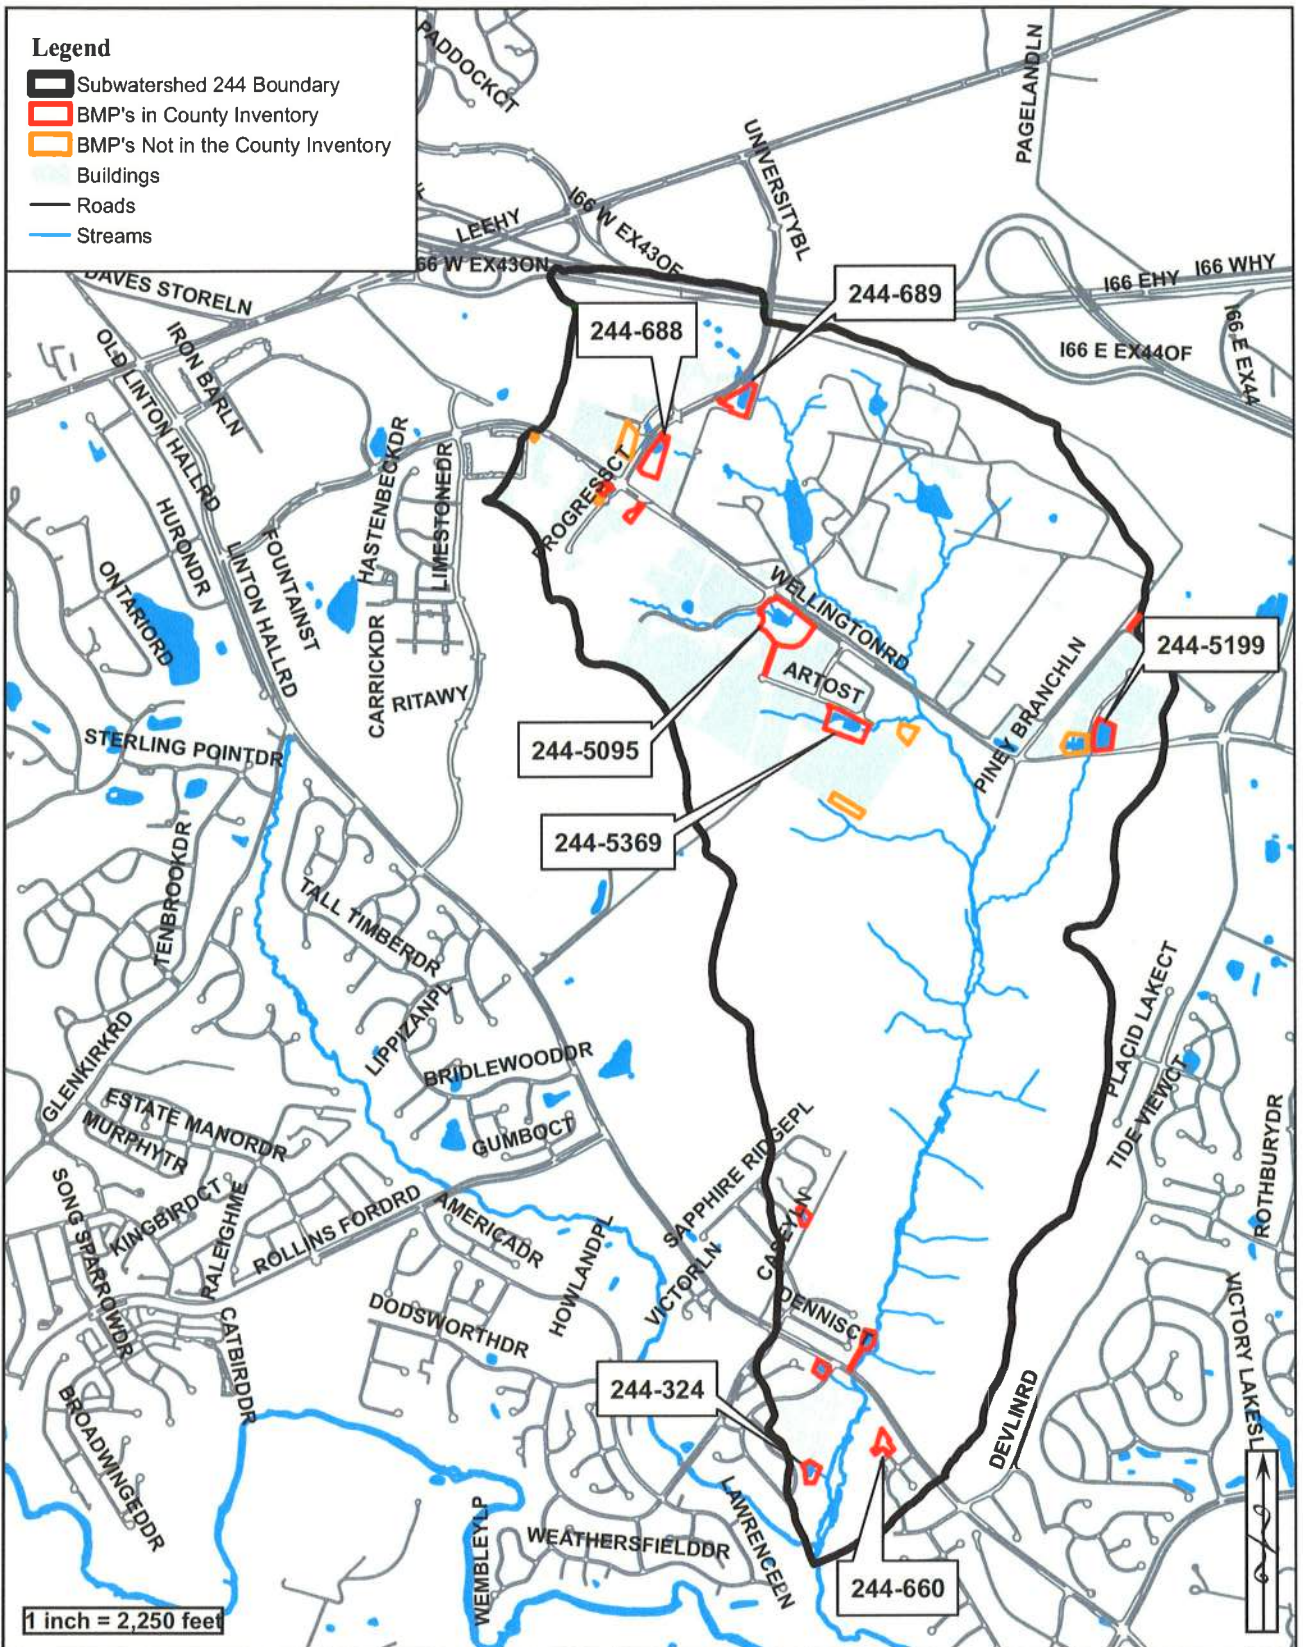
Figure:
4

- Six facilities would benefit from major improvements such as sediment removal from the basin or adding forebays. Two sites appear to have been filled-in by adjacent parking lots and may require significant reconstruction.

Title:
**Stormwater Facility
Reconnaissance Inventory
Tributary to Rocky Branch (244)
Subwatershed**

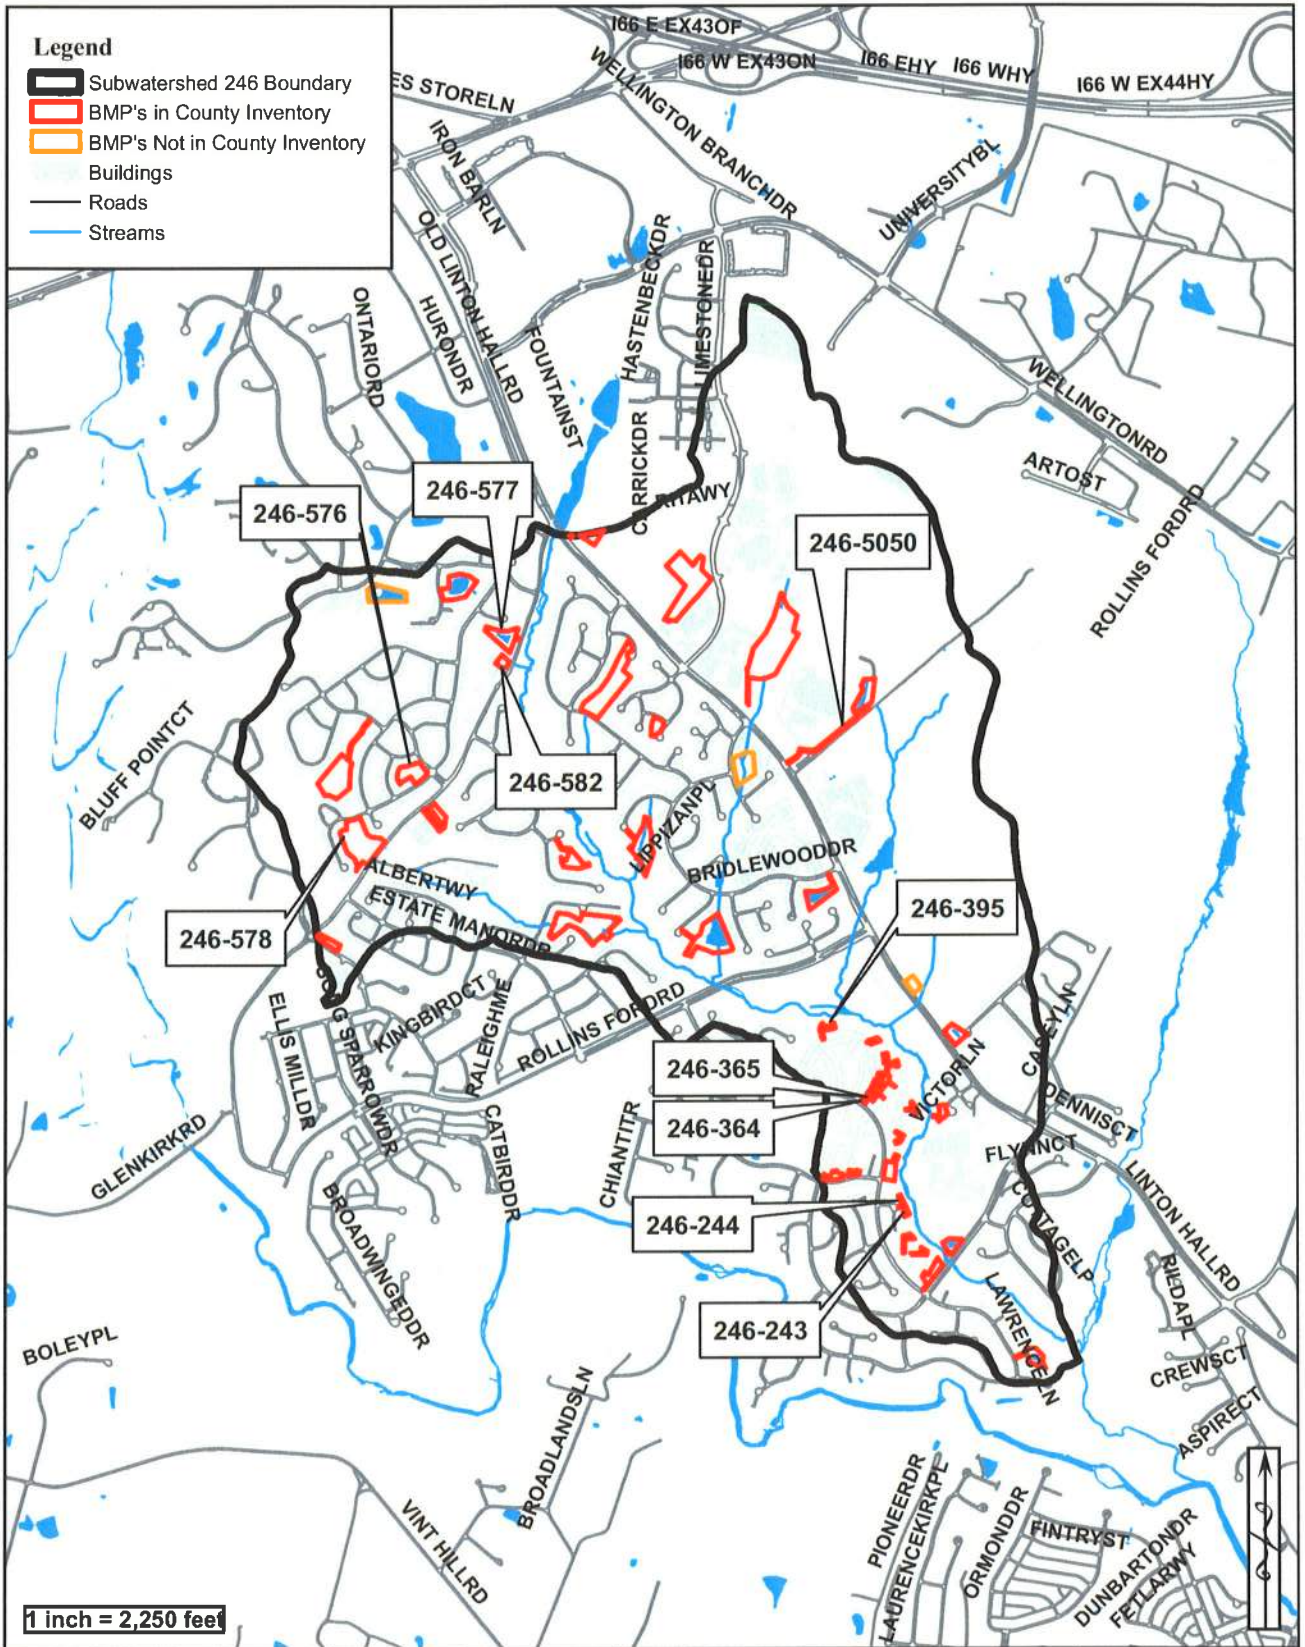
Figure:
5

Title:
**Stormwater Facility
Reconnaissance Inventory
Rocky Branch (246)
Subwatershed**

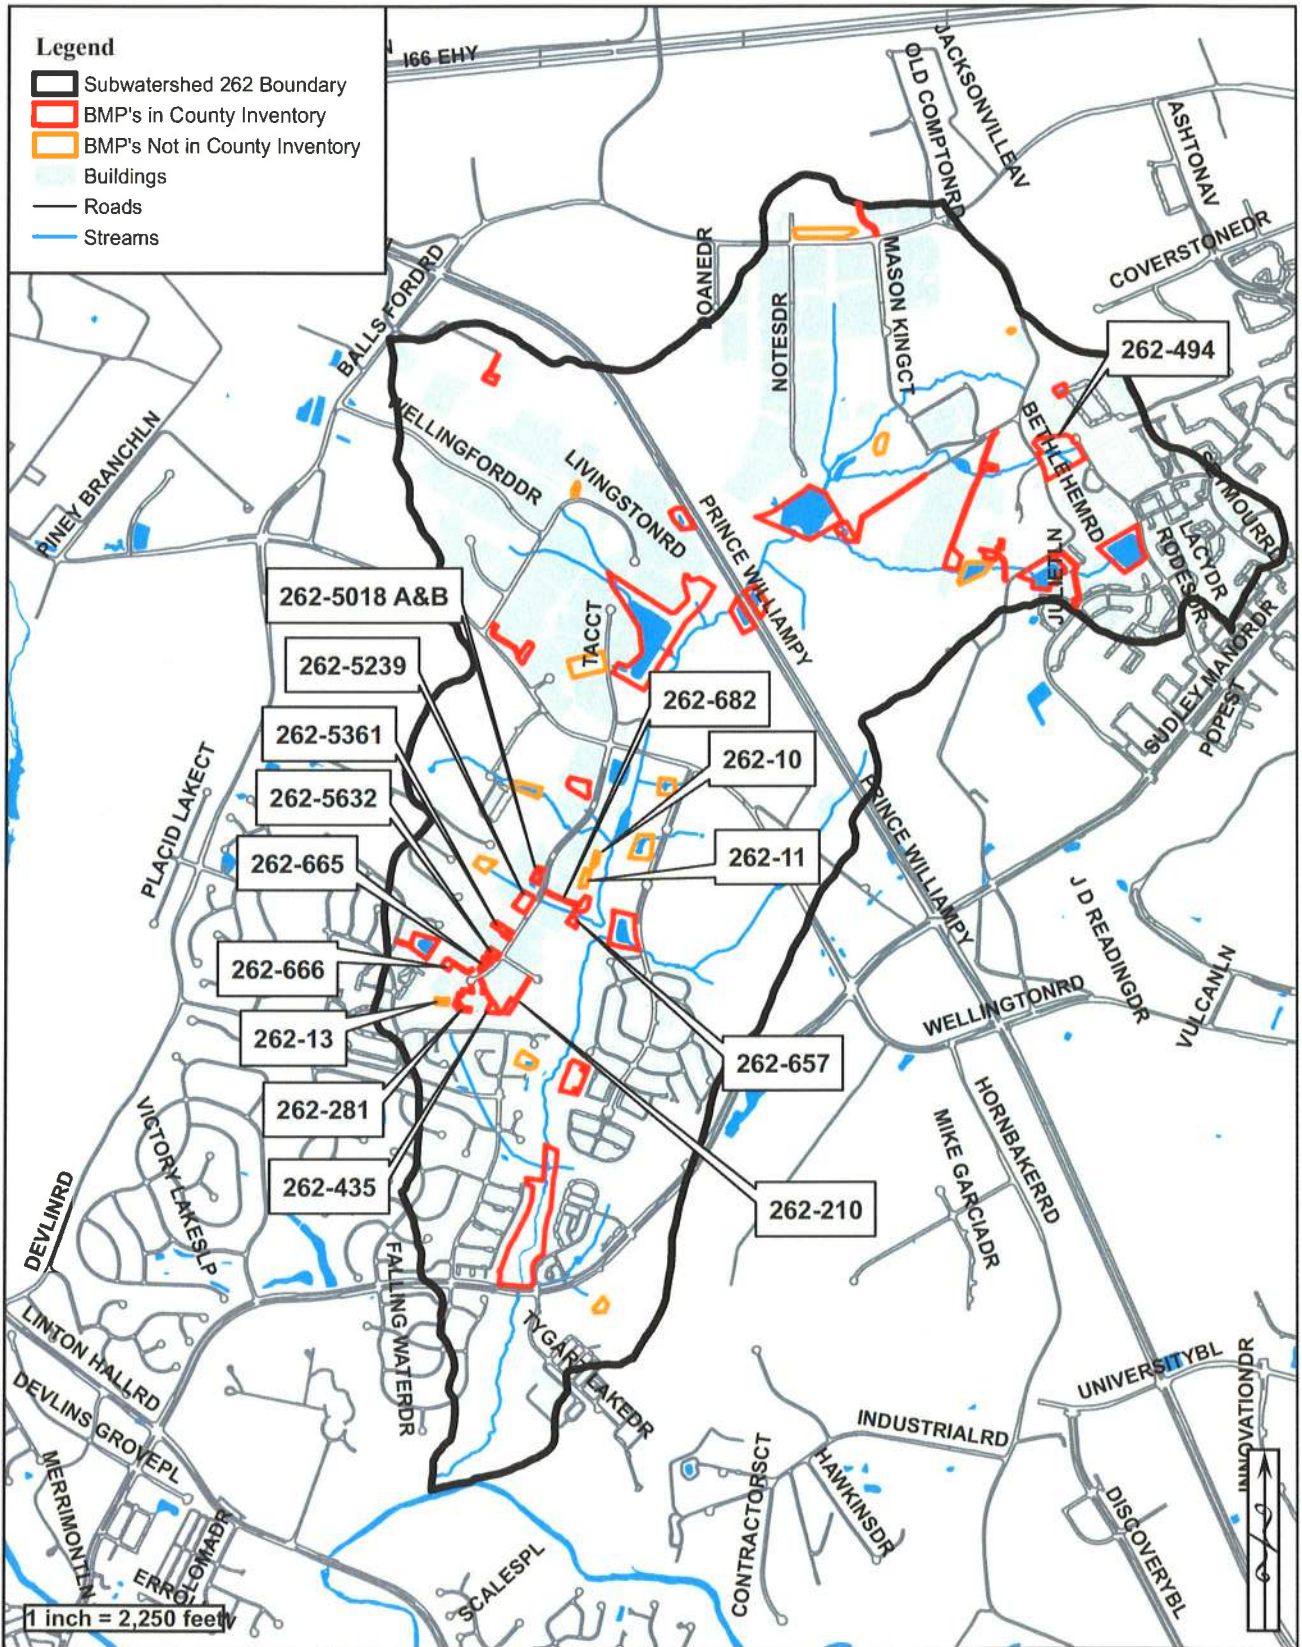
<p>Source: Prince William County GIS</p>	<p>Title: Stormwater Facility Reconnaissance Inventory Dawkins Branch (262) Subwatershed</p>	<p>Figure: 6</p>
---	--	---	-----------------------------

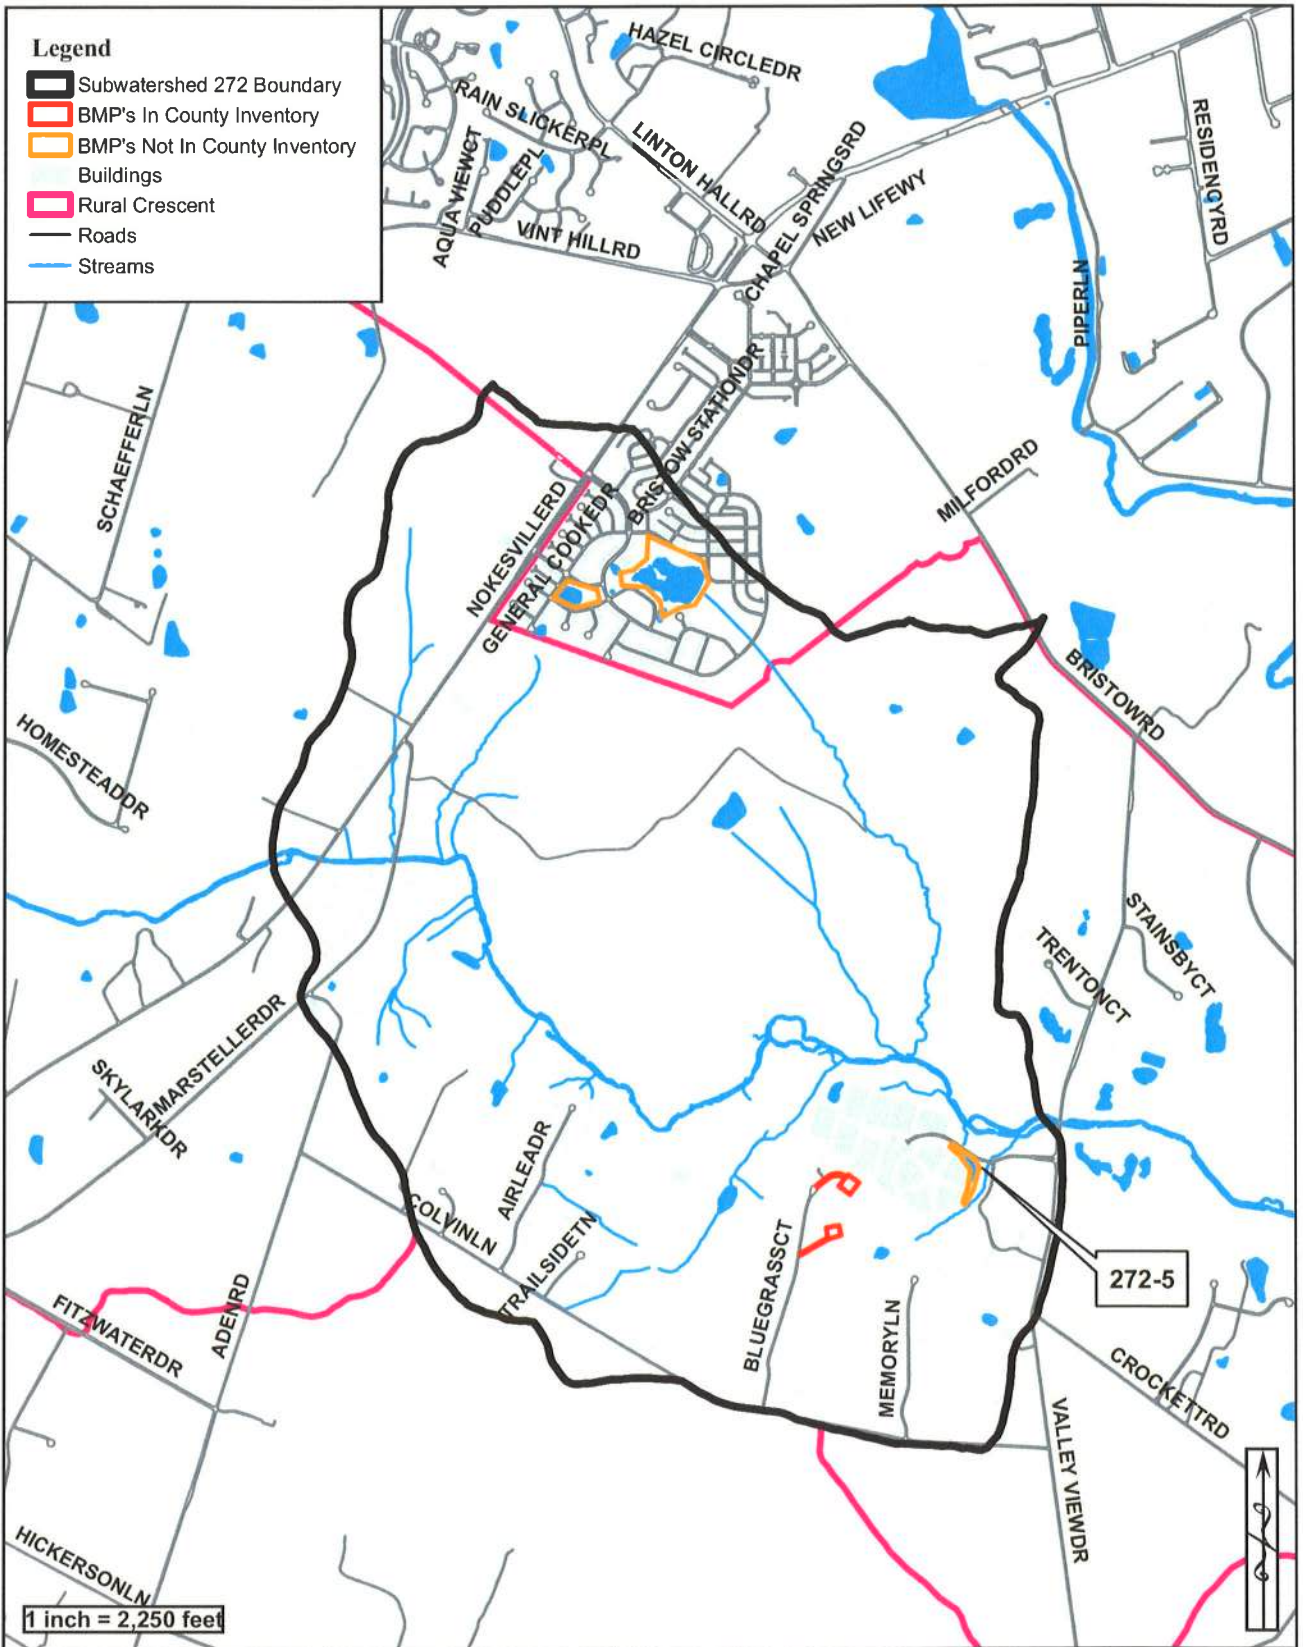
<p>Source: Prince William County GIS</p>	<p>Title: Stormwater Facility Reconnaissance Inventory Kettle Run (272) Subwatershed</p>	<p>Figure: 7</p>
---	--	---	----------------------

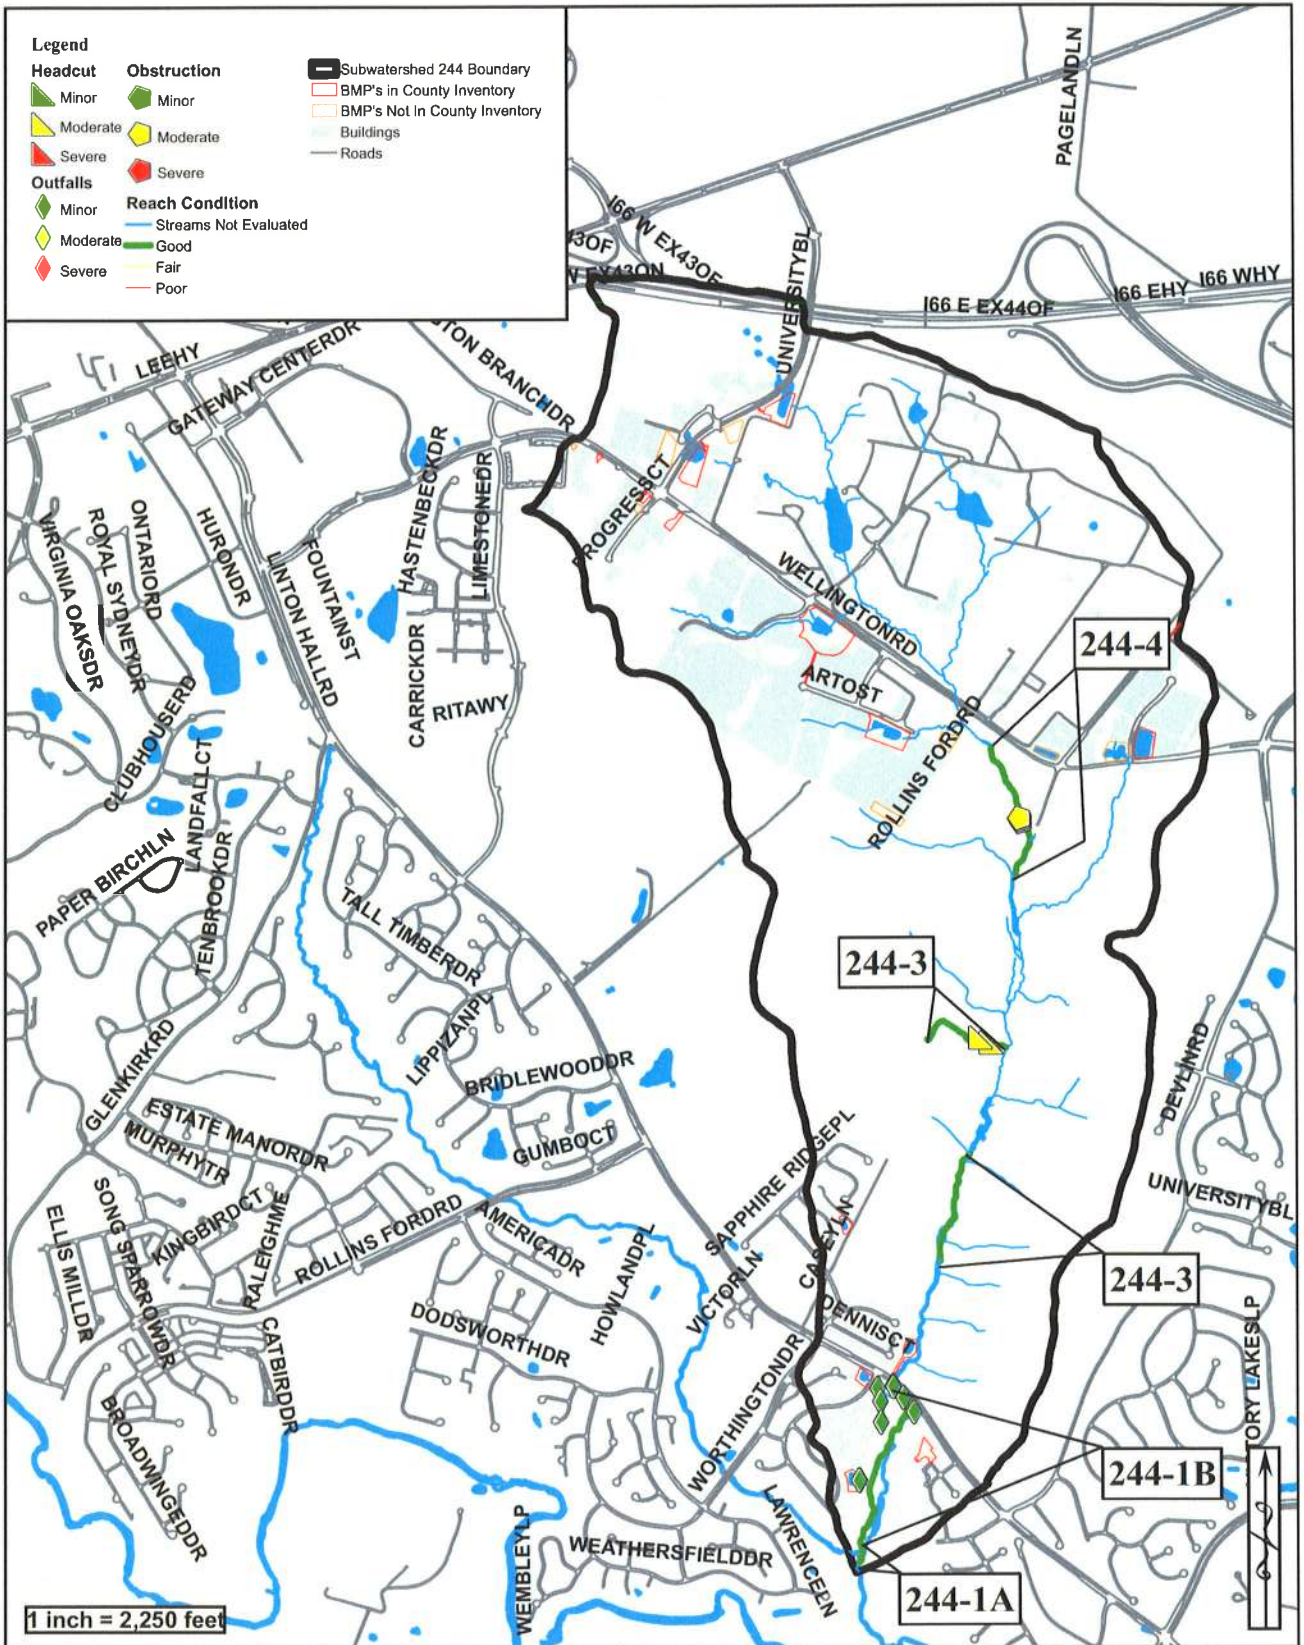
Figure:
8

The 18 stream reaches that were assessed represent a total of 19,387 linear feet of stream channel, out of an estimated total of 258,069 linear feet of channel within the five subwatersheds, or approximately 8% of the total. The location of each stream reach within its subwatershed is presented in **Figures 8 through 12**. The overall condition score is indicated by color coding each stream reach.

Title:
**Stream Assessment
 Tributary to Rocky Branch (244)
 Subwatershed**

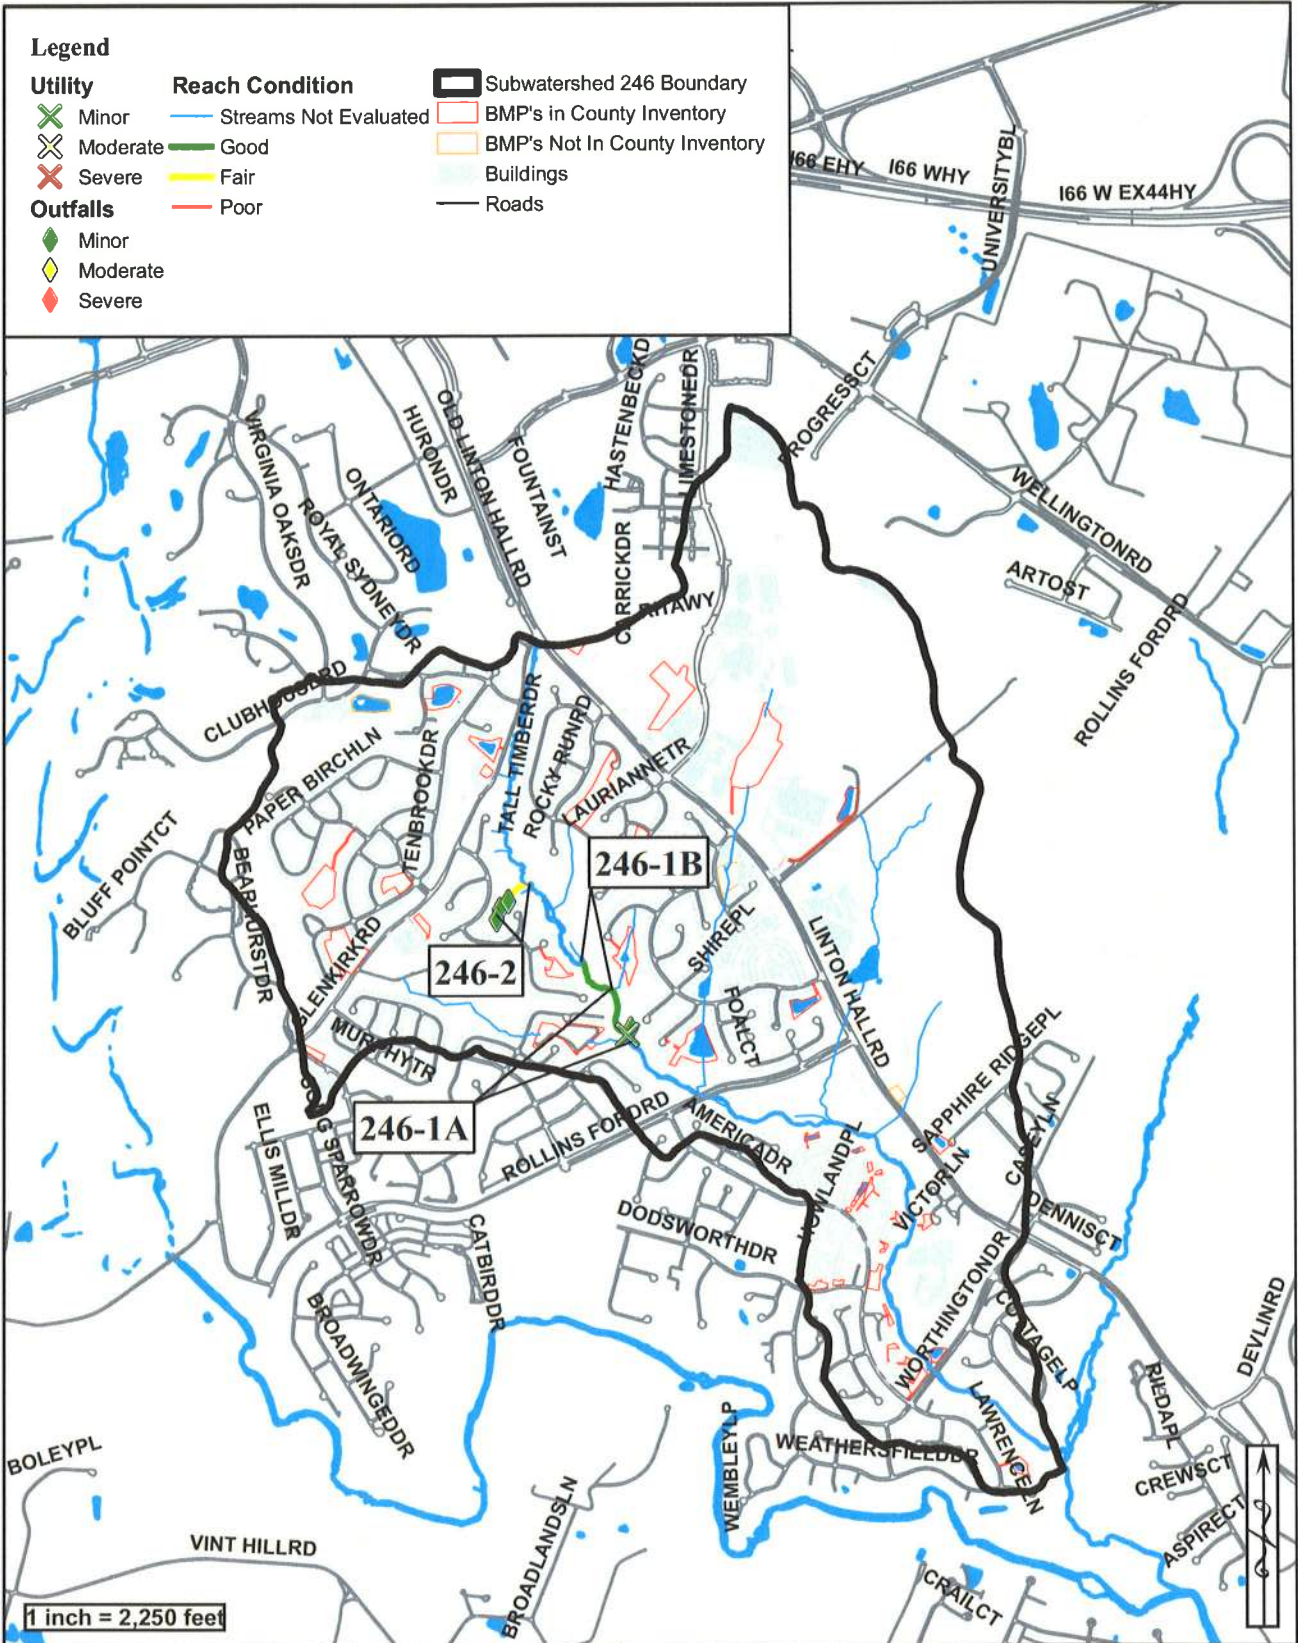
<p>Source: Prince William County GIS</p>	<p>Title: Stream Assessment Rocky Branch (246) Subwatershed</p>	<p>Figure: 9</p>
---	--	--	----------------------

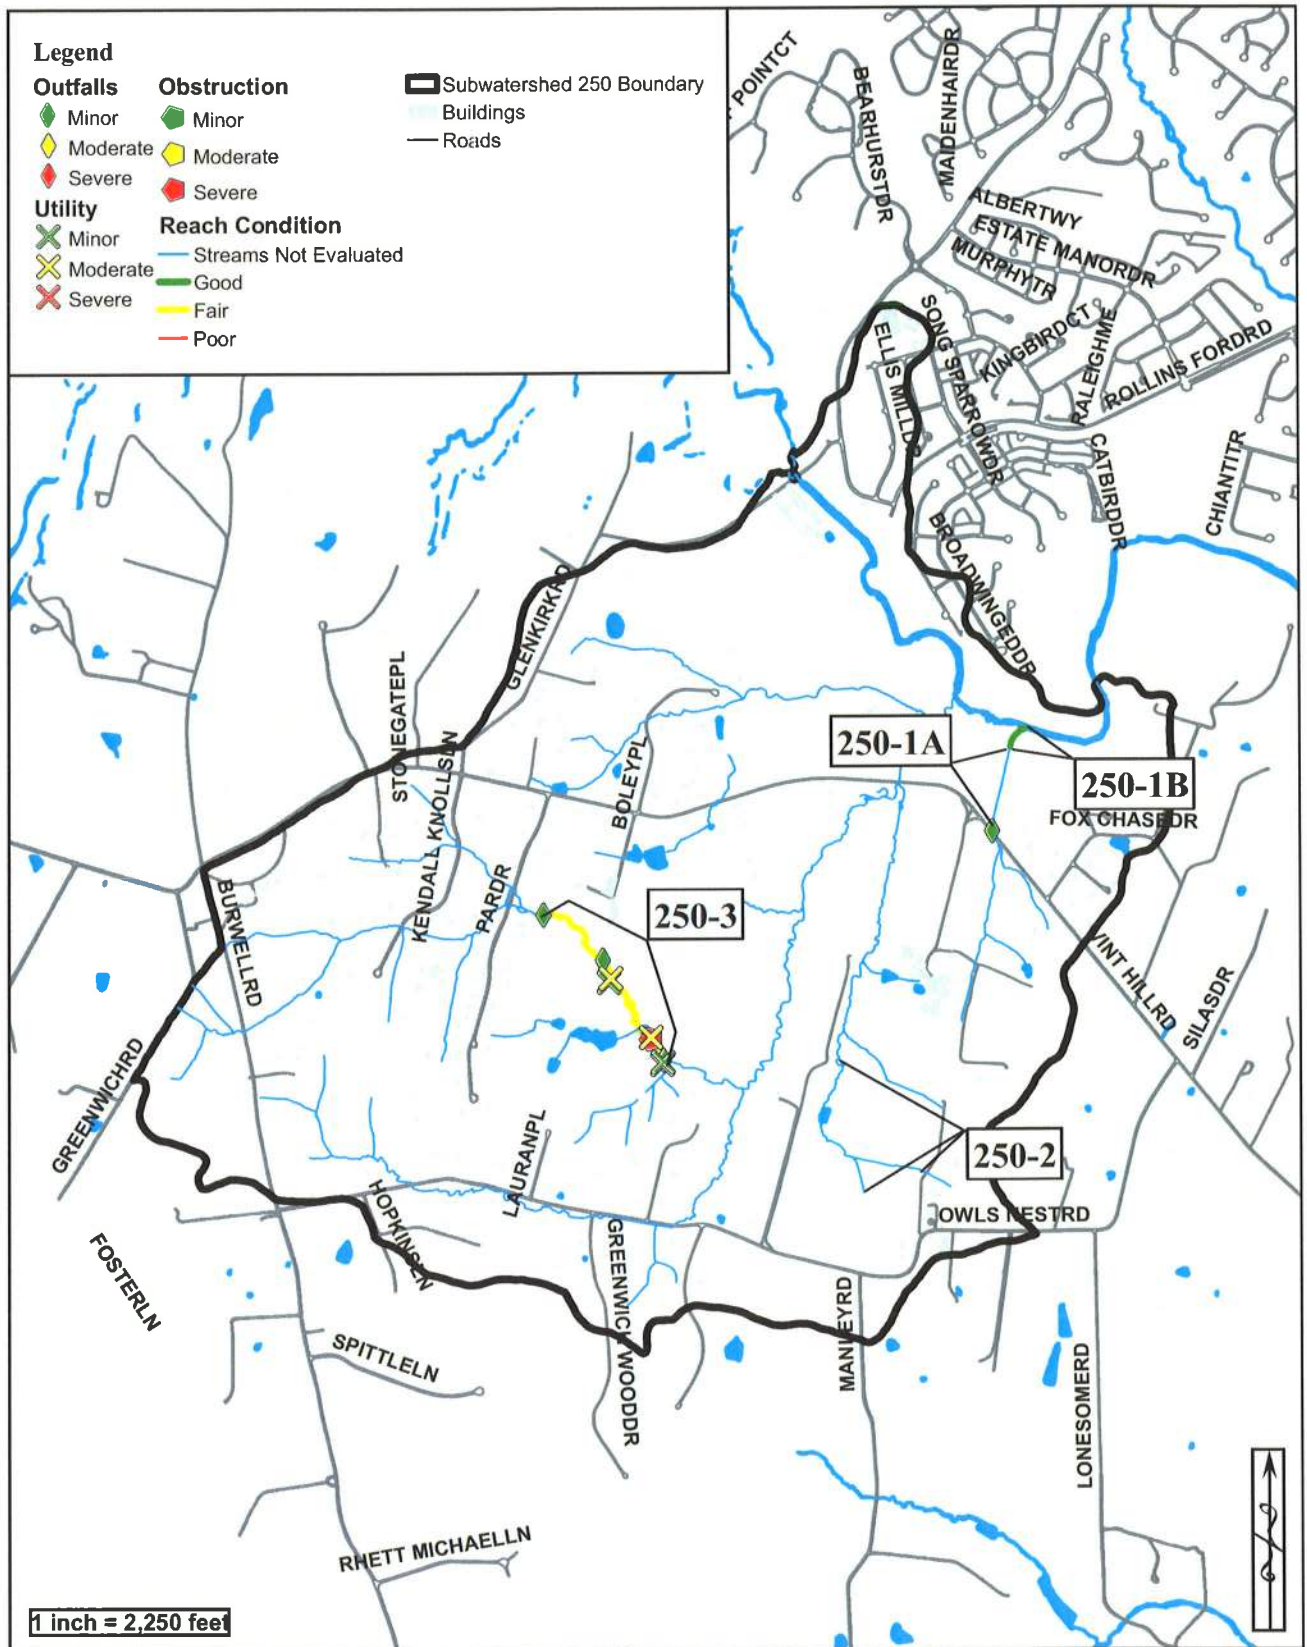
Figure:
10

Title:
**Stream Assessment
Tribuary to Broad Run (250)
Subwatershed**

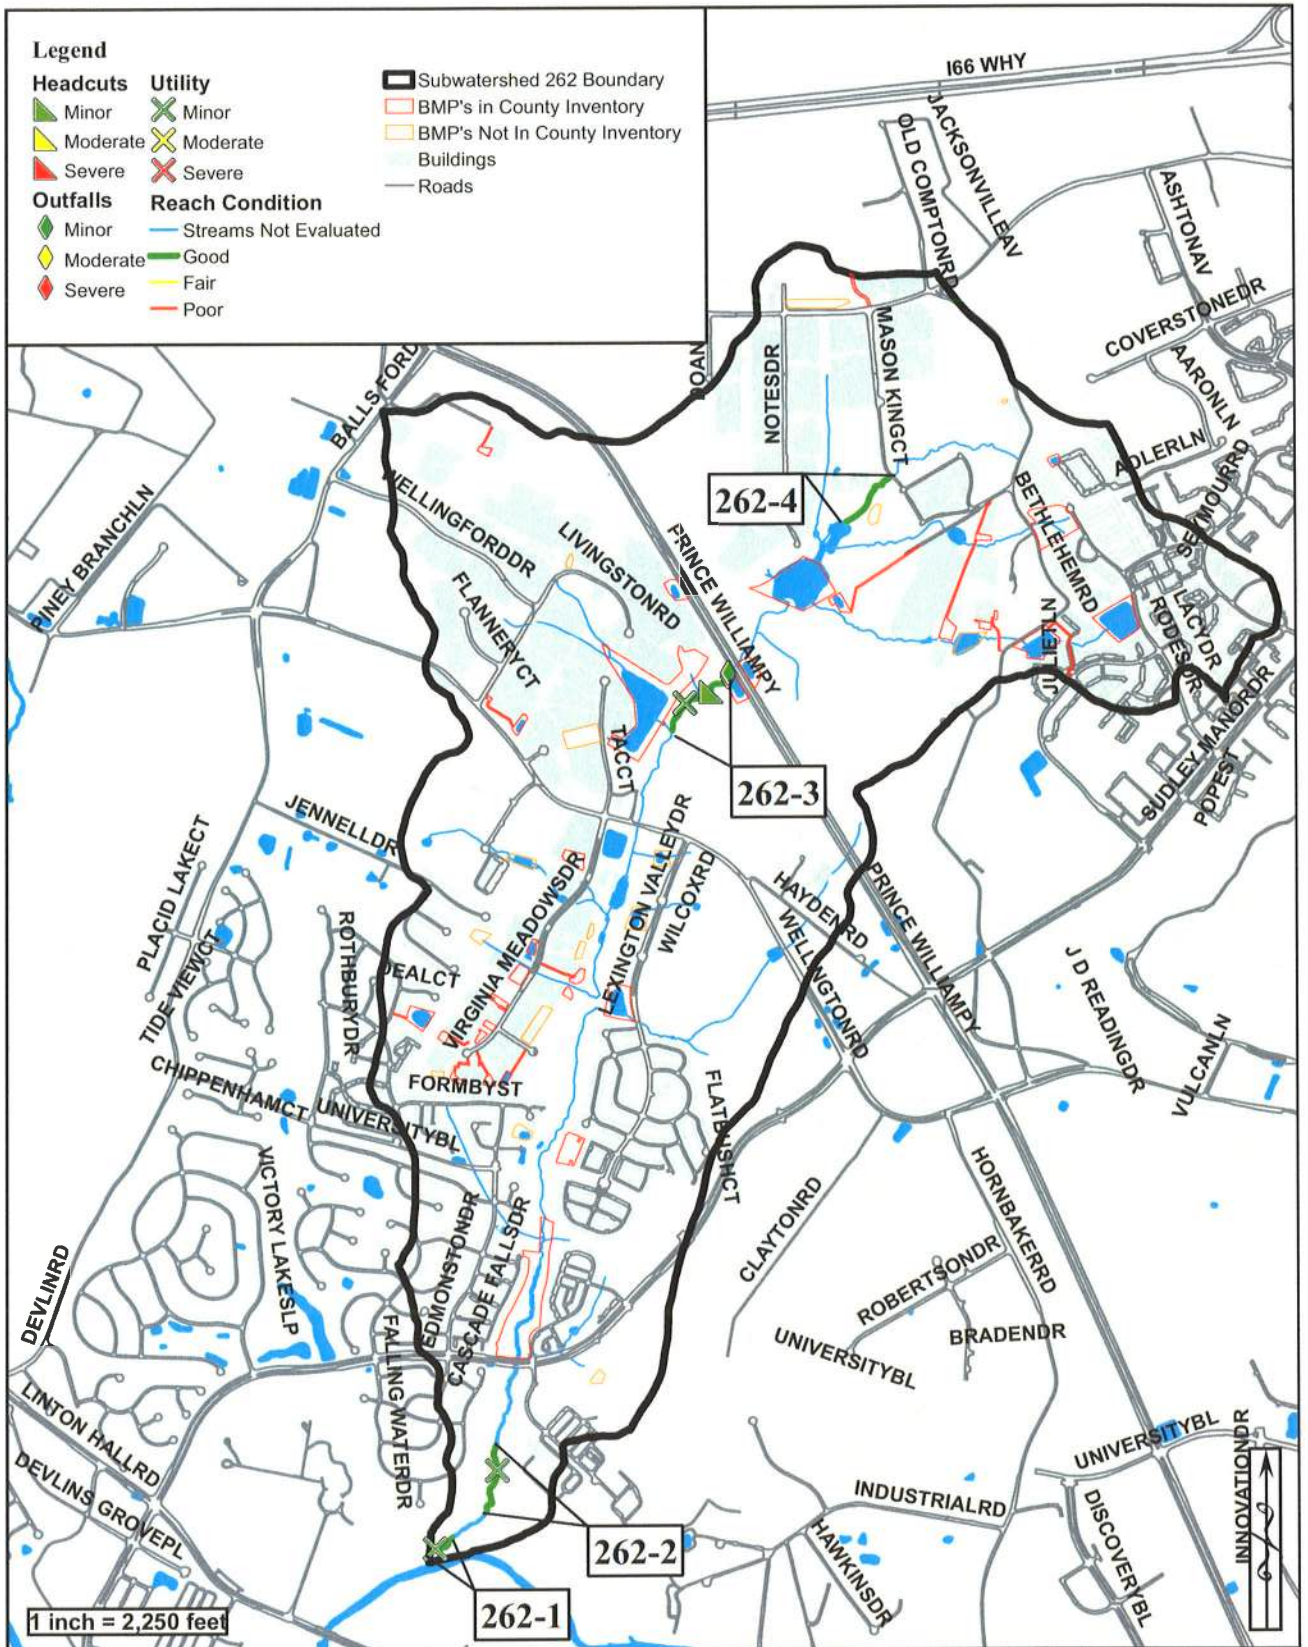
<p>Source: Prince William County GIS</p>	<p>Title: Stream Assessment Dawkins Branch (262) Subwatershed</p>	<p>Figure: 11</p>
---	--	--	-----------------------

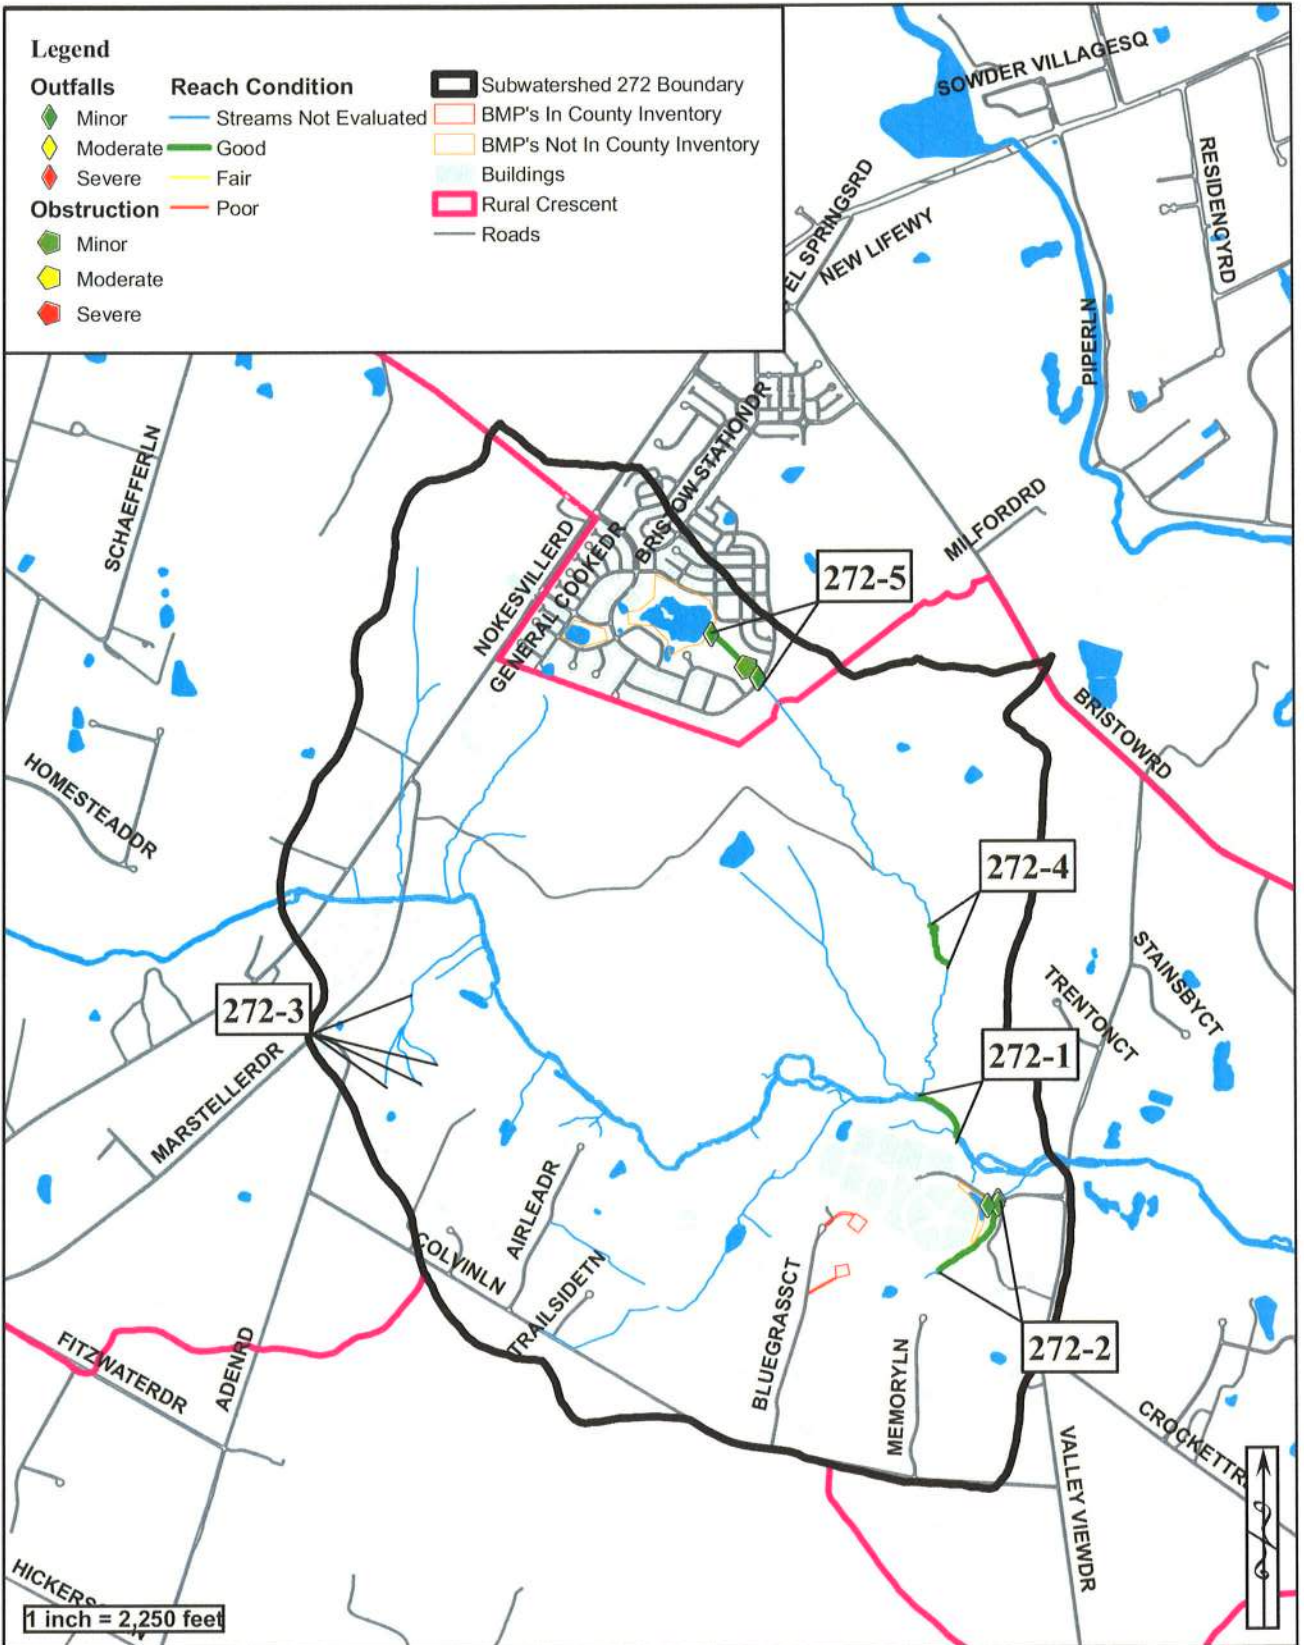
<p>Source:</p> <p>Prince William County GIS</p>	<p>Title:</p> <p>Stream Assessment Kettle Run (272) Subwatershed</p>	<p>Figure:</p> <p>12</p>
---	---	---	--------------------------
