Appendix F Index

Stream Assessment Photographs

Appendix F
Stream Assessment Photographs
Occoquan Watershed – Study of Four Subsheds
WSSI #25156.01

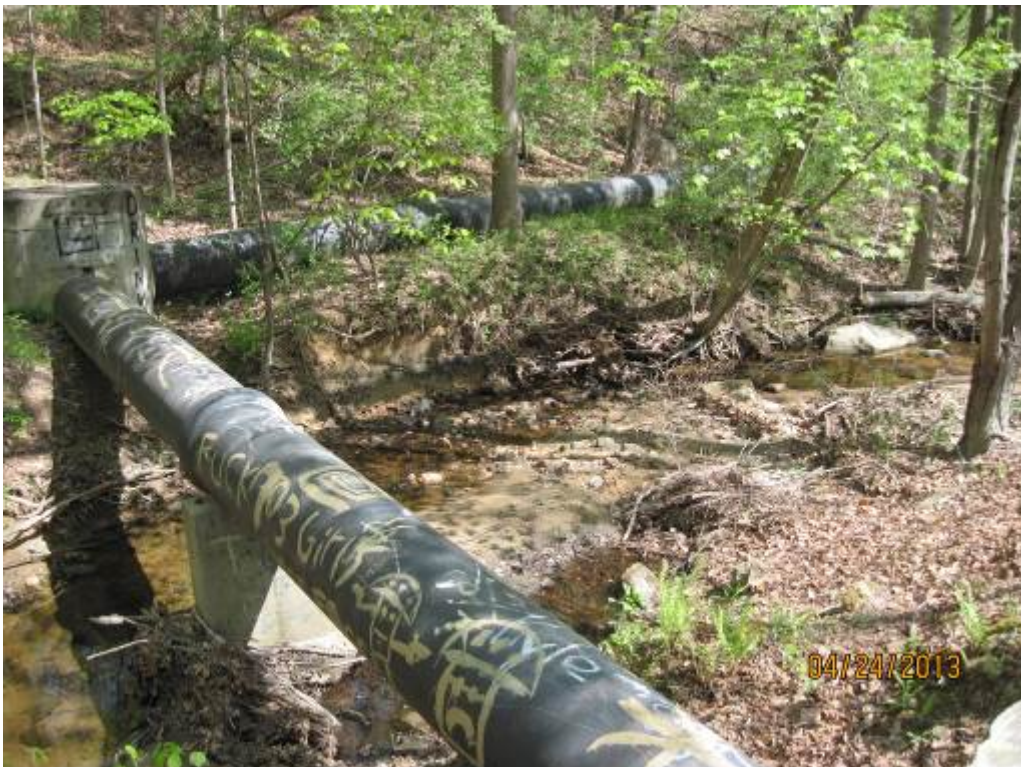
10. Looking downstream at an elevated utility that crosses Stream Reach 4. The pier in the stream has resulted in some instability and active erosion along the banks in this area, and some spot-improvements may be warranted.

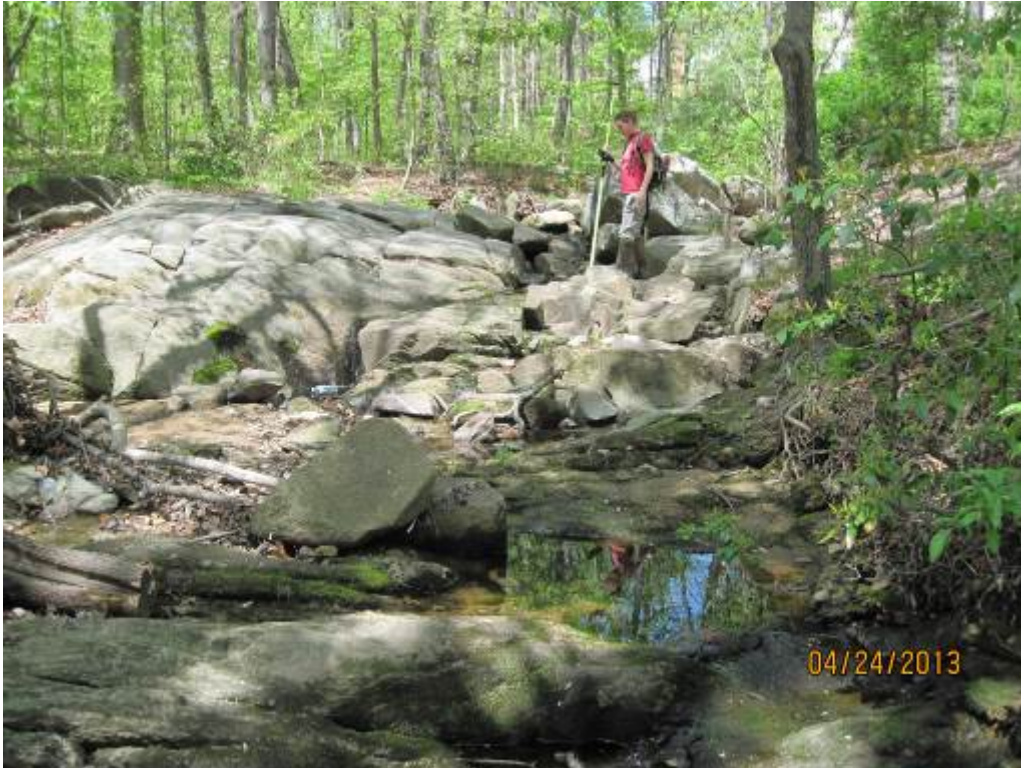
17. Looking upstream at an area of exposed bedrock within Stream Reach 5. This small section of the stream is stable.

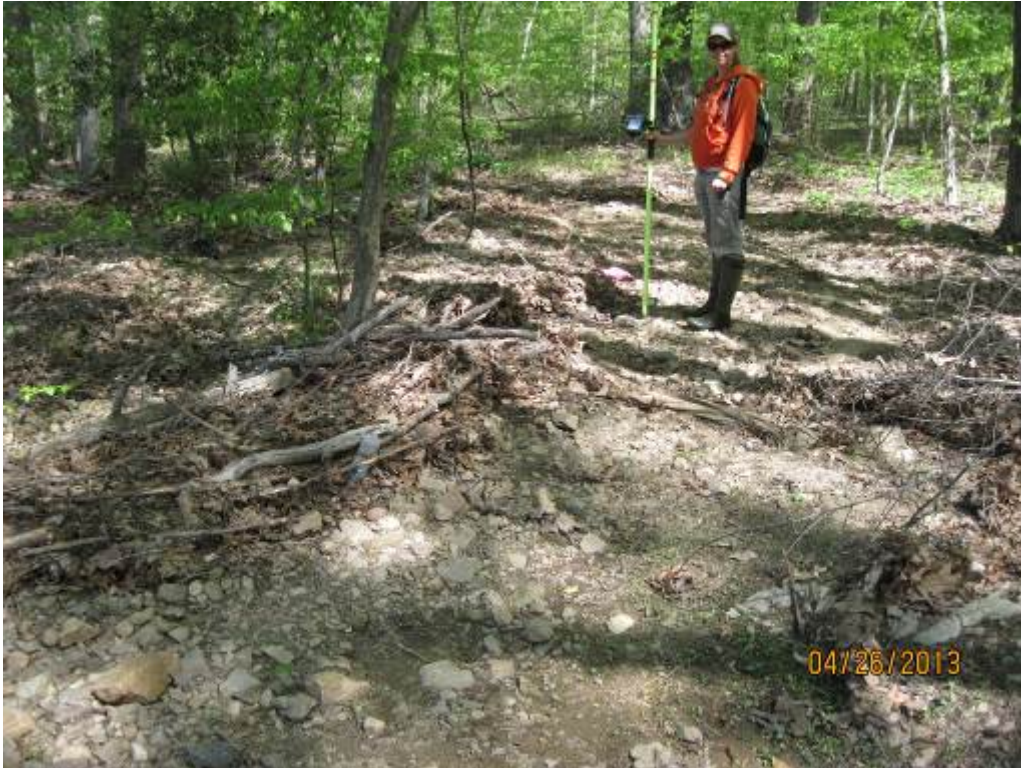
45. Looking downstream at a fully aggraded portion of Stream Reach 12. Due to the aggradation, a channel is not visible in this area.
